# Building and Timber Pest Inspection Report

Inspection Date: Wed, 25 Feb 2026

Property Address: 6 Gill Ave, Liverpool NSW 2170, Australia

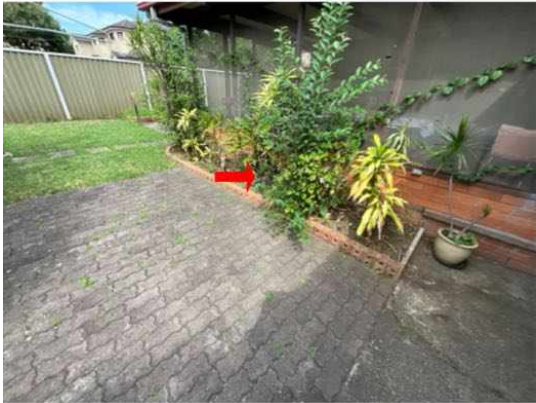
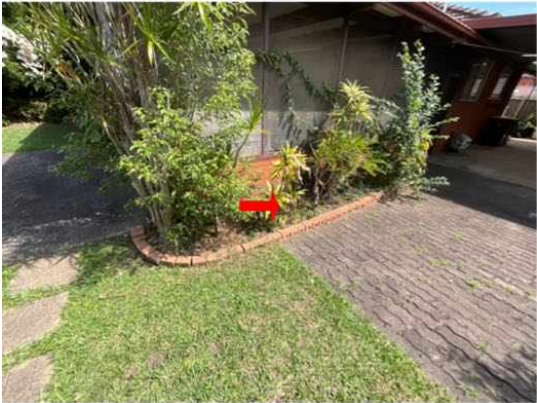
**Finding 6.09**

Building: Main Building  
 Location: Garden beds  
 Finding: Garden Beds  
 Information: Garden beds were found to be evident in the garden area. These garden beds can include untreated timber, and with a combination of moisture from watering hosing can make conditions conducive to termite activity and termite ingress.

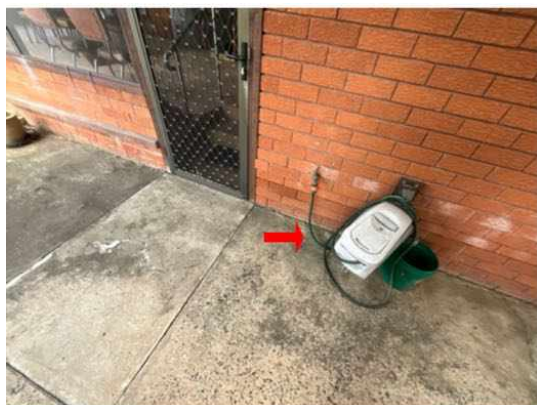
**Finding 6.10**

Location: External tap  
 Finding: Tap - No drain  
 Information: The external tap in this area was noted to have no drain at the time of inspection.

This keeps the surrounding surfaces damp while using the tap, which becomes conducive to termite activity.

A licensed plumber must be appointed to ensure an appropriate drain is installed.

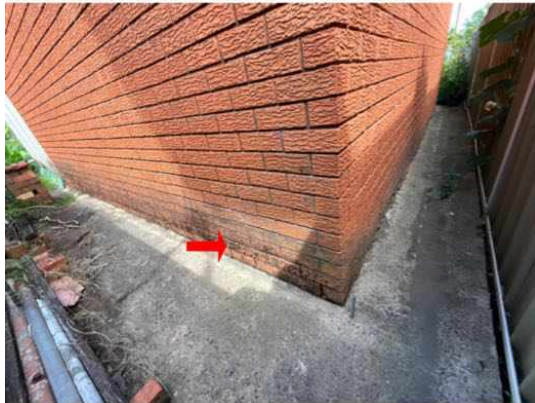
### Finding 6.11

Building: Main Building  
 Location: Garage  
 Finding: Slab Edge - Exposure  
 Information: Slab Edge Exposure: Where external concrete slab edges are not exposed there is a high risk of concealed termite entry. In some buildings built since July 1995 the edge of the slab forms part of the termite shield system. In these buildings an inspection zone of at least 75mm should be maintained to permit detection of termite entry. The concrete edge should not be concealed by render, tiles, cladding, flashings, adjoining structures, paving, soil, turf or landscaping etc. Where this is the case you should arrange to have the slab edge exposed for inspection. Concealed termite entry may already be taking place but could not be detected at the time of the inspection. This may have resulted in concealed timber damage. Does the slab edge inspection zone fully comply?

Not able to comment. A very high proportion of termite attacks are over the edge of both Infill and other concrete slabs types. Covering the edge of a concrete slab makes concealed termite entry easy. Infill slab type construction has an even higher risk of concealed termite ingress as the slab edge is concealed due to the construction design and cannot be exposed. The type of slab may only be determined by assessment of the construction plans by a qualified person e.g. Builder, Architect. Construction Plans may be obtainable by your local Council or Builder. Termite activity and or damage may be present in concealed timbers of the building. We strongly recommend frequent regular inspections in accordance with AS 3660.2. Where the

slab edge is not fully exposed or the slab is an infill slab or the slab type cannot be determined then we strongly recommend inspections every 3 to 6 months in accordance with AS 3660.2 or AS 4349.3.

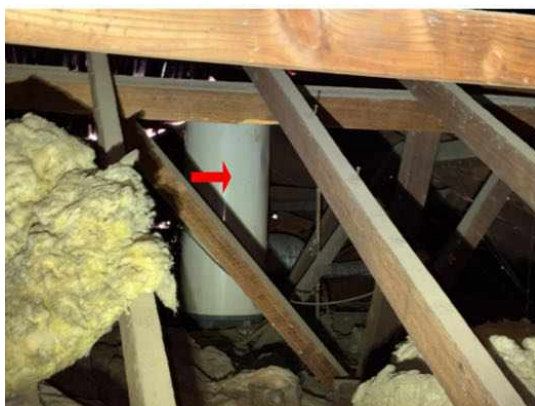
### Finding 6.12

Building:	Main Building
Location:	Roof Void
Finding:	Gravity-Fed HWS - Disconnected
Information:	It was noted at the time of inspection that a disconnected gravity-fed hot water system (HWS) remains in this area.

Despite this plumbing structure being unused, it is likely to be storing residual water, and is therefore susceptible to rust and corrosion. If allowed to continue, rust and corrosion is likely to lead to damage to adjoining building elements, and may also make the area susceptible to termite or timber pest activity.

While it is a costly exercise to remove the disused gravity-fed HWS, it is advisable in the short-term future to prevent any further damage to the area. Further consultation with a licensed plumber is required to gain further advice on removal of the structure.

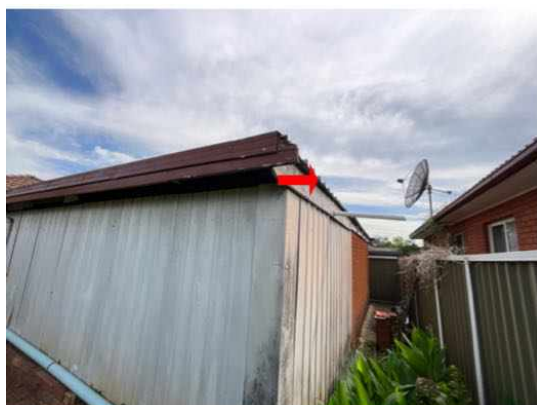
### Finding 6.13

Building:	Main Building
Location:	Garage
Finding:	Roof plumbing - Missing
Information:	Some sections of the roof are not adequately drained via gutters and downpipes. Gutters and downpipes that are not installed adequately are likely to result in excessively damp conditions against the exterior surfaces and around the base perimeter of the building.

Excessive moisture creates an environment which accelerates the deterioration of building elements in the area, as well as being conducive to termite and pest infestation. Such an environment is likely to necessitate repair and/or replacement of building elements, which are prone to sustaining wood rot, rust or corrosion.

A roofing plumber should be appointed as soon as possible to install relevant roof plumbing materials. Depending on the extent of the damage, repair and/or replacement of damaged building elements may be required.

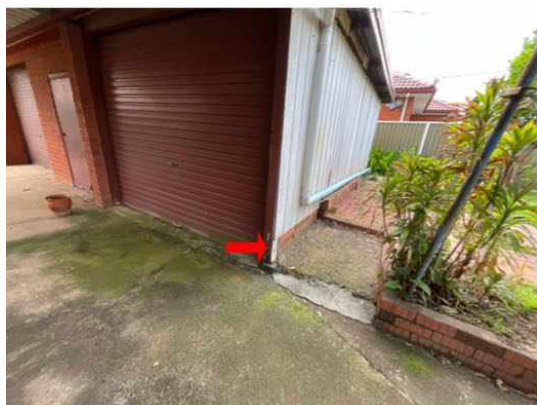
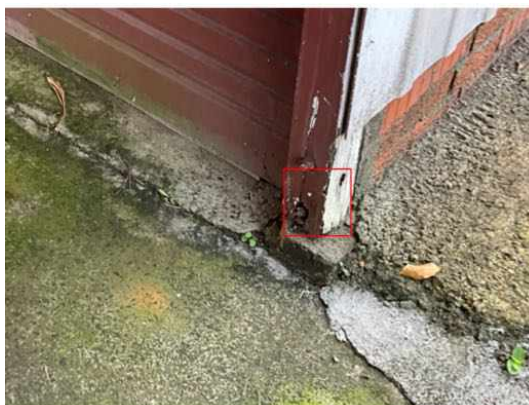
Building:	Main Building
Location:	Garage
Finding:	Wood rot/decay
Information:	This building element shows evidence of wood rot. Wood rot, also known as Fungal Decay, occurs when timbers and other cellulose building materials are exposed to damp conditions on an ongoing basis. This could be the result of exposure to weathering over a prolonged period of time, or the attraction of excessive moisture from other abutting building materials. Contributing factors also include poor air ventilation in the area.

Wood rot is often associated with general damp problems and is evidenced by a 'musty' smell or mould and mildew occurring on surfaces. If left unmanaged, damp

conditions can lead to further health problems and the decay of timbers will continue.

Early intervention and regular maintenance, particularly of exterior timbers, will prolong the useful life of these building elements. Prior to any works being performed, the cause of the moisture that has created the visible wood rot should be identified and addressed in a suitable manner. Replacement of affected timbers may then be a necessary step in protecting surrounding building elements from such deterioration.

A licensed plumber may be appointed to assess the cause of excessive moisture and to provide advice on any remedial works as required. A licensed carpenter may also be required to replace affected building materials.

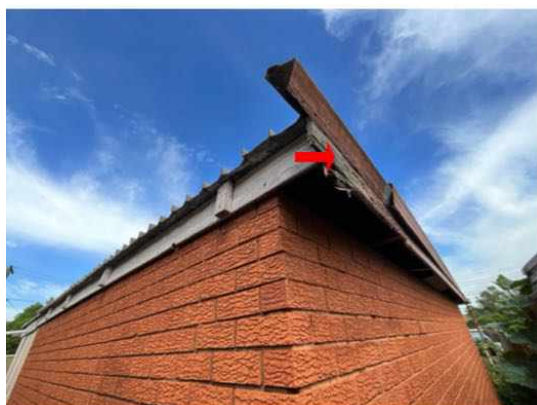
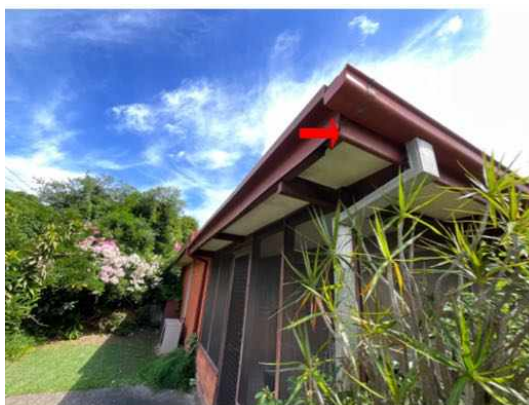
### Finding 7.02

Building:	Main Building
Location:	Multiple areas
Finding:	Fascias - Wood rot/decay
Information:	Wood rot was found to be affecting fascias and barges in this area, evidenced by the presence of mould on the surface in some areas. Wood rot, also known as Fungal Decay, occurs when timbers and other cellulose building materials are exposed to damp conditions on an ongoing basis.

It is likely that this wood rot has developed as a result of faults in the roof plumbing, creating excessive moisture in this areas. Otherwise frequent exposure to rain and other weather conditions also make fascias and barges susceptible to accelerated deterioration.

Early intervention and regular maintenance will prolong the useful life of these building elements. Prior to any works being performed, the cause of the moisture that has created the visible wood rot should be identified and addressed in a suitable manner.

It is advised that a roof plumber be appointed to inspect all roof plumbing and subsequently identify the cause of the wood rot. Replacement of affected fascias and barges may then be a necessary step in protecting surrounding building elements from such deterioration.

A licensed plumber may be appointed to assess the cause of excessive moisture and to provide advice on any remedial works as required. A licensed carpenter may also be required to replace affected building materials.

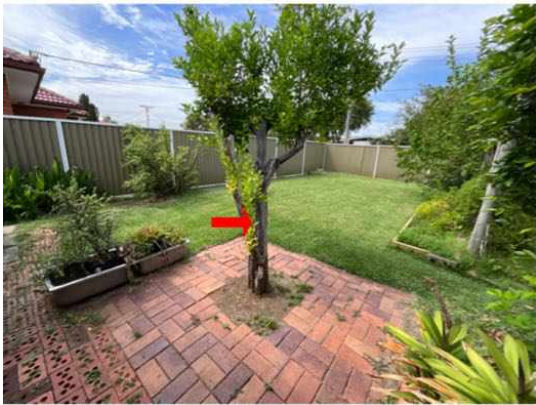
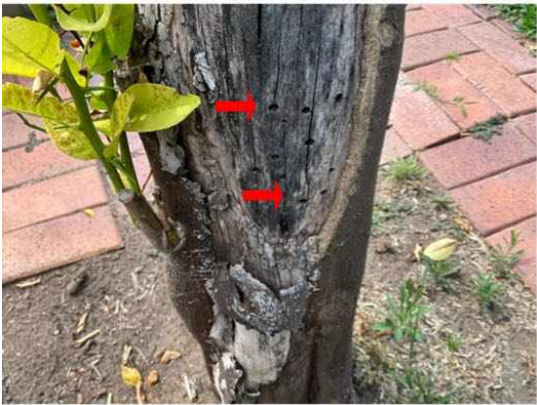
### Finding 8.01

Building:	Main Building
Location:	Trees
Finding:	Evidence of wood borer activity identified
Information:	Wood borers small beetles that colonise in exposed timber elements are a common timber pest that are regularly mistaken for termites. Although wood borer activity is generally not detrimental to the affected timber they may lead to serious damage and necessitate replacement of certain building elements if left unattended.

The other commonly known borer the Anobium borer is more likely to attack floorboards and may cause severe structural damage to flooring areas.

As no live wood borer activity was identified treatment is not required at this time. Replacement of affected timbers may be considered by the client for superficial reasons.

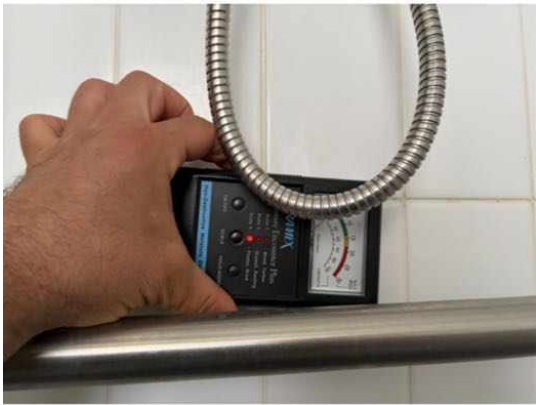
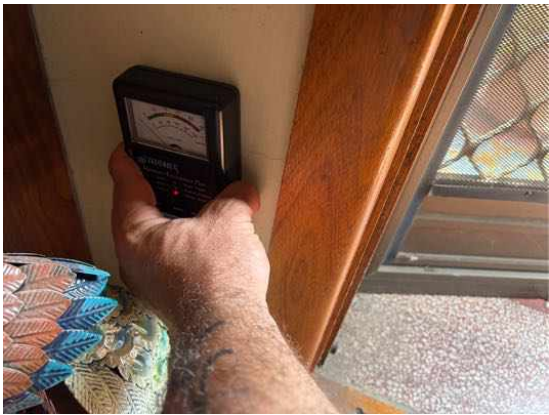
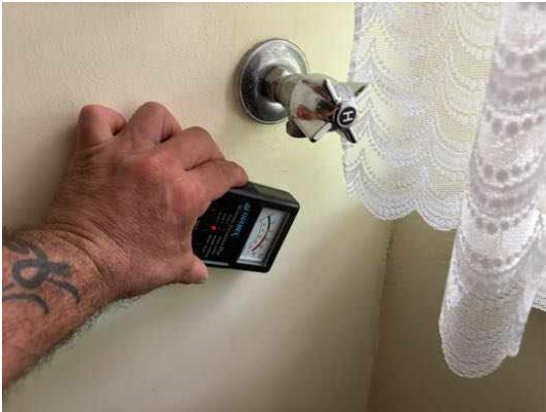
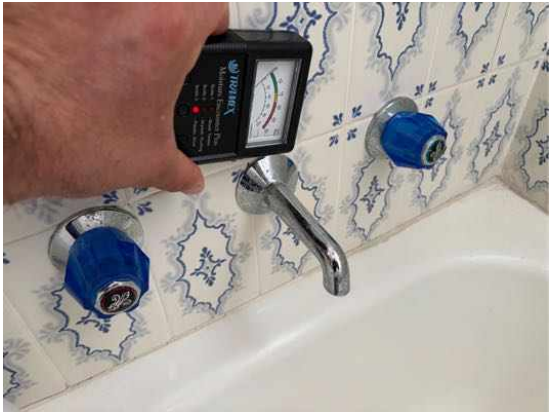
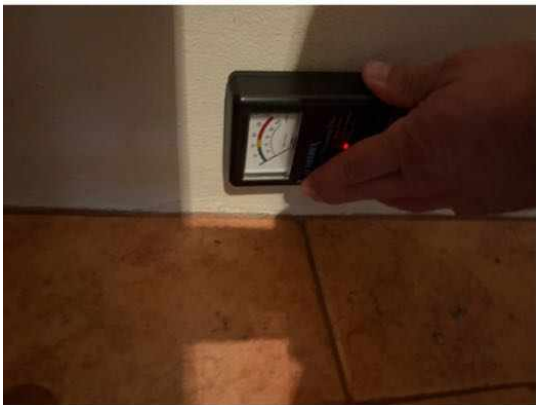
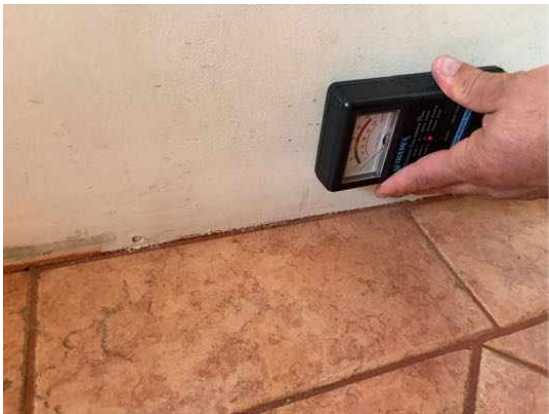
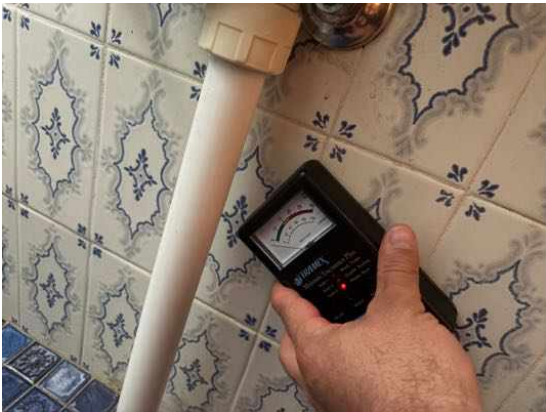
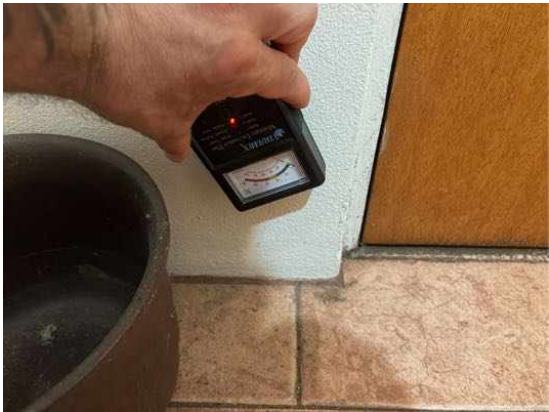
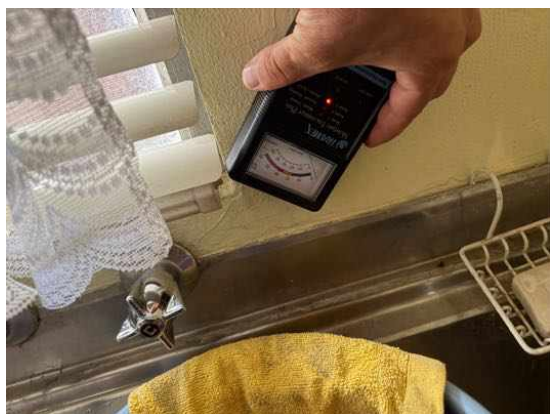
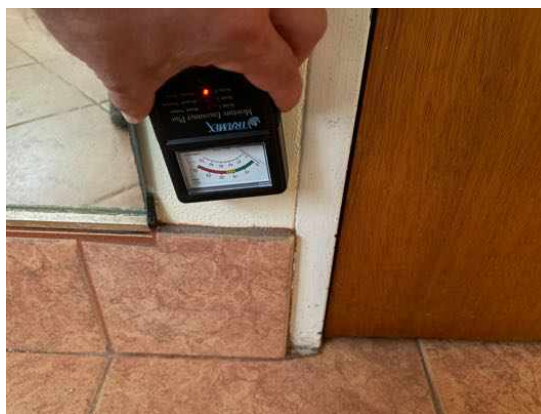
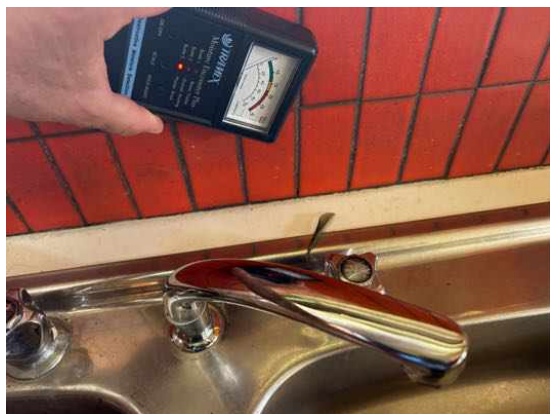
Building: Main Building  
 Location: All Areas  
 Finding: Moisture metre  
 Information: During the inspection the property was checked for moisture using a moisture metre.  
 This is for information only.

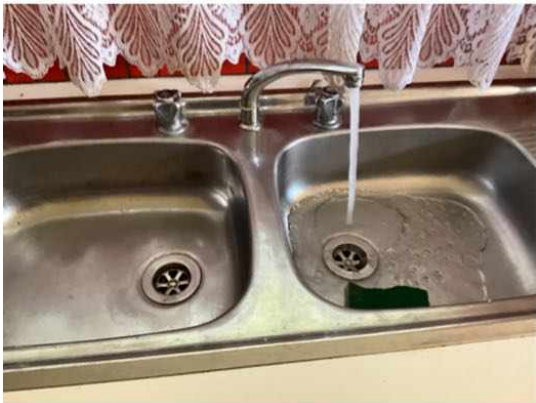
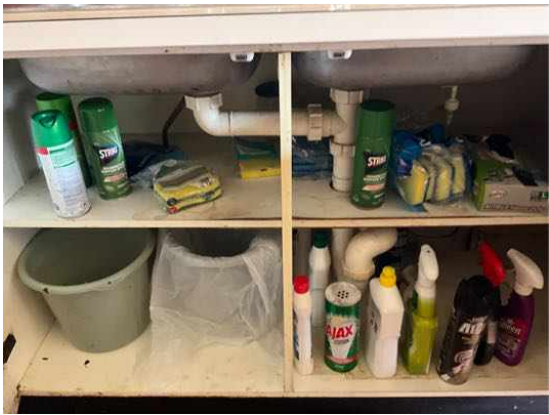
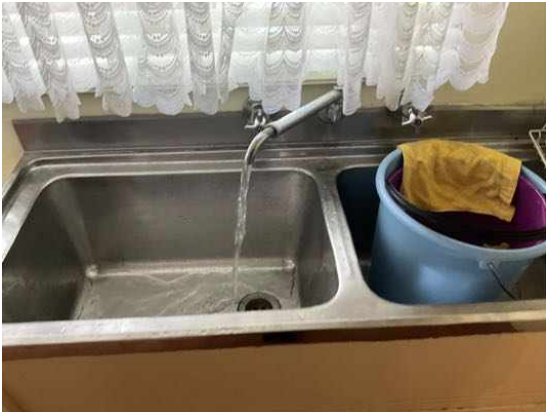
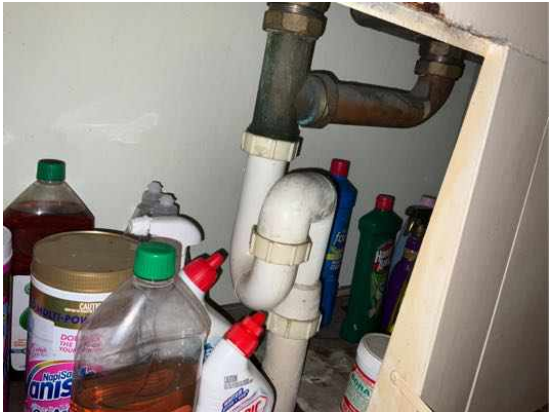
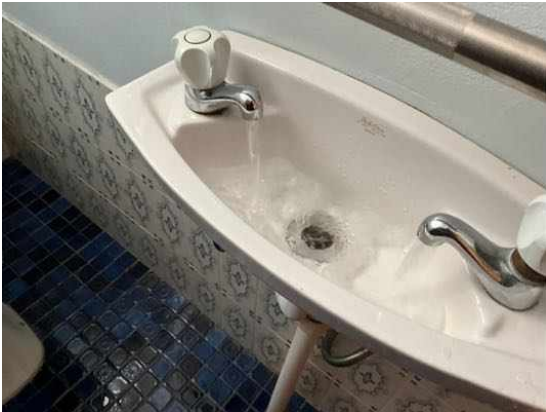
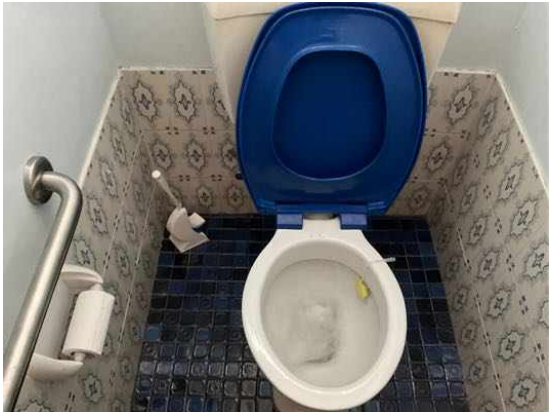
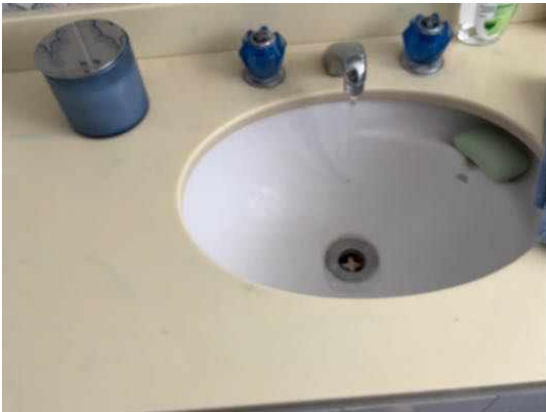
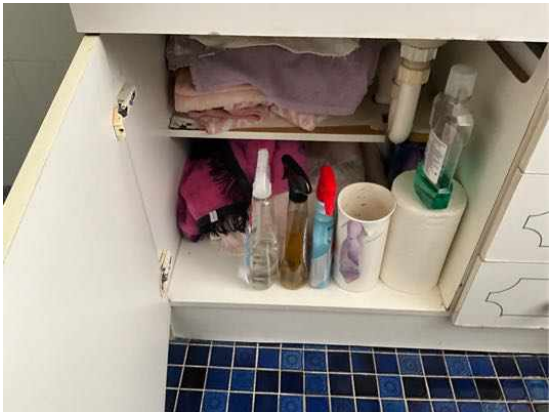
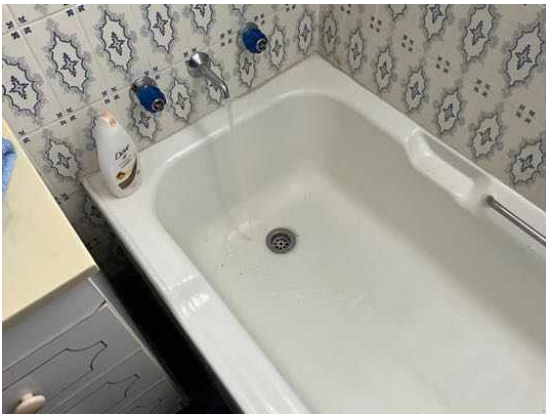
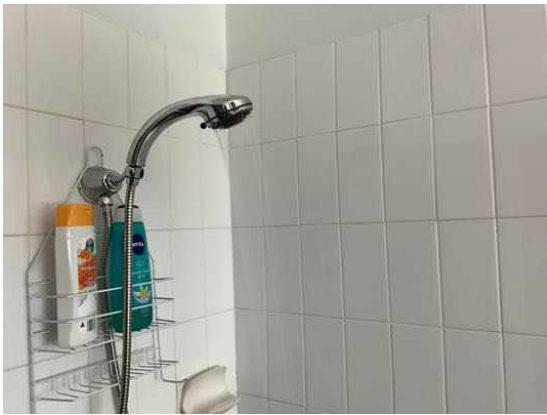
Building: Main Building  
 Location: All Wet Areas  
 Finding: Waterproofing  
 Information:

All taps, mixers and toilets were tested for operation, except for those obstructed. The waterproofing to the shower recess was assessed by checking the walls in and around the shower recess for varying moisture content. There were no significant variations across the tested areas. No sign of recent water damage was evident upon a visual inspection of the surrounding walls, where the visual nature of the inspection was possible.

Consequently, there is no conclusive evidence of any current shower recess leakage other than those which may have already been mentioned earlier in this report. It is reasonable to assume the shower waterproofing is sound. Note that if the shower is not used, or has not been used for some time, moisture readings would not vary significantly and this can lead to erroneous results. It is not possible under the visual inspection criteria (under which a prepurchase inspection is carried out) to categorically determine if there are leaks. If a more accurate assessment is required, a special purpose inspection should be requested. Alternatively, the assumption should be made that the shower may leak.

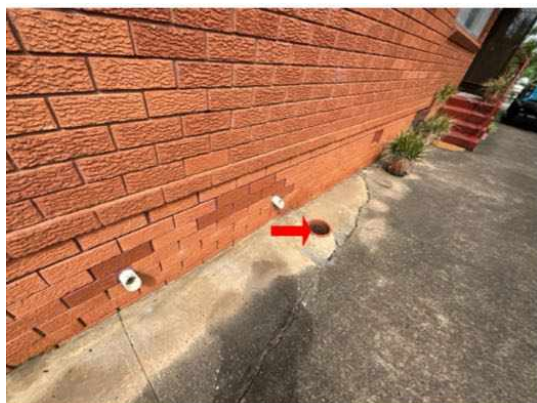
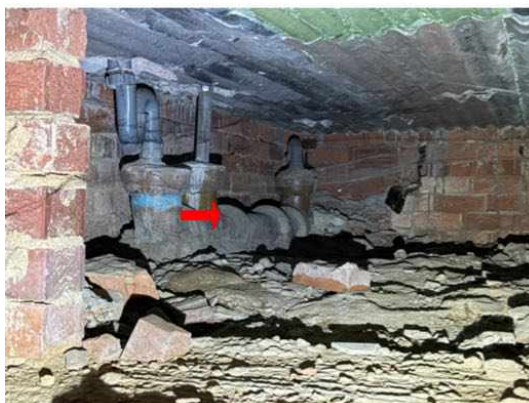
Building: Main Building  
 Location:  
 Finding: Pipework - Old urban wear pipes  
 Information: Old urban wear pipes were identified at the time of inspection.

Consultation with a licensed plumber is advised. CCTV inspection on pipes may be required.

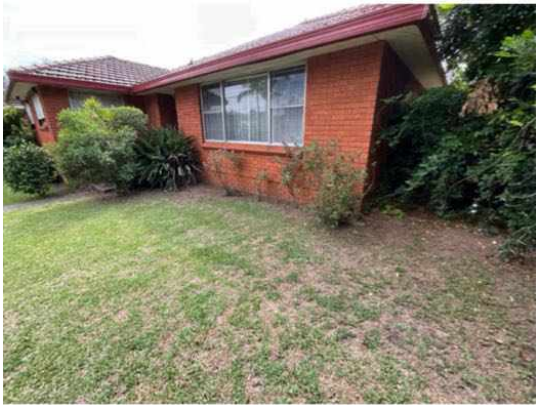
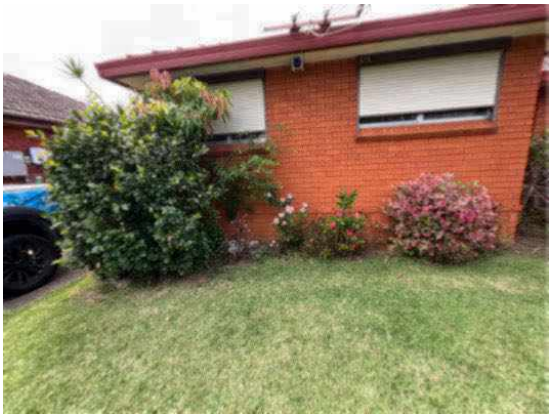
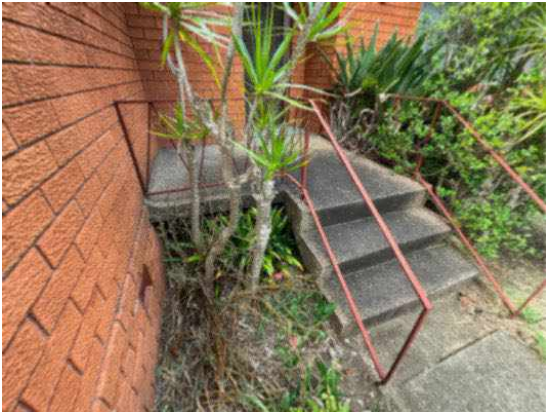
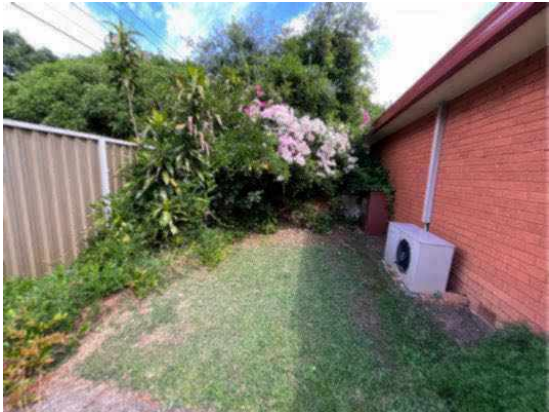
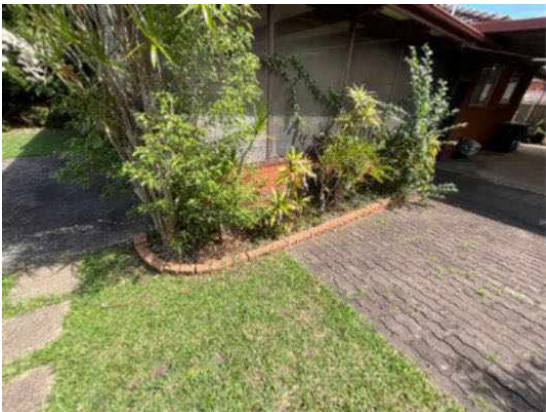
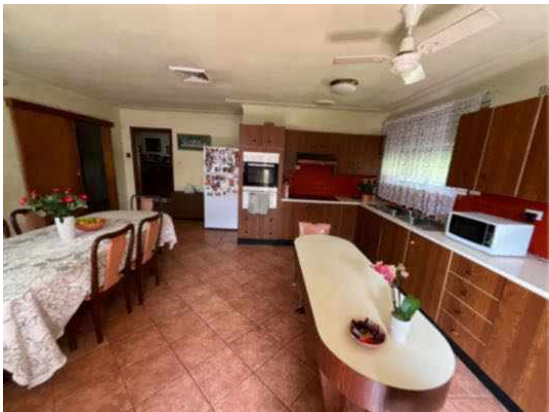
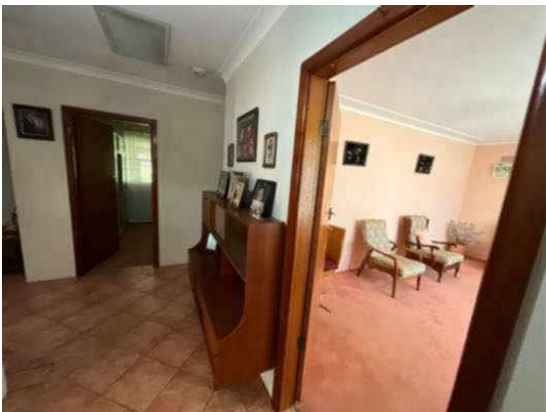
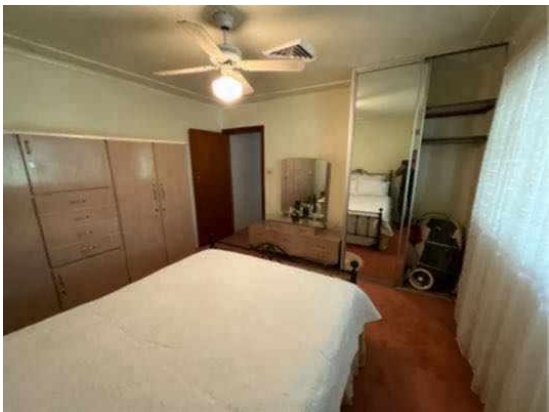
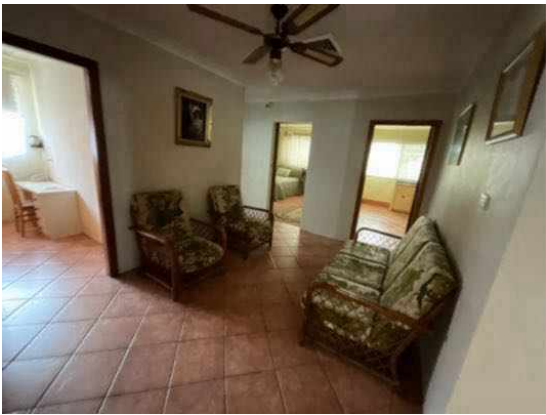
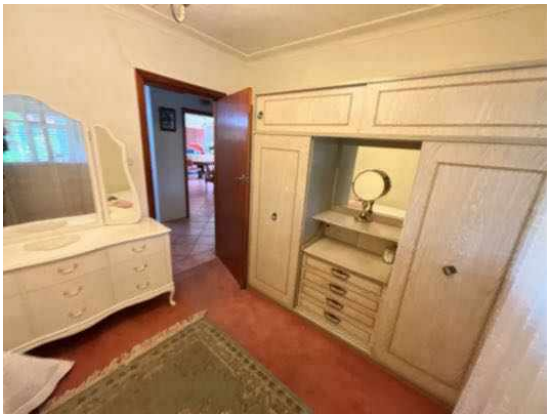
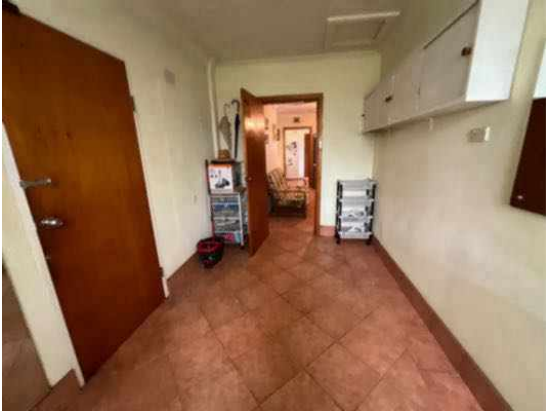
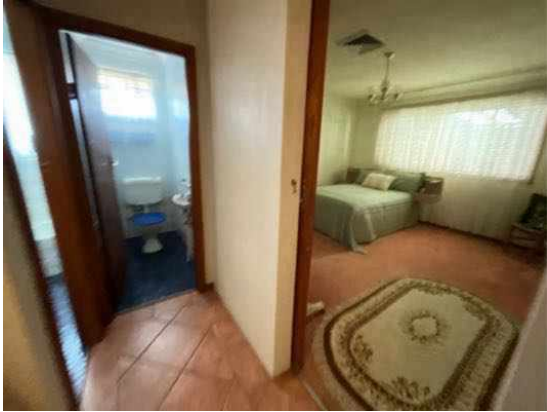
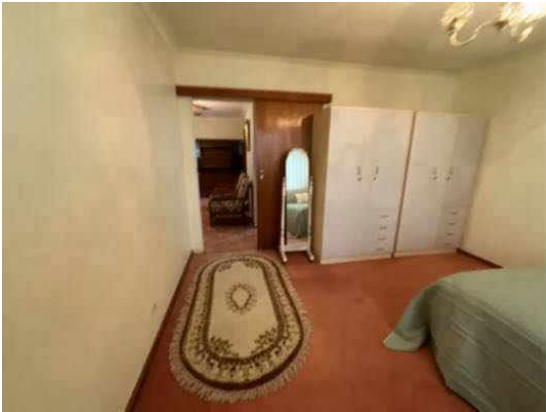
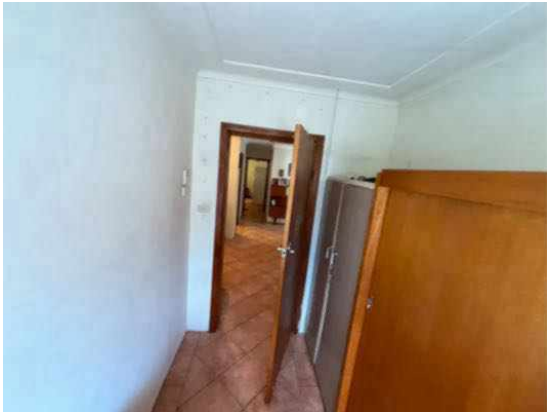
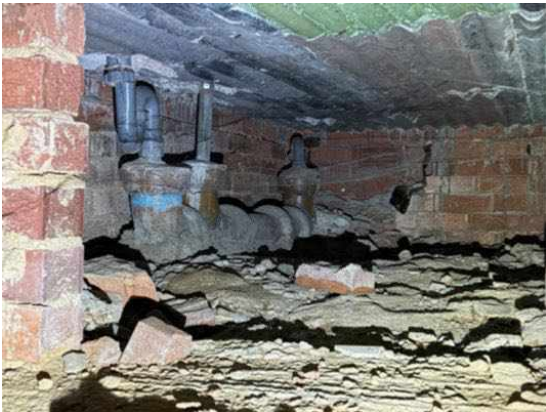
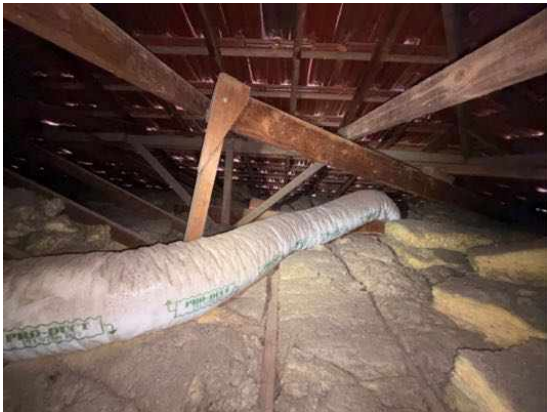
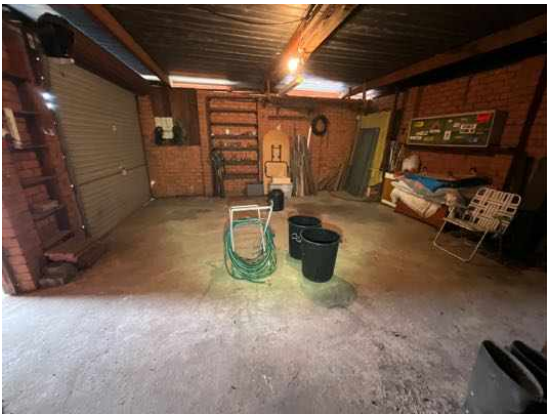
Building: Main Building  
 Location: All Areas  
 Finding: Additional Photos - Obstructions and Limitations  
 Information:

These photographs are an indication of the obstructions and limitations which impeded full inspection of the property at the time of inspection. These obstructions can hide an array of defects and should be removed to allow full inspection to be carried out. A re-inspection is recommended once the areas are made accessible.
