Building and Timber Pest Inspection Report

Inspection Date: Mon, 23 Feb 2026

Property Address: 152 Clovelly Rd Randwick, NSW, Australia

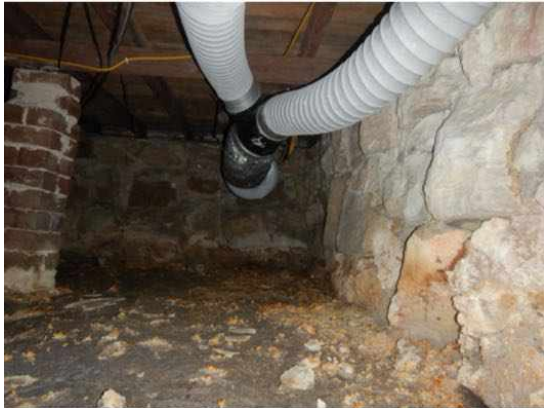
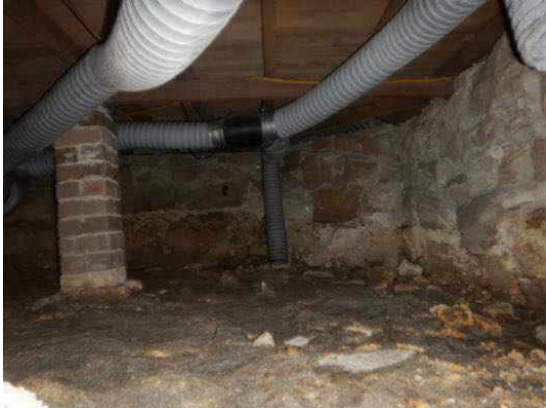
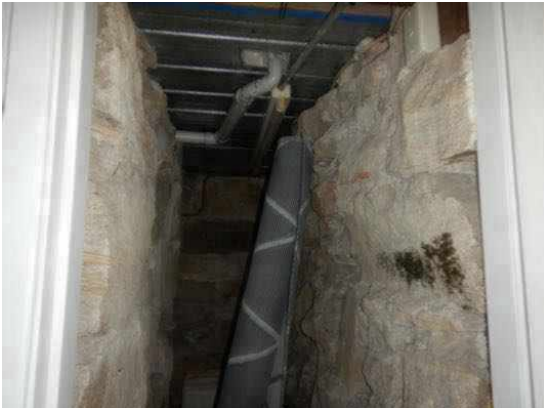
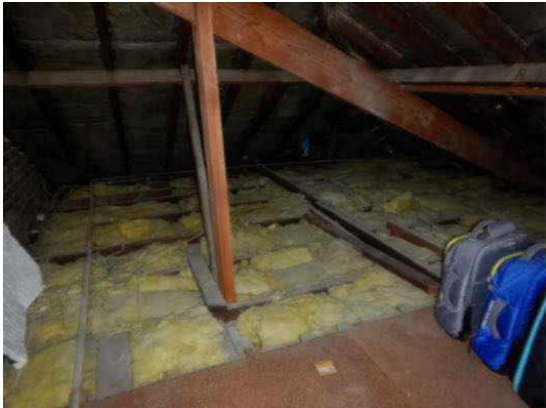
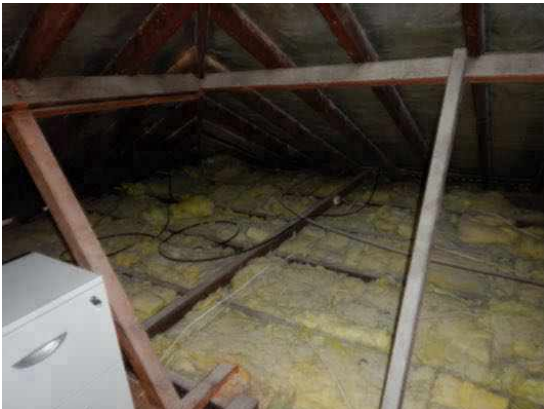
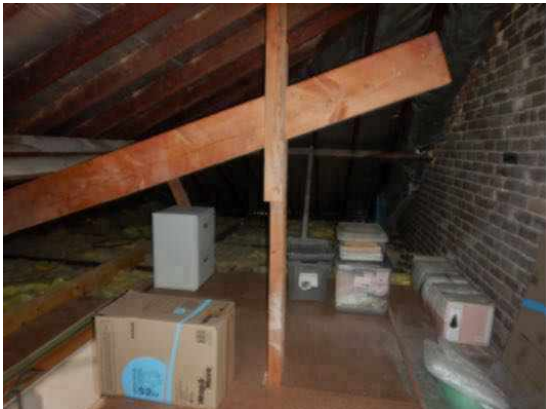
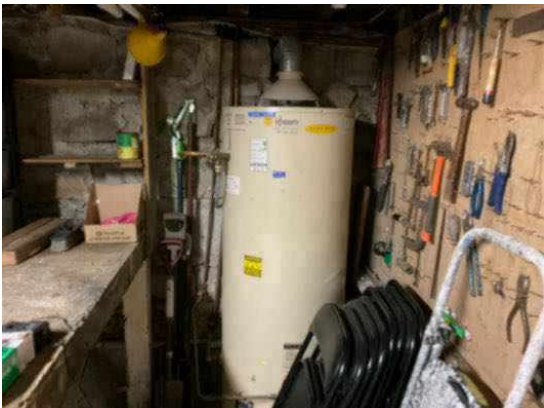
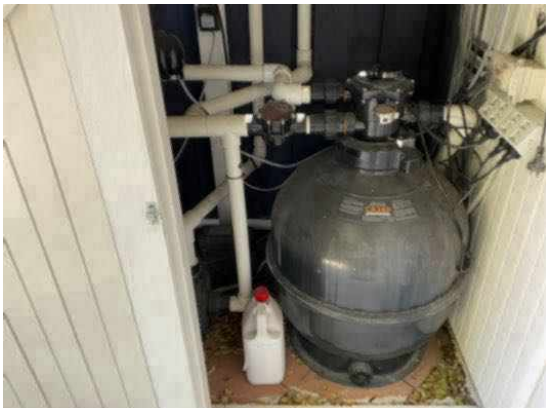
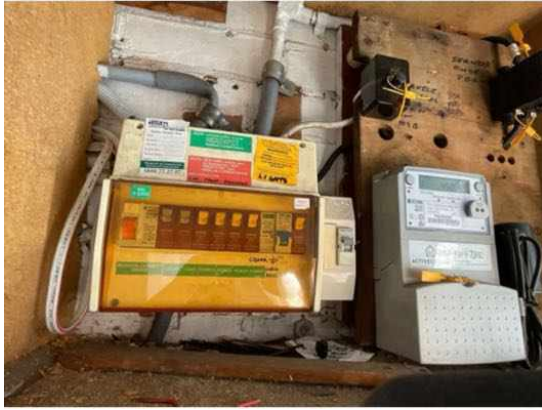
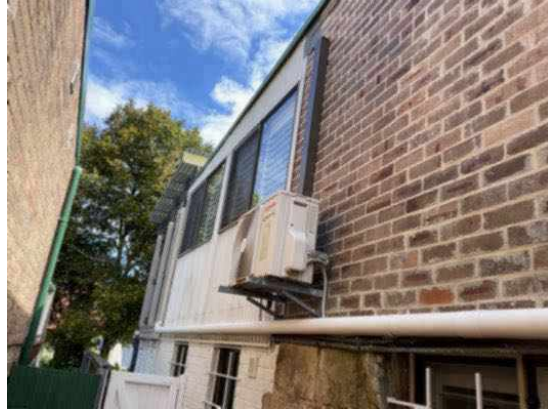
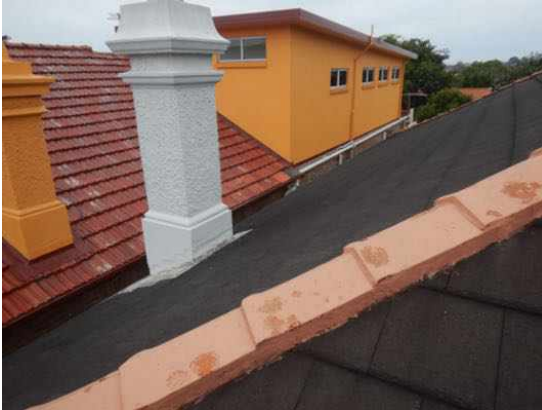
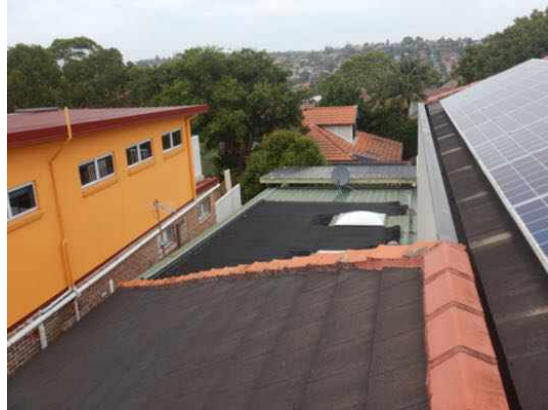
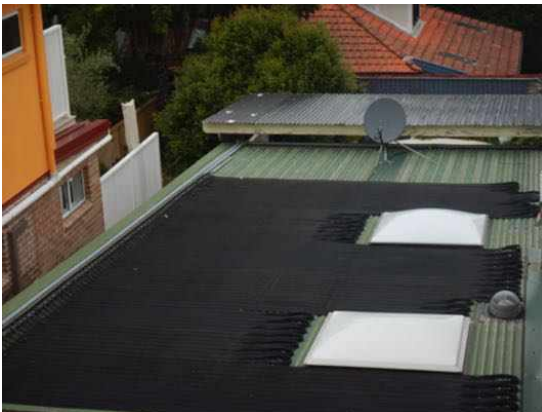
This property has insulation in the roof void as shown in the additional photos.

The subfloor had a mechanical ventilation system set up to assist in the ventilation of the moist subfloor air. Consultation with a subfloor ventilation specialist is recommended to advise if any further measures need to be taken.
