Building Inspection Report

Inspection Date: Mon, 30 Mar 2026

Property Address: 43 Sanctuary Way, Beaconsfield VIC 3807,
Australia

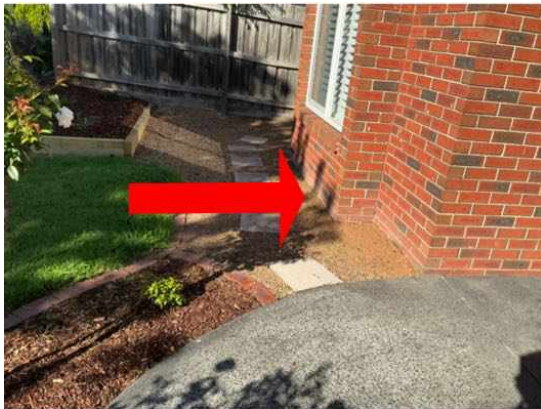
Defects 3.02

Building: Main Building
 Location: All External Areas
 Finding: Site drainage - Inadequate
 Information: The site drainage in all yards was found to be inadequate at the time of inspection, creating potential for subsequent water damage to associated building elements.

It is important that water does not lie against the base of walls; surrounding paths and ground levels should be sloped to drain water away from walls. Downpipes should not discharge stormwater onto lower walls or plinths. Stormwater should be carried away by large, regularly cleaned drains. Ground levels may need to be lowered to expose a buried DPC.

Where site drainage is inadequate, installation of an Agricultural (Aggie) Drain may be required. A qualified plumber should be appointed to further inspect the property and perform any remedial works as necessary. Water damage and secondary defects are likely to occur if left unmanaged.

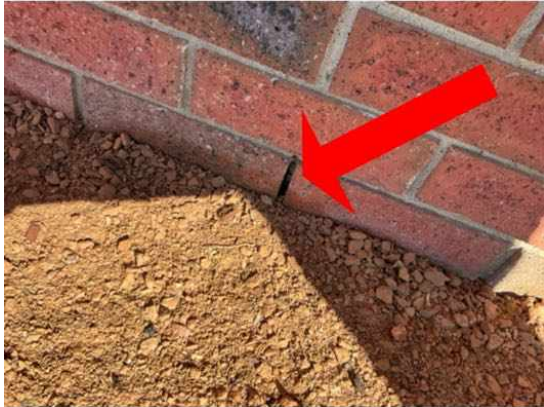
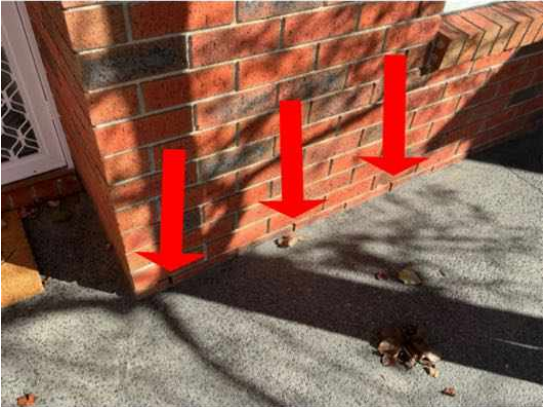
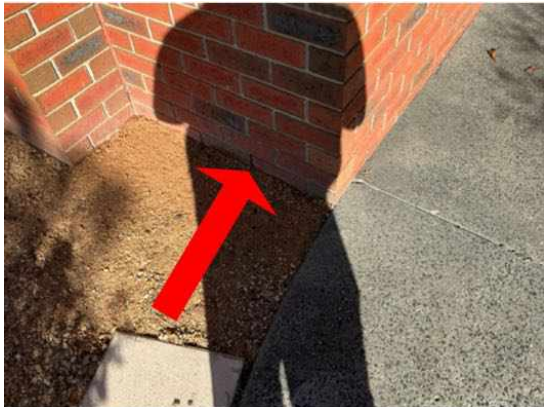
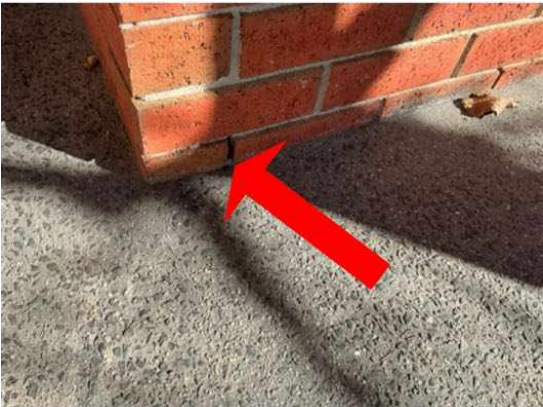
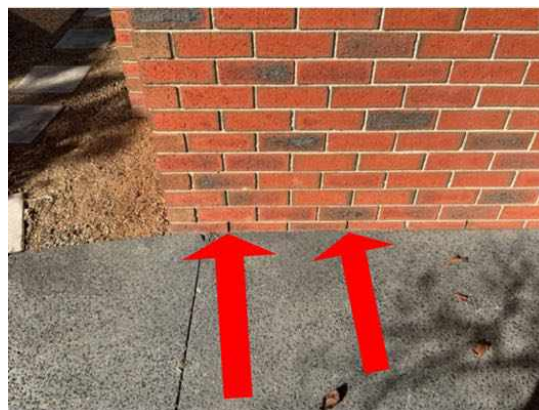
Defects 3.05

Building: Main Building
Location: All External Areas
Finding: Insufficient Clearance to External Weep Holes
Information: Inspection revealed that the external weep holes around the base of the external walls have insufficient clearance, with landscaping materials such as soil positioned directly beneath or against them. Weep holes are essential for allowing moisture within the wall cavity to escape and for enabling ventilation of the internal wall space.

When weep holes are obstructed or have inadequate clearance, their function is compromised. This can result in moisture being trapped within the wall cavity, leading to potential structural deterioration, rising damp, or even termite ingress—especially in timber-framed dwellings.

It is recommended that the landscaping be adjusted to ensure a minimum vertical clearance of at least 75mm below the lowest part of the weephole. This will allow for proper drainage and ventilation and help protect the structural integrity of the property.

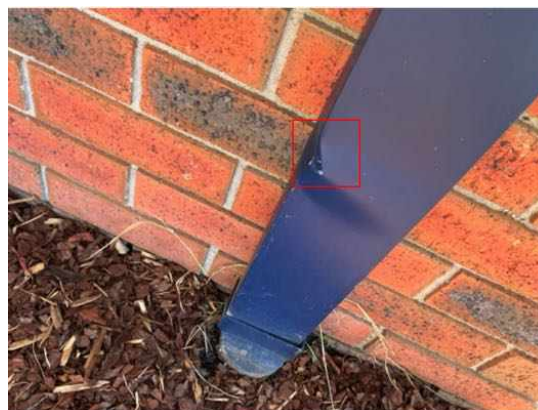
Defects 3.07

One of the downpipes located on the front elevation at the left-hand side (LHS) of the garage wall was observed to be dented. No significant damage or leakage was noted at the time of inspection.

This condition is considered minor and primarily cosmetic; however, deformation of the downpipe may slightly restrict water flow if severe or worsen over time.

Rectification can be carried out at the client's discretion. If required, a licensed plumber can assess and repair or replace the affected section to ensure optimal performance and appearance.

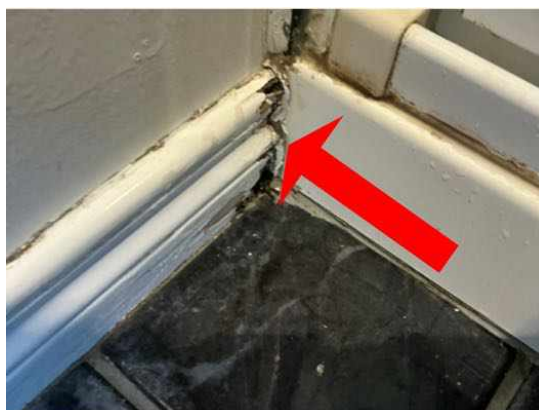
Defects 3.10

Location: Ensuite
 Finding: Elevated Moisture Readings to Adjacent Wall
 Information:

Elevated moisture readings were detected to the plaster wall adjacent to the shower, and the skirting board in this area shows signs of moisture-related deterioration.

This condition may be associated with minor water ingress, potentially from shower usage or localised sealing issues. At the time of inspection, no extensive damage was evident; however, ongoing moisture exposure may lead to further deterioration if not addressed.

It is recommended that a licensed plumber be engaged to inspect the shower area and confirm the source of moisture. Any defective seals or joints should be rectified, and the affected skirting board replaced if required. Ongoing monitoring is advised following repairs.

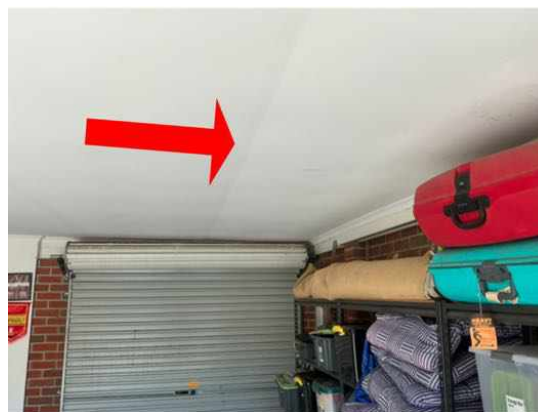
Defects 3.11

Building: Main Building
 Location: Garage
 Finding: Ceiling sagging - Garage
 Information: Sections of the ceiling were found to be sagging at the time of inspection. Sagging to the fixed ceiling structure generally indicates that the building materials have swollen,

due to contact with water, or that fixings (e.g. nails or glue) have become loose and require reattachment. This is a very common defect in carports due to their lack of insulation and or their susceptibility to moisture. Condensation builds up in the roof and rests on the plasterboard softening it somewhat which makes it more likely to sag and release from its fixing points.

Where minor sagging is evident, comparatively minor works, such as re-gluing of ceiling sheets, may be required. Such works may be performed by relevant tradespeople, such as plasterers and painters. Where excessive moisture has caused the roofing structure to swell and sag, the source of the water leak should primarily be identified prior to any remedial works being performed.

While damage is minimal at this stage a licensed plasterboard contractor should be appointed to repair the ceiling. Insulating the area could be considered by the client once repaired.

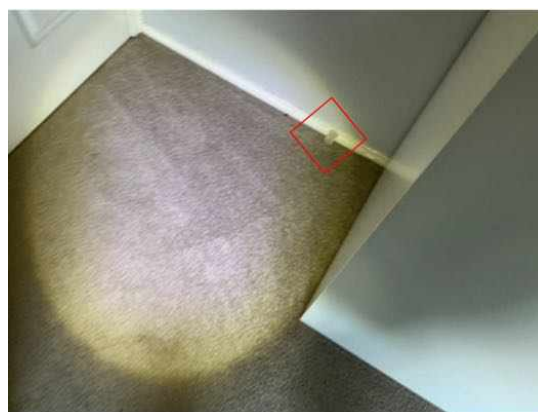
Defects 3.13

Building:	Main Building
Location:	Bedroom 2
Finding:	Door stop - Missing
Information:	The door stop is missing or is inadequate to stop the door handle from damaging the wall. Although some building elements may seem irrelevant or unnecessary, all building elements play a key role in the operation and function of the overall structure and its performance.

Re-installation or replacement of the door stop is advised as soon as possible to prevent any subsequent damage to the door or associated structures. A general handyman may be appointed to perform these works at client discretion.

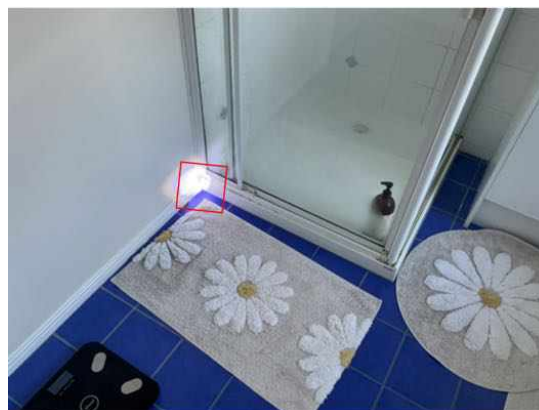
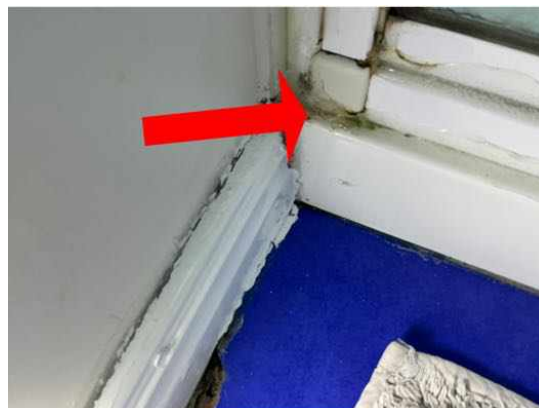
Defects 3.14

Building:	Main Building
Location:	Bathroom 2
Finding:	Shower screen - Leaking
Information:	Leaking was evident to the 2nd bathroom's shower screen at the time of inspection. It is suspected that the leaking has occurred as a result of deteriorated or missing caulking to the shower or general ageing of the building elements.

Leaking from the shower where left unattended, is likely to lead to water damage to adjoining flooring and walls. Such damage can lead to water damage and necessitate extensive remedial works being required. Active water leaks may also create an environment that is susceptible to the formation and development of mould.

Appointment of a caulking contractor is required to repair or replace the caulking to the shower area. Such works should be performed as soon as possible to ensure that no further damage occurs.

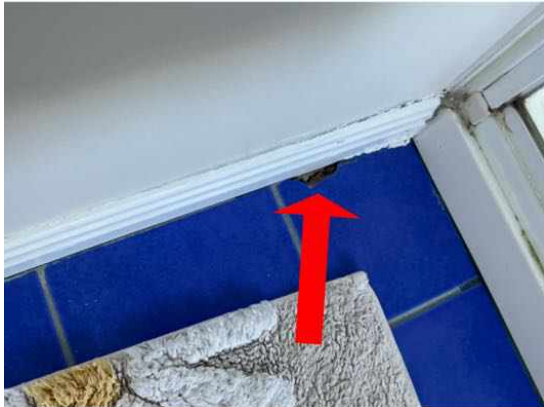
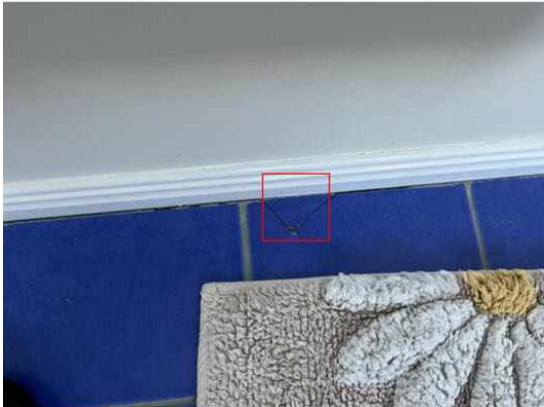
Defects 3.15

Building:	Main Building
Location:	Bathroom 2
Finding:	Floor tiles - Cracked
Information:	Cracking in the floor tiles was evident in 2nd bathroom at the time of inspection. It is suspected that this cracking has occurred as a result of the floor being uneven and lacking a solid or suitable foundation for the tiles to be laid on. Settlement in the floor foundations may also have caused movement and resulted in the cracking of tiles in this area.

Cracked tiles throughout the household detract from the overall appearance of the affected areas, as well as creating potential for water penetration to adjoining building elements. If left unmanaged, water damage may occur as a result of constant water penetration over a prolonged period of time.

While not considered a matter of urgency, replacement of cracked floor tiles is advised as a solution. A tiling contractor or general handyperson may be appointed to perform these works at client discretion. Where cracks become more numerous, consultation with a registered builder specialising in re-stumping may be required.

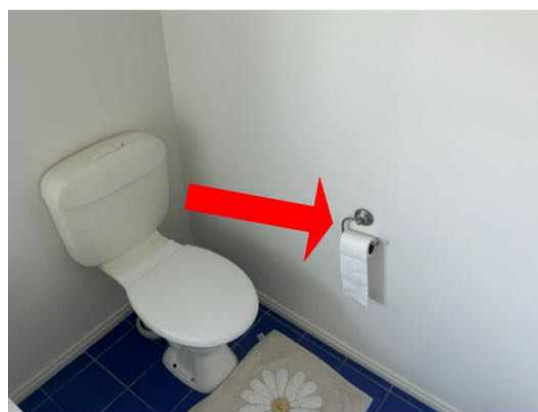
Defects 3.17

Building:	Main Building
Location:	Bathroom 2
Finding:	Toilet roll holder - Loose
Information:	The toilet roll holder was found to be loose at the time of inspection. While not a major operational defect, function can deteriorate if the problem is left unmanaged.

It is advised that the homeowner performs remedial works to re-attach the toilet roll holder to its original fixing. A general handyperson may be required to perform these works.

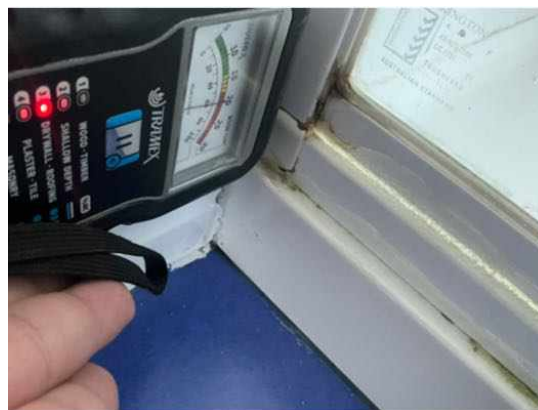
Defects 3.18

Building:	Main Building
Location:	Bathroom 2
Finding:	Excessive Moisture Detected in Plaster Wall Adjacent to Shower
Information:	During the inspection, elevated moisture levels were recorded in the plaster wall on the left-hand side of the shower using a moisture meter. Excessive moisture in this area can create conditions that promote termite infestations, fungal growth, and wood decay.

The moisture buildup may be caused by deteriorated or inadequate waterproofing, leaking plumbing pipes, or poor drainage around the shower area. It is highly recommended that a licensed plumber or builder investigates the source of the moisture and ensures that all plumbing and drainage fixtures are functioning properly to prevent further damage to the internal property. Regular maintenance of these systems is essential to prevent excessive moisture and associated risks.

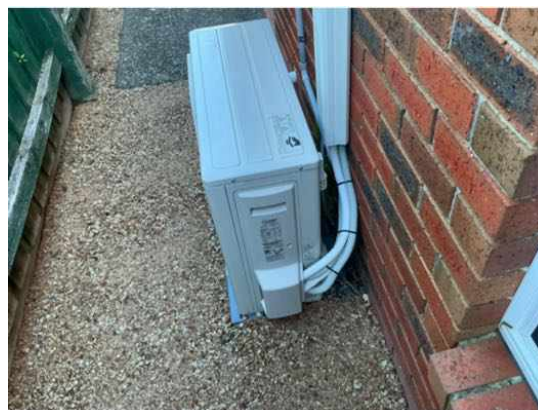
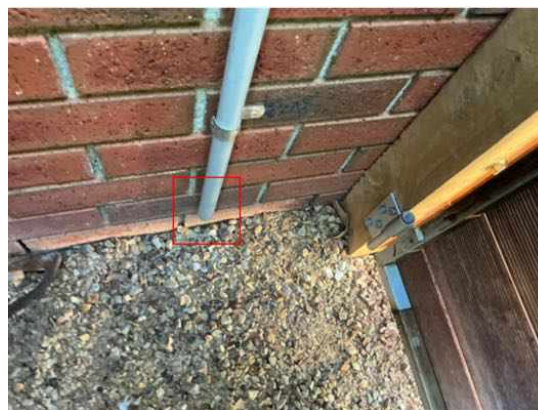
Defects 3.19

Building:	Main Building
Location:	Yard - Side
Finding:	AC Overflows - Not plumbed to suitable drainage
Information:	Upon inspection, it was found that the AC overflow is not plumbed or connected to suitable drainage. This could lead to the surrounding area becoming excessively damp, which in turn may cause secondary defects such as rot, rust, corrosion of associated building elements, and the formation of fungal decay. In addition, prolonged damp conditions could create potential slip hazards. Poor site drainage may exacerbate the issue, potentially attracting termite activity to the area.

We recommend that a licensed plumber be appointed to properly plumb the AC overflow and connect it to suitable drainage. This will help ensure that the area remains dry and free from secondary defects.

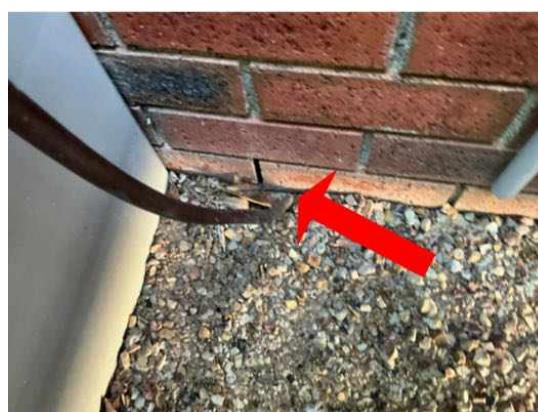
Defects 3.20

Building:	Main Building
Location:	Yard - Side
Finding:	HWS Overflow - Not Connected
Information:	The Hot Water System (HWS) overflow was found to be disconnected from storm water drainage and is creating excessive moisture in the surrounding area.

These damp conditions can lead to secondary defects such as rot, rust or corrosion of associated building elements, the formation of fungal decay, or even the creation of potential slip hazards. When coupled with poor site drainage, pooling of water may also attract termite activity to this area.

It is highly recommended that a licensed plumber be appointed to connect the HWS overflow in order to prevent such an environment from being created. These minor works should be carried out as soon as possible.

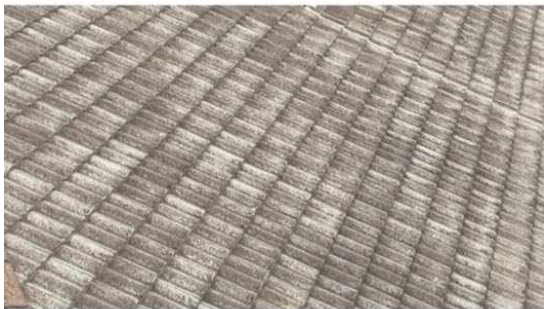
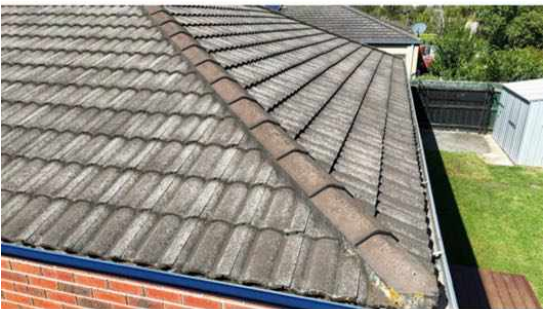
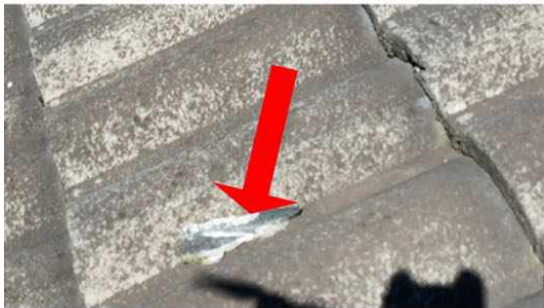
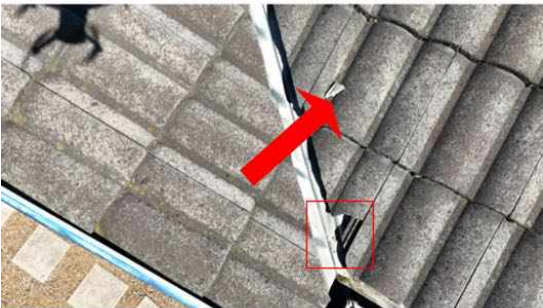
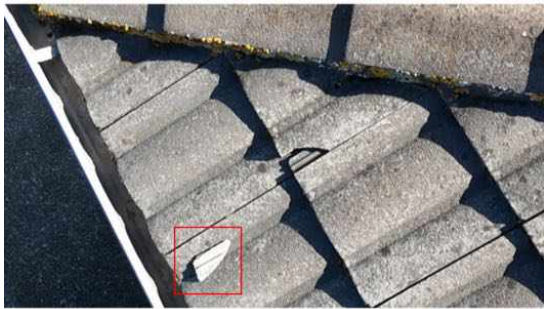
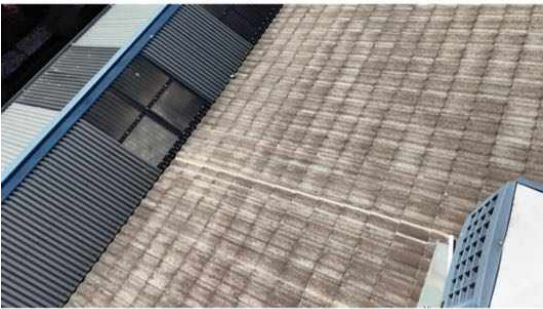
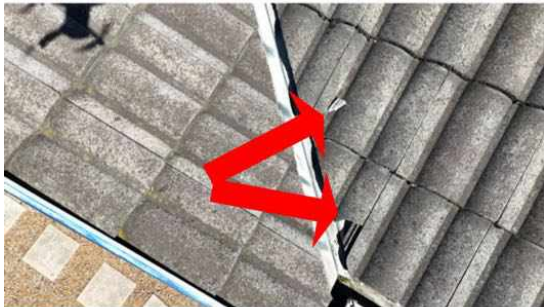
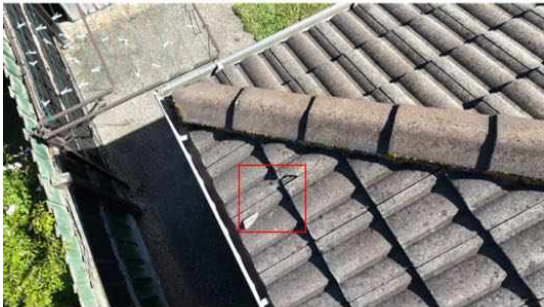
Defects 3.22

Building:	Main Building
Location:	Roof Exterior
Finding:	Roof tiles - Broken
Information:	Upon inspection of the exterior roof covering, broken roofing tiles were identified. Broken and friable roof tiles are generally the result of ageing and weathering of what is essentially a porous material. It appears that the two broken roof tiles have been

repaired using a silicon adhesive which is not considered a permanent repair. A full replacement of the affected roof tiles is required.

If left to further deteriorate, broken and brittle roof tiles are likely to lead to water penetration via the roof into the ceiling space, causing secondary damage to ceiling linings, insulation and roof structures. Broken roof tiles are also likely to detract from the effectiveness of the roof drainage system, creating potential for secondary damage to the exterior roof covering and roof plumbing.

Replacement of broken tiles is required and should be performed by a roofing contractor as soon as possible. Also, we highly advise client to have the roof tiles spray sealed on regular basis for long term protection.

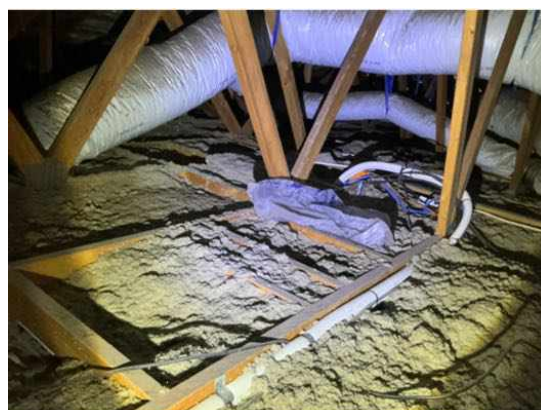
Noted Item

Building:	Main Building
Location:	All Internal Areas
Finding:	Obstructions and Limitations - Interior
Information:	These photographs are an indication of the obstructions and limitations which impeded the inspection of the internal areas of the property at the time of inspection. These obstructions can hide an array of defects and should be removed to allow full inspection to be carried out. A re-inspection is recommended once the areas are made accessible.
