Building and Timber Pest Inspection Report

Inspection Date: Thu, 19 Feb 2026

Property Address: 16 Dundas St, Wangaratta VIC 3677,
Australia

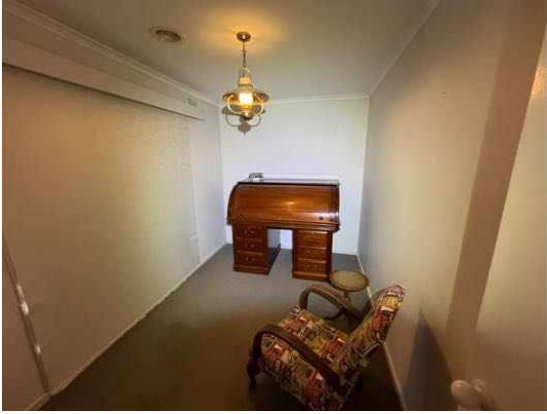
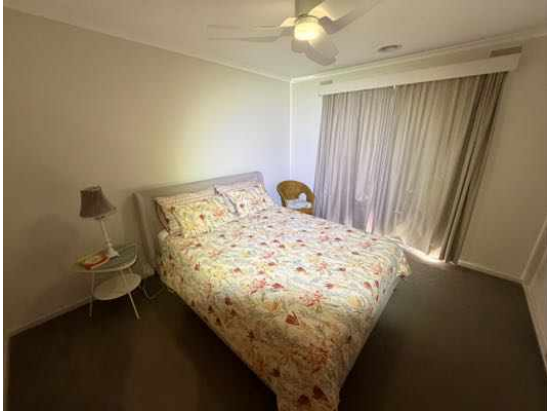
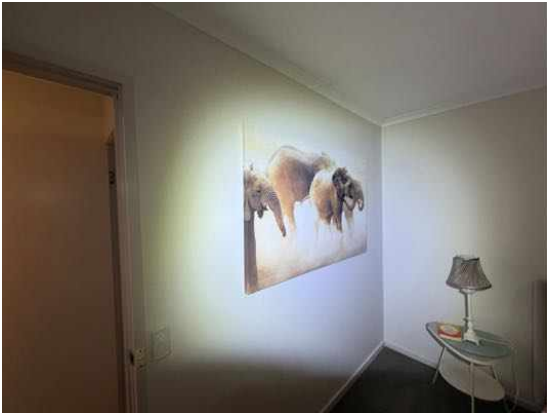
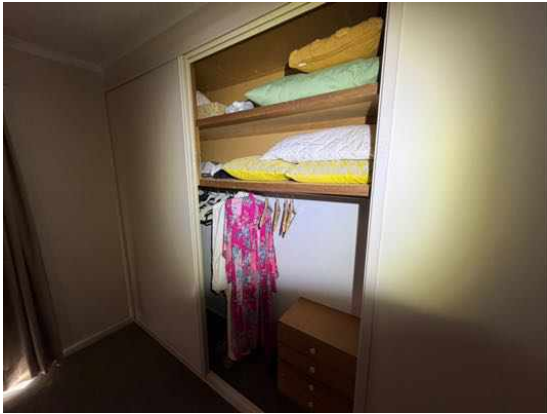
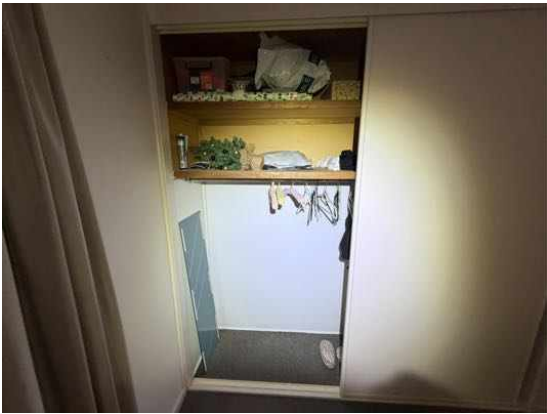
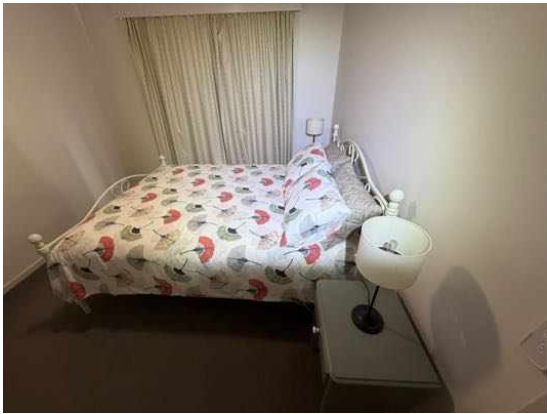
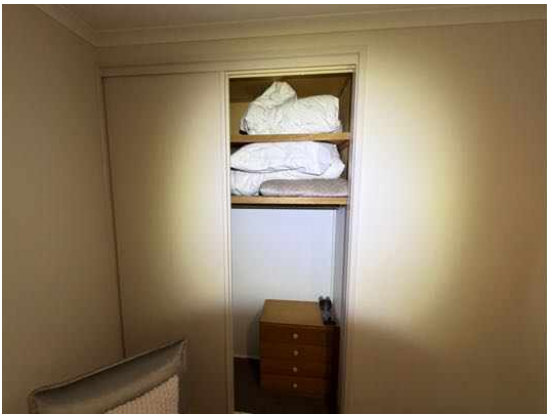
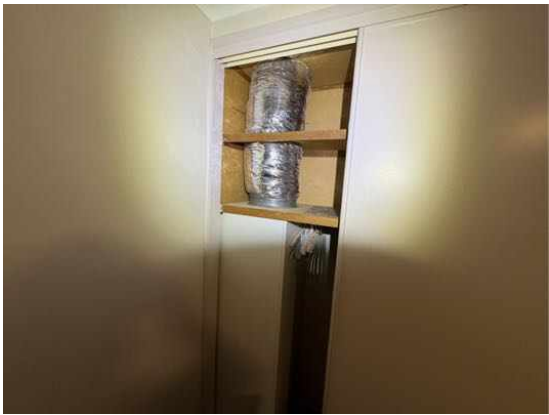
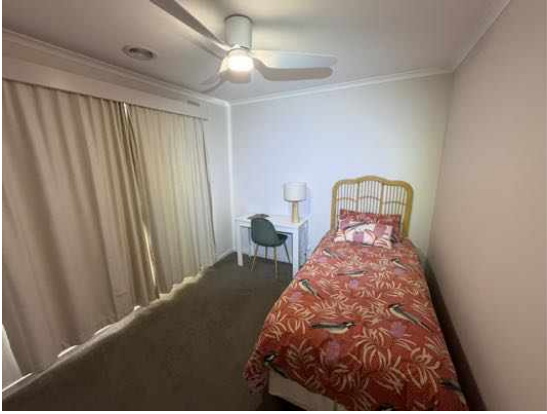
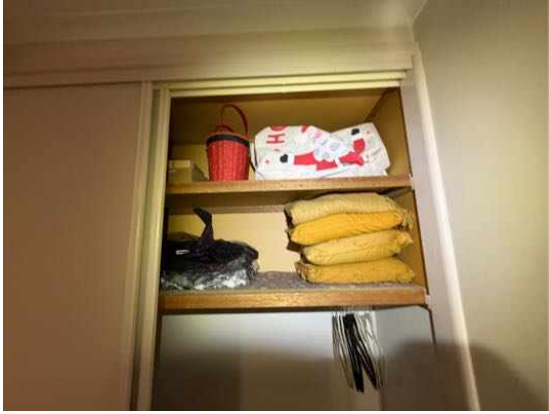
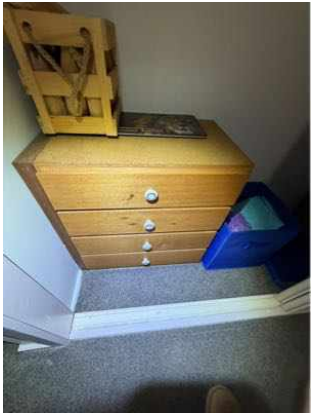
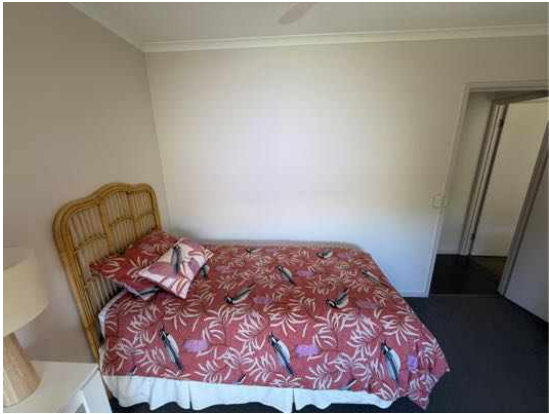
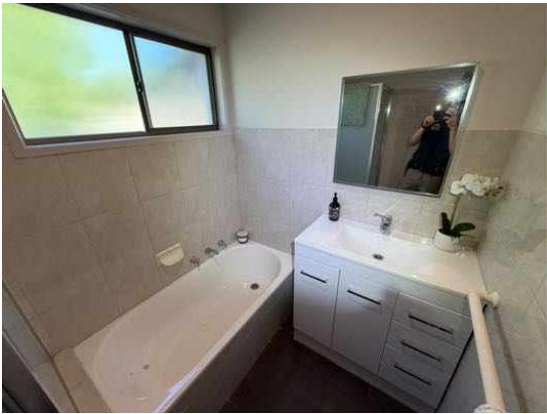
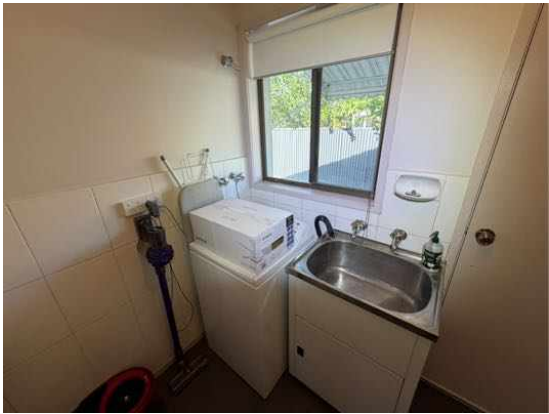
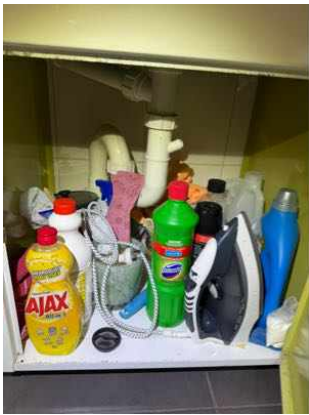
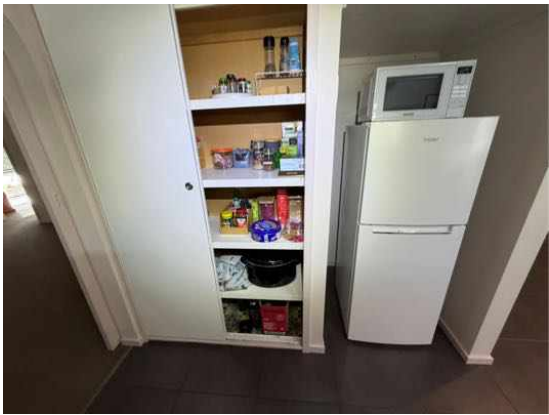
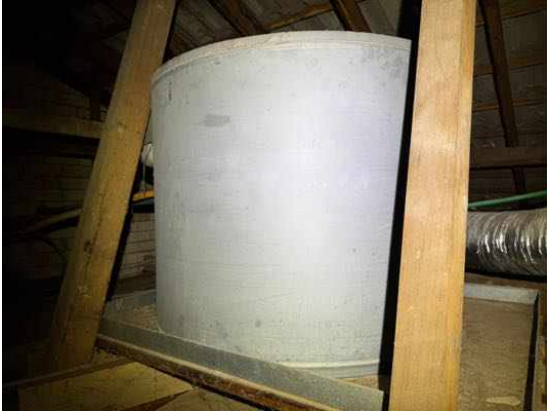
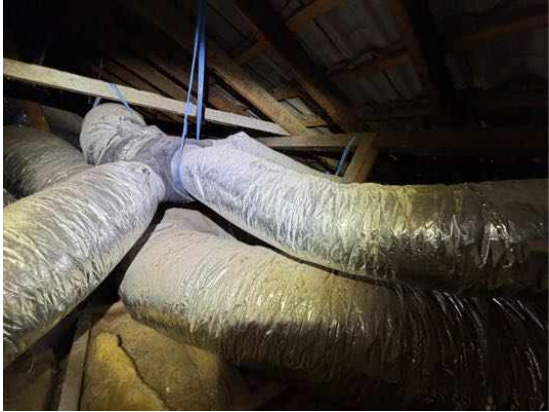
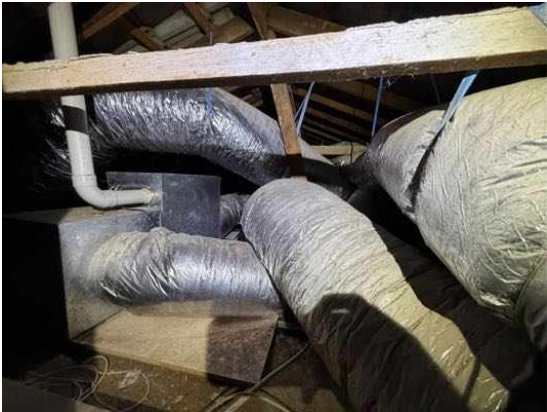
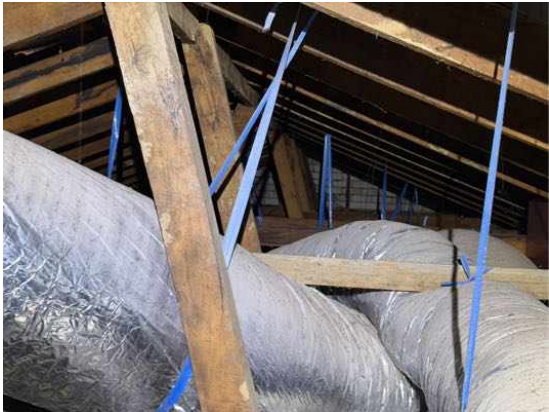
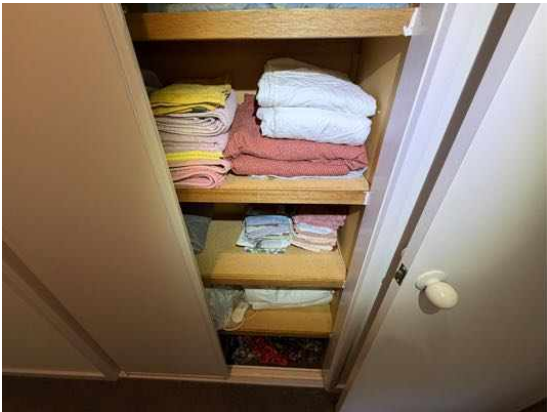
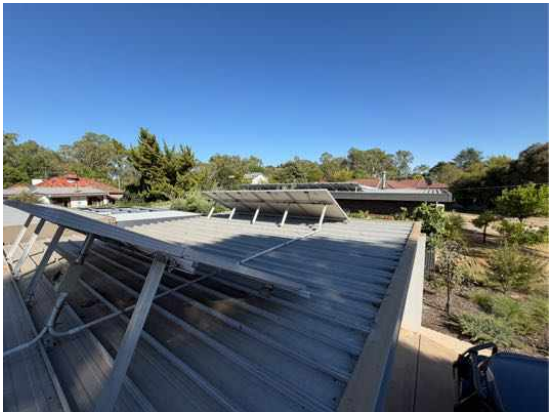
Building: Main Building
Location: All Areas
Finding: Additional Photos - Obstructions and Limitations
Information: These photographs are an indication of the obstructions and limitations which impeded full inspection of the property at the time of inspection. These obstructions can hide an array of defects and should be removed to allow full inspection to be carried out. A re-inspection is recommended once the areas are made accessible.
