# Building and Timber Pest Inspection Report

Inspection Date: Fri, 27 Mar 2026

Property Address: 90 Carlisle St, Ingleburn NSW 2565,  
Australia

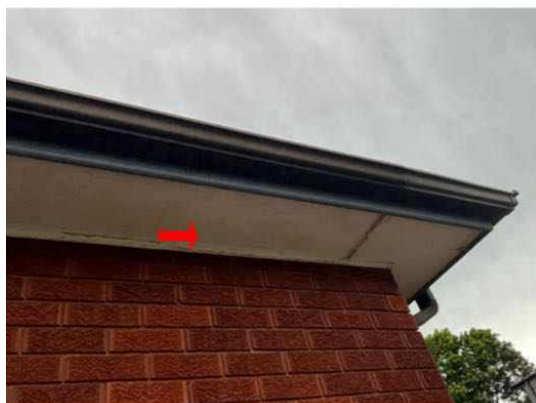
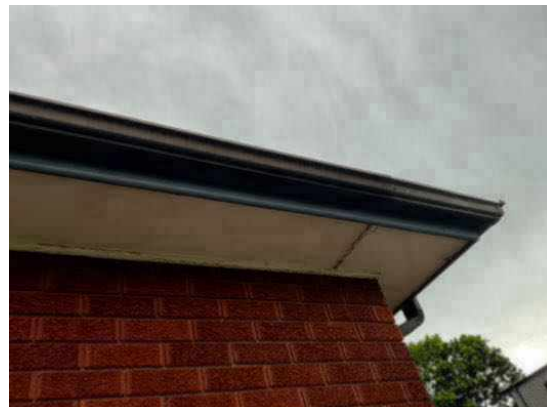
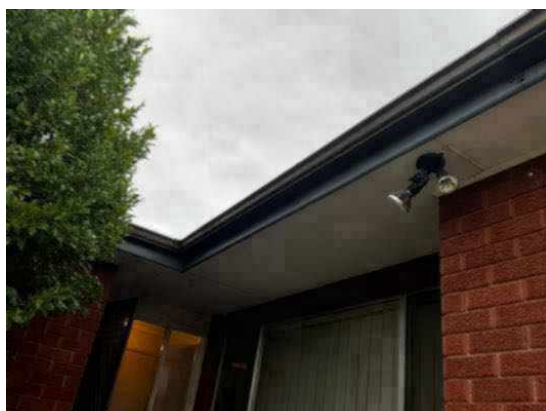
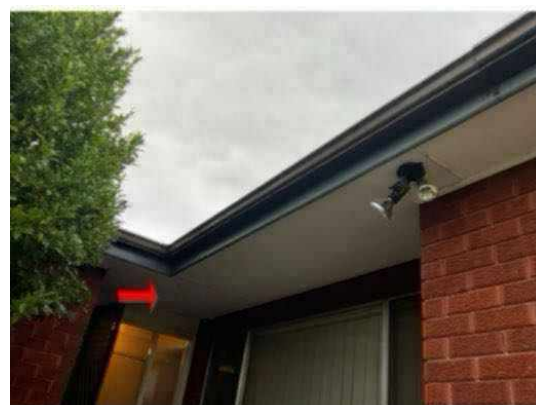
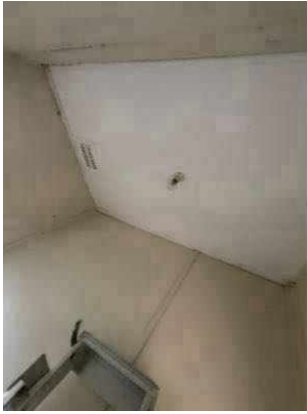
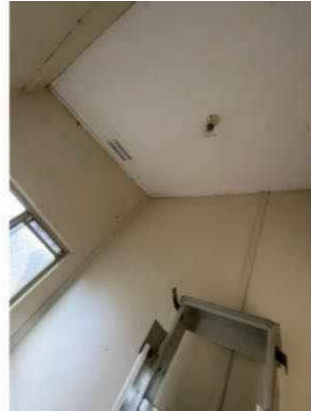
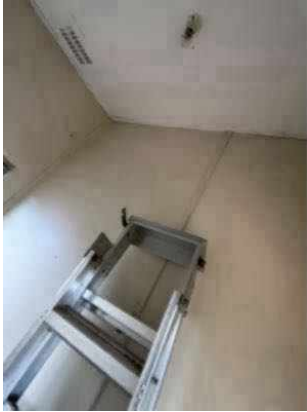
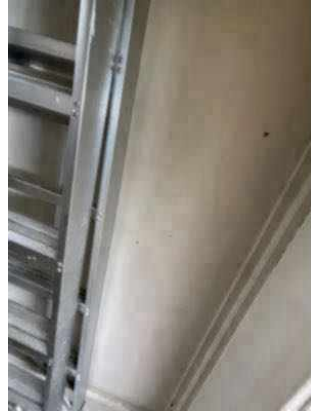
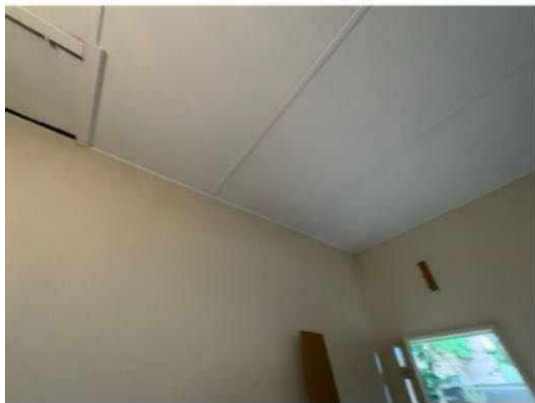
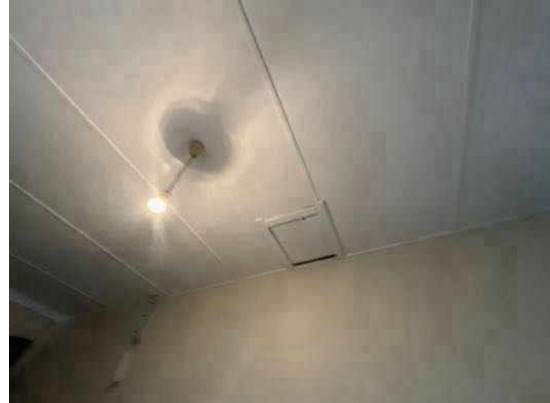
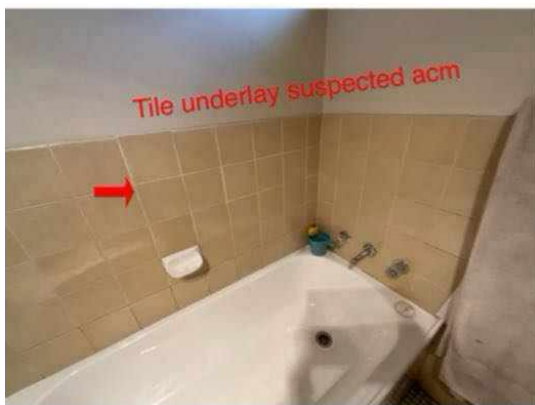
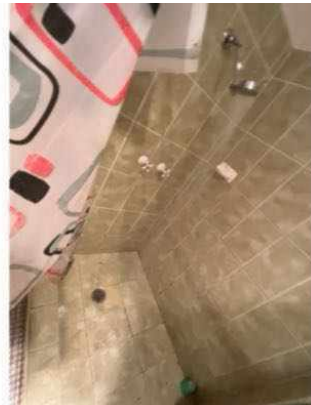
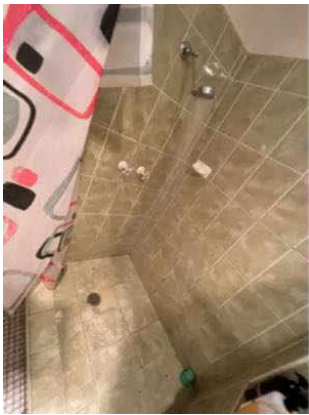
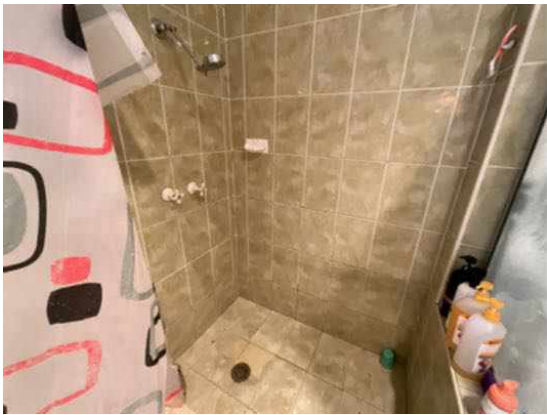
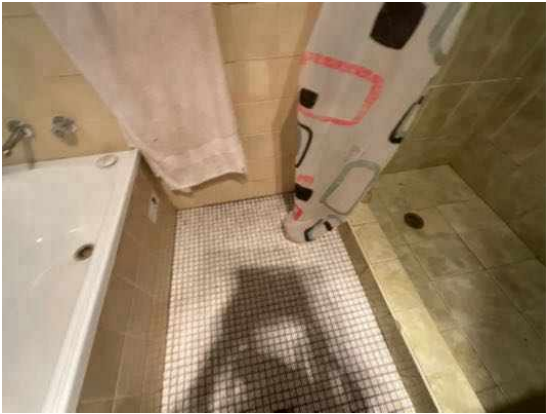
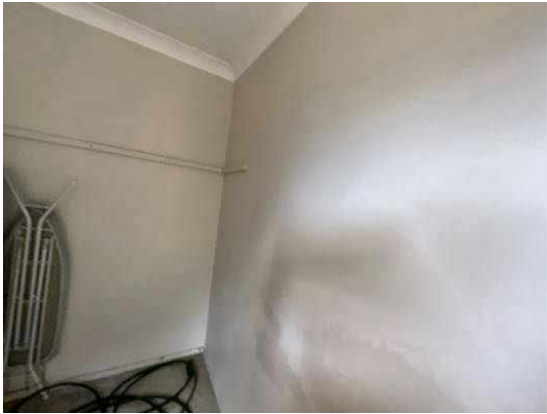
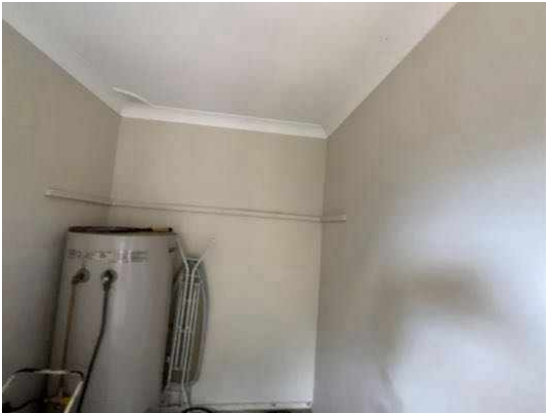
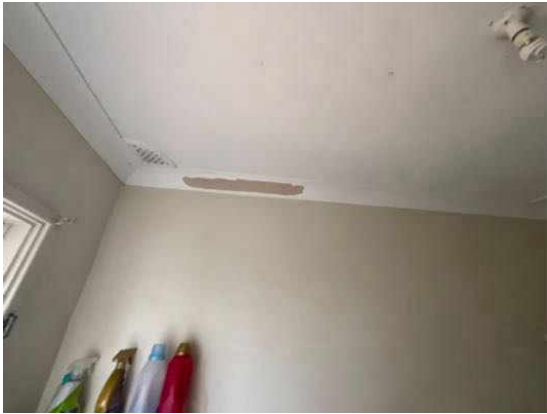
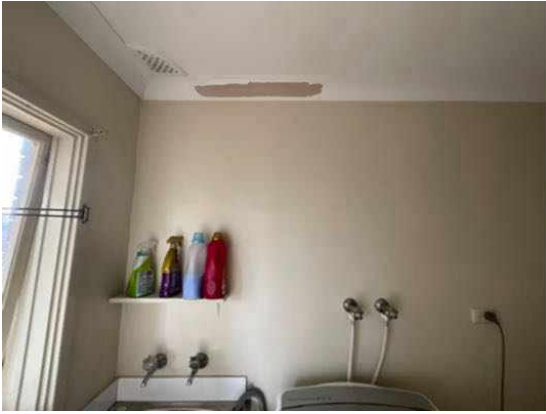
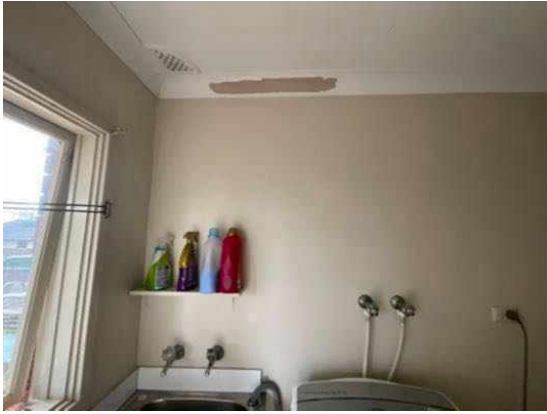
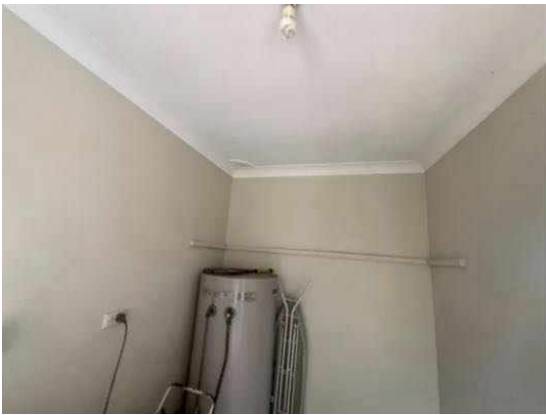
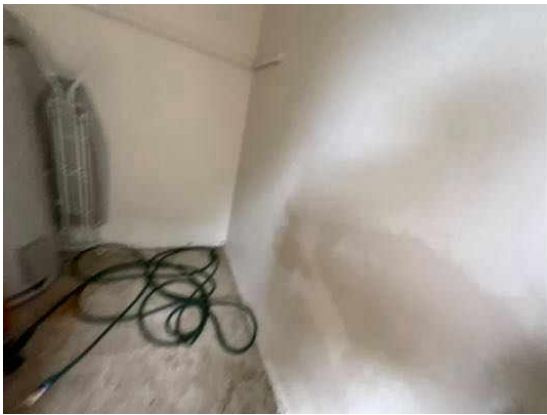
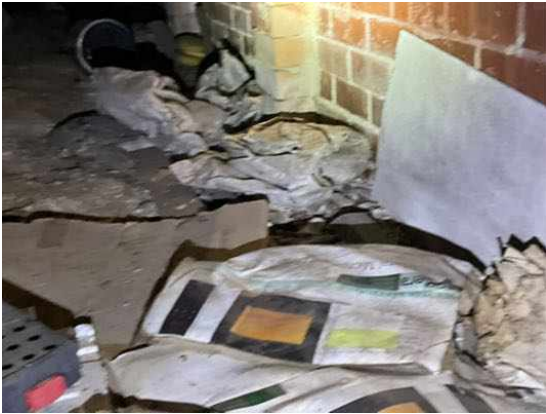
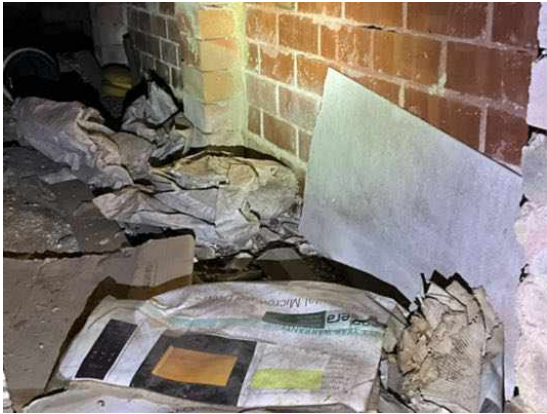
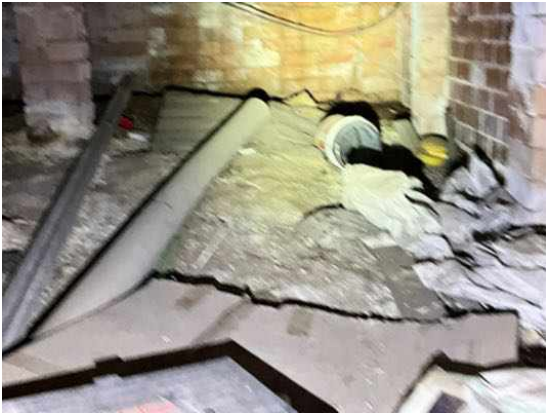
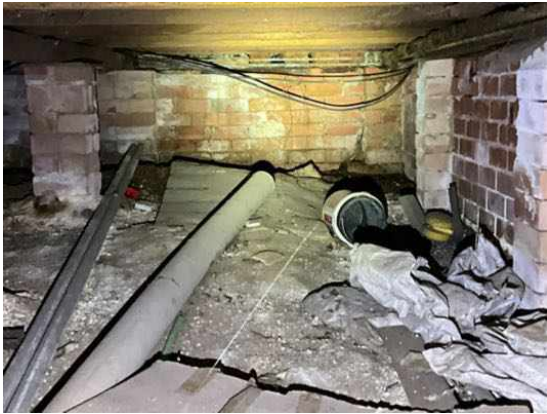
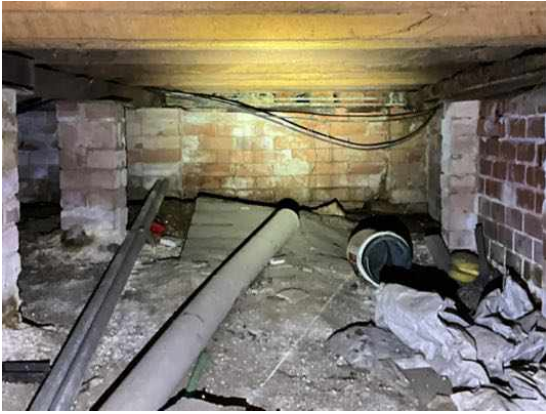
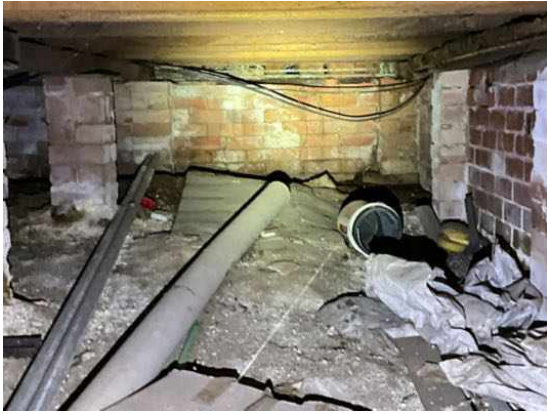
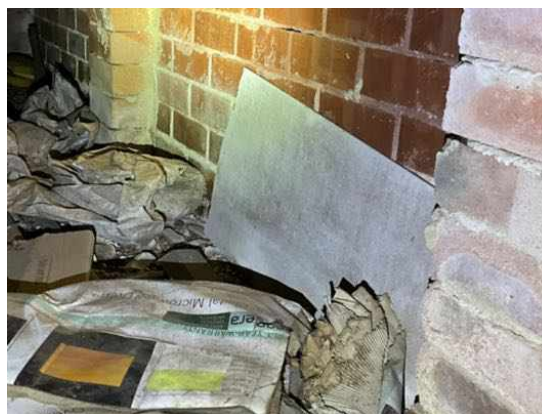
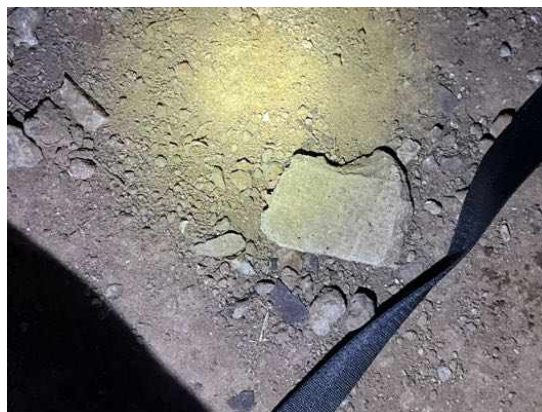
Building:	Main Building
Location:	All Areas
Finding:	Asbestos - Suspected ACM Identified on Site
Information:	Reporting on Asbestos is outside the Scope of this Report. This suspected defect is highlighted as a caution only. We suspect, based on our experience in the building industry, that there is a higher risk of the identified building element containing asbestos.

As Asbestos Reporting is outside the scope of this report, we advise that you consider a separate Asbestos Inspection and Condition Audit, which can include the taking of samples for definitive confirmation of the presence of Asbestos.

In the interim, the client is advised to act with caution, especially when considering any damage to building materials general wear and tear renovations extensions demolition and general maintenance activities due to the suspected presence of Asbestos.

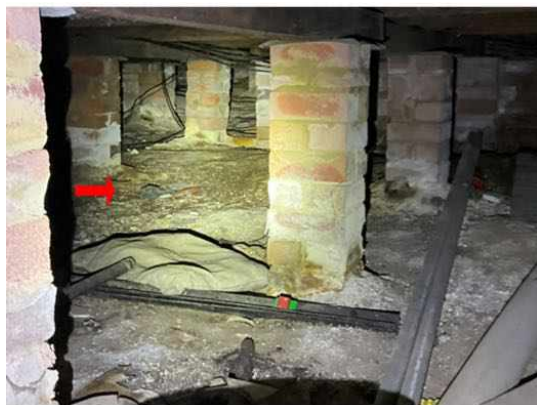
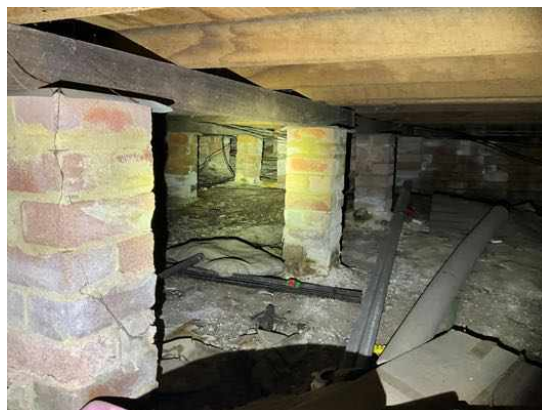
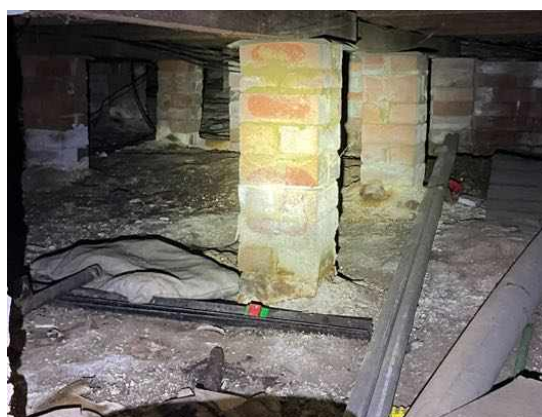
## Finding 1.02

Building:	Main Building
Location:	Subfloor
Finding:	Mould - Present
Information:	Mold growth is present throughout the property, primarily due to inadequate ventilation. Poor airflow and moisture accumulation within the house have created ideal conditions for mold to thrive.

- **Health Hazards**: Mold growth can pose serious health risks to occupants, particularly those with allergies, asthma, or other respiratory conditions. Prolonged exposure to mold spores can cause respiratory issues, skin irritation, and other allergic reactions.
- **Structural Damage**: Mold can degrade building materials over time, leading to rot and weakening of the structural components such as timber, drywall, and insulation, which can result in costly repairs.
- **Decreased Property Value**: The presence of mold can significantly reduce the value of the property, as it indicates underlying moisture and ventilation issues that need addressing.

A licensed mold remediation specialist should be engaged to remove the mold and treat affected areas. In addition, a ventilation expert or builder should assess and improve the house's ventilation system, possibly installing exhaust fans, vents, or mechanical ventilation systems to ensure adequate airflow and prevent future mold growth.

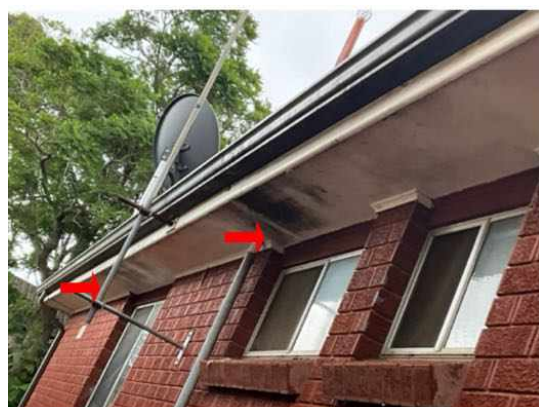
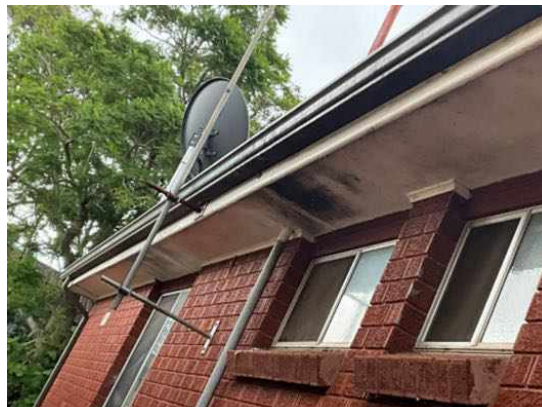
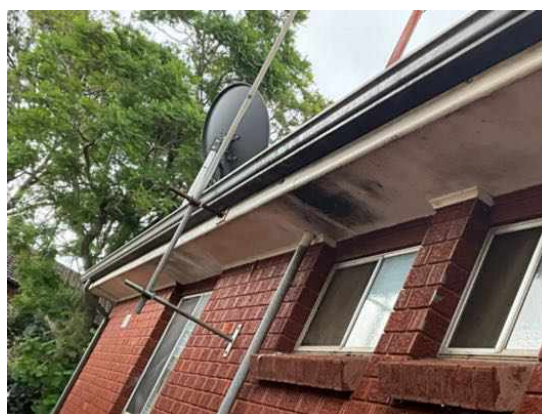
### Finding 2.01

Building:	Main Building
Location:	All Areas
Finding:	Eaves - water Stained
Information:	Water stains are present on eaves, indicating a potential water leak or seepage issue.

Prolonged water exposure can lead to structural damage, mold growth, and compromise the aesthetic appeal of the affected area. Additionally, it may indicate underlying issues that, if unaddressed, can escalate and result in more extensive damage.

A qualified plumber or water damage restoration specialist should investigate and address the source of the water stains. Repairing leaks, improving waterproofing, and, if necessary, restoring the affected surfaces are crucial to preventing further damage and maintaining the integrity of the space.

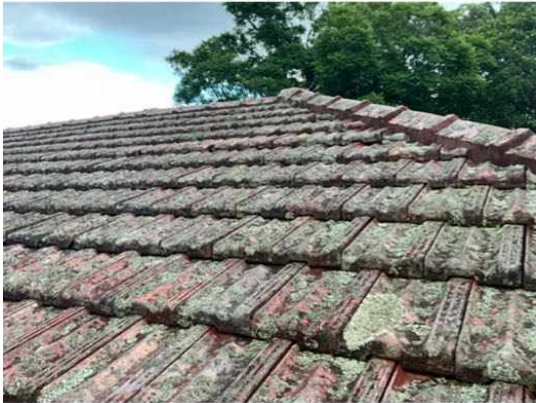
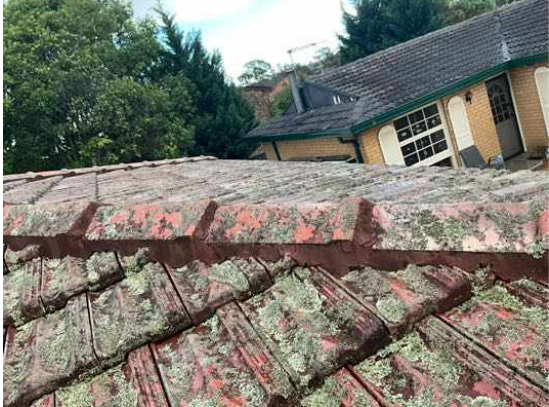
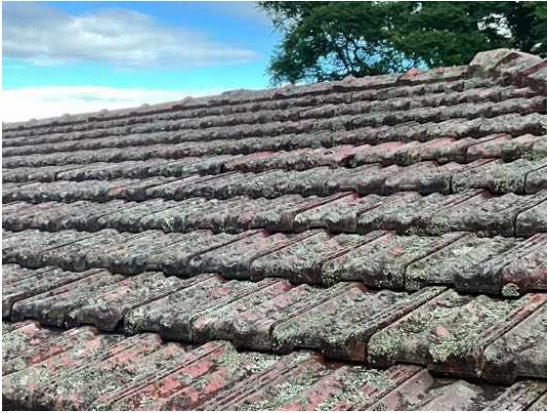
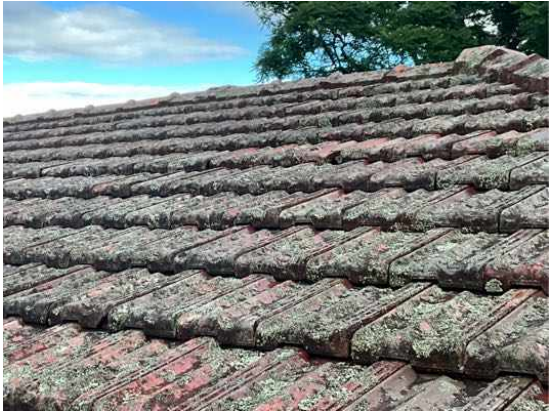
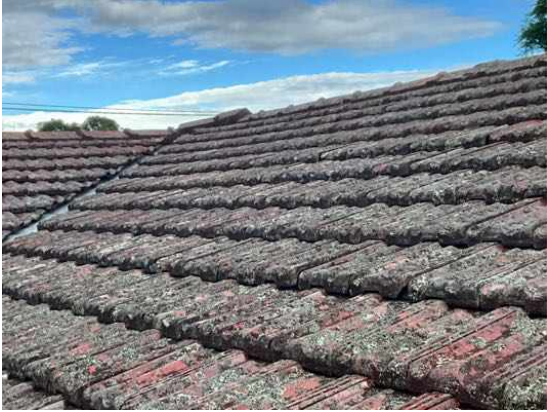
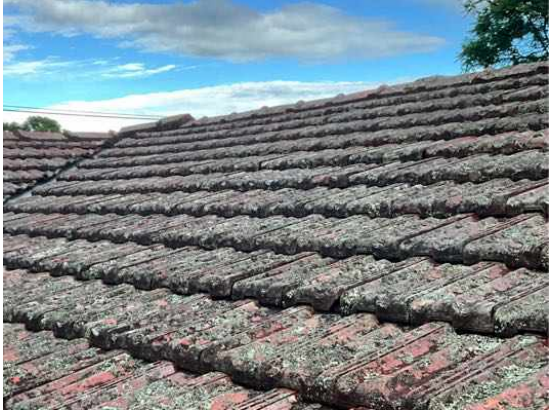
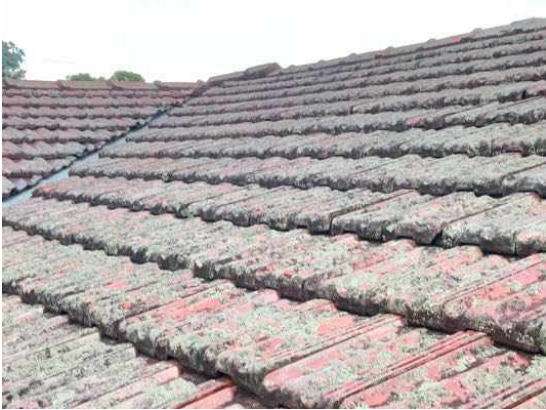
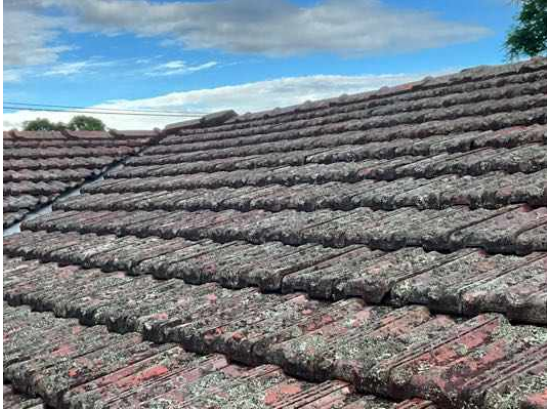
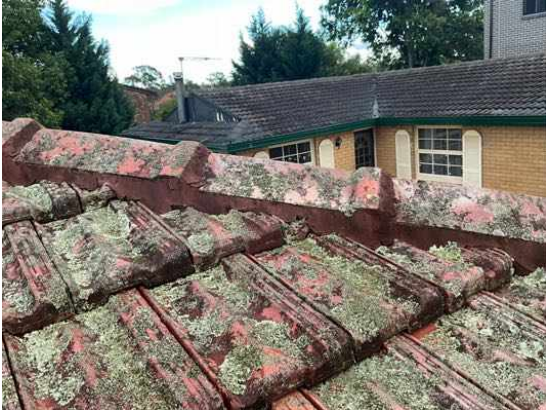
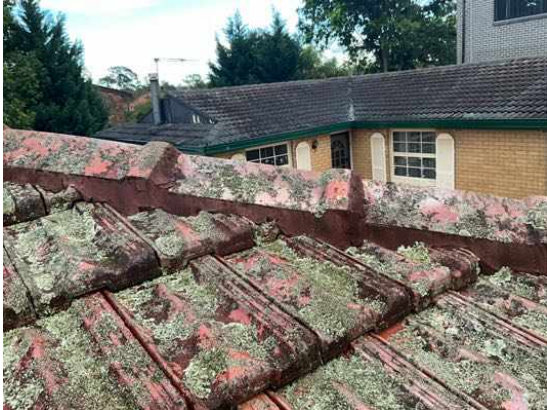
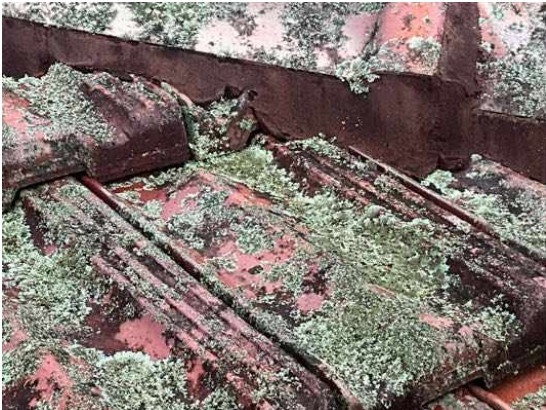
Building:	Main Building
Location:	Roof Exterior
Finding:	Roof Weathered
Information:	Upon inspection of the exterior roofing, the majority of roof was not in a fair condition. While weathering of the roof is consistent with the age of the property, maintenance works are required.

Isolated areas of mortar have come loose in the valleys and minor cracking is also present. Re-pointing and re-sealing the may be considered as an interim solution by the client to help preserve and extend the life span of the tiles.

Where left unmanaged, deteriorating roof are likely to lead to a number of secondary defects, including minor water leaks and weather exposure to internal roofing structures.

Consultation with a roofing contractor is highly advised to gain advice on cost of

remedial works that may be required in the short to medium term. Remedial works are likely to increase the longevity of the exterior roofing structure.

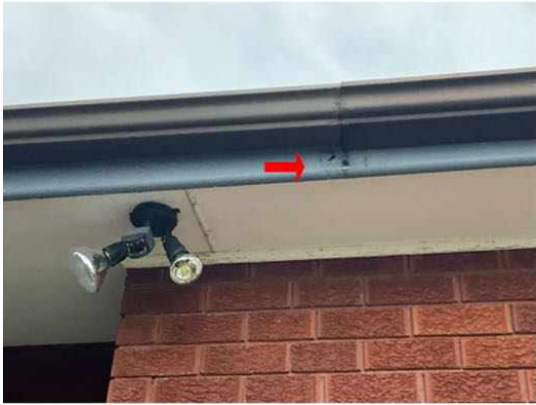
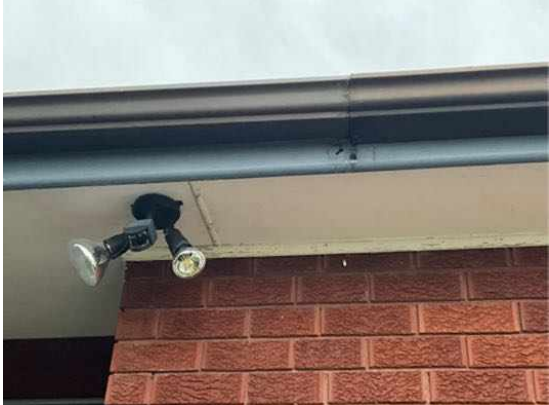
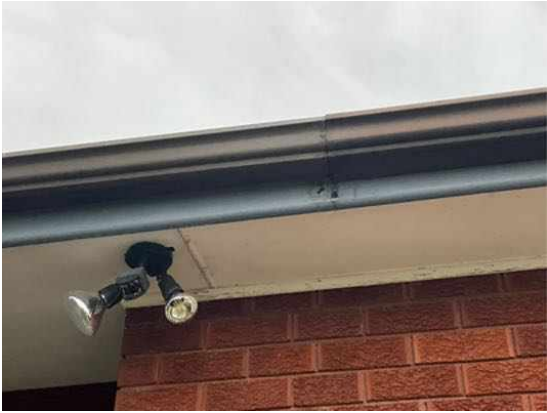
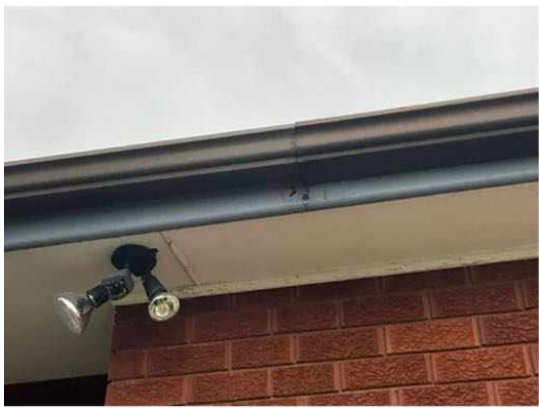
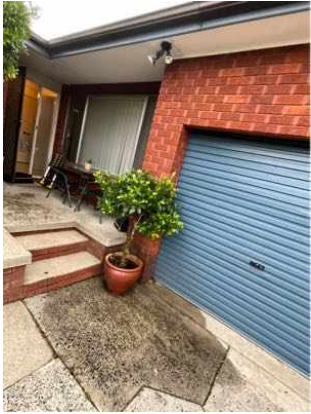
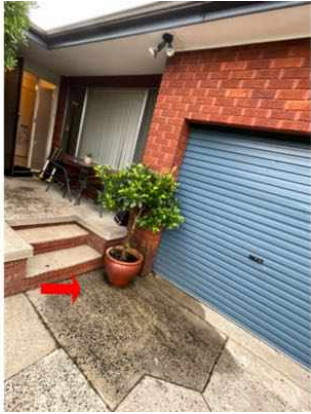
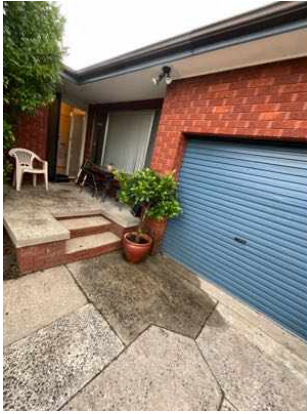
**Finding 2.03**

Building: Main Building  
Location: Roof Exterior  
Finding: Downpipe leakage  
Information: The downpipes in the drainage system exhibit leaking water.

The leaking downpipes pose a risk of water damage to the building’s foundation, exterior walls, and surrounding landscape. Prolonged exposure to moisture can lead to structural deterioration, mold growth, and compromised drainage.

A qualified plumber or roofing specialist should inspect and replace the leaking downpipes. Repair or replacement may involve fixing the areas, applying protective

coatings, or installing new downpipes to ensure proper drainage and prevent further water damage. Early intervention is crucial to avoid escalating issues.

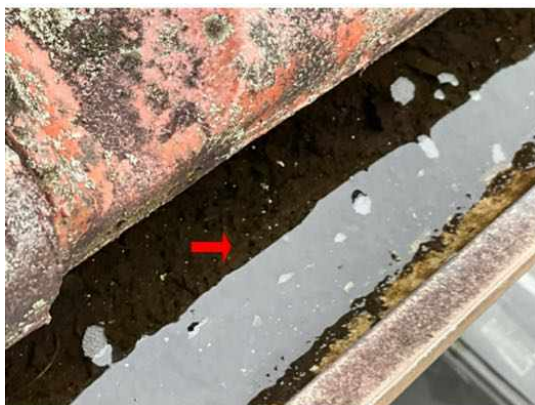
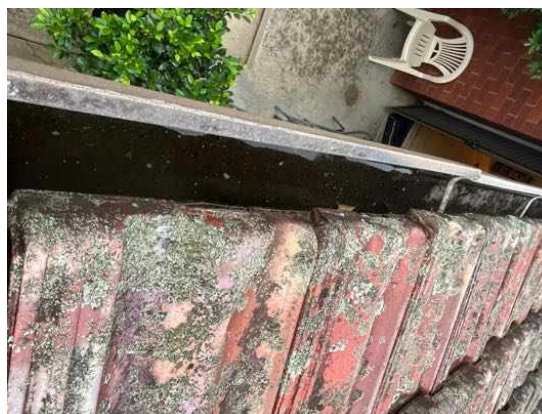
### Finding 2.04

Building:	Main Building
Location:	Roof Exterior
Finding:	Gutters - Water pooling
Information:	Water was found to be pooling in sections of the roof guttering. This is generally a secondary defect caused by blocked or partially blocked gutters. Such blockages and subsequent water pooling are likely to lead to rust and water damage to associated structures if left unattended.

Any areas of guttering that shows evidence of water pooling should be checked for partial or full blockages and any secondary damage that may have occurred as a result. Depending on the extent of the damage, building elements may require repair and/or replacement to ensure adequate roof drainage and function of exterior plumbing system.

A roofing plumber should be appointed as soon as possible to rectify this issue. It is highly advised that all gutters be maintained on a frequent basis to ensure the condition of roof plumbing.

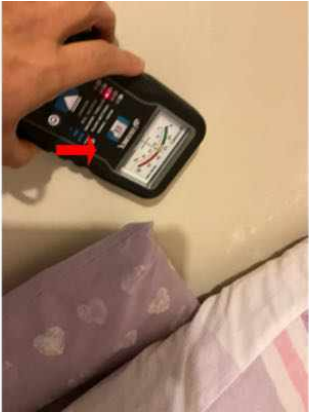
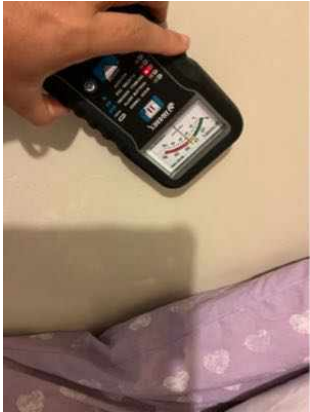
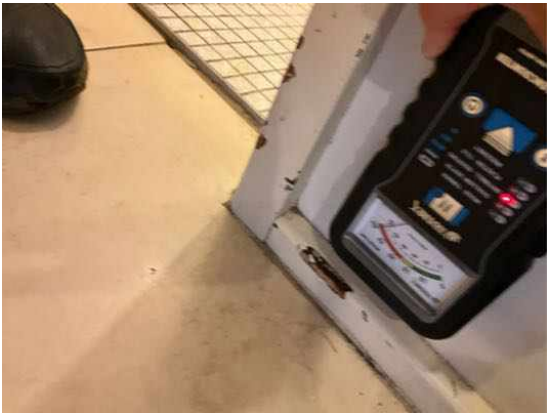
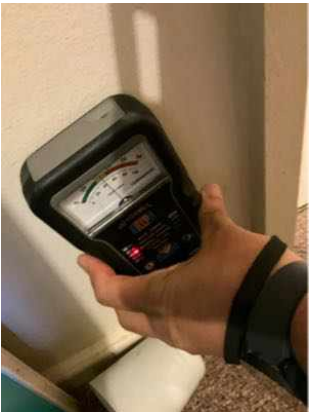
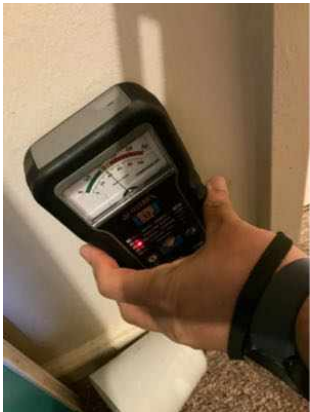
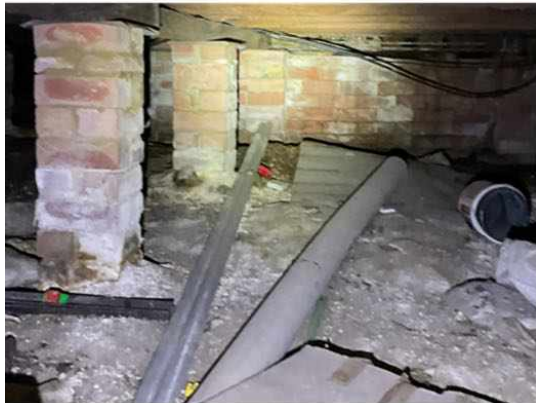
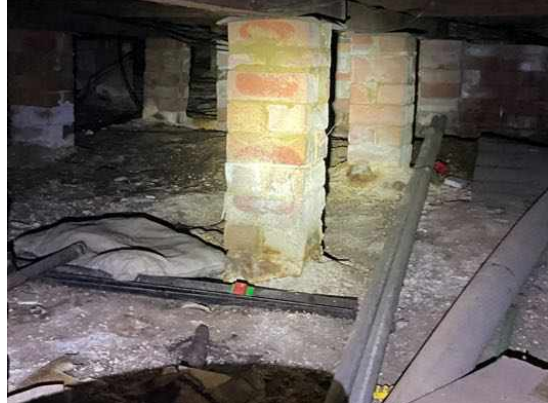
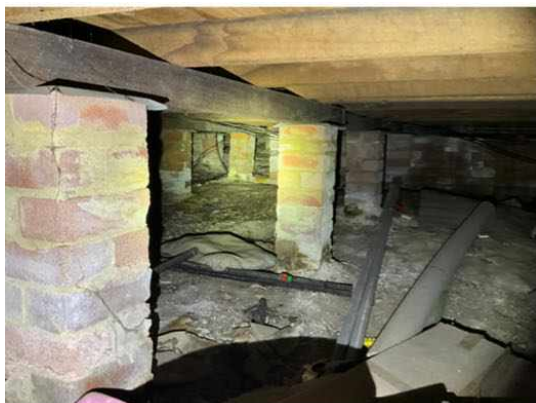
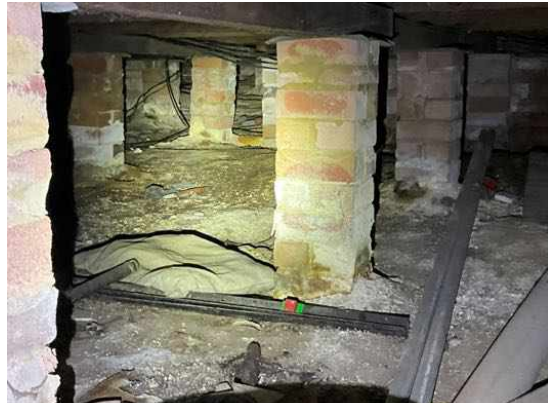
### Finding 2.05

Building:	Main Building
Location:	All Areas
Finding:	Damp - Rising
Information:	Rising damp describes the upward movement of water in low sections of building elements (e.g. walls) by capillary action - the movement of water through porous materials such as bricks, sandstone or mortar.

Rising damp is generally managed by the installation of a damp proof course during construction. A Damp Proof Course (DPC) is an impermeable barrier at the base of the wall above ground level. However, many 19th Century buildings have no damp course installed, or the materials have failed. The DPC may have been omitted as a consequence of poor workmanship, or it may have been bridged where materials built up against the side of the house allow moisture ingress above the DPC level.

The first step in addressing rising damp is to diagnose the cause. The identified cause should be addressed first before addressing the appearance and other defects which have resulted from the rising damp. If the original cause is not resolved, further cases of damp are likely to ensue, resulting in secondary defects.

Consultation with a qualified plumber is advised immediately to identify the cause of the damp and perform remedial works as required.

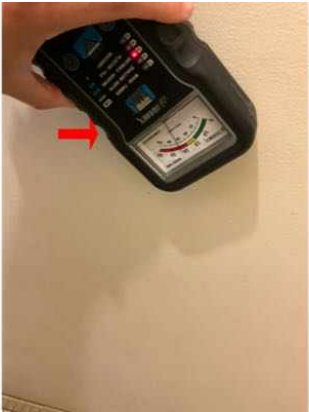
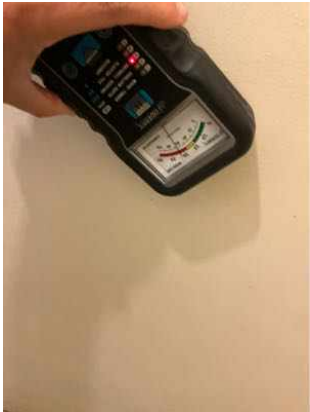
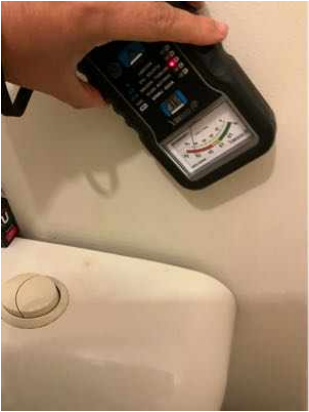
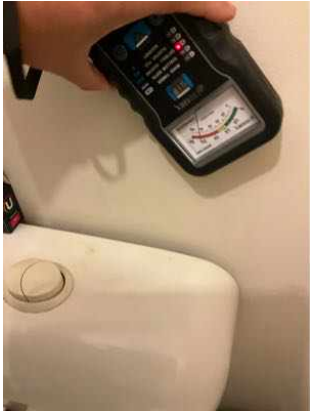
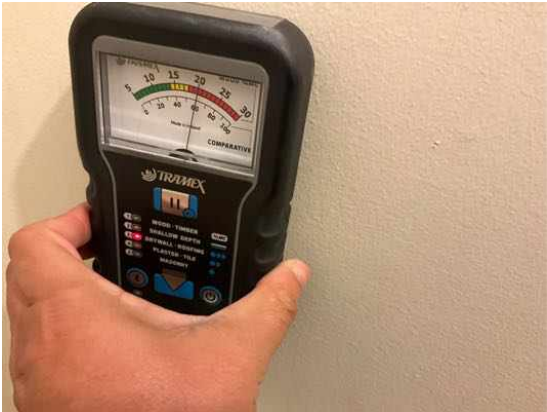
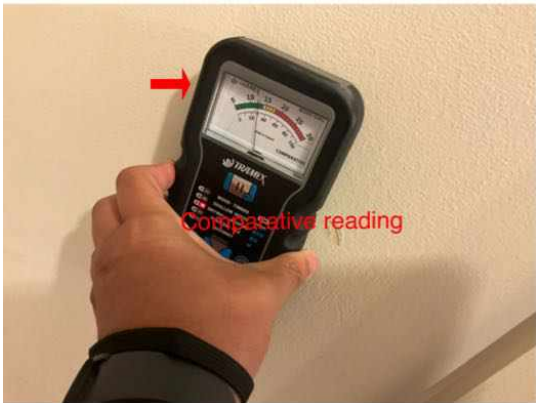
## Finding 2.06

Building:	Main Building
Location:	Toilet (WC)
Finding:	Evidence of excessive moisture - Drywall
Information:	Excessive moisture is present at the time of , indicating a potential water leakage issue within the wall.

The prolonged presence of moisture can lead to mold growth, deteriorate the structure, and create an environment conducive to health hazards. Additionally, it may compromise the adhesive holding the tiles, leading to their detachment.

A licensed plumber or a qualified contractor specializing in water damage remediation

should investigate the source of the moisture, fix any leaks, and address the damage. Additionally, replacing affected tiles and ensuring proper waterproofing are crucial to preventing future issues.

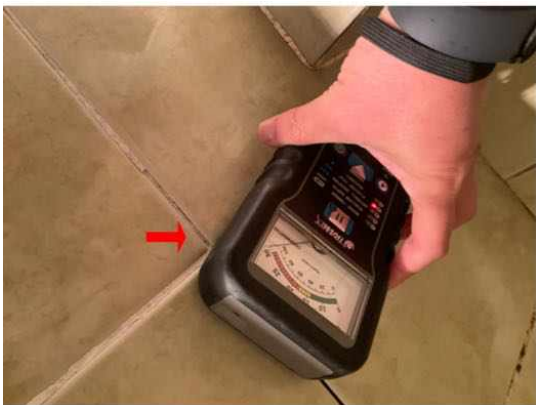
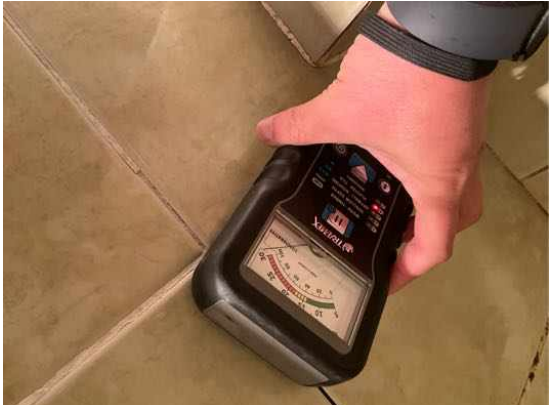
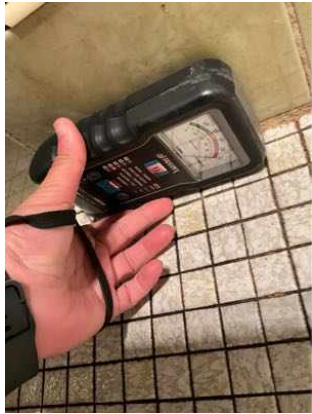
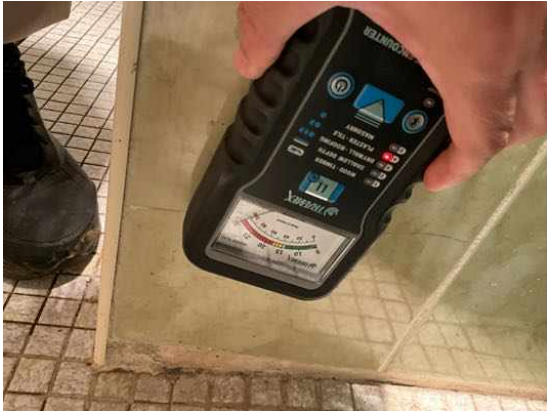
**Finding 2.07**

Building: Main Building  
 Location: Bathroom  
 Finding: Evidence of excessive moisture was present at the time of inspection  
 Information: Excessive moisture is present behind the bathroom tiles, indicating a potential water leakage issue within the wall.

The prolonged presence of moisture can lead to mold growth, deteriorate the structure, and create an environment conducive to health hazards. Additionally, it may compromise the adhesive holding the tiles, leading to their detachment.

A licensed plumber or a qualified contractor specializing in water damage remediation should investigate the source of the moisture, fix any leaks, and address the damage. Additionally, replacing affected tiles and ensuring proper waterproofing are crucial to preventing future issues.

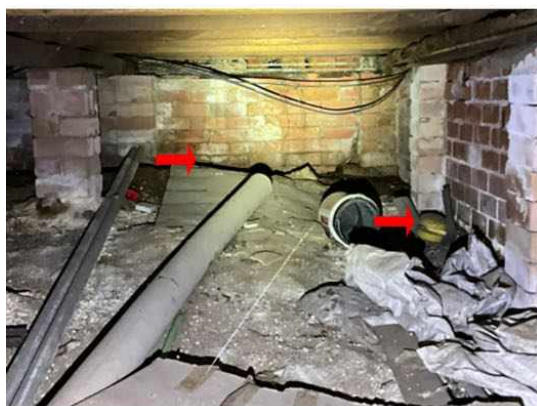
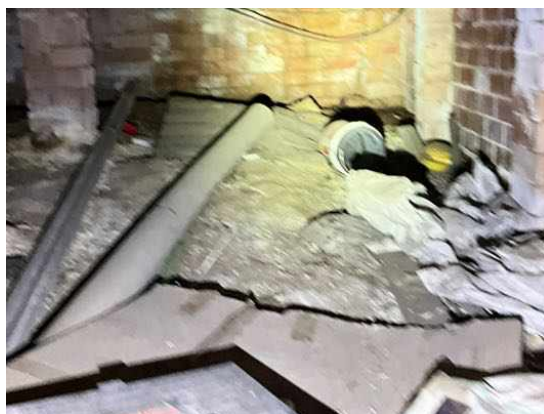
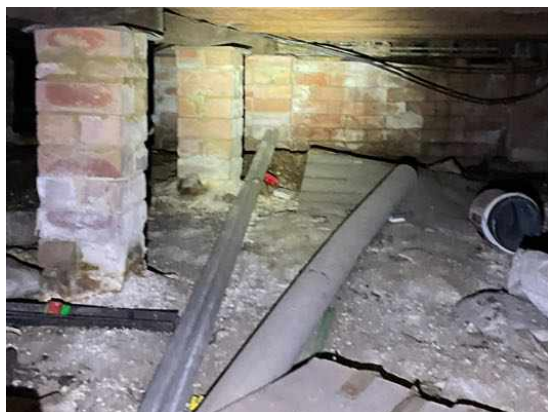
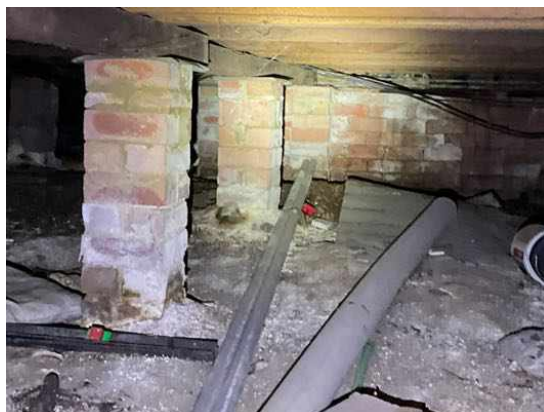
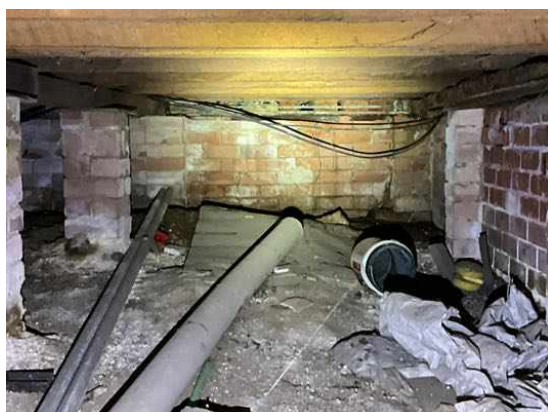
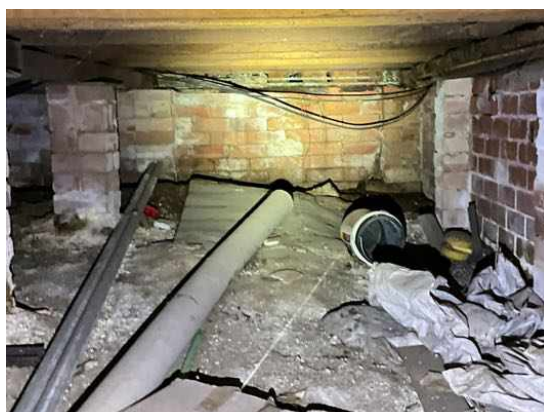
### Finding 2.08

Building:	Main Building
Location:	Subfloor
Finding:	BRICKWORK – NO DAMP-PROOF COURSE (DPC) CAUSING RISING DAMP
Information:	The brickwork shows signs of rising dampness due to the absence of a damp-proof course (DPC), allowing moisture from the ground to rise through capillary action. This has the potential to cause visible staining, salt efflorescence, and long-term deterioration of mortar joints and brickwork integrity.

To rectify this, a new DPC system must be installed – either by chemical injection (e.g. silicone-based DPC cream) or through physical membrane insertion. Remedial works may also include removal and replacement of severely deteriorated bricks, repointing of mortar joints, and the application of a breathable waterproof barrier to minimise future moisture ingress.

All rectification works should be undertaken by a licensed builder or damp specialist, ensuring compliance with NCC Volume 2, Part 3.3.4 and AS 3700 (Masonry Structures) for structural durability and moisture protection.

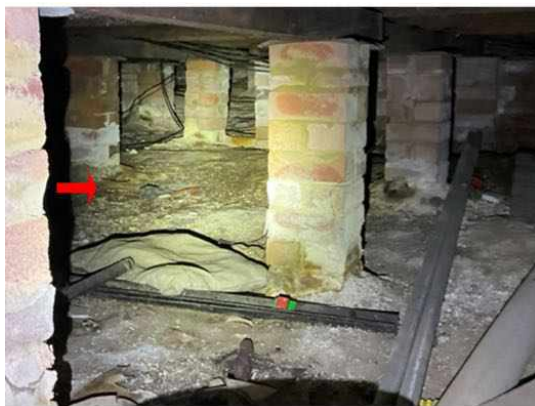
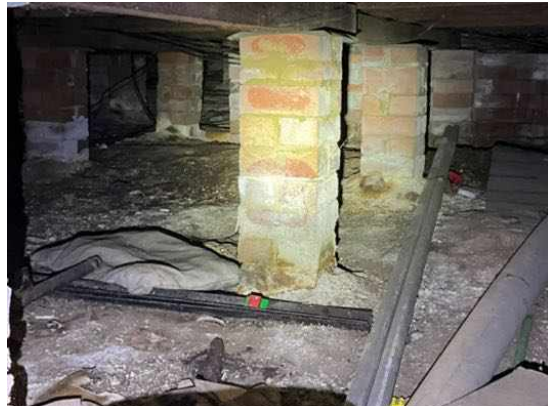
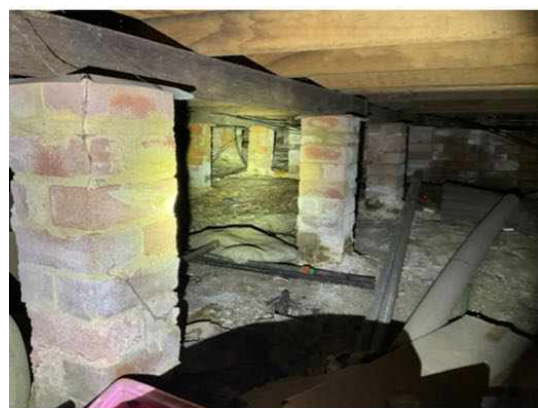
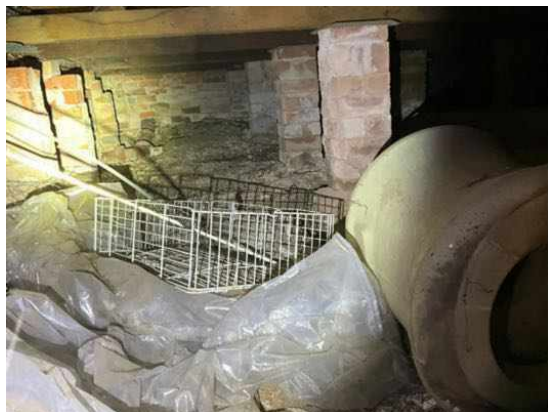
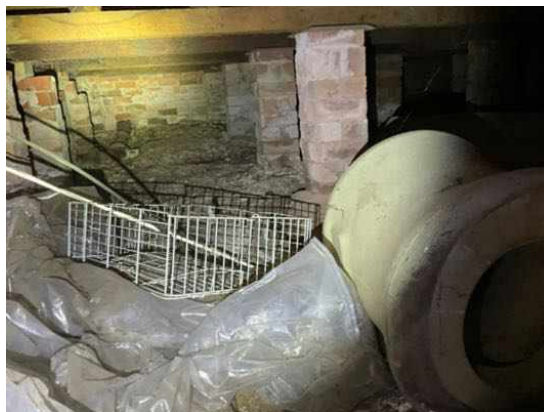
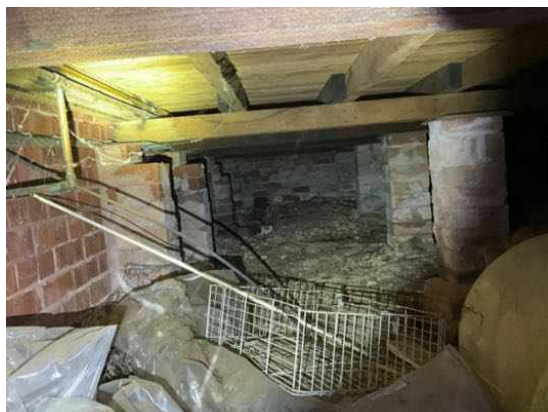
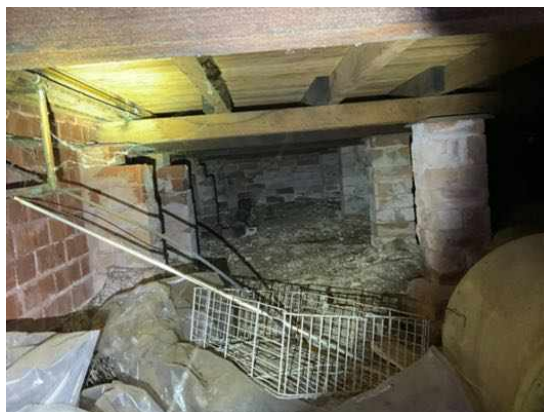
### Finding 2.09

Finding: Subfloor - Site drainage - Inadequate

Information: The site exhibits poor drainage under the subfloor, leading to several critical issues. Water accumulates and does not properly drain away from the subfloor area, creating a hazardous condition.

2. Risk of subfloor structural damage due to prolonged moisture exposure.
3. Potential for mold and mildew growth, compromising indoor air quality and a potential of Termite attack.
4. Safety hazard for occupants due to slippery surfaces and potential electrical hazards.

The poor site drainage under the subfloor poses a significant safety risk to the occupants, as it can lead to structural damage and health hazards.

This issue requires immediate attention and rectification. A licensed and experienced plumber or licensed builder specialising in drainage and foundation work should be engaged to assess the problem and implement necessary drainage solutions, such as improved grading, installation of drainage systems, and moisture barrier enhancements. Regular maintenance and inspections should also be scheduled to prevent future occurrences. Water damage and secondary defects are likely to occur if left unmanaged.

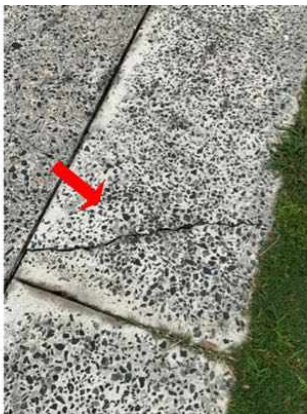
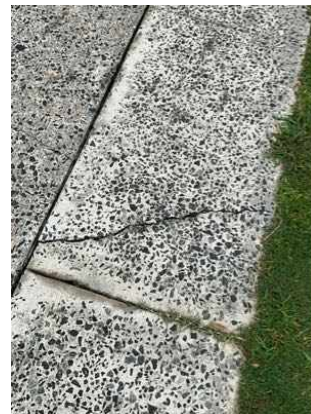
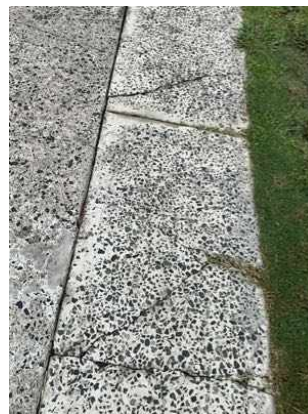
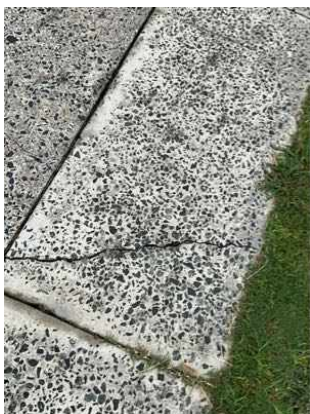
### Finding 3.01

Building:	Main Building
Location:	All Areas
Finding:	Noticeable Cracking in Concrete Slab
Information:	Noticeable cracking has been observed in the concrete slab, failing to meet the required construction and quality standards.

- Cracks are visible on the surface and may extend through the depth of the slab.
- Evidence of improper curing or inadequate reinforcement leading to cracking.

The presence of noticeable cracks in the concrete slab can result in:

- Compromised structural integrity of the slab, potentially leading to failure under load.

- Water ingress through cracks, causing corrosion of reinforcement and further weakening the structure.
- Potential trip hazards and aesthetic issues, reducing the overall value and safety of the property.
- Increased maintenance and repair costs due to ongoing deterioration.

- A structural engineer should be engaged to assess the extent of the cracking and recommend appropriate repair methods.
- A licensed contractor or concrete repair specialist should carry out the recommended repairs under the guidance of the structural engineer.

A detailed inspection should be conducted post-repair to confirm compliance with the required standards and to ensure that the structural integrity of the concrete slab has been restored.
