# Building and Timber Pest Inspection Report

Inspection Date: Fri, 27 Mar 2026

Property Address: 90 Carlisle St, Ingleburn NSW 2565,  
Australia

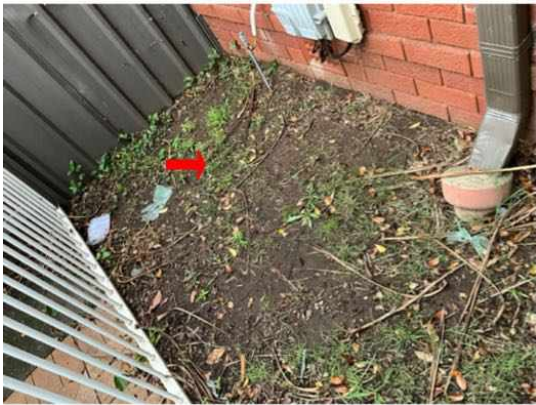
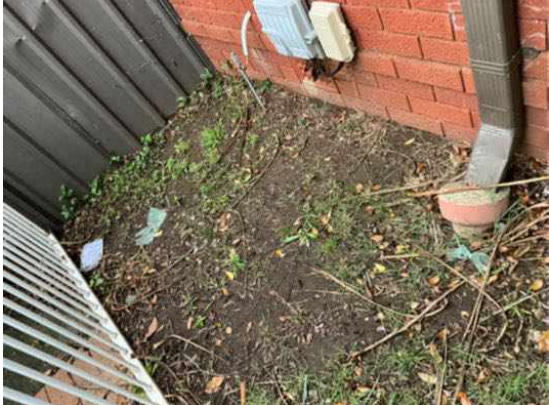
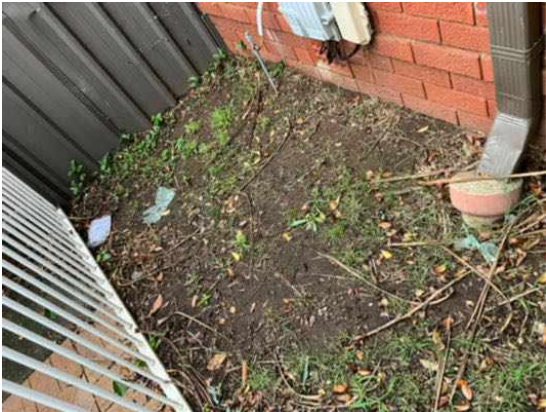
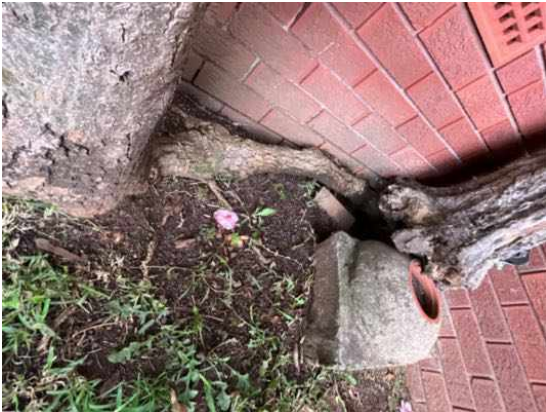
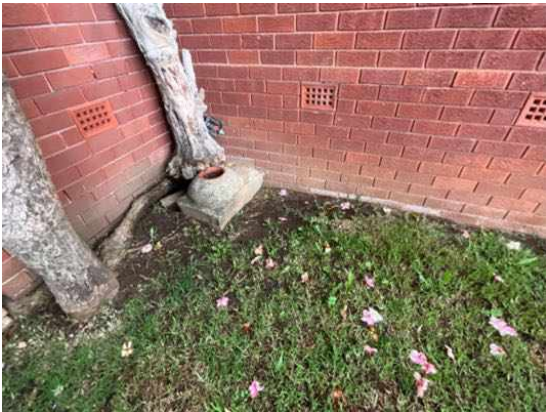
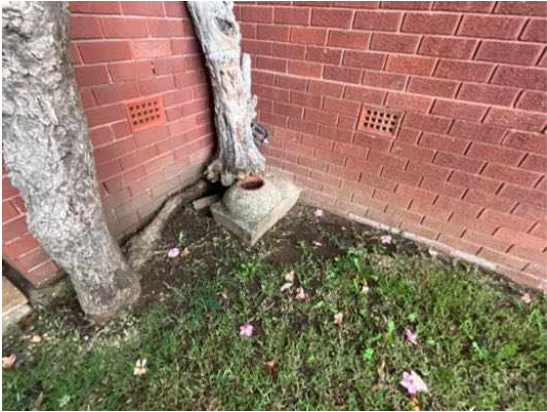
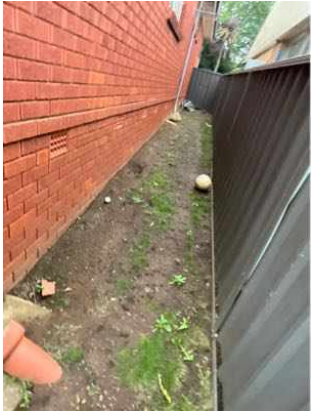
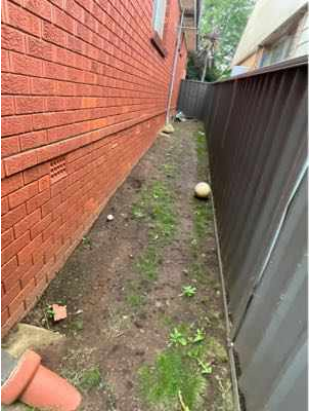
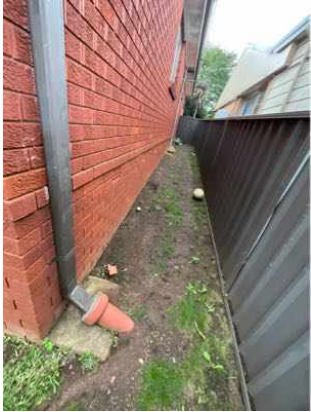
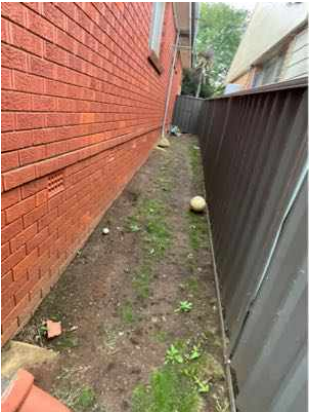
### Finding 3.02

Building:	Main Building
Location:	All Areas
Finding:	Perimeter - Insufficient Fall
Information:	The perimeter ground levels were found to have an inadequate slope away from the adjoining building structure, creating potential for water pooling in this area.

Perimeter is required to fall from the building by a minimum of 25mm in the first metre and bare ground should fall away from the house by 50mm in the first meter. This standard ensures that excessive moisture does not pool around the base of building structures, which creates potential for water and structural damage, as well as making the area susceptible to termite and timber pest activity.

Where ground levels do not have adequate fall, a licensed paving contractor should be appointed to install or remove and re-level pavement.

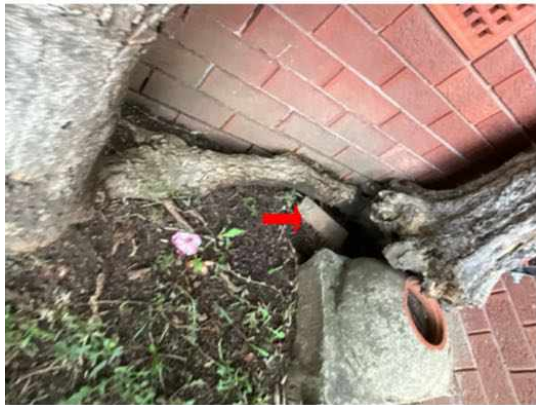
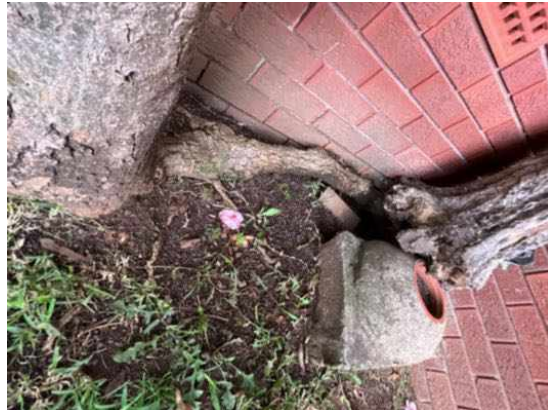
**Finding 3.03**

Building: Main Building  
Location: Yard - Back  
Finding: Tree Roots Adjacent to Structure  
Information: Tree roots were observed encroaching beneath and in close proximity to the building structure and footings. This condition has the potential to cause future structural movement, displacement of footings, cracking to masonry elements, and possible damage to underground services as the roots continue to grow and expand.  
Risk:  
Ongoing root growth may lead to differential movement, cracking of brickwork, and

disturbance of foundations, which can result in costly structural repairs if left unmanaged.

It is recommended that a qualified arborist be engaged to assess the tree and root system, and to provide advice on appropriate management such as root pruning, installation of root barriers, or tree removal if required. Further assessment by a structural engineer may be necessary where structural impact is identified.

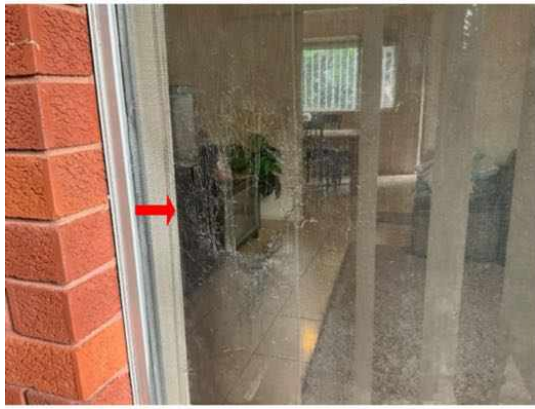
### Finding 3.04

Building:	Main Building
Location:	Front Elevation
Finding:	Damaged insect grill
Information:	The insect grill is damaged , compromising its ability to prevent insects from entering the designated area.

Increased likelihood of insect infiltration, potentially leading to hygiene issues and discomfort for occupants.

A qualified maintenance technician or facilities management team should address the broken insect grill promptly to restore its functionality and prevent the associated risks.

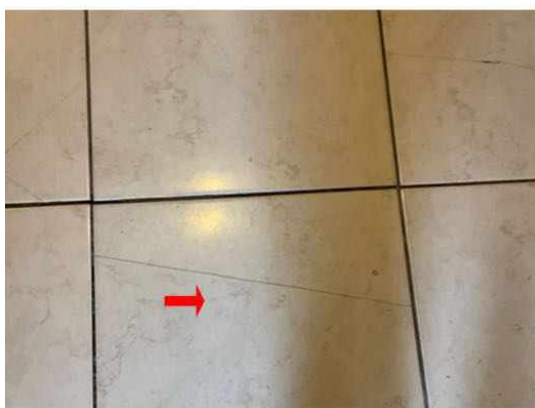
### Finding 3.05

Building: Main Building  
 Location: All Areas  
 Finding: Floor Tile crack  
 Information: A floor tile has a visible crack on the surface.

The damaged tile presents a trip hazard, may lead to cuts if stepped on barefoot, and can allow moisture ingress into the substrate, which may cause further deterioration or loosening of adjacent tiles. It also affects the overall appearance of the floor.

A licensed tiler should be engaged to remove the damaged tile and install a matching replacement. If spare tiles are unavailable, additional remedial work may be required to blend the repair with surrounding finishes.

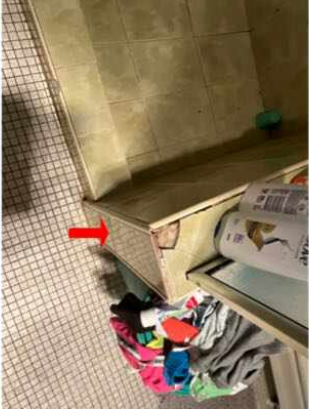
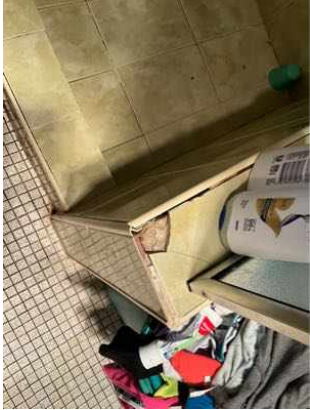
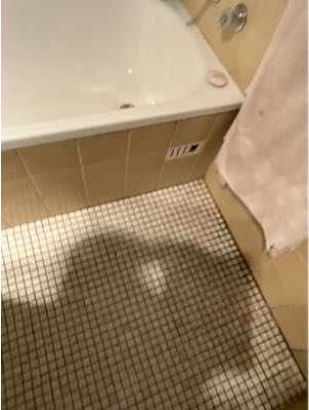
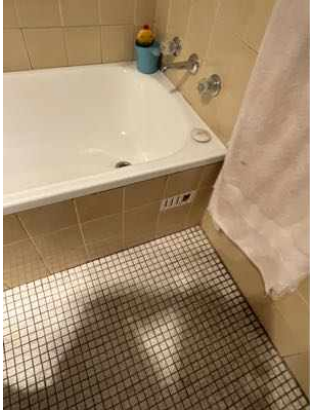
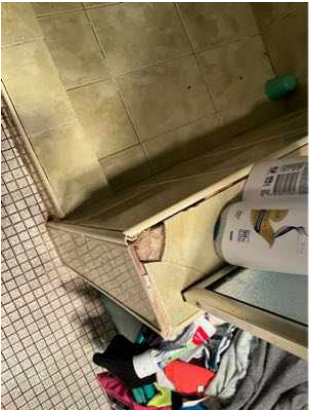
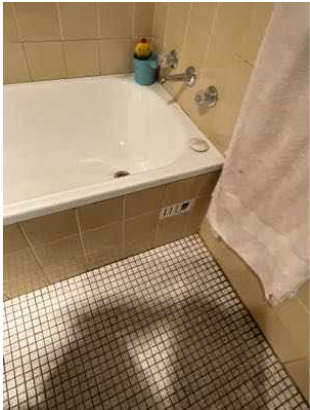
### Finding 3.06

Finding: Tiles - Cracked or damaged

Information: Cracking was evident to the tiling in this area at the time of inspection. While the cracking appears to be minor, this area is frequently exposed to water, allowing potential for water penetration into adjoining sections of walls or flooring.

If left unmanaged, water penetration to these areas may lead to subsequent water damage, which is likely necessitate repair work to affected building elements.

A tiling contractor should be appointed to ensure that no further water damage

occurs. The re-application of silicone and grouting throughout remaining tile work is also advised, to further protect the area against water penetration.

Where water penetration has led to water damage, appointment of a relevant tradesperson may be required to repair damaged building elements.

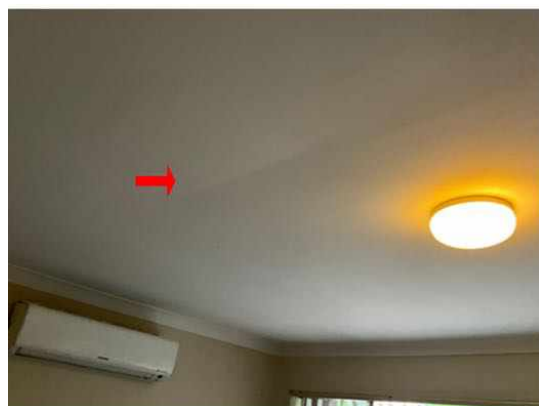
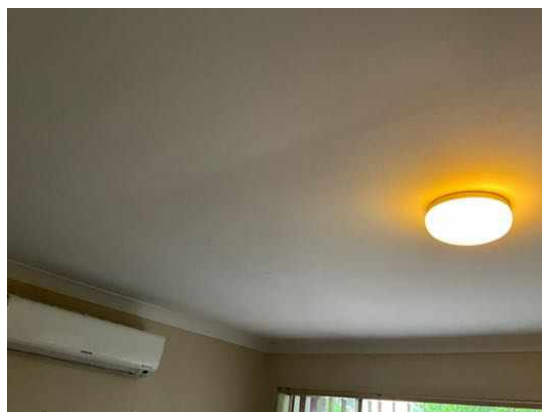
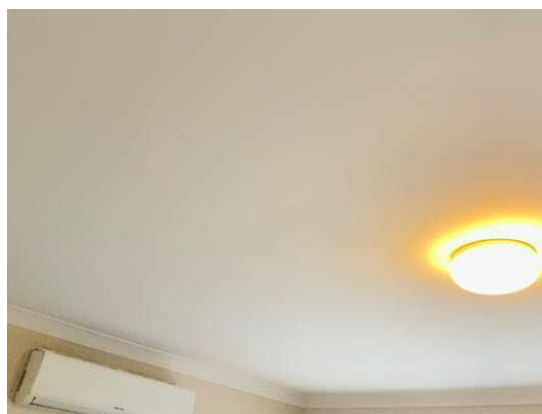
### Finding 3.07

Building:	Main Building
Location:	Living Room
Finding:	Sagging Ceiling Lining
Information:	The ceiling lining exhibits visible sagging/deformation, which is indicative of potential failure of the fixing system and/or deterioration of the plasterboard. This condition may be associated with inadequate fixing, moisture ingress, or age-related material fatigue. The defect is considered significant as it may compromise the structural integrity of the ceiling lining.

- Risk of sudden collapse of the ceiling lining, posing a safety hazard to occupants
- Potential presence of underlying issues such as roof leaks or moisture damage
- Progressive deterioration if not addressed in a timely manner

It is recommended that a licensed builder or qualified plasterer be engaged to assess and rectify the issue. Further investigation may be required to identify any underlying causes (e.g. roof leaks), and repairs should be carried out in accordance with relevant Australian Standards.

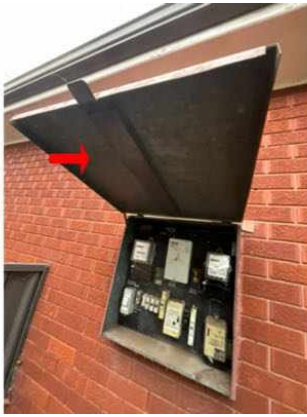
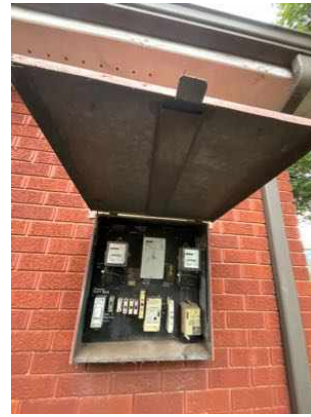
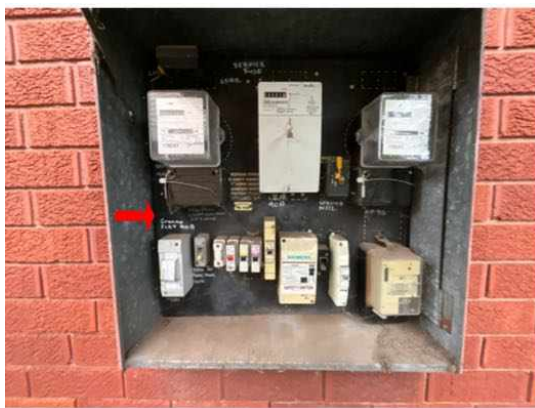
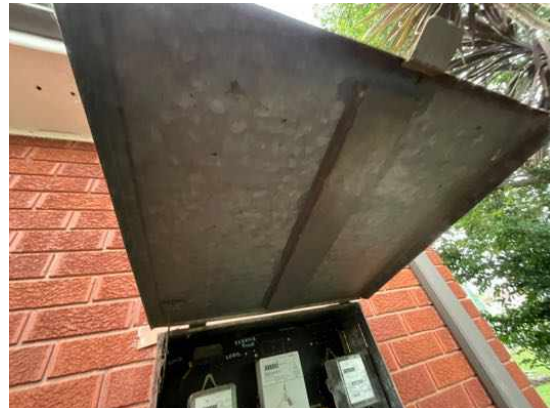
Building: Main Building  
 Location: Exterior walls - left side  
 Finding: No Evidence of Termite Management System - Durable notice / Legible Sticker  
 Information: The application of a pre & post-construction chemical termite barrier is highly recommended for all properties. Such barriers are highly effective in preventing termite attack on any timber building elements throughout the property.

Client must seek further information from the vendor or real estate agent if the

conditions of termite management systems were maintained.

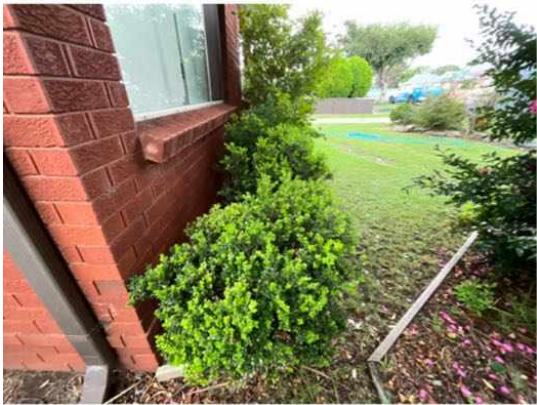
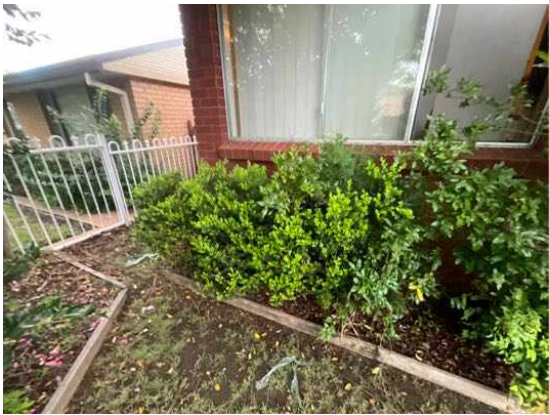
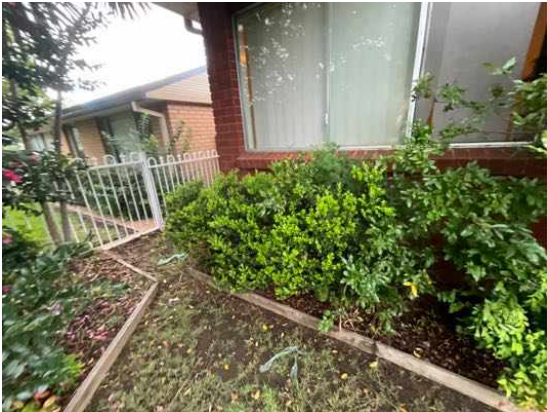
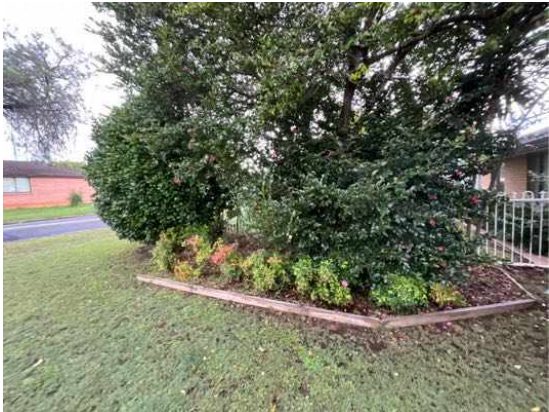
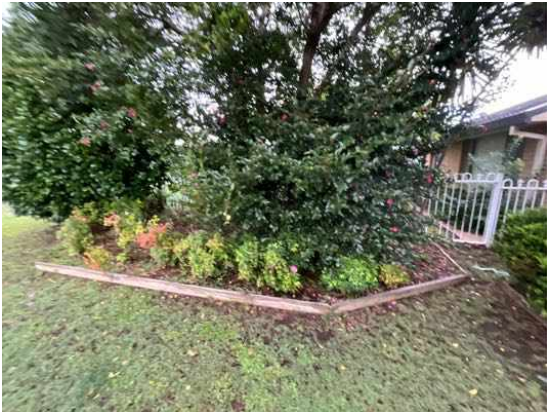
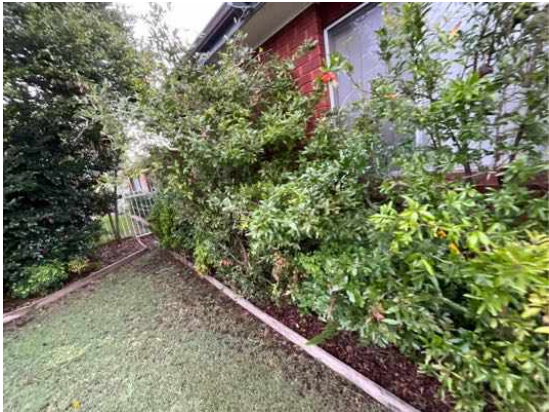
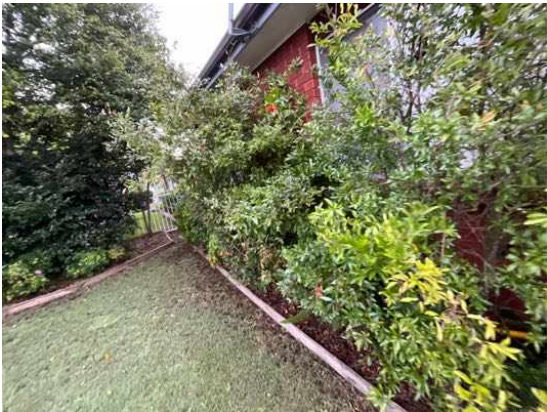
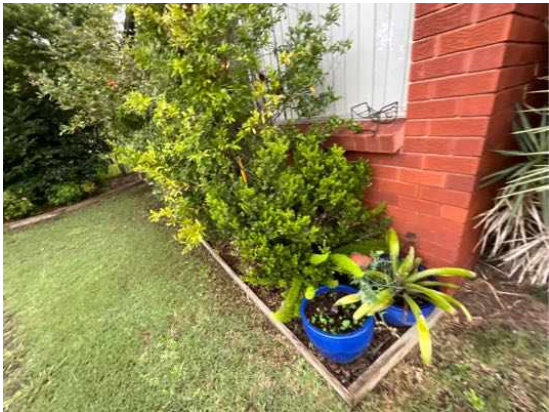
### Finding 6.02

Building:	Main Building
Location:	All Areas
Finding:	Dense vegetation around a property can increase the risk of termite infestation
Information:	The presence of dense vegetation around a property can increase the risk of termite infestation, as it provides a conducive environment for them. To address this, consider maintaining a clear space between the vegetation and your home. If you suspect a termite issue, it's advisable to consult with a licensed pest control professional for inspection and treatment.

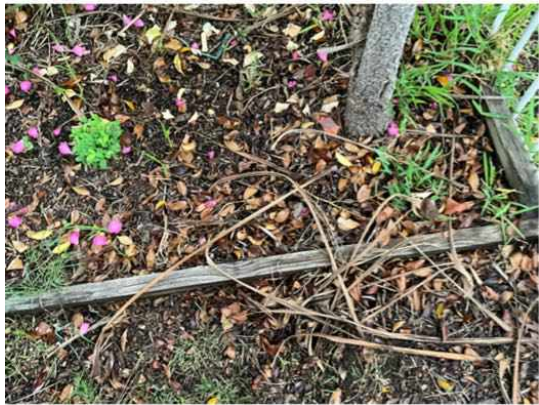
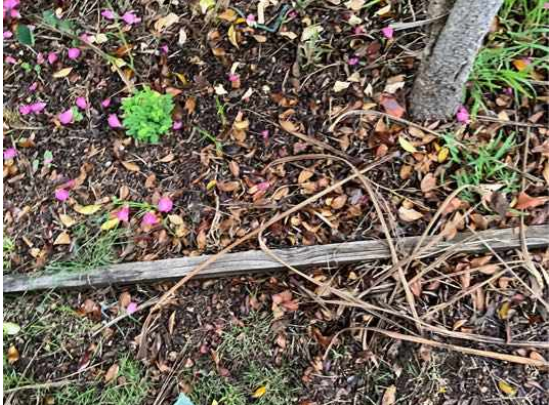
**Finding 6.03**

Building: Main Building  
Location: All Areas  
Finding: Timber on ground / conducive conditions to termite damage  
Information: Timber on the ground is indeed conducive to termite damage. Termites are known to thrive in moist environments, and wood in contact with soil or moisture is more susceptible to infestation.

To prevent this, it's important to keep timber elevated and away from direct ground contact. Regular inspections and proper termite control measures are also essential to protect your wooden structures from termite damage.

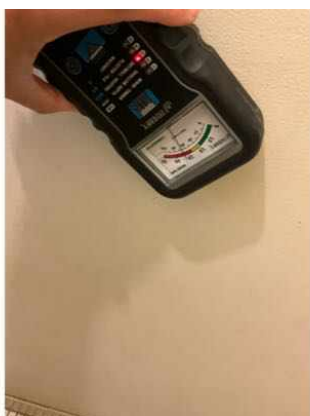
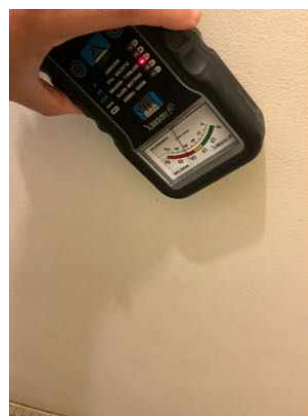
### Finding 6.04

Building:	Main Building
Location:	All Areas
Finding:	Excessive moisture - Conducive to Timber pest
Information:	Excessive moisture can attract termites and produce conditions that promote fungal growth and wood decay.

Excessive moisture is generally caused by deteriorated inadequate or missing roof drainage leaking plumbing pipes or fixtures poorly plumbed HWS overflows or condenser units and poor site drainage.

Prior to any remedial works being performed a qualified plumber should be appointed to further inspect the property and to identify the cause of the excessive moisture. Works to remove affected building elements may then be necessary and should be performed by an appropriate tradesperson.

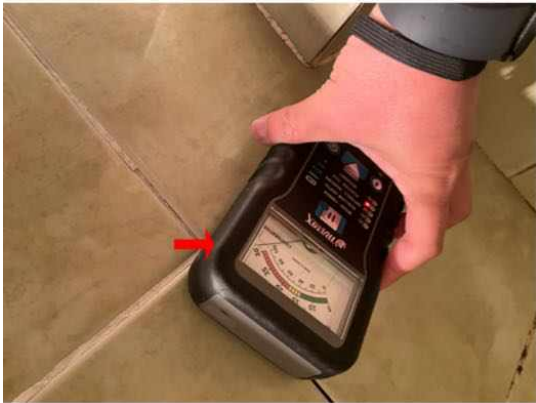
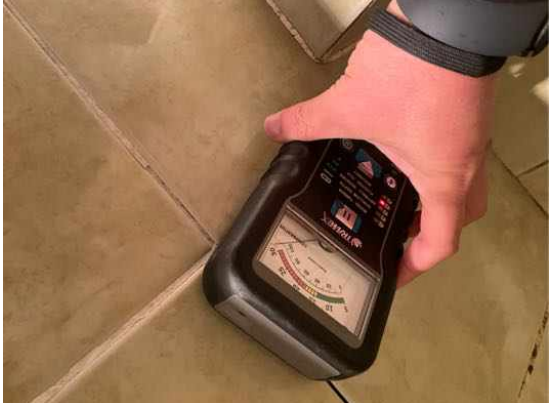
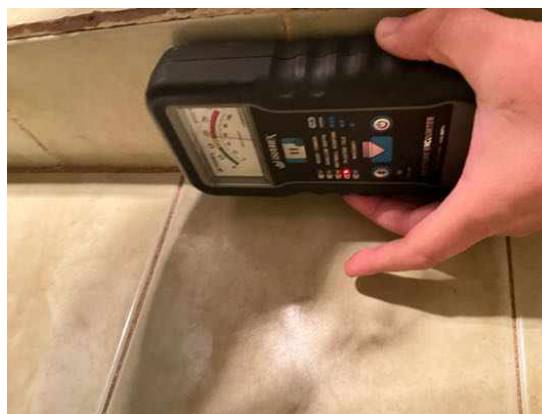
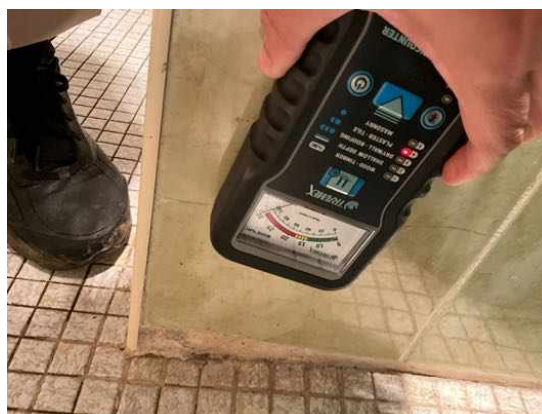
### Finding 6.05

Building:	Main Building
Location:	Bathroom
Finding:	Excessive moisture - Conducive to Timber pest
Information:	Excessive moisture can attract termites and produce conditions that promote fungal growth and wood decay.

Excessive moisture is generally caused by deteriorated inadequate or missing roof drainage leaking plumbing pipes or fixtures poorly plumbed HWS overflows or condenser units and poor site drainage.

Prior to any remedial works being performed a qualified plumber should be appointed to further inspect the property and to identify the cause of the excessive moisture. Works to remove affected building elements may then be necessary and should be performed by an appropriate tradesperson.

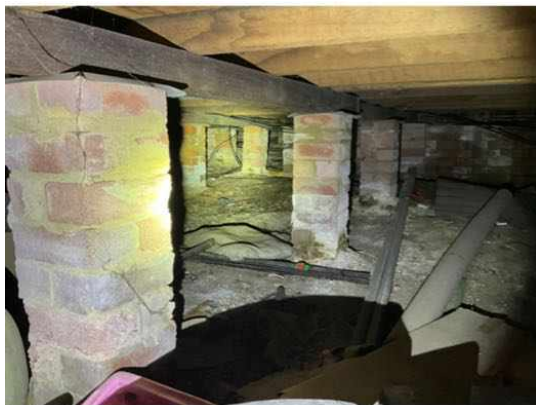
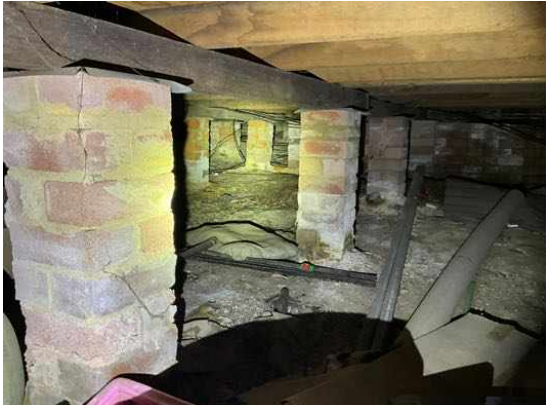
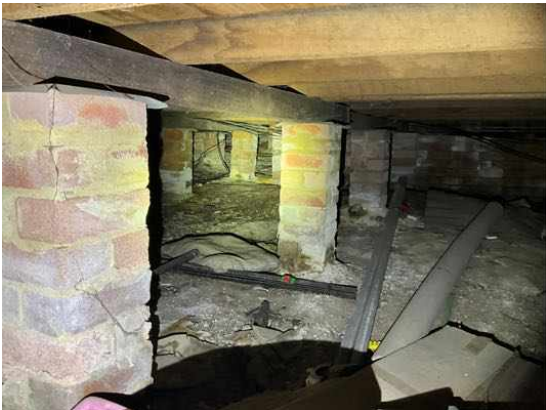
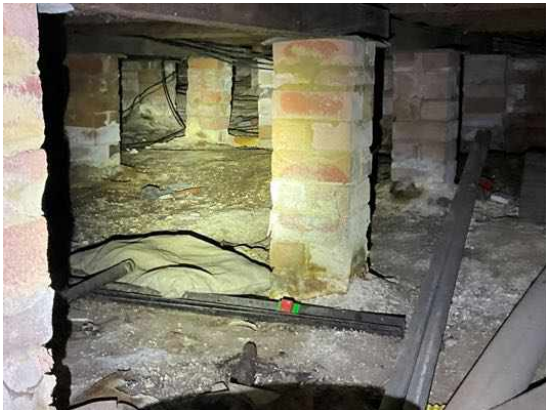
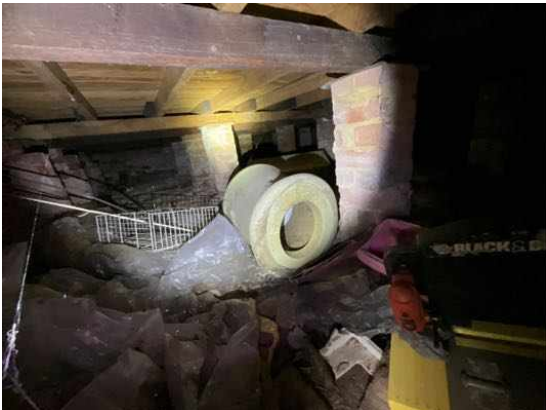
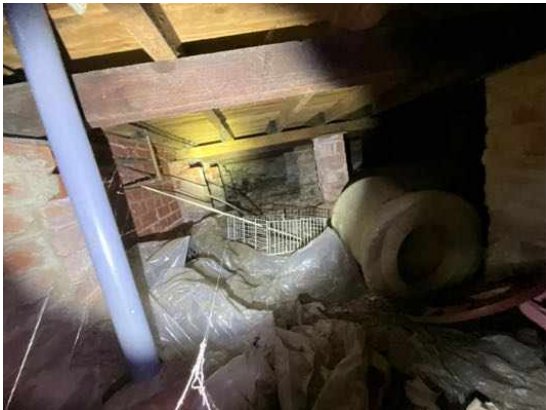
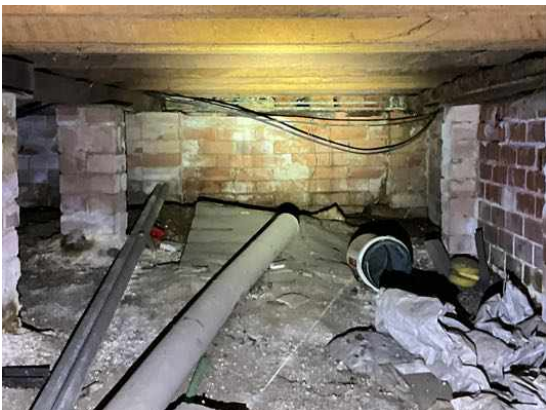
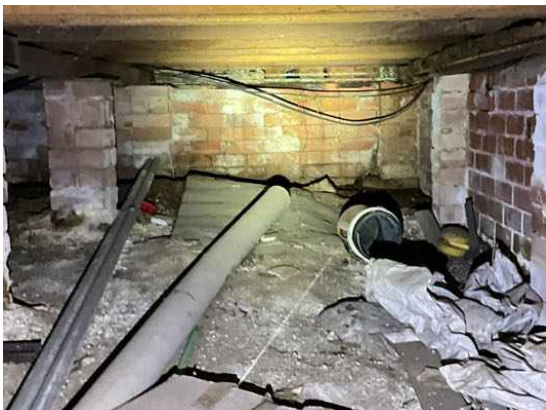
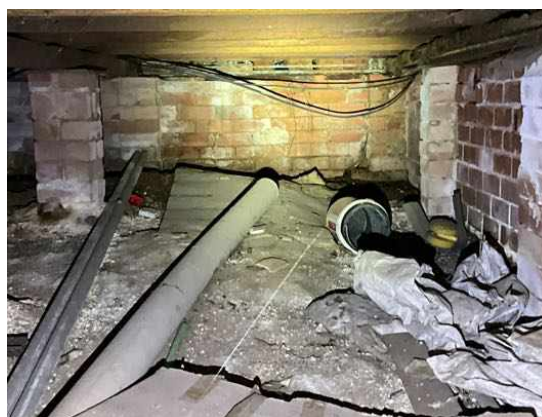
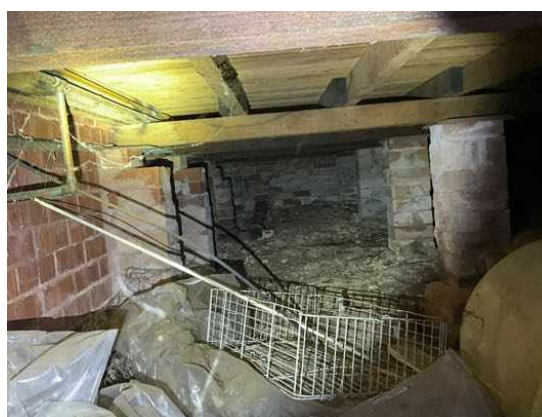
### Finding 6.06

Building:	Main Building
Location:	Subfloor
Finding:	Subfloor - poor ventilation, inadequate site drainage, water stains
Information:	The subfloor lacks adequate ventilation, suffers from inadequate site drainage, exhibits water stains, creating conducive conditions for timber pests such as termites.

Risk: The combination of poor ventilation, inadequate drainage, water stains significantly increases the risk of timber pest infestations. Termites are attracted to moist environments and can thrive in subfloors with high humidity levels and water damage. The lack of proper ventilation and drainage exacerbates moisture retention, providing an ideal habitat for timber pests to establish colonies and cause extensive damage to the subfloor structure. Additionally, water stains indicate previous or ongoing moisture issues, which further attract timber pests and contribute to the deterioration of timber materials.

A licensed pest control professional specializing in timber pest management should be consulted to assess the extent of the infestation and develop a comprehensive treatment plan. They can implement strategies to eliminate existing timber pests, such as termites and prevent future infestations by addressing underlying moisture issues. Additionally, a qualified plumber or builder may be needed to improve subfloor ventilation, enhance site drainage, repair water-damaged areas. Regular inspections and maintenance are essential to ensure ongoing protection against timber pests and

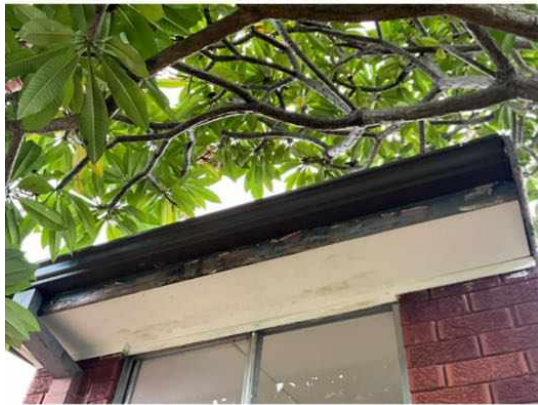
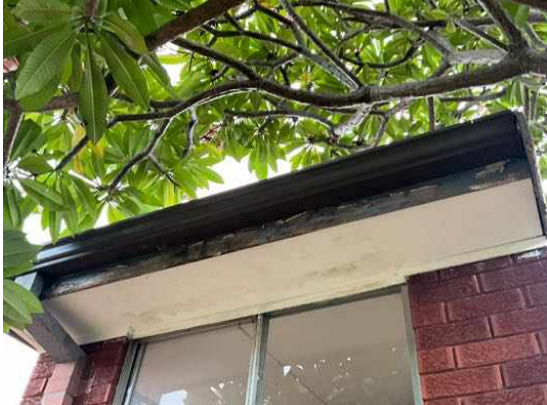
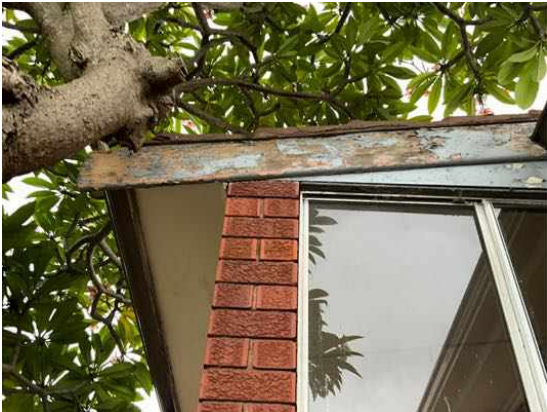
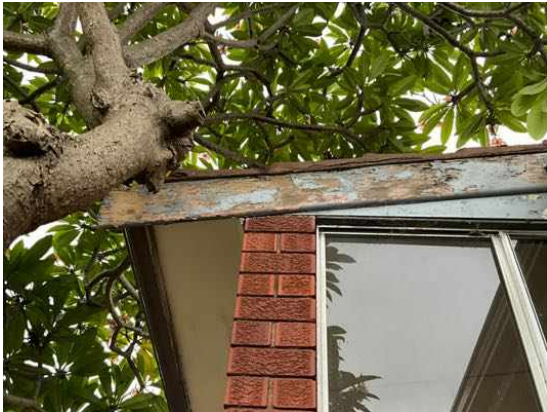
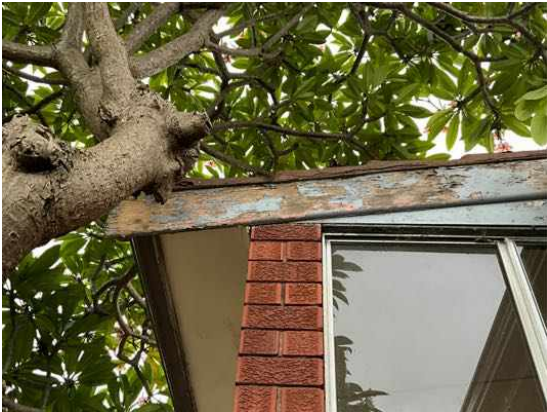
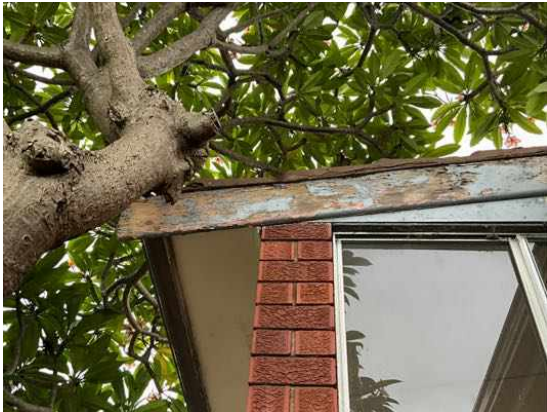
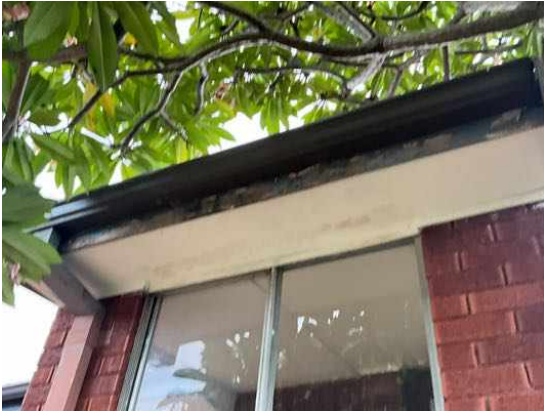
### Finding 7.01

Building:	Main Building
Location:	All Areas
Finding:	Wood rot
Information:	This building element shows evidence of wood rot. Wood rot, also known as Fungal Decay, occurs when timbers and other cellulose building materials are exposed to damp conditions on an ongoing basis. This could be the result of exposure to weathering over a prolonged period of time, or the attraction of excessive moisture from other abutting building materials. Contributing factors also include poor air ventilation in the area.

Wood rot is often associated with general damp problems and is evidenced by a 'musty' smell or mould and mildew occurring on surfaces. If left unmanaged, damp conditions can lead to further health problems and the decay of timbers will continue.

Early intervention and regular maintenance, particularly of exterior timbers, will prolong the useful life of these building elements. Prior to any works being performed, the cause of the moisture that has created the visible wood rot should be identified and addressed in a suitable manner. Replacement of affected timbers may then be a

A qualified plumber may be appointed to assess the cause of excessive moisture and to provide advice on any remedial works as required. A qualified carpenter or registered builder may also be required to replace affected building materials.

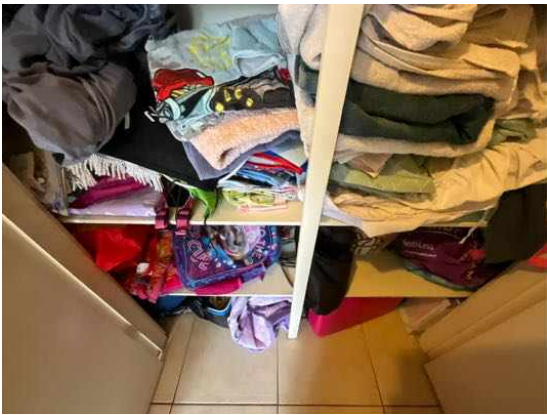
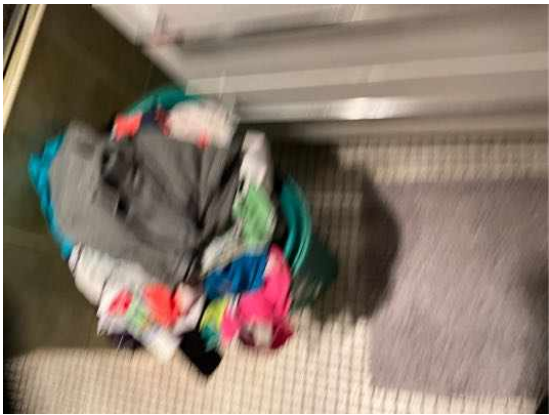
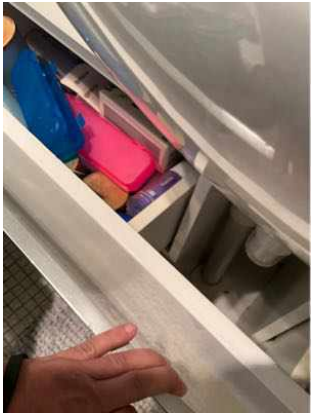
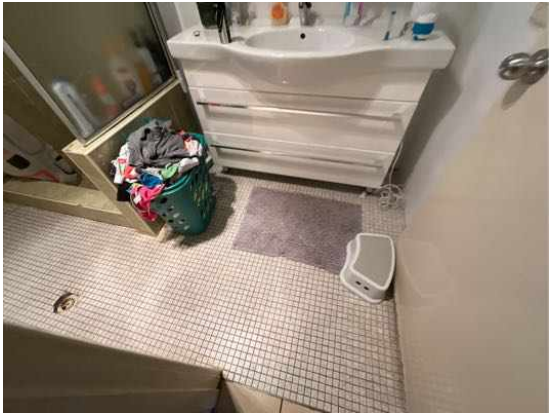
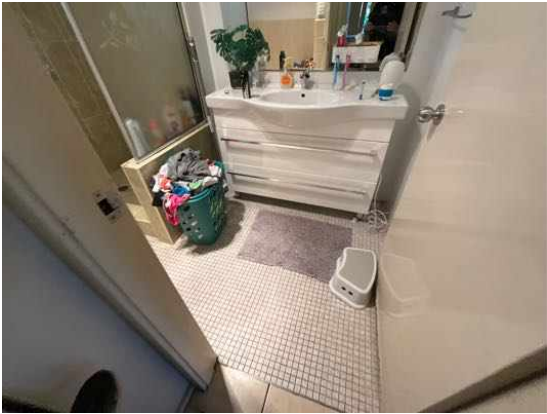
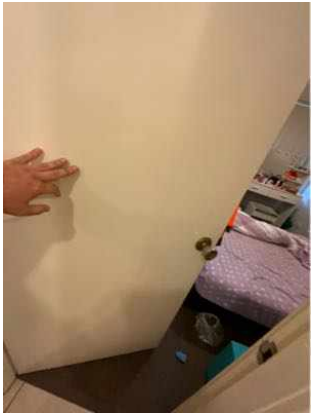
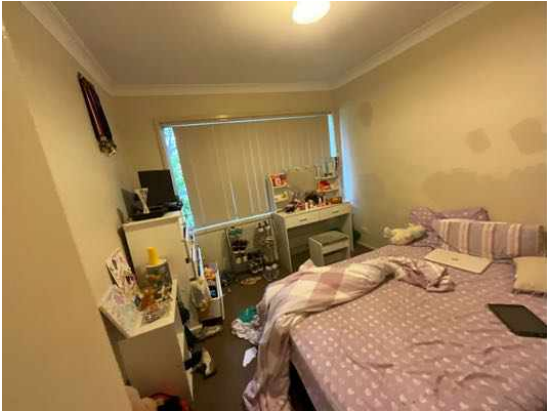
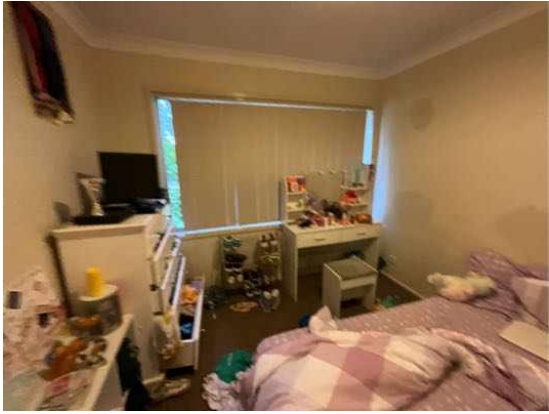
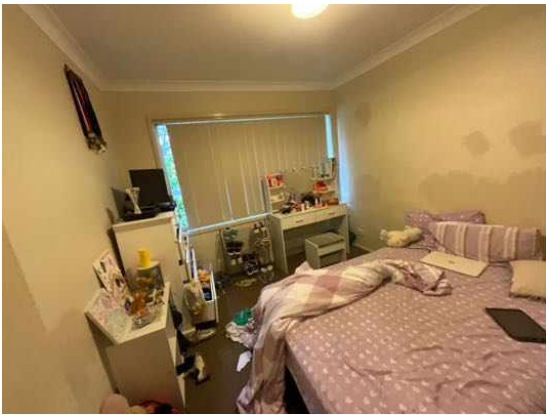
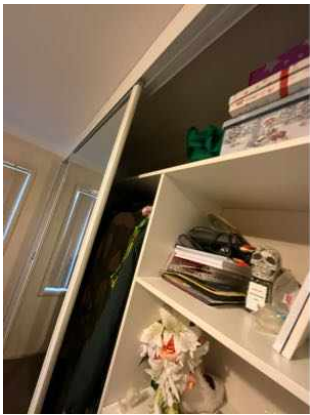
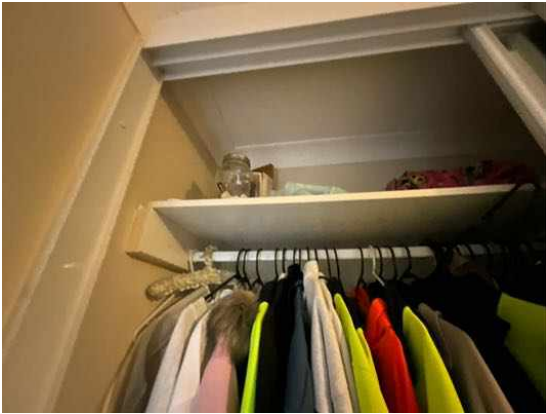
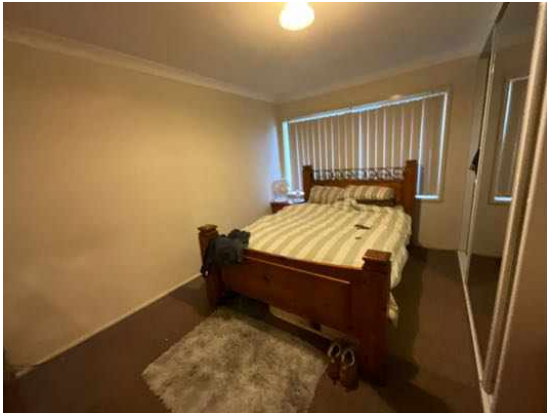
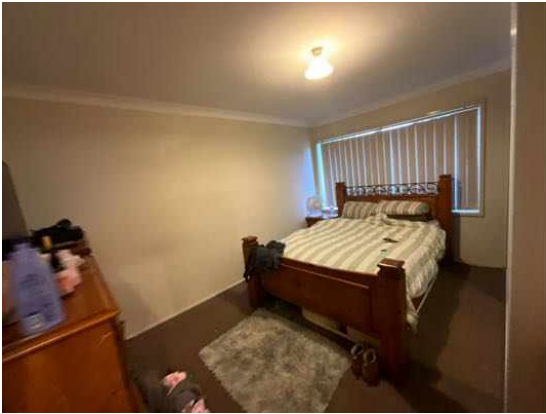
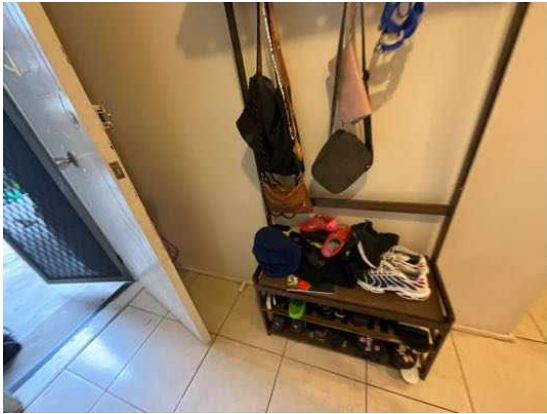
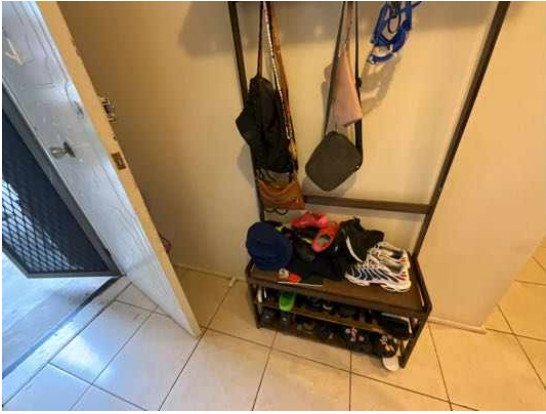
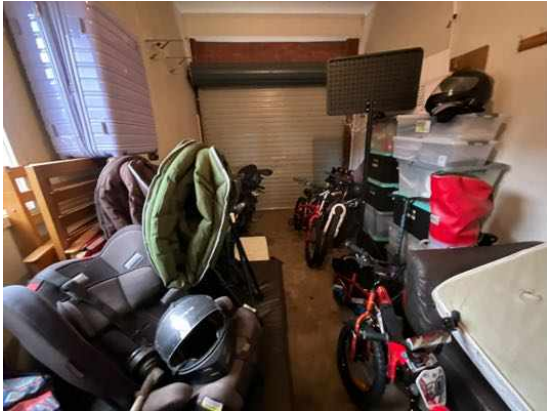
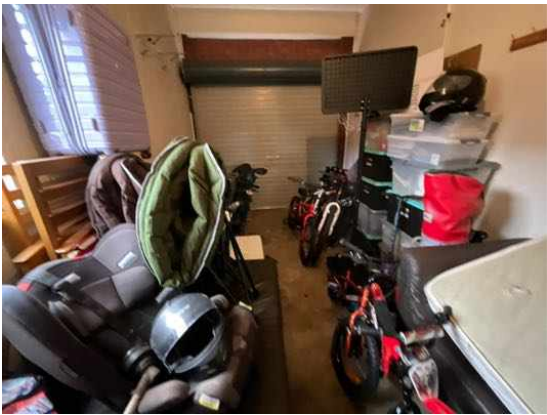
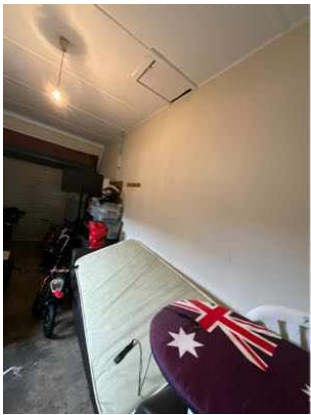
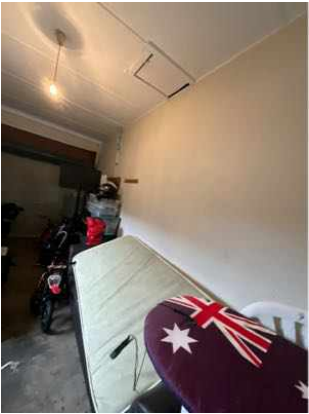
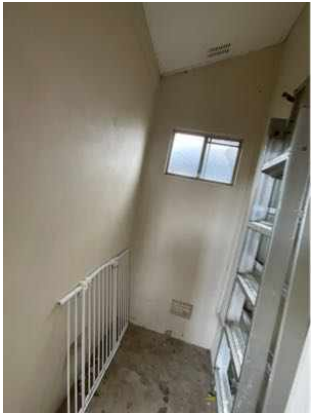
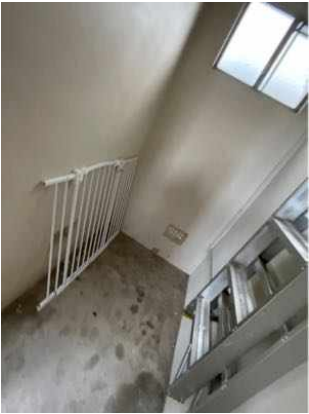
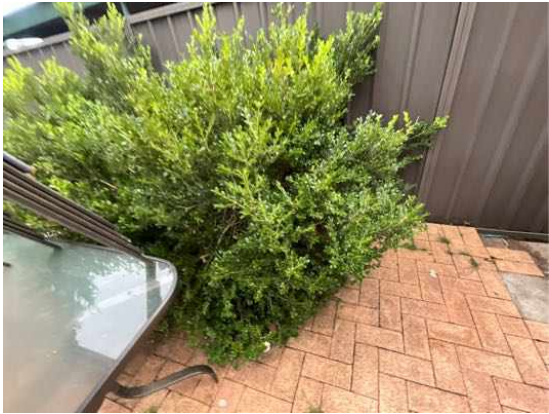
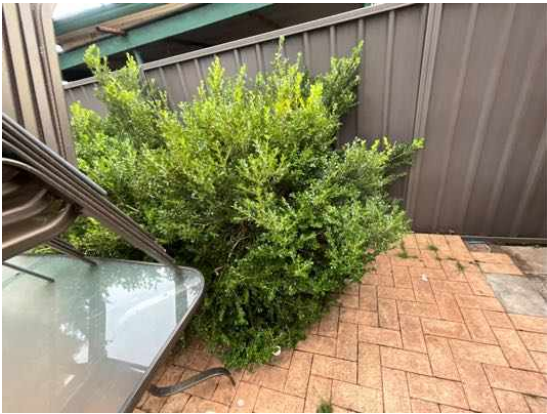
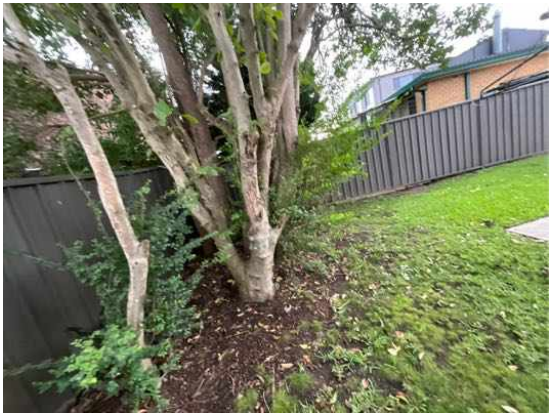
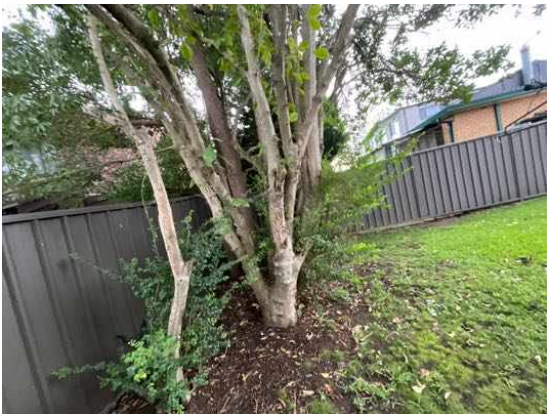
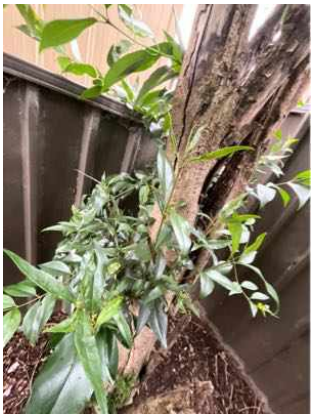
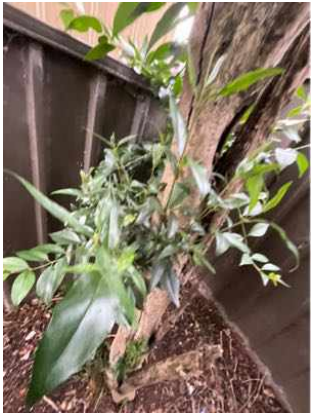
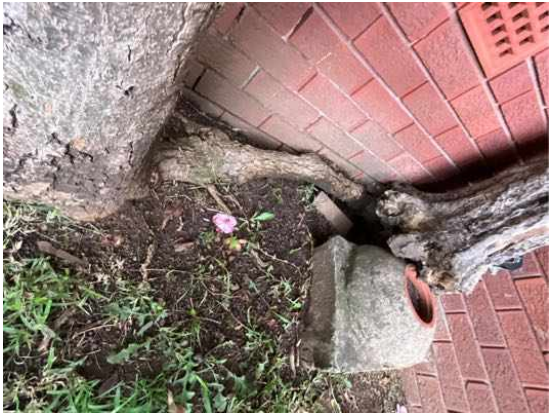
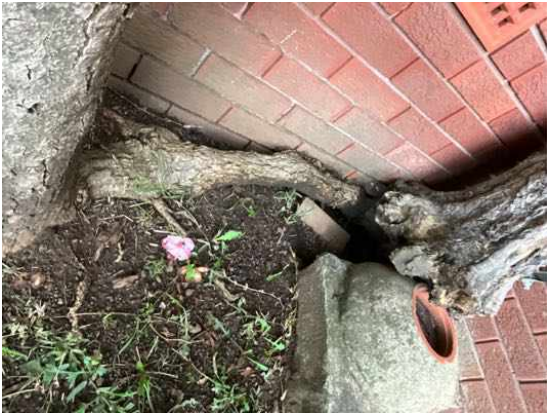
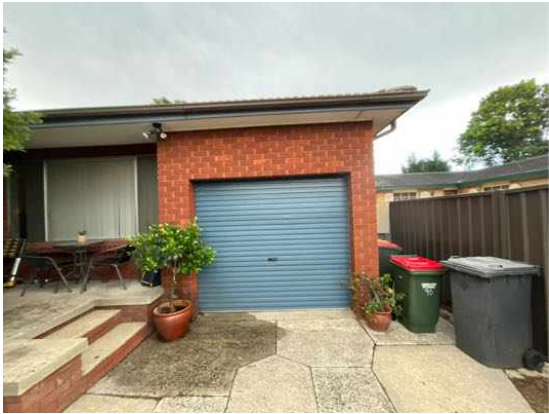
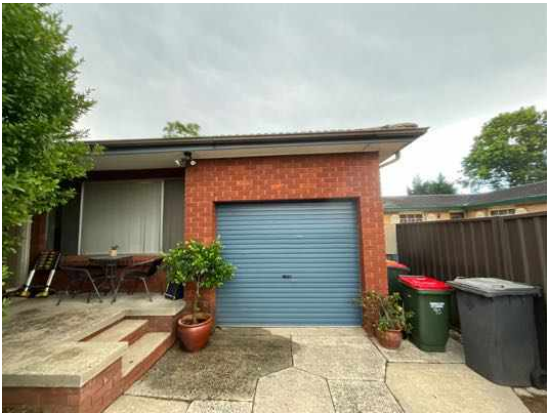
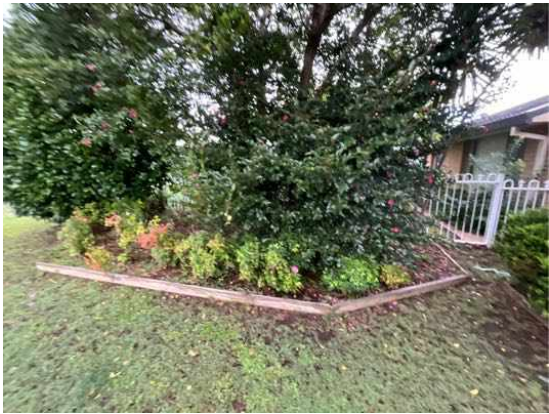
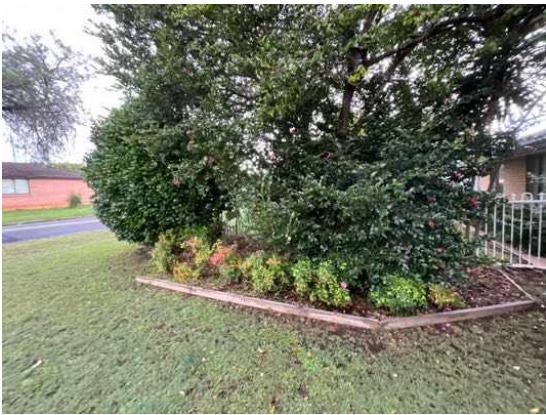
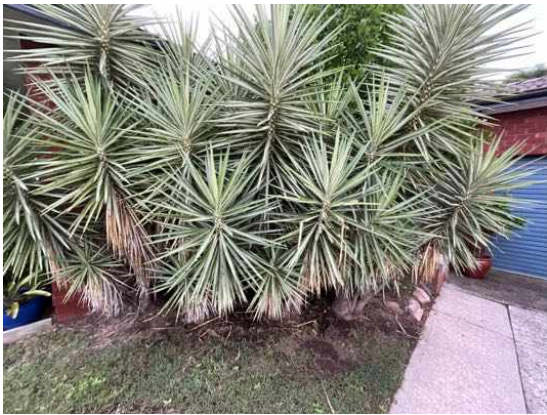
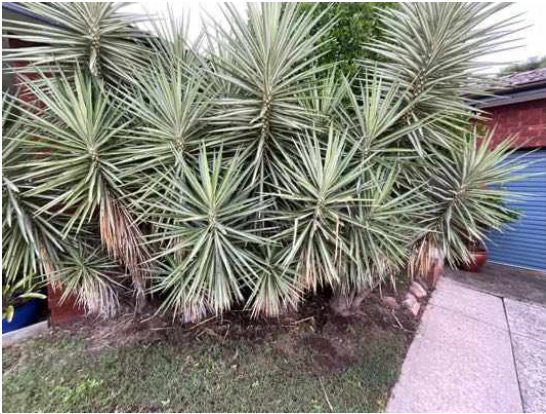
Building: Main Building  
Location: All Areas  
Finding: Additional Photos - Obstructions and Limitations  
Information: These photographs are an indication of the obstructions and limitations which impeded full inspection of the property at the time of inspection. These obstructions can hide an array of defects and should be removed to allow full inspection to be carried out. A re-inspection is recommended once the areas are made accessible.
