Building and Timber Pest Inspection Report

Inspection Date: Wed, 11 Mar 2026

Property Address: 144/2 Melody Ct, Warana QLD 4575,
Australia

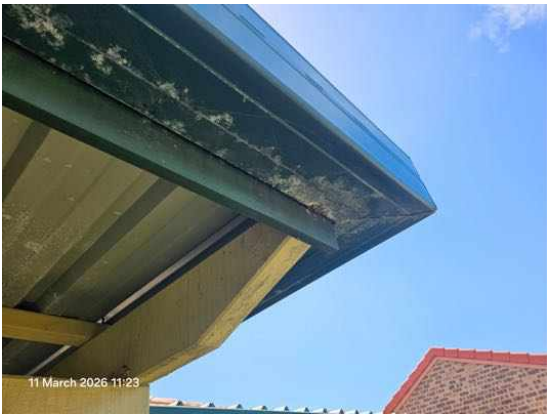
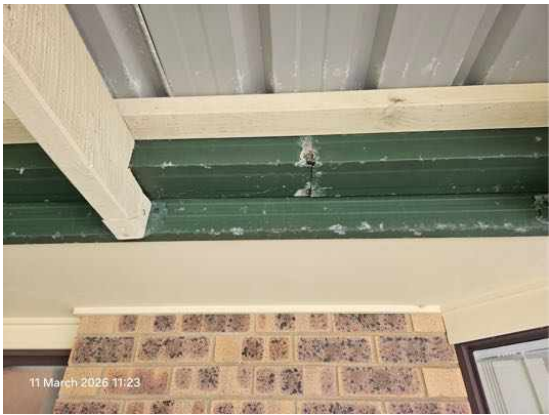
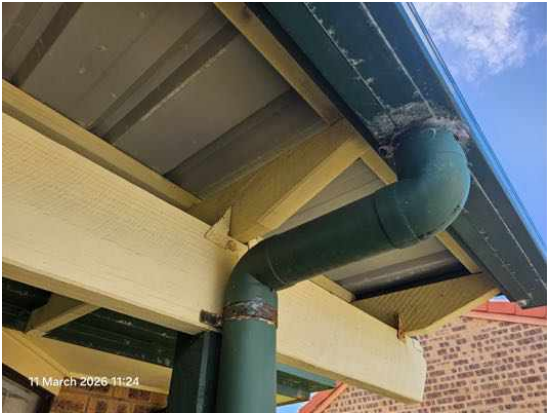
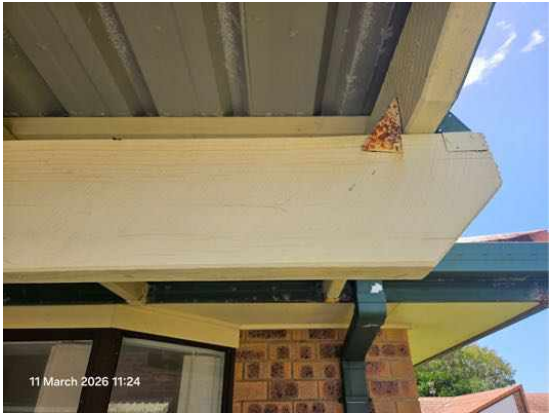
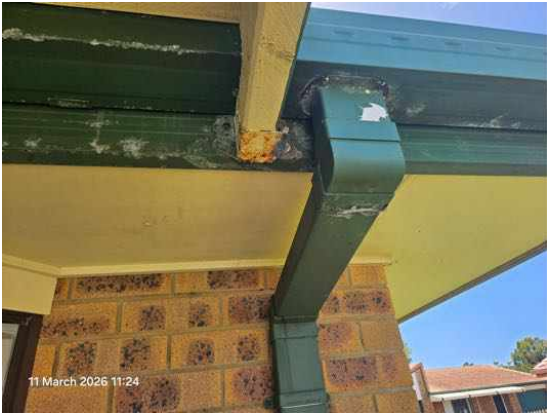
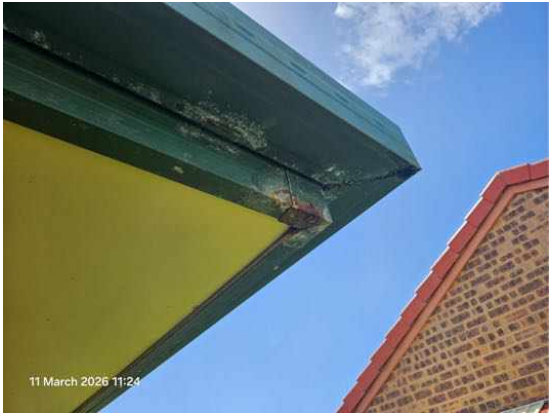
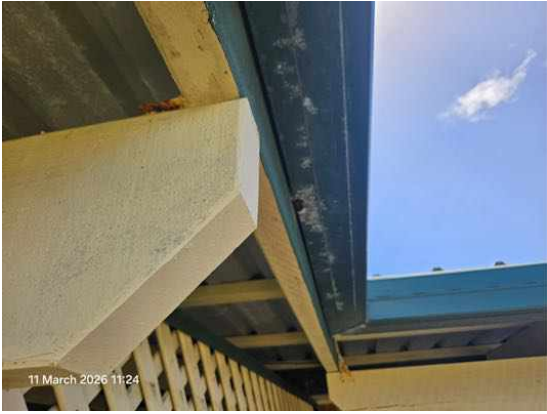
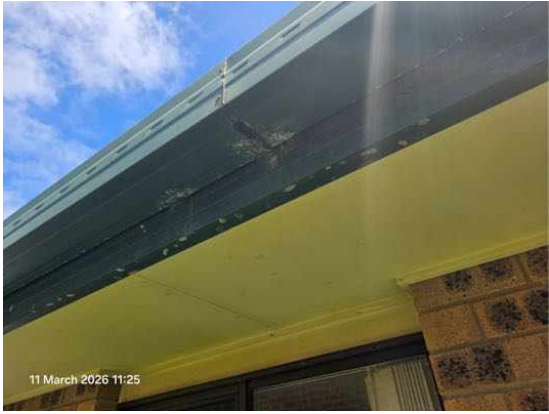
Building: Main Building
 Location: As shown
 Finding: Miscellaneous minor defects
 Information: Below are listed the miscellaneous minor defects identified on the day of inspection.

1. Downpipes require sealing at the joints.
2. Rear door sill tiles are loose and require re-gluing and grouting.

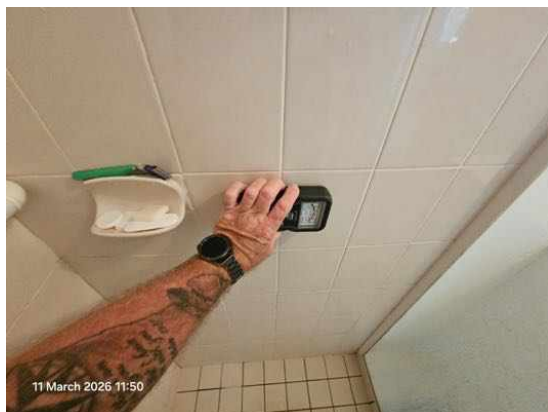
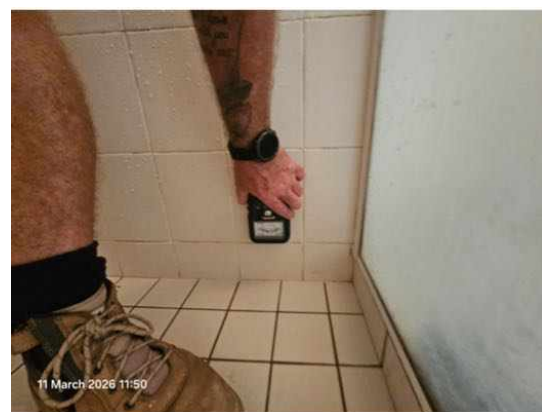
Building: Main Building
Location: Bathroom
Finding: No moisture detected in bathroom
Information: On the day of inspection the shower in the bathroom was measured for moisture using a "Tramex" moisture meter. During this inspection no moisture was detected in these areas and the tiled / sheeted surfaces appear to be in fair condition. The grout and sealant will require renewal.

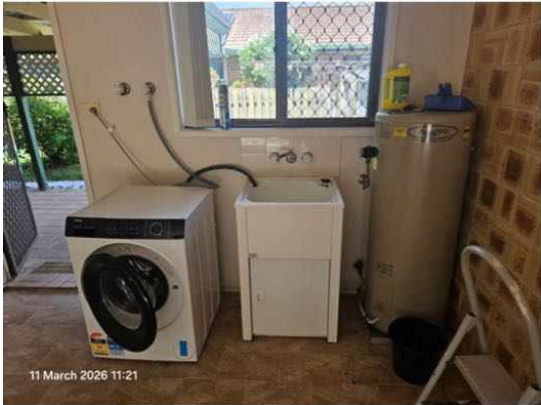
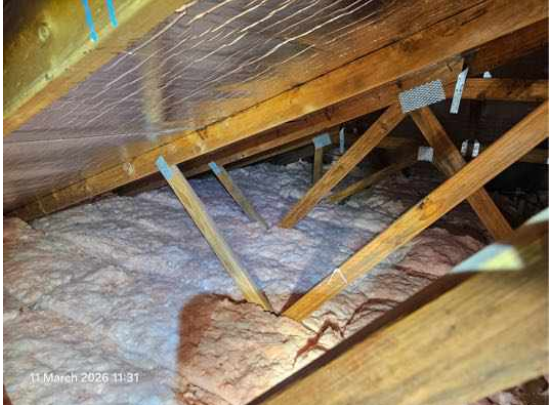
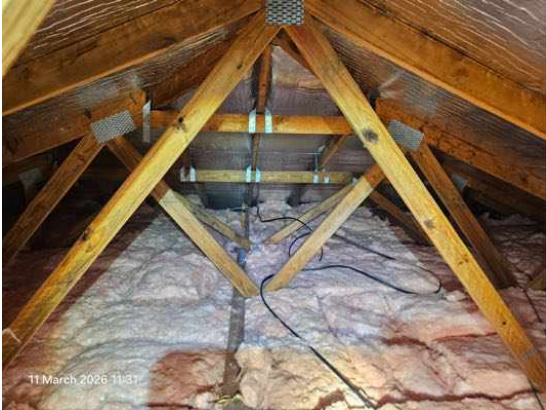
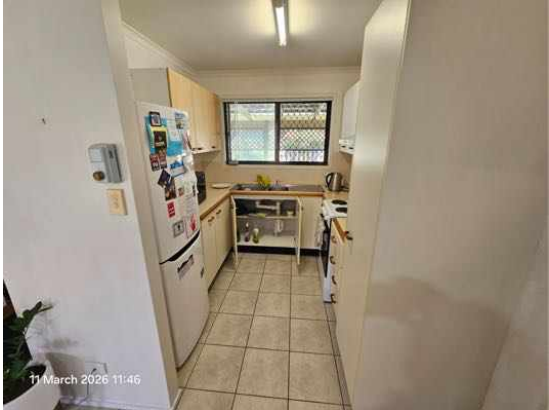
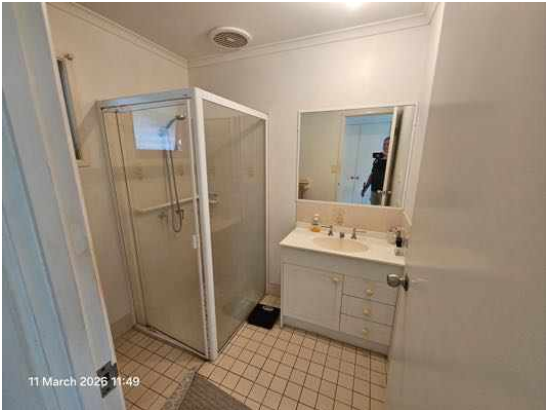
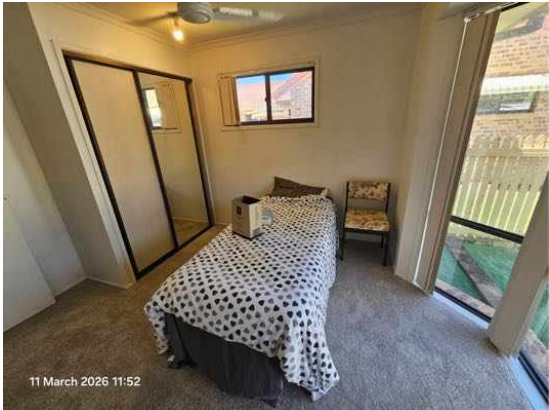
Building:	Main Building
Location:	All Areas
Finding:	Additional Photos - Obstructions and Limitations
Information:	These photographs are an indication of the obstructions and limitations which impeded full inspection of the property at the time of inspection. These obstructions can hide an array of defects and should be removed to allow full inspection to be carried out. A re-inspection is recommended once the areas are made accessible.

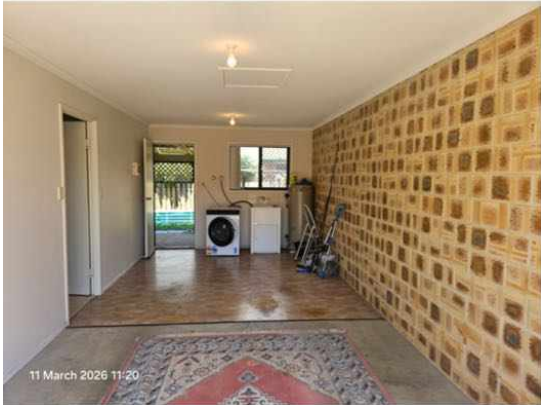
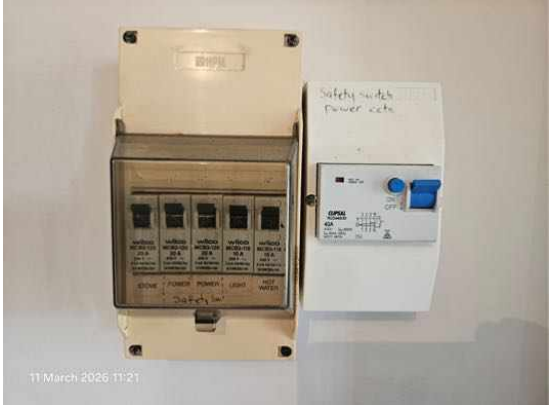
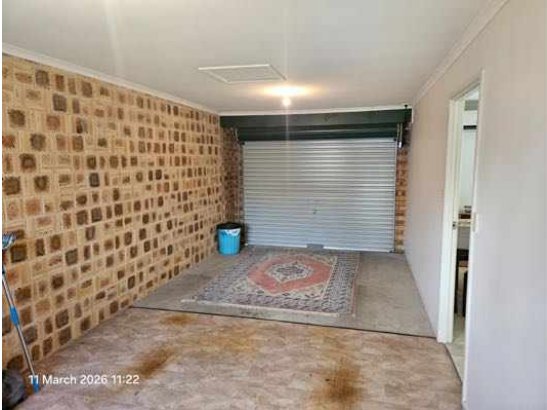
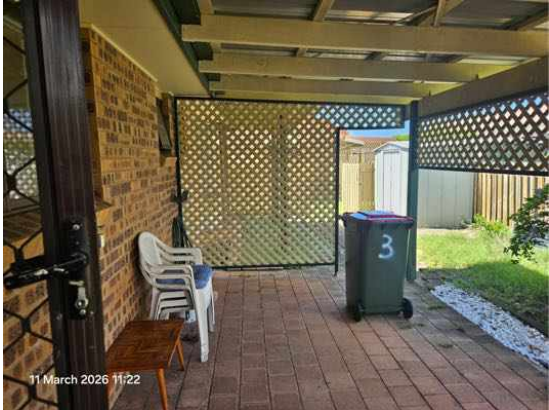
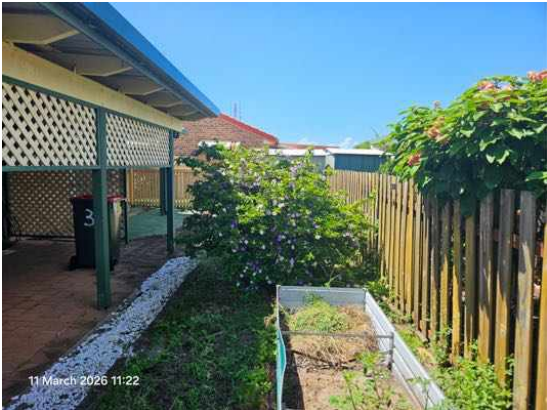
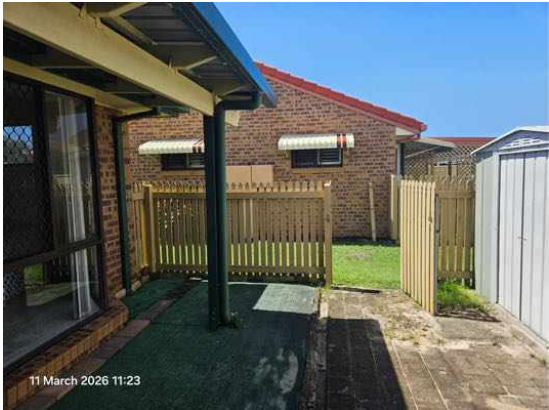
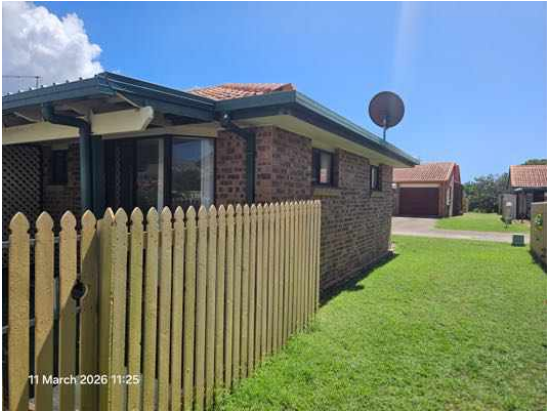
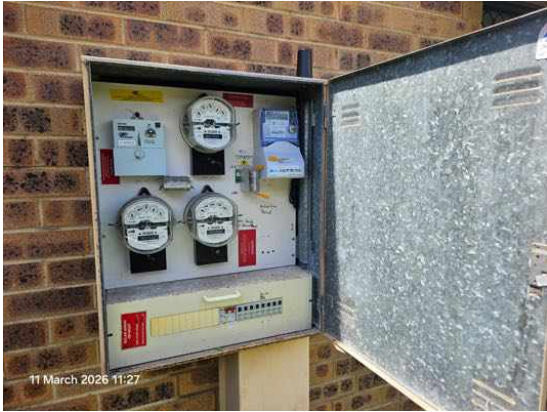
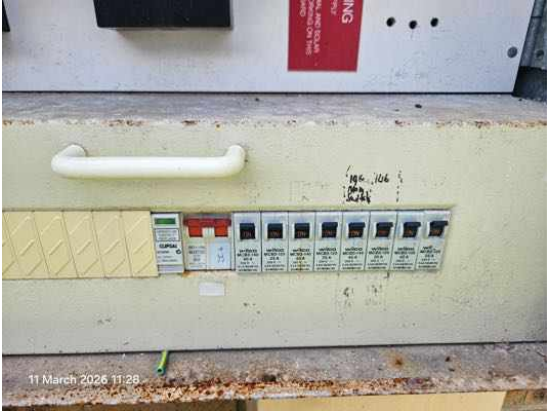
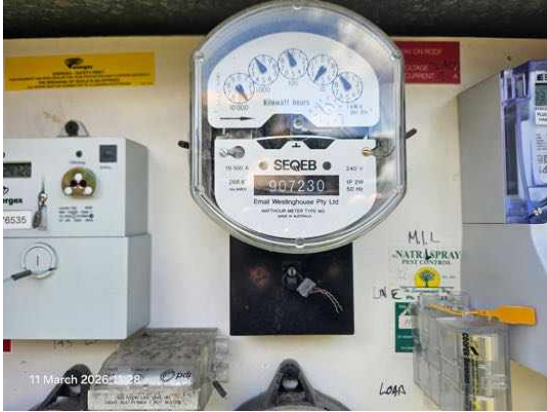
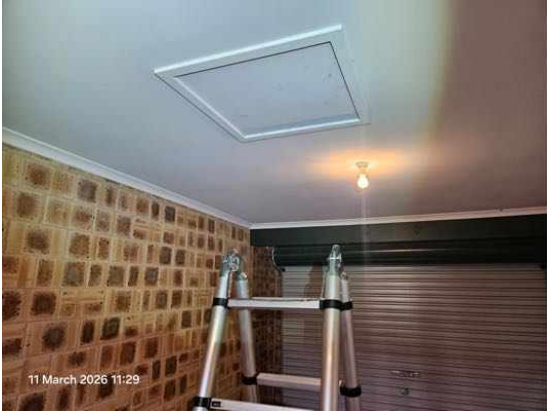
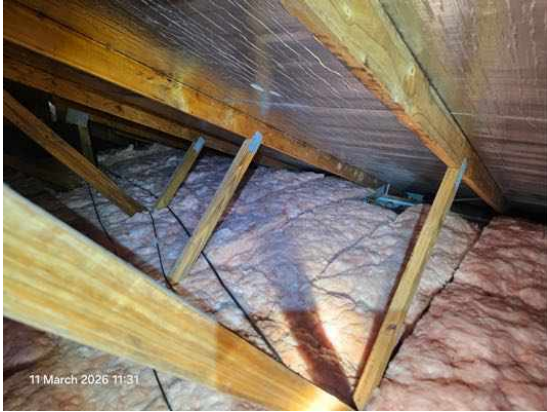
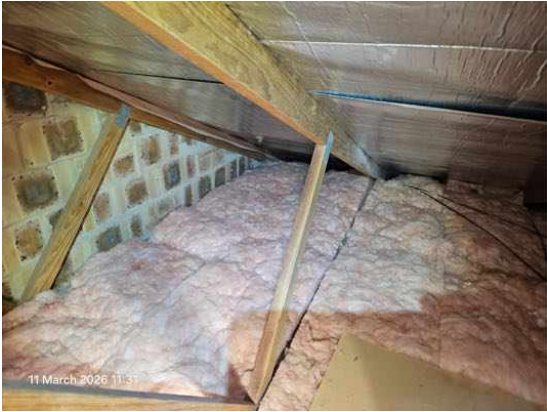
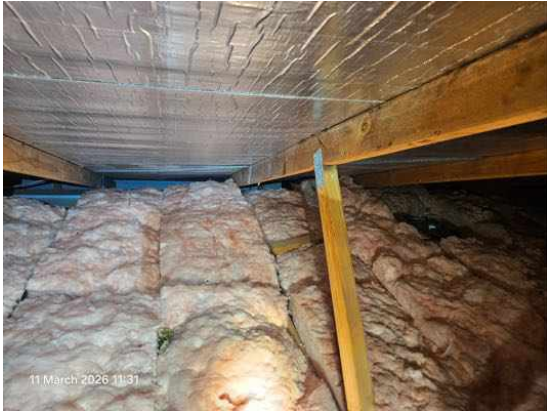
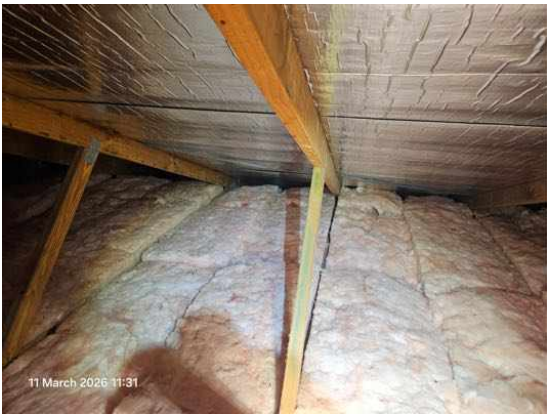
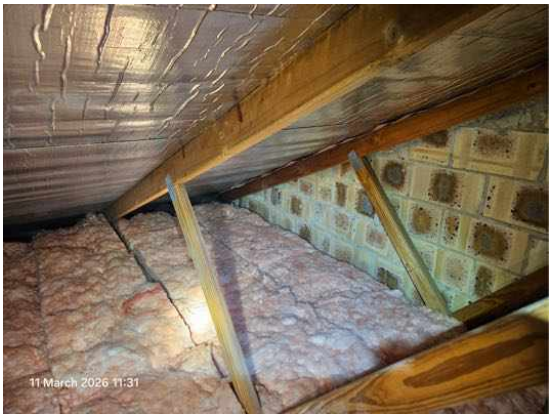
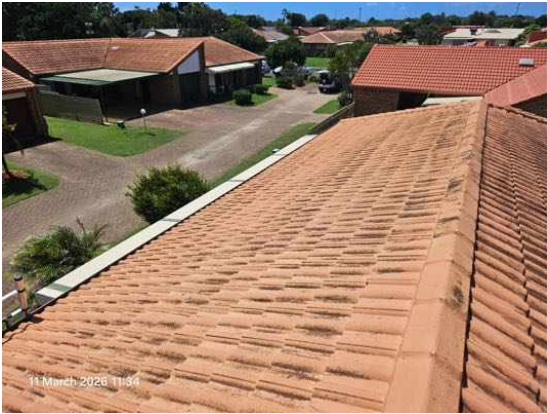
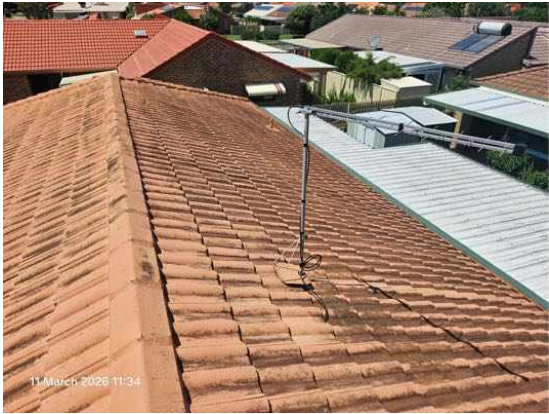
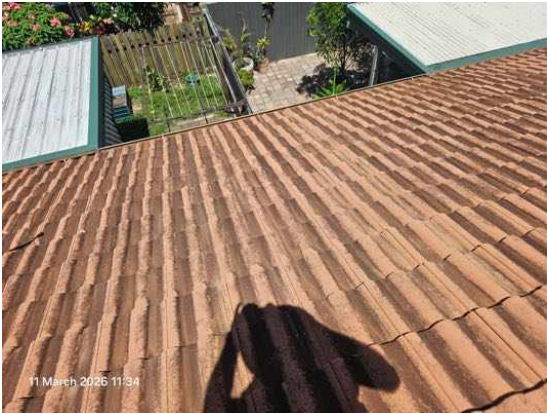
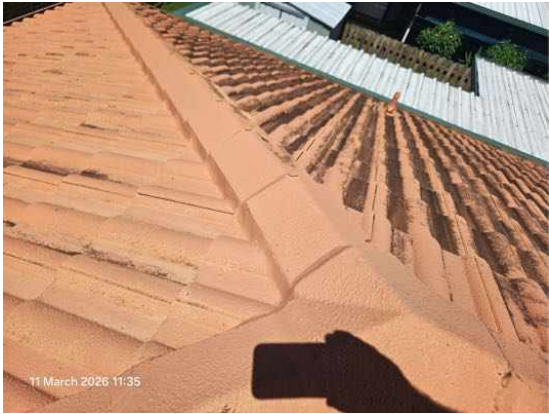
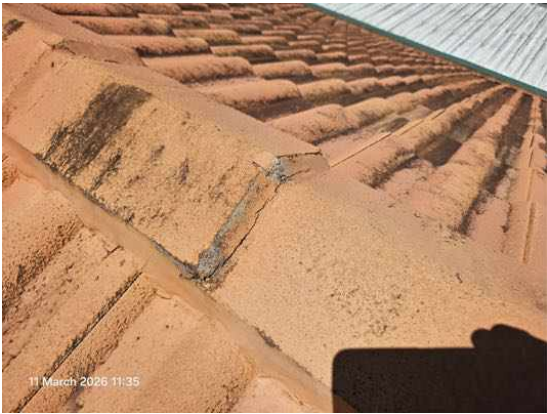
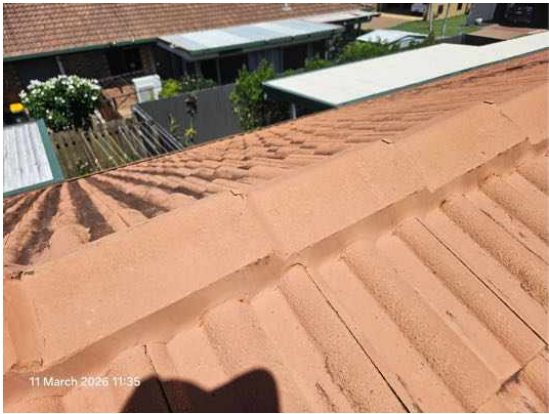
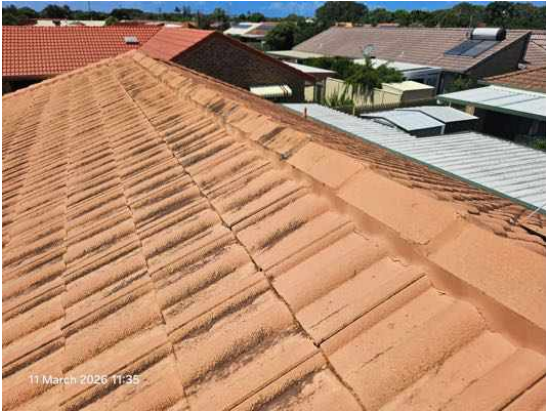
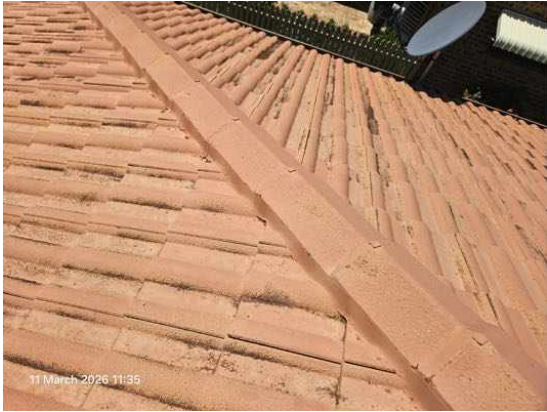
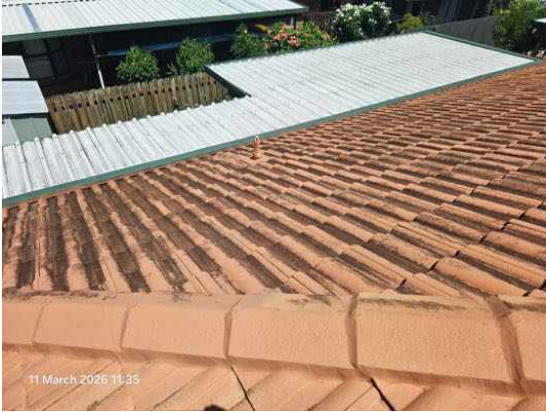
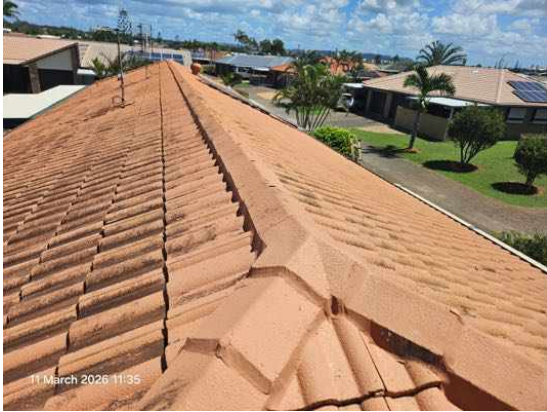
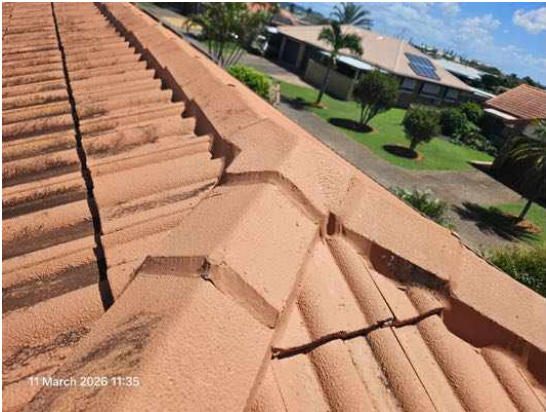
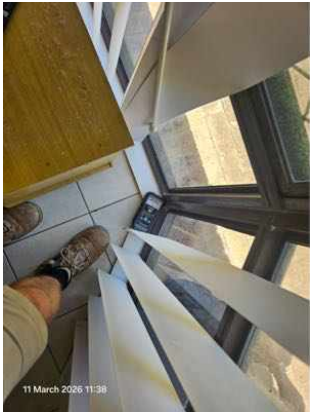
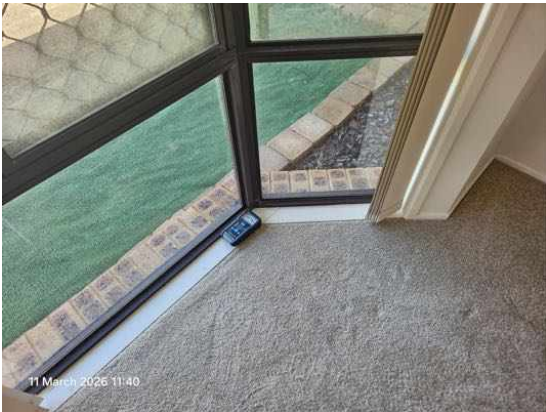
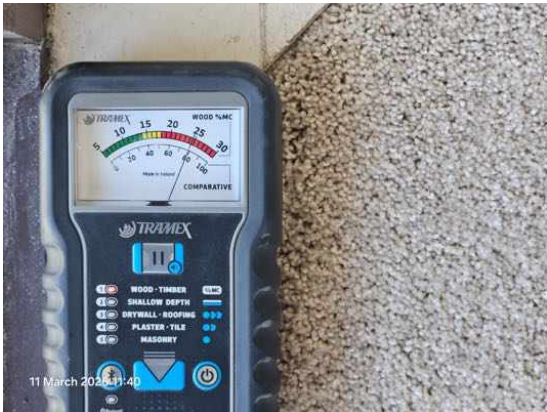
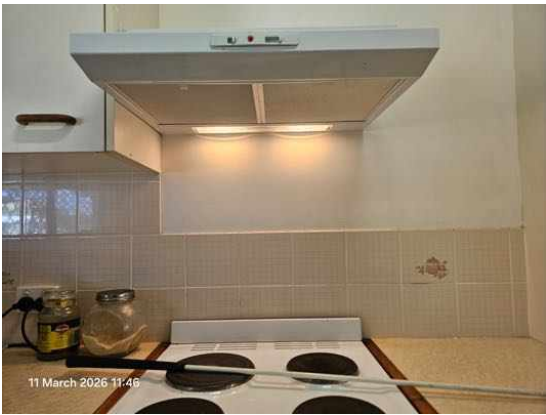
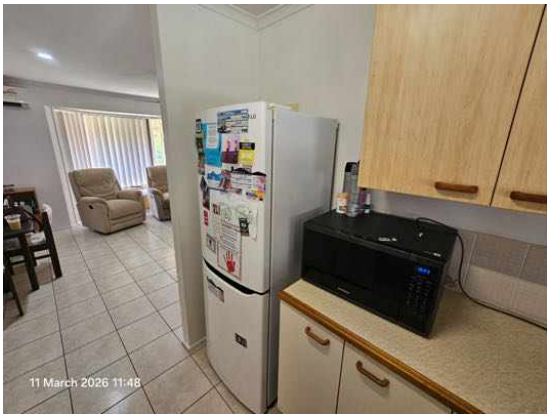
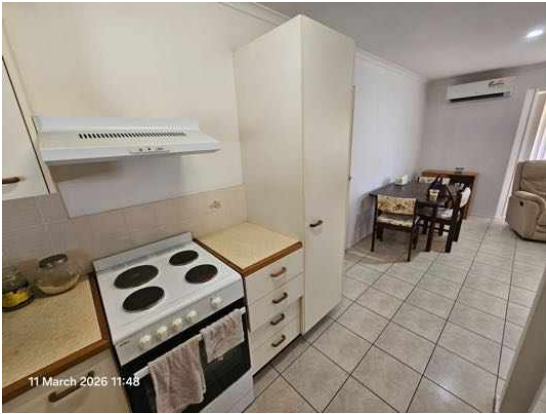
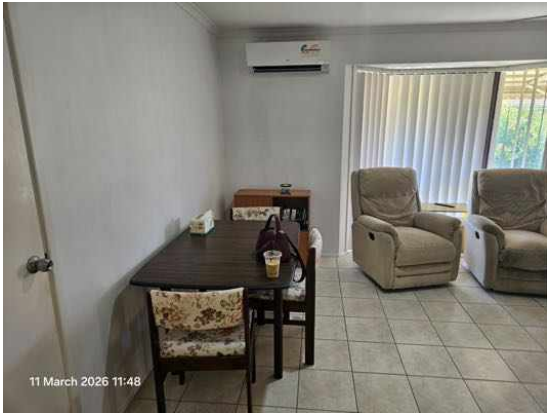
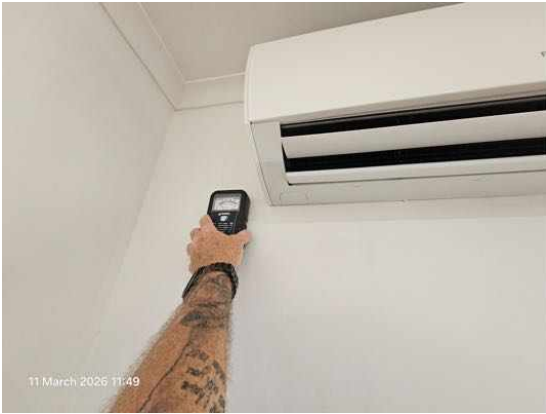
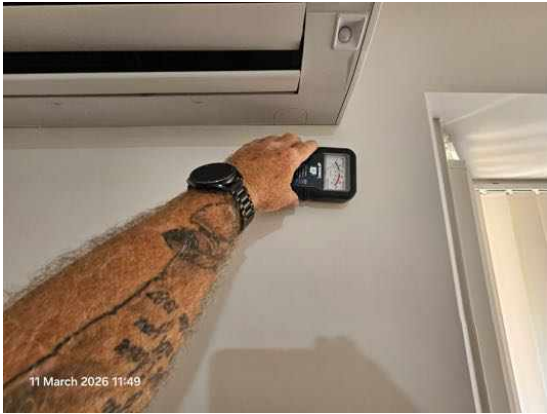
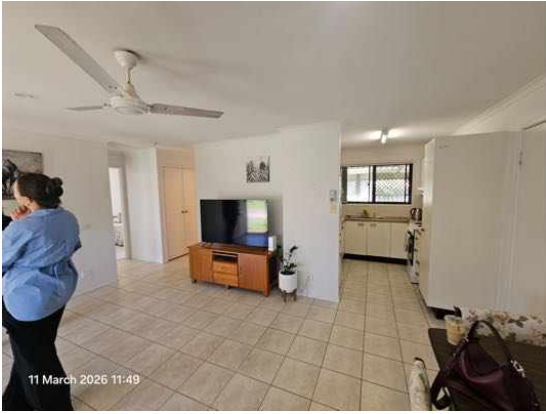
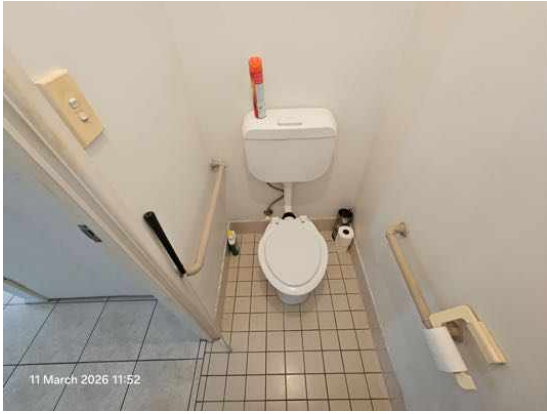
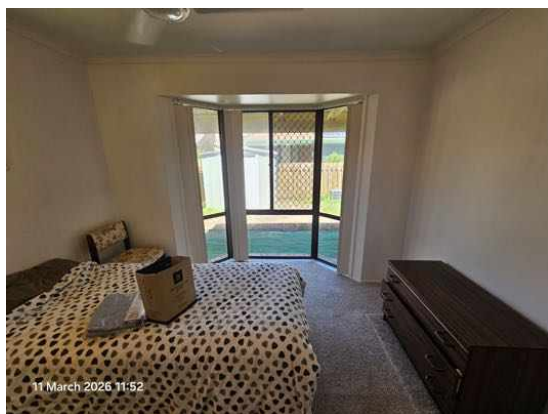
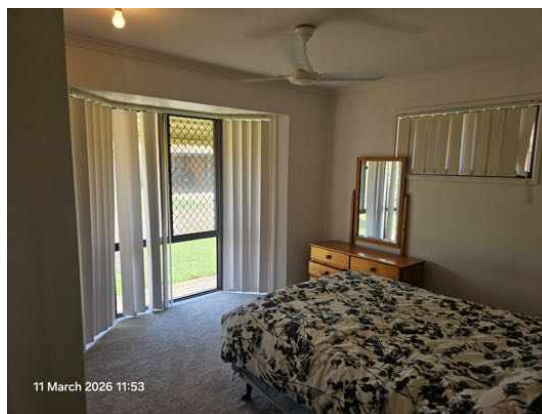
Building: Main Building
Location: All Areas
Finding: Additional Photos for client reference
Information: Additional photos are provided for your general reference.
