## Building Inspection Report

Inspection Date: Thu, 12 Mar 2026

Property Address: 16 Cyprus St, Lalor VIC 3075, Australia

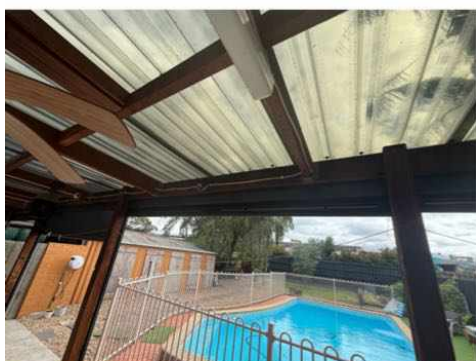
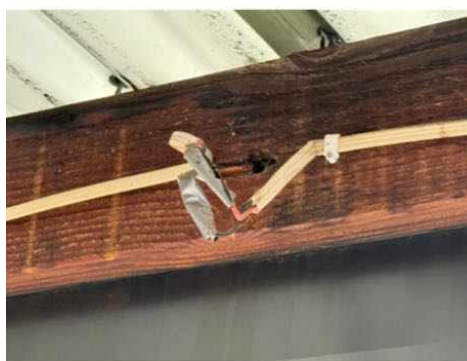
#### Defects 1.01

Building:	Building 1
Location:	Pergola area > All Areas
Finding:	Electrical wires not adequately terminated
Information:	At the time of the inspection in the rear pergola area, electrical cables were exposed and easily reached. These are converted to be not adequately terminated or protected with a junction box around it. Exposed electrical cabling represents a potential safety hazard including for fire and personal contact to inspectors, tradespersons and occupants that enter these areas. Contact a licensed electrician to ensure these areas are safe to enter. Electrician is required for a further inspection and investigation and rectification of any potential safety hazards.

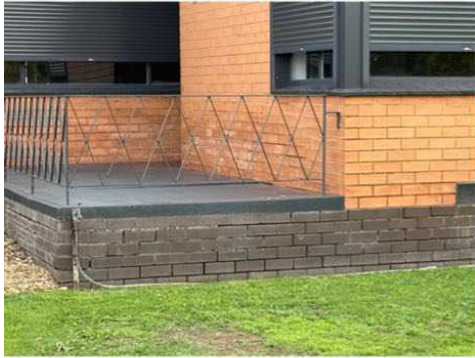
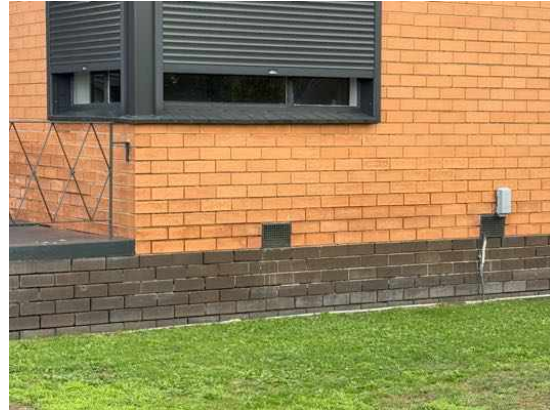
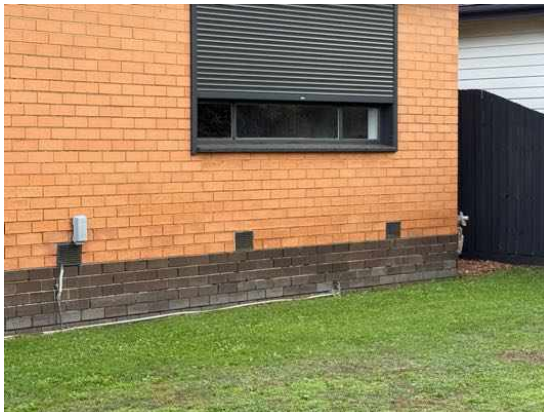
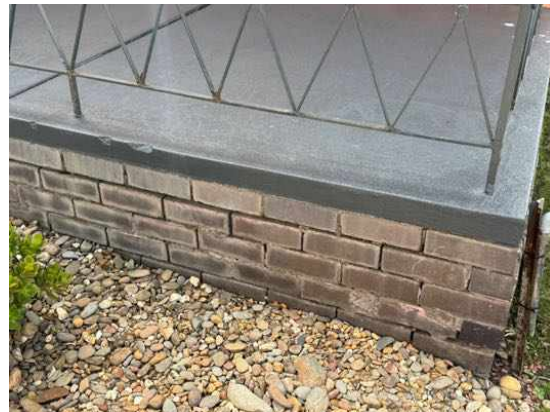
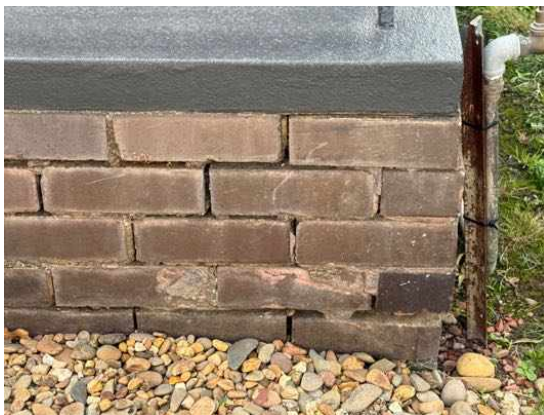
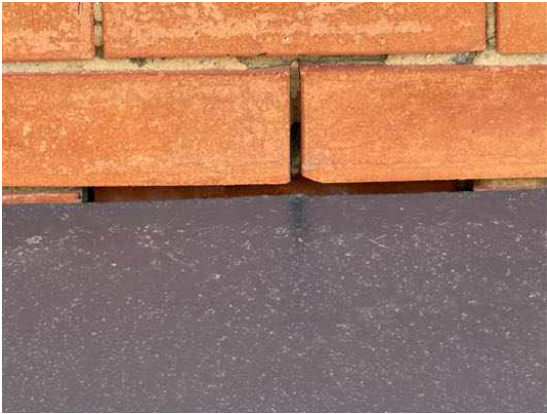
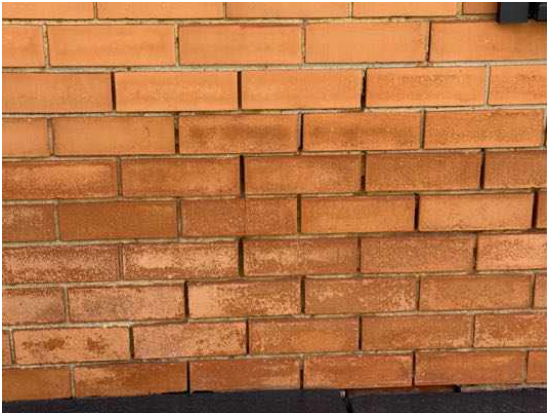
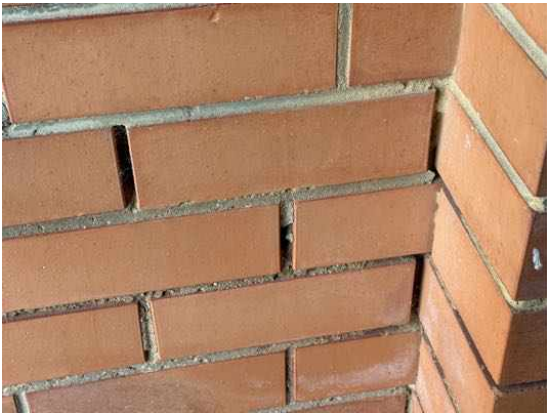
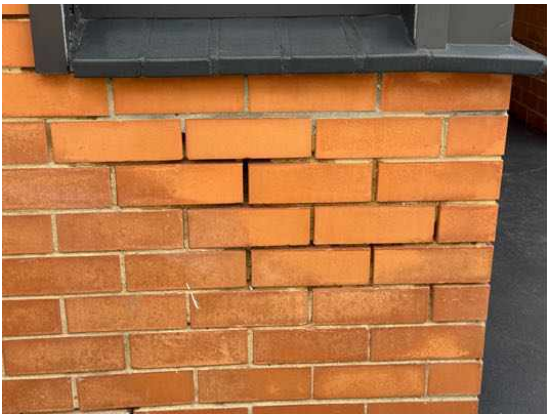
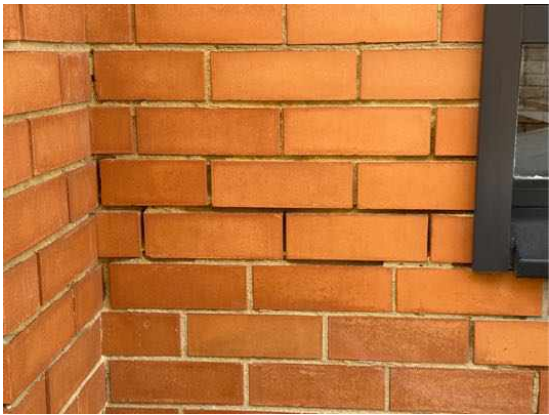
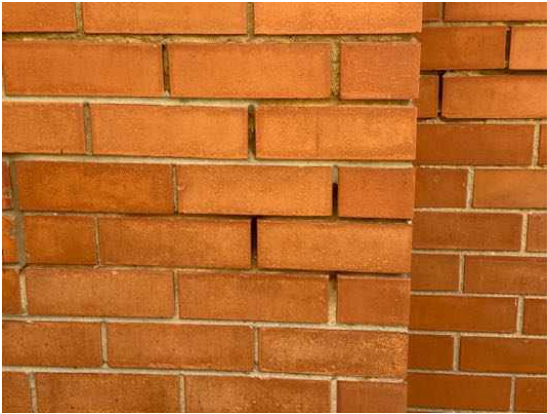
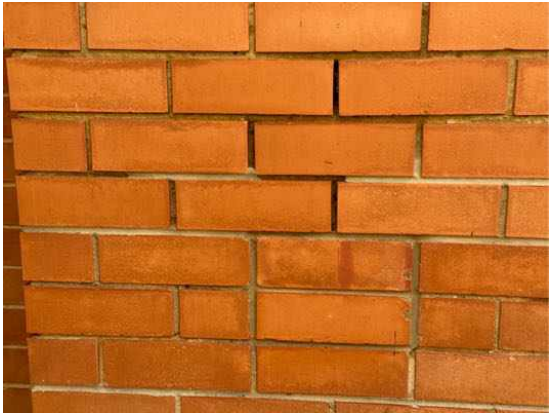
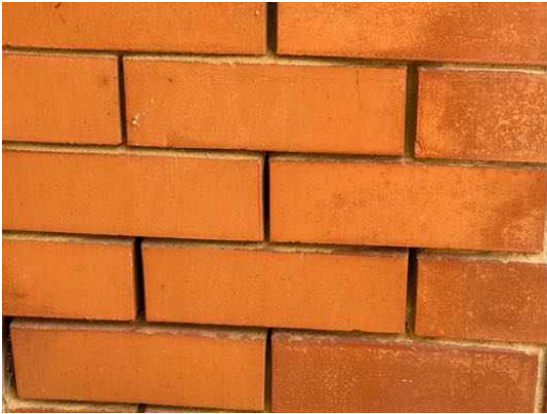
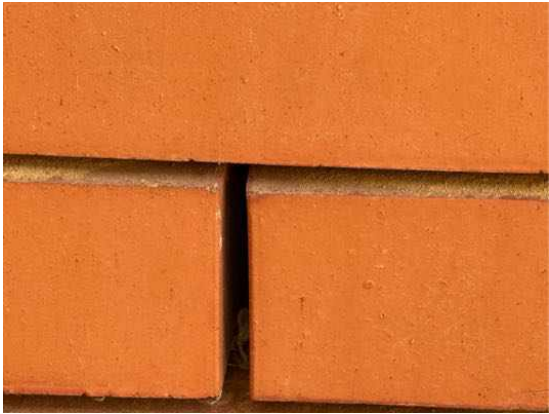
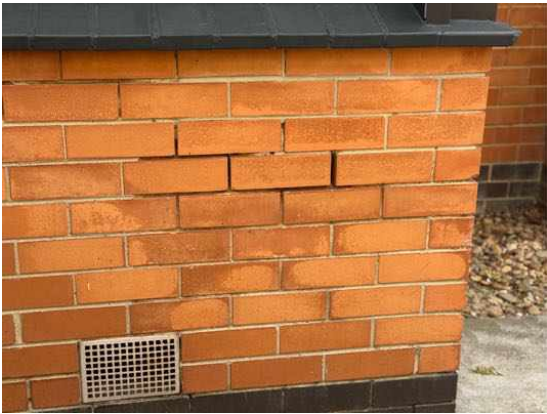
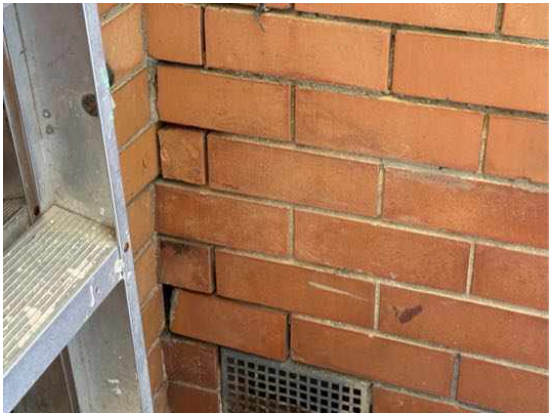
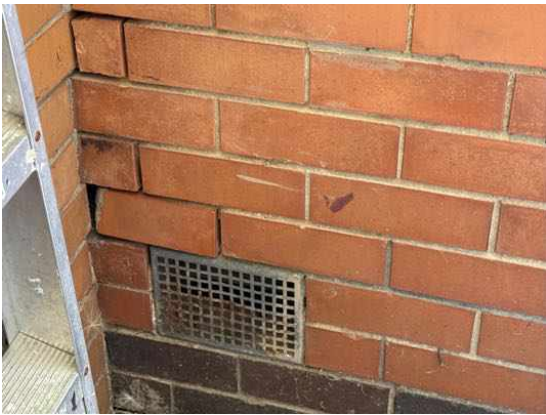
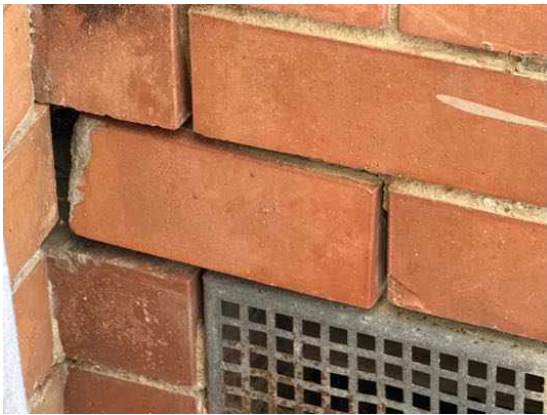
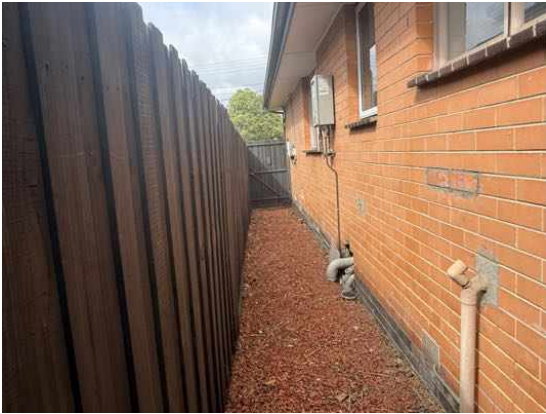
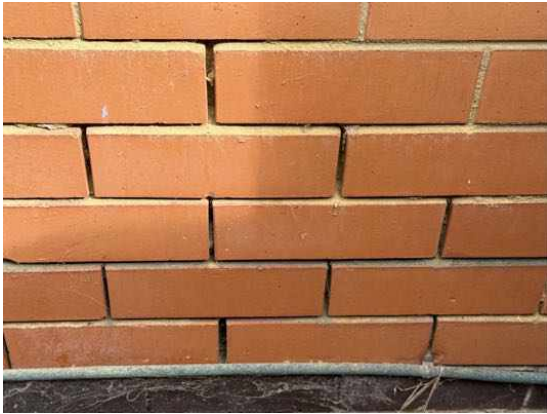
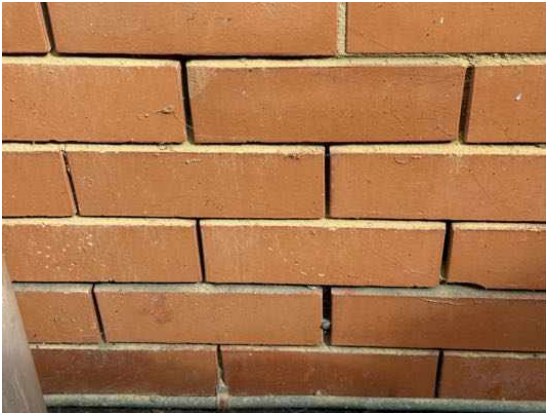
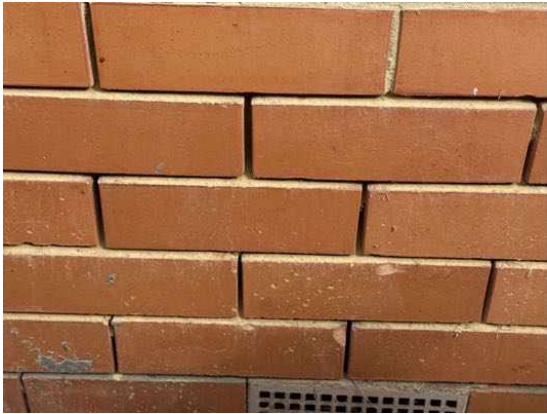
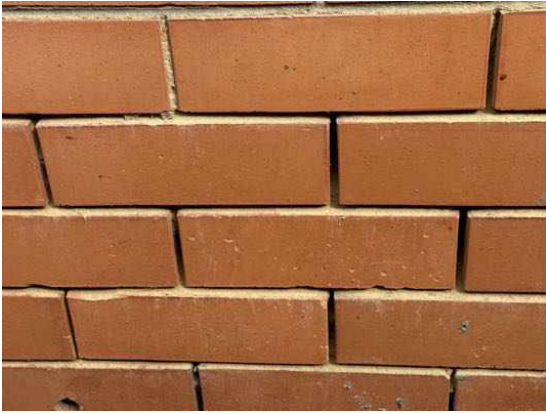
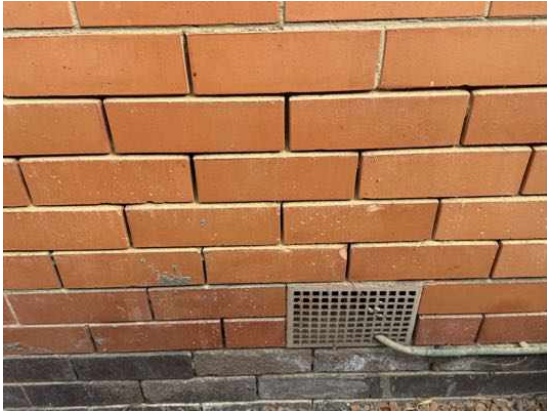
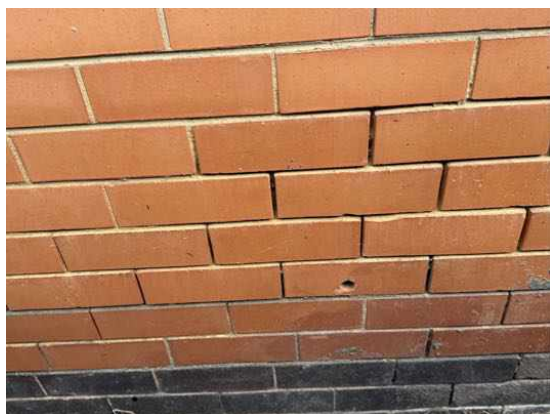
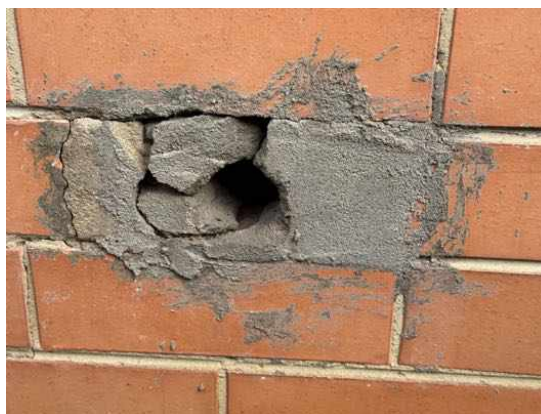
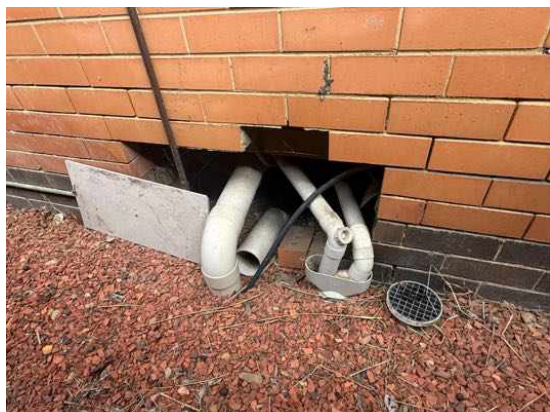
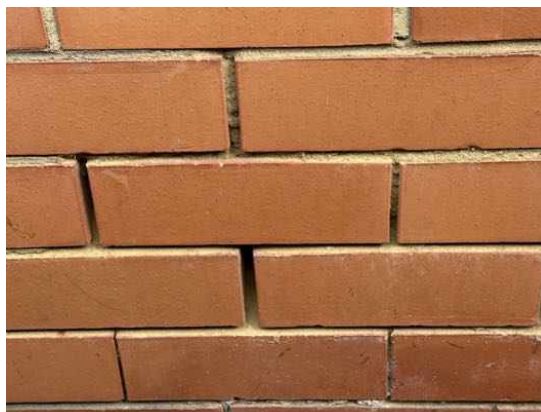
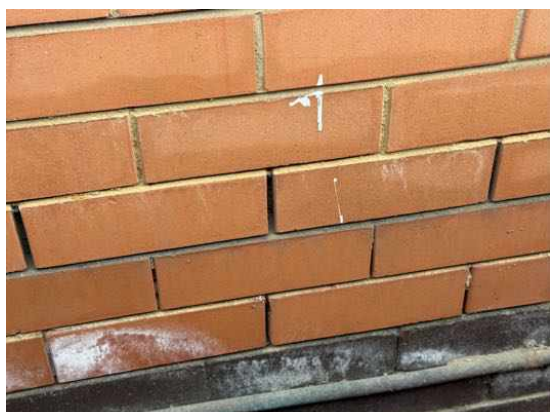
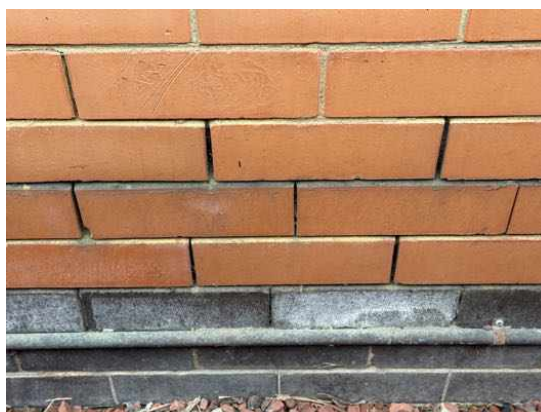
#### Defects 2.01

Building:	Building 1
Location:	All Areas > All Areas
Finding:	Brickwork mortar missing - gaps, holes and voids
Information:	At the time of the inspection the exterior brickwork showed numerous / a lot of areas where mortar has been dislodged or missing. The numerous gaps, holes or voids that have been left in the exterior brickwork are considered to be excessive. All exterior brickwork walls will require extensive repair to rectify these areas, they are required to be fully filled in and patched to prevent the further damage and deterioration from exposure and exterior weather conditions.

type of defects would allow water and moisture, insect, pests, vermin to ingress into wall cavities that will overtime create secondary defects and damage as a result.

The damage and deterioration in brickwork is suspected to be a result of poor filling of the mortar beds and perpendes during the brickwork installation and construction or poor trade practices. When gaps, holes and voids are filled or patched the tradespersons must ensure mortar colour and consistency are as near as possible to match the existing mortar and remains the same as the original installation of brickwork mortar.

These types of defects should be rectified before any further weathering can occur and will prevent gaps, holes and voids from enlarging or deteriorating further. These

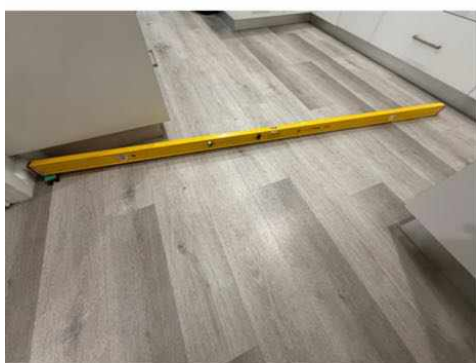
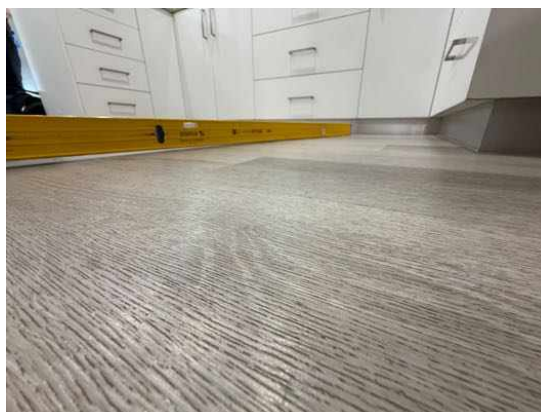
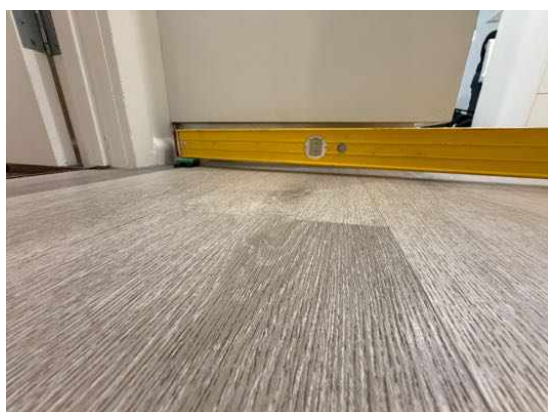
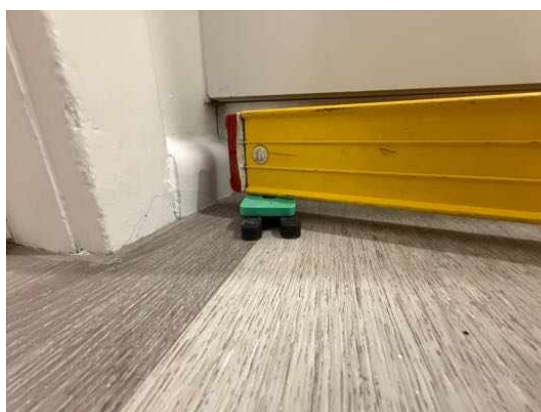
### Defects 3.01

Building:	Building 1
Location:	All Areas > All Areas
Finding:	Floor levels
Information:	The internal flooring in some areas throughout the home were observed to be showing signs of being out of level and uneven. Uneven and out of level floors with a property of this age is considered in most cases to be mostly normal however some areas were considered to be excessive. The uneven and out of level floors in a home is

Floor levels can have complex and varying causes, which will influence the required remedial works. Remedial may be necessary and the client should begin by consulting a registered builder who has expertise in re-stumping to determine the required scope of works that may be deemed necessary. This may include some form of underpinning to some areas, at the same time as addressing the underlying cause of the uneven and out of level floors. Client may also consider consultation with a geotechnical engineer to understand what and how the surrounding soil is reacting to surrounding moisture.

A Registered Builder would generally carry out these types of works or can be guided and advised by an geotechnical or structural engineer where deemed to be required. It is advised that the floors be closely monitored to identify any further movement even after floor have been rectified. Where flooring is uneven further, a potentially invasive inspection of the subfloor stumps and floor structures is required. Remedial works may require floors to be removed where subfloor are tight and or to close a proximity to the ground.

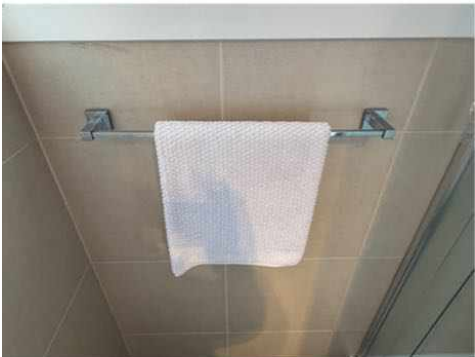
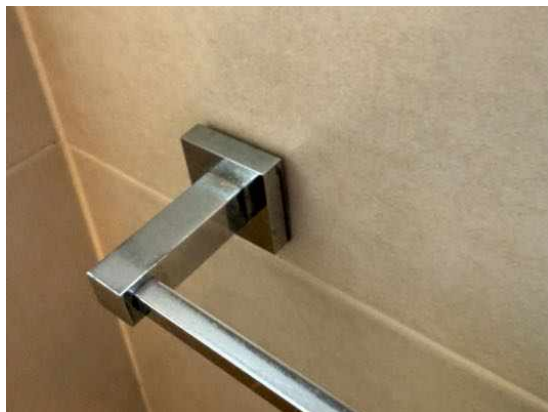
**Defects 3.02**

Building: Building 1  
Location: Bathroom > All Areas  
Finding: Bathroom towel rail loose  
Information: Bathroom towel rail was observed to be loose and may require maintenance to make good, this occurs generally due to substandard installation and or poor workmanship. A qualified carpenter should be appointed to repair or replace the affected towel rail, this type of defect is at the clients discretion.

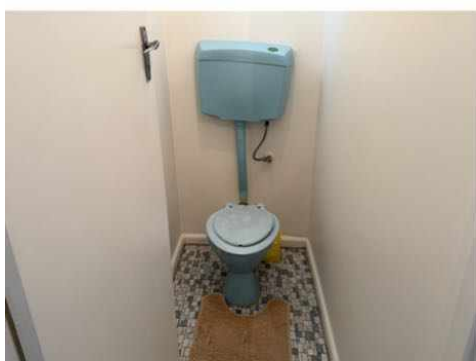
### Defects 3.03

Building:	Building 1
Location:	Rear toilet > All Areas
Finding:	Toilet roll holder - missing
Information:	The toilet roll holder was found to be missing to the lower bathroom at the time of inspection. While not a major operational defect, function can deteriorate if the problem is left unmanaged. It is recommended that the client appoint a qualified carpenter to reattach or renew the toilet roll holder to its original position. A qualified carpenter may be required to perform these works.

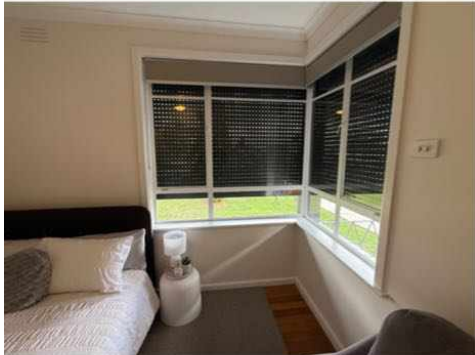
### Defects 3.04

Building:	Building 1
Location:	All Areas > All Areas
Finding:	Flyscreens
Information:	Numerous flyscreens were found to be missing to the windows throughout the home at the time of inspection. Whether the flyscreens have not been installed or have been removed for maintenance and or painting purposes, this missing building element detracts from the operational state of the window.

Where not replaced, missing flyscreens allow pest and insect ingress into the adjoining room/s. It is advised that all missing building elements be installed or

replaced in order to ensure the full function of all building structures.

A qualified carpenter may be appointed to replace flyscreens at the discretion of the client.

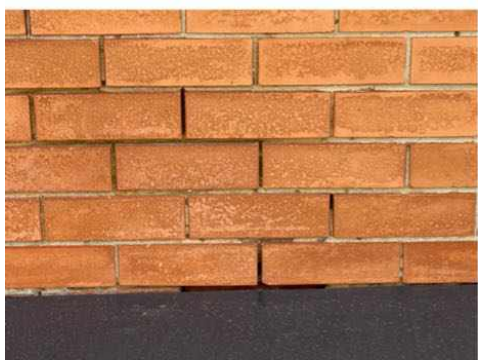
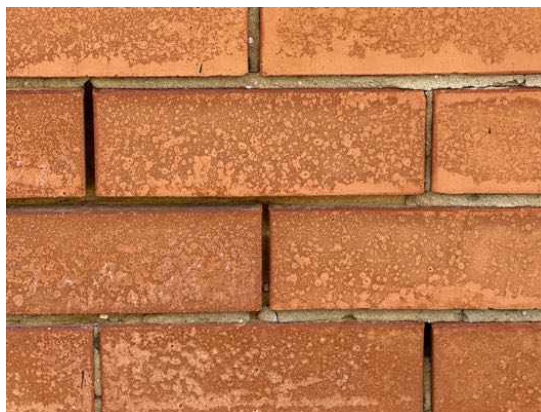
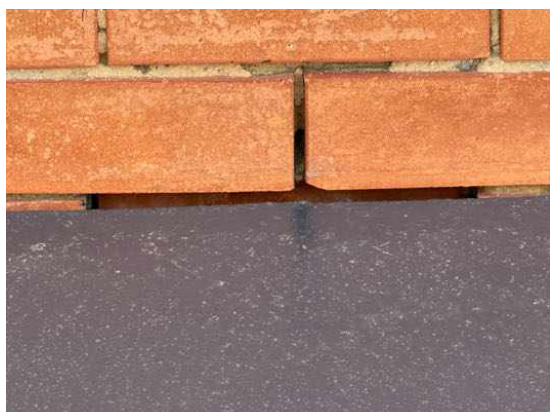
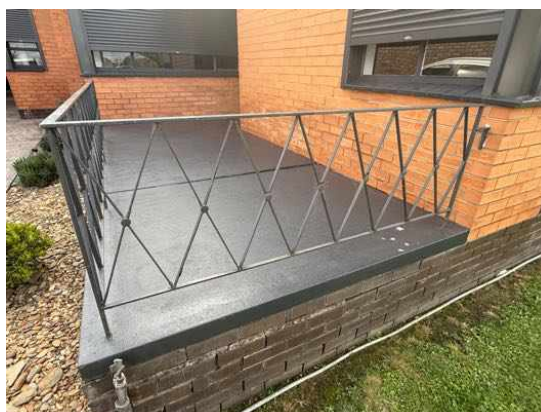
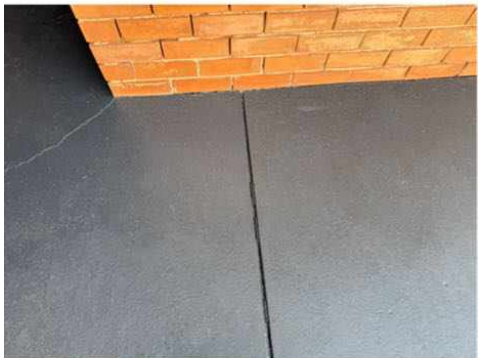
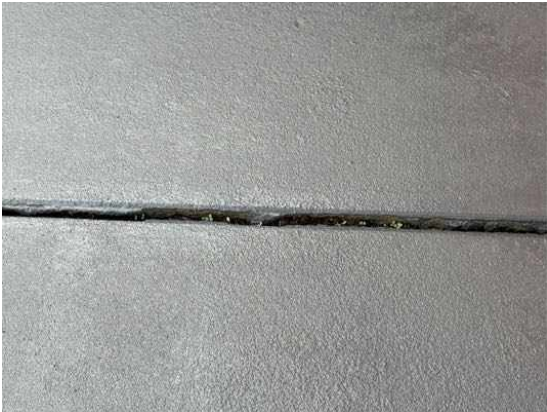
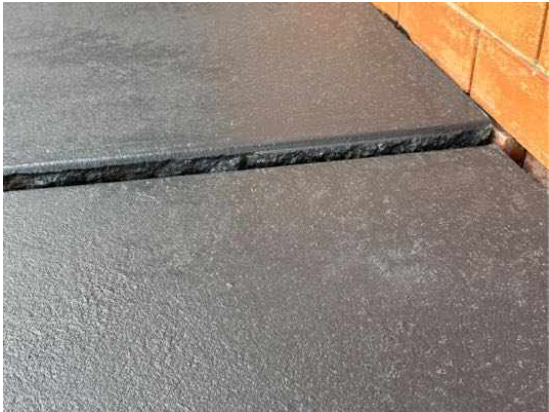
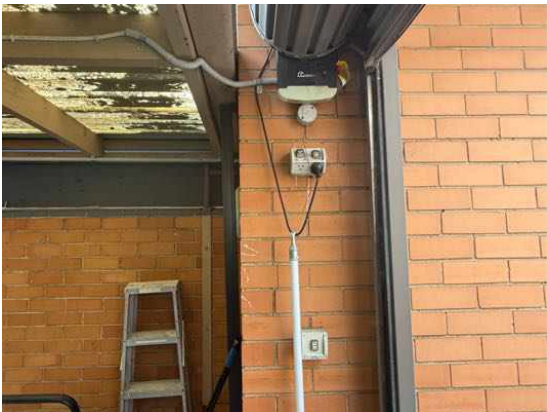
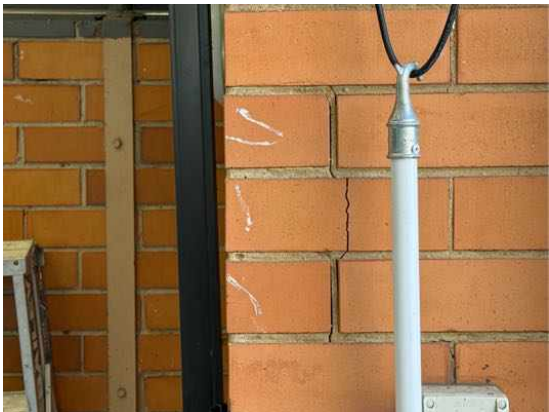
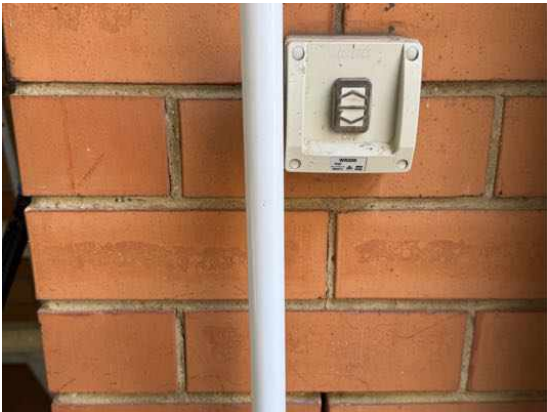
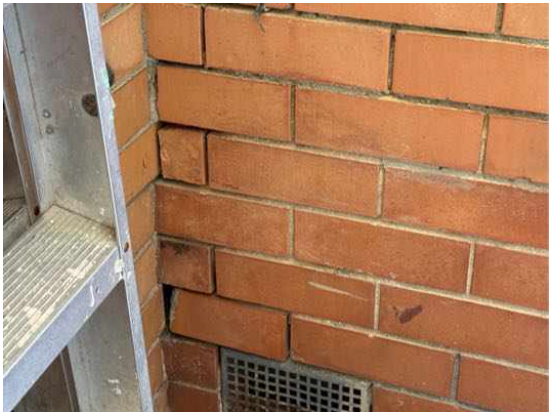
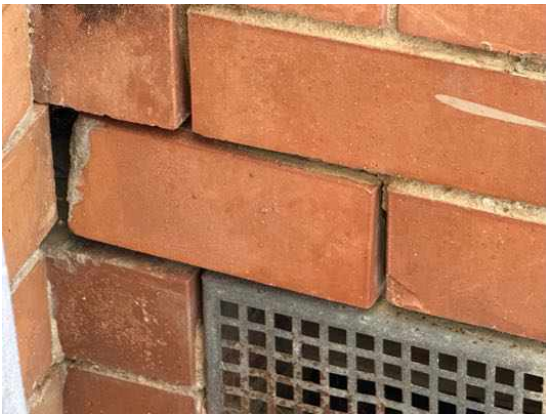
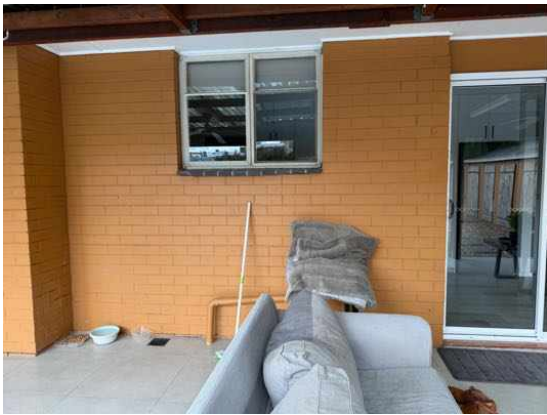
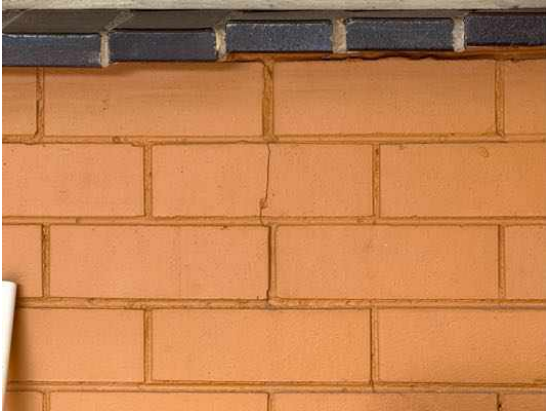
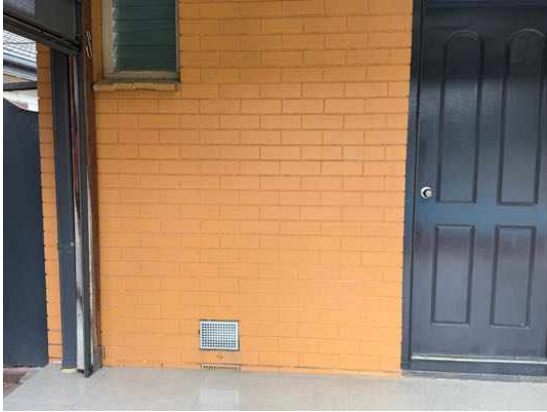
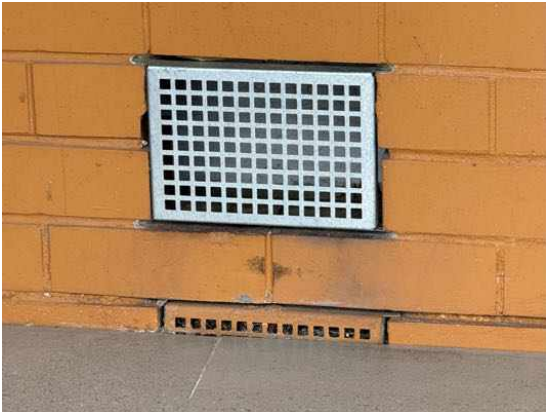
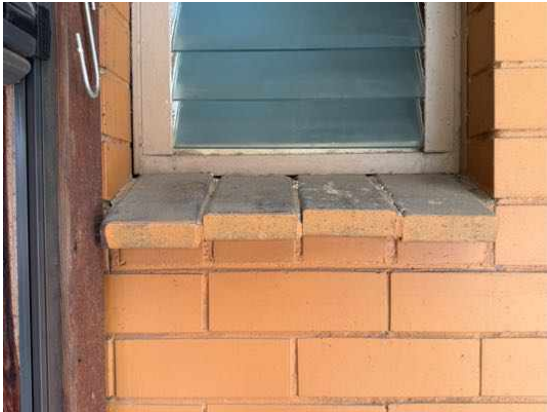
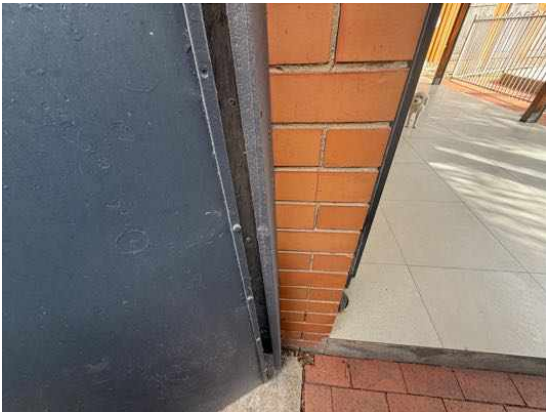
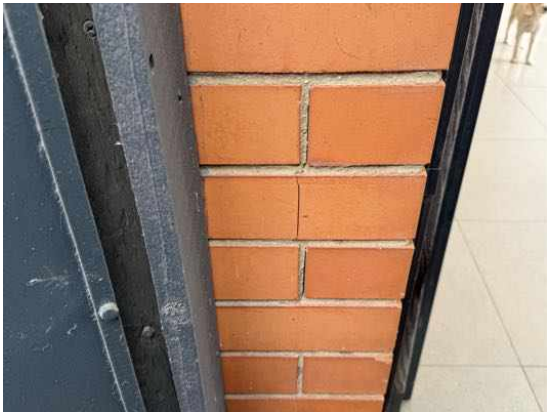
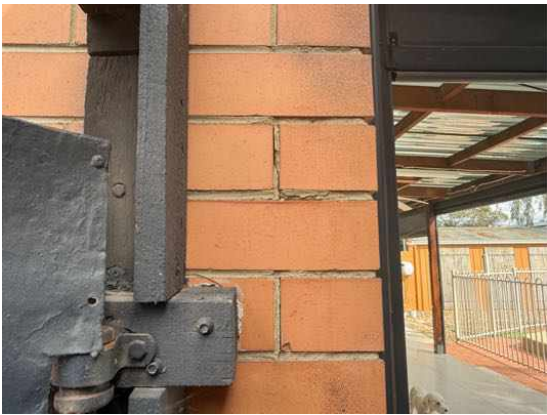
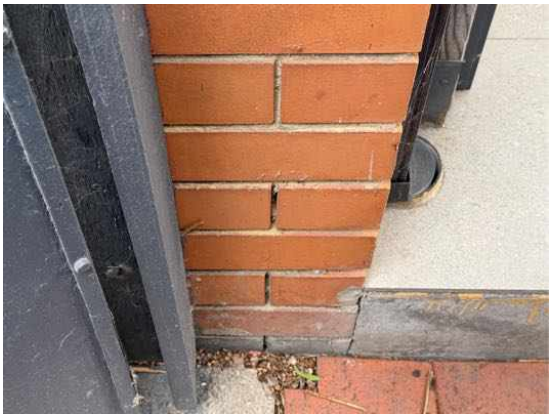
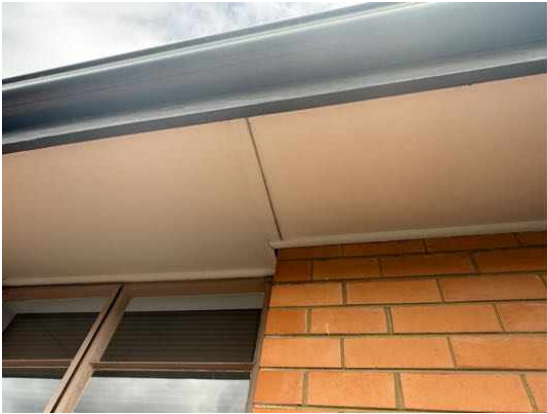
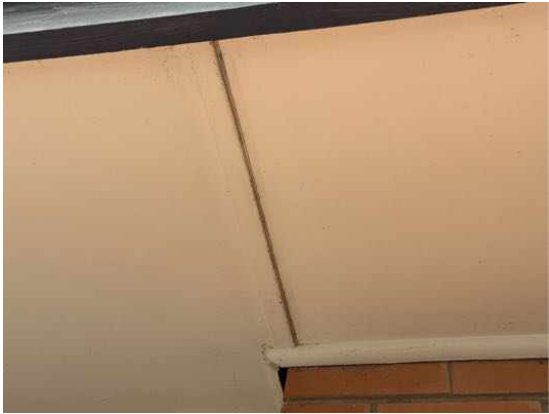
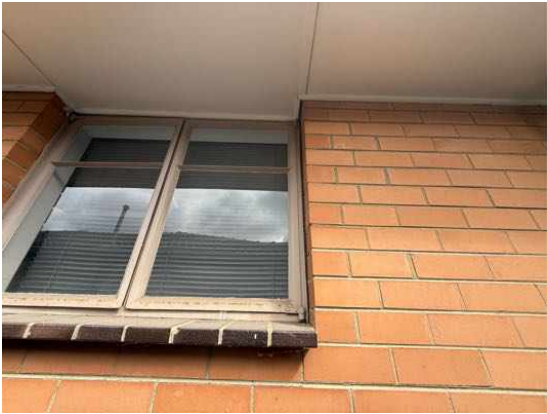
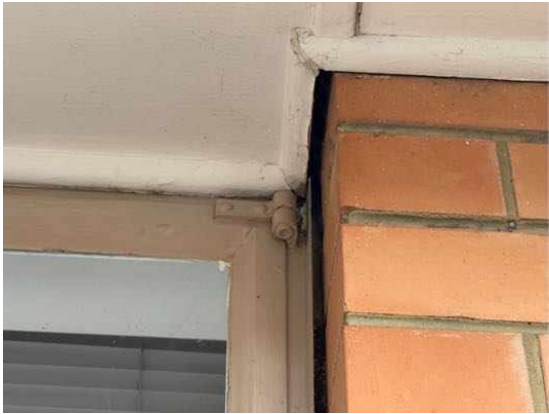
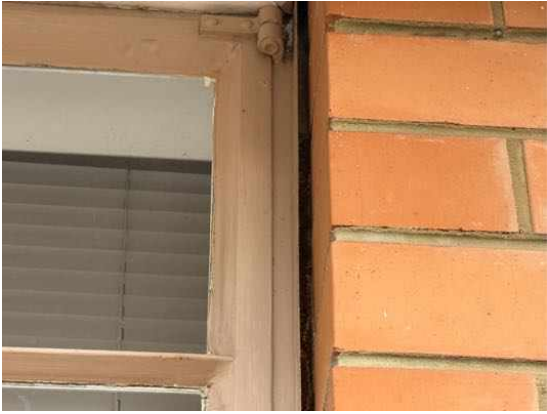
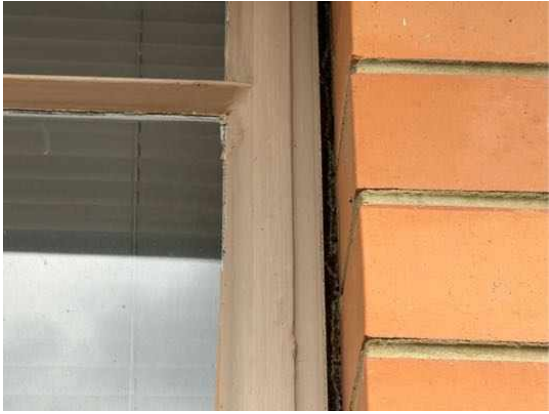
### Defects 3.05

Building: Building 1  
Location: All Areas > All Areas  
Finding: Brickwork - cracks and movement  
Information: At the time of the inspection numerous cracks and movement were observed throughout the exterior brickwork of the home. There was some areas of unevenness

and out of level floor areas in the home and this is likely to indicate some subsidence and movement in the foundations and the associated building structures in the property. Structural issues are generally the underlying cause of such brickwork movement and cracking. It is suspected that this damage has been created due to movement and general subsidence of associated foundations as well as normal age and deterioration. The brickwork cracks and movement may develop further over time with the potential for necessitating some remedial works or even in extreme cases replacement of the brickwork.

Noticeable brickwork cracks and movement are a common occurrence in external brickwork and are a likely result of some building movement, general expansion, and/or contraction in some building elements in different weather conditions. The client is recommended to appoint a structural engineer to inspect the structural integrity of these areas and affected brickwork, to assess the safety of the associated structures. Where remedial work is deemed to necessary or required the engineer can also nominate a scope of works required for rectification or even the prevention of further damage and deterioration. Always contact a Registered builder and or Structural engineer should cracks widen lengthen or become more numerous, even after any repair works have been completed.
