## Building Inspection Report

Inspection Date: Thu, 12 Mar 2026

Property Address: 16 Cyprus St, Lalor VIC 3075, Australia

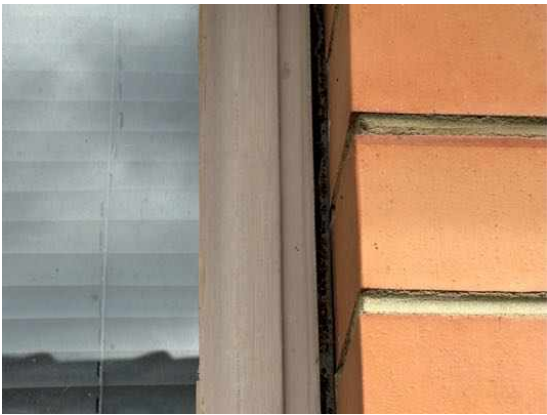
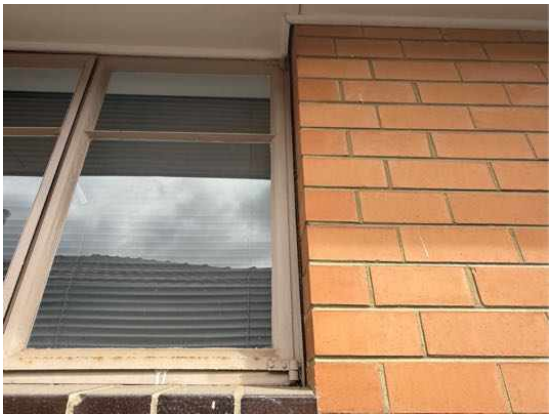
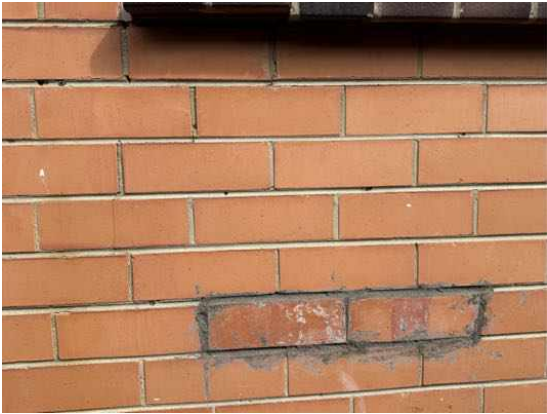
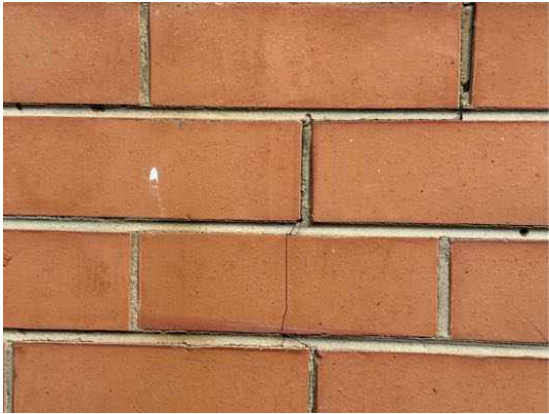
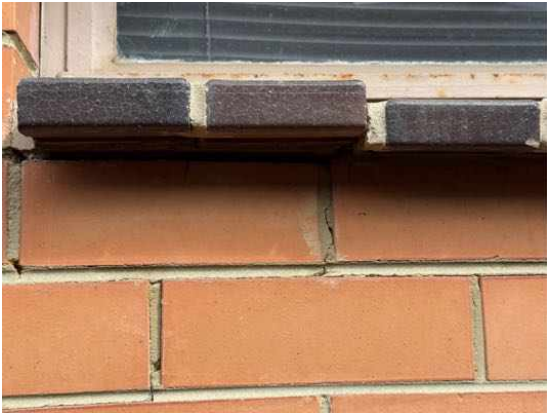
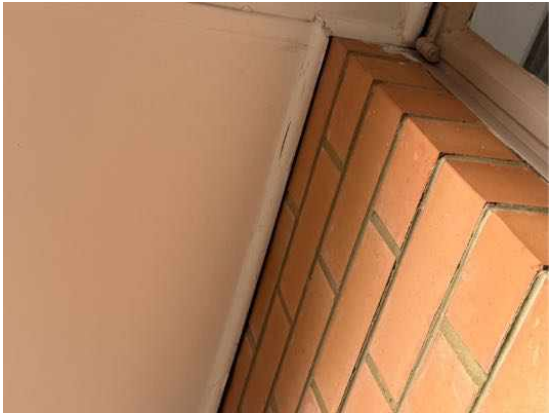
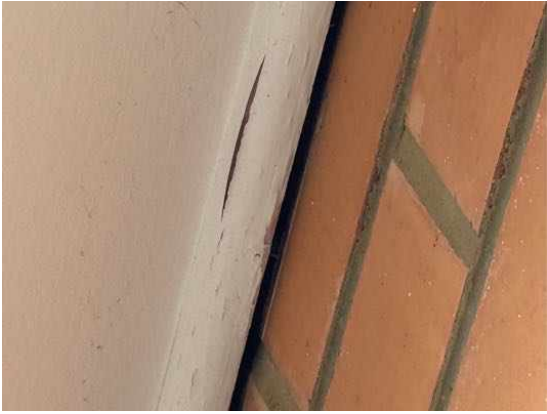
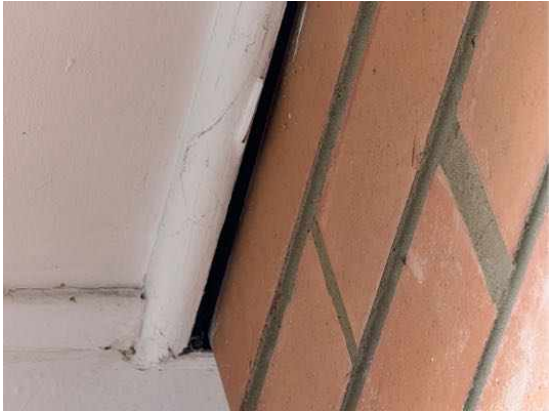
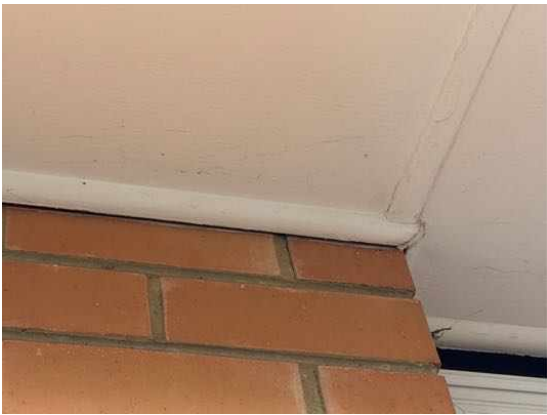
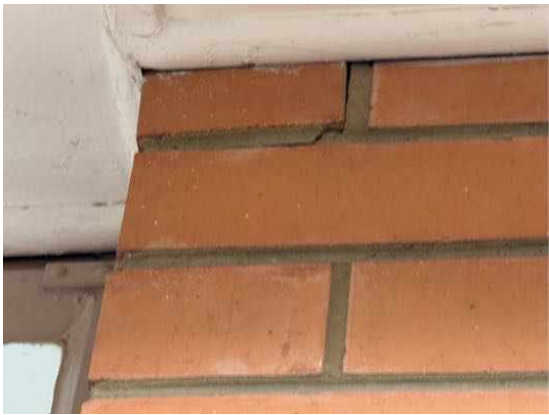
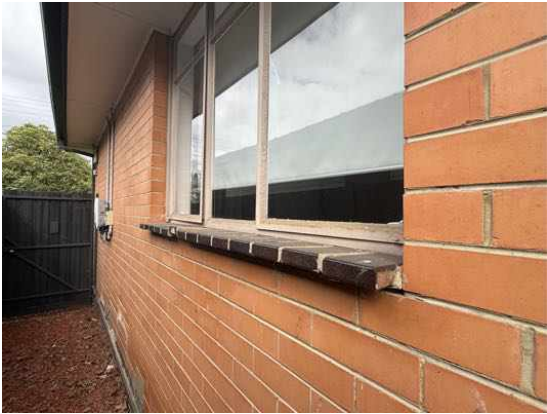
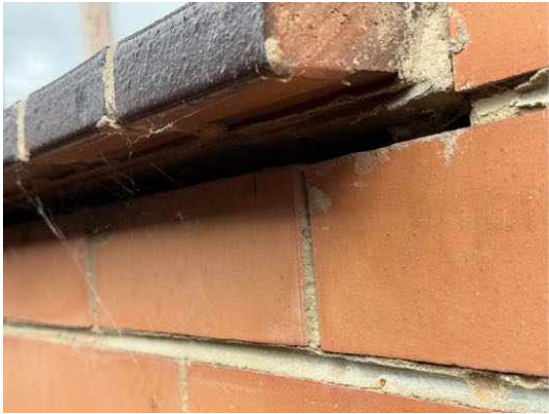
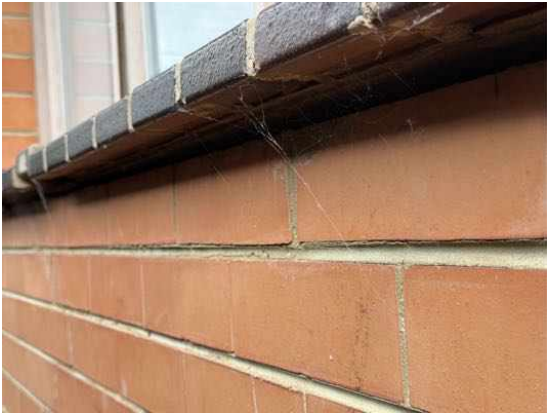
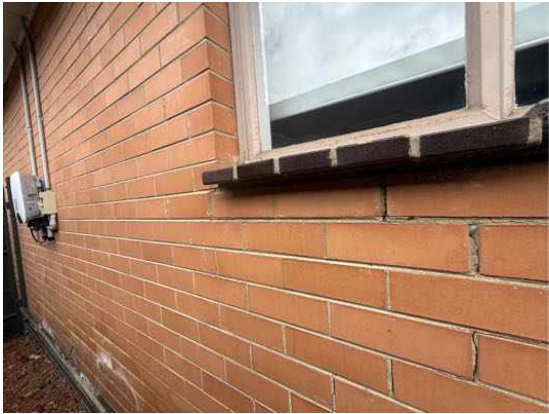
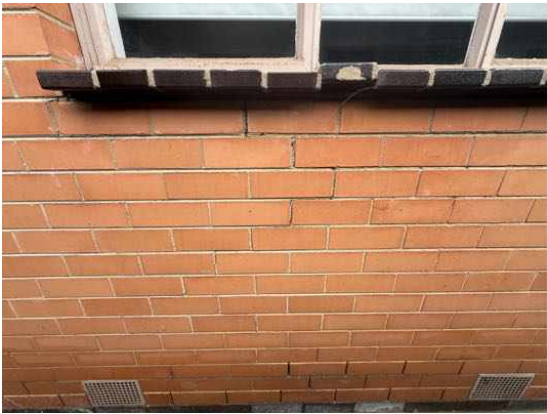
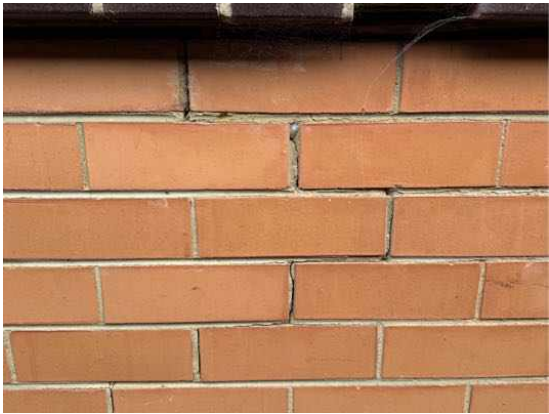
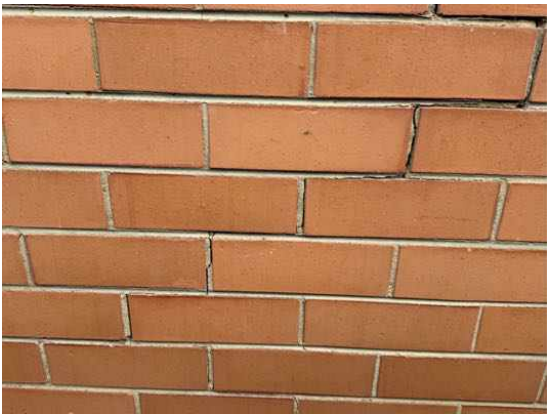
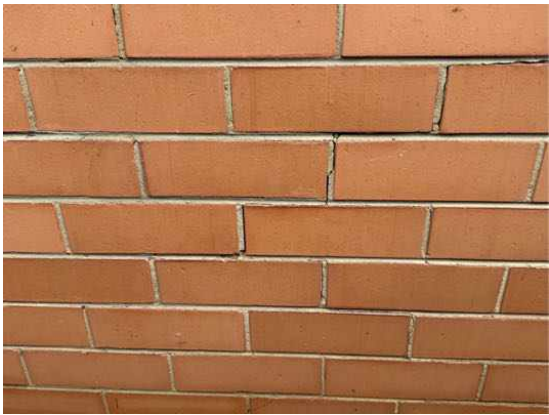
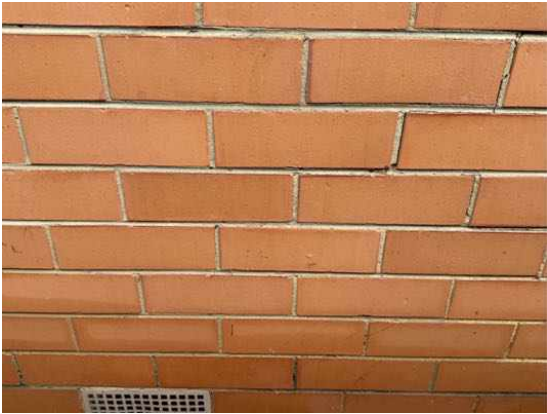
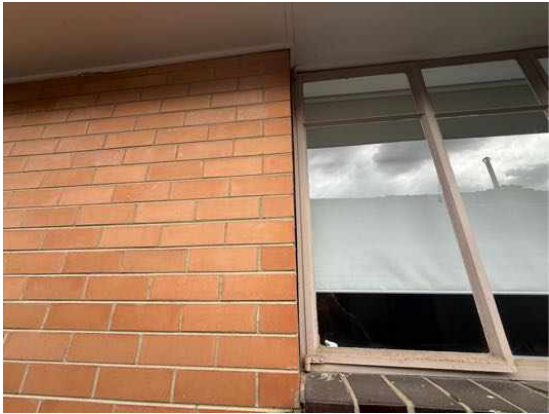
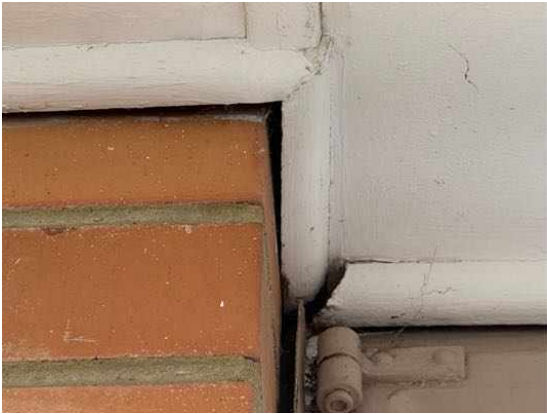
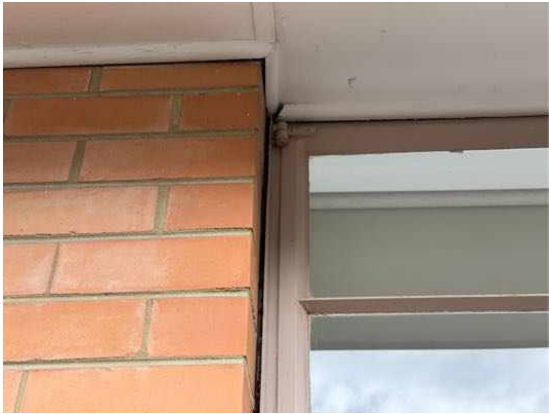
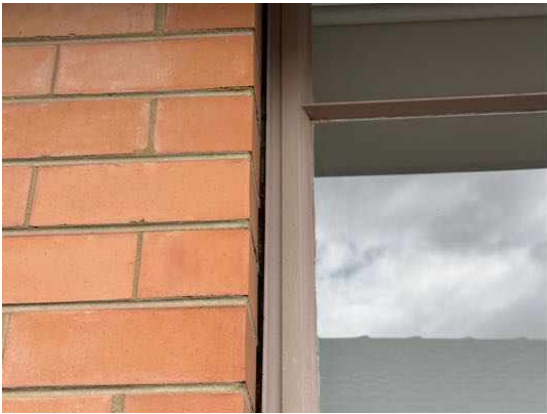
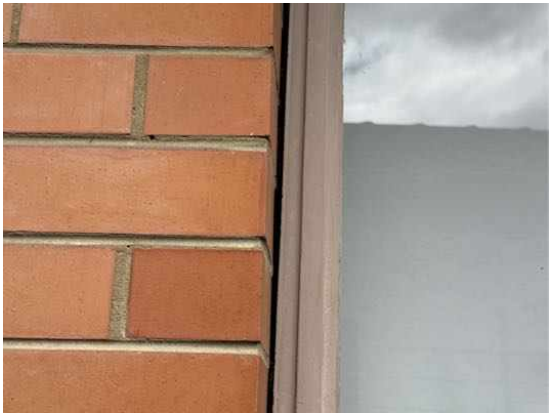
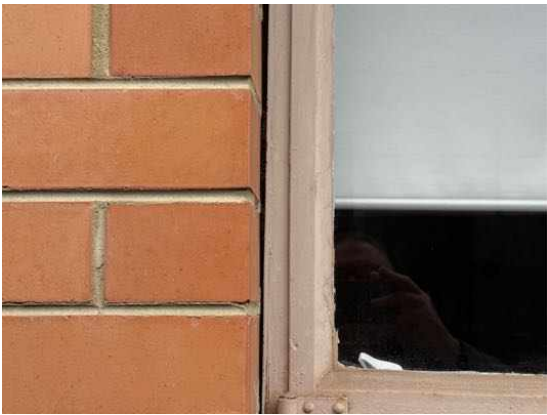
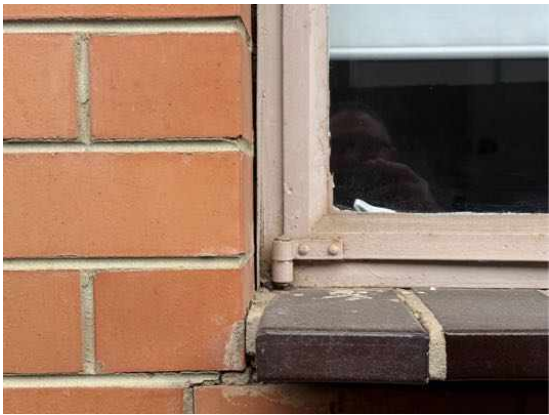
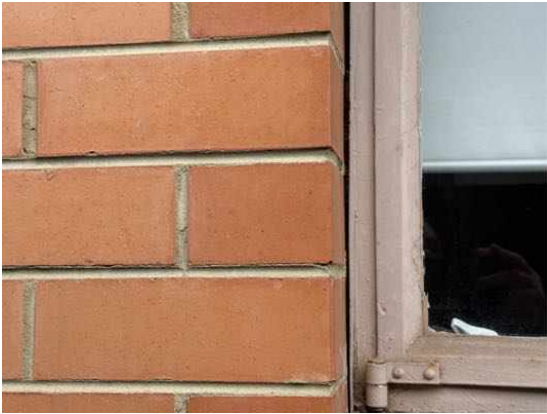
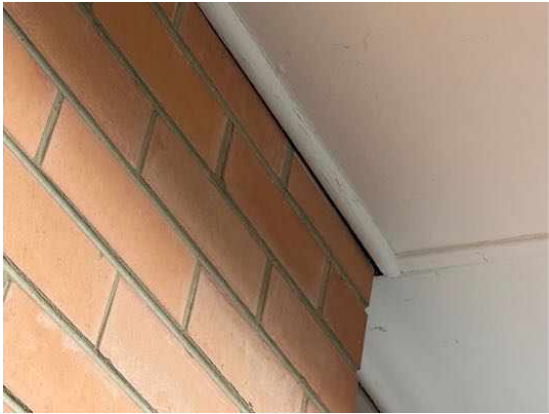
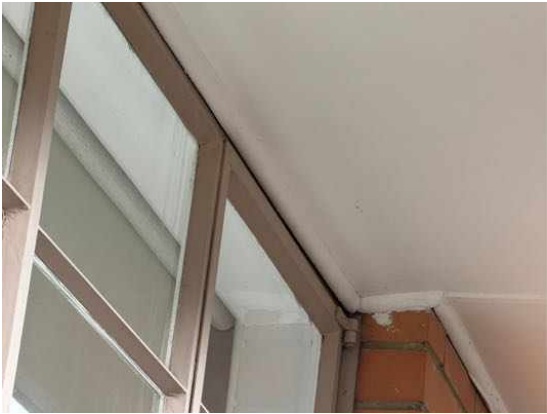
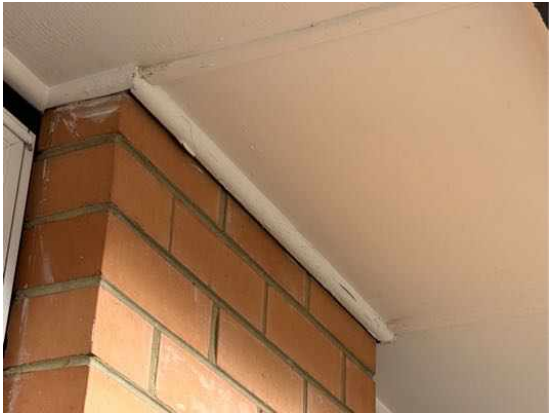
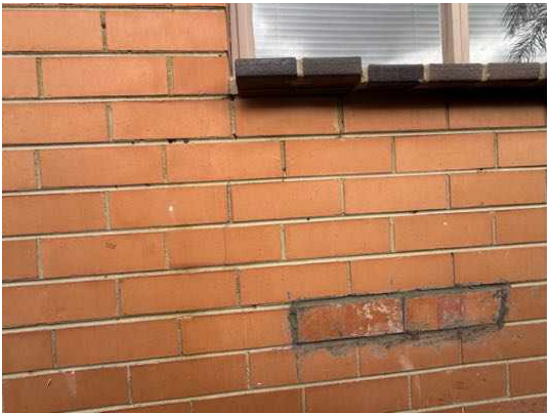
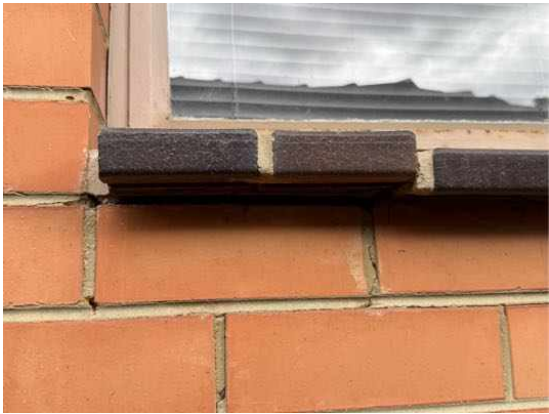
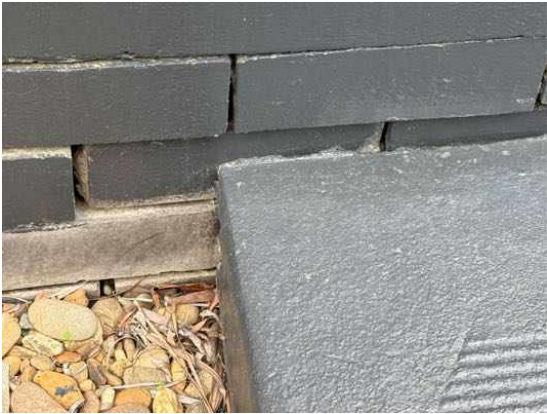
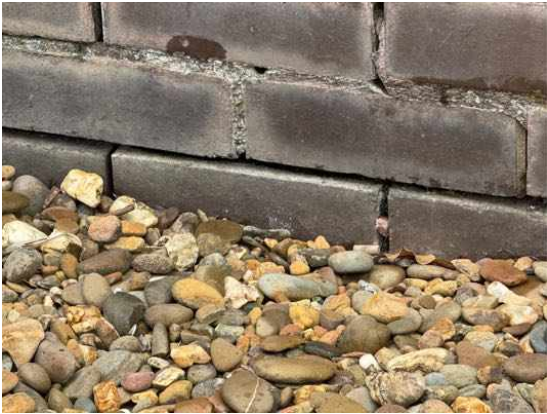
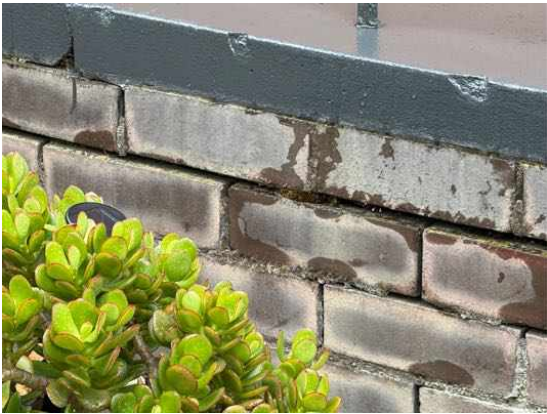
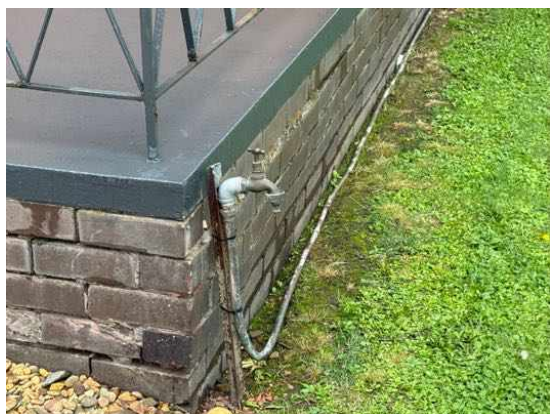
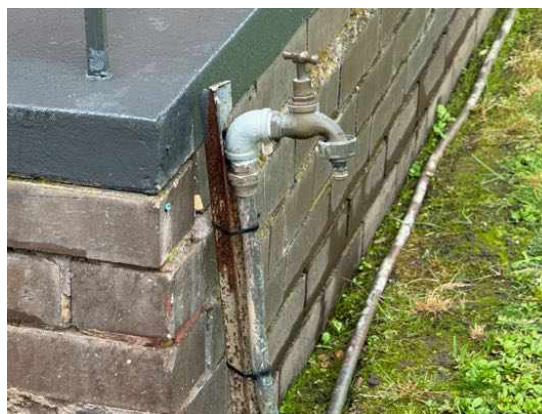
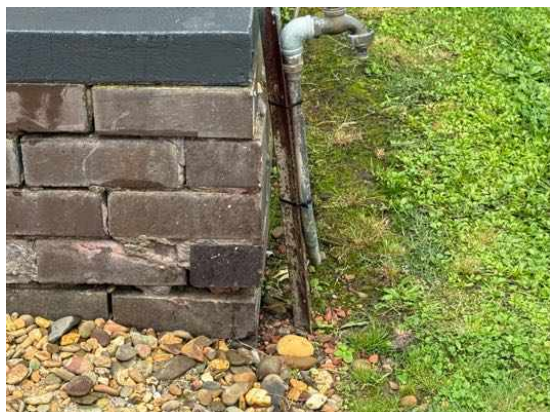
### Defects 3.05

Building: Building 1  
Location: All Areas > All Areas  
Finding: Brickwork - cracks and movement  
Information: At the time of the inspection numerous cracks and movement were observed throughout the exterior brickwork of the home. There was some areas of unevenness

and out of level floor areas in the home and this is likely to indicate some subsidence and movement in the foundations and the associated building structures in the property. Structural issues are generally the underlying cause of such brickwork movement and cracking. It is suspected that this damage has been created due to movement and general subsidence of associated foundations as well as normal age and deterioration. The brickwork cracks and movement may develop further over time with the potential for necessitating some remedial works or even in extreme cases replacement of the brickwork.

Noticeable brickwork cracks and movement are a common occurrence in external brickwork and are a likely result of some building movement, general expansion, and/or contraction in some building elements in different weather conditions. The client is recommended to appoint a structural engineer to inspect the structural integrity of these areas and affected brickwork, to assess the safety of the associated structures. Where remedial work is deemed to necessary or required the engineer can also nominate a scope of works required for rectification or even the prevention of further damage and deterioration. Always contact a Registered builder and or Structural engineer should cracks widen lengthen or become more numerous, even after any repair works have been completed.

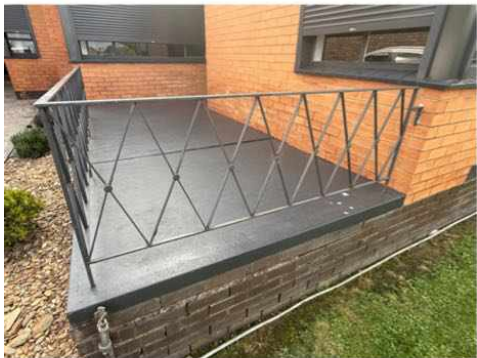
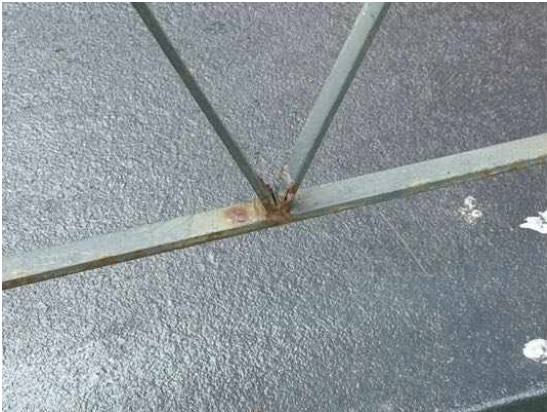
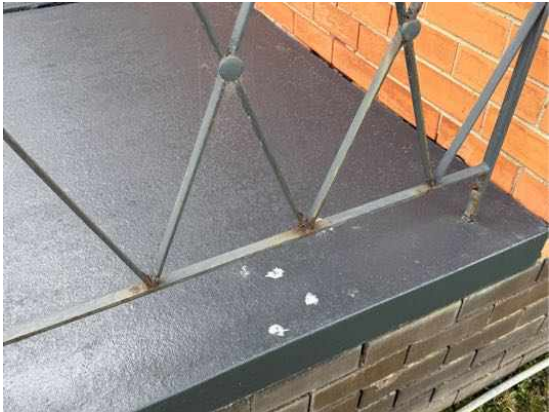
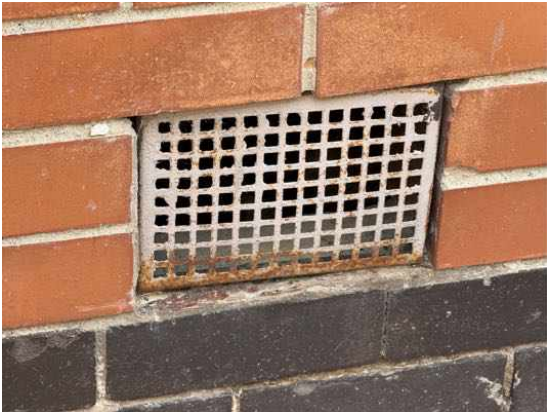
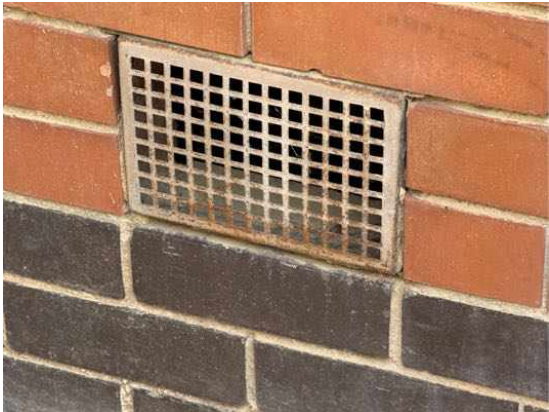
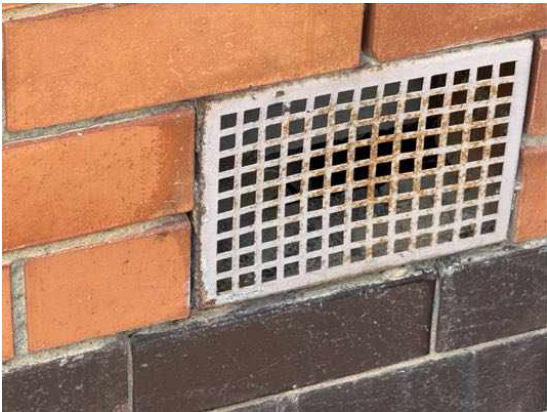
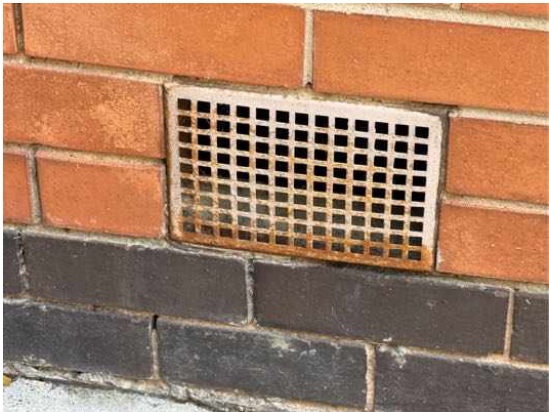
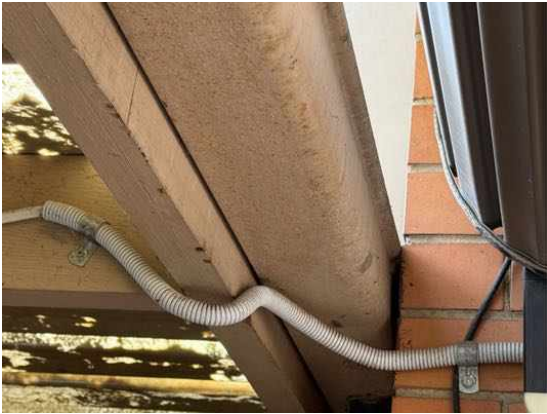
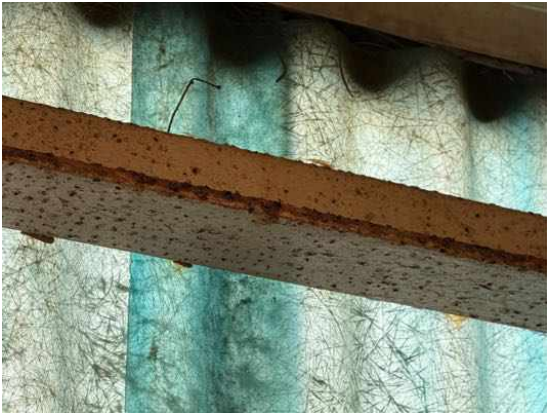
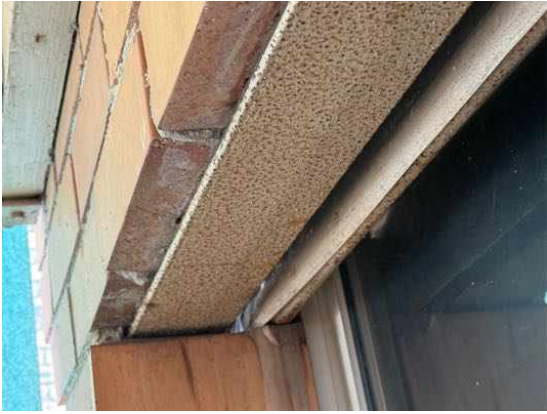
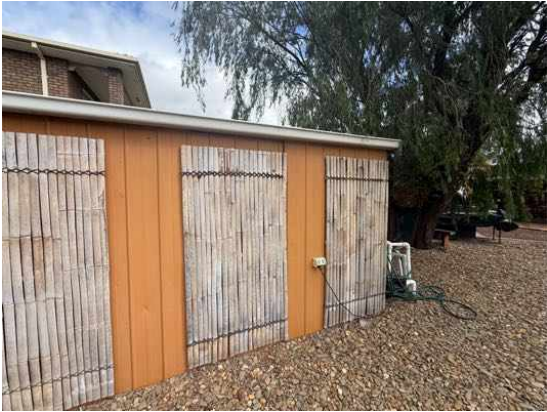
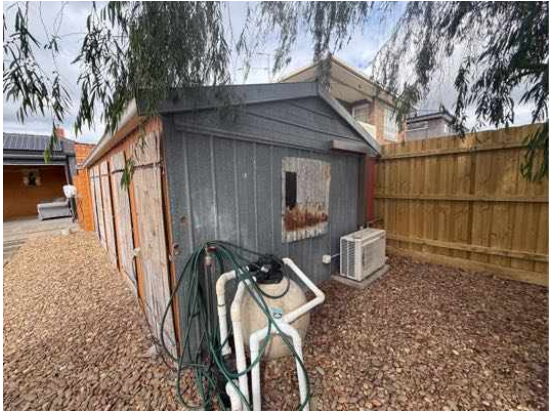
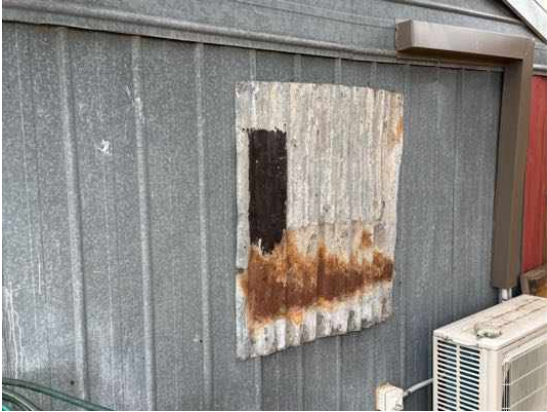
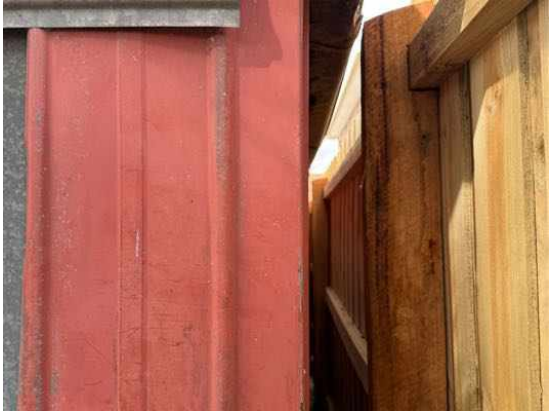
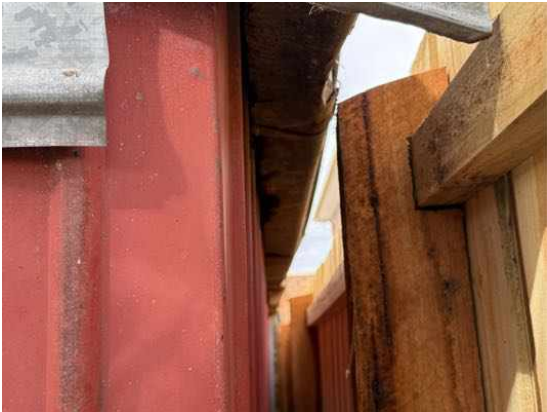
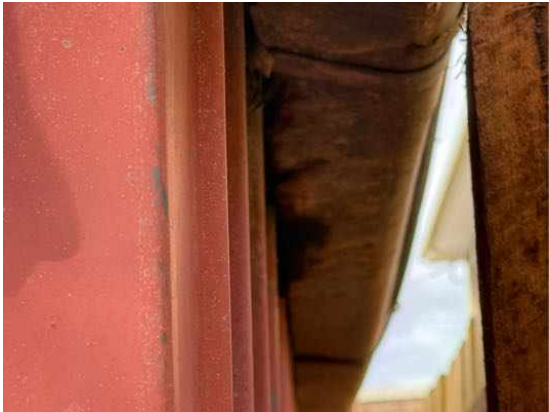
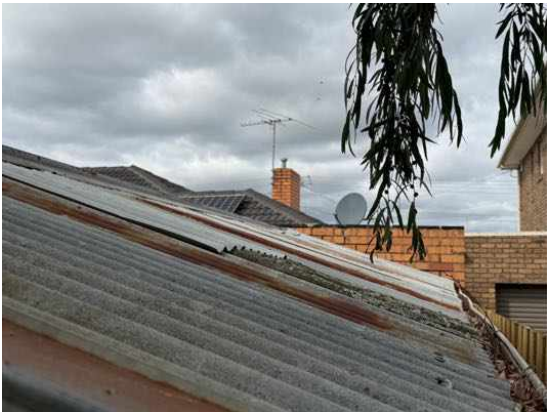
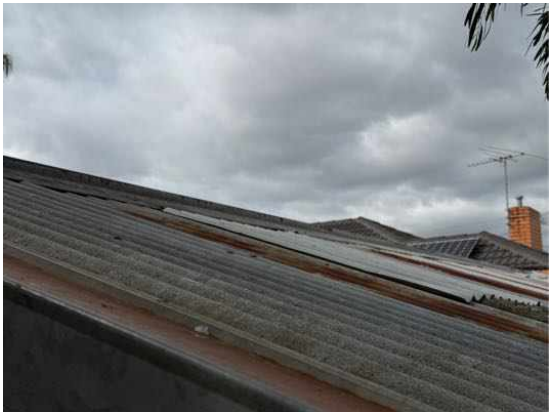
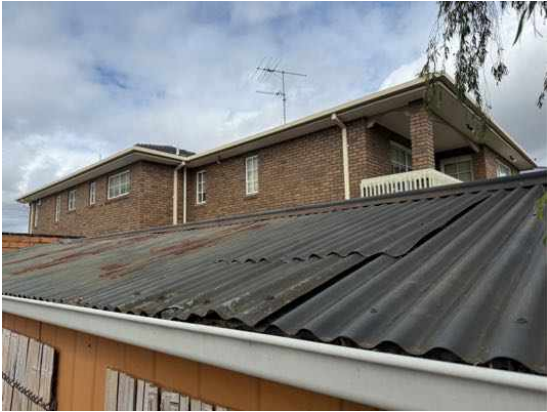
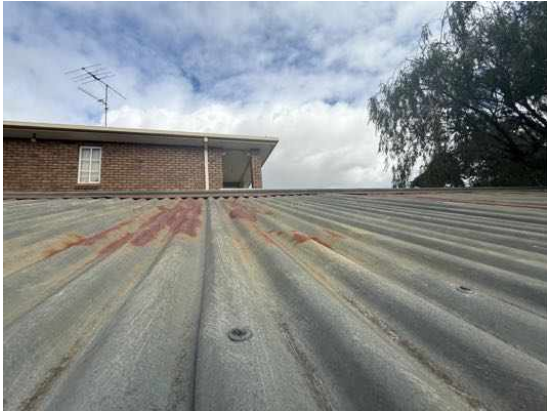
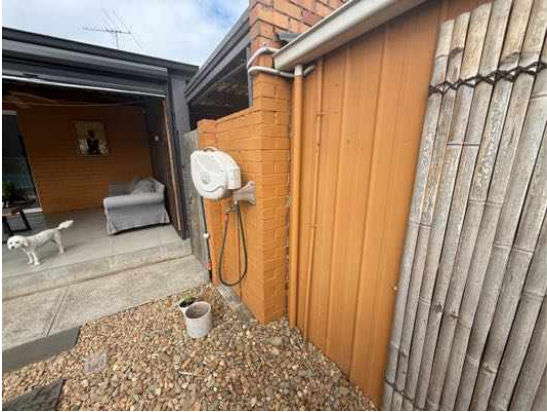
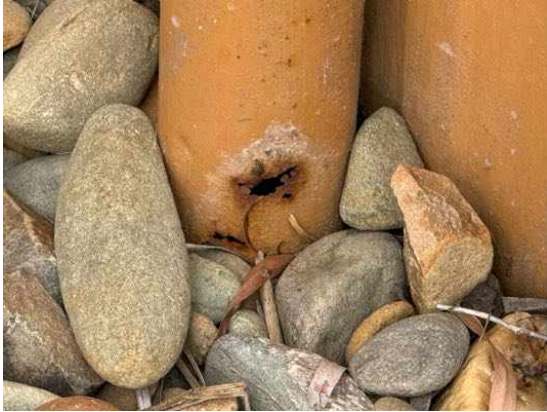
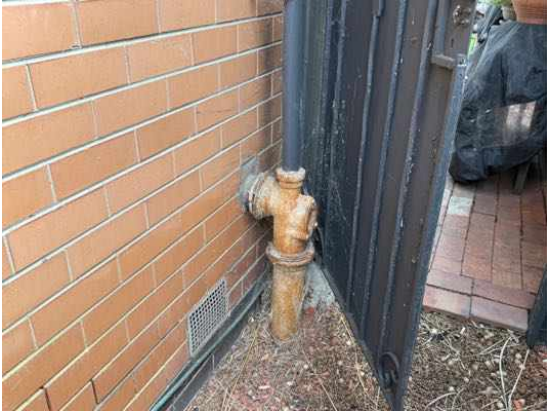
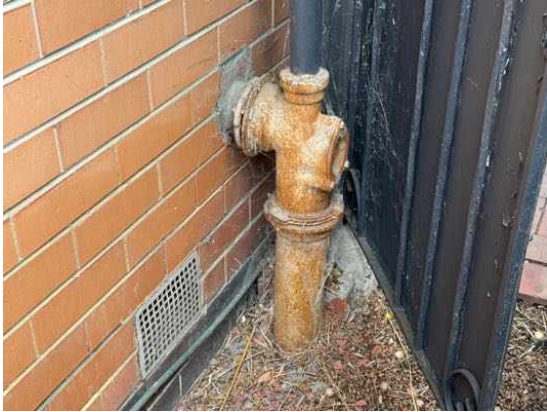
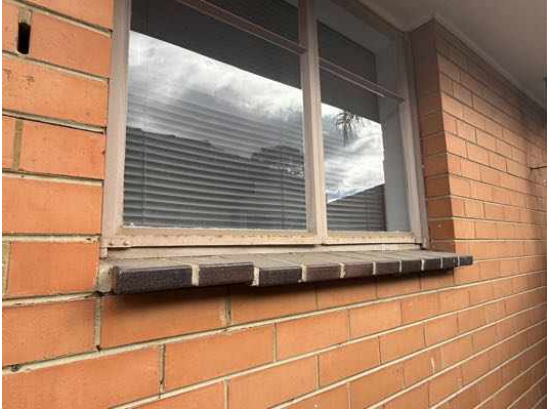
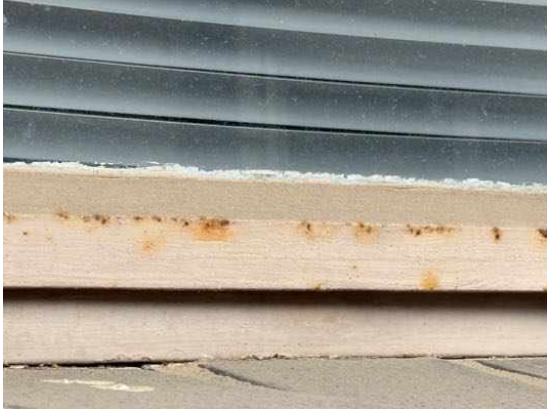
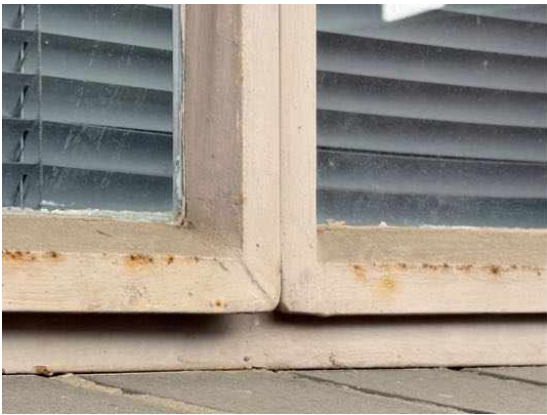
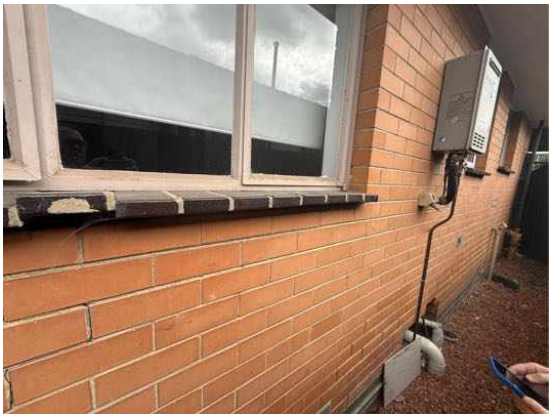
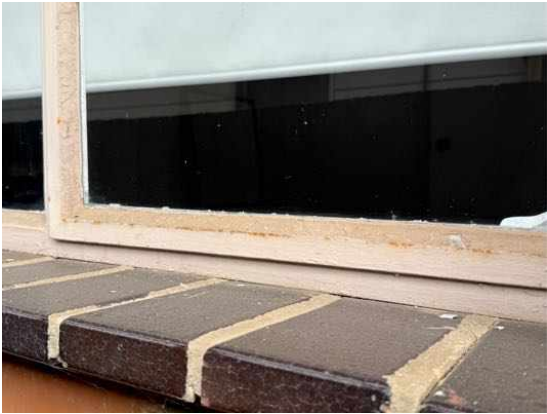
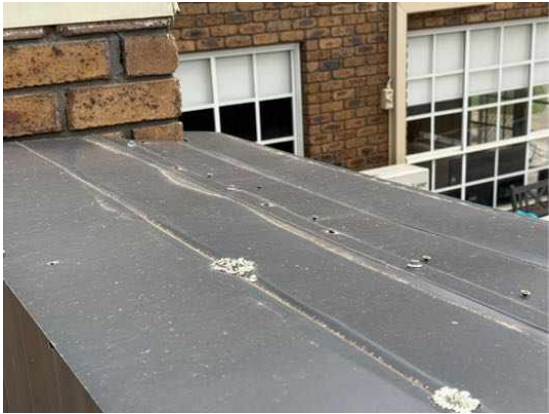
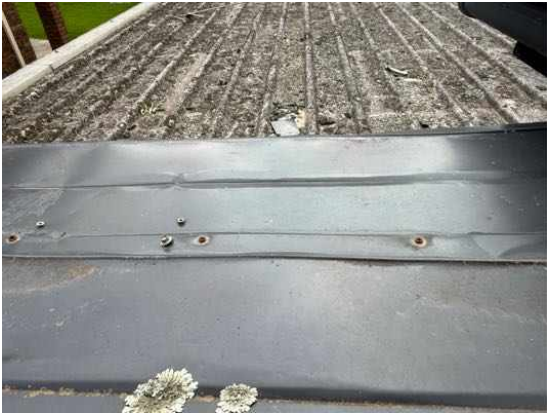
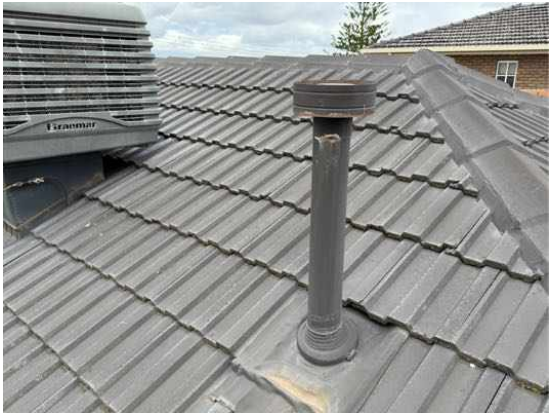
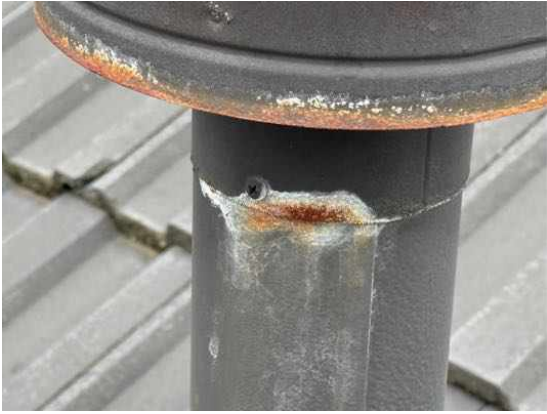
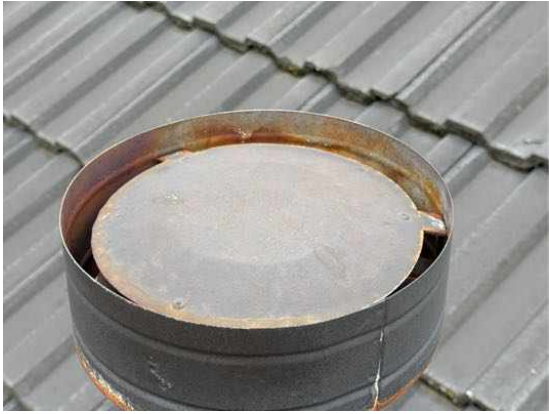
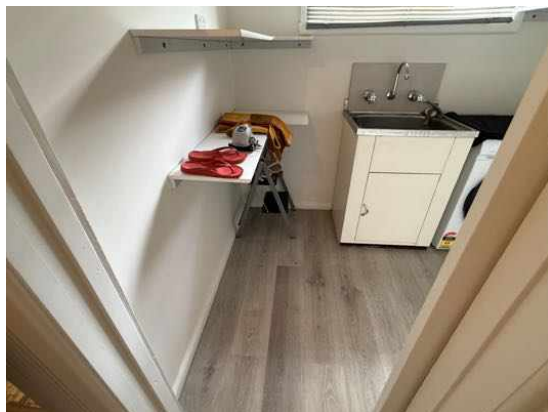
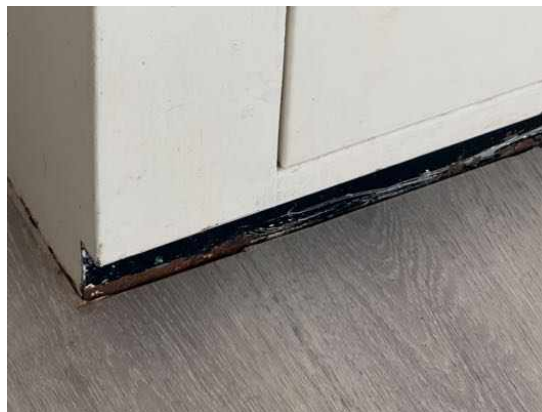
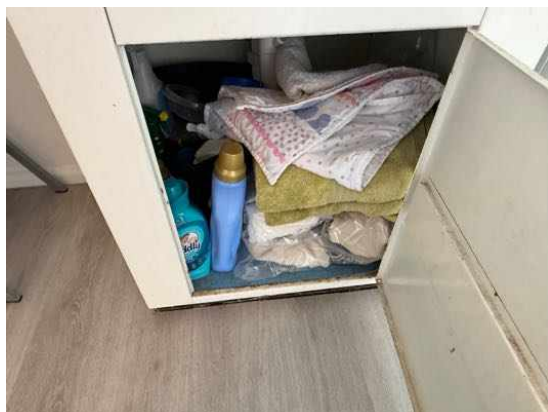
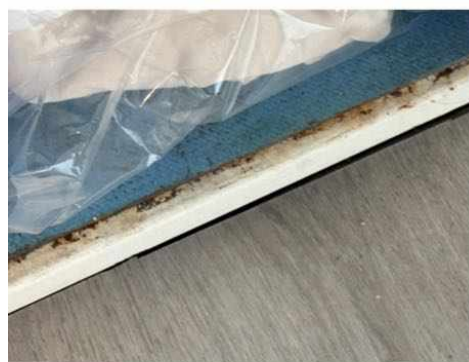
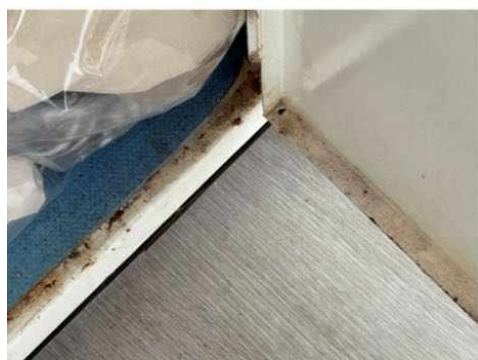
### Defects 3.06

Building:	Building 1
Location:	All Areas > All Areas
Finding:	Building element - Rusted or corroded
Information:	Some exterior building elements and materials that show evidence of rusting and corrosion, has likely developed as a result of excessive exposure to moisture, harsh weather conditions and or inadequate coatings. A surface that is found to be rusted provides no protection to the underlying iron, the deteriorating condition is likely to worsen if not addressed and left unmanaged, it is therefore recommended that the relevant tradespersons remove as much rust as possible, clean and re-paint these areas.

Where possible, the use of galvanized (treated) metals or aluminium coated metals aid in rust prevention, as does regular general maintenance. Rust formation can be controlled with coatings, such as paint, that isolate the iron from the environment. Rusting and corrosion should be managed by ideally removing or limiting the affected surface from exposure to moisture and harsh weather conditions. A qualified painter or other relevant tradespersons may be appointed to paint affected areas and a qualified carpenter to replace any building elements that have been severely affected by rust or water damage.

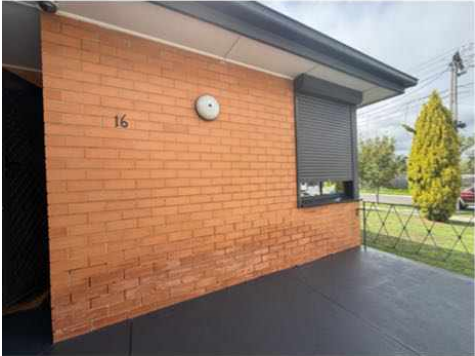
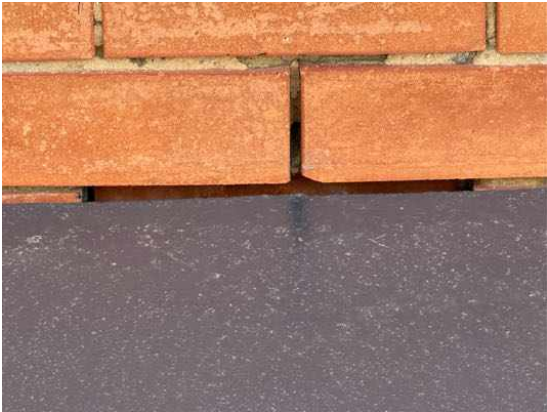
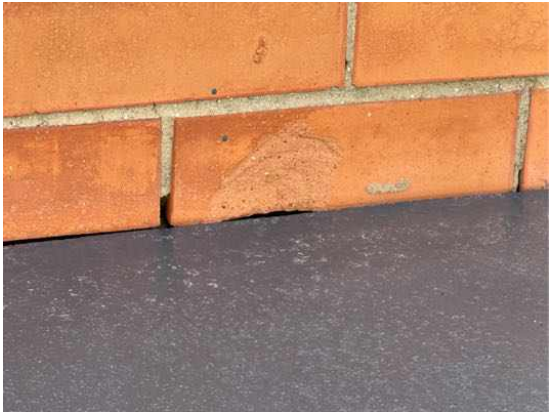
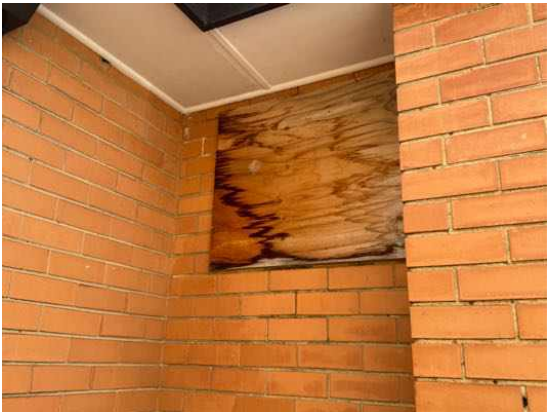
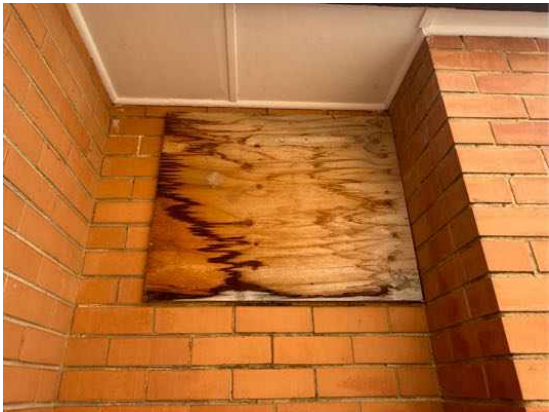
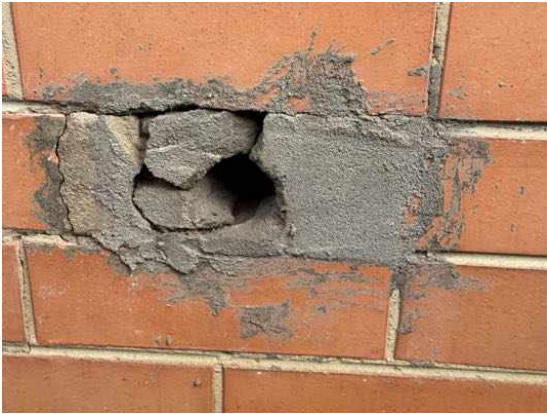
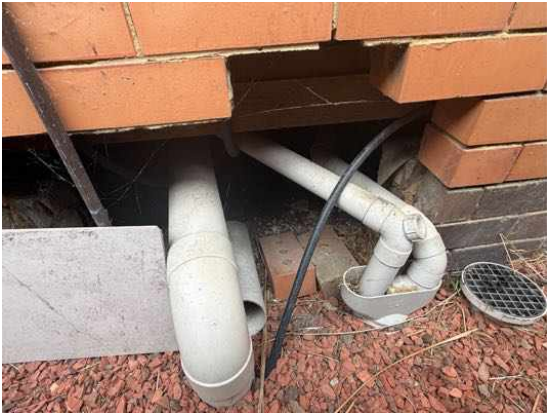
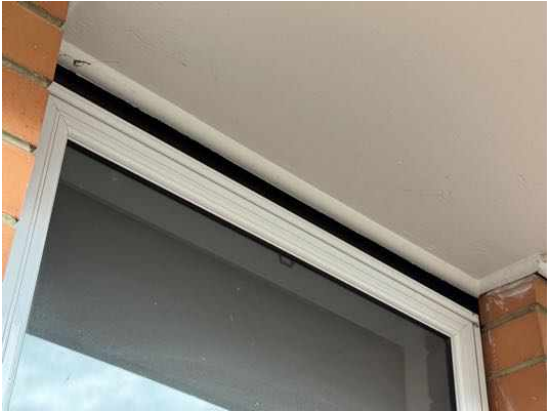
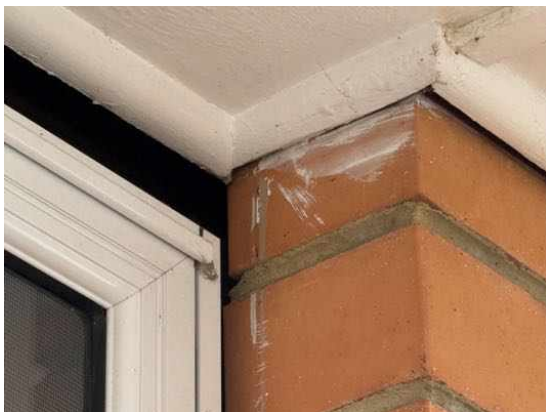
### Defects 3.07

Building: Building 1  
 Location: All Areas > All Areas  
 Finding: Subfloor door and other holes in the exterior walls  
 Information: The subfloor door was observed to be missing and no subfloor door installed. Other holes in the exterior walls or open areas like the subfloor door should be rectified and adequately filled or trimmed to prevent the ingress of unwanted pests and vermin. A window around on the back right hand side of the home has not been finished with a trim of flashing.

Gaps and holes around the home makes the area susceptible to spiders, insect and vermin ingress to the internal areas bringing disease and unhealthy environments As

such, associated internal building elements are likely to deteriorate without the adequate protection a home needs. Further secondary defects are suspected to occur if these areas are left unmanaged. All holes, gaps or cracks should be adequately covered, filled, flashed by a suitable building material, sealant or trimmings as soon as possible to prevent any inevitable future deterioration and secondary damage. Such works should be completed in the short term future by the relevant tradespersons.

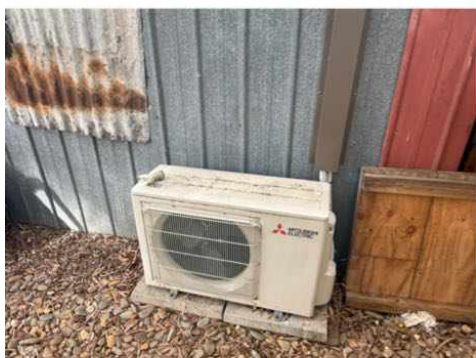
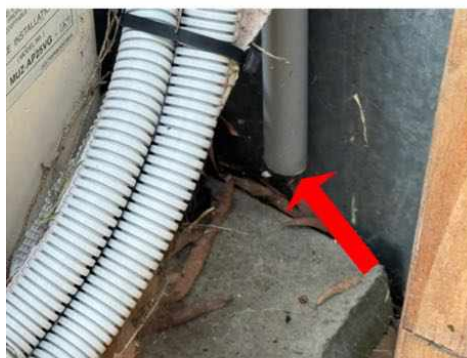
### Defects 3.08

Building:	Building 1
Location:	Teen retreat > All Areas
Finding:	Air-conditioning overflow not connected
Information:	The air-conditioning overflow were found not to be connected to any form of storm water drainage system and may in the future create excessive moisture in the surrounding area, as these units get aged and deteriorated.

These damp conditions can lead to secondary defects such as rot, rust or corrosion of associated building elements, the formation of fungal decay, or even the creation of potential slip hazards. When coupled with poor site drainage, pooling of water may also attract termite activity to this area.

It is recommended that all air-conditioning unit overflow be connected to drainage system in order to prevent such an environment from being created.
