## Building Inspection Report

Inspection Date: Thu, 12 Mar 2026

Property Address: 16 Cyprus St, Lalor VIC 3075, Australia

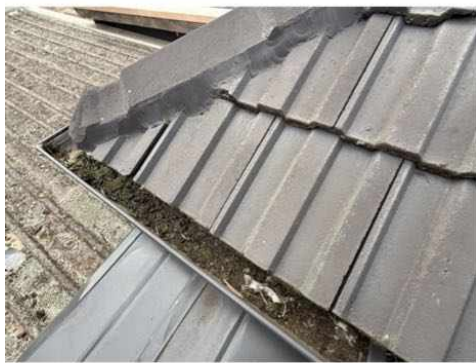
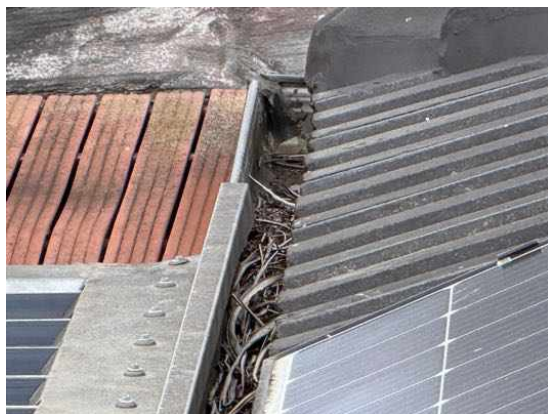
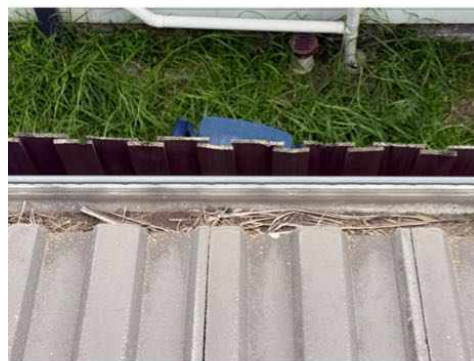
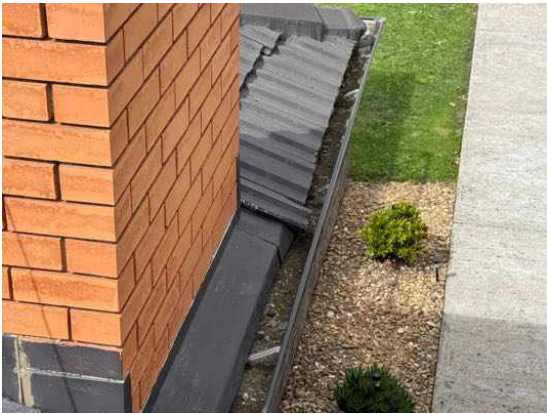
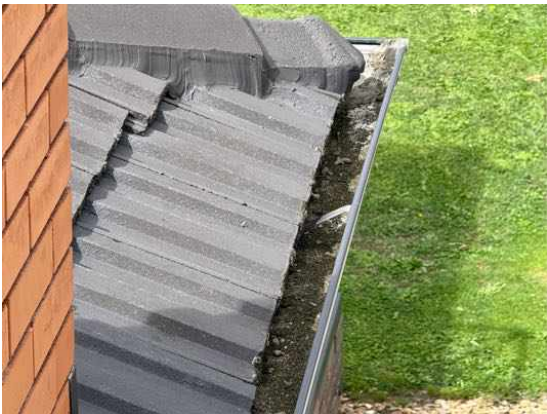
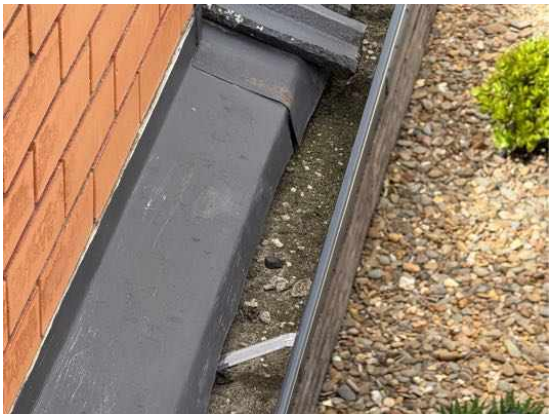
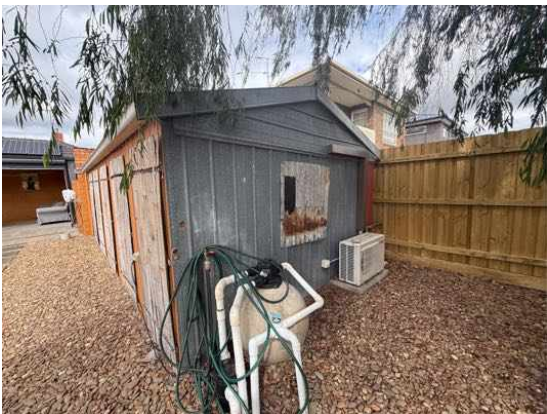
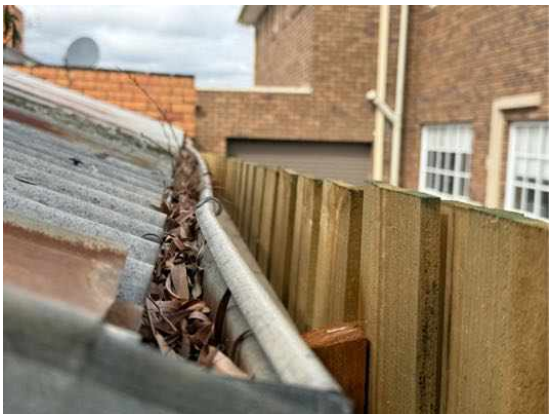
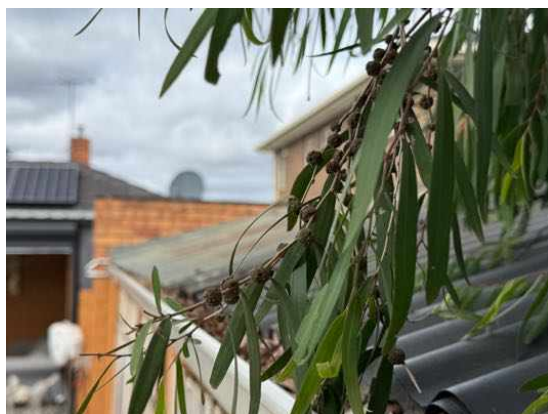
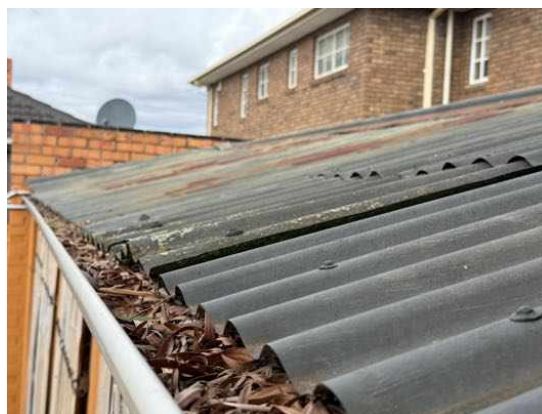
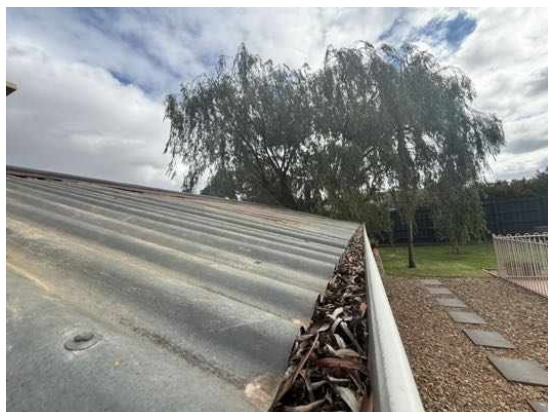
### Defects 3.09

Building:	Building 1
Location:	All Areas > All Areas
Finding:	Gutters - minor blockages
Information:	Roof plumbing structures, such as guttering and downpipes, should be free of all

Blocked gutters are likely to lead to high levels of moisture in the affected areas. Such moisture will not only cause rust and decay of the associated building materials, but can also provide conditions that are conducive to termite and timber pest activity. Blockages in gutters should therefore be removed immediately to ensure dry conditions are maintained.

It is recommended that blocked gutters be cleaned and leaf matter and debris be removed by a relevant tradespersons as a priority.

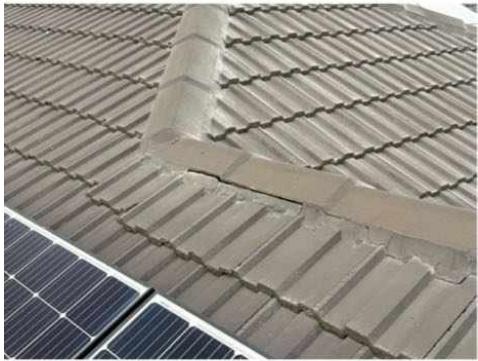
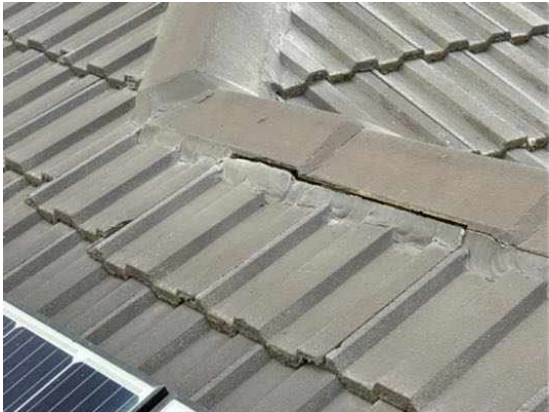
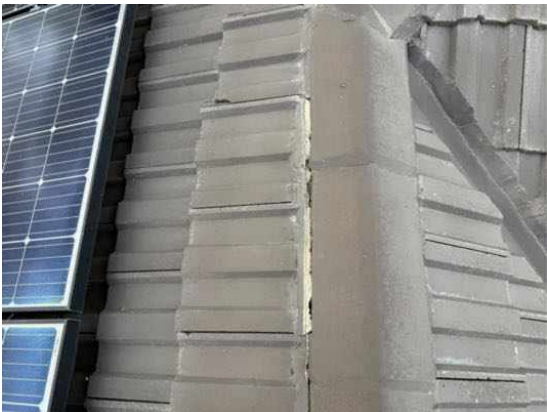
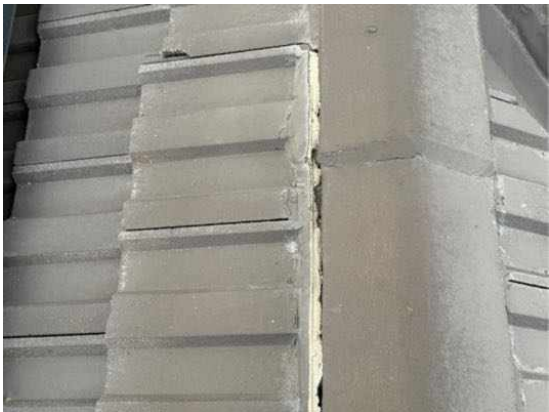
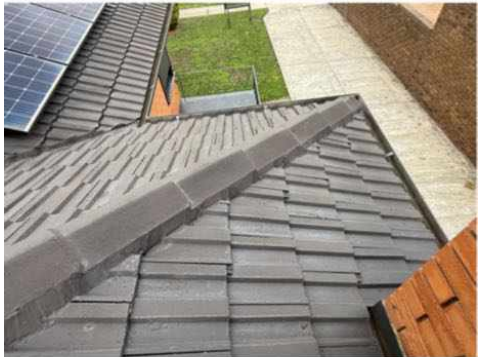
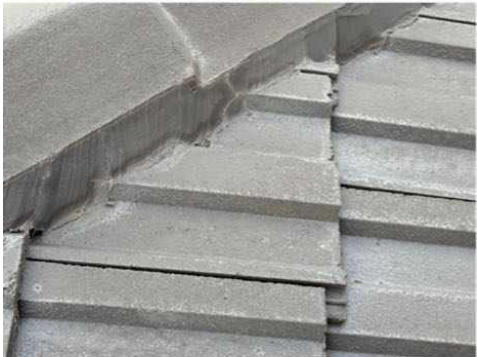
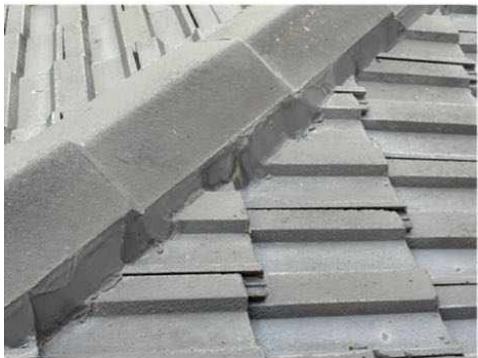
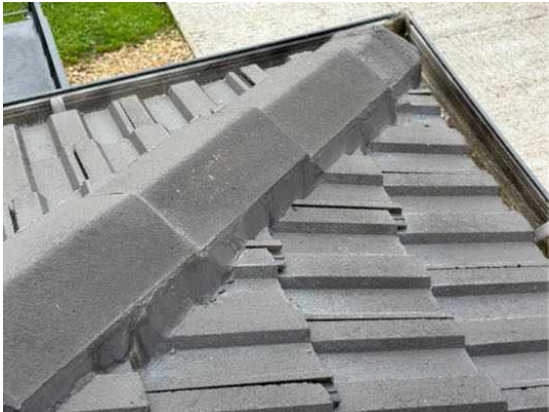
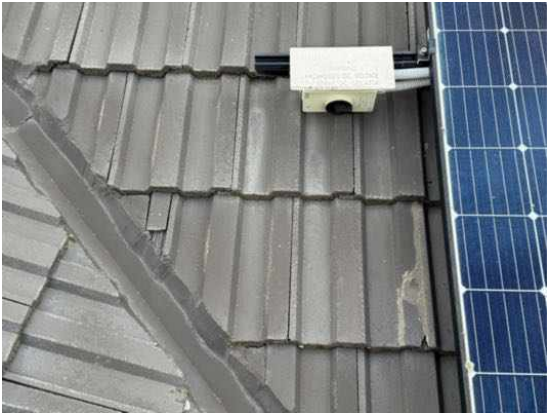
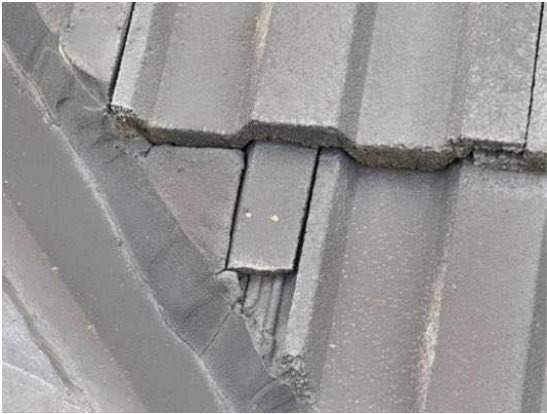
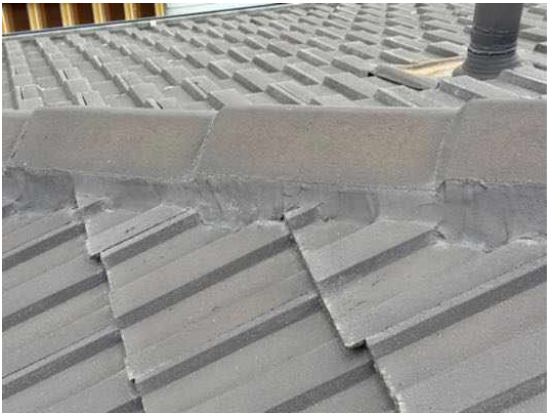
### Defects 3.10

Building:	Building 1
Location:	All Areas > All Areas
Finding:	Roof tiles - broken, chipped, dislodged or show some slippage
Information:	Upon inspection of the roof tiles, it was observed that numerous roof tiles slipped down or have been dislodged from their original positions and have not been repositioned before the roof restoration was completed. Numerous roof tiles may slip over time due to a number of minor causes, including not placed correctly upon installation, not stuck down on the top of valley irons, flashings, roof tile chips and breakages, failings in the adjoining battens, or fixings that may have failed.

In this case I suspect that tiles have just slipped or dislodged from they original positions overtime, these roof tiles when readjusted should receive some form of fixing to fix them down. Either by a good adhesive or a good quality silicon sealant. Roof tiles that have moved from their original position may allow water penetration into the roof void, exposing roofing structures to excessive moisture. This creates an environment that is conducive to water damage and accelerated deterioration of all associated building elements below these areas.

Replacement of broken, loose or missing roofing tiles is also highly recommended immediately or in the short term future to prevent the development of any secondary defects overtime if left unmanaged. A roofing plumber or roof tiler should be appointed to complete such works as deemed to be necessary.

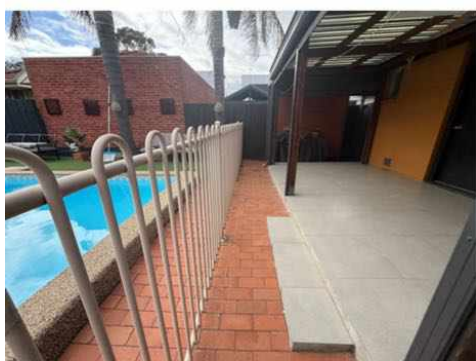
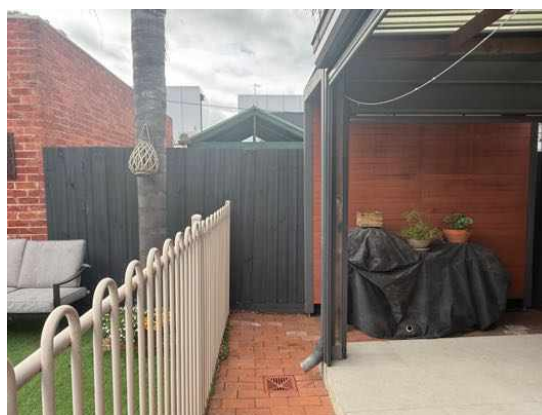
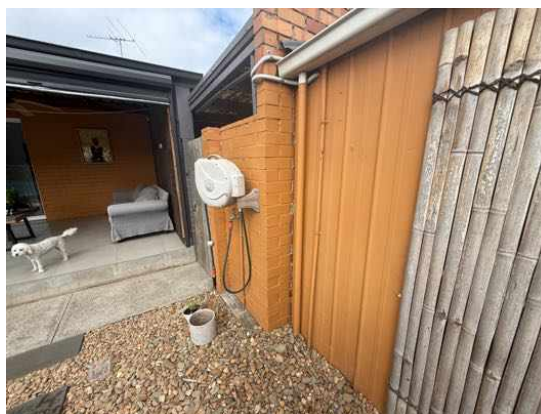
### Defects 3.11

Building:	Building 1
Location:	All Areas > All Areas
Finding:	Down-pipe on the rear pergola is not properly connected to stormwater
Information:	It was observed at the time of inspection that the rear pergola down-pipe was observed to be emptying onto the rear paved area. The down-pipe was situated over the top of a stormwater - sump or pit, it should be either connected properly to the stormwater drainage system or fully inserted down into stormwater sump or pit so as to prevent any splashes. Where down-pipes sit above the pit, these surrounding areas are always susceptible to excessive splashing and moisture, rust, corrosion, termite and pest.

The down-pipe on the outside of the teen retreat was observed to be rusted and corroded showing a small rusted hole. If these down-pipes are not rectified or left unmanaged, moisture, wood rot, rust and corrosion is likely to lead to further damage and deterioration to the adjoining building elements and surrounding areas. This also makes these areas more susceptible to termite and pest activity. It is recommended that client appoint and seek advice and consultation with a licensed plumber to gain advice and rectify affected areas in the short term future.

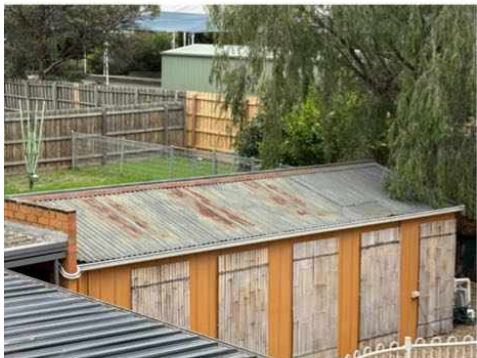
### Defects 3.12

Building:	Building 1
Location:	All Areas > All Areas
Finding:	Teen retreat roofing iron - rusted and corroding
Information:	Garage / teen retreat roofing iron and flashings were observed to be showing signs of excessive rust and corrosion from exposure to exterior weather conditions, inadequate coatings. As these types of surfaces rust they provide no protection to the underlying iron, the deteriorating condition is likely to worsen if not addressed in the short-term future.

Where possible, the use of galvanized (treated) metals or aluminium coated metals aid in rust prevention, as does regular general maintenance. Rust formation can be usually controlled with coatings, such as paint, that isolate the iron from the environment however these areas appeared to be past repair or painting. Rusting and corrosion should be managed by ideally removing the affected areas or limiting the affected surface from exposure weather conditions or to excessive moisture. A qualified roof plumber should be appointed to provide remedial work to the affected areas of rust, corrosion or water damage.

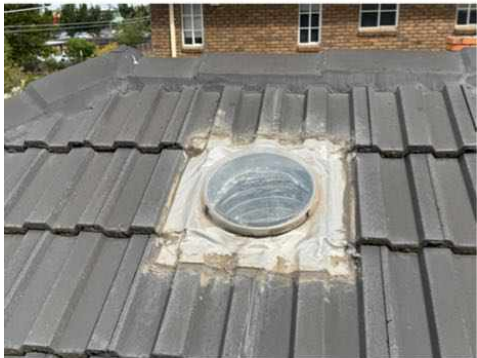
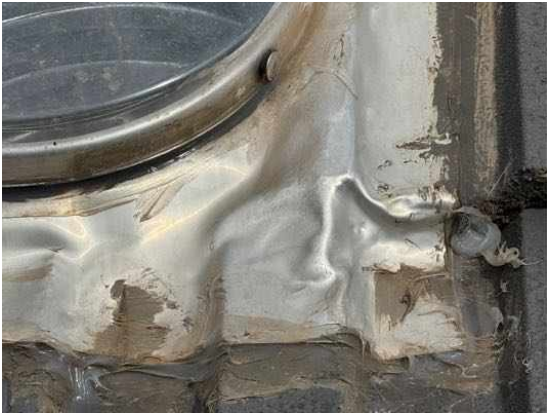
**Defects 3.13**

Building: Building 1  
Location: All Areas > All Areas  
Finding: Roof flashing - non-standard  
Information: The roof flashing that has been installed to this roof skylight is not the correct flashing that should be used and not considered to be adequate and fit for purpose as a skylight flashing. This type of flashing is normally used as a bottom timber window flashing. However the flashing does appear to be working at the time of the inspection and may be ok for a short time, however if left as is and unmanaged this type of flashing is suspected not excepted to keep the roof water-tight or weatherproof.

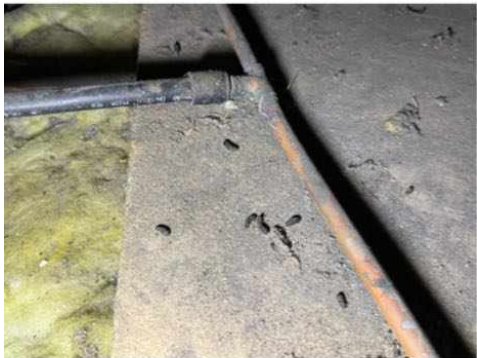
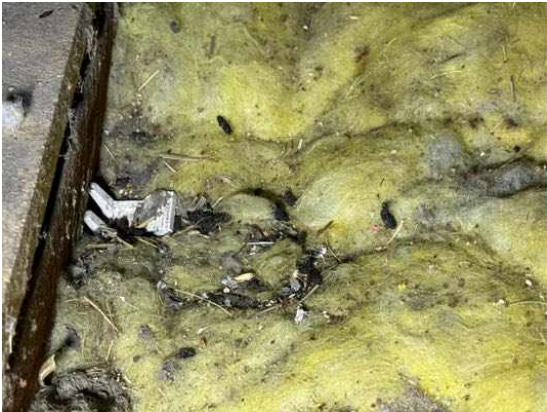
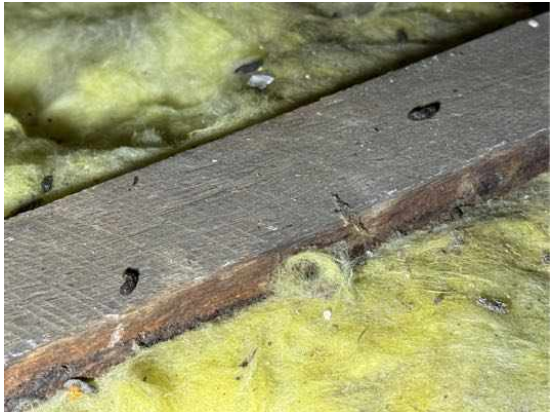
**Defects 3.14**

Building: Building 1  
Location: All Areas > All Areas  
Finding: Evidence of Vermin in the roof space  
Information: Evidence of pests or rodents were present in the roof space at time of inspection. Pests such as possums, insects, spiders and rodents can cause issues ranging from smells and stains through to physical damage to wiring and other important building elements in the roof void. A licensed pest controller should be appointed to free the roof void of any pests and to install deterrents or seal access points to ensure that rodents can not enter the roof space as easily.

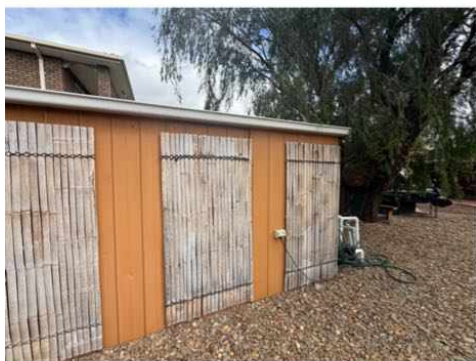
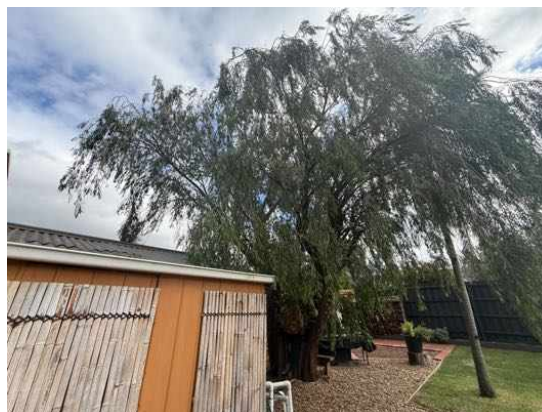
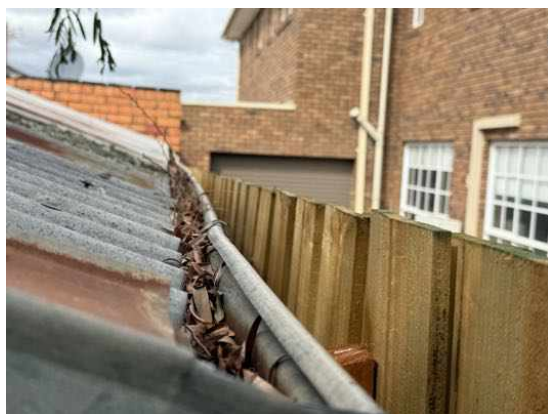
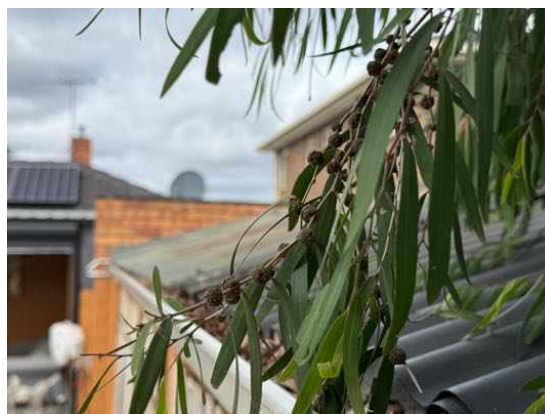
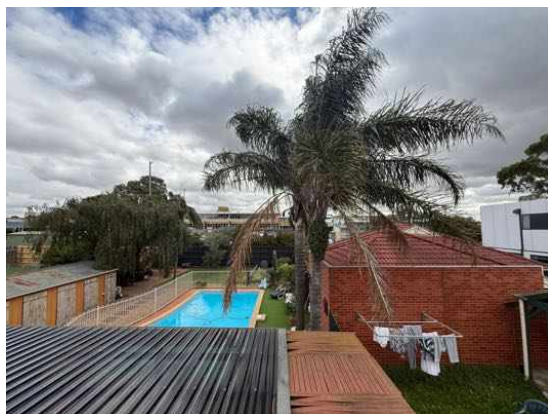
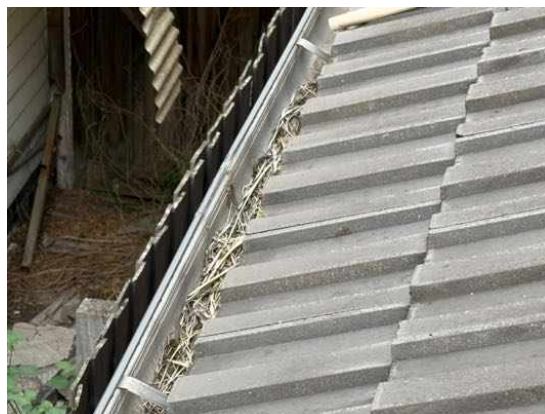
Building: Building 1  
Location: Teen retreat > All Areas  
Finding: Trees - Overhanging and filling gutters  
Information: Overhanging trees often result in excessive amounts of leaf debris accumulating in gutters. Gutters are a critical part of the building's management of storm water and rain. It is therefore important that they be kept clear to prevent secondary damage to associated building elements, including exterior and interior walls, ceiling linings and any adjoining building elements. Where gutters get blocked from excessive leaf matter, water pooling is highly likely to occur more frequently, fast-tracking, rust and corrosion of the roof plumbing elements and making these areas even more susceptible to secondary defects

It is highly recommended that if at all possible, all overhanging tree branches be removed to prevent further damage. Such works can be performed by the homeowner; however, appointment of a landscape contractor or an arborist may be required. Consultation with a licensed roof plumber is required where guttering has been damaged.

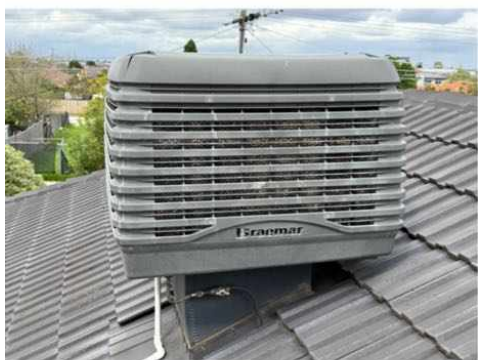
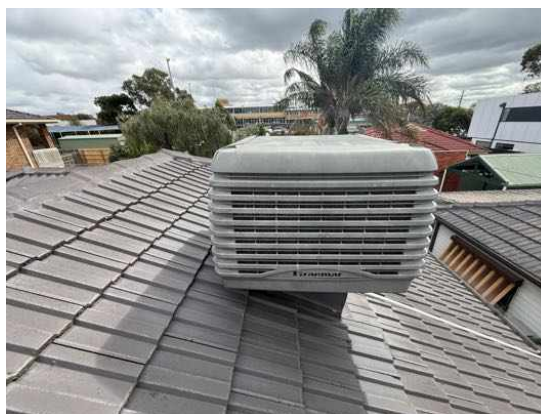
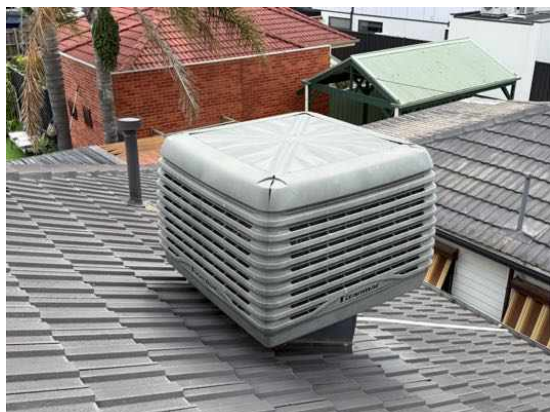
Building: Building 1  
 Location: All Areas > All Areas  
 Finding: Evaporative air conditioner  
 Information: Reporting on the Evaporative air conditioning unit, including as to whether they are working, is outside the Scope of this Report. Please note that this is highlighted as a recommendation only. It is recommended that the Evaporative air conditioning unit to receive maintenance and servicing. Servicing of this unit will improve occupants well being and ensure good functionality and prolonged serviceability. if left unmaintained, Evaporative air conditioning unit may be or become a health hazard.

We suspect, based on our experience in the building industry, that Evaporative air conditioning unit get over looked and do not get any maintenance for long periods of time. The Evaporative air conditioning unit may therefore be in a, less than perfect condition, so we recommend that they always ensure that these areas be addressed prior to their use, this is to ensure home and occupant health and safety.

A air-conditioner serviceman should be appointed to assess the condition of the unit and to service and clean as deemed necessary, this is at the discretion of the client.

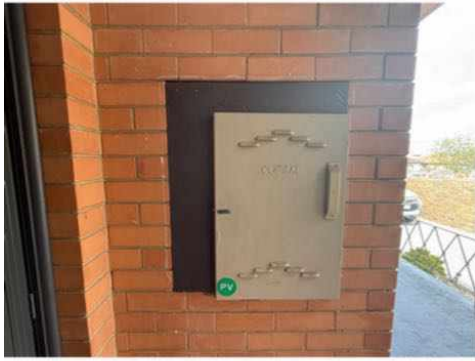
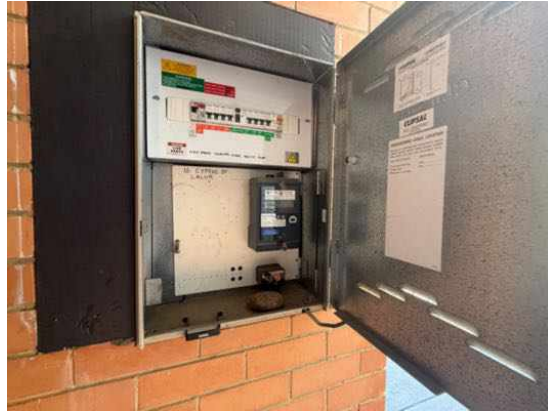
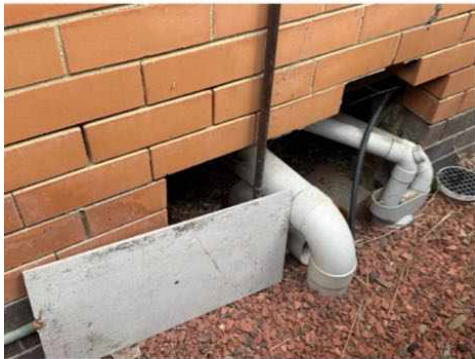
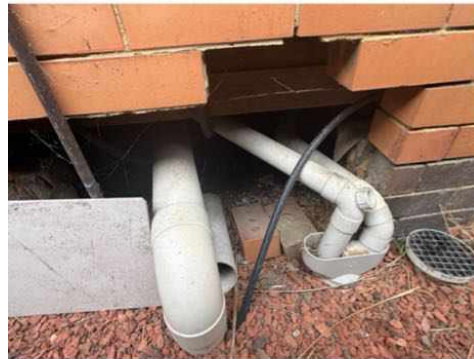
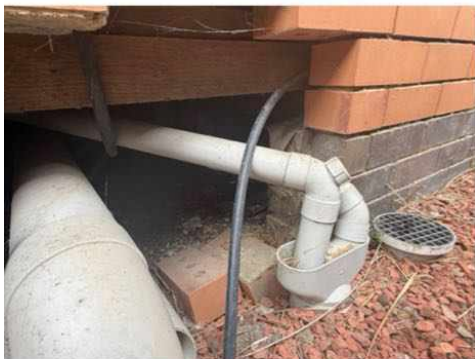
Building:	Building 1
Location:	All Areas > All Areas
Finding:	Termite Management System - no evidence of a chemical installation or durable notice
Information:	At the time of the inspection no application of a chemical termite barrier or durable notice was observed. Such barriers are highly effective and highly recommended for all properties in preventing termite attack on any timber building elements throughout the property.

A durable notice should be placed in the switchboard unit or in the another accessible area to indicate current termite barriers. At the time of inspection, no evidence to suggest preventative works taking place. The client may consider gaining further advice from builders or a pest controller and as to the costs and procedures involved with this application. It is recommended that obtaining such advice be a short-term priority.

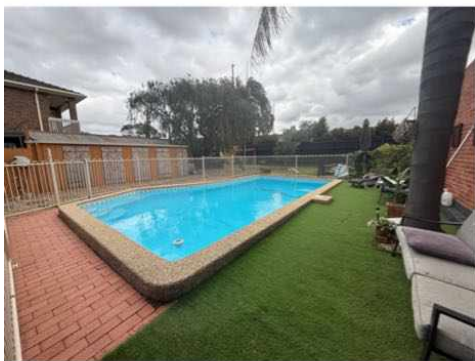
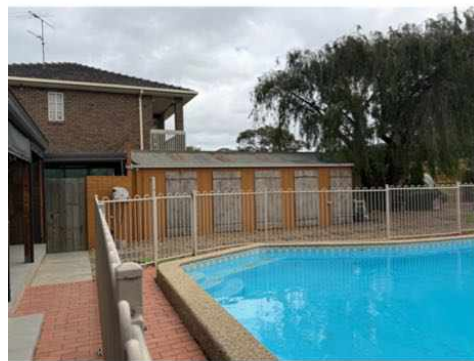
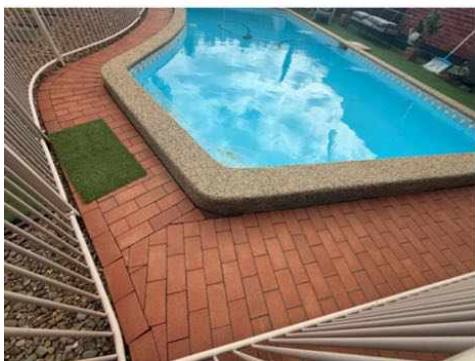
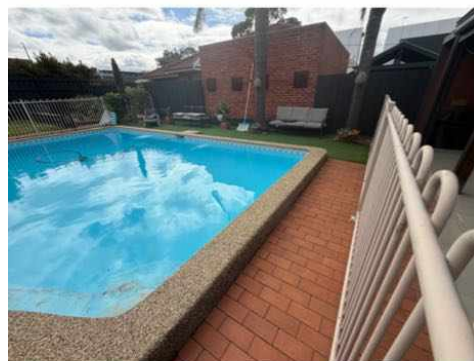
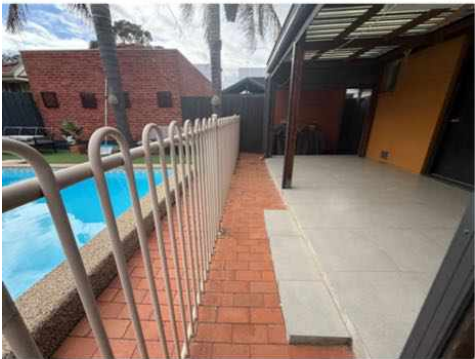
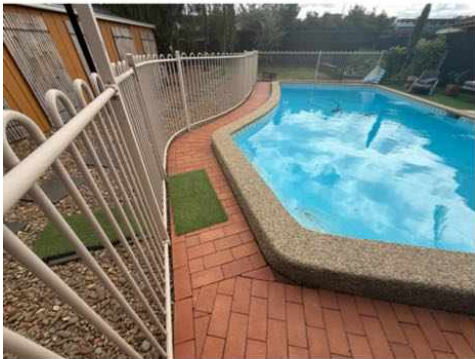
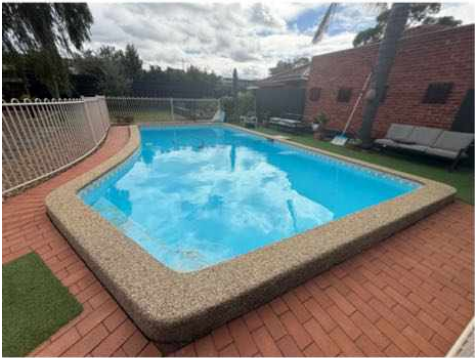
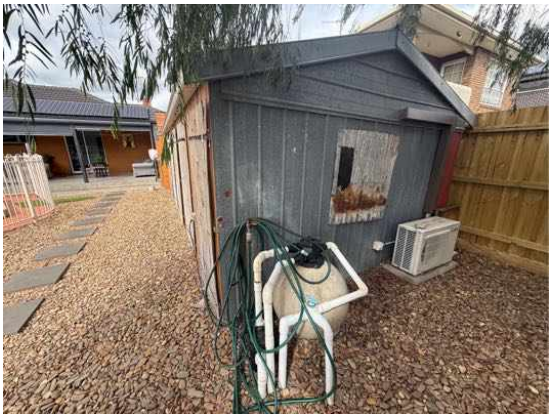
Building:	Building 1
Location:	Rear areas > All Areas
Finding:	Swimming pool and spa regulations.
Information:	Reporting on pools, pool areas, pool fencing, fixtures and fittings is outside the scope of this report due to new regulations with inspections of these areas. However we like to highlight these areas to ensure occupant safety. This a recommendation only and for the clients consideration and at the clients discretion. With swimming pools and spas on average, four young children die in Victoria in home swimming pools or spas each year, and many more are taken to hospital for near-drownings. We highly encourage the active supervision of young children in and around swimming pools and

Due to new regulations on pool and spa areas we highly recommend that a pool inspection specialist be appointed to inspect the pool and surrounding areas and provide advice on what may be required to improve safety and the implementation of the new regulations. It is highly recommended the client to implement any current requirements to ensure that the pool area is safe for all occupants.

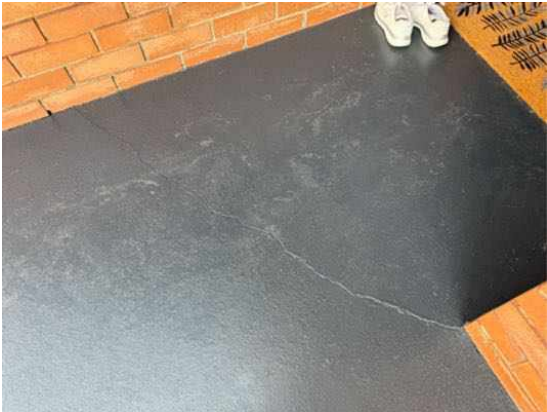
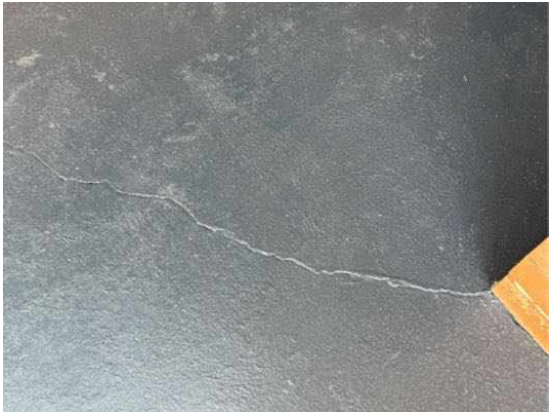
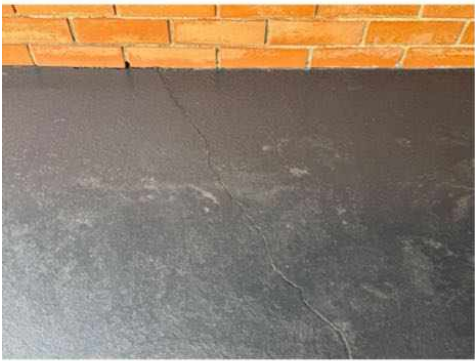
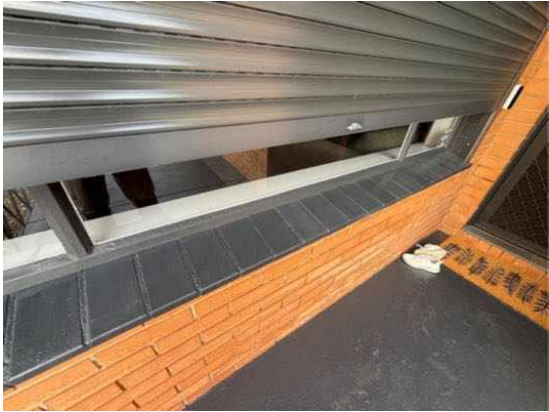
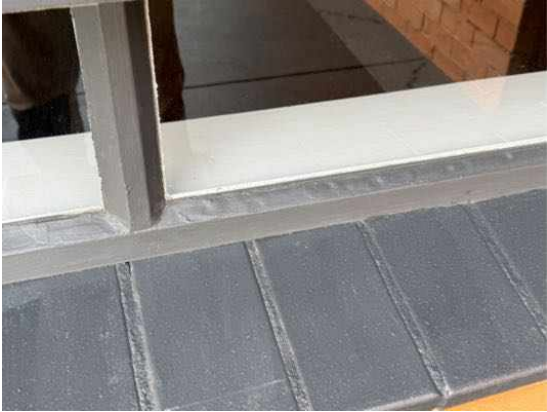
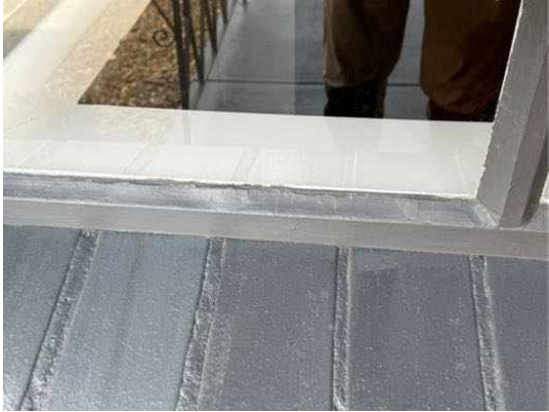
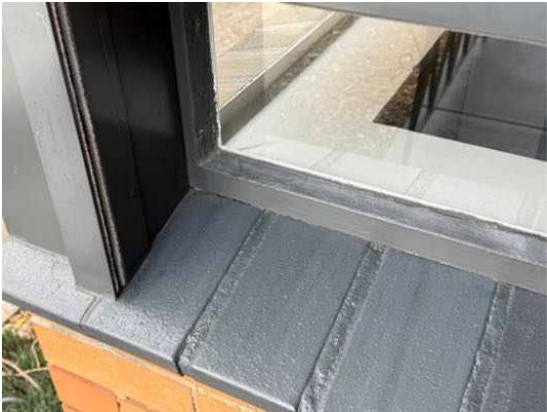
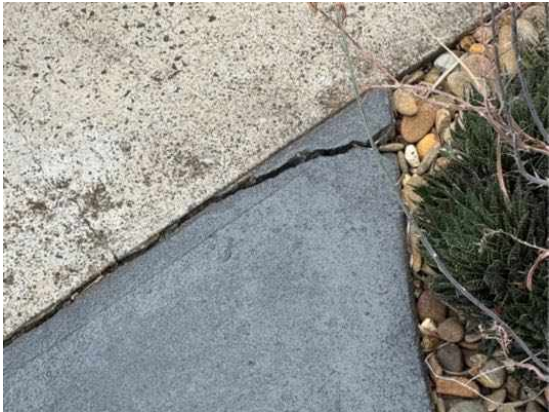
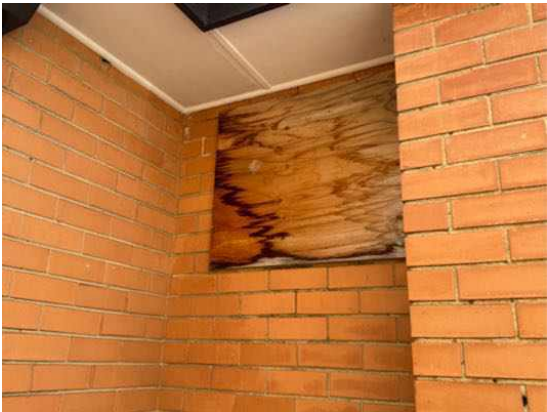
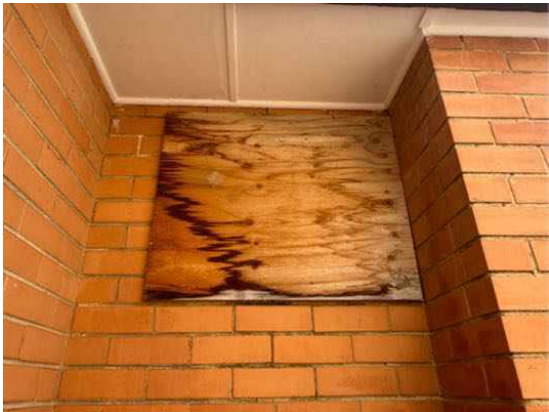
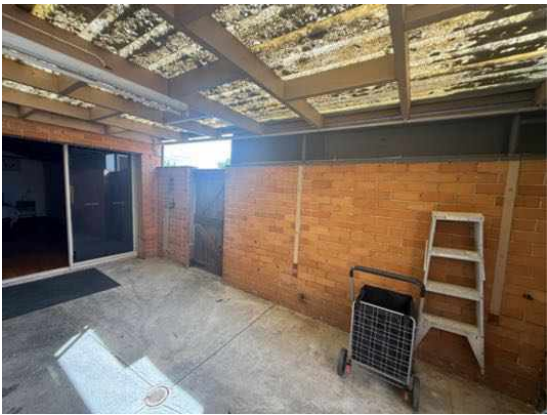
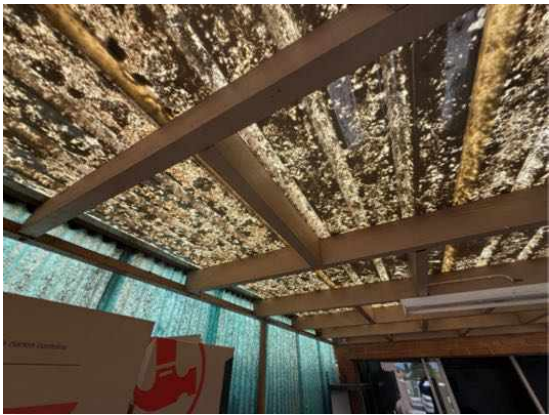
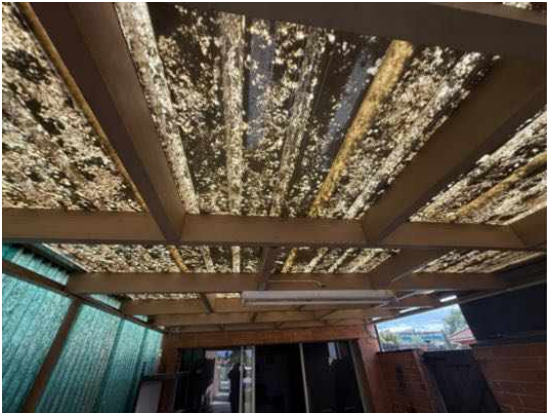
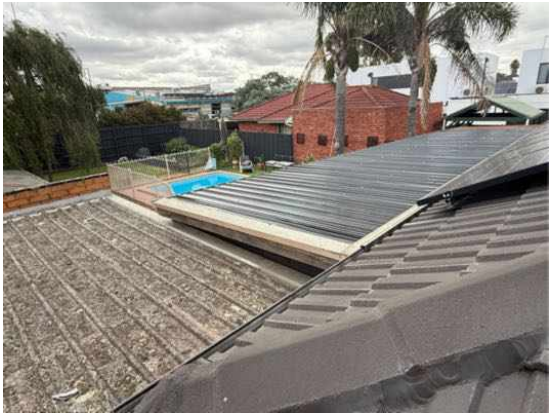
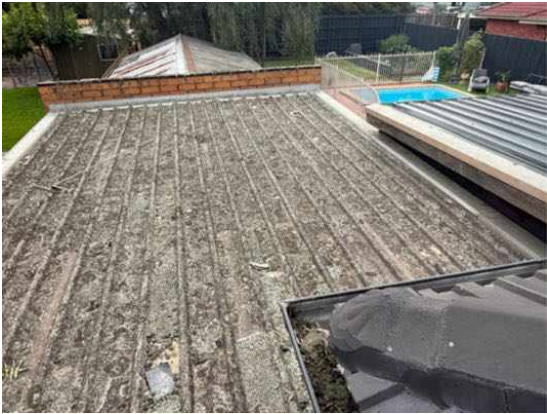
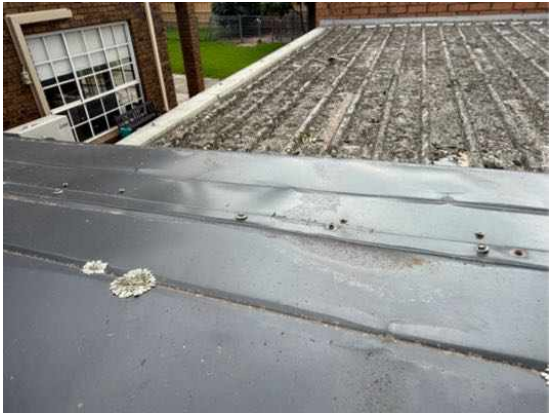
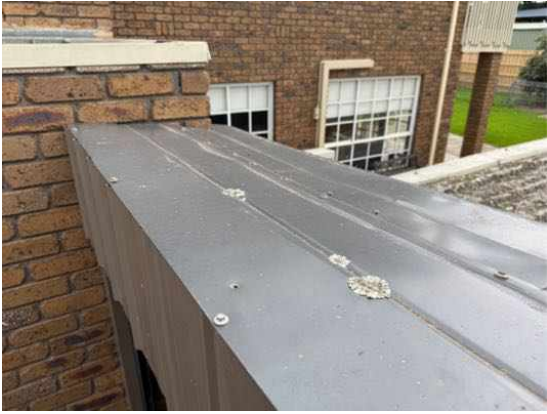
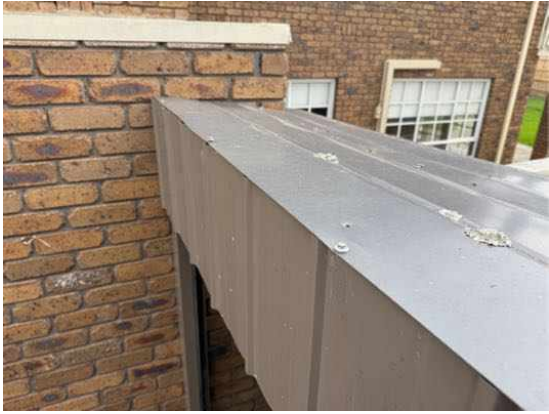
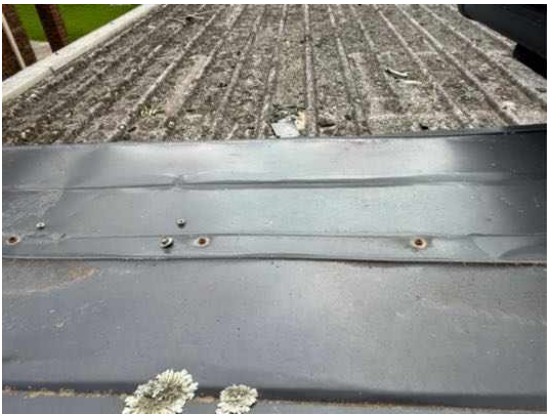
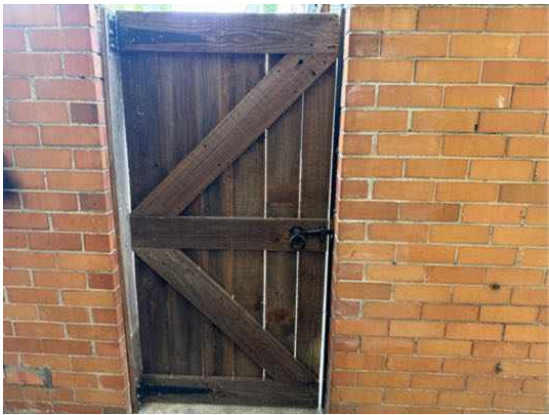
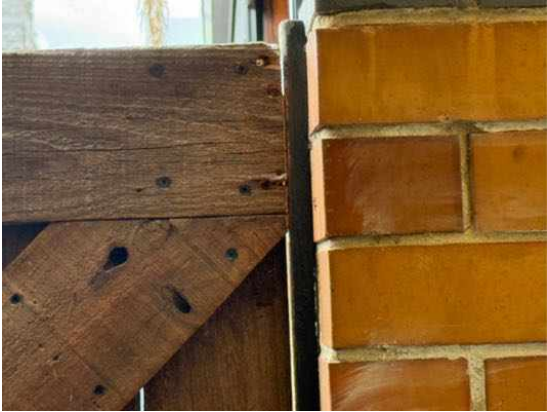
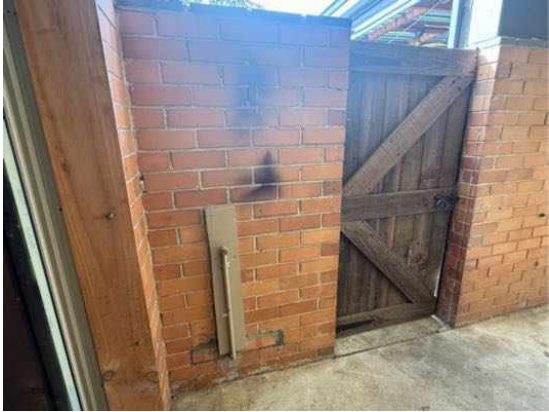
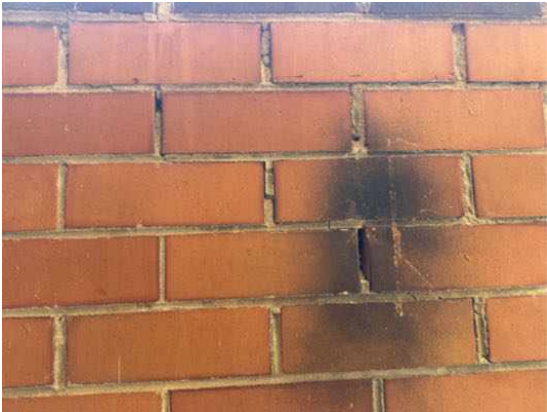
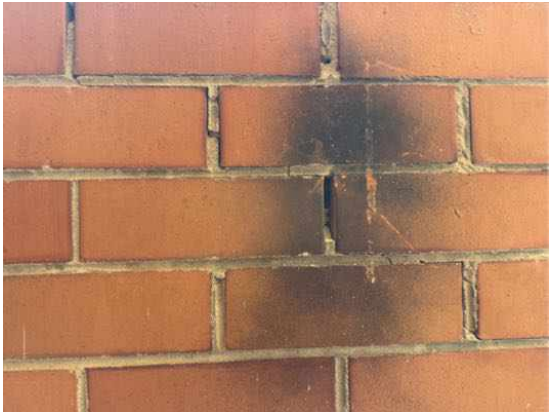
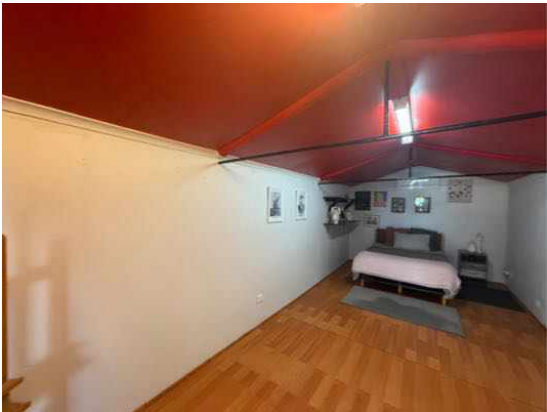
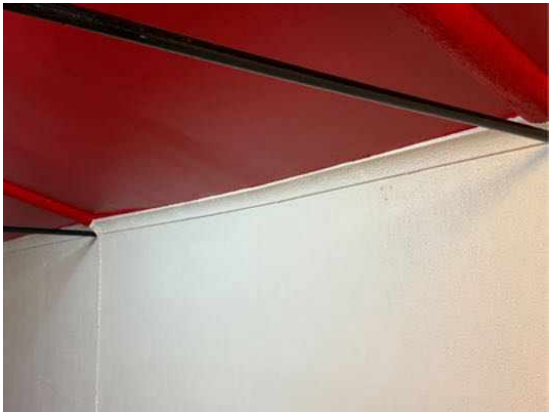
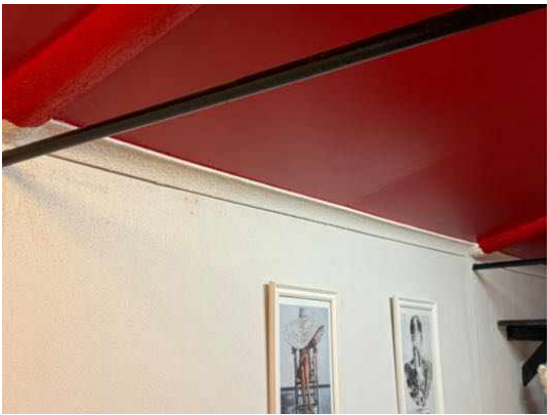
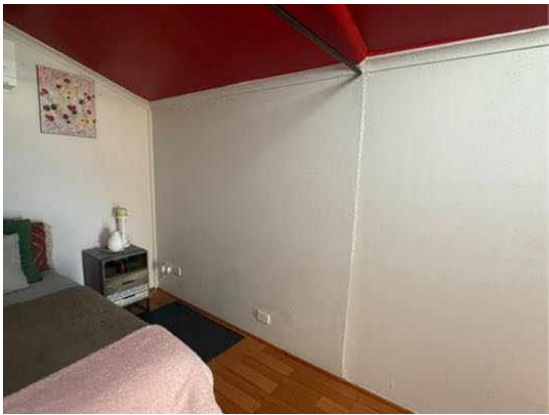
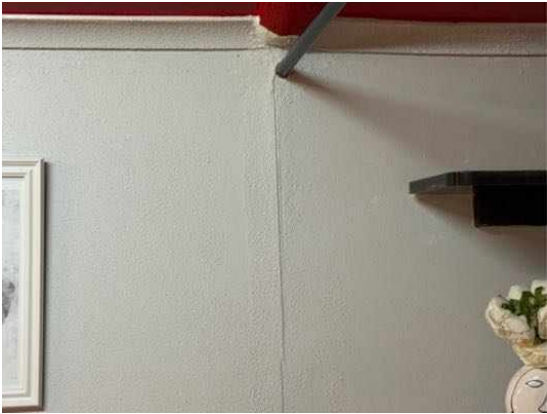
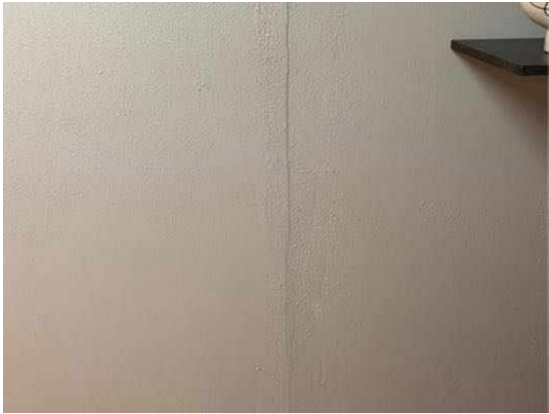
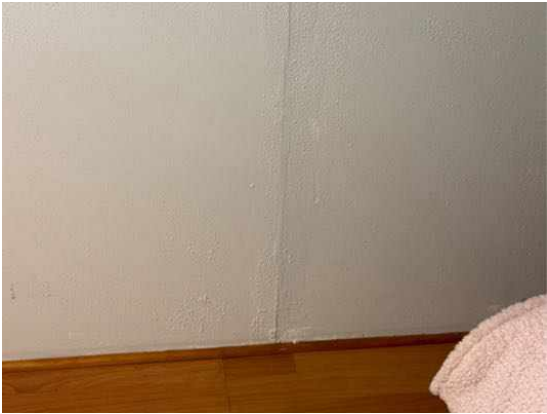
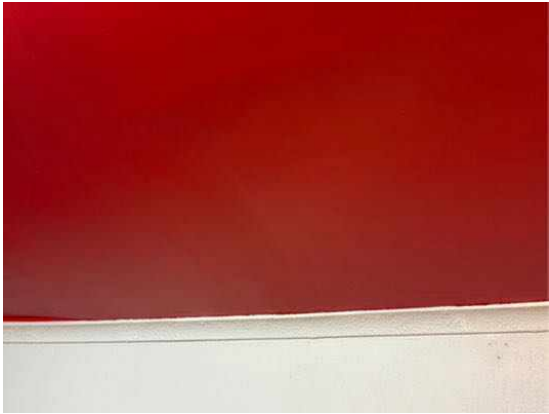
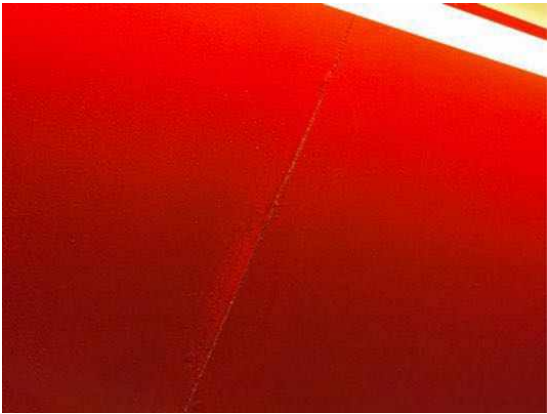
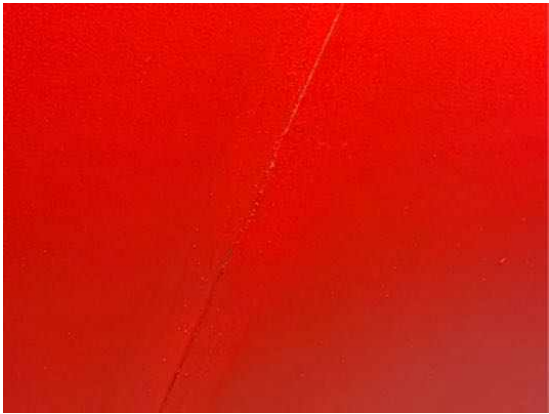
Building: Building 1  
Location: All Areas > All Areas  
Finding: Additional Photos  
Information: Additional photos are provided for either future maintenance items for clients attention and or general reference. Arrows may have been included to highlight areas of importance. Please discuss these photos with your building consultant for clarification.

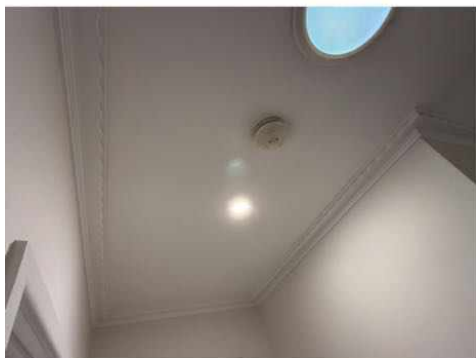
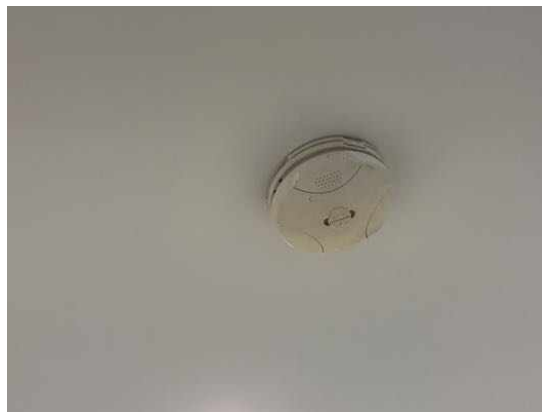
Building: Building 1  
 Location: All Areas > All Areas  
 Finding: Smoke detectors and alarms  
 Information: Reporting on Smoke Detectors or Alarms, including hard wired smoke detection systems and their legislative requirements, is outside the Scope of this Report. Please note that this defect is highlighted as a caution only. We suspect, based on our experience in the building industry, that smoke detectors are sometimes get over looked, or they may be in a poor condition, so we recommend that they always should be addressed prior to occupation to improve occupant safety.

Always ensure sufficient working and suitable smoke detectors are installed prior and

during to occupying any building. Additionally, it is advised that all smoke detectors be tested by the homeowner on a monthly basis.

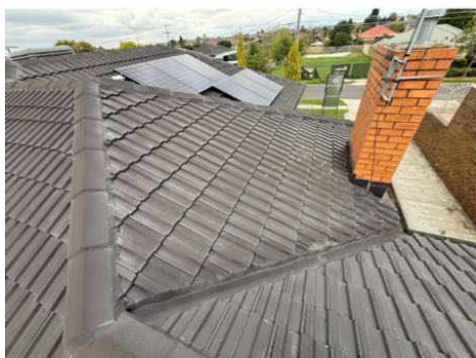
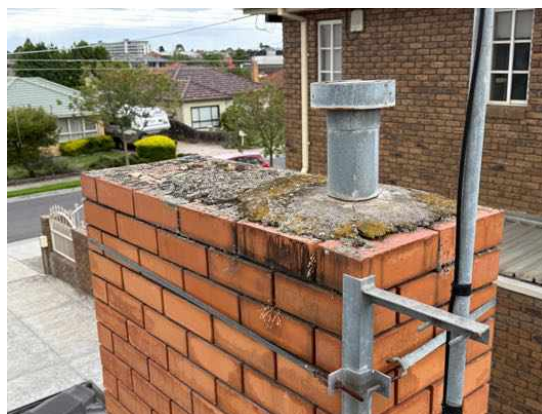
Building: Building 1  
 Location: All Areas > All Areas  
 Finding: In case client intends to re-engage the fireplace in the future  
 Information: Reporting on the fireplace and or the associated chimneys, including as to whether they are working or not and their legislative requirements, is outside the Scope of this Report. However this is in case client intends to re-engage the fireplace in the future. Please note that this is highlighted as a caution only. It is highly recommended that if the fireplace is at sometime uncovered it is highly recommended that the fireplace and associated chimneys get checked before use when they may not have been used in a sometime. If left unmaintained and not cleaned adequately a fireplace and chimneys may be or become a fire hazard.

We suspect, based on our experience in the building industry, that fireplaces and the associated chimneys get over looked and do not get chimney swept or any maintenance for long periods of time. The chimney may therefore be in a poor condition, so we recommend that they always ensure that these areas be addressed prior to their use, this is to ensure home and occupant safety.
