## Building Inspection Report

Inspection Date: Thu, 12 Mar 2026

Property Address: 16 Cyprus St, Lalor VIC 3075, Australia

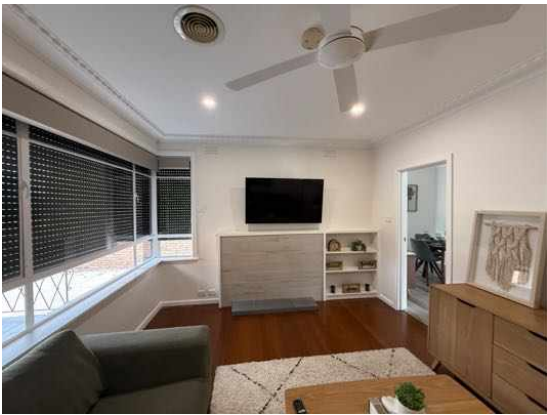
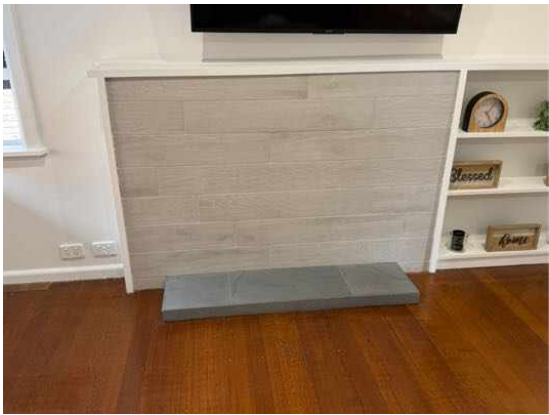
Building: Building 1  
 Location: All Areas > All Areas  
 Finding: In case client intends to re-engage the fireplace in the future  
 Information: Reporting on the fireplace and or the associated chimneys, including as to whether they are working or not and their legislative requirements, is outside the Scope of this Report. However this is in case client intends to re-engage the fireplace in the future. Please note that this is highlighted as a caution only. It is highly recommended that if the fireplace is at sometime uncovered it is highly recommended that the fireplace and associated chimneys get checked before use when they may not have been used in a sometime. If left unmaintained and not cleaned adequately a fireplace and chimneys may be or become a fire hazard.

We suspect, based on our experience in the building industry, that fireplaces and the associated chimneys get over looked and do not get chimney swept or any maintenance for long periods of time. The chimney may therefore be in a poor condition, so we recommend that they always ensure that these areas be addressed prior to their use, this is to ensure home and occupant safety.
