Building and Timber Pest Inspection Report

Inspection Date: Fri, 13 Feb 2026

Property Address: 69 Rennie St, Thornbury VIC 3071, Australia

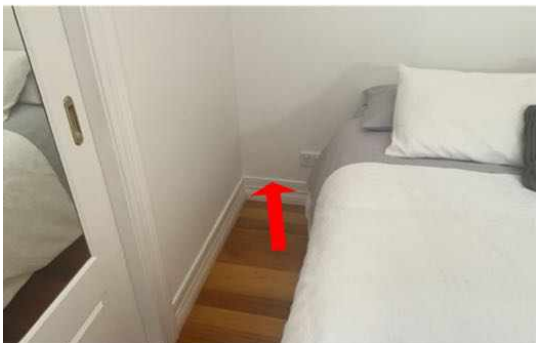
Finding: Cracking - fine

Information: Some fine cracking was noted throughout the property.

Although fine cracks are quite noticeable, they are often only considered to be an appearance defect, and usually do not indicate any structural damage. Generally, the cause of a fine crack is indicative of a separation between building materials and finishes (e.g. paint, plaster, etc.) along joins.

Cracking of this nature can generally be repaired with minor sanding, filling and/or repainting. Such works should be performed by a qualified painter or a general handyman.

Monitoring of all cracking should be conducted frequently. Always contact a building inspector should cracks widen, lengthen, or become more numerous.

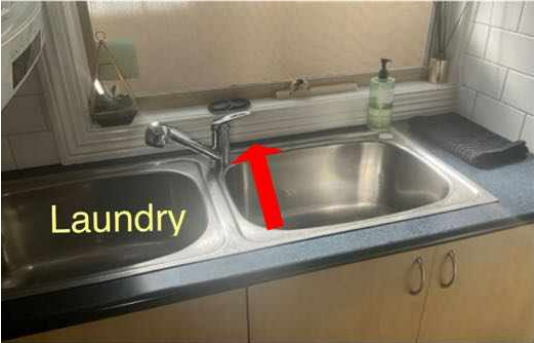
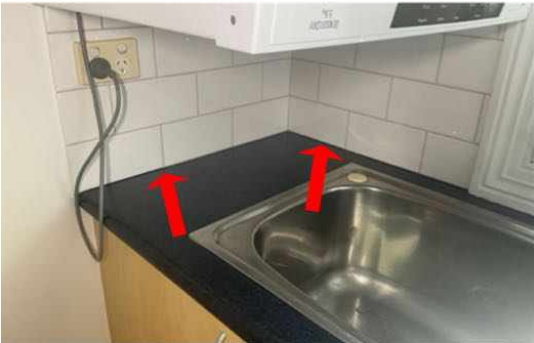
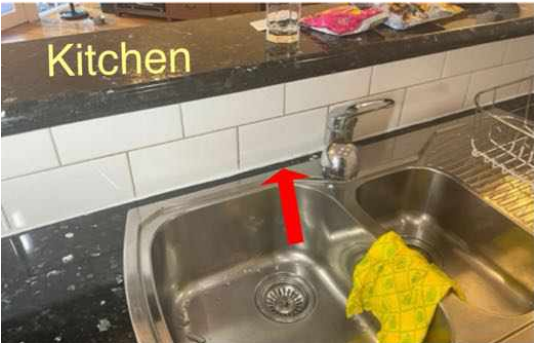
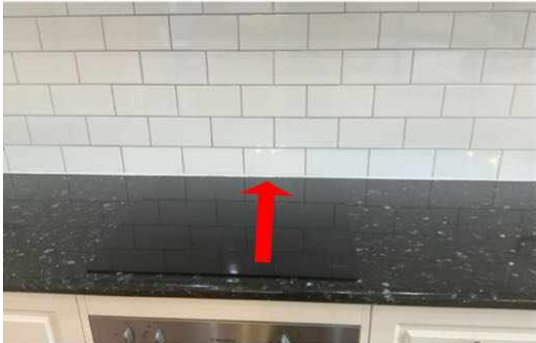
Finding 3.02

Building:
Location: All Areas
Finding: Sealant - Missing or degraded
Information: Sealant is missing or degraded in this area. Sealant is used to protect gaps and crevices in building materials to ensure that they are water-tight and prevent water penetration to the associated structures.

Where sealant is missing or degraded , a tiling contractor should be appointed immediately to re-apply any silicone where necessary. Failure to do so may lead to water damage to the surrounding area.

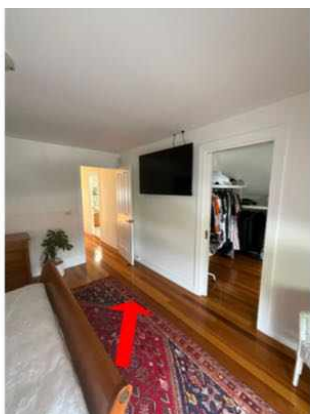
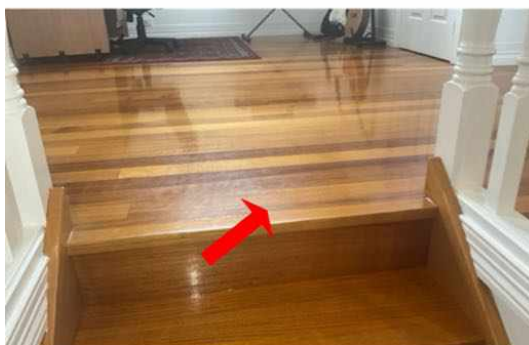
Finding 3.03

Building:
Location: All Areas
Finding: Floor - creaking slightly in some areas
Information: The internal flooring in these areas were creaking slightly when walked upon at the time of inspection.

Creaking floors generally indicate that the floorboards or the subfloor structures are coming loose from the supporting structure that they are installed on.

The areas should be monitored for any changes or unevenness. Should this occur, consultation with a registered builder should be undertaken to determine the cause . The potential resolution may involve regluing and screwing the floor down through to replacement of subfloor support structures.

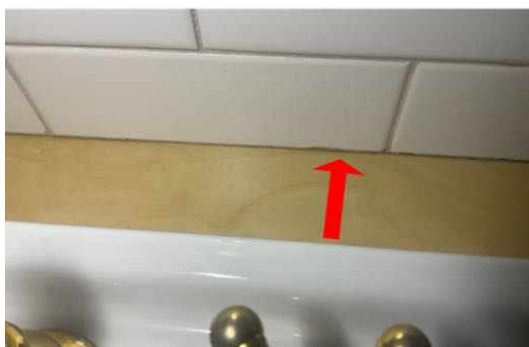
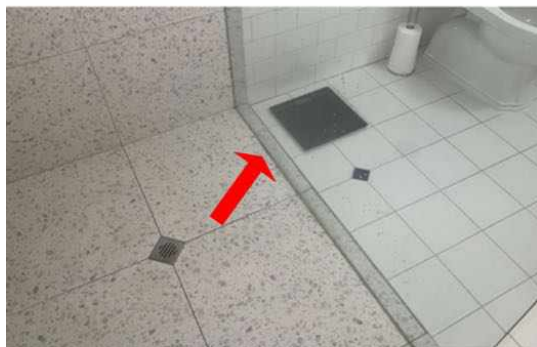
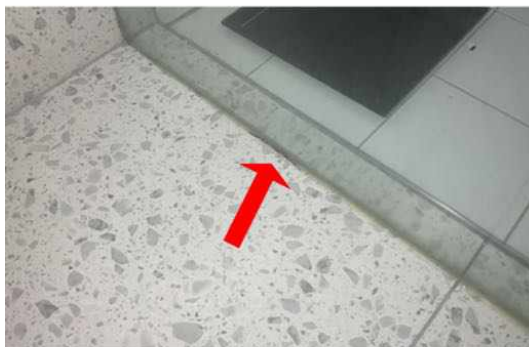
Finding 3.04

Finding: Grout and sealant - Missing or degraded within the bathroom area

Information: It was noted on inspection that grout or sealant is degraded to areas within the bathroom.

Different materials move at different rates, generally causing cracking to grout at this point. Build up of moisture in the bathroom can also cause grout and sealants to degrade and become mouldy.

Any damaged or degraded materials should be scraped out and flexible and mould resistant materials should be applied to affected areas to prevent any subsequent water damage that may occur. Regular maintenance and replacement of damaged or missing grout/ sealant is highly recommended to the wet areas, as this is a regular wear and tear defect. Both grout and sealant in areas that come into regular contact with water should be maintained for the long term care of your property.

A bathroom specialist or tiling contractor should be appointed to complete these works as soon as possible.

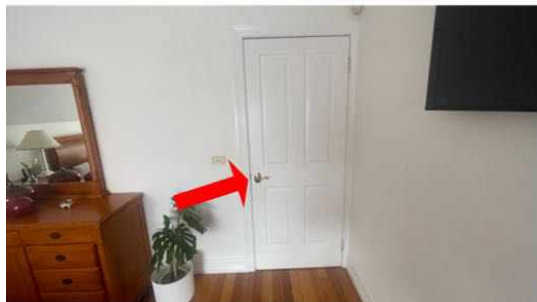
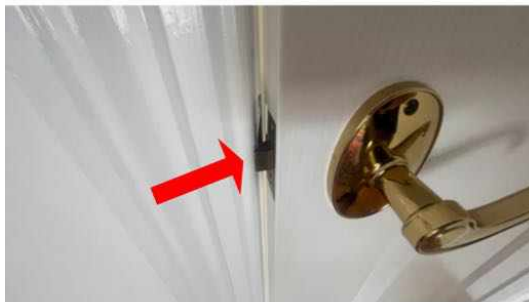
This is a common defect and is expected in a property of this age, whether being due to substandard installation or general deterioration of the door hardware.

Readjustment of the striker plate is recommended at client discretion. Works such as these can be completed by a general handyman or qualified carpenter.

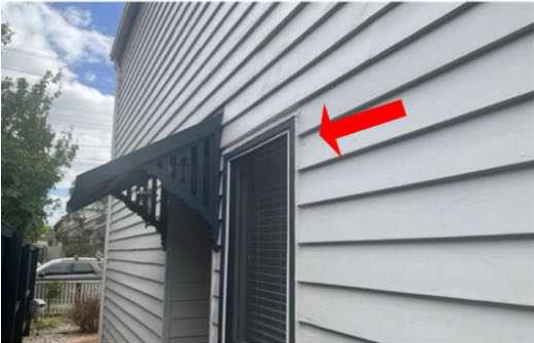
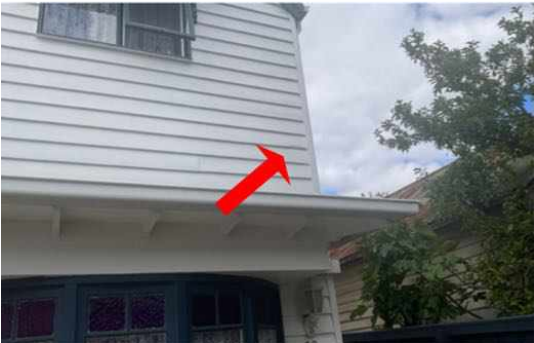
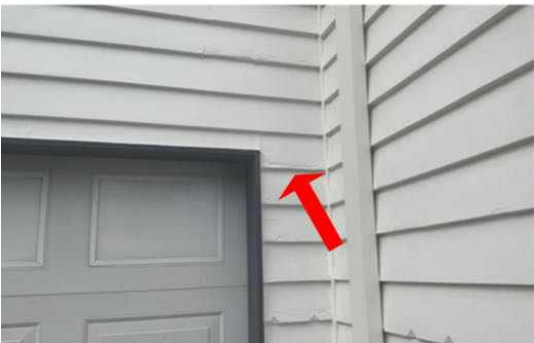
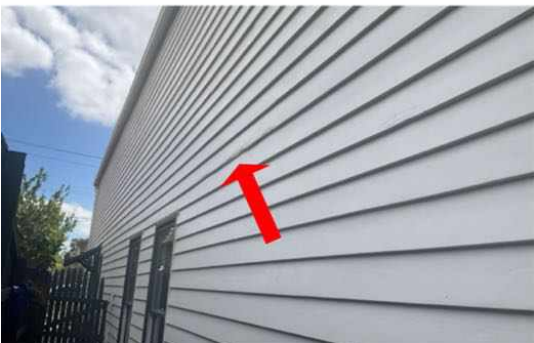
Building:
Location: All External Areas
Finding: Weatherboards - Rotting
Information: Some of the external weatherboards show signs of fungal decay (wood rot) in several sections. This wood rot is suspected to have developed over a prolonged period of time due to frequent weather exposure, which is expected in a property of this age and condition

To maintain the condition of the external wall cladding, any severely affected weatherboards should be substituted as soon as possible with pre-treated replacements. Where weatherboards have rotted due to excessive moisture other than rain penetration, the cause of the moisture should be identified immediately by a licensed plumber. A qualified carpenter should be appointed to repair and replace rotting weatherboards.

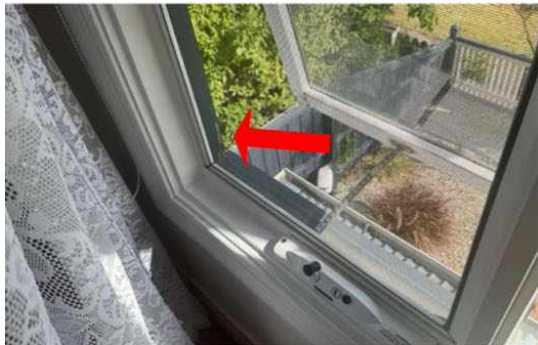
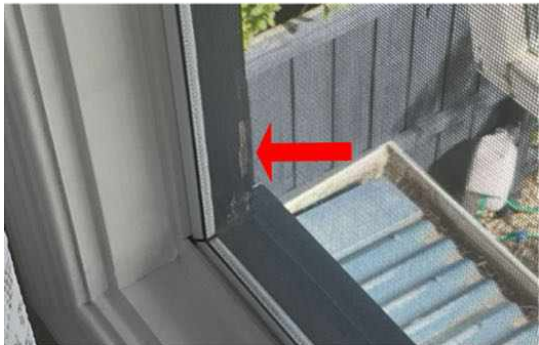
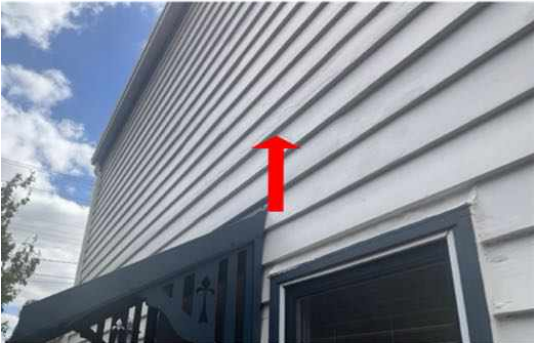
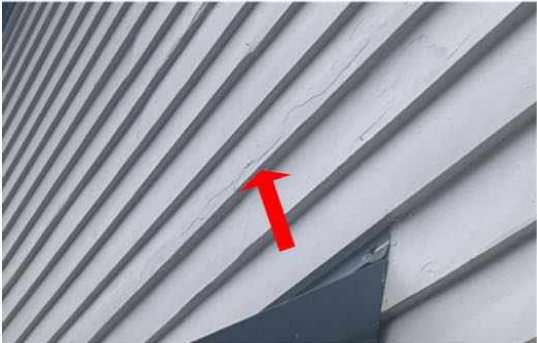
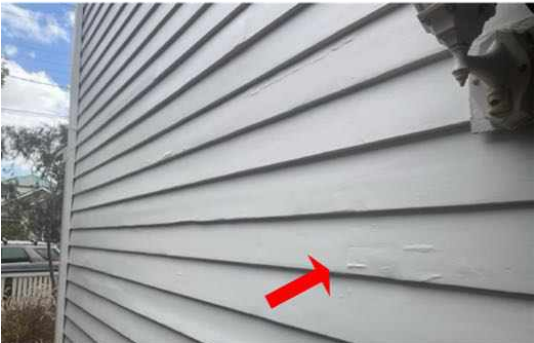
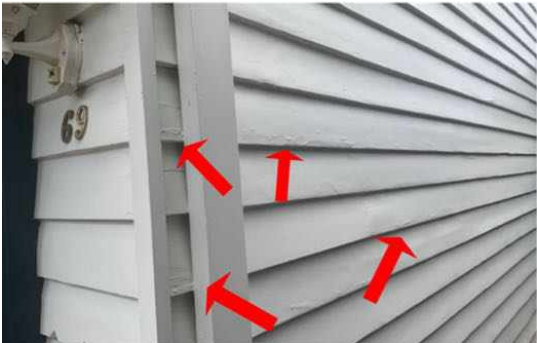
Finding 3.10

If left unattended, replacement of these timbers is likely to be necessary in the short-term future.

Please note: other timbers around the property may be weathering slightly but not showing here

Adequate treatment of these timbers is required as soon as possible by a painting contractor or general handyman.

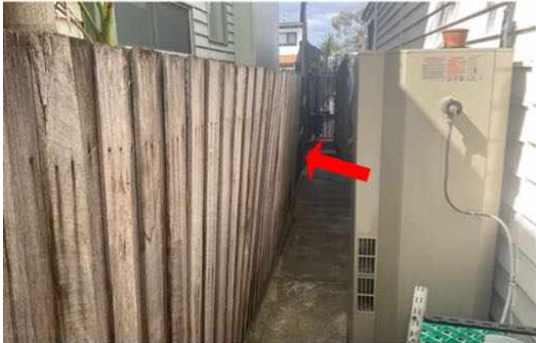
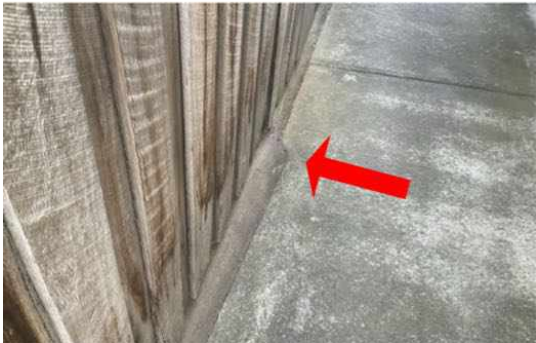
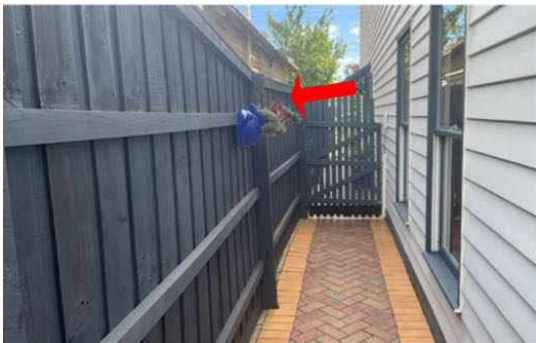
Should further damage occur, repair of several elements of the fencing may be required. Replacement may also be a consideration.

A licensed fencing contractor should be appointed to provide further advice and perform rectification works as necessary.

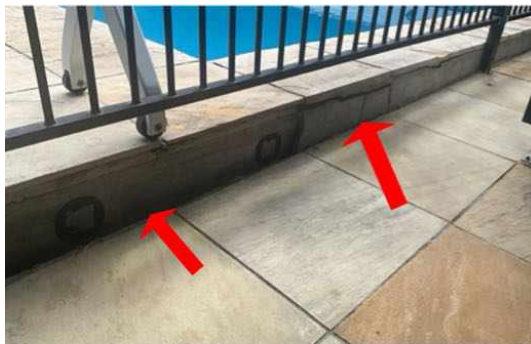
Whilst minor in nature, repairs should be conducted to prevent water ingress behind the remaining render and subsequent further damage.

A suitably qualified renderer should be engaged to perform this task.

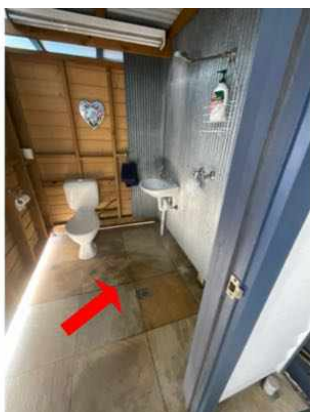
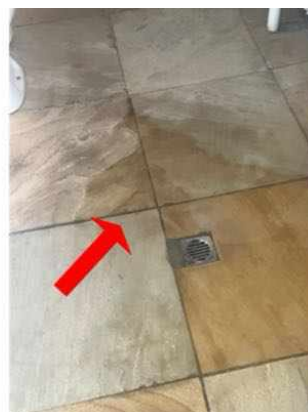
Finding 3.15

This pooling is minor overall but is still considered unsatisfactory, as correct tiling practices would not permit this situation to occur. Pooling water around floor tiles can create a slip hazard in extreme cases and also create conditions that are conducive to mould growth over time.

In severe cases (not in this instance) , works may involve some sections of tiling and flooring repair and replacement. A tiling contractor can be appointed to provide further advice on reparation options and to perform works as necessary.

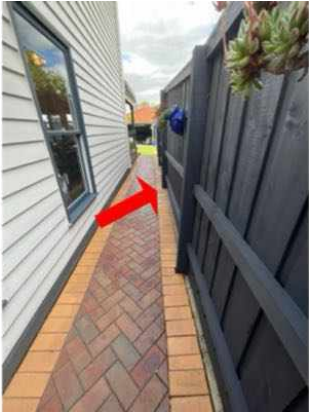
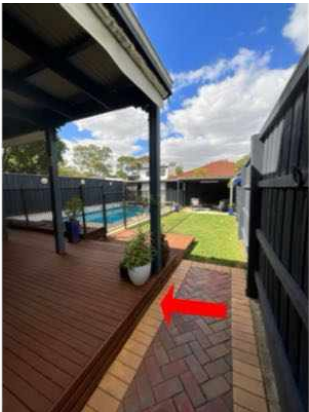
element.

Where possible, the removal of any such materials that may be conducive to termite activity should be carried out as soon as possible to minimise the risk of termite attack. Where not possible or practical, regular monitoring of timber elements is recommended. Replacement of any damaged materials should be carried out where necessary.

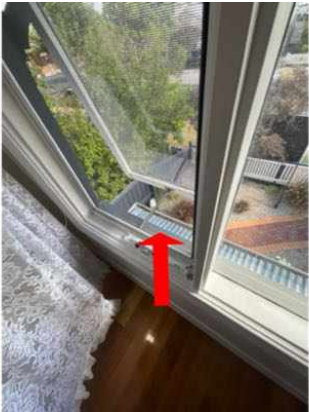
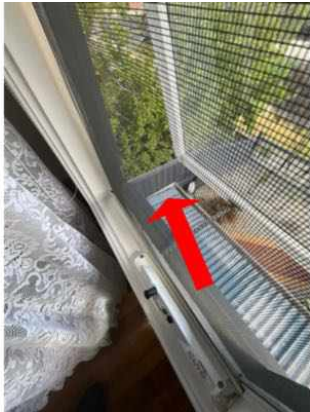
Information: It was noted on inspection that the windows to the second storey of the property are suspected to open wider than current standards for safety regulations allow.

Second storey windows should be limited to 125mm openings so as to prevent falling hazards.

This item is noted as an information item only, however caution should be taken around this window especially when young children are present.

There are a number of retro fit limiters that could be applied to the window should the owner wish to do so.

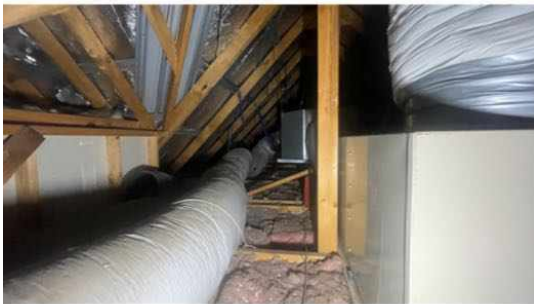
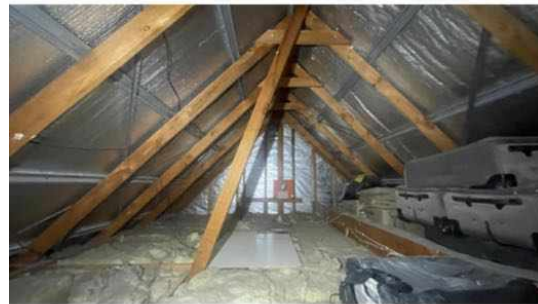
Finding: Insulation - generally good coverage of insulation within the roof void

Information: At the time of inspection, there appeared to be a generally good coverage of insulation within the roof void.

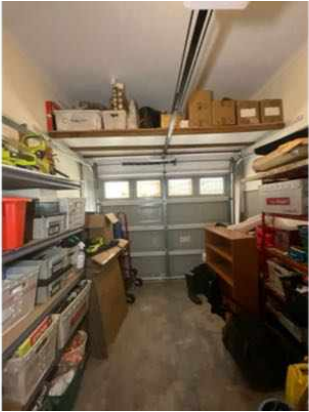
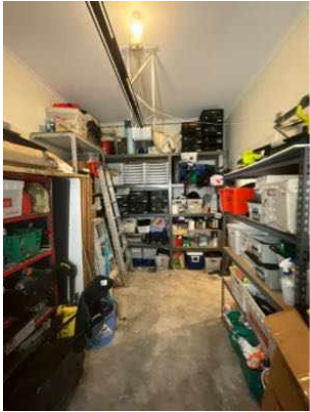
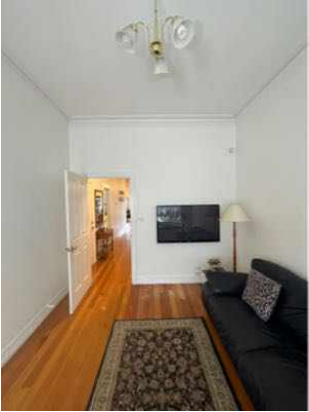
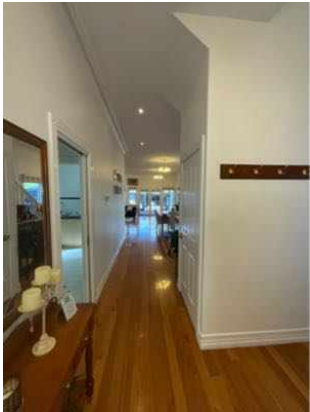
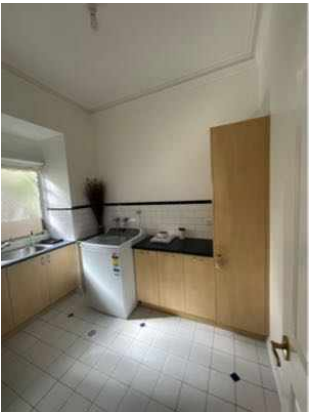
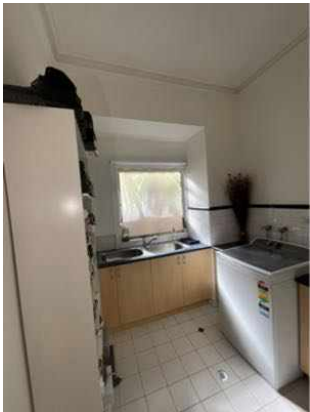
Finding: Additional Photos - Obstructions and Limitations

Information: These photographs are an indication of the obstructions and limitations which impeded full inspection of the property at the time of inspection. These obstructions can hide an array of defects and should be removed to allow full inspection to be carried out. A re-inspection is recommended once the areas are made accessible.
