Building and Timber Pest Inspection Report

Inspection Date: Thu, 5 Feb 2026

Property Address: 17 Fernyhough St, Rouse Hill NSW 2155,
Australia

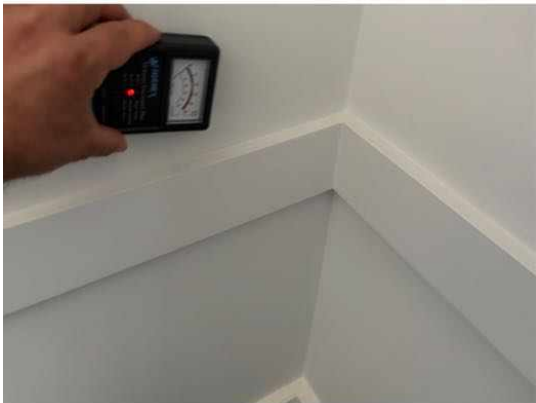
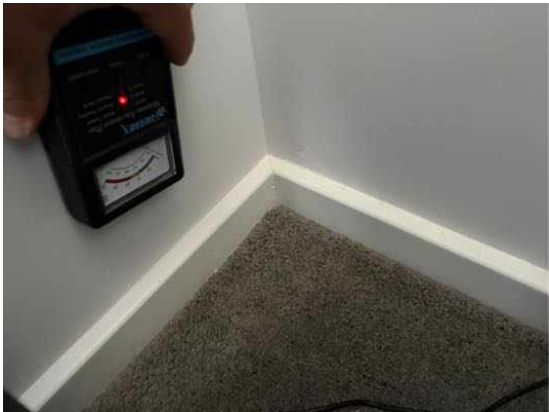
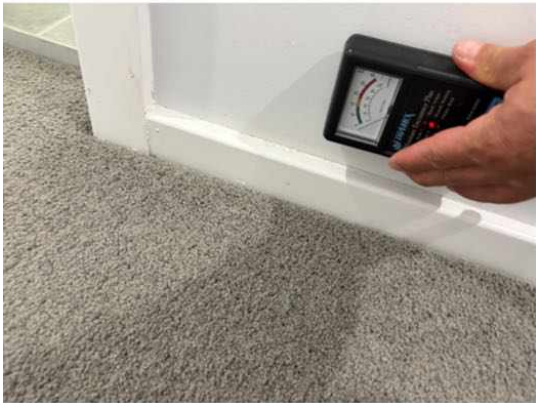
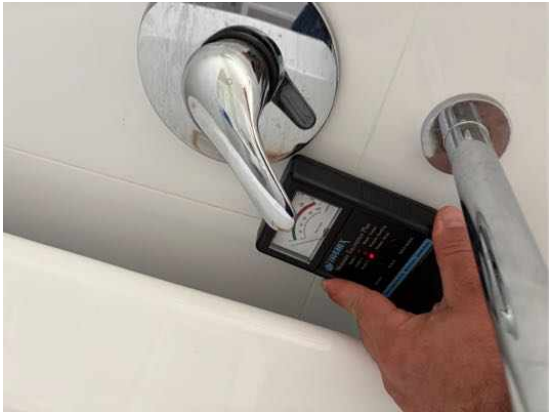
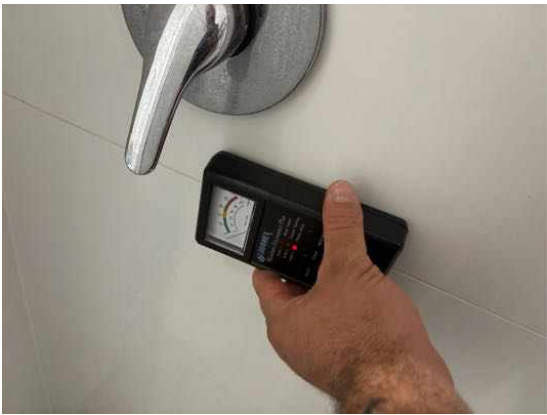
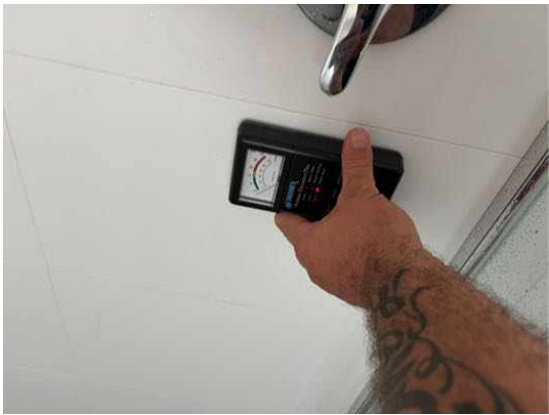
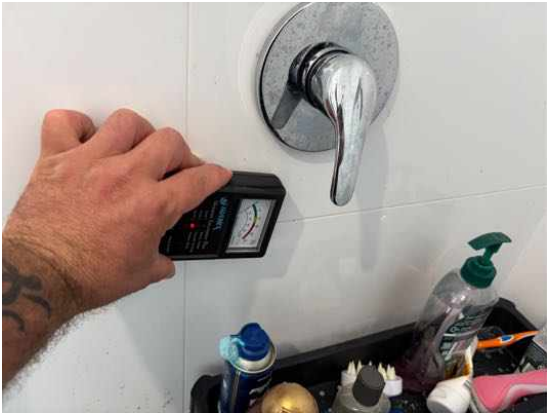
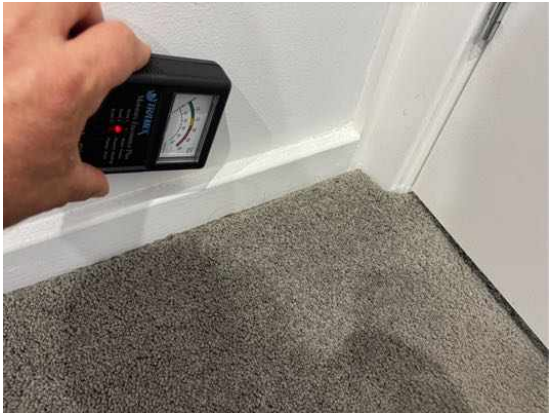
Building: Main Building
Location: All Areas
Finding: Moisture metre
Information: During the inspection the property was checked for moisture using a moisture metre.

This is for information only.

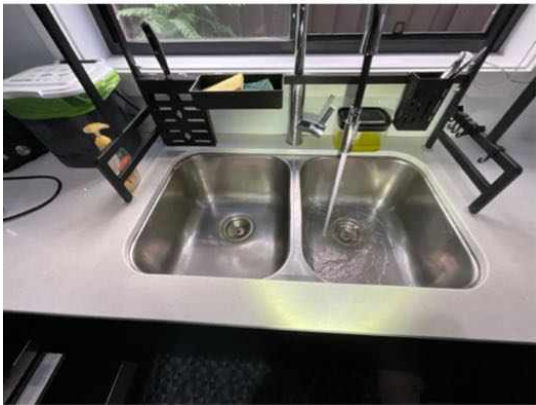
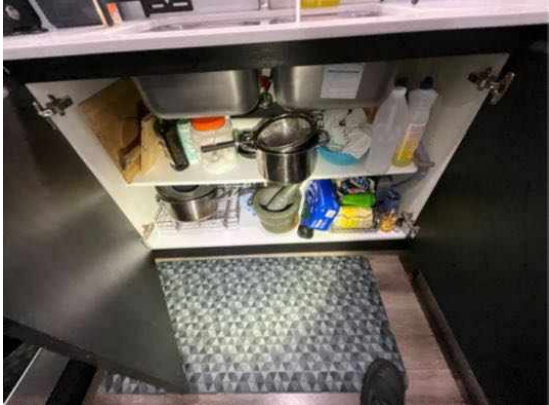
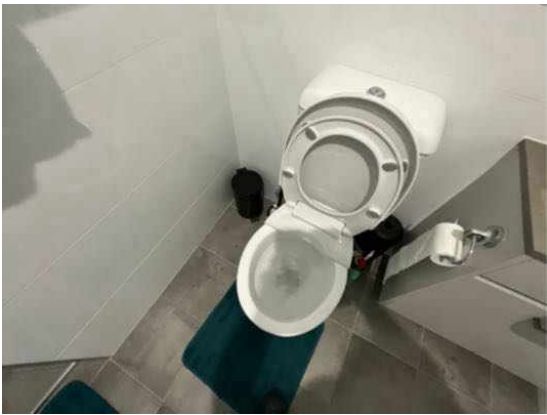
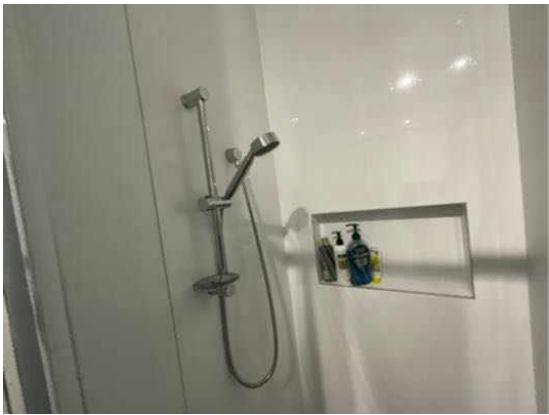
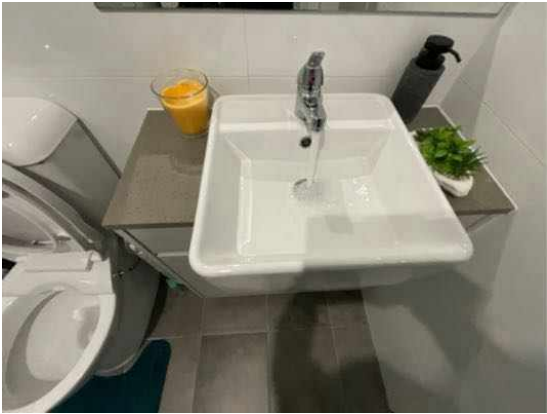
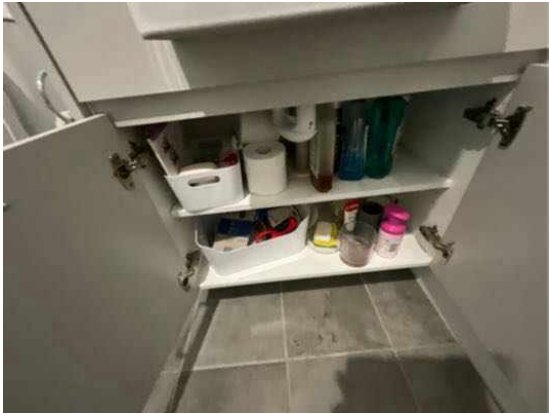
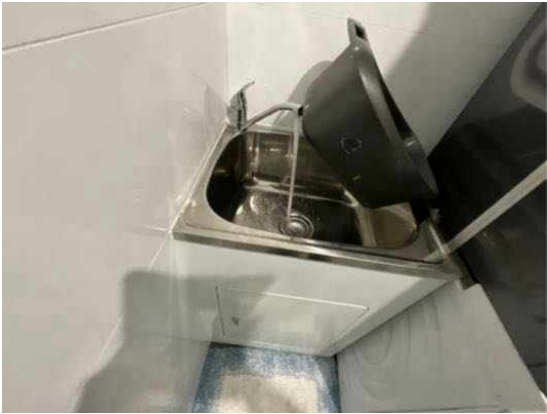
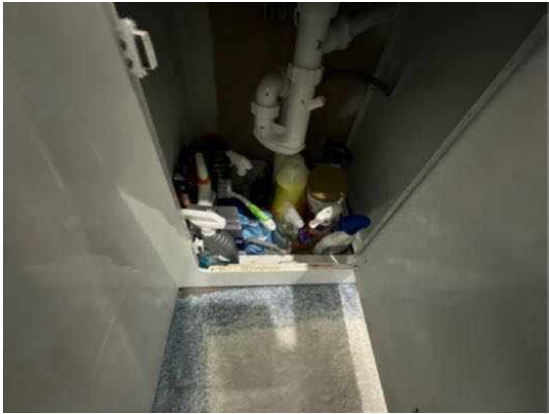
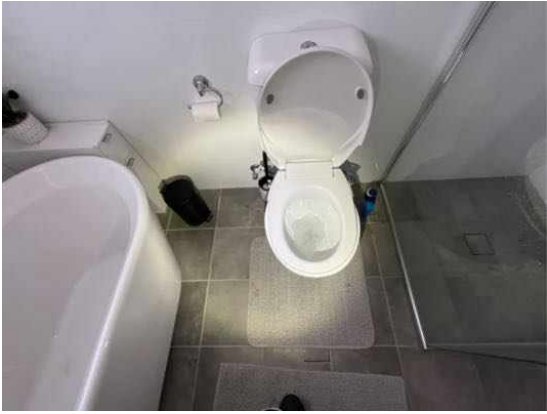
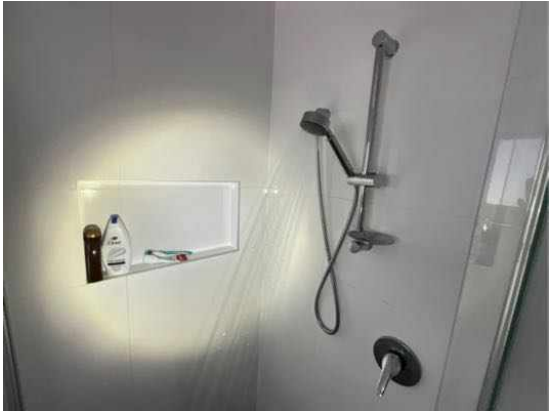
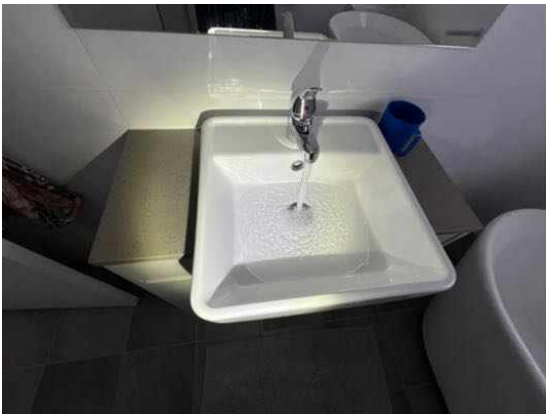
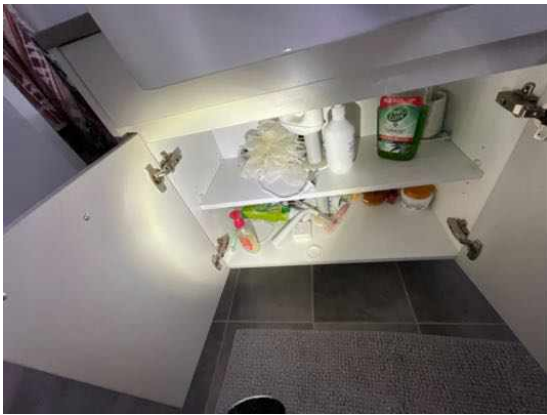
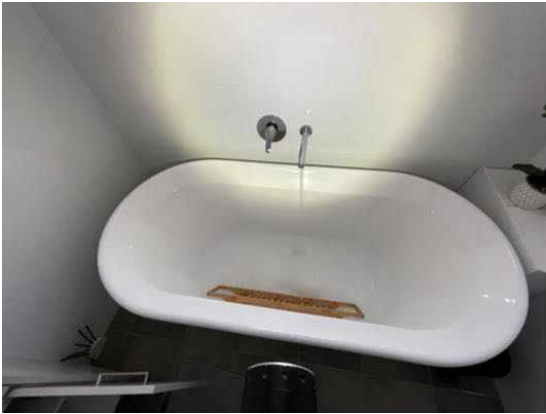
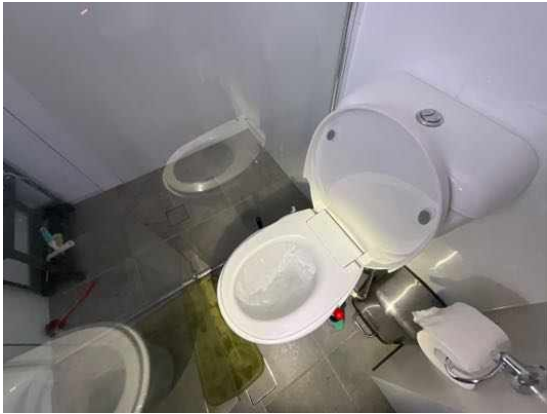
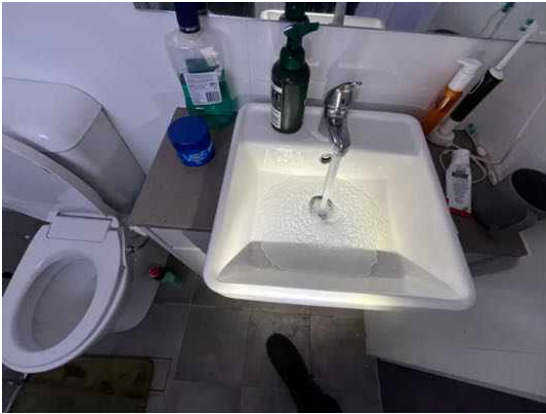
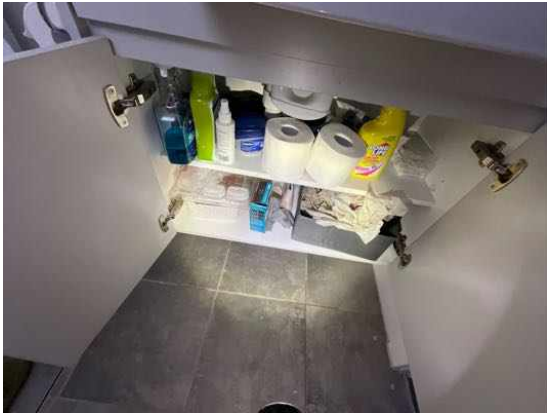
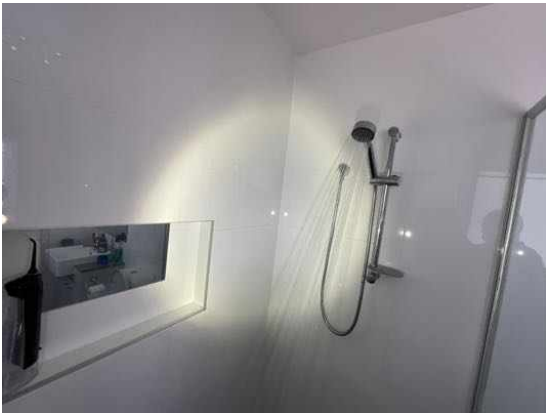
Building: Main Building
Location: All Wet Areas
Finding: Additional Photos
Information:

Additional photos are provided for your general reference.

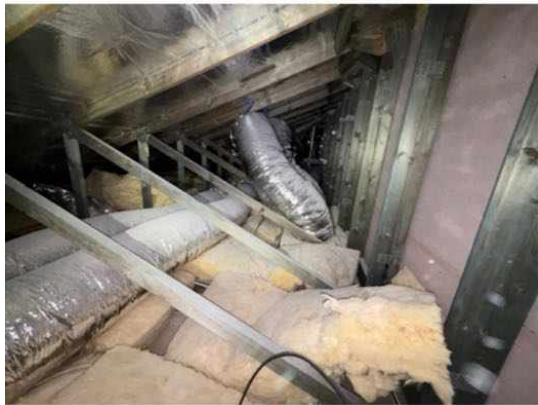
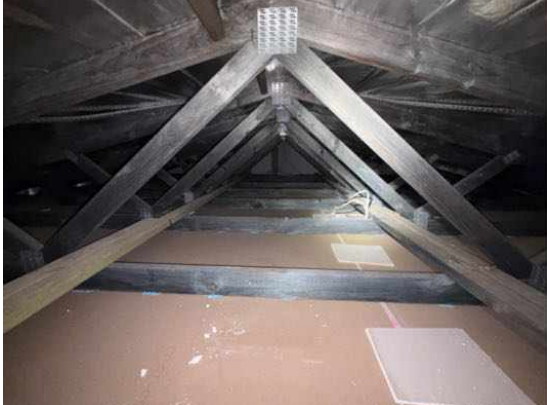
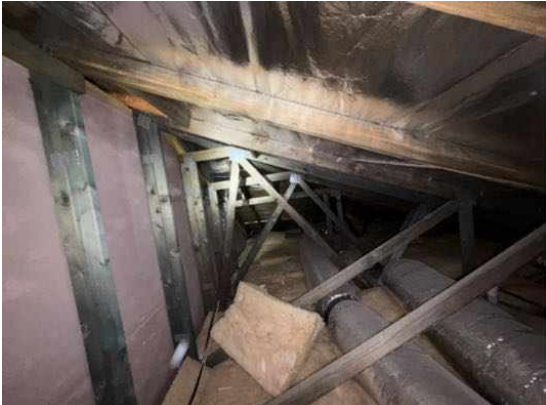
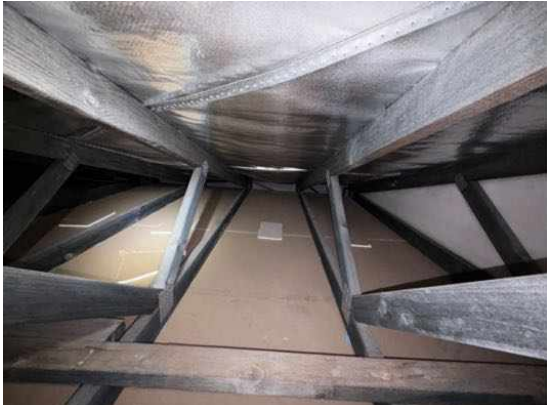
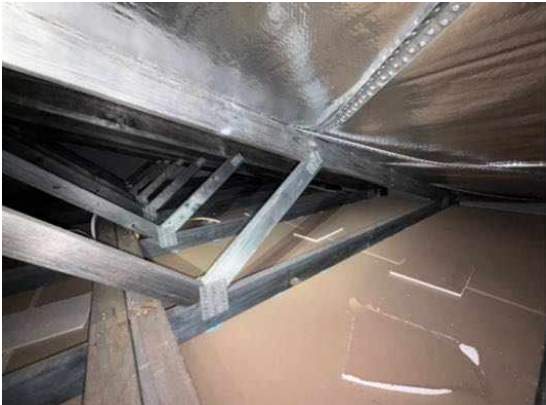
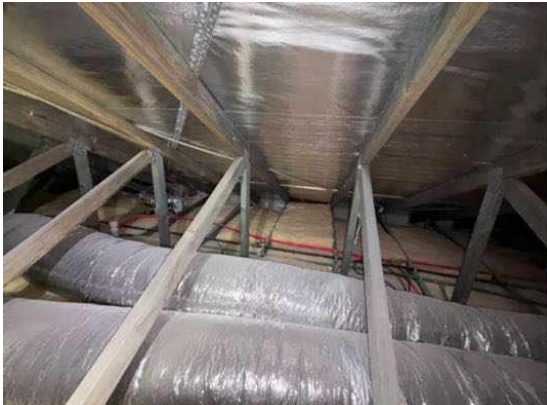
Building: Main Building
Location: Roof Void
Finding: Additional Photos
Information:

Additional photos are provided for your general reference.

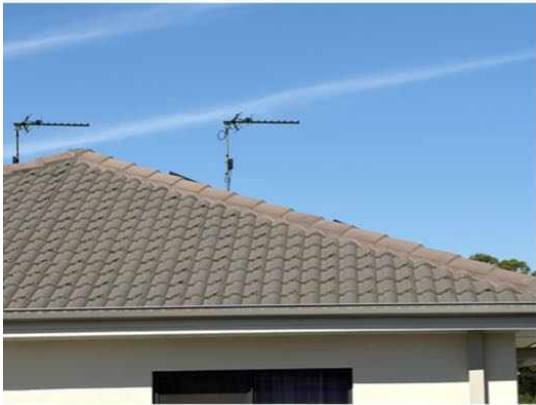
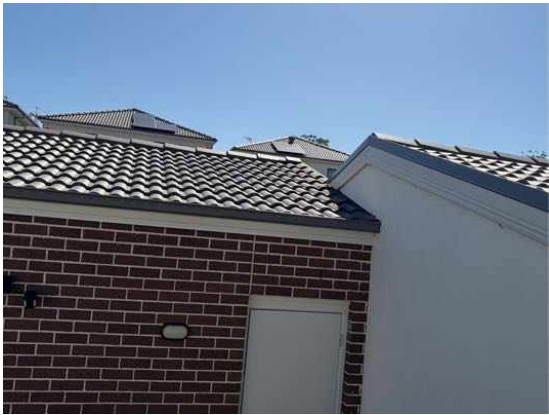
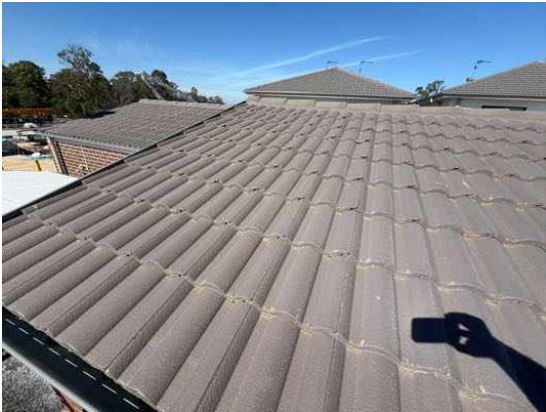
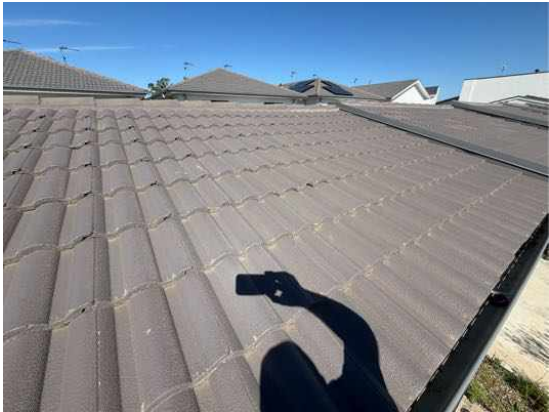
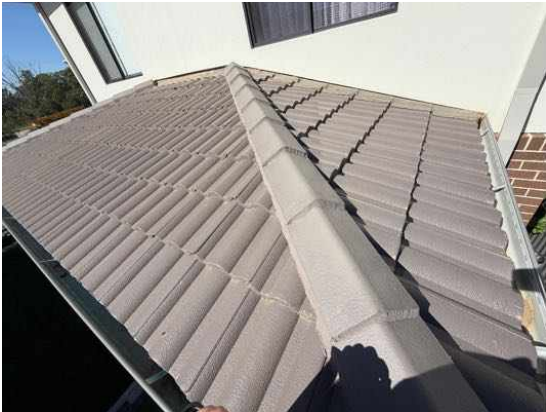
Building: Main Building
Location: Roof Exterior
Finding: Additional Photos
Information:

Additional photos are provided for your general reference.

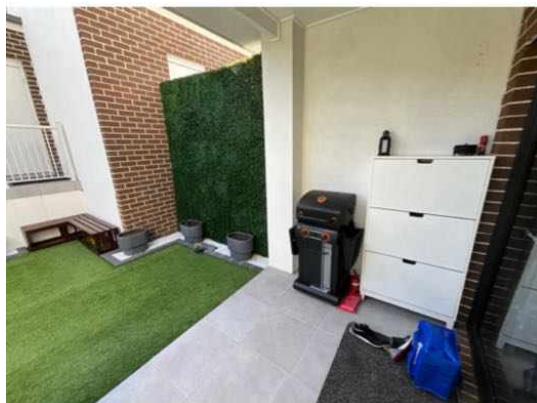
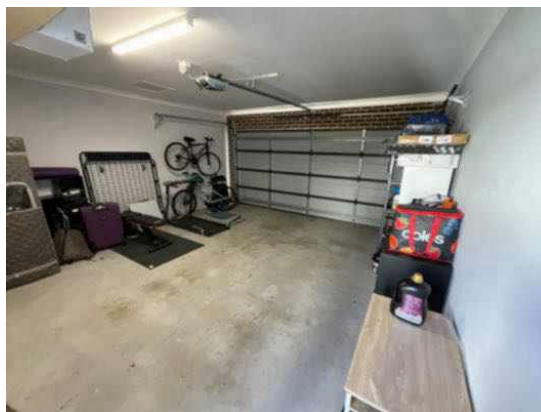
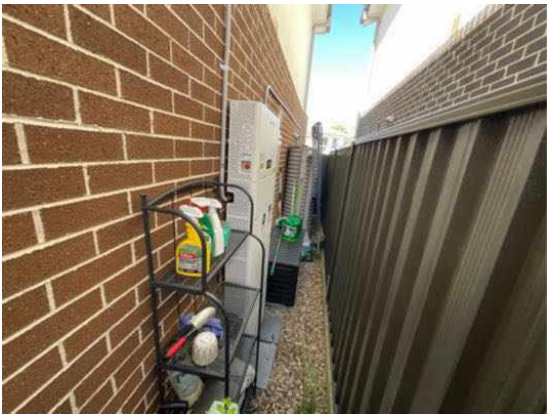
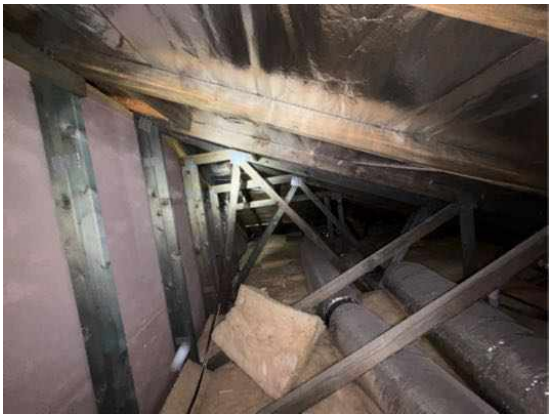
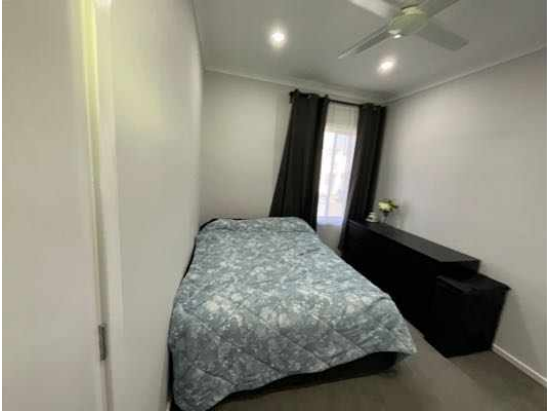
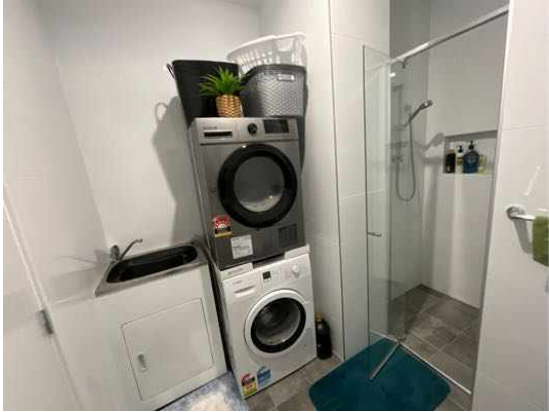
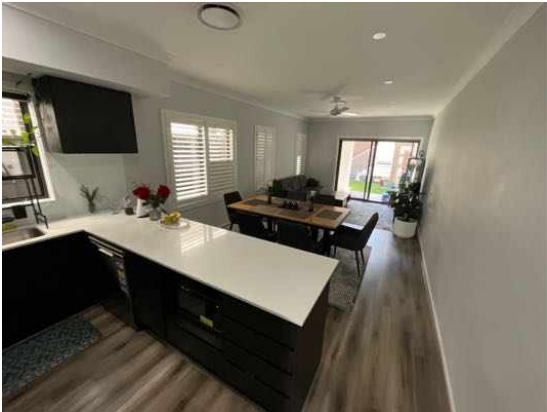
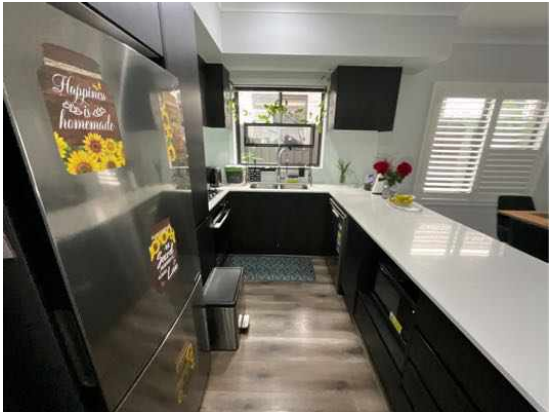
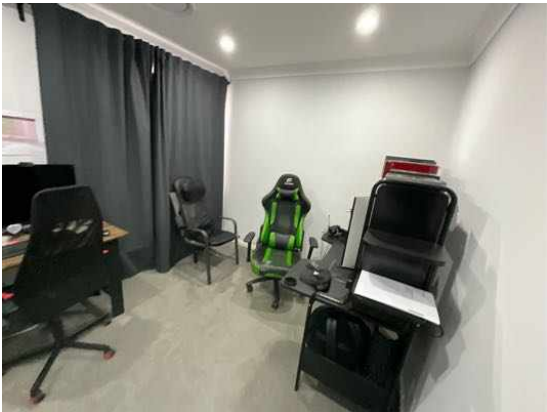
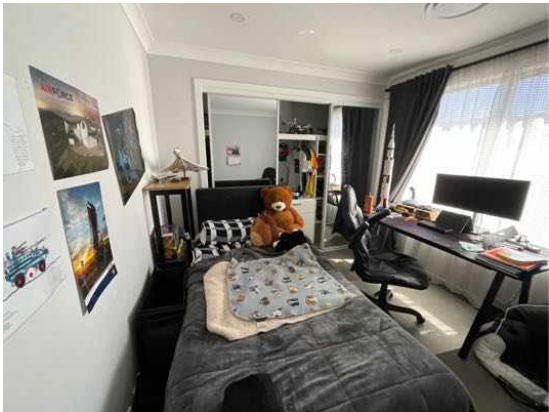
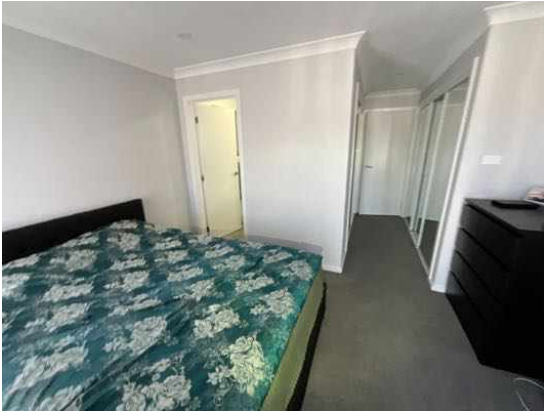
Building:	Main Building
Location:	All Areas
Finding:	Additional Photos - Obstructions and Limitations
Information:	These photographs are an indication of the obstructions and limitations which impeded full inspection of the property at the time of inspection. These obstructions can hide an array of defects and should be removed to allow full inspection to be carried out. A re-inspection is recommended once the areas are made accessible.

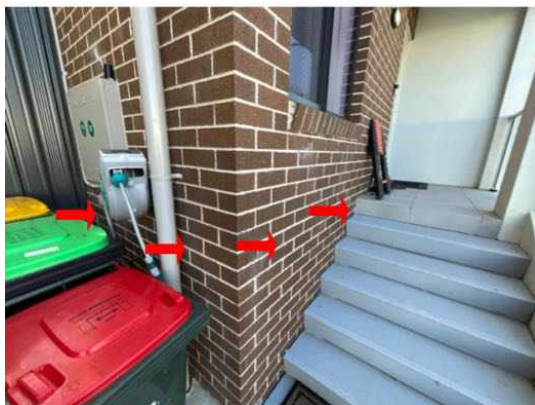
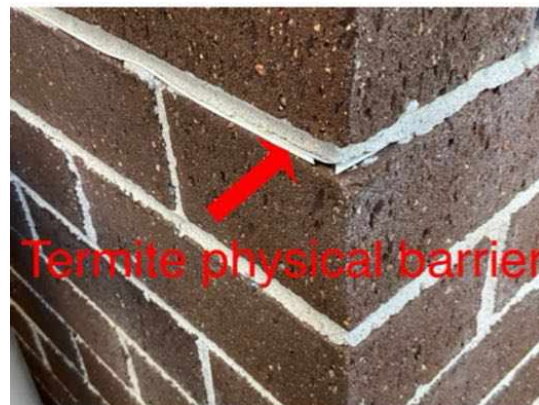
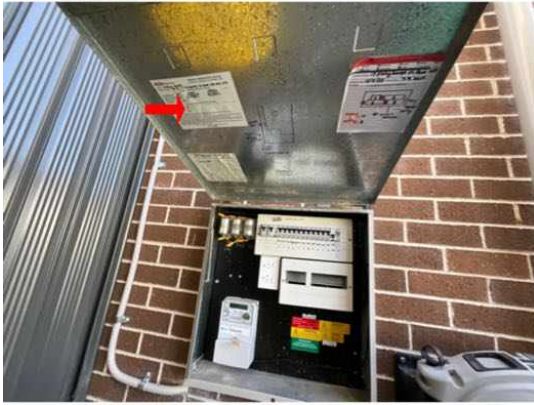
The following items were noted as - Evidence of a previous termite management program

Where a Termite Management System has been identified you should refer to the type of barrier date of installation warranty conditions and any documentation provided by a builder or past owner. Consult the company who installed the barrier to confirm whether the system is still under warranty.

Most chemical termite management systems expire and require replenishment and all physical systems are primarily designed to prevent concealed entry.
