Building and Timber Pest Inspection Report

Inspection Date: Mon, 16 Mar 2026

Property Address: 272 Lane Cove Rd, North Ryde NSW 2113,
Australia

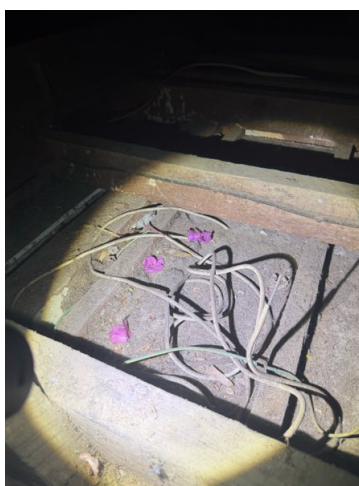
Finding: Electrical wires exposed

Information: Exposed electrical wiring was identified. Exposed electrical wiring represents a potential safety hazard including for fire and personal contact. Contact a licensed electrician urgently for further inspection investigation and rectification.

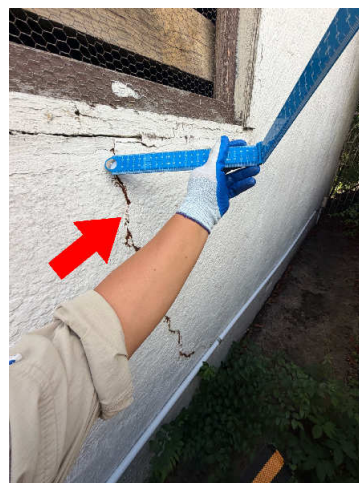
Finding 2.01

Finding: Brickwork - Cracking [Extensive repairs required]

Major cracking is evident to the brickwork in this area. When managing this degree of cracking, major extensive repair work is generally required. Such work is likely to involve replacement of sections of affected brickwork.

Structural issues are generally the underlying cause of such cracking. It is suspected that this damage has been created due to movement of key structural elements or general subsidence of associated footings.

A structural engineer and bricklayer should be appointed immediately to inspect the structural integrity of the affected brickwork and to assess the safety of the associated structures. The engineer can also nominate a scope of works required for rectification.

Always contact a building inspector or engineer should cracks widen lengthen or become more numerous, even after repair works have been completed.

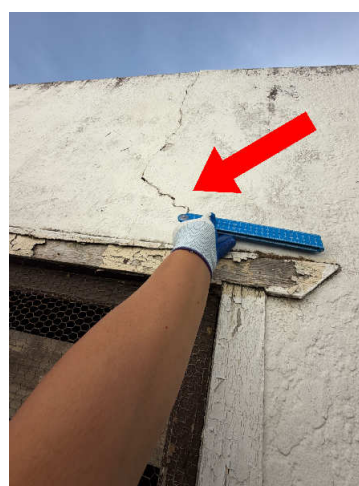
Finding 2.02

Information: A vertical separation approximately 10 mm wide was observed at the junction between the side wall and the main external wall. The rendered joint has opened and the render has separated along the interface of the two adjoining wall sections.

The separation appears consistent with differential movement between adjoining wall structures and failure of the rendered joint. The opening may allow moisture penetration and pest entry if left unsealed.

A qualified structural engineer should inspect the affected area and clean and repair the joint using a suitable flexible sealant or expansion joint system, followed by patching and repainting of the render to maintain weatherproofing and accommodate ongoing movement.

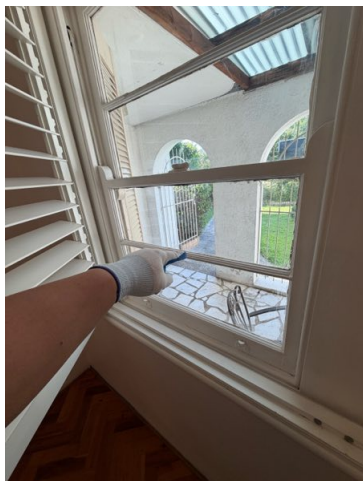
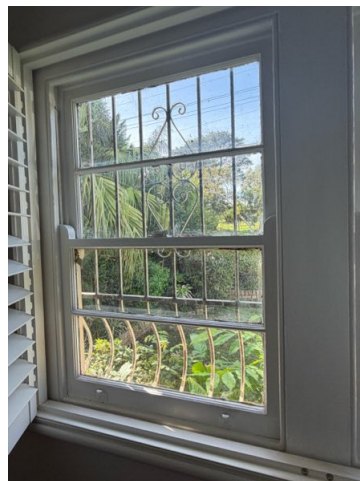
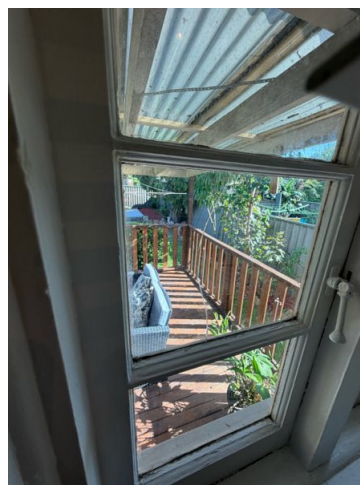
Finding 3.03

Finding: Window Glass - Cracked

Information: It was noted the window glass is cracked during the time of the inspection.

The crack may affect the transparency and clarity of the glass, distorting the view through the window. Furthermore, if the crack compromises the window's structural integrity, it can potentially compromise its ability to retain heat, maintain insulation, or withstand external pressures.

It is important to address a cracked window glass promptly to prevent further damage, potential safety hazards, and energy loss. Seeking professional assistance or replacing the damaged glass altogether is recommended to restore the window's functionality and aesthetics while ensuring the overall safety and security of the premises.

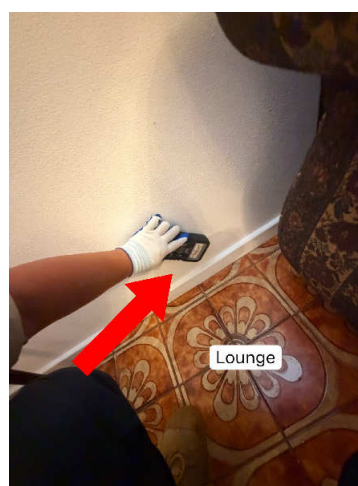
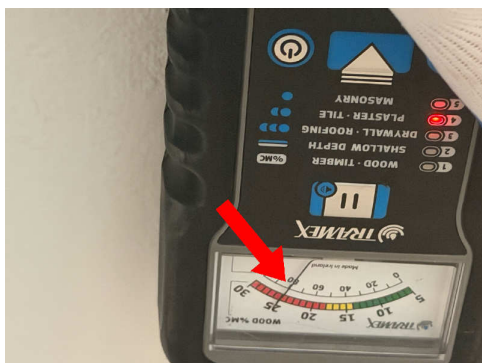
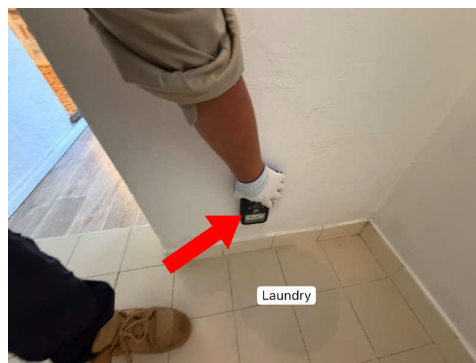
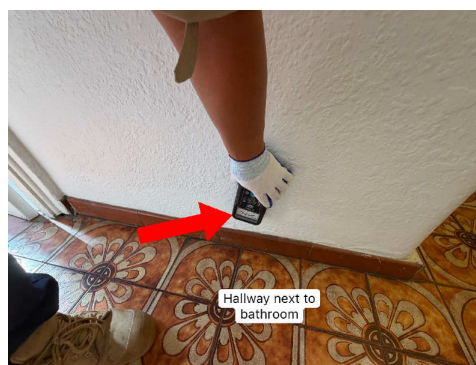
Information: Damp (or structural damp) refers to the presence of unwanted moisture in the structure of a building, either as the result of intrusion from outside, or condensation from within the structure. Generally, structural damp is caused by rain penetration, rising damp, and leaks from plumbing pipes.

Unmanaged damp facilitates the formation and development of mould, fungi growth and wood rot, decaying associated building materials and compromising their structural integrity. Damage to finishes is also likely to occur, including lifting, bubbling, peeling and staining of paint, plaster and wallpaper.

The first step in addressing damp is to diagnose the cause. The identified cause should be addressed first prior to repairing the appearance and other defects which have resulted from the rising damp. If the original cause is not resolved, further cases of damp are likely to ensue, resulting in secondary defects.

Consultation with a qualified plumber is advised immediately to identify the cause of damp and perform remedial works as required. Where excessive mould growth is present, further inspection by a specialist environmental health inspector should also be considered.

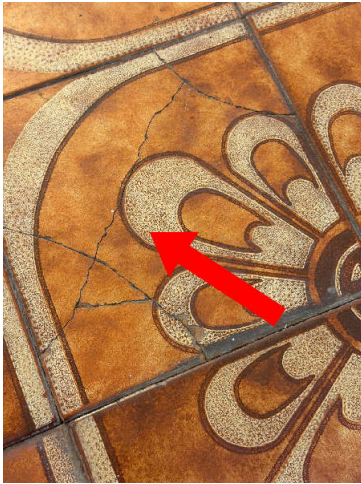
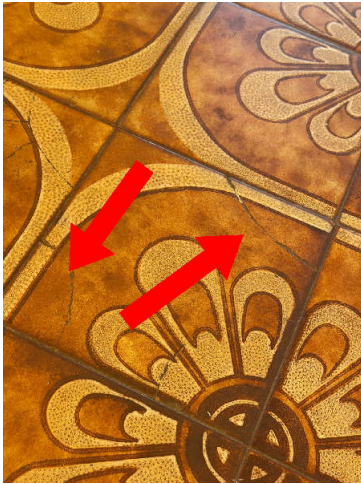
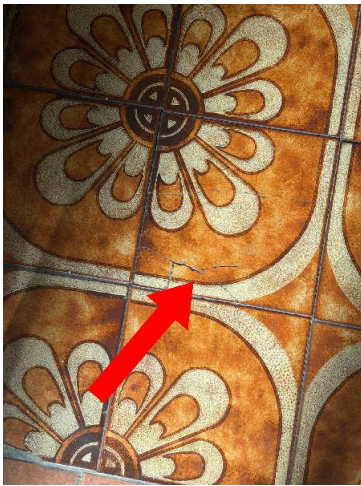
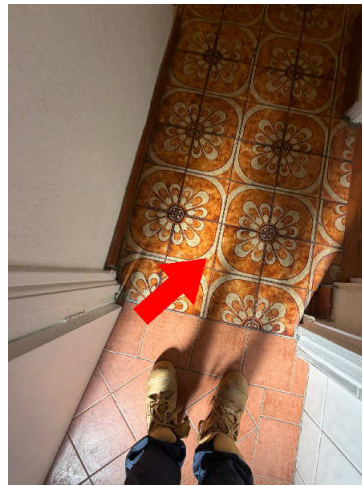
Finding 3.05

Finding: Cracked floor tiles

Information: Cracking in the floor tiles was evident in this area at the time of inspection. It is suspected that this cracking has occurred as a result of minor settlement or shrinkage of the slab.

Cracked tiles throughout the household detract from the overall appearance of the affected areas however it is unlikely to create or lead to any secondary defects.

While not considered a matter of urgency, replacement of cracked floor tiles is recommended at the clients discretion. A tiling contractor may be appointed to perform these works. Where cracks become more numerous, contact a licensed building inspector for further investigation.

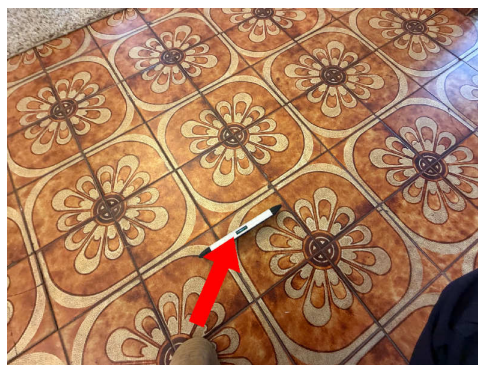
Finding 3.06

Building: Main Building
Location: All Internal Areas
Finding: Flooring - Uneven

The internal flooring in this area is out of level and uneven. Uneven flooring is likely to indicate minor defects such as expected movement of the foundations of the property, but may also indicate subsidence of the associated subfloor stumps.

It is advised that the flooring be closely monitored to identify any further movement. Where flooring remains relatively unchanged for an extended period of time (i.e. several months), it is likely that this defect has been caused by expected movement of the foundations of the property.

However, where flooring is uneven further, potentially invasive inspection of the subfloor structures and stumps in this area is required. In this case, works to repair are likely to be required, and would be carried out by a registered builder specialising in re-stumping.

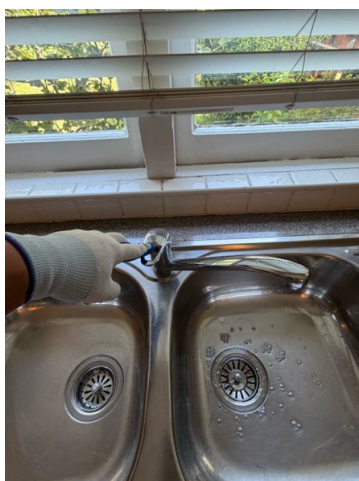
**Finding 3.07**

Information: This tap shows evidence of water hammer being present. Water hammer, a pressure surge resulting when a fluid is forced to suddenly change direction, is a common defect in plumbing fittings, particularly those that are aged and not frequently maintained. Water hammer is generally caused by factors that create high water pressure in the affected plumbing fixture, usually evidenced by a faint banging noise during operation of the affected tap.

Although water hammer is generally considered to be a minor defect, subsequent damage such as erosion of tap hardware and/or water damage to associated building elements is likely to occur if left unmanaged.

A licensed plumber should be appointed as soon as possible to replace any affected tap hardware and perform any remedial works as necessary. Please be advised that the appointment of a cabinet maker or qualified carpenter may be necessary if water damage to associated building elements has occurred.

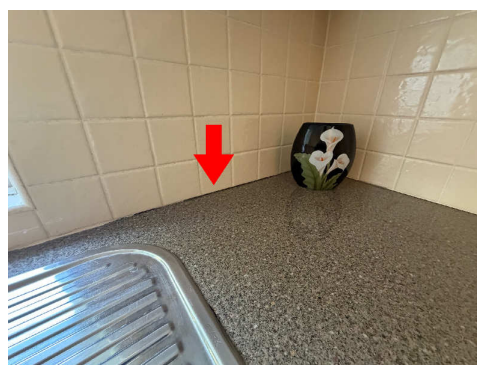
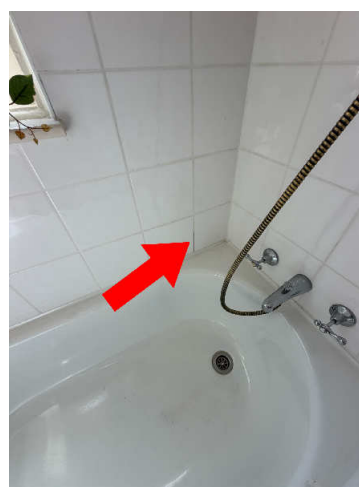
Finding 3.08

Finding: Sealant and grouting - Missing or damaged

It was noted on inspection that sealant or grout is degraded in multiple locations of the property.

Different materials and floor areas move at different rates, generally causing cracking to grout or sealant at this point. A flexible sealant is required to allow for expected expansion and contraction, while keeping the joint water tight and protective of all associated building materials.

Flexible and mould resistant materials should be applied to affected areas to prevent any subsequent water damage that is likely to occur. Regular maintenance and replacement of damage or missing or damaged sealant and grout is highly recommended to the wet areas, as this is a regular wear and tear defect. Sealant and grouting in areas that come into regular contact with water should be maintained for the long term care of your property.

A sealant specialist or tiling contractor should be appointed to complete these works as soon as possible

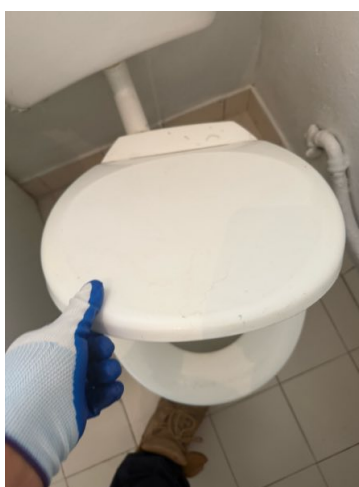
Finding 3.09

| Finding: | Toilet Seat - Loose |
| Information: | The toilet seat has been identified as loose, with noticeable movement or instability upon use. Visual inspection reveals that the connection between the seat and the toilet bowl is compromised, leading to a lack of secure attachment. The issue may be attributed to wear and tear, improper installation, or degraded fastening mechanisms. |

An experienced handyman or licensed plumber should be appointed to this matter.

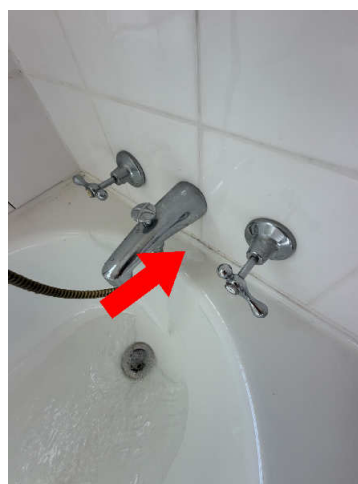
Finding 3.11

Finding: Spout - Leaking

Information: The Spout in this area was found to be leaking at the time of inspection. This is a common defect that is consistent with general ageing of the building element. However, it may be indicative of substandard plumbing workmanship if the tap is relatively new.

While this defect only seems minor, if left unmanaged, it is likely to result in the development of rust, water damage and/or extensive water usage.

It is advised that a handyman or licensed plumber be appointed to perform remedial works on the affected tap. Such works should be performed prior to the development of secondary defects to ensure adequate functionality of all associated building elements.

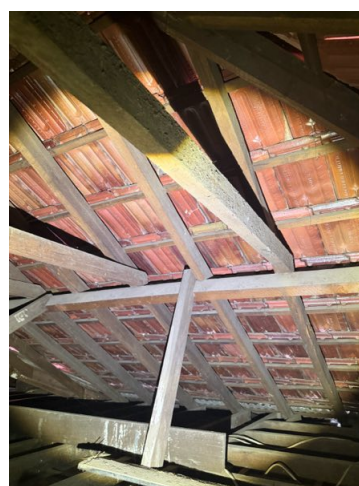
Finding 3.12

Finding: Sarking - Missing

Information: Sarking is missing under the roof sheeting. Sarking acts as an insulator that helps with noise reduction and protects against water penetration. Sarking plays a key role in the operation and function of the overall roofing structure and its performance.

Although not a requirement at the time of construction, replacement of any missing building element is advisable (although this can be quite expensive to do after the time of construction). Where sarking is missing, regular inspections of the roof tiles for cracking and potential moisture penetration is required.

Sarking may be retrospectively fitted by a registered builder at the discretion of the client.

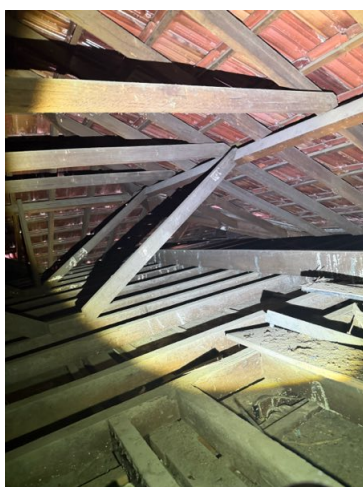
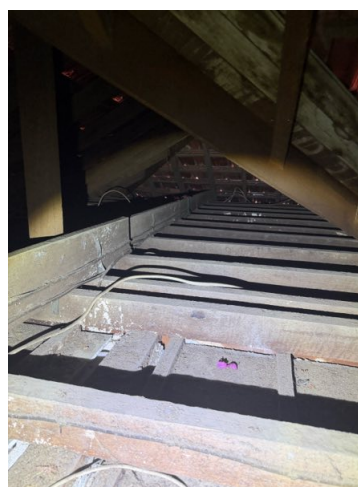
Finding 3.13

Finding: Insulation - Missing

Information: Upon inspection of the roof void it was noted that insulation is not present.

Insufficient insulation will result in a comparatively higher cost to heat and cool a property as there is a lack of Insulation (or uneven coverage of insulation) which works as a barrier to heat transfer. This helps to keep out unwanted heat in summer and preserves warmth inside your home in winter. It can also help soundproof your home from unwanted airborne noise transfer.

Where insulation is absent, the area does not meet current Australian Standards. Installation of adequate insulation is required and should be conducted as soon as possible.

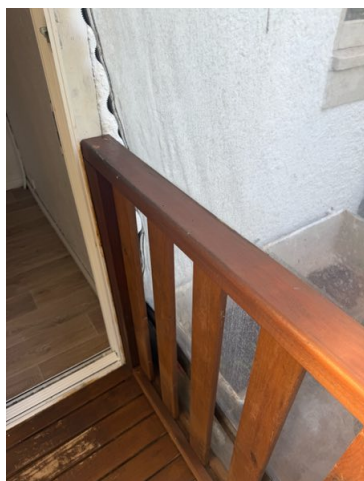
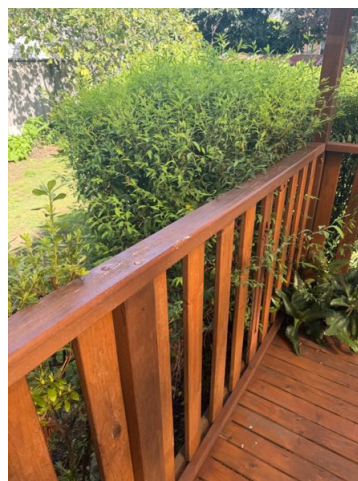
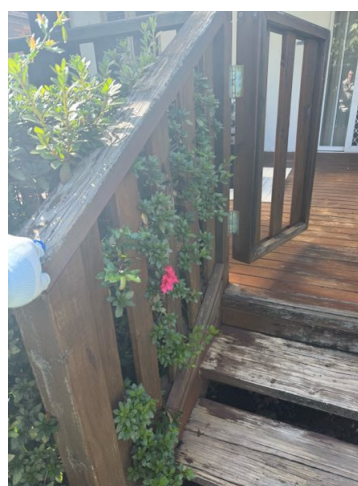
Finding 3.14

Information: The handrail, a crucial safety feature designed to provide support and stability, has been insecurely installed, raising significant safety concerns. The attachment of the handrail to the supporting structure is compromised, compromising its ability to bear weight and fulfill its intended function. This condition poses a serious risk to individuals relying on the handrail for support, especially on stairs or elevated areas.

Engage the services of a qualified contractor or structural engineer to assess the overall condition and provide recommendations for repair or replacement.

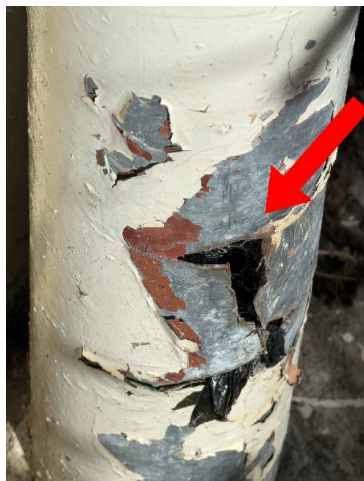
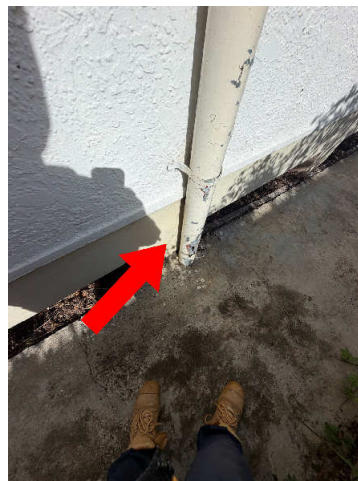
Finding 3.15

Finding: Down-pipe - Damaged.

Information: The external down pipe shows evidence of damaged at the time of inspection. This damage is likely to have developed due to minor leaks, providing excess moisture to affected areas. Such damage is expected of a building element of this age and with this level of exposure to excessive moisture.

Any leaks should be identified and rectified by a licensed plumber as soon as possible. Prevention of further deterioration will delay the need for replacement of the pipe in the near future.

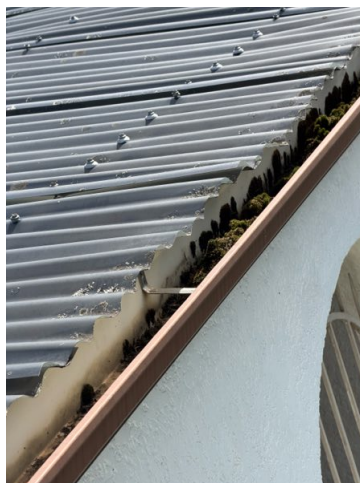
Finding 3.16

Information: Rubbish was found in the gutter during the time of inspection.

Remove rubbish in order to prevent blockage of the gutter and down pipes.

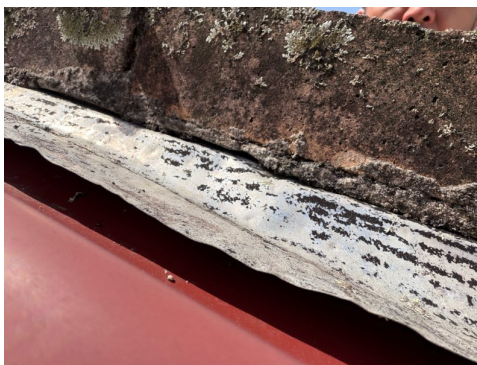
Building: Main Building
Location: Roof Exterior
Finding: Roof plumbing - Flashing inadequate

Information: Some sections of the roof are missing or have inadequate roof flashings. Flashings are metal and other materials which are applied to seals and intersections between roof coverings and building elements. They are designed to aid in weatherproofing of roof joins.

Flashings that are not installed adequately or are missing are likely to result in water penetration to the interior of the property, as well as creating excessively damp conditions against the exterior surfaces and around the base perimeter of the building.

Premature ageing and secondary building defects are imminent where roof plumbing is missing or inadequately installed. Additionally, water pooling also creates an environment that is susceptible to termite and pest infestation.

A roofing plumber should be appointed as soon as possible to install relevant roof plumbing materials, ensuring that no further damage is sustained.

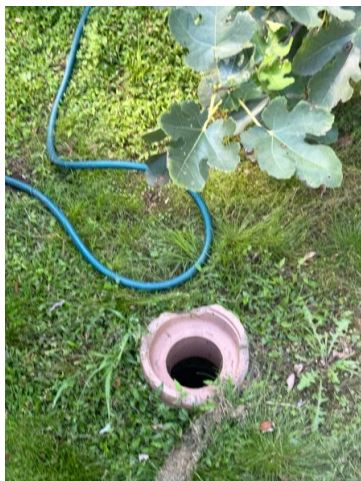
Finding 3.19

Finding: Floor Waste Grate - Missing

Information: The floor waste grate in this area is found to be missing, leading to a critical issue where it can no longer prevent rubbish, hairs, and potentially hazardous materials from entering the drainage system.

The grate should be promptly replaced with a suitable, functional, and durable replacement.

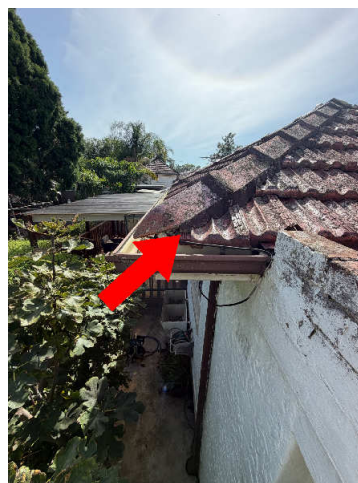
Finding 3.20

Finding: Roof tiles - Broken

Information: Upon inspection of the exterior roof covering, broken roofing tiles were identified. Broken and friable roof tiles are generally the result of ageing and weathering of what is essentially a porous material.

If left to further deteriorate, broken and brittle roof tiles are likely to lead to water penetration via the roof into the ceiling space, causing secondary damage to ceiling linings, insulation and roof structures. Broken roof tiles are also likely to detract from the effectiveness of the roof drainage system, creating potential for secondary damage to the exterior roof covering and roof plumbing.

Replacement of broken tiles is required and should be performed by a roofing contractor as soon as possible.

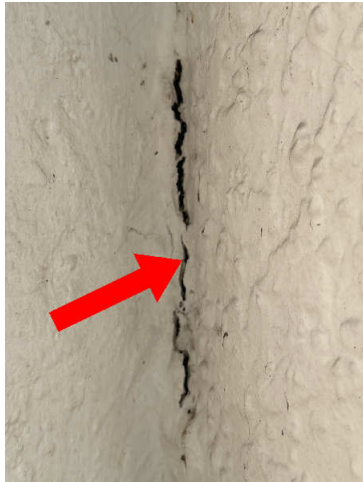
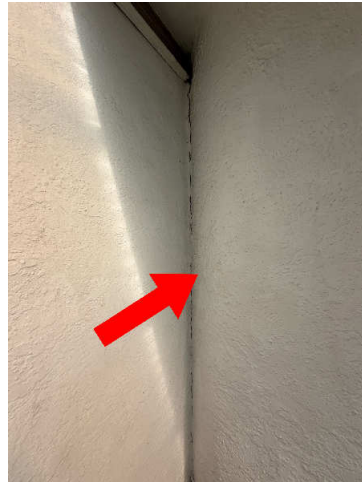
Finding 3.21

Finding: Brickwork - Cracking [Repair required]

Information: Major cracking was identified to the brickwork in this area. Cracks of this type are likely to have been caused by minor expected movement of building elements, but may also have a structural cause that is more significant.

A qualified bricklayer should be contacted immediately to estimate and perform repair and restoration works. Consultation with a structural engineer may be required where structural instability is found to be the underlying cause of the cracking.

Always contact a building inspector should cracks widen, lengthen, or become more numerous.

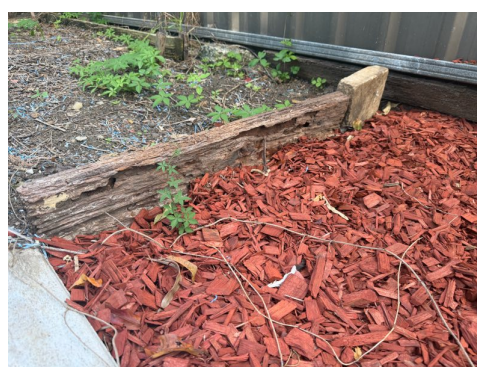
No evidence was found

It is advised that the area be visually inspected frequently to ensure that the condition of affected building materials does not worsen.

A licensed pest controller may be appointed to provide a further invasive inspection if further damage is evident. Damage caused by termites found in backyard areas is considered a defect if the termite management system is not installed in accordance with the BCA / NCC and relevant Australian Standards.

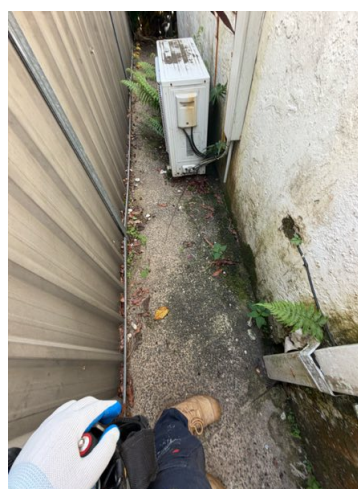
If left unattended damp or wet conditions may have many consequences including the development of fungal decay and/or wood rot as well as providing an environment that may be conducive to termite or timber pest attack.

A qualified plumber should be appointed immediately to identify the cause of the excessive moisture in order to prevent further damage. The water leak should be resolved prior to any repairs of the damaged area which may require localised replacement of building materials and refinishing..

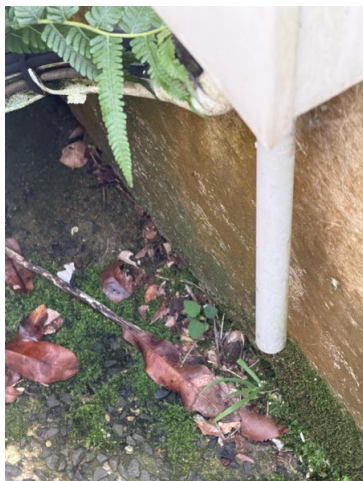
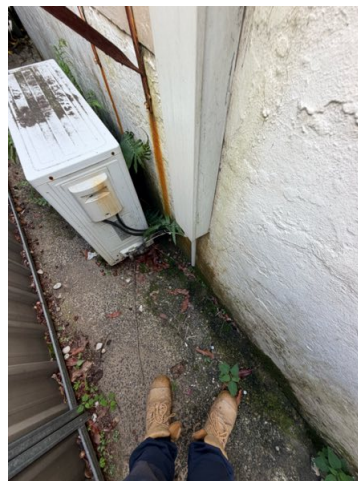
Finding 6.02

Finding: Air Conditioner - Disconnected overflow

Information: The Air Conditioner (A/C) overflow was found to be disconnected from storm water drainage and is creating excessive moisture in the surrounding area.

Such leaking creates an environment which is conducive to an array of defects, including water damage to associated building elements and the attraction of termite or timber pest infestation.

It is highly recommended that a licensed plumber be appointed to connect the A/C overflow in order to prevent such an environment from being created. These minor works should be carried out as soon as possible.

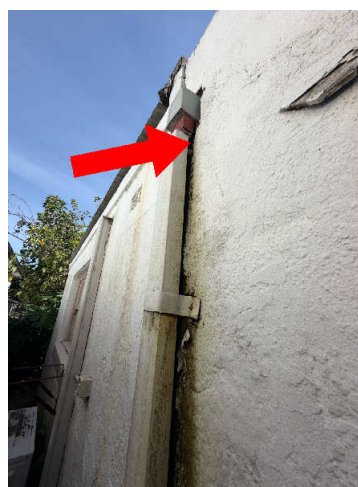
Finding 6.03

Information: The overflow was found to be disconnected from storm water drainage and is creating excessive moisture in the surrounding area.

Such leaking creates an environment which is conducive to an array of defects, including water damage to associated building elements and the attraction of termite or timber pest infestation.

It is highly recommended that a licensed plumber be appointed to connect the overflow in order to prevent such an environment from being created. These minor works should be carried out as soon as possible.

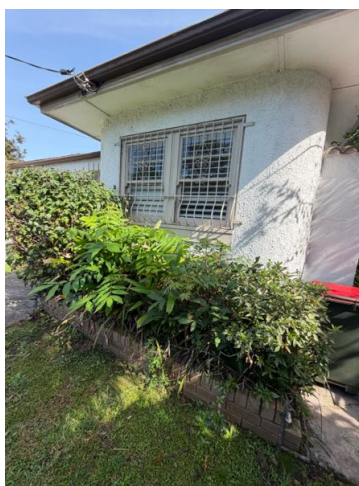
Finding 6.04

| Finding: | Garden Beds - Conditions Conducive to Termites |
| Information: | <p>Garden beds were found to be evident in close proximity to the building. Garden beds immediately adjacent to the perimeter of the building block the visual inspection of these areas providing a concealed termite entry point.</p> <p>Where garden beds have raised ground levels, this allows termites to easily access the weep holes or the subfloor vents to the brickwork.</p> <p>Garden beds can include untreated timber and a combination of moisture from watering produce conditions conducive to termite activity and ingress.</p> <p>Further advice from a Timber Pest Technician is required to ensure appropriate Termite Management systems are implemented.</p> |

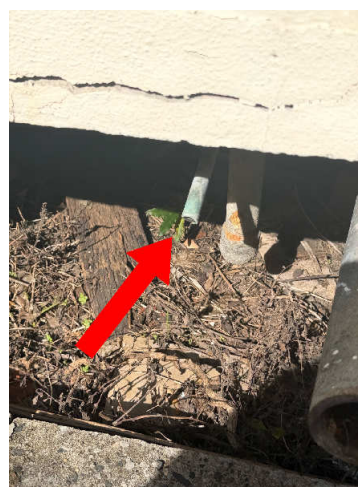
Finding 6.05

Information: The Hot Water System (HWS) overflow was found to be disconnected from storm water drainage and is creating excessive moisture in the surrounding area.

These damp conditions can lead to secondary defects such as rot, rust or corrosion of associated building elements, the formation of fungal decay, or even the creation of potential slip hazards. When coupled with poor site drainage, pooling of water may also attract termite activity to this area.

It is highly recommended that a licensed plumber be appointed to connect the HWS overflow in order to prevent such an environment from being created. These minor works should be carried out as soon as possible.

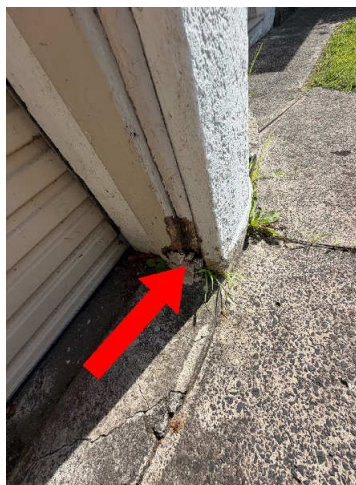
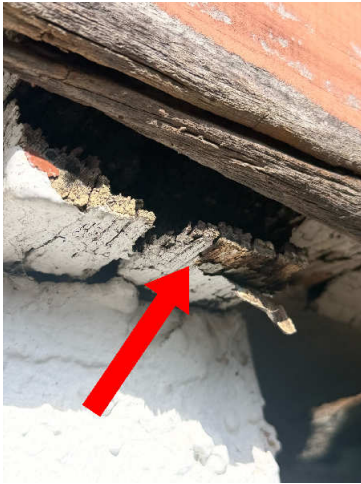
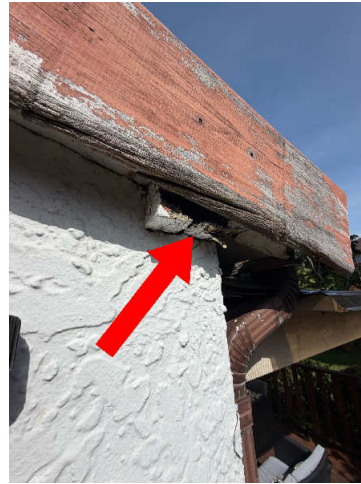
Finding 7.01

Building: Main Building
Location: All External Areas
Finding: Wood rot

This building element shows evidence of wood rot. Wood rot, also known as Fungal Decay, occurs when timbers and other cellulose building materials are exposed to damp conditions on an ongoing basis. This could be the result of exposure to weathering over a prolonged period of time, or the attraction of excessive moisture from other abutting building materials. Contributing factors also include poor air ventilation in the area.

Wood rot is often associated with general damp problems and is evidenced by a 'musty' smell or mould and mildew occurring on surfaces. If left unmanaged, damp conditions can lead to further health problems and the decay of timbers will continue.

Early intervention and regular maintenance, particularly of exterior timbers, will prolong the useful life of these building elements. Prior to any works being performed, the cause of the moisture that has created the visible wood rot should be identified and addressed in a suitable manner. Replacement of affected timbers may then be a necessary step in protecting surrounding building elements from such deterioration.

A qualified plumber may be appointed to assess the cause of excessive moisture and to provide advice on any remedial works as required. A qualified carpenter or registered builder may also be required to replace affected building materials.

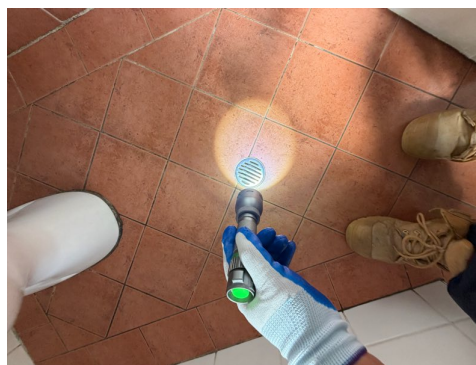
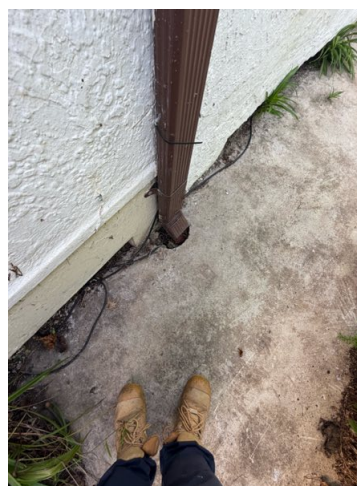
Information: The inspection has revealed the presence of rubbish in the drainage system, raising concerns about a potential blockage.

It is important to note that the drainage inspection is outside the scope of this report. Given the severity of the suspected blockage and to ensure a thorough assessment, engaging a licensed plumber with expertise in drainage systems is strongly advised.

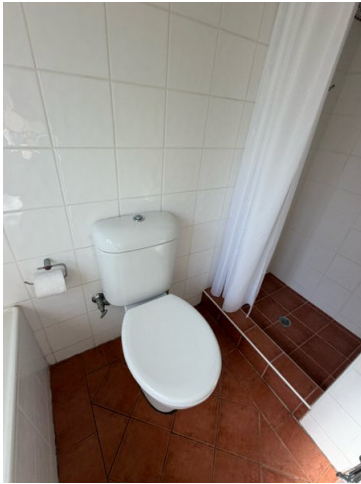
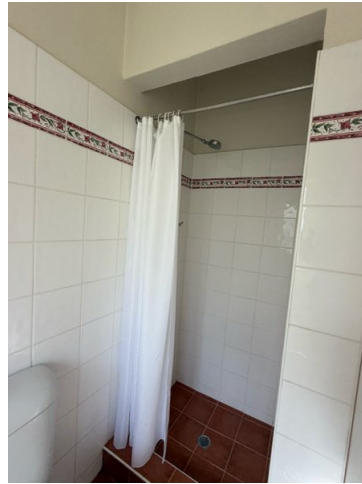
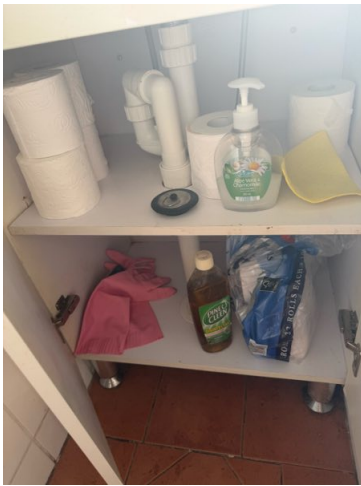
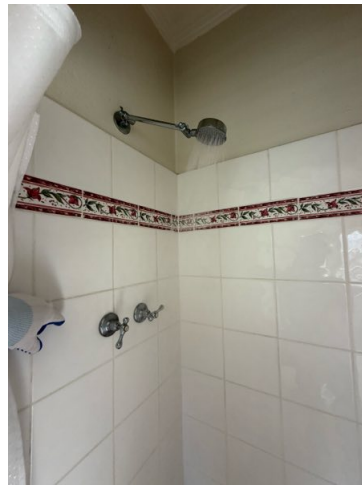
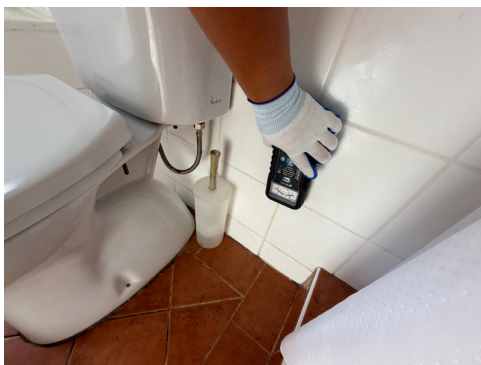
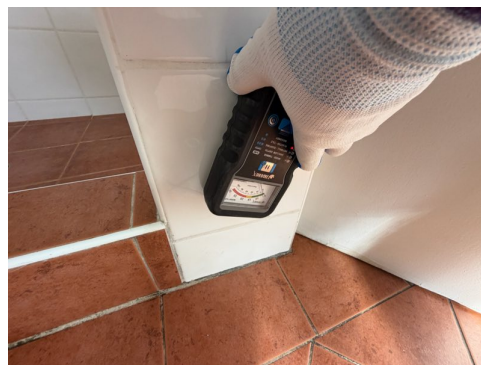
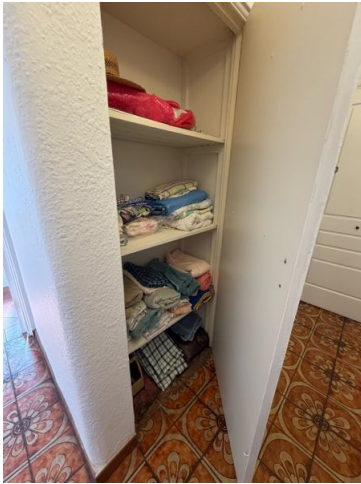
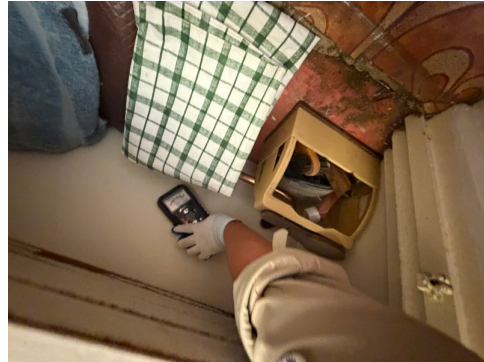
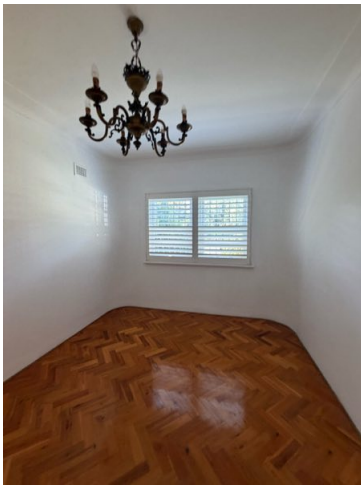
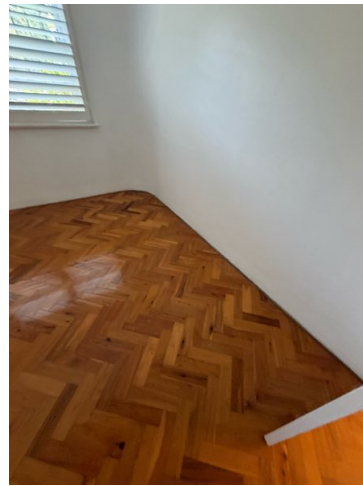
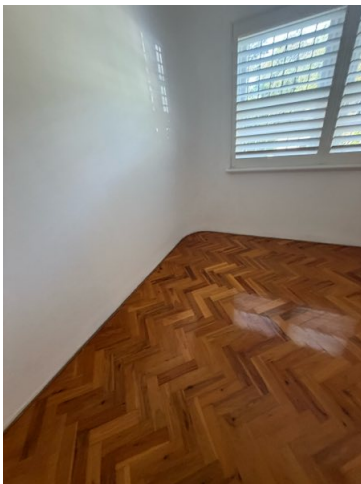
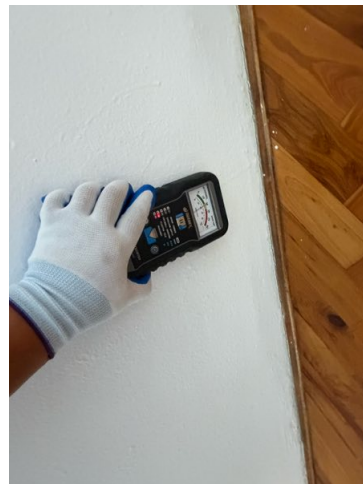
Information: Additional photos are provided for your general reference and may include obstructions, limitations, testing of water, moisture readings or minor maintenance items.

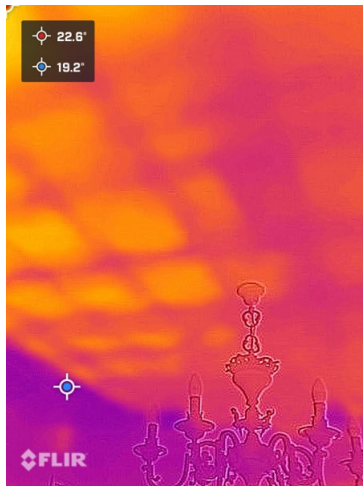
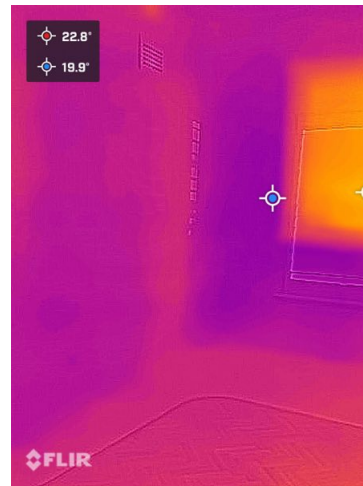
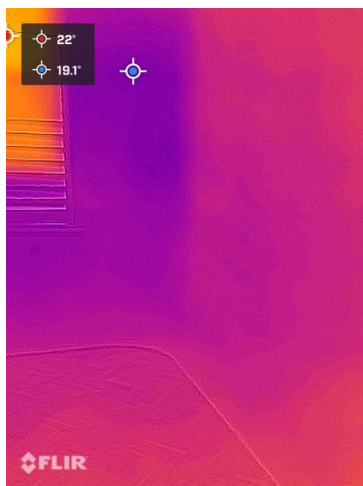
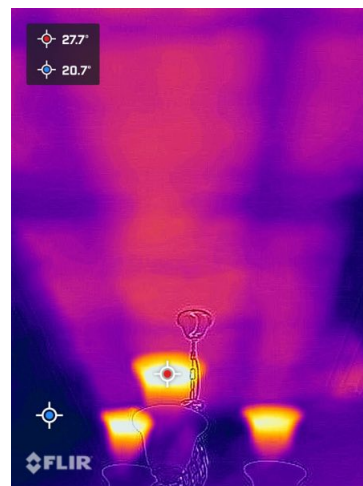
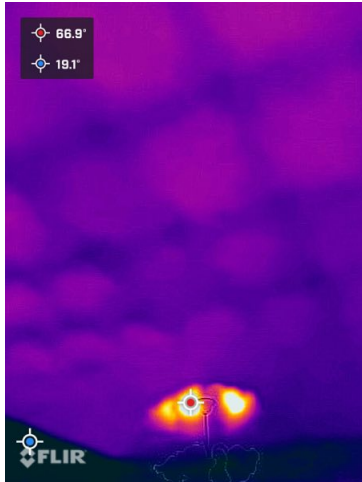
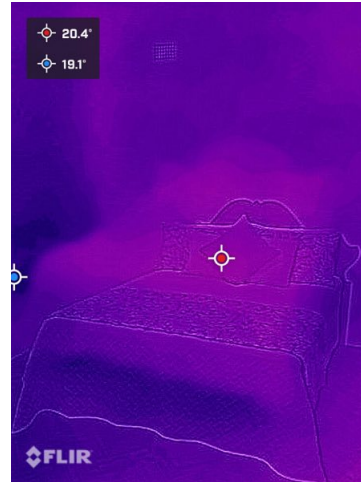
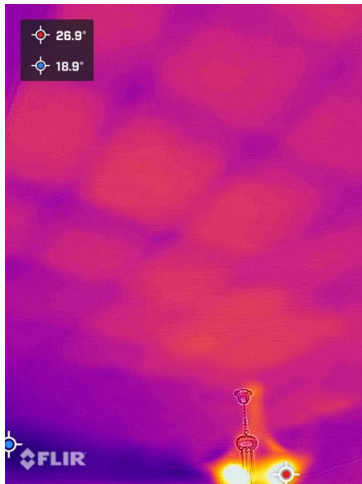
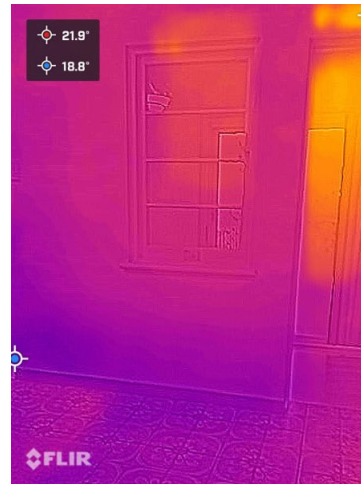
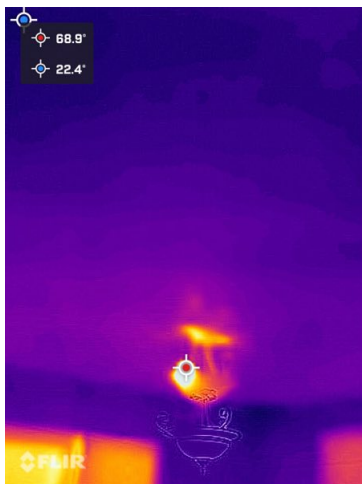
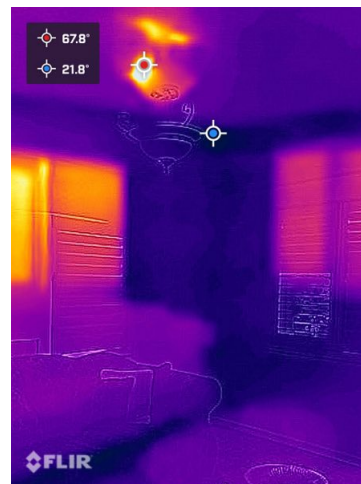
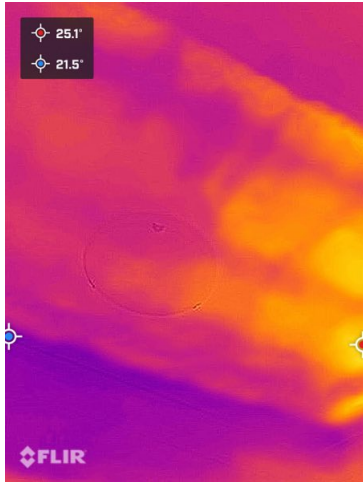
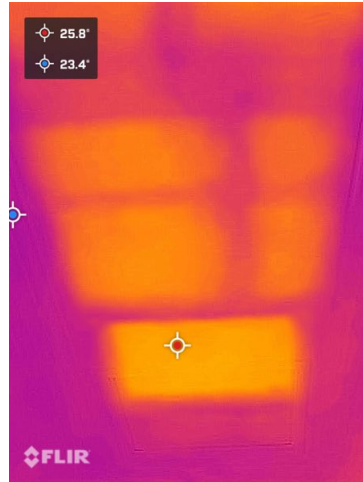
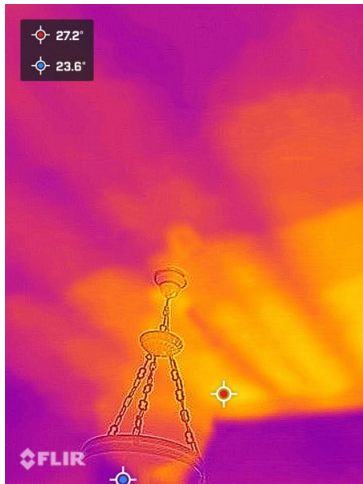
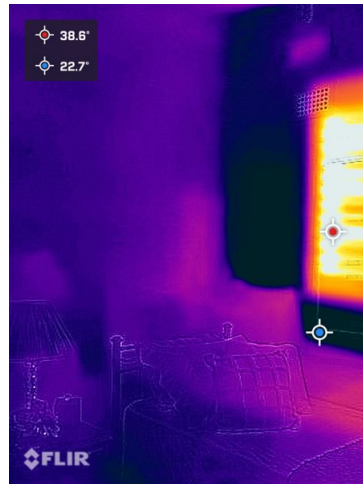
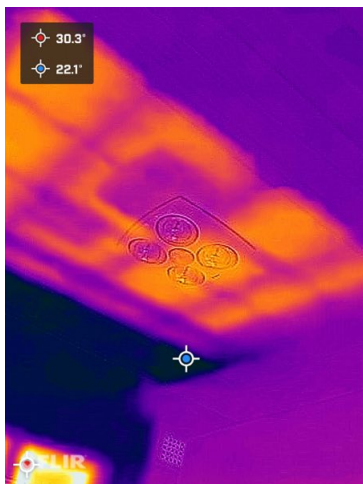
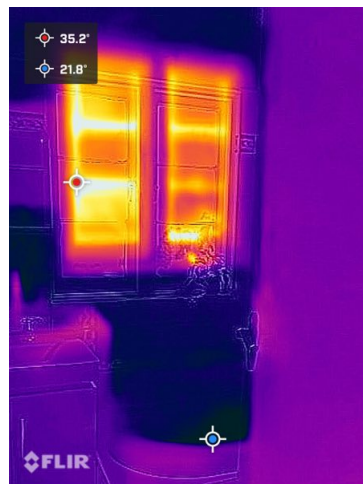
Finding: Additional Thermal Image Photos - Interior Area

Information: These Thermal Image photographs are an indication of the interior area at the time of inspection.

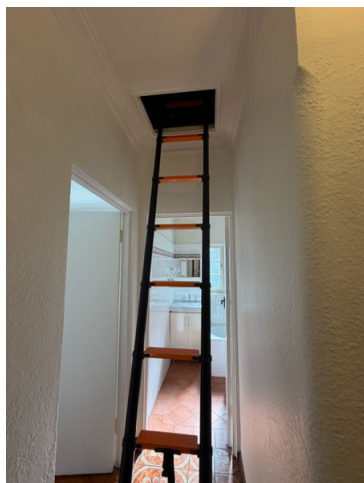
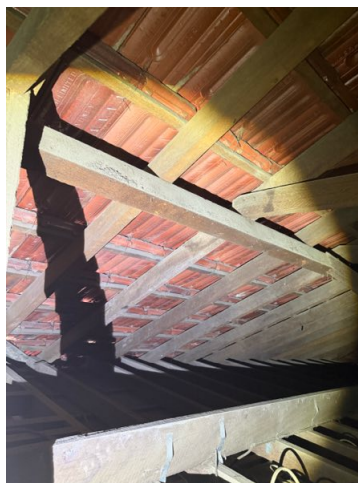
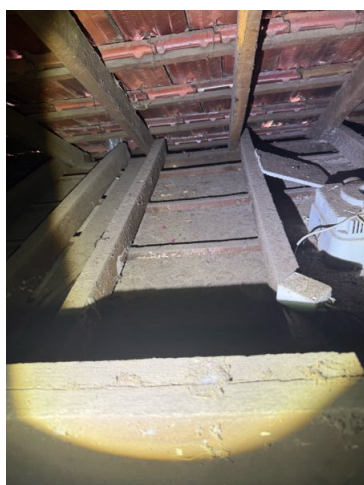
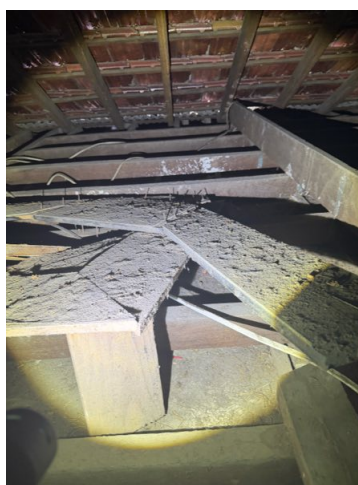
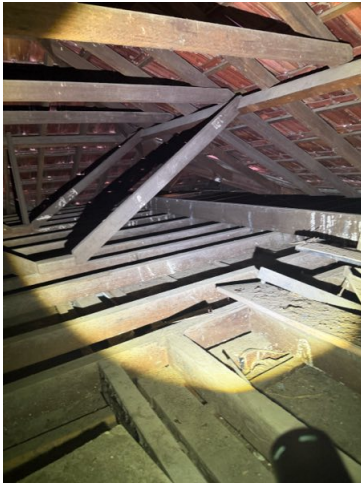
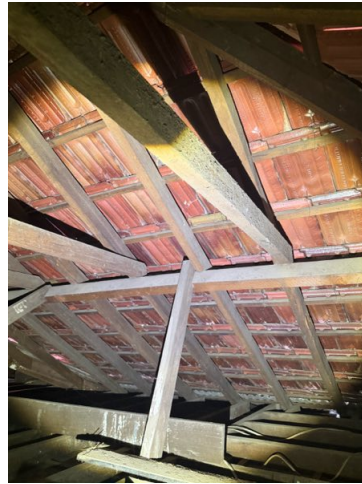
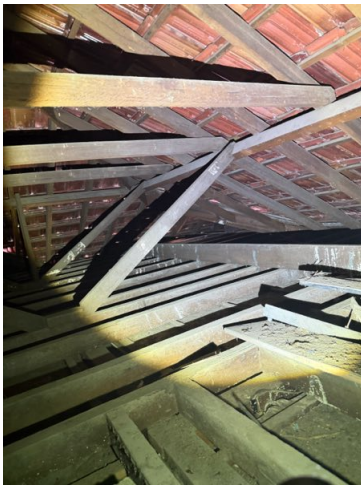
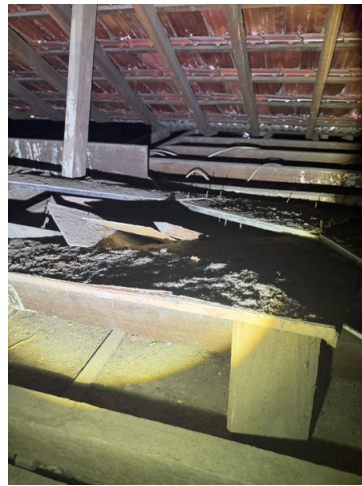
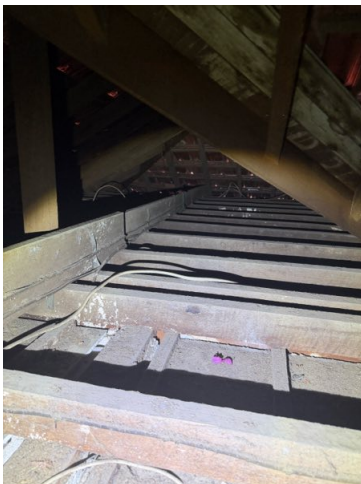
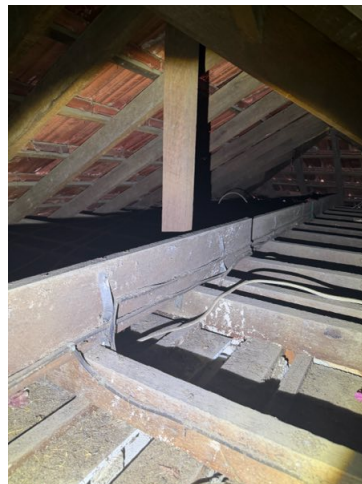
Finding: Additional Photos - Roof Exterior Area

Information: Additional photos are provided for your general reference and may include obstructions, limitations or minor maintenance items.

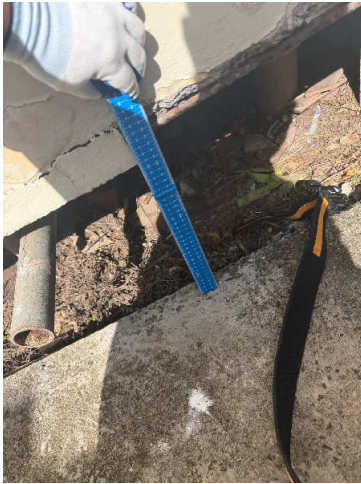
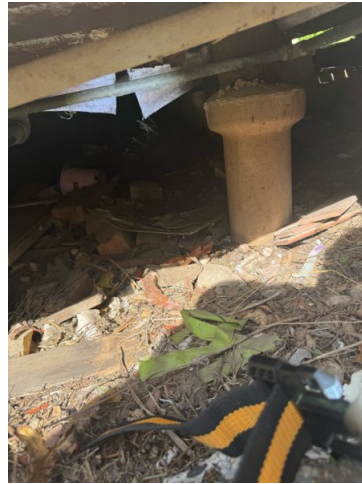
Finding: Lack of Access to Subfloor

Information: The additional photos indicate during the time of the inspection there were Lack of Access to subfloor due to obstruction and entry point smaller than 400mm*600mm.

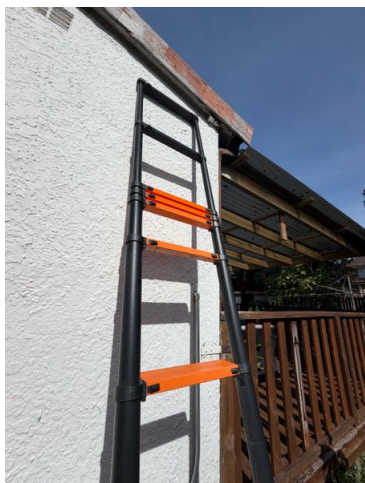
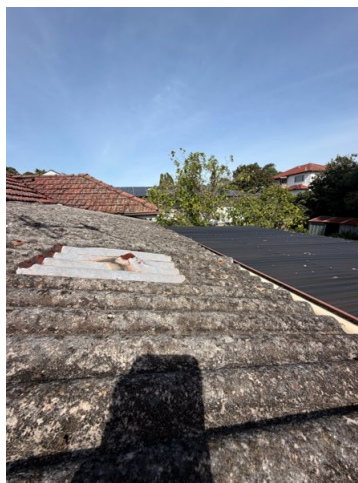
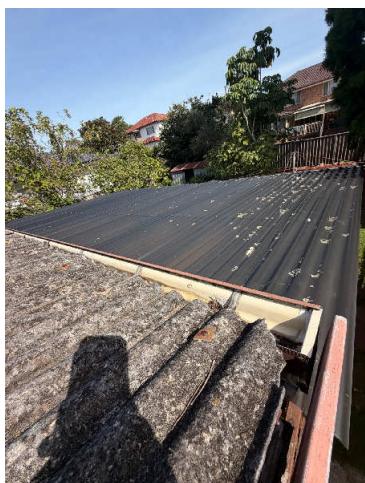
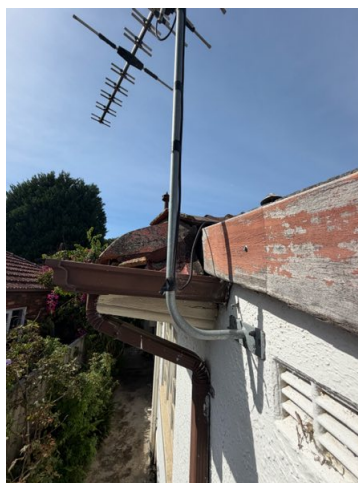
Finding: Additional Photos - Exterior Area

Information: Additional photos are provided for your general reference and may include obstructions, limitations or minor maintenance items.
