Building and Timber Pest Inspection Report

Inspection Date: Mon, 16 Mar 2026

Property Address: 272 Lane Cove Rd, North Ryde NSW 2113,
Australia

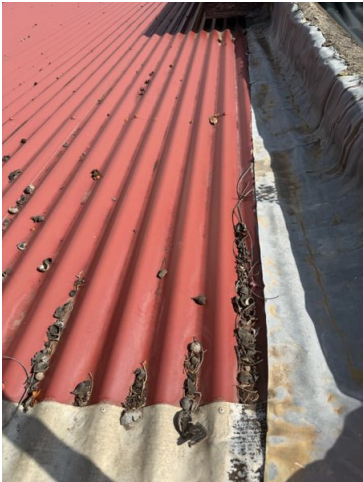
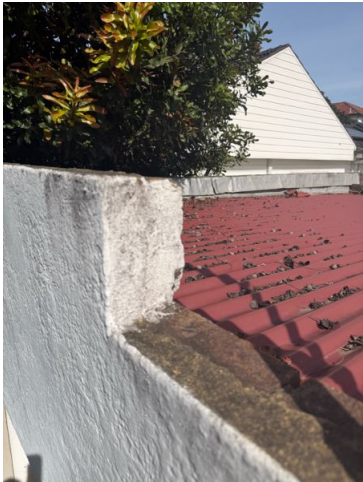
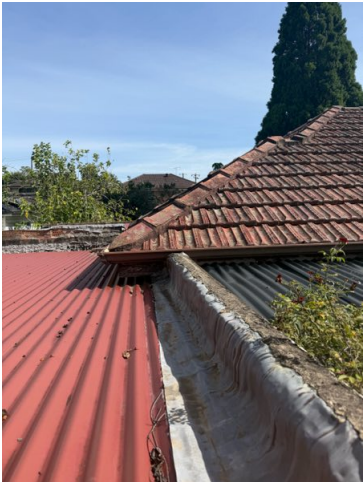
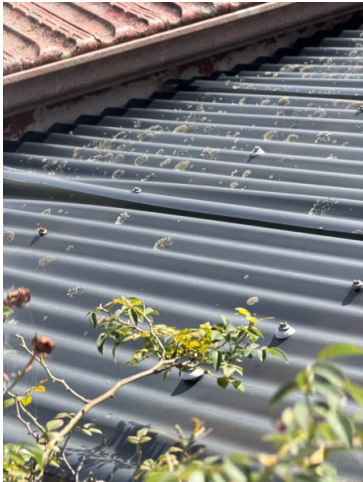
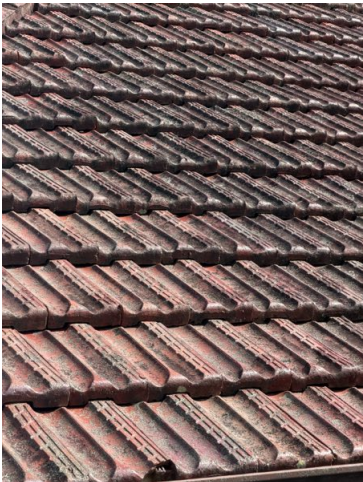
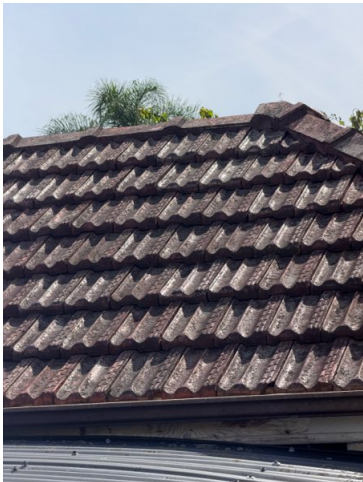
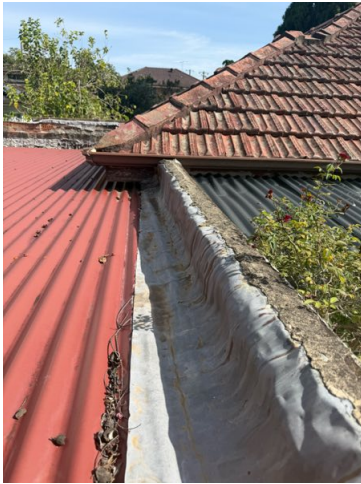
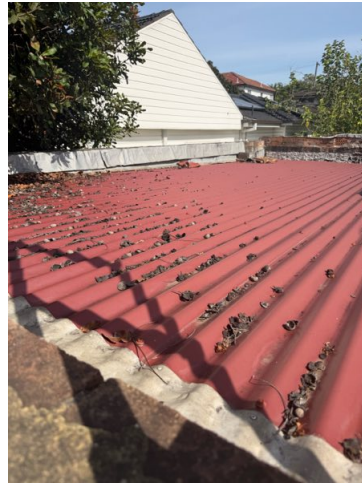
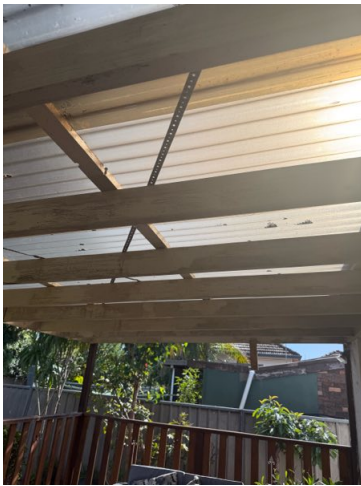
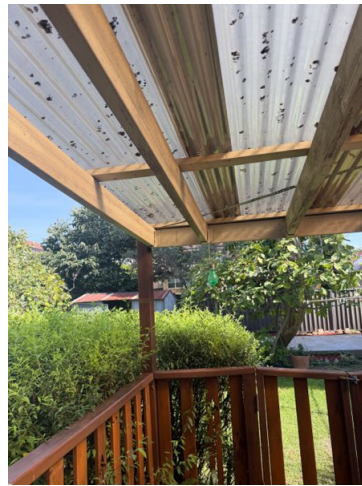
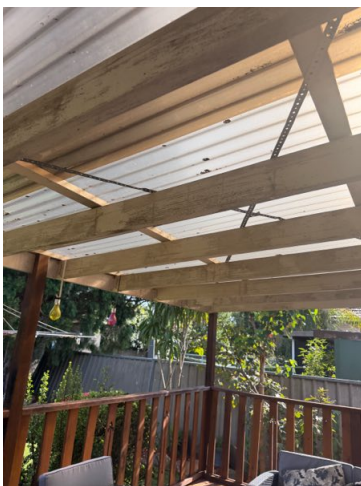
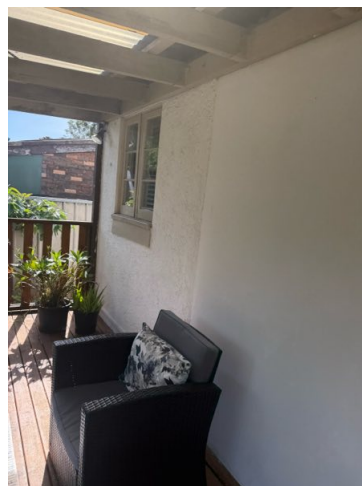
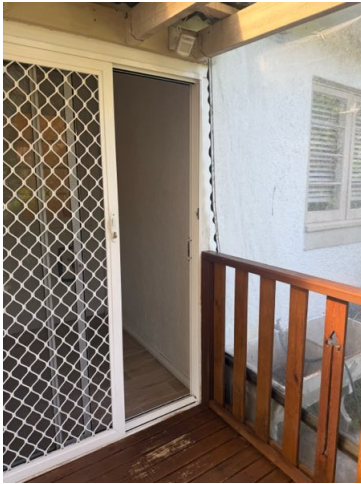
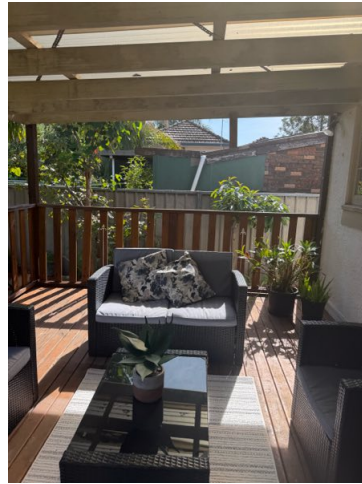
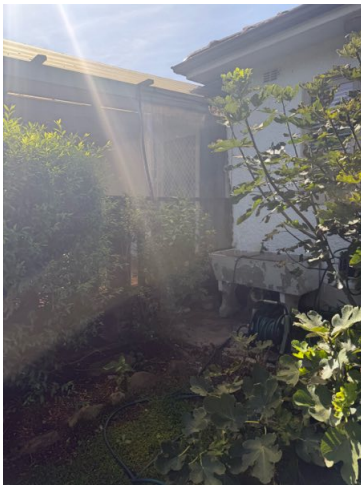
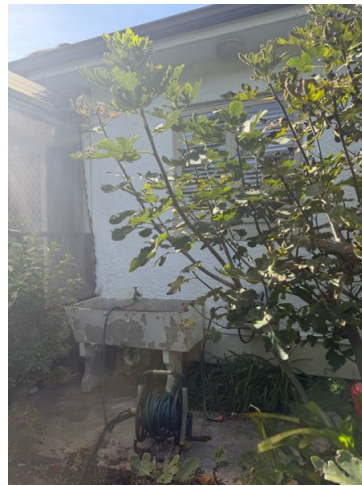
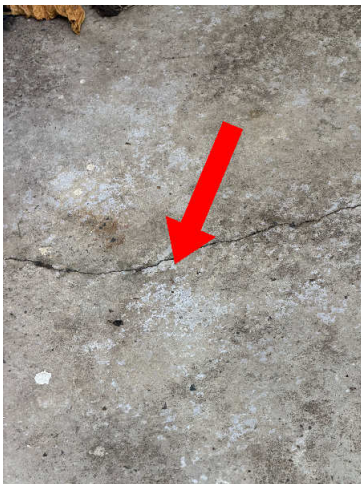
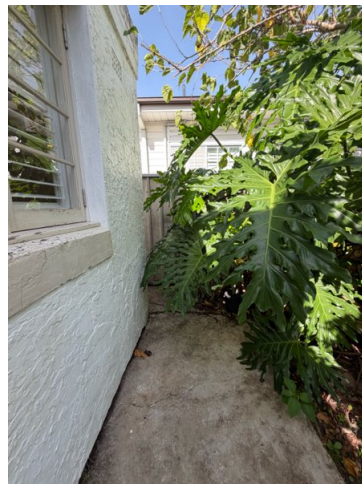
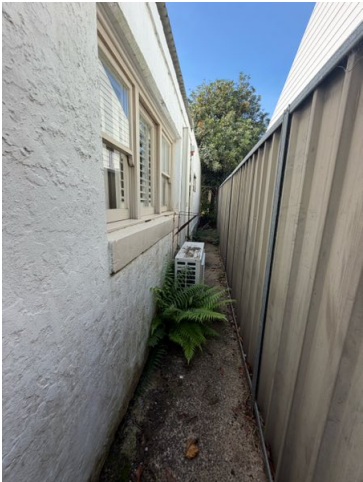
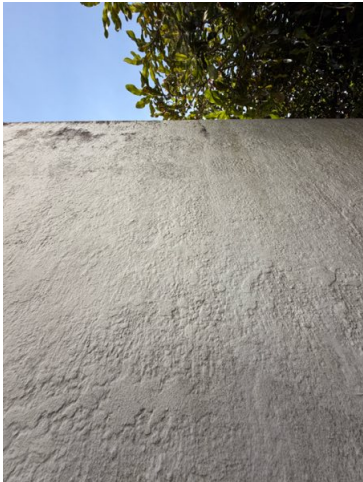
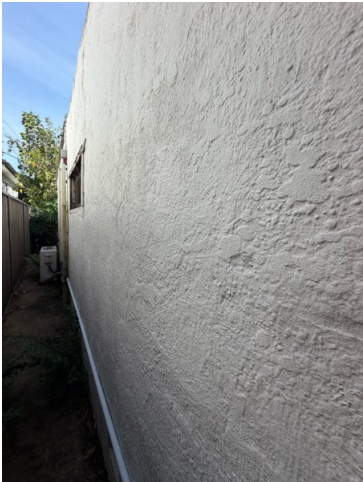
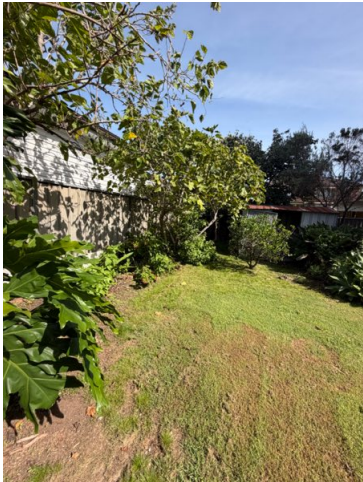
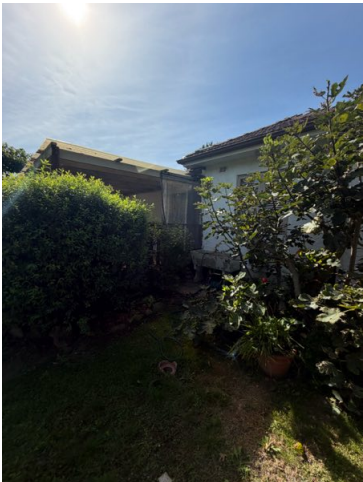
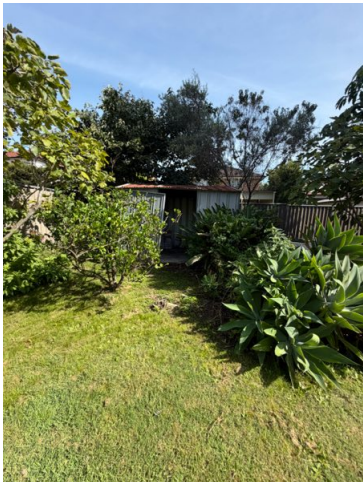
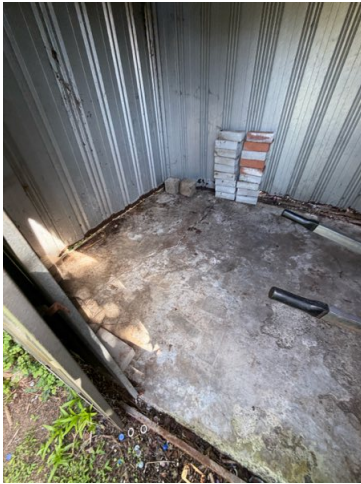
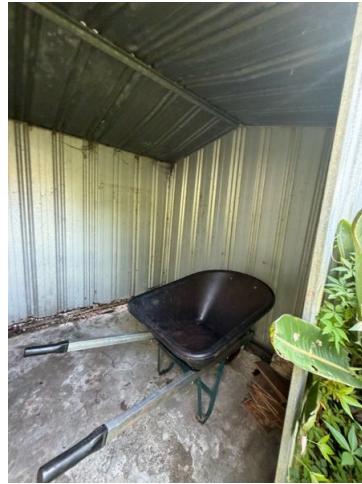
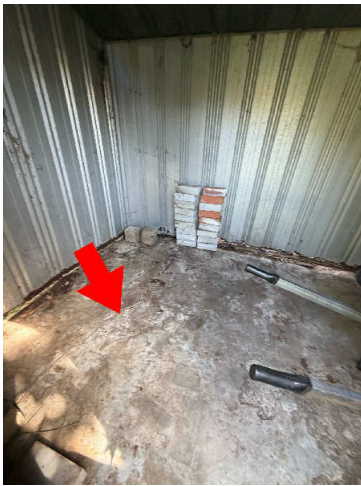
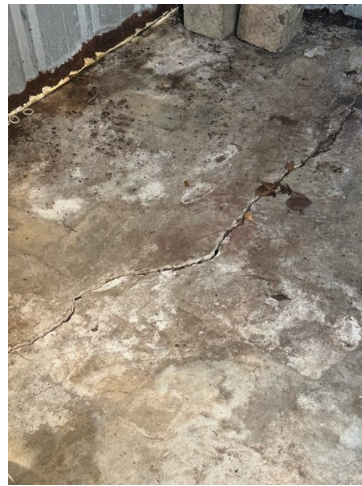
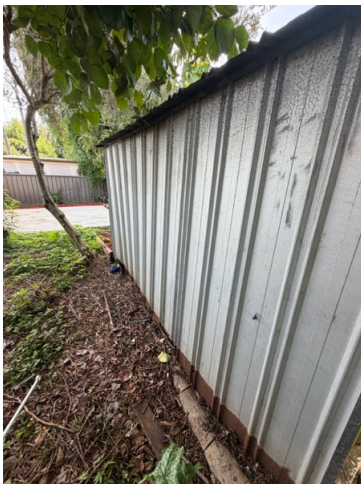
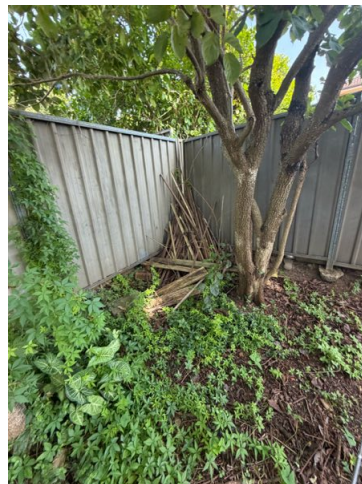
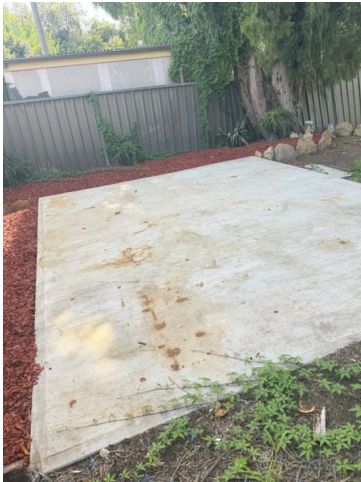
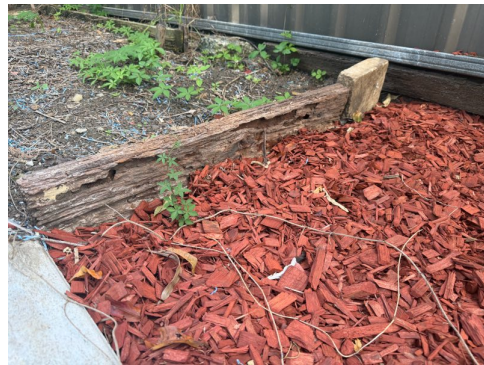
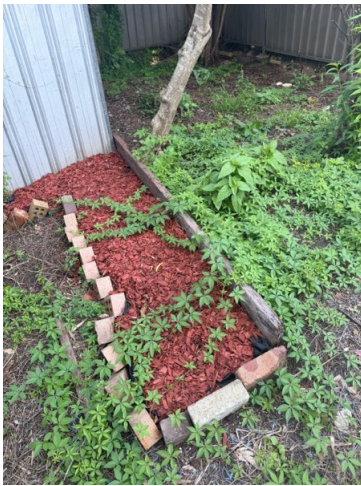
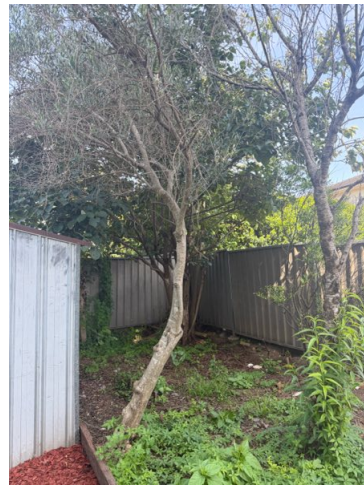
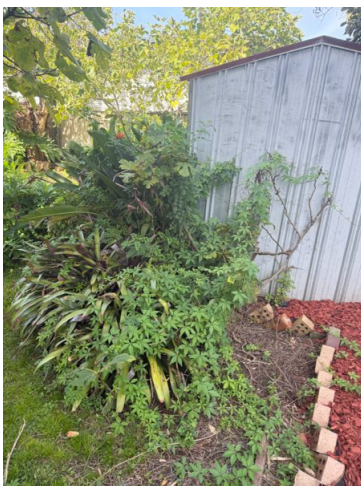
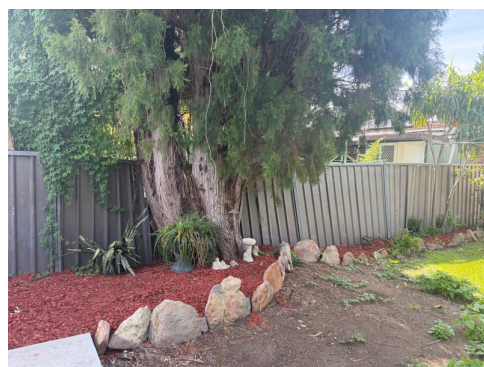
Information: Additional photos are provided for your general reference and may include obstructions, limitations, testing of water, moisture readings or minor maintenance items.

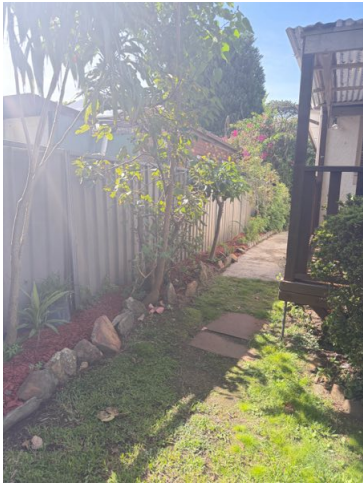
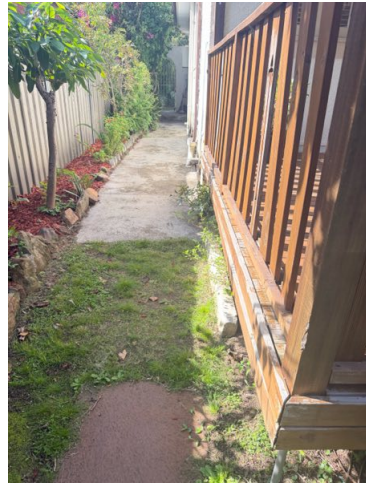
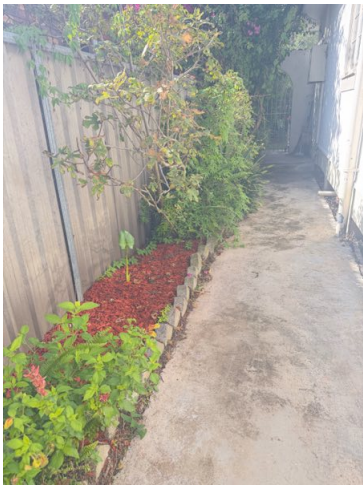
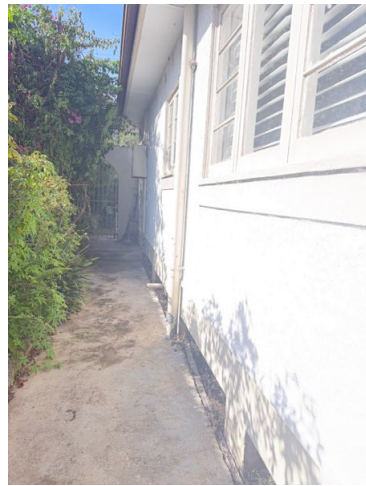
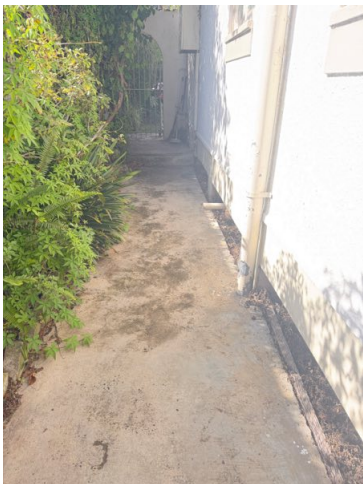
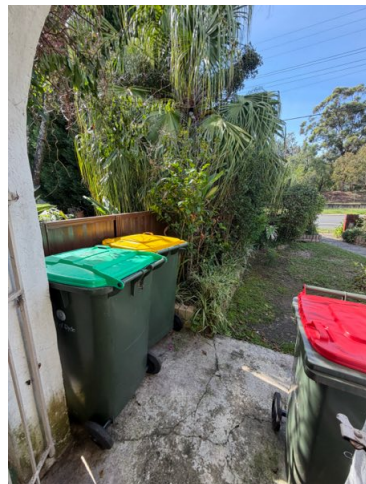
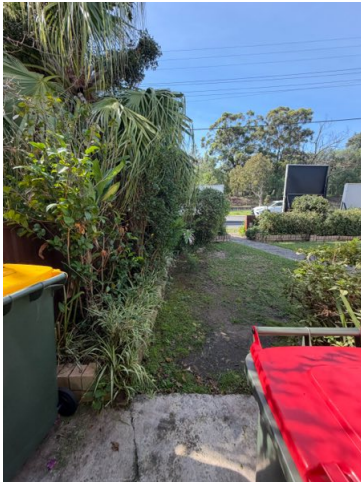
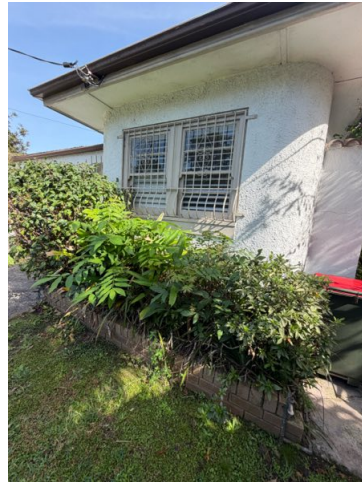
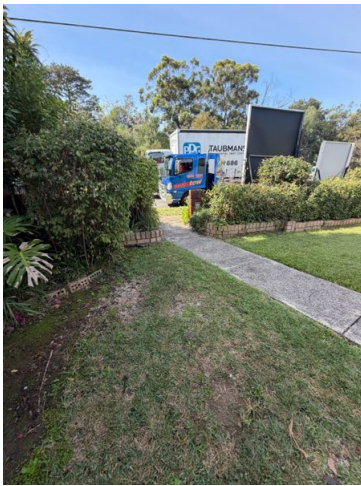
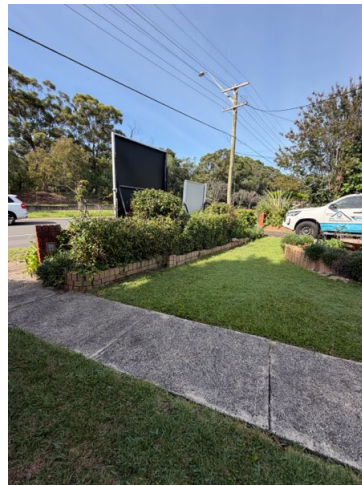
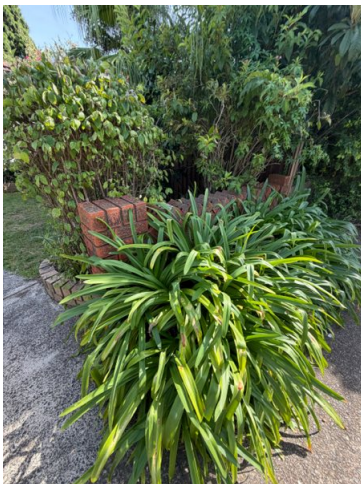
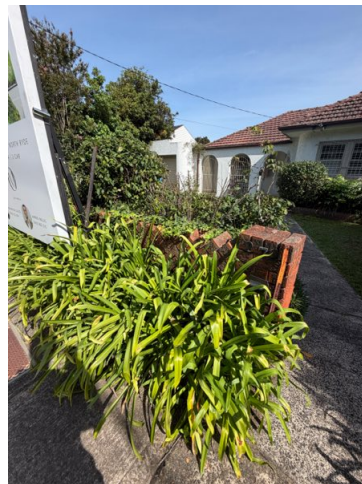
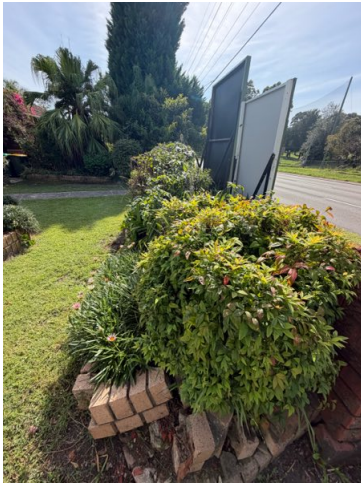
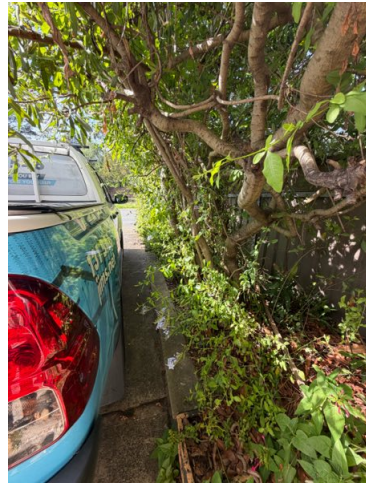
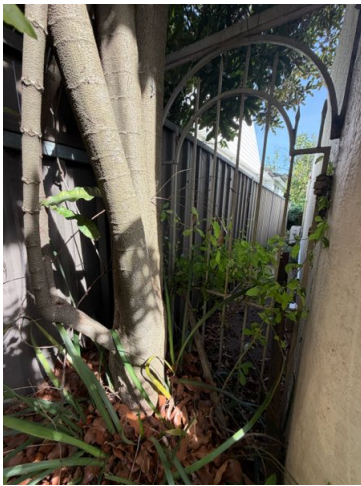
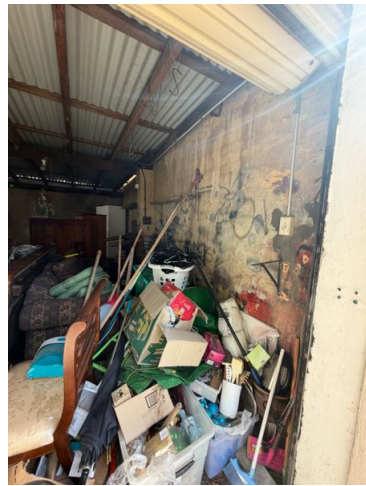
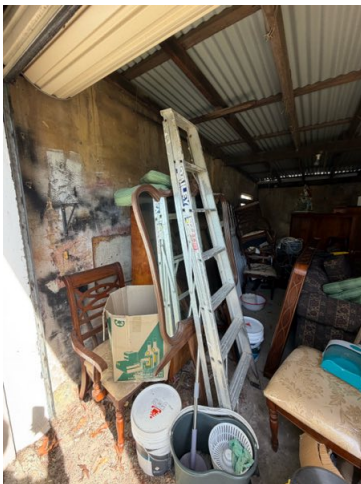
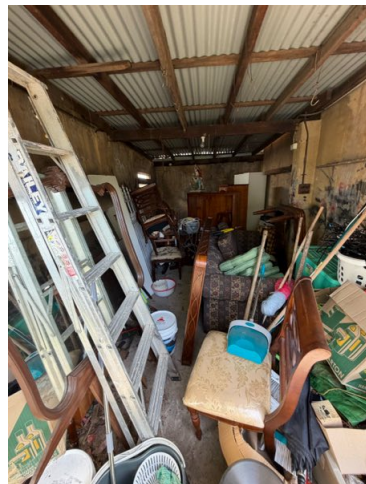
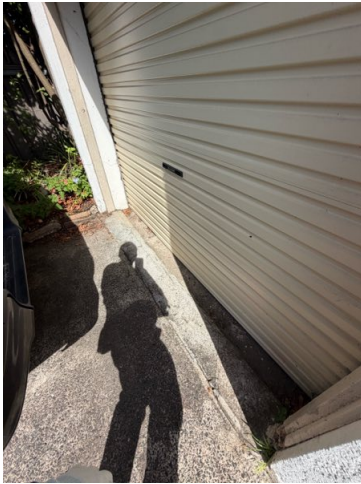
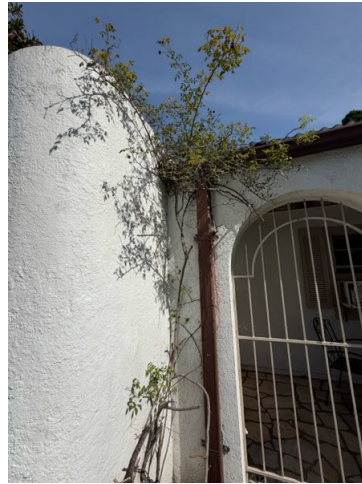
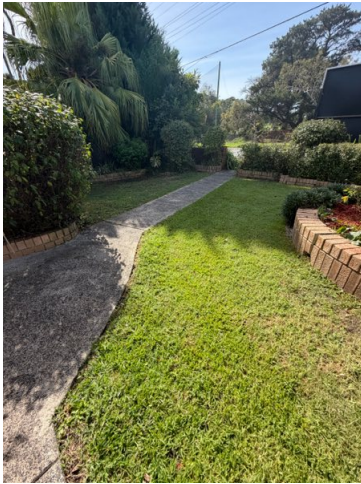
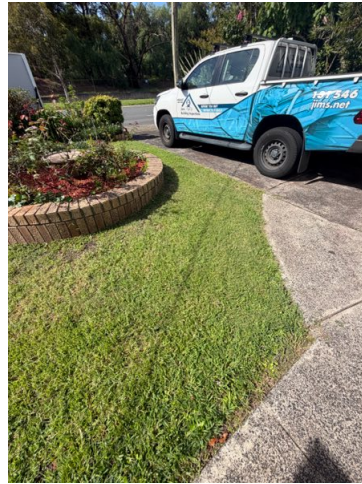
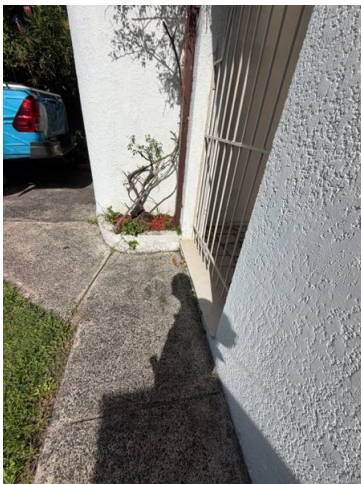
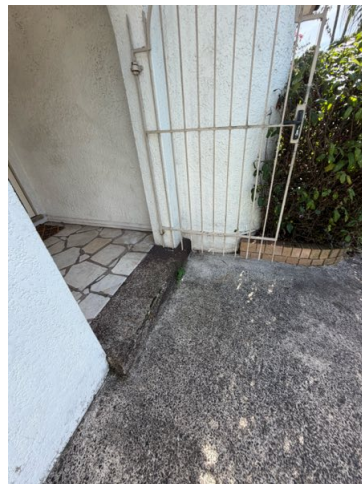
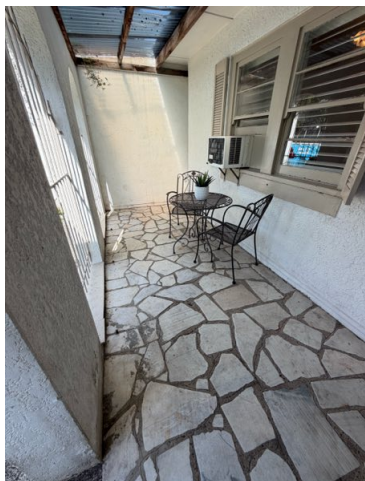
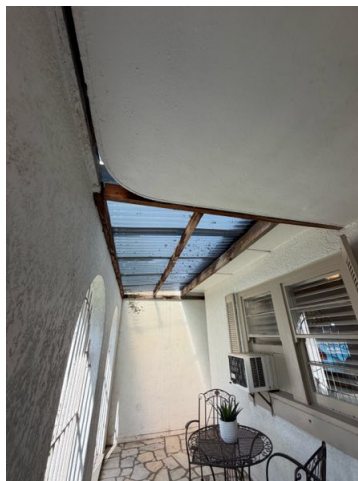
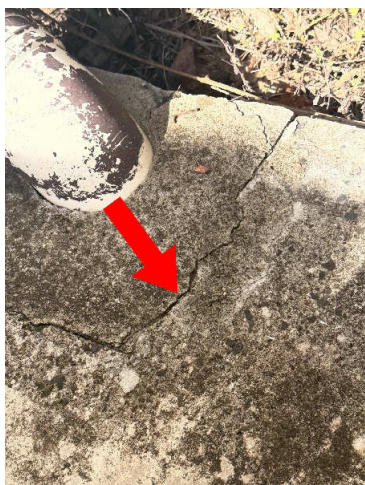
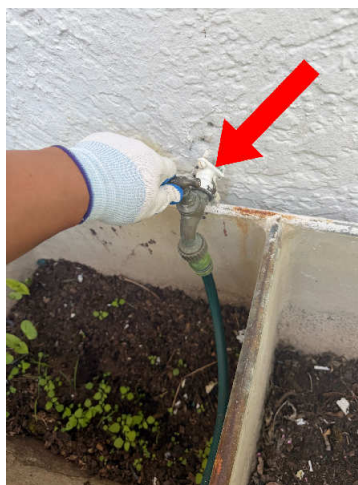
The following items were noted as -Evidence of a previous termite management program
