# Building and Timber Pest Inspection Report

Inspection Date: Thu, 5 Mar 2026

Property Address: 30 Greenbank Street, Hurstville, NSW 2220

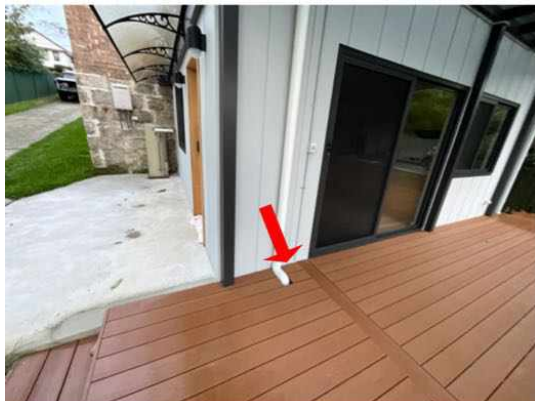
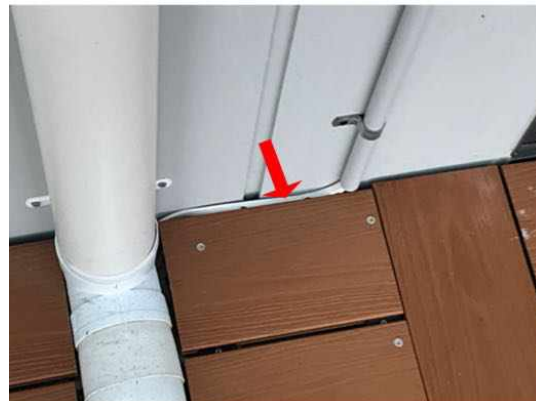
| Finding: | Conduit - Missing |
| Information: | A conduit has not been installed to exterior wires in this area. This is a safety measure that is aimed at protecting the wires and preventing any personal injury that may result if wires are squashed or damaged. |

Without a conduit providing adequate protection, external wiring is likely to become damaged and deteriorated over time, creating an electrical safety hazard. Damage to the wiring is also likely to result in the associated elements losing function.

A qualified electrician should be contacted immediately to install a conduit around the wires and provide any further advice on additional works that may be required to increase the safety of the wiring and its surrounding area.

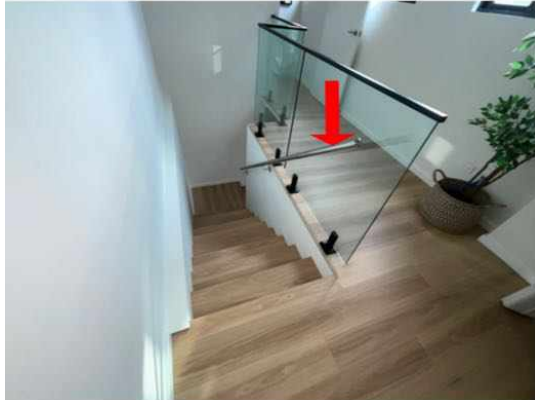
#### Finding 1.02

| Finding: | Loose handrail — Fall from heights |

The handrail was further loose and moving upon minimal force applied with hand.

These handrails pose a risk and persons coming in contact may fall from heights if these handrails fail, thus causing sever injury.

A licensed builder must be appointed as soon as possible to rectify any non-compliance.

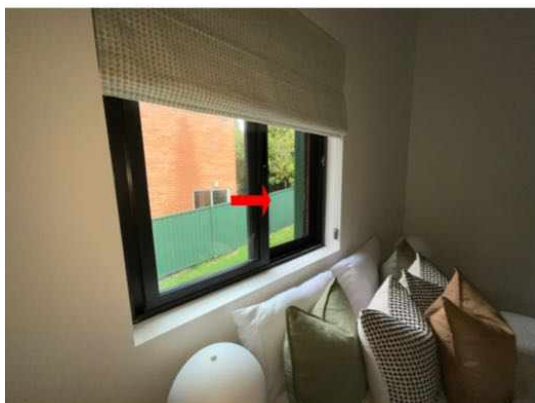
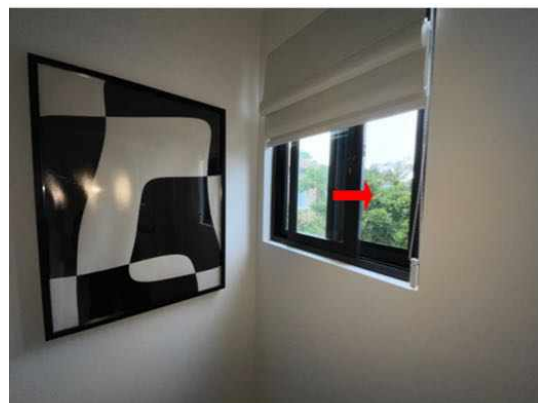
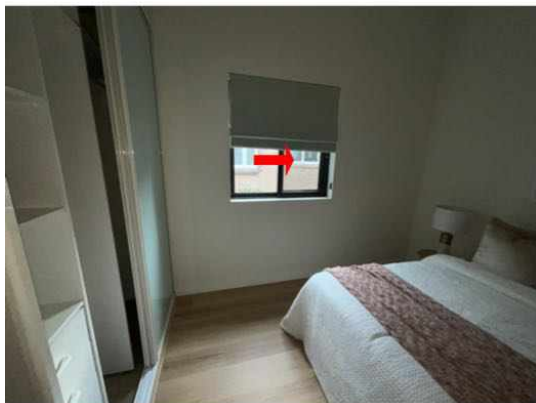
### Finding 1.03

| Finding: | Window restrictors - Missing |
| Information: | Window restrictors were found to be missing. |

The National Construction Code (NCC) requirements apply to all openable bedroom windows in residential buildings, including hotels, motels and for all windows in early childhood centres.

Windows need to be locked at 12.5cm when the devices are engaged. The safety devices must be robust and child proof. The alternative is security screens such as bars or grills on the windows so long as they have gaps no bigger than 12.5cm. Flyscreens do not comply unless they are the reinforced security type and capable of resisting the very strong outward pressure which would prevent a child falling through. The laws apply to openable windows in a building within 1700mm of the internal floor and if the internal floor is more than 2m above the ground floor outside.

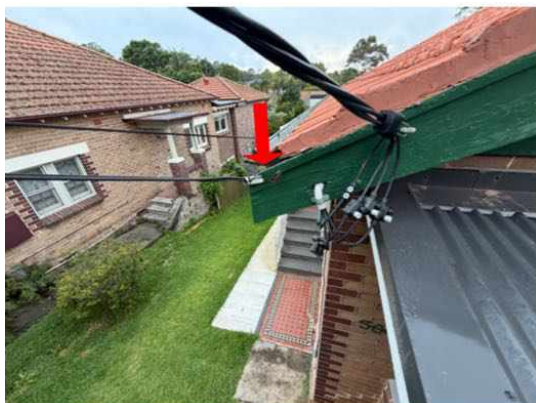
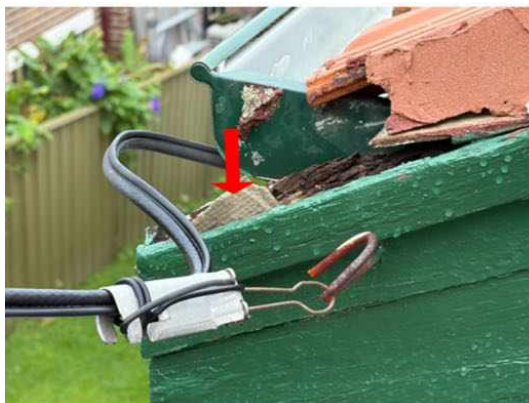
### Finding 1.04

| Information: | Reporting on Asbestos is outside the Scope of this Report. This suspected defect is highlighted as a caution only. We suspect, based on our experience in the building industry, that there is a higher risk of the identified building element containing asbestos. |

As Asbestos Reporting is outside the scope of this report, we advise that you consider a separate Asbestos Inspection and Condition Audit, which can include the taking of samples for definitive confirmation of the presence of Asbestos.

In the interim, the client is advised to act with caution, especially when considering any damage to building materials general wear and tear renovations extensions demolition and general maintenance activities due to the suspected presence of Asbestos.

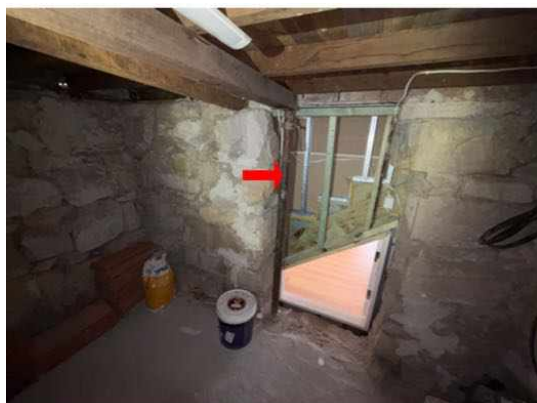
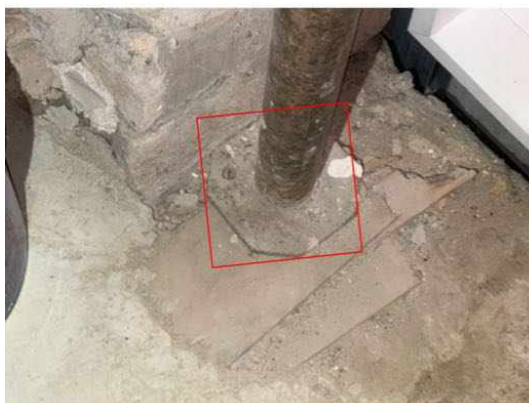
### Finding 2.01

Location: Subfloor  
 Finding: Unconventional handyman work  
 Information: This handyman work appears to have been completed to a substandard level and does not comply with regular building practices. Where handyman work is not completed satisfactorily, accelerated deterioration of the associated building elements is likely to occur and secondary defects to surrounding structures may develop.

It is highly recommended that the substandard work be rectified by professional services. Works to improve this area are likely to increase the safety and the operation of the associated building elements.

The client should exercise care when coming into the immediate vicinity of the substandard works. Rectification works are advised as soon as possible by a licensed builder.

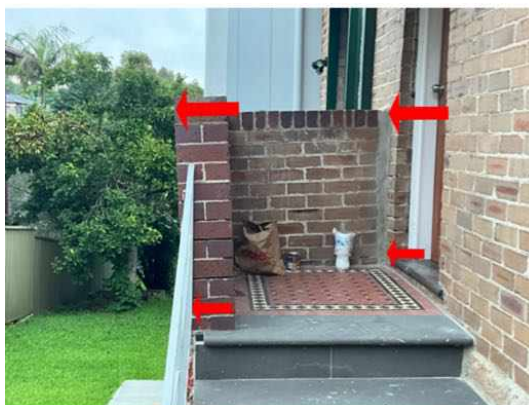
## Finding 2.02

Building: Main Building  
 Location: Right hand side  
 Finding: Subsidence  
 Information: It appears that the subfloor structure has been affected by movement of the foundations, often referred to as sinking or subsidence. Whilst a degree of movement is expected in subfloors over time, especially as environmental conditions change and

General subsidence is usually initiated by changes in soil moisture content. The most critical factor is identifying the specific causes, and identifying if this is a recurring or ongoing problem, or one that has been resolved by previous works in the past.

Subsidence can have complex and varying causes, which will influence the required remedial works. It is advised to begin by consulting a structural engineer to determine the required scope of works. This generally includes some form of underpinning, as well as addressing the underlying cause. Consultation with a geotechnical engineer may also be necessary where changes to soil moisture content is apparent.

A licensed Builder would then generally carry out works as advised by an Engineer.

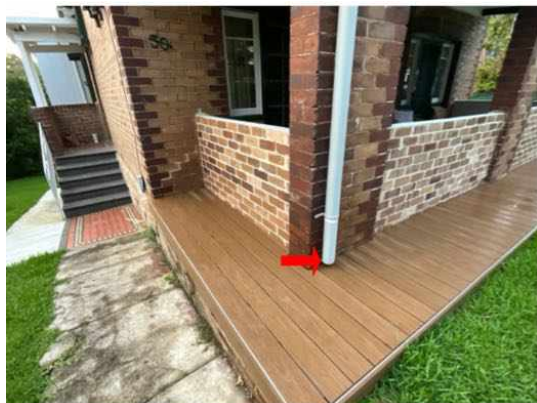
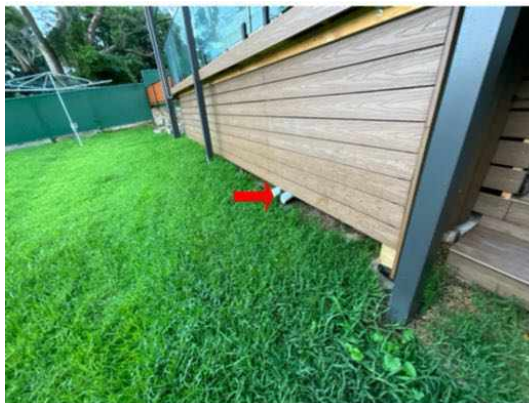
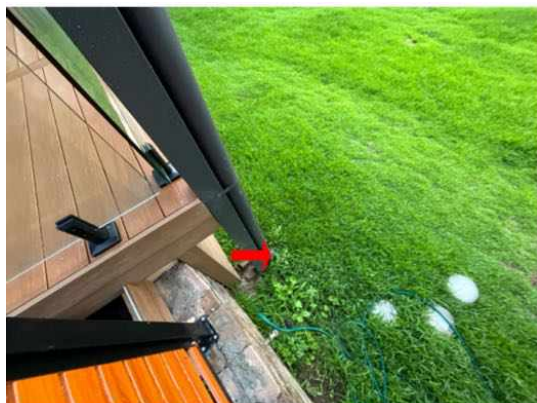
### Finding 2.03

Where roof plumbing doesn't drain adequately, the area at the base perimeter can become excessively damp, potentially creating an environment that is susceptible to rust and corrosion of surrounding building elements, as well as attracting termites and other pests.

It is highly recommended that a plumber be appointed to further inspect the area and to install adequate drainage equipment where necessary.

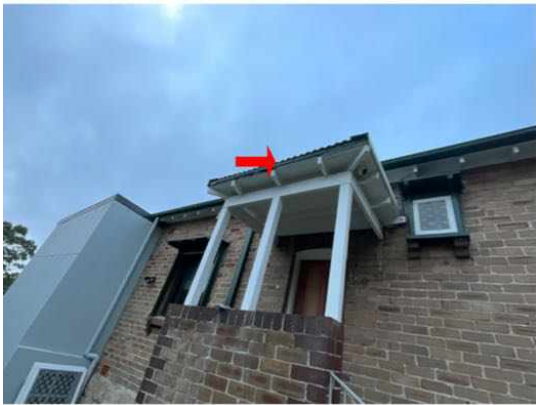
### Finding 3.01

| Finding: | Roof plumbing - Missing |
| Information: | Some sections of the roof are not adequately drained via gutters and downpipes. Gutters and downpipes that are not installed adequately are likely to result in excessively damp conditions against the exterior surfaces and around the base perimeter of the building. |

Excessive moisture creates an environment which accelerates the deterioration of building elements in the area, as well as being conducive to termite and pest infestation. Such an environment is likely to necessitate repair and/or replacement of building elements, which are prone to sustaining wood rot, rust or corrosion.

A roofing plumber should be appointed as soon as possible to install relevant roof plumbing materials. Depending on the extent of the damage, repair and/or replacement of damaged building elements may be required.

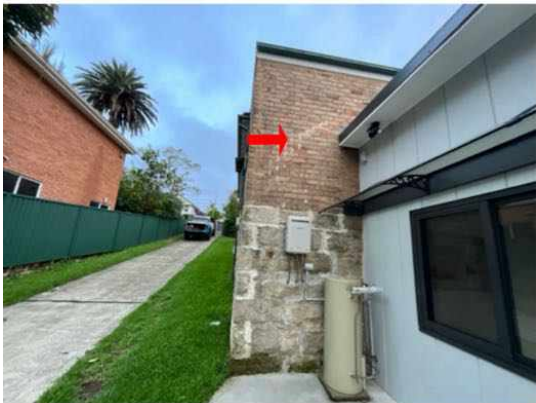
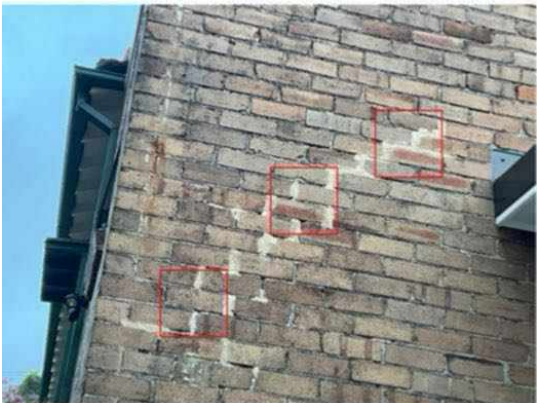
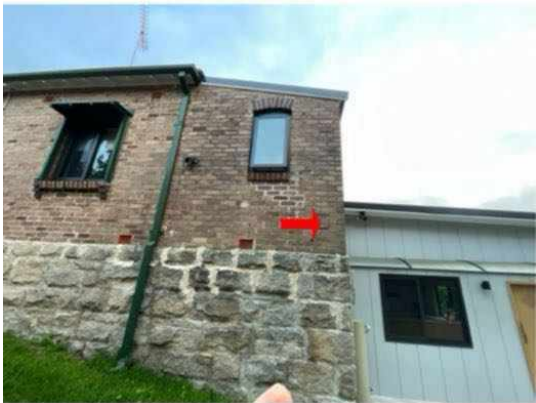
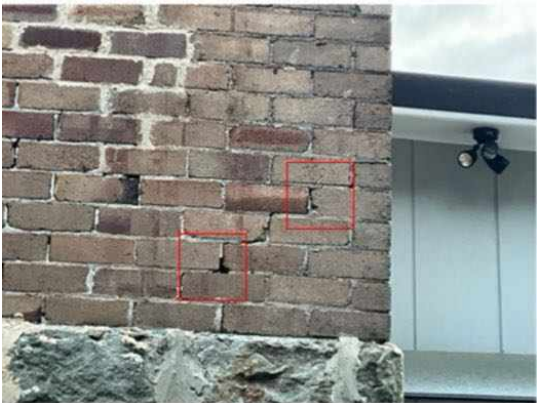
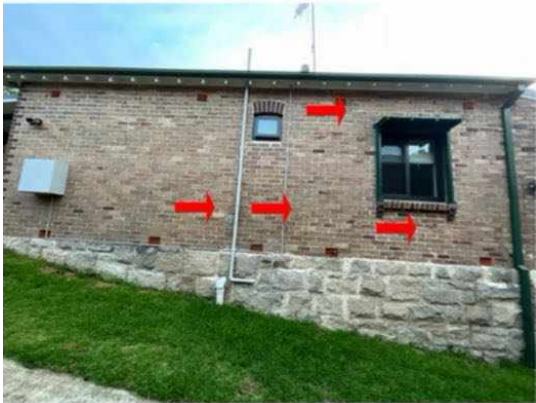
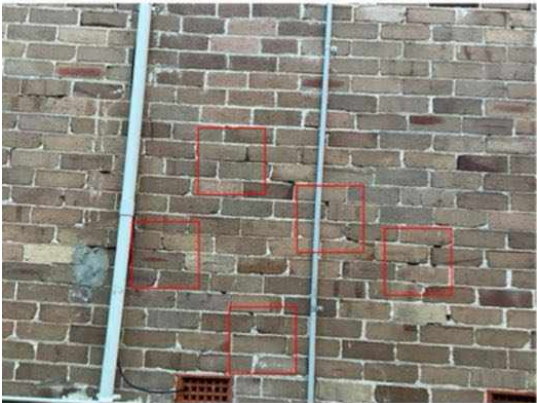
**Finding 3.02**

Building: Main Building  
Location: Multiple areas  
Finding: Brickwork - Cracking noticeable  
Information: There were several cracks and or crack repairs evident to external brickwork.

Noticeable cracks are a common occurrence in external brickwork and are a likely result of age expected building movement, general expansion, and/or contraction of building materials in different weather conditions. Noticeable cracks in brickwork may develop if left unattended, with potential for necessitating major remedial works or replacement of the brickwork.

It is highly advised that a licensed bricklayer be appointed to provide necessary works to cracked brickwork to prevent any further damage. Such works should be conducted as soon as possible.

Always monitor these cracks and contact a building inspector should cracks widen, lengthen, or become more numerous.

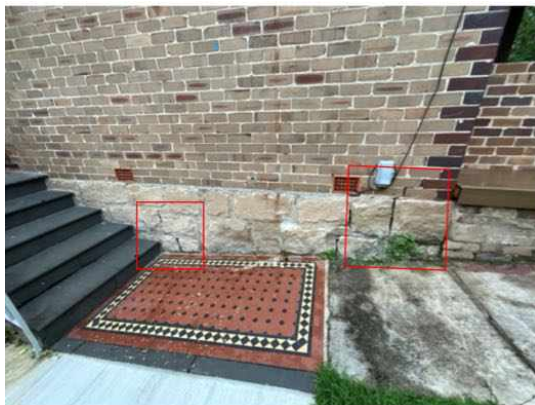
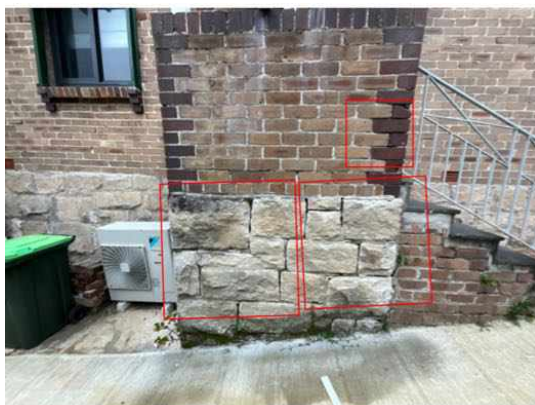
Finding 3.03

Building: Main Building  
 Location: Front right corner  
 Finding: Mortar - Deteriorated (Erosion)  
 Information: The mortar to the brickwork in this area was found to be deteriorated. Mortar, or 'bedding', is the material which fills joins and intersections between bricks in masonry walls and structures.

Commonly referred to as corrosion or erosion, the bricks and mortar are aged and likely to have been affected by a variety of factors, including moisture, salt-based deterioration, and more.

Mortar and brickwork should be replaced to ensure the structure remains in their intended location and to prevent gaps, which would allow water or moisture ingress and secondary damage as a result.

This can be addressed by a licensed bricklayer where areas of deterioration are localised and easily accessible.

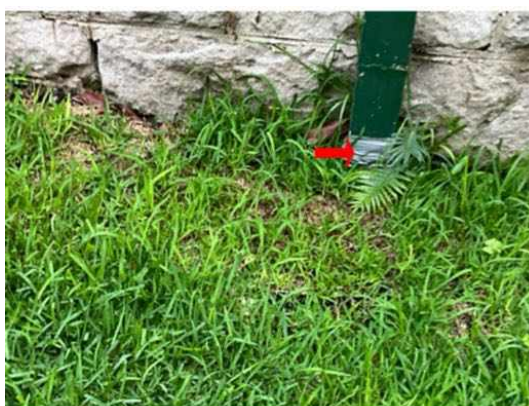
### Finding 3.04

Building: Main Building  
 Location: Exterior walls - left side  
 Finding: Unconventional handyman work

Information: This handyman work appears to have been completed to a substandard level and does not comply with regular building practices. Where handyman work is not completed satisfactorily, accelerated deterioration of the associated building elements is likely to occur and secondary defects to surrounding structures may develop.

It is highly recommended that the substandard work be rectified by professional services. Works to improve this area are likely to increase the safety and the operation of the associated building elements.

The client should exercise care when coming into the immediate vicinity of the substandard works. Rectification works are advised as soon as possible by a licensed roof plumber.

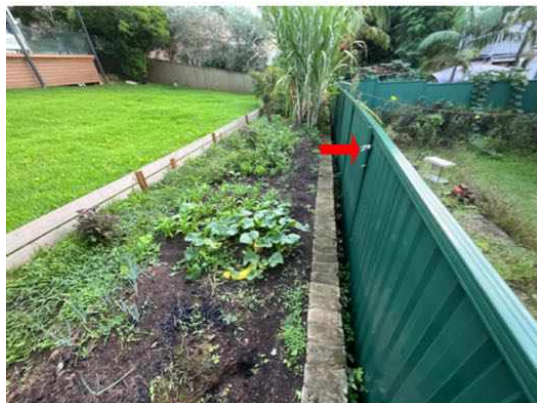
### Finding 3.05

Finding: Fencing - Deteriorated

Information: It was noted at the time of inspection that sections of the fencing in this area has deteriorated. Typically fencing deteriorates due to age and or wear, rot and or rust which is generally expected for a structure of this age, due to prolonged exposure to weather conditions. Sometimes inadequate installation or maintenance can be to blame.

If left unattended, it is likely that further damage will occur. It is suspected that repair of several elements of the fencing may be required however replacement may be a consideration of the client also.

A licensed fencing contractor should be appointed to provide further advice and perform rectification works as necessary.

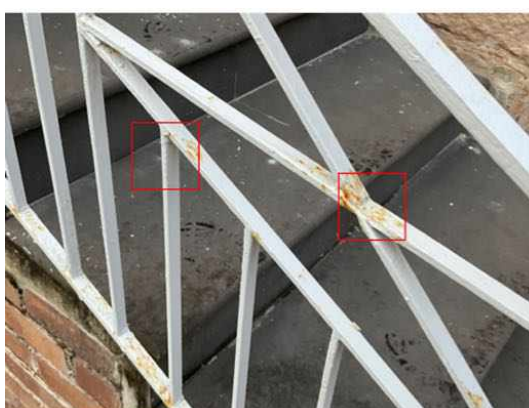
### Finding 3.06

| Finding: | Building element - Rusted or corroded |
| Information: | This building element shows evidence of rusting and corrosion, which is likely to have developed as a result of excessive exposure to moisture and or inadequate coatings. |

As surface rust provides no protection to the underlying iron, the deteriorating condition is likely to worsen if not addressed in the short-term future.

Where possible, the use of galvanized (treated) metals or aluminium coated metals aid in rust prevention, as does regular general maintenance. Rust formation can be controlled with coatings, such as paint, that isolate the iron from the environment.

Rusting and corrosion should be managed by ideally removing or limiting the affected surface from exposure to moisture. A registered builder may be appointed to replace any building elements that have been severely affected by rust or water damage.

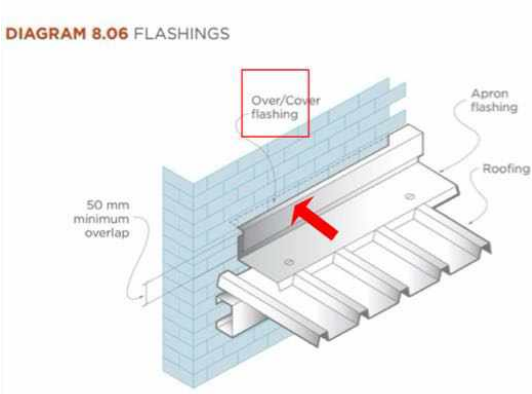
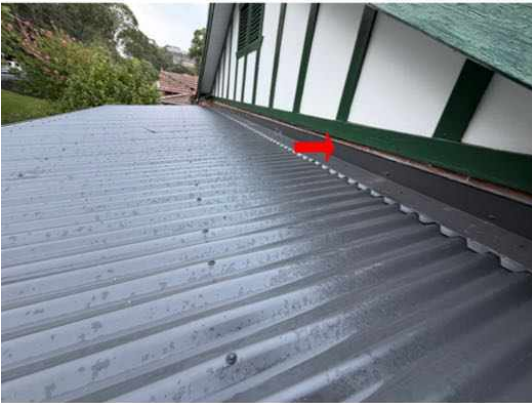
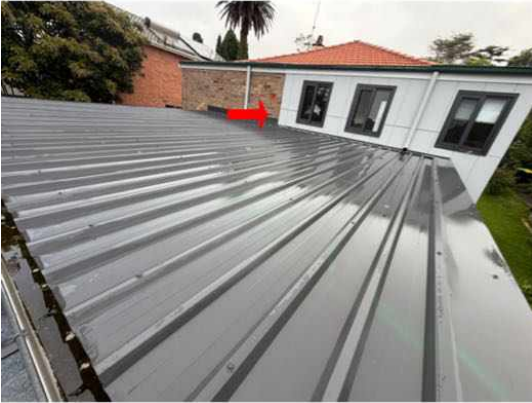
Building: Main Building  
 Location: Rear extension, front verandah  
 Finding: Flashing - Defective  
 Information: Instances where flashings are defective were noted. It is expected the silicon to wear out causing water leaks in this area.

Flashings that are not installed adequately or are missing are likely to result in water penetration to the interior of the property, as well as creating excessively damp conditions against the exterior surfaces and around the base perimeter of the building.

Premature ageing and secondary building defects are imminent where roof plumbing is missing or inadequately installed. Additionally, water pooling also creates an environment that is susceptible to termite and pest infestation.

This must be rectified immediately by a licensed roof contractor. The solution is to chase the brickwork and insert the flashing or otherwise to install over flashings with appropriate fixings.

The client is highly advised to ensure the manufacturer installation guide is followed.

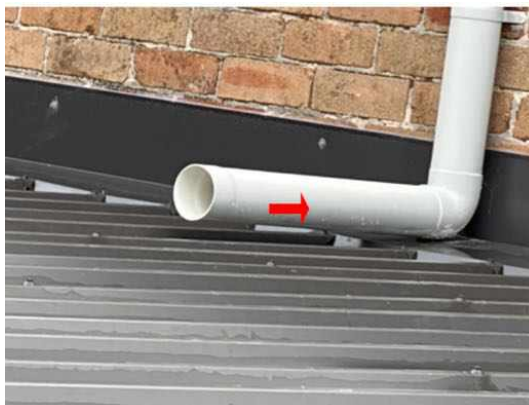
**Finding 3.09**

Building: Main Building  
 Location: Rear extension  
 Finding: Downpipe Spreader — Missing  
 Information: The downpipe spreader to the lower roof is missing. A spreader has a series of holes and is designed to spread the water so it is distributed evenly. This is considered to be incomplete works and should be completed urgently by a licensed roof plumber to avoid potential water leaks.

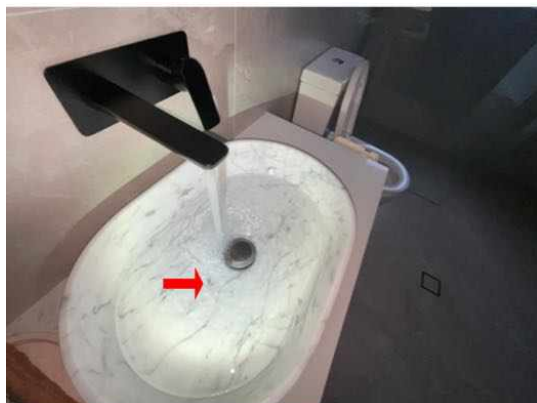
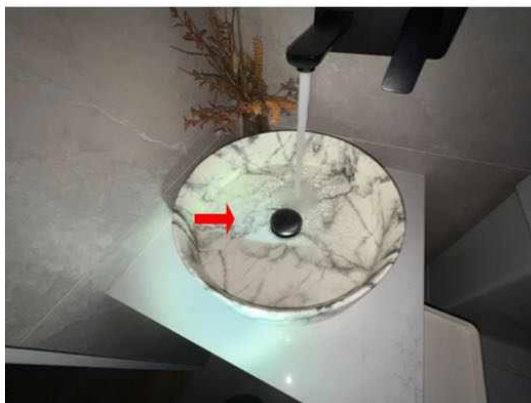
The sink/basin drain appeared to be partially blocked at the time of inspection. Blockages here are usually caused by hair and other debris. If left unmanaged, a lack of general maintenance may lead to the development of more significant defects, such as water damage to surrounding building materials.

A licensed plumber should be appointed to remove the blockage at the client discretion.

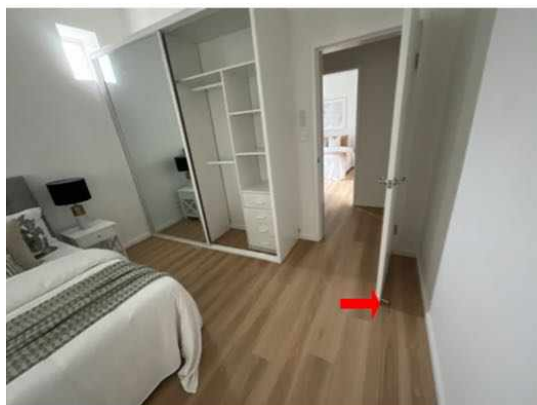
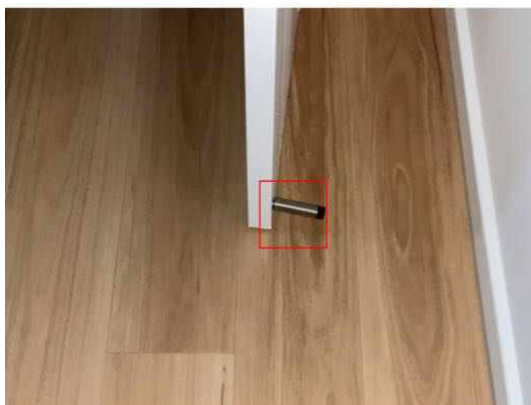
**Finding 3.12**

Building: Main Building  
 Location: Front bedroom  
 Finding: Building element - Damaged  
 Information: Breakage occurs generally when the building materials have either aged and decayed, or as a result of damage (accidental or deliberate).

Repair and/or replacement of broken elements is advised to ensure that additional secondary defects do not arise as a consequence. Such works are necessary, as all building elements play a key role in the operation and function of the overall structure and its performance.

A relevant tradesperson should be appointed to repair or replace the affected building element prior to any subsequent damage being caused.

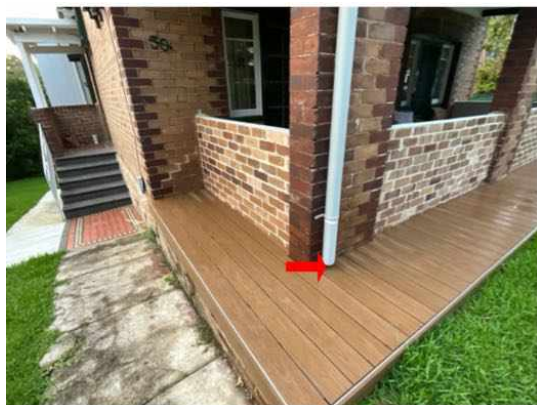
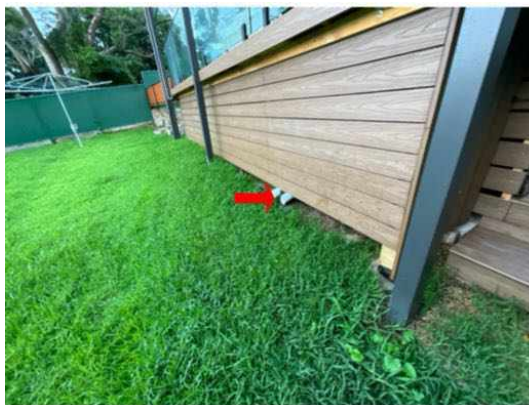
become excessively damp, potentially creating an environment that is susceptible to rust and corrosion of surrounding building elements, as well as attracting termites and other pests.

It is highly recommended that a plumber be appointed to further inspect the area and to install adequate drainage equipment where necessary.

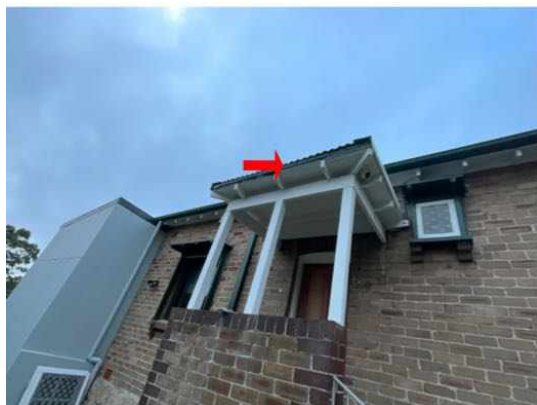
### Finding 6.02

| Finding: | Roof plumbing - Missing |
| Information: | Some sections of the roof are not adequately drained via gutters and downpipes. Gutters and downpipes that are not installed adequately are likely to result in excessively damp conditions against the exterior surfaces and around the base perimeter of the building. |

Excessive moisture creates an environment which accelerates the deterioration of building elements in the area, as well as being conducive to termite and pest infestation. Such an environment is likely to necessitate repair and/or replacement of building elements, which are prone to sustaining wood rot, rust or corrosion.

A roofing plumber should be appointed as soon as possible to install relevant roof plumbing materials. Depending on the extent of the damage, repair and/or

replacement of damaged building elements may be required.

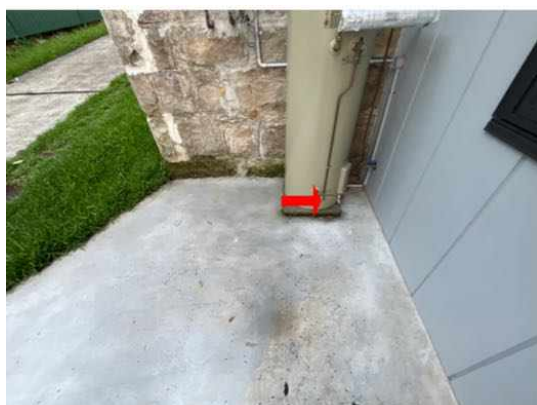
These damp conditions can lead to secondary defects such as rot, rust or corrosion of associated building elements, the formation of fungal decay, or even the creation of potential slip hazards. When coupled with poor site drainage, pooling of water may also attract termite activity to this area.

It is highly recommended that a licensed plumber be appointed to install adequate drainage to the overflow. These works will ensure that the area remains dry and free of any secondary defects.

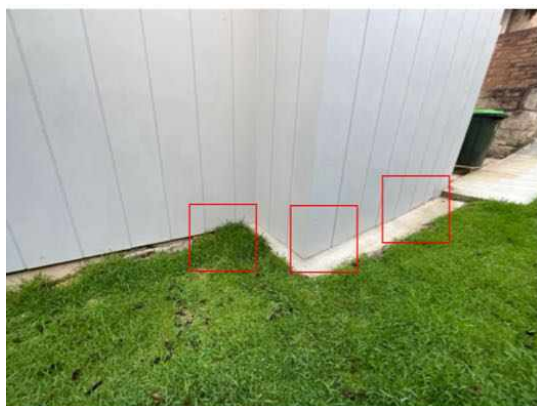
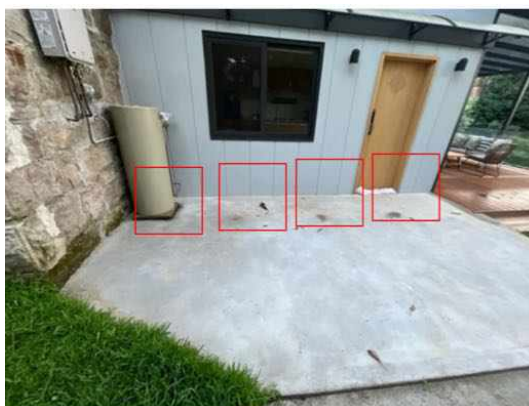
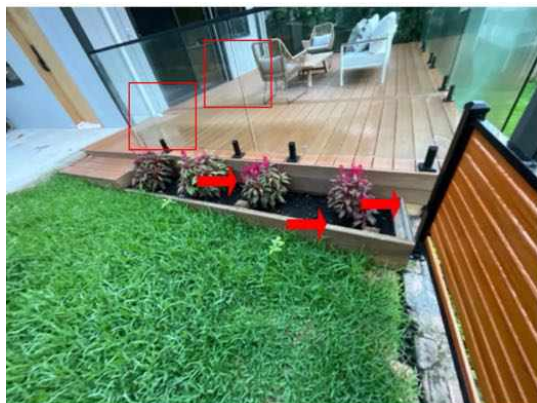
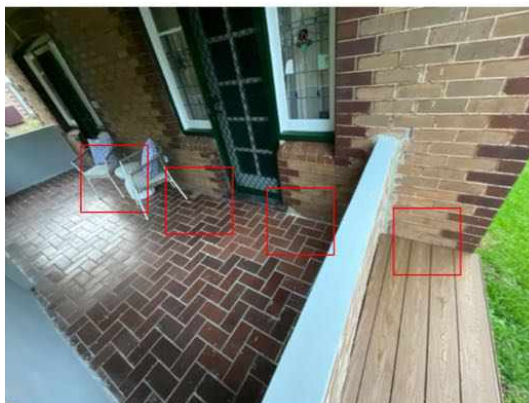
### Finding 6.05

Generally this takes the form of finished ground levels external paving or concrete being retrospectively installed above the damp course level the adjacent internal floor level or weep and ventilation holes.

Where bridging has occurred full inspection is prevented and termites may enter a property in a concealed or undetectable manner.

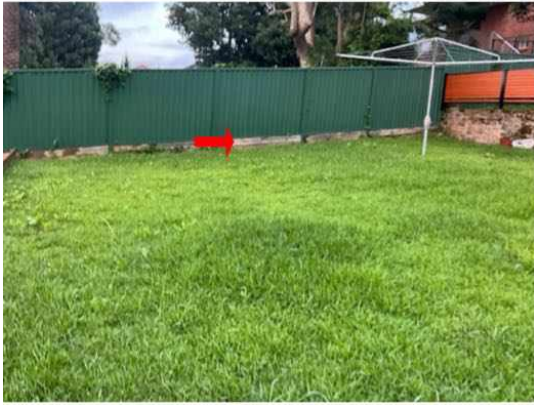
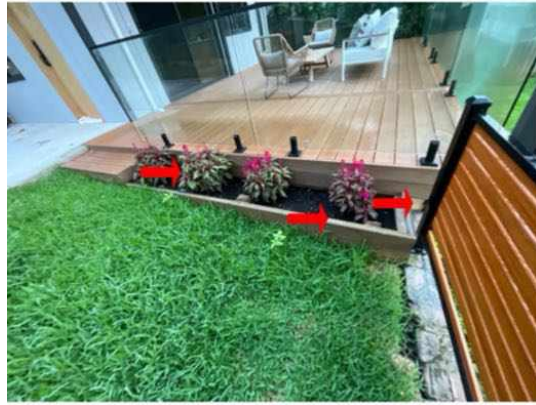
### Finding 6.06

| Information: | Where timber elements are in direct contact with the ground and consequently moisture or dampness they become conducive to termite activity. Whether timber is used as a building element part of a fencing structure or stored as an unused item they can provide an environment that is attractive to termite infestation. |

When met with excessive moisture timber begins to decay and develop wood rot. Any timbers that are in direct contact with external grounds especially if left untreated or non-durable also provide ingress for subterranean termites into that particular element.

The removal of any such materials that may be conducive to termite activity should be removed as soon as possible to minimise the risk of termite attack.

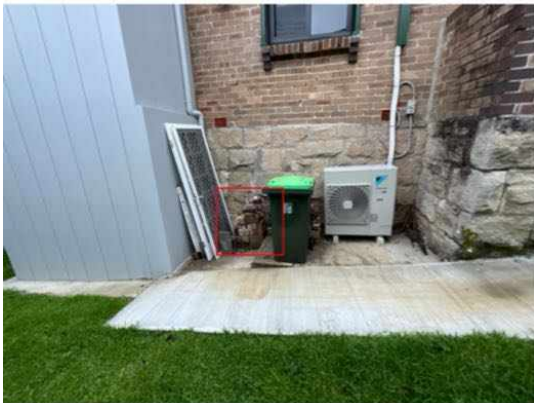
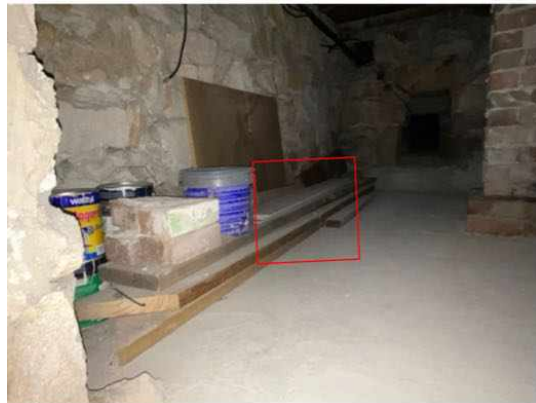
### Finding 6.07

Information: The storing of timbers in the subfloor space or around the external property increases the risk of termite activity being present. As they are likely to come into contact with weather conditions or excessive moisture wood rot is likely to develop on timbers that are not treated.

It is highly recommended that any stored timbers be immediately removed from areas in which they may attract any termite / timber pest attack. Minimisation of risk / prevention of termite attack is far more adequate than dealing with the presence of termite activity.

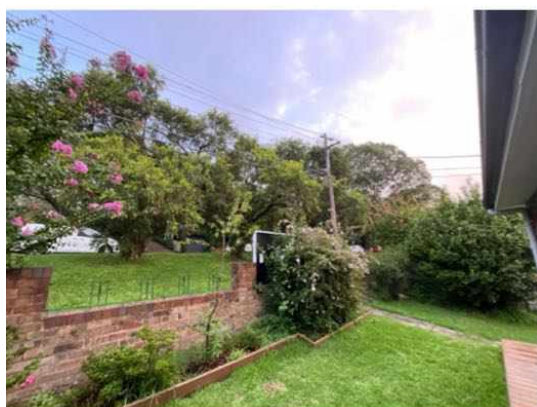
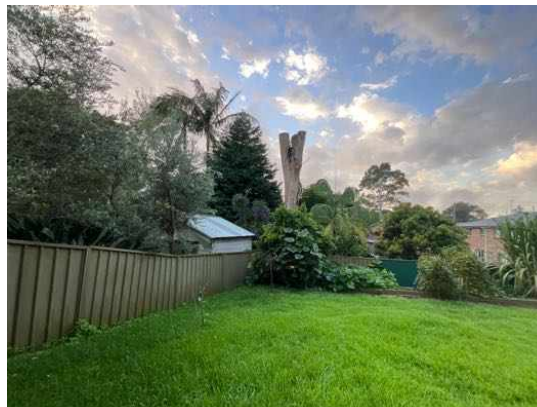
### Finding 6.08

| Finding: | Surrounding bushland - Conductive |
| Information: | Home and or building is situated in a high risk area for termite activity, due to close proximity to surrounding bushland. |

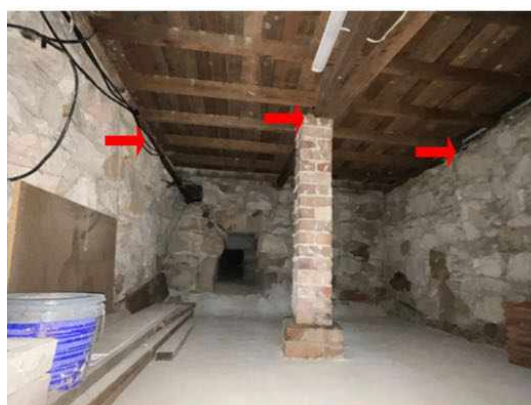
Where ant caps have not been installed, frequent monitoring of these areas should be carried out in order to identify any signs of termite or timber pest workings.

A licensed builder must be appointed urgently to replace any missing ant caps.

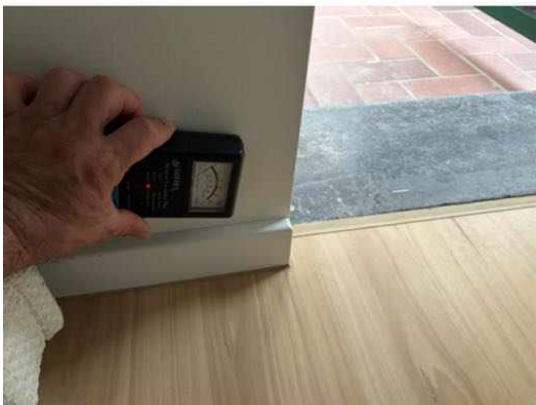
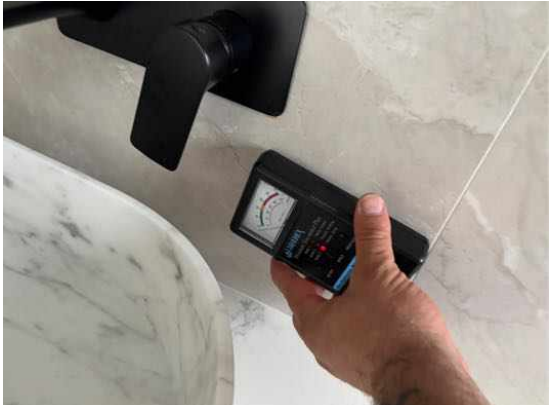
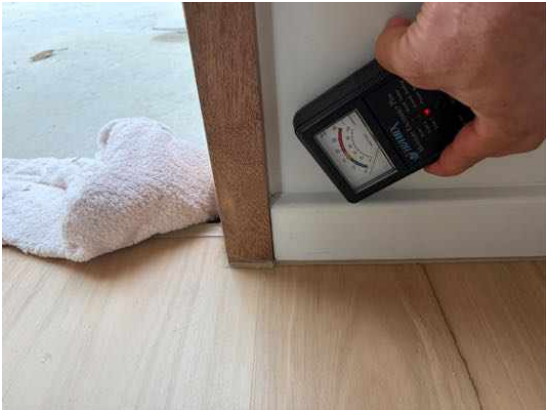
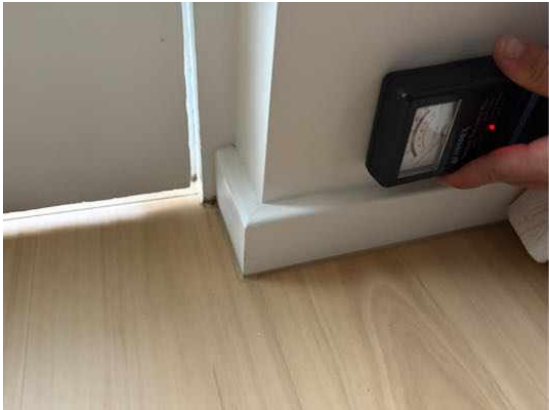
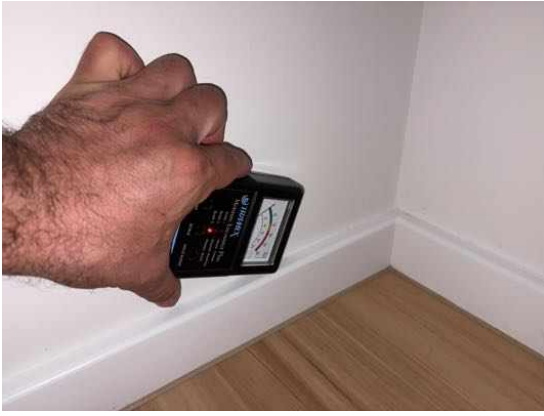
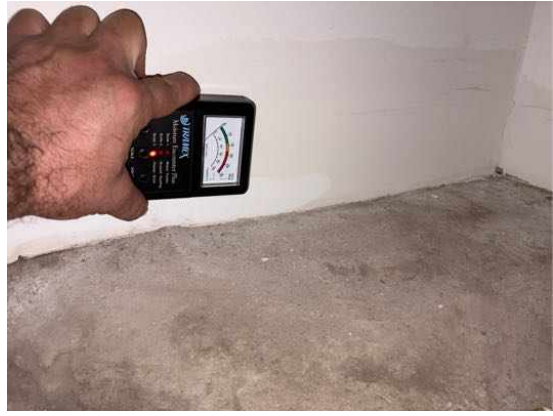
#### Noted Item

Building: Main Building  
Location: All Areas  
Finding: Moisture metre  
Information: During the inspection the property was checked for moisture using a moisture metre.

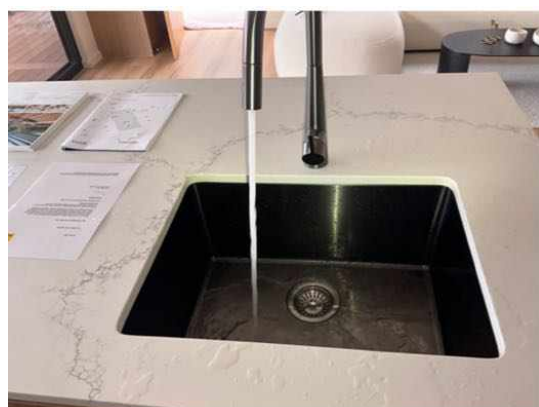
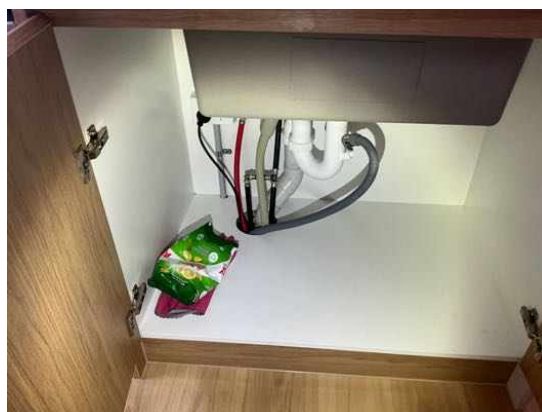
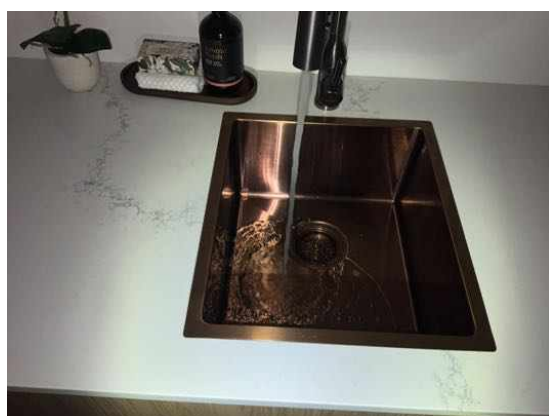
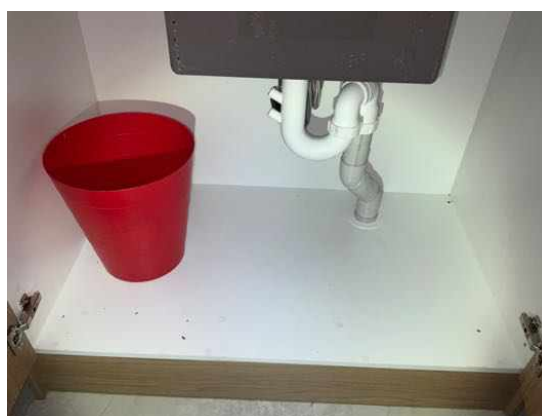
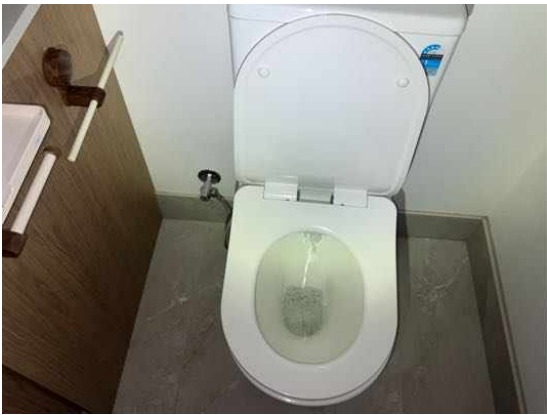
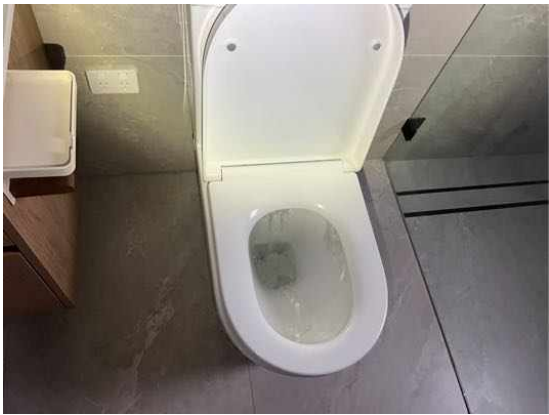
Noted Item

Building: Main Building  
Location: All Wet Areas  
Finding: Waterproofing  
Information:

All taps, mixers and toilets were tested for operation, except for those obstructed. The waterproofing to the shower recess was assessed by checking the walls in and around the shower recess for varying moisture content. There were no significant variations across the tested areas. No sign of recent water damage was evident upon a visual inspection of the surrounding walls, where the visual nature of the inspection was possible.

Consequently, there is no conclusive evidence of any current shower recess leakage other than those which may have already been mentioned earlier in this report. It is reasonable to assume the shower waterproofing is sound. Note that if the shower is not used, or has not been used for some time, moisture readings would not vary significantly and this can lead to erroneous results. It is not possible under the visual inspection criteria (under which a prepurchase inspection is carried out) to categorically determine if there are leaks. If a more accurate assessment is required, a special purpose inspection should be requested. Alternatively, the assumption should be made that the shower may leak.

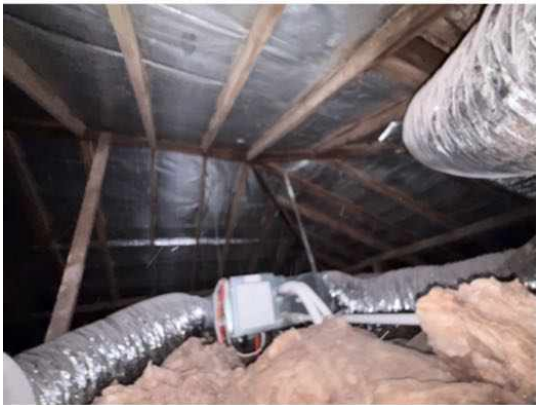
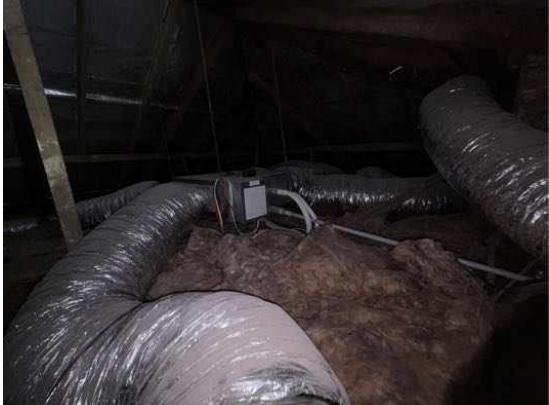
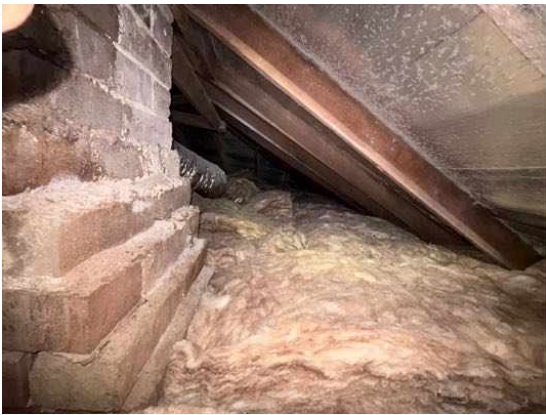
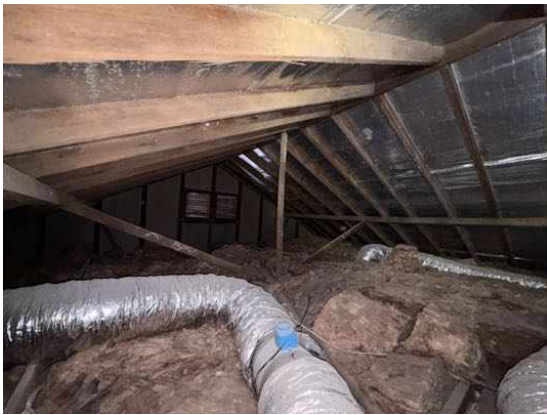
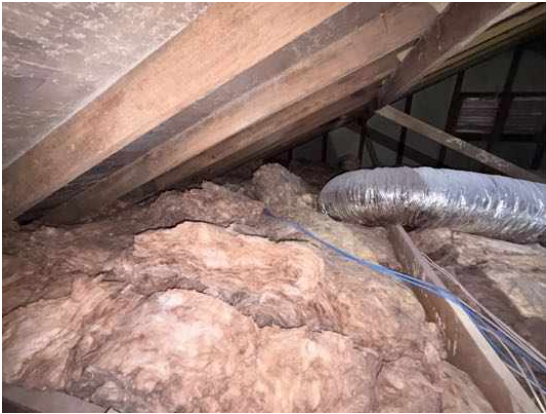
Building: Main Building  
Location: Roof Void  
Finding: Additional Photos  
Information:

Additional photos are provided for your general reference.

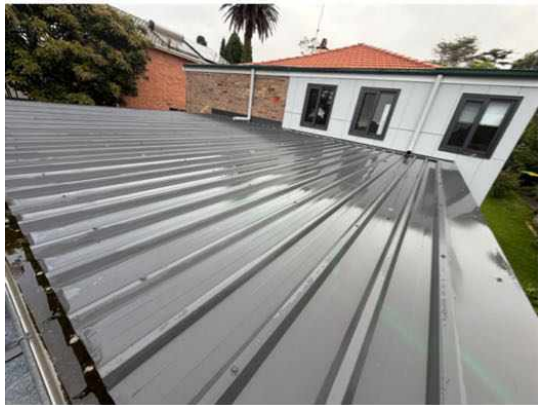
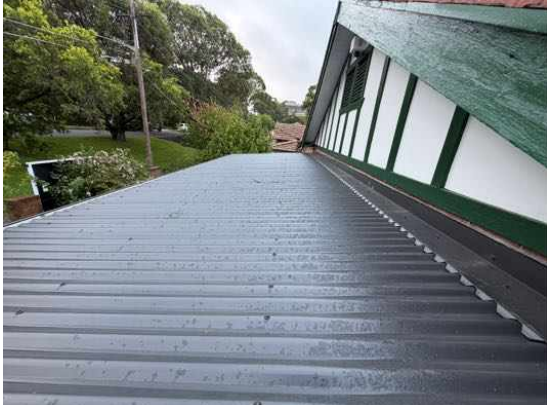
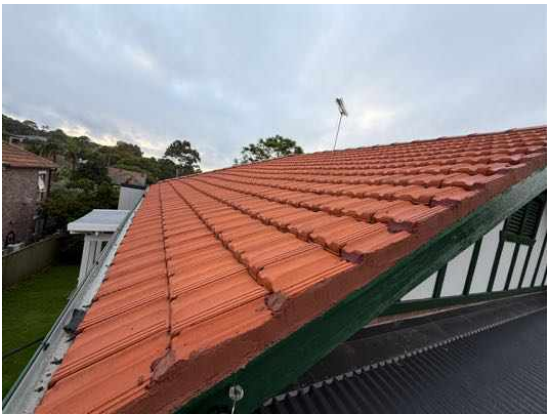
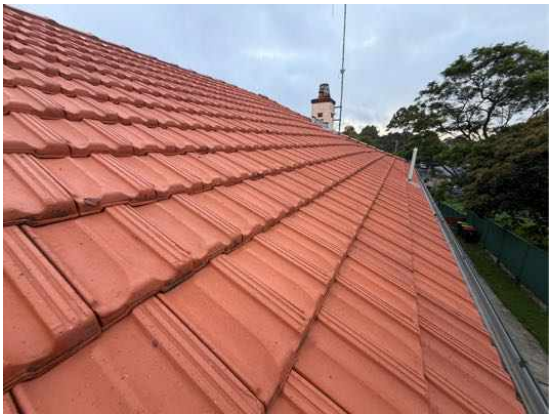
Building: Main Building  
Location: Roof Exterior  
Finding: Additional Photos  
Information:

Additional photos are provided for your general reference.

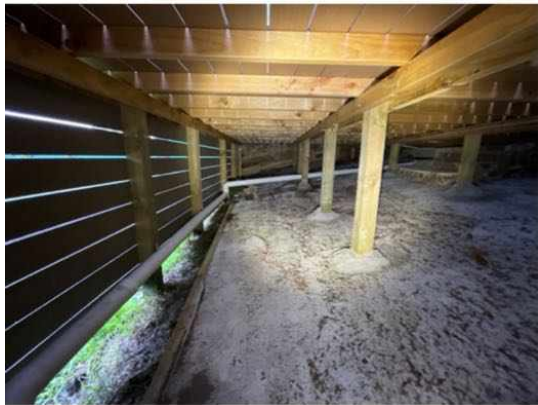
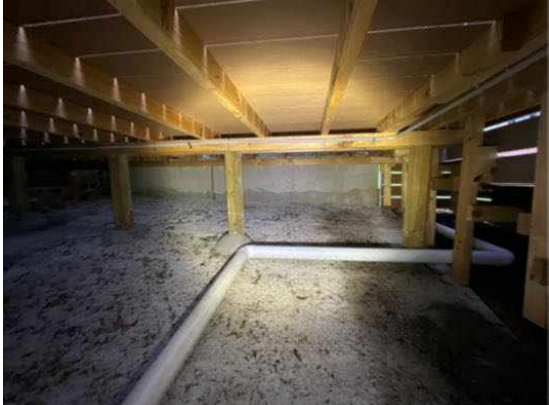
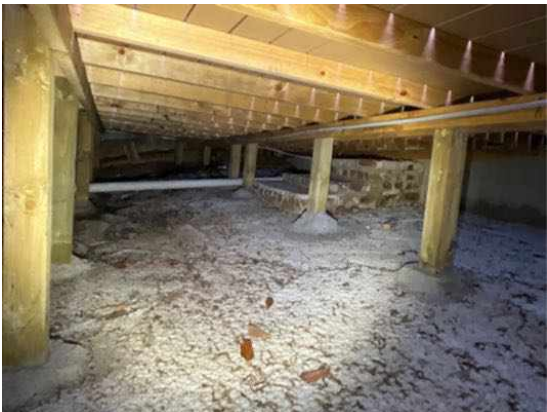
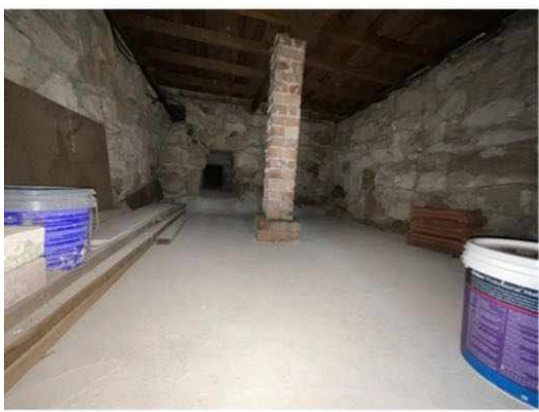
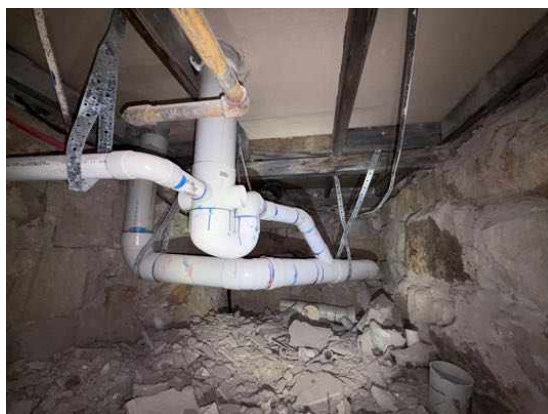
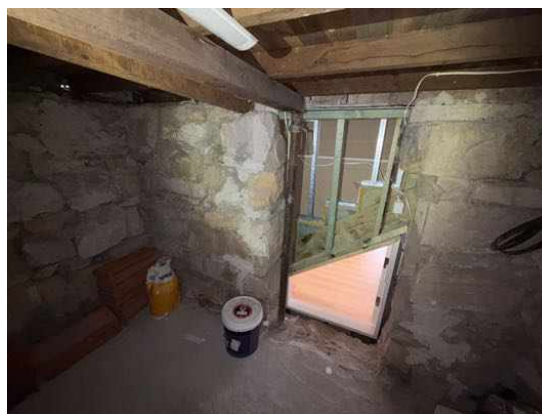
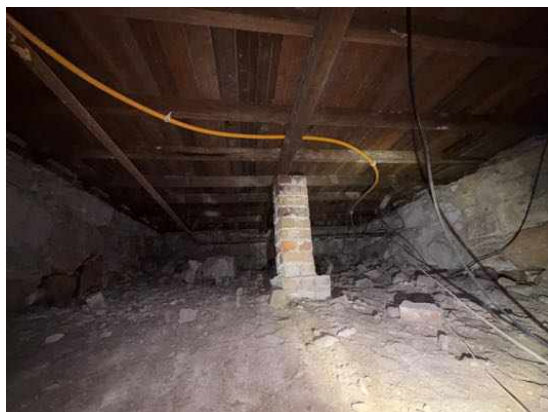
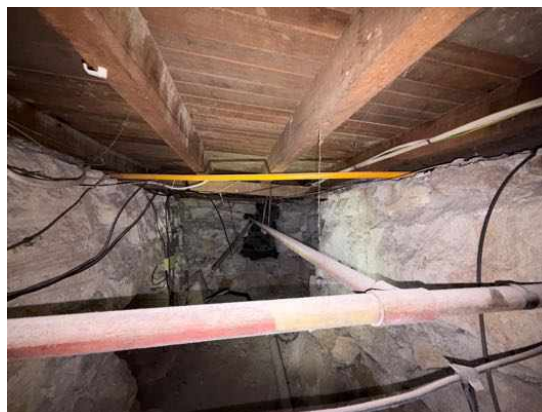
Building: Main Building  
Location: Subfloor  
Finding: Additional Photos  
Information:

Additional photos are provided for your general reference.
