# Building and Timber Pest Inspection Report

Inspection Date: Thu, 5 Mar 2026

Property Address: 30 Greenbank Street, Hurstville, NSW 2220

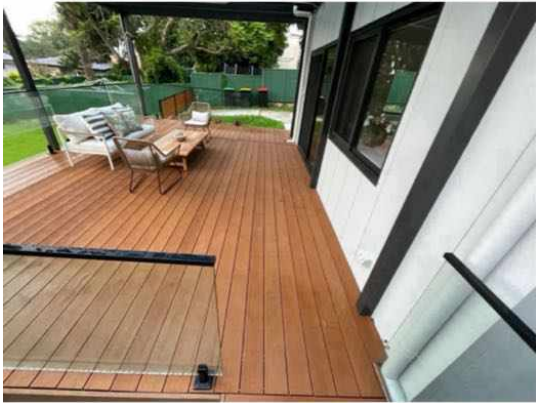
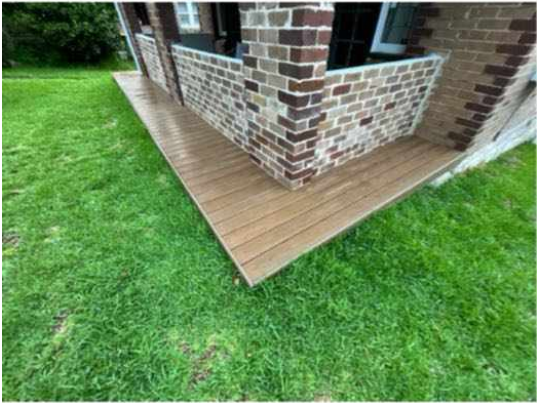
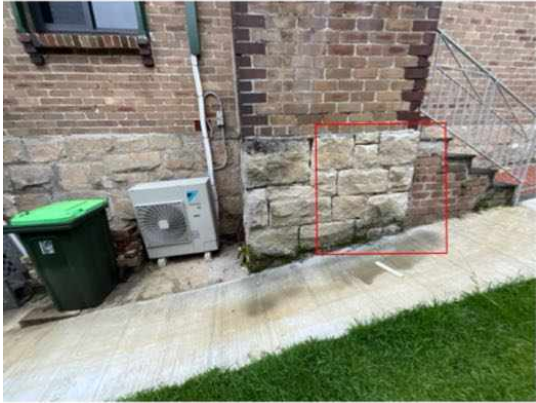
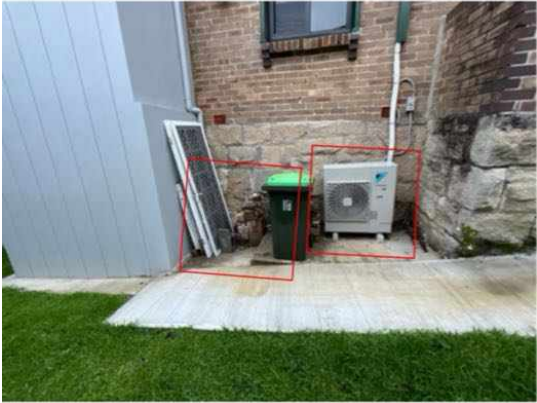
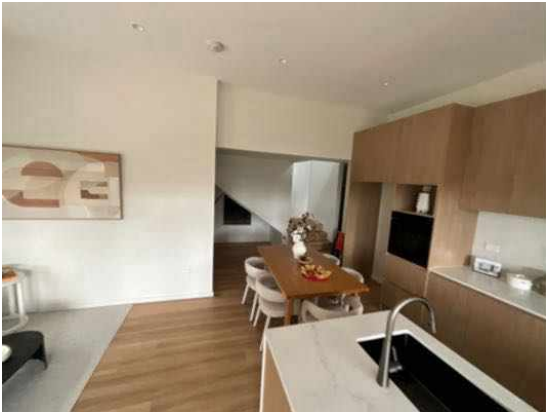
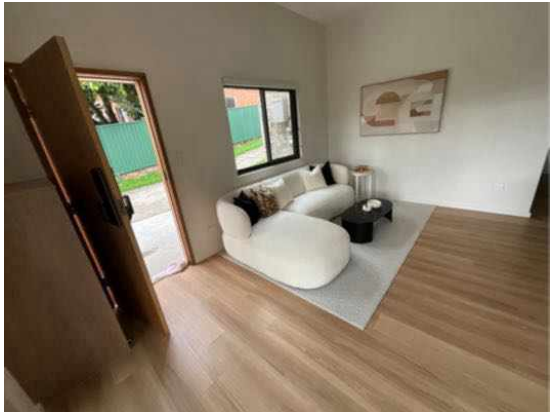
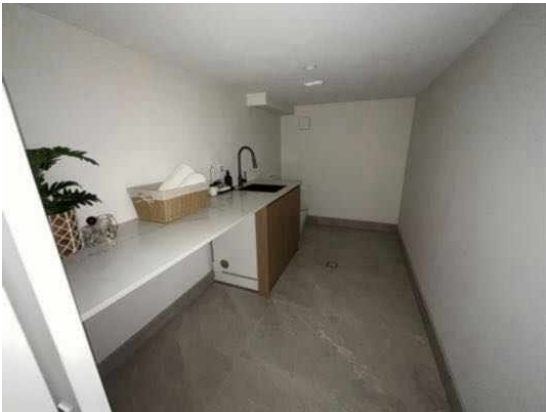
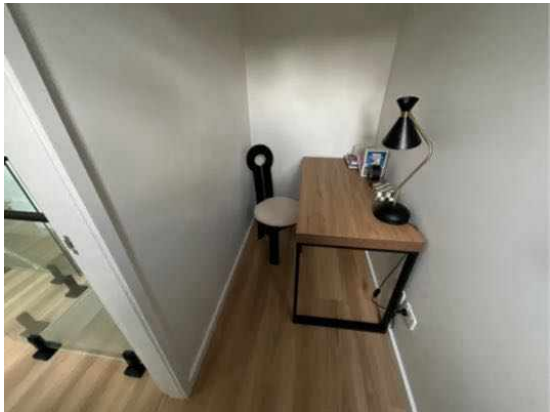
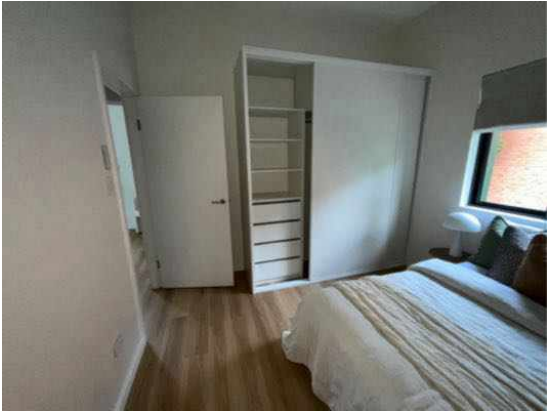
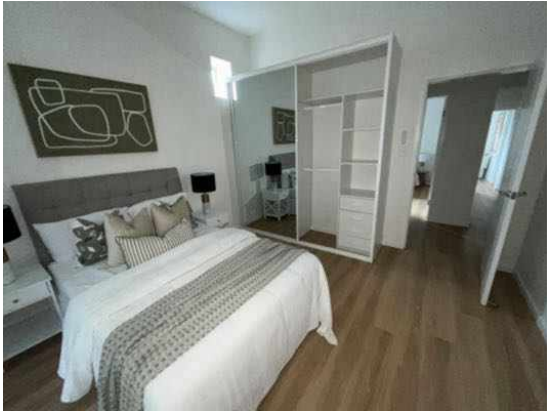
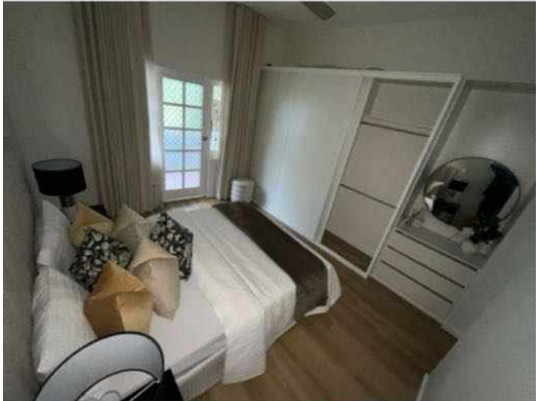
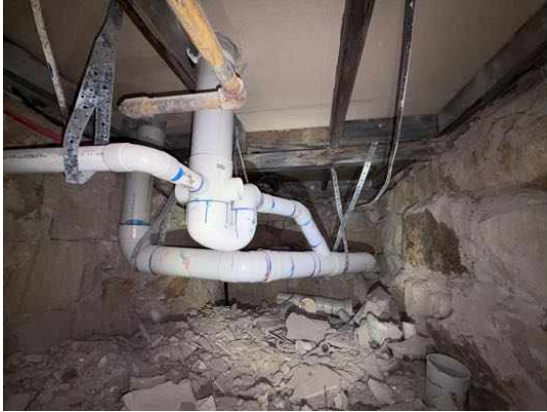
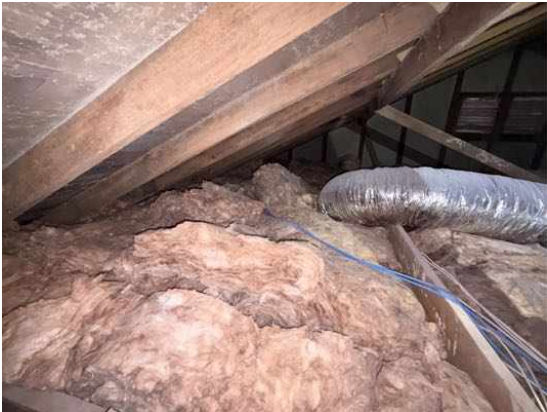
Building: Main Building  
 Location: All Areas  
 Finding: Additional Photos - Obstructions and Limitations  
 Information:

These photographs are an indication of the obstructions and limitations which impeded full inspection of the property at the time of inspection. These obstructions can hide an array of defects and should be removed to allow full inspection to be carried out. A re-inspection is recommended once the areas are made accessible.
