# Building and Timber Pest Inspection Report

Inspection Date: Sat, 14 Feb 2026

Property Address: 61 Devlin St, Ashcroft NSW 2168, Australia

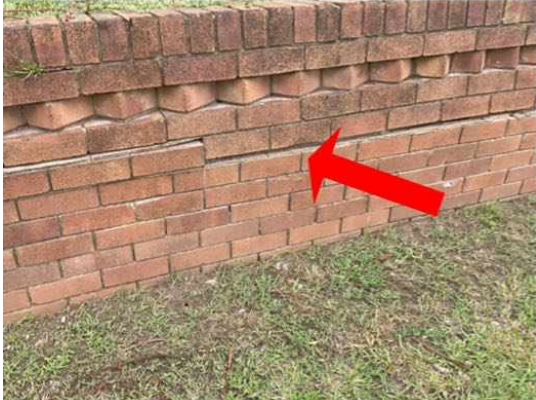
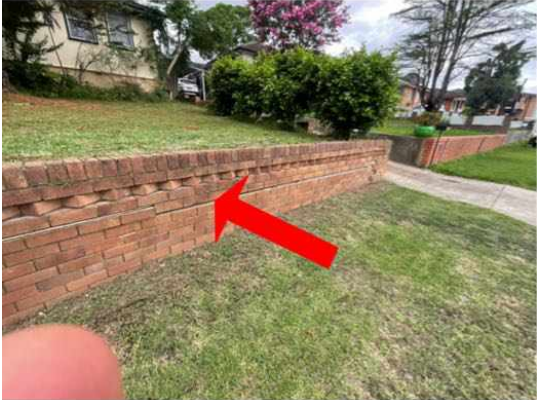
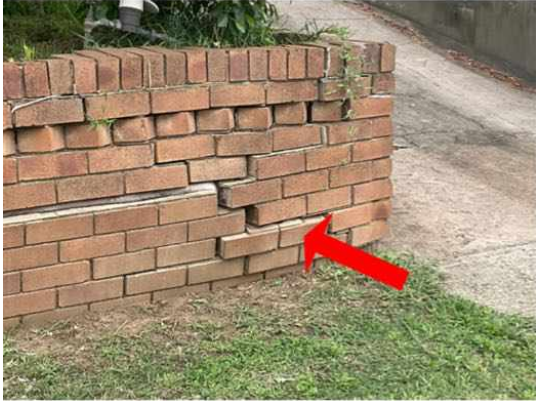
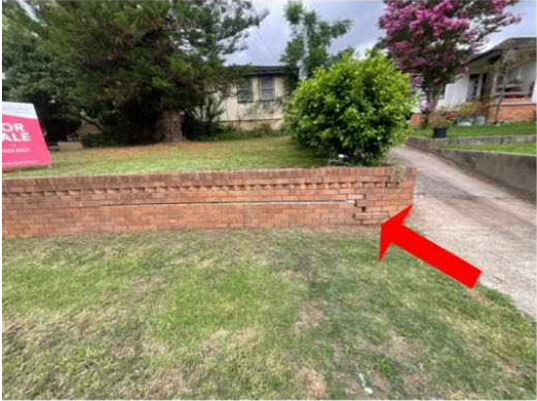
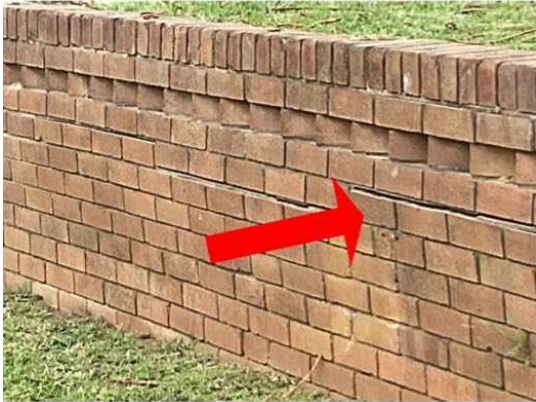
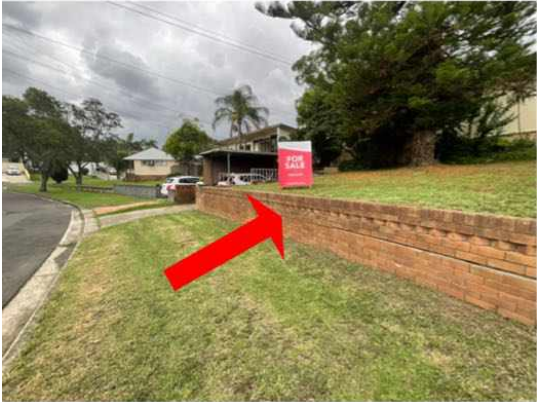
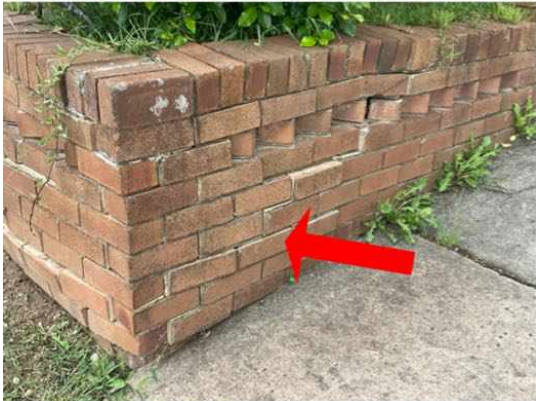
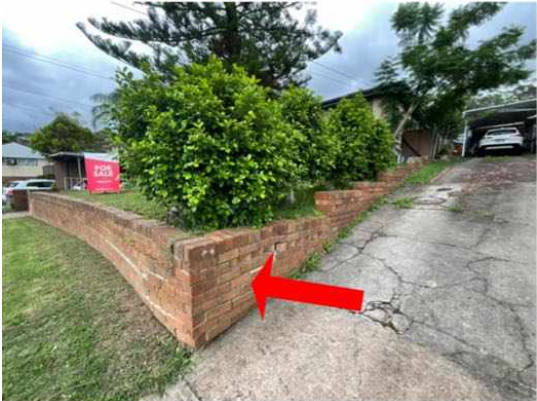
| Finding: | Retaining wall - Defective |

If left unmanaged, the retaining wall may become a safety hazard if it continues to destabilise. Where retaining walls further rot and decay, an environment is created that is conducive to termite and pest infestation.

Significant repair and replacement should be expected. Where retaining walls are considered structural walls, a structural engineer / surveyor should be consulted regarding required remedial works. Otherwise, a landscaper or retaining wall installer may be appointed to repair or replace the wall, at the discretion of the client.

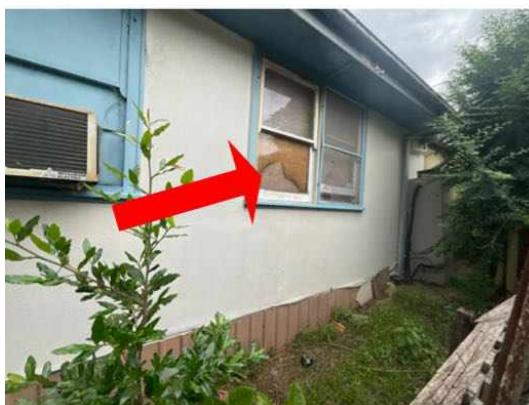
| Finding: | Window - Cracked |

The likelihood of this windowpane further cracking and shattering is increased exponentially, providing a safety hazard in the area. The cracked window also impairs the weather tightness of the building, creating potential for minor water leaks.

A qualified glazier is required to repair the window as soon as possible. Depending on the extent of the cracking, replacement of the window may be required. Please be advised that any persons coming into contact with the cracked window should do so with due caution to avoid any personal injury that may ensue.

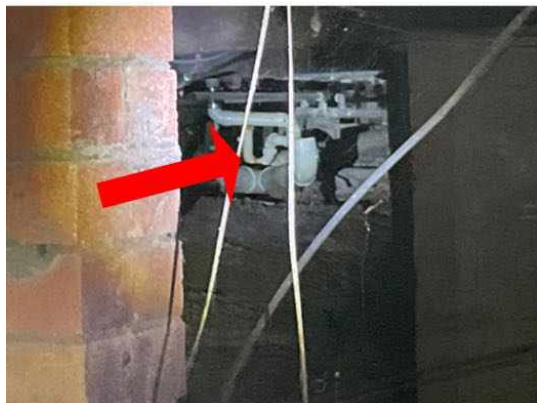
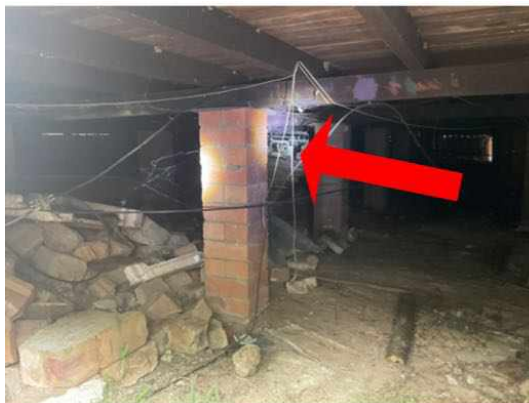
| Finding: | Plumbing work - appears defective |
| Information: | An instance of potentially defective plumbing work was identified. Whilst we are not licensed plumbers it appears that work which is not compliant with the relevant plumbing regulations and or the contract documents has occurred. The area of suspected non-compliance or poor workmanship should be referred to the builder and or the Building Surveyor or Certifier. The builder is required to provide a Certificate of Compliance when required by the relevant regulations. |

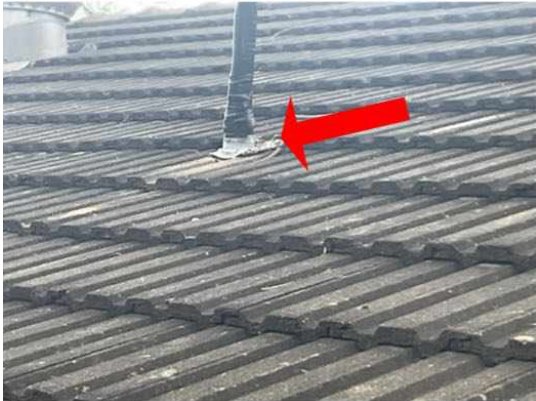
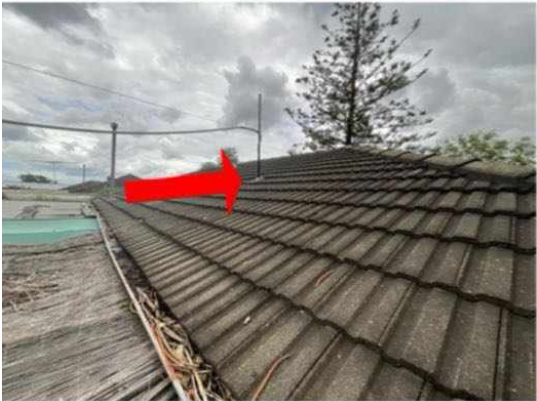
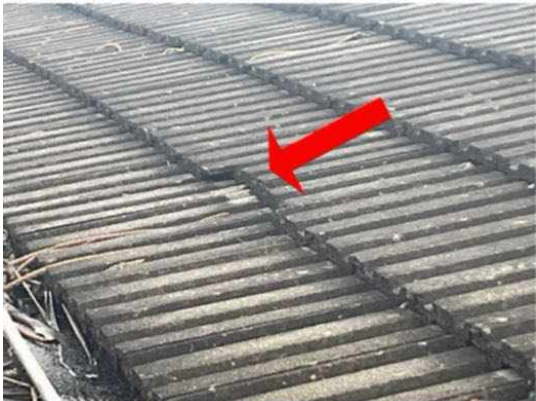
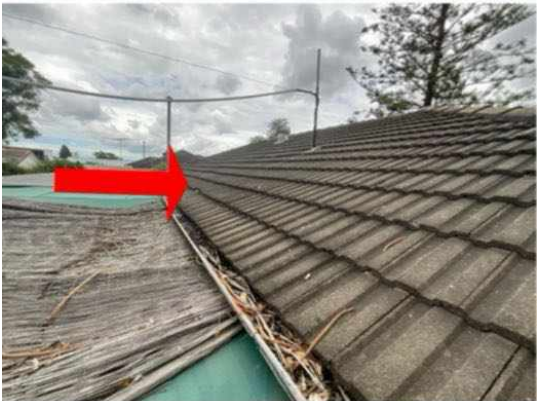
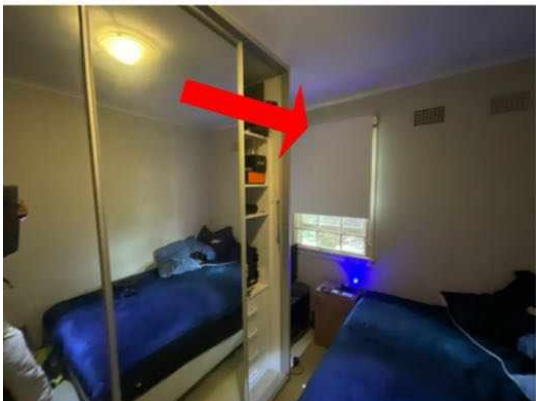
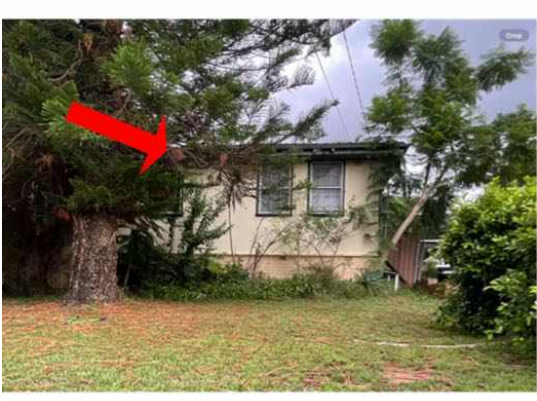
Where water leaks are active, rain penetration is likely to cause water damage to associated structures and building elements in this area, which can have a range of implications. If left unmanaged, the development of major structural damage to the roofing and associated structures may occur.

A roof plumber should be appointed as soon as possible to primarily identify the cause of the leak, and to provide subsequent repair works as necessary. Depending on the extent of the damage, replacement of sections of the roof covering and/or roofing structures may be required, and may be performed by a registered builder or qualified carpenter.

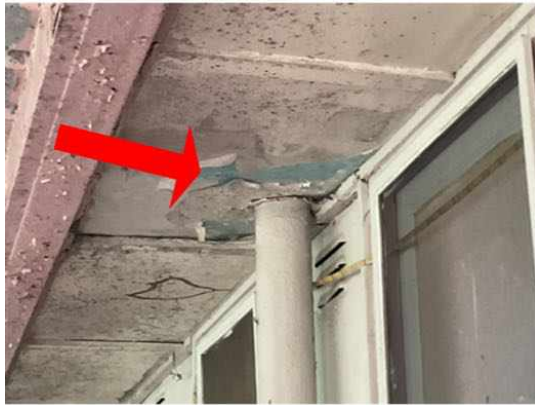
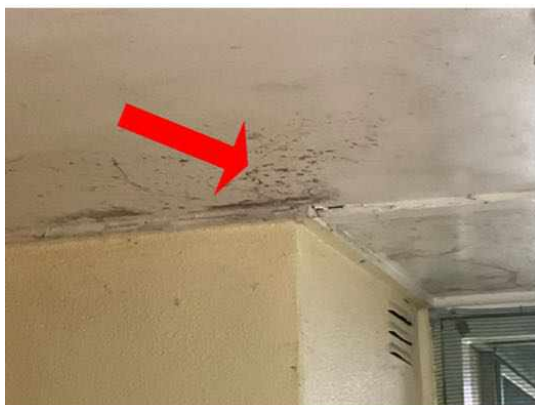
**Finding 2.04**

Building: Main Building  
Location: Roof Exterior  
Finding: Eaves - Water damaged

Information: Water damage to the eave lining is generally an indication of excessive moisture being present in the roof void, usually via a leak to the roof covering.

Where water damage is evident to the eaves, the primary requirement is to identify and rectify the source of the leak. A roofing plumber should be appointed as soon as possible to identify the leak and perform rectification works as necessary, ensuring the water damage is restricted.

Once the leak is repaired, consultation with relevant tradespeople, including carpenter, plasterers and painters, is advised. Rectification works may include replacement of eaves lining or minor repainting, depending on the extent of the damage.

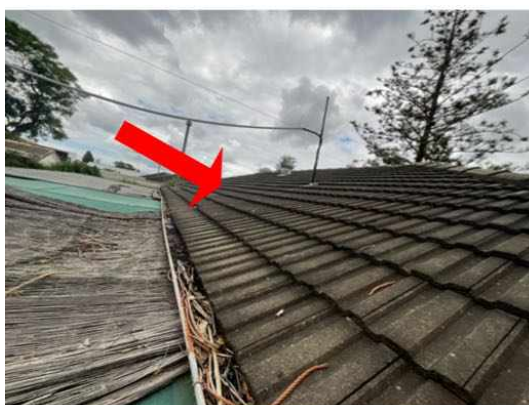
## Finding 2.05

| Information: | The hipped roofing structure was found to be sagging in sections at the time of inspection. It appears that the weight of the roof tiles on the corner has caused the hip to sag which in turn has left fascia's and guttering out of level. Further inspection could reveal currently hidden defects. |

Sagging roof structures are likely to create strain on associated building elements, creating potential for secondary damage due to these stresses and gutter not falling towards down pipes. The roof is also unlikely to have sufficient support, which will lead to further sagging if left unmanaged.

It is highly advised that a roofing contractor be appointed as soon as possible to provide further advice on repair options.

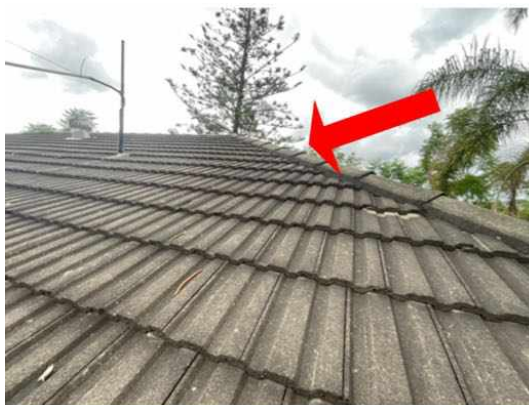
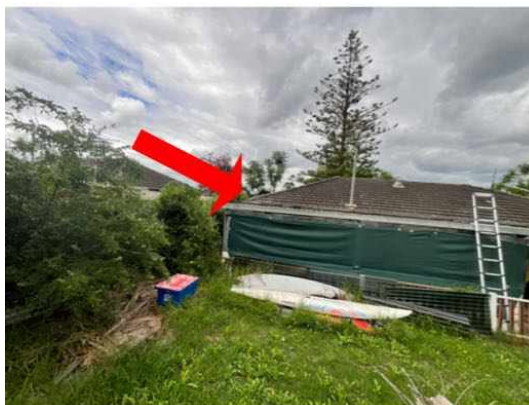
## Finding 2.06

| Finding: | Mortar - Deterioration |
| Information: | Mortar, or 'bedding', is the material which fills joints and intersections between tiles and other building elements on the exterior roof covering, such as gable ends, hip capping and valleys. Upon inspection of the exterior roof, it was noted that sections of the mortar show varying levels of deterioration. |

Mortar generally deteriorates as a result of frequent exposure to weather conditions over a prolonged period of time. Mortar that is deteriorating may allow water ingress into the roof void, putting associated building elements and roofing structures at risk of water damage. Deteriorated mortar also detracts from the functionality of roof tiles and other roofing elements, potentially decreasing weather tightness and roof drainage.

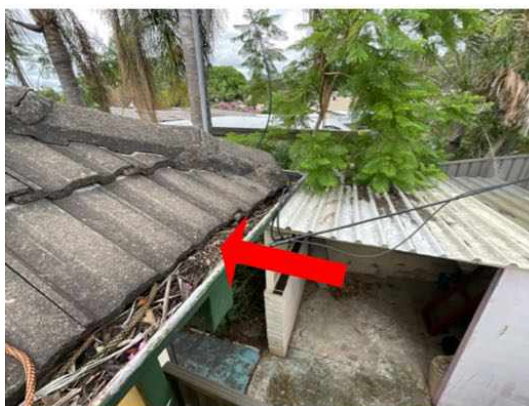
### Finding 2.07

Blocked gutters are likely to lead to high levels of moisture in the affected areas. Such moisture will not only cause rust and decay of the associated building materials, but can also provide conditions that are conducive to termite and timber pest activity. Blockages in gutters should therefore be removed immediately to ensure dry conditions are maintained.

Consult a Licensed Plumber for further specific advice on remedial works that may be required. In the interim, it is highly advised that blocked gutters be removed by the homeowner or a general handyperson as a matter of urgency.

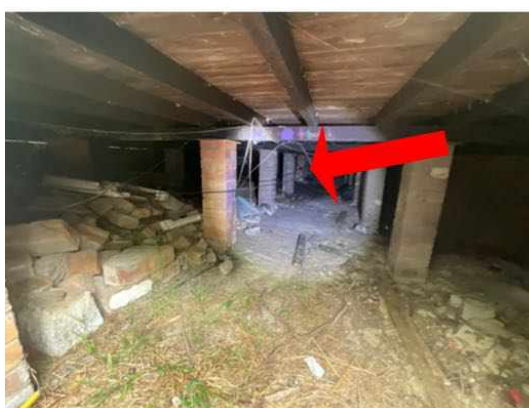
### Finding 2.08

| Information: | Damages were evident in the structure in the subfloor of the property indicating that it may not be structurally sound or compliant with current building regulations. While some damages are expected of structures of this design, it is suspected that land slippage, footing damaged or forceful impact may cause the stability of the walls to further decline. Additional bracing and supporting of the is required immediately to ensure its safety and structural integrity. |

If left unmanaged, the structure is likely to deteriorate further, potentially creating an environment which is unsafe.

An structure engineer and a registered builder with the assistance of trades, e.g. qualified carpenter, should be appointed to perform remedial works as a matter of urgency.

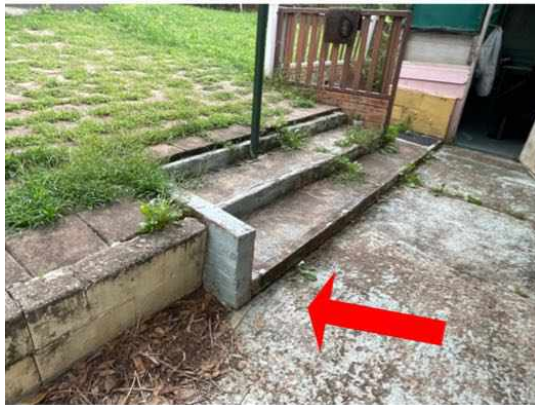
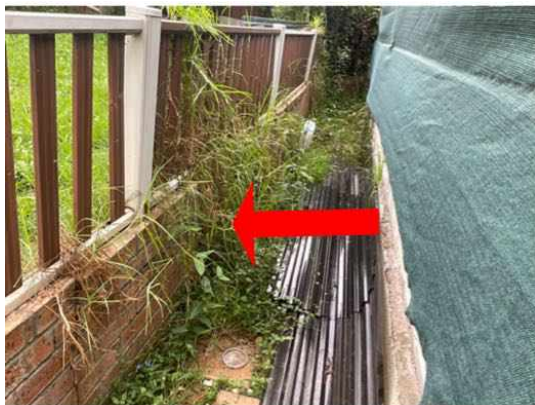
### Finding 2.09

Finding: Site drainage - Inadequate  
 Information: The site drainage in this area was found to be inadequate at the time of inspection, creating potential for subsequent water damage to associated building elements.

It is important that water does not lie against the base of walls; surrounding paths and ground levels should be sloped to drain water away from walls. Downpipes should not discharge stormwater onto lower walls or plinths. Stormwater should be carried away by large, regularly cleaned drains. Ground levels may need to be lowered to expose a buried DPC.

Where site drainage is inadequate, installation of an Agricultural (Aggie) Drain may be required. A qualified plumber should be appointed to further inspect the property and perform any remedial works as necessary. Water damage and secondary defects are likely to occur if left unmanaged.

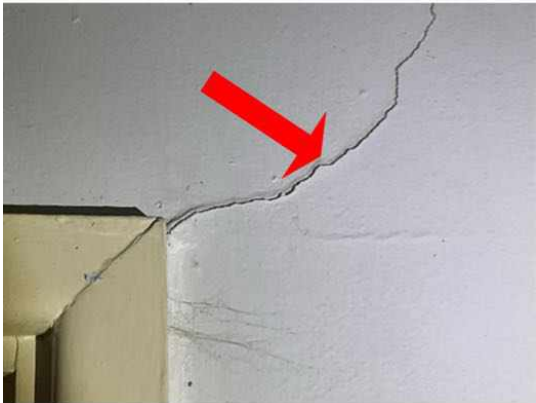
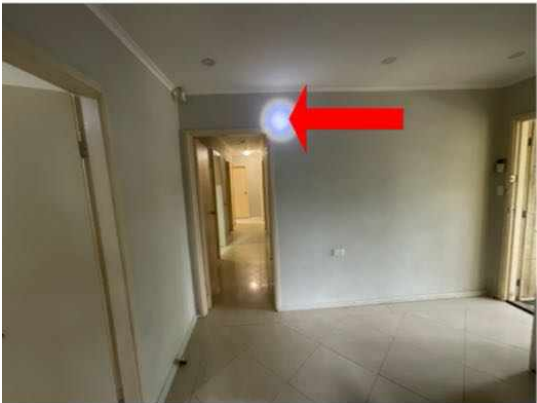
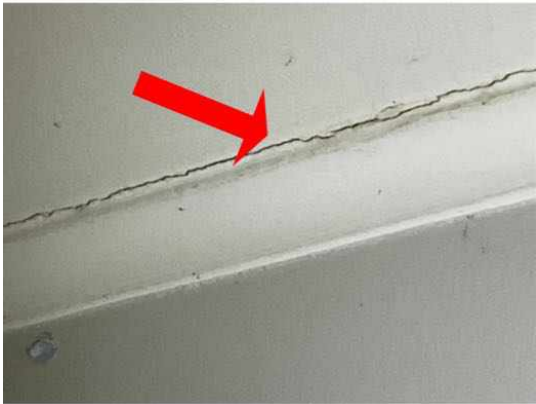
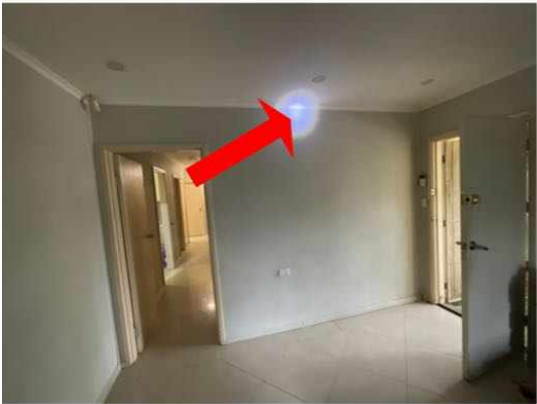
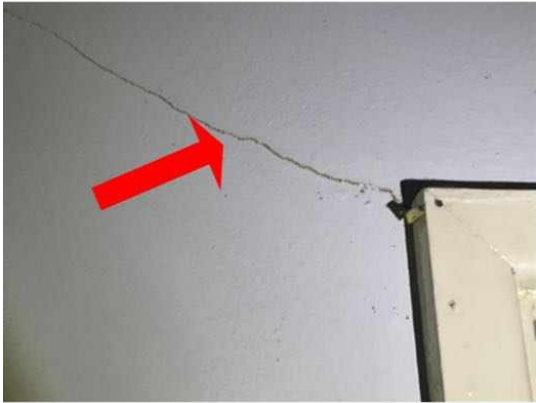
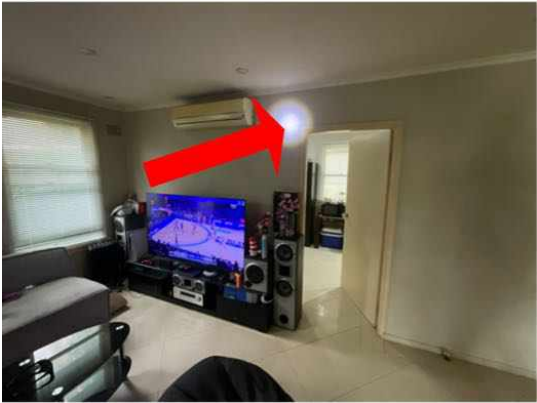
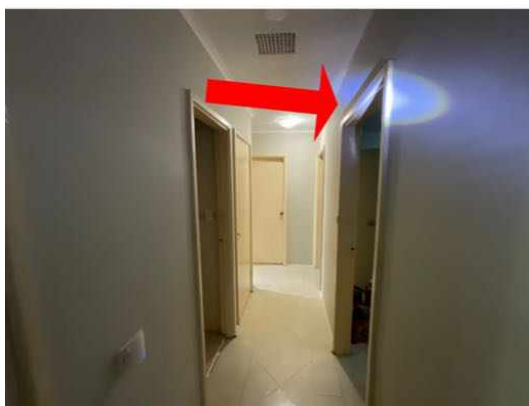
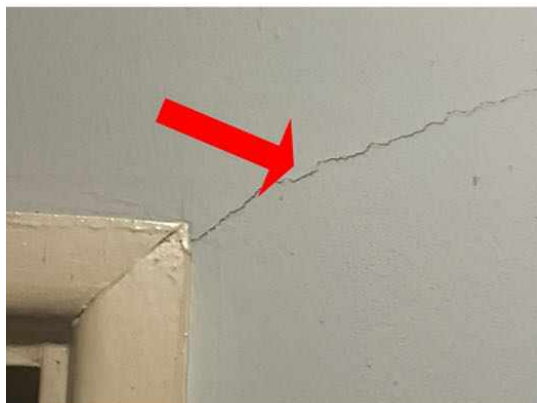
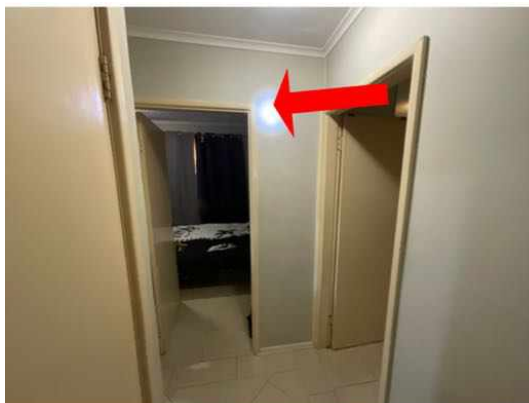
### Finding 3.01

Building: Main Building  
 Location: All Internal Areas  
 Finding: Cracking - Damage Category 1 - Fine (up to 1mm)

Although fine cracks are quite noticeable, they are often only considered to be an appearance defect, and usually do not indicate any structural damage. Generally, the cause of a fine crack is indicative of a separation between building materials and finishes (e.g. paint, plaster, etc.) along joins.

Cracking of this nature can generally be repaired with minor sanding, filling and/or repainting. Such works should be performed by a qualified painter or a general handyman.

Monitoring of all cracking should be conducted frequently. Always contact a building inspector should cracks widen, lengthen, or become more numerous.

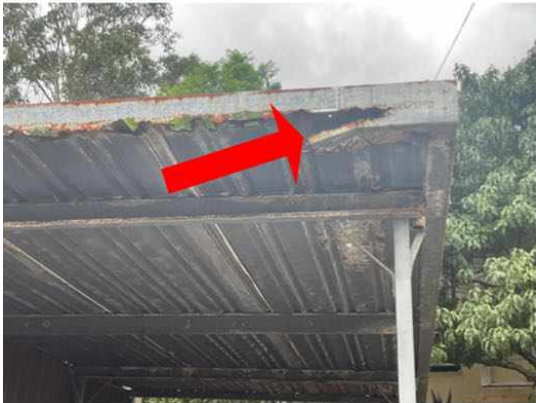
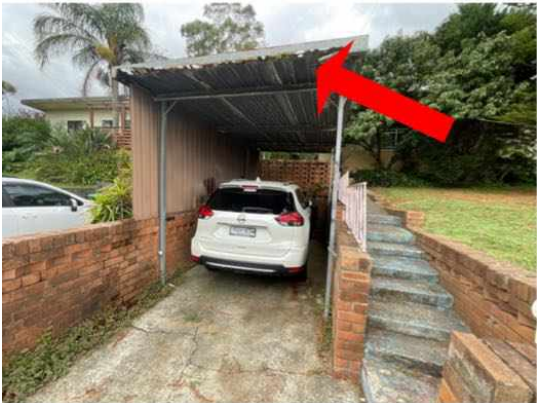
### Finding 3.02

| Finding: | Building element - Rusted or corroded |
| Information: | This building element shows evidence of rusting and corrosion, which is likely to have developed as a result of excessive exposure to moisture and or inadequate coatings. |

As surface rust provides no protection to the underlying iron, the deteriorating condition is likely to worsen if not addressed in the short-term future.

Where possible, the use of galvanized (treated) metals or aluminium coated metals aid in rust prevention, as does regular general maintenance. Rust formation can be controlled with coatings, such as paint, that isolate the iron from the environment.

Rusting and corrosion should be managed by ideally removing or limiting the affected surface from exposure to moisture. A registered builder may be appointed to replace any building elements that have been severely affected by rust or water damage.

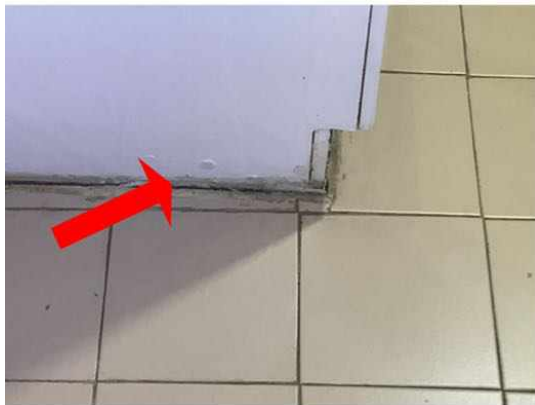
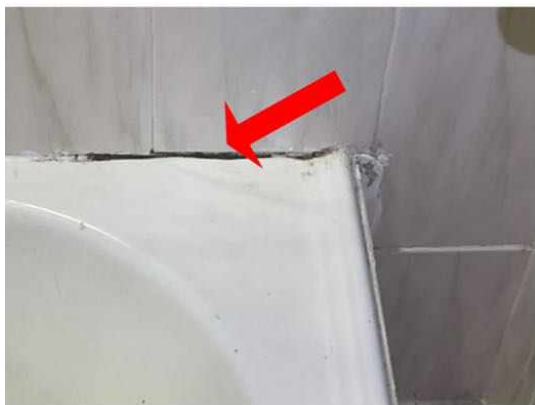
Building: Main Building  
Location: Bathroom  
Finding: Sealant and grouting - Missing or damaged  
Information: It was noted on inspection that sealant or grout is degraded to the tiled shower alcove and or other areas of the bathroom.

Different materials and floor areas move at different rates, generally causing cracking to grout or sealant at this point. A flexible sealant is required to allow for expected expansion and contraction, while keeping the joint water tight and protective of all associated building materials.

There appears to be excessive mould to the sealant and grout which will likely require scraping out and replacement.

Flexible and mould resistant materials should be applied to affected areas to prevent any subsequent water damage that is likely to occur. Regular maintenance and replacement of damage or missing or damaged sealant and grout is highly recommended to the wet areas, as this is a regular wear and tear defect. Sealant and grouting in areas that come into regular contact with water should be maintained for the long term care of your property.

A sealant specialist or tiling contractor should be appointed to complete these works as soon as possible

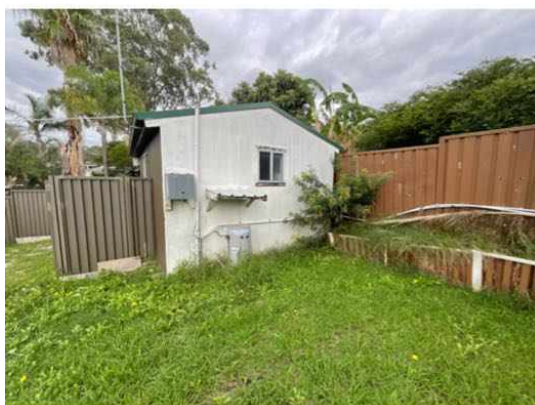
#### Finding 6.01

Building: Main Building  
Location: All Areas  
Finding: Garden Beds - Conditions Conducive to Termites  
Information: Garden beds were found to be evident in the garden area. These garden beds can include untreated timber, and with a combination of moisture from watering hosing can make conditions conducive to termite activity and termite ingress.

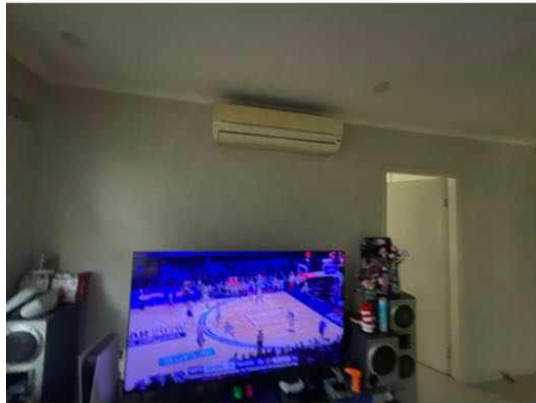
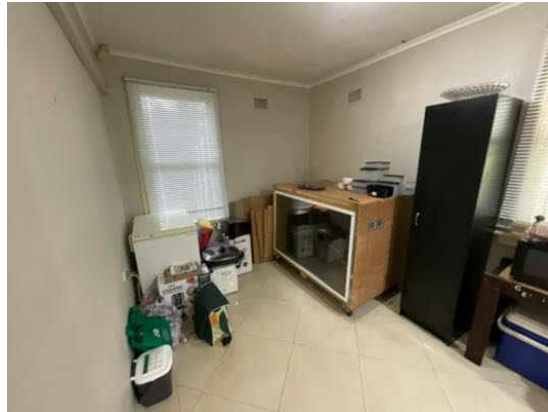
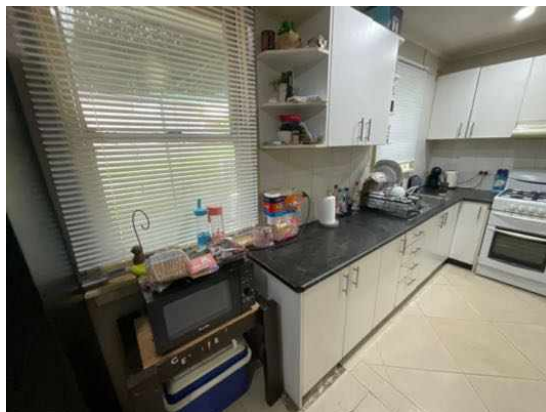
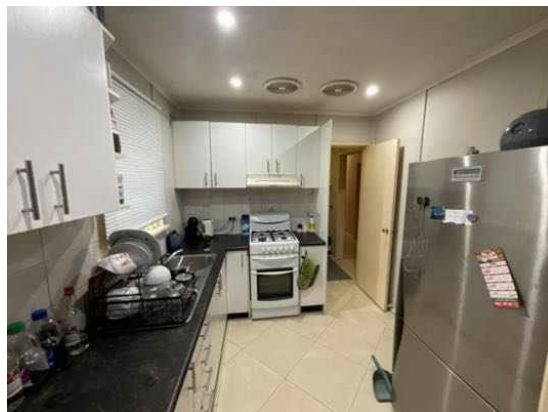
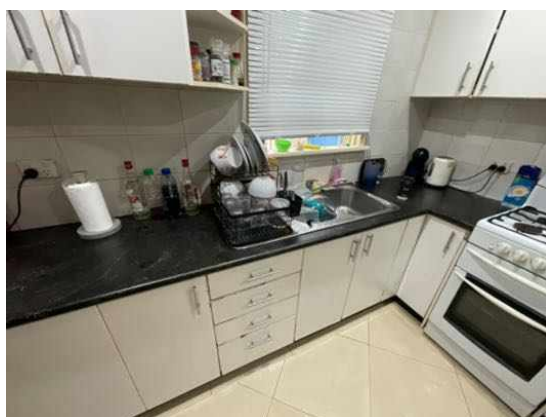
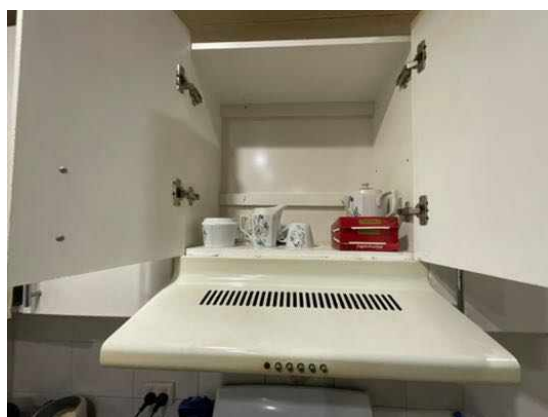
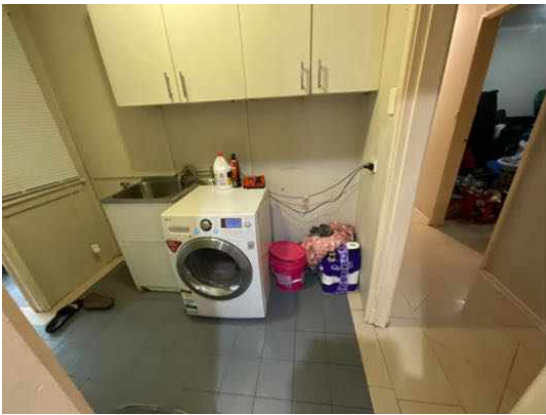
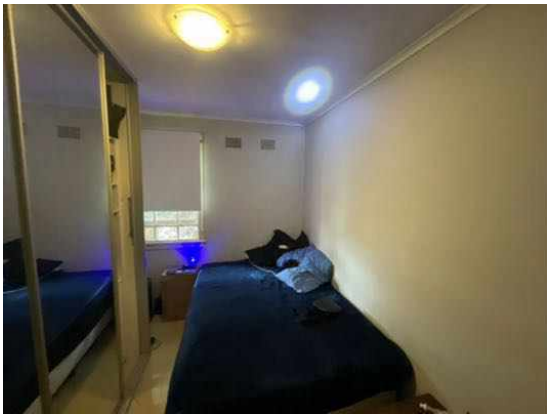
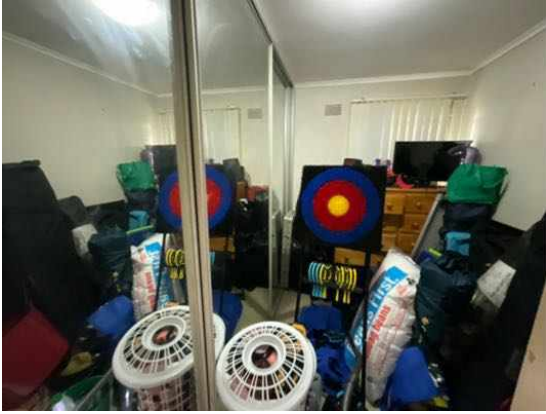
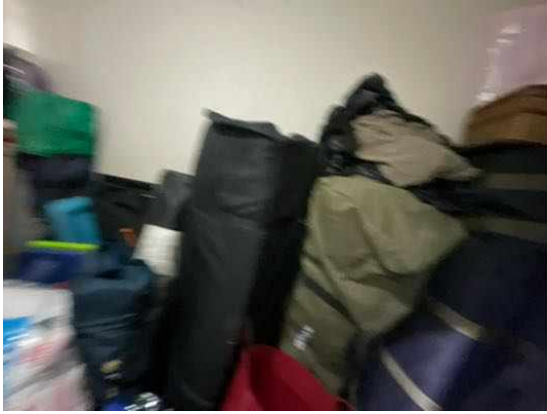
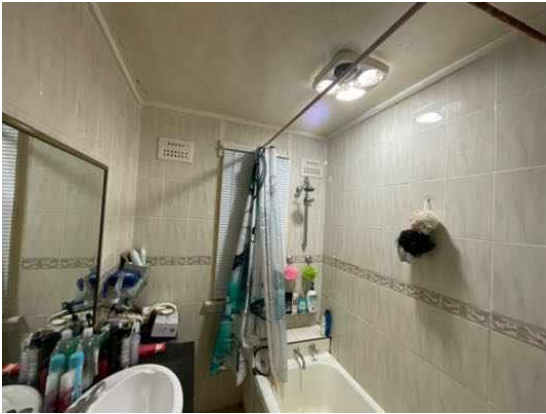
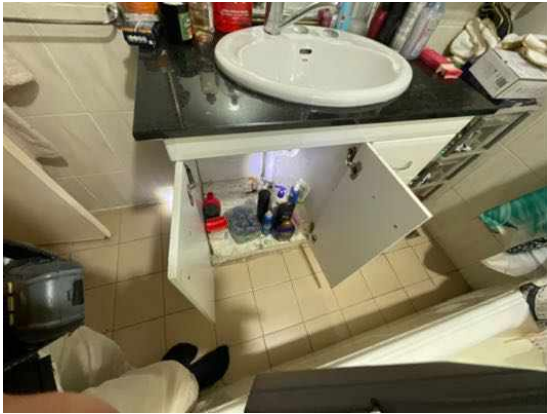
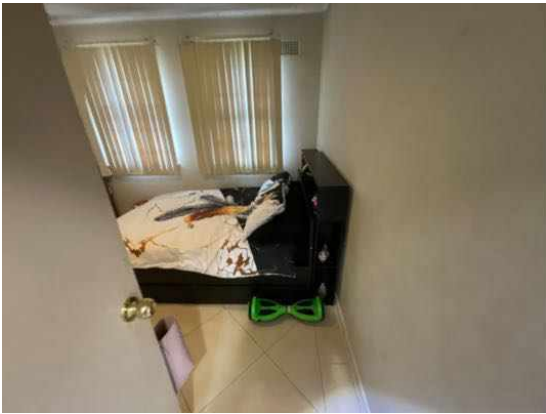
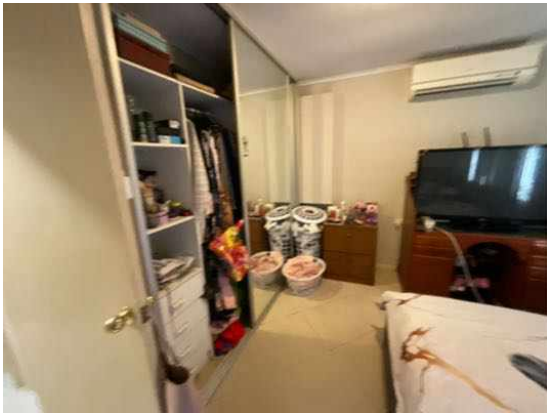
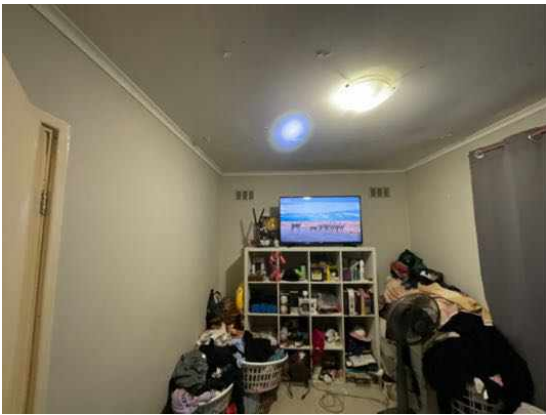
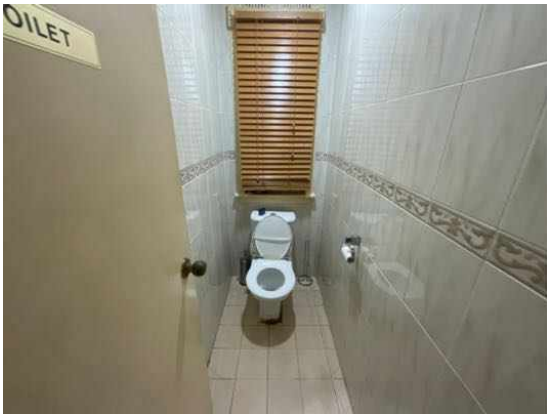
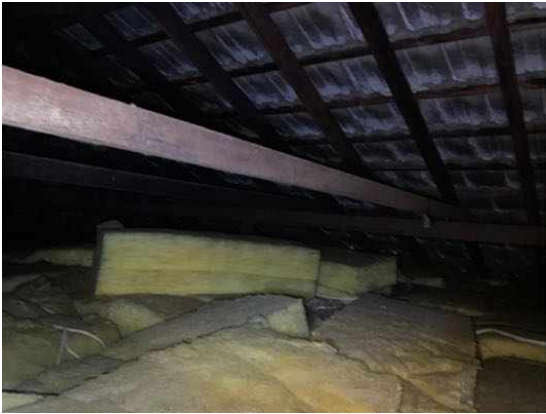
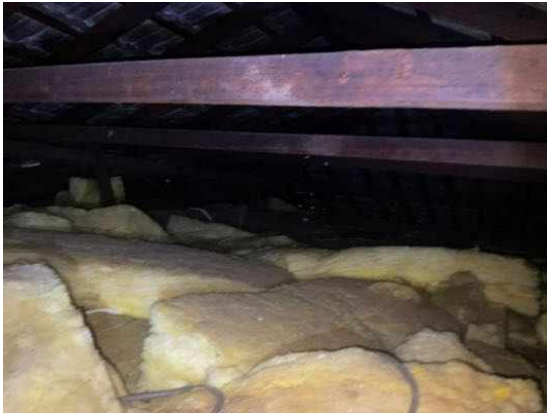
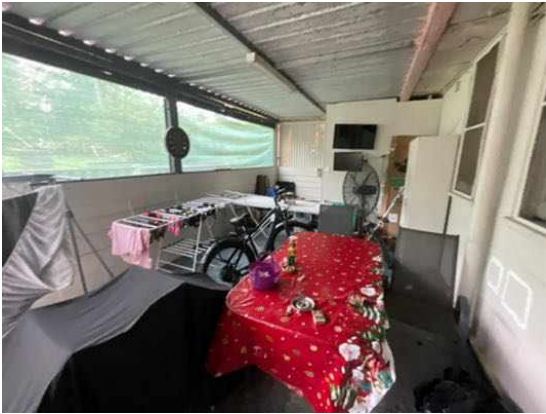
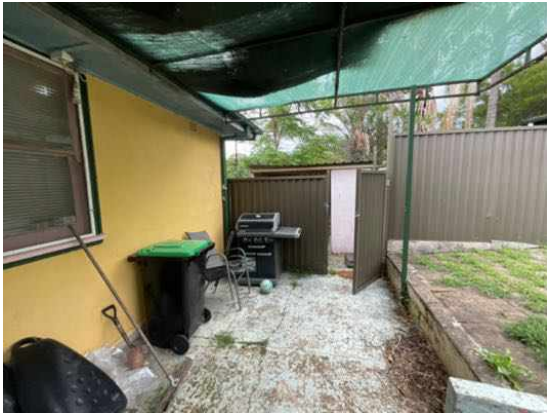
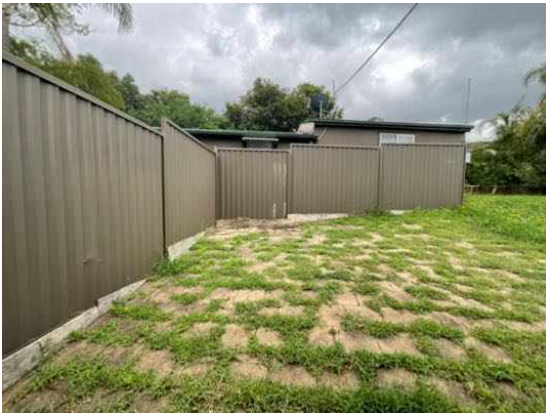
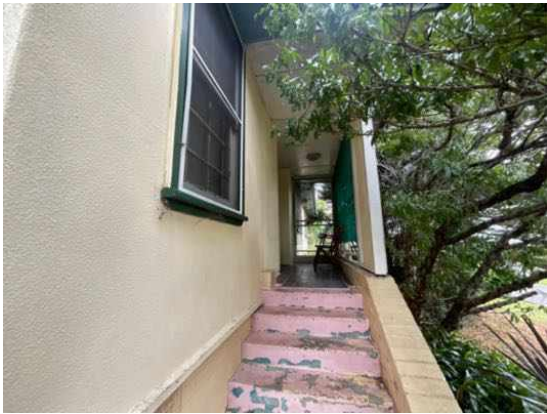
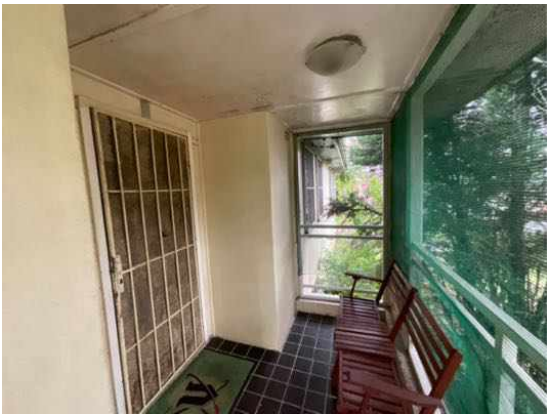
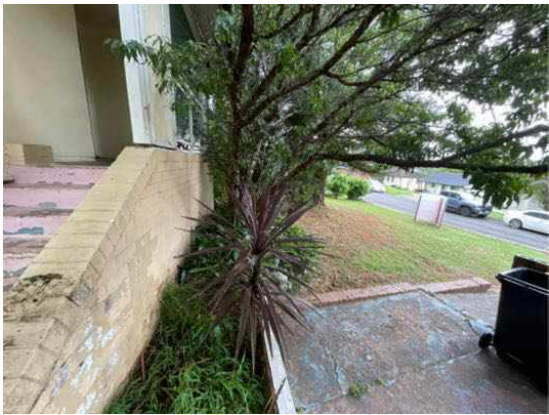
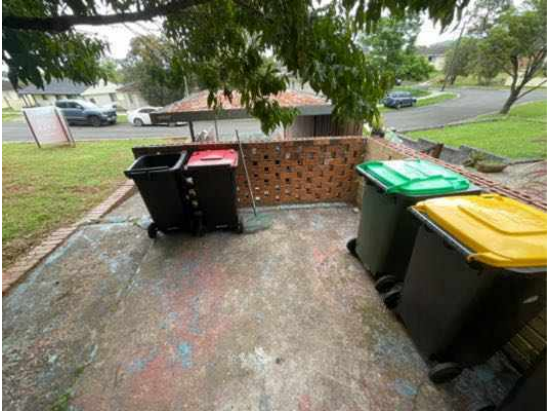
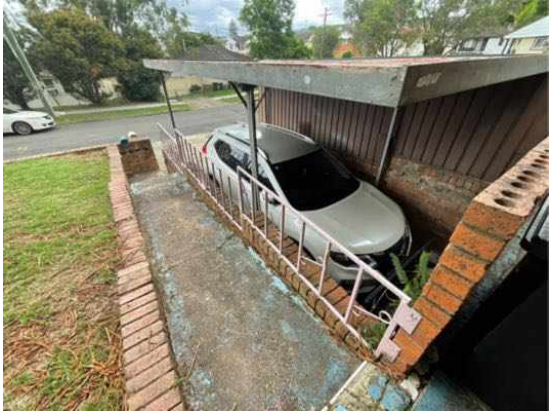
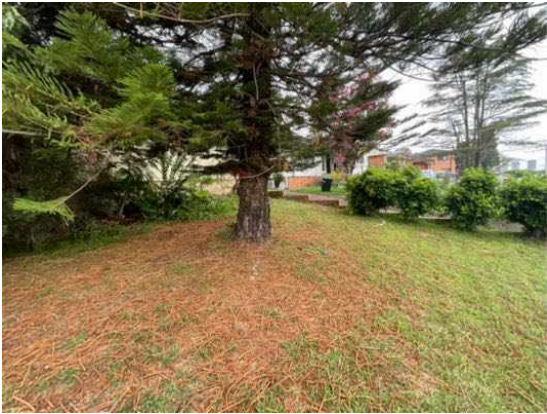
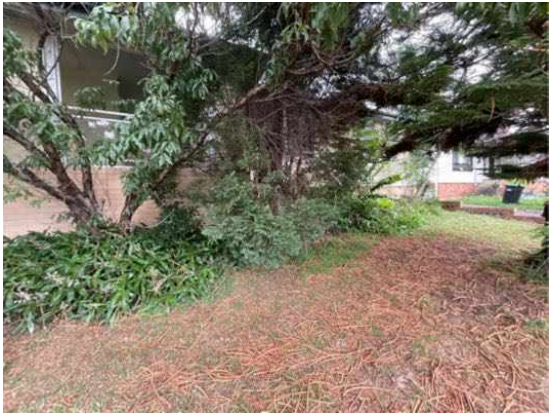
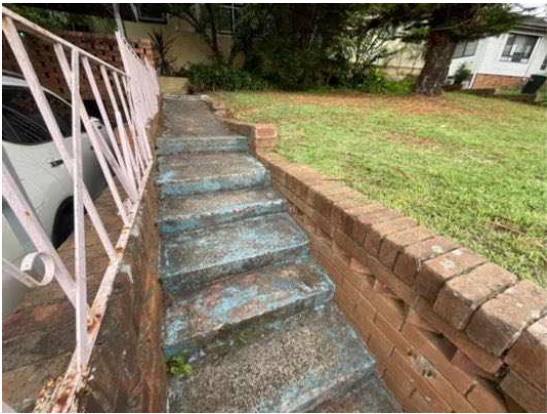
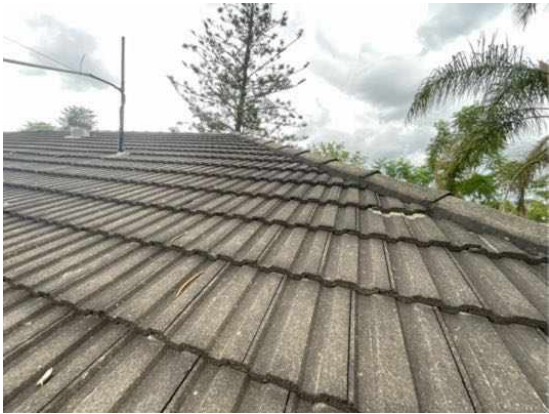
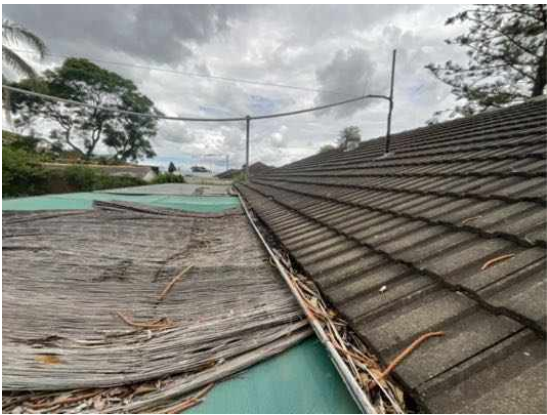
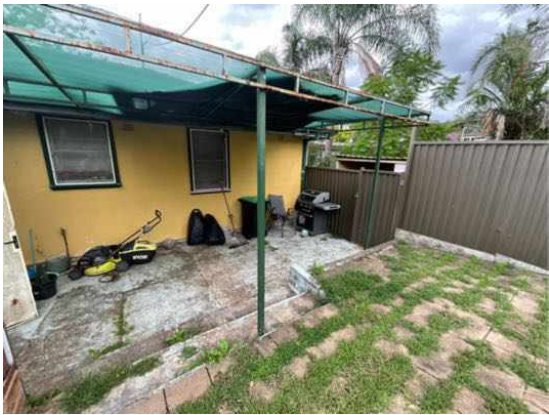
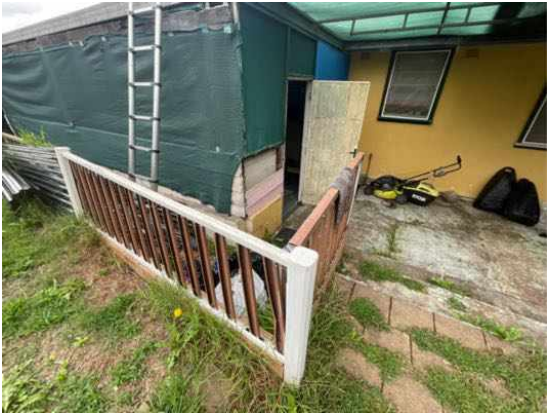
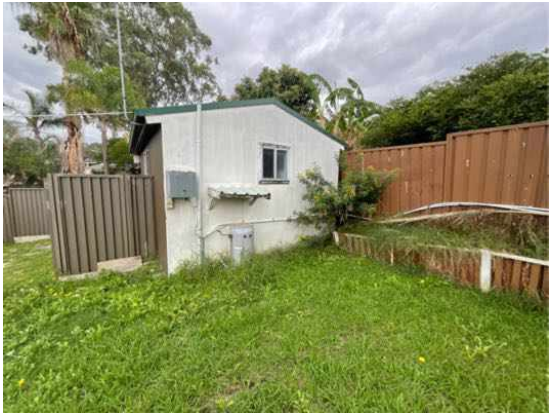
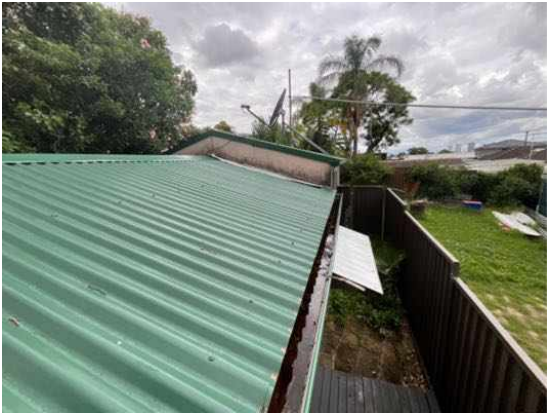
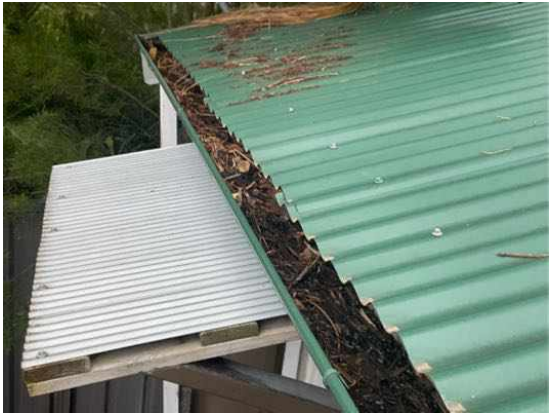
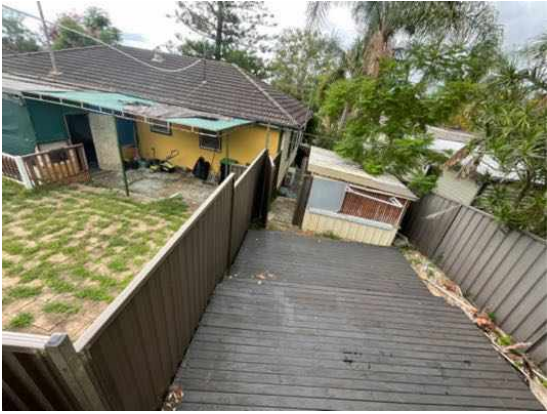
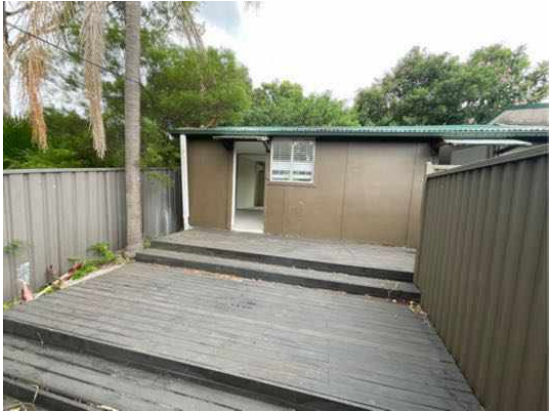
Finding: Additional Photos - Obstructions and Limitations

Information: These photographs are an indication of the obstructions and limitations which impeded full inspection of the property at the time of inspection. These obstructions can hide an array of defects and should be removed to allow full inspection to be carried out. A re-inspection is recommended once the areas are made accessible.
