# Building and Timber Pest Inspection Report

Inspection Date: Sat, 14 Feb 2026

Property Address: 61 Devlin St, Ashcroft NSW 2168, Australia

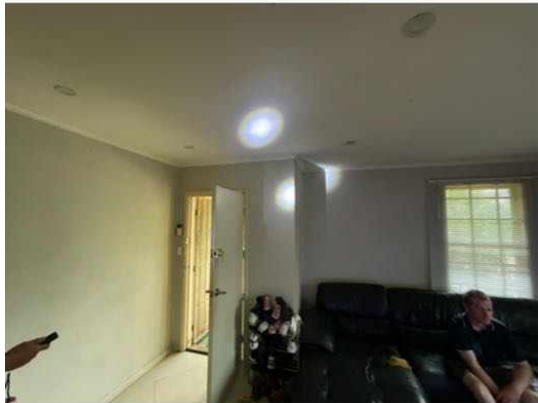
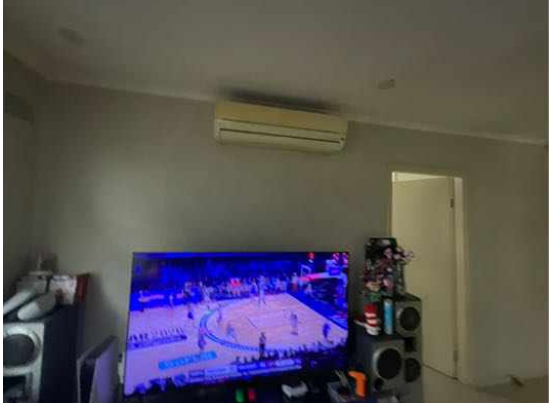
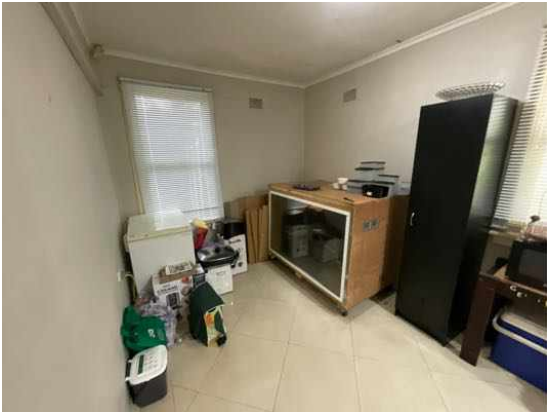
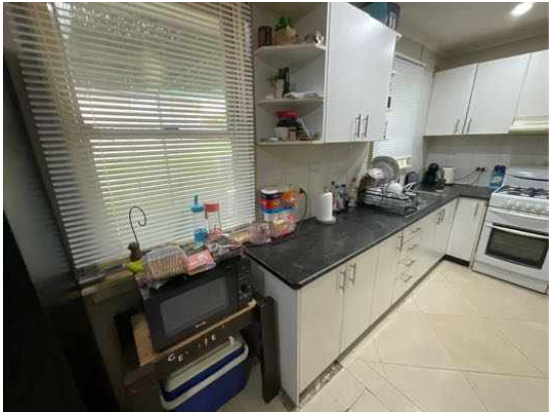
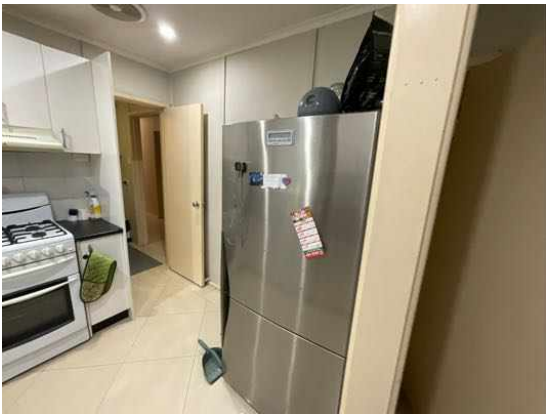
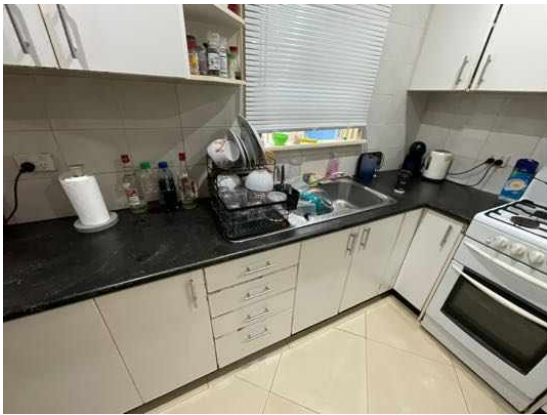
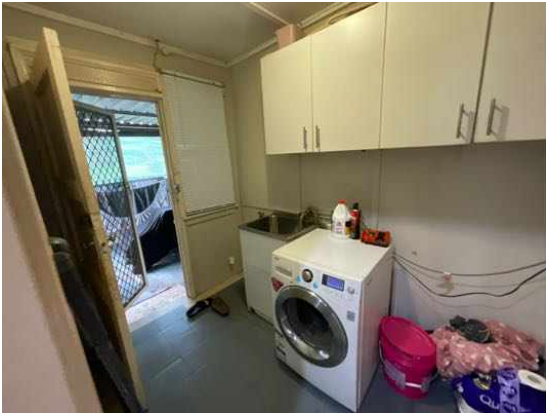
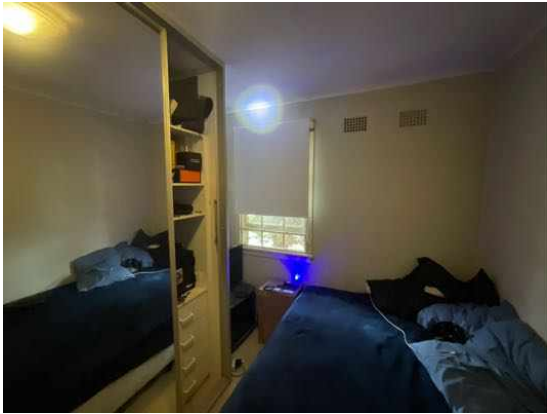
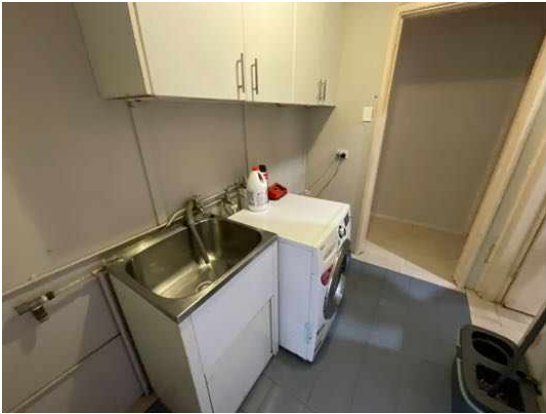
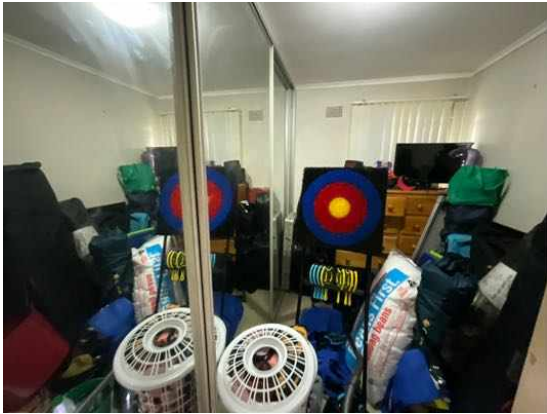
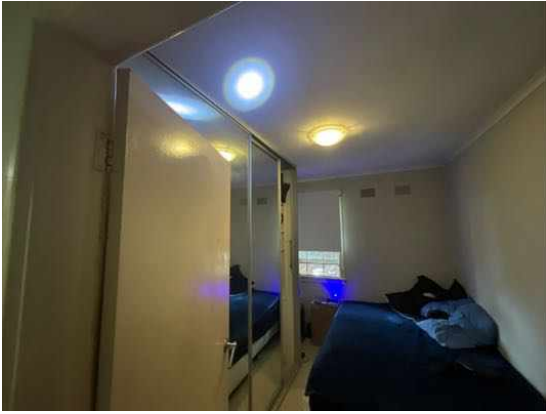
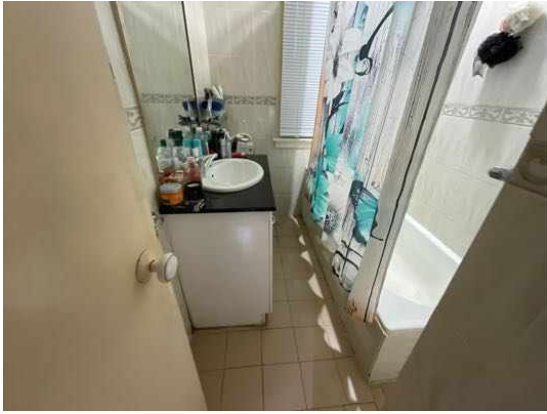
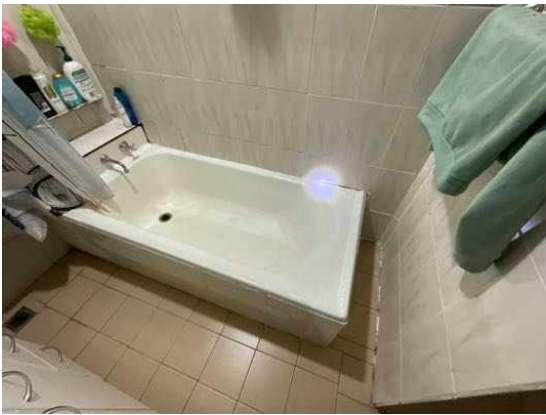
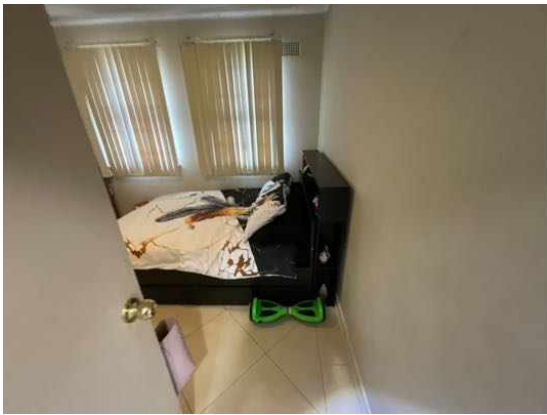
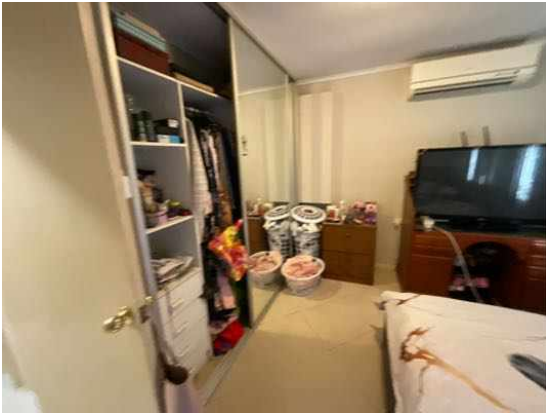
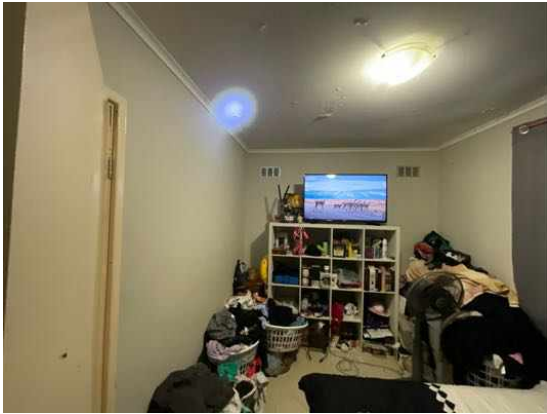
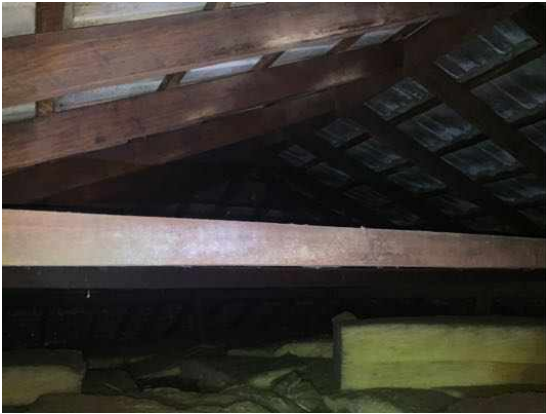
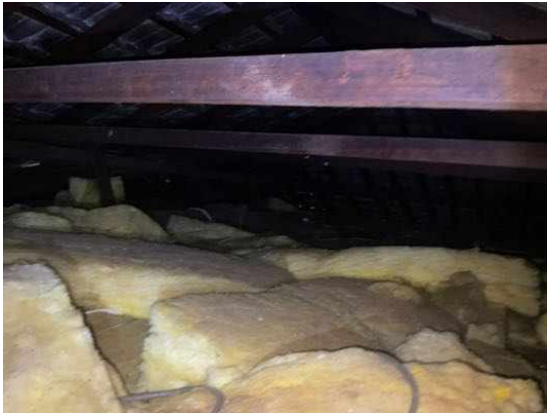
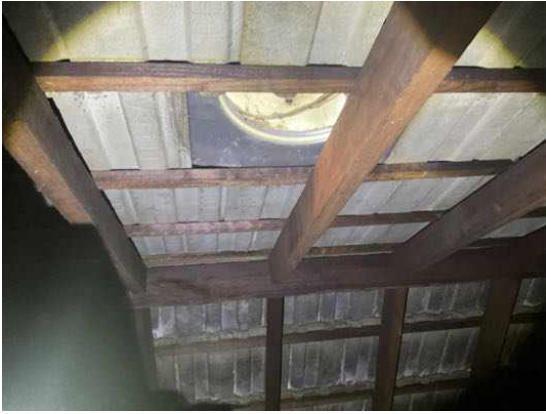
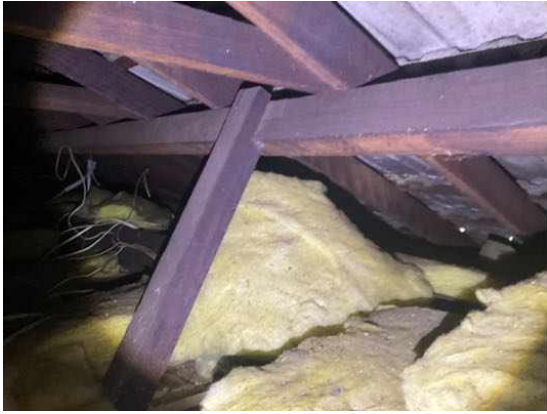
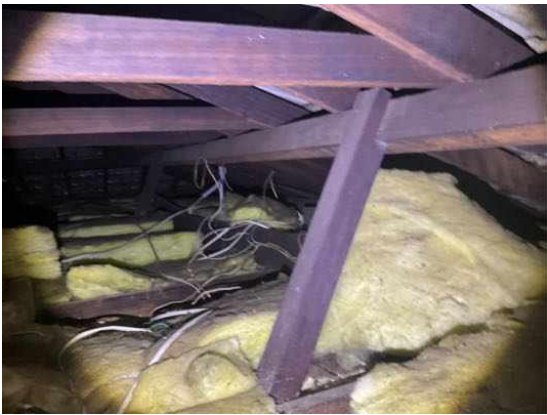
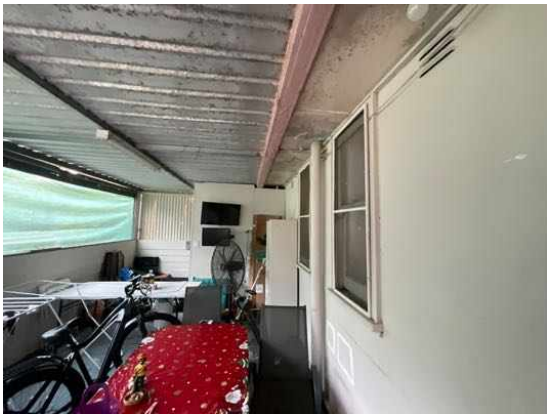
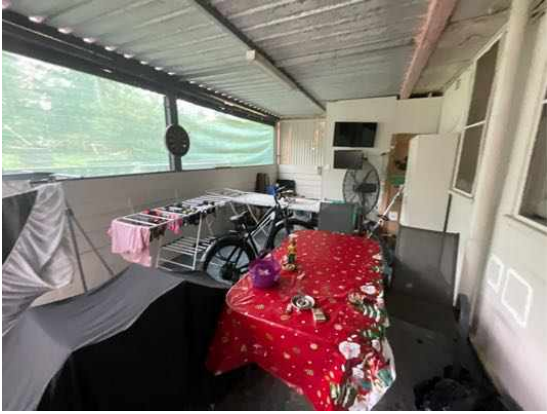
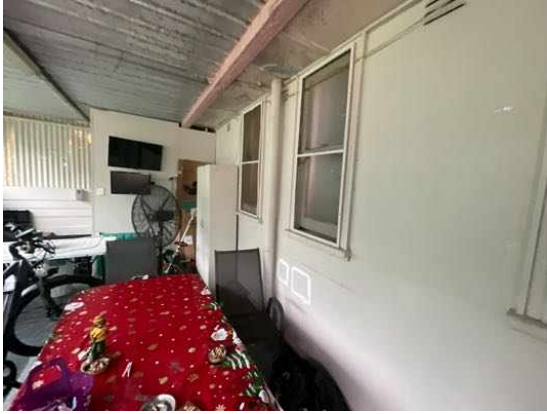
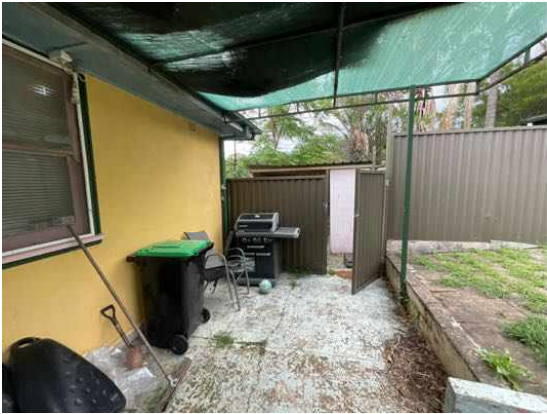
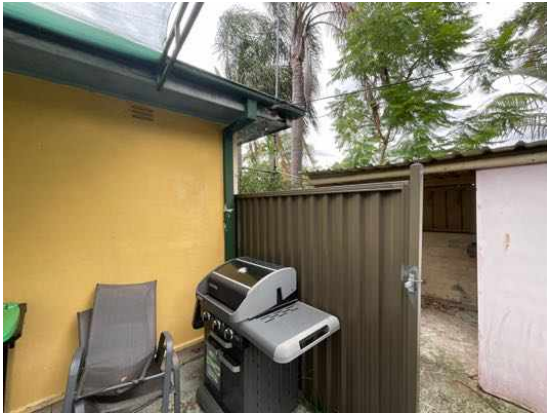
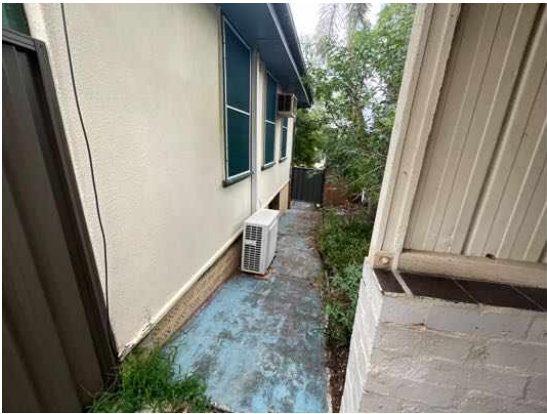
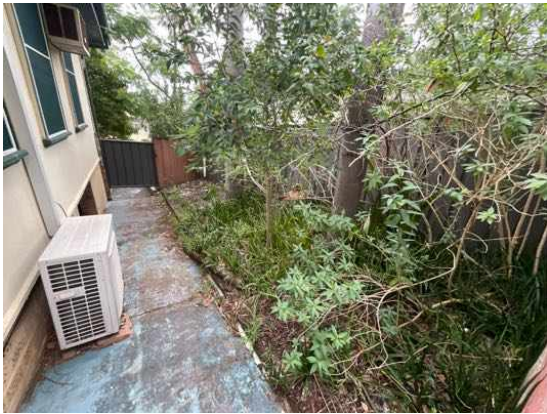
Building: Main Building  
Location: All Areas  
Finding: Additional Photos  
Information: Additional photos are provided for your general reference

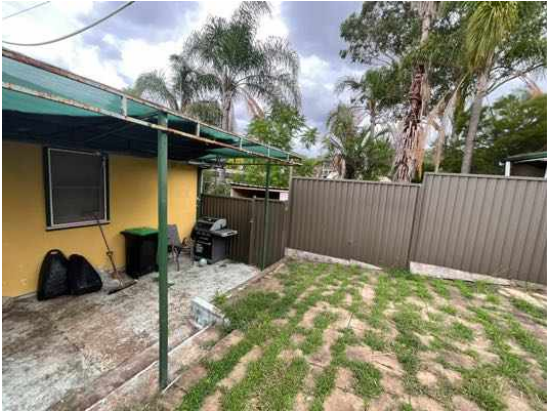
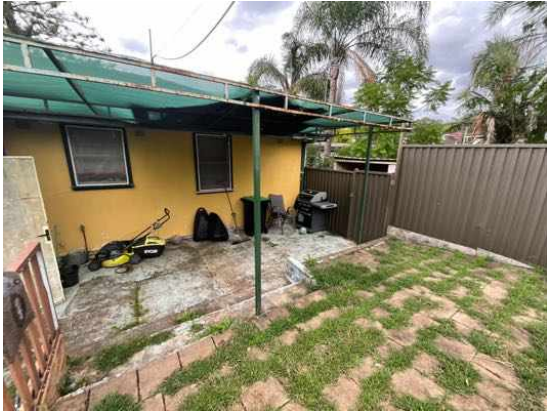
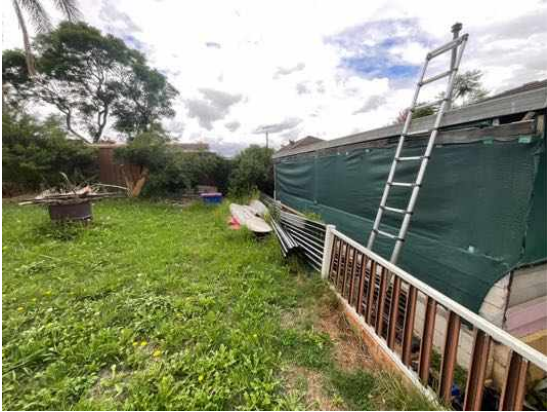
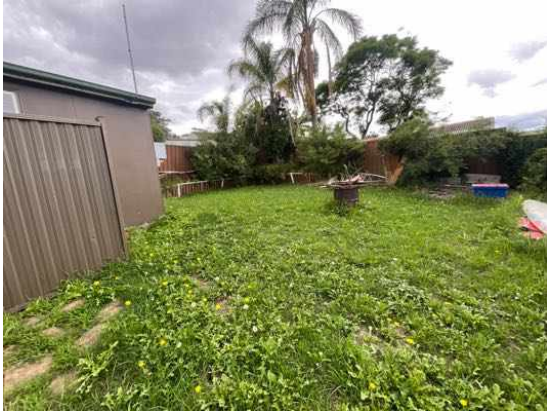
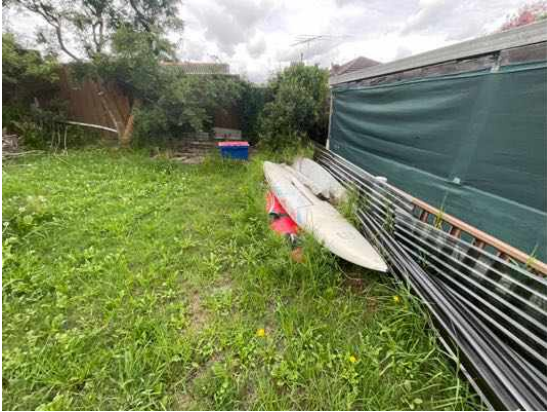
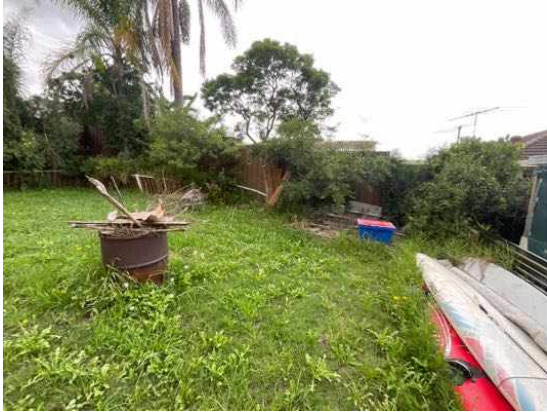
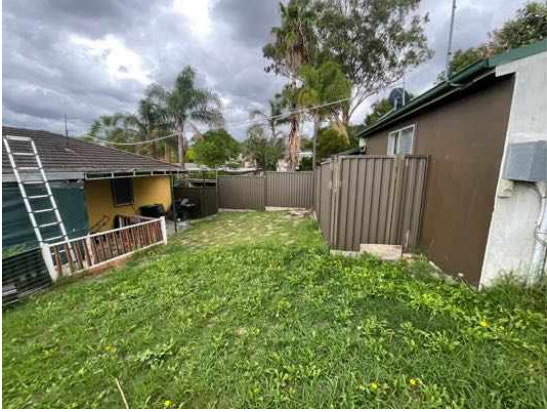
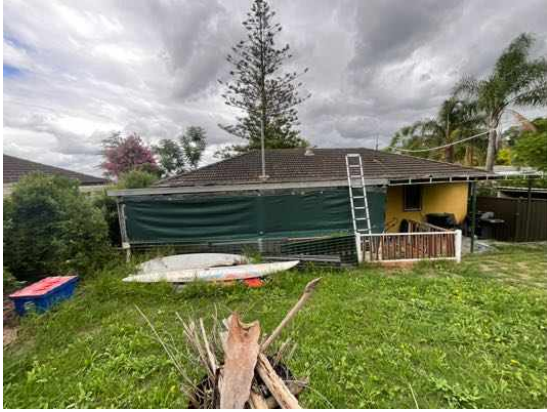
Information: These photographs are an indication of the obstructions and limitations which impeded full inspection of the property at the time of inspection. These obstructions can hide an array of defects and should be removed to allow full inspection to be carried out. A re-inspection is recommended once the areas are made accessible.
