Building and Timber Pest Inspection Report

Inspection Date: Fri, 27 Feb 2026

Property Address: G05/690 Princes Highway, Kogarah NSW
2217

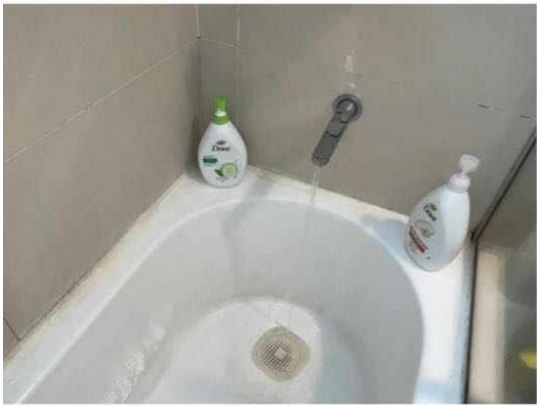
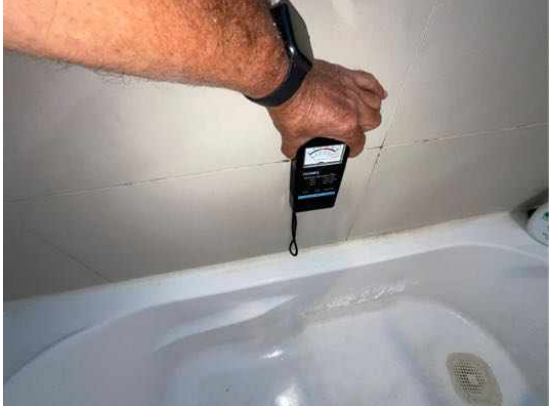
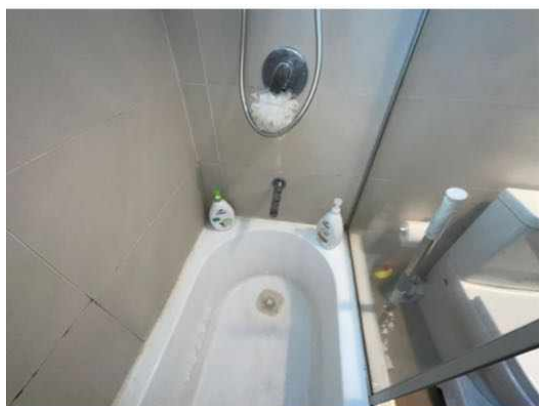
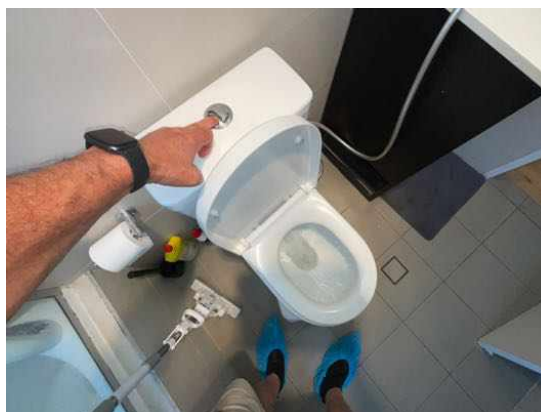
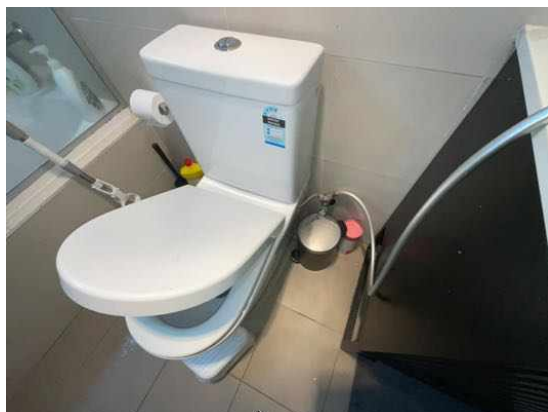
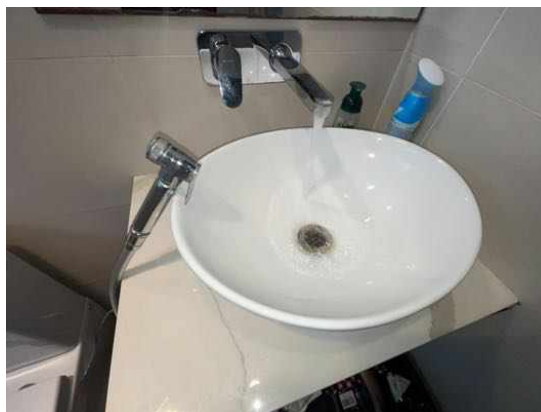
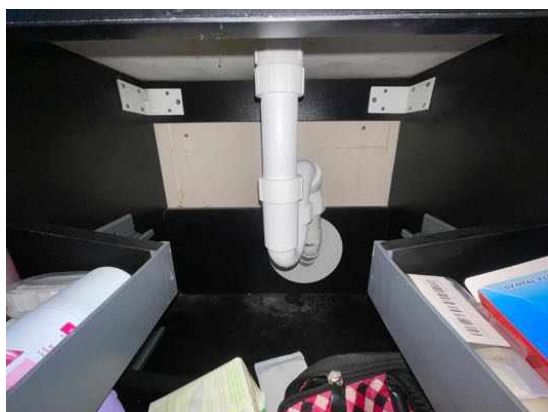
Building: Main Building
 Location: All Areas
 Finding: Water Pressure – Observation Only.
 Information: During the inspection, water pressure appeared to be within a normal operating range based on a basic functional check. However, this observation was made without the use of pressure testing equipment and does not constitute an assessment by a licensed plumber.

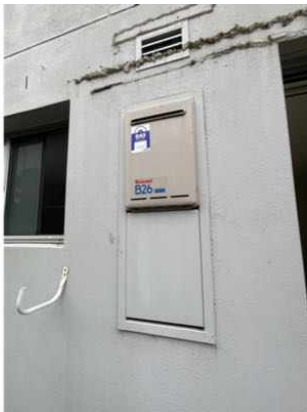
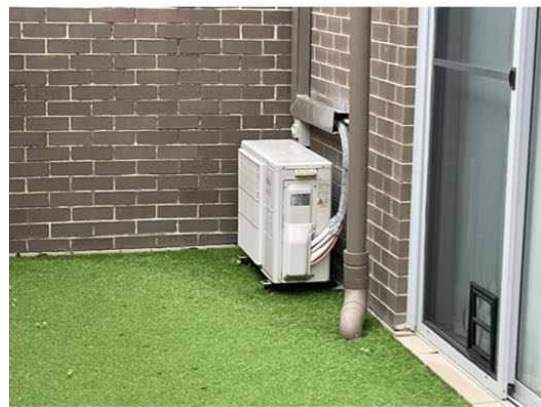
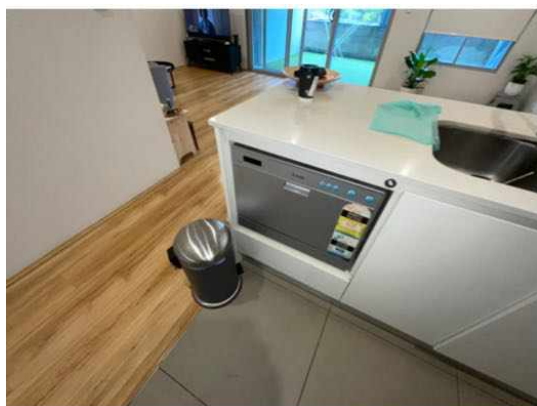
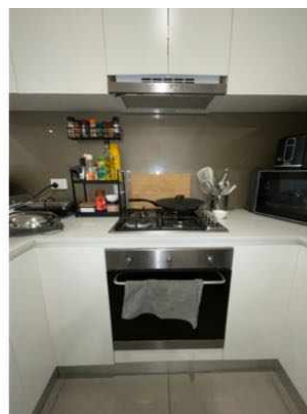
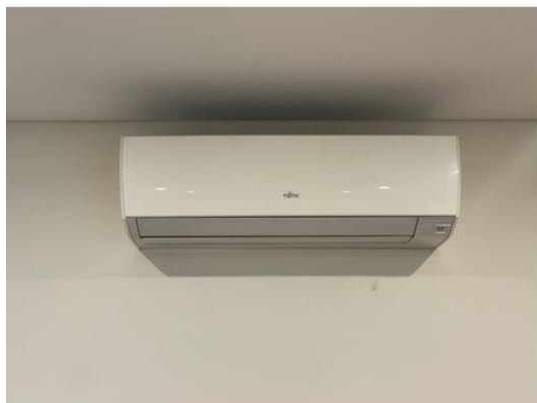
Additional photos have been supplied with this report for your general reference.
