Building Inspection Report

Inspection Date: Tue, 31 Mar 2026

Property Address: 5/92 New St, South Kingsville VIC 3015,
Australia

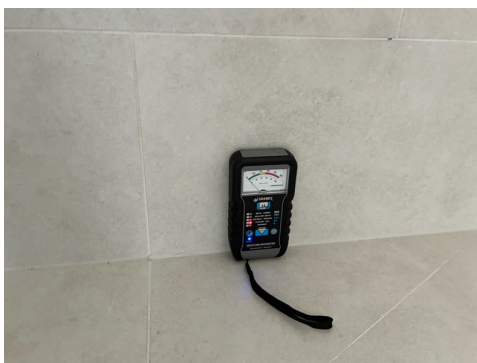
Defects 3.04

Finding: Shower moisture (damp) - Monitor

Information: At the time inspection moisture was evident to the lower 400mm of wall to the shower wall (shower head side only) of the Ground Floor Guest Ensuite. There is no high reading around the taps nor are there high readings transferring to the other side of the wall. Both sealant and grout appear in acceptable condition at present.

Always ensure that sealant and grout is in good condition to prevent any moisture issues occurring in the future.

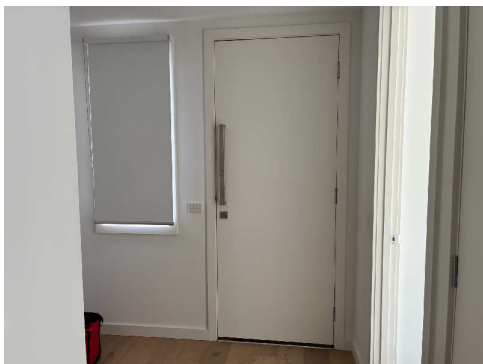
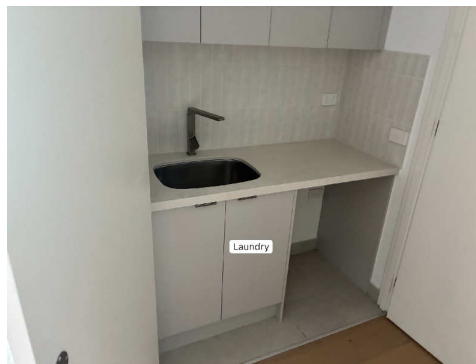
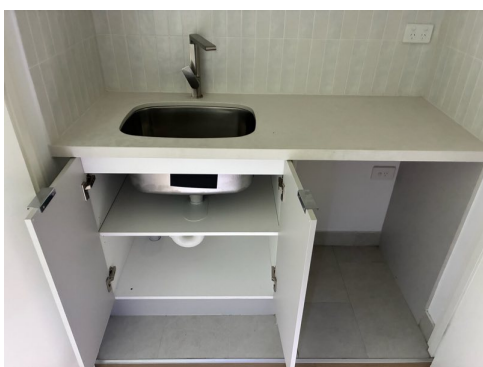
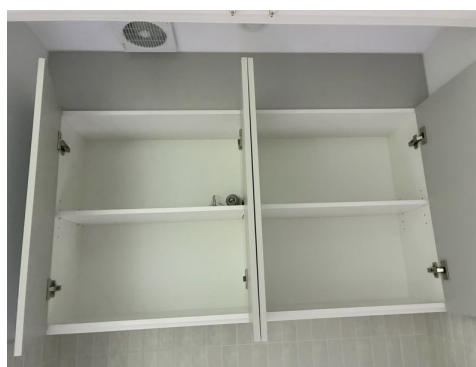
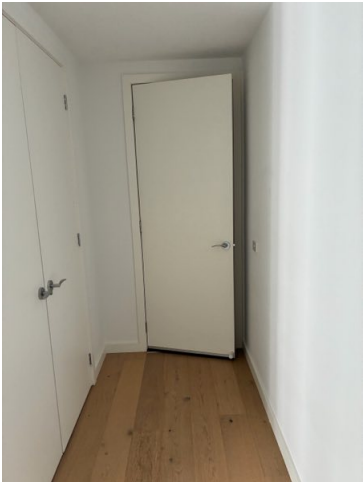
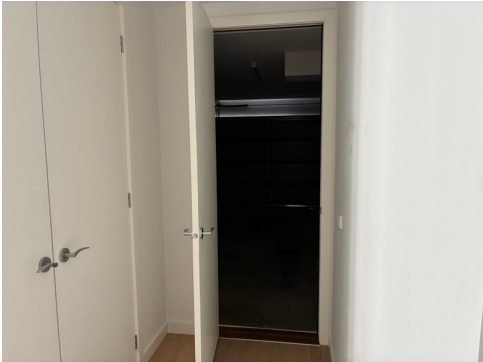
Finding: Additional Photos - Obstructions/Limitations and general photos

Information: These photographs are an indication of the obstructions and limitations which impeded full inspection of the property at the time of inspection. These obstructions can hide an array of defects and should be removed to allow full inspection to be carried out. A re-inspection is recommended once the areas are made accessible.

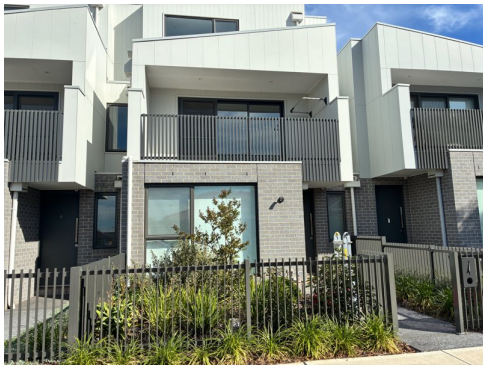
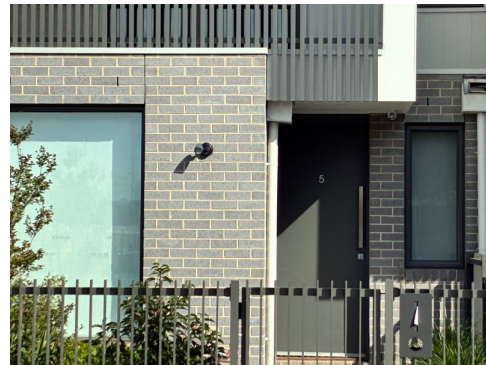
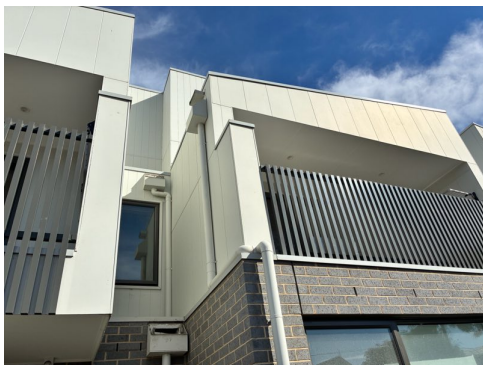
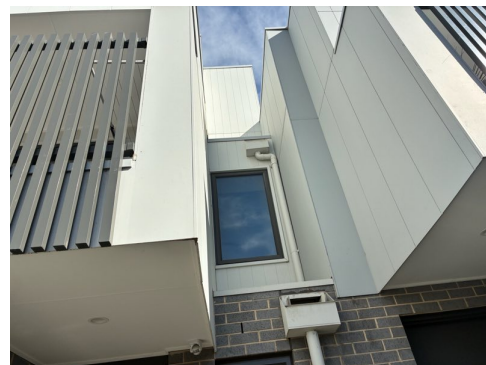
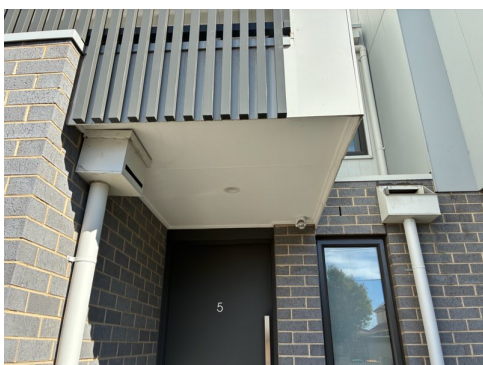
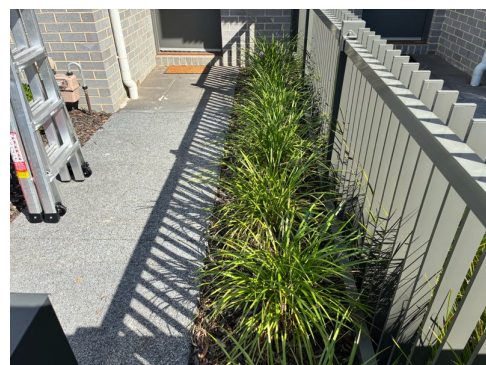
Finding: Additional Photos - Obstructions/Limitations and general photos

Information: These photographs are an indication of the obstructions and limitations which impeded full inspection of the property at the time of inspection. These obstructions can hide an array of defects and should be removed to allow full inspection to be carried out. A re-inspection is recommended once the areas are made accessible.
