Building and Timber Pest Inspection Report

Inspection Date: Tue, 10 Mar 2026

Property Address: 7 Lynch Cl, Epping VIC 3076, Australia

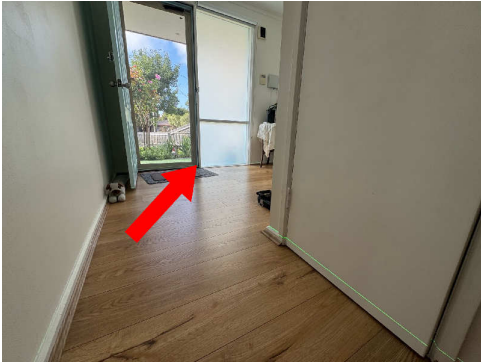
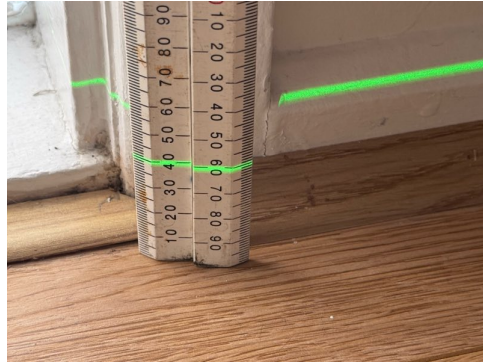
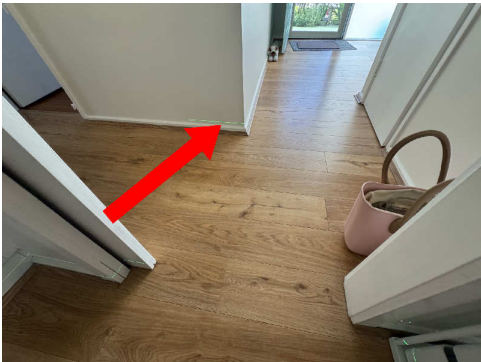
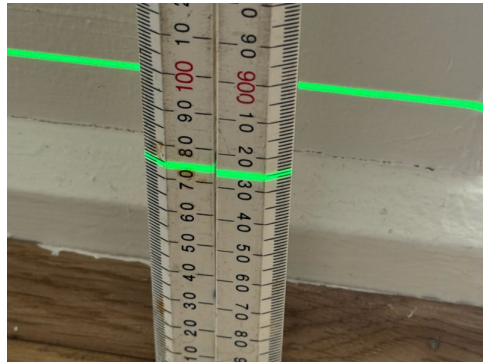
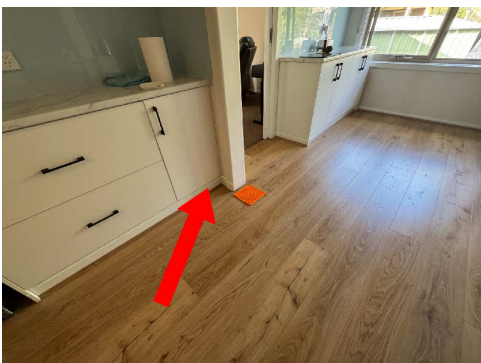
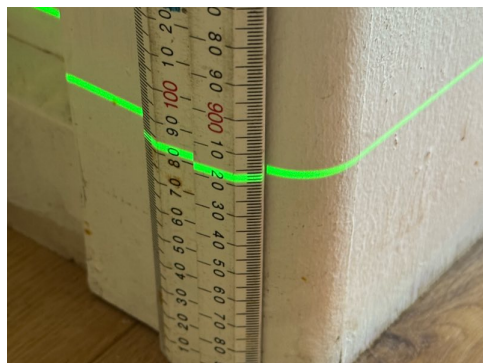
Information: It appears that the subfloor structure has been affected by movement of the foundations, often referred to as sinking or subsidence. A degree of movement is expected in subfloors over time, especially as environmental conditions change and buildings settle after construction.

The apparent subsidence is evidenced by some or all of the following, gapping and movement to eave linings, gaps and cracks to brickwork, usually adjacent to windows or openings, excessive footpath movement and undulation of floors.

General subsidence is usually initiated by changes in soil moisture content. The most critical factor is identifying the specific causes, and identifying if this is a recurring or ongoing problem, or one that has been resolved by previous works in the past.

Subsidence can have complex and varying causes, which will influence the required remedial works. If movement continues It is advised to consult a structural engineer to determine if repair works are warranted. Works may include some form of underpinning, as well as addressing the underlying cause. Consultation with a geotechnical engineer may also be necessary where changes to soil moisture content is apparent.

A Registered Builder would then generally carry out works as advised by an Engineer.

At this point it is recommended to contain storm water flows, ensure pavements flow away from the building to lessen any excessive wetting and drying effects.

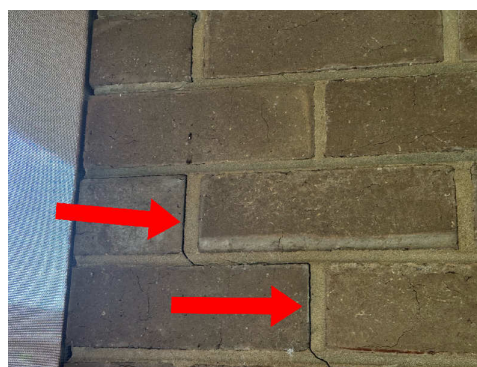
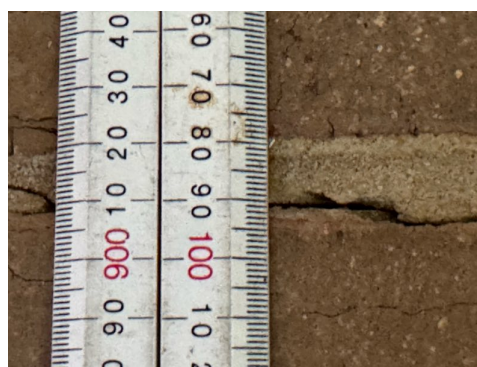
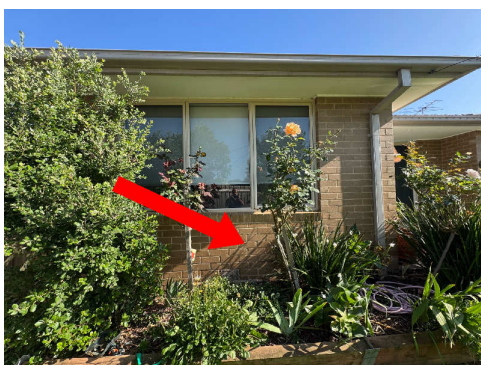
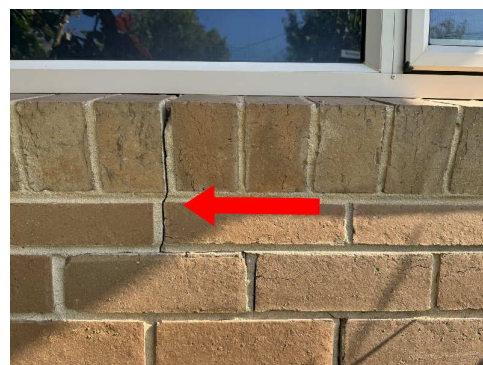
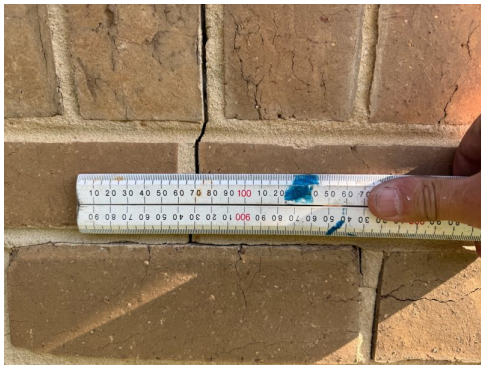
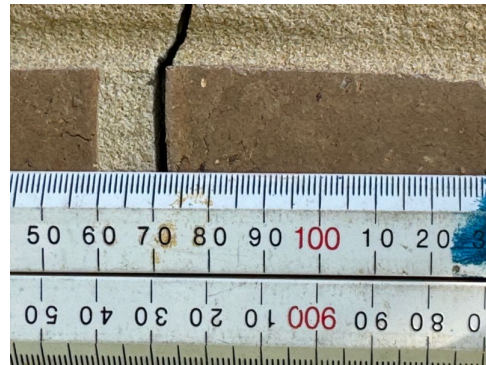
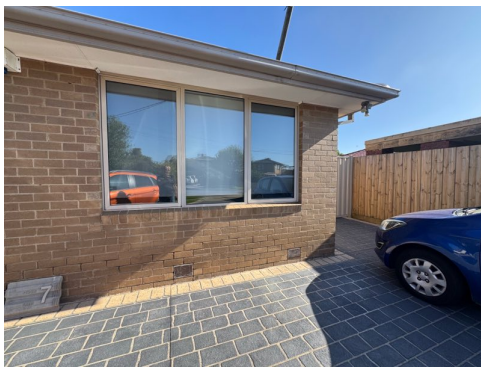
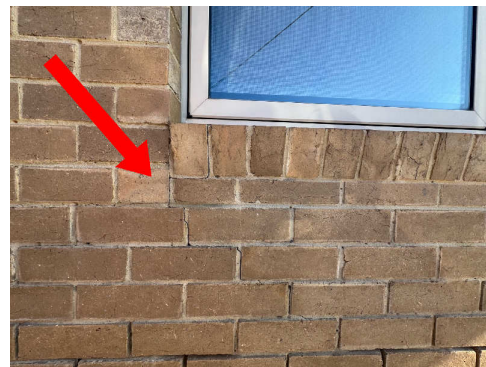
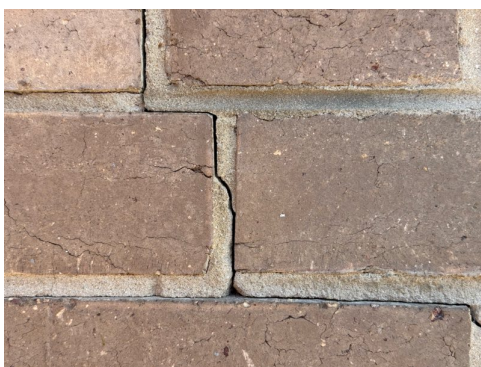
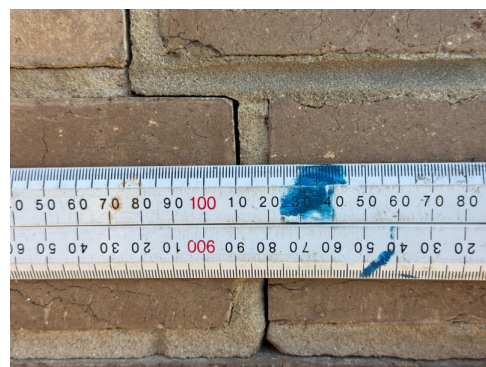
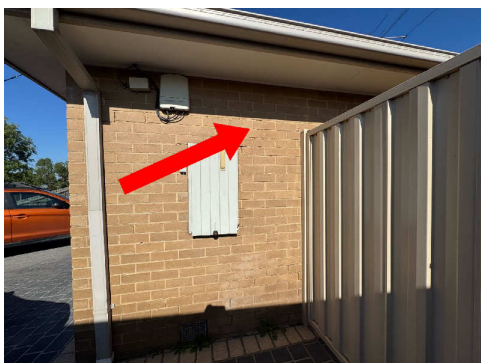
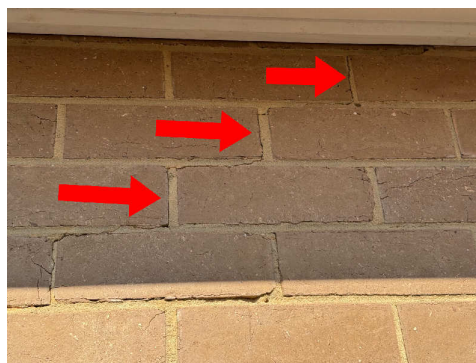
Finding 3.02

Building: Main Building
Location: Walls All Areas
Finding: Brickwork - Step cracking

Step cracking was identified to the brickwork in this area at the time of inspection. Step cracking, which is similar to other forms of cracking, has a variety of possible causes. However, the most common is the subsidence of adjacent footings.

Step cracking is a relatively common defect, and is most likely to occur adjacent to windows, doors and other openings. Mortar failure in the gaps between affected bricks indicates the stresses and tensions affecting the wall.

Where step cracking is extensive or severe, the client is advised to consult a structural engineer. Minor step cracking can be used as a warning sign to address factors causing stress to the wall, which can include the effect of surrounding trees, water leaks, soil erosion, or even the presence of reactive soils in the surrounding area.

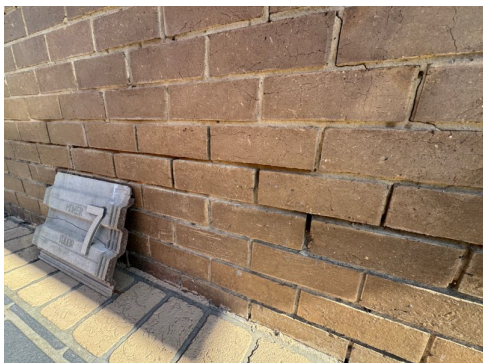
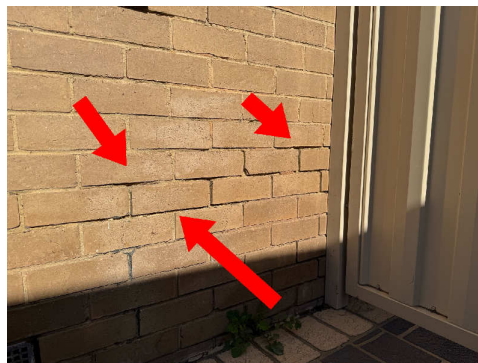
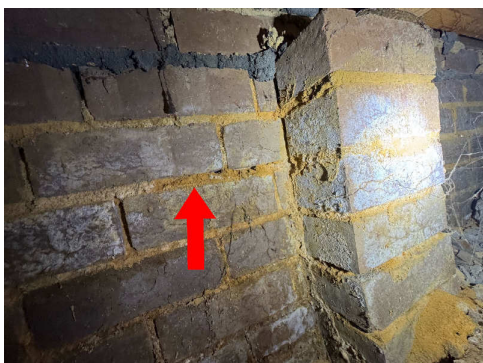
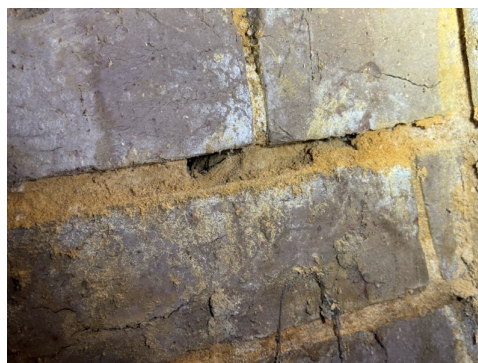
Finding 3.03

Finding: Brickwork - Deteriorated mortar

Information: Mortar, or 'bedding', is the material which fills joins and intersections between bricks in masonry walls and structures. Sections of mortar in this brickwork were identified as having deteriorated, which is generally expected for a property of this age and condition.

Mortar may deteriorate as a result of age of building materials, minor movement of bricks, or frequent exposure to weathering. Mortar should be replaced to ensure that bricks remain in their intended location and to prevent gaps, which would allow water or moisture ingress and secondary damage as a result.

Mortar deterioration can be addressed by a bricklayer where areas of deterioration are localised and easily accessible. Alternatively, appointment of a registered builder is advised, to repoint large areas of decaying mortar. Where secondary structural defects have become evident, consultation with a structural engineer may be required.

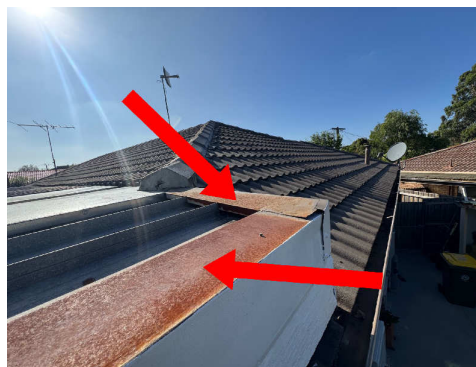
Finding 3.04

Building: Main Building
Location: Roof Exterior
Finding: Building element - Rusted or corroded

Information: This building element shows evidence of rusting and corrosion, which is likely to have developed as a result of excessive exposure to moisture and or inadequate coatings.

As surface rust provides no protection to the underlying iron, the deteriorating condition is likely to worsen if not addressed in the short-term future.

Where possible, the use of galvanized (treated) metals or aluminium coated metals aid in rust prevention, as does regular general maintenance. Rust formation can be controlled with coatings, such as paint, that isolate the iron from the environment.

Rusting and corrosion should be managed by ideally removing or limiting the affected surface from exposure to moisture. A registered builder may be appointed to replace any building elements that have been severely affected by rust or water damage.

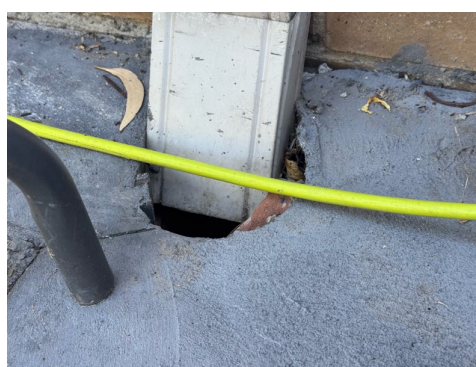
Finding 3.05

Building: Main Building
Location: Exterior walls - right side
Finding: Stormwater drain - Not sealed

Information: At the time of inspection it was noted that the storm water system was not sealed, creating potential for subsequent blockages and water damage to associated building elements
The storm water system should be sealed against vermin and debris entering the storm water system,

A qualified plumber should be appointed to further inspect the property and perform any necessary remedial works. It is also recommended that a CCTV inspection of the stormwater drainage system be carried out to identify any blockages, damage, or defects that may be contributing to poor site drainage. Water damage and secondary defects are likely to occur if the issue remains unmanaged.

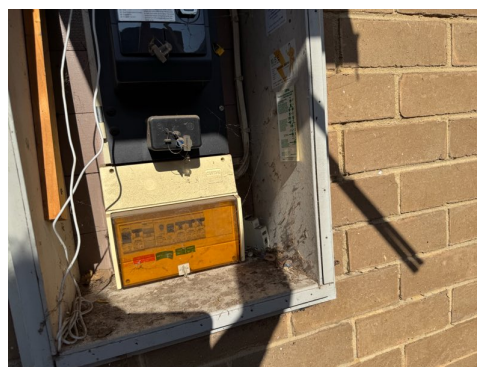
Information: The application of a post-construction chemical termite barrier is highly recommended for all properties, particularly if live termite activity has been found on the site previously. Such barriers are highly effective in preventing termite attack on any timber building elements throughout the property.

A durable notice should be placed in the switchboard unit to indicate current termite barriers. At the time of inspection, it appeared as though no termite management system has been installed, with no evidence to suggest preventative works taking place.

The client may consider gaining further advice from a pest controller as to the costs and procedures involved with this application. It is recommended that obtaining such advice be a short-term priority.

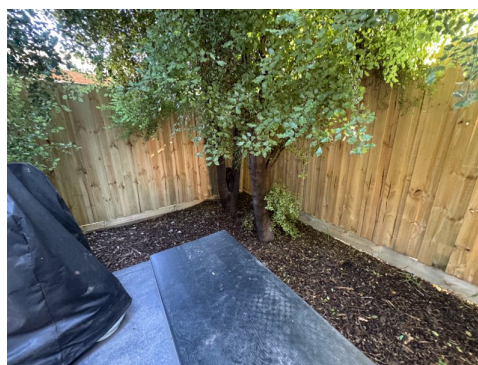
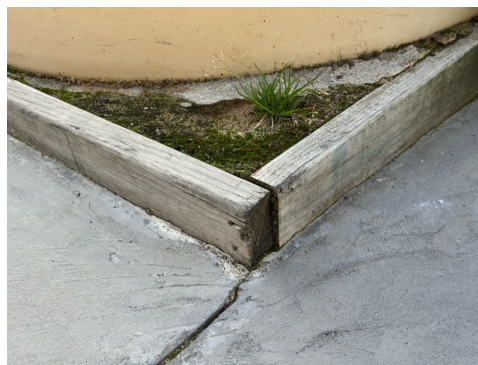
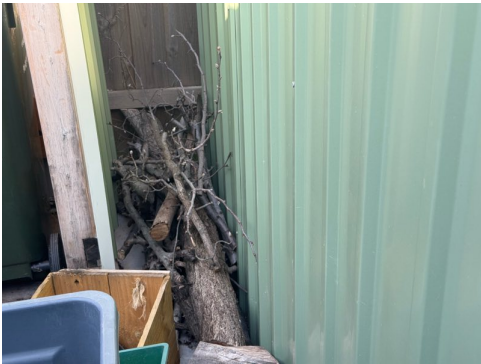
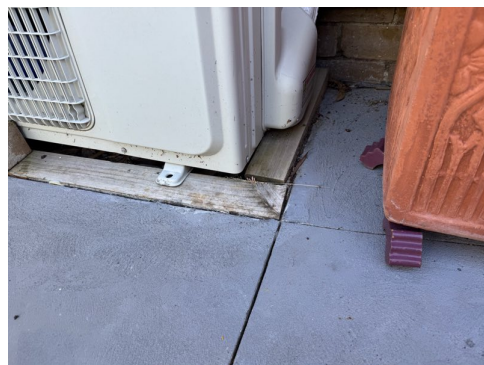
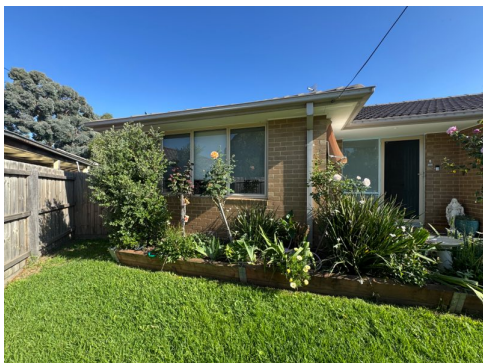
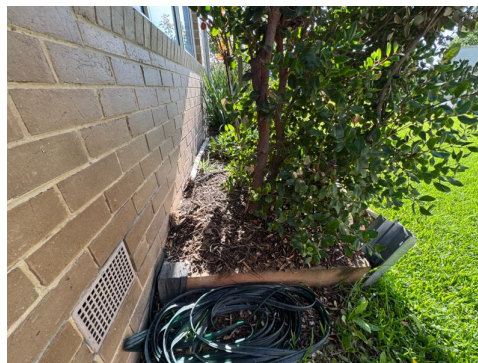
Finding 6.02

Building: Main Building
Location: All External Areas
Finding: Building materials in direct ground contact - conducive to termites

Where timber elements are in direct contact with the ground and consequently moisture or dampness they become conducive to termite activity. Whether timber is used as a building element part of a fencing structure or stored as an unused item they can provide an environment that is attractive to termite infestation.

The removal of any such materials that may be conducive to termite activity should be removed as soon as possible to minimise the risk of termite attack. Where it is not possible frequent inspections of these areas shall be undertaken to provide early detection of infestation

It is highly recommended that termite or timber pest inspections be carried out every 6-12 months to aid protection of the property against infestation.

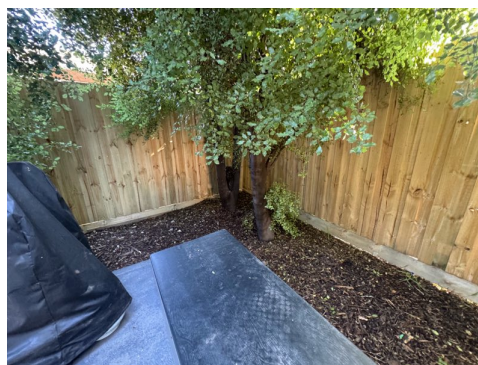
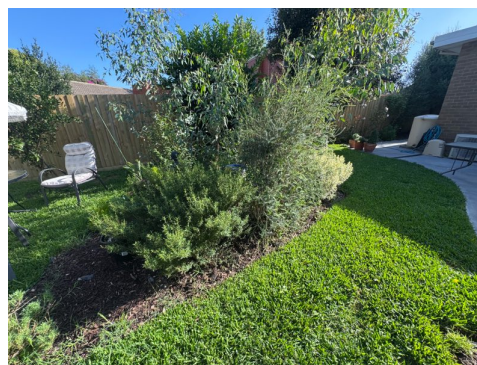
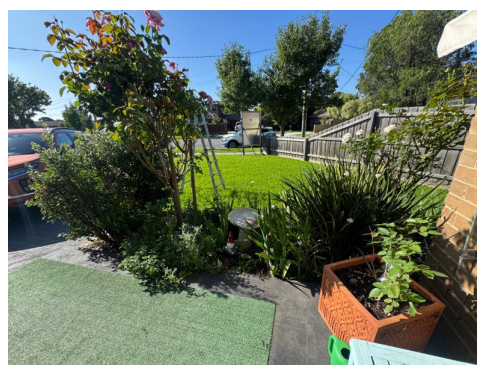
Finding 6.03

Finding: Garden Beds - Conditions Conducive to Termites

Information: Garden beds were found at the time of inspection. These garden beds can include untreated timber, and with a combination of moisture from watering hosing can make conditions conducive to termite activity and termite ingress.

The building of gardens or planting of shrubs close to the perimeter of the building may promote termite activity. It is highly recommended that termite or timber pest inspections be carried out every 6-12 months to aid protection of the property against infestation.

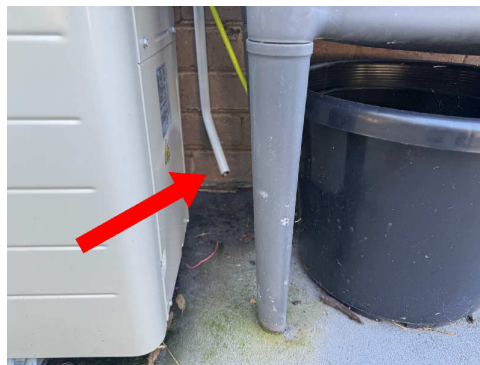
Finding 6.04

Finding: Air conditioner - Disconnected overflow

Information: The Air Conditioner (A/C) overflow was found to be disconnected from storm water drainage and is creating excessive moisture in the surrounding area. Such leaking creates an environment which is conducive to an array of defects, including water damage to associated building elements and the attraction of termite or timber pest infestation. It is highly recommended that a licensed plumber be appointed to connect the A/C overflow in order to prevent such an environment from being created. These minor works should be carried out as soon as possible.

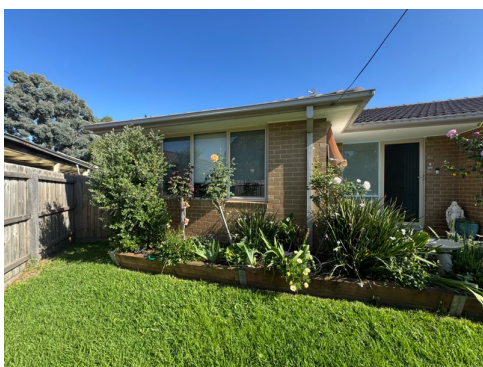
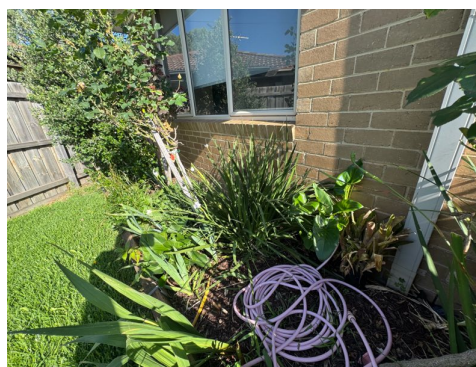
Finding 6.05

Building: Main Building
Location: Yard - Front
Finding: Bridging - Vegetation

The removal and replanting of species that do not provide "cover" or cutting back of existing vegetation will greatly assist in preventing bridging.

To minimise the risk of termite attack, materials conducive to termite activity should be removed as soon as possible, and re-inspection should be arranged.

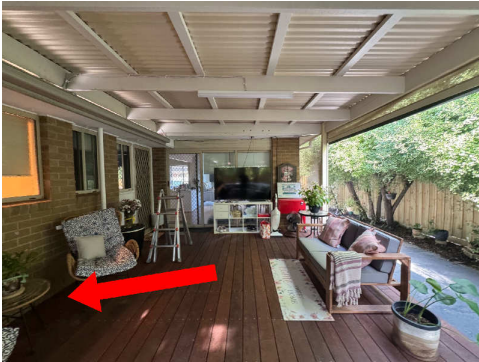
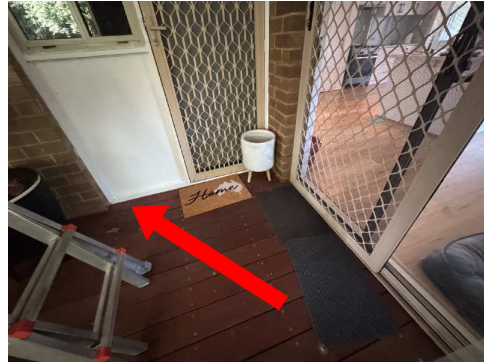
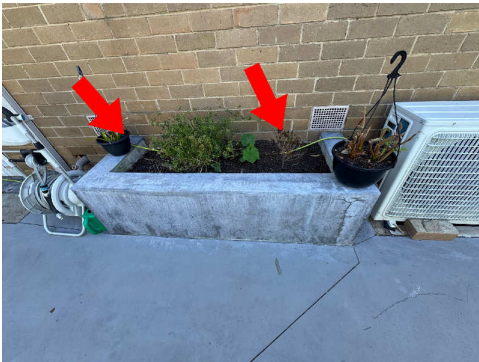
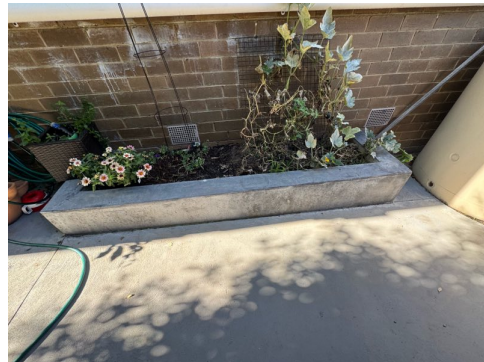
Finding 6.07

An array of debris was found in the subfloor area at the time of inspection. Debris in this area restricts subfloor ventilation and creates potential for concealed pest entry. Stored timbers and other materials may also make the area susceptible to termite activity and wood rot.

A clear and empty subfloor will be better ventilated and easier to maintain in a dry condition. The removal of any timber debris is vital in minimising the risk of termite or wood borer activity.

Debris in the subfloor should be removed as soon as possible. Depending on the location and amount of debris and stored items, the homeowner may elect to undertake this task. Alternatively there are a large number of rubbish removal subcontractors that could undertake these works.

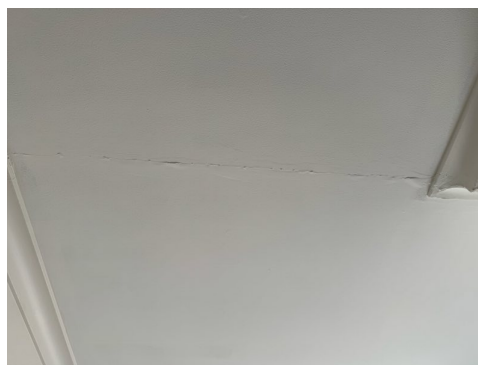
Finding: Cracking - Damage Category 1 - Fine (up to 1mm)

Information: Although fine cracks are quite noticeable, they are often only considered to be an appearance defect, and usually do not indicate any structural damage. Generally, the cause of a fine crack is indicative of a separation between building materials and finishes (e.g. paint, plaster, etc.) along joints.

Cracking of this nature can generally be repaired with minor sanding, filling and/or repainting. Such works should be performed by a qualified painter or a general handyman.

Monitoring of all cracking should be conducted frequently. Always contact a building inspector should cracks widen, lengthen, or become more numerous.

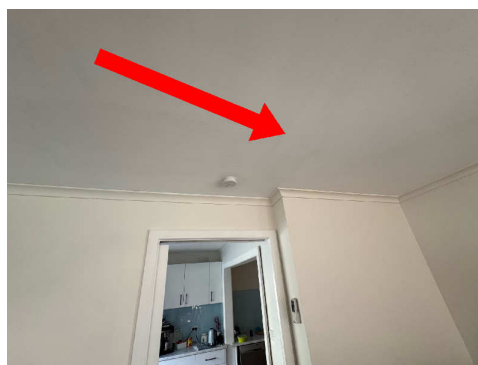
Finding: Cracking - Damage Category 0 - Hairline (less than 1 mm)

Information: Hairline cracks are very minor in nature and generally are only ever an appearance defect. While such cracking may be noticeable in some cases, it is quite common and does not indicate any structural damage.

Cracking of this nature can generally be repaired with minor sanding, filling and/or repainting. Such works should be performed by a qualified painter or a general handyman.

Monitoring of all cracking should be conducted frequently. Always contact a building inspector should cracks widen, lengthen, or become more numerous.

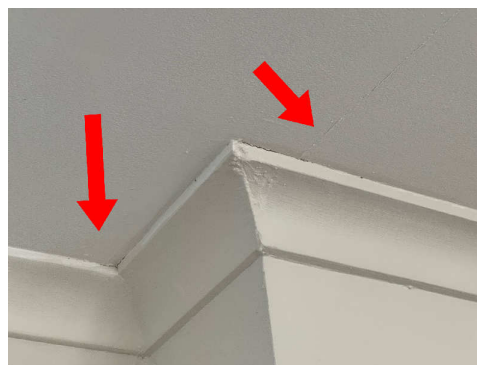
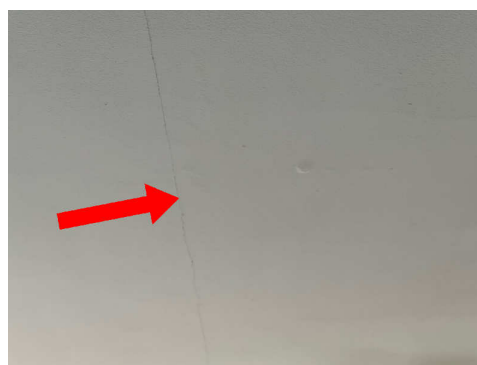
Finding: Cracking - Damage Category 0 - Hairline (less than 1mm)

Information: Hairline cracks are very minor in nature and generally are only ever an appearance defect. While such cracking may be noticeable in some cases, it is quite common and does not indicate any structural damage.

Cracking of this nature can generally be repaired with minor sanding, filling and/or repainting. Such works should be performed by a qualified painter or a general handyman.

Monitoring of all cracking should be conducted frequently. Always contact a building inspector should cracks widen, lengthen, or become more numerous.

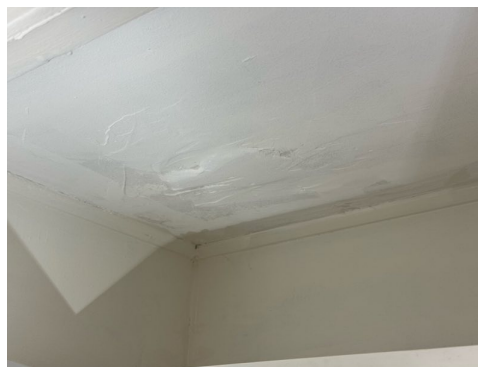
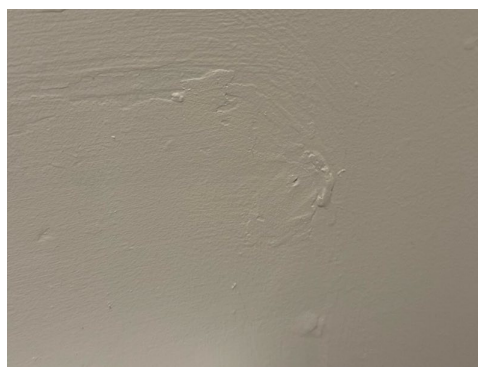
Building: Main Building
Location: All Internal Areas
Finding: Paint finish - Substandard (all areas)

The paint finishes throughout the property were found to have been completed to a substandard level. Substandard painting is generally classified as an appearance defect. However, the substandard appearance may also be indicative of poor surface preparation and substandard workmanship.

If this applies, further areas of poor and incomplete finishes could develop over time. Furthermore, substandard paint finishes in areas exposed to moisture, e.g. external areas or wet areas, could lead to deterioration of underlying building materials.

Substandard paint finishes should be sanded back, filled, leveled and repainted, as applicable.

A painting contractor should be appointed to perform necessary works to aid the appearance of the affected area and to ensure that the area is protected against further deterioration at the clients discretion.

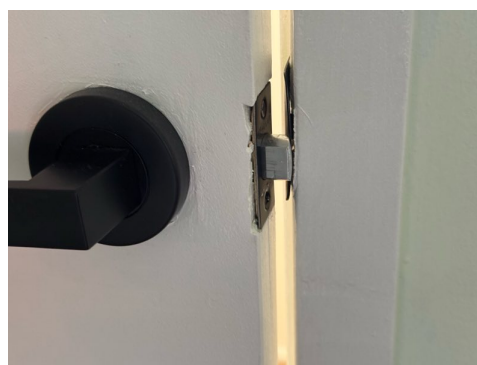
| Finding: | Door - Striker plate misaligned |
| Information: | <p>The striker plate to this door appears to have become misaligned and has consequently resulted in the door's operation being compromised.</p> <p>This is a common defect, whether being due to substandard installation or general deterioration of the door hardware.</p> <p>Readjustment of the striker plate is recommended as soon as possible to improve the operational state of the associated door.. Works such as these can be completed by a qualified carpenter or general handyperson.</p> |

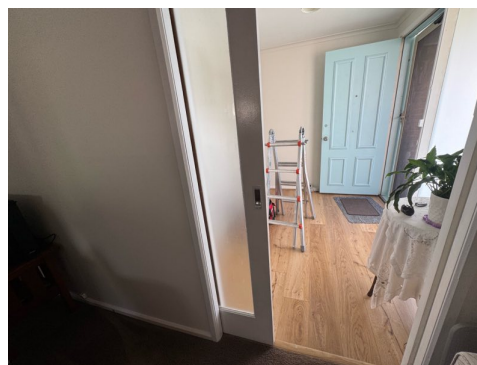
| Finding: | Door - Stiff to slide |
| Information: | <p>The door to this area was difficult to slide along the associated track at the time of the inspection.</p> <p>Generally, factors such as the general age of the building element and a lack of maintenance are the usual causes for this defect.</p> <p>Minor repairs and/or cleaning is advised to improve the operational state of the associated door.</p> <p>A qualified carpenter or general handyperson should be appointed to perform rectification works as soon as possible.</p> |

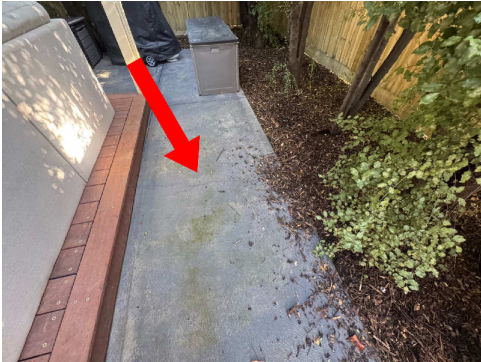
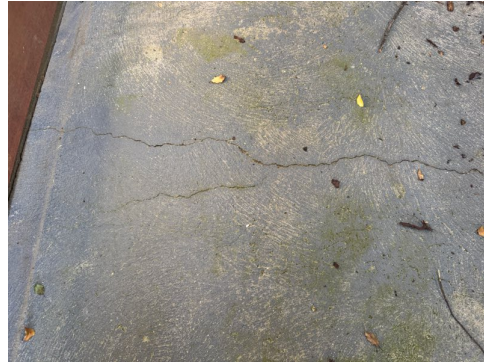
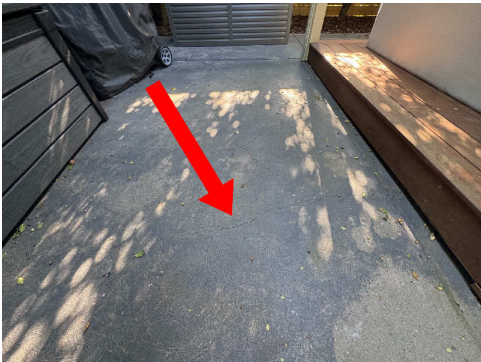
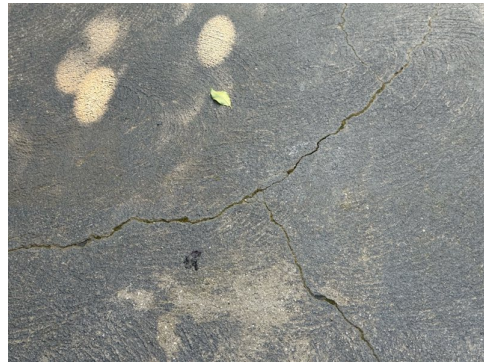
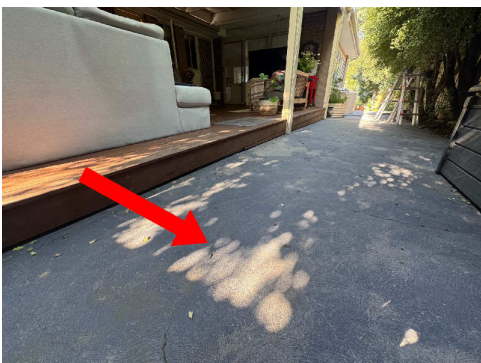
Finding: Cracking - External Concrete Paving Damage Category 0 - Hairline (less than 1mm)

Information: Hairline cracks were identified in external concrete paving. Hairline cracks are very minor in nature and generally are only ever an appearance defect. To be classified as a Category 0 or hairline crack, the crack width would be less than 0.3mm. While such cracking may be noticeable in some cases, it is common and does not indicate any structural damage.

Generally the cause of a hairline crack in existing concrete paving such as driveways and pathways is indicative of the expansion and contraction of the concrete. Such causes are generally due to environmental factors, such as moisture levels, weather conditions, root systems of nearby trees or the soil types on which they are laid.

Hairline cracks may also be due to poor original installation of the concrete. Factors such as poor compaction of the sub surface and/or inadequate reinforcing of the slab may create cracking and other secondary defects.

Monitoring of all cracking should be conducted frequently. Always contact a building inspector should cracks widen, lengthen, or become more numerous.

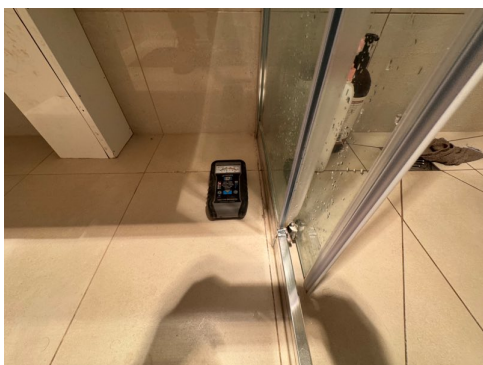
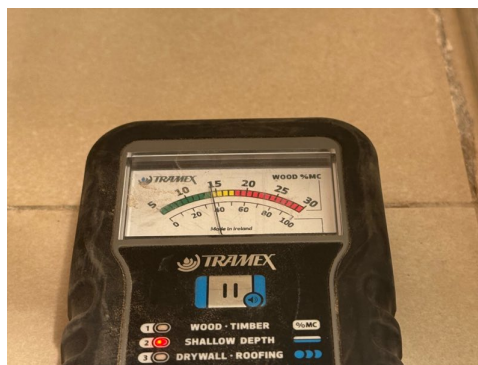
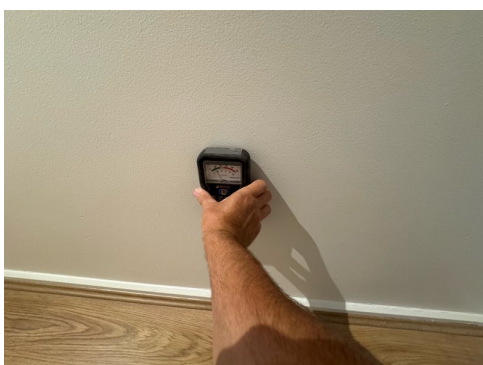
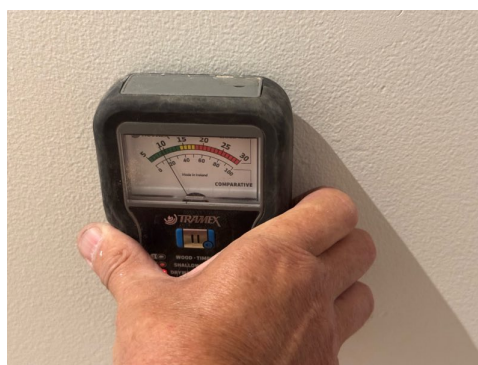
Information: There was no visible evidence of water escape from the accessible areas around the wet areas of the property at the time of inspection. Plasterboard walls, ceilings, carpet, cabinetry or timber skirting adjoining the wet areas showed no evidence of water staining or damage. Moisture readings taken did not indicate any areas of elevated dampness to the external areas and to the opposing walls. The client should be aware that all wet areas should be inspected regularly. Deteriorated grout and sealants should be immediately addressed to prevent water from escaping. Even the smallest break in sealants or grout will allow water to escape into the adjoining structures. If there are any signs of deterioration to sealants and grout, cracked tiles or bases, water damage or water escape a registered building practitioner should be immediately engaged.

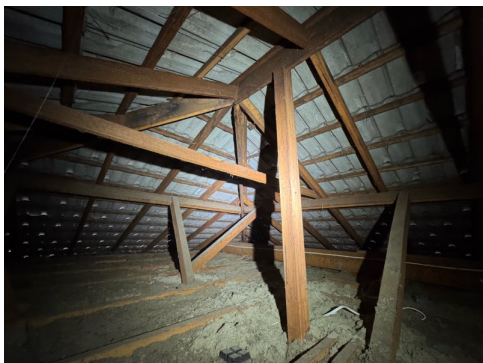
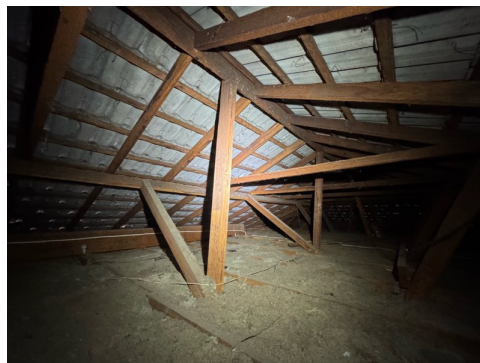
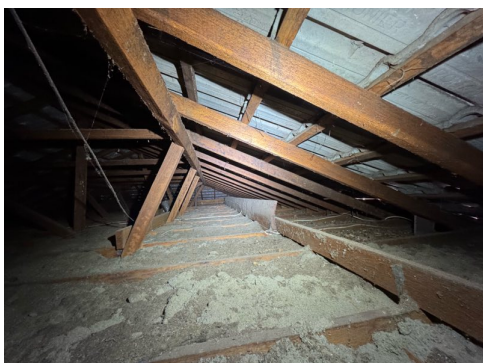
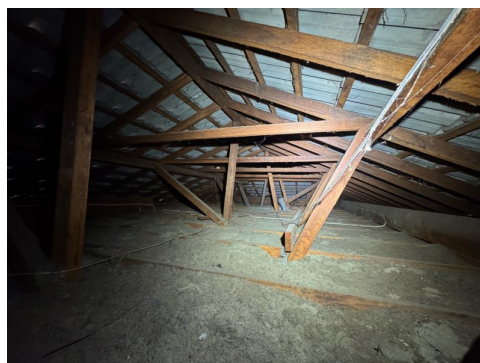
Finding: Additional Photos - Obstructions and Limitations

Information: These photographs are an indication of the obstructions and limitations which impeded full inspection of the property at the time of inspection. These obstructions can hide an array of defects and should be removed to allow full inspection to be carried out. A re-inspection is recommended once the areas are made accessible.

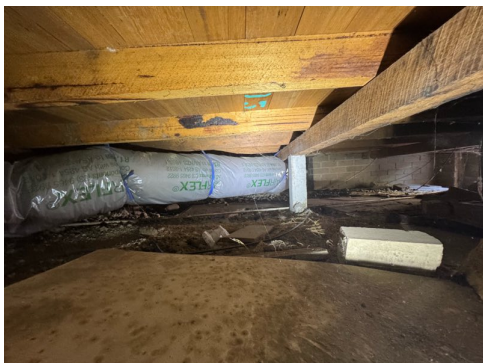
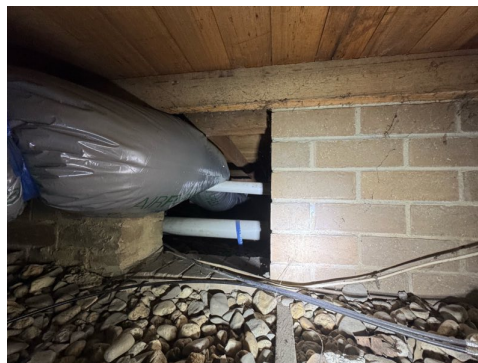
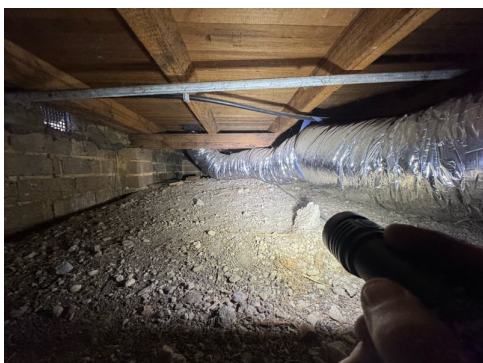
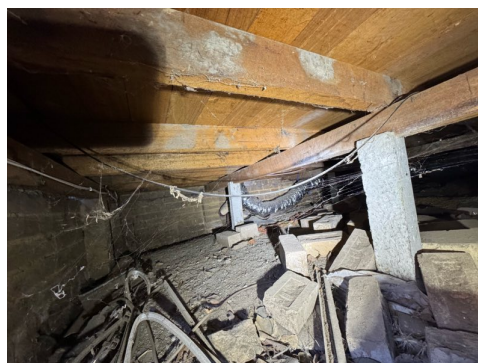
Finding: Additional Photos - Obstructions and Limitations

Information: These photographs are an indication of the obstructions and limitations which impeded full inspection of the property at the time of inspection. These obstructions can hide an array of defects and should be removed to allow full inspection to be carried out. A re-inspection is recommended once the areas are made accessible.

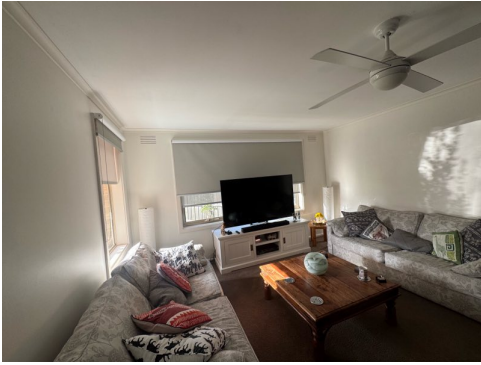
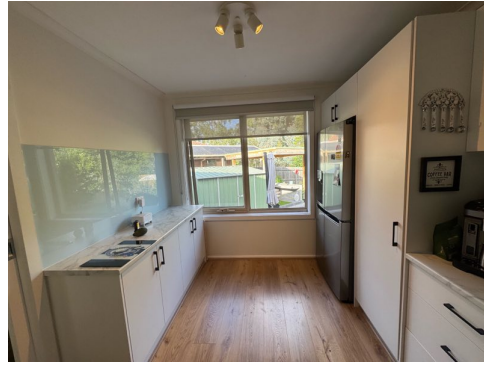
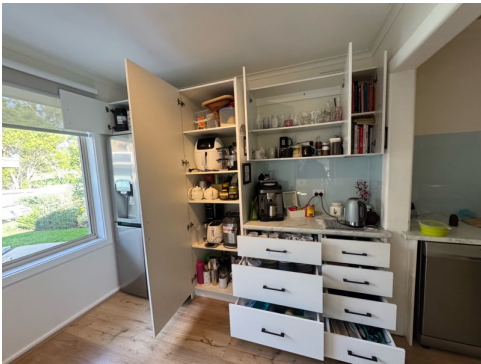
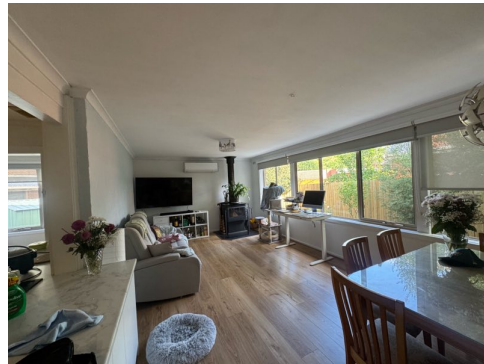
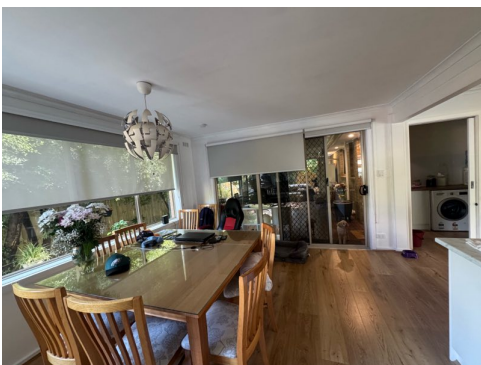
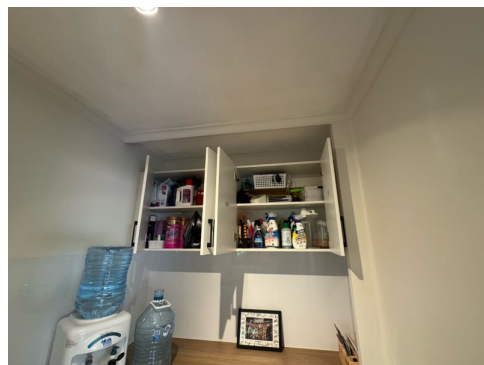
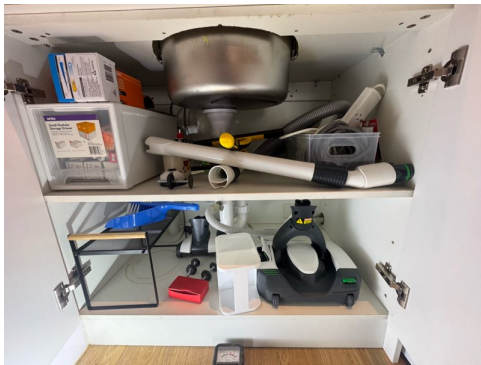
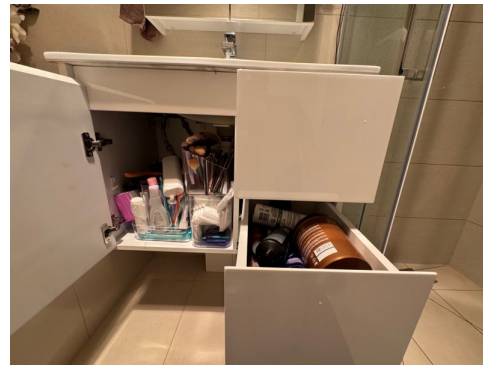
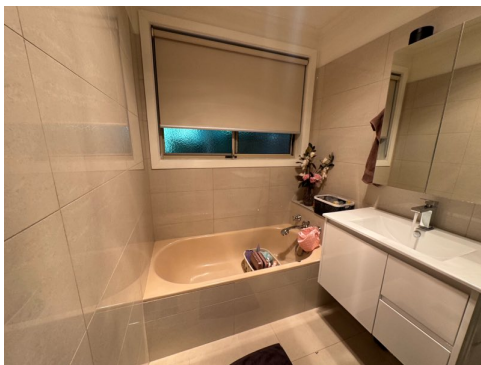
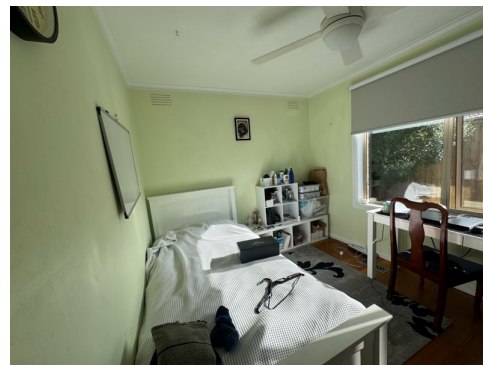
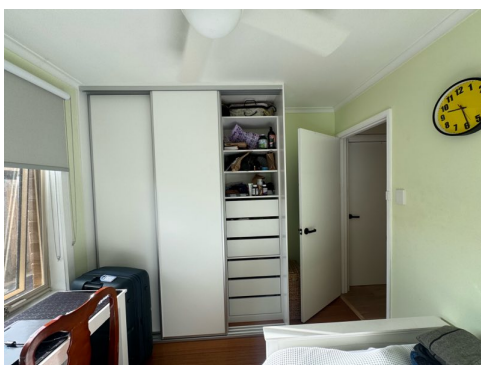
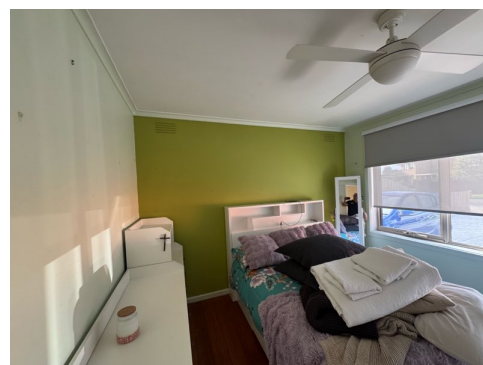
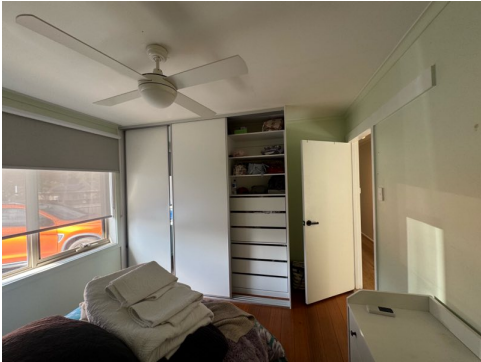
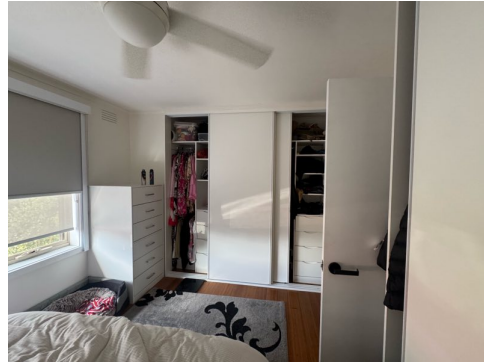
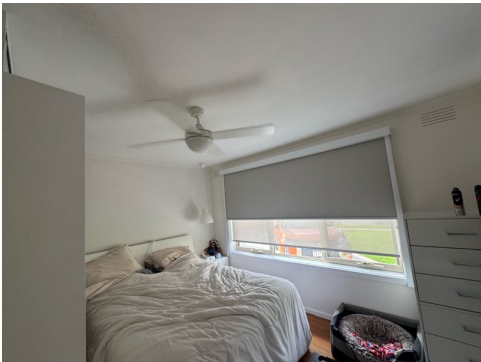
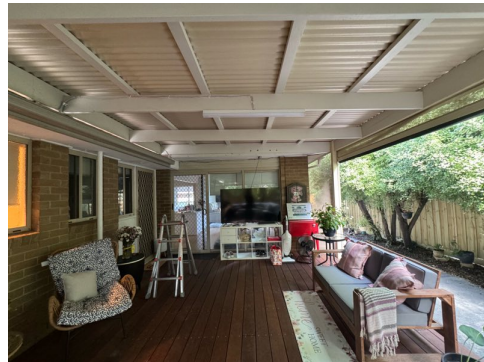
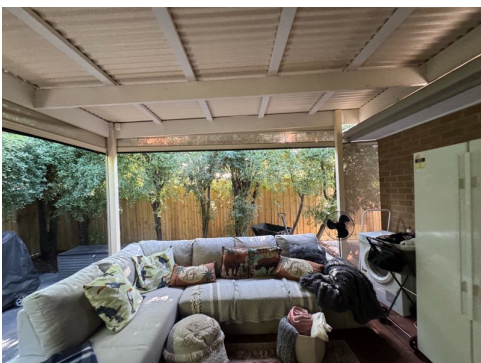
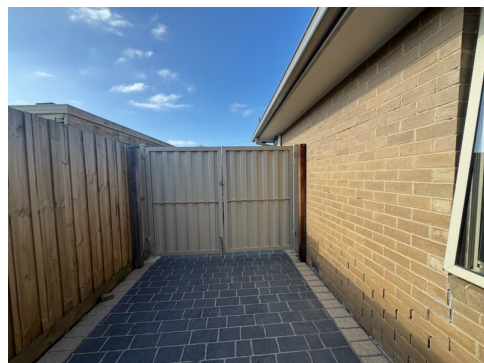
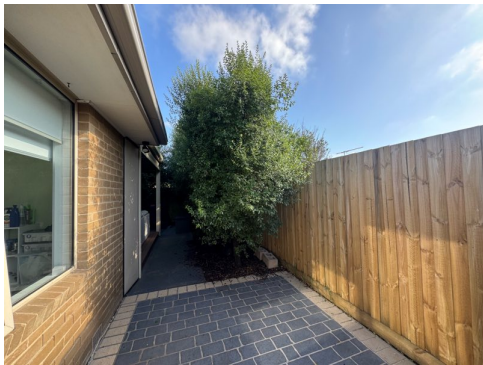
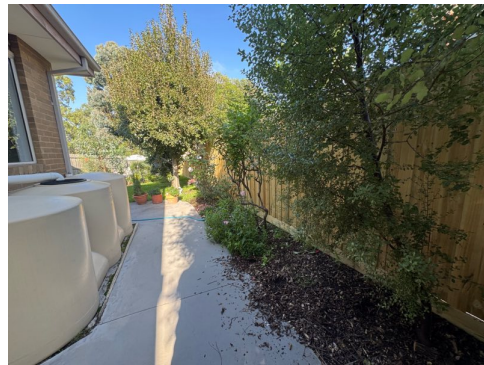
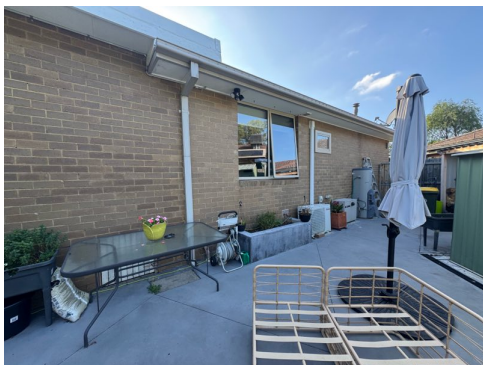
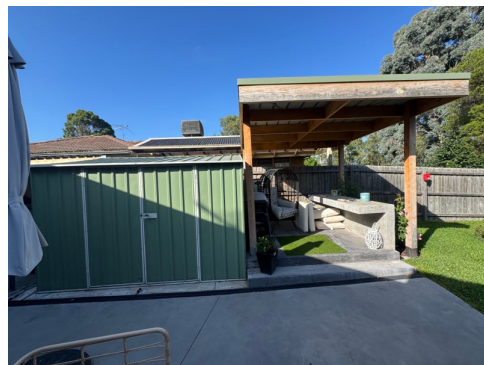
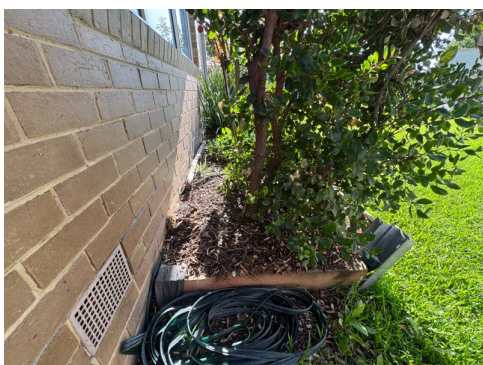
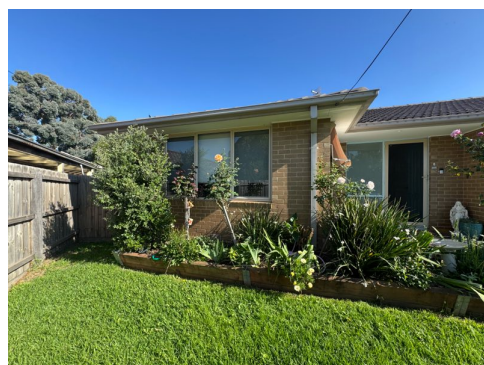
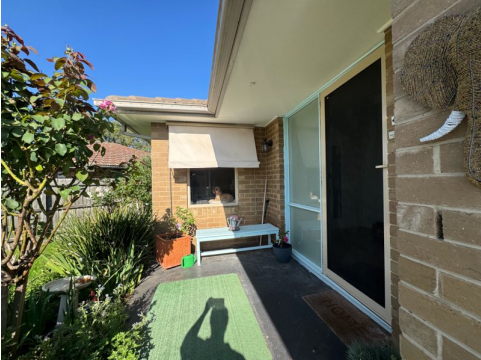
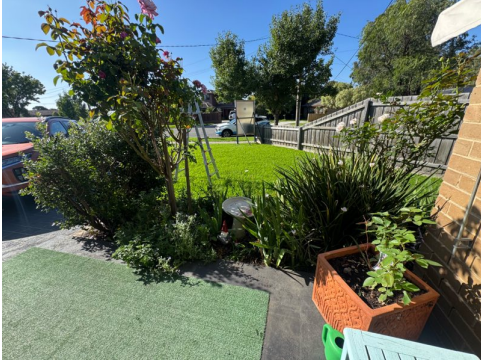
Finding: Additional Photos - Obstructions and Limitations

Information: These photographs are an indication of the obstructions and limitations which impeded full inspection of the property at the time of inspection. These obstructions can hide an array of defects and should be removed to allow full inspection to be carried out. A re-inspection is recommended once the areas are made accessible.
