## Building Inspection Report

Inspection Date: Tue, 10 Mar 2026

Property Address: 175/1 Fontenoy Rd, Macquarie Park NSW  
2113, Australia

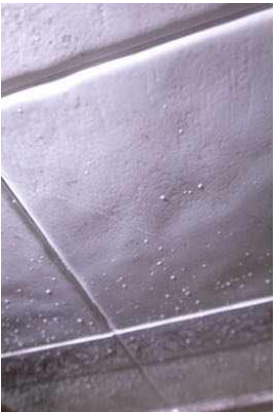
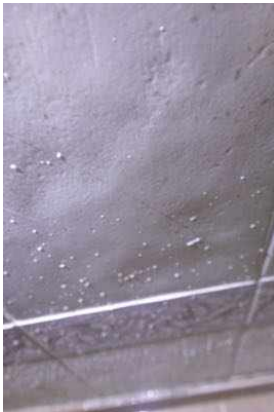
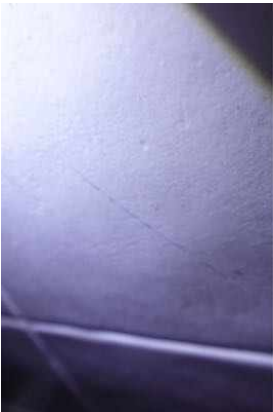
### Defects 3.04

Building:	Main Building
Location:	Several tiles
Finding:	Tiles - Cracked or damaged
Information:	Cracking were evident to the tiling in these area at the time of inspection. While the cracking appears to be minor, these area are frequently exposed to water, allowing potential for water penetration into adjoining sections of walls or flooring.

If left unmanaged, water penetration to these areas may lead to subsequent water damage, which is likely necessitate repair work to affected building elements.

water damage occurs. The re-application of silicone and grouting throughout remaining tile work is also advised, to further protect the area against water penetration.

Where water penetration has led to water damage, appointment of a relevant licensed tradesperson may be required to repair damaged building elements.

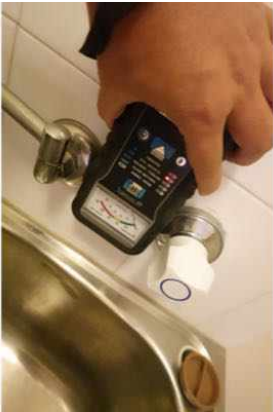
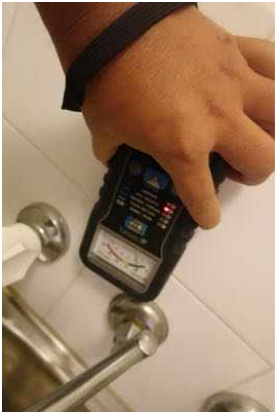
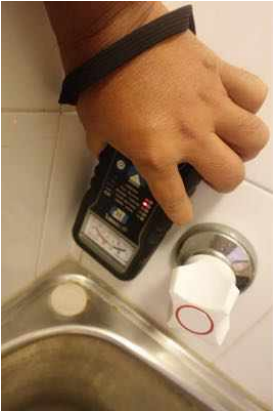
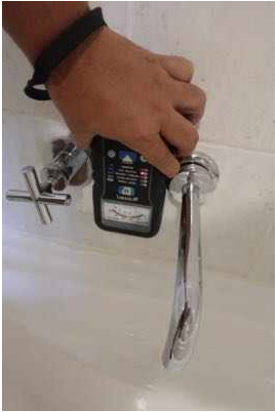
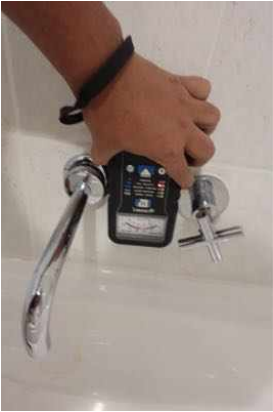
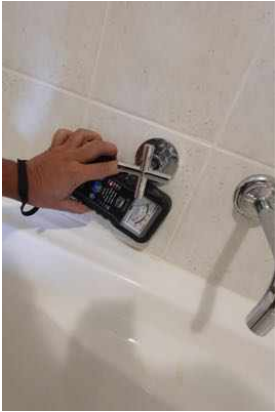
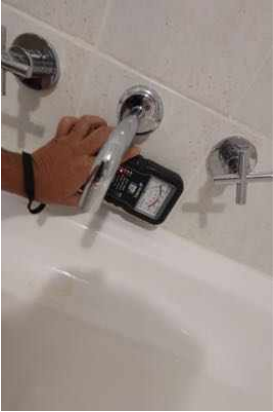
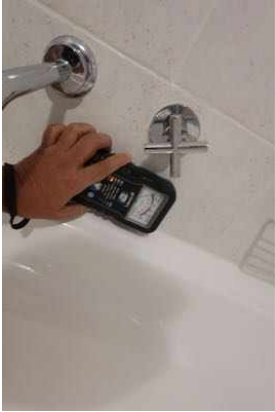
Building: Main Building  
Location:  
Finding: Moisture check  
Information: During inspection, moisture meter was used and no high moisture detected at the time of inspection.

Please note if the wet areas have not been used for some time, moisture readings would not vary significantly and this can lead to erroneous results.

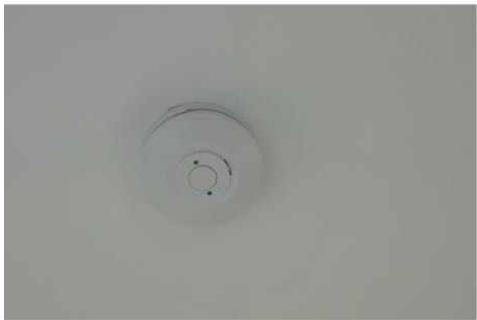
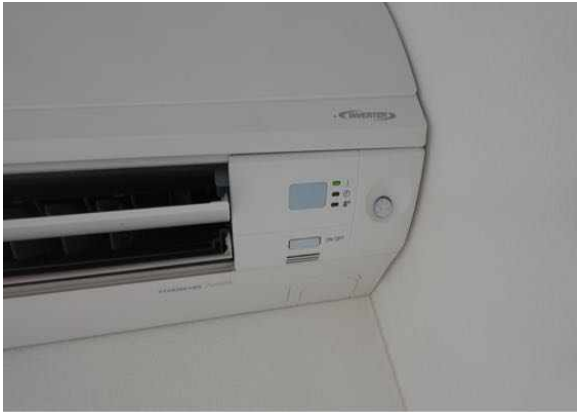
Building: Main Building  
Location: All Areas  
Finding: Additional Photos  
Information: Additional photos are provided for your general reference only.
