Building and Timber Pest Inspection Report

Inspection Date: Tue, 3 Feb 2026

Property Address: 19 Sanibel Ct, Parrearra QLD 4575,
Australia

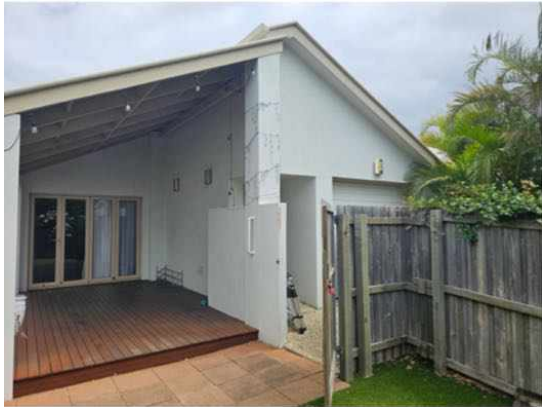
Finding 3.01

Building: Main Building
Location: As shown
Finding: Damage / deterioration to external walls.
Information: Noted during the inspection of the external areas was rust, paint deterioration and minor damage to walls.

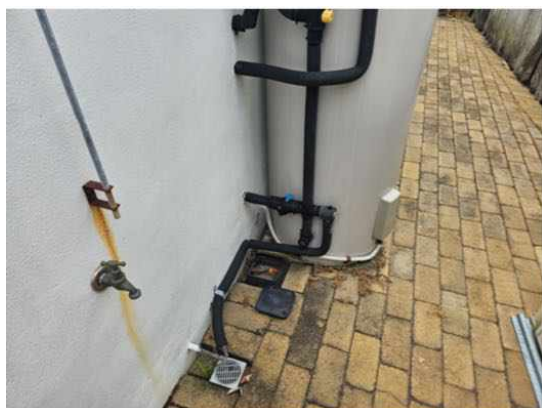
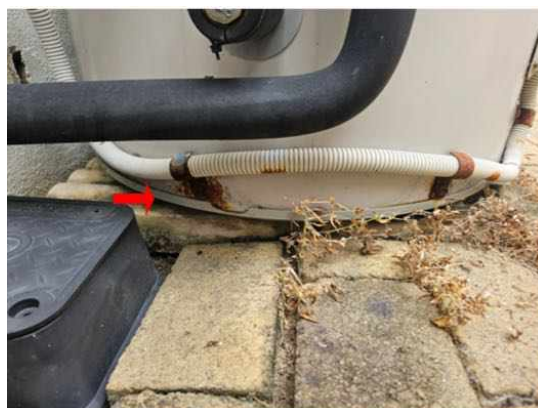
Finding 3.02

Building:	Main Building
Location:	Rear elevation
Finding:	Hot water system casing - Rusted
Information:	The areas hot water system casing where the conduit saddles are attached show evidence of rust forming, which is likely to have developed as a result of weathering and incorrect metal type of the saddles.

As surface rust provides no protection to the underlying metal, the deteriorating condition is likely to worsen if not addressed in the short-term future. It is recommended that the saddles be removed and replaced with galvanised or stainless steel products. Treating the rust with appropriate products is strongly advised.

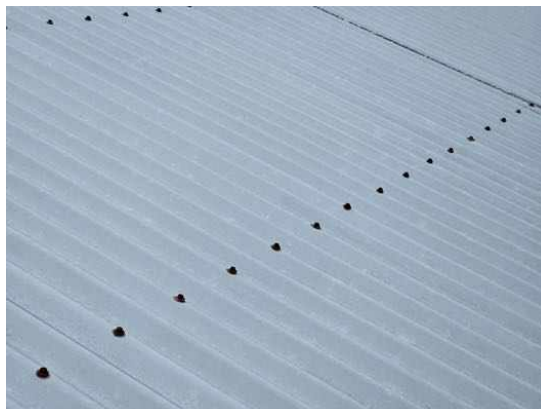
Finding 3.03

Building: Main Building
 Location: All External Areas
 Finding: Roof screws - rusting
 Information: It was noted during inspection, that throughout the roof surface the majority of roof screws are showing signs of rust at varying degrees ranging from minor to moderate.

This should be monitored over time, and should the condition worsen, consider replacement of the screws. As roof screws deteriorate they can have an effect on the adjoining roof materials.

A roofing plumber could be appointed at the clients discretion to replace the screws in question.

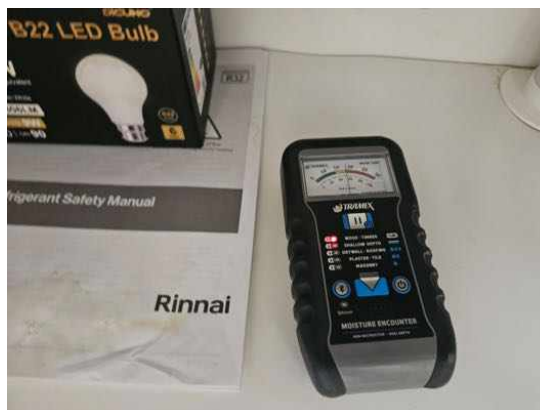
Finding 3.04

Building: Main Building
 Location: Laundry
 Finding: Laundry tub cabinet - moisture
 Information: It was observed during the inspection that the floor of the laundry tub cabinet has minor elevated moisture readings. This is possibly from a previous leak.

This should be monitored and if there is a deterioration, repairs carried out accordingly.

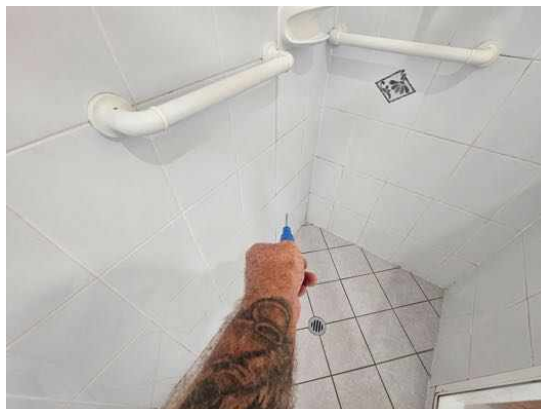
Finding 3.05

Building:	Main Building
Location:	Ensuite - Master
Finding:	Sealant and grouting - degraded
Information:	It was noted on inspection that the sealant and grout is degraded to the ceramic tiled shower alcove of the ensuite.

Different materials and floor areas move at different rates, generally causing cracking to grout or sealant at this point. A flexible sealant is required to allow for expected expansion and contraction, while keeping the joint water tight and protective of all associated building materials.

Flexible and mould resistant materials should be applied to affected areas to prevent any subsequent water damage that is likely to occur. Regular maintenance and replacement of damage or missing or damaged sealant and grout is highly recommended to the wet areas, as this is a regular wear and tear defect. Sealant and grouting in areas that come into regular contact with water should be maintained for the long term care of your property.

A sealant specialist or tiling contractor should be appointed to complete these works as soon as possible

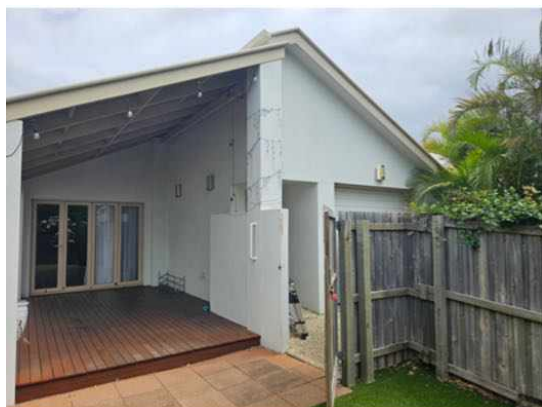
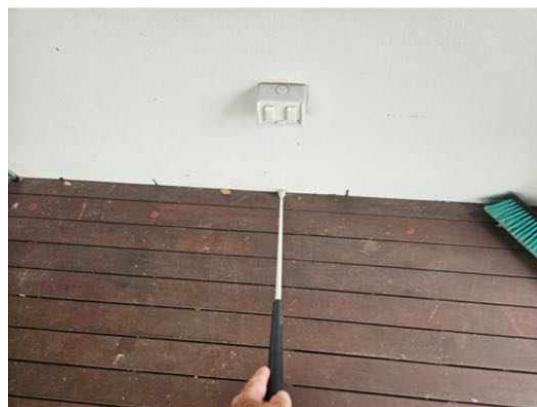
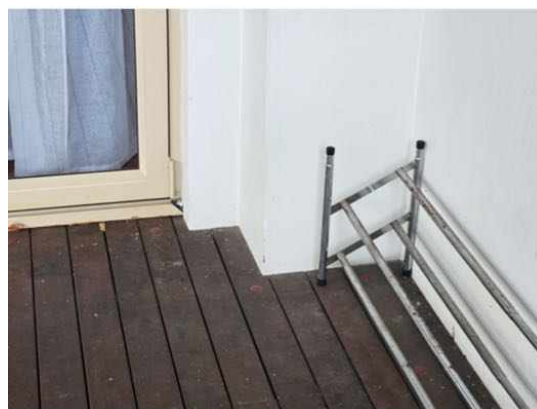
Where the slab edge cannot be properly inspected, there is a high risk of termite attack. It is usually recommended that termite or timber pest inspections be carried out every 6-12 months to aid protection of the property against infestation.

The deck structure is close to the ground and cannot be inspected visually from under the structure, a chemical barrier system appears to be in place to mitigate much of the risk created by the reduction of inspection ability. The barrier must be kept current.

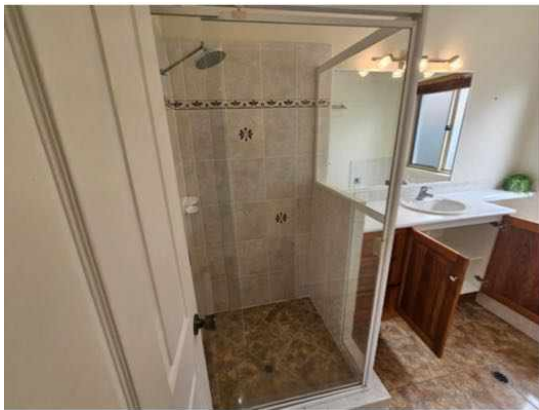
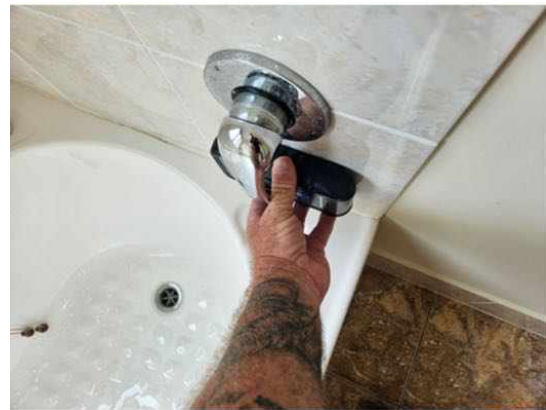
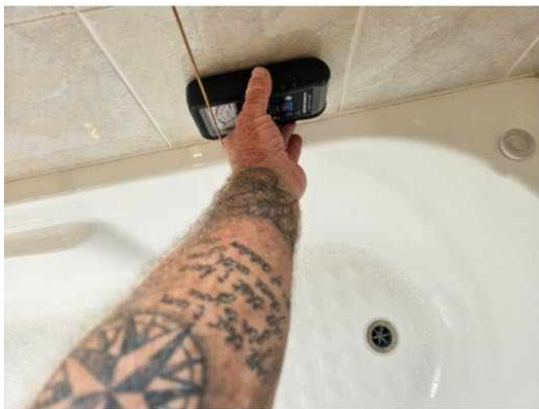
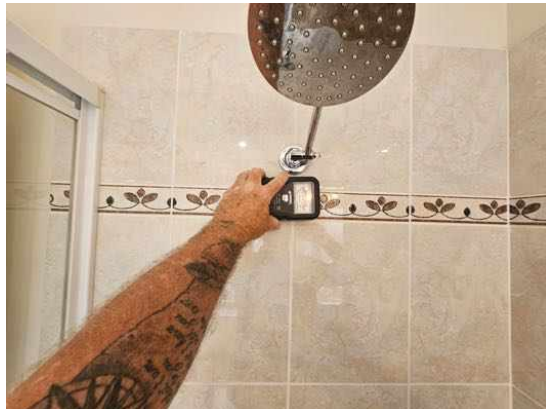
Building: Main Building
Location: Bathroom
Finding: No moisture detected in bathroom / ensuite
Information: On the day of inspection the showers in the bathroom/s and ensuite are measure for moisture using a "Tramex" moisture meter. During this inspection no moisture was detected in these areas and the tiled / sheeted surfaces appear to be in good order.

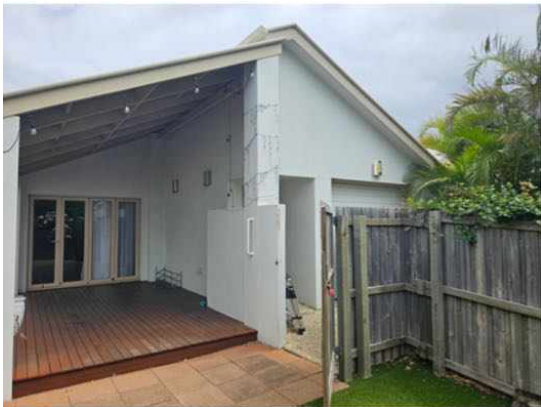
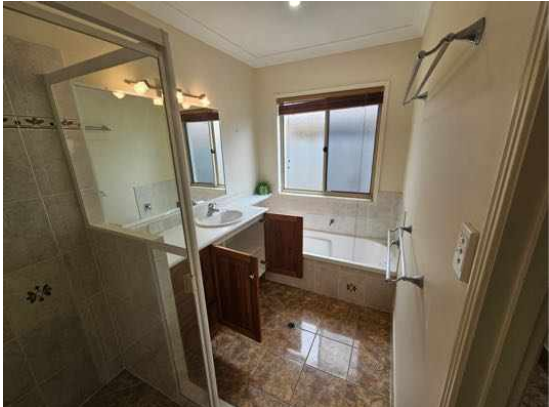
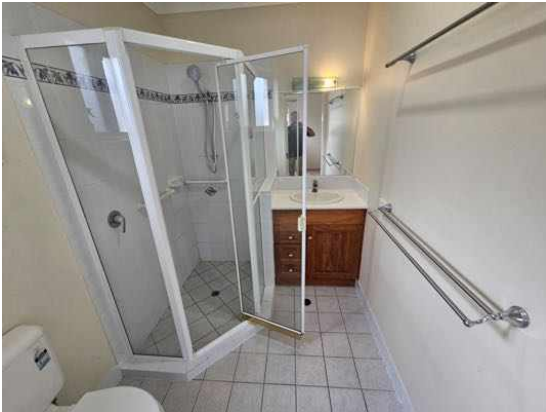
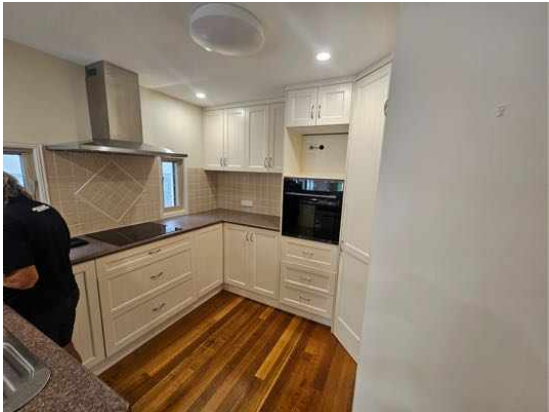
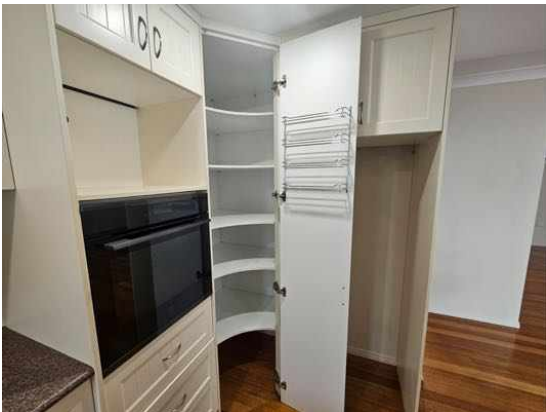
Building: Main Building
Location: All Areas
Finding: Additional Photos - Obstructions and Limitations
Information: These photographs are an indication of the obstructions and limitations which impeded full inspection of the property at the time of inspection. These obstructions can prevent full inspections of the areas shown.

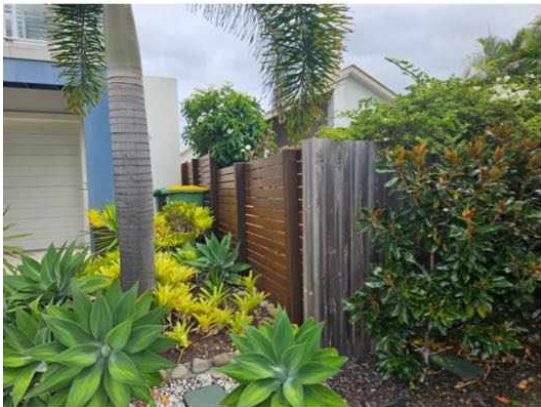
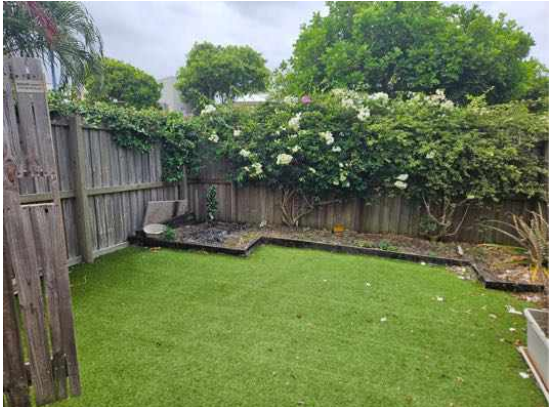
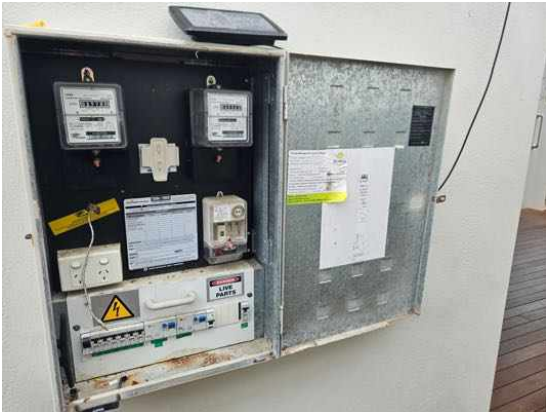
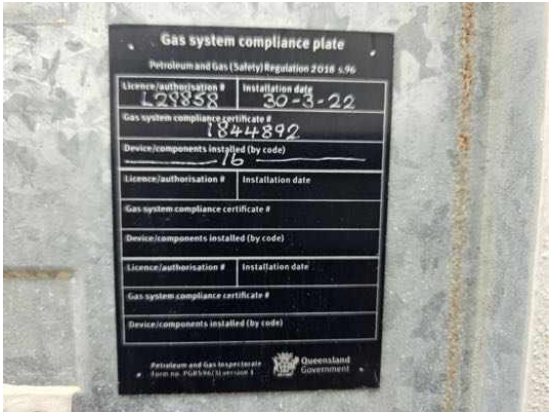
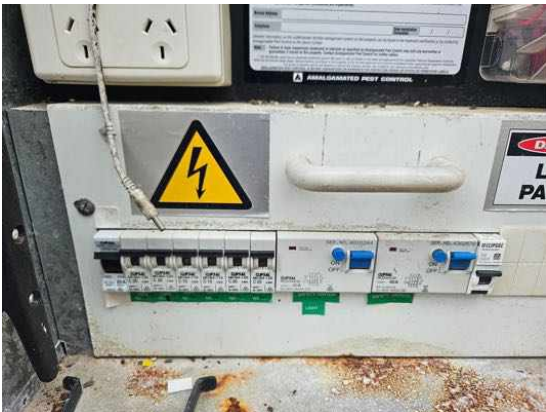
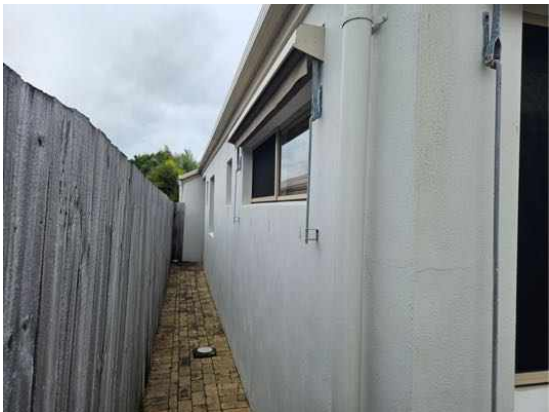
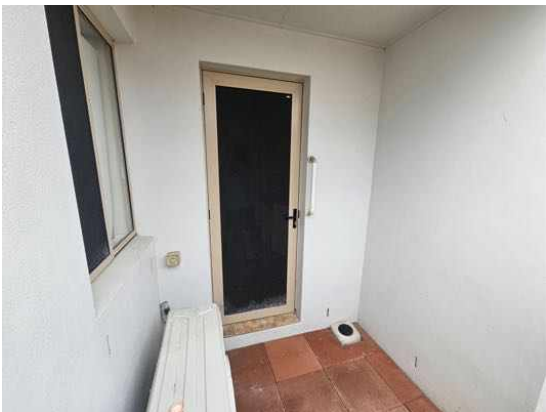
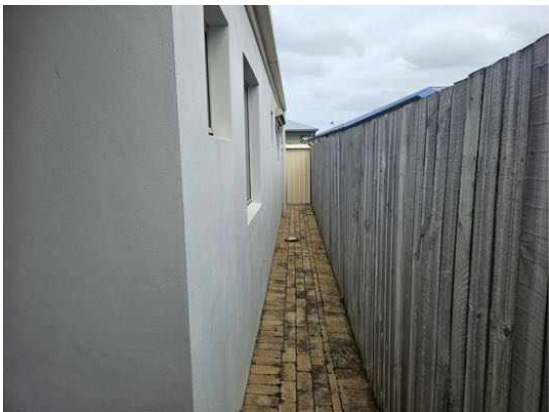
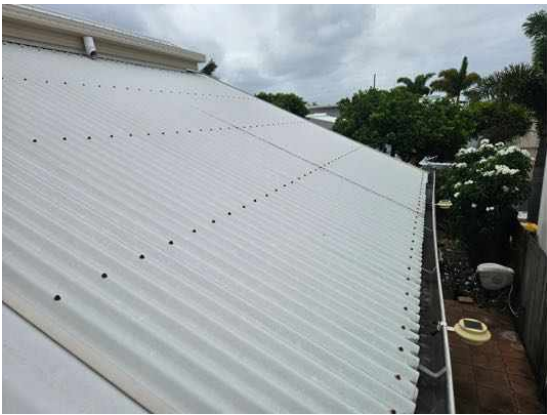
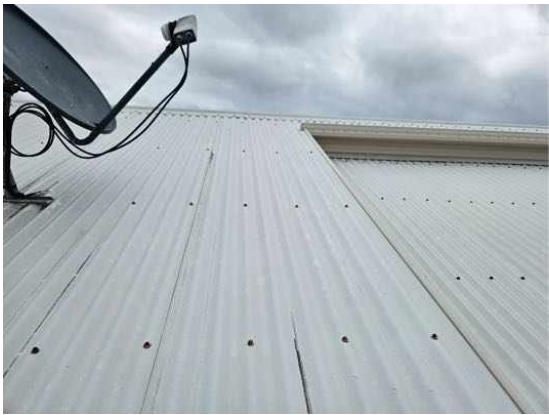
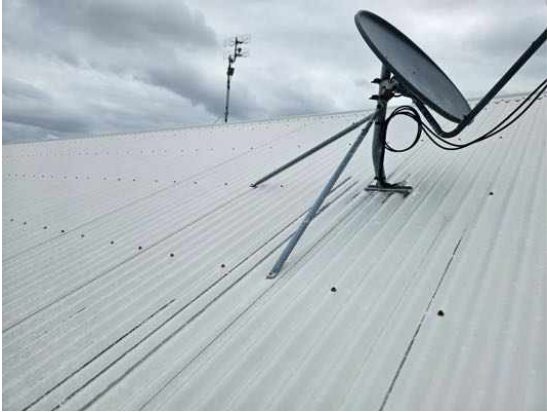
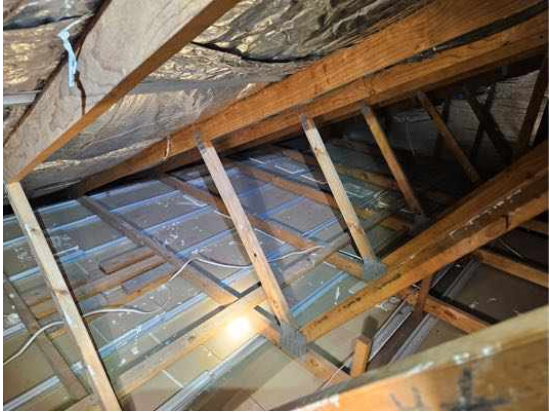
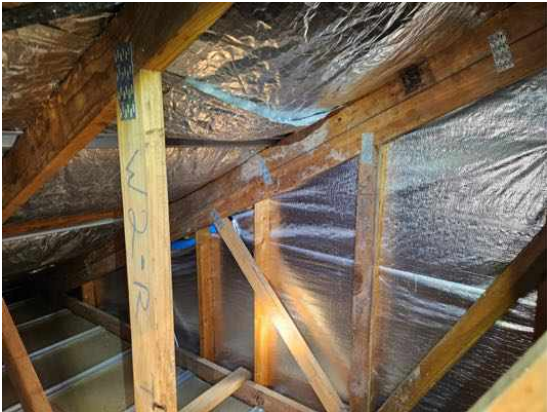
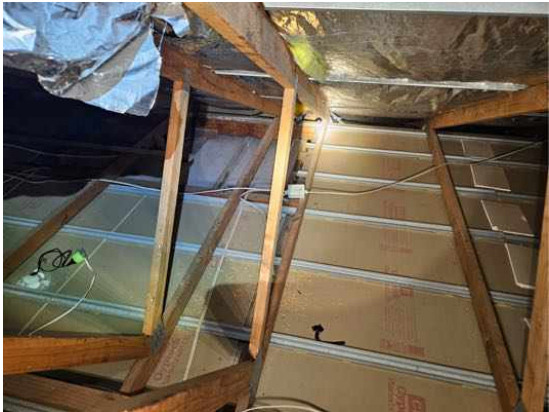
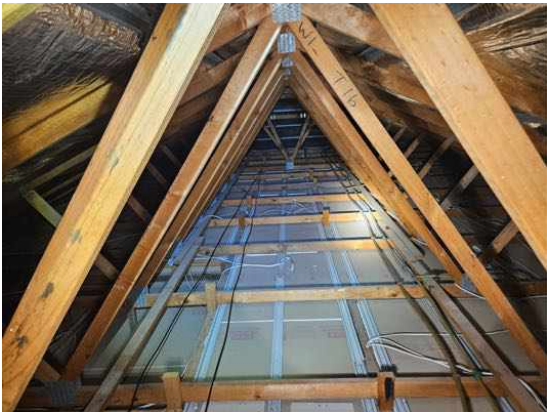
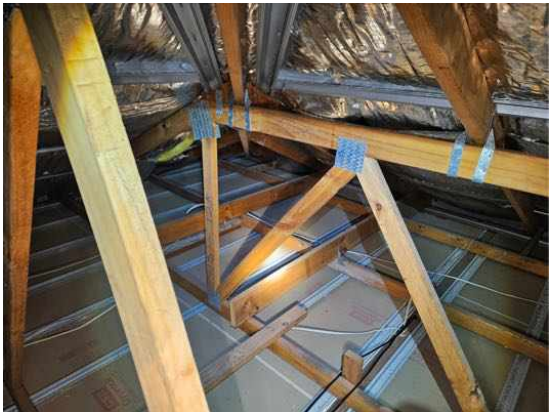
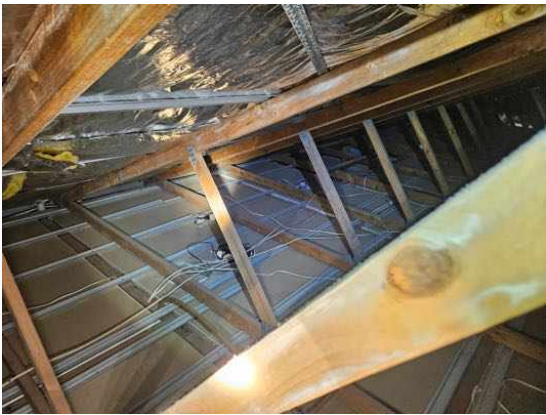
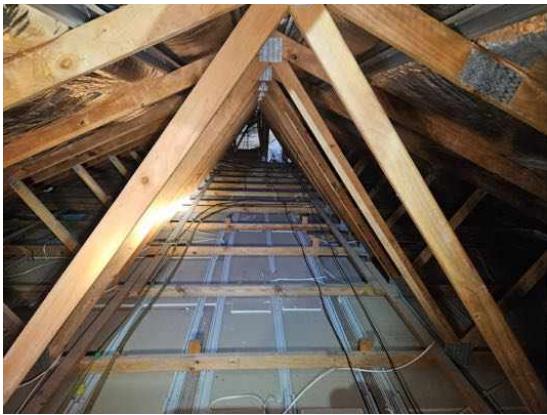
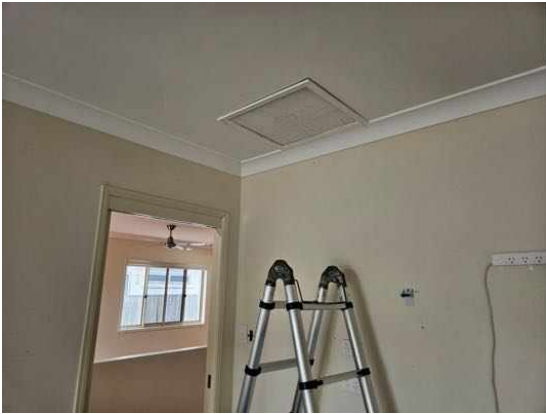
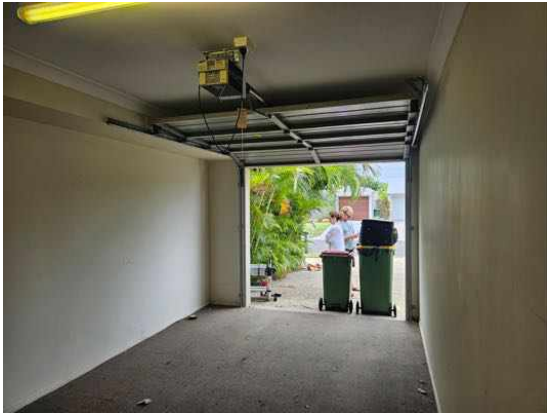
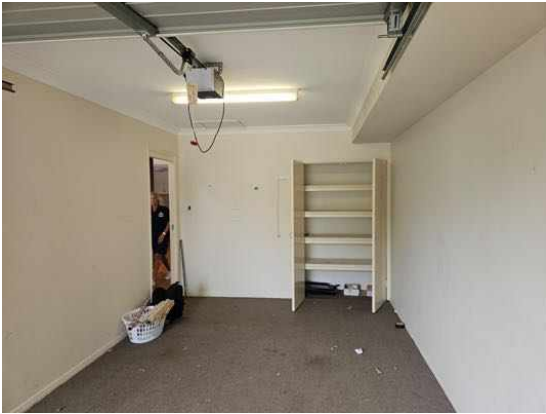
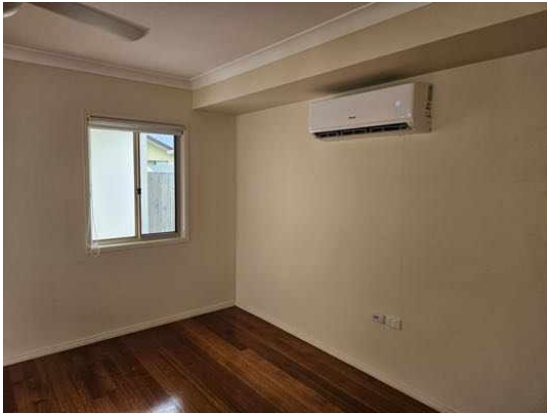
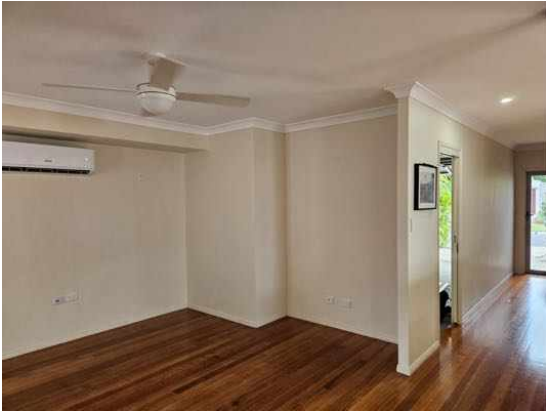
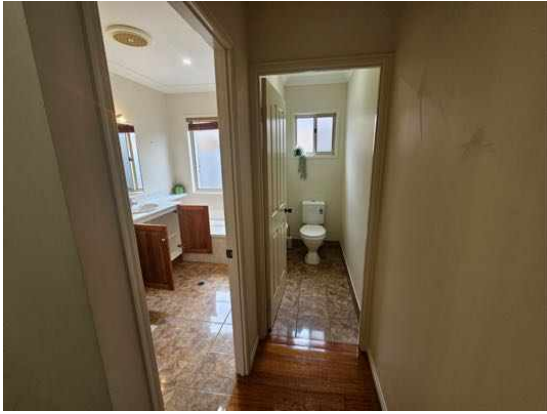
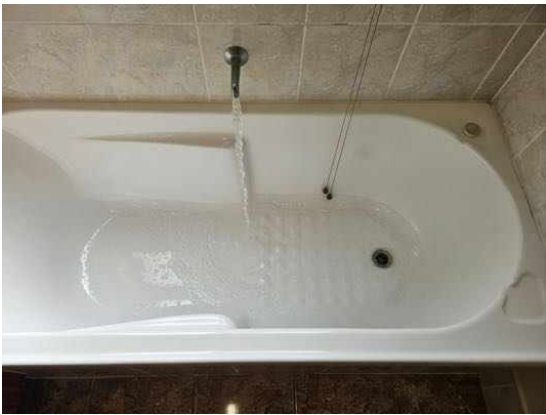
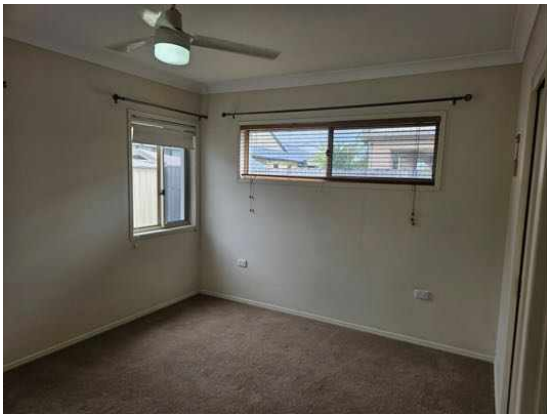
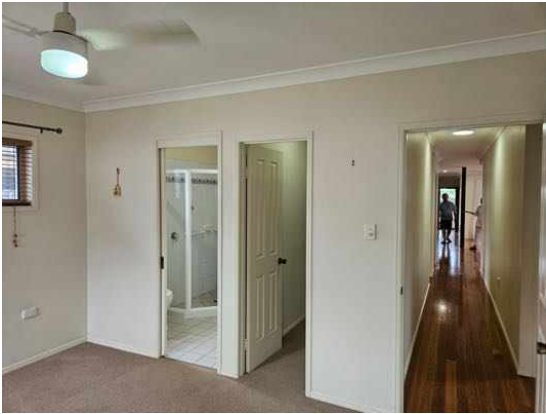
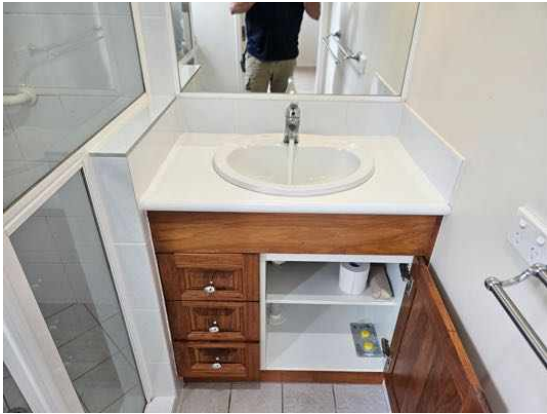
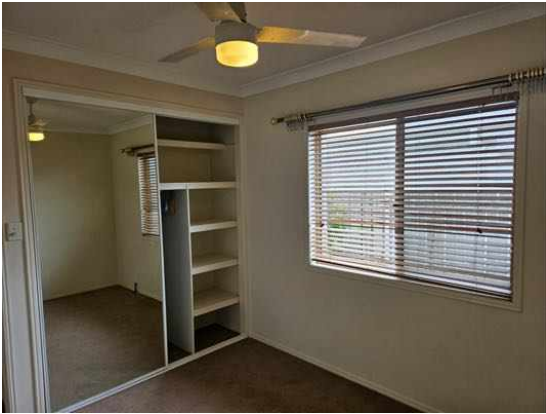
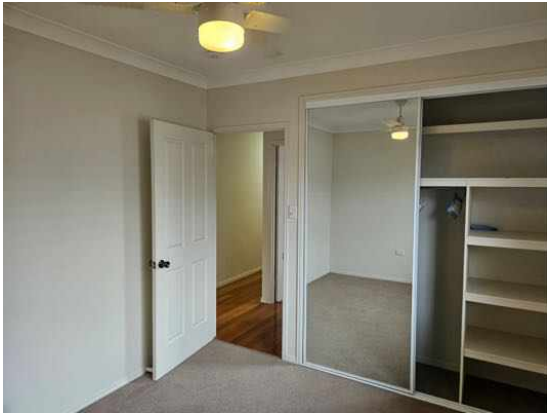
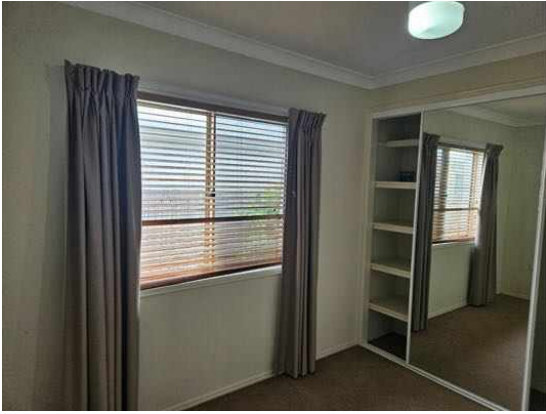
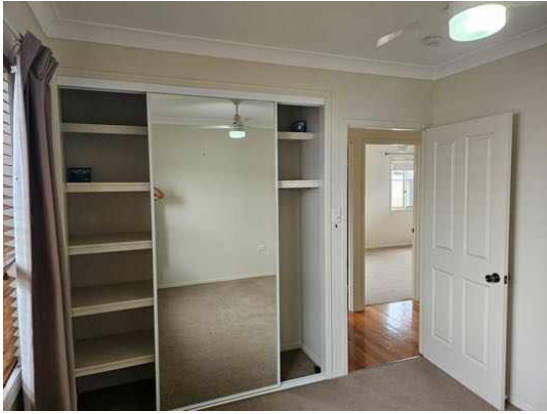
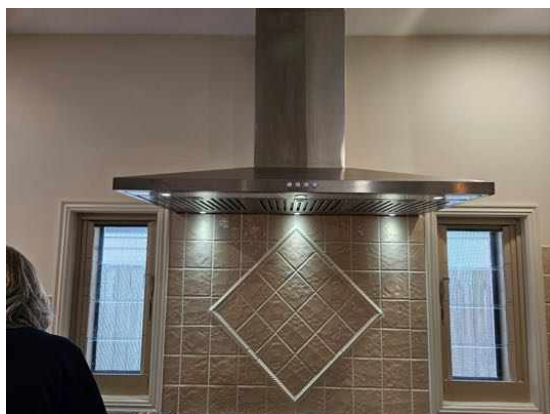
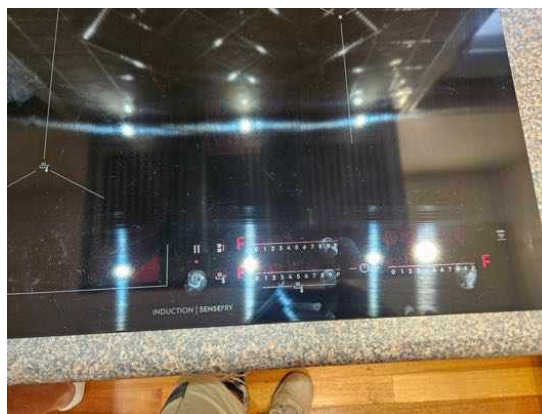
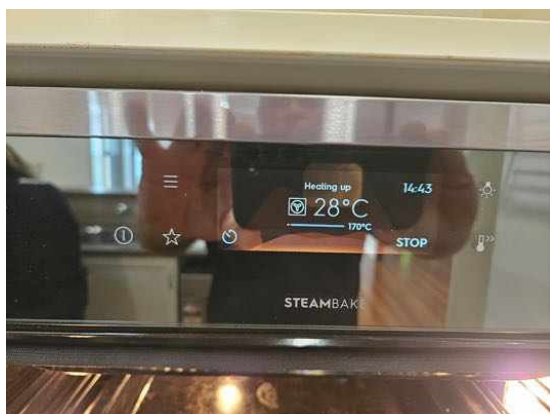
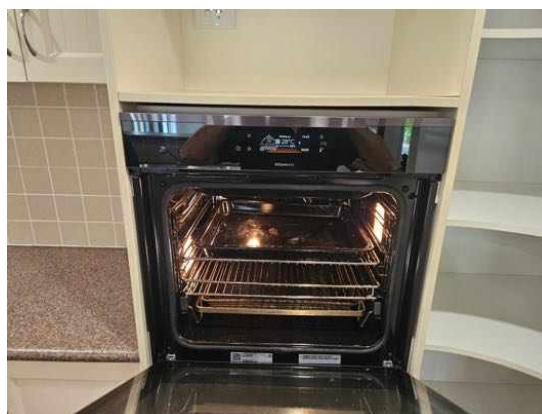
Building: Main Building
Location: All Areas
Finding: Additional Photos for client reference
Information: Additional photos are provided for your general reference.

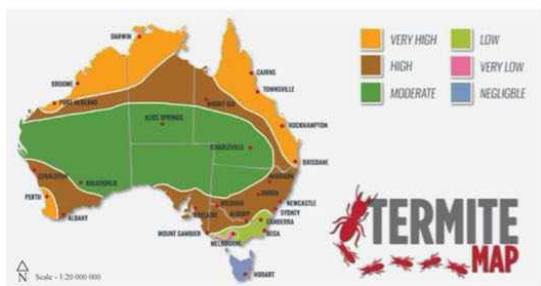
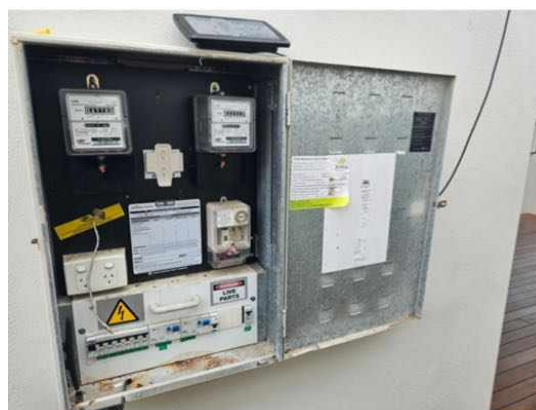
Building:	Main Building
Location:	Meter box, kitchen cupboard
Finding:	Durable pest inspection notice - not assessable
Information:	On the day of inspection it was noted that the durable timber pest inspection / treatment notice was missing, not visible or out of date. These notices / stickers are to verify the timber pest inspection dates, the inspector, the currency and type of timber pest system / barrier in place or being used in and around the property.

Annual, or more regular, inspections are crucial in maintaining and managing the properties timber pest risk profile. By not having regular inspections of the property raises the properties risk of undetected defects and damage. Without regular inspection at intervals of not greater than annually the buildings risk profile will be categorised as high. Properties with trees within 50m and with gardens close to the building are at greater risk and will have a high risk profile.

It is recommended that a licensed timber pest controller be contacted to assess the properties needs and provide costings for an annual inspection programme.

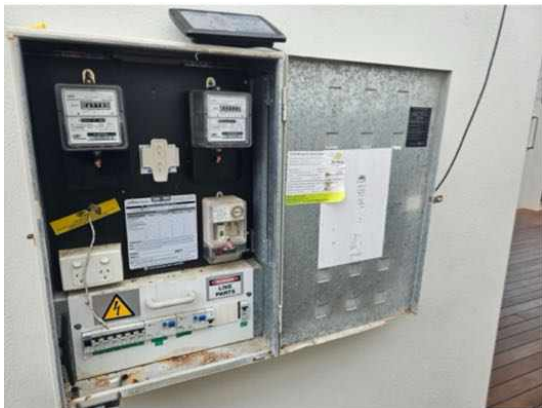
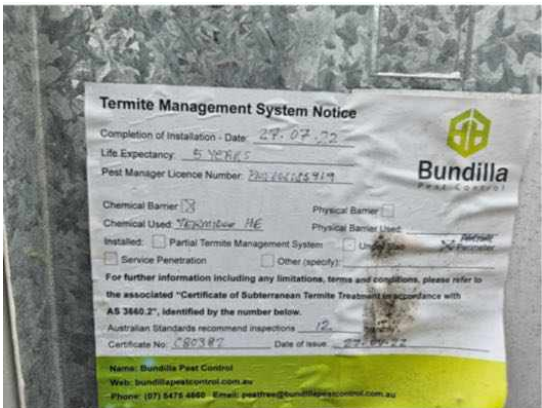
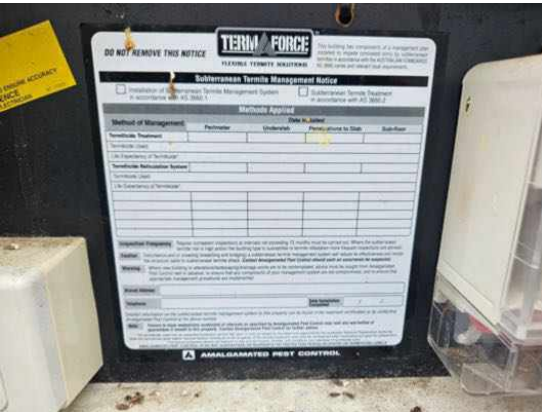
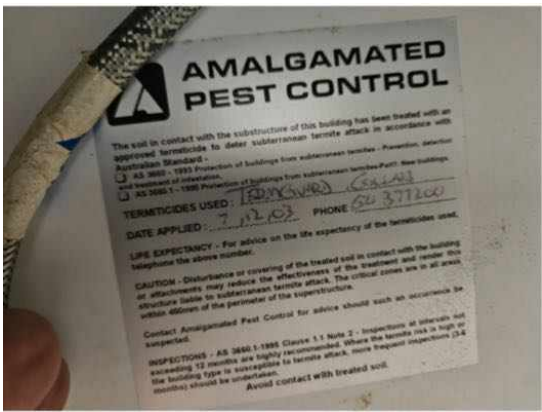
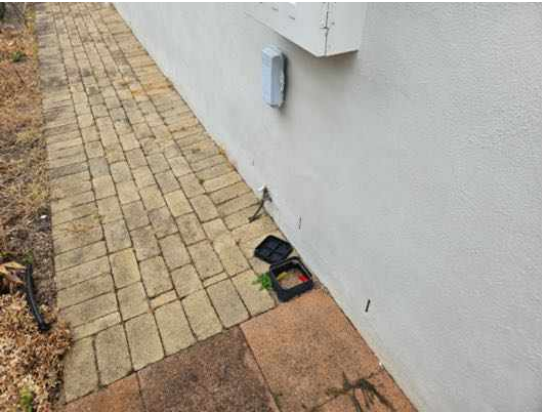
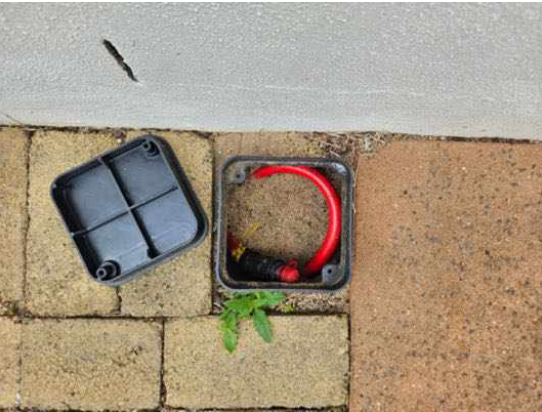
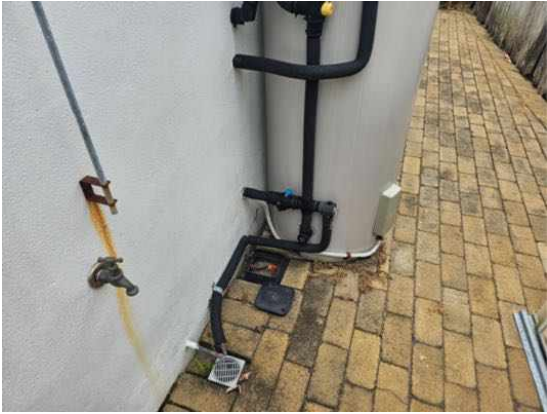
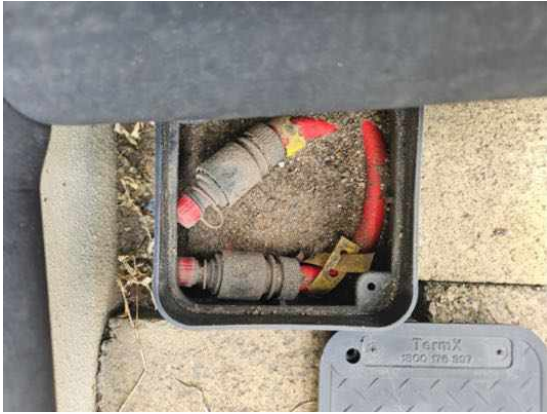
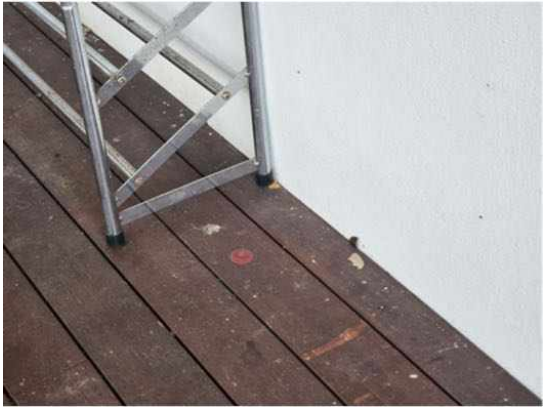
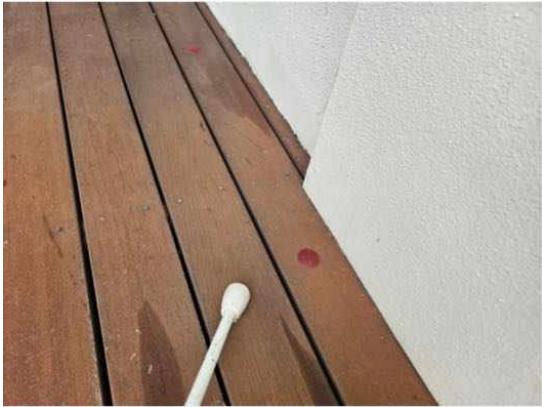
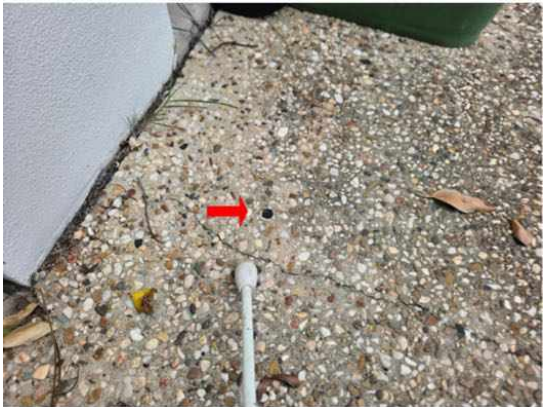
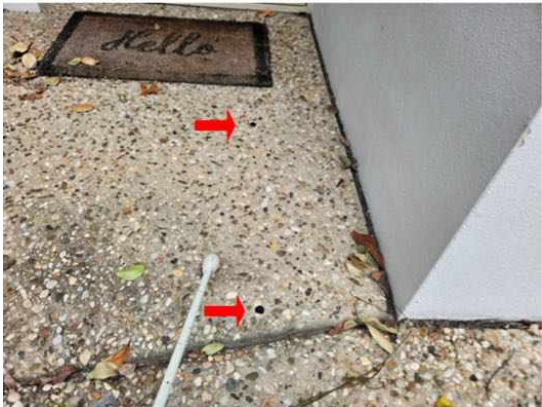
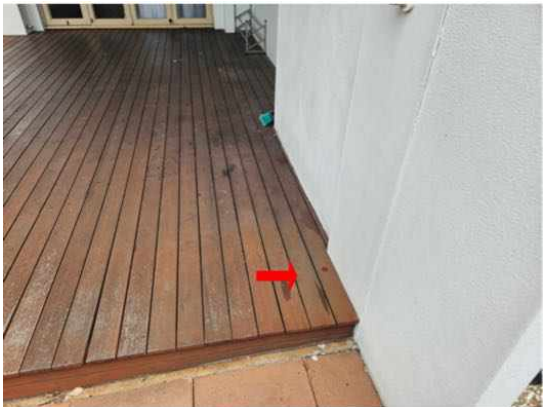
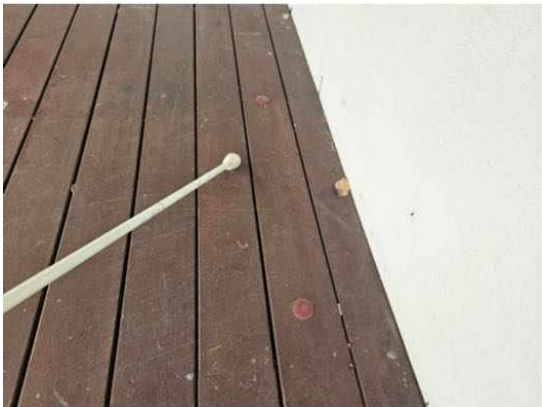
The building employs a combined physical and chemical barrier system to the perimeter and slab penetrations. It appears that the chemical barrier is due for recharging in 2027.

In order for a barrier system to be effective, the property must have regular inspections at intervals of not greater than 12 months. Depending on the risk profile attributed to the property, these inspections may be recommended at lesser time periods.
