# Building and Timber Pest Inspection Report

Inspection Date: Fri, 30 Jan 2026

Property Address: 46 Warrain Cres, Currarong NSW 2540, Australia

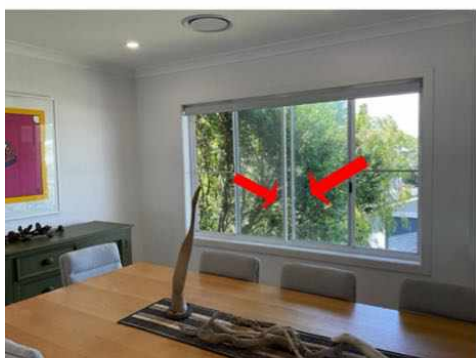
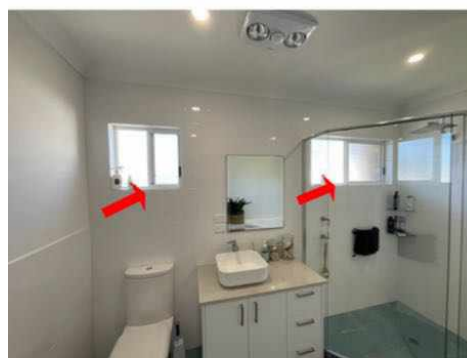
Building:	Building 1
Location:	Pictured upstairs windows
Finding:	Window opening restrictors missing.
Information:	The Building Code of Australia rules require all openable windows (where the internal floor is more than 2m above the ground outside) in residential rooms to be fitted with a suitable screen or restrictor. Windows located 1.7m above the floor level do not require protection.

Window restrictors are required where people who are vulnerable to the risk of falling have access to windows. This means all windows above ground level which do not have another fall prevention safety measure in place, such as a balcony or balustrade should have a restrictor.

These need to be added urgently for the safety of all persons.

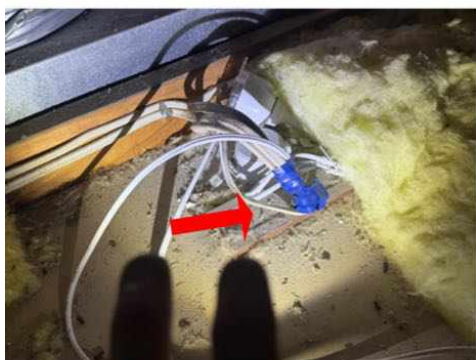
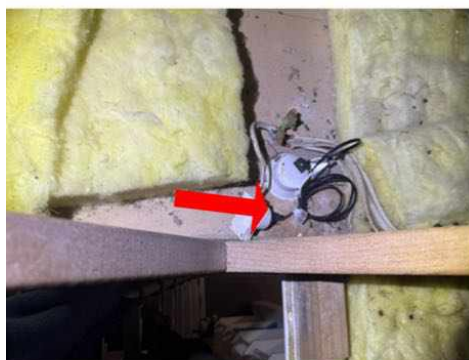
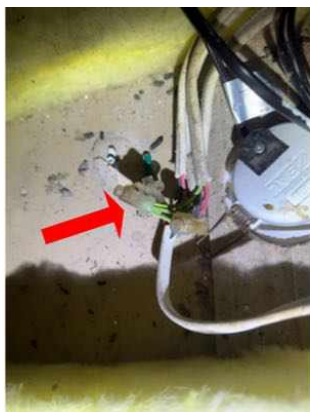
#### Finding 1.02

Building:	Building 1
Location:	Roof Cavity
Finding:	Electrical cables missing a junction box
Information:	These two electrical fittings in this west roof area was found to be missing a junction boxes at the time of inspection.

This missing fittings and loose cables does expose electrical works, and may create a safety hazard if there is potential contact with persons in the area.

A Licensed electrician should be appointed to rectify these areas immediately.

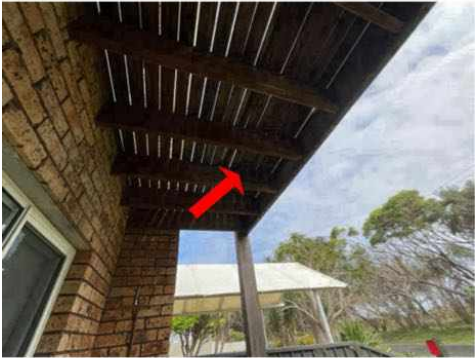
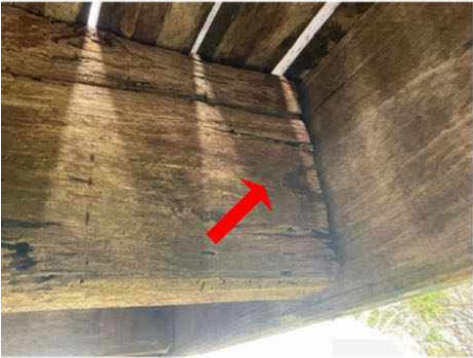
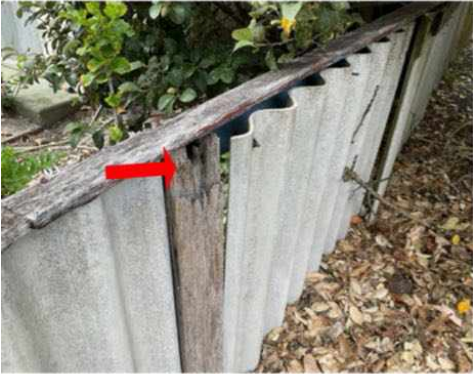
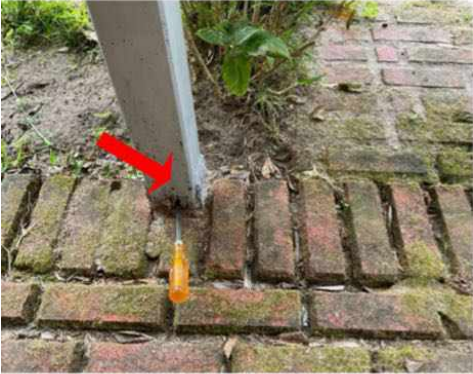
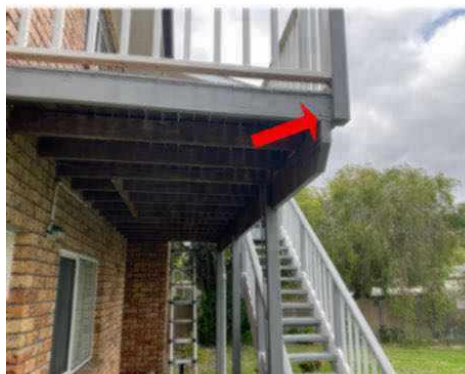
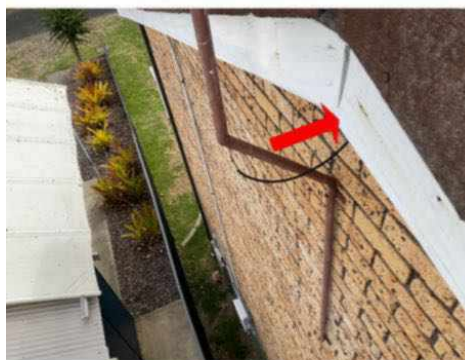
Building:	Building 1
Location:	Front and rear decks, some posts may require replacement.
Finding:	Wood rot
Information:	The building shows evidence of wood rot. Photos 5-8 of the 2 areas of the rear deck will need repair or replacement in the next year.

Wood rot, also known as Fungal Decay, occurs when timbers and other cellulose building materials are exposed to damp conditions on an ongoing basis. This could be the result of exposure to weathering over a prolonged period of time, or the attraction of excessive moisture from other abutting building materials.

Early intervention and regular maintenance, particularly of exterior timbers, will prolong the useful life of these building elements. Replacement of affected these timbers may then be a necessary step in protecting surrounding building elements from such deterioration.

A qualified carpenter or registered builder may also be required to replace affected building materials.

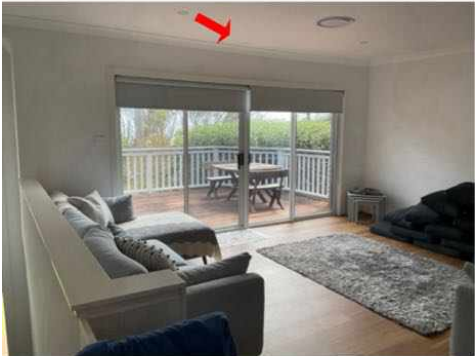
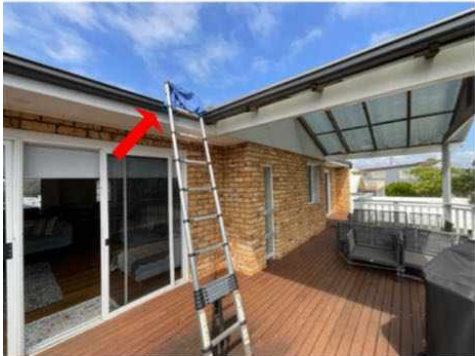
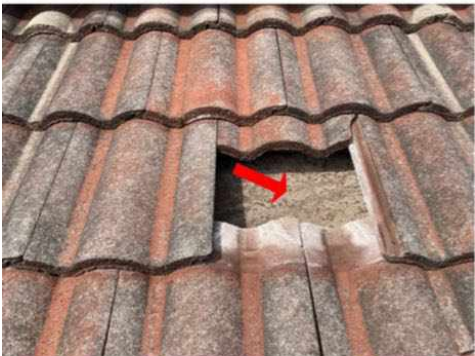
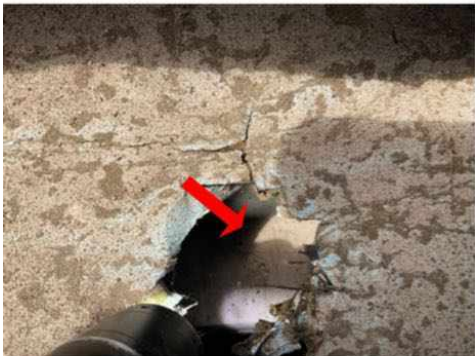
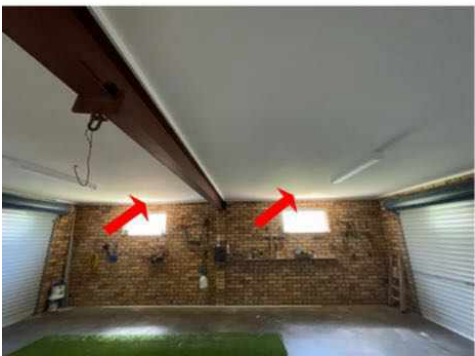
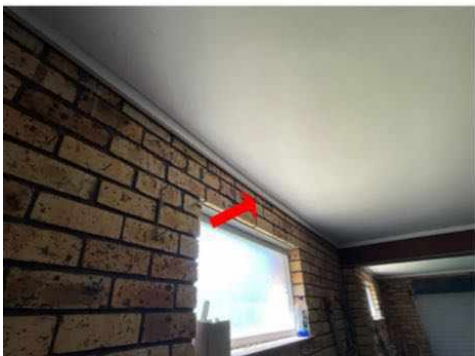
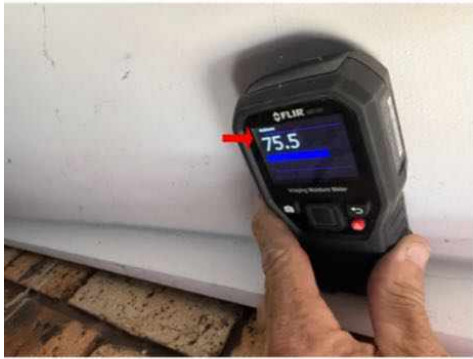
### Finding 3.02

Building:	Building 1
Location:	Pictured front lounge room and left garage areas
Finding:	Ceilings - deflection evident
Information:	The ceiling in the front lounge room was found to have a very minor deflection at the time of inspection. The garage ceilings were sagging with moisture in the front garage ceiling. Sagging or deflection to the fixed ceiling structures can indicate that the building materials have swollen, due to contact with water, or that fixings (e.g. nails or glue) have become loose and require reattachment. Often it may also be a natural sag in timbers over time.

In some cases, sagging ceiling linings may also indicate that there are structural issues, causing surfaces to warp, twist or sag, or that structural timber elements have been weakened from termite activity. Where sagging appears to be major, appointment of a structural engineer is advised to further inspect the property and identify the cause of the damage and determine the rectification works required.

Due to the urgency of this report, a damaged front roof tile was removed and a very limited inspection was undertaken in a small area of damaged sarking.

No water damage or termite activity was observed from this very limited inspection of the lounge room wall top plate (observed through a 15cm hole in the sarking).

Where minor sagging is evident, comparatively minor works, such as re-gluing of ceiling sheets, may be required. Such works may be performed by relevant tradespeople, such as plasterers and painters. Where excessive moisture has caused the roofing structure to swell and sag, the source of the water leak should primarily be identified prior to any remedial works being performed.

Further investigation is required to determine the source if the moisture in the garage ceiling before repair of the garage ceiling can take place.

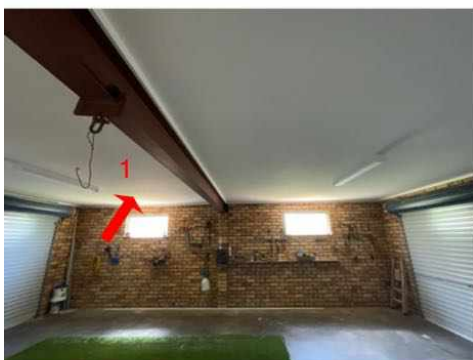
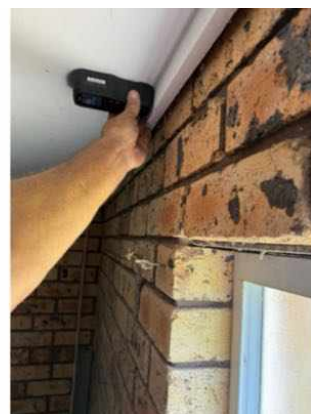
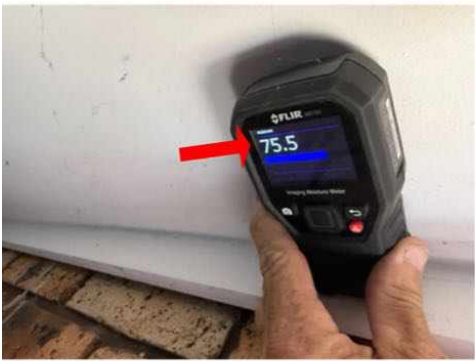
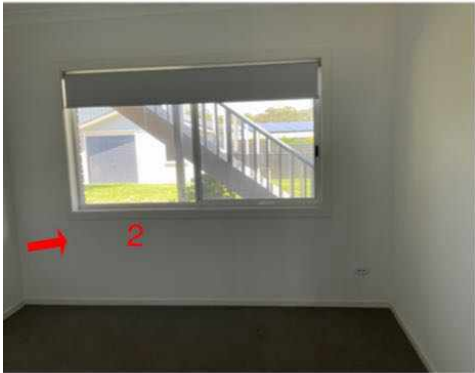
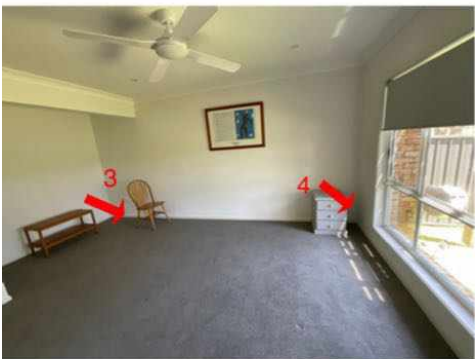
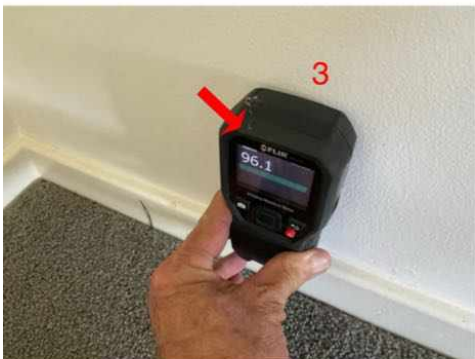
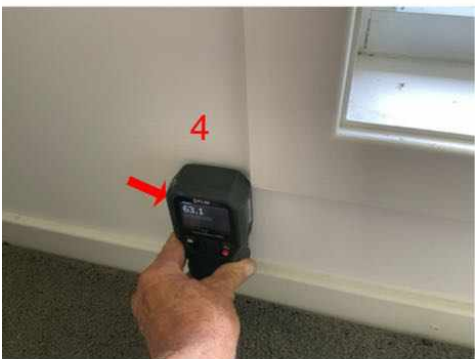
### Finding 3.03

Building:	Building 1
Location:	Garage and lower bedrooms
Finding:	Evidence of excessive moisture was present at the time of inspection
Information:	Excessive moisture was found in 4 lower areas. High readings of 63.1 to 96.1 were recorded. No damage was visible in these areas except the sagging garage ceilings.

Excessive moisture can attract termites and produce conditions that promote termite attack, fungal growth and wood decay.

Excessive moisture is generally caused by deteriorated inadequate or missing roof drainage, missing external sealant or mortar, leaking plumbing pipes or fixtures poorly plumbed HWS overflows or condenser units and poor site drainage.

It is highly recommended that all plumbing and drainage fixtures and fittings be maintained regularly in order to prevent excessive moisture being present in the internal property.

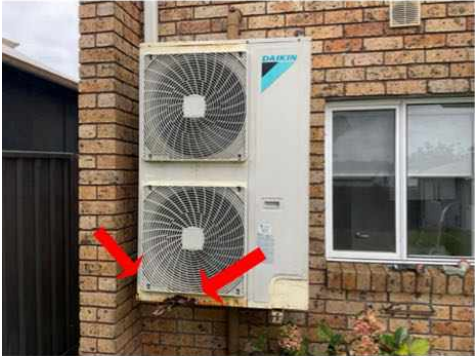
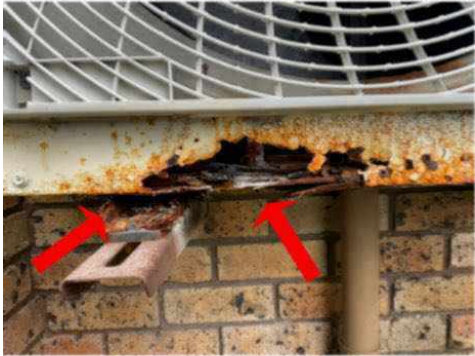
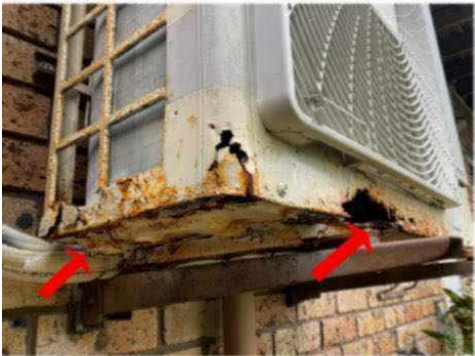
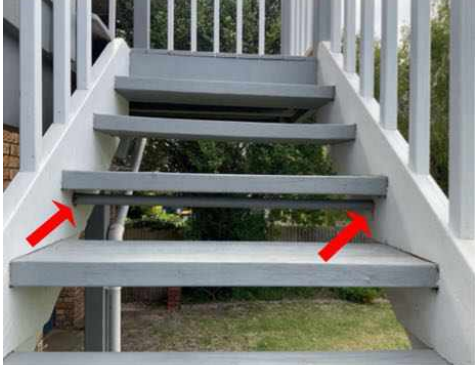
Finding 3.04

Building: Building 1  
Location: Pictured areas of both buildings  
Finding: Rust or corrosion  
Information: These areas shows evidence of rusting and corrosion, which is likely to have developed as a result of excessive exposure to moisture and or inadequate coatings.

The rust to the air conditioner unit is severe (the AC bracket rust is minor) and the other pictured areas are also minor.

As surface rust provides no protection to the underlying iron, the deteriorating condition is likely to worsen if not addressed in the short-term future.

Where possible, the use of galvanized (treated) metals or aluminium coated metals aid in rust prevention, as does regular general maintenance. Rust formation can be controlled with coatings, such as paint, that isolate the iron from the environment.

Rusting and corrosion should be managed by ideally removing or limiting the affected surface from exposure to moisture.

The AC unit and other rusted areas may need replace in the future.

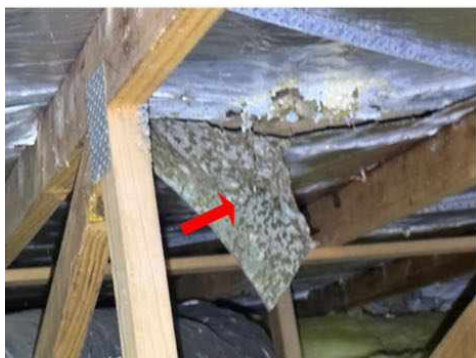
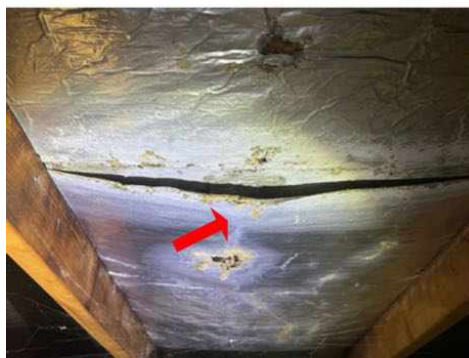
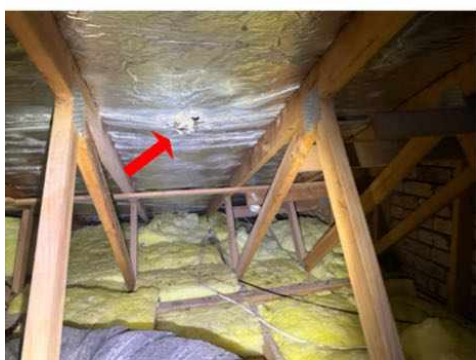
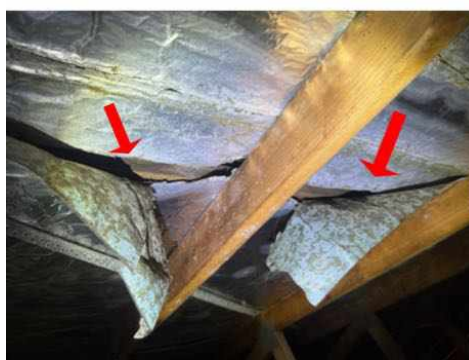
Building:	Building 1
Location:	Roof Void
Finding:	Sarking damaged and minor mould evident
Information:	Sarking, a laminated aluminium foil applied to the interior of the roof covering, assists in insulating the property and acting as a vapour-barrier to the roof void and, subsequently, to the household.

Where sarking is damaged, both insulation and moisture protection of the property are inhibited. This creates a loss of energy and thus negatively impacts the energy

efficiency of the property, allowing potential for moisture ingress from condensation or leaking roof tiles.

It is important to repair any holes or damaged sections of sarking to ensure that the building material is fully functional. A registered builder or qualified carpenter should be consulted to provide further advice on this defect and to perform rectification works at client discretion.

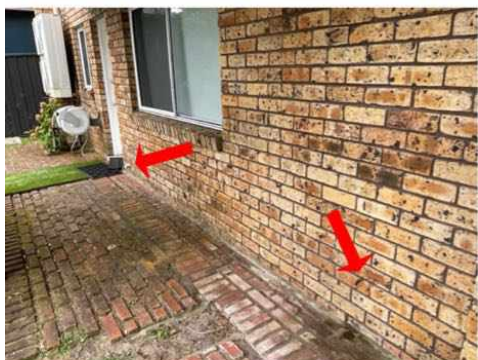
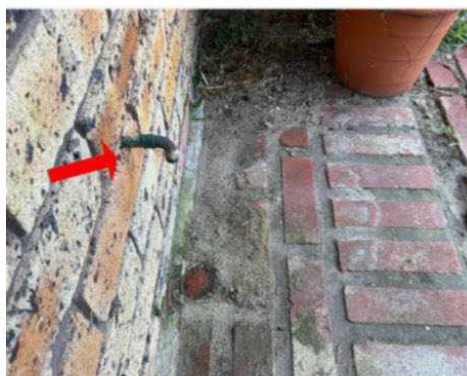
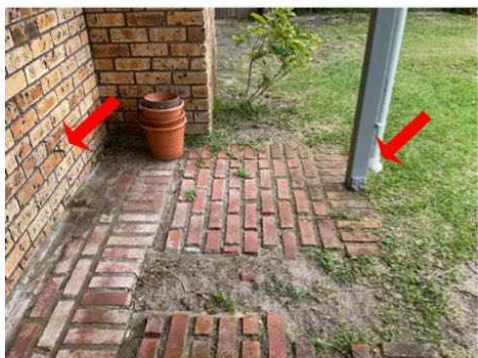
### Finding 3.08

Building:	Building 1
Location:	Rear Walls
Finding:	Site drainage - Inadequate
Information:	The site drainage in this area was found to be inadequate at the time of inspection, creating potential for subsequent water damage to associated building elements.

The air conditioner, hot water system, laundry floor waste and rear downpipe overflows all run against the rear house walls/ paving.

It is important that water does not lie against the base of walls; surrounding paths and ground levels should be sloped to drain water away from walls. Downpipes should not discharge stormwater onto lower walls or plinths. Stormwater should be carried away by large, regularly cleaned drains. Ground levels may need to be lowered to expose a buried DPC.

Where site drainage is inadequate, installation of an Agricultural (Aggie) Drain may be required. A qualified plumber should be appointed to further inspect the property and perform any remedial works as necessary. Secondary defects are likely to occur if left unmanaged.

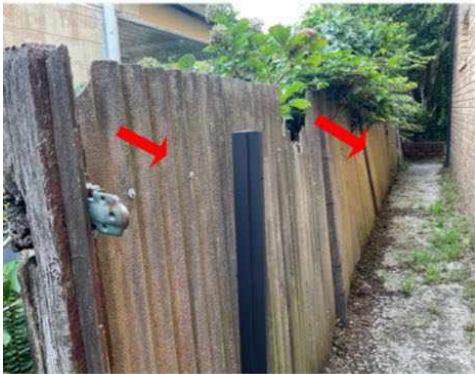
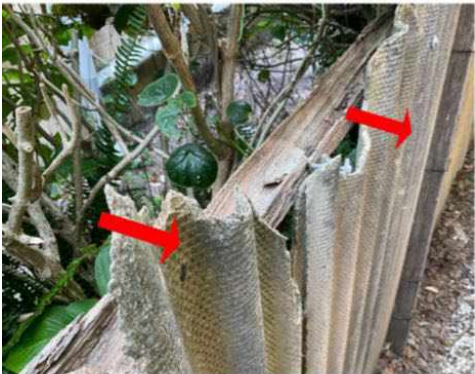
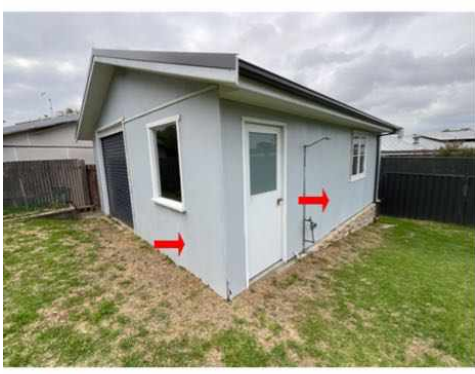
### Finding 3.09

Building:	Building 1
Location:	Exterior left fences and rear shed
Finding:	Asbestos - Suspected ACM Identified on Site
Information:	Reporting on Asbestos is outside the Scope of this Report. This suspected defect is highlighted as a caution only. We suspect, based on our experience in the building industry, that there is a higher risk of the identified fences and rear shed containing asbestos, some poor condition.

As Asbestos Reporting is outside the scope of this report, we advise that you consider a separate Asbestos Inspection and Condition Audit, which can include the taking of samples for definitive confirmation of the presence of Asbestos.

In the interim, the client is advised to act with caution, especially when considering any damage to building materials general wear and tear renovations extensions demolition and general maintenance activities due to the suspected presence of Asbestos.

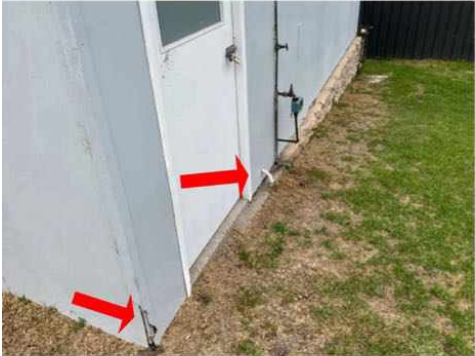
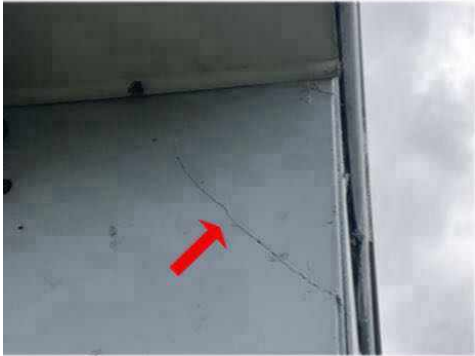
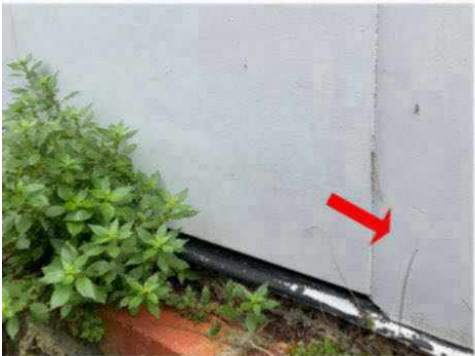
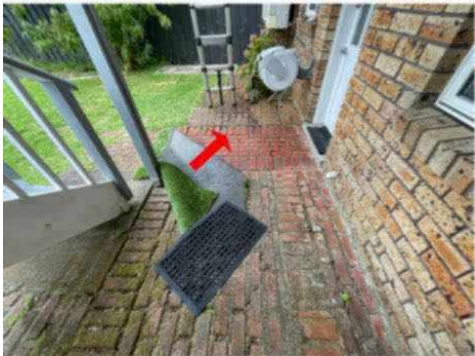
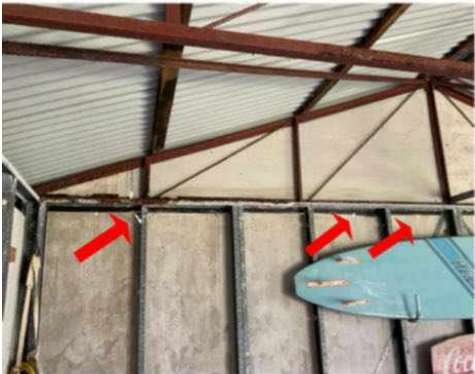
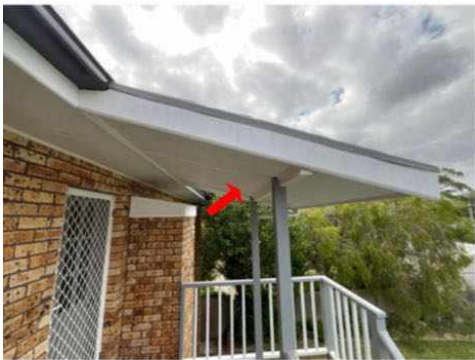
**Finding 3.10**

Building: Building 1  
 Location: Pictured external areas  
 Finding: Building elements - Damaged  
 Information: Evidence of minor missing or damaged areas was identified at the time of the inspection. These include -

- 1. The rear shed has minor damage to some wall cladding (possibly asbestos) and the right side wall electrical conduit.

2. The rear house external entry has paving damage where some water may pool in high rain events.

3. The rear roof external eave shows minor sagging and loose panels.

A carpenter would be the trade responsible for rectification of these areas when convenient.

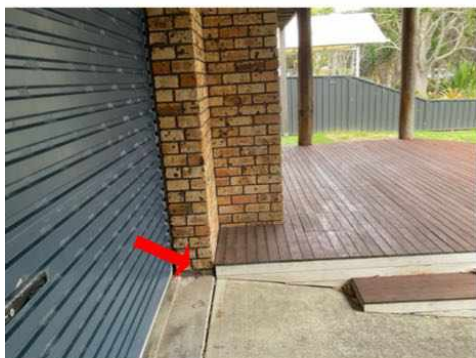
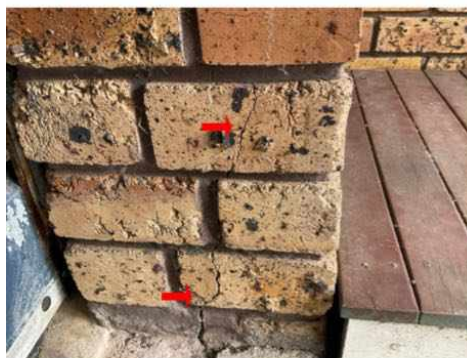
Building:	Building 1
Location:	Exterior wall
Finding:	Step cracking to brickwork (minor)
Information:	Step cracking was identified to the brickwork in this area at the time of inspection. Step cracking, which is similar to other forms of cracking, has a variety of possible causes. However, the most common is the subsidence of adjacent footings.

Step cracking is a relatively common defect, and is most likely to occur adjacent to windows, doors and other openings. Mortar failure in the gaps between affected bricks indicates the stresses and tensions affecting the wall.

Where step cracking is extensive or severe, the client is advised to consult a structural engineer. This minor step cracking can be used as a warning sign to address factors causing stress to the wall, which can include the effect of surrounding trees, water leaks, soil erosion, or even the presence of reactive soils in the surrounding area.

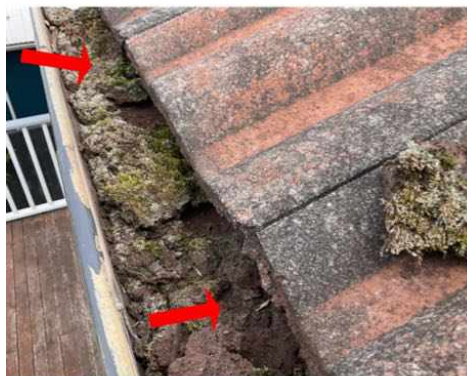
### Finding 3.13

Building:	Building 1
Location:	Roof exterior
Finding:	Gutters - Full and blocked
Information:	The guttering on around the roof was found to be blocked at the time of the inspection. Roof plumbing structures, such as guttering and downpipes, should be free of all debris to prevent blockages. Blockages of the guttering and downpipes will lead to pooling and accumulated water overflows, which is likely to subsequently flood eaves and exterior walls.

Blocked gutters are likely to lead to high levels of moisture in the affected areas which can cause rust and decay of the gutters and downpipes and wood rot to adjoining timber areas. Blockages in gutters should therefore be removed immediately to ensure dry conditions are maintained.

It is highly advised that gutters be cleaned by the homeowner or a general handyperson as a matter of urgency.

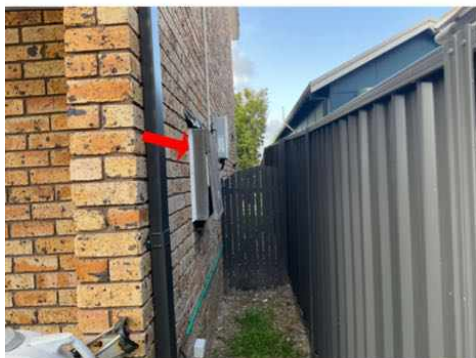
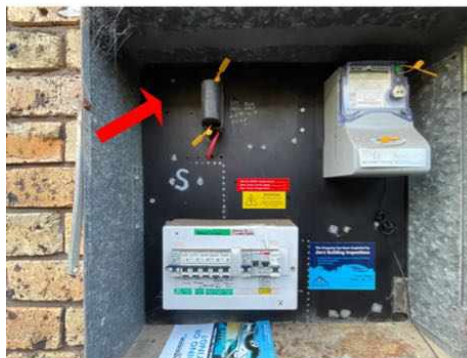
Building:	Building 1
Location:	Meter Box
Finding:	Termite Management System - no evidence of a chemical installation
Information:	The application of a post-construction chemical termite barrier is highly recommended for all properties. Such barriers are highly effective in preventing termite attack on any timber building elements throughout the property.

A durable notice should be placed in the switchboard unit to indicate current termite barriers. At the time of inspection, no durable notice was evident and it appeared as though no chemical termite management system has been installed, with no evidence to suggest preventative works taking place since the property was built.

The client may consider gaining further advice from a pest controller as to the costs and procedures involved with a 'chemical' application. It is recommended that obtaining such advice be a short-term priority.

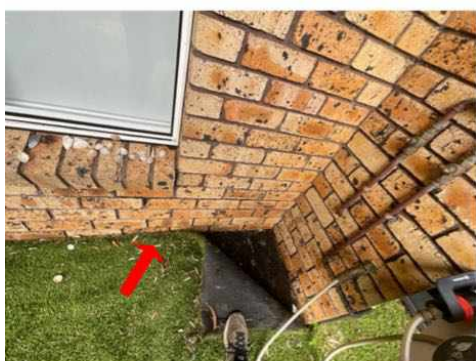
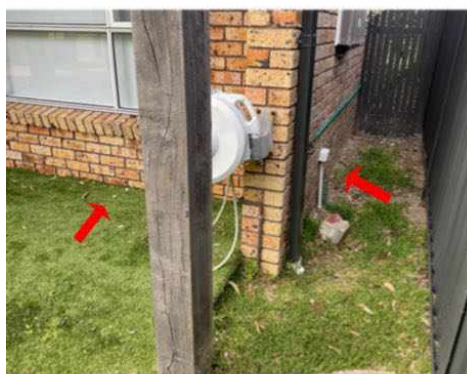
## Finding 6.02

Building:	Building 1
Location:	Exterior walls
Finding:	Slab Edge - Exposure
Information:	An inspection zone of at least 75mm in relation to the exposed slab edge, between the bottom brick and the perimeter pavement, is required. This inspection zone should be maintained in order to force termites into the open where they can be detected more readily during regular inspections. The slab edge should not be concealed by anything that may prevent inspection of the area, including render, landscaping, soil, turf, paving, concrete cladding or other structures.

If the slab edge is not properly exposed there is a high risk of termite attack. Sometimes, in order to determine the type of slab, a suitably qualified person such as an architect or builder may be required to consult the construction plans.

Where the slab edge cannot be properly inspected, it is highly recommended that termite or timber pest inspections be carried out every 6-12 months to aid protection of the property against infestation.

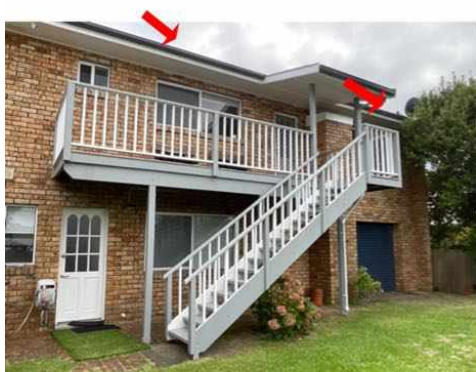
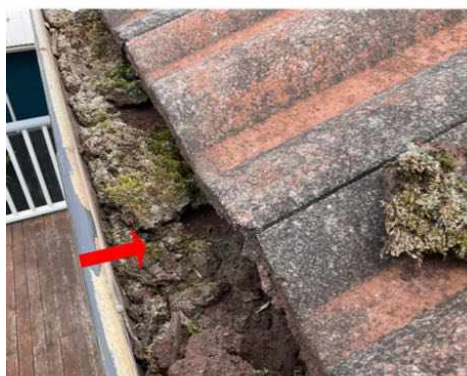
### Finding 6.03

Building:	Building 1
Location:	Roof exterior
Finding:	Gutters - Full and blocked
Information:	The guttering on around the roof was found to be blocked at the time of the inspection. Roof plumbing structures, such as guttering and downpipes, should be free of all debris to prevent blockages. Blockages of the guttering and downpipes will lead to pooling and accumulated water overflows, which is likely to subsequently flood eaves and exterior walls.

Blocked gutters are likely to lead to high levels of moisture in the affected areas. Such moisture will not only cause rust and decay of the associated building materials, but can also provide conditions that are conducive to termite and timber pest activity. Blockages in gutters should therefore be removed immediately to ensure dry conditions are maintained.

It is highly advised that gutters be cleaned by the homeowner or a general handyperson as a matter of urgency.

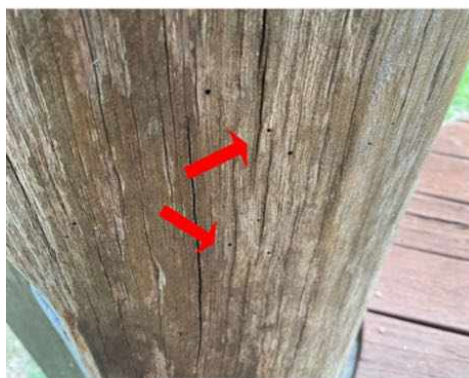
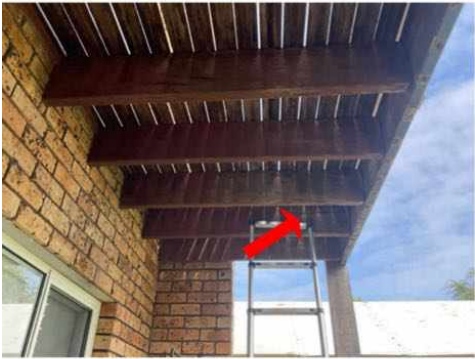
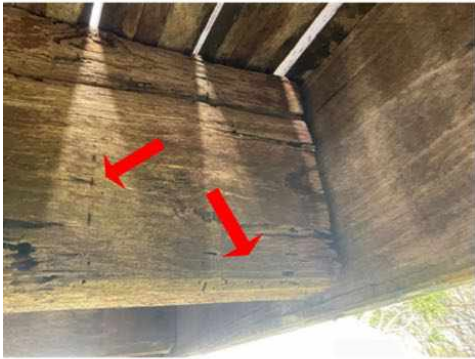
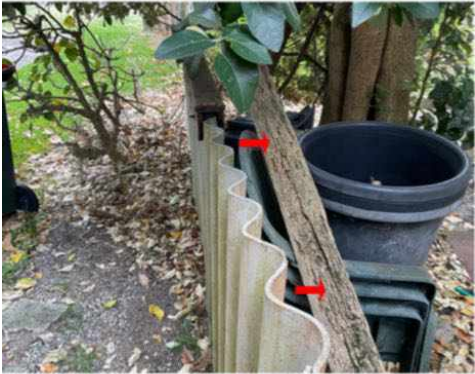
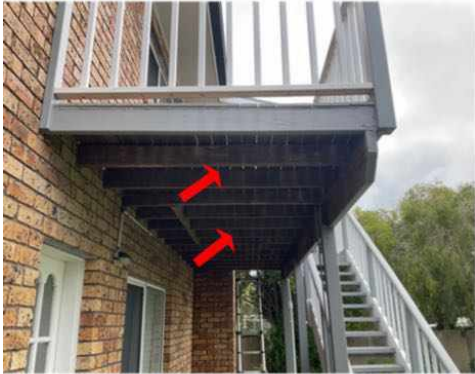
Building:	Building 1
Location:	Many decking areas
Finding:	Evidence of wood borer activity identified (all appears minor)
Information:	Wood borers small beetles that colonise in exposed timber elements are a common timber pest that are regularly mistaken for termites. Although wood borer activity is generally not detrimental to the affected timber they may lead to serious damage and necessitate replacement of certain building elements if left unattended.

The other commonly known borer the Anobium borer is more likely to attack floorboards and may cause severe structural damage to flooring areas.

As no live wood borer activity was identified, treatment is not required at this time. Annual monitoring should be undertaken in areas where wood rot is occurring due to bora damage.

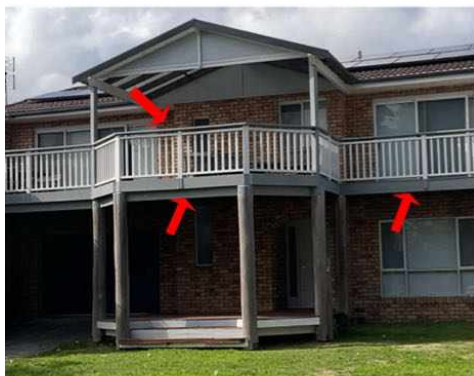
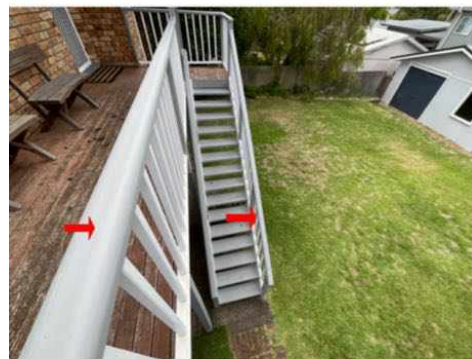
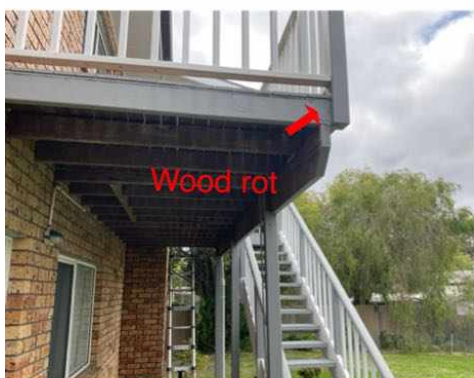
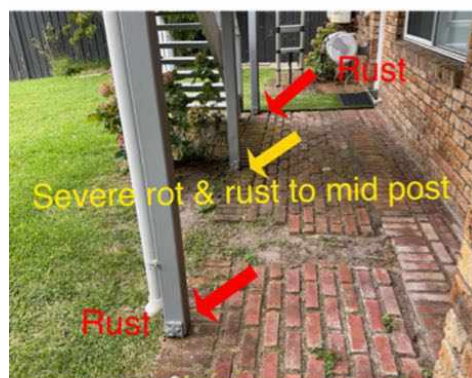
Nothing contained in this report should be taken as an indicator that an assessment has been made, on any elevated structure, as suitable for any specific number of people or purpose. This can only be done by a qualified engineer. For the purpose of this report, the Structure includes the front and rear elevated decks, handrails and stairs that show some wood rot, bora damage and rust.

You should also arrange annual inspections of the structure by an engineer or other suitably qualified person to ensure any maintenance, that may become necessary, is identified. Care must be taken not to overload the structure.

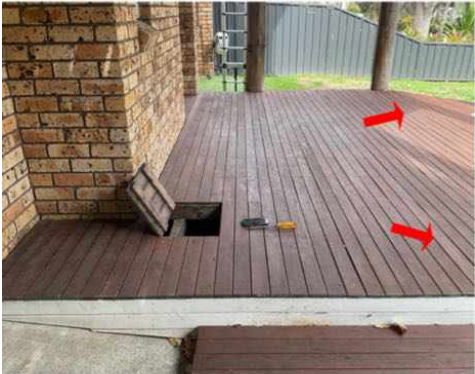
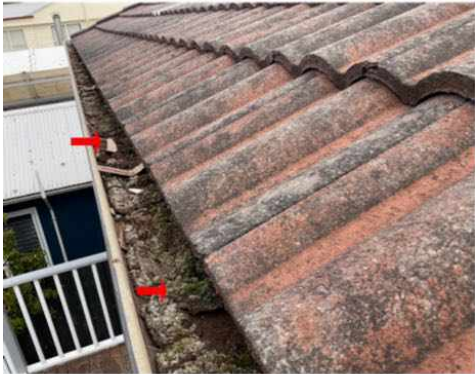
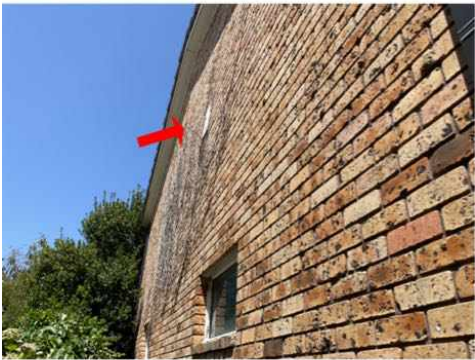
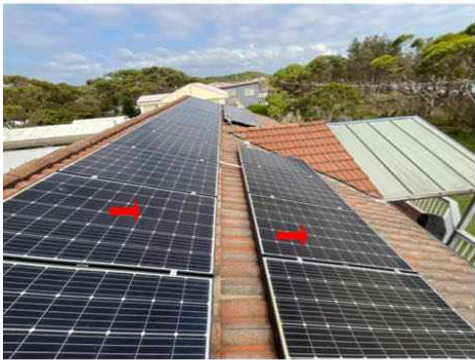
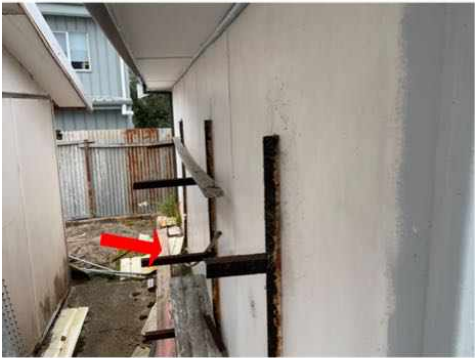
**Noted Item**

Building: Building 1  
Location: All External Areas  
Finding: Additional Photos - Obstructions and Limitations of EXTERNAL AREAS  
Information: These photographs are an indication of the obstructions and limitations which impeded full inspection of external areas at the time of inspection. These obstructions can hide an array of defects and should be removed to allow full inspection to be carried out. A re-inspection is recommended once the areas are made accessible.

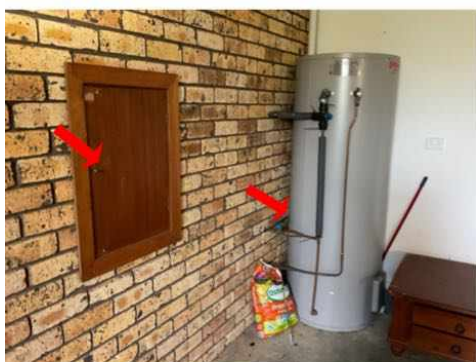
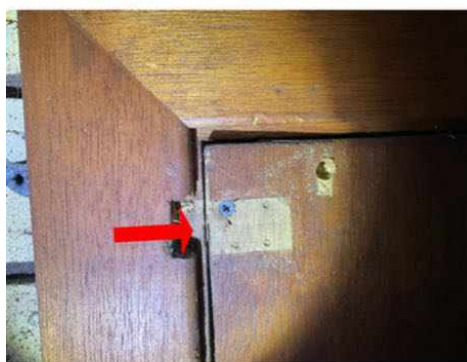
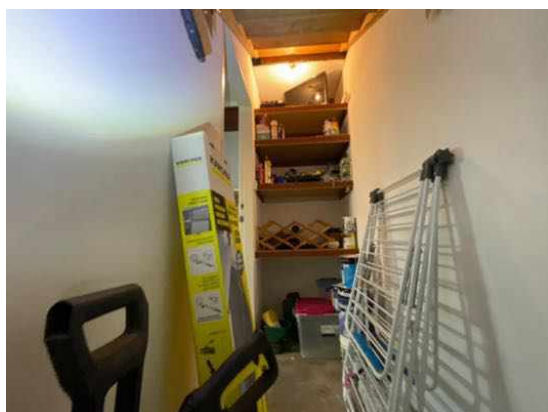
Building: Building 1  
 Location: All Internal Areas  
 Finding: Additional Photos - Obstructions and Limitations of INTERNAL AREAS  
 Information: These photographs are an indication of the obstructions and limitations which impeded full inspection of Internal areas at the time of inspection. These obstructions can hide an array of defects and should be removed to allow full inspection to be carried out. A re-inspection is recommended once the areas are made accessible.

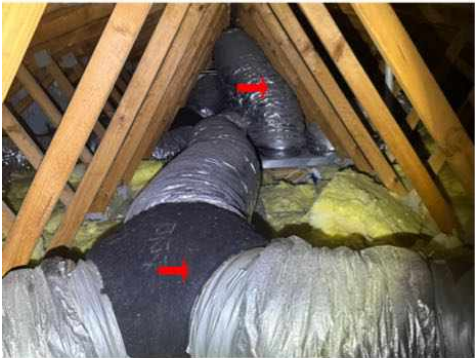
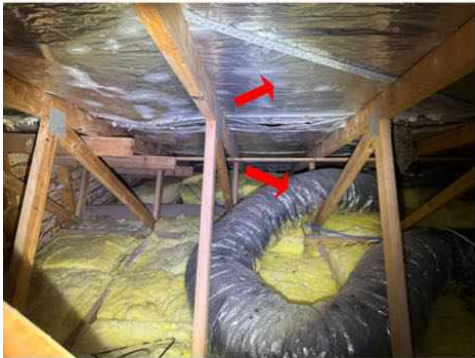
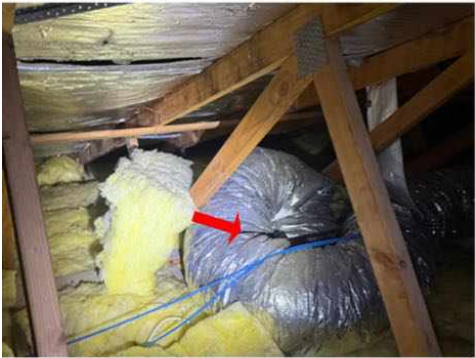
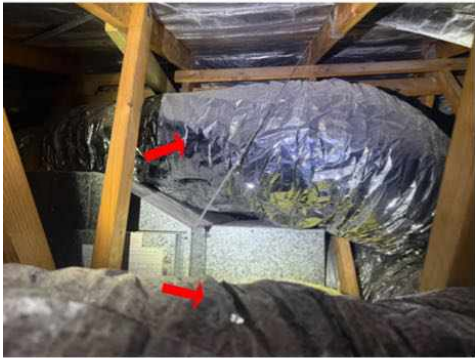
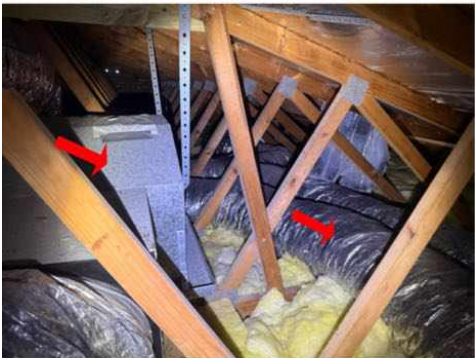
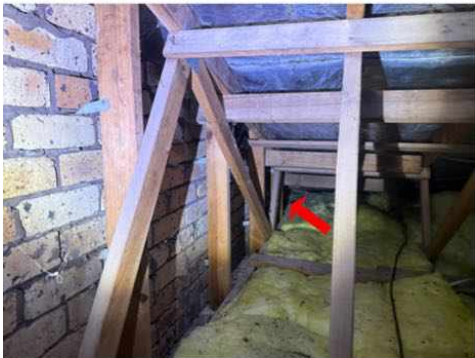
Building: Building 1  
 Location: All Roof cavity areas  
 Finding: Additional Photos - Obstructions and Limitations of the ROOF CAVITY  
 Information: These photographs are an indication of the obstructions and limitations which impeded full inspection of roof cavity areas at the time of inspection. These obstructions can hide an array of defects and should be removed to allow full inspection to be carried out if applicable. A re-inspection is recommended once the areas are made accessible.

The inspection was also limited to areas with an allowable crawl space of 600mm x 600mm, in particular towards the external walls where the roof line diminishes, these areas were not accessible.

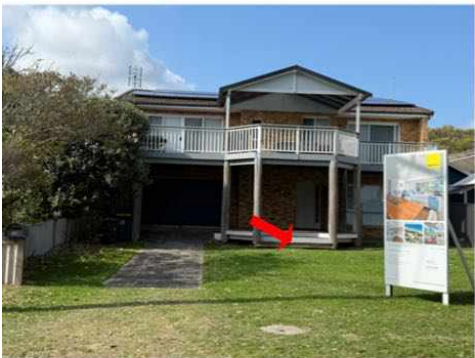
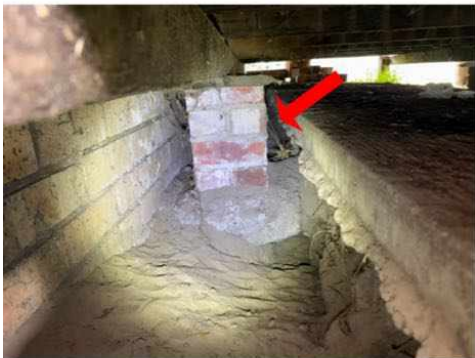
Building: Building 1  
Location: All Subfloor Areas  
Finding: Additional Photos - Obstructions and Limitations of SUBFLOOR AREAS  
Information: These photographs are an indication of the obstructions and limitations which impeded full inspection of subfloor areas at the time of inspection. These obstructions can hide an array of defects and should be removed to allow full inspection to be carried out. A re-inspection is recommended once the areas are made accessible.

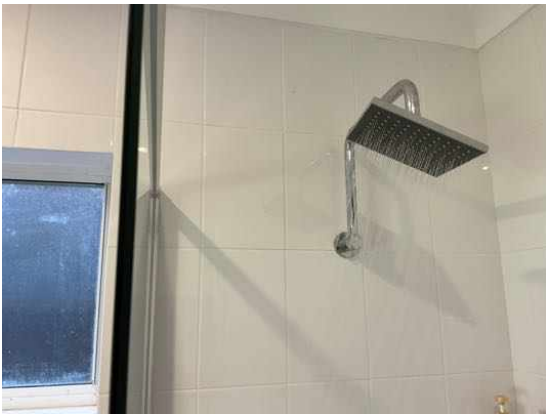
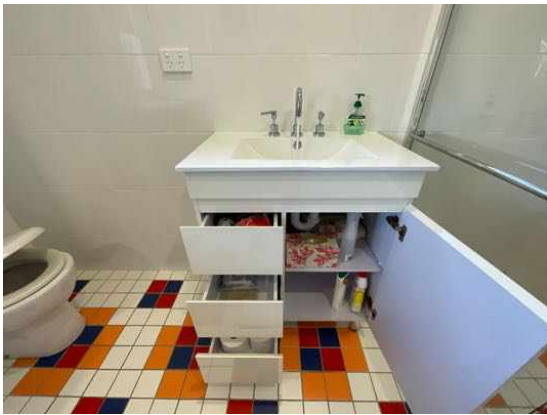
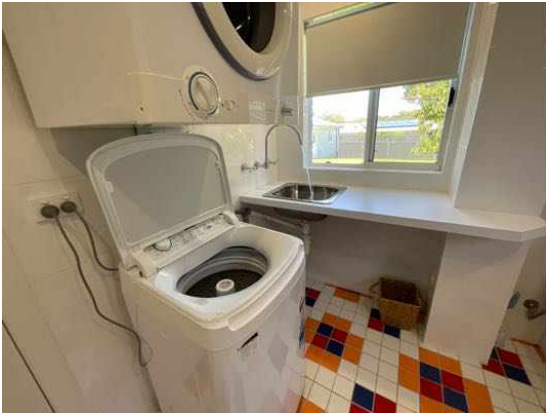
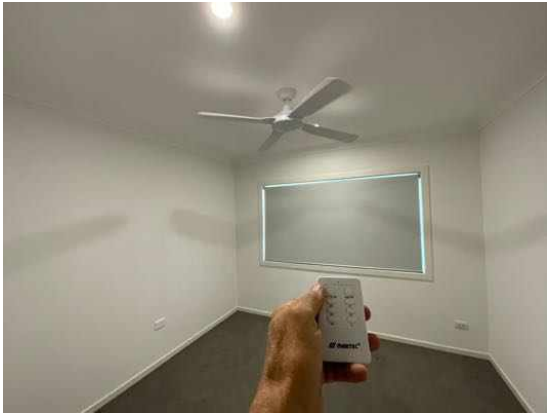
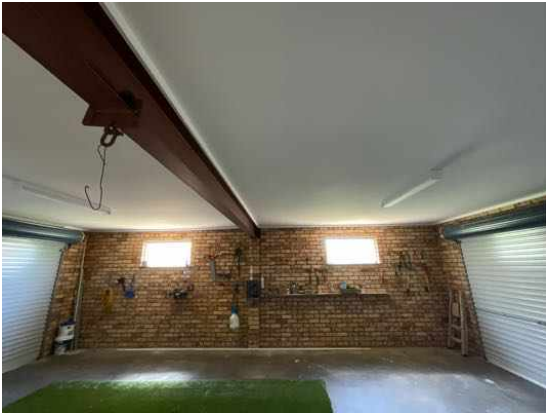
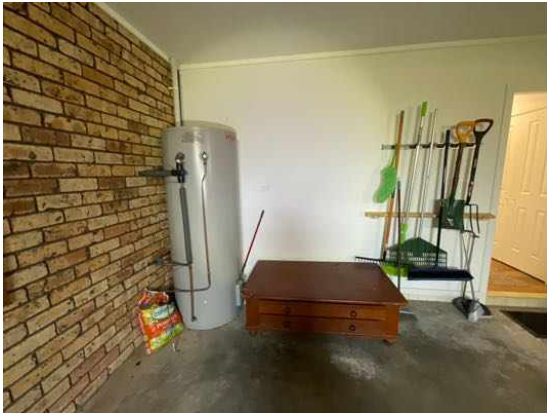
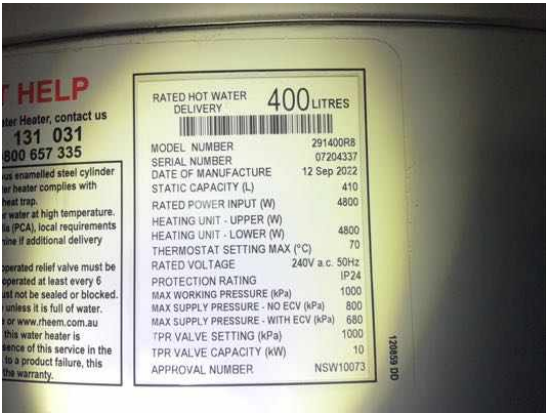
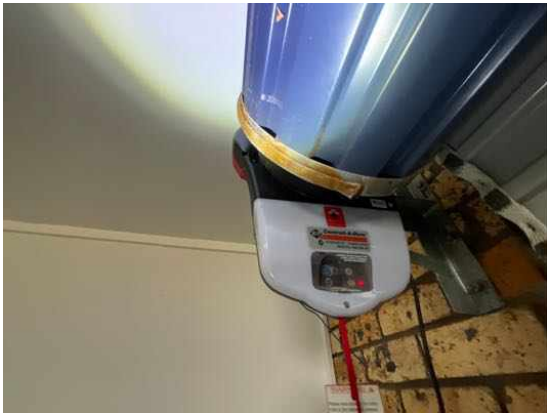
Building: Building 1  
Location: All Internal Areas  
Finding: Additional Photos  
Information: Additional photos are provided for your general reference

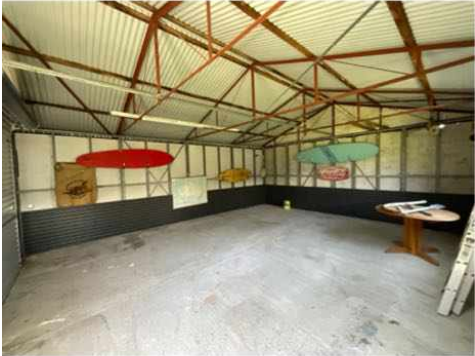
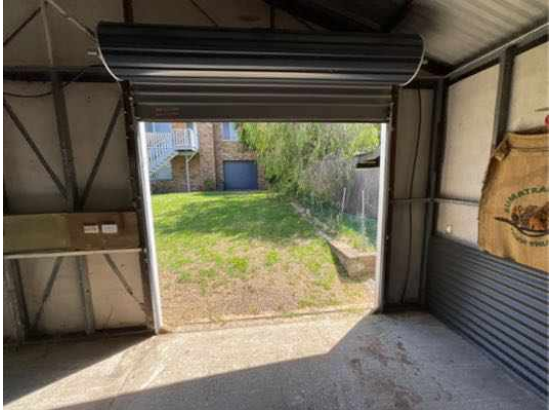
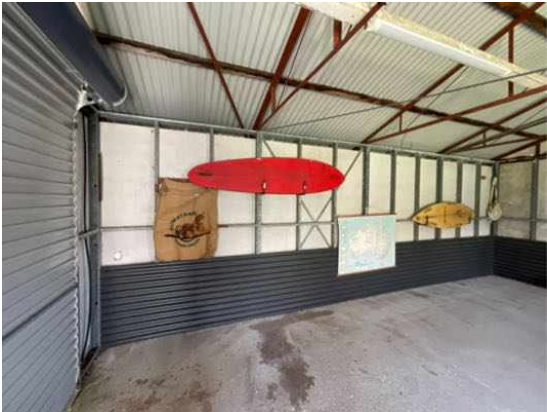
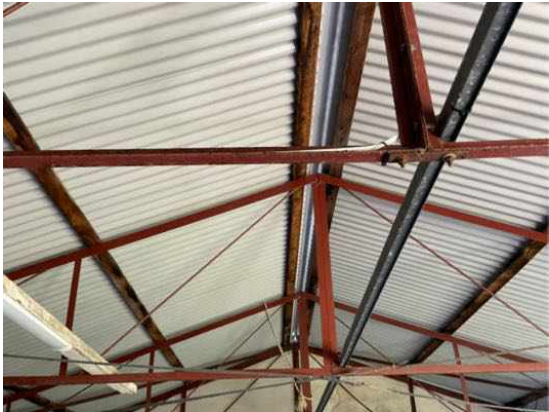
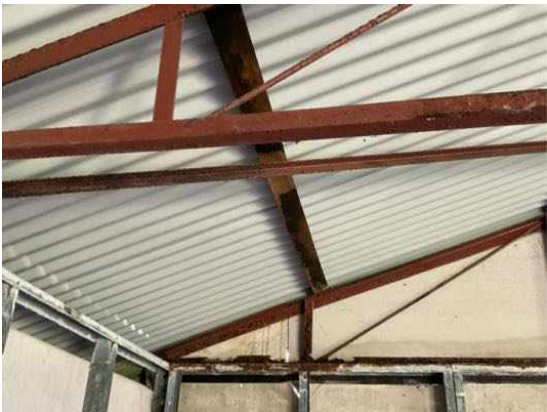
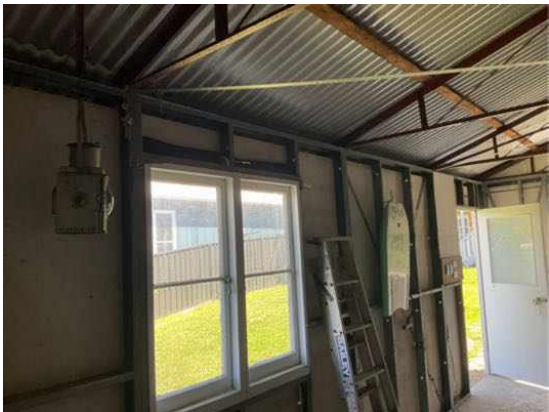
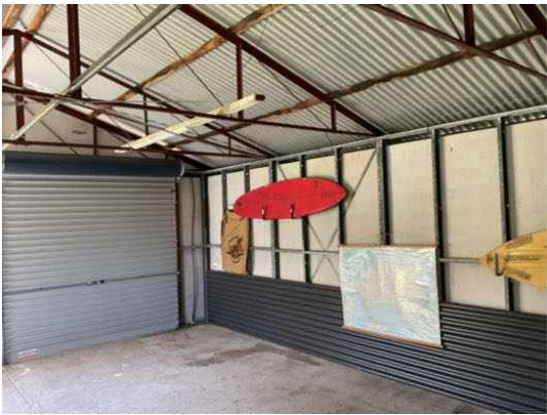
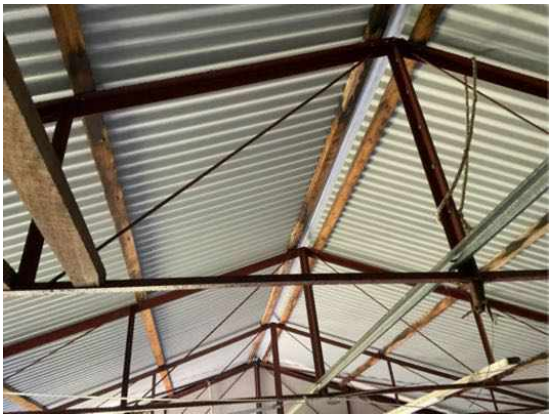
Building: Building 2  
Location: All Internal Areas  
Finding: Additional Photos  
Information: Additional photos are provided for your general reference
