# Building and Timber Pest Inspection Report

Inspection Date: Fri, 30 Jan 2026

Property Address: 46 Warrain Cres, Currarong NSW 2540, Australia

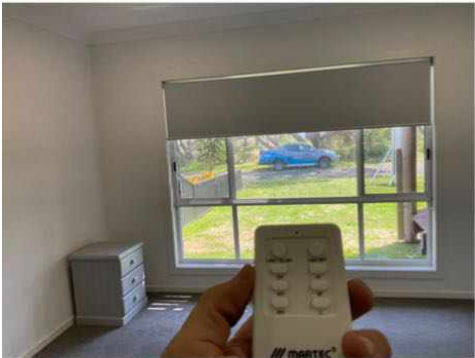
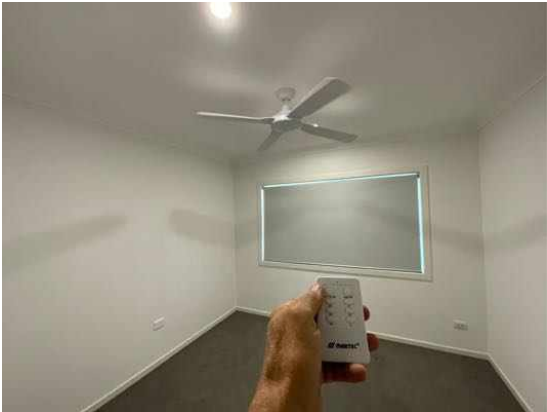
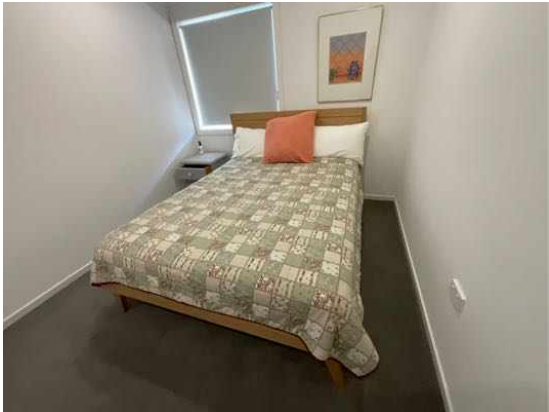
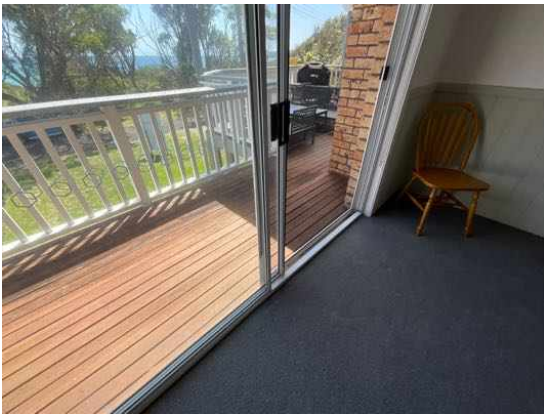
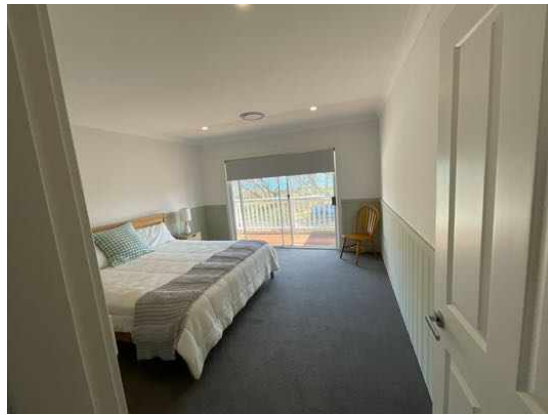
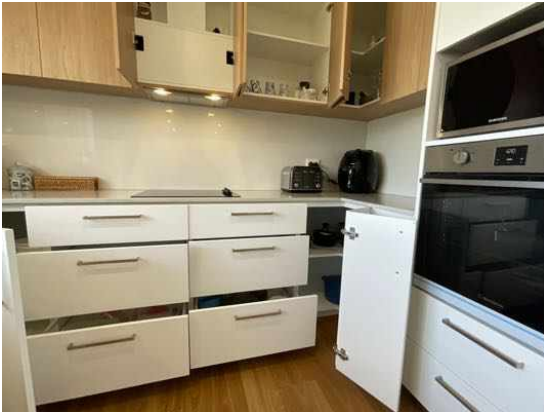
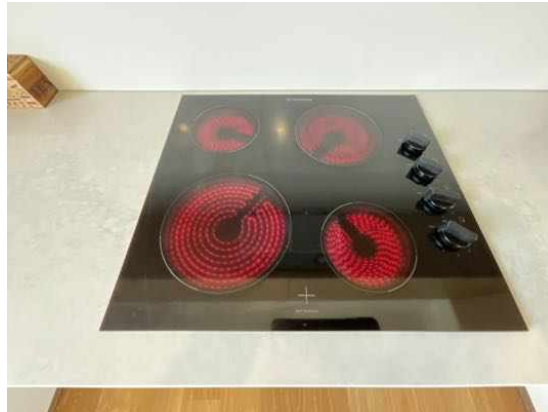
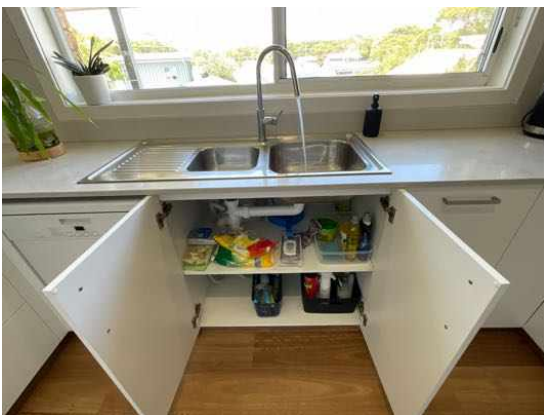
Building: Building 1  
Location: All Internal Areas  
Finding: Additional Photos  
Information: Additional photos are provided for your general reference

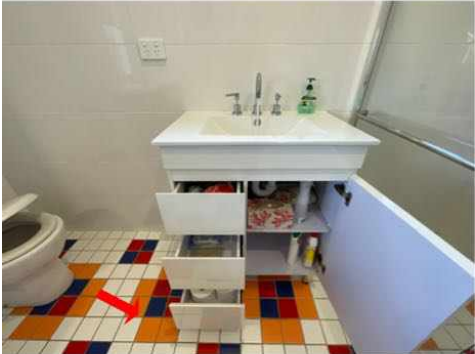
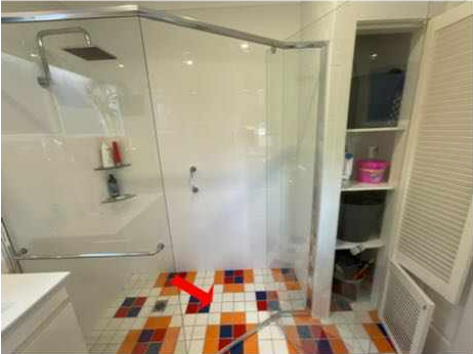
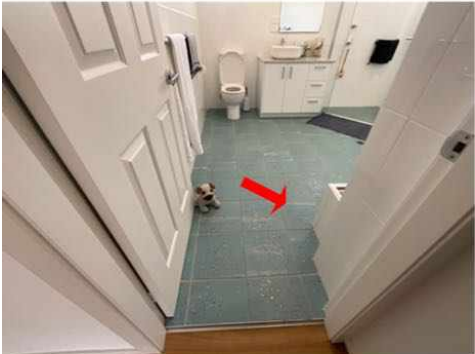
Building: Building 1  
 Location: Bathrooms and laundry  
 Finding: Waterproofing membranes - Information Only  
 Information: Internal Water Proofing Membranes, are crucial in preventing water ingress into the property is important to know that the Membrane System used is to Australian Standards and has been installed correctly.

With older property's where this information is unavailable all wet areas should be monitored. If any leaks, water staining, peeling or bubbling of the paint become evident to any adjacent walls or ceilings below a licensed builder or waterproofing specialist is recommended to investigate further.
