Building Inspection Report

Inspection Date: Mon, 16 Feb 2026

Property Address: 2/38 Oakes Ave, Clayton South VIC 3169,
Australia

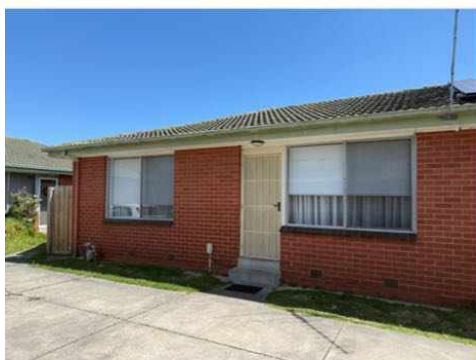
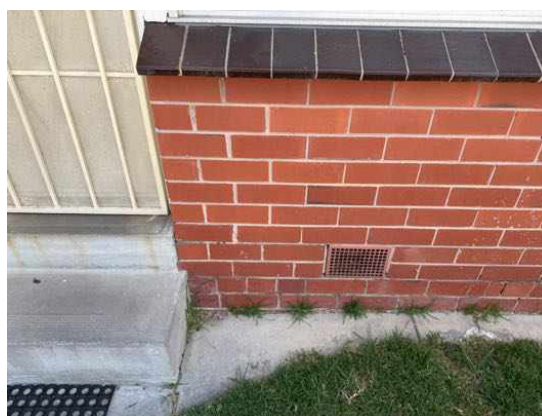
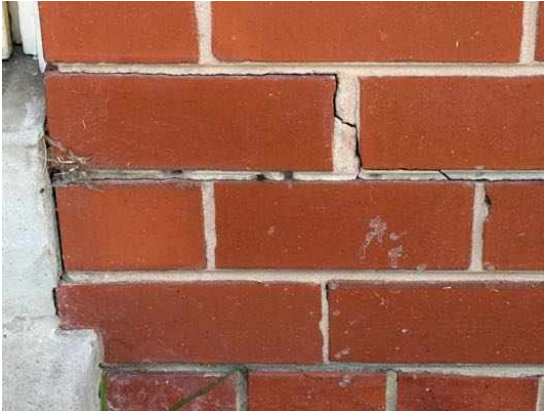
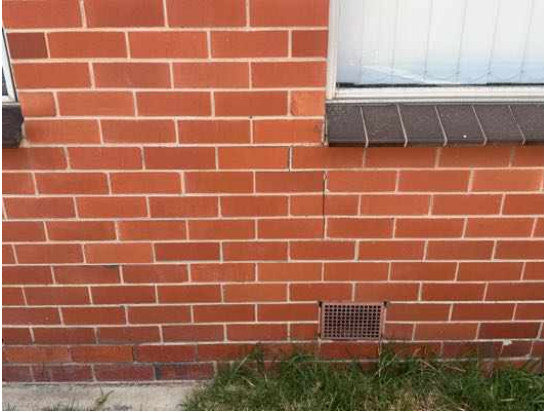
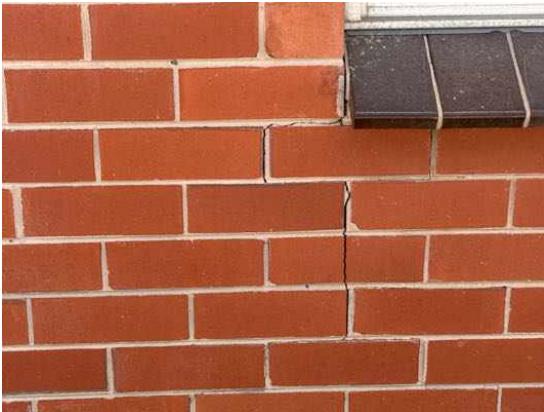
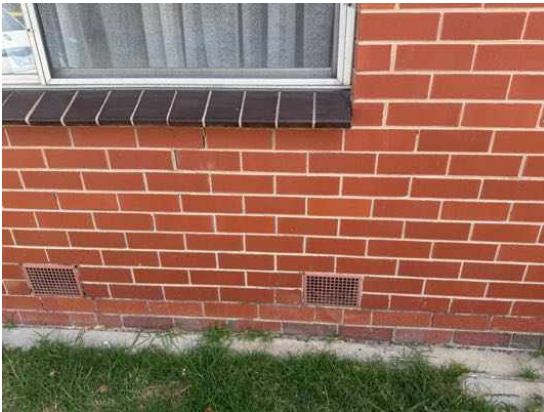
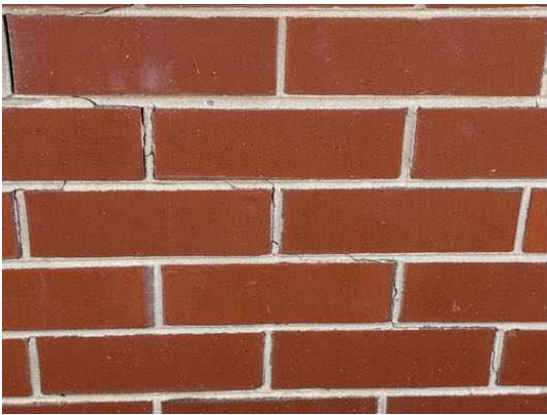
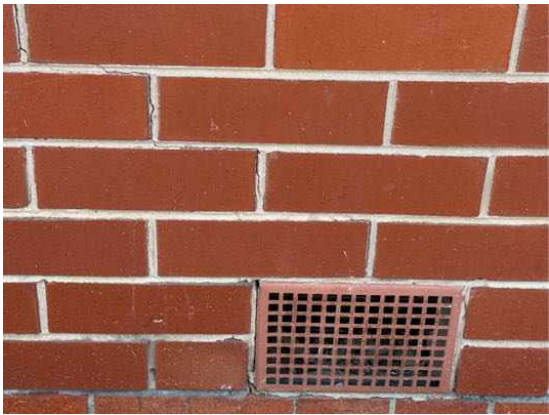
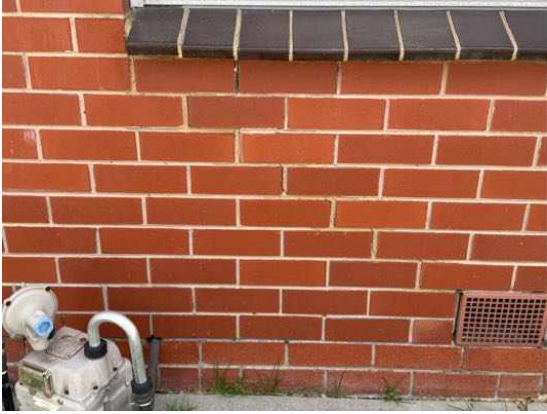
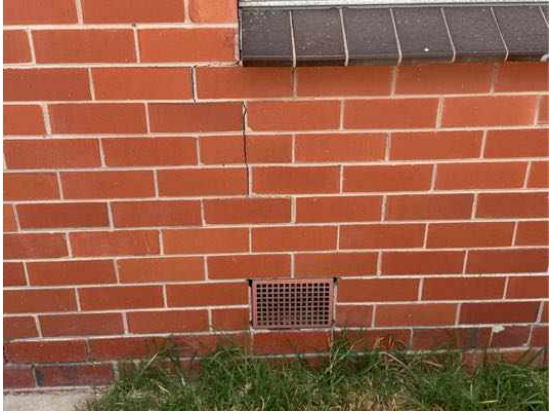
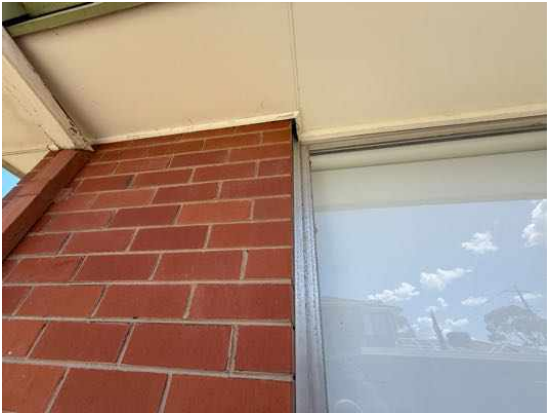
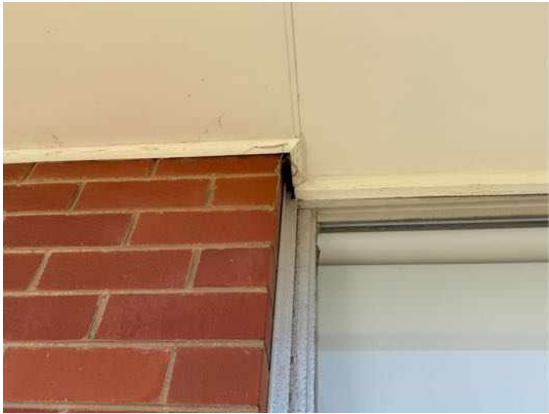
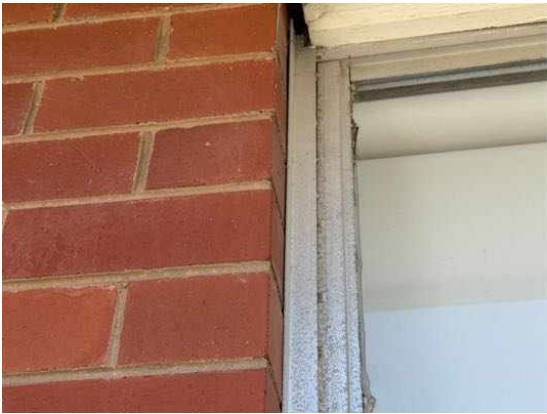
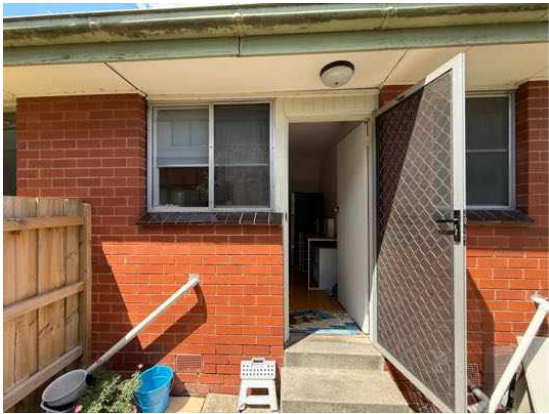
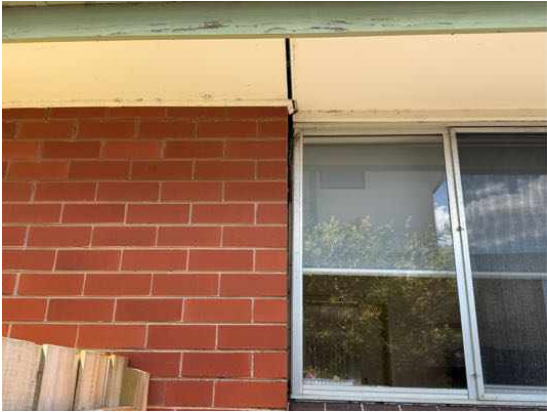
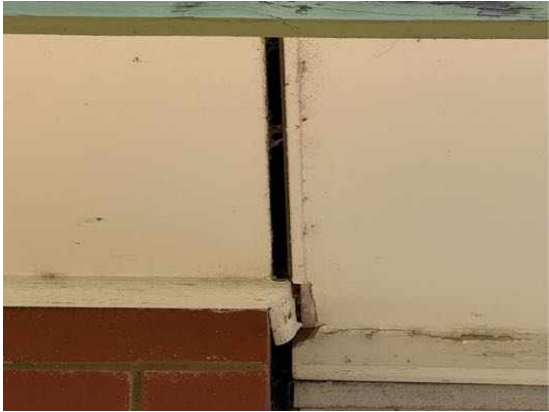
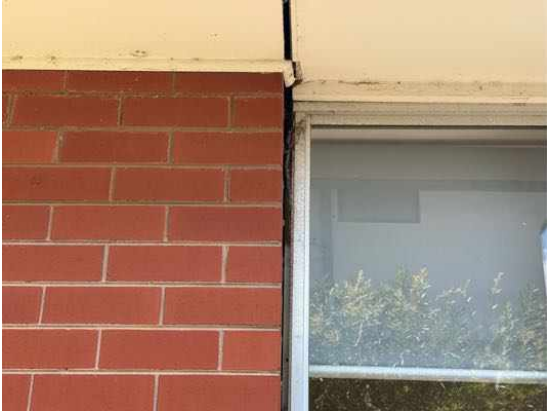
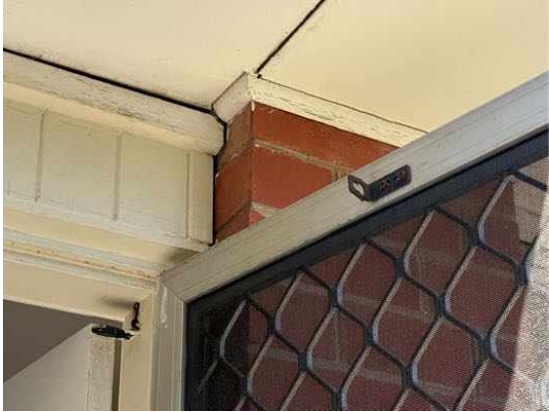
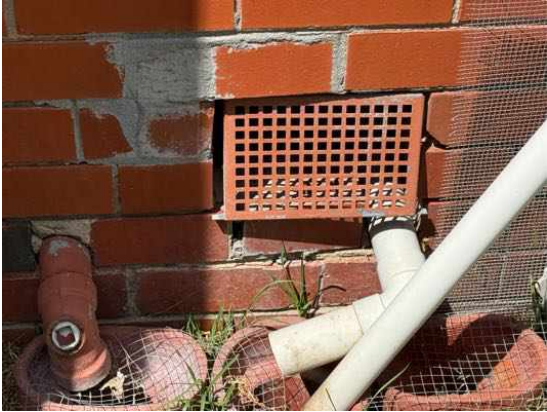
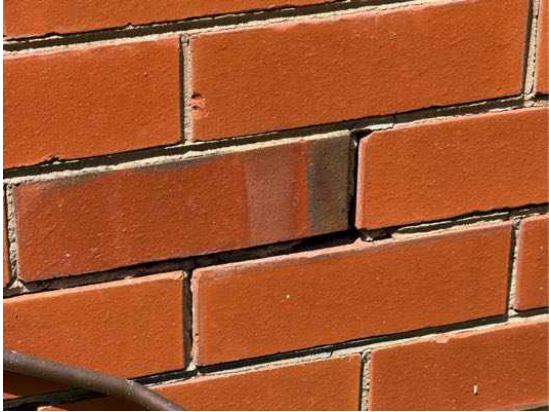
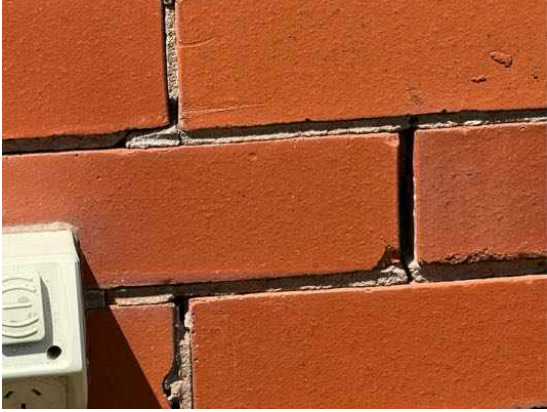
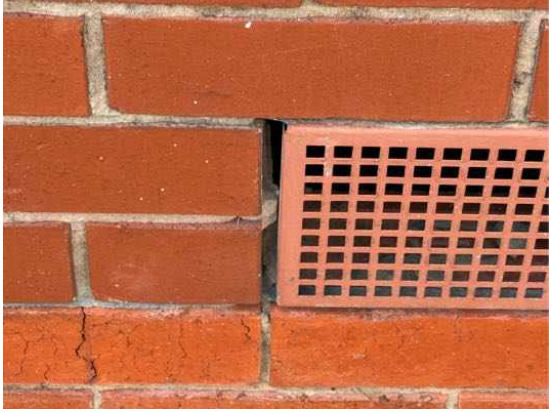
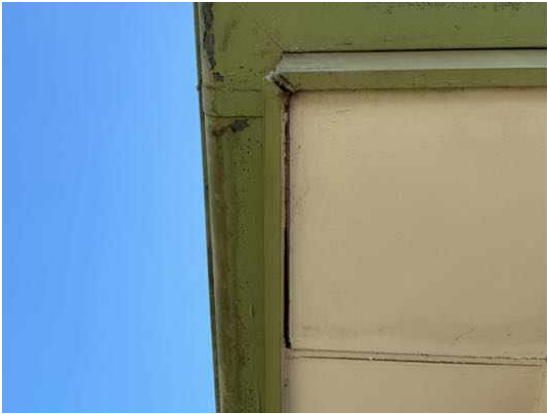
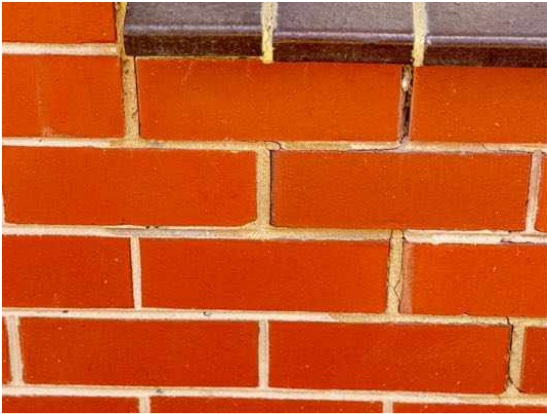
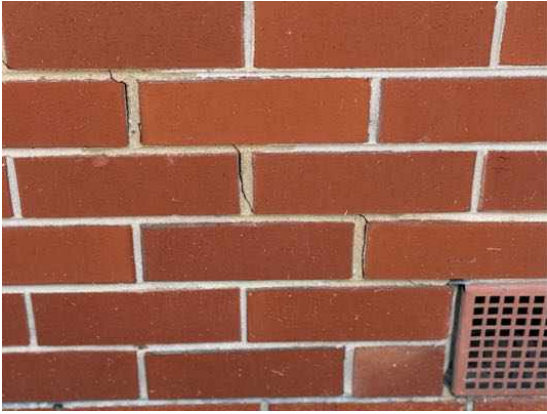
Defects 2.01

Building:	Building 1
Location:	All Areas > All Areas
Finding:	Brickwork - cracks and excessive movement
Information:	At the time of the inspection numerous cracks throughout the front brickwork were observed. Due to the number of areas of brickwork cracks, damage and the expected further movement over time and the amount of remedial repair involved to rectify, they are considered to be a major defect. The front brickwork showed excessive movement which is suspected to require repair at some time in the future, which will necessitate in major remedial works and or replacement of the brickwork. A Structural Engineer is recommended to further inspect these areas.

Structural issues are generally the underlying cause of these types of brickwork cracking and movement. Brickwork cracks are a common occurrence and are a likely result of excessive movement, subsidence, and expansion and contraction of building materials in different weather conditions. Cracks in brickwork such as these are suspected to further develop over time. And if left unattended with potential for necessitating major remedial works or replacement of the brickwork.

The client should elect to appoint a structural engineer and a builder to inspect the structural integrity of these areas of affected brickwork, to assess the safety of the associated structures. The engineer can also nominate a scope of works required for the rectification. Always contact a Registered builder or engineer should cracks widen lengthen or become more numerous, even after repair works have been completed.

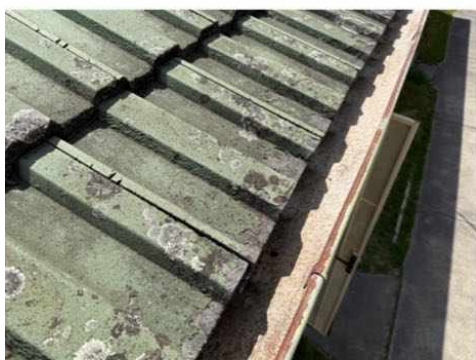
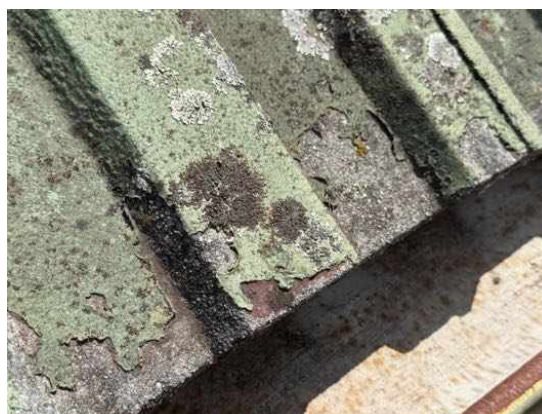
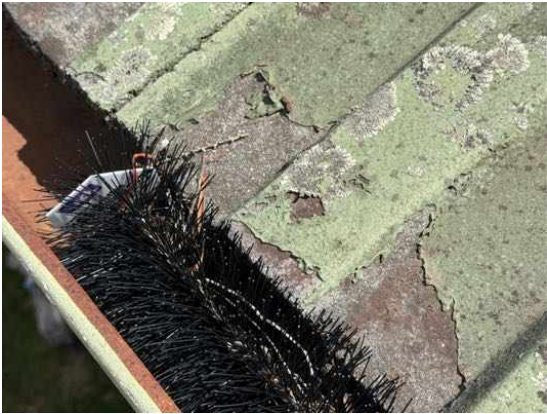
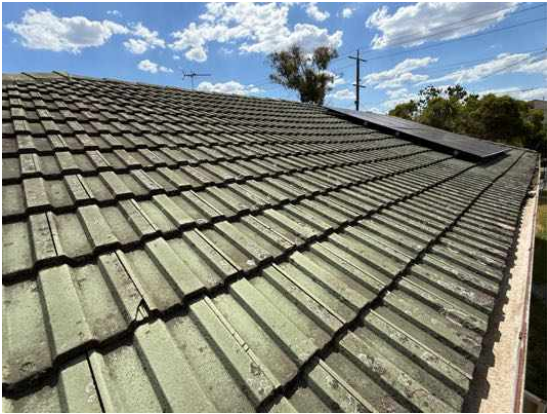
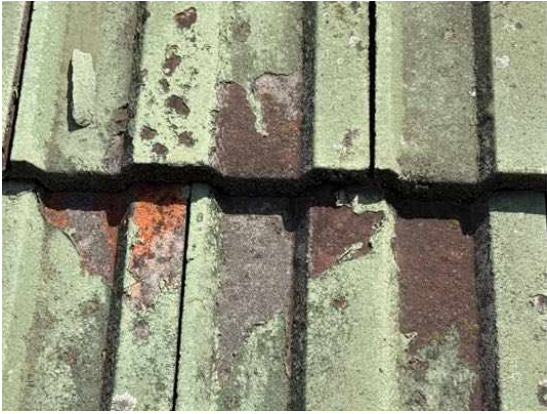
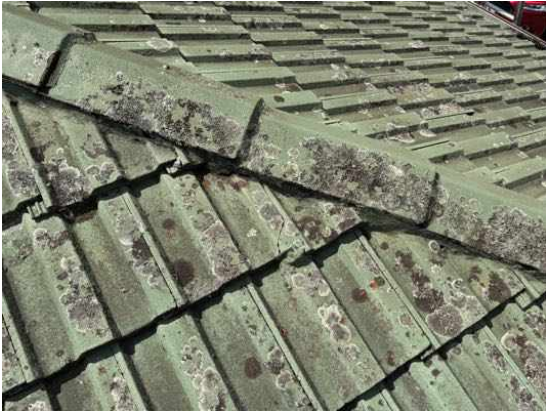
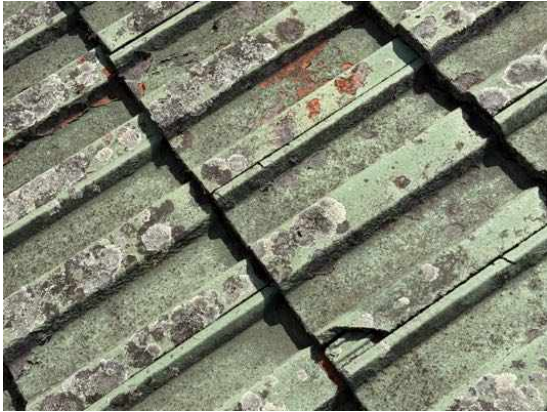
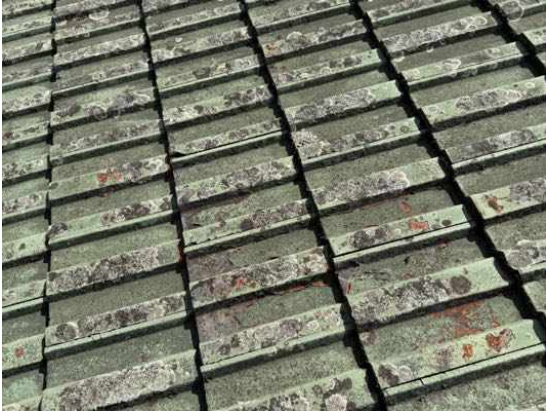
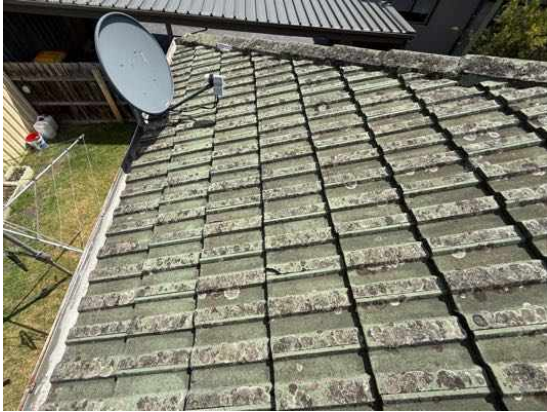
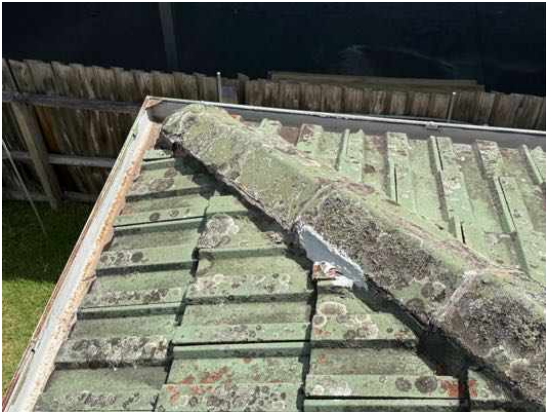
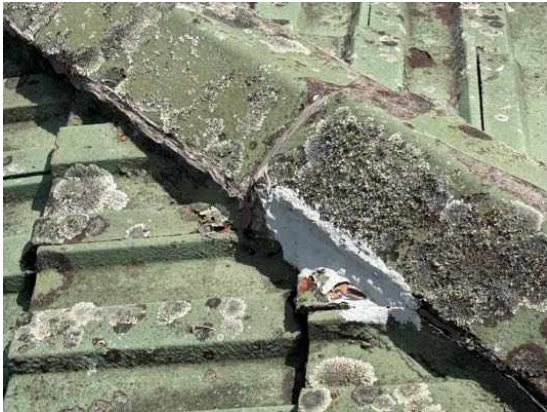
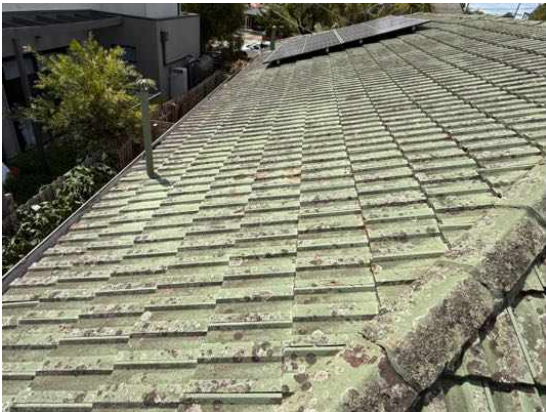
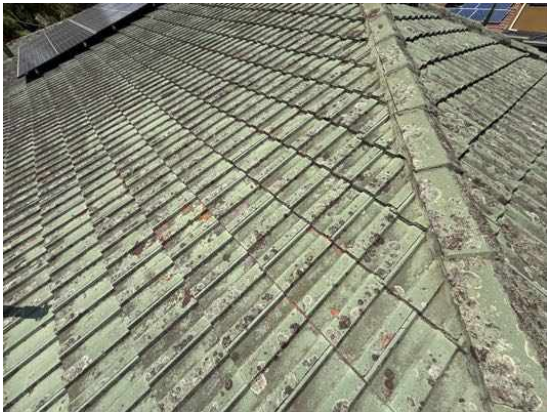
Defects 3.01

Building:	Building 1
Location:	All Areas > All Areas
Finding:	Roof tiles - aged and weathered
Information:	Upon inspection of the exterior roofing, the roof tiles were considered to be showing weathering, ageing and deterioration. The roof tiles are essentially a concrete porous material and when the roof tiles get aged and deteriorated the top finish of the roof tiles is diminished, the roof tile will eventually begin to absorb moisture into the concrete porous material and secondary defects can result. Over time the roof tiles top protective surfaces will further deteriorate which can lead to water penetration via the roof into the ceiling space, causing secondary damage to roof structure, ceiling linings, insulation. They are suspected to require re-sealing and maintenance to keep the roof tiles watertight in the future.

Where left unmanaged, deteriorating roof tiles are likely to lead to a number of secondary defects, including minor water leaks and weather exposure to internal roofing structures. Consultation with a roof sealing company or a roofing contractor is recommended to gain advice on cost of future works that may be required. Remedial works and maintenance of the roof tiles will increase the longevity of the roof tiles and the roofing structure.

Replacement of some areas of the roof pointing and any broken or chipped roof tiles is required and should be performed by a roofing contractor as soon as possible. As time goes on the concrete tiles will become more porous during outside wet conditions and therefore the possibility of secondary defects in the future. While weathering of the tiles is consistent with the age of the property, maintenance works are and will be required in the future to maintain a weather and waterproof roof.

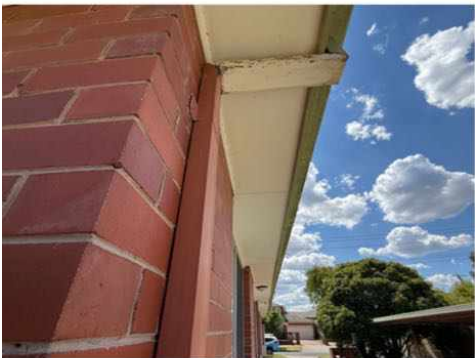
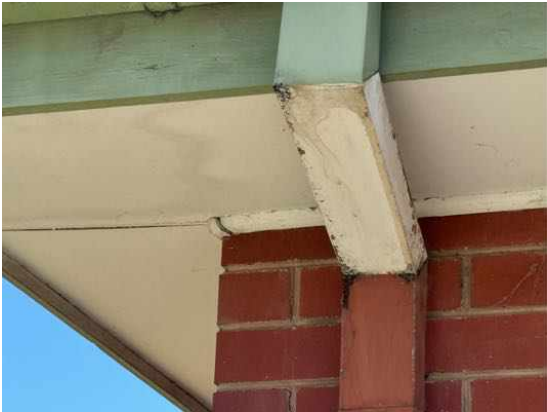
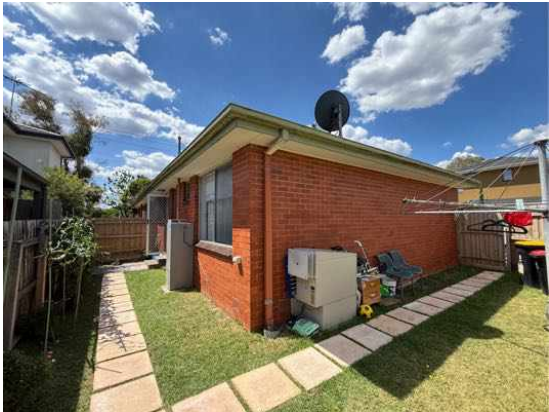
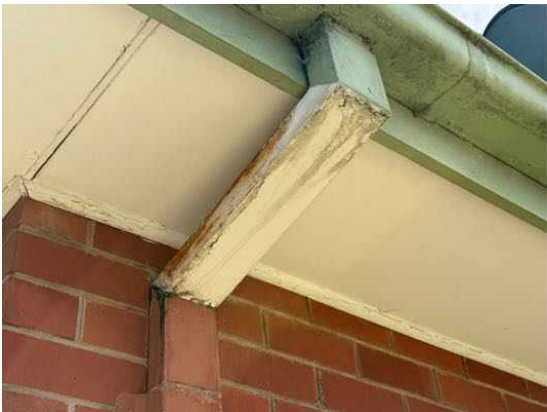
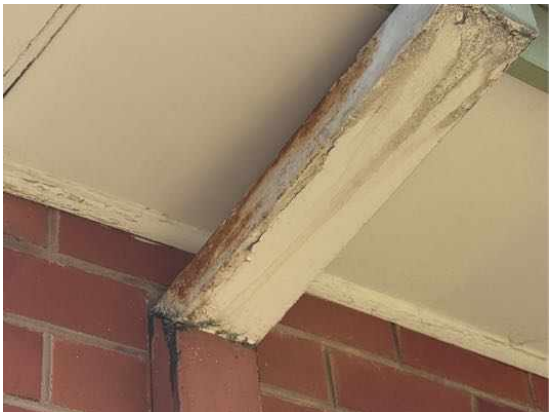
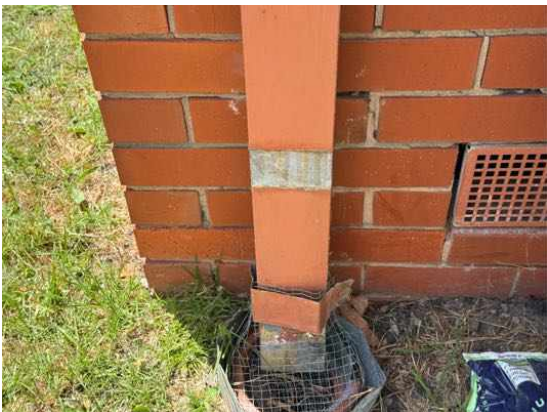
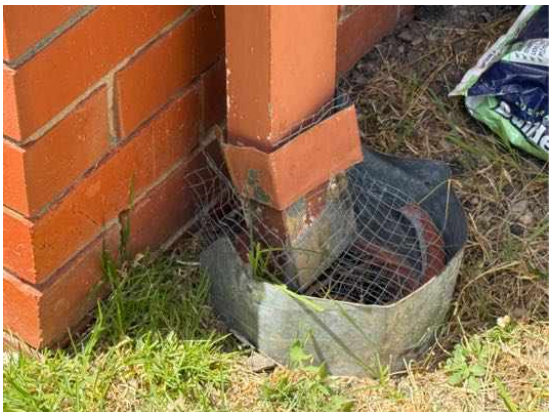
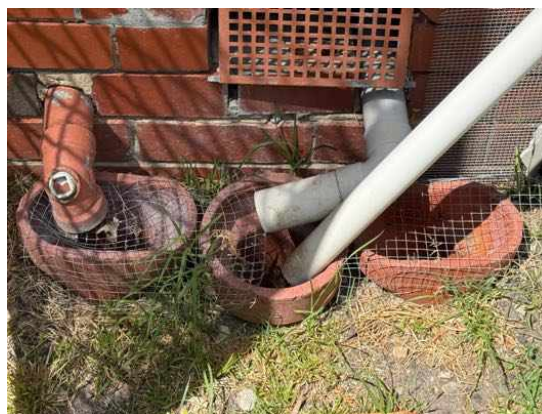
Defects 3.02

Building:	Building 1
Location:	All Areas > All Areas
Finding:	Downpipes weeping from joins
Information:	It was observed at the time of inspection that some down-pipes were weeping from joins. This will therefore make these areas susceptible to moisture, wood rot, rust, corrosion, termite and pest. If left unmanaged, moisture, wood rot, rust and corrosion is likely to lead to damage to adjoining areas, building structures and building elements, this also makes these areas more susceptible to termite or timber pest activity.

It is recommended that client appoint and seek advice and consultation with a licensed plumber to rectify these downpipes.

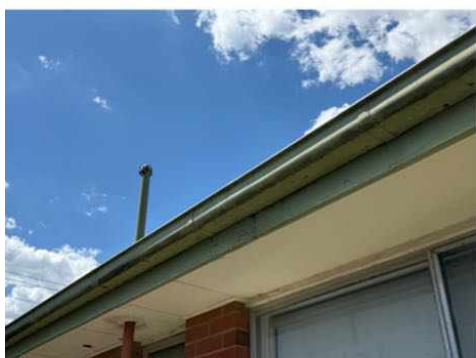
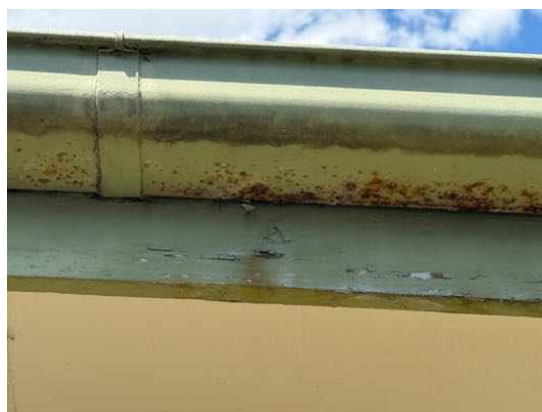
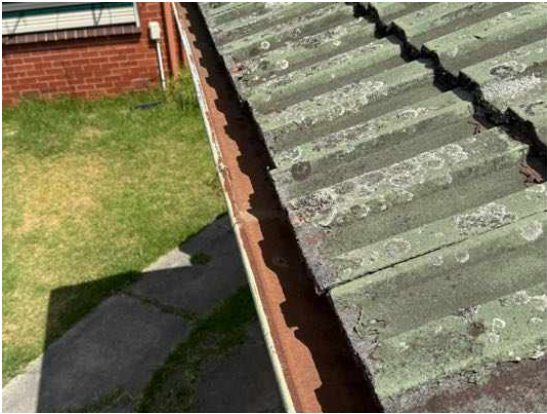
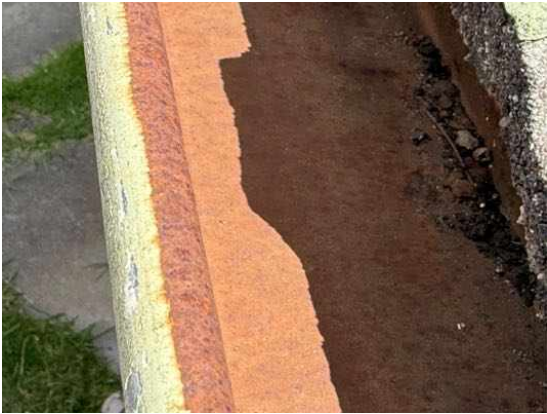
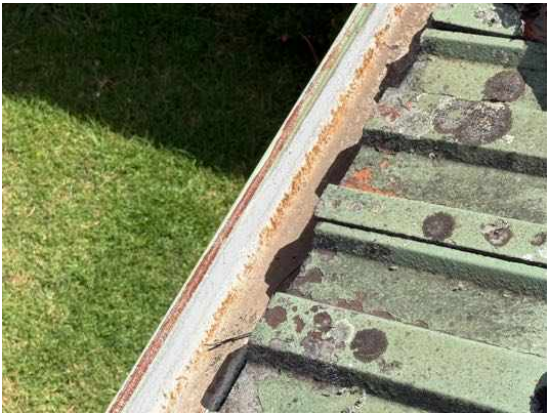
Defects 3.03

Building:	Building 1
Location:	All Areas > All Areas
Finding:	Roof gutters - Rusted or corroded
Information:	The roof guttering in some areas around the perimeter of the home were observed to be rusted and deteriorated, It is suspected that this has been caused by blockages within the gutters over time, resulting in water pooling or standing water, this type of defect may have prematurely rusted guttering and other elements of the roof plumbing.

Rusted roof plumbing will generally develop holes and leaks that can affect other building elements with poor drainage of storm water. Poorly drained roof areas will also lead to damp conditions surrounding the base perimeter of the building which, if left unmanaged, can lead to a range of secondary building defects. Client may consider to repair or replacement of rusted roof plumbing in order to reinstate the roof drainage system to a good operational level. To further maintain these areas, gutters should be cleaned frequently, allowing the avoidance of any partial blockages.

A licensed plumber should be appointed to undertake these works. It is recommended that such works be completed as soon as possible to prevent any further damage and deterioration.

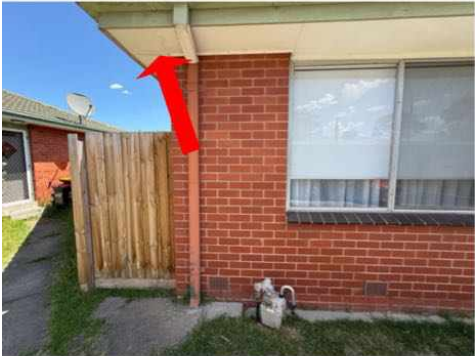
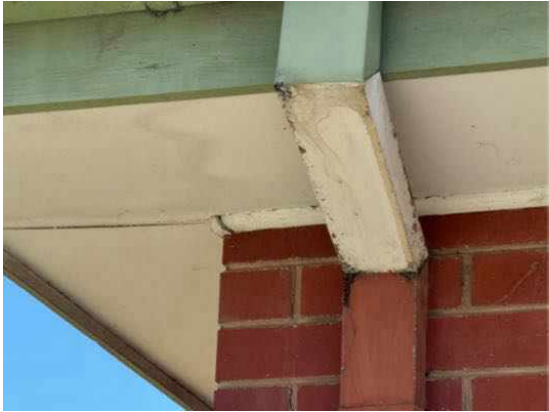
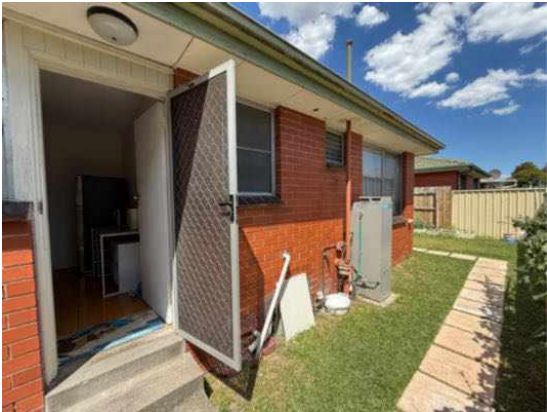
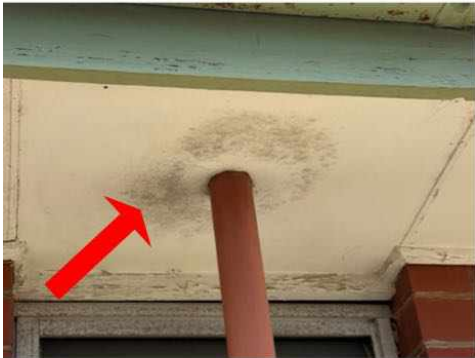
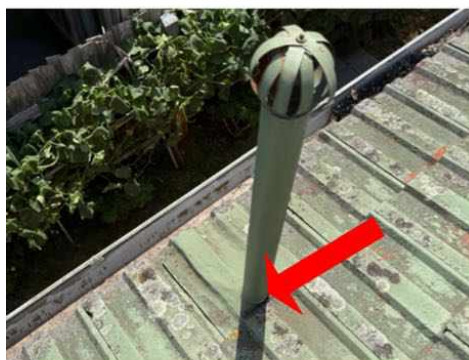
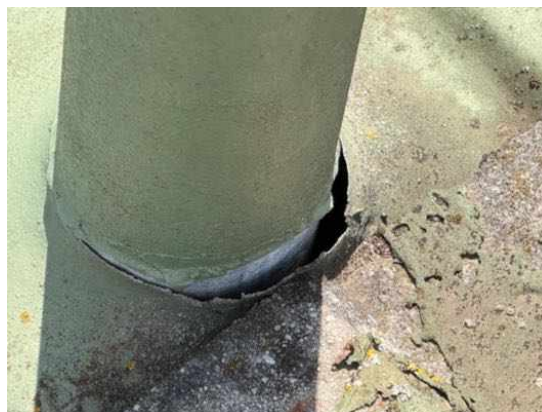
Defects 3.04

Building: Building 1
Location: All Areas > All Areas
Finding: Eaves damage- deterioration
Information: Due to excessive movement in the brickwork, moisture damage and staining from roof leaks, numerous areas throughout the roof exterior eaves linings, some remedial work is suspected to be required. Most of the damage is suspected to have come from the excessive movement however some has also come from either as a result of old and deteriorated roof flashing, dislodged roof tiles or overwhelmed roof gutters above. Where the eaves shows signs of moisture and stains the primary requirement is to identify and rectify any source of excessive moisture and or roof leaks.

The damage to the eave sheeting in these areas detracts from the appearance of the structure, as well as potentially compromising the adjoining roof structures and integrity of the adjoining roof structure. Where eaves show moderate to severe damage, remedial works are suspected to be required immediately to prevent further and secondary damage and defects. Where water damage is suspected as being the underlying cause, appointment of a roofing contractor and licensed plumber is recommended to find a solution and identify the source of the damage and or water leak in the short term future.

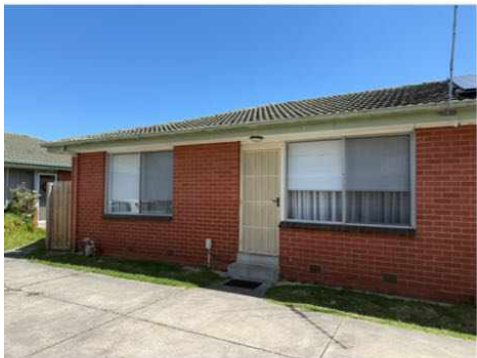
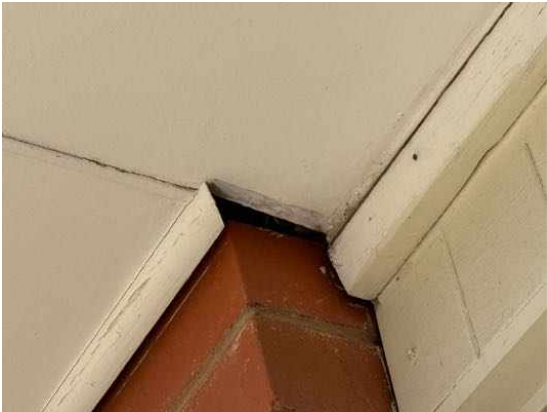
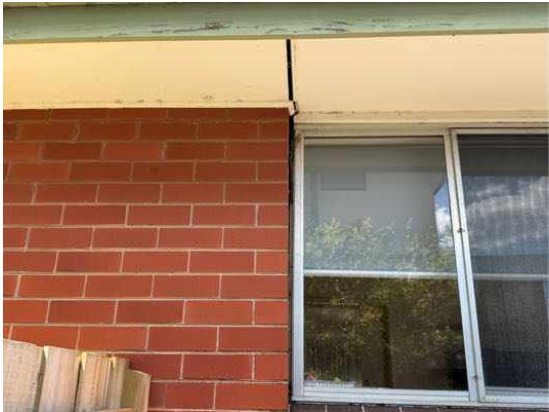
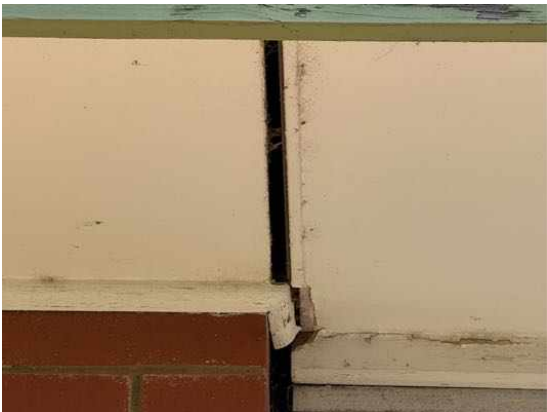
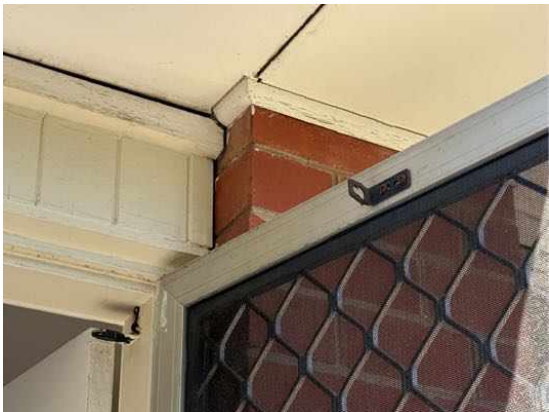
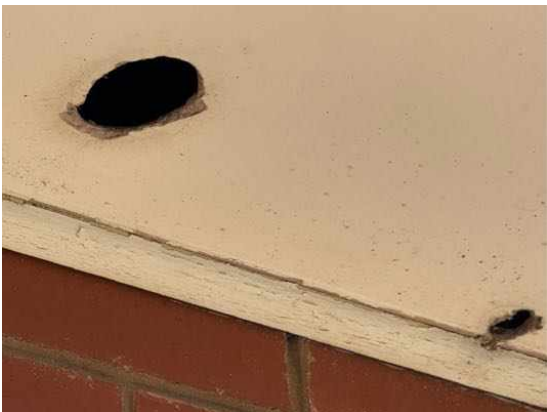
Defects 3.05

Building:	Building 1
Location:	Entry > Front Left
Finding:	Beads - quads to the exterior eaves have dislodged and missing
Information:	It was observed at the time of inspection that the front entry eaves beads have been dislodged and missing, it is suspected that this defect has resulted from the excessive movement in these areas over time. Beads - quads to the eaves acts like cornice or skirtings to cover the intersections or joins of building materials. These types of defects will allow water, moisture, insects and other pests to gain access and occupy these areas to the internal areas between the brickwork and wall framing.

Quads and beading is also important in weatherproofing the surrounding building elements and preventing water, moisture, insects termite and other pest ingress. Quads and beading works to protect the joins of building materials, which are more susceptible to deterioration and decay. Remedial work to re-fit some of the beading or quads or fill these areas with the appropriate building sealant is recommended to ensure the protection and longevity of any associated building elements. Such works may be performed by a qualified carpenter or relevant capable tradespersons.

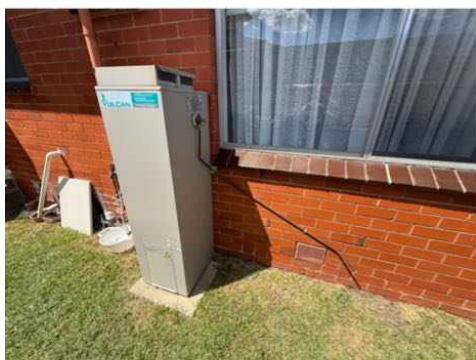
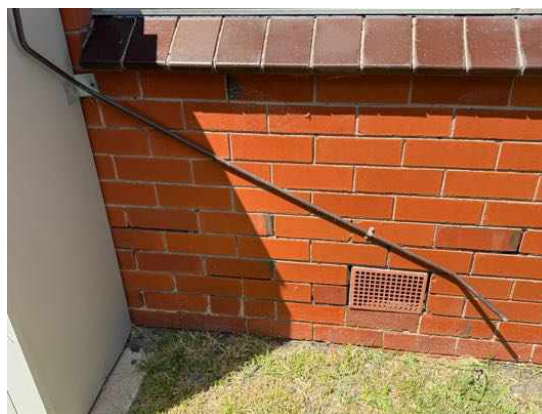
Defects 3.06

Building:	Building 1
Location:	All Areas > All Areas
Finding:	HWS Overflow - Not Connected
Information:	The Hot Water System (HWS) overflow was found to be disconnected from storm water drainage and may be or in the future create excessive moisture in the surrounding area.

These damp conditions can lead to secondary defects such as rot, rust or corrosion of associated building elements, the formation of fungal decay, or even the creation of potential slip hazards. When coupled with poor site drainage, pooling of water may also attract termite activity to this area.

It is highly recommended that a licensed plumber be appointed to connect the HWS overflow in order to prevent such an environment from being created. These minor works should be carried out as soon as possible.

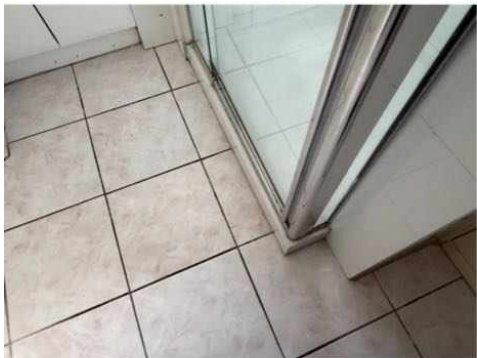
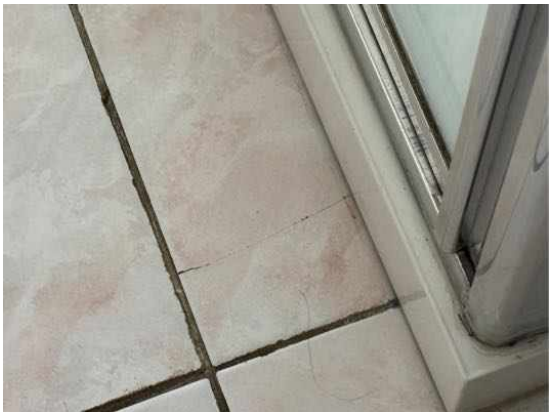
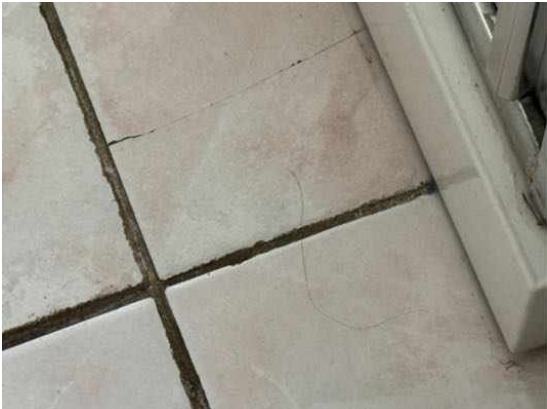
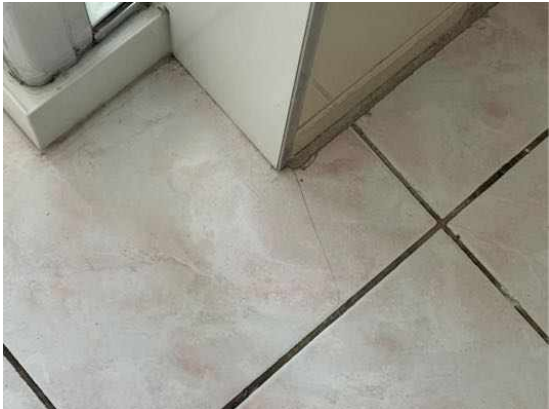
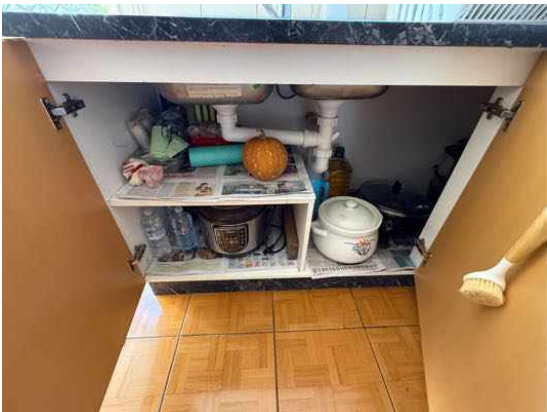
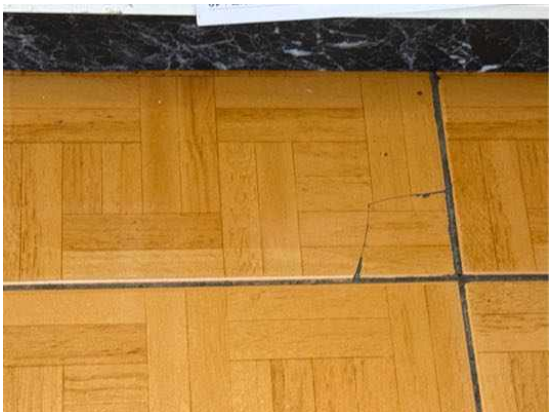
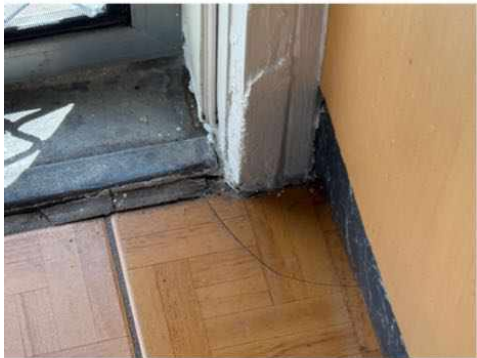
Defects 3.07

Building:	Building 1
Location:	Bathroom > All Areas
Finding:	Cracked floor and wall tiles
Information:	Cracks in the floor and wall tiles was observed at the time of inspection. It is suspected that this cracking has occurred as a result of either some movement or impact damage. These tile crack edges are suspected to be razor sharp which will represent a safety hazard to occupants using this bathroom. Cracked tiles in this type of area will create or lead to secondary defects, due to the vicinity of moisture and wet areas, all damaged tiling should be rectified or repaired as a priority.

Broken tiles also detract from the overall appearance of the affected areas, cracked tiles in this area may create or lead to secondary defects, replacement of cracked tiles is recommended in the short term future. A tiling contractor may be appointed to perform these works. Where cracks become more numerous, contact a licensed Registered builder for further investigation.

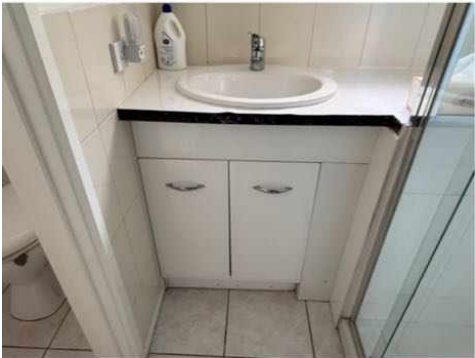
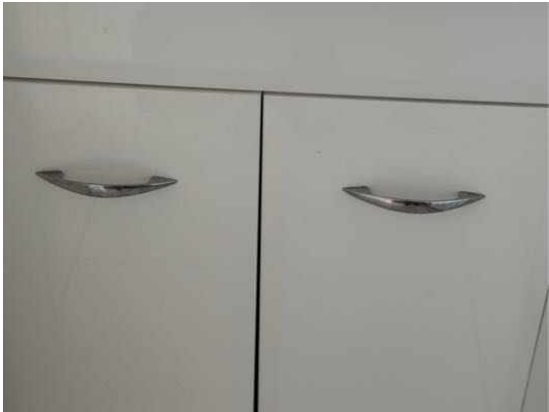
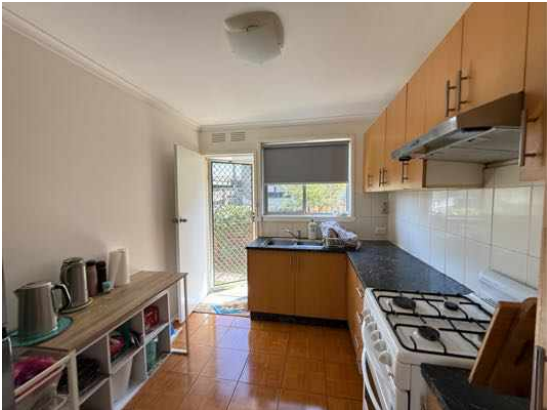
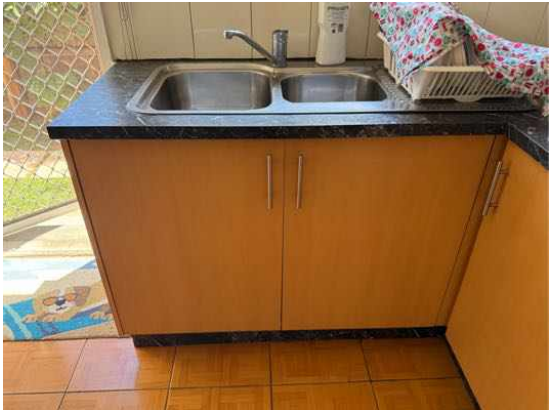
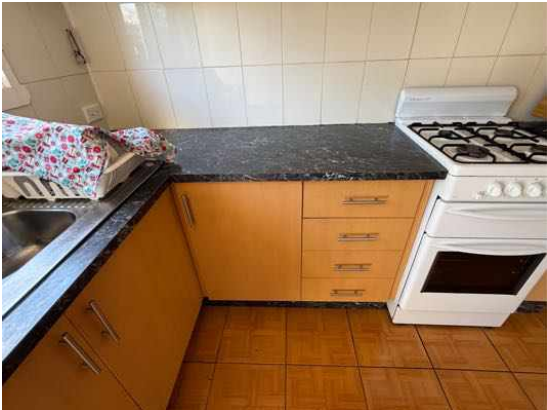
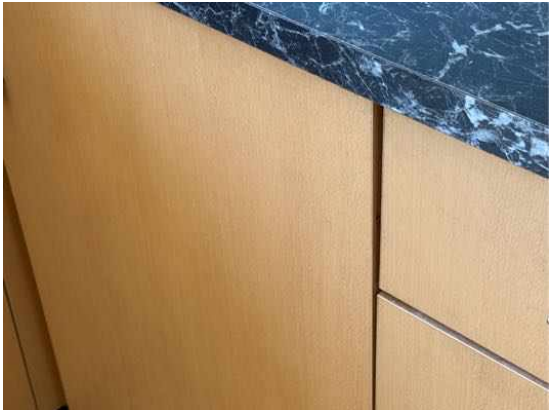
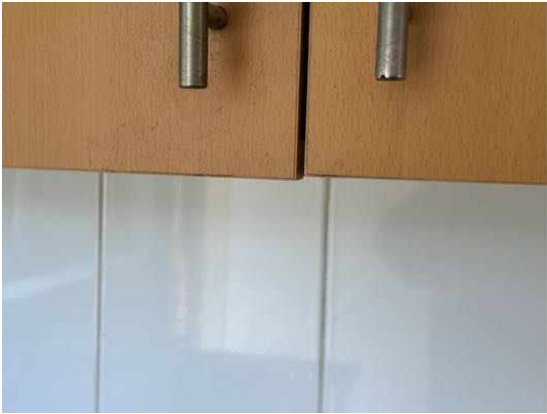
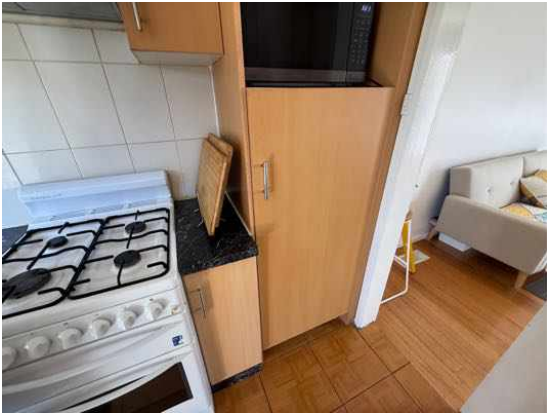
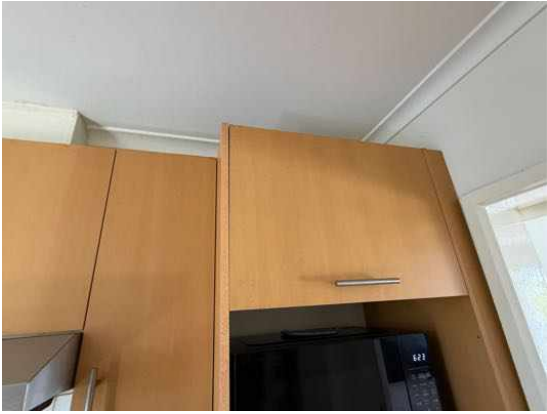
Defects 3.08

Building: Building 1
Location: Bathroom > All Areas
Finding: Cabinet doors
Information: Cabinet doors were observed to be out of misalignment, some with chips to cabinet doors and drawers, more damage may occur to cabinets, cabinet doors and drawers if left unmanaged, these defects detract from the appearance of the cabinetry. Numerous doors may require adjustment to make good, mostly they are in an operational state and appear to be working correctly. To improve operation of the affected cupboard doors and or drawers, a qualified cabinet maker or carpenter may be appointed. Such works should be completed at discretion of the client.

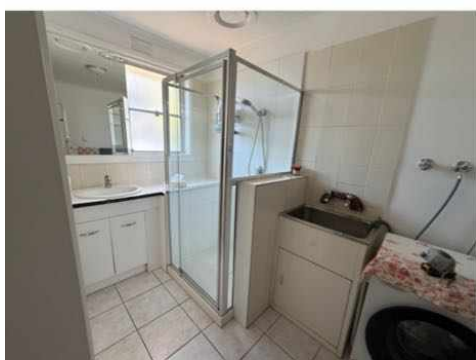
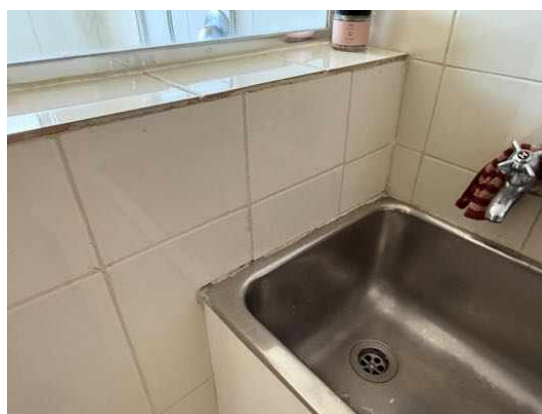
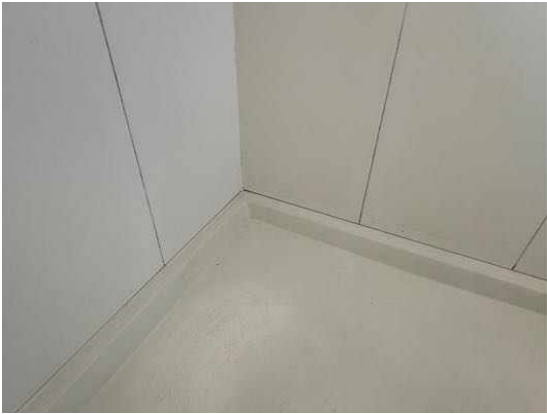
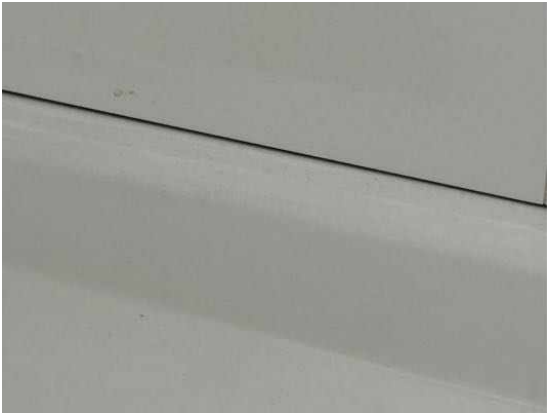
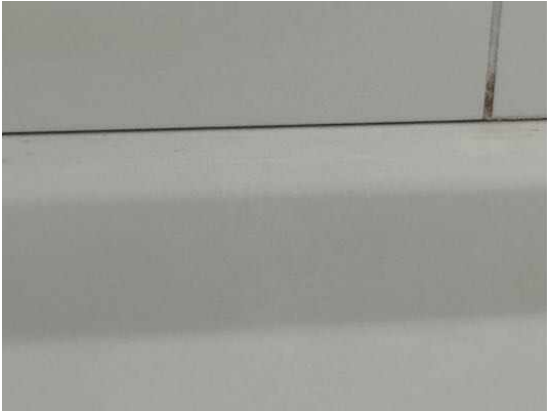
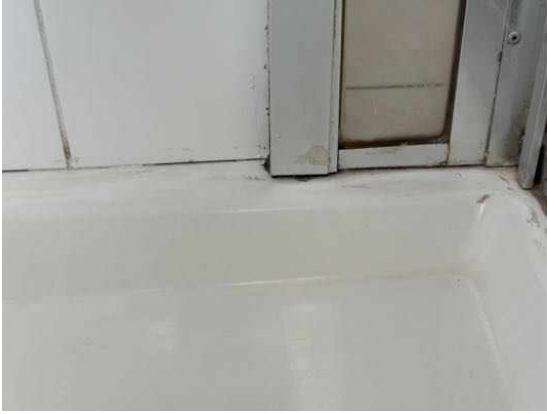
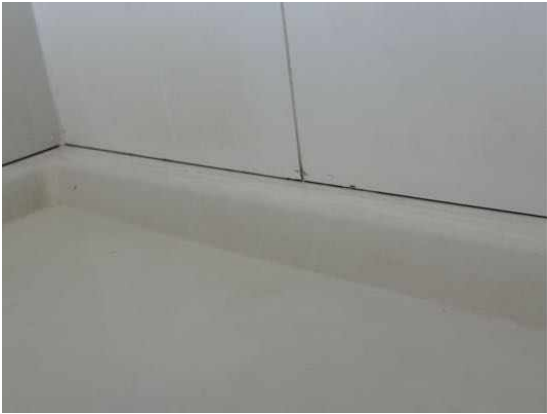
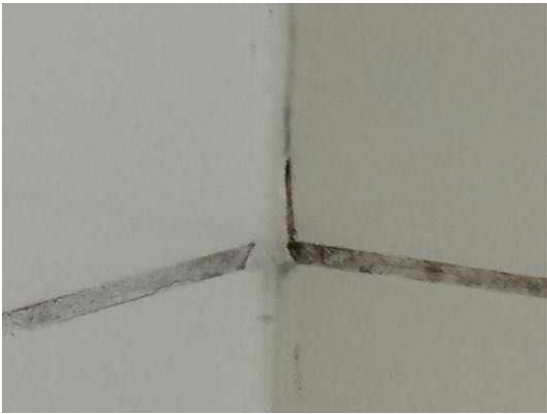
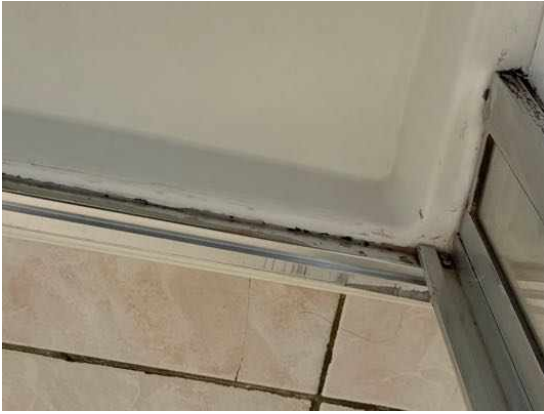
Defects 3.09

Building:	Building 1
Location:	Bathroom > All Areas
Finding:	Grout and sealant missing
Information:	Grout and sealant was observed to be missing in numerous areas of the bottom laundry floor, . Grout and sealants are used to protect gaps and crevices between the wall and floor tiles and other building materials to ensure that they are water-tight and prevent water penetration to the associated structures. These wet areas are frequently exposed to water and excessive moisture, allowing the potential for water penetration into substrate and subsequently damaging the surrounding building elements. Further deterioration is expected if left unmanaged, water penetration to these areas may lead to subsequent water damage, which is likely necessitate repair work to affected building elements.

Where grout is missing, a tiling contractor should be appointed immediately to apply grout and re-apply any silicone where necessary. Failure to do so is likely to lead to water damage to the surrounding area. A tiling contractor should be appointed to ensure that these types of defects are rectified adequately and quickly. The re-application of grout and sealants throughout these wall and floor tile areas is highly recommended, to protect these areas against water penetration getting into and below the substrate.
