Building Inspection Report

Inspection Date: Mon, 16 Feb 2026

Property Address: 2/38 Oakes Ave, Clayton South VIC 3169,
Australia

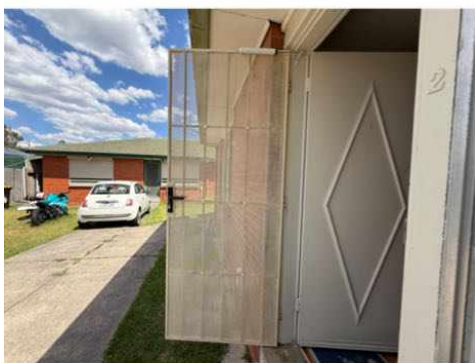
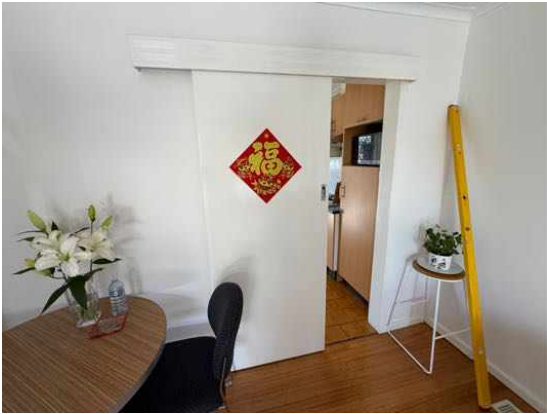
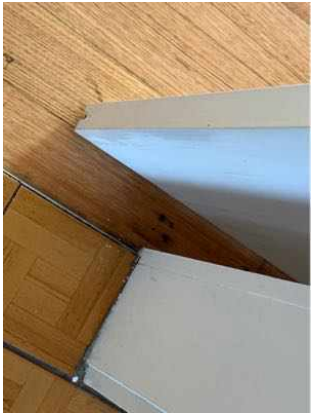
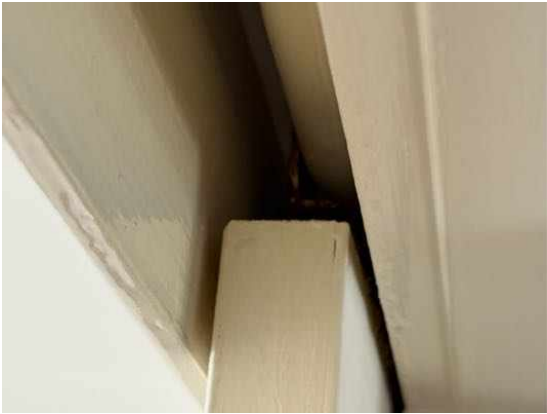
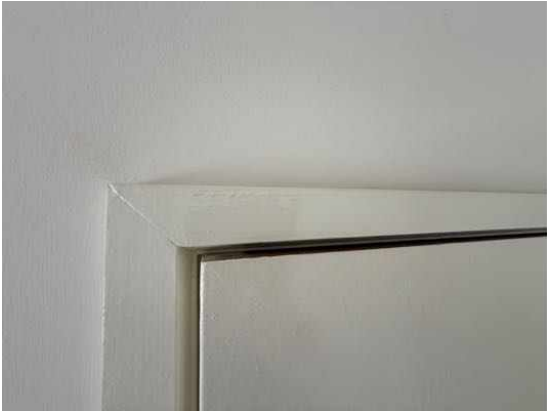
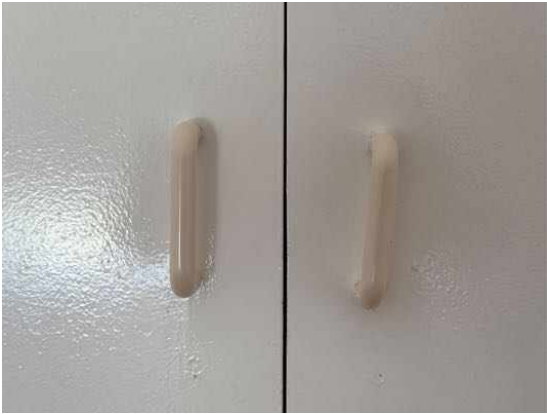
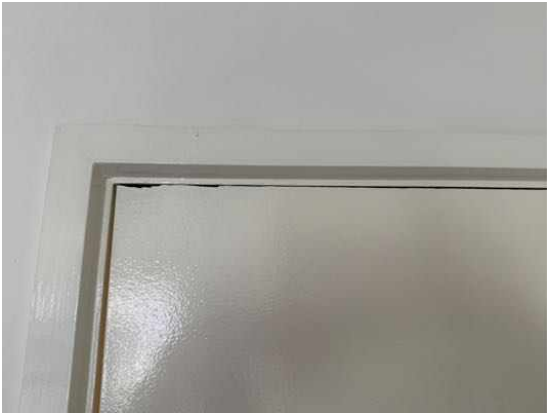
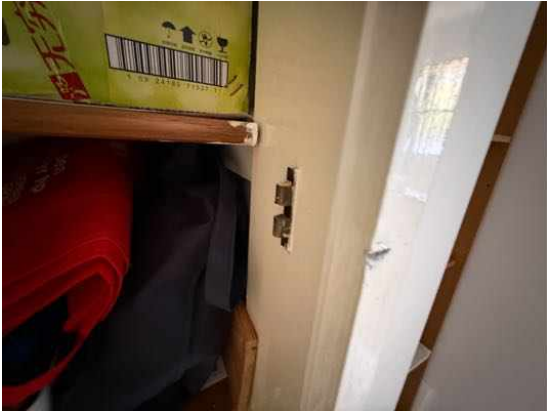
Defects 3.10

Building:	Building 1
Location:	All Areas > All Areas
Finding:	Doors adjustments and maintenance
Information:	Some doors throughout the home were observed to require only minor maintenance and adjustments to make good during standard operation. Doors should get some adjustment and maintenance to ensure doors operate correctly during standard operation. These types of defects can inhibit the functionality of the affected doors as well as creating potential for secondary defects to associated building elements, such as the door jamb and floor. Generally, factors such as a lack of maintenance or general deterioration are the usual causes for these types of defects.

It is suspected that back garage door is damaged and deteriorated beyond repair. Replacement of some door hardware may be required where deemed to be necessary, as well as minor repairs and cleaning. A qualified carpenter should be appointed to perform minor rectification works in the future.

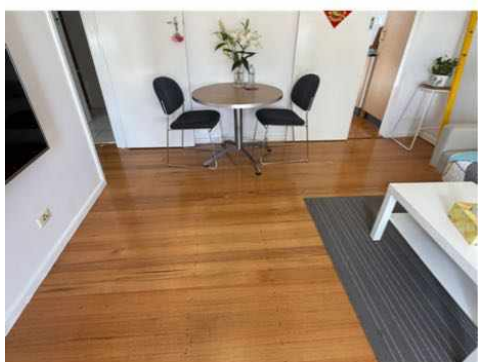
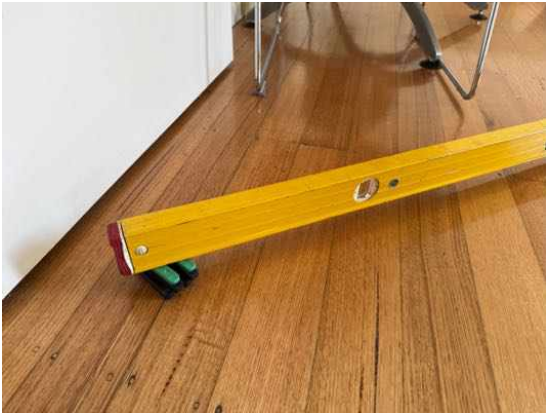
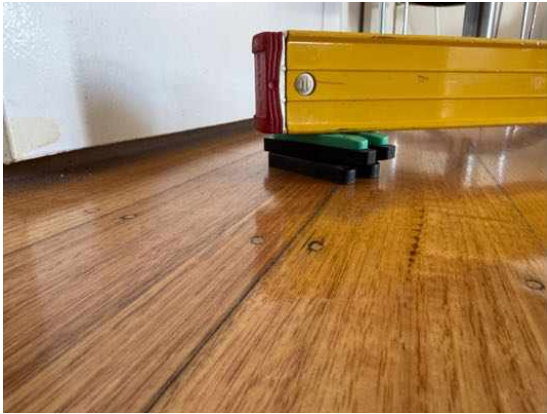
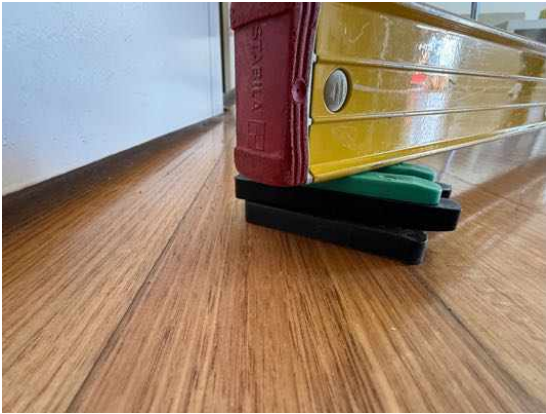
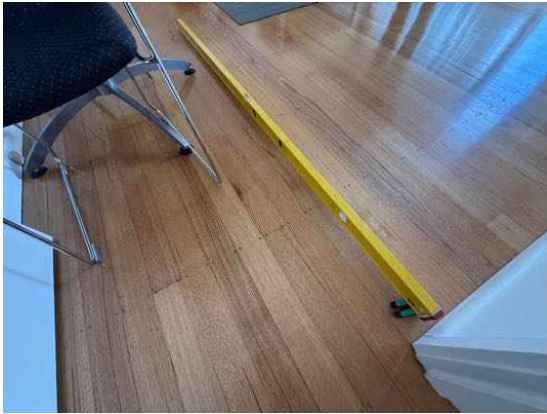
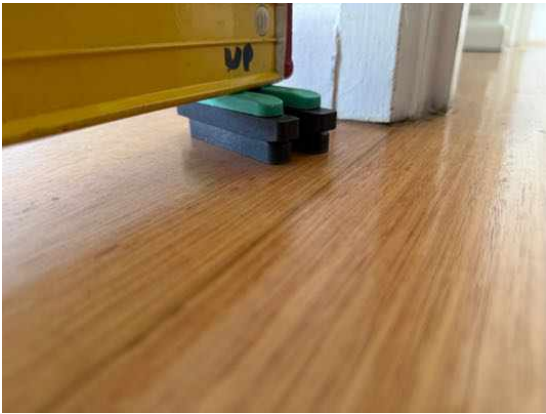
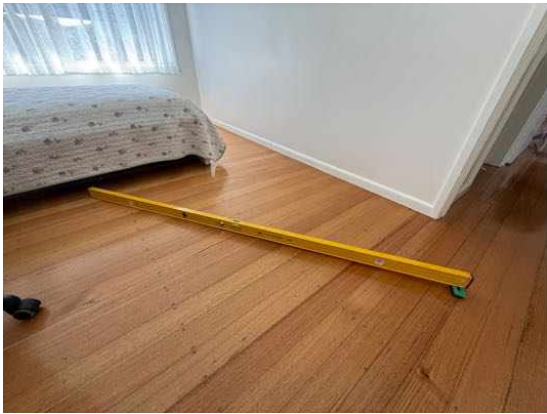
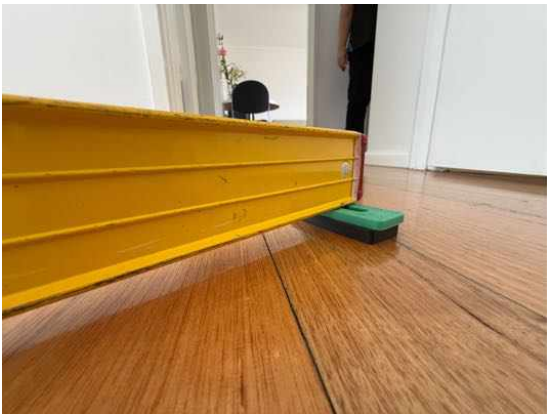
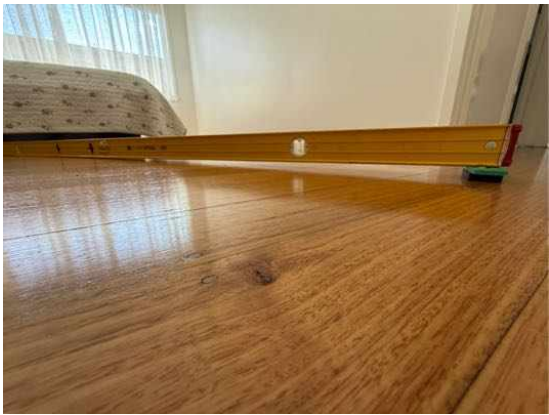
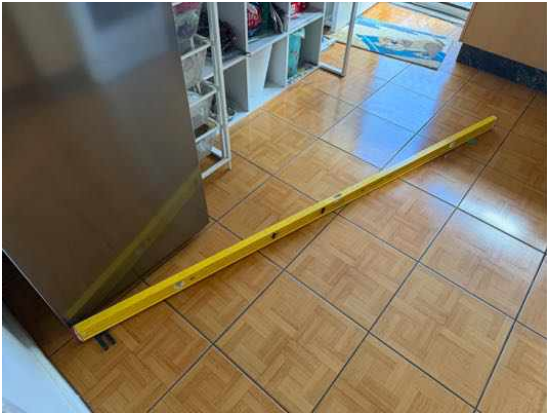
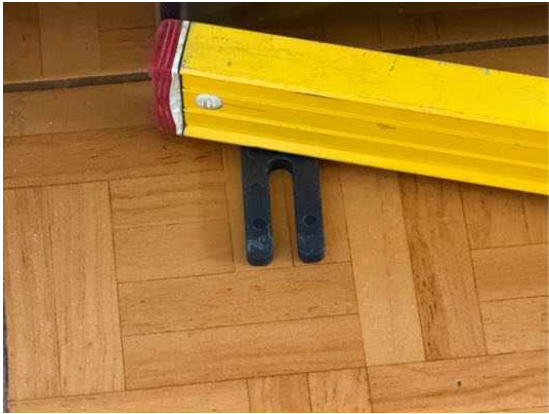
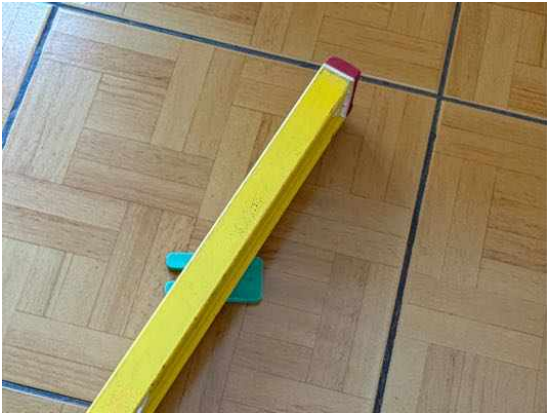
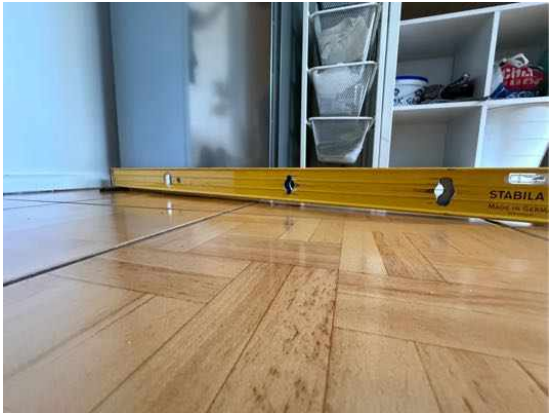
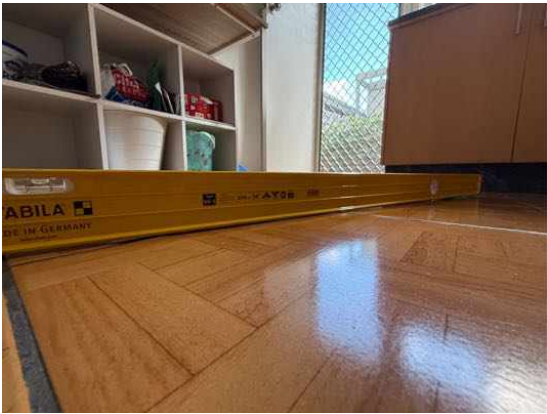
Defects 3.11

Building:	Building 1
Location:	All Areas > All Areas
Finding:	Floor levels
Information:	The numerous internal flooring areas throughout the home were observed to be showing signs of being out of level and uneven. The uneven and out of level floors were considered excessive in a couple of areas. The uneven and out of level floors throughout the home is suspected to indicate some subsidence and or movement. No access to the subfloor at the time of the inspection.

Floor levels can have complex and varying causes, which will influence the required remedial works. It is recommended that any remedial works required should be in conjunction with other works at the same time as addressing other underlying causes. A Registered Builder would generally carry out these types of works or can be guided and advised by a structural engineer where deemed to be required. It is advised that the floors be closely monitored to identify any further movement even after floor have been rectified.

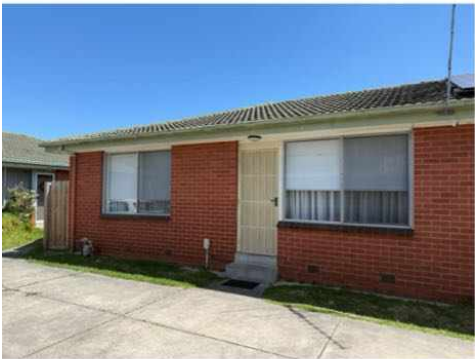
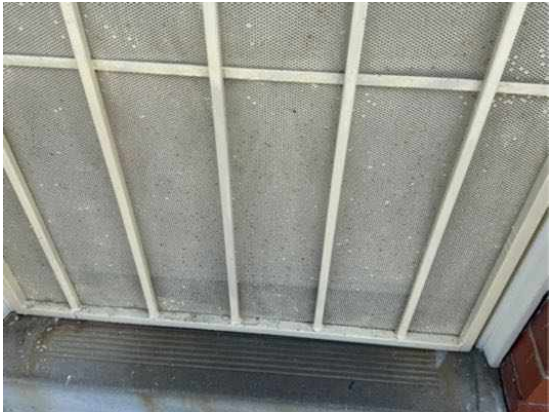
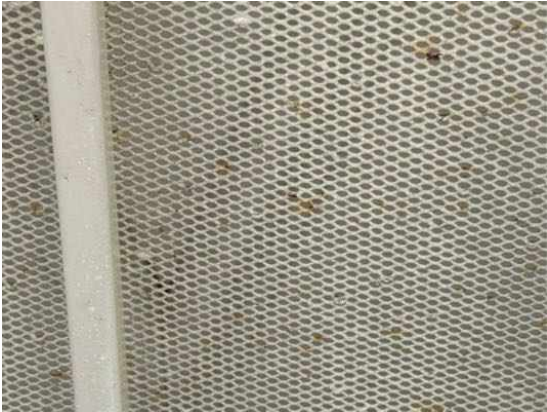
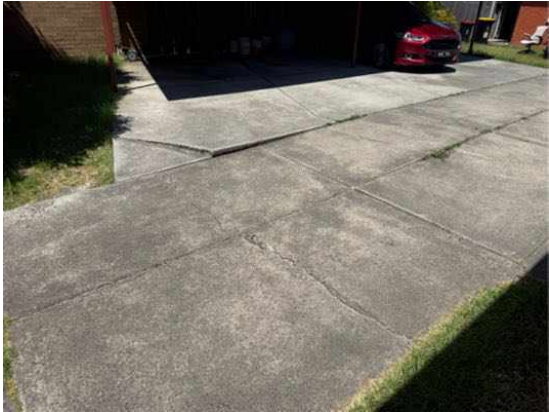
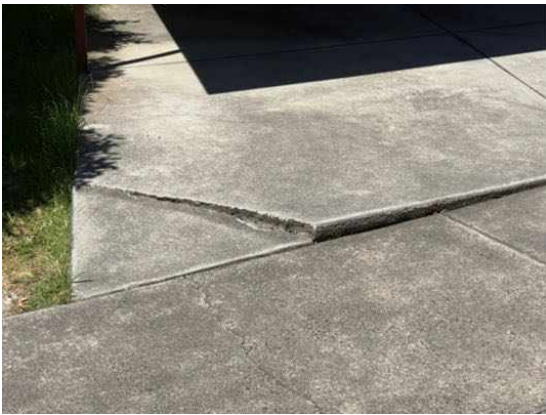
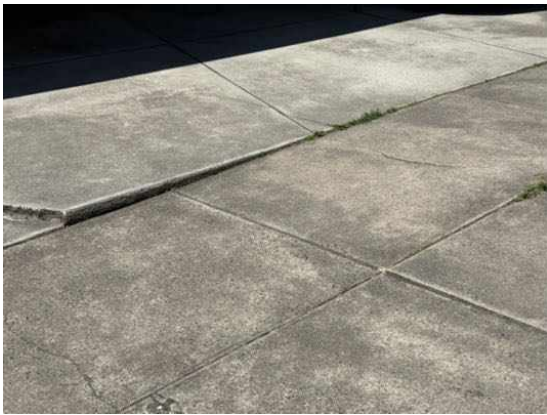
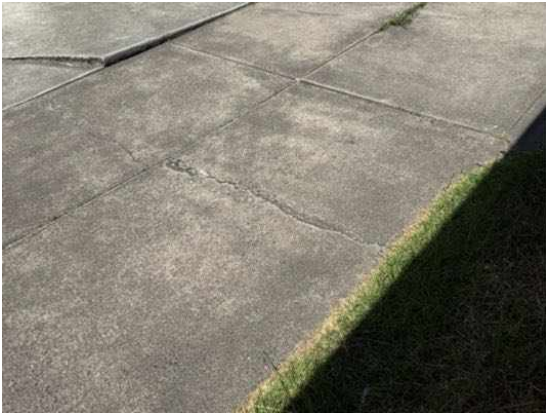
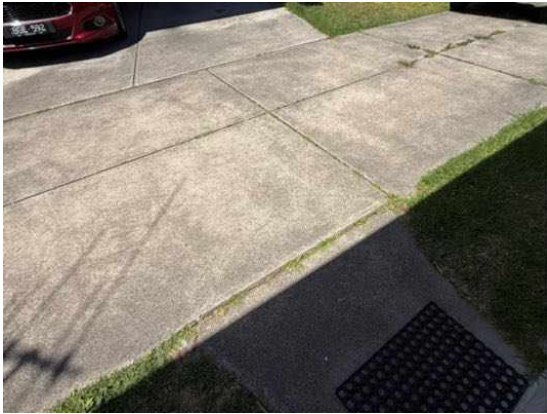
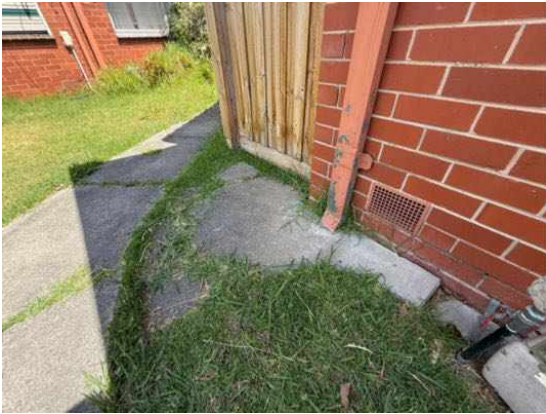
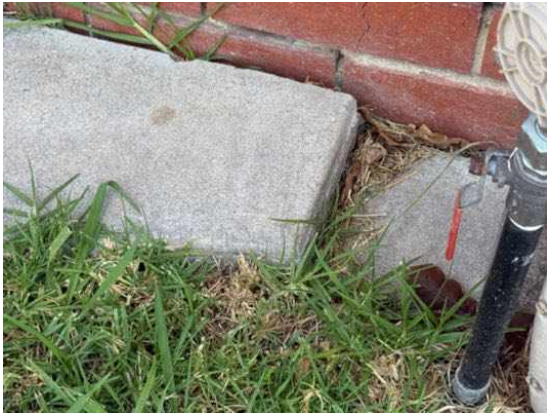
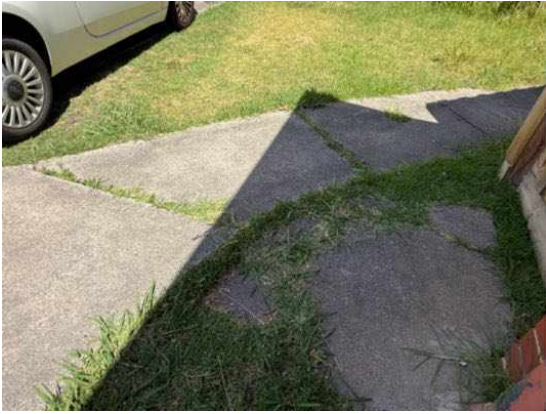
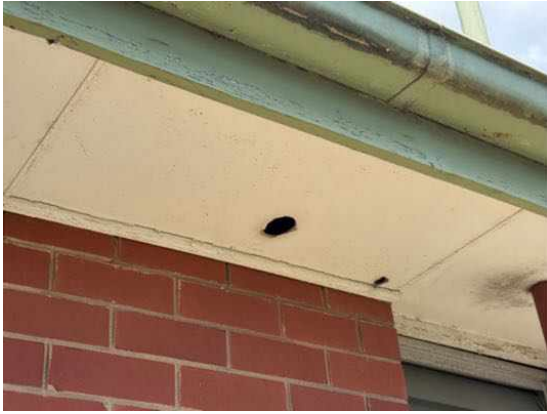
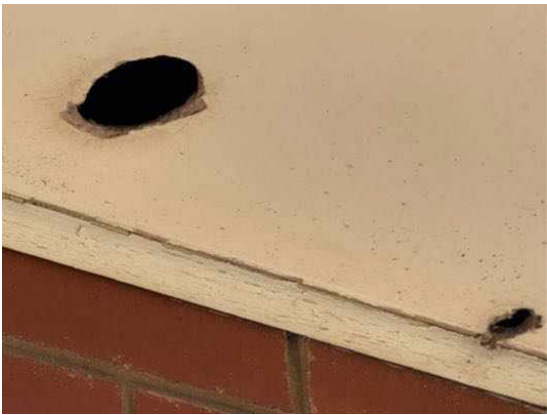
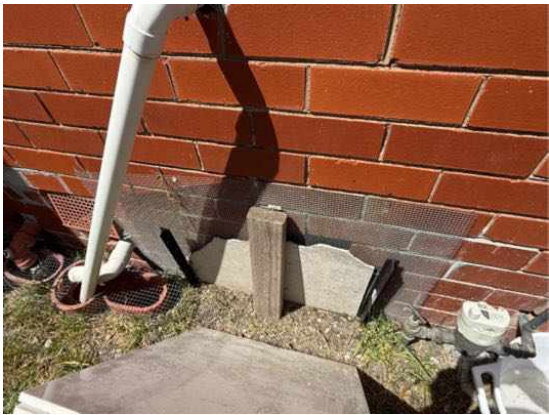
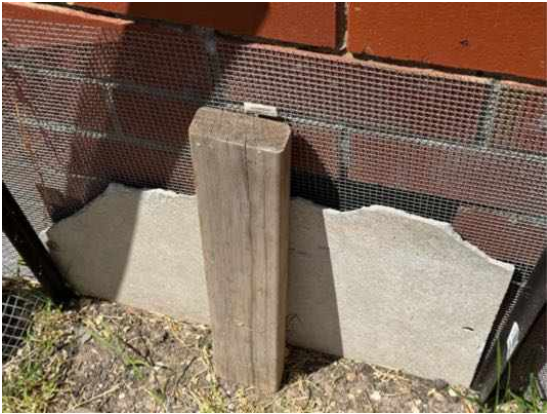
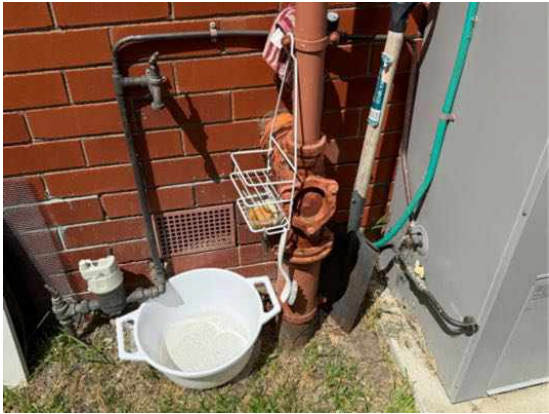
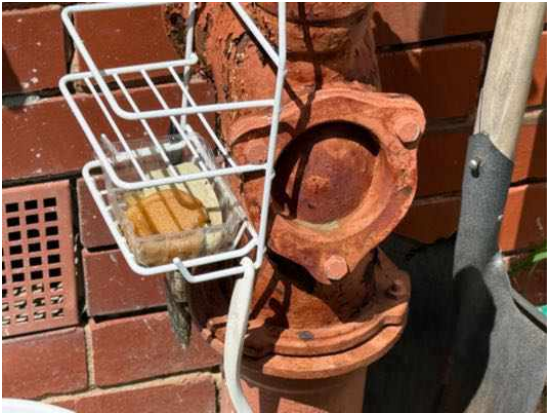
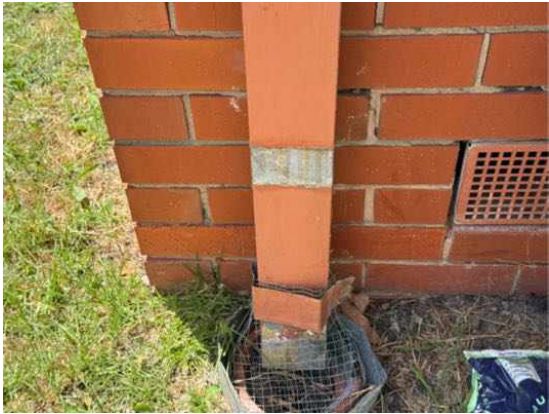
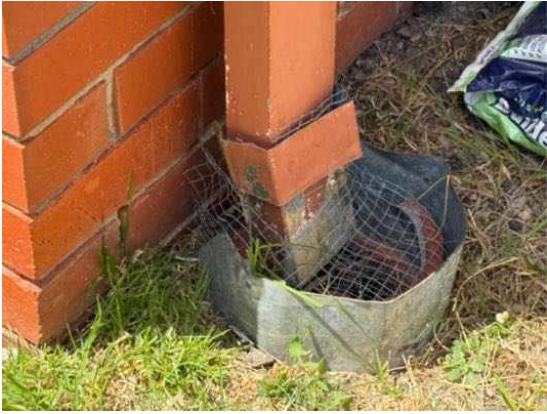
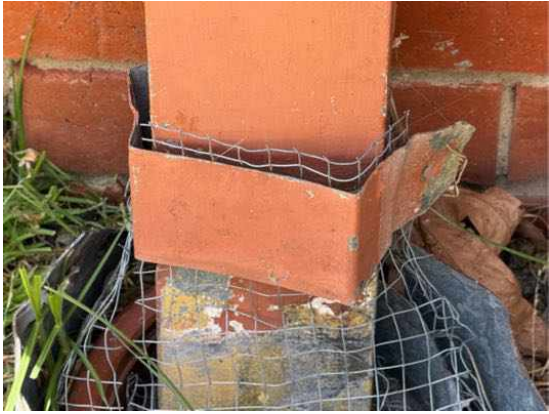
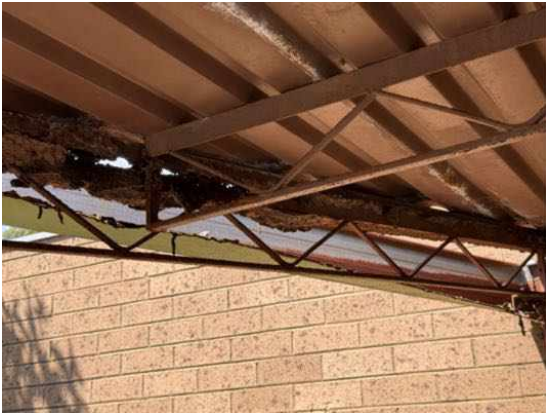
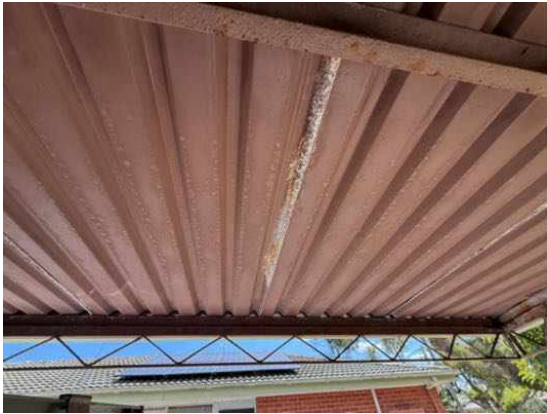
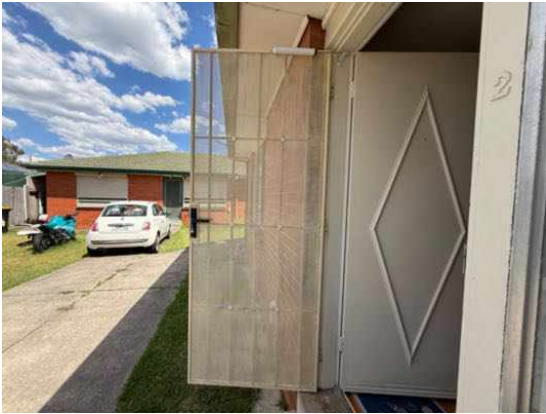
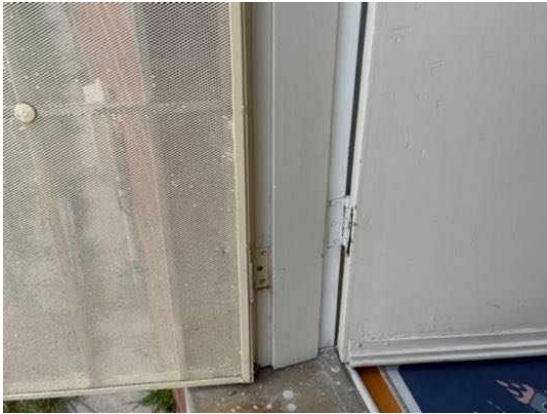
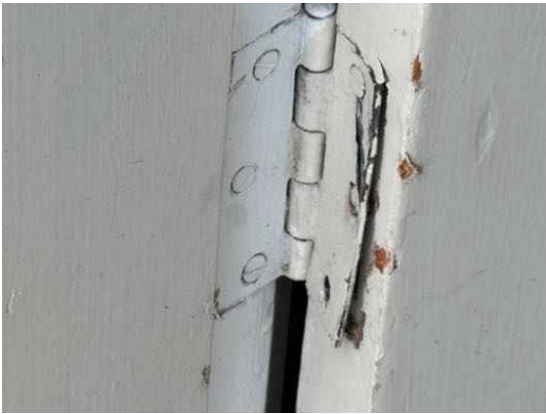
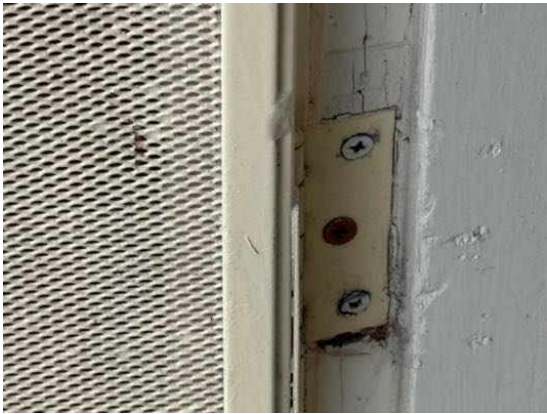
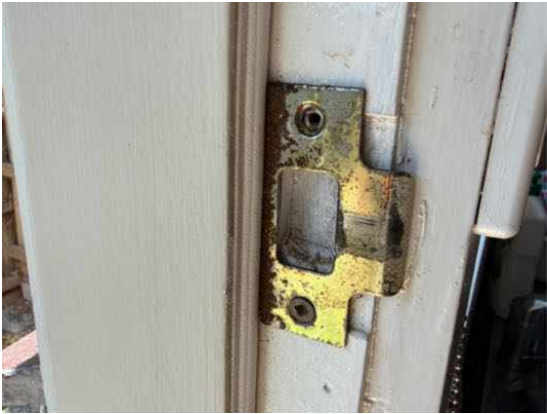
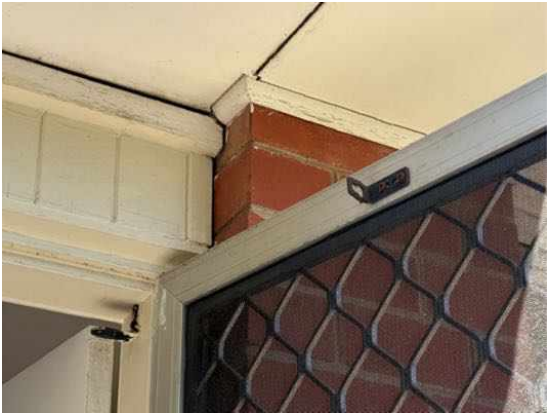
Building: Building 1
Location: All Areas > All Areas
Finding: Additional Photos
Information: Additional photos are provided for either future maintenance items for clients attention and or general reference. Arrows may have been included to highlight areas of importance. Please discuss these photos with your building consultant for clarification.

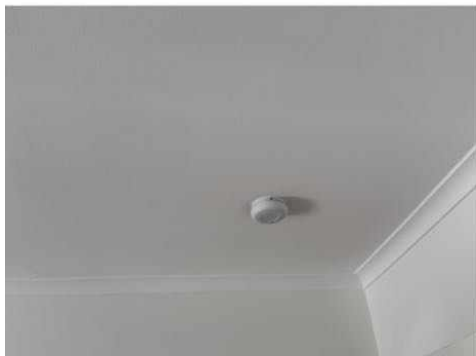
Building: Building 1
Location: All Areas > All Areas
Finding: Smoke detectors and alarms
Information: Reporting on Smoke Detectors or Alarms, including hard wired smoke detection systems and their legislative requirements, is outside the Scope of this Report. Please note that this defect is highlighted as a caution only. We suspect, based on our experience in the building industry, that smoke detectors are sometimes get over looked, or they may be in a poor condition, so we recommend that they always should be addressed prior to occupation to improve occupant safety.

Always ensure sufficient working and suitable smoke detectors are installed prior and

during to occupying any building. Additionally, it is advised that all smoke detectors be tested by the homeowner on a monthly basis.

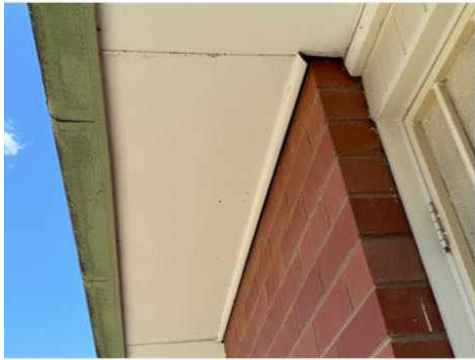
Location: All Areas > All Areas
Finding: Asbestos - Suspected ACM Identified on Site
Information: Reporting on Asbestos is outside the Scope of this Report. This suspected defect is highlighted as a caution only. We suspect, based on our experience in the building industry, that there is a higher risk of the identified building element containing asbestos.

As Asbestos Reporting is outside the scope of this report, we advise that you consider a separate Asbestos Inspection and Condition Audit, which can include the taking of samples for definitive confirmation of the presence of Asbestos. Asbestos sampling can only be taken upon ownership of the property only, due to being an invasive procedure.

In the interim, the client is advised to act with caution, especially when considering any damage to building materials general wear and tear renovations extensions demolition and general maintenance activities due to the suspected presence of Asbestos.
