Building and Timber Pest Inspection Report

Inspection Date: Wed, 11 Feb 2026

Property Address: 14A Caley St, Chifley NSW 2036, Australia

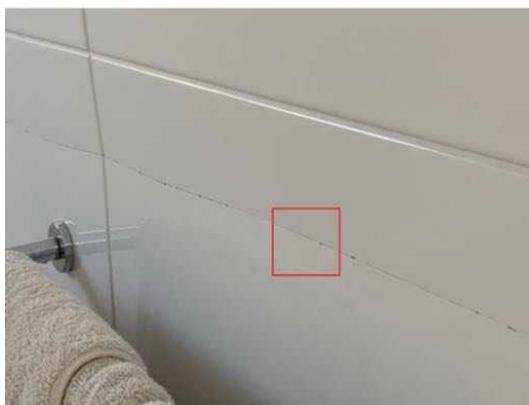
Building:	Main Building
Location:	Bathroom
Finding:	Tiles - Cracked and bulging
Information:	Cracking was evident to the tiling in this wall area at the time of inspection. the cracking appears to be major, this area is frequently exposed to water, allowing potential for water penetration into adjoining sections of walls or flooring.

If left unmanaged, these tiles may also pose a safety hazard, which is likely necessitate repair work to affected building elements.

A tiling contractor should be appointed to ensure that no further water damage occurs. The re-application of silicone and grouting throughout remaining tile work is also advised, to further protect the area against water penetration.

Where water penetration has led to water damage, appointment of a relevant tradesperson may be required to repair damaged building elements.

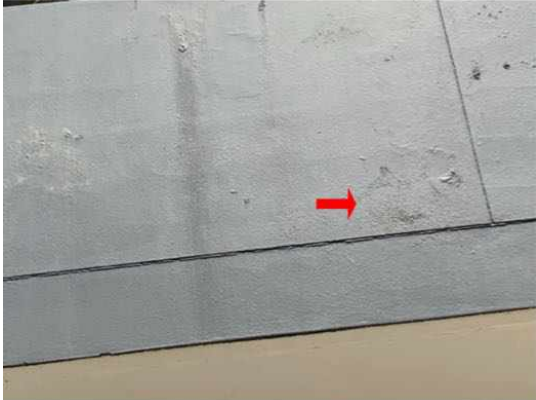
Finding 3.01

Building:	Main Building
Location:	Exterior walls - front
Finding:	Painted surface - Bubbling
Information:	Sections of paint in this area was found to have bubbled and deteriorated. Paint bubbling is generally an indication of excessive moisture in the area, that is currently hidden by the painted surface.

The presence of excessive moisture can have major implications on associated building elements if left unattended. While only seemingly minor at this stage, the damage cannot be determined due to the paint obstructing any further inspection of the damage.

It is highly advised that the affected paint be cleaned to allow a further, more invasive inspection by a licensed plumber. Failure to act on this defect may necessitate major works in the future.

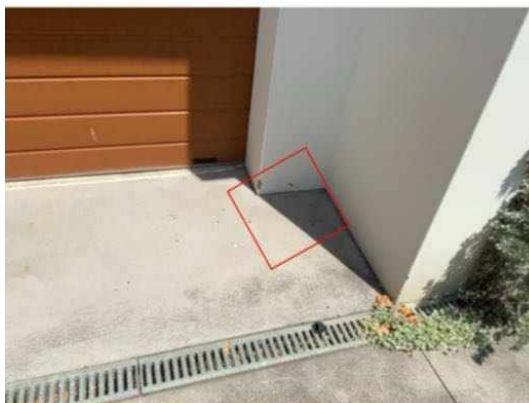
Finding 3.02

Building: Main Building
 Location: Exterior walls - front
 Finding: Cracking - Damage Category 2 - Noticeable (up to 5mm)
 Information: Noticeable cracks are a common occurrence as a result of many primary defects. Such causes may include age, general wear and tear, expected building movement, general expansion/contraction of building materials in different weather conditions, and/or minor failings in the installation or application of building materials.

However, noticeable cracks are easily filled and repaired. A plasterer can be consulted to install an expansion joint at this point to allow for this movement during different weather conditions.

Monitoring of all cracking should be conducted frequently. Always contact a building inspector should cracks widen, lengthen, or become more numerous.

Relevant tradespeople, painters and plasterers, should be appointed to perform remedial works, as deemed necessary.

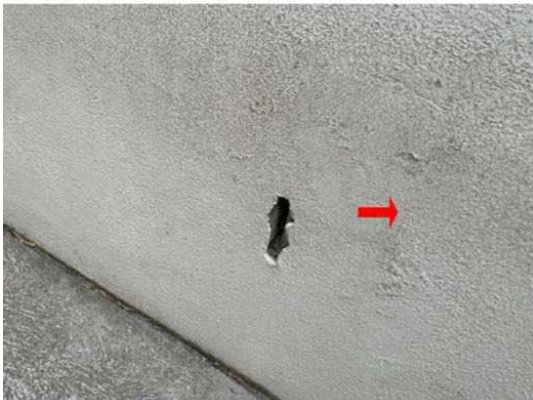
Building:	Main Building
Location:	Exterior walls - left side
Finding:	Painted surface - Bubbling
Information:	Sections of paint in this area was found to have bubbled and deteriorated. Paint bubbling is generally an indication of excessive moisture in the area, that is currently hidden by the painted surface.

The presence of excessive moisture can have major implications on associated building elements if left unattended. While only seemingly minor at this stage, the damage cannot be determined due to the paint obstructing any further inspection of the damage.

It is highly advised that the affected paint be cleaned to allow a further, more invasive inspection by a licensed plumber. Failure to act on this defect may necessitate major works in the future.

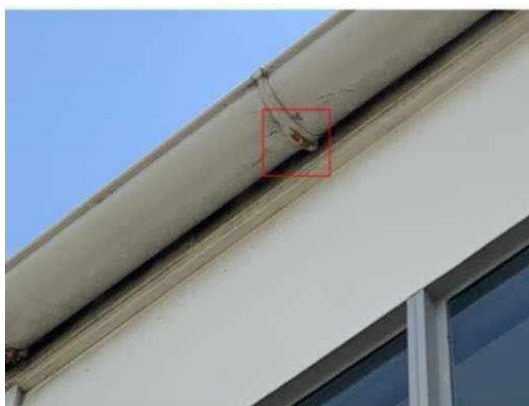
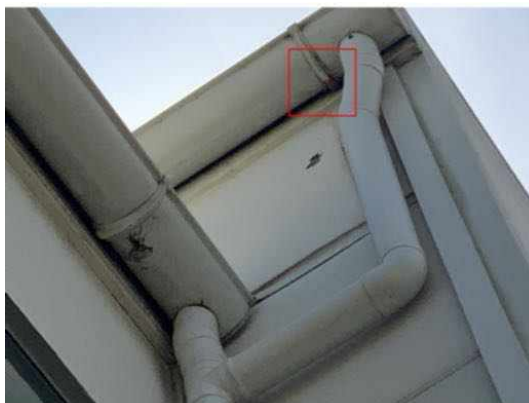
Finding 3.07

Building:	Main Building
Location:	Exterior walls - left side
Finding:	External painting deteriorated
Information:	Much of the external paintwork including but not limited to windows, fascias, guttering, veranda and other external fitments have been neglected and require attention to prepare and re-paint.

Whilst incomplete or missing paint finish is generally an appearance defect, it can also lead to the development of secondary building defects over time. Incomplete areas of paint finish expose the area to moisture, potentially accelerating the deterioration of underlying building materials.

Degraded paint finishes should be sanded back, filled, leveled and painted, as applicable. Where inadequate or missing paint protection has led to the deterioration of the associated building element, repair and/or replacement of this building element may be required.

A painting contractor should be appointed as soon as possible to perform necessary works to aid the appearance of the affected area and to ensure the area is protected against further deterioration. Alternatively, the homeowner following manufacturer instructions may perform these works.

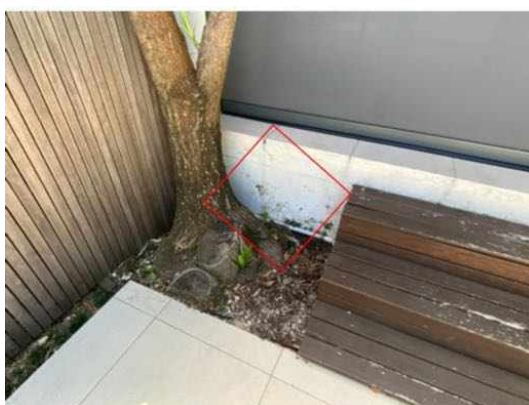
Rising damp is generally managed by the installation of a damp proof course during construction. The DPC may have been omitted as a consequence of poor workmanship, or it may have been bridged where materials built up against the side of the house allow moisture ingress above the DPC level.

The first step in addressing rising damp is to diagnose the cause. The identified cause should be addressed first before addressing the appearance and other defects which have resulted from the rising damp. If the original cause is not resolved, further cases of damp are likely to ensue, resulting in secondary defects.

Consultation with a qualified plumber is advised immediately to identify the cause of the damp and perform remedial works as required.

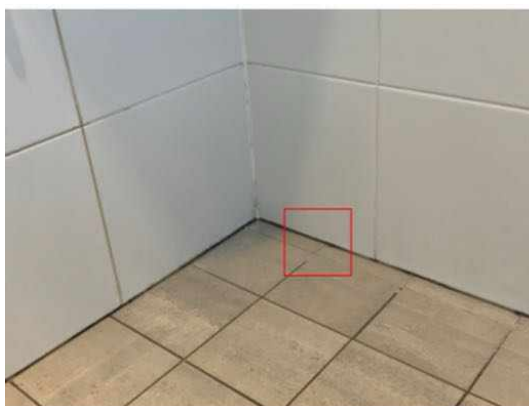
Finding 3.13

Building:	Main Building
Location:	Ensuite - Master
Finding:	Tiles - Cracked or damaged
Information:	Cracking was evident to the tiling in this area at the time of inspection. While the cracking appears to be minor, this area is frequently exposed to water, allowing potential for water penetration into adjoining sections of walls or flooring.

If left unmanaged, water penetration to these areas may lead to subsequent water damage, which is likely necessitate repair work to affected building elements.

A tiling contractor should be appointed to ensure that no further water damage occurs. The re-application of silicone and grouting throughout remaining tile work is also advised, to further protect the area against water penetration.

Where water penetration has led to water damage, appointment of a relevant tradesperson may be required to repair damaged building elements.

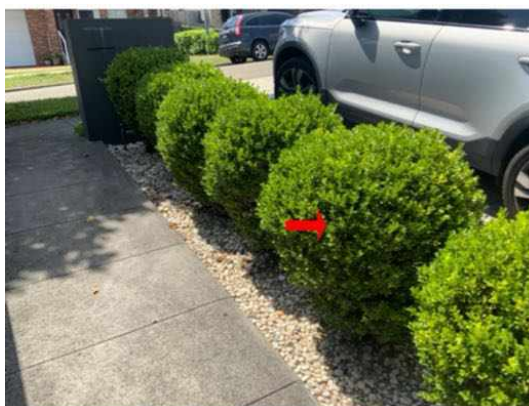
Finding 6.01

Building:	Main Building
Location:	Exterior walls - front
Finding:	Garden Beds - Conditions Conducive to Termites
Information:	Garden beds were found to be evident in the garden area. These garden beds can include untreated timber, and with a combination of moisture from watering hosing can make conditions conducive to termite activity and termite ingress.
