Building and Timber Pest Inspection Report

Inspection Date: Mon, 23 Mar 2026

Property Address: U1 197 Willarong Rd, Caringbah NSW 2229,
Australia

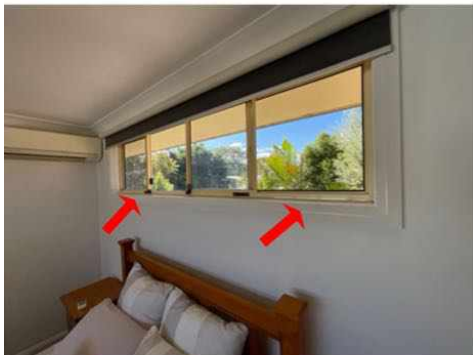
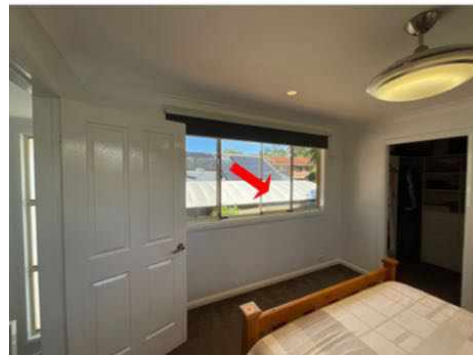
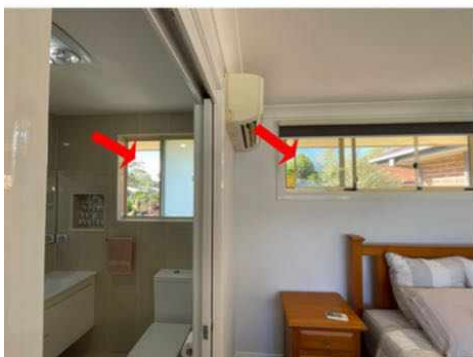
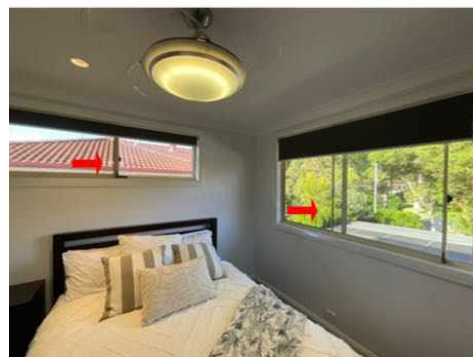
Building: Building 1
 Location: Pictured upstairs windows
 Finding: Window opening restrictors missing.
 Information: These pictured windows are missing window restrictors. The Building Code of Australia rules require all openable windows (where the internal floor is more than 2m above the ground outside) in residential rooms to be fitted with a suitable screen or restrictor. Windows located 1.7m above the floor level do not require protection.

Window restrictors are required where people who are vulnerable to the risk of falling have access to windows. This means all windows above ground level which do not have another fall prevention safety measure in place, such as a balcony or balustrade should have a restrictor.

These need to be added urgently for the safety of all persons.

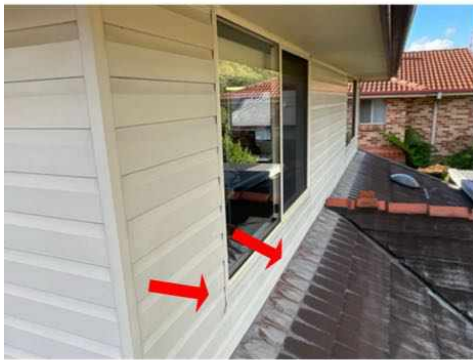
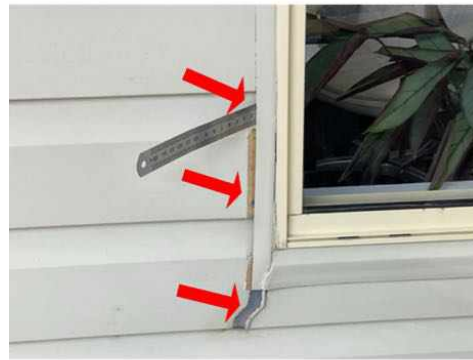
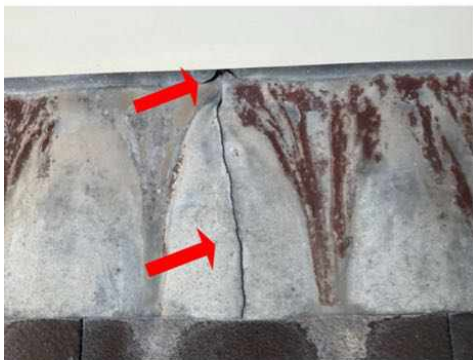
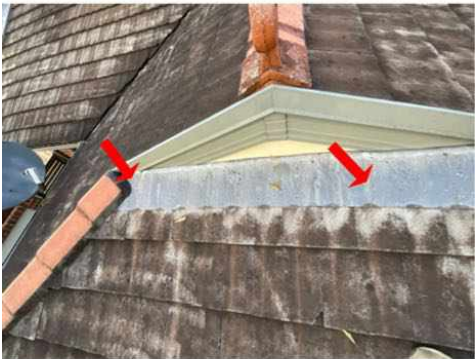
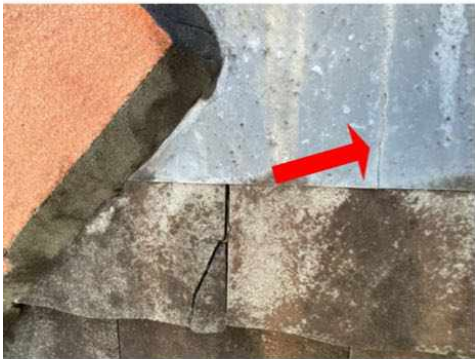
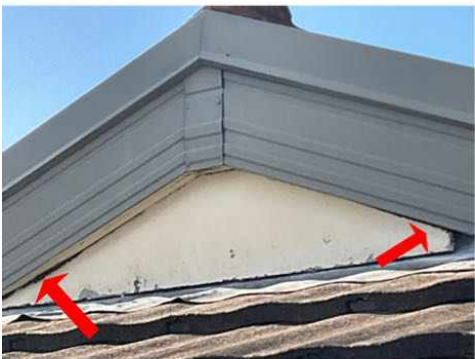
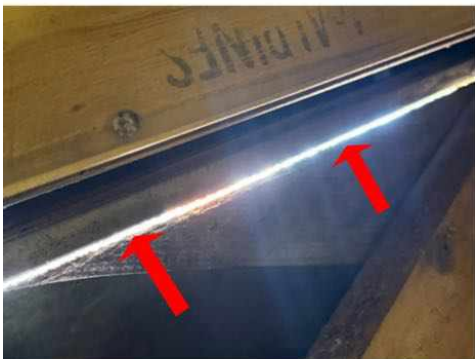
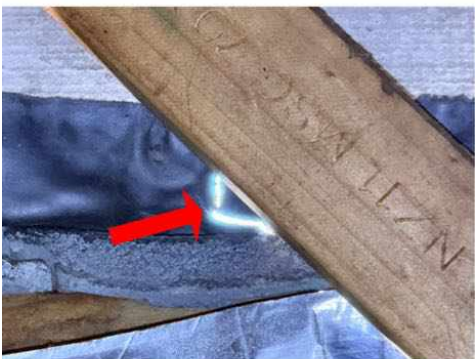
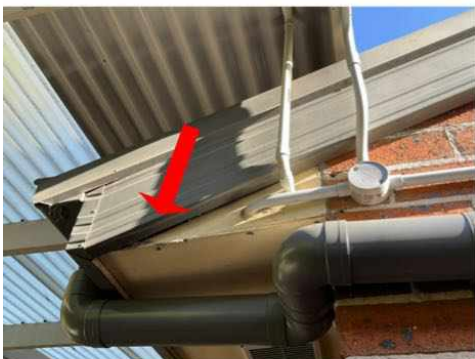
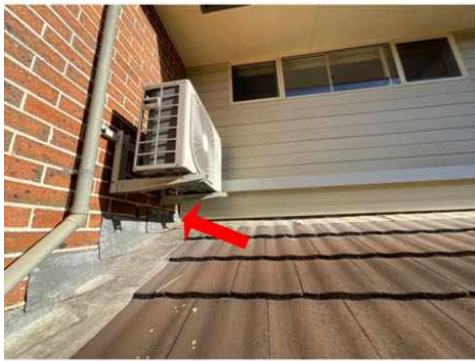
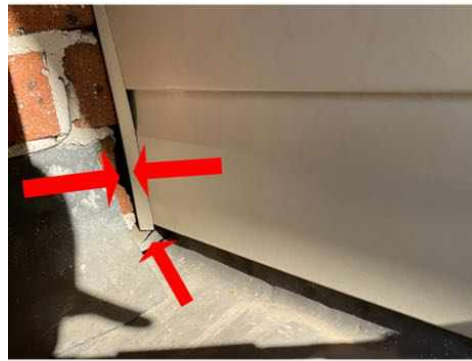
Finding 2.01

Building:	Building 1
Location:	Pictured roof areas
Finding:	Flashing and cladding areas cracked / missing
Information:	Missing and cracked flashings and one cladding area were evident to external roof and wall areas at the time of inspection.

Regardless of the location, if left unmanaged, even minor leaks that can occur in these areas can lead to serious damage of internal building elements, potentially resulting in the need for replacement of building materials. Damage to ceilings and wood rot may also arise if these missing / damaged flashings are left unmanaged, leading to deterioration of internal areas.

A roofing contractor should be engaged to repair / install/ replace these flashing areas immediately.

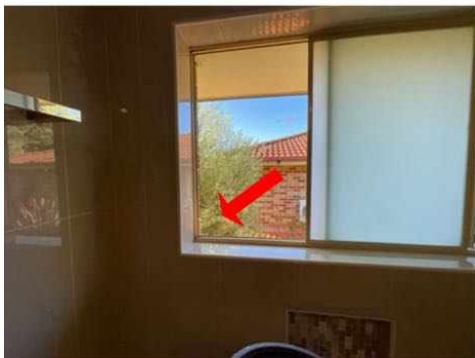
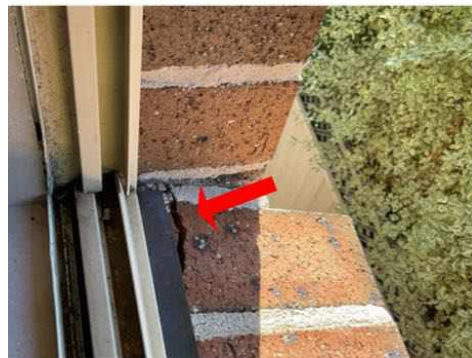
Finding 3.01

Building:	Building 1
Location:	Exterior rear bathroom wall
Finding:	Sealant (external) - missing
Information:	It was noted on inspection that areas of external sealant was missing to this brick bathroom window area.

A flexible sealant or replacement brick is required to protect the associated building materials from rainwater ingress.

A sealant specialist or bricklayer should be appointed to complete these works as soon as possible

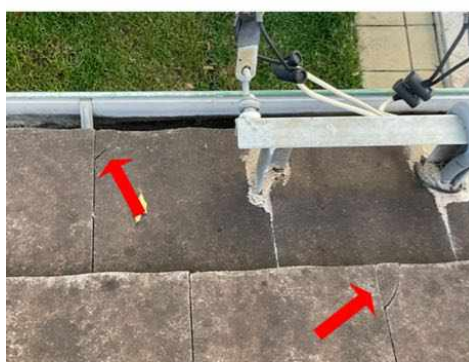
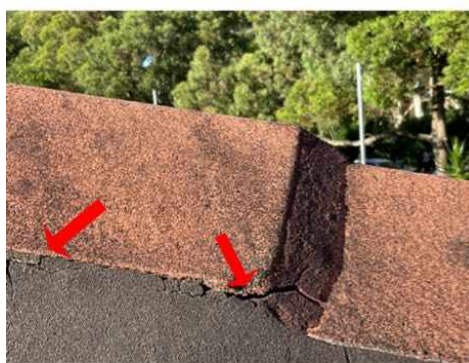
Finding 3.02

Building:	Building 1
Location:	Roof Exterior
Finding:	Roof tiles - Weathered
Information:	Upon inspection of the exterior roofing, the majority of roof tiles and mortar (excluding

flashings) were considered to be in a good condition. While weathering of the tiles is consistent with the age of the property, maintenance works are required.

Isolated areas of mortar and tiles show minor cracking present. Re-pointing and re-sealing the may be considered as an interim solution by the client to help preserve and extend the life span of the tiles. Where left unmanaged, deteriorating roof tiles are likely to lead to a number of secondary defects, including minor water leaks and weather exposure to internal roofing structures.

Consultation with a roofing contractor is highly advised to gain advice on cost of remedial works that may be required in the short to medium term. Remedial works are likely to increase the longevity of the exterior roofing structure (see also missing and damaged flashings defect).

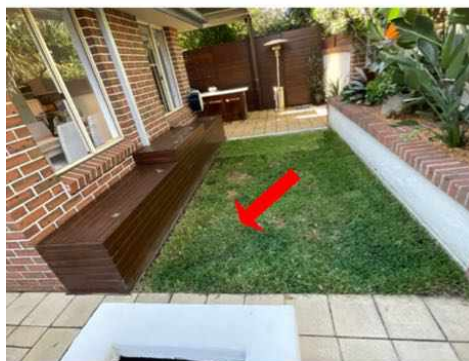
Finding 3.03

Building:	Building 1
Location:	Rear / side walls
Finding:	Site drainage - Inadequate
Information:	The site drainage in these areas appears to be inadequate at the time of inspection, creating potential for subsequent water damage to associated building elements.

No drainage is evident to these wall areas. Water may pool in these areas, evidenced by a rusted rear garage door frame, the damaged garage wall mortar, the ground

It is important that water does not lie against the base of walls; surrounding paths and ground levels should be sloped to drain water away from walls. Downpipes should not discharge stormwater onto lower walls or plinths. Stormwater should be carried away by large, regularly cleaned drains. Ground levels may need to be lowered to expose a buried DPC.

Where site drainage is inadequate, installation of an Agricultural (Aggie) Drain may be required. A qualified plumber should be appointed to further inspect the property and perform any remedial works as necessary. It appears a rear strip drain is required to stop further defects.

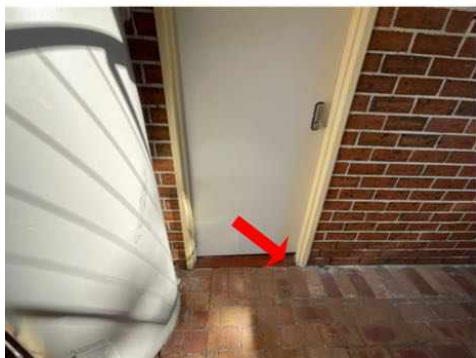
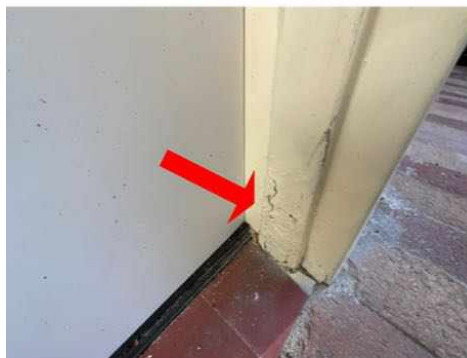
Finding 3.04

Building: Building 1
 Location: Rear garage door frame
 Finding: Door frame - Rusted or corroded
 Information: This door frame shows evidence of rusting and corrosion, which is likely to have developed as a result of excessive exposure to moisture and or inadequate coatings.

As surface rust provides no protection to the underlying iron, the deteriorating

condition is likely to worsen if not addressed in the short-term future.

Where possible, the use of galvanized (treated) metals or aluminium coated metals aid in rust prevention, as does regular general maintenance. Rust formation can be controlled with coatings, such as paint, that isolate the iron from the environment.

Rusting and corrosion should be managed by ideally removing or limiting the affected surface from exposure to moisture. A registered builder may be appointed to replace any building elements that have been severely affected by rust or water damage.

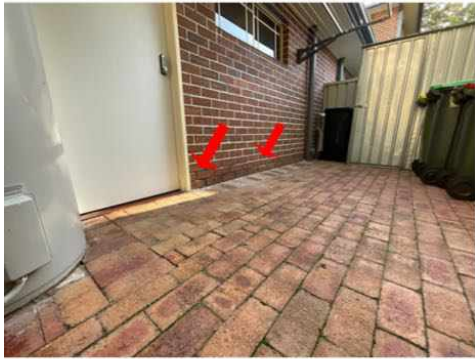
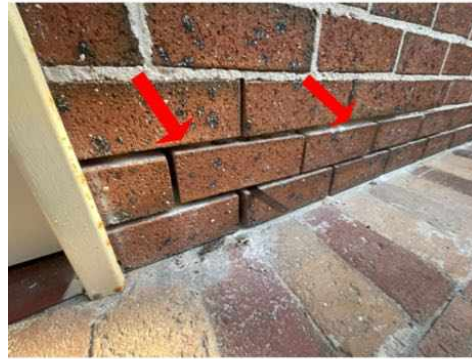
Finding 3.05

Building:	Building 1
Location:	Exterior garage wall
Finding:	Brickwork - Deteriorated mortar
Information:	Mortar, or 'bedding', is the material which fills joints and intersections between bricks in masonry walls and structures. Sections of mortar in this rear garage brickwork was identified as having deteriorated. Mortar may deteriorate as a result of age of building materials, minor movement of bricks, or frequent exposure to weathering. Mortar should be replaced to ensure that bricks remain in their intended location and to prevent gaps, which would allow water or moisture ingress and secondary damage as a result.

Mortar deterioration can be addressed by a bricklayer where areas of deterioration are localised and easily accessible. Alternatively, appointment of a registered builder is advised, to repoint large areas of decaying mortar. Where secondary structural defects have become evident, consultation with a structural engineer may be required.

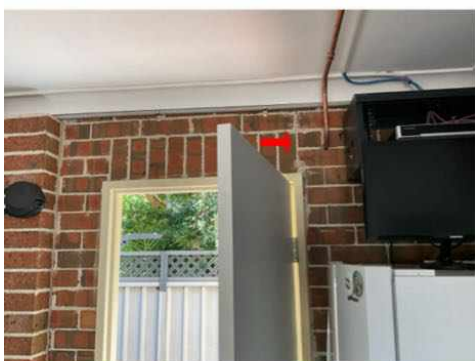
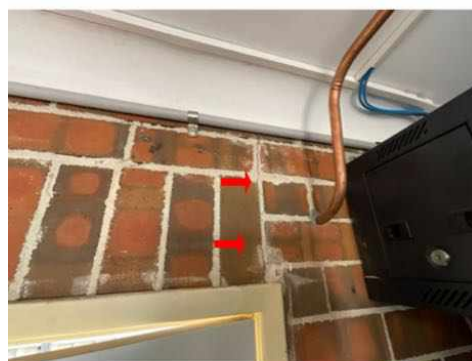
Finding 3.06

Building:	Building 1
Location:	Exterior wall
Finding:	Step cracking to brickwork (minor under 1mm)
Information:	Step cracking was identified to the brickwork in this rear garage area at the time of inspection. Step cracking, which is similar to other forms of cracking, has a variety of possible causes. However, the most common is the subsidence of adjacent footings.

Step cracking is a relatively common defect, and is most likely to occur adjacent to windows, doors and other openings. Mortar failure in the gaps between affected bricks indicates the stresses and tensions affecting the wall.

Where step cracking is extensive or severe, the client is advised to consult a structural engineer. This minor step cracking can be used as a warning sign to address factors causing stress to the wall, which can include the effect of surrounding trees, water leaks, soil erosion, or even the presence of reactive soils in the surrounding area.

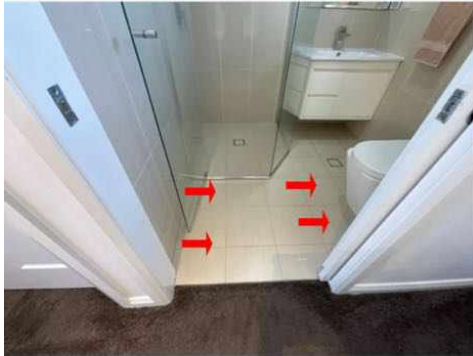
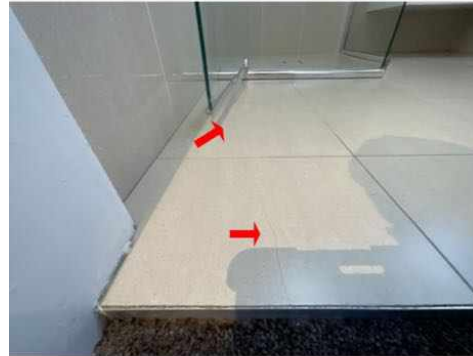
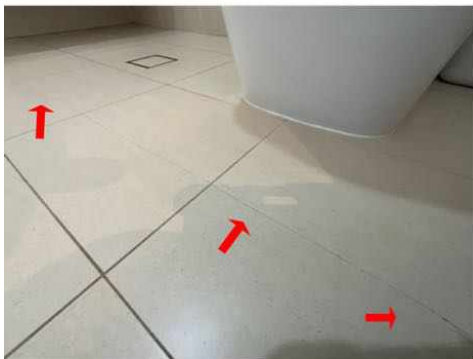
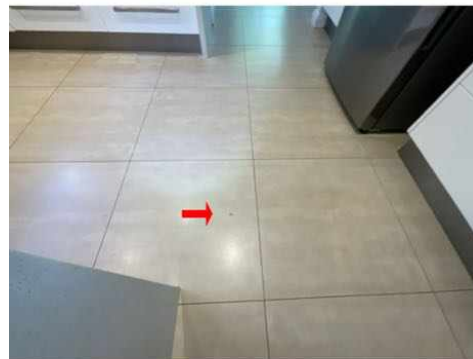
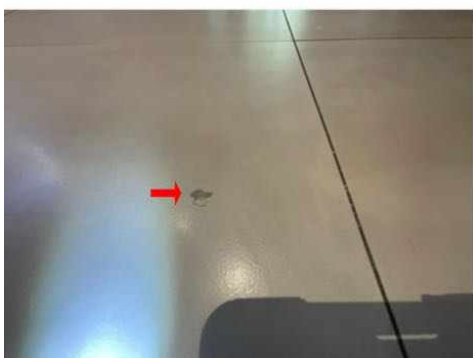
Finding 3.07

Building:	Building 1
Location:	Bathroom, kitchen
Finding:	Tiles cracked or chipped

Cracked tiles were evident in the ensuite and 1 chipped tile was found in the kitchen at the time of inspection. It is suspected that this cracking has occurred as a result of minor settlement. Cracked tiles throughout the household detract from the overall appearance of the affected areas. In wet areas of kitchens and bathrooms, it can lead to water damage of adjoining walls and floors.

Replacement of cracked tiles is recommended as soon as possible. A tiling contractor may be appointed to perform these works. Where cracks become more numerous, contact a licensed building inspector for further investigation.

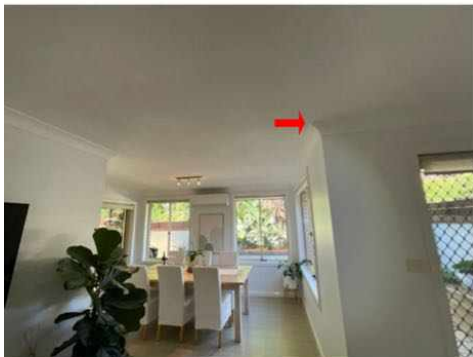
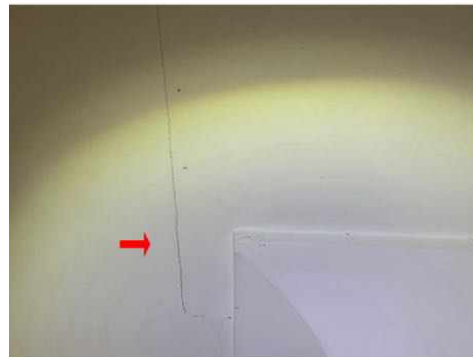
Building:	Building 1
Location:	Bathrooms, stairs, lounge, garage & other small areas
Finding:	Cracking - Damage Category 1 - Fine (up to 1mm)
Information:	Although fine cracks are quite noticeable, they are often only considered to be an appearance defect, and usually do not indicate any structural damage. Generally, the cause of a fine crack is indicative of a separation between building materials and finishes (e.g. paint, plaster, etc.) along joins.

Cracking of this nature can generally be repaired with minor sanding, filling and/or repainting. Such works should be performed by a qualified painter or a general handyman.

Monitoring of all cracking should be conducted frequently. Always contact a building inspector should cracks widen, lengthen, or become more numerous.

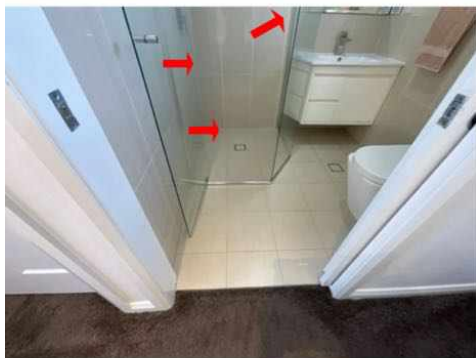
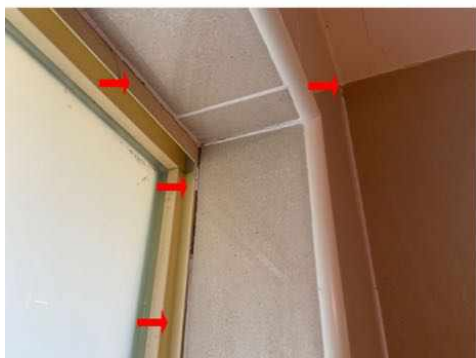
Finding 3.10

Building:	Building 1
Location:	Bathrooms
Finding:	Sealant and grouting - Missing or damaged
Information:	It was noted on inspection that sealant or grout is degraded to these pictured areas.

Different materials and floor areas move at different rates, generally causing cracking to grout or sealant at this point. A flexible sealant is required to allow for expected expansion and contraction, while keeping the joint water tight and protective of all associated building materials.

Flexible and mould resistant materials should be applied to affected areas to prevent any subsequent water damage that is likely to occur. Regular maintenance and replacement of damage or missing or damaged sealant and grout is highly recommended to the wet areas, as this is a regular wear and tear defect. Sealant and grouting in areas that come into regular contact with water should be maintained for the long term care of your property.

A sealant specialist or tiling contractor should be appointed to complete these works as soon as possible

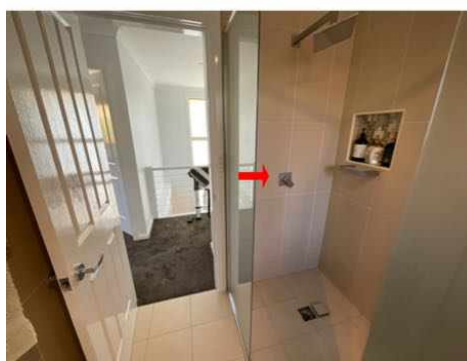
Building:	Building 1
Location:	Bathroom- ensuite
Finding:	Taps - Water hammer
Information:	These taps shows evidence of water hammer being present. Water hammer, a pressure surge resulting when a fluid is forced to suddenly change direction, is a common defect in plumbing fittings, particularly those that are aged and not frequently maintained. Water hammer is generally caused by factors that create high water pressure in the affected plumbing fixture, usually evidenced by a faint banging noise during operation of the affected tap.

Although water hammer is generally considered to be a minor defect, subsequent damage such as erosion of tap hardware and/or water damage to associated building elements is likely to occur if left unmanaged.

A licensed plumber should be appointed as soon as possible to replace any affected tap hardware and perform any remedial works as necessary. Please be advised that the appointment of a cabinet maker or qualified carpenter may be necessary if water damage to associated building elements has occurred.

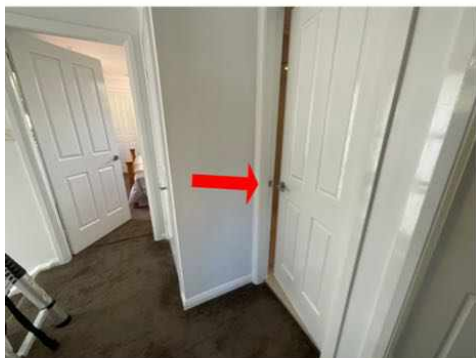
Building: Building 1
Location: Pictured areas
Finding: Door handle - Not latching
Information: It was noted that the door in this area was not latching during operation at the time of inspection. Whilst detracting from the functionality of this building element, this minor defect may also be a security risk, and may therefore have serious implications if left unattended.

It is suspected that this defect has occurred due to minor issues with the associated hinges. Such damage is identified as general wear and tear, which is expected for building elements of this age.

A qualified carpenter or general handyperson may be appointed to perform rectification works as necessary, at client discretion. If left unattended, further functional impairment is likely to occur.

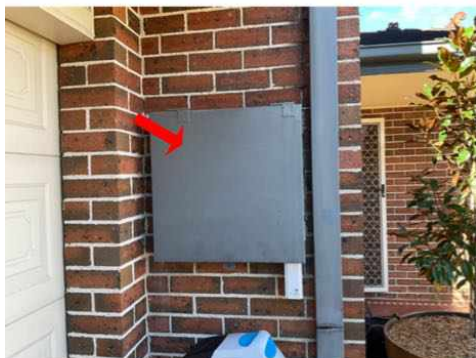
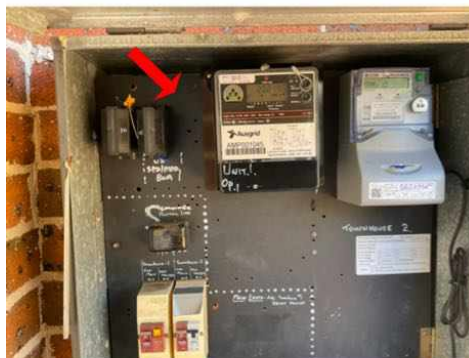
Building:	Building 1
Location:	Meter Box
Finding:	Termite Management System - no evidence of a chemical installation
Information:	The application of a post-construction chemical termite barrier is highly recommended for all properties. Such barriers are highly effective in preventing termite attack on any timber building elements throughout the property.

A durable notice should be placed in the switchboard unit to indicate current termite barriers. At the time of inspection, no durable notice was evident and it appeared as though no chemical termite management system has been installed, with no evidence to suggest preventative works taking place since the property was built.

The client may consider gaining further advice from a pest controller as to the costs and procedures involved with a 'chemical' application. It is recommended that obtaining such advice be a short-term priority.

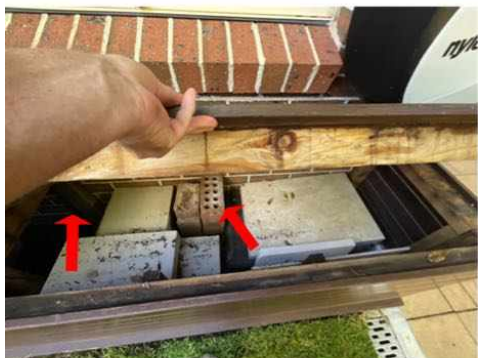
Finding 6.02

Building:	Building 1
Location:	Yard - front
Finding:	Bridging of termite barriers
Information:	Where these boxes obstructs inspection of building elements, also known as bridging as it provides a bridging point for the access of termites, full inspection can not be achieved. Consequently moisture or dampness may be present and the areas becomes conducive to termite activity. Plants, decks and these boxes against or very close to buildings provide cover, shade and can provide an environment that is attractive to termite infestation.

The removal of any such materials that may be conducive to termite activity should be carried out as soon as possible and arrange re inspection to minimize the risk of termite attack.

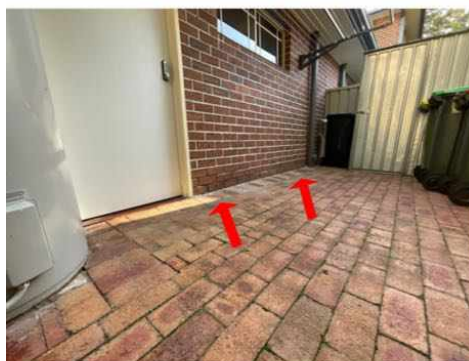
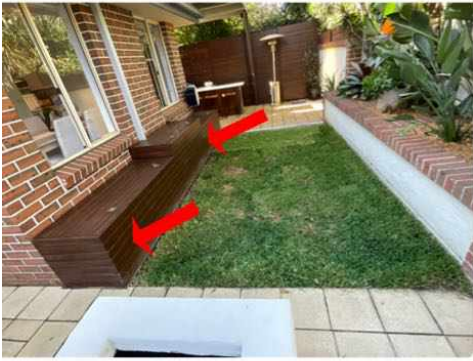
Finding 6.03

Building:	Building 1
Location:	Exterior walls
Finding:	Slab Edge - Exposure
Information:	An inspection zone of at least 75mm in relation to the exposed slab edge, between the bottom brick and the perimeter pavement, is required. This inspection zone should be maintained in order to force termites into the open where they can be detected more readily during regular inspections. The slab edge should not be concealed by anything that may prevent inspection of the area, including render, landscaping, soil, turf, paving, concrete cladding or other structures.

If the slab edge is not properly exposed there is a high risk of termite attack. Sometimes, in order to determine the type of slab, a suitably qualified person such as an architect or builder may be required to consult the construction plans.

Where the slab edge cannot be properly inspected, it is highly recommended that termite or timber pest inspections be carried out every 6-12 months to aid protection of the property against infestation.

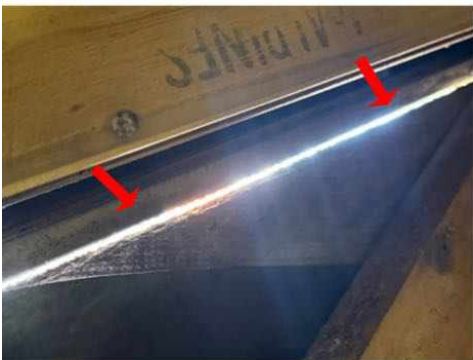
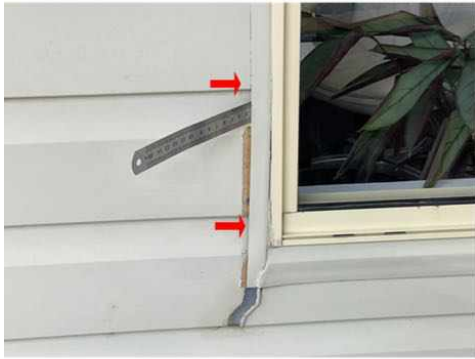
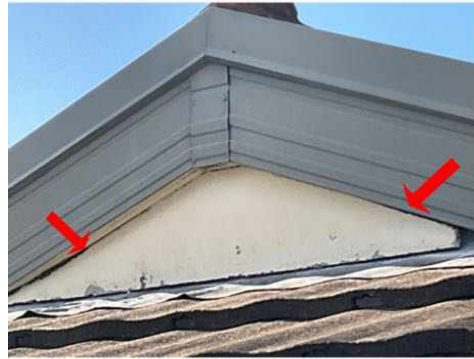
Finding 6.04

Building:	Building 1
Location:	All missing/ damaged sealant/ flashing areas
Finding:	Sealant (external) - missing and attractive to termites
Information:	It was noted on inspection that areas of external sealant was missing to small areas of the external walls. A flexible sealant or flashing is required to protect the associated building materials from rainwater ingress. Any moisture ingress into the property is very attractive to termites. Flexible sealants or flashing should be applied to these affected areas to prevent termite activity.

A roofing contractor/ roof plumber should be appointed to complete these works as soon as possible.

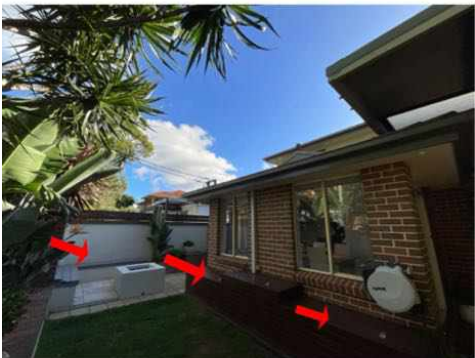
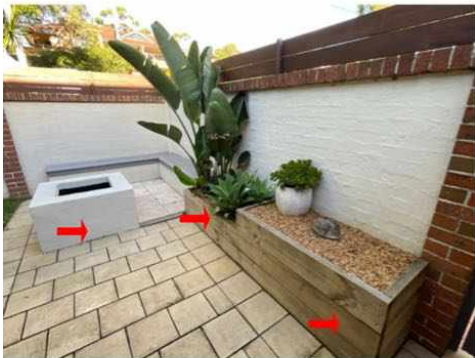
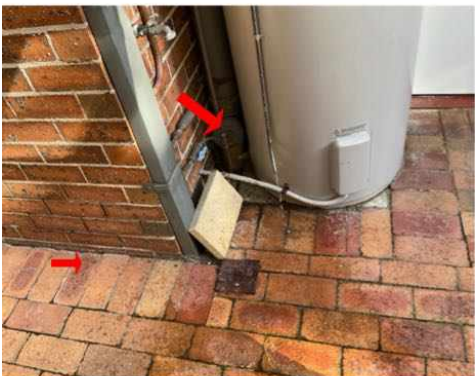
Building: Building 1
 Location: All External Areas
 Finding: Additional Photos - Obstructions and Limitations of EXTERNAL AREAS
 Information: These photographs are an indication of the obstructions and limitations which impeded full inspection of external areas at the time of inspection. These obstructions can hide an array of defects and should be removed to allow full inspection to be carried out. A re-inspection is recommended once the areas are made accessible.

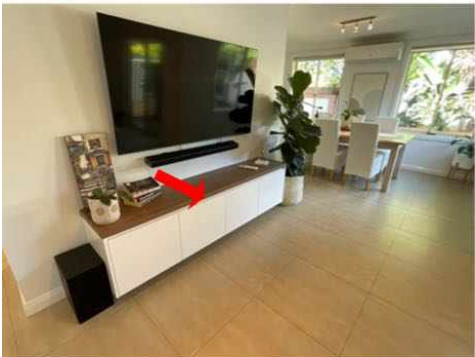
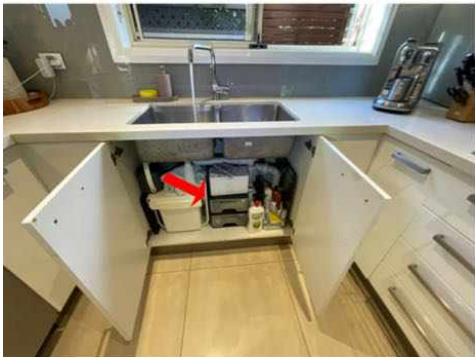
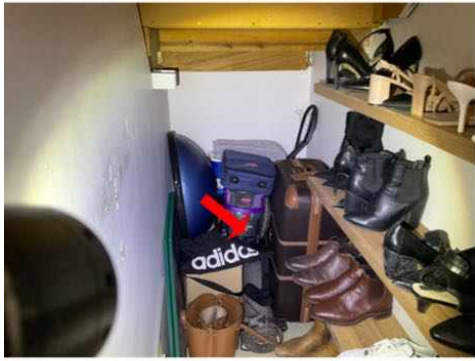
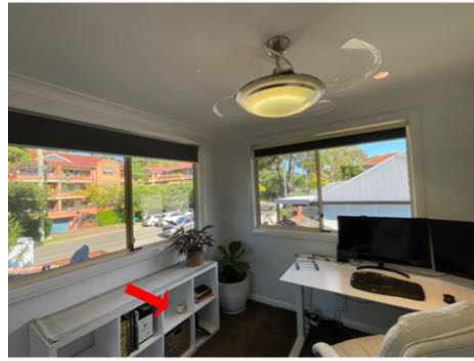
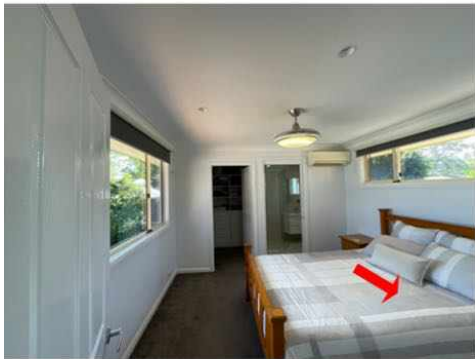
Building: Building 1
Location: All Internal Areas
Finding: Additional Photos - Obstructions and Limitations of INTERNAL AREAS
Information: These photographs are an indication of the obstructions and limitations which impeded full inspection of Internal areas at the time of inspection. These obstructions can hide an array of defects and should be removed to allow full inspection to be carried out. A re-inspection is recommended once the areas are made accessible.

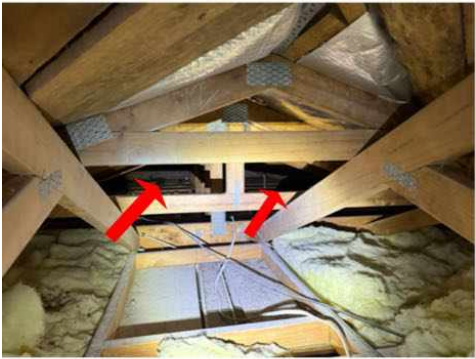
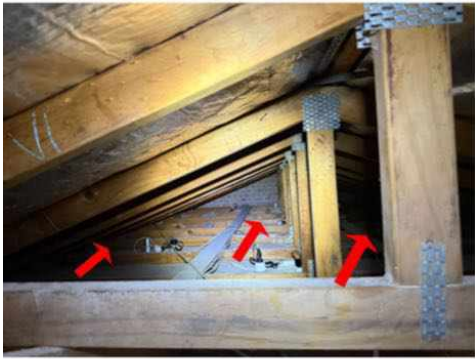
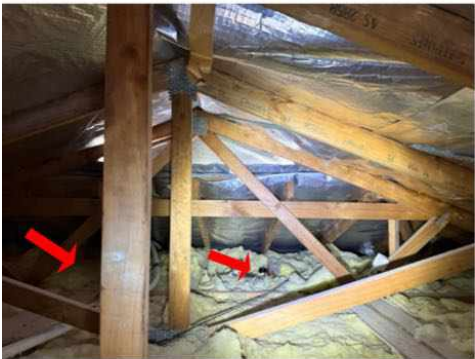
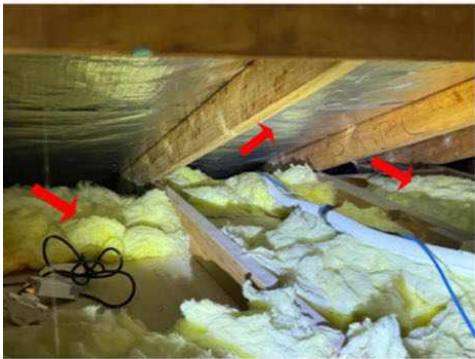
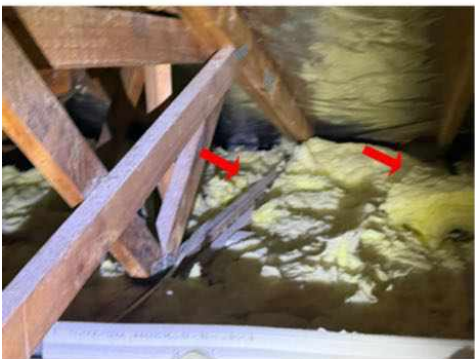
The left roof void had no physical access due to blocking roof trusses (see obstructions of the roof void at rear of the report). This left area could only be observed from a distance. The second floor roof was inspected from a few areas on the lower roof, approximately 25% of the upper roof was visible.

Building:	Building 1
Location:	All Roof cavity areas
Finding:	Additional Photos - Obstructions and Limitations of the ROOF CAVITY
Information:	<p>These photographs are an indication of the obstructions and limitations which impeded full inspection of roof cavity areas at the time of inspection. These obstructions can hide an array of defects and should be removed to allow full inspection to be carried out if applicable. A re-inspection is recommended once the areas are made accessible.</p> <p>The inspection was also limited to areas with an allowable crawl space of 600mm x 600mm, in particular towards the external walls where the roof line diminishes, these areas were not accessible.</p>

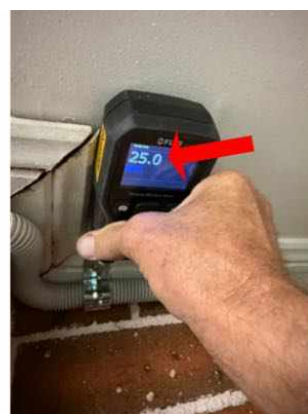
Building: Building 1
 Location: Garage
 Finding: Elevated moisture - identified
 Information: A slightly elevated moisture reading of 25 and minor paint damage was found in the front right garage wall. Nearby readings were all zero.

This moisture can produce conditions that promote fungal growth and wood decay.

Elevated moisture is generally caused by deteriorated, inadequate or missing roof drainage and damaged sealant or missing flashings.

Prior to any internal remedial works being performed, a qualified roof plumber or roofing contractor should be appointed to repair or replace all damaged and missing flashings on the external walls/roof areas.

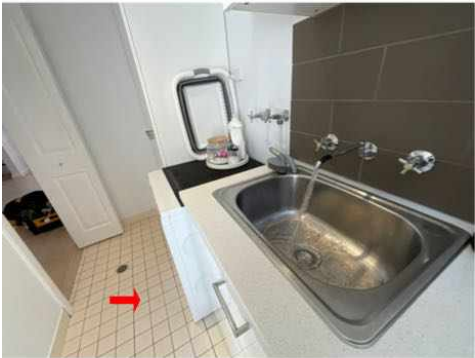
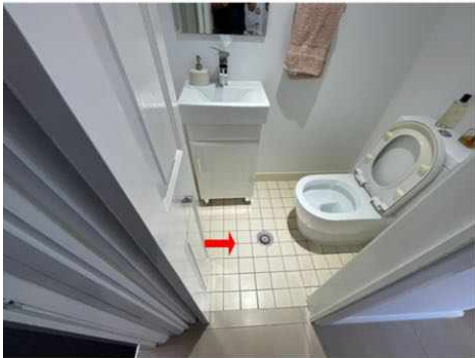
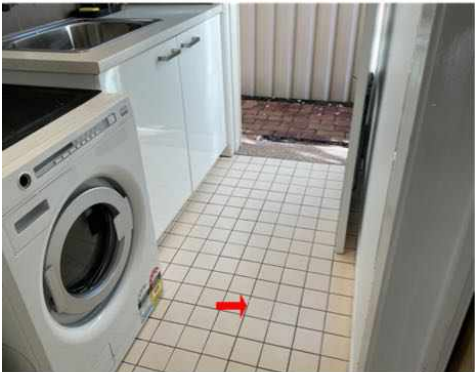
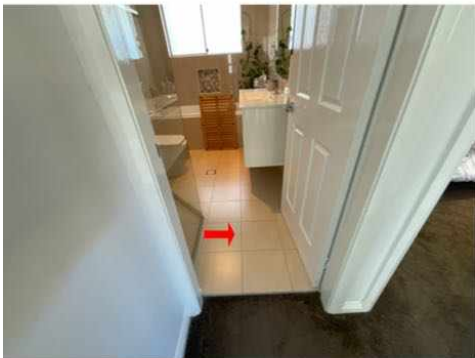
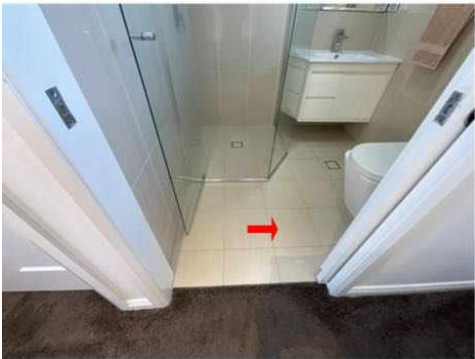
- Membrane used and Manufacturers Specifications.
- The Installer and Installation Certification.

With older property's where this information is unavailable all wet areas should be monitored. If any leaks, water staining, peeling or bubbling of the paint become evident to any adjacent walls or ceilings below a licensed builder or waterproofing specialist is recommended to investigate further.
