# Building and Timber Pest Inspection Report

Inspection Date: Tue, 24 Feb 2026

Property Address: 99 Broughton St, Camden NSW 2570,  
Australia

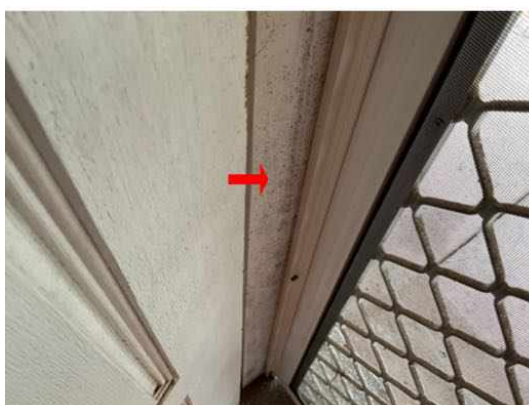
Building:	Main Building
Location:	Alfresco
Finding:	Mould - Present
Information:	Where evidence of mould growth was noted, there may be environmental, biological or health issues associated with the report. A specialist inspection by a suitably qualified environmental health inspector is warranted, where mould is extensive or where any queries regarding air quality spores or other related issues apply.

Generally, the client is advised to ensure that the general environment is free of moisture and humidity to aid in the prevention of mould formation and development. Any mould found during the inspection should be cleaned immediately by a cleaning contractor or the homeowner as applicable.

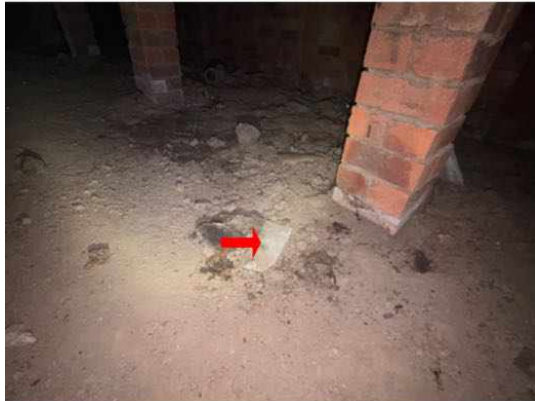
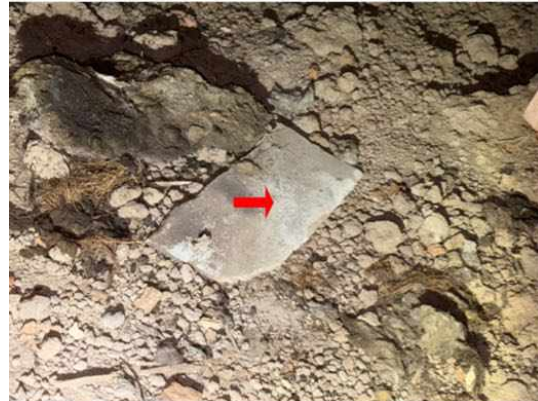
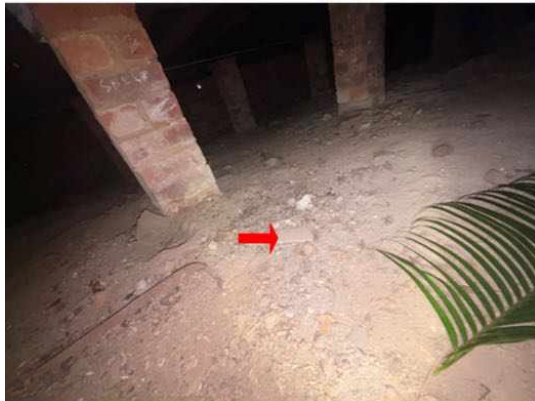
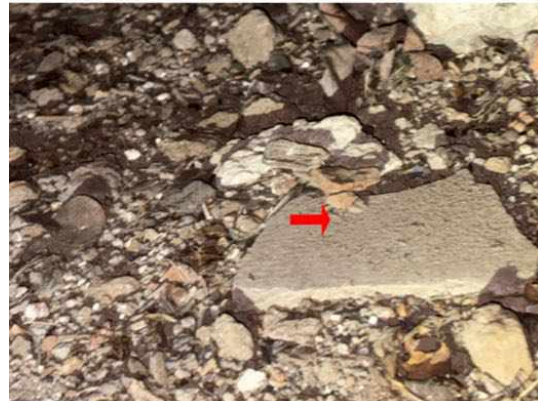
#### Finding 1.02

Building:	Main Building
Location:	Subfloor
Finding:	Asbestos - Suspected ACM Identified on Site
Information:	Reporting on Asbestos is outside the Scope of this Report. This suspected defect is highlighted as a caution only. We suspect, based on our experience in the building industry, that there is a higher risk of the identified building element containing asbestos.

As Asbestos Reporting is outside the scope of this report, we advise that you consider a separate Asbestos Inspection and Condition Audit, which can include the taking of samples for definitive confirmation of the presence of Asbestos.

In the interim, the client is advised to act with caution, especially when considering any damage to building materials general wear and tear renovations extensions demolition and general maintenance activities due to the suspected presence of Asbestos.

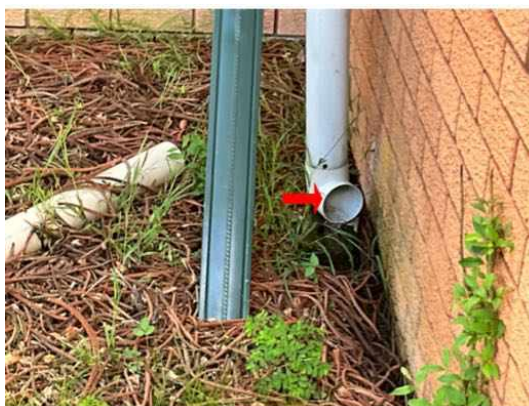
### Finding 2.01

Where roof plumbing doesn't drain adequately, the area at the base perimeter can become excessively damp, potentially creating an environment that is susceptible to rust and corrosion of surrounding building elements, as well as attracting termites and other pests.

It is highly recommended that a plumber be appointed to further inspect the area and to install adequate drainage equipment where necessary.

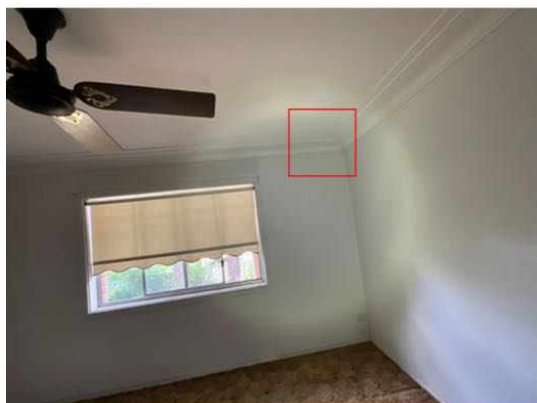
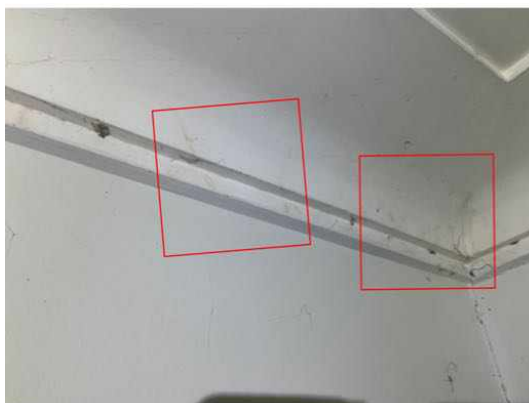
Finding: Ceiling - Water damaged  
 Information: Water damage to the ceiling lining is generally an indication of excessive moisture being present in the roof void, usually via a leak to the roof covering.

Where water damage is evident to the ceiling, the primary requirement is to identify and rectify the source of the leak. A roofing plumber should be appointed as soon as possible to identify the leak and perform rectification works as necessary, ensuring the water damage is restricted.

Once the leak is repaired, consultation with relevant tradespeople, including plasterers and painters, is advised. Rectification works may include replacement of ceiling lining or minor repainting, depending on the extent of the damage.

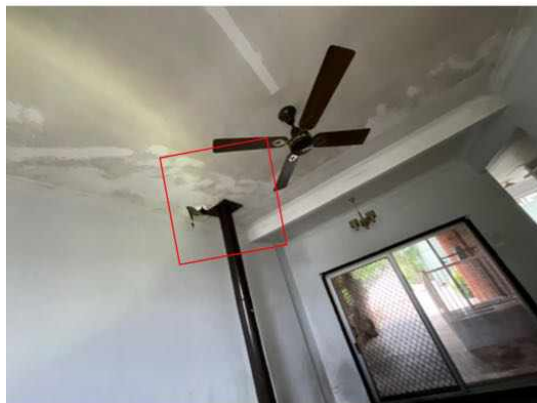
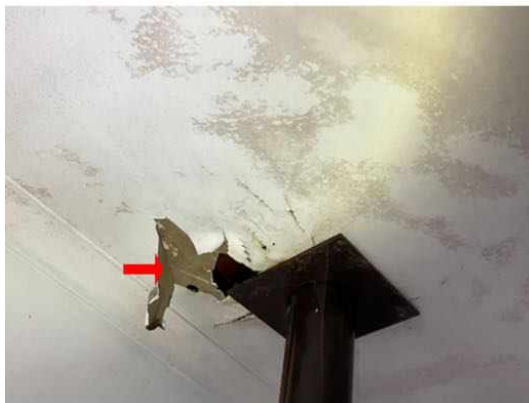
### Finding 2.04

Building: Main Building  
 Location: Garage  
 Finding: Ceiling - Water damaged  
 Information: Water damage to the ceiling lining is generally an indication of excessive moisture being present in the roof void, usually via a leak to the roof covering.

Where water damage is evident to the ceiling, the primary requirement is to identify and rectify the source of the leak. A roofing plumber should be appointed as soon as possible to identify the leak and perform rectification works as necessary, ensuring the water damage is restricted.

Once the leak is repaired, consultation with relevant tradespeople, including plasterers and painters, is advised. Rectification works may include replacement of ceiling lining or minor repainting, depending on the extent of the damage.

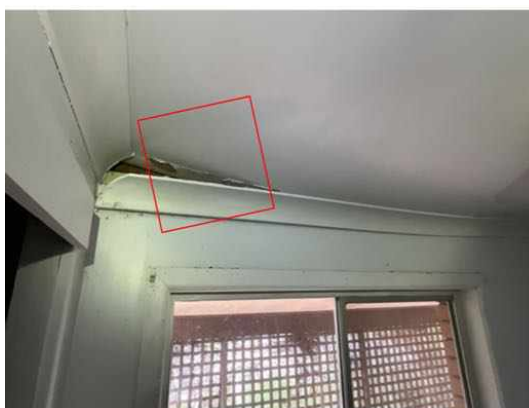
### Finding 2.05

Building:	Main Building
Location:	Rear bedroom
Finding:	Ceiling - Sagging
Information:	Sections of the ceiling were found to be sagging at the time of inspection. Sagging to the fixed ceiling structure generally indicates that the building materials have swollen, due to contact with water, or that fixings (e.g. nails or glue) have become loose and require reattachment.

In some cases, sagging ceiling linings may also indicate that there are structural issues, causing surfaces to warp, twist or sag. Where sagging appears to be major, appointment of a structural engineer is advised to further inspect the property and identify the source and rectification works required.

Where minor sagging is evident, comparatively minor works, such as re-gluing of ceiling sheets, may be required. Such works may be performed by relevant tradespeople, such as plasterers and painters. Where excessive moisture has caused the roofing structure to swell and sag, the source of the water leak should primarily be identified prior to any remedial works being performed.

The appropriate action should be taken by the client as soon as possible to ensure that any potential further damage is limited.

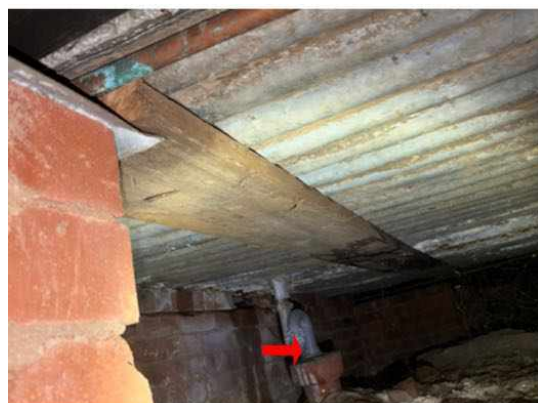
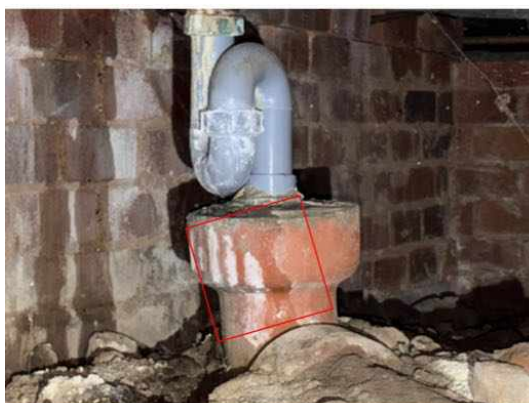
## Finding 2.06

Building:	Main Building
Location:	Bathroom
Finding:	Pipework - Leaking into subfloor
Information:	Dampness to localised sections of the subfloor area was identified. It is suspected that this dampness has occurred due to leaking pipes in this area, which may be exacerbated by poor site drainage and inadequate subfloor ventilation.

Dampness in this area is likely to lead to wood rot and general deterioration of structures within the subfloor space. Excessive moisture also creates an environment which is conducive to termite and pest infestation.

A licensed plumber should be appointed immediately to repair any pipes that may be leaking. This will ensure a dry subfloor space as well as improving the water efficiency of the property.

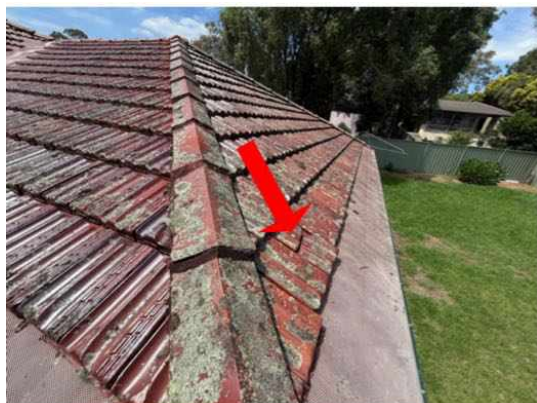
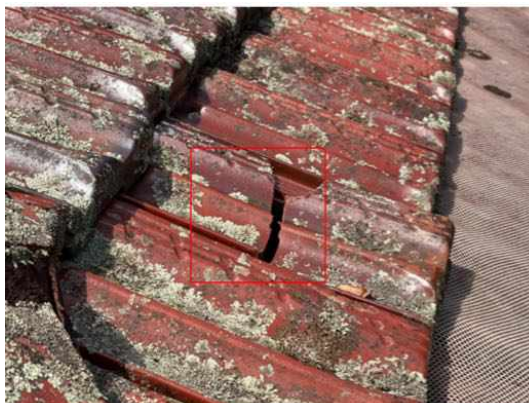
## Finding 2.07

Building:	Main Building
Location:	Roof Exterior
Finding:	Roof tiles - Broken
Information:	Upon inspection of the exterior roof covering, broken roofing tiles were identified. Broken and friable roof tiles are generally the result of ageing and weathering of what is essentially a porous material.

If left to further deteriorate, broken and brittle roof tiles are likely to lead to water penetration via the roof into the ceiling space, causing secondary damage to ceiling linings, insulation and roof structures. Broken roof tiles are also likely to detract from the effectiveness of the roof drainage system, creating potential for secondary damage to the exterior roof covering and roof plumbing.

Replacement of broken tiles is required and should be performed by a roofing contractor as soon as possible.

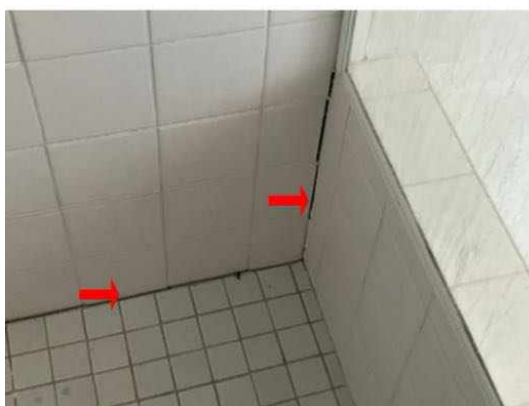
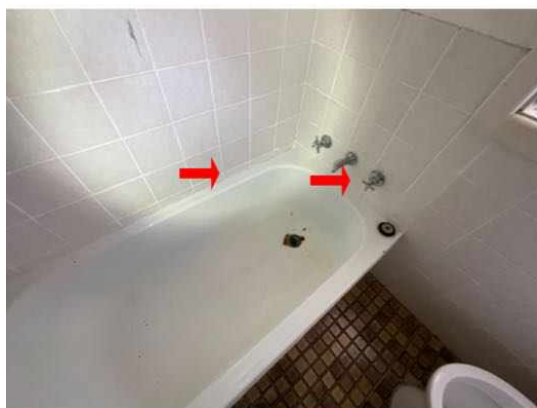
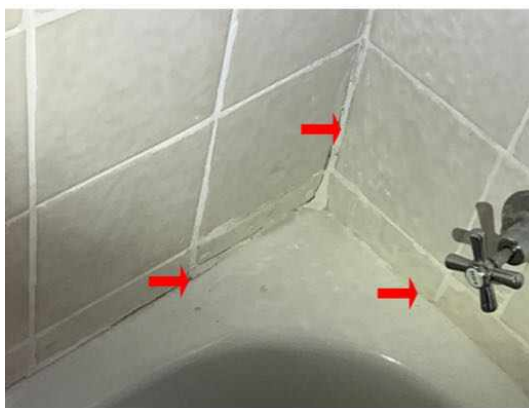
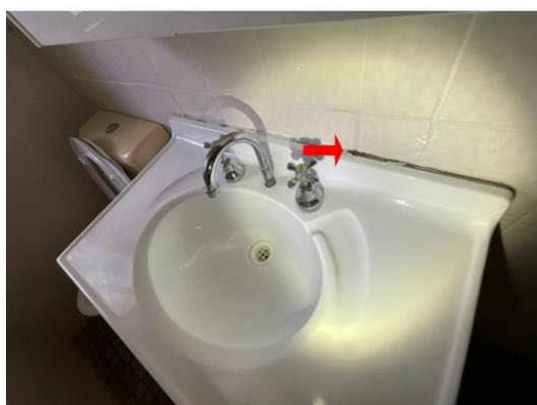
### Finding 2.08

Building: Main Building  
 Location: All Wet Areas  
 Finding: Sealant and grouting - Missing or damaged  
 Information:

It was noted on inspection that sealant or grout is degraded to this area.

Different materials and floor areas move at different rates, generally causing cracking to grout or sealant at this point. A flexible sealant is required to allow for expected expansion and contraction, while keeping the joint water tight and protective of all associated building materials.

Flexible and mould resistant materials should be applied to affected areas to prevent any subsequent water damage that is likely to occur. Regular maintenance and replacement of damage or missing or damaged sealant and grout is highly recommended to the wet areas, as this is a regular wear and tear defect. Sealant and grouting in areas that come into regular contact with water should be maintained for the long term care of your property.

A sealant specialist should be appointed to complete these works as soon as possible.

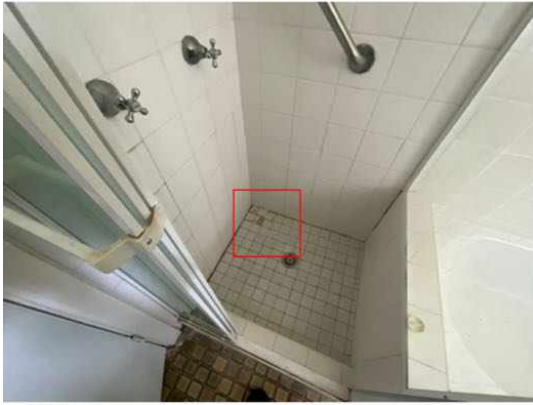
### Finding 2.09

Finding: Tiles - Damaged

Information: Damage was evident to the tiling in this area at the time of inspection. This area is frequently exposed to water, allowing potential for water penetration into adjoining sections of walls or flooring.

If left unmanaged, water penetration to these areas may lead to subsequent water damage, which is likely necessitate repair work to affected building elements.

A tiling contractor should be appointed to ensure that no further water damage occurs. The re-application of silicone and grouting throughout remaining tile work is also advised, to further protect the area against water penetration.

Where water penetration has led to water damage, appointment of a relevant tradesperson may be required to repair damaged building elements.

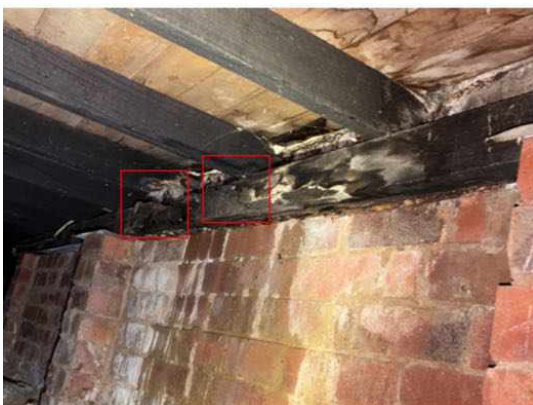
### Finding 2.10

Building:	Main Building
Location:	Subfloor
Finding:	Subfloor structure - Wood rot
Information:	The subfloor structure in this area is showing signs of deterioration and wood rot (fungal decay) of the timbers. It is suspected that this defect has developed as a result of water leak at some stage.

Damp conditions cause the timbers to fail, resulting in the subfloor structures failing to bear the load (or weight) of the building as originally intended. Without repairs and maintenance, including potential replacement of affected elements, it is likely that serious structural faults will result, as well as an array of minor defects.

The presence of wood rot to the subfloor structure is also conducive to termite infestation.

Rectification or replacement of the affected timber building element is required immediately by a licensed builder.

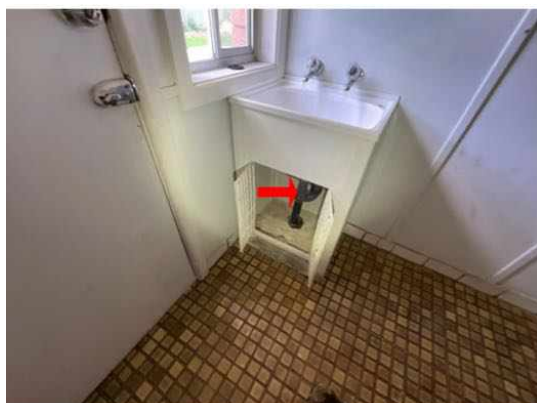
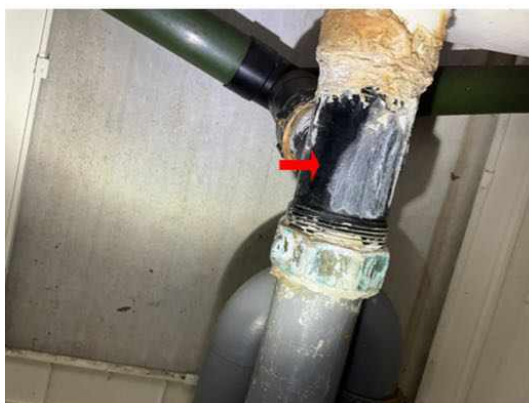
#### Finding 3.01

Building:	Main Building
Location:	Laundry
Finding:	Water leak - Active
Information:	Generally, water leaks occur when a particular area of the property is not weather or water tight. As the surrounding area was found to be damp at the time of inspection, the leak is considered ongoing and hence requires urgent action.

Regardless of the location, even minor leaks that are left unmanaged can lead to serious damage of associated building elements and result in the need for replacement of building materials. Mould and other hazards such as electrical hazards may also arise if the leak is left to develop.

It is highly advised that the cause of the leak be identified and resolved immediately by a licensed plumber to prevent any further damage. Depending on the extent of the damage previously sustained, repair and/or replacement of any affected building materials may be required.

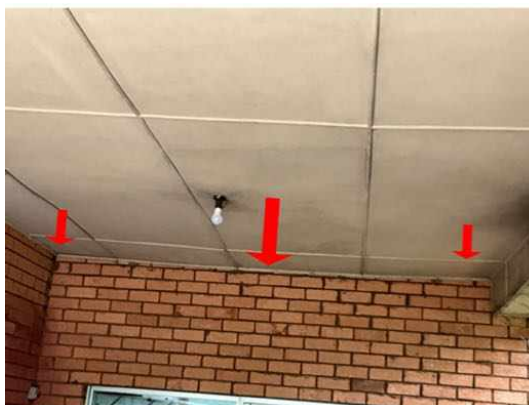
### Finding 3.02

Building:	Main Building
Location:	Carport
Finding:	Ceiling sagging - Carport
Information:	Sections of the ceiling were found to be sagging at the time of inspection. Sagging to

the fixed ceiling structure generally indicates that the building materials have swollen, due to contact with water, or that fixings (e.g. nails or glue) have become loose and require reattachment. This is a very common defect in carports due to their lack of insulation and or their susceptibility to moisture. Condensation builds up in the roof and rests on the plasterboard softening it somewhat which makes it more likely to sag and release from its fixing points.

Where minor sagging is evident, comparatively minor works, such as re-gluing of ceiling sheets, may be required. Such works may be performed by relevant tradespeople, such as plasterers and painters. Where excessive moisture has caused the roofing structure to swell and sag, the source of the water leak should primarily be identified prior to any remedial works being performed.

In some cases, sagging ceiling linings may also indicate that there are structural issues, causing surfaces to warp, twist or sag. Where sagging appears to be major, appointment of a structural engineer is advised to further inspect the property and identify the source and rectification works required.

While damage is minimal at this stage a licensed plasterboard contractor should be appointed to repair the ceiling. Insulating the area could be a considered by the client once repaired.

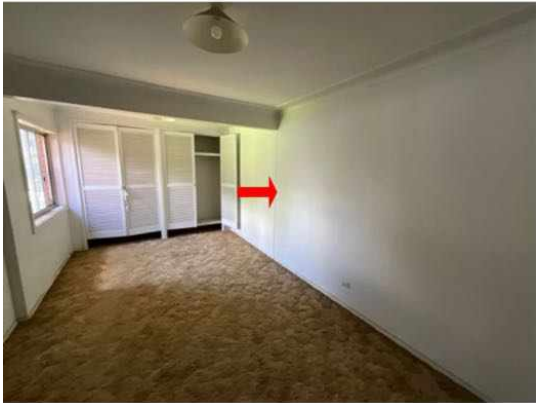
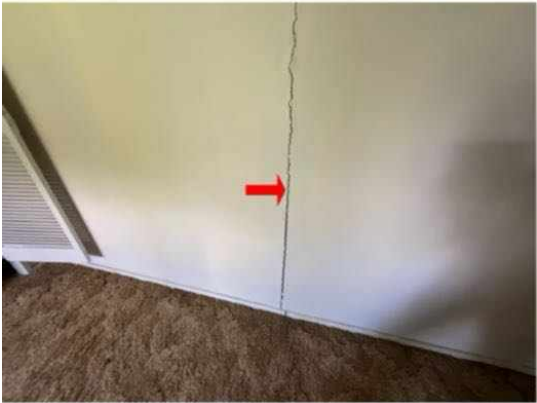
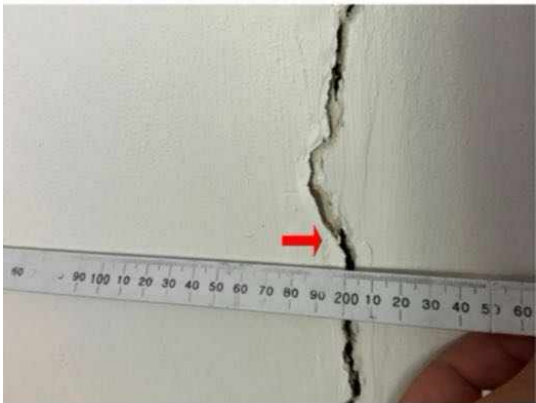
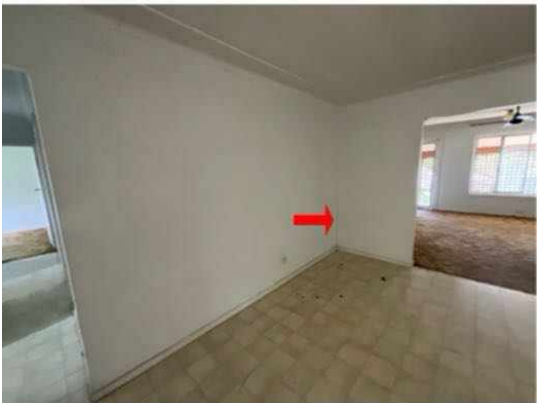
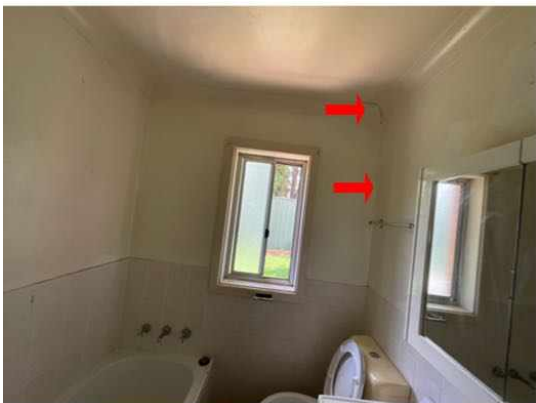
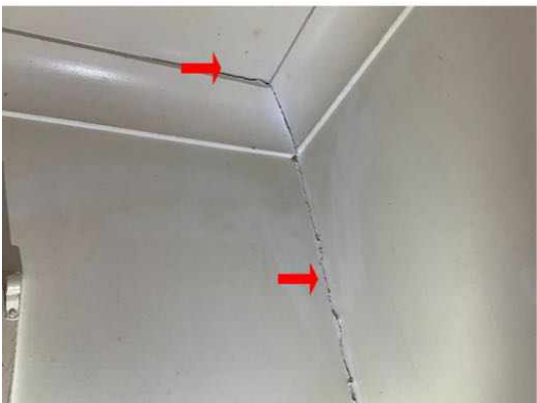
### Finding 3.03

Building:	Main Building
Location:	Dining/bed, Bathroom
Finding:	Cracking - Damage Category 2 - Noticeable (up to 5mm)
Information:	Noticeable cracks are a common occurrence as a result of many primary defects. Such causes may include age, general wear and tear, expected building movement, general expansion/contraction of building materials in different weather conditions, and/or minor failings in the installation or application of building materials.

Noticeable cracks may result in minor sticking or jamming of associated doors and windows, which require easement. However, noticeable cracks are easily filled and repaired. A plasterer can be consulted to install an expansion joint at this point to allow

for this movement during different weather conditions.

Monitoring of all cracking should be conducted frequently. Always contact a building inspector should cracks widen, lengthen, or become more numerous. Additionally, your building inspector should also be contacted if associated building elements such as doors and windows become more difficult to operate over time.

Relevant tradespeople, such as carpenters, painters and plasterers, should be appointed to perform remedial works, as deemed necessary.

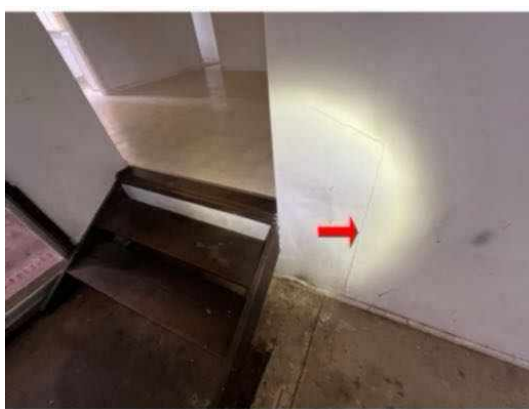
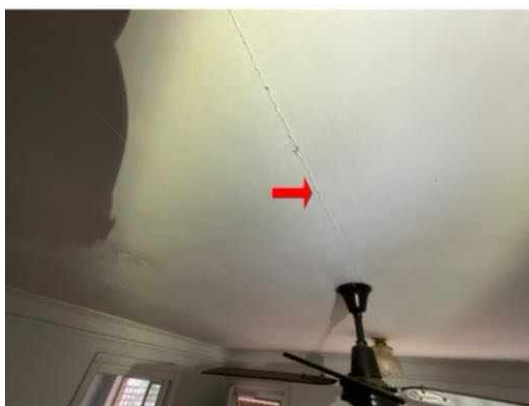
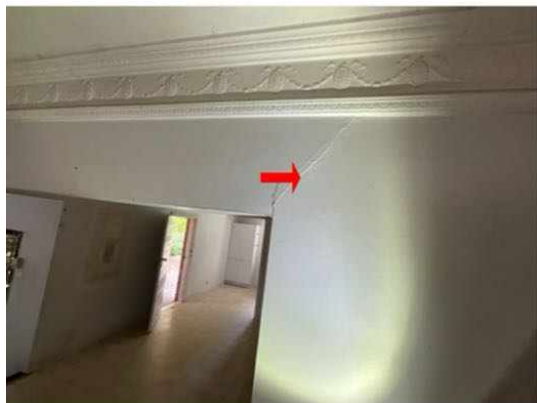
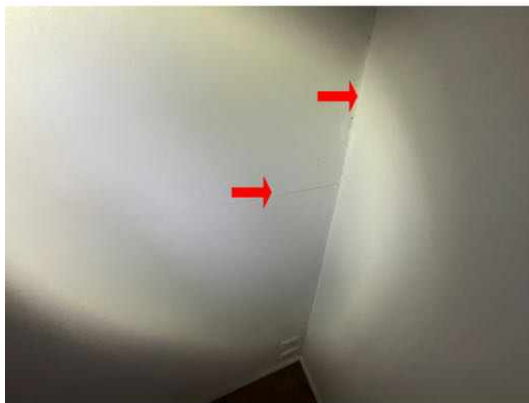
**Finding 3.04**

Building: Main Building

Location: Multiple areas  
Finding: Cracking - Damage Category 1 - Fine (up to 1mm)  
Information: Although fine cracks are quite noticeable, they are often only considered to be an appearance defect, and usually do not indicate any structural damage. Generally, the cause of a fine crack is indicative of a separation between building materials and finishes (e.g. paint, plaster, etc.) along joins.

Cracking of this nature can generally be repaired with minor sanding, filling and/or repainting. Such works should be performed by a qualified painter or a general handyman.

Monitoring of all cracking should be conducted frequently. Always contact a building inspector should cracks widen, lengthen, or become more numerous.

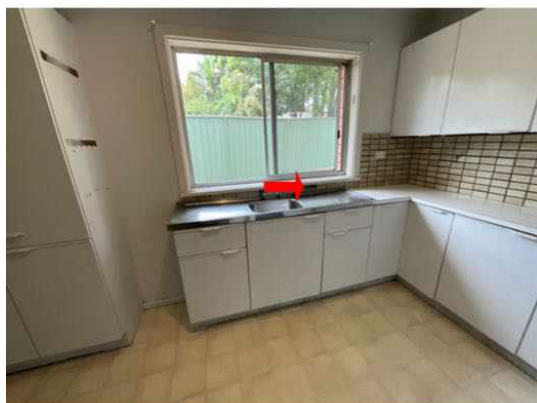
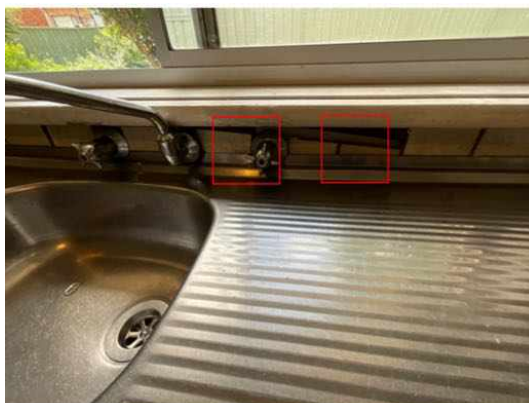
### Finding 3.05

Building:	Main Building
Location:	Kitchen
Finding:	Building element - Damaged
Information:	Breakage occurs generally when the building materials have either aged and decayed, or as a result of damage (accidental or deliberate).

Repair and/or replacement of broken elements is advised to ensure that additional secondary defects do not arise as a consequence. Such works are necessary, as all building elements play a key role in the operation and function of the overall structure and its performance.

A relevant tradesperson should be appointed to repair or replace the affected building element prior to any subsequent damage being caused.

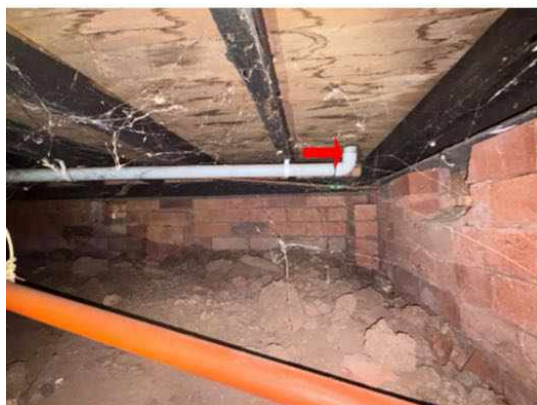
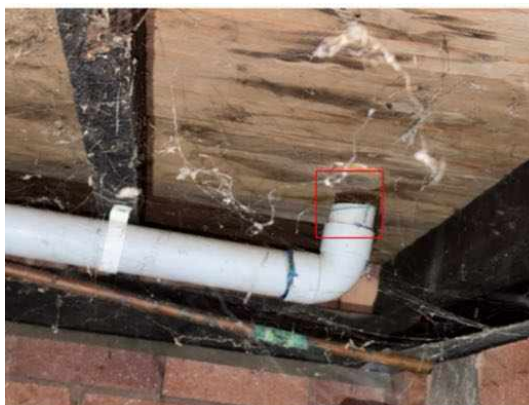
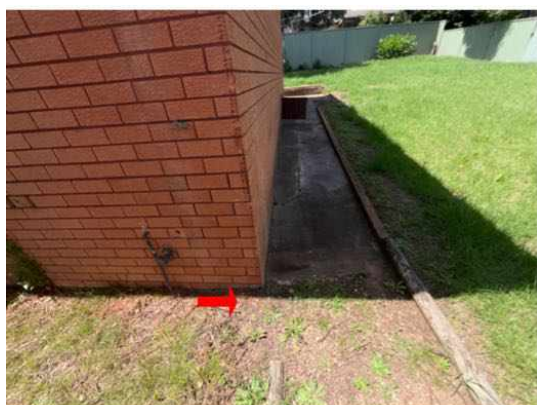
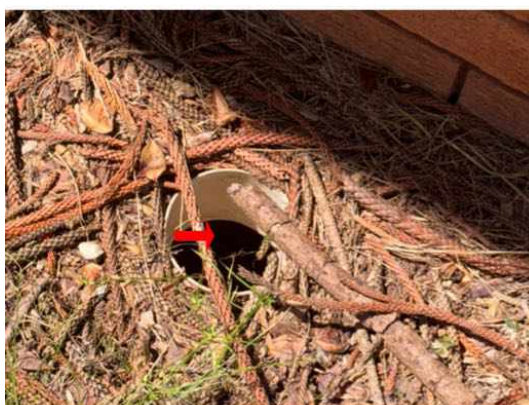
Building:	Main Building
Location:	Multiple areas
Finding:	Plumbing - Point of connection non-compliant
Information:	At the time of inspection it was noted that connections between above ground pipe work and below ground sewer/storm water systems were incomplete.

Additionally, where sewer pipes are concerned, gases can escape from unsealed connections which can pose a serious health risk.

Engagement of a certified plumber is strongly recommended to ensure all connection points are sealed in accordance with the plumbing construction guidelines.

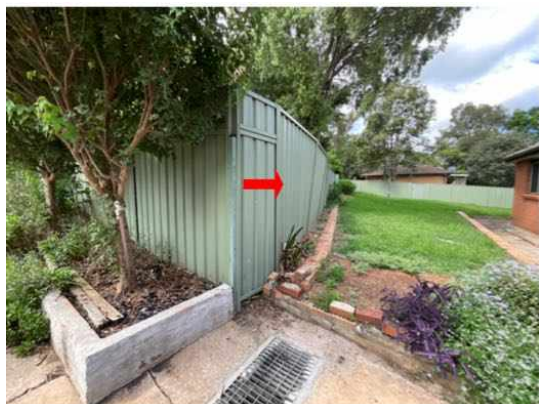
### Finding 3.07

Building:	Main Building
Location:	Fencing
Finding:	Fencing - Deteriorated
Information:	It was noted at the time of inspection that sections of the fencing in this area has deteriorated. Typically fencing deteriorates due to age and or wear, rot and or rust which is generally expected for a structure of this age, due to prolonged exposure to weather conditions. Sometimes inadequate installation or maintenance can be to blame.

If left unattended, it is likely that further damage will occur. It is suspected that repair of several elements of the fencing may be required however replacement may be a

consideration of the client also.

A licensed fencing contractor should be appointed to provide further advice and perform rectification works as necessary.

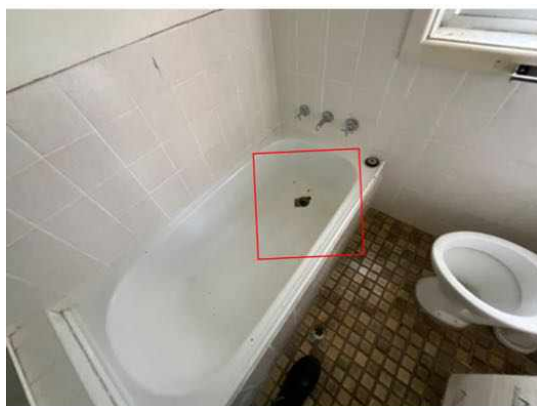
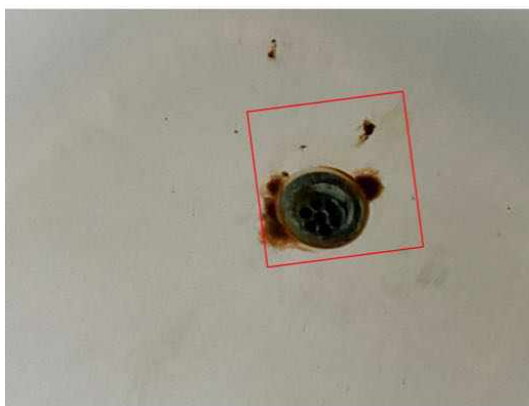
### Finding 3.08

Finding: Building element - Rusted or corroded

Information: This building element shows evidence of rusting and corrosion, which is likely to have developed as a result of excessive exposure to moisture and or inadequate coatings.

As surface rust provides no protection to the underlying iron, the deteriorating condition is likely to worsen if not addressed in the short-term future. This will then allow water leakage to the subfloor space.

Rusting and corrosion should be managed by ideally removing or limiting the affected surface from exposure to moisture. A licensed plumber must be appointed to replace the bath tub.

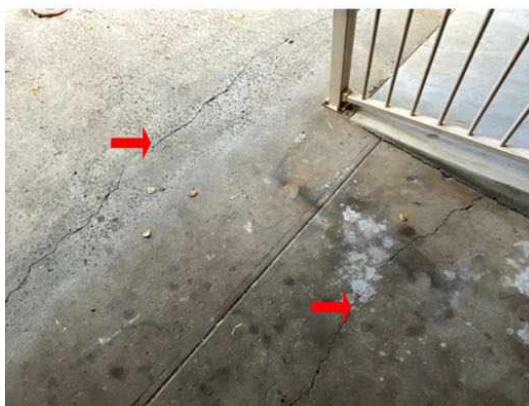
### Finding 3.09

Building:	Main Building
Location:	Carport
Finding:	Cracking - External Concrete Paving Damage Category 1 - Fine (less than 2mm)
Information:	Fine cracks were identified in external concrete paving. Although fine cracks are quite noticeable, they are often only considered to be an appearance defect, and usually do not indicate any structural damage. To be considered a Category 1 or fine crack, the crack is found to be less than 2mm in width.

Generally the cause of a hairline crack in existing concrete paving such as driveways and pathways is indicative of the expansion and contraction of the concrete. Such causes are generally due to environmental factors, such as moisture levels, weather conditions, root systems of nearby trees or the soil types on which they are laid.

Fine cracks may also be due to poor original installation of the concrete. Factors such as poor compaction of the sub surface and/or inadequate reinforcing of the slab may create cracking and other secondary defects.

Monitoring of all cracking should be conducted frequently. Always contact a building inspector should cracks widen, lengthen, or become more numerous.

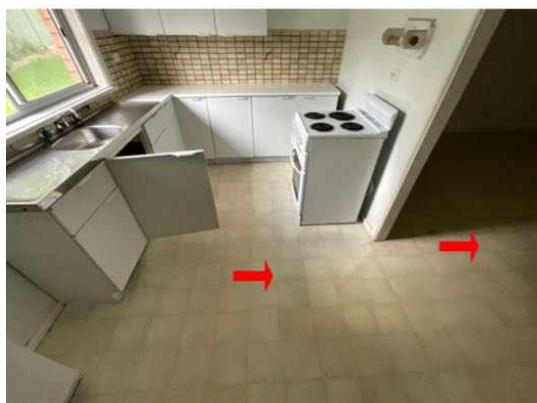
Bouncy floors generally indicate that the floorboards or the subfloor structures are coming loose from the joists that they are installed on. Bouncy flooring may also be the result of gaps between flooring and joist structures, which require packing.

Although not a matter of urgency, the client is advised to seek quotations for required repairs from a licensed Builder.

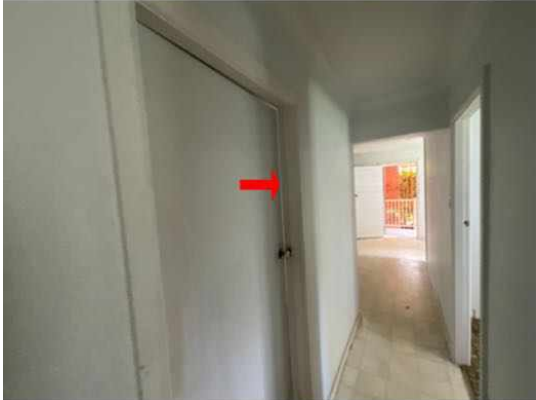
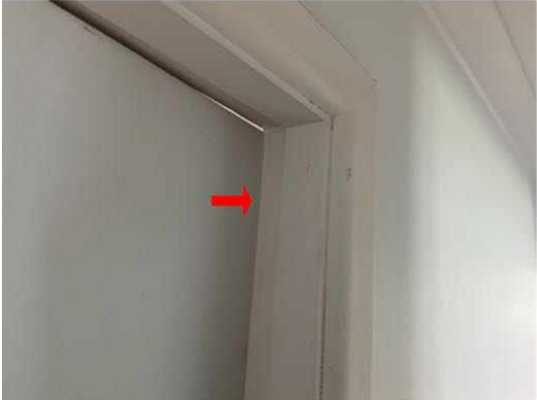
### Finding 3.14

Building:	Main Building
Location:	Bedroom 3
Finding:	Door - Binding/jamming
Information:

Binding and/or jamming of this door is evident during standard operation. This defect inhibits the functionality of the affected door as well as creating potential for secondary defects to associated building elements, such as damage to the floor covering or adjacent frame.

A door that binds to flooring or to the associated door frame may have several causes, ranging from minor defects, such as poor installation of the door or deteriorated hinges.

A licensed carpenter should be appointed to perform minor rectification works at client discretion.

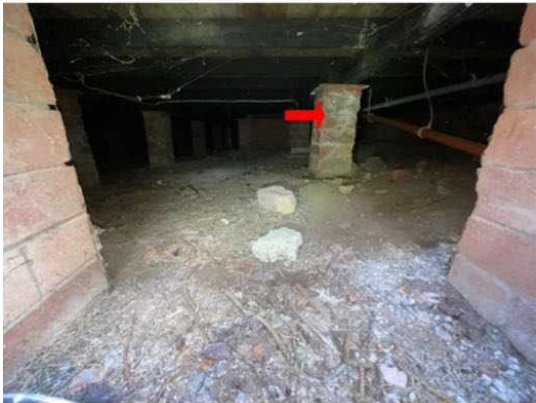
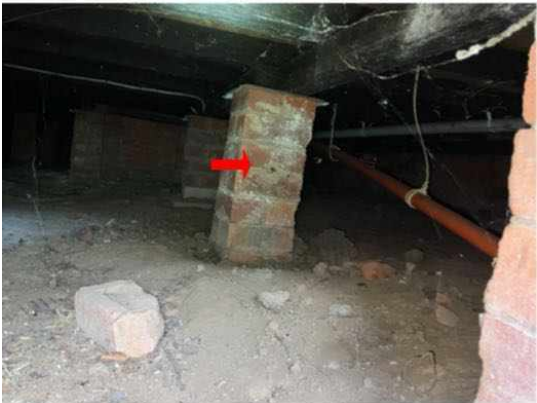
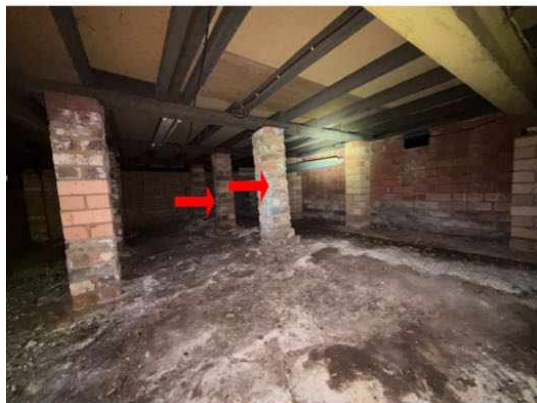
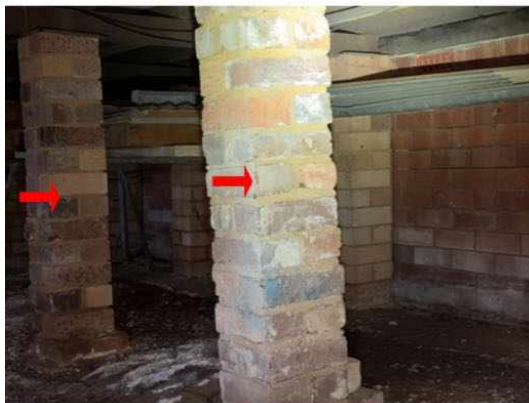
**Finding 3.15**

Building: Main Building  
Location: Subfloor  
Finding: Piers - Leaning  
Information: Pier to the subfloor structure is leaning, indicating that its structural integrity may have been affected. The cause of this instability is likely to be caused by movement / minor subsidence of the pier due to moisture.

Although only minor the pier should be monitored to avoid potential structural damage, which is likely to lead to a range of major and minor defects. Improving site drainage is recommended to avoid further movement / subsidence of the affected pier.

If further movement is evident appointment of a structural engineer is advised to assess the condition of the piers and provide advice on remedial works that may be required.

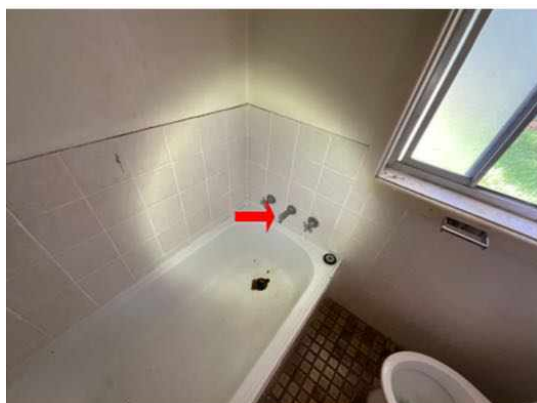
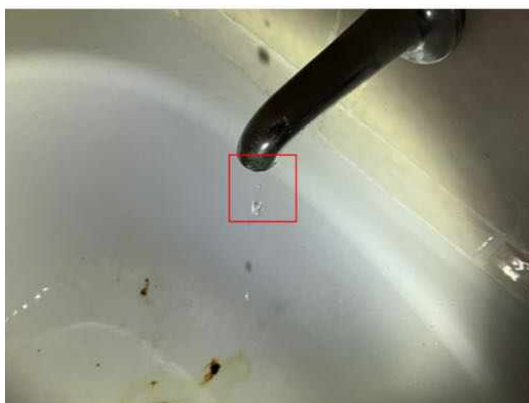
### Finding 3.16

Building:	Main Building
Location:	Bathroom
Finding:	Washers - Degraded
Information:	The washers on the taps in this area appear to have degraded as a result of general ageing. Degraded washers generally result in slow, persistent leakage from taps and plumbing hardware.

Replacement of washers will ensure that water wastage does not occur and that the persistent water leak does not result in secondary damage to surrounding structures. Such damage may range from rust and corrosion to damage of surfaces, e.g. bench tops, etc.

A qualified plumber should be appointed to replace degraded washers and to further inspect associated plumbing fixtures and fittings. Where water damage has occurred, a carpenter or cabinet maker may be appointed to replace affected building elements.

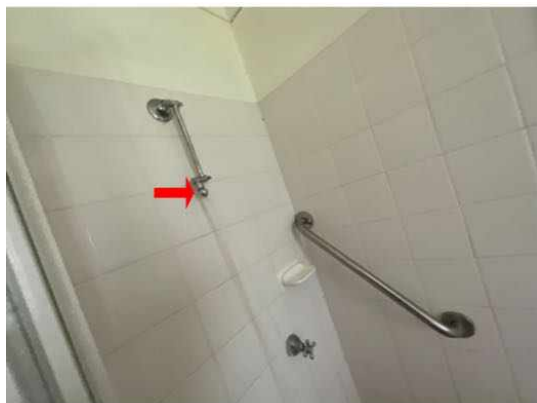
### Finding 3.17

Building:	Main Building
Location:	Bathroom
Finding:	Building element - Missing

Replacement of any missing building element should be conducted as soon as possible to ensure that no damage or functional issues occur to associated building materials.

The appropriate tradesperson should be appointed as soon as possible to replace the missing building element.

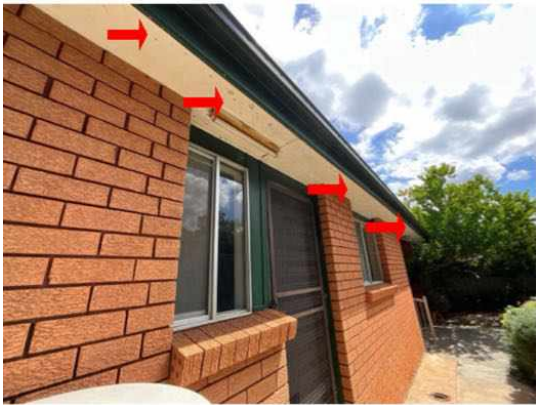
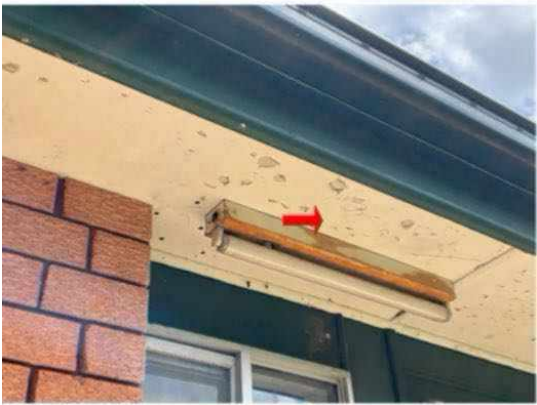
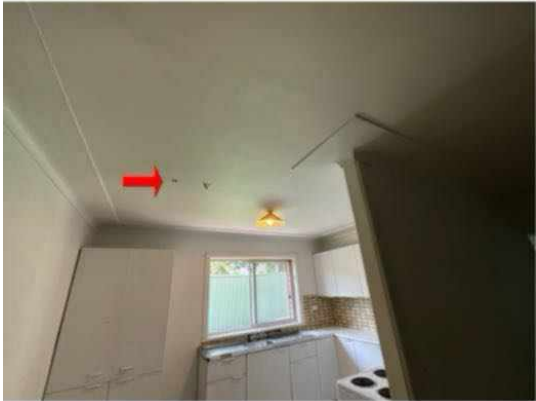
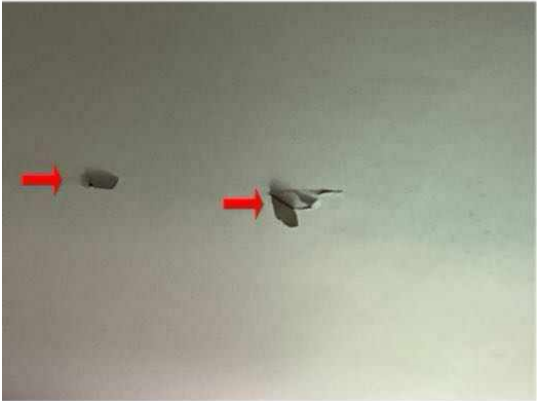
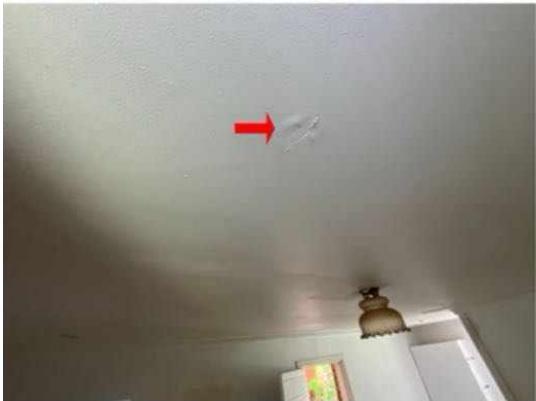
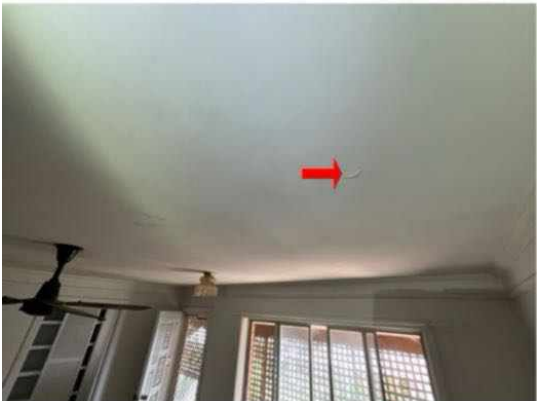
### Finding 3.18

**Finding:** Paint cracking and peeling

**Information:** Cracking and ultimately flaking of paint can occur for a variety of reasons. Often these failures are due to the fact that the paint has inadequate adhesion and flexibility, both common problems with lower quality exterior flat paints.

When timber is involved, moisture intrusion results in swelling of the wood surface followed by contraction as the wood dries. The expansion and contraction cycles, can result in cracking and subsequent paint failure by flaking and peeling.

A qualified painter should be appointed to rectify the problem.

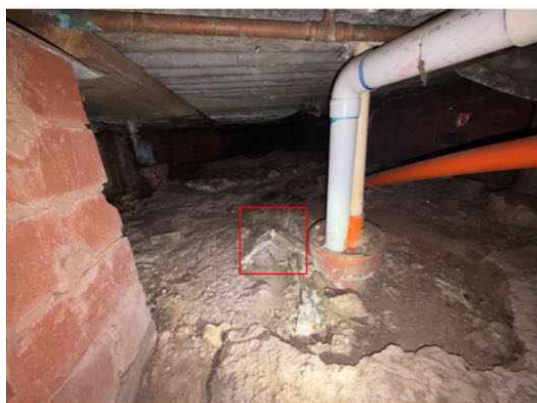
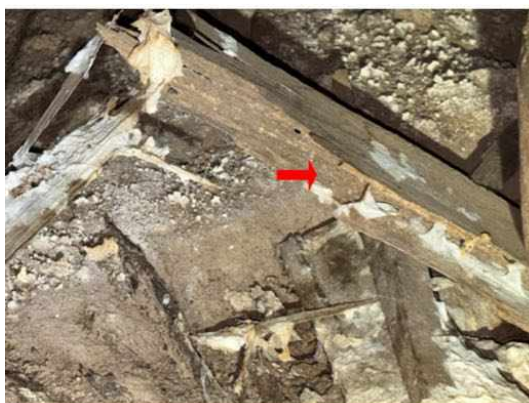
Building:	Main Building
Location:	Subfloor
Finding:	Evidence of termite damage
Information:	Despite no live termite or timber pest activity being indicated, previous termite damage was found to have affected this area or otherwise termite workings were identified at the time of inspection. This damage is considered to be inactive.

A licensed termite specialist should be appointed to provide a treatment plan compliant to the current Australian Standard.

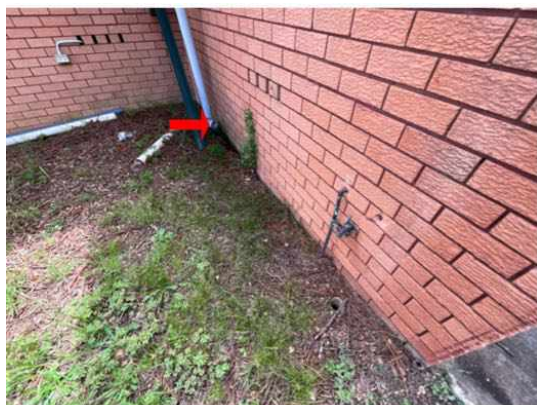
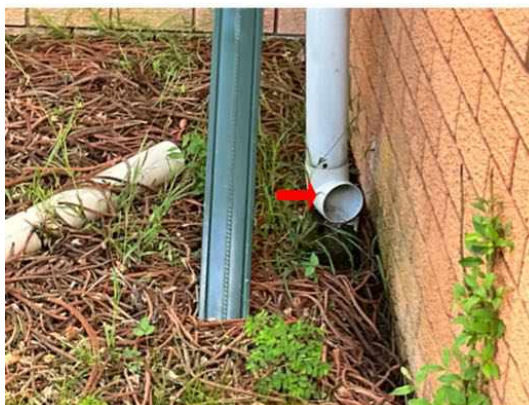
### Finding 6.01

Where roof plumbing doesn't drain adequately, the area at the base perimeter can become excessively damp, potentially creating an environment that is susceptible to rust and corrosion of surrounding building elements, as well as attracting termites and other pests.

It is highly recommended that a plumber be appointed to further inspect the area and to install adequate drainage equipment where necessary.

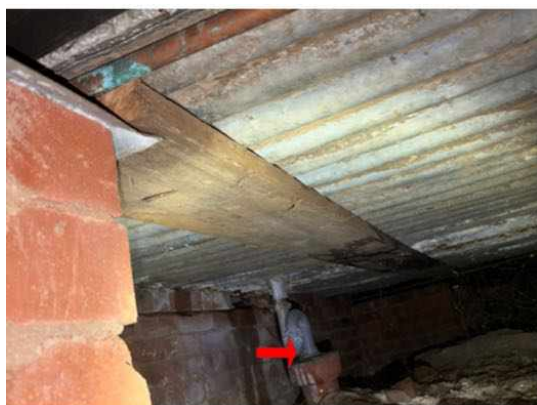
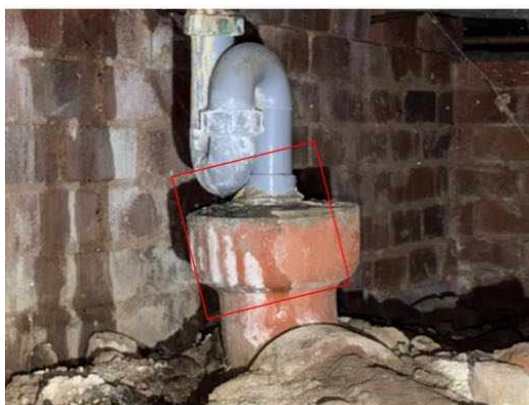
Building:	Main Building
Location:	Bathroom
Finding:	Pipework - Leaking into subfloor
Information:	Dampness to localised sections of the subfloor area was identified. It is suspected that this dampness has occurred due to leaking pipes in this area, which may be exacerbated by poor site drainage and inadequate subfloor ventilation.

Dampness in this area is likely to lead to wood rot and general deterioration of structures within the subfloor space. Excessive moisture also creates an environment which is conducive to termite and pest infestation.

A licensed plumber should be appointed immediately to repair any pipes that may be leaking. This will ensure a dry subfloor space as well as improving the water efficiency of the property.

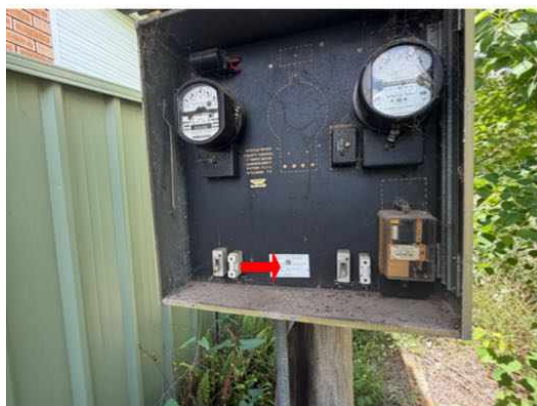
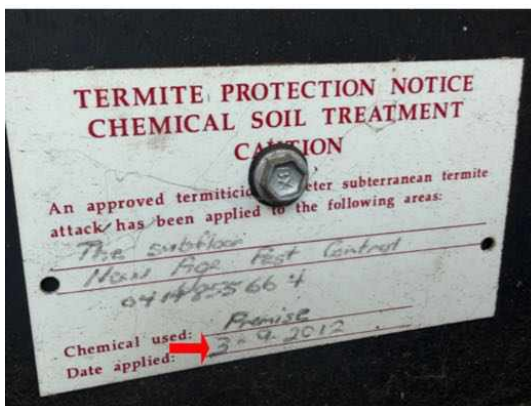
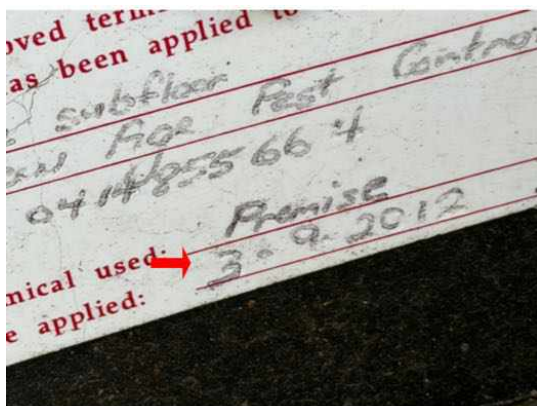
### Finding 6.04

Building:	Main Building
Location:	All Areas
Finding:	Re-application of chemical termite barrier - required
Information:	Chemical treated barriers deteriorate over time necessitating the need for re-application of a barrier every 6-10 years depending on the product type environment etc. Due to this deterioration chemical barriers decline in their effectiveness exponentially if not replenished.

Consult the record of installation to identify the type of chemical and date of application. It is then advised to consult a licensed pest controller regarding reapplication intervals. Annual inspections are almost always required for all system types.

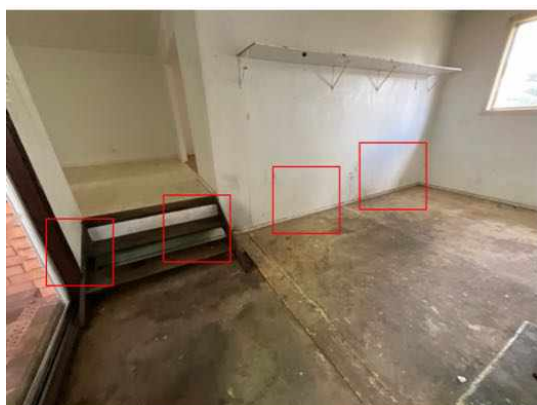
Generally this takes the form of finished ground levels external paving or concrete being retrospectively installed above the damp course level the adjacent internal floor level or weep and ventilation holes.

Where bridging has occurred full inspection is prevented and termites may enter a property in a concealed or undetectable manner.

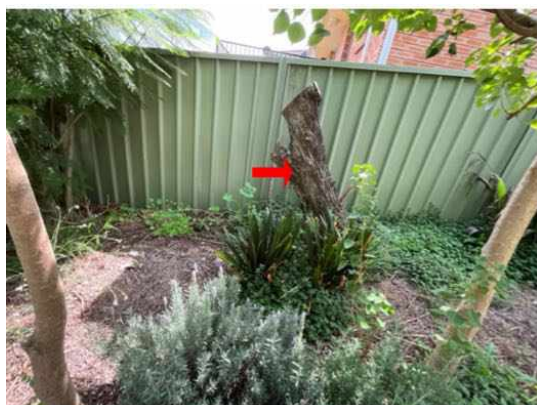
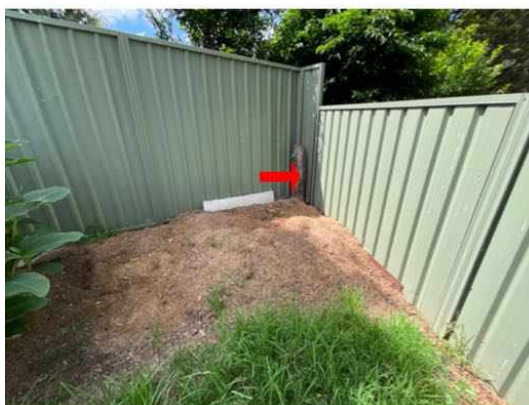
### Finding 6.07

Building:	Main Building
Location:	Yard
Finding:	Tree stump - Remove
Information:	Old tree stumps were found around the property. Attached photos are examples of these.

Any tree stumps in ground contact provide opportunity for concealed termite infestation and are likely to be subject to decay as the soil retains moisture or damp conditions against the tree stump.

All tree stumps should be removed where possible. Frequent pest inspections are advised to readily identify any termite activity in these areas.
