# Building and Timber Pest Inspection Report

Inspection Date: Tue, 24 Feb 2026

Property Address: 99 Broughton St, Camden NSW 2570,  
Australia

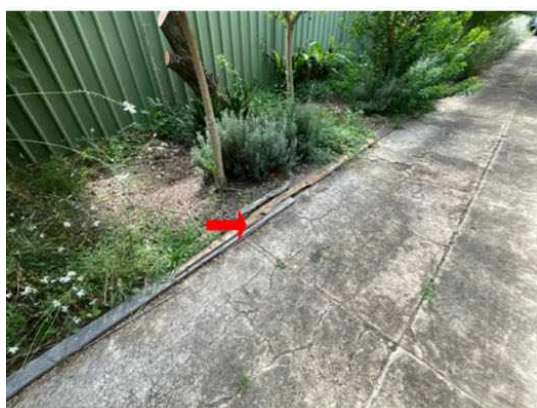
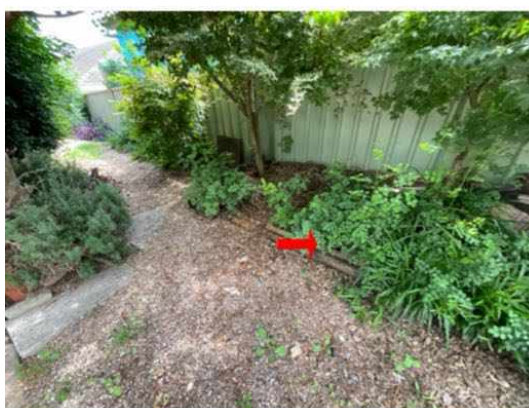
### Finding 6.08

Building:	Main Building
Location:	Fencing & Landscaping
Finding:	Building materials in direct ground contact - conducive to termites
Information:	Where timber elements are in direct contact with the ground and consequently moisture or dampness they become conducive to termite activity. Whether timber is used as a building element part of a fencing structure or stored as an unused item they can provide an environment that is attractive to termite infestation.

When met with excessive moisture timber begins to decay and develop wood rot. Any timbers that are in direct contact with external grounds especially if left untreated or non-durable also provide ingress for subterranean termites into that particular element.

The removal of any such materials that may be conducive to termite activity should be removed as soon as possible to minimise the risk of termite attack.

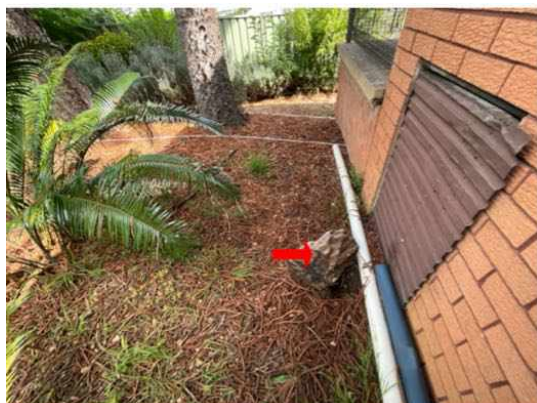
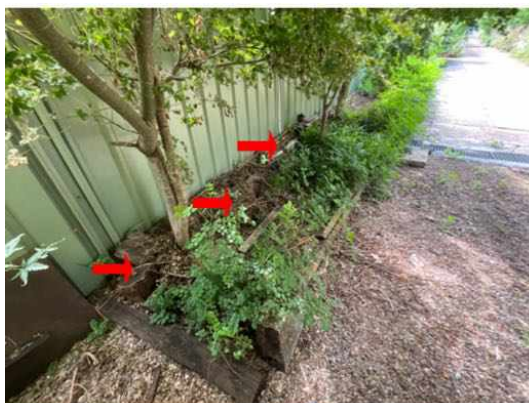
### Finding 6.09

Building:	Main Building
Location:	Yard
Finding:	Stored timbers - subfloor space or external area
Information:	The storing of timbers in the subfloor space or around the external property increases the risk of termite activity being present. As they are likely to come into contact with weather conditions or excessive moisture wood rot is likely to develop on timbers that are not treated.

It is highly recommended that any stored timbers be immediately removed from areas in which they may attract any termite / timber pest attack. Minimisation of risk / prevention of termite attack is far more adequate than dealing with the presence of termite activity.

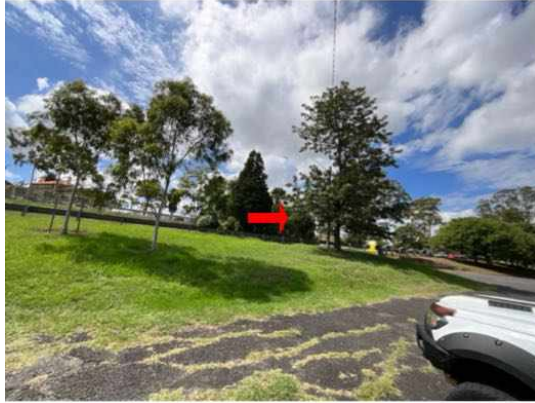
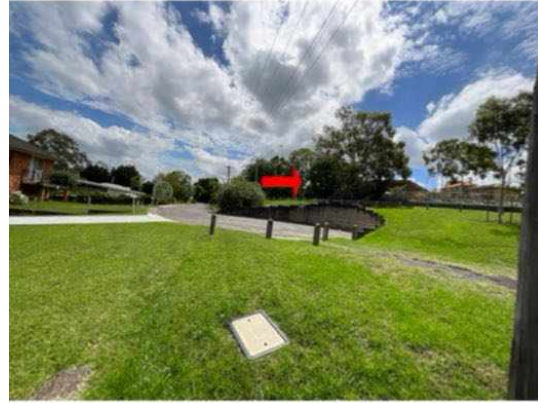
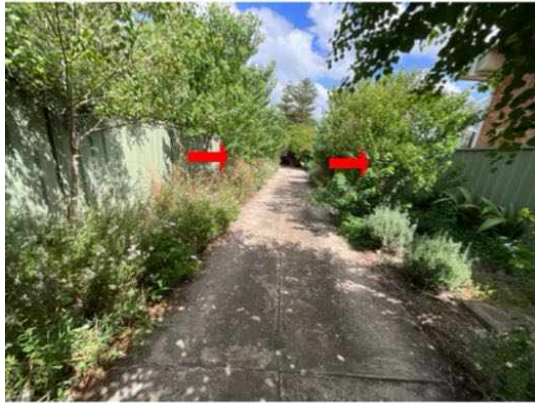
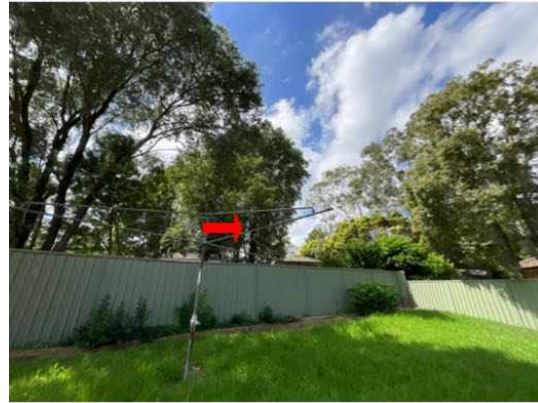
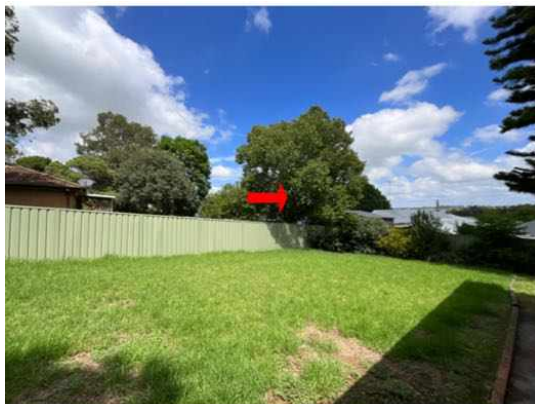
### Finding 6.10

Building:	Main Building
Location:	
Finding:	Surrounding bushland - Conducive
Information:	Home and or building is situated in a high risk area for termite activity, due to close proximity to surrounding bushland.

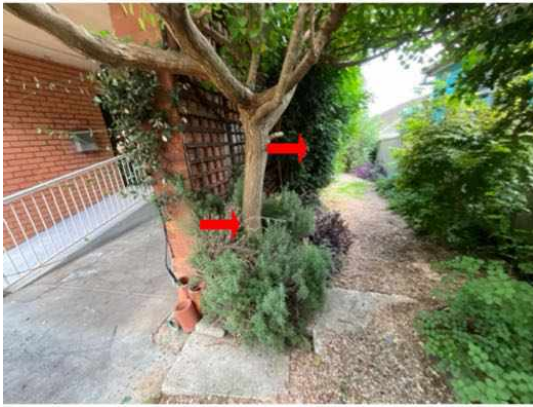
### Finding 6.11

Building:	Main Building
Location:	Vegetation
Finding:	Vegetation - Abutting property
Information:	Vegetation against external wall may have an invasive root system. If there are weak points in the brick work or concrete slab, it is possible for the roots to gain entry into these areas. Once the roots have gained entry, it is possible for termites to gain concealed entry via these roots. It is recommended to remove the vegetation and root system where possible.

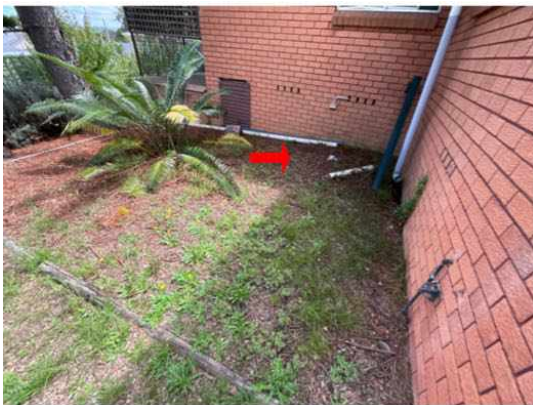
### Finding 6.12

Building:	Main Building
Location:	Garden beds
Finding:	Garden Beds
Information:	Garden beds were found to be evident in the garden area. These garden beds can include untreated timber, and with a combination of moisture from watering or hosing can make conditions conducive to termite activity and termite ingress.

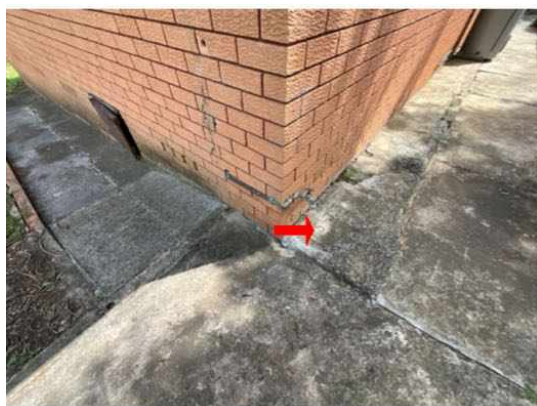
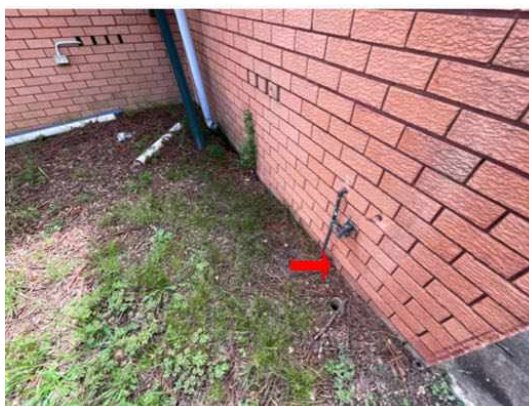
### Finding 6.13

Building:	Main Building
Location:	External tap
Finding:	Tap - No drain
Information:	The external tap in this area was noted to have no drain at the time of inspection.

This keeps the surrounding surfaces damp while using the tap, which becomes conducive to termite activity.

A licensed plumber must be appointed to ensure an appropriate drain is installed.

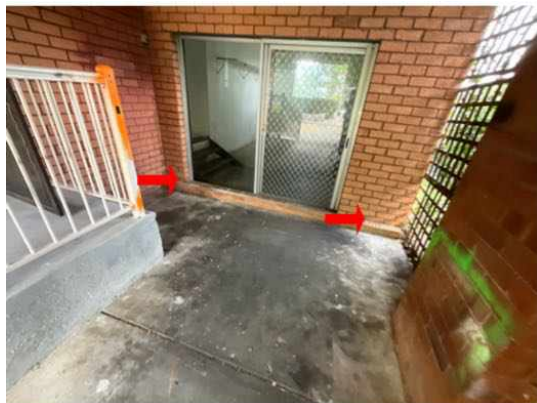
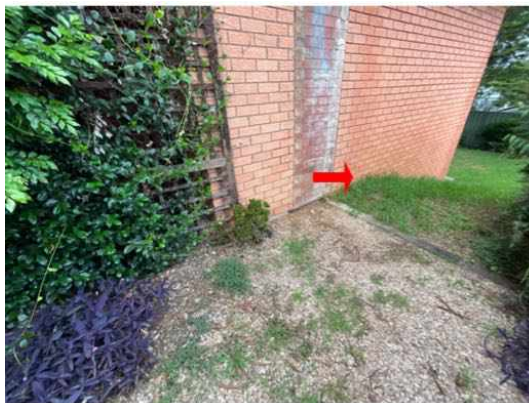
### Finding 6.14

Information: Slab Edge Exposure: Where external concrete slab edges are not exposed there is a high risk of concealed termite entry. In some buildings built since July 1995 the edge of the slab forms part of the termite shield system. In these buildings an inspection zone of at least 75mm should be maintained to permit detection of termite entry. The concrete edge should not be concealed by render, tiles, cladding, flashings, adjoining structures, paving, soil, turf or landscaping etc. Where this is the case you should arrange to have the slab edge exposed for inspection. Concealed termite entry may already be taking place but could not be detected at the time of the inspection. This may have resulted in concealed timber damage. Does the slab edge inspection zone fully comply?

Not able to comment. A very high proportion of termite attacks are over the edge of both Infill and other concrete slabs types. Covering the edge of a concrete slab makes concealed termite entry easy. Infill slab type construction has an even higher risk of concealed termite ingress as the slab edge is concealed due to the construction design and cannot be exposed. The type of slab may only be determined by assessment of the construction plans by a qualified person e.g. Builder, Architect. Construction Plans may be obtainable by your local Council or Builder. Termite activity and or damage may be present in concealed timbers of the building. We strongly recommend frequent regular inspections in accordance with AS 3660.2. Where the slab edge is not fully exposed or the slab is an infill slab or the slab type cannot be determined then we strongly recommend inspections every 3 to 6 months in accordance with AS 3660.2 or AS 4349.3.

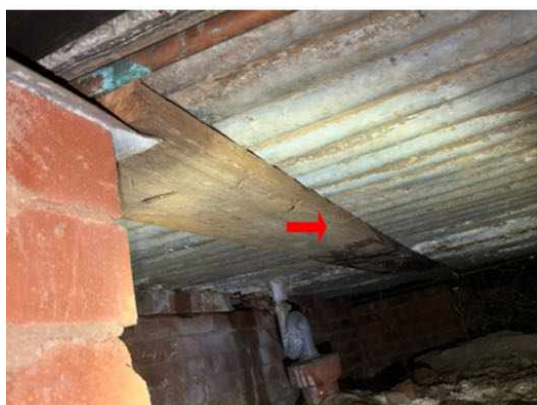
### Finding 6.15

Building:	Main Building
Location:	Subfloor
Finding:	Formwork timbers - left in situ
Information:	Formwork timber appears to have been left on site and in situ after concrete construction. Formwork timber is used to support and shape the concrete while pouring during the construction process. Leaving formwork timbers in the subfloor space or around the exterior of the property increases the risk of termite activity being present. As they are likely to come into contact with weather conditions or excessive moisture wood rot is likely to develop on timbers that are not treated. It is highly recommended that any formwork timbers be immediately removed from areas in which they may attract any termite/timber pest attack. Minimisation of risk/prevention of termite attack is far more adequate than dealing with the presence of termite activity.

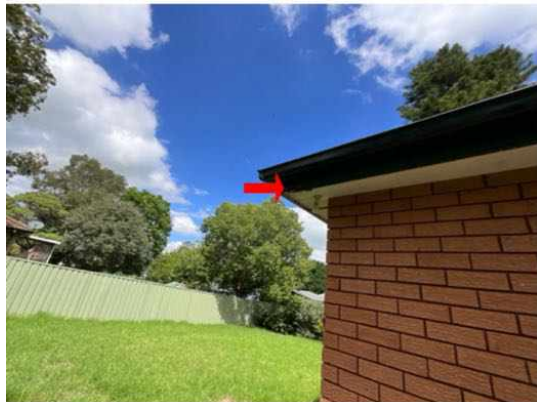
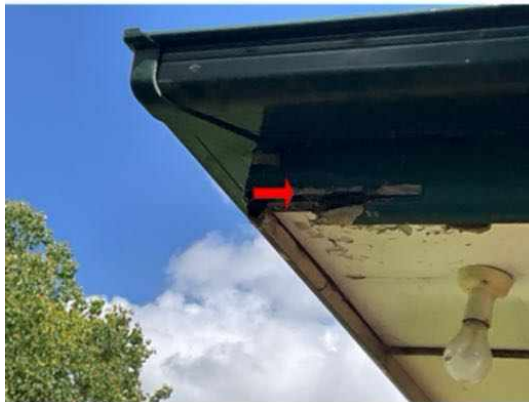
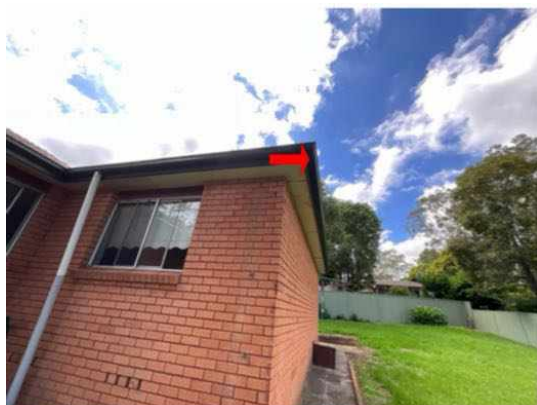
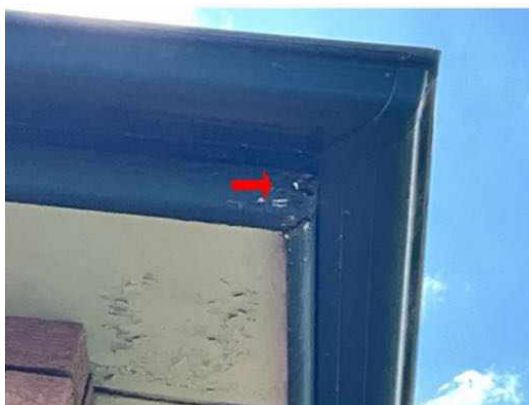
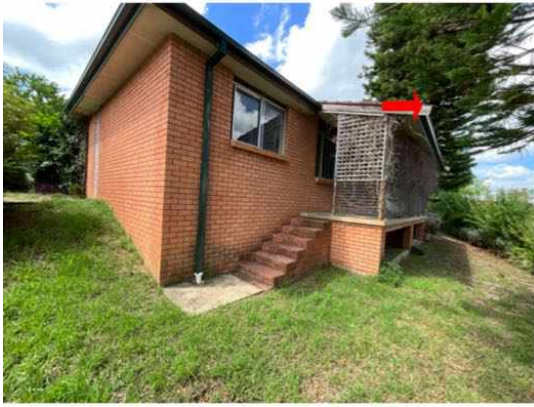
### Finding 7.01

Finding: Fascias - Wood rot/decay  
Information: Wood rot was found to be affecting fascias and barges in this area, evidenced by the presence of mould on the surface in some areas. Wood rot, also known as Fungal Decay, occurs when timbers and other cellulose building materials are exposed to damp conditions on an ongoing basis.

It is likely that this wood rot has developed as a result of faults in the roof plumbing, creating excessive moisture in this areas. Otherwise frequent exposure to rain and other weather conditions also make fascias and barges susceptible to accelerated deterioration.

Early intervention and regular maintenance will prolong the useful life of these building elements. Prior to any works being performed, the cause of the moisture that has created the visible wood rot should be identified and addressed in a suitable manner.

It is advised that a roof plumber be appointed to inspect all roof plumbing and subsequently identify the cause of the wood rot. Replacement of affected fascias and barges may then be a necessary step in protecting surrounding building elements from such deterioration.

A licensed plumber may be appointed to assess the cause of excessive moisture and to provide advice on any remedial works as required. A licensed carpenter may also be required to replace affected building materials.

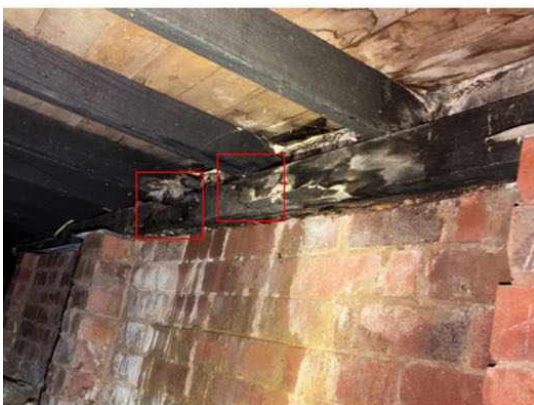
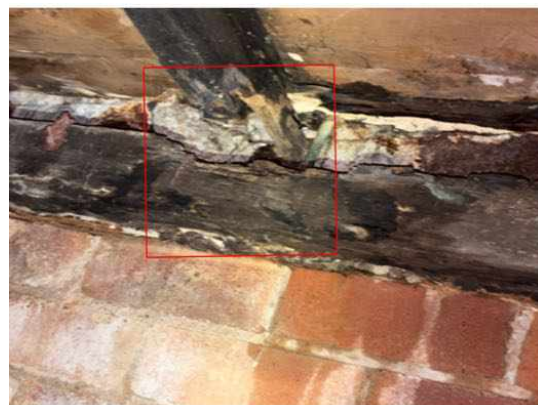
## Finding 7.02

Finding: Subfloor structure - Wood rot

Information: The subfloor structure in this area is showing signs of deterioration and wood rot (fungal decay) of the timbers. It is suspected that this defect has developed as a result of water leak at some stage.

Damp conditions cause the timbers to fail, resulting in the subfloor structures failing to bear the load (or weight) of the building as originally intended. Without repairs and maintenance, including potential replacement of affected elements, it is likely that serious structural faults will result, as well as an array of minor defects.

The presence of wood rot to the subfloor structure is also conducive to termite infestation.

Rectification or replacement of the affected timber building element is required immediately by a licensed builder.

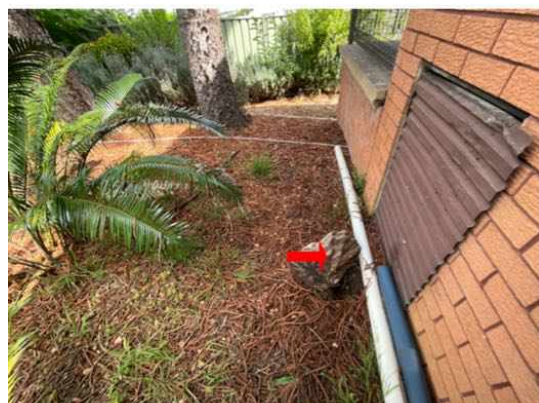
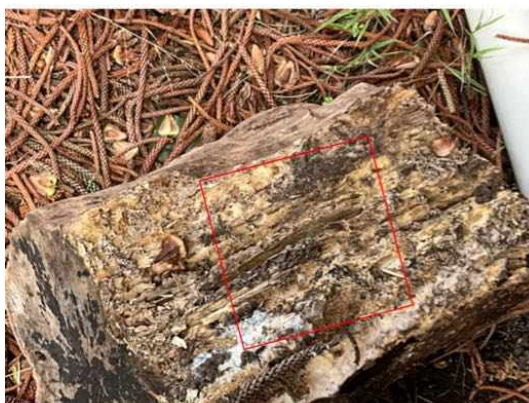
## Finding 8.01

Information: Wood borers small beetles that colonise in exposed timber elements are a common timber pest that are regularly mistaken for termites. Although wood borer activity is generally not detrimental to the affected timber they may lead to serious damage and necessitate replacement of certain building elements if left unattended.

The other commonly known borer the Anobium borer is more likely to attack floorboards and may cause severe structural damage to flooring areas.

As no live wood borer activity was identified treatment is not required at this time. Replacement of affected timbers may be considered by the client for superficial reasons.

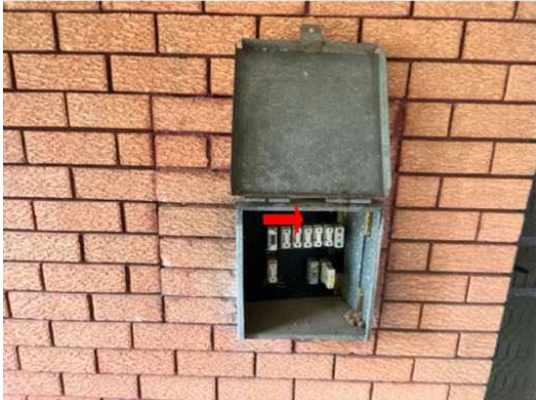
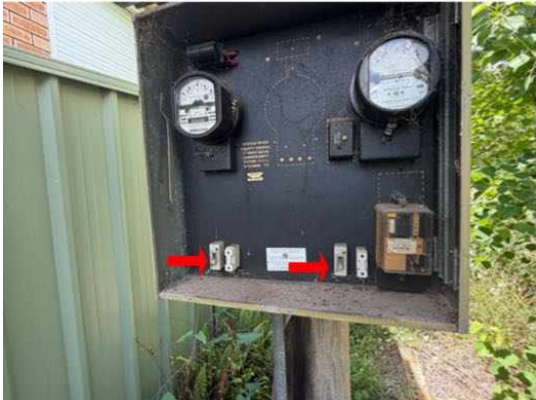
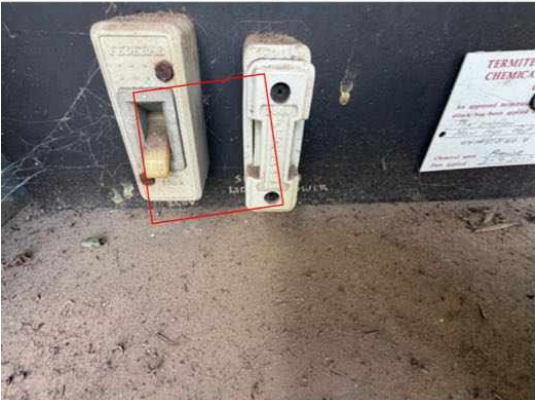
The electrical switchboard while appearing to have adequate safety switches installed has old ceramic fuses in place.

While this on its own on is not considered a defect it is noted for the clients consideration that a switchboard upgrade may be required in the short to mid term to improve the functionality of the electrical system. A licensed electrician could be appointed to provide quotation for the works at the client's discretion which may in turn expose other required works to bring the system up to a compliant state.

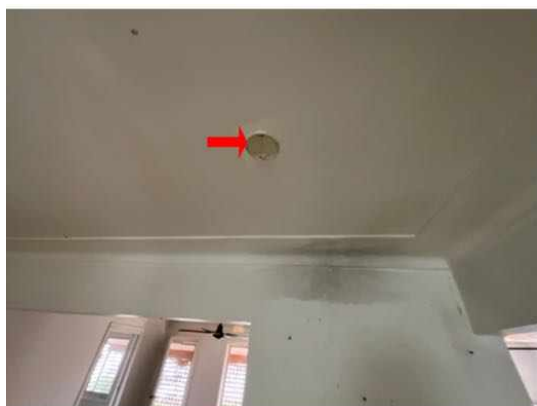
Building: Main Building  
Location: Dining Room

Please note that this defect is highlighted as a caution only. We suspect, based on our experience in the building industry, that the absence of smoke detectors, or their poor condition, should be addressed as a matter of urgency to improve occupant safety.

Always ensure sufficient working and suitable smoke detectors are installed prior to occupying any building. Additionally, it is advised that all smoke detectors be tested by the homeowner on a monthly basis.

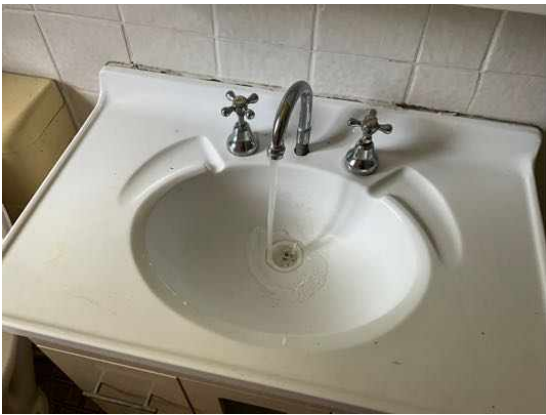
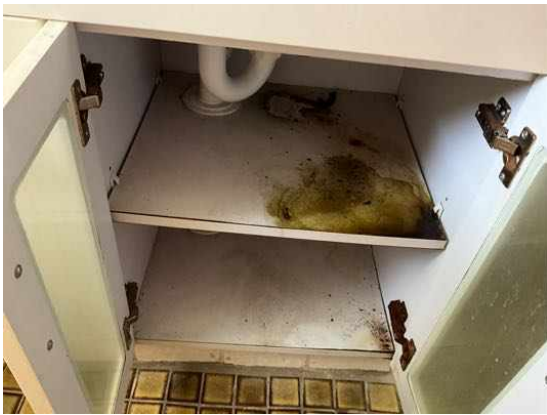
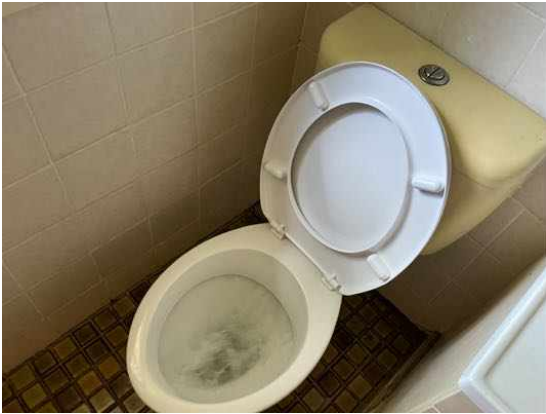
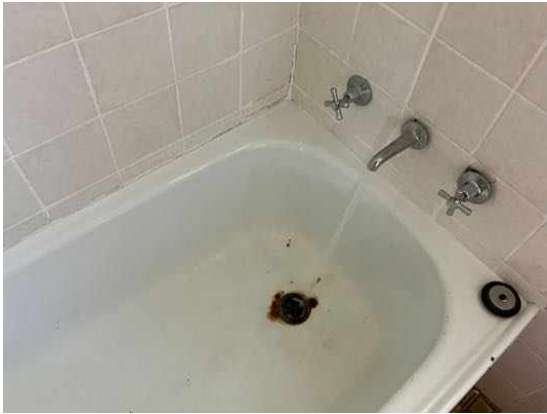
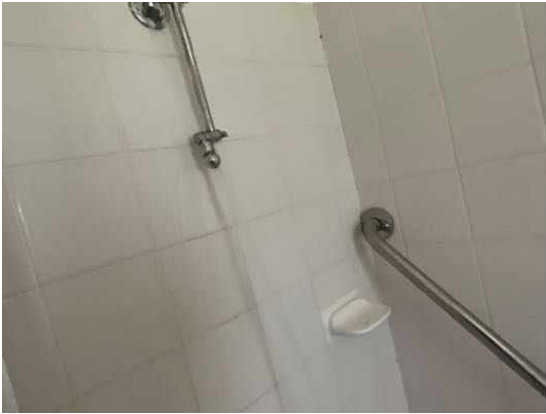
All taps, mixers and toilets were tested for operation, except for those obstructed. The waterproofing to the shower recess was assessed by checking the walls in and around the shower recess for varying moisture content. There were no significant variations across the tested areas. No sign of recent water damage was evident upon a visual inspection of the surrounding walls, where the visual nature of the inspection was possible.

Consequently, there is no conclusive evidence of any current shower recess leakage other than those which may have already been mentioned earlier in this report. It is reasonable to assume the shower waterproofing is sound. Note that if the shower is not used, or has not been used for some time, moisture readings would not vary significantly and this can lead to erroneous results. It is not possible under the visual inspection criteria (under which a prepurchase inspection is carried out) to categorically determine if there are leaks. If a more accurate assessment is required, a special purpose inspection should be requested. Alternatively, the assumption should be made that the shower may leak.

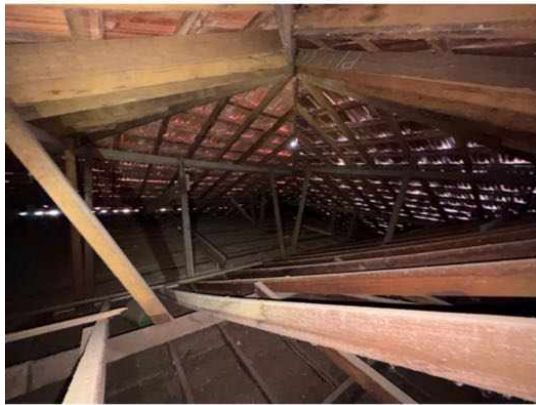
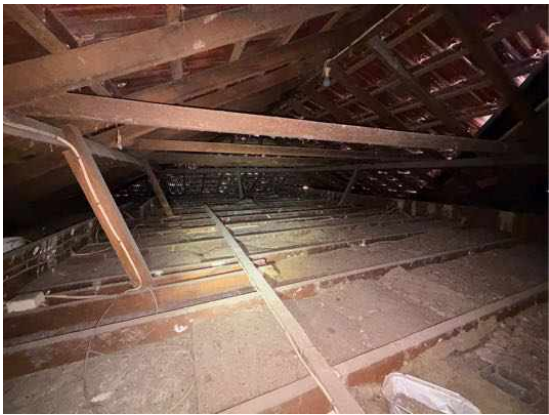
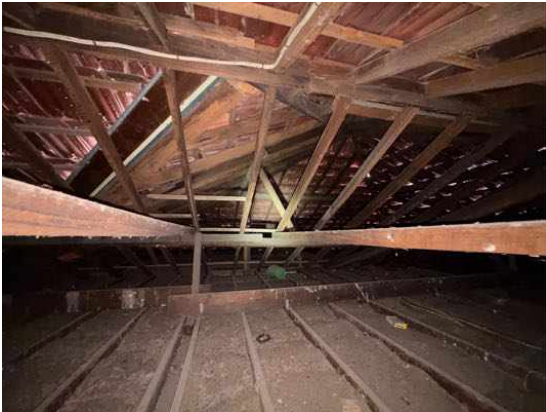
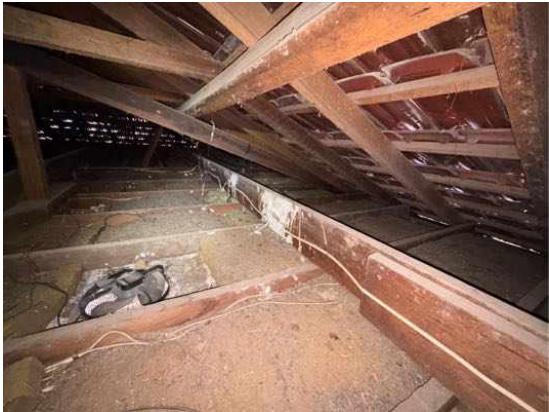
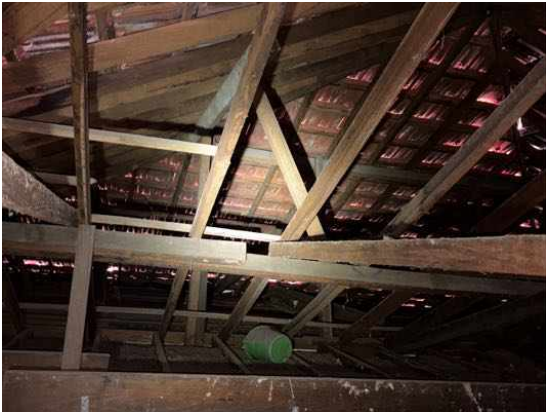
Building: Main Building  
Location: Roof Void  
Finding: Additional Photos  
Information:

Additional photos are provided for your general reference.

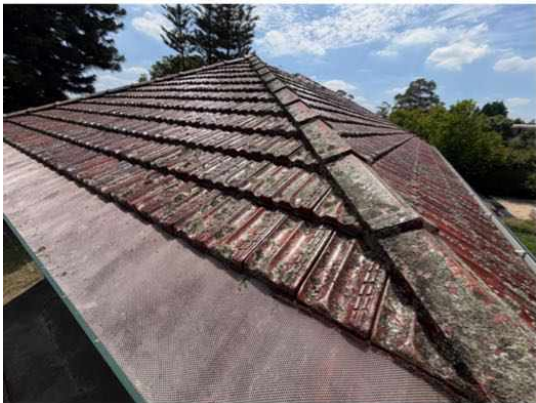
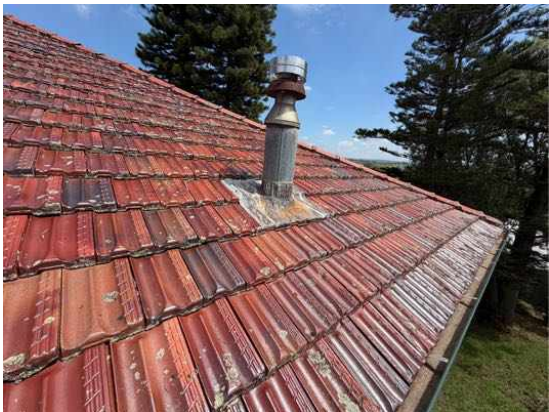
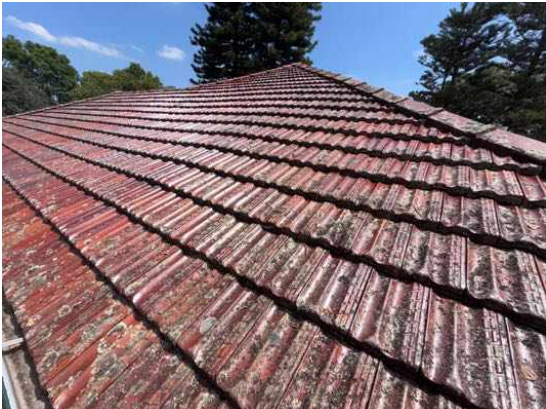
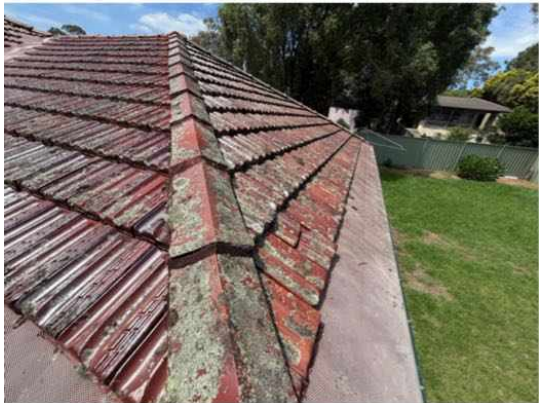
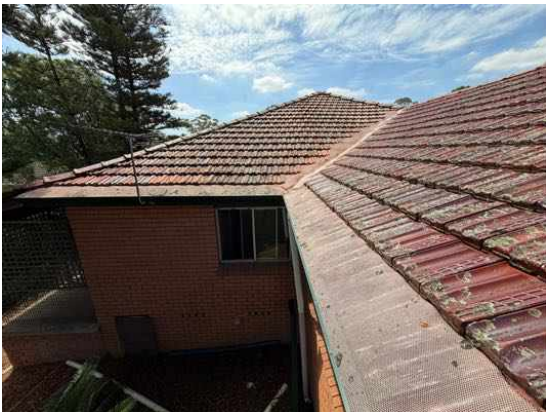
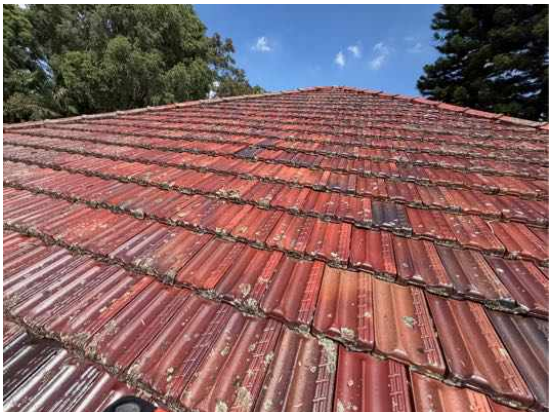
Building: Main Building  
Location: Roof Exterior  
Finding: Additional Photos  
Information:

Additional photos are provided for your general reference.

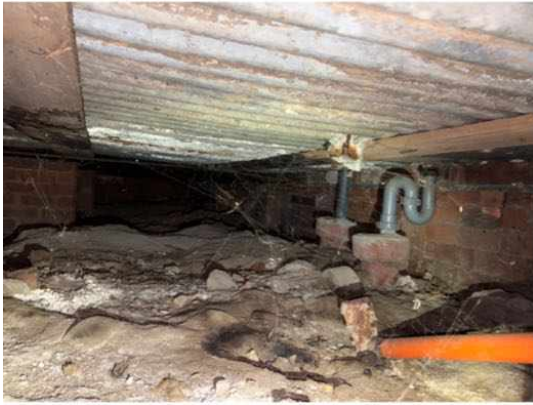
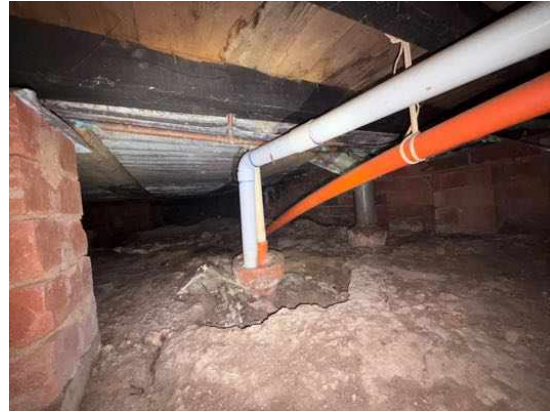
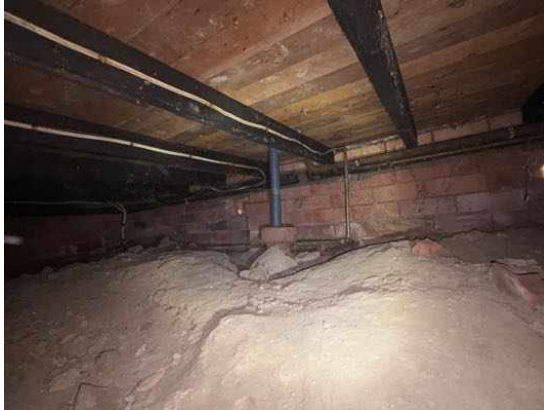
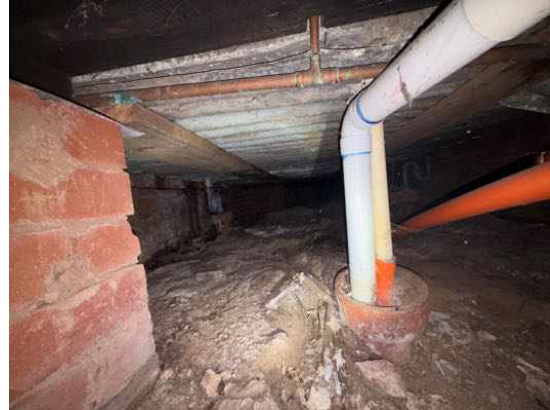
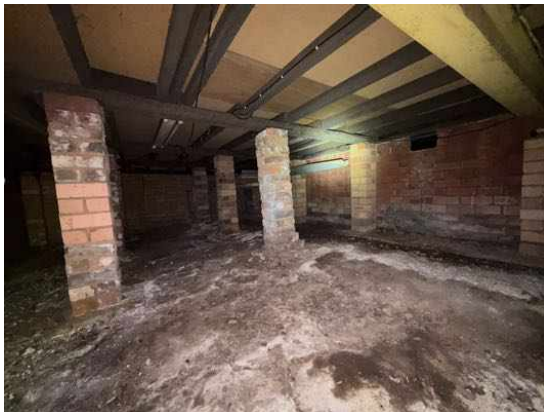
Building: Main Building  
Location: Subfloor  
Finding: Additional Photos  
Information:

Additional photos are provided for your general reference.

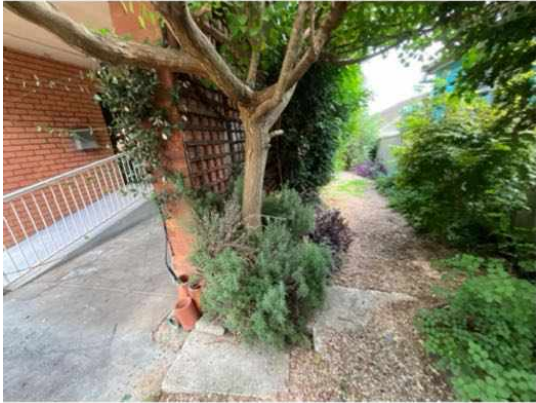
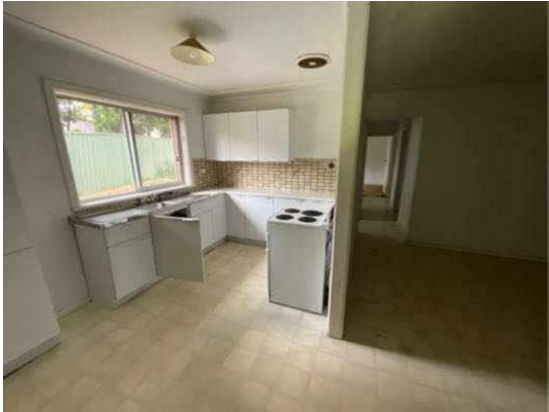
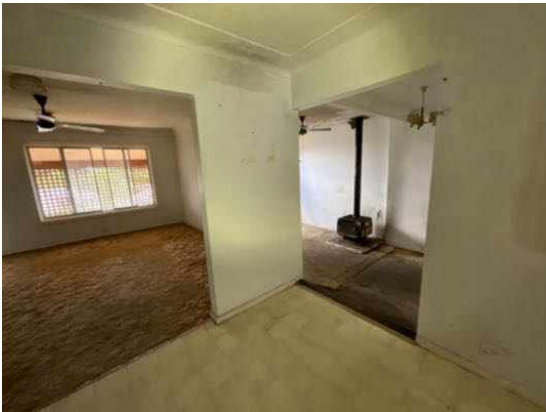
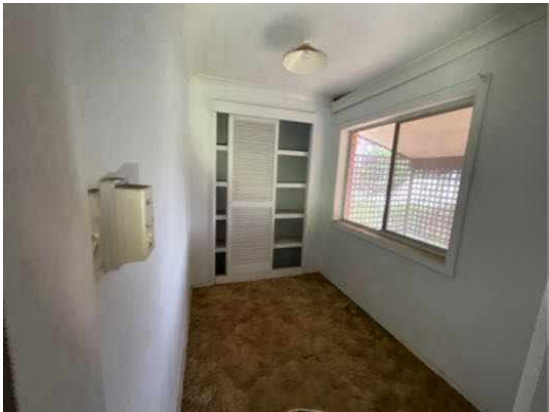
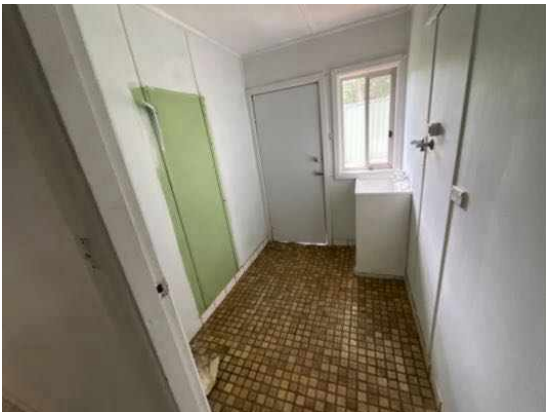
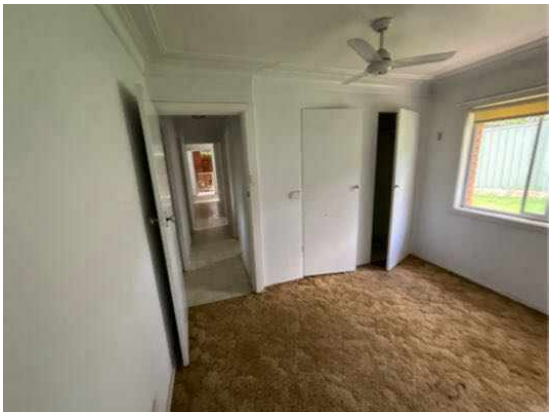
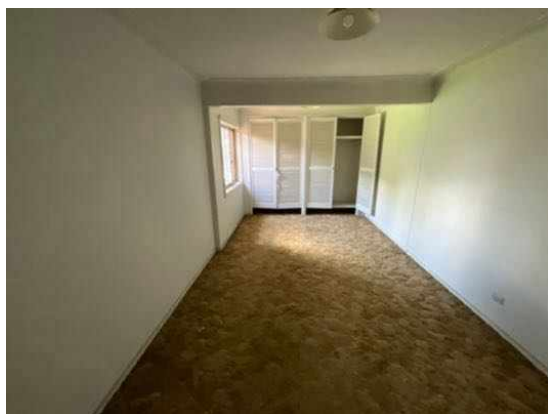
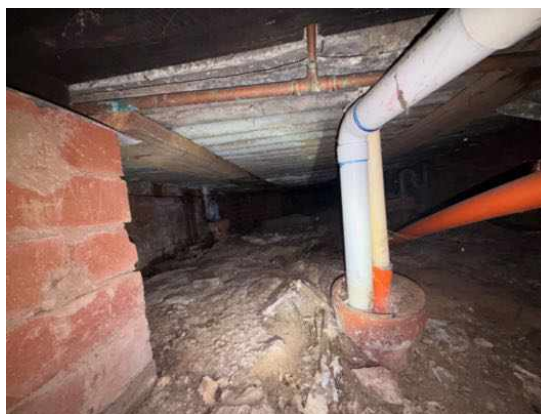
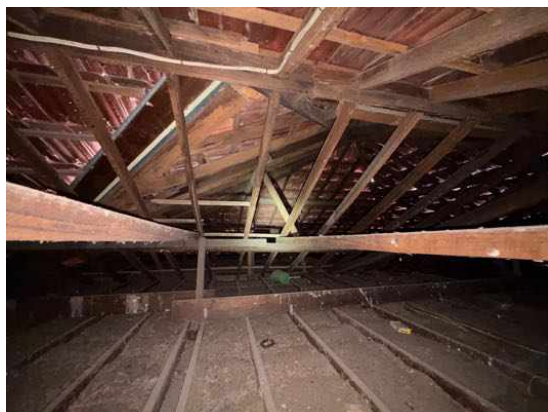
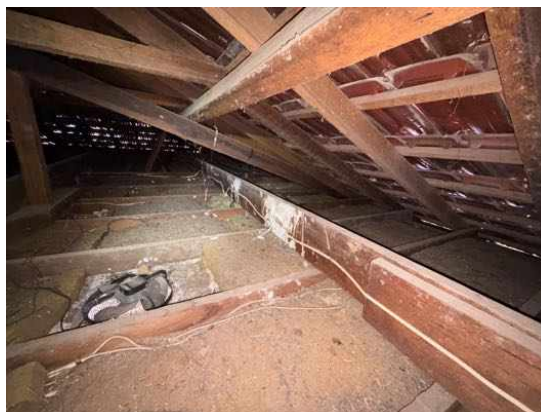
Finding: Additional Photos - Obstructions and Limitations  
Information:

These photographs are an indication of the obstructions and limitations which impeded full inspection of the property at the time of inspection. These obstructions can hide an array of defects and should be removed to allow full inspection to be carried out. A re-inspection is recommended once the areas are made accessible.

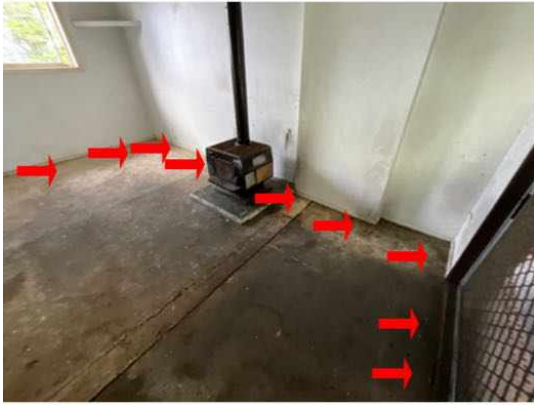
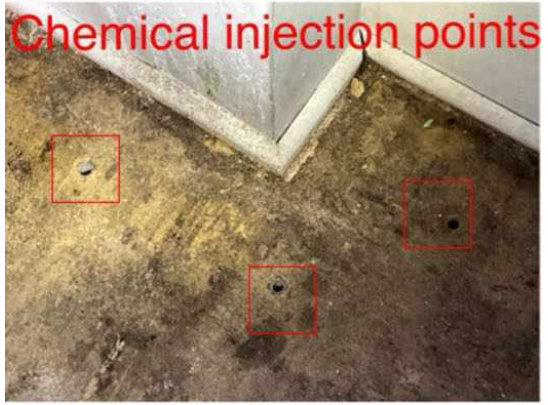
Chemical injection points

Where a Termite Management System has been identified you should refer to the type of barrier date of installation warranty conditions and any documentation provided by a builder or past owner. Consult the company who installed the barrier to confirm whether the system is still under warranty.

Most chemical termite management systems expire and require replenishment and all physical systems are primarily designed to prevent concealed entry.
