Building and Timber Pest Inspection Report

Inspection Date: Thu, 19 Feb 2026

Property Address: 21/37 Stephen's Street Yarraville

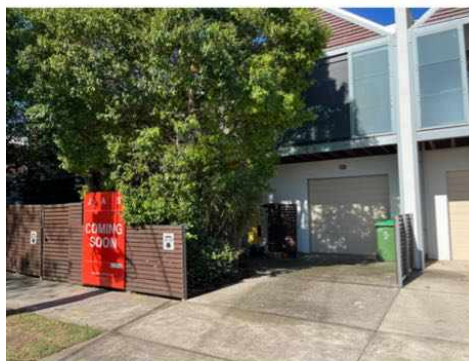
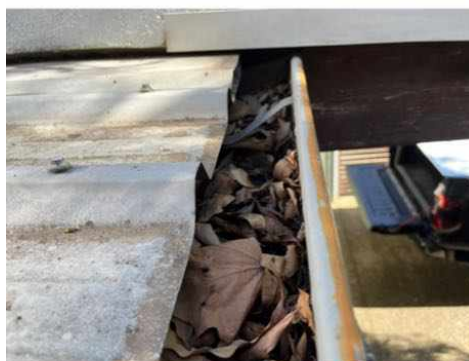
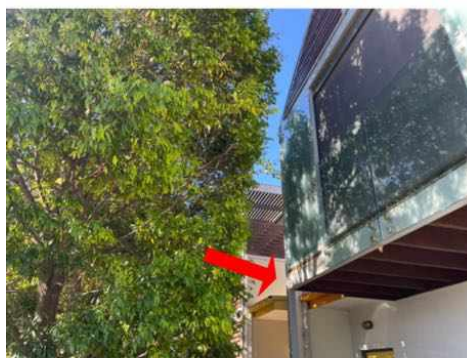
Gutters are a critical part of the building's management of storm water and rain. It is therefore important that they be kept clear to prevent secondary damage to associated building elements, including exterior and interior walls, ceiling linings and any adjoining building elements. Where gutters are blocked, pooling of rainwater is likely to occur, fast-tracking rust and corrosion of the roof plumbing elements.

We noted that most of the guttering was actually clean but the gutter nearest the entry door was heavily filled with leaf litter.

It is highly advised that all overhanging tree branches be removed as soon as possible to prevent any further damage.

Such works should be performed by the homeowner; however, appointment of a landscape contractor or an arborist may be required. Consultation with a licensed roof plumber is required where guttering has been damaged or alternative methods of litter management are required.

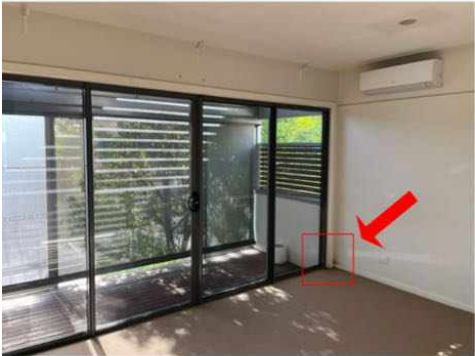
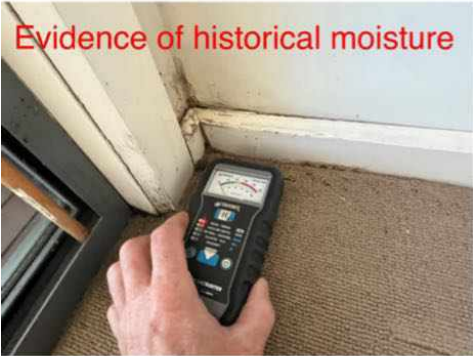
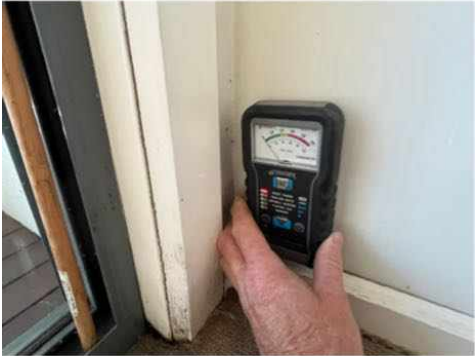
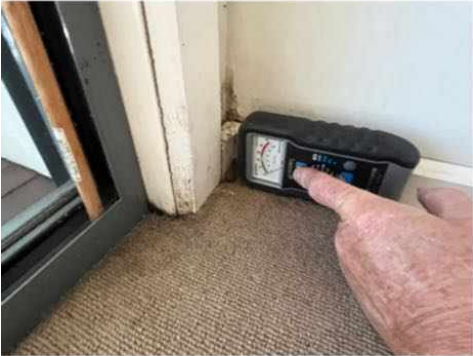
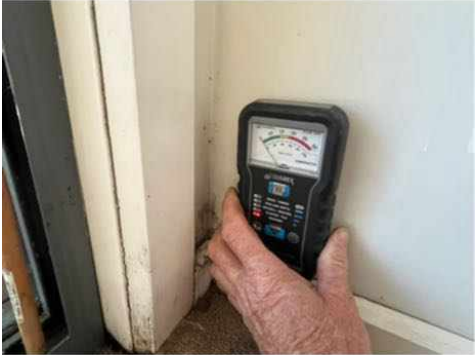
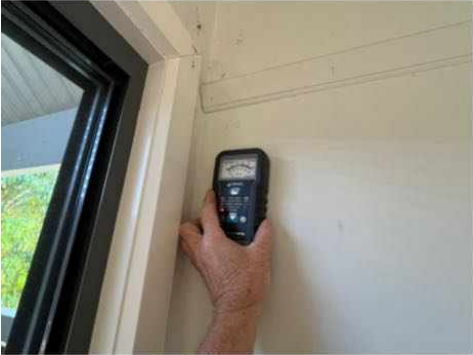
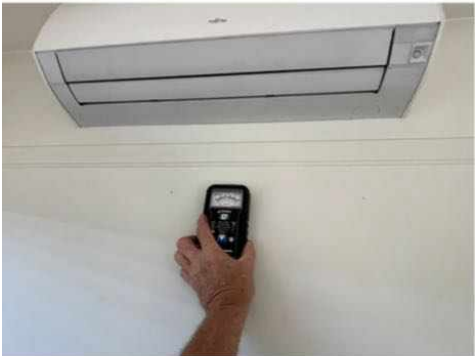
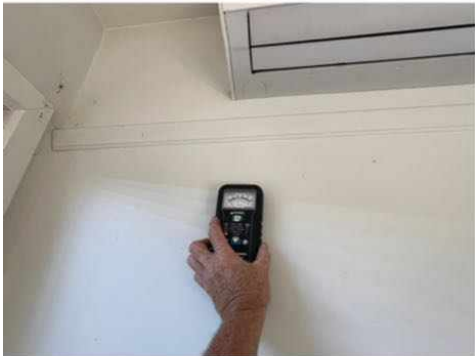
Finding 3.02

Building:	Main Building
Location:	Upstairs front bedroom
Finding:	Evidence of historical moisture - identified
Information:	There is staining and minor moisture damage on the surface of the plaster, skirting board, carpet and door frame in the front bedroom.

At the time of the inspection there was no elevated moisture readings when the surfaces were checked with a moisture meter.

This maybe due to a lack of recent rain or it may be that moisture is only an issue under certain conditions, such as blocked and overflowing gutters, the impact,of rain only coming from a certain direction or repairs that have been carried out have addressed the entry of moisture.

There is some minor cracking around the exterior wall - glass patio doors that could be sealed which might also assist.

Prior to any remedial works being performed an invasive inspection should be considered to gain a better understanding of any damage behind the surface layers.

It may be necessary to engage a qualified plumber should to help identify the cause of the excessive moisture if dampness returns or becomes an issue after rain.

Cracks should be sealed

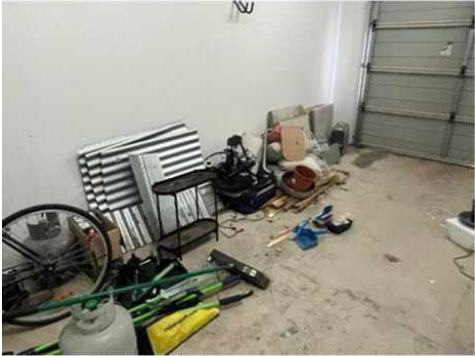
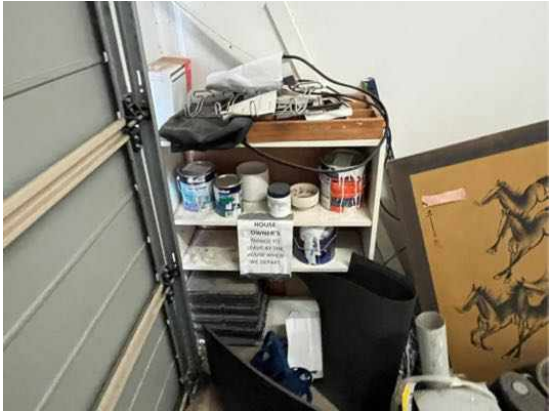
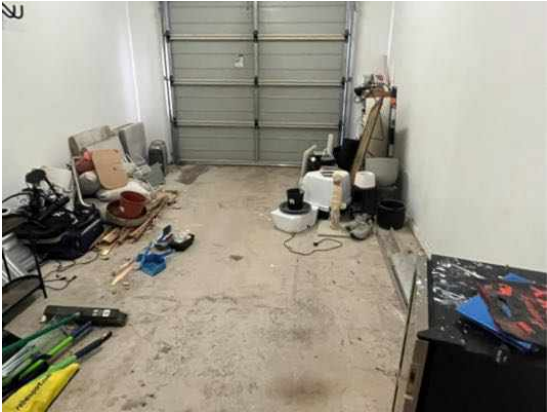
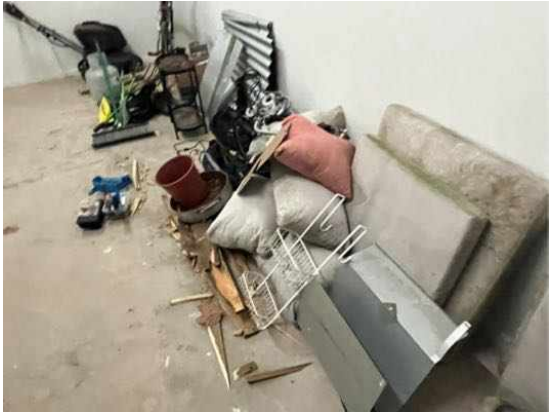
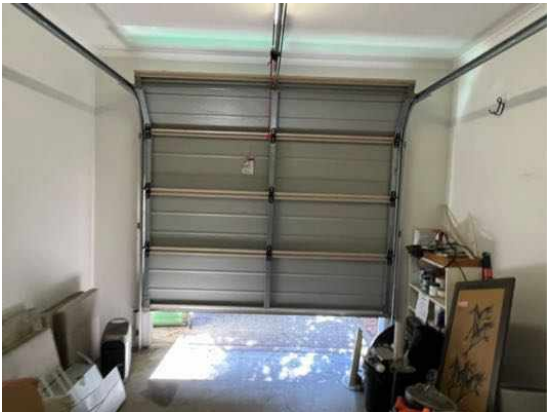
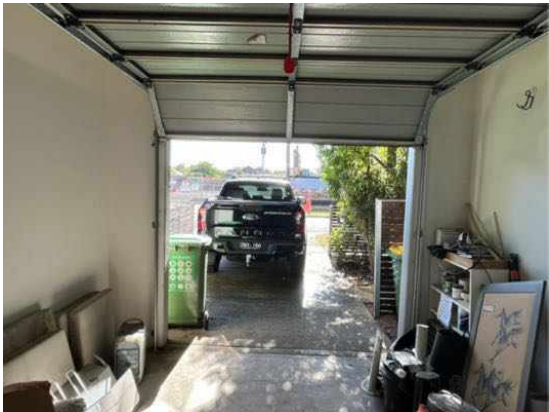
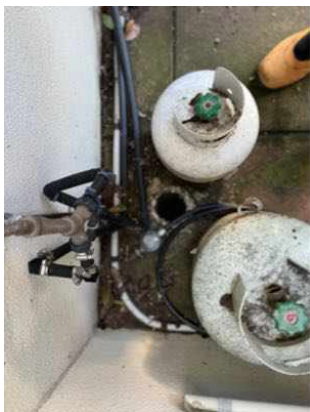
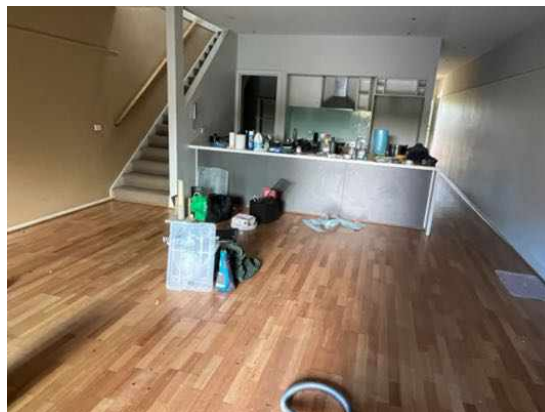
Building: Main Building
Location: All Areas
Finding: Additional Photos - Obstructions and Limitations
Information: These photographs are an indication of the obstructions and limitations which impeded full inspection of the property at the time of inspection.

These obstructions can hide an array of defects and should be removed to allow full inspection to be carried out.

A re-inspection is recommended once the areas are made accessible.

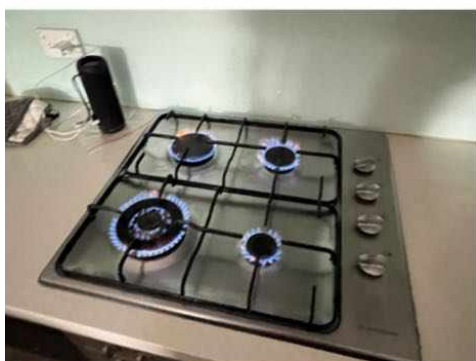
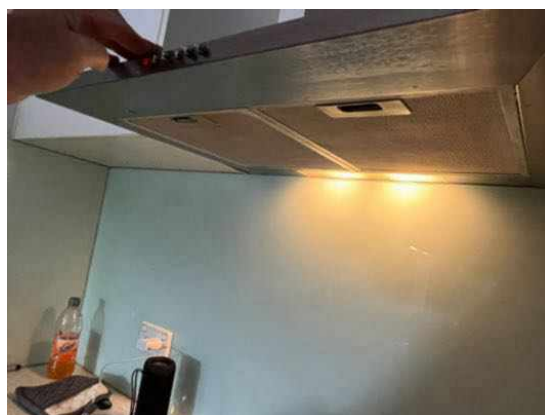
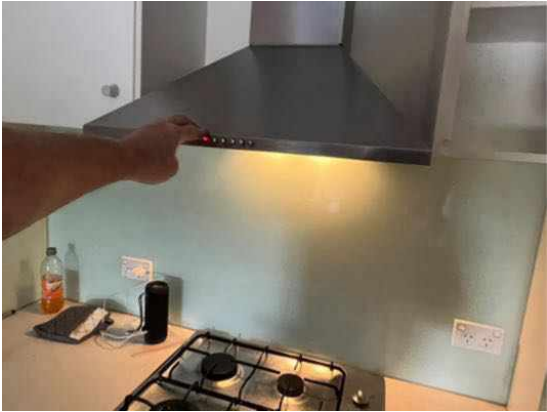
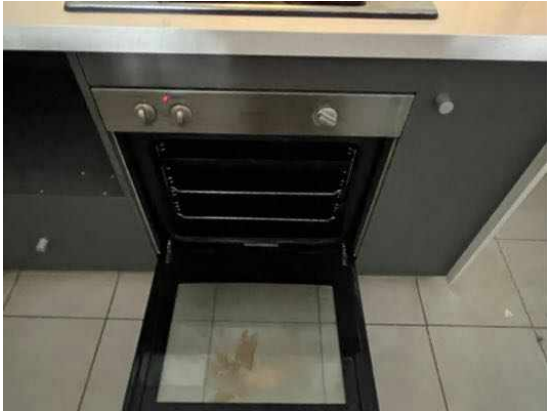
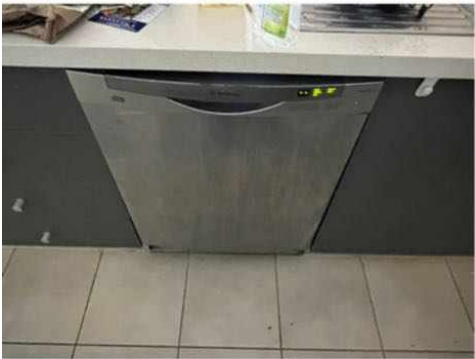
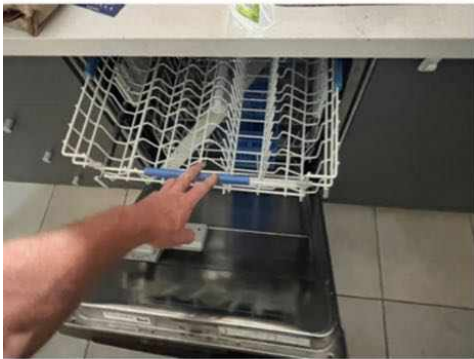
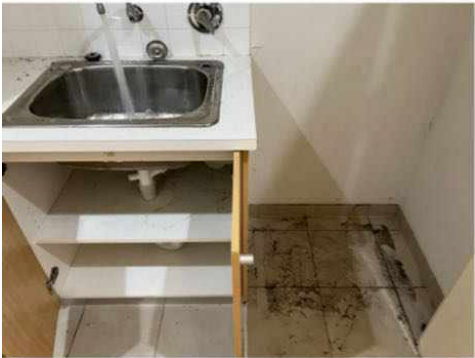
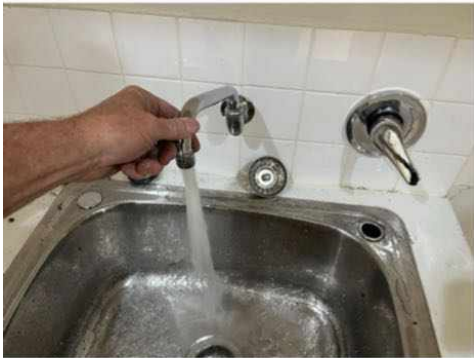
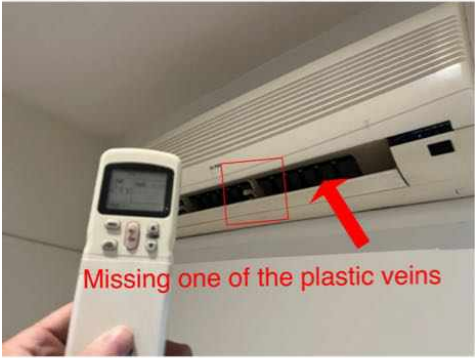
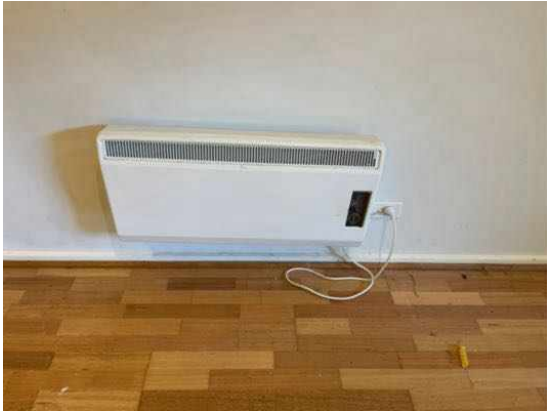
Building: Main Building
Location: Kitchen appliances, laundry, bathrooms bedrooms and living areas.
Finding: Additional Photos
Information: Additional photos are provided for your general reference.

Note window openings were not possible where the windows were locked and no key was available.

One of the AC units had a part missing - see photo

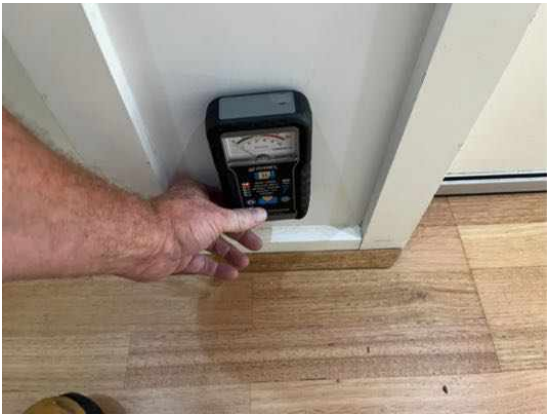
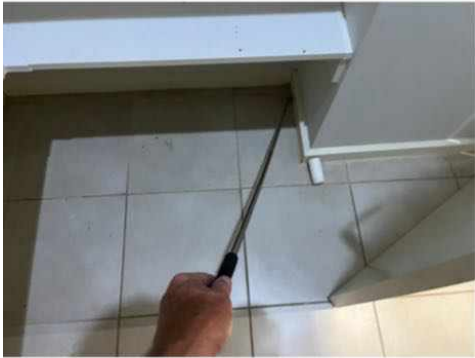
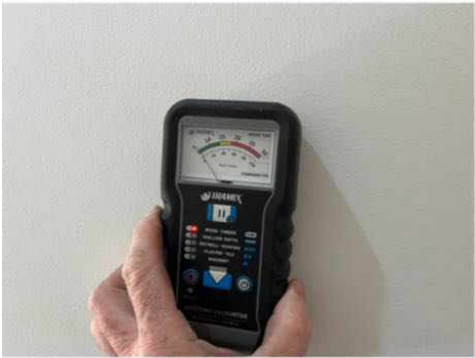
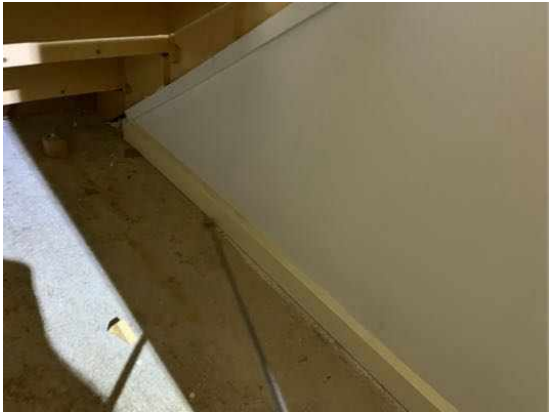
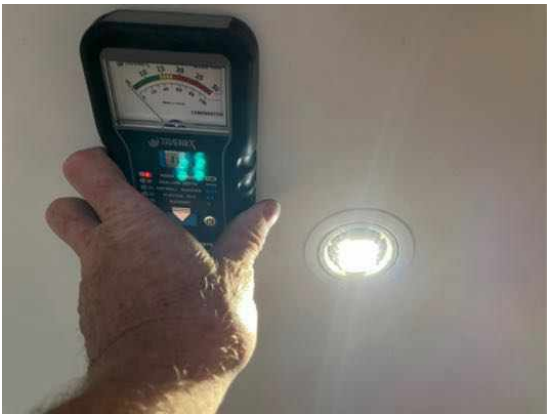
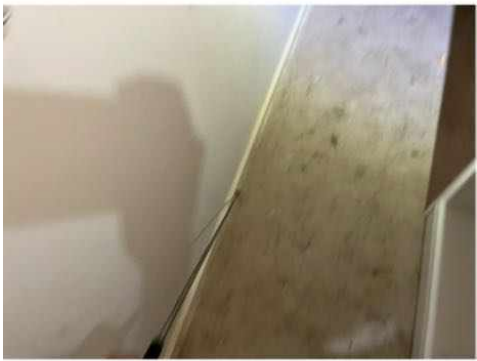
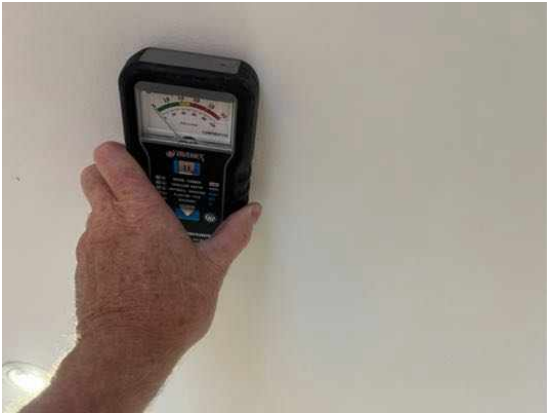
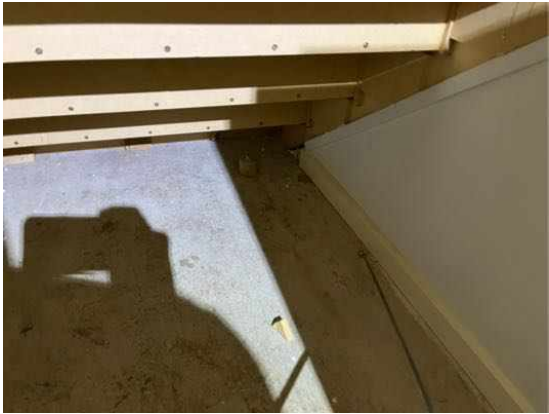
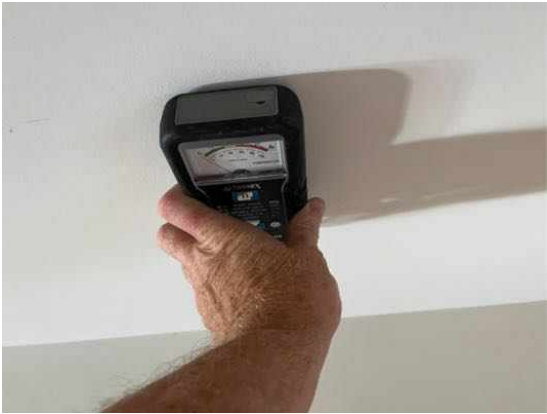
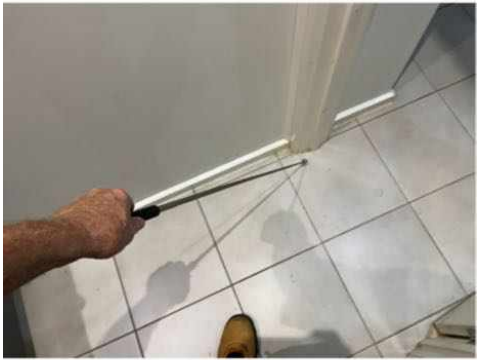
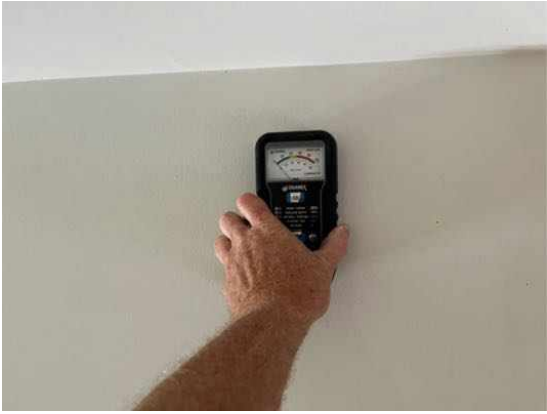
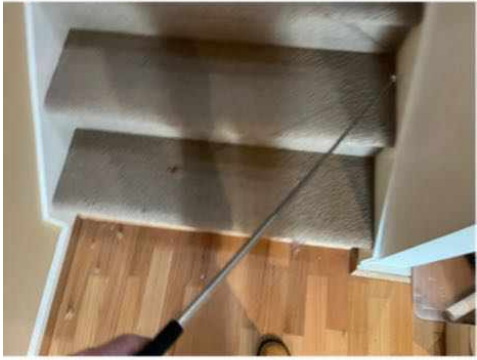
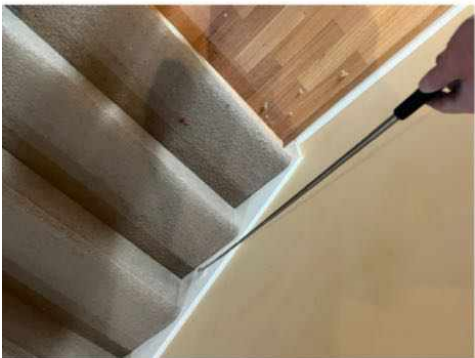
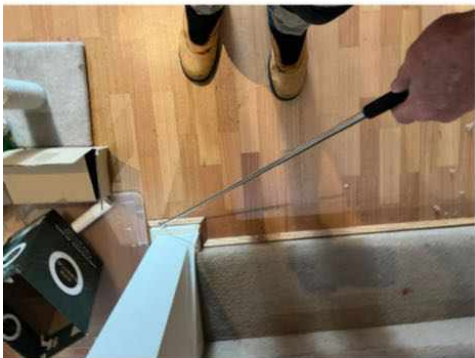
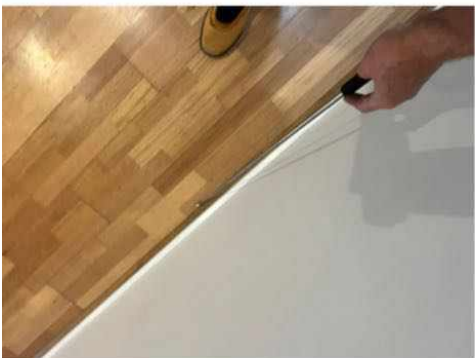
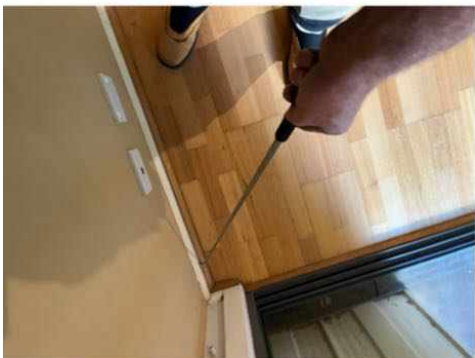
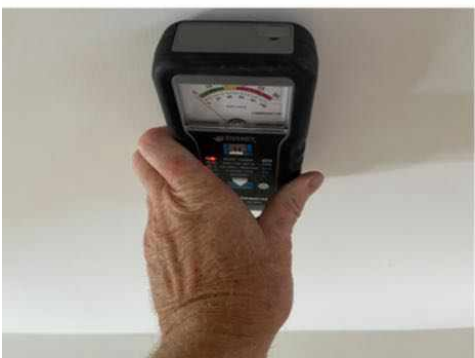
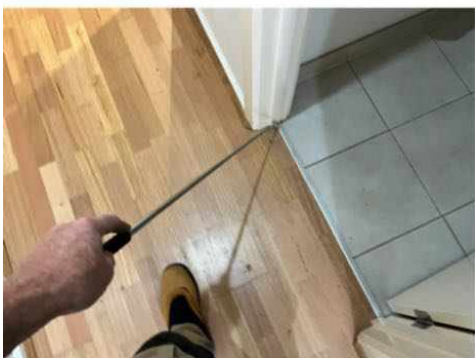
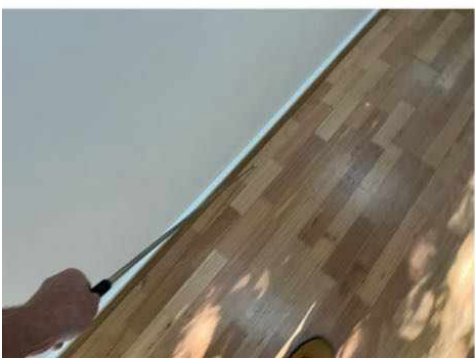
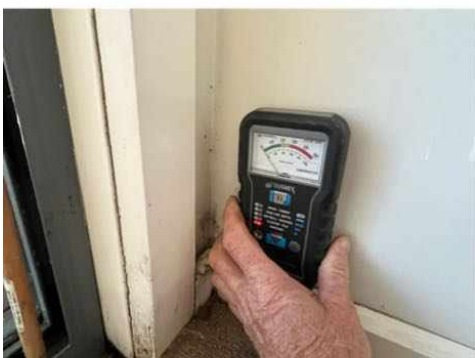
Building: Main Building
Location: All Areas
Finding: Termite Techniques
Information: All areas of the dwelling are checked with particular attention paid to wet areas which were closely assessed to check for excessive levels of moisture and temperature anomalies.

No evidence of termite activity was found inside the house at the time of the inspection.

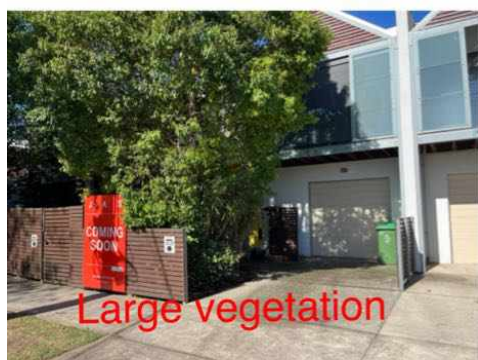
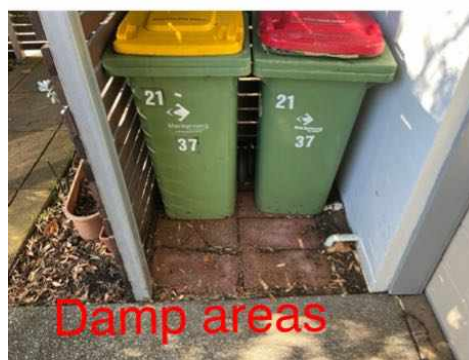
Building: Main Building
Location: All Areas
Finding: External - Termite Techniques
Information: All areas around the perimeter of the dwelling were inspected where access was possible.

No evidence of termite activity was found outside the dwelling or the environs at the time of the inspection.

No termite or timber pest activity was detected at the time of the inspection.

Limitations do exist where access is blocked or restricted, therefore we strongly recommend a termite treatment.

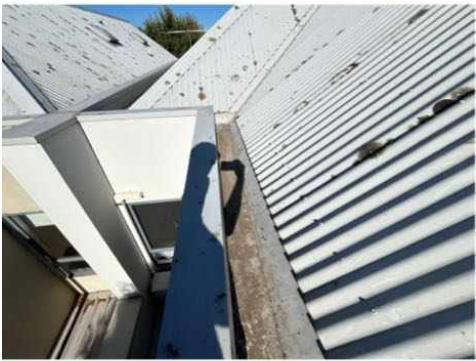
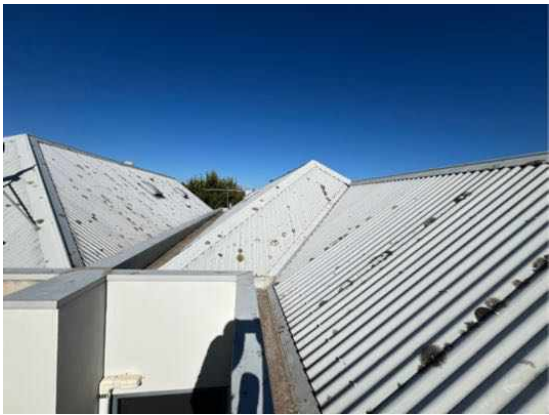
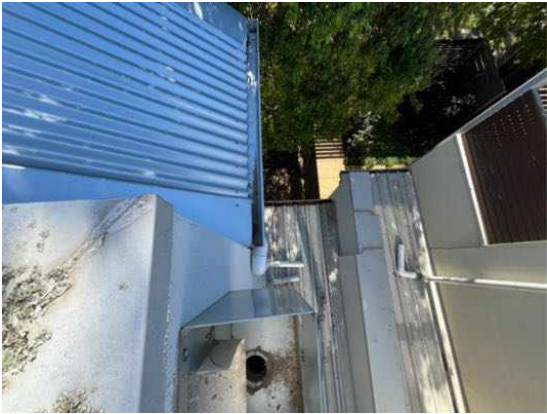
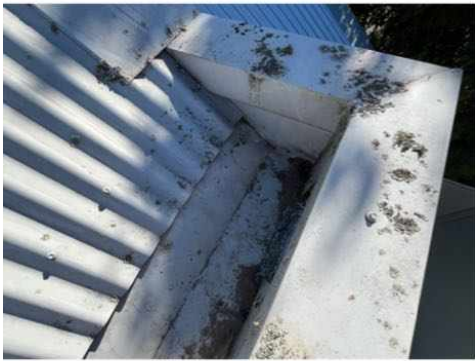
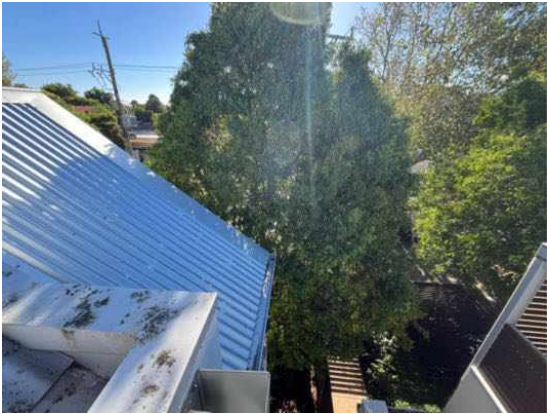
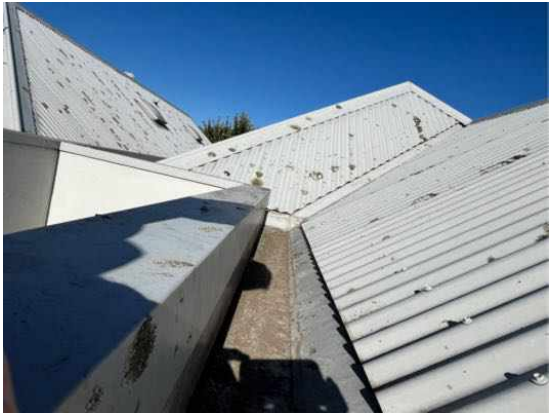
Building: Main Building
 Location: Roof Exterior
 Finding: Additional Photos
 Information: Additional photos are provided for your general reference
