Building and Timber Pest Inspection Report

Inspection Date: Wed, 7 Jan 2026

Property Address: 6/5 Dunlop Rd, Blue Haven NSW 2262,
Australia

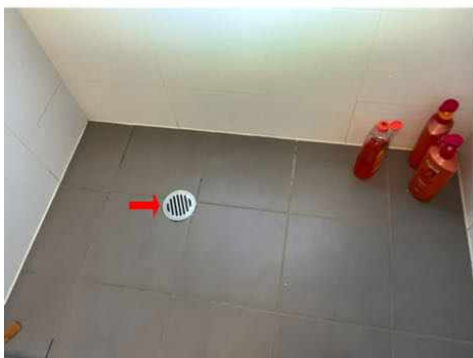
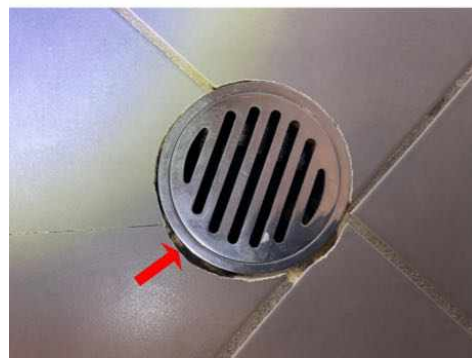
Building: Main Building
Location: Bathroom > Rear Right
Finding: Sealant and grouting - Missing or damaged
Information: It was noted on inspection that sealant or grout around the floor waste within the shower was damaged. This may lead to future water ingress below the tiles.

Different materials and floor areas move at different rates, generally causing cracking to grout or sealant at this point. A flexible sealant is required to allow for expected expansion and contraction, while keeping the joint water tight and protective of all associated building materials.

Flexible and mould resistant materials should be applied to affected areas to prevent any subsequent water damage that is likely to occur. Regular maintenance and replacement of damage or missing or damaged sealant and grout is highly recommended to the wet areas, as this is a regular wear and tear defect. Sealant and grouting in areas that come into regular contact with water should be maintained for the long term care of your property.

A sealant specialist or tiling contractor should be appointed to complete these works as soon as possible

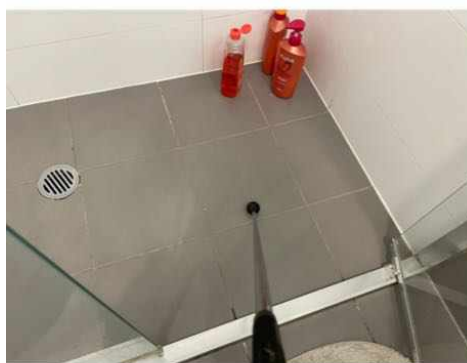
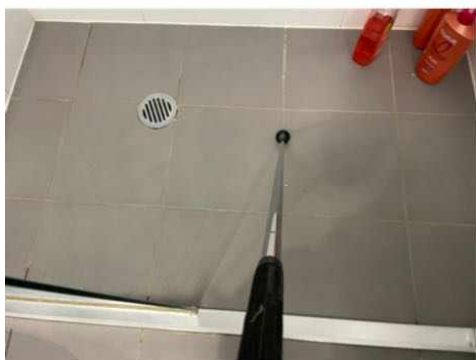
Finding 3.02

Building: Main Building
Location: Bathroom > Rear Right
Finding: Tiles - Drummy
Information: Drummy tiled areas were identified to approximately 30% of the tiles to the bathroom and several tiles to the shower alcove. at the time of inspection. The term 'drummy' refers to tiles that have become detached from their fixing, despite otherwise being in relatively good condition. Such defects are generally caused by physical or moisture damage to the area. Drummy tiled areas may also be a direct result of poor workmanship during the construction process.

Tiled areas may swell and shrink with changes in air humidity if the area has sustained moisture damage. Any exposure to moisture is capable of causing tiled areas to become drummy and/or cracked over a prolonged period of time. Drummy tiled areas generally require removal and replacement of affected tiles, with adequate sealant and grouting.

Specialist trades are available for these types of services. A builder may be required to undertake works if damage is extensive or if secondary building defects have resulted. Otherwise, it is advised that a tiling contractor be appointed to perform works as necessary. Immediate action is recommended to ensure that no further damage is sustained in the affected area.

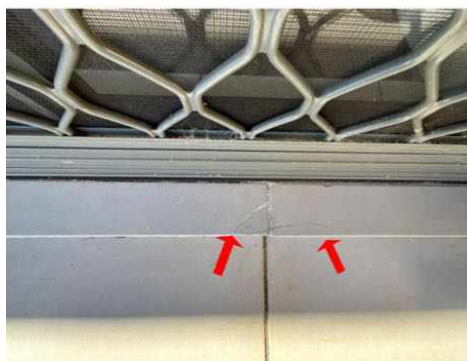
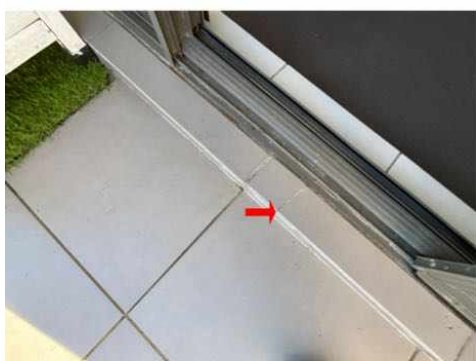
Location: Balcony > Front
 Finding: Floor tiles - Cracked
 Information: Cracking in the floor tiles was evident to the balcony step the time of inspection. It is suspected that this cracking has occurred as a result of the floor being uneven and lacking a solid or suitable foundation for the tiles to be laid on or potential impact damage.

Cracked tiles detract from the overall appearance of the affected areas, as well as creating potential for water penetration to adjoining building elements. If left unmanaged, water damage may occur as a result of constant water penetration over a prolonged period of time.

While not considered a matter of urgency, replacement of cracked floor tiles is advised as a solution. A tiling contractor or general handyperson may be appointed to perform these works at client discretion.

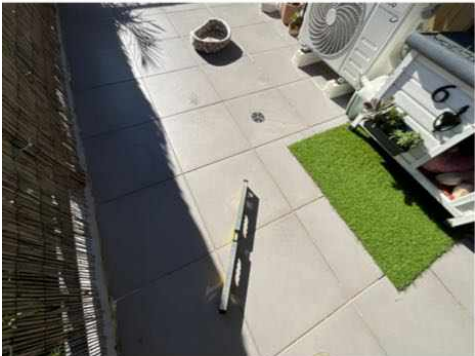
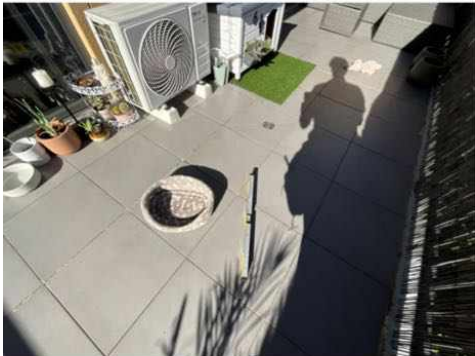
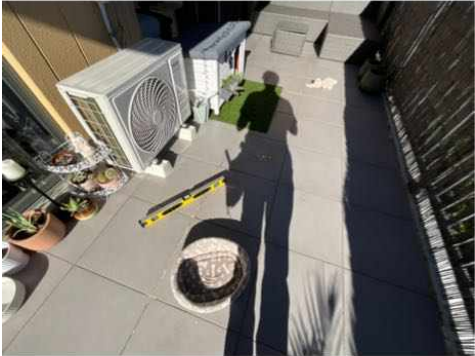
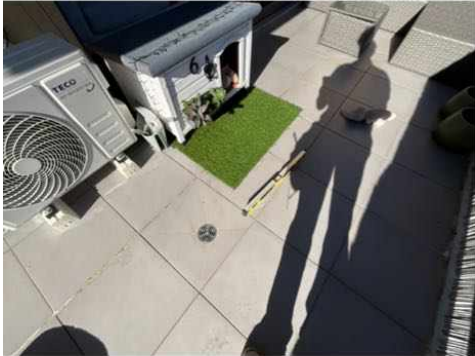
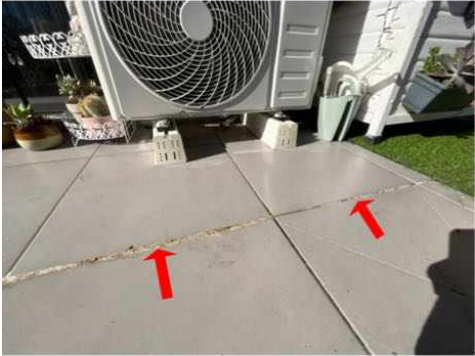
Finding 3.05

Building: Main Building
 Location: Balcony > Front
 Finding: Floor Tiles - Uneven
 Information: The floor tiles to the balcony were generally observed to be in fair condition at the time of inspection and appeared to fall adequately towards the floor waste, allowing for

drainage as intended. However, several tiles were noted to be slightly uneven, resulting in an inconsistent finish across parts of the tiled surface.

The unevenness of some tiles may be noticeable underfoot and may detract from the overall appearance of the balcony. In isolated areas, uneven tiles can also allow small amounts of water to pool locally, which may contribute to staining or accelerated wear to grout over time.

It is recommended that the tiled surface be monitored and that any uneven tiles be assessed by a suitably qualified tiler as part of general maintenance. Localised re-levelling or replacement of affected tiles may be considered to improve the consistency and finish of the balcony surface.

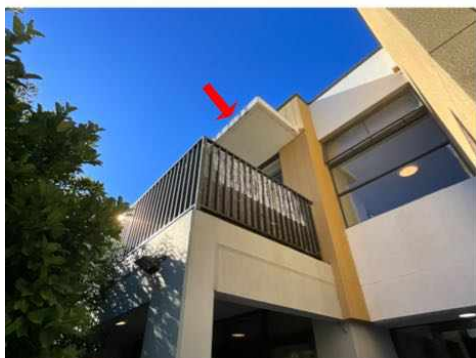
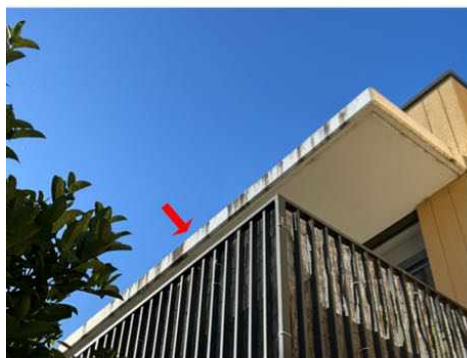
Finding 3.06

Building:	Main Building
Location:	Balcony > Front
Finding:	Staining - Balcony overhang
Information:	Staining was observed to the front face of the balcony overhang, which appears to be consistent with water runoff from the roof edge. No gutters are installed to this section, and the staining appears to be an aesthetic issue only at the time of inspection.

The staining detracts from the overall appearance of the building but does not indicate any visible structural damage or active moisture issues. Ongoing runoff may continue to mark the surface over time if left as is.

No immediate remedial works are required. If desired, the staining may be cleaned or treated as part of general maintenance.

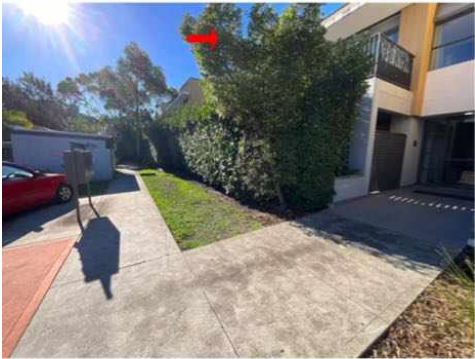
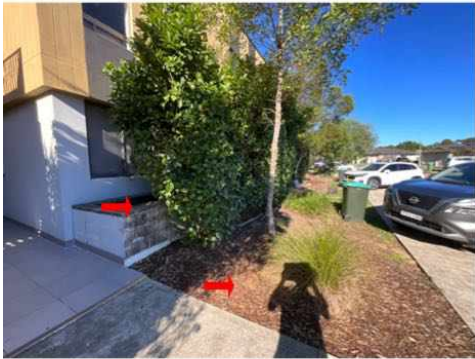
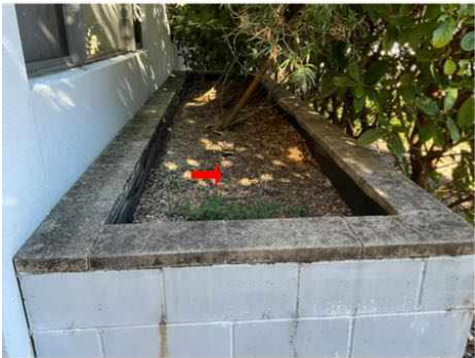
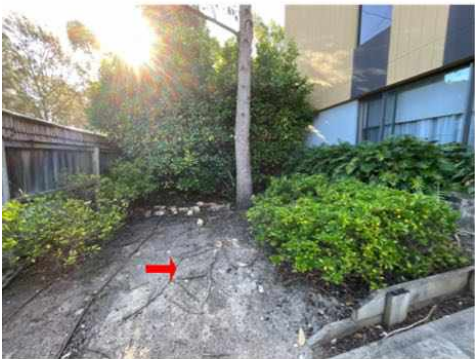
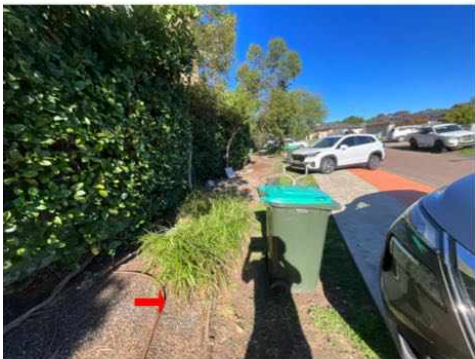
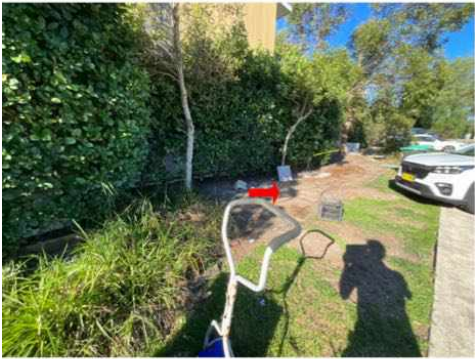
Finding 3.07

Building:	Main Building
Location:	All External Areas > All Areas
Finding:	External Defects
Information:	Although these items form part of the strata-managed areas, a number of external defects were observed at the time of inspection. These include capping to sections of the retaining wall not being fixed adequately, graffiti to several areas, and slight weathering to timber fencing with localised staining evident.

If left unattended, these issues may continue to detract from the overall presentation of the property and could gradually worsen through ongoing exposure to weather and general use. While the defects appear largely maintenance-related in nature, timely attention would help preserve the condition and appearance of the common areas.

It is recommended that these items be referred to the owners corporation or strata manager for review. Remedial works may include securing the retaining wall capping,

removal of graffiti, maintenance or treatment of the timber fencing, and general landscaping works to address overgrowth and areas in disrepair.

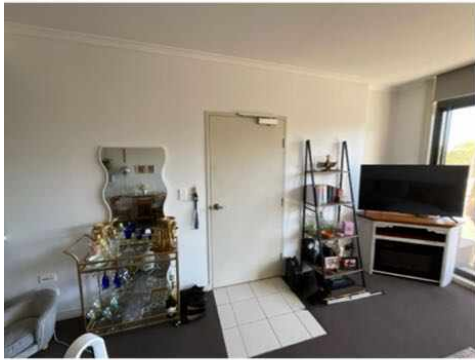
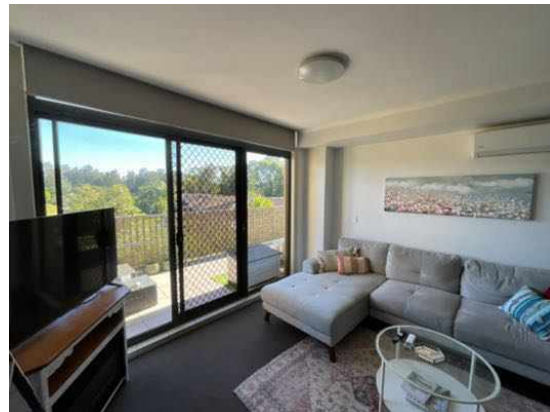
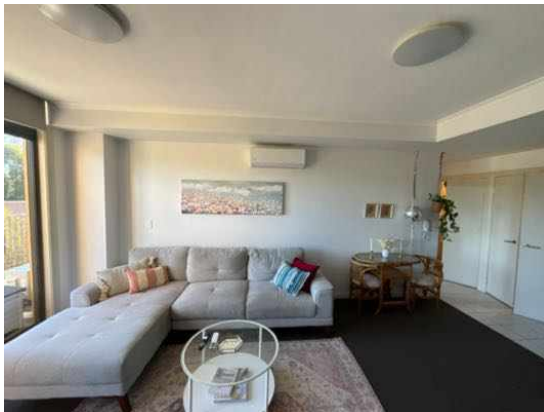
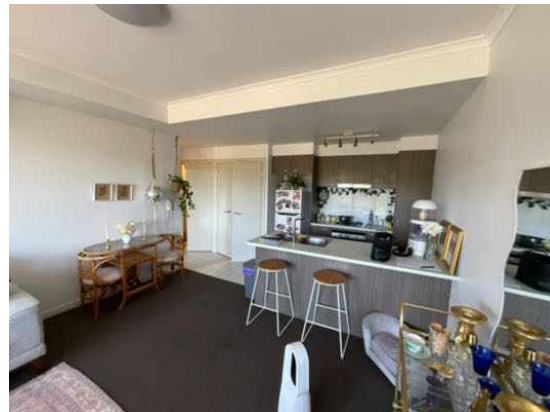
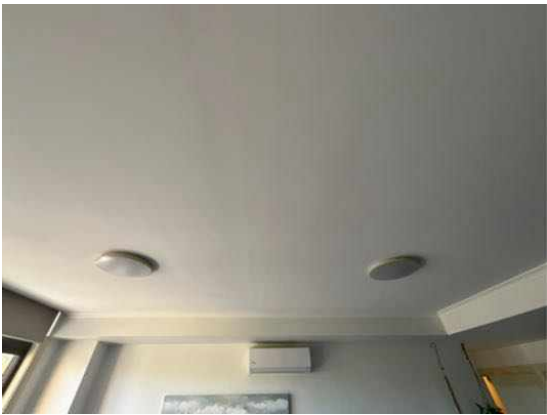
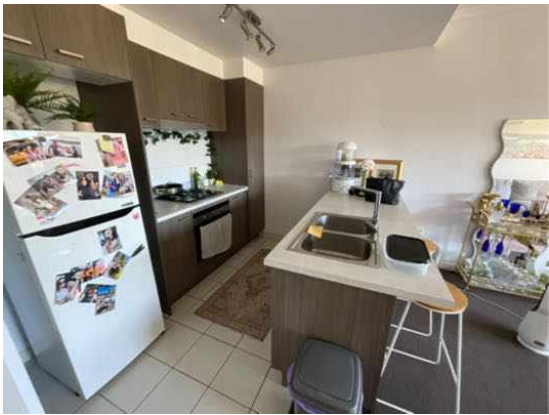
Building: Main Building
Location: All Internal Areas > All Areas
Finding: Additional Photos - Obstructions and Limitations
Information: These photographs are an indication of the obstructions and limitations which impeded full inspection of the property at the time of inspection. These obstructions can hide an array of defects and should be removed to allow full inspection to be carried out. A re-inspection is recommended once the areas are made accessible.

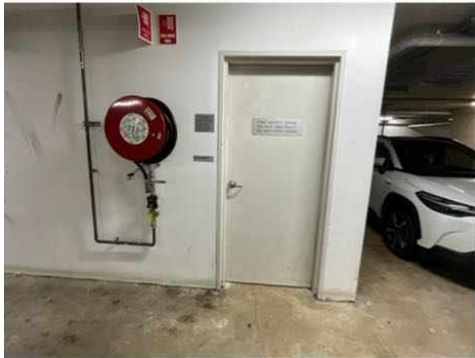
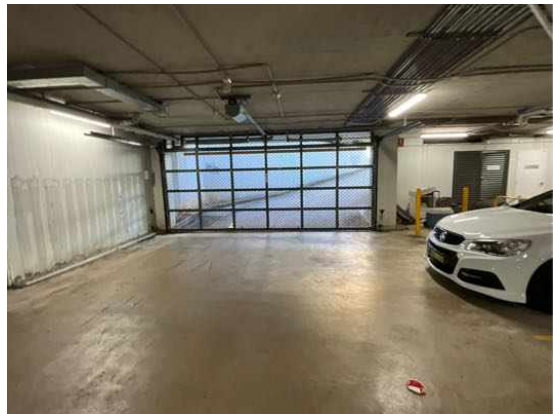
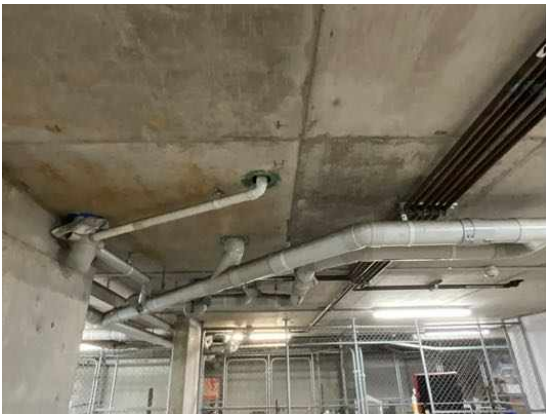
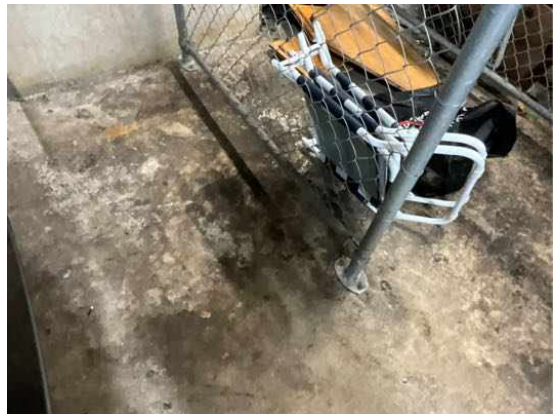
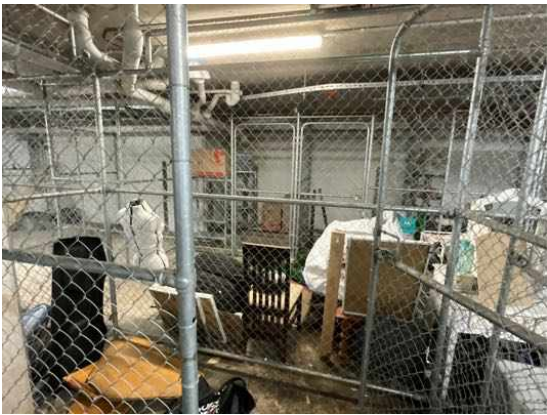
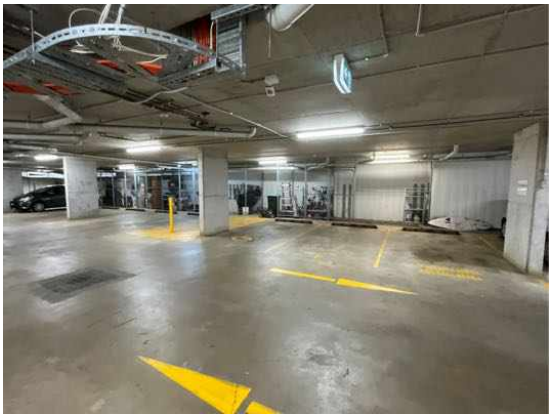
Building: Main Building
Location: All External Areas > All Areas
Finding: Additional Photos - Communal Areas
Information: Additional photos are provided for your general reference

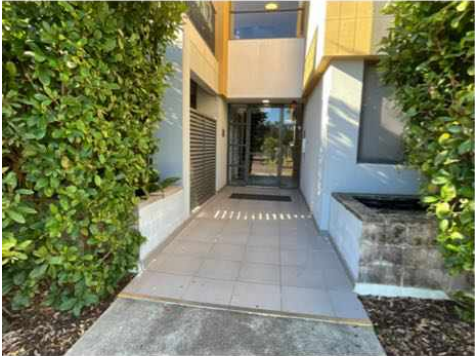
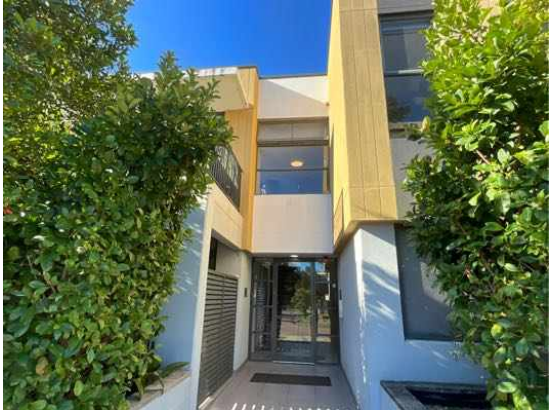
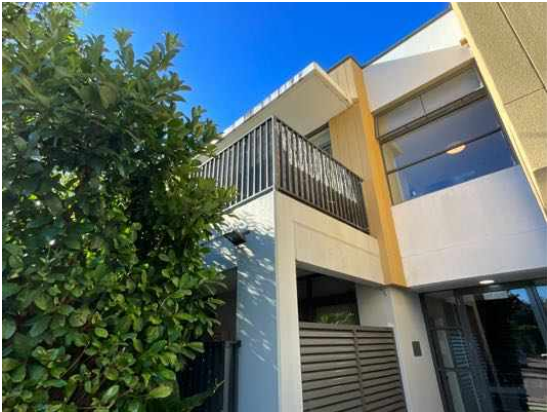
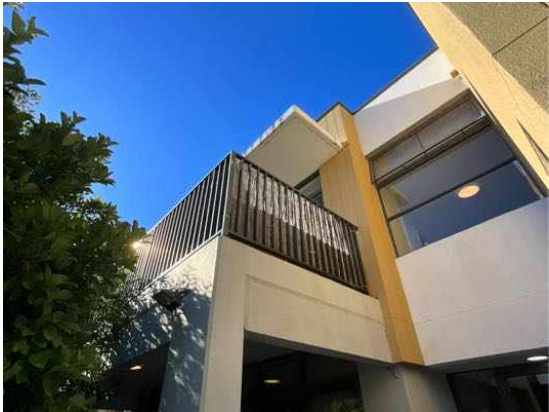
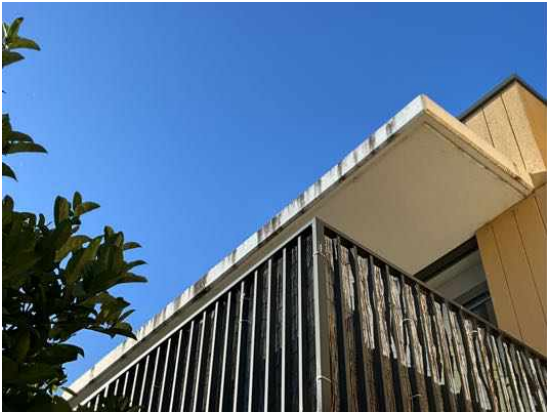
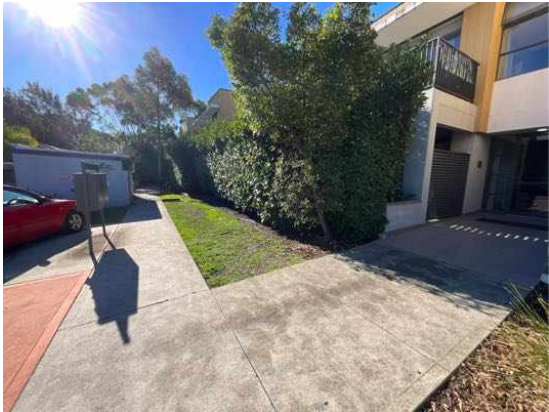
Building: Main Building
Location: All External Areas > All Areas
Finding: Additional Photos - External Areas (Communal)
Information: Additional photos are provided for your general reference

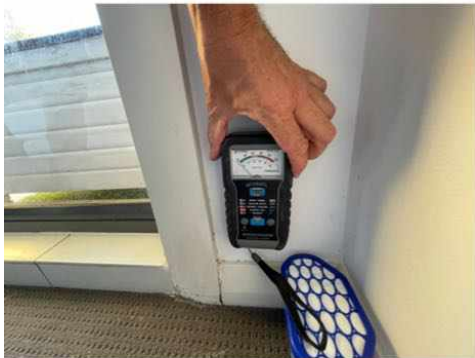
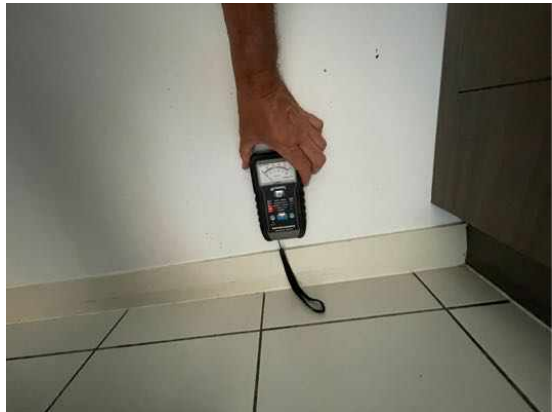
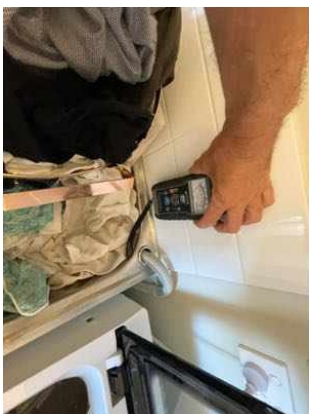
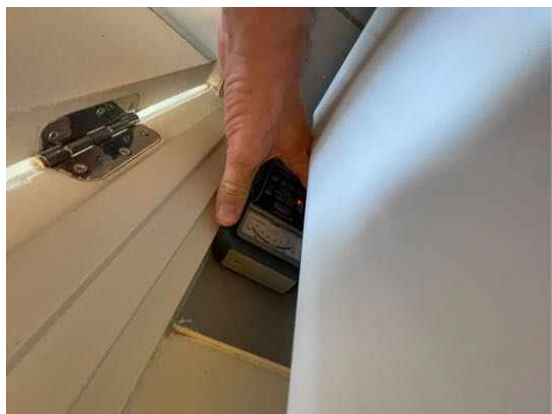
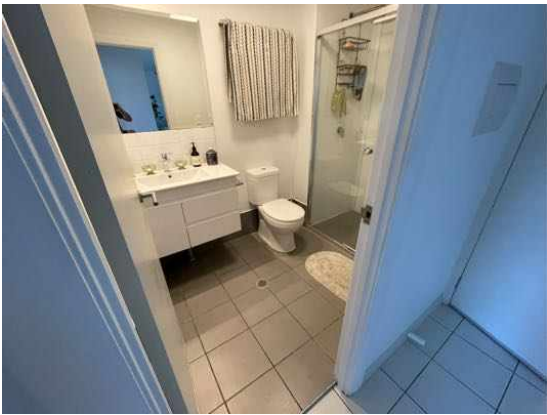
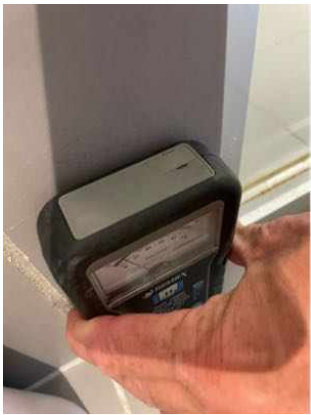
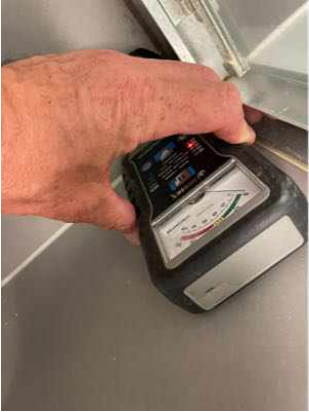
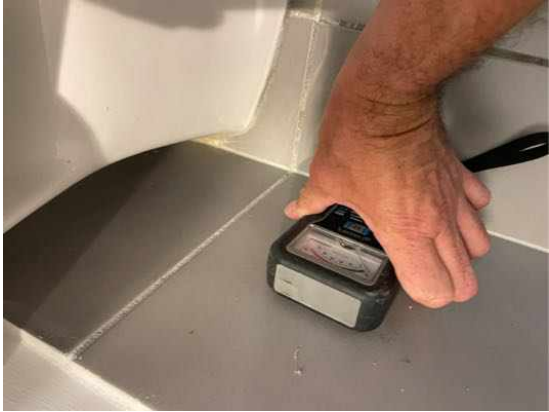
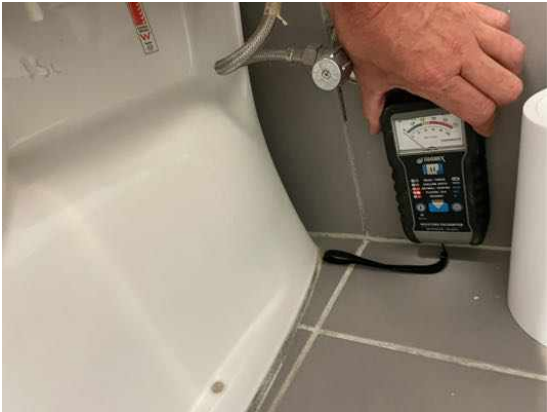
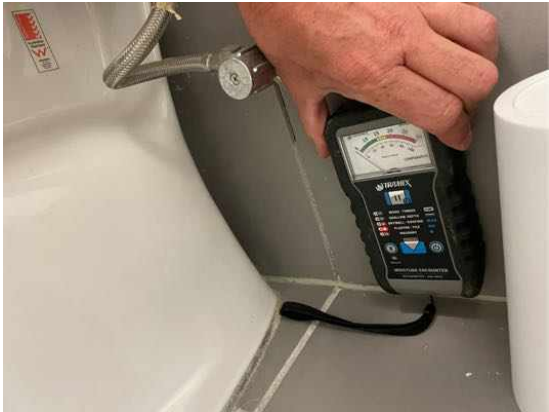
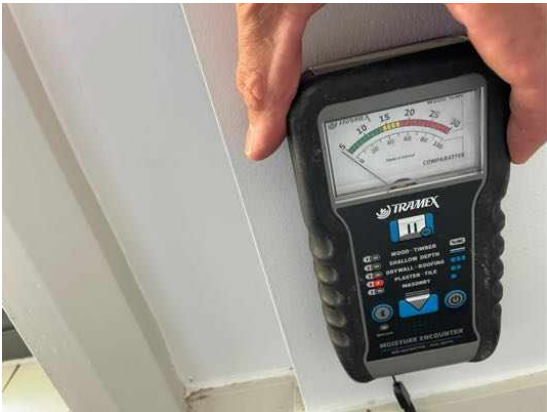
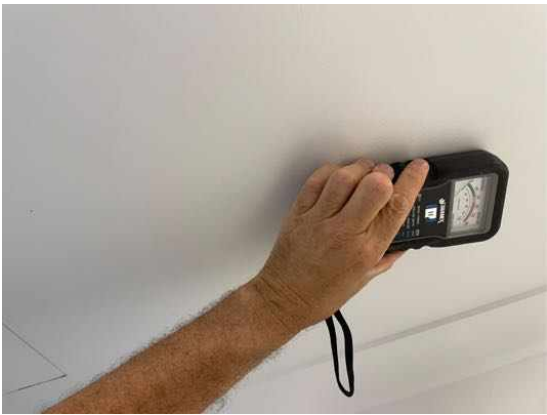
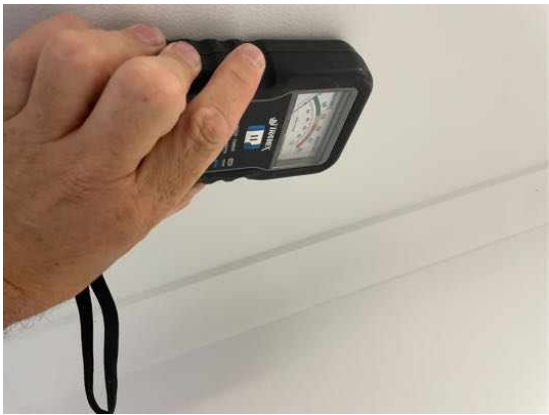
Building: Main Building
Location: All External Areas > All Areas
Finding: Moisture Readings
Information: Moisture readings were taken to the wet areas and below and beside windows. There was no elevated moisture levels located at the time of the inspection.
