# Building and Timber Pest Inspection Report

Inspection Date: Mon, 16 Feb 2026

Property Address: 80 Douglas McInnes Dr, Laidley QLD 4341,  
Australia

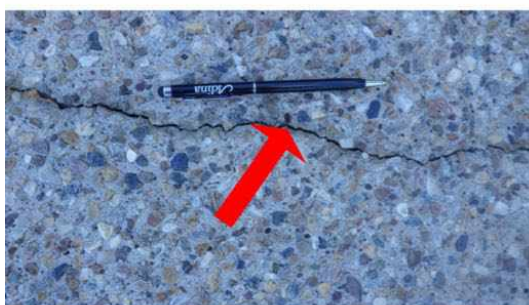
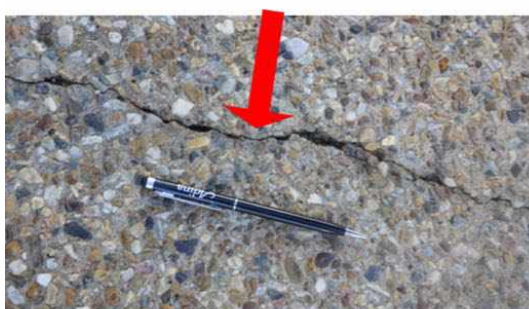
Building:	Main Building
Location:	Driveway > Ground Level
Finding:	Cracking in concrete slab - Category 1
Information:	Cracking coded as Category 1 was identified in the driveway and footpaths concrete slab (as per example photos). A Category 1 crack is described as a fine but noticeable crack, with the slab at an otherwise reasonable level.

To be considered Category 1, the approximate width of the crack is less than 1.0mm, or a less than 10mm change in offset when a 3m straight edge is placed over the defect.

Category 1 cracks should be monitored for a period of 12 months. At the end of the monitoring period, identified cracks that are rated greater than Category 2 are considered defects, and require rectification.

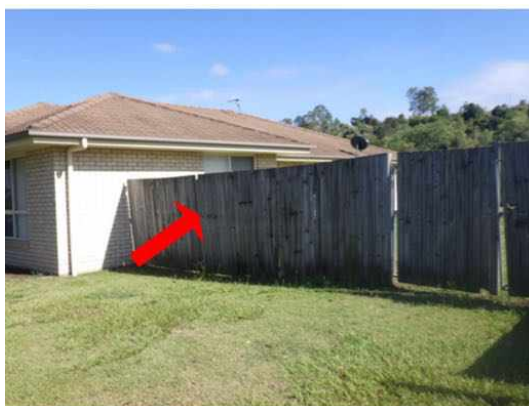
### Finding 3.02

Building:	Main Building
Location:	Yard > All Areas
Finding:	Fencing - Deteriorated
Information:	It was noted at the time of inspection that sections of the fencing and gates throughout the property have deteriorated. Typically fencing deteriorates due to age and or wear, rot and or rust which is generally expected for a structure of this age, due to prolonged exposure to weather conditions. Sometimes inadequate installation or maintenance can be to blame.

If left unattended, it is likely that further damage will occur. It is suspected that repair of several elements of the fencing may be required however replacement may be a consideration of the client also.

A licensed fencing contractor should be appointed to provide further advice and perform rectification works as necessary.

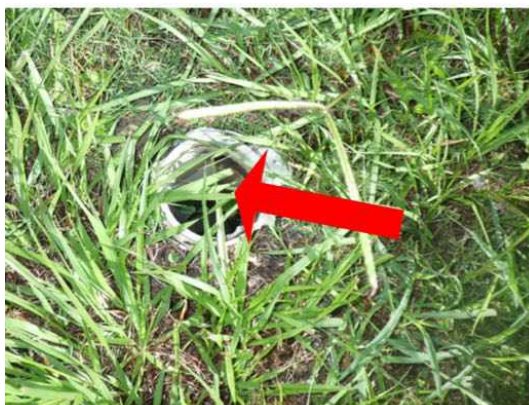
### Finding 3.03

Building:	Main Building
Location:	Yard - Back > Rear Left
Finding:	Sewer line - Caps Missing
Information:	At the time of inspection it was noted the sewer line was missing the protective riser cap to the rear left side of the property.

It is assumed the cap has been previously removed or damaged. The missing sewer line cap creates potential for sewer line blockages.

A licensed plumber or general handyman should be engaged to replace the sewer line cap..

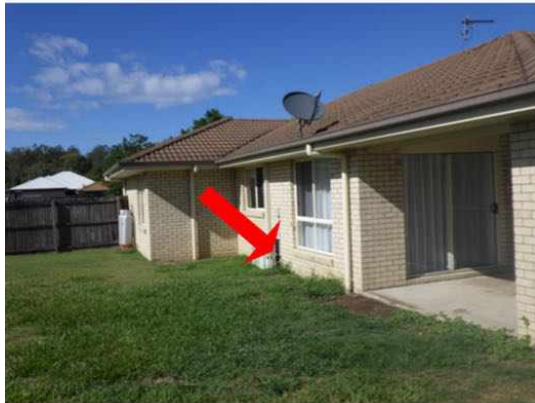
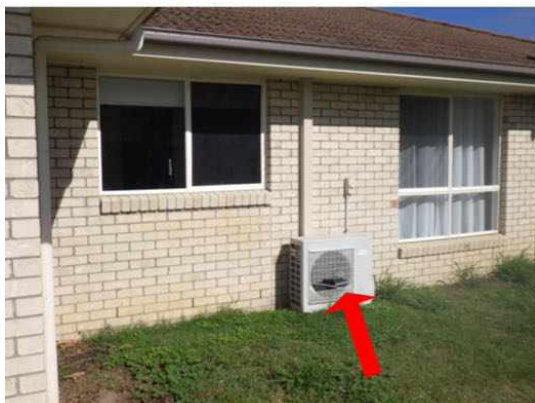
### Finding 3.04

Building:	Main Building
Location:	Exterior walls - right side > Centre Right
Finding:	Air Conditioning Unit deteriorated
Information:	At the time of inspection sections of the air conditioning unit, electrical cabling and pipe work insulation showed evidence of damage and deterioration. It is suspected that this deterioration has developed as a result of excessive exposure to weather, including UV exposure in daylight. Deteriorated insulation reduces the effectiveness of

If left in an exposed position, it is likely that the deterioration will continue and worsen over time, potentially resulting in secondary building defects as well as a further loss in insulating properties.

Some areas of replacement of pipe insulation is likely to be required. Further preventative measures to remove or protect the material from future exposure are also advisable. Consultation with a licensed air conditioning installer is advised to gain quotes for the repair and/or replacement of deteriorated insulation and/or unit.

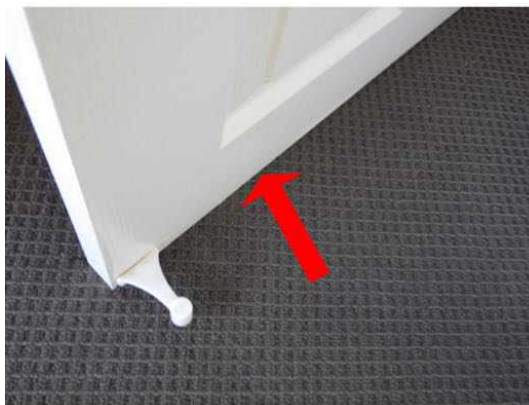
### Finding 3.05

Building:	Main Building
Location:	Bedroom 2 > Front
Finding:	Door Rubbing
Information:	It was noted that the bottom edge of the bedroom 2 door is rubbing on the carpet making the door stiff to open and close at the time of inspection.

This is noted as a minor defect that you need to be aware of.

A licensed carpenter or general handyman could be engaged to ease the door at the clients discretion.

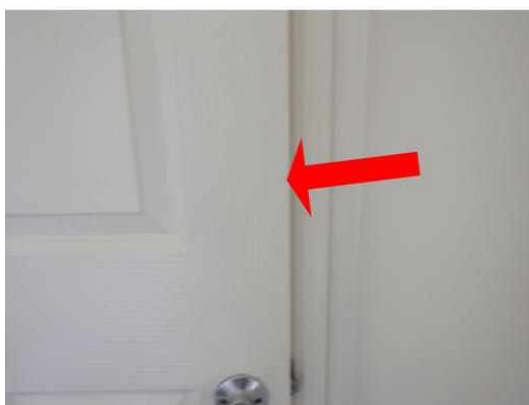
### Finding 3.06

Building:	Main Building
Location:	Bedroom 3 > Front
Finding:	Door - Binding/Jamming
Information:	Binding and/or jamming of the bedroom 3 door on the door frame was evident during standard operation. This defect inhibits the functionality of affected door as well as creating potential for secondary defects to associated building elements, such as damage to the door framing.

A door that binds to the associated door frame or sill may have several causes, such as poor installation of the door or deteriorated hinges.

A qualified carpenter or general handyperson could be appointed to perform minor rectification works at client discretion.

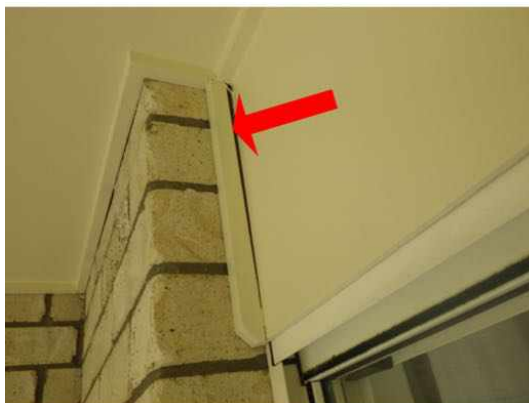
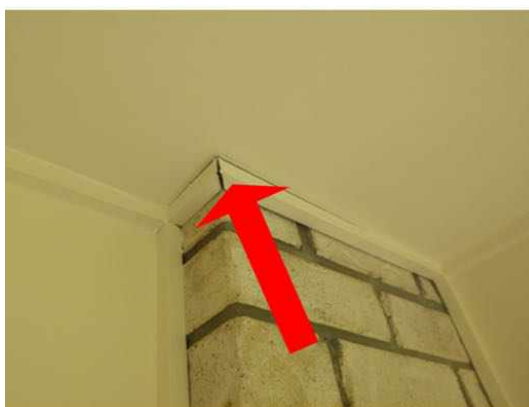
### Finding 3.07

Building:	Main Building
Location:	Alfresco > Centre Left
Finding:	Beading - Loose
Information:	It was noted at the time of inspection that beading in parts of the eaves in the alfresco area is loose..

Beading is important in weatherproofing the surrounding building elements and preventing termite or pest ingress. Furthermore, beading works to protect the joins of building materials, which are more susceptible to deterioration and decay.

Repair of the beading is advised to ensure the protection and longevity of any associated building elements. Such works may be performed by a general handyman.

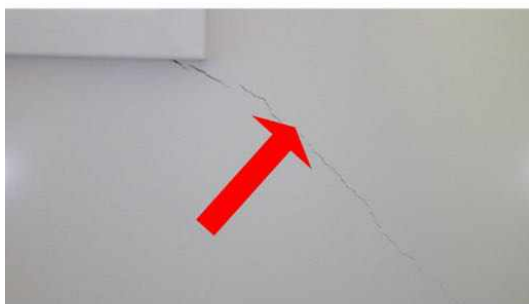
### Finding 3.08

Building:	Main Building
Location:	Ensuite > Centre,Rear
Finding:	Cracking - Wall
Information:	There is cracking to an area of the wall lining in the ensuite area.

The cracking appears minor in nature and is generally only ever an appearance defect. While such cracking may be noticeable in some cases, it is quite common and does not indicate any structural damage.

Cracking of this nature can generally be repaired with minor sanding, filling and/or repainting. Such works should be performed by a qualified painter or a general handyman.

Monitoring of all cracking should be conducted frequently. Always contact a building

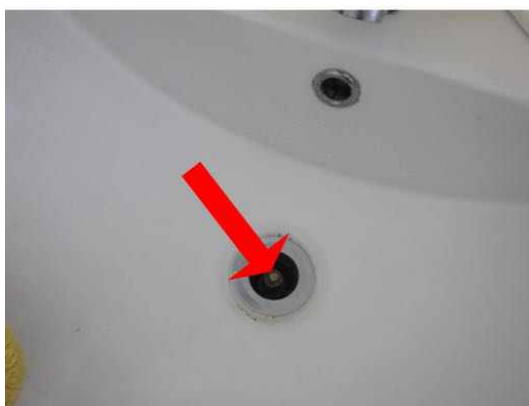
### Finding 3.09

Building: Main Building  
 Location: Ensuite > Rear Right  
 Finding: Basin - Pop up waste.  
 Information: The ensuite basin pop up waste was damaged or broken at the time of inspection. It is advised that maintenance is carried out on the waste so as it functions as intended.

A handyman could be appointed to perform any remedial works where required.

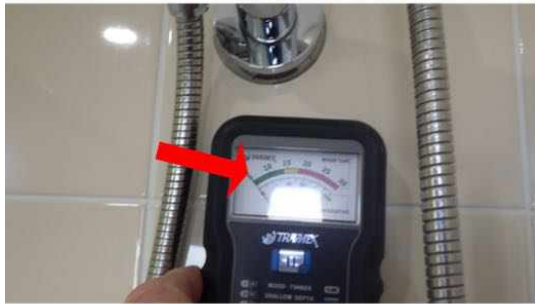
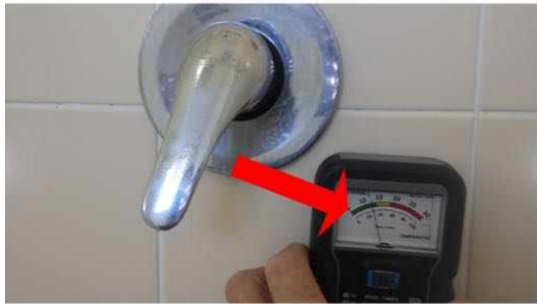
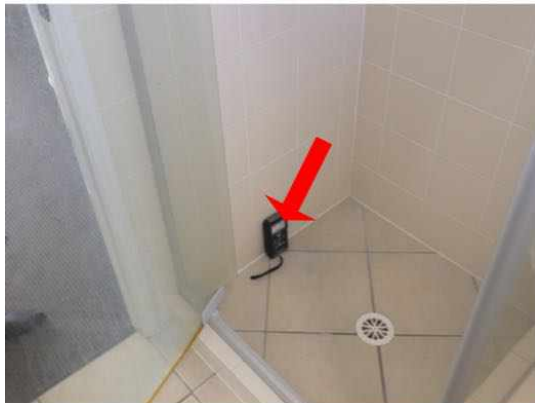
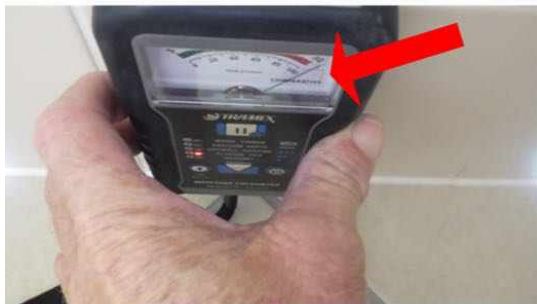
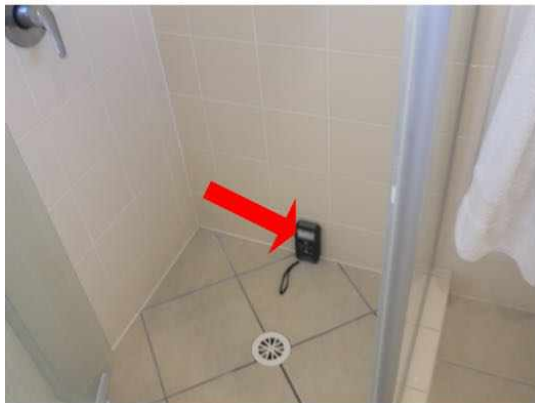
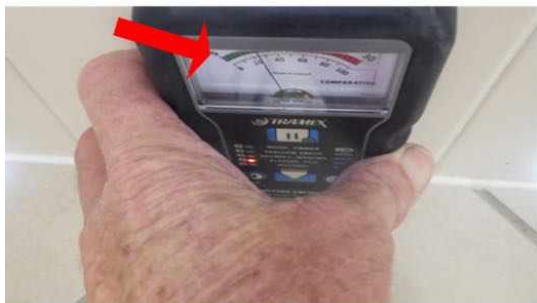
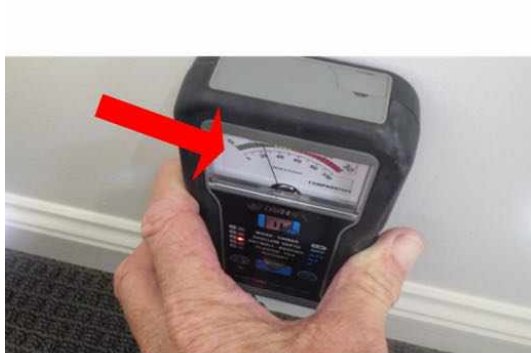
### Finding 3.10

Building: Main Building  
 Location: Ensuite > Front Left  
 Finding: Shower - Monitor  
 Information: Elevated moisture level readings were recorded to the lower 200mm of wall to the ensuite shower alcove at the time of inspection. There was no elevated moisture level readings around the tap area, and no elevated readings transferring to the other side of the wall in the areas where moisture readings were able to be obtained. Both sealant and grout appear in good condition at present.

This defect is quite common, and is suspected to have been caused by moisture permeating or leaching through the grouting and perhaps gaps in the sealant.

Monitoring the area is advised and if any visual signs of excessive moisture appear (peeling paint, mould) then consultation with a qualified plumber or bathroom specialist would be advised to identify the cause of damp and to perform remedial works as required.

Always ensure that sealant and grout is in good condition to prevent any moisture issues occurring in the future.

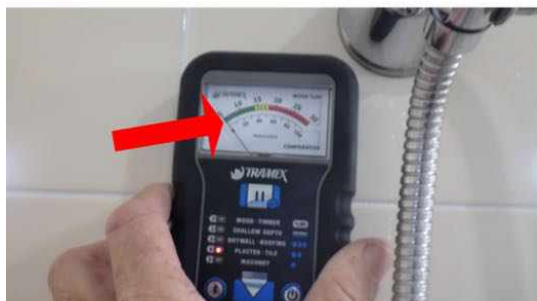
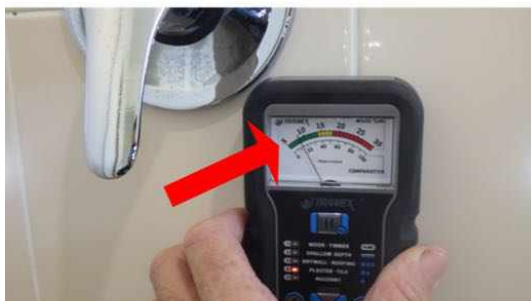
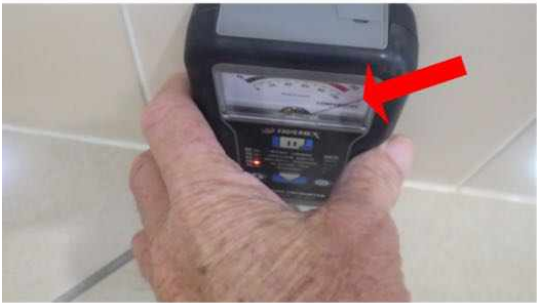
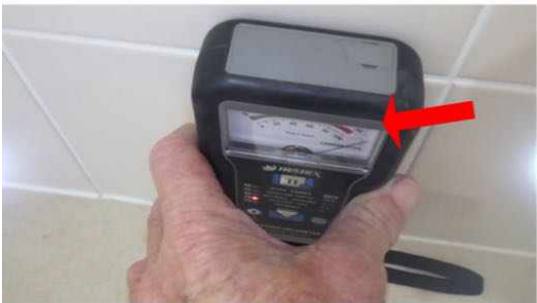
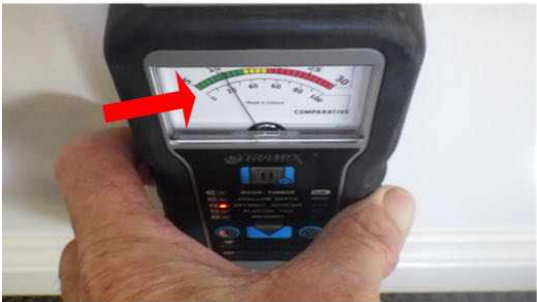
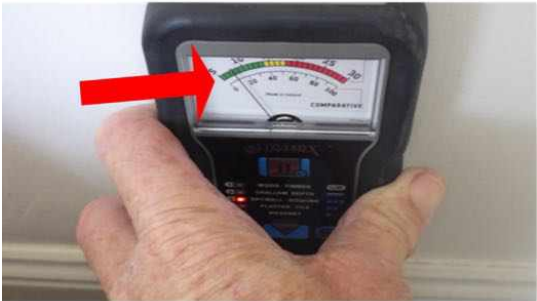
### Finding 3.11

Building: Main Building  
Location: Bathroom > Front Left  
Finding: Shower - Monitor  
Information: Elevated moisture level readings were recorded to the lower 200mm of wall to the bathroom shower alcove at the time of inspection. There was no elevated moisture level readings around the tap area, and no elevated readings transferring to the other side of the wall in the areas where moisture readings were able to be obtained. Both sealant and grout appear in good condition at present.

This defect is quite common, and is suspected to have been caused by moisture permeating or leaching through the grouting and perhaps gaps in the sealant.

Monitoring the area is advised and if any visual signs of excessive moisture appear (peeling paint, mould) then consultation with a qualified plumber or bathroom specialist would be advised to identify the cause of damp and to perform remedial works as required.

Always ensure that sealant and grout is in good condition to prevent any moisture issues occurring in the future.

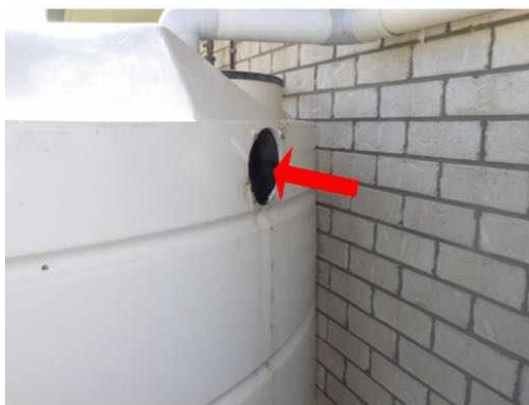
Where roof plumbing doesn't drain adequately, the area at the base perimeter can become excessively damp, potentially creating an environment that is susceptible to rust and corrosion of surrounding building elements, as well as attracting termites and other pests.

It is recommended that a plumber or handyman be appointed to repair or replace the overflow pipe as necessary.

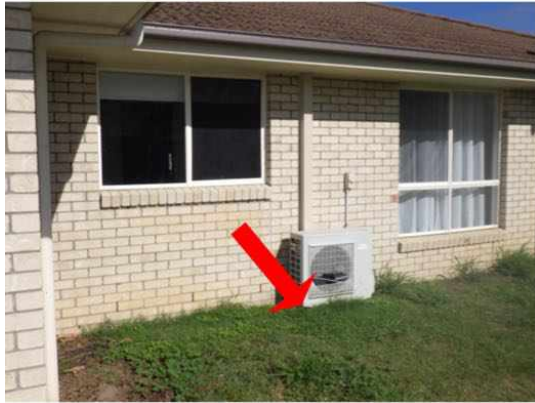
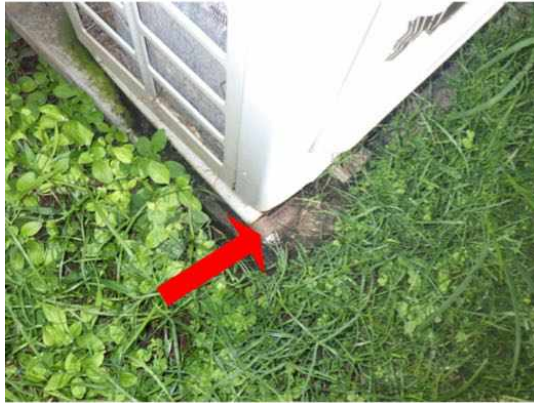
### Finding 6.02

Building:	Main Building
Location:	Exterior walls - right side > Centre Right
Finding:	Overflow - Not plumbed for drainage
Information:	The air conditioning unit overflow is not plumbed or connected to suitable drainage, which can result in the surrounding area becoming excessively damp. These damp

conditions can lead to secondary defects such as rot, rust or corrosion of associated building elements, the formation of fungal decay, or even the creation of potential slip hazards. When coupled with poor site drainage, pooling of water may also attract termite activity to this area. It is highly recommended that a qualified plumber be appointed to install adequate drainage to the overflow. These works will ensure that the area remains dry and free of any secondary defects.

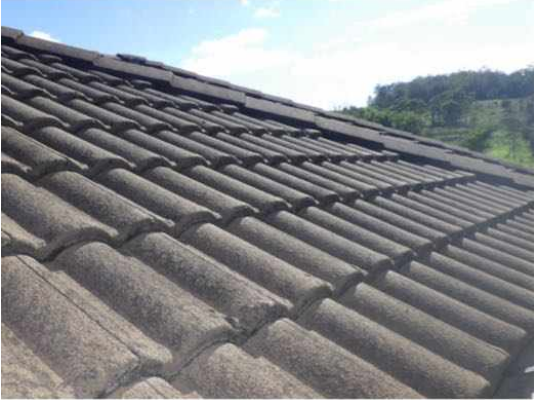
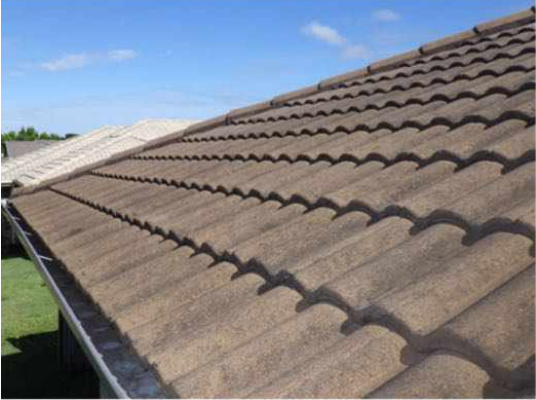
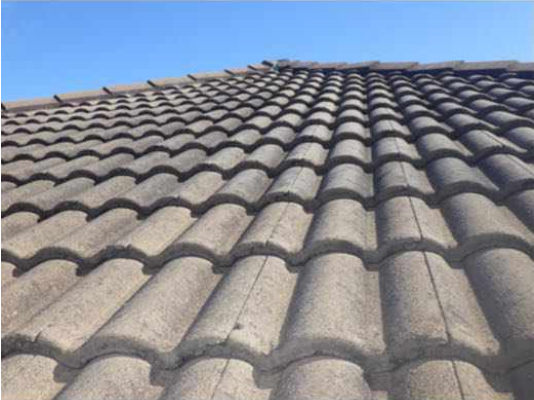
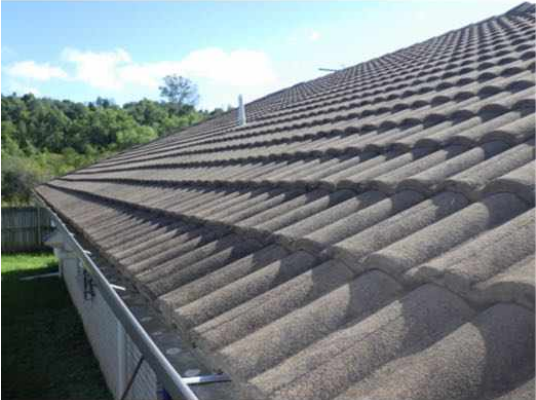
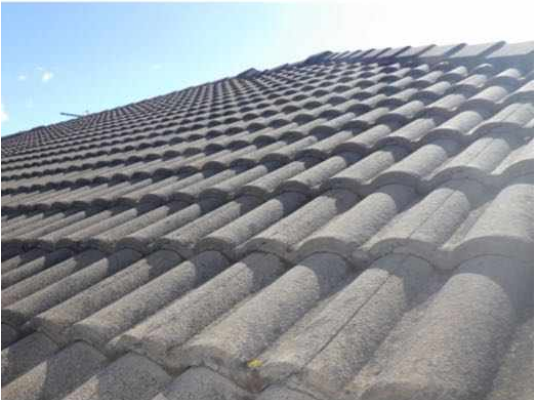
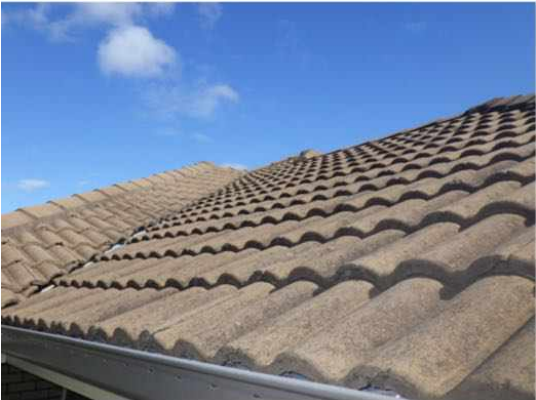
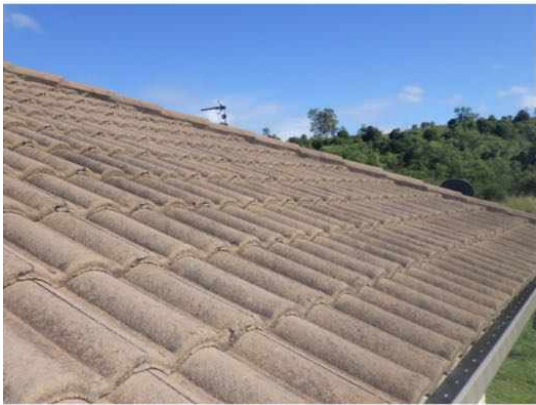
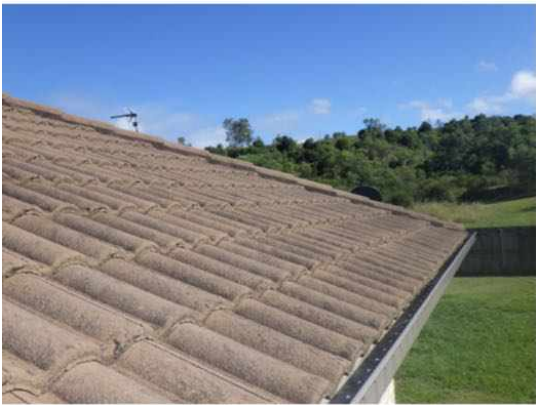
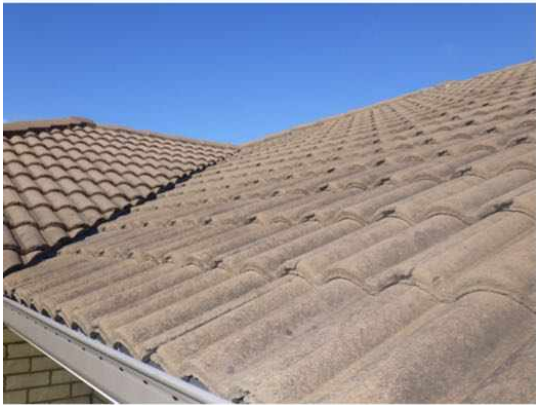
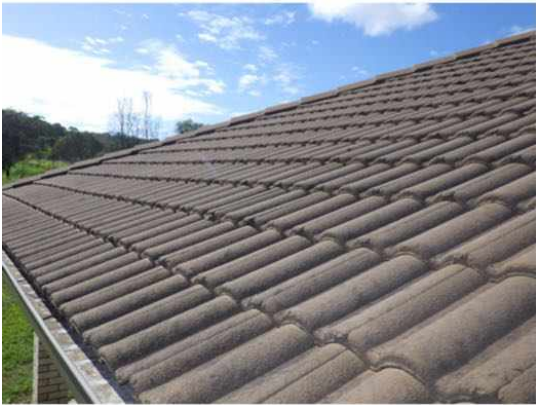
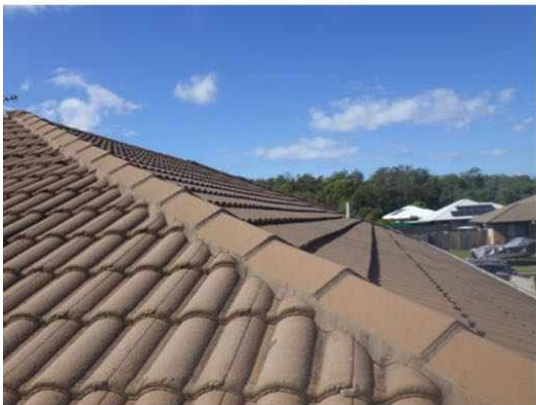
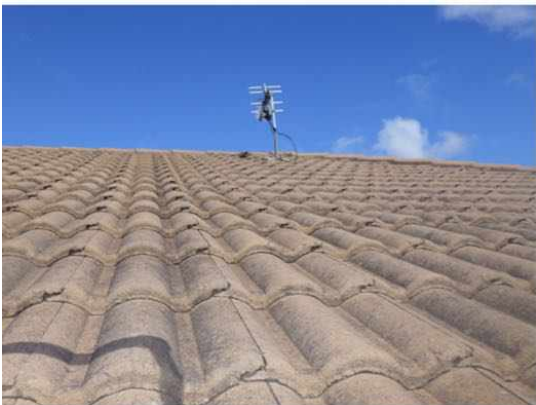
Building: Main Building  
Location: Roof Exterior > Existing  
Finding: No obvious defect  
Information: No obvious defects found at the time of inspection.

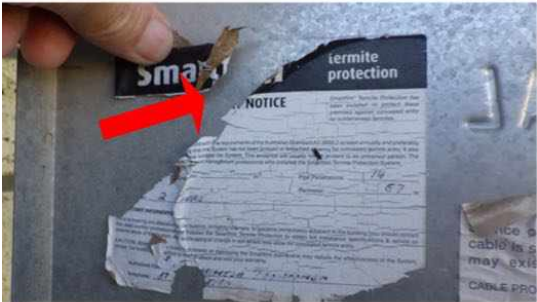
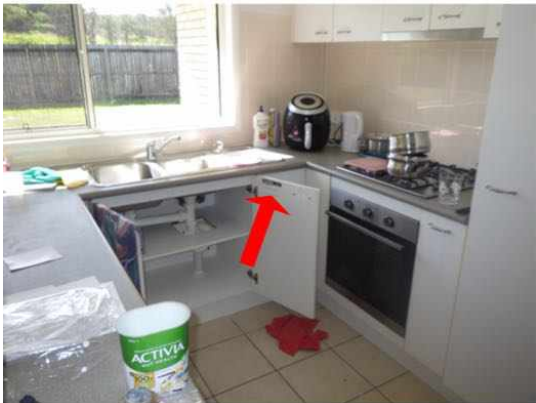
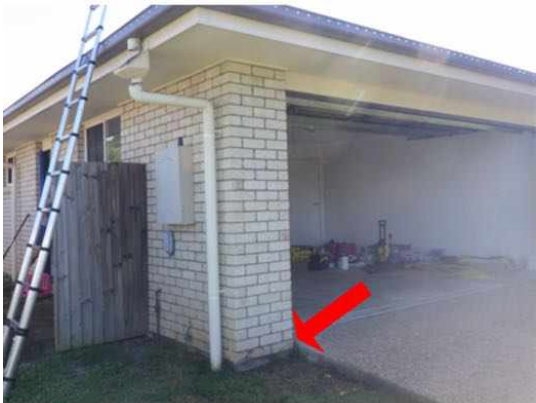
In this instance evidence of a previously installed physical barrier was observed, along with durable notice's inside the electrical meter box and kitchen area under sink cabinetry. This system requires regular annual inspections.

No evidence of regular or annual inspections was found.

Where a Termite Management System has been identified you should refer to the type of barrier date of installation warranty conditions and any documentation provided by the barrier installation company or past owner.
