Building and Timber Pest Inspection Report VR

Inspection Date: Thu, 20 Nov 2025

Property Address: 19 Hill St, Bundanoon NSW 2578,
Australia

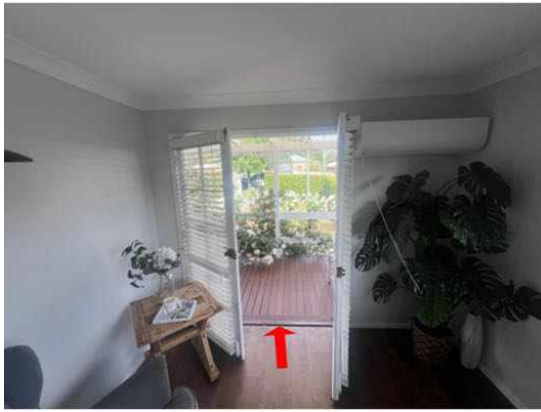
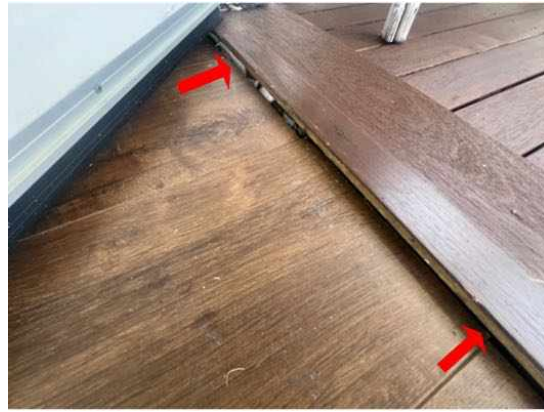
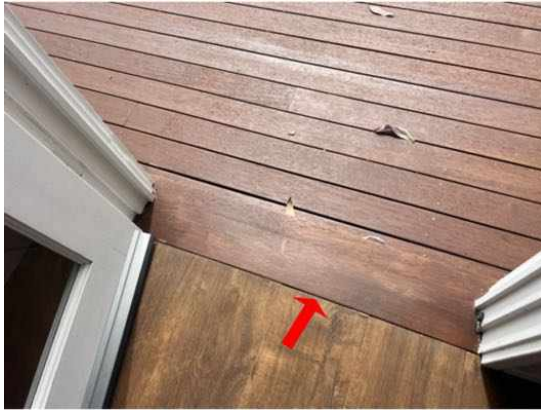
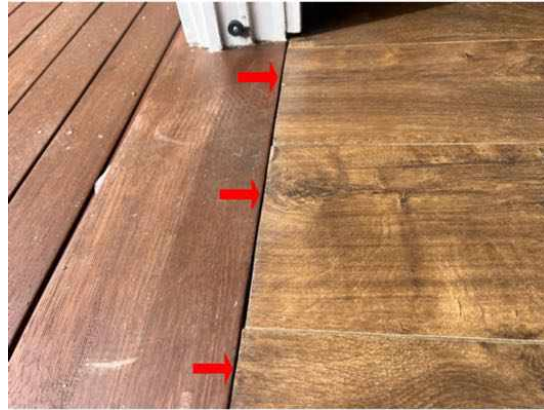
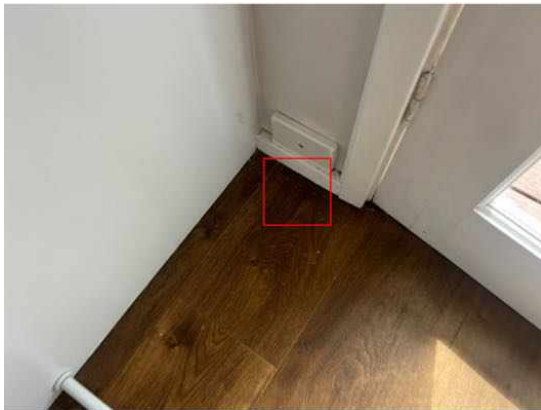
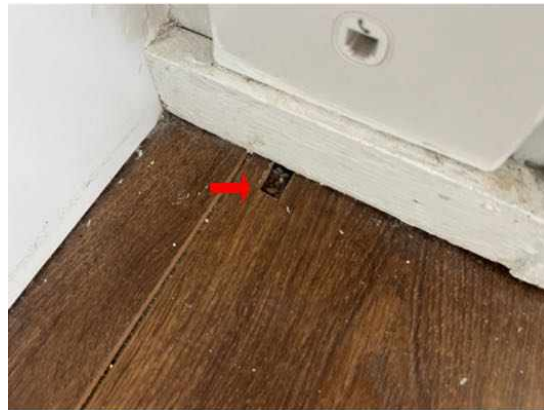
Finding 3.02

Information: The internal flooring in this area is out of level and uneven. Uneven flooring is likely to indicate minor defects such as expected movement of the foundations of the property, but may also indicate subsidence of the associated subfloor stumps.

Note: 600mm level used , deviations in levels for ne install of floors is 4mm over 2metres.

It is advised that the flooring be closely monitored to identify any further movement. Where flooring remains relatively unchanged for an extended period of time (i.e. several months), it is likely that this defect has been caused by expected movement of the foundations of the property.

However, where flooring is uneven further, potentially invasive inspection of the subfloor structures and stumps in this area is required. In this case, works to repair are likely to be required, and would be carried out by a registered builder specialising in re-stumping.

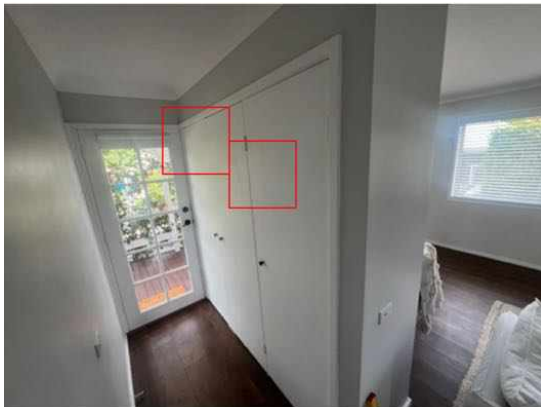
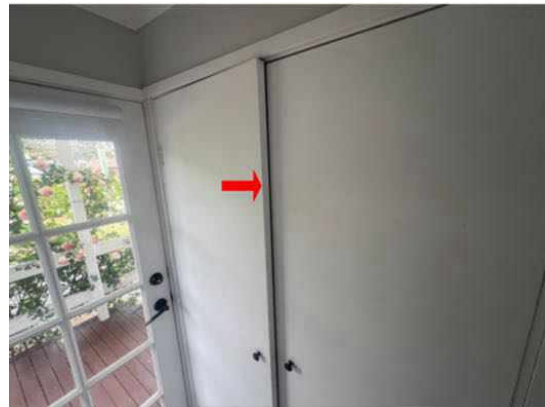
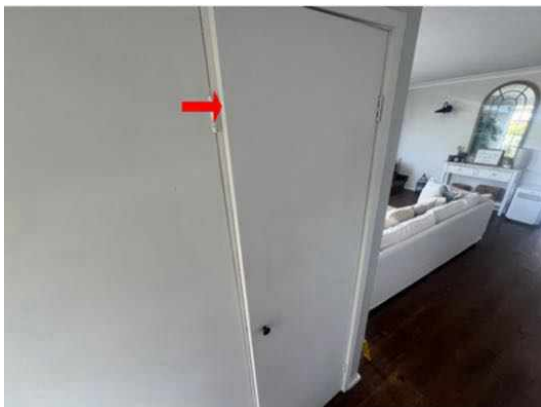
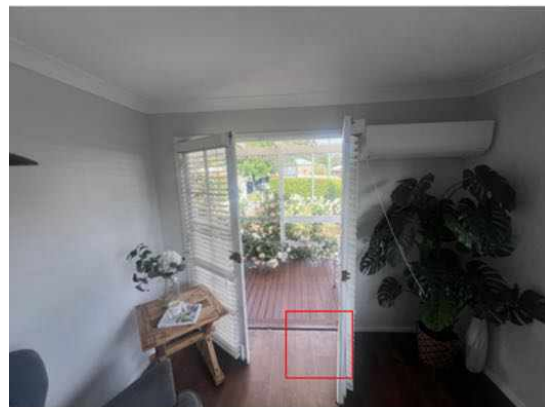
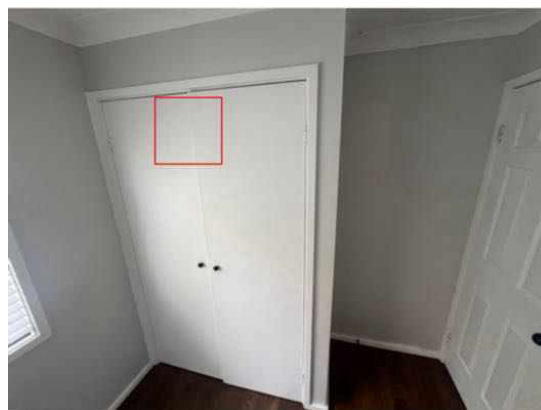
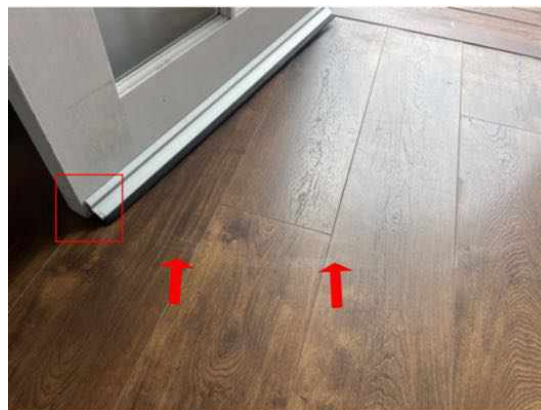
Finding 3.03

Building: Main Building
Location: Entry (linen), Sitting Room, Bedroom 3 (robe), verandah
Finding: Doors - Binding/Jamming
Information: Binding and/or jamming of several doors throughout the property were evident during standard operation. This defect inhibits the functionality of affected doors as well as creating potential for secondary defects to associated building elements, such as damage to the floor covering.

A door that binds to flooring or to the associated door frame may have several causes, ranging from minor defects, such as poor installation of the door or deteriorated hinges, through to major structural issues, such as damage to subfloor structures.

Where door binding/jamming appears to indicate major structural issues, a registered builder specialising in re-stumping should be appointed to provide an estimate on the cost of rectification.

For minor causes, a qualified carpenter or general handyperson should be appointed to perform minor rectification works at client discretion.

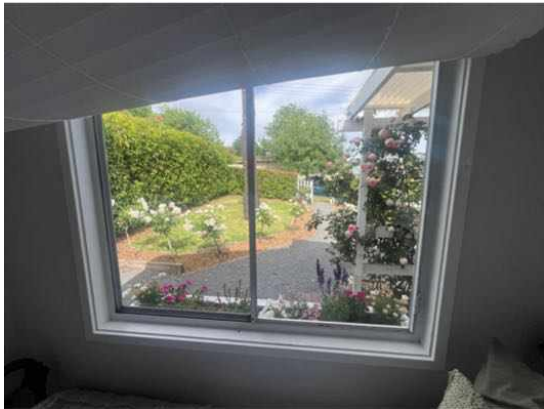
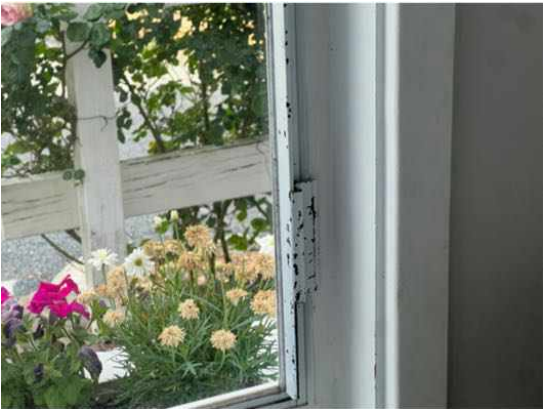
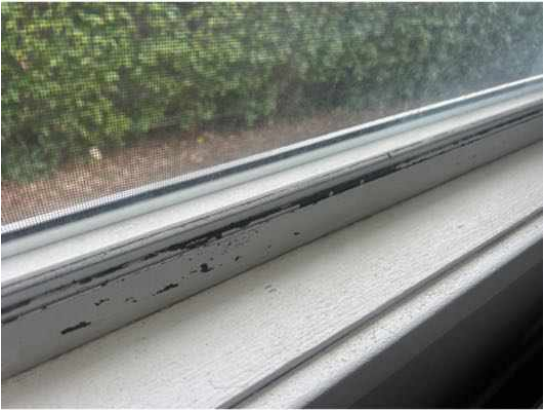
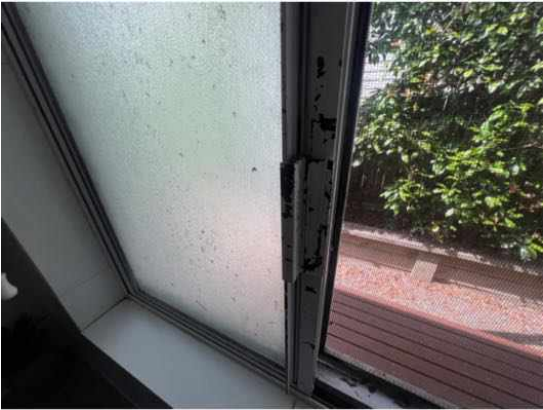
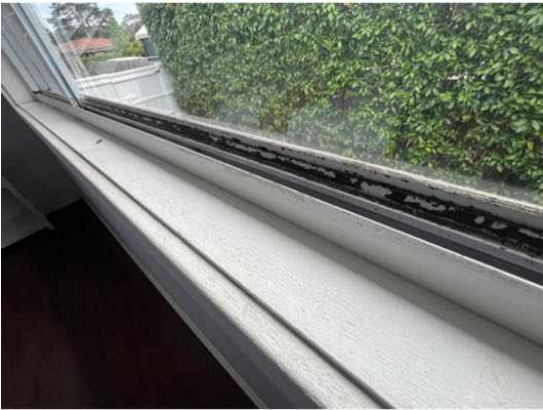
Finding 3.04

Building:	Main Building
Location:	All Internal Areas
Finding:	Painting deteriorated - Window frames throughout
Information:	The paint work in these areas of the property require attention to prepare and re paint. Whilst incomplete or missing paint finish is generally an appearance defect, it can also lead to the development of secondary building defects over time. Incomplete areas of paint finish exposes the area to moisture, potentially accelerating the deterioration of underlying building materials.

Degraded paint finishes should be sanded back, filled, leveled and painted, as applicable. Where inadequate or missing paint protection has led to the deterioration of the associated building element, repair and/or replacement of this building element may be required.

A painting contractor should be appointed at the clients discretion to perform necessary works to aid the appearance of the affected area and to ensure the area is protected against further deterioration. Alternatively, the homeowner following manufacturer instructions may perform these works

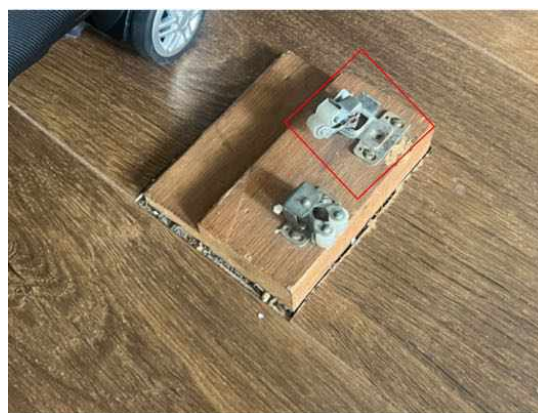
Finding 3.05

Building:	Main Building
Location:	Bedroom 3
Finding:	Building element - Damaged
Information:	Breakage occurs generally when the building materials have either aged and decayed, or as a result of damage (accidental or deliberate).

Repair and/or replacement of broken elements is advised to ensure that additional secondary defects do not arise as a consequence. Such works are necessary, as all building elements play a key role in the operation and function of the overall structure and its performance.

A handy person or carpenter should be appointed to repair or replace the affected building element prior to any subsequent damage being caused.

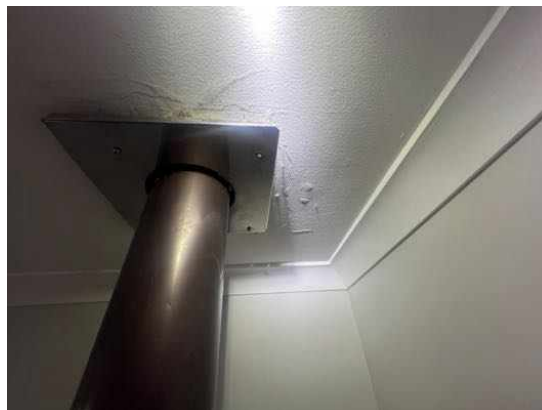
Finding 3.06

Building:	Main Building
Location:	Living Room
Finding:	Ceiling Paint - Flaking
Information:	Flaking paint was identified on the ceiling at the time of inspection. This defect is commonly caused by moisture ingress, poor surface preparation, or the natural ageing and deterioration of paint over time.

Flaking paint not only detracts from the aesthetic appeal of the ceiling but may also expose the underlying surface to further deterioration, including moisture absorption and potential damage.

It is recommended that a qualified painter be engaged to prepare and repaint the affected area to ensure proper adhesion and a durable finish. Investigation into potential underlying causes, such as moisture issues, should also be considered to prevent recurrence.

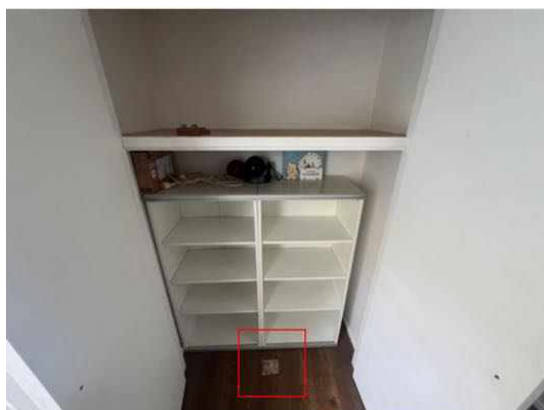
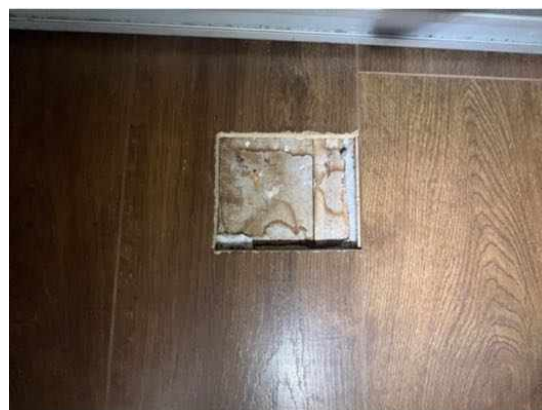
Finding 3.07

Building:	Main Building
Location:	Bedroom 2
Finding:	Incomplete or substandard works - flooring
Information:	The works to this area appear to be incomplete or have been completed to a substandard level.

Works that have not been completed to a satisfactory level create potential for the development of building defects and may impede on the safety and integrity of the overall structure.

It is highly recommended that a carpenter or flooring specialist be appointed to complete these works and ensure the safety of the area and the longevity of all associated building elements.

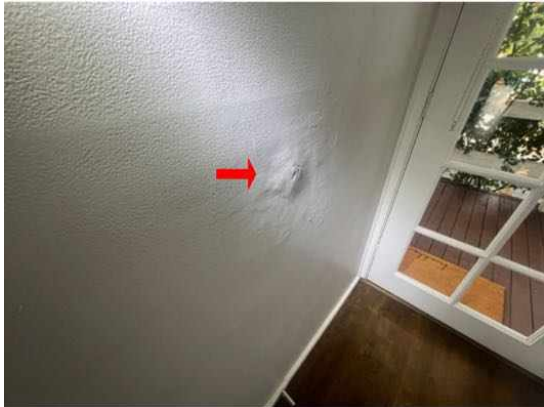
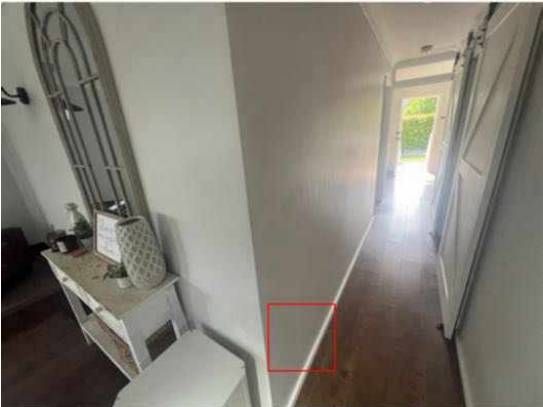
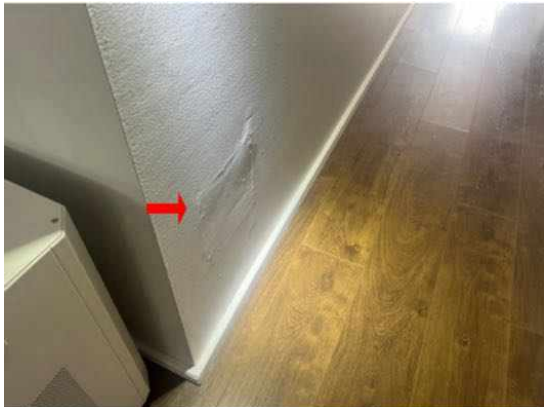
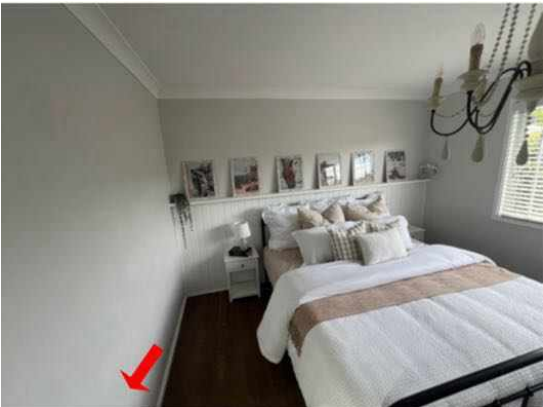
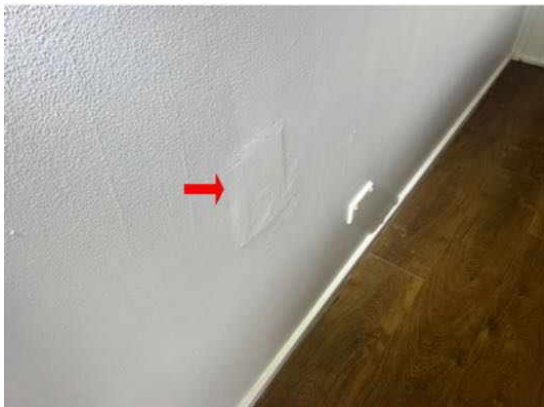
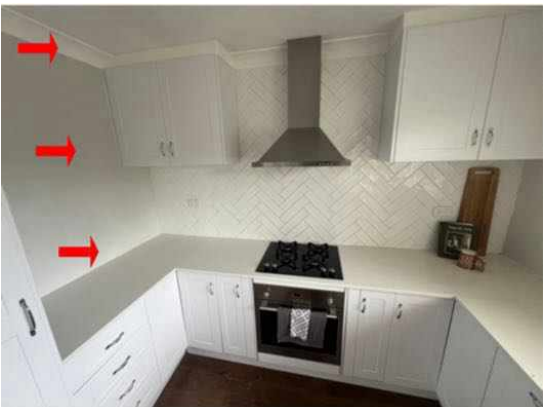
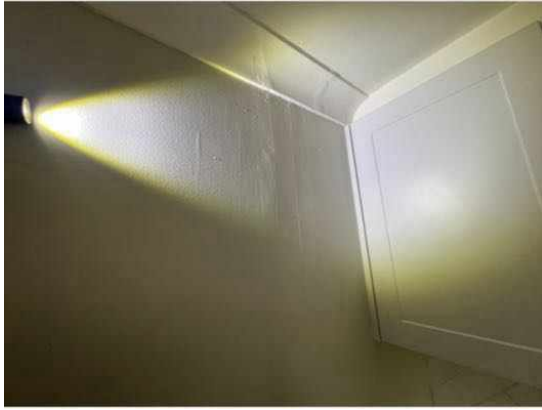
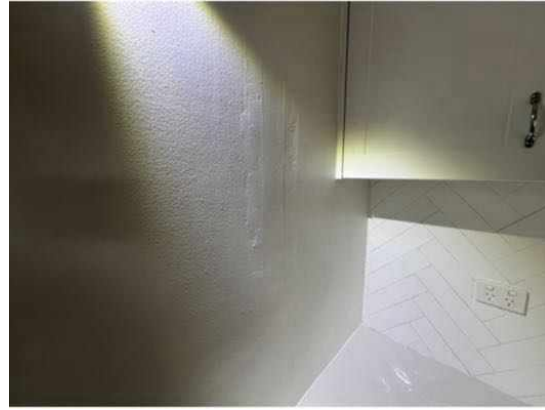
inappropriate materials, or a failure to complete the installation to an acceptable standard.

Where installation is substandard or incomplete, the client should engage a plasterer or registered builder to undertake rectification. Unfinished and poorly executed building work is more likely to deteriorate prematurely, potentially leading to secondary defects in associated building elements and affecting the overall aesthetic quality.

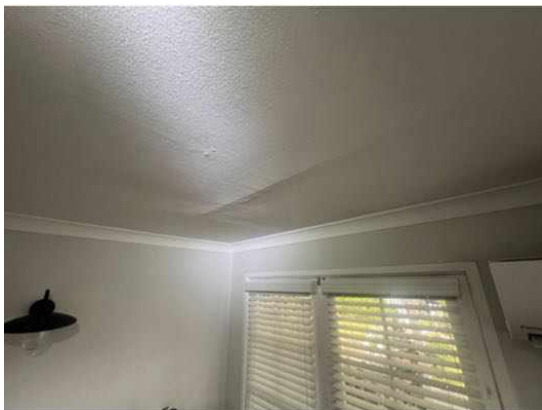
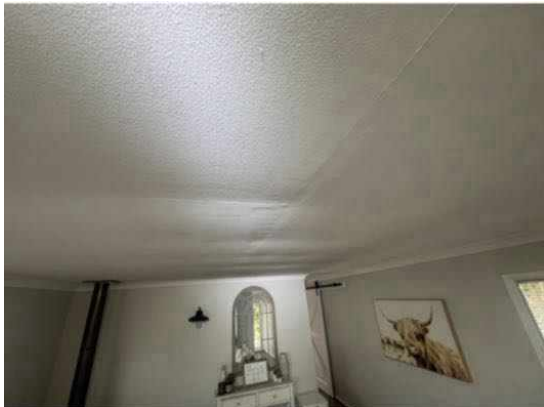
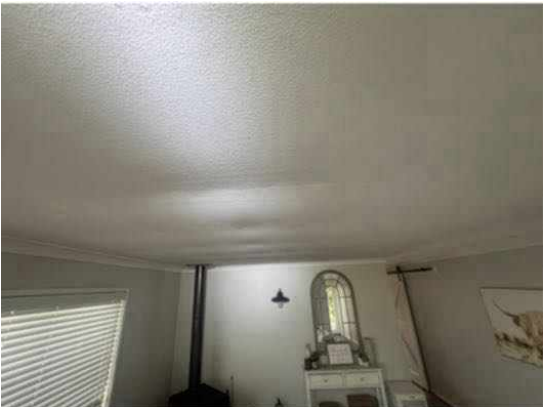
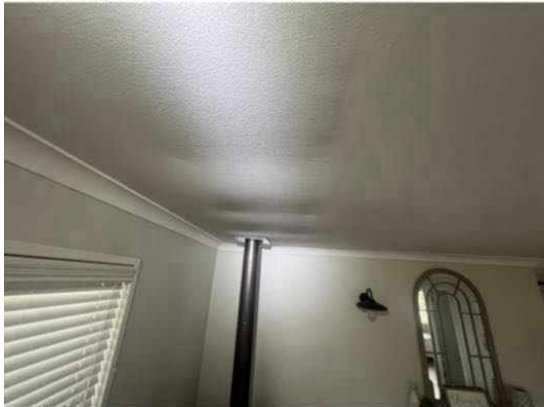
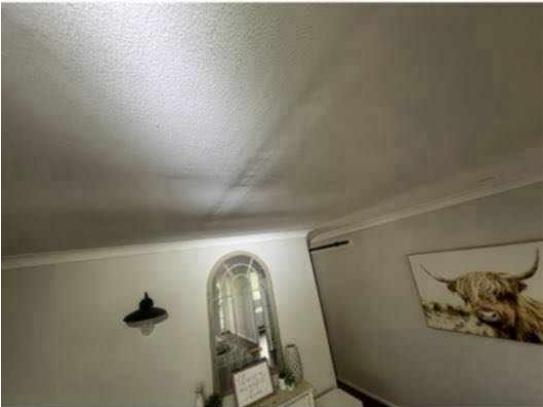
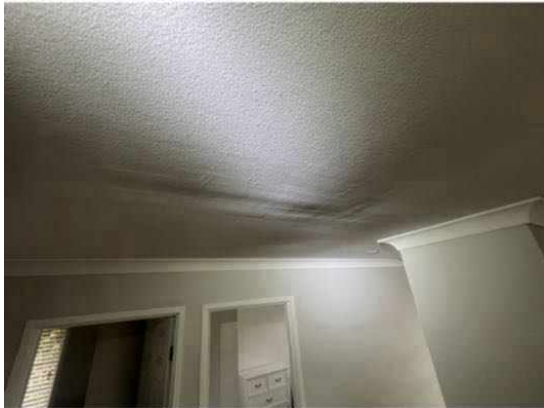
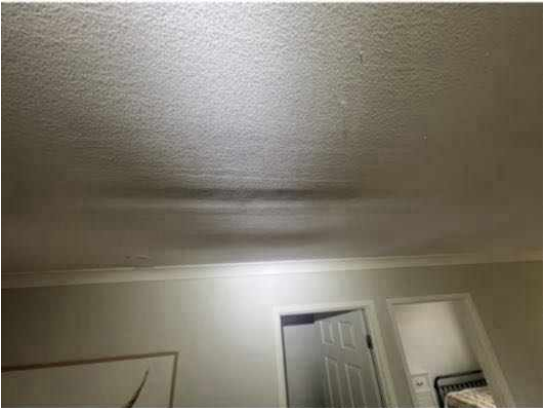
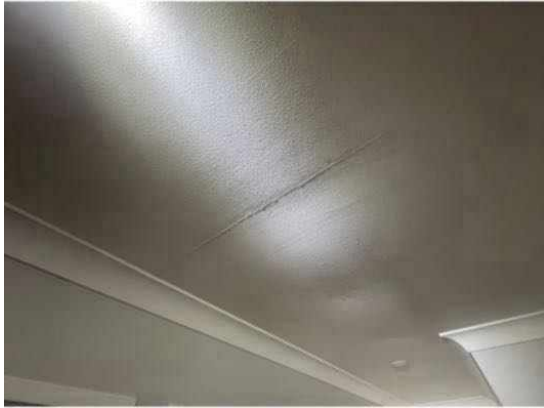
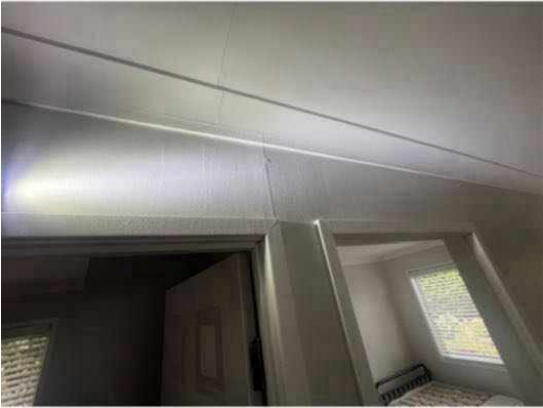
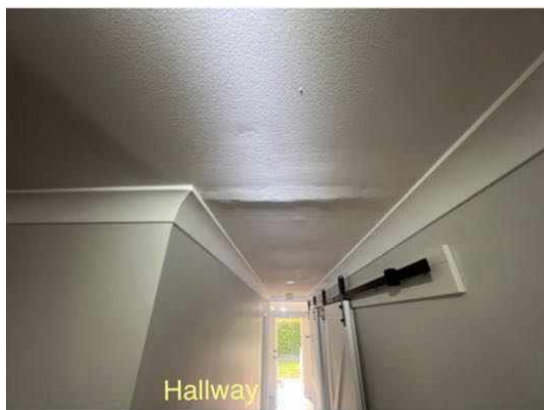
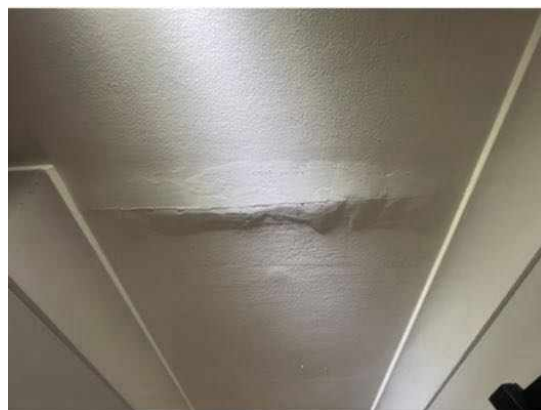
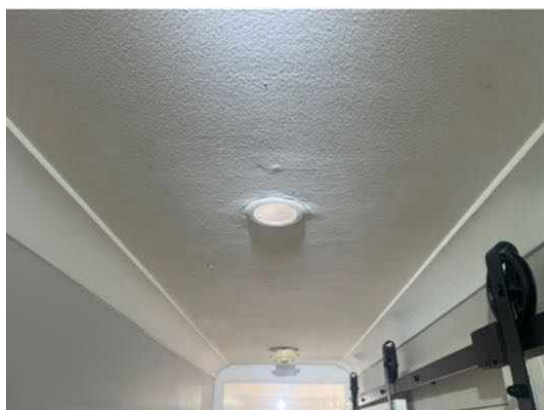
Finding 3.09

Finding: Ceiling - Sagging, Cracking, and Substandard Finishes

Information: The inspection identified several ceiling defects, including localised sagging, cracking, and inconsistent flushing of joint lines. Minor sagging across the ceiling surface suggests that back-blocking may have been omitted or inadequately installed. Cracking and uneven joint treatment were also noted, along with areas of substandard patching where prior repairs have not been completed to an acceptable finish.

These conditions are not considered structural but indicate surface movement and workmanship deficiencies that may worsen if deterioration continues. The affected areas should be assessed by a qualified plasterer to confirm the extent of movement and ensure appropriate repairs are undertaken to restore a uniform ceiling finish.

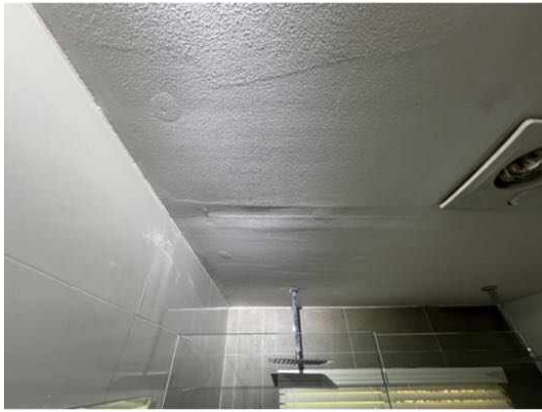
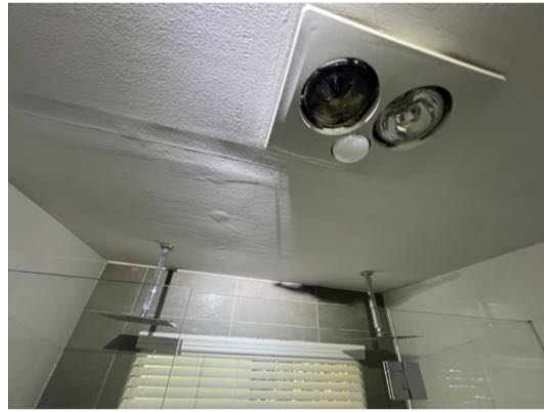
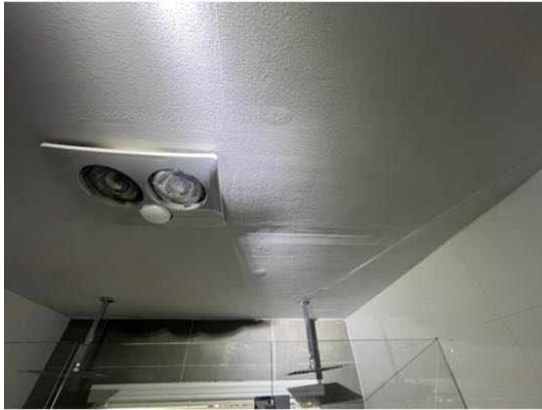
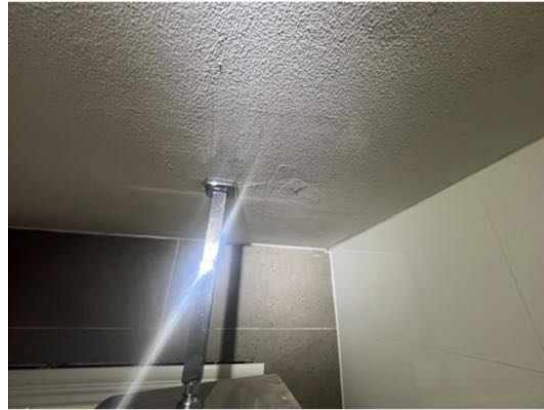
Finding 3.10

Building:	Main Building
Location:	Bathroom
Finding:	Ceiling - Incomplete or substandard works
Information:	The works to this area appear to be incomplete or have been completed to a substandard level.

Works that have not been completed to a satisfactory level create potential for the development of building defects and may impede on the safety and integrity of the overall structure.

It is highly recommended that a licensed plasterboard contractor should be appointed to repair the ceiling. To ensure the safety of the area and the longevity of all associated building elements.

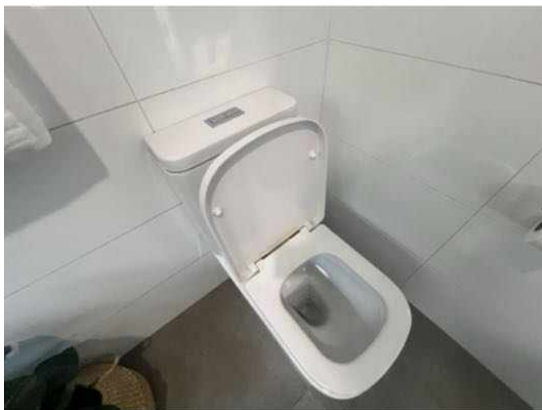
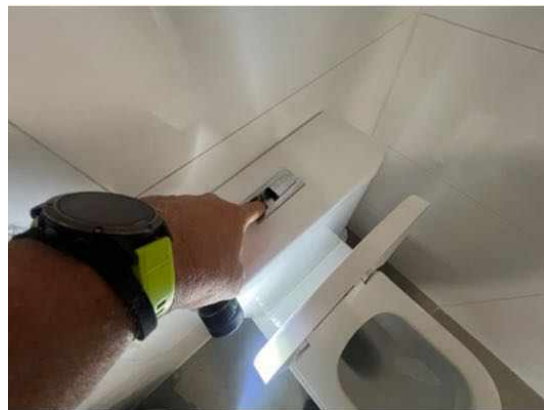
Finding 3.11

Building:	Main Building
Location:	Bathroom
Finding:	Toilet - Not flushing
Information:	Non-operational items should be addressed to ensure that the full function of the building structure is available. Where some building elements are not operating as intended, it is possible that secondary building defects could arise due to their non-operation.

Repair and/or replacement of the faulty building element is recommended. It is highly recommended that a licensed plumber be engaged to perform any necessary works.

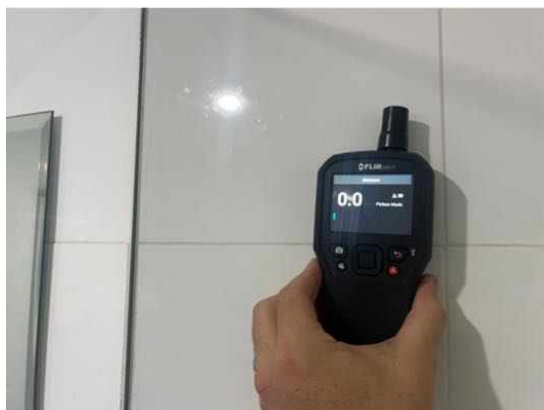
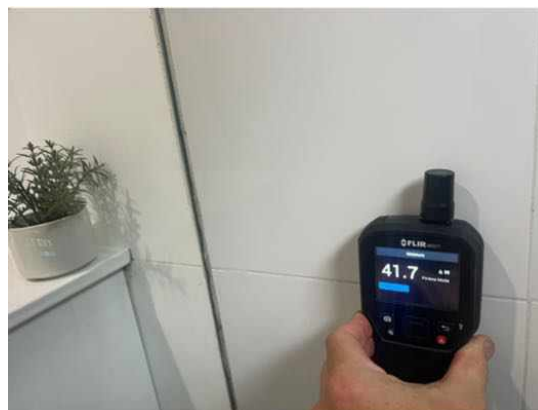
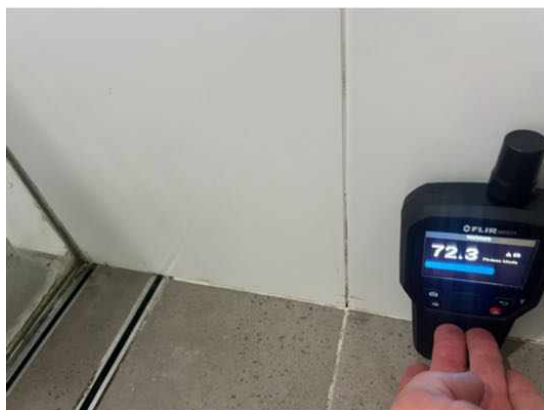
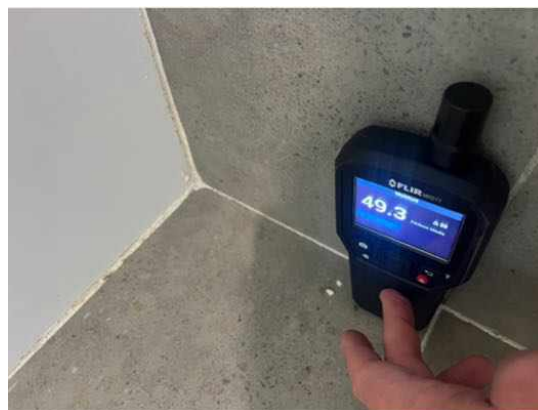
Finding 3.12

Building:	Main Building
Location:	Bathroom
Finding:	Moisture in Shower (BV1)
Information:	Moisture is evident behind the tiles to the shower alcove. This defect is quite common, and is suspected to have been caused by moisture permeating through the grouting in this area. Leaking pipes within the adjoining wall is also a possible cause.

Damp (or structural damp) refers to the presence of unwanted moisture in the structure of a building, either as the result of intrusion from outside, or condensation from within the structure. In the shower area, internal water leaks or other sources of excessive moisture are generally the cause of damp. Always ensure that sealant and grout is in good condition to prevent any moisture issues occurring in the future.

Consultation with a qualified plumber or bathroom specialist is advised to identify the cause of damp and to perform remedial works as required.

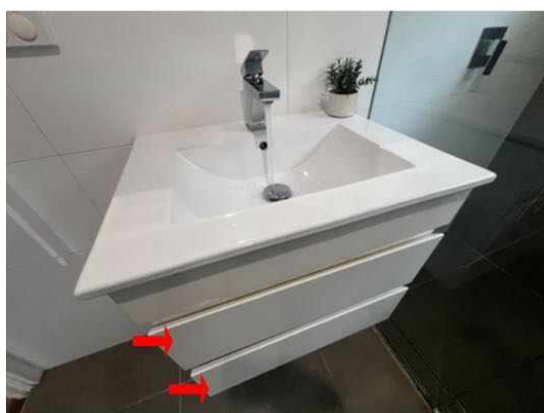
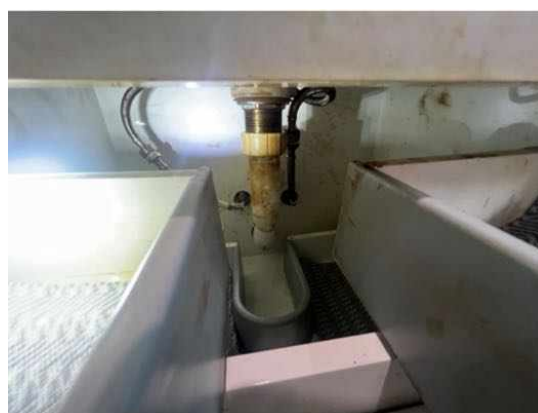
Finding 3.13

Building:	Main Building
Location:	Bathroom
Finding:	Misaligned Vanity Doors/Drawers
Information:	The Joinery doors and doors are identified as not closing properly at the time of inspection. These defects may result from wear and tear, movement of materials, or substandard installation.

It is recommended that a qualified cabinet maker, joiner or handyman to be engaged to realign the door to ensure proper functionality and a tidy appearance.

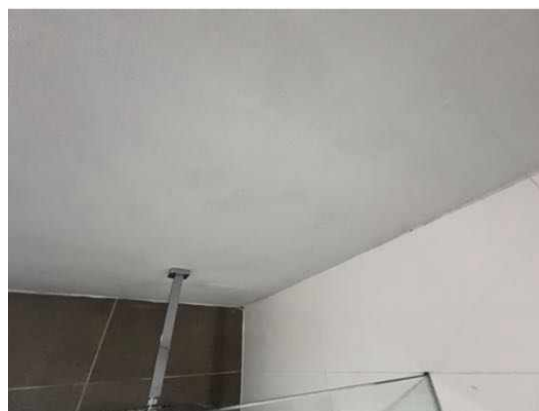
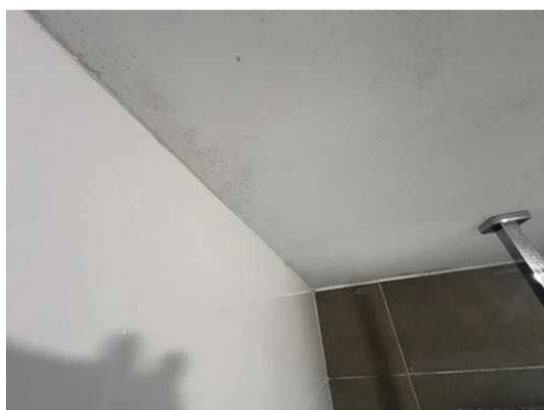
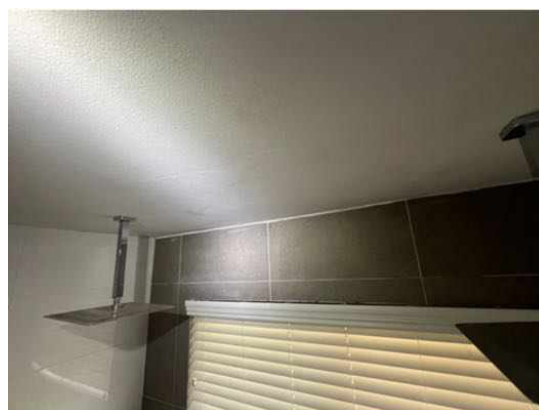
Finding 3.14

Building:	Main Building
Location:	Bathroom
Finding:	Mould - ceiling
Information:	Mould spotting was observed on the ceiling at the time of inspection. This condition is typically indicative of prolonged moisture exposure, which may be caused by water ingress, inadequate ventilation, or condensation buildup.

If left unmanaged, persistent moisture can lead to further mould growth, deterioration of building materials, and potential health concerns.

It is recommended that a licensed plumber or building professional be engaged to investigate the source of moisture and undertake any necessary remedial works. Remediation of the mould-affected areas should also be carried out to prevent further deterioration.

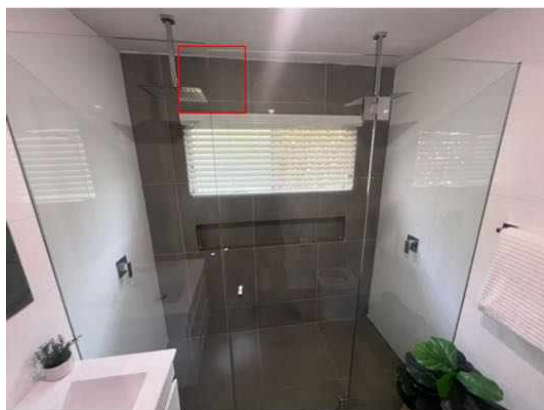
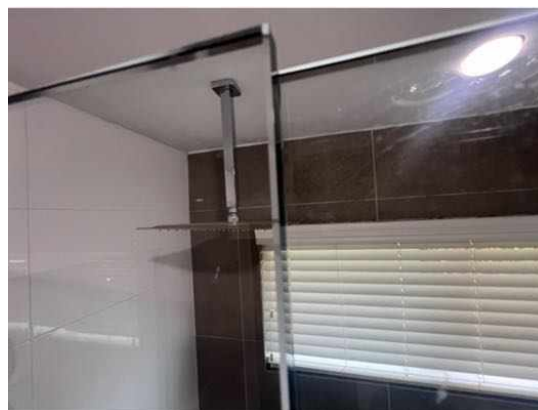
Finding 3.15

Building:	Main Building
Location:	Bathroom
Finding:	Shower Screen - Door Contacting Fixed Panel
Information:	The frameless shower screen door was observed to contact the adjoining fixed glass panel when opened or closed. This condition indicates poor alignment or insufficient clearance between panels. Repeated impact may lead to chipping of the glass edges, stress fractures, or loosening of fittings over time.

A licensed glazier should be engaged to inspect the shower screen assembly, realign the door, and ensure all fittings are secure and operating smoothly to prevent further damage.

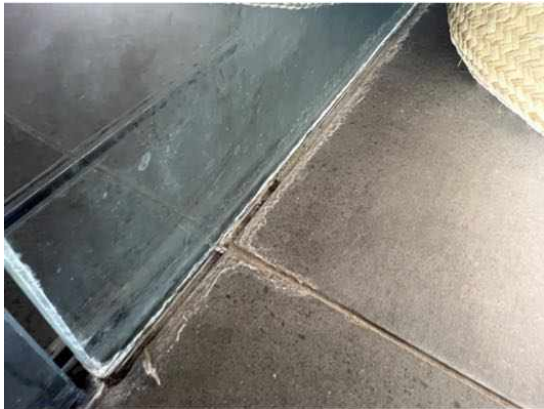
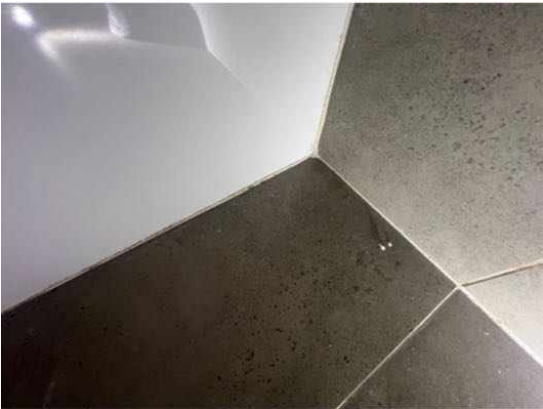
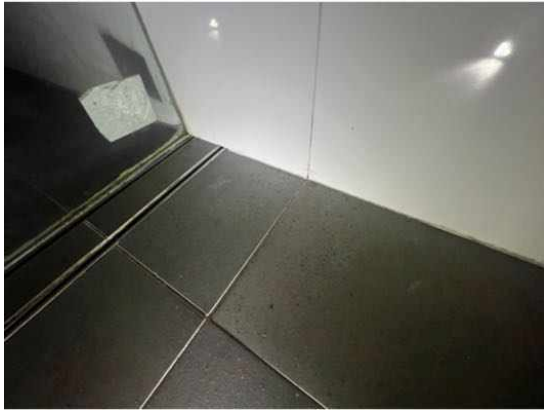
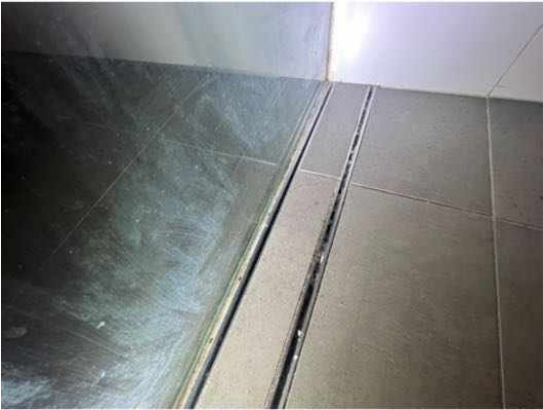
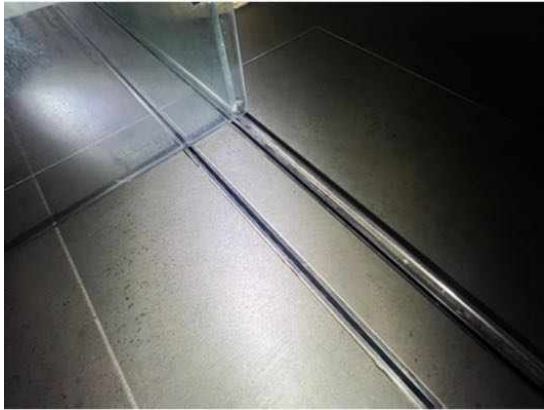
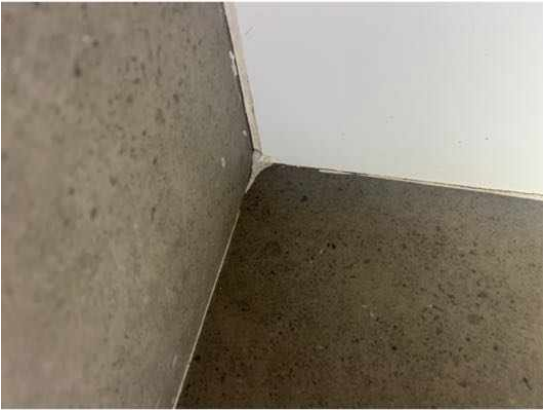
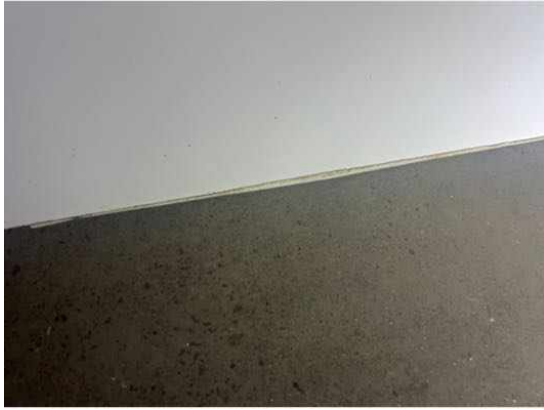
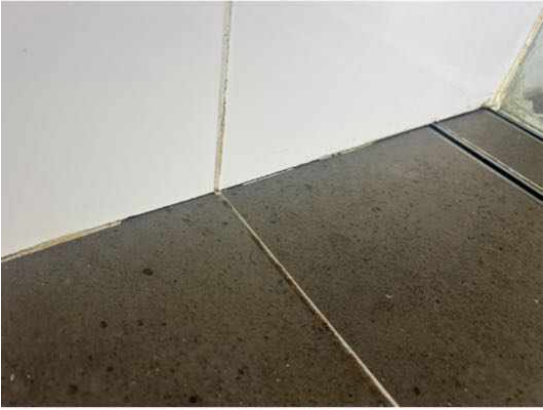
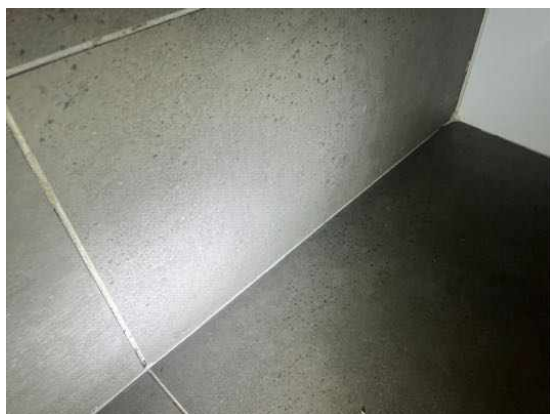
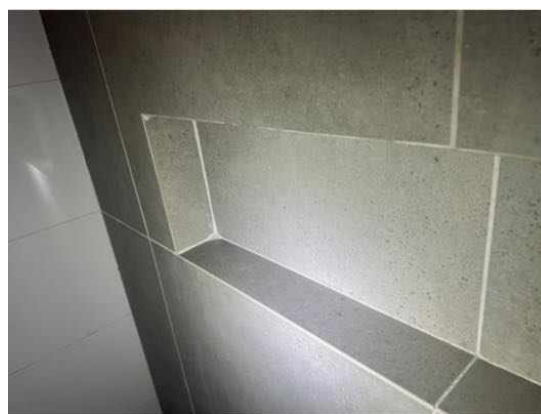
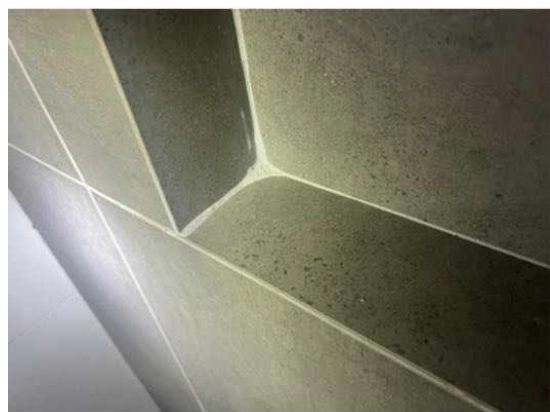
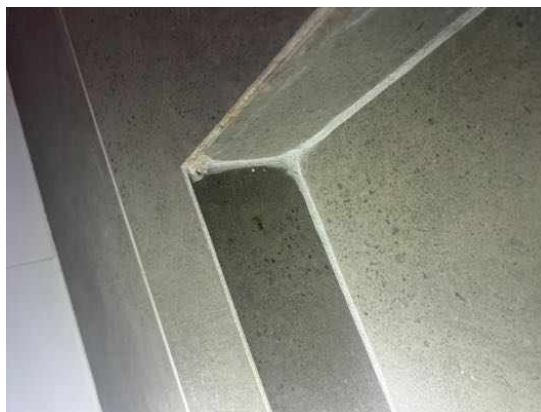
Building:	Main Building
Location:	Bathroom
Finding:	Shower damp - Sealant and grout
Information:	Damp is evident to the lower 400mm of wall to the shower alcove. This defect is quite common, and is suspected to have been caused by moisture permeating or leaching through the grouting and sealant in this area, which shows evidence of deterioration. Leaking pipes within the wall is also a possible cause however this seems unlikely in this instance as there is no moisture build up around the taps or transferring to the other side of the wall. There appears to be no sealant around the tap spindles which may be a small contributing factor.

Damp (or structural damp) refers to the presence of unwanted moisture in the structure of a building, either as the result of intrusion from outside, or condensation from within the structure. In the shower area, internal water leaks, degraded materials or other sources of excessive moisture are generally the cause of damp.

Unmanaged damp in the shower recess is likely to facilitate the formation and development of mould and fungi growth, decaying associated building materials and compromising their structural integrity of associated elements. It is important to address damp conditions, as the World Health Organisation notes that excess moisture leads - on almost all indoor materials - to growth of microbes such as moulds, fungi and bacteria, which subsequently emit spores and other matter into the indoor air. Exposure to these contaminants is associated with a wide range of respiratory and other health-related problems. Damp conditions also create a conducive environment for termite infestation.

Consultation with a bathroom sealant specialist is advised immediately to identify the cause of damp and to perform remedial works as required.

Always ensure that sealant and grout is in good condition to prevent any moisture issues occurring in the future.

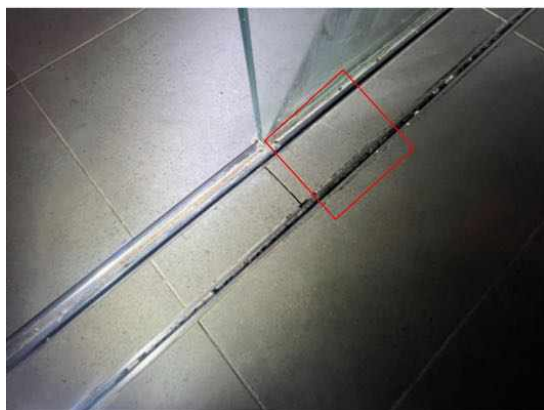
Finding 3.17

Building:	Main Building
Location:	Bathroom
Finding:	Tiles - Cracked or damaged
Information:	Cracking was evident to the tiling in this area at the time of inspection. While the cracking appears to be minor, this area is frequently exposed to water, allowing potential for water penetration into adjoining sections of walls or flooring.

If left unmanaged, water penetration to these areas may lead to subsequent water damage, which is likely necessitate repair work to affected building elements.

A tiling contractor should be appointed to ensure that no further water damage occurs. The re-application of silicone and grouting throughout remaining tile work is also advised, to further protect the area against water penetration.

Where water penetration has led to water damage, appointment of a relevant tradesperson may be required to repair damaged building elements.

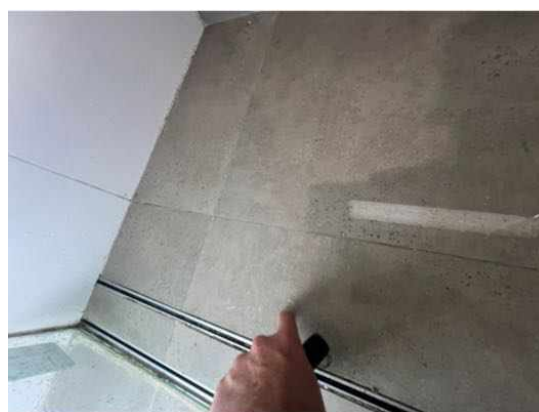
Finding 3.18

Building:	Main Building
Location:	Bathroom
Finding:	Shower base - Water pooling
Information:	Evidence of water pooling around the floor waste in the shower recess was noticed at the time of inspection. It is suspected that this excessive moisture is attributed to insufficient fall in the shower floor tiles.

This pooling is minor overall but is still considered unsatisfactory, as standard tiling practices would not permit this situation to occur. Pooling water around floor wastes can create a slip hazard in extreme cases and create conditions that are conducive to mould growth over time. Where left unmanaged, the degradation of sealant and grouting is also likely to occur, possibly necessitating further repair works.

Remedial works may involve some sections of tiling and flooring repair and replacement. A tiling contractor or bathroom specialist should be appointed to provide further advice on reparation options and to perform works as necessary.

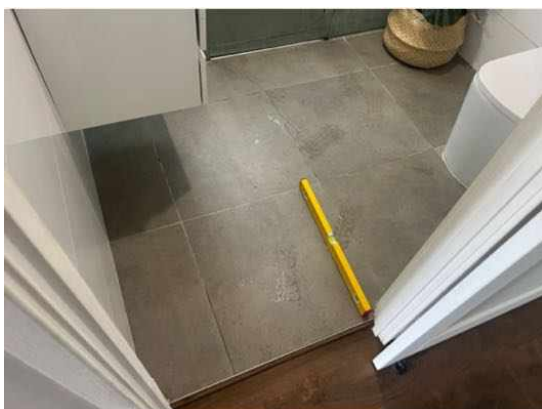
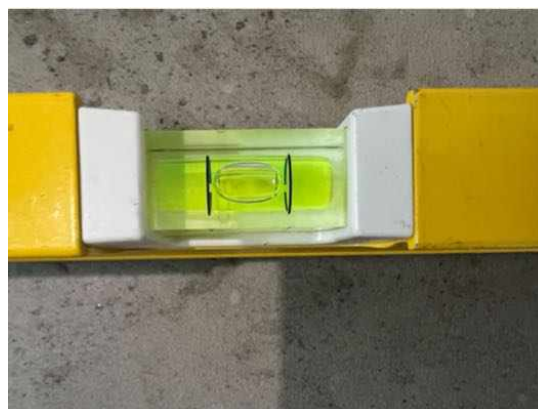
Finding 3.19

Building:	Main Building
Location:	Bathroom

Finding: Incorrect fall
Information: Water in the wet area was observed to be tracking toward the doorway instead of draining completely to the floor grate. This indicates inadequate fall, which may lead to pooling, water damage to surrounding areas, and potential slip hazards.

A registered builder or a licensed floor and wall tiler should be appointed to assess and rectify the floor gradient to ensure effective drainage and prevent moisture-related defects.

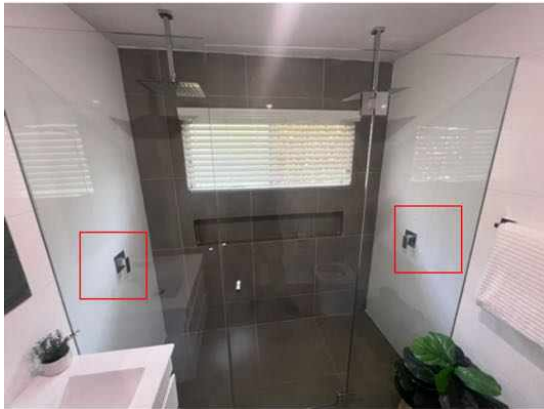
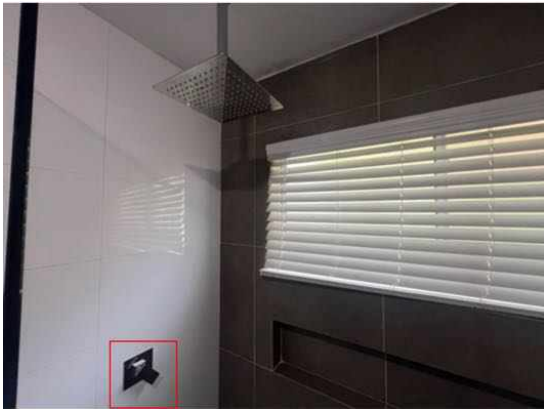
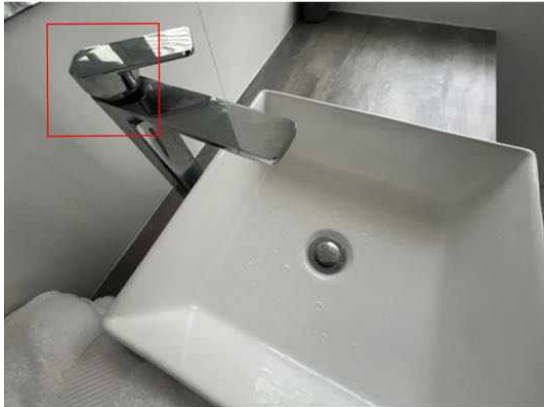
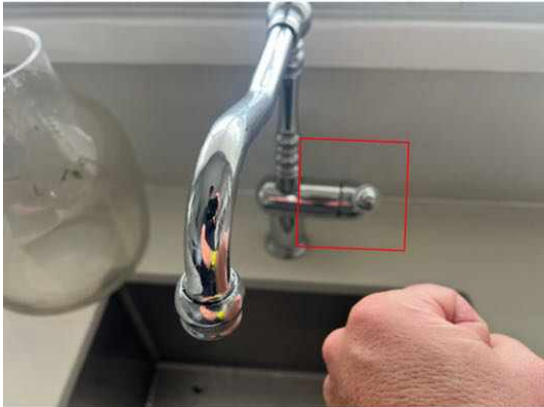
Finding 3.20

Building: Main Building
Location: Bathroom. Laundry, Kitchen
Finding: Tap - Water hammer
Information: This tap shows evidence of water hammer being present. Water hammer, a pressure surge resulting when a fluid is forced to suddenly change direction, is a common defect in plumbing fittings, particularly those that are aged and not frequently maintained. Water hammer is generally caused by factors that create high water pressure in the affected plumbing fixture, usually evidenced by a faint banging noise during operation of the affected tap.

Although water hammer is generally considered to be a minor defect, subsequent damage such as erosion of tap hardware and/or water damage to associated building elements is likely to occur if left unmanaged.

A licensed plumber should be appointed as soon as possible to replace any affected tap hardware and perform any remedial works as necessary. Please be advised that the appointment of a cabinet maker or qualified carpenter may be necessary if water damage to associated building elements has occurred.

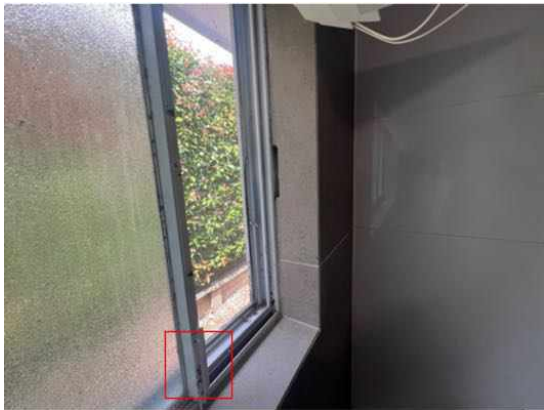
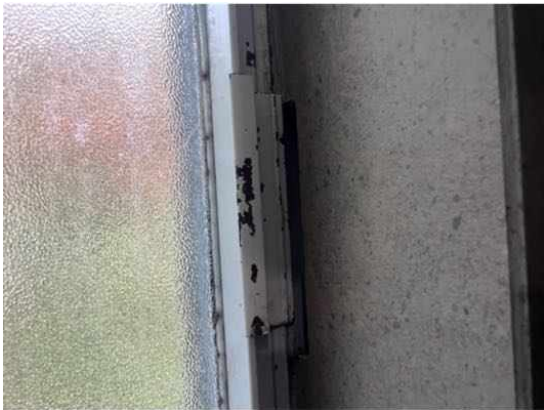
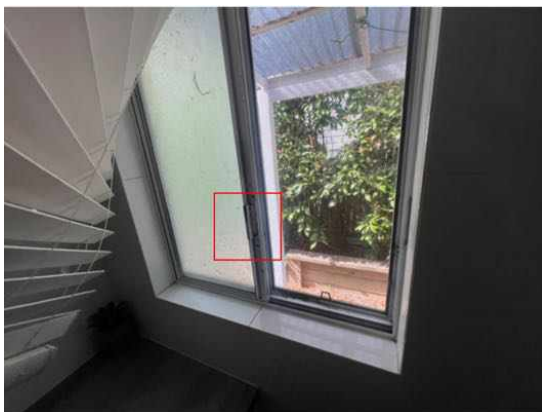
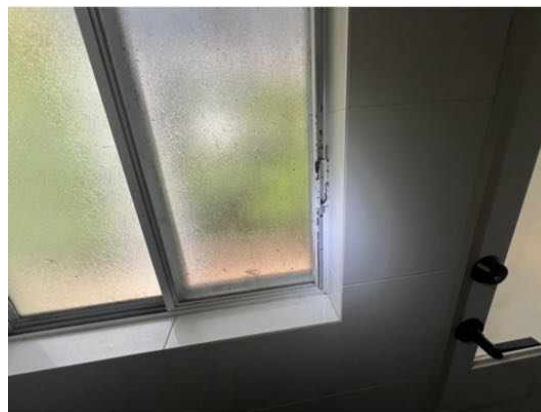
Finding 3.21

Building: Main Building
 Location: Bathroom, Laundry
 Finding: Window Lock - Obstructed by Tiled Reveal
 Information: The window lock was found to be non-functional due to interference from newly installed tiles within the window reveal. The additional tile thickness prevents the locking mechanism from fully engaging.

While this defect does not affect structural performance, it restricts proper operation and security of the window. A qualified handyman or carpenter should be engaged to adjust the lock mechanism or modify the reveal to allow full function of the lock.
