Building and Timber Pest Inspection Report VR

Inspection Date: Thu, 20 Nov 2025

Property Address: 19 Hill St, Bundanoon NSW 2578,
Australia

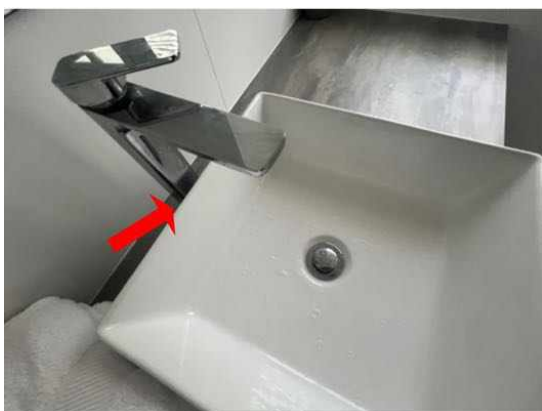
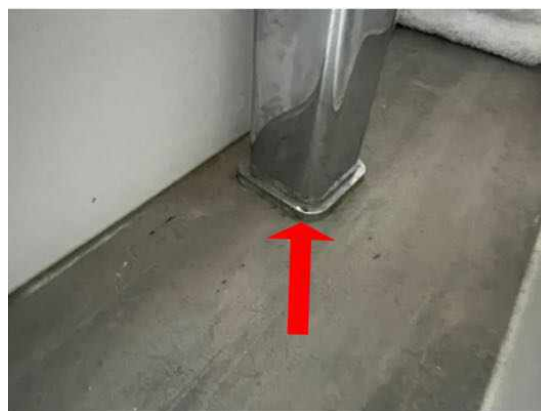
Finding 3.22

Finding: Tap - Loose

Information: The tap in this area has not been installed correctly, or has deteriorated with age, and is consequently loose. This tap being loose creates potential for water leaks and subsequent water damage to the surrounding area.

Where taps or spouts are loose, a qualified plumber should be appointed to re-fix the plumbing fitting.

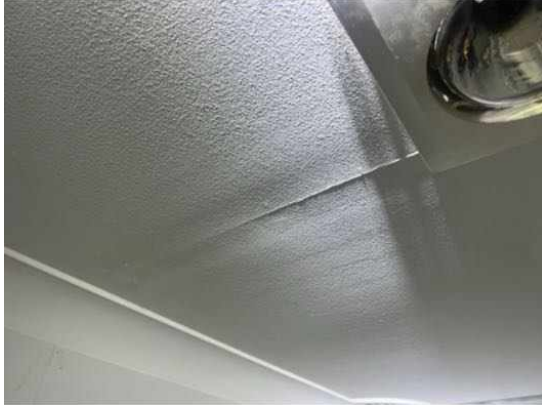
Finding 3.23

Finding: Ceiling – hairline crack

Information: Hairline linear cracking was observed at butt joints between ceiling sheets. This type of cracking is commonly caused by minor settlement movement, material shrinkage, or general aging flexing along joint lines over time.

While these issues are largely cosmetic at this stage, they indicate a history of movement. If left unmanaged, further deterioration or more noticeable ceiling

deformation may occur.

It is recommended that a qualified plasterer or painter be engaged to assess and undertake remedial works to ensure the ceiling is properly prepared and refinished to an acceptable standard.

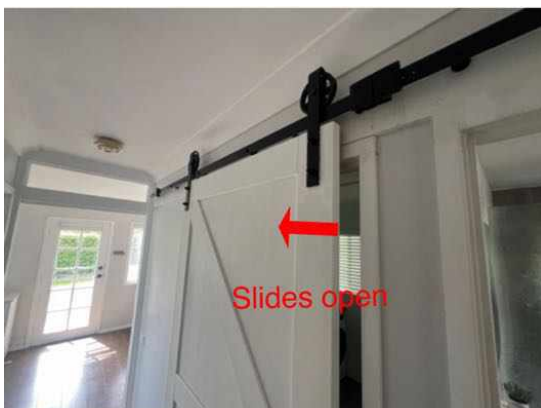
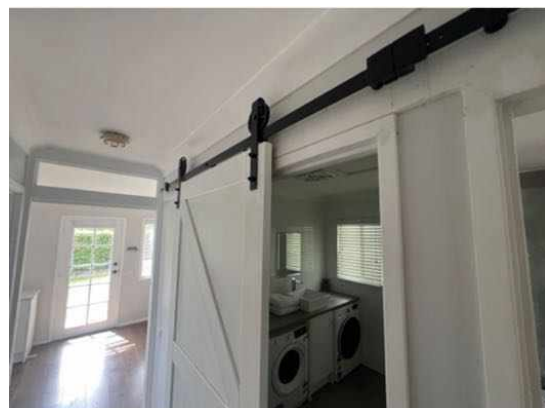
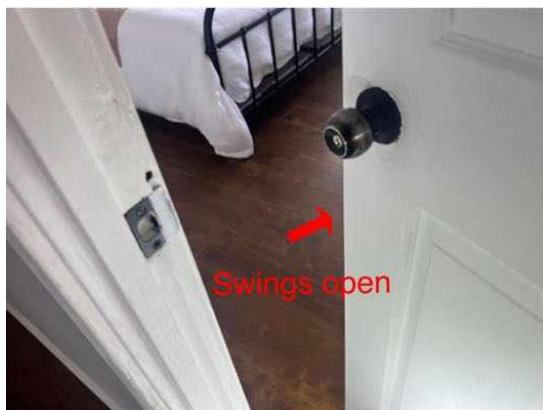
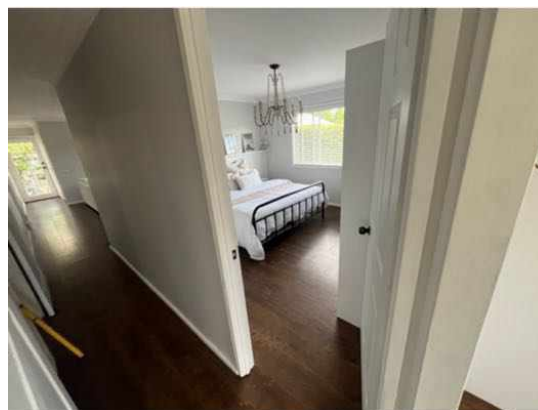
Finding 3.24

Building:	Main Building
Location:	Laundry, Bedroom - Master
Finding:	Door - swings drifts open not stationary
Information:	The door was observed to swing or drift open and closed on its own, failing to remain stationary when positioned. A properly installed door should stay in place unless intentionally moved, and this condition is typically caused by a substandard door or jamb installation, or slight unevenness in the floor surface.

While not structural, this defect is inconvenient and detracts from normal use. A carpenter or general handyperson should be engaged to inspect the installation and make necessary adjustments to ensure the door remains stable when open or closed.

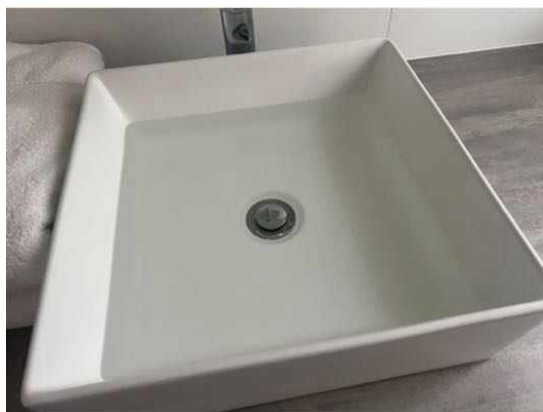
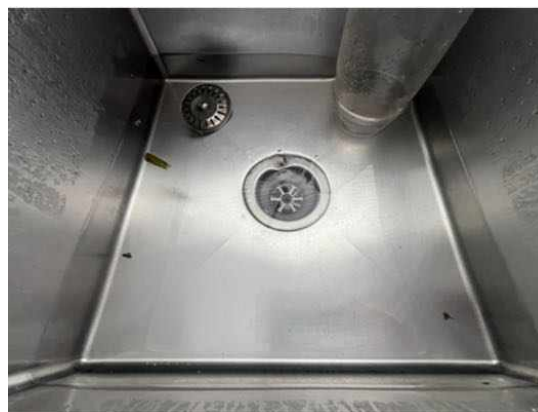
Finding 3.25

Building:	Main Building
Location:	Laundry, Kitchen
Finding:	Sink - Slow Drainage
Information:	The sink was noted to be draining slowly at the time of inspection. This condition is commonly caused by a partial blockage within the waste pipe or inadequate fall in the plumbing line.

If left unresolved, slow drainage may worsen over time and lead to further blockages or overflows. A licensed plumber should be engaged to investigate the cause and carry out any necessary cleaning or rectification to restore proper function.

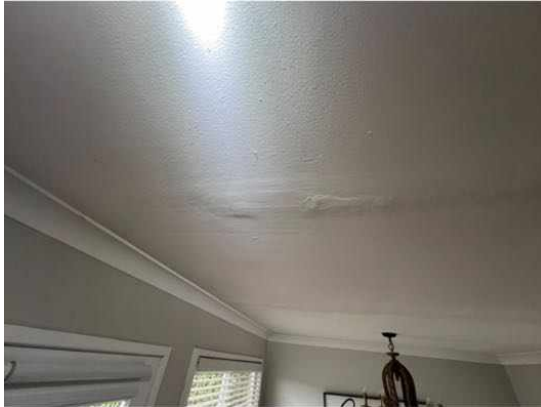
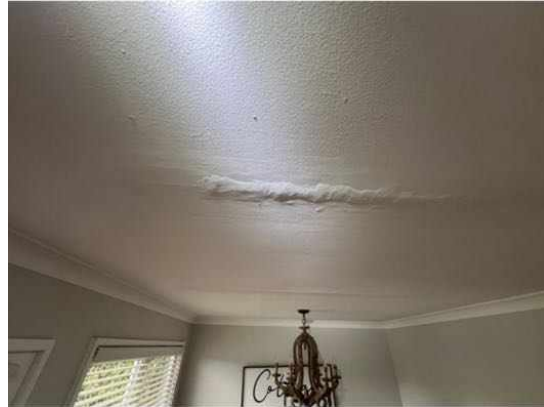
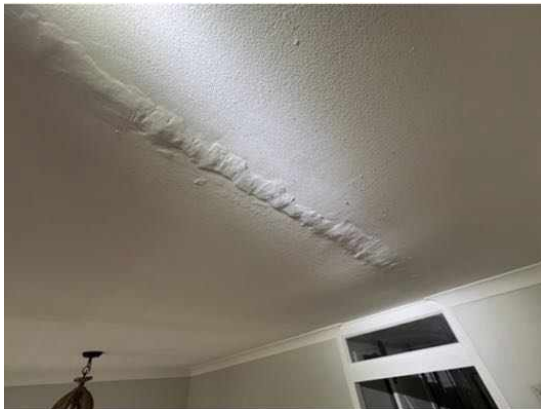
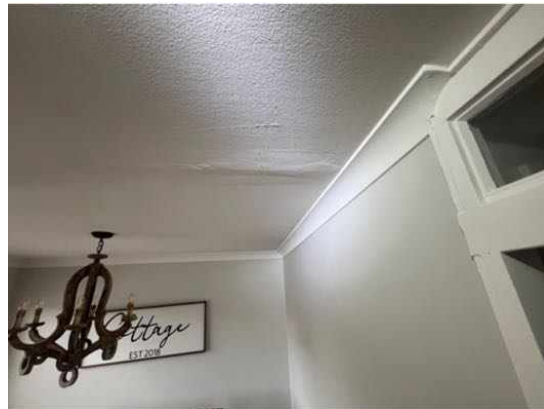
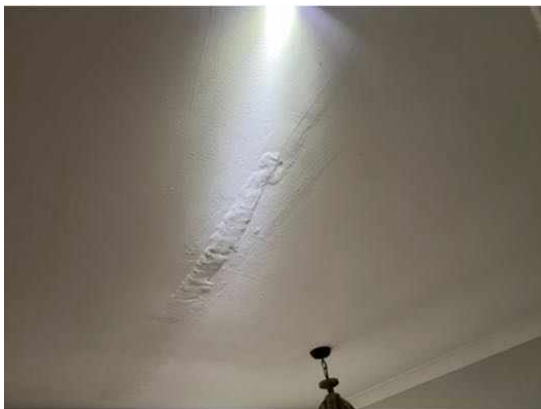
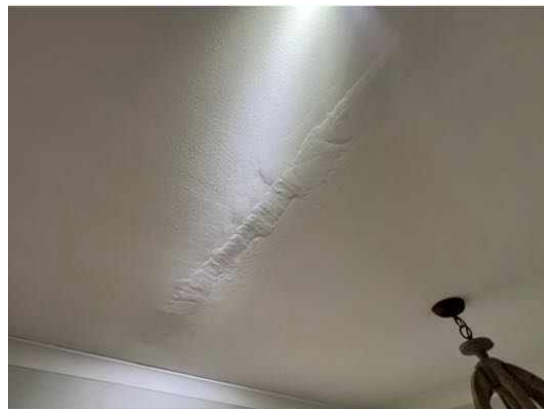
Finding 3.26

Building:	Main Building
Location:	Dining Room
Finding:	Ceiling - Incomplete or substandard works
Information:	The works to this area appear to be incomplete or have been completed to a substandard level.

Works that have not been completed to a satisfactory level create potential for the development of building defects and may impede on the safety and integrity of the

overall structure.

It is highly recommended that a licensed plasterboard contractor should be appointed to repair the ceiling. To ensure the safety of the area and the longevity of all associated building elements.

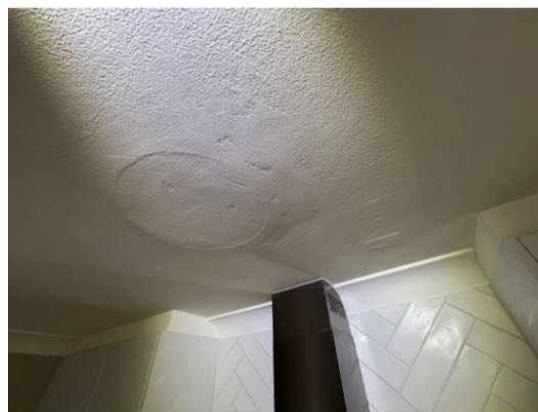
Finding 3.27

Building:	Main Building
Location:	Kitchen
Finding:	Ceiling - Incomplete or substandard works
Information:	The works to this area appear to be incomplete or have been completed to a

Works that have not been completed to a satisfactory level create potential for the development of building defects and may impede on the safety and integrity of the overall structure.

It is highly recommended that a licensed plasterboard contractor should be appointed to repair the ceiling. To ensure the safety of the area and the longevity of all associated building elements.

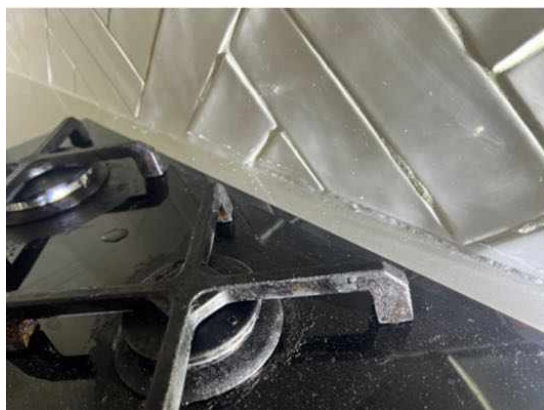
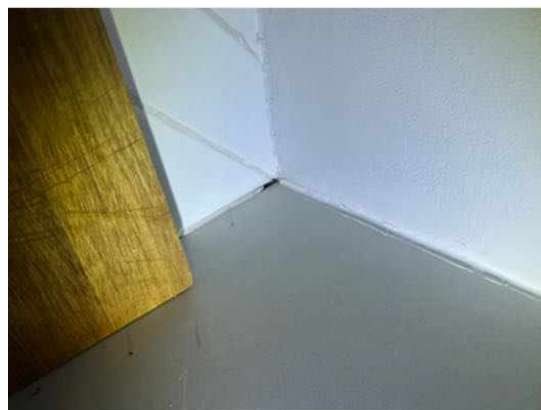
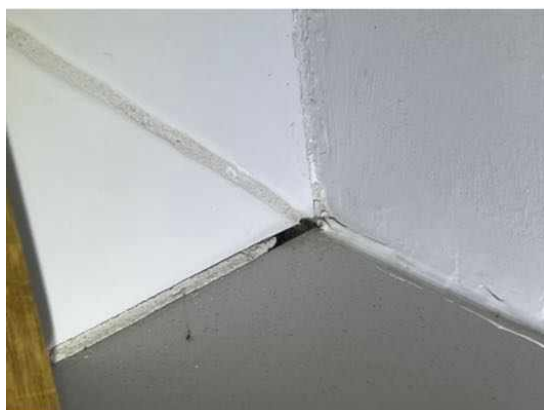
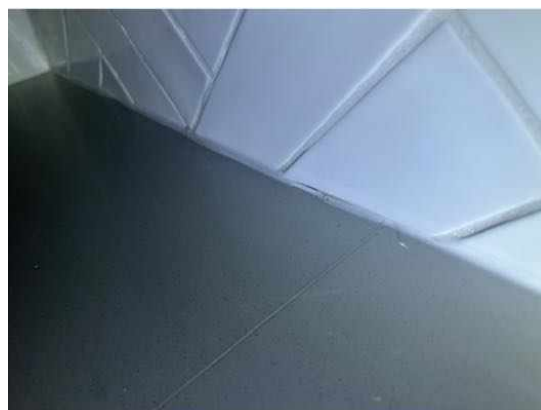
Building:	Main Building
Location:	Kitchen
Finding:	Sealant and grouting - Missing or damaged
Information:	It was noted on inspection that sealant or grout is degraded to the Kitchen area

Different materials and floor areas move at different rates, generally causing cracking to grout or sealant at this point. A flexible sealant is required to allow for expected expansion and contraction, while keeping the joint water tight and protective of all associated building materials.

There appears to be excessive mould to the sealant and grout which will likely require scraping out and replacement.

Flexible and mould resistant materials should be applied to affected areas to prevent any subsequent water damage that is likely to occur. Regular maintenance and replacement of damage or missing or damaged sealant and grout is highly recommended to the wet areas, as this is a regular wear and tear defect. Sealant and grouting in areas that come into regular contact with water should be maintained for the long term care of your property.

A sealant specialist or tiling contractor should be appointed to complete these works as soon as possible

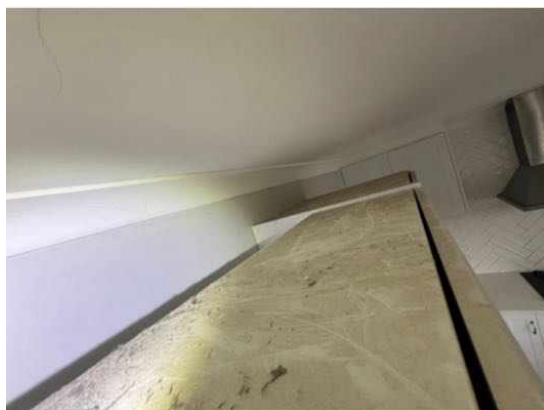
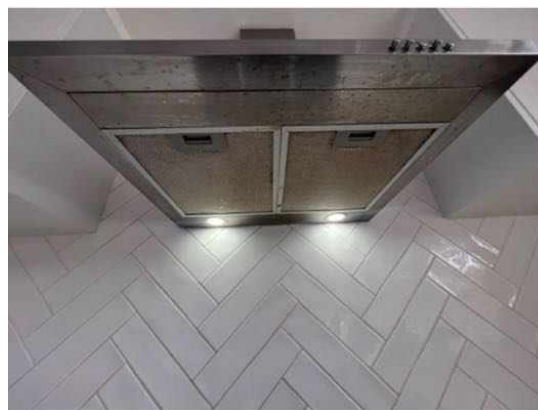
Finding 3.29

Building:	Main Building
Location:	Kitchen
Finding:	Surface - Requires cleaning
Information:	Regular cleaning and maintenance improves the longevity of all building elements. A build up of dirt and debris can reduce the useful life of building materials and may result in earlier replacement of items being required.

Excessive dirt is also likely to lead to secondary hazards, including potential health hazards, as the building elements begin to harbour bacteria and/or mould.

Remedial cleaning is recommended in order to improve the appearance of this area as well as to counteract the development of bacteria. Such works can be performed by a cleaning contractor and should be completed at the discretion of the client.

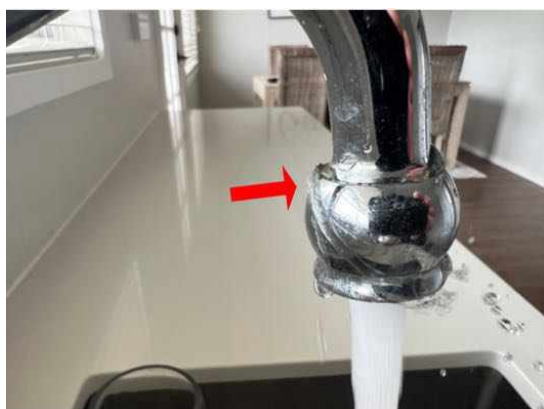
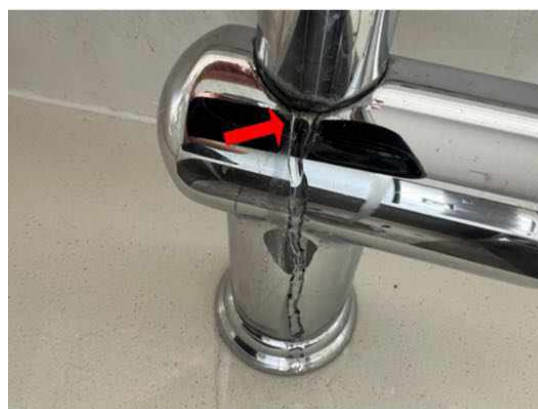
Finding 3.30

Finding: Tap - Leaking

Information: The tap in this area was found to be leaking at the time of inspection. This is a common defect that is consistent with general ageing of the building element. However, it may be indicative of substandard plumbing workmanship if the tap is relatively new.

While this defect only seems minor, if left unmanaged, it is likely to result in the development of rust, water damage and/or extensive water usage.

It is advised that a handyman or licensed plumber be appointed to perform remedial works on the affected tap. Such works should be performed prior to the development of secondary defects to ensure adequate functionality of all associated building elements.

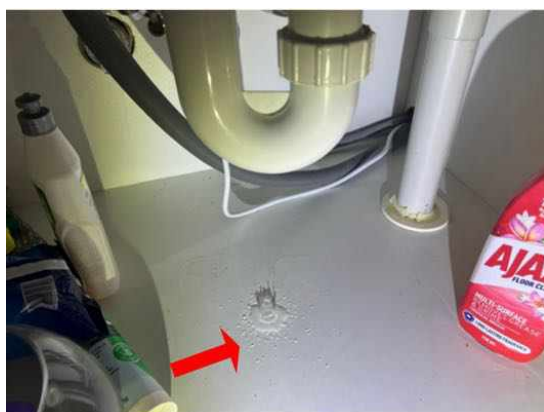
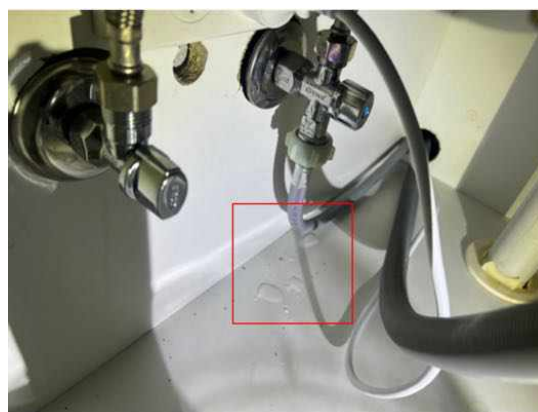
Finding 3.31

Finding: Water leak - Active

Information: Generally, water leaks occur when a particular area of the property is not weather or water tight. As the surrounding area was found to be damp at the time of inspection, the leak is considered ongoing and hence requires urgent action.

Regardless of the location, even minor leaks that are left unmanaged can lead to serious damage of associated building elements and result in the need for replacement of building materials. Mould and other hazards such as electrical hazards may also arise if the leak is left to develop.

It is highly advised that the cause of the leak be identified and resolved immediately by a licensed plumber to prevent any further damage. Depending on the extent of the damage previously sustained, repair and/or replacement of any affected building materials may be required.

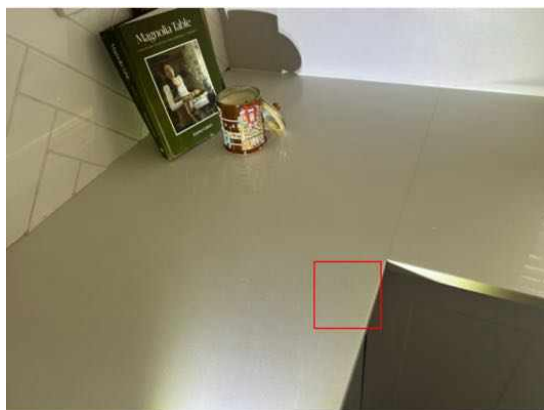
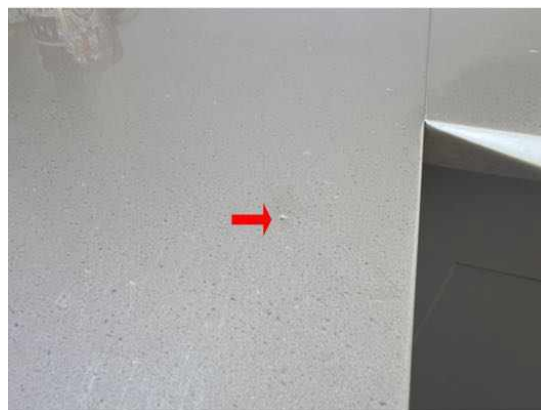
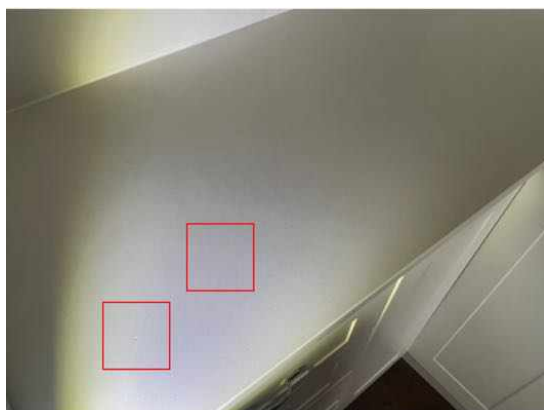
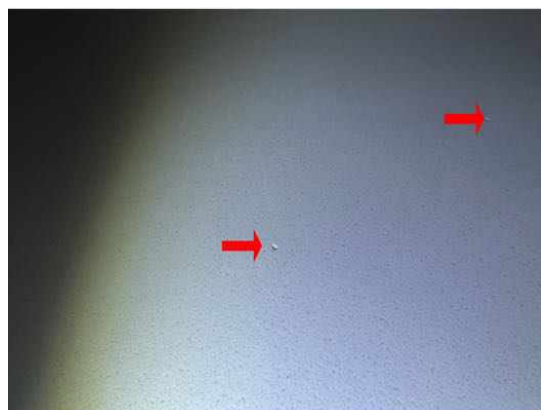
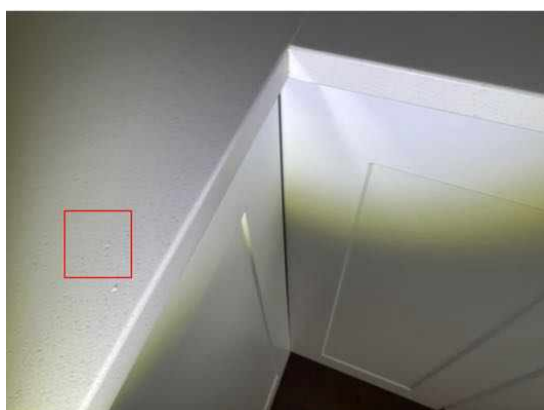
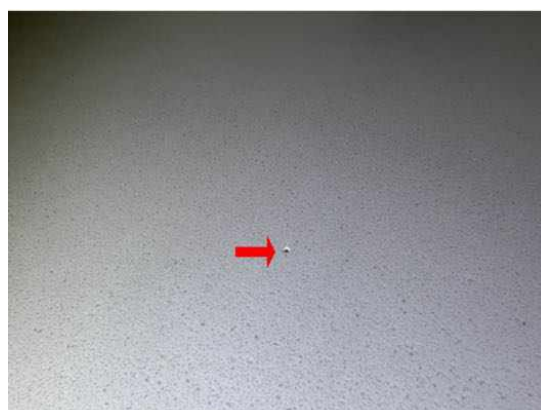
Finding 3.32

Building: Main Building
 Location: Kitchen
 Finding: Stone Benchtop – Chip to Surface
 Information: A visible chip was identified to the surface of the stone benchtop. This type of damage is typically the result of excessive impact, point loading, or internal stress within the material.

Chipping may compromise both the appearance and integrity of the benchtop and could worsen over time with ongoing use or exposure to temperature fluctuations.

Assessment by a qualified stone or cabinetry specialist is recommended to determine whether repair or replacement is necessary.

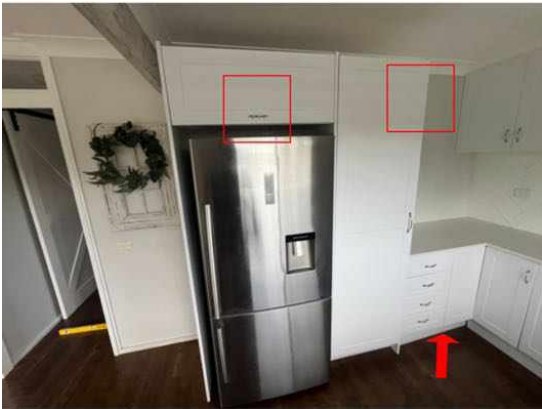
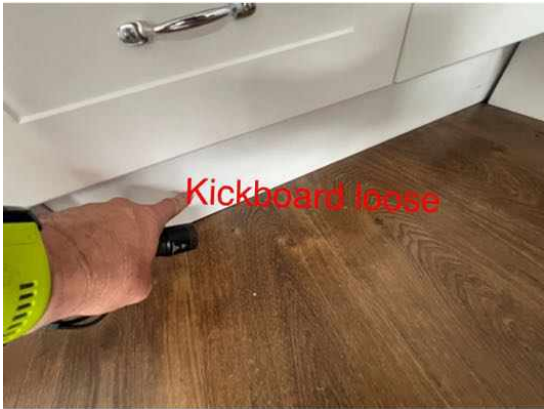
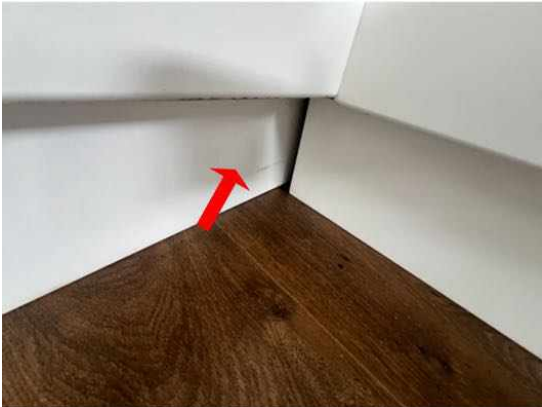
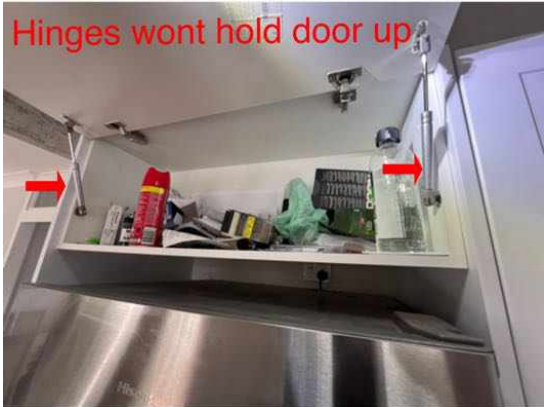
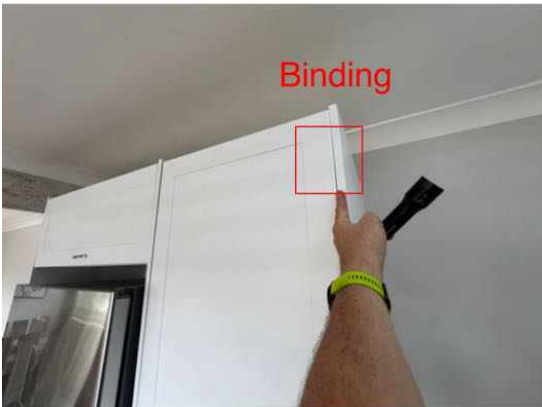
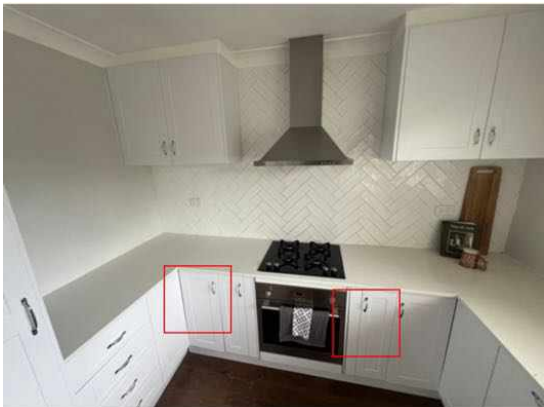
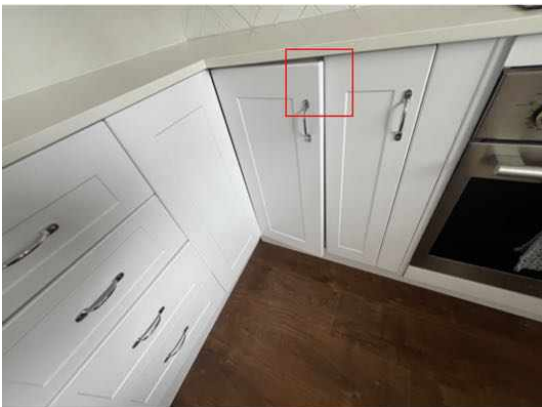
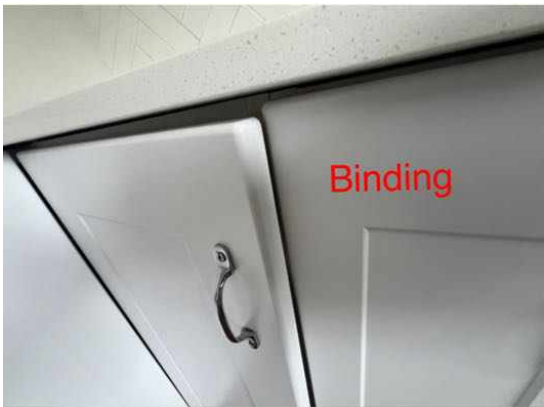
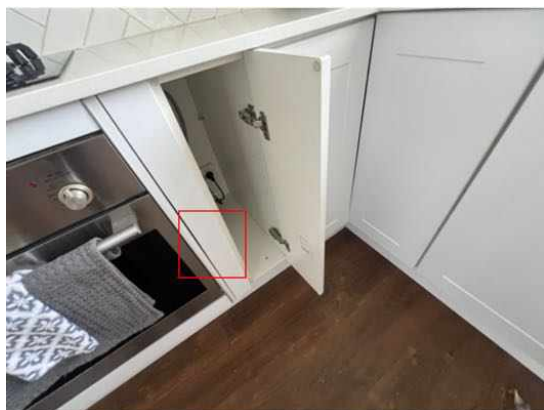
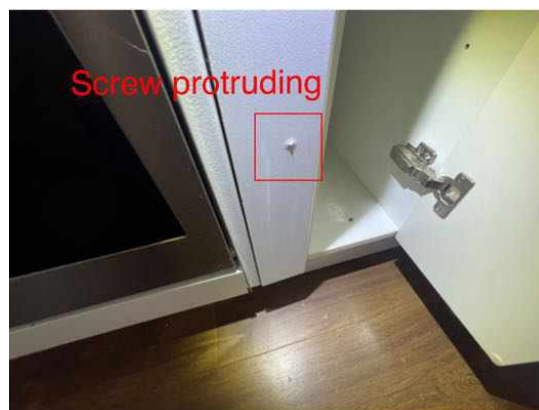
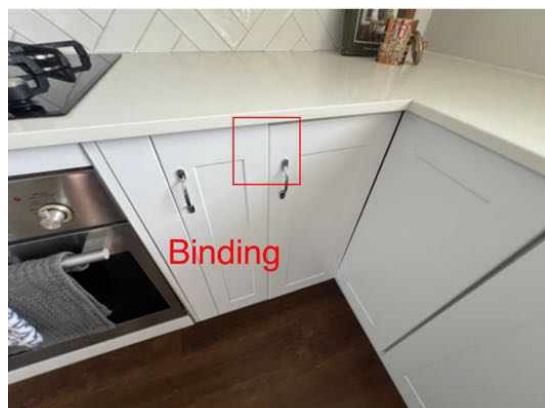
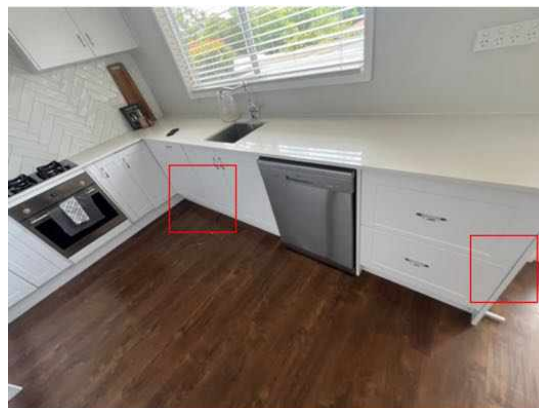
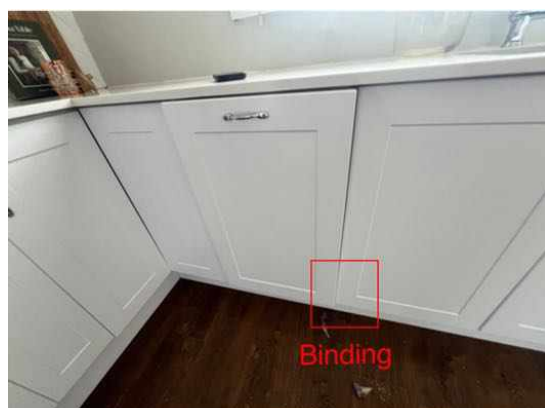
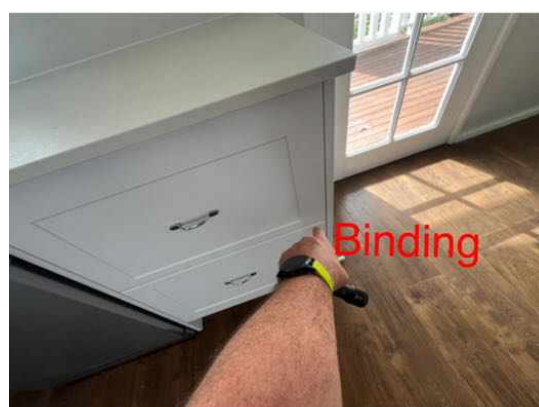
Finding 3.33

Building:	Main Building
Location:	Kitchen
Finding:	Misaligned Joinery Doors/Drawers
Information:	The Joinery doors and drawers are identified as not closing properly at the time of inspection. These defects may result from wear and tear, movement of materials, or substandard installation.

It is recommended that a qualified cabinet maker, joiner or handyman to be engaged to realign the door to ensure proper functionality and a tidy appearance.

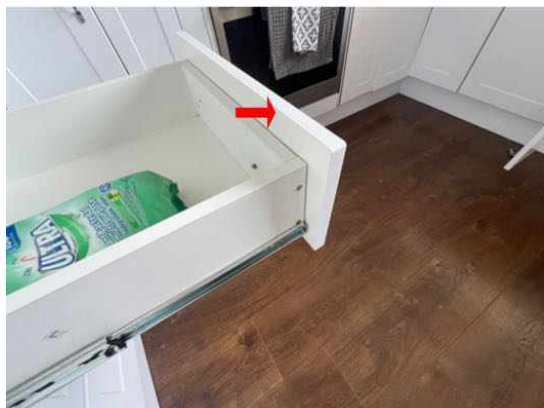
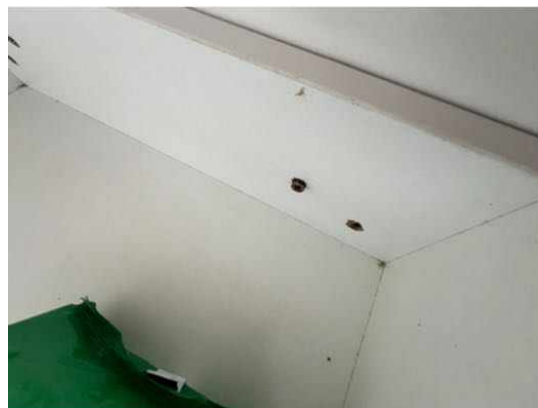
Finding 3.34

Building: Main Building
 Location: Kitchen
 Finding: Joinery - Loose Drawer Face
 Information: The drawer face was observed to be loose at the time of inspection. This may be due to inadequate fixings, general wear and tear, or poor initial installation.

If left unmanaged, further loosening may occur, potentially leading to detachment or damage to the associated cabinetry.

It is recommended that a qualified cabinetmaker or carpenter be engaged to assess and secure the drawer face to restore its functionality and ensure longevity.

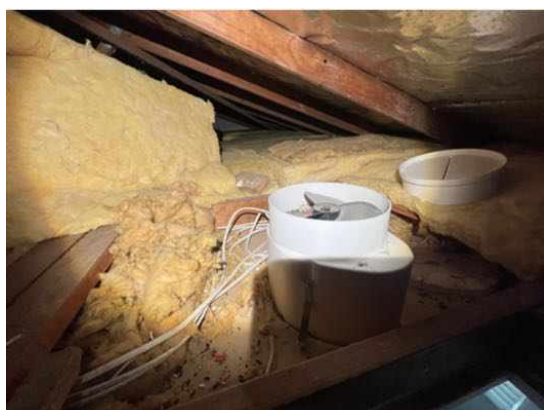
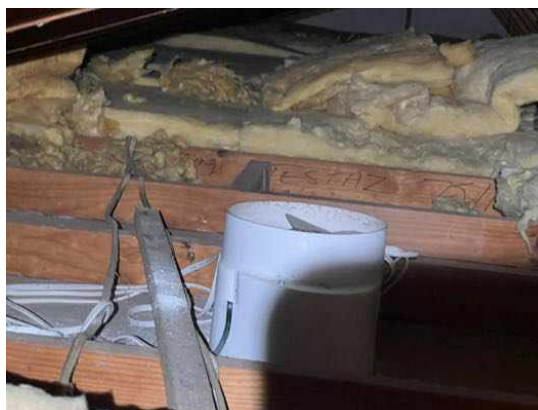
Finding 3.35

Information: The exhaust fan in this area has not been fitted with a flue to adequately vent extracted air to the exterior of the property. This defect has resulted in extracted air being discharged directly into the ceiling void. Such conditions may lead to the accumulation of moisture-laden air, which can cause deterioration to building elements, promote mould growth, and reduce the effectiveness of insulation in the roof space.

Additionally, the presence of insulation fibres around the fan presents a potential health hazard, as the disturbed fibres may circulate into the internal living spaces.

It is recommended that a licensed plumber be appointed to install an appropriate flue system that vents directly to the exterior, ensuring the area is adequately ventilated and compliant with best building practices.

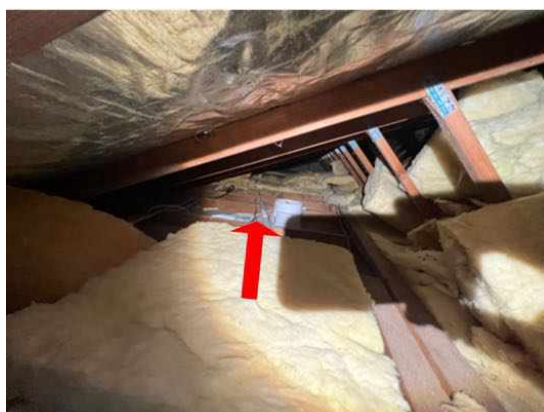
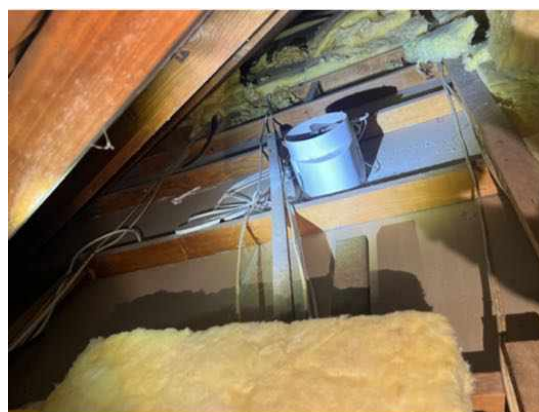
Finding 3.36

Location: Roof Void
 Finding: Insulation - Missing in areas
 Information: Upon inspection of the roof void it was noted that insulation is not present in some areas

Insufficient insulation will result in a comparatively higher cost to heat and cool a property as there is a lack of Insulation (or uneven coverage of insulation) which works as a barrier to heat transfer. This helps to keep out unwanted heat in summer and preserves warmth inside your home in winter. It can also help soundproof your home from unwanted airborne noise transfer.

Where insulation is absent, the area does not meet current Australian Standards. Installation of adequate insulation is required and should be conducted as soon as possible.

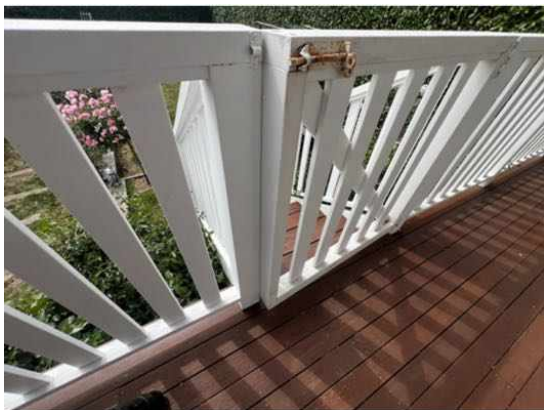
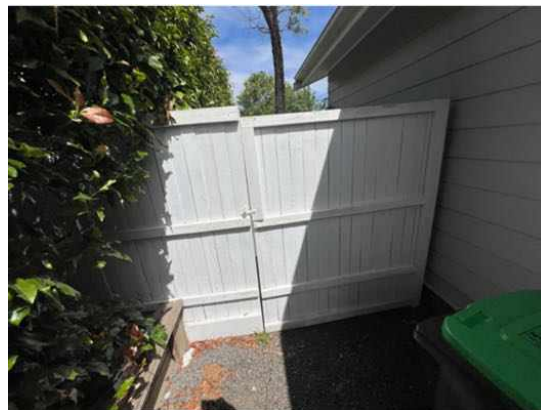
Finding 3.37

Building: Main Building
 Location: Rear Verandah, Side Gate (right)
 Finding: Gate - Binding/jamming (minor)
 Information: Binding and/or jamming of this gate is evident during standard operation. This defect inhibits the functionality of the affected door as well as creating potential for secondary defects to associated building elements.

A gate that binds to paving or to the associated gate frame may have several causes, ranging from minor defects, such as poor installation of the door or deteriorated hinges.

For minor causes, a qualified carpenter or general handyperson should be appointed to perform minor rectification works at client discretion.

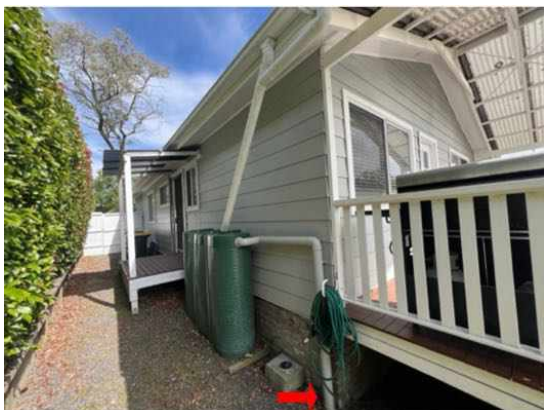
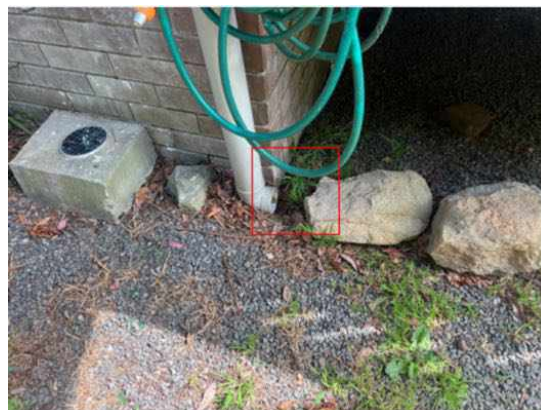
Finding 3.38

Building:	Main Building
Location:	Exterior walls - right side
Finding:	Stormwater drain - Not connected
Information:	The roof plumbing is not adequately connected to stormwater drainage on the site. This disconnection negatively impacts the functional capacity of the roof plumbing.

Where roof plumbing doesn't drain adequately, the area at the base perimeter can become excessively damp, potentially creating an environment that is susceptible to rust and corrosion of surrounding building elements, as well as attracting termites and other pests.

It is highly recommended that a plumber be appointed to further inspect the area and to install adequate drainage equipment where necessary.

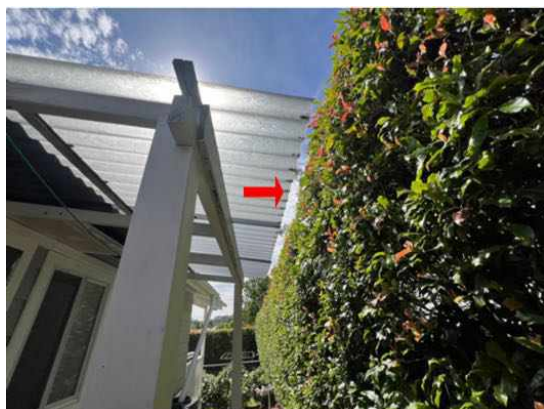
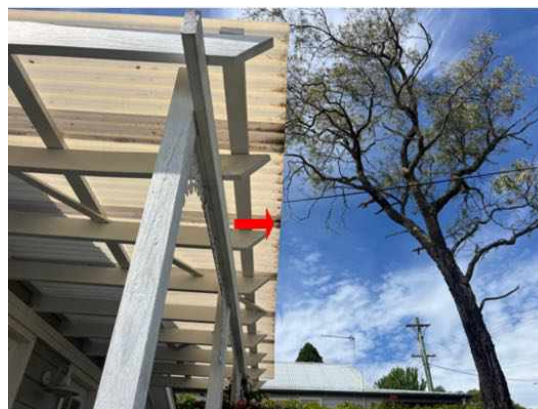
Building:	Main Building
Location:	Exterior walls - right side, Front
Finding:	Guttering - Not Installed.
Information:	The absence of guttering at this property increases the risk of water pooling around the foundation, which creates conditions highly conducive to termite activity. Without

adequate guttering, rainwater is not effectively directed away from the building, potentially causing prolonged moisture retention, soil erosion, or water ingress into lower areas. These conditions can attract termites and facilitate their movement into the structure.

It is recommended that a licensed roof plumber install guttering to ensure proper water drainage and minimise the risk of moisture-related issues and termite infestations. This work should be prioritised to protect the building's structural integrity.

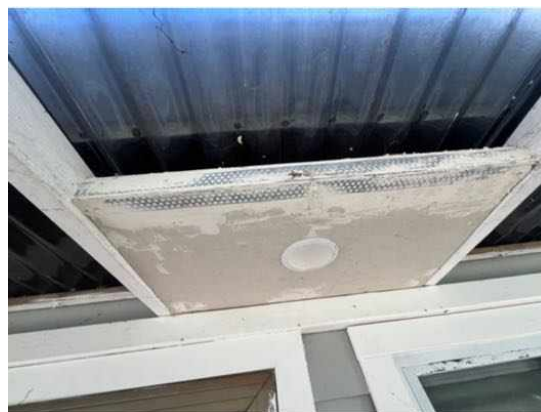
Finding 3.40

Building:	Main Building
Location:	Exterior walls - right side (laundry)
Finding:	Paint finish - Incomplete
Information:	The paint finish in this area was identified as being incomplete at the time of inspection.

Whilst incomplete or missing paint finish is generally an appearance defect, it can also lead to the development of secondary building defects over time. Incomplete areas of paint finish expose the area to moisture, potentially accelerating the deterioration of underlying building materials.

Incomplete paint finishes should be sanded back, filled, leveled and painted, as applicable. Where inadequate or missing paint protection has led to the deterioration of the associated building element, repair and/or replacement of this building element may be required.

A painting contractor should be appointed as soon as possible to perform necessary works to aid the appearance of the affected area and to ensure the area is protected against further deterioration. Alternatively, the homeowner following manufacturer instructions may perform these works.

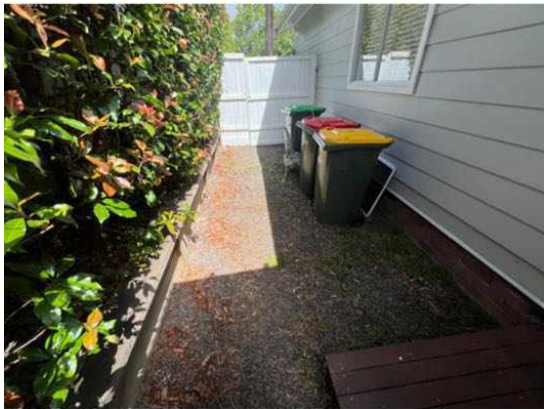
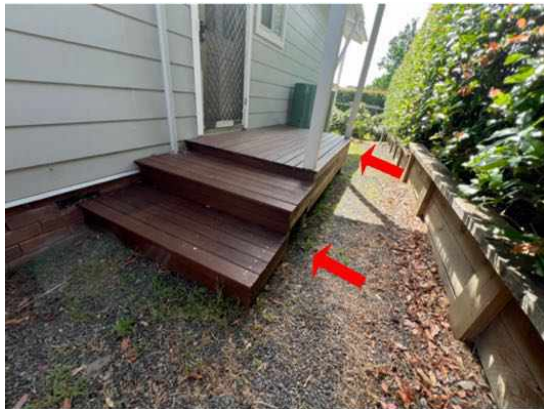
Finding 3.42

Building: Yard
 Location: Yard - Side
 Finding: Site drainage - Inadequate
 Information:

The site drainage in this area was found to be inadequate at the time of inspection, creating potential for subsequent water damage to associated building elements.

It is important that water does not lie against the base of walls; surrounding paths and ground levels should be sloped to drain water away from walls. Downpipes should not discharge stormwater onto lower walls or plinths. Stormwater should be carried away by large, regularly cleaned drains. Ground levels may need to be lowered to expose a buried DPC.

Where site drainage is inadequate, installation of an Agricultural (Aggie) Drain may be required. A qualified plumber should be appointed to further inspect the property and perform any remedial works as necessary. Water damage and secondary defects are likely to occur if left unmanaged.

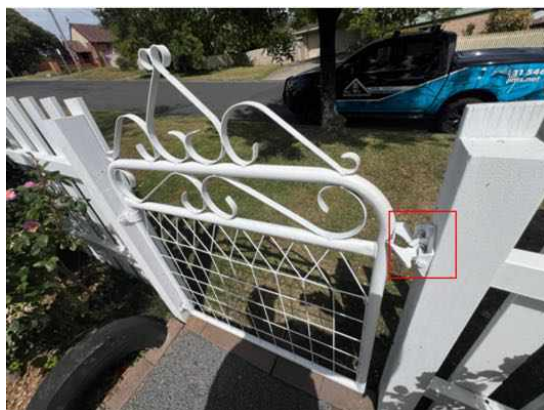
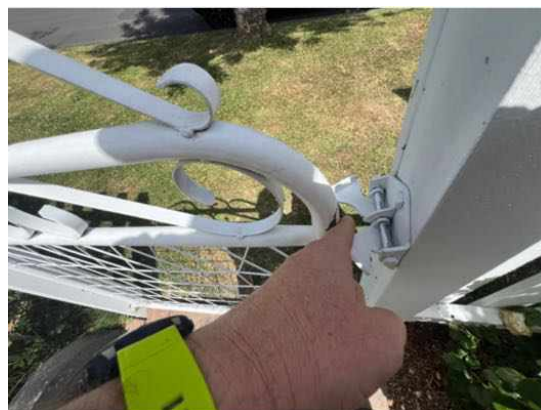
Finding 3.43

Building: Yard
 Location: Yard - Side (left), Front gate
 Finding: Gate Lock - Not working
 Information: The lock in this area was not operational at the time of inspection. Where locks have deteriorated to a point where they are no longer usable, the gates have sagged due to the weight of the timber panelling, or lock installed incorrectly and not functioning, the security of the property is immediately compromised.

Adjustment of gate or of the lock is highly recommended. Consultation with a carpenter or general handyman is required to gain further advice on any added security that may be available for the area and remedial works.

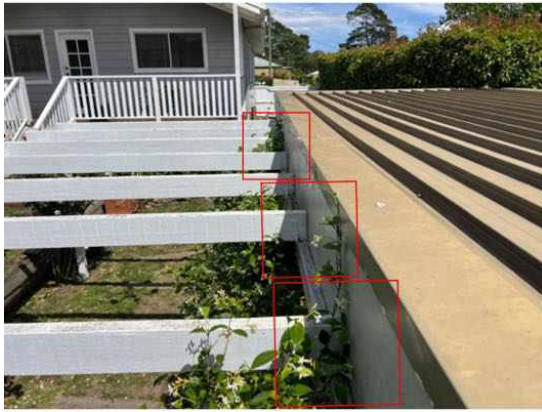
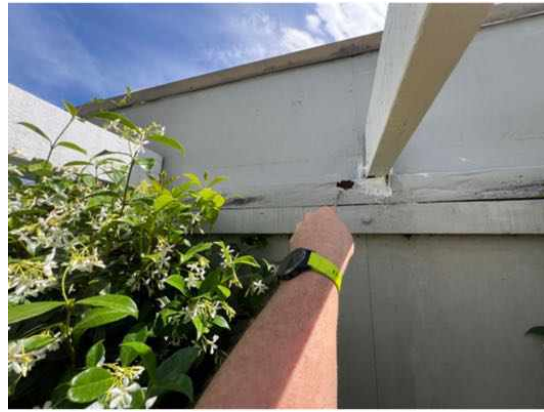
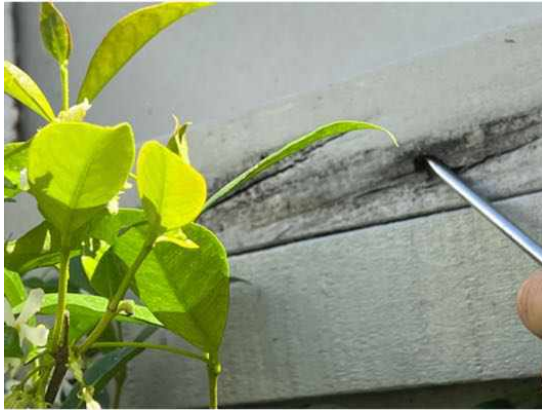
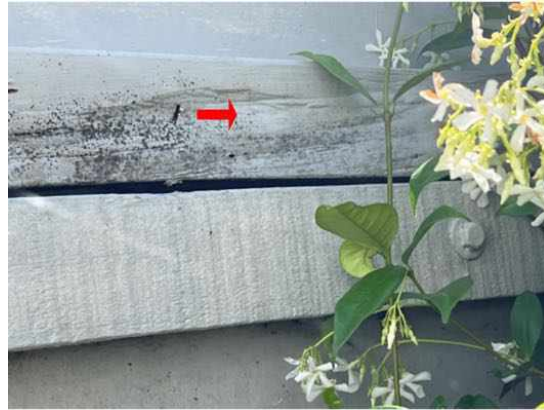
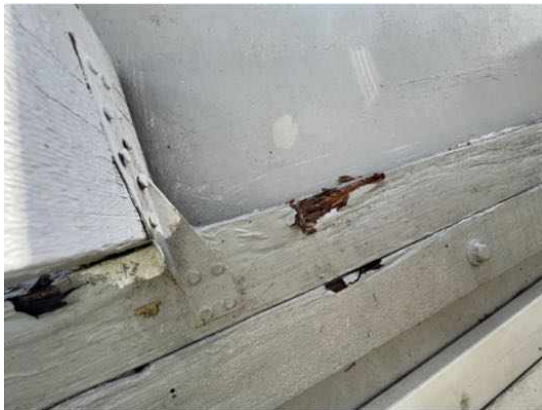
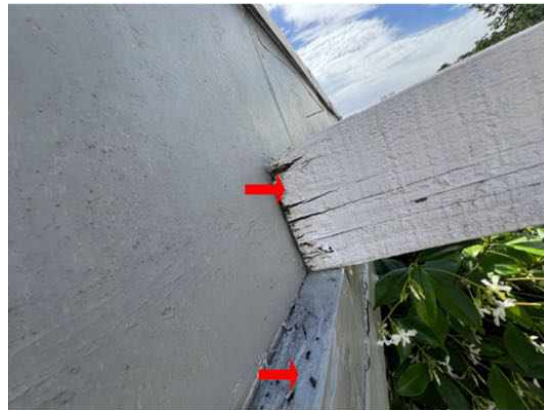
Finding 3.44

Building:	Garage
Location:	Pergola (Garage)
Finding:	Wood rot - pergola
Information:	This pergola shows evidence of wood rot. Wood rot, also known as Fungal Decay, occurs when timbers and other cellulose building materials are exposed to damp conditions on an ongoing basis. This could be the result of exposure to weathering over a prolonged period of time, or the attraction of excessive moisture from other abutting building materials. Contributing factors also include poor air ventilation in the area.

Wood rot is often associated with general damp problems and is evidenced by a 'musty' smell or mould and mildew occurring on surfaces. If left unmanaged, damp conditions can lead to further health problems and the decay of timbers will continue.

Early intervention and regular maintenance, particularly of exterior timbers, will prolong the useful life of these building elements. Prior to any works being performed, the cause of the moisture that has created the visible wood rot should be identified and addressed in a suitable manner. Replacement of affected timbers may then be a necessary step in protecting surrounding building elements from such deterioration.

A qualified plumber may be appointed to assess the cause of excessive moisture and to provide advice on any remedial works as required. A qualified carpenter or registered builder may also be required to replace affected building materials.

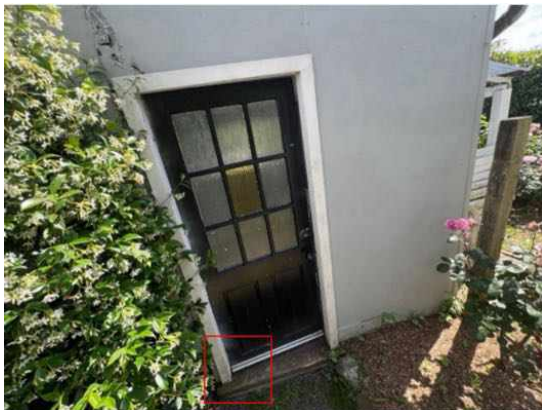
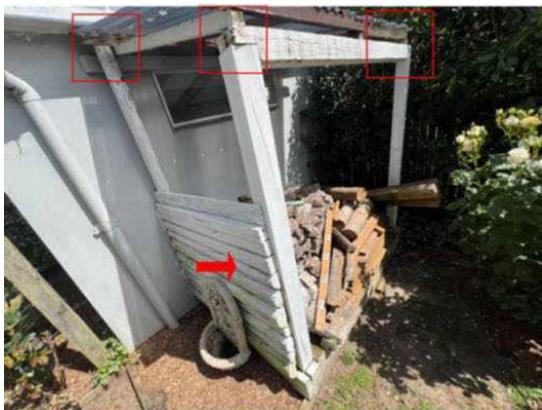
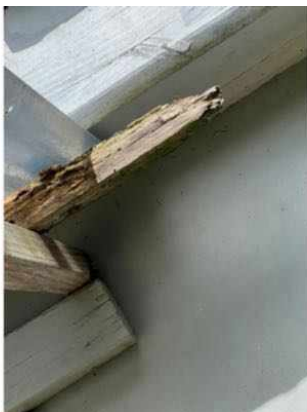
Finding 3.45

Building: Garage
 Location: Garage
 Finding: Wood rot
 Information:

This building element shows evidence of wood rot. Wood rot, also known as Fungal Decay, occurs when timbers and other cellulose building materials are exposed to damp conditions on an ongoing basis. This could be the result of exposure to weathering over a prolonged period of time, or the attraction of excessive moisture from other abutting building materials. Contributing factors also include poor air ventilation in the area.

Wood rot is often associated with general damp problems and is evidenced by a

'musty' smell or mould and mildew occurring on surfaces. If left unmanaged, damp conditions can lead to further health problems and the decay of timbers will continue.

Early intervention and regular maintenance, particularly of exterior timbers, will prolong the useful life of these building elements. Prior to any works being performed, the cause of the moisture that has created the visible wood rot should be identified and addressed in a suitable manner. Replacement of affected timbers may then be a necessary step in protecting surrounding building elements from such deterioration.

A qualified plumber may be appointed to assess the cause of excessive moisture and to provide advice on any remedial works as required. A qualified carpenter or registered builder may also be required to replace affected building materials.

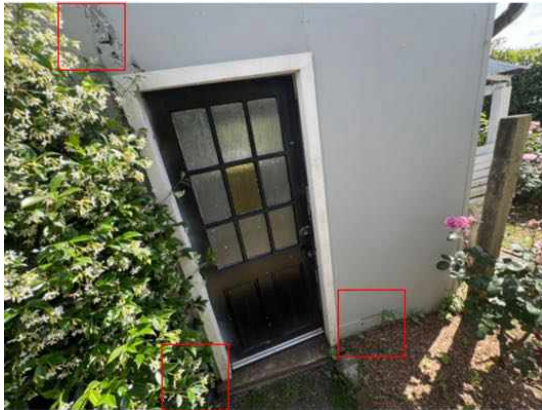
Building:	Garage
Location:	Garage
Finding:	Garage external sheeting - Damaged
Information:	Breakage occurs generally when the building materials have either aged and decayed, or as a result of damage (accidental or deliberate).

Repair and/or replacement of broken elements is advised to ensure that additional secondary defects do not arise as a consequence. Such works are necessary, as all building elements play a key role in the operation and function of the overall structure and its performance.

A licensed carpenter should be appointed to repair or replace the affected building element prior to any subsequent damage being caused.

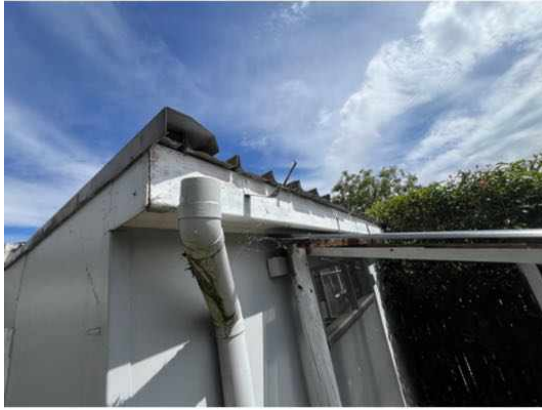
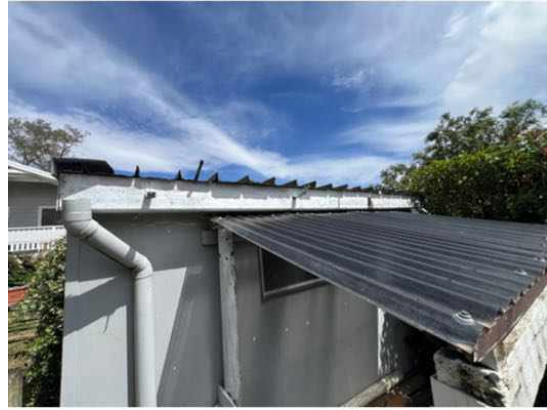
Finding 3.48

Building:	Garage
Location:	Garage
Finding:	Guttering - Not Installed.
Information:	The absence of guttering at this property increases the risk of water pooling around the foundation, which creates conditions highly conducive to termite activity. Without adequate guttering, rainwater is not effectively directed away from the building, potentially causing prolonged moisture retention, soil erosion, or water ingress into lower areas. These conditions can attract termites and facilitate their movement into the structure.

It is recommended that a licensed roof plumber install guttering to ensure proper water drainage and minimise the risk of moisture-related issues and termite infestations. This work should be prioritised to protect the building's structural integrity.
