Building and Timber Pest Inspection Report VR

Inspection Date: Thu, 20 Nov 2025

Property Address: 19 Hill St, Bundanoon NSW 2578,
Australia

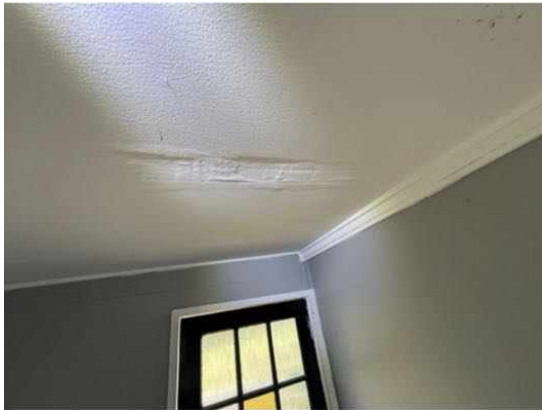
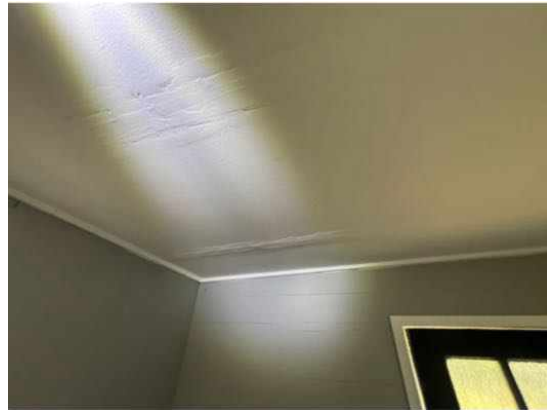
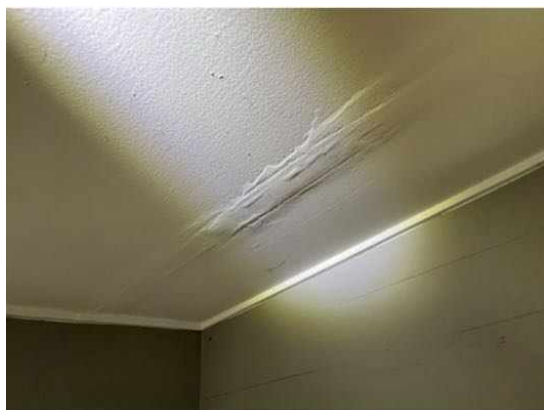
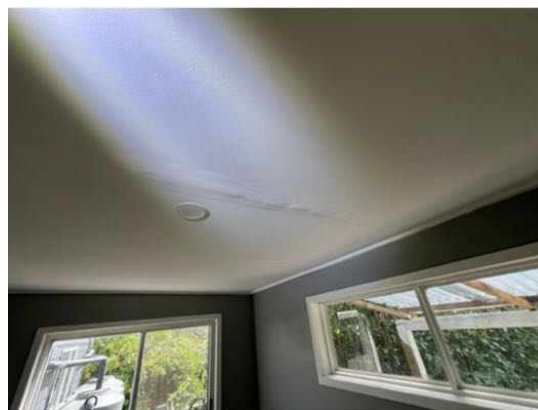
Finding 3.49

Building:	Garage
Location:	Garage
Finding:	Plasterboard - substandard or incomplete
Information:	The installation and finish of this plasterboard appear to be substandard or incomplete. Substandard work is typically the result of poor workmanship, the use of inappropriate materials, or a failure to complete the installation to an acceptable standard.

Where installation is substandard or incomplete, the client should engage a plasterer or registered builder to undertake rectification. Unfinished and poorly executed building work is more likely to deteriorate prematurely, potentially leading to secondary defects in associated building elements and affecting the overall aesthetic quality.

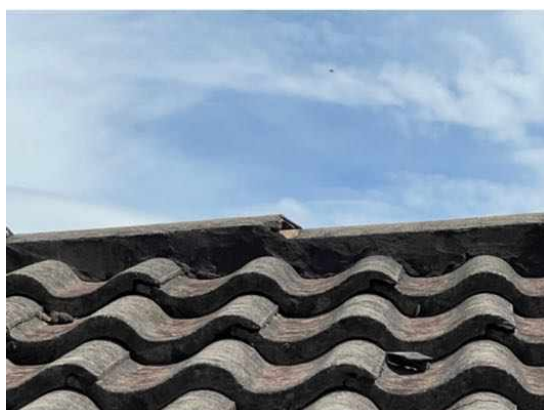
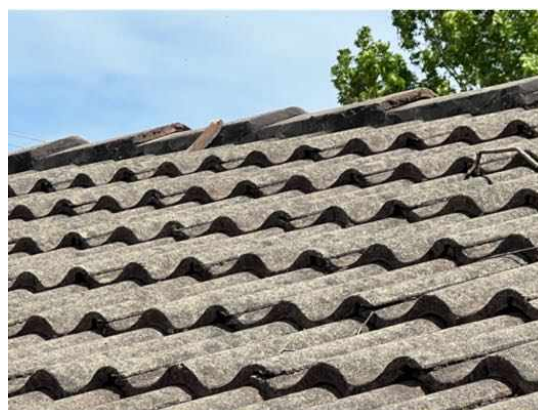
Finding 3.50

Building:	Main Building
Location:	Roof Exterior
Finding:	Mortar - Deterioration (minor)
Information:	Mortar, or 'bedding', is the material which fills joints and intersections between tiles and other building elements on the exterior roof covering, such as gable ends, hip capping and valleys. Upon inspection of the exterior roof, it was noted that sections of the mortar show varying levels of deterioration.

Mortar generally deteriorates as a result of frequent exposure to weather conditions over a prolonged period of time. Mortar that is deteriorating may allow water ingress into the roof void, putting associated building elements and roofing structures at risk of water damage. Deteriorated mortar also detracts from the functionality of roof tiles and other roofing elements, potentially decreasing weather tightness and roof drainage.

Mortar deterioration can be attended to by a handyperson where areas of deterioration are localised and easily accessible. Otherwise, consultation with a roofing contractor is advised where greater works are required.

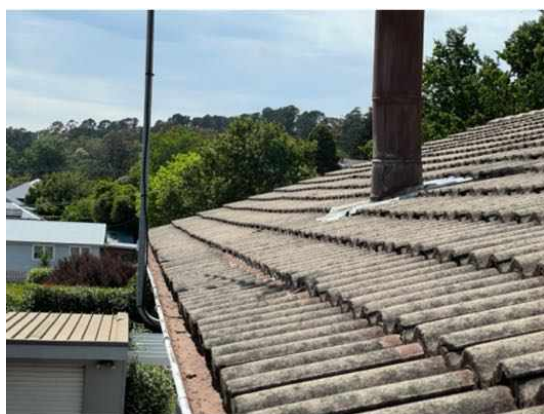
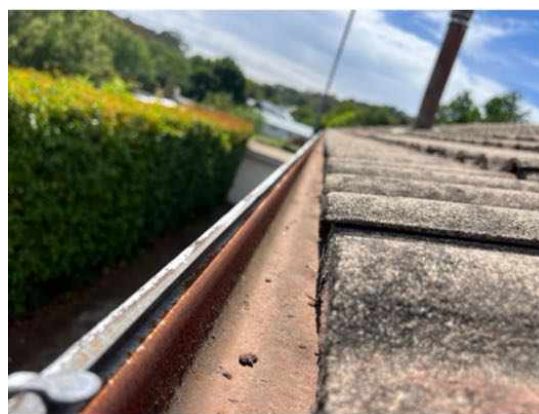
Finding 3.51

Building:	Main Building
Location:	Roof Exterior

Finding: Roof plumbing - Rusted or corroded
Information: The roof plumbing has areas of rust and corrosion. It is suspected that this has been caused by blockages, resulting in pooling or standing water, that have prematurely rusted elements of the roof plumbing.

Rusted roof plumbing will generally develop holes and leaks that can affect other building elements with poor drainage of storm water. Poorly drained roof areas will also lead to damp conditions surrounding the base perimeter of the building which, if left unmanaged, can lead to a range of secondary building defects.

Repair and/or replacement of rusted roof plumbing is highly required in order to reinstate the roof drainage system to a fully operational level. To further maintain these areas, gutters should be cleaned frequently, allowing the avoidance of any partial blockages.

A licensed plumber or specialist roof restoration company should be appointed to undertake these works. It is advised that such works be completed as soon as possible to prevent any further damage and deterioration.

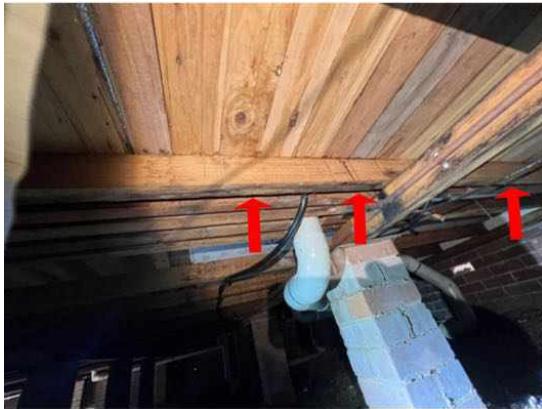
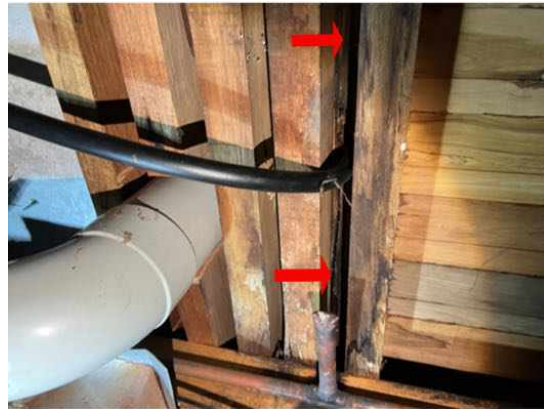
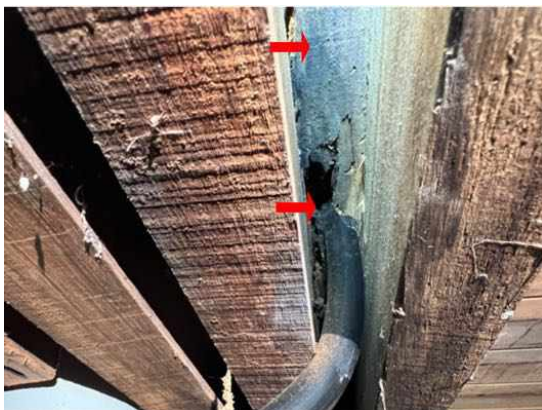
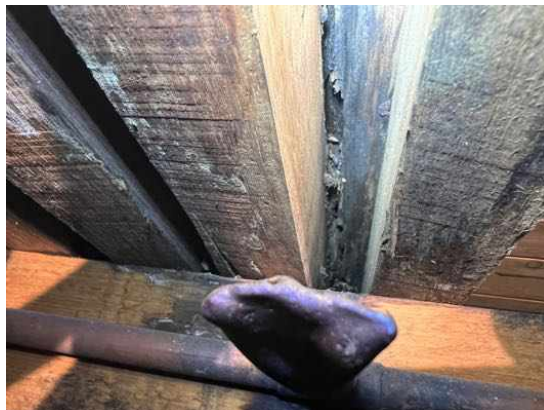
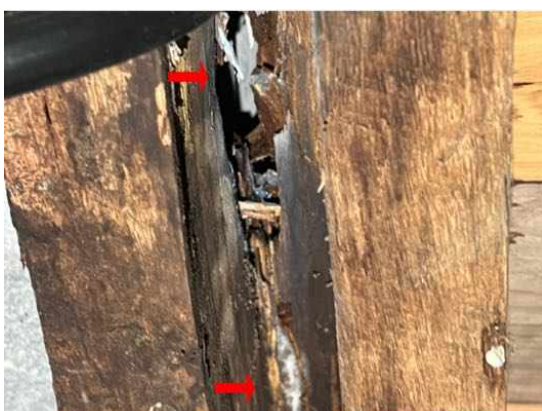
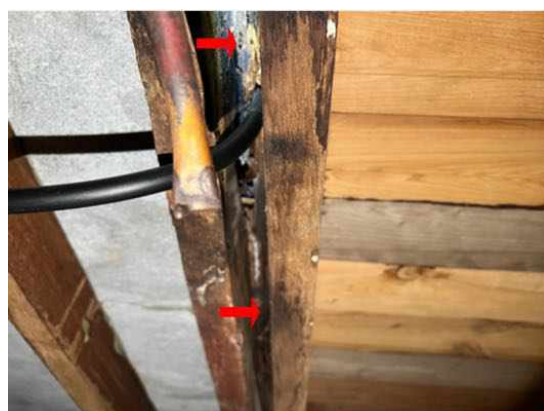
Finding 3.52

Building: Main Building
Location: Subfloor
Finding: Wood rot
Information: This building element shows evidence of wood rot. Wood rot, also known as Fungal Decay, occurs when timbers and other cellulose building materials are exposed to damp conditions on an ongoing basis. This could be the result of exposure to weathering over a prolonged period of time, or the attraction of excessive moisture from other abutting building materials. Contributing factors also include poor air ventilation in the area.

Wood rot is often associated with general damp problems and is evidenced by a 'musty' smell or mould and mildew occurring on surfaces. If left unmanaged, damp conditions can lead to further health problems and the decay of timbers will continue.

Early intervention and regular maintenance, particularly of exterior timbers, will prolong the useful life of these building elements. Prior to any works being performed, the cause of the moisture that has created the visible wood rot should be identified and addressed in a suitable manner. Replacement of affected timbers may then be a necessary step in protecting surrounding building elements from such deterioration.

A qualified plumber may be appointed to assess the cause of excessive moisture and to provide advice on any remedial works as required. A qualified carpenter or registered builder may also be required to replace affected building materials.

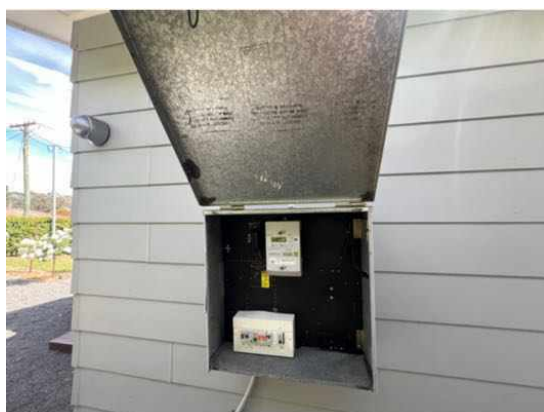
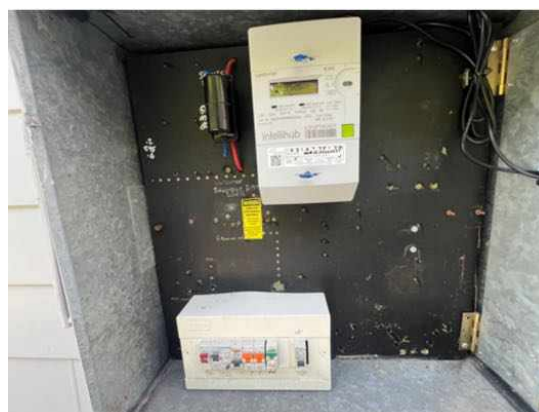
At the time of inspection, no Durable Notice was identified, and there was no evidence to suggest that a termite management system had been installed or that preventative treatments had taken place. In the absence of a recorded termite barrier, the property remains susceptible to potential termite attack on timber building elements.

It is recommended that the purchaser make further inquiries with the vendor regarding any past termite treatments or history of termite activity at the property, including any treatments applied to trees on-site. Additionally, consultation with a licensed pest controller is advised to assess the feasibility and cost of installing a post-construction chemical termite barrier. If a termite management system is installed, a Durable Notice should be placed in the switchboard unit or another accessible location to indicate the type of barrier in place and its maintenance requirements.

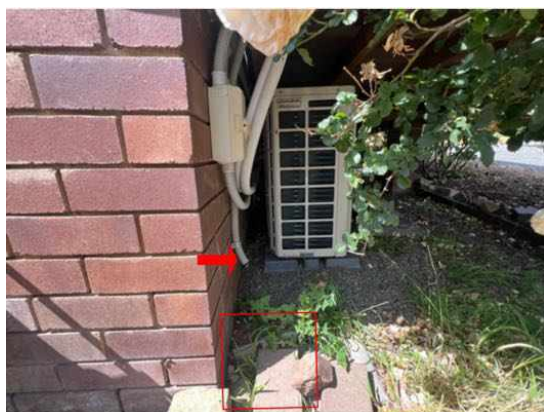
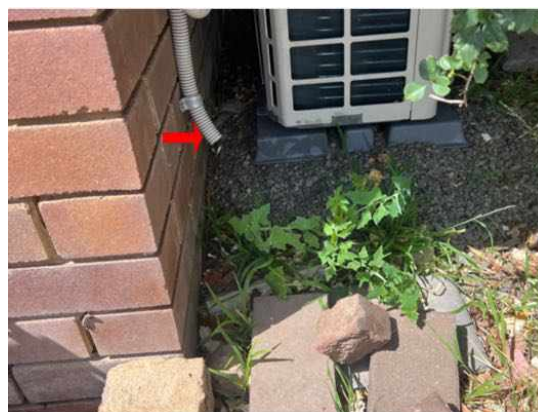
Finding: Air conditioner - Disconnected overflow
 Information: The Air Conditioner (A/C) overflow was found to be disconnected from storm water drainage and is creating excessive moisture in the surrounding area.

Such leaking creates an environment which is conducive to an array of defects, including water damage to associated building elements and the attraction of termite or timber pest infestation.

It is highly recommended that a licensed plumber be appointed to connect the A/C overflow in order to prevent such an environment from being created. These minor works should be carried out as soon as possible.

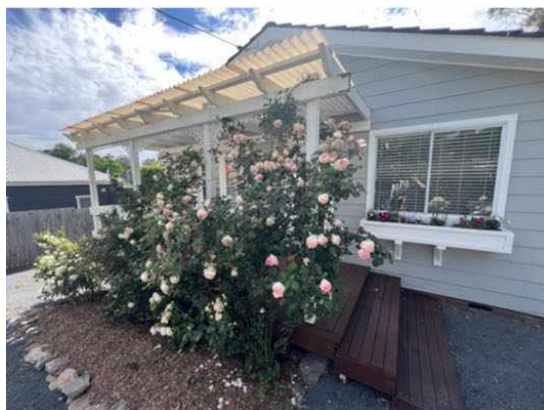
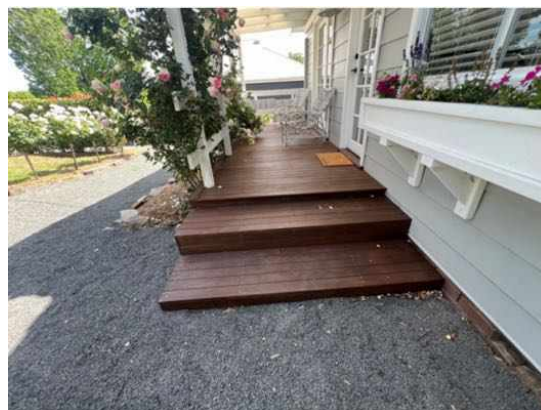
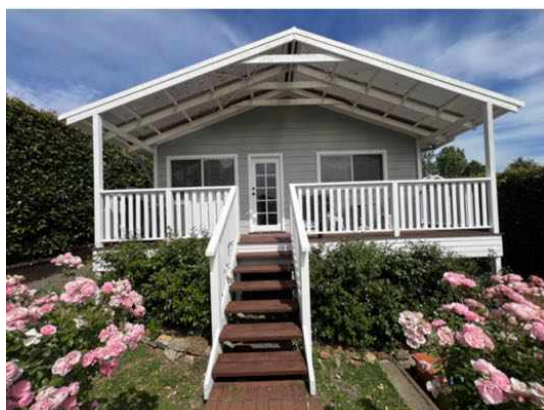
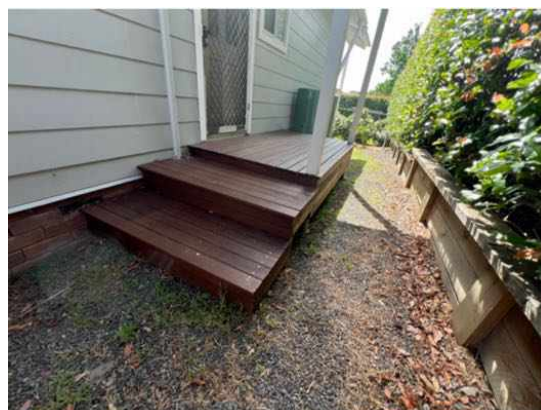
Finding 6.05

Building: Main Building
 Location: Deck
 Finding: Bridging (decking)- Attachments to Buildings.
 Information: Decking to the front porch and side patio about dwelling causing bridging and concealment. Bridging occurs when items against a building provide a concealed entry point for termites into the building or by passing around a termite management system.

Where any part of an attachment to a building is not isolated and is not provided with a clear gap of not less than 25mm from the building, bridging occurs. Attachments to buildings such as hot water services, downpipes, verandahs, decks, steps, fences, service conduits and the like provide the opportunity for concealed entry.

Building attachments of this nature need to be frequently inspected for termite activity by a qualified inspector.

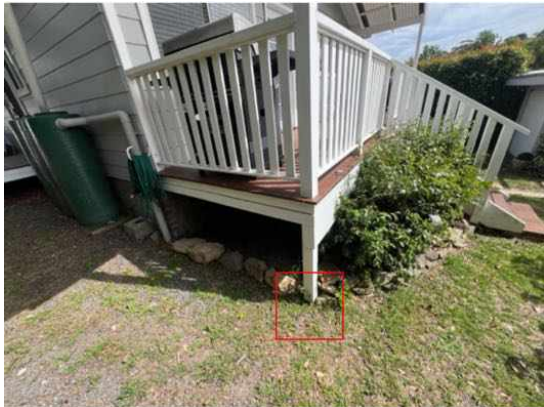
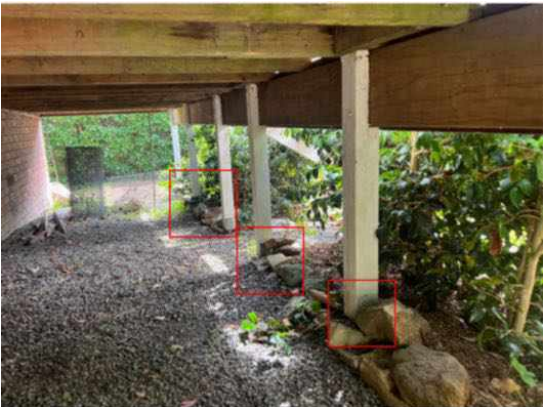
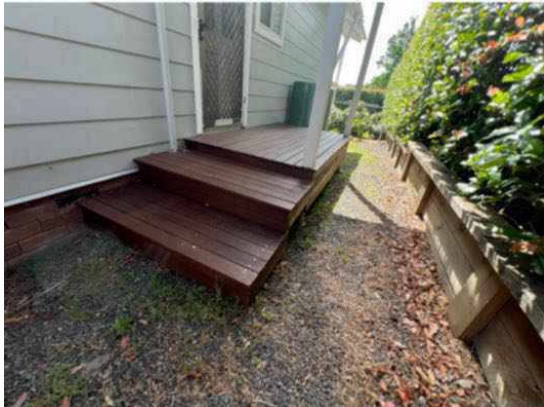
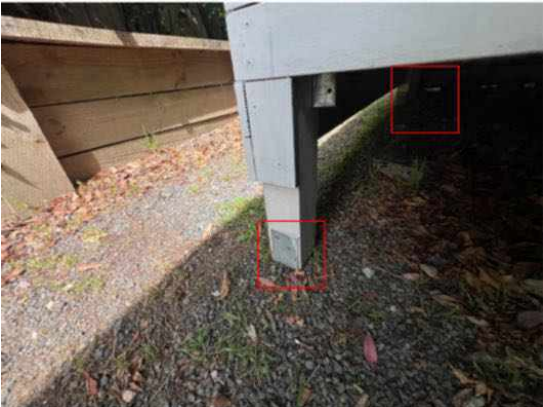
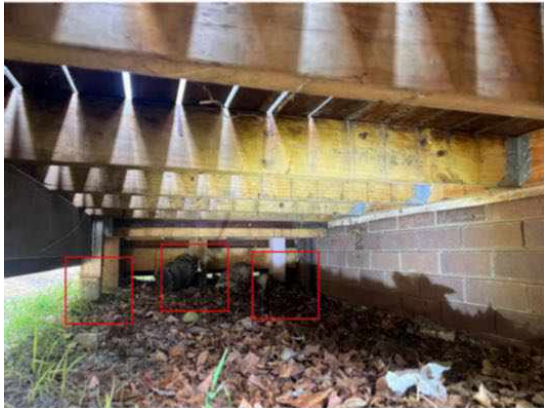
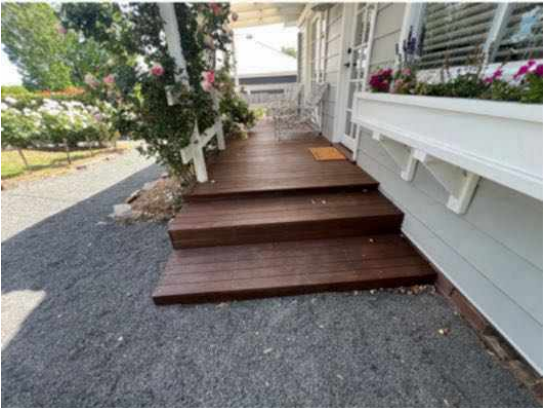
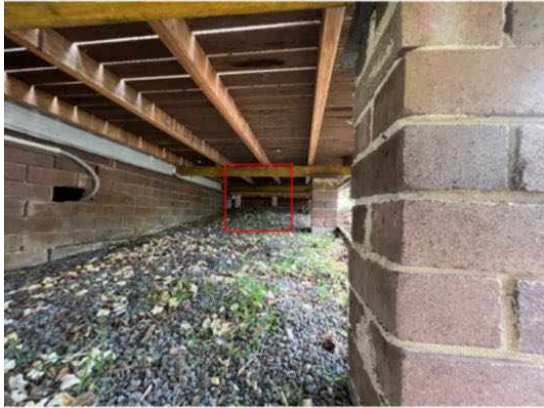
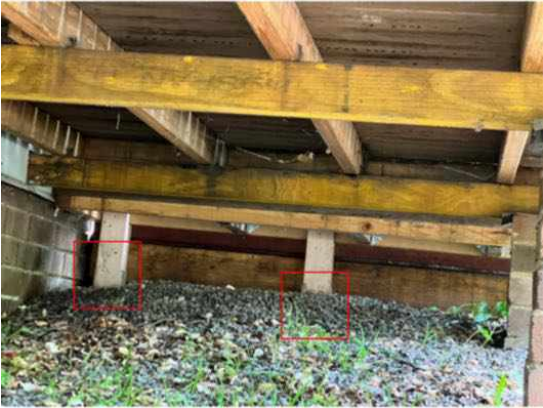
Finding 6.06

Building:	Main Building
Location:	Deck, Subfloor
Finding:	Bridging of termite barrier - Posts.
Information:	Posts that are attached to home from ground to structure without a 75mm inspection zone (metal stirrup) causes a bridging point. Bridging of termite barriers occurs when termites bridge (usually by building a mud tunnel) a termite barrier or inspection zone or where termites have a passage allowing them to bridge the barrier.

Generally this takes the form of finished ground levels external paving or concrete being retrospectively installed above the damp course level the adjacent internal floor level or weep and ventilation holes.

Where bridging has occurred full inspection is prevented and termites may enter a property in a concealed or undetectable manner.

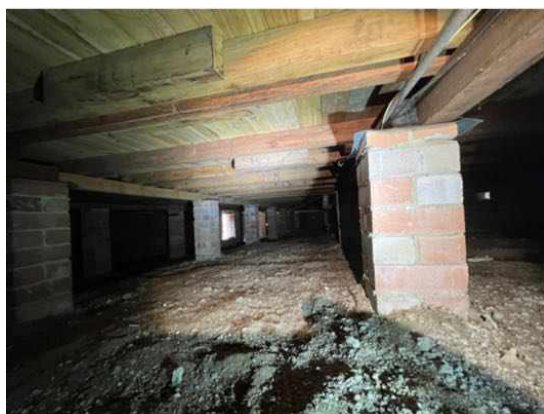
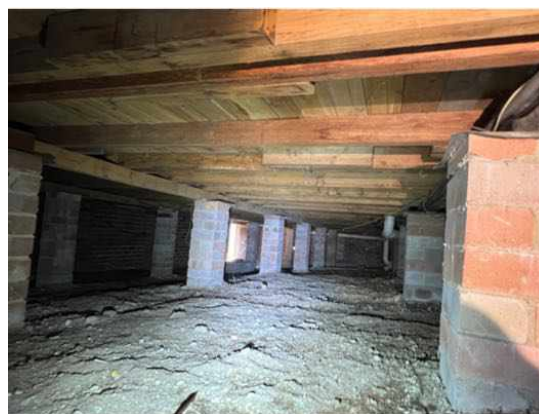
Information: An area of the subfloor was observed to have wet ground. Wet conditions in the subfloor are often indicative of inadequate drainage or water ingress, which can create an environment conducive to rising damp, timber rot, or pest activity.

It is recommended that a drainer/registered plumber or registered builder be engaged to assess the subfloor and provide advice on improving drainage to prevent further moisture-related issues. Regular monitoring of this area is also advised to ensure conditions remain stable.

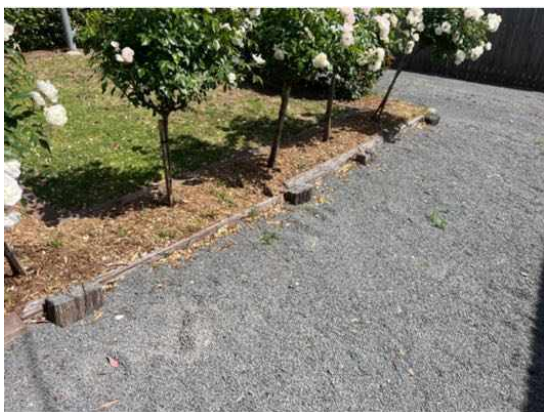
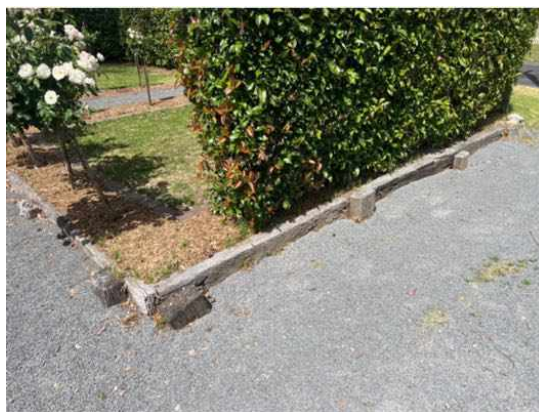
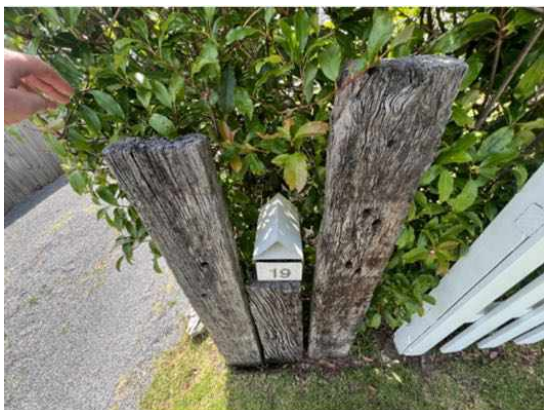
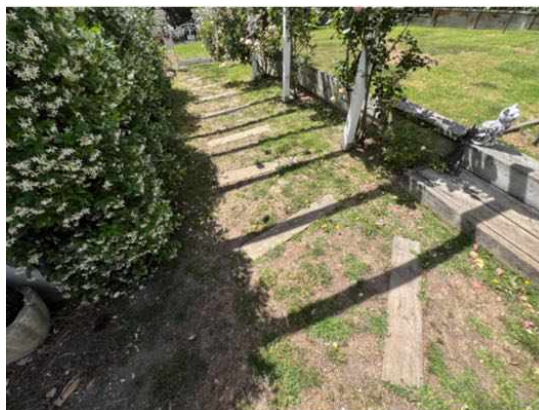
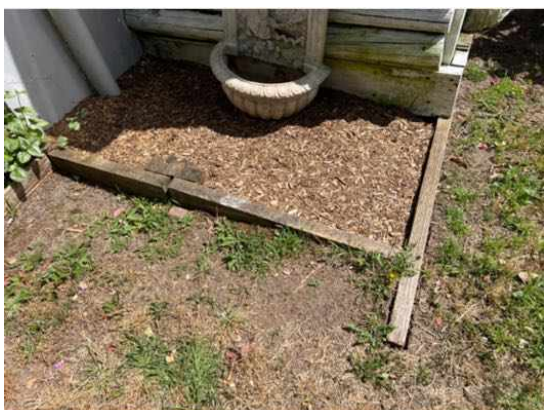
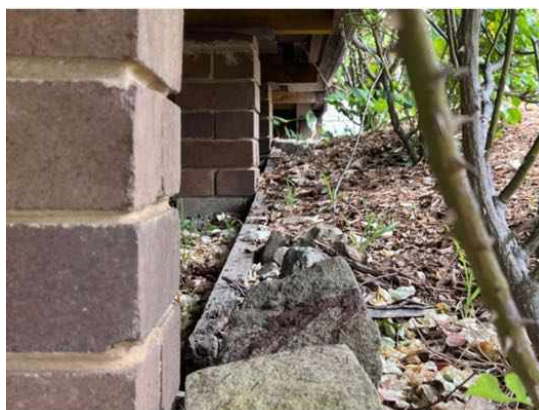
Finding 6.08

Building:	Yard
Location:	The Site
Finding:	In ground contact
Information:	Any timbers in direct ground contact provide opportunity for concealed termite entry and are likely to be subject to premature rot and decay as the soil retains moisture or damp conditions against the timbers.

Remove untreated timber that is in direct contact with external grounds. Consider replacement with more durable materials i.e. treated timber or non timber elements. Frequent pest inspections are advised to readily identify any termite activity in these areas.

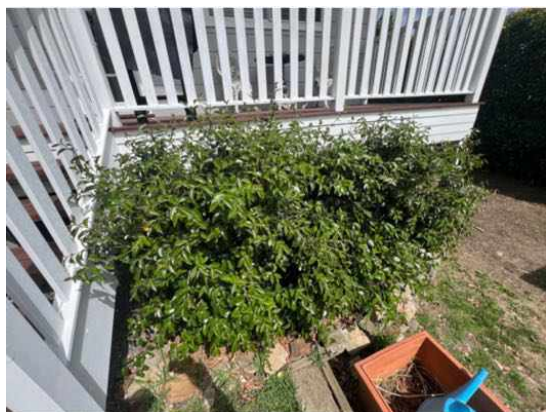
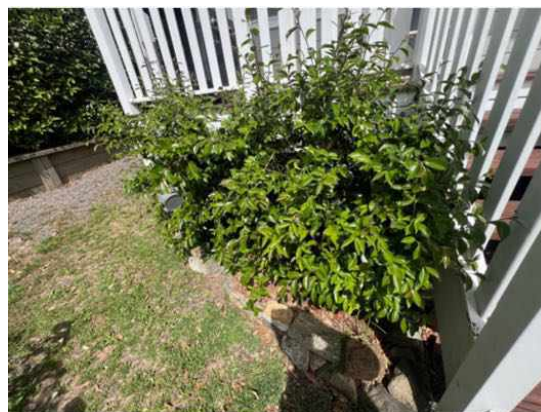
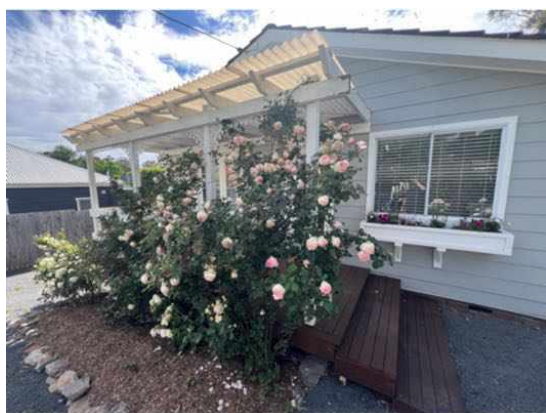
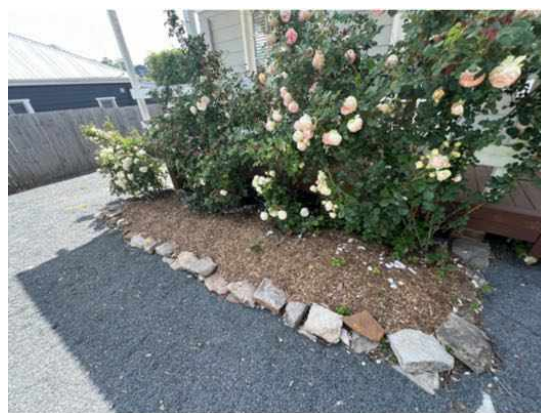
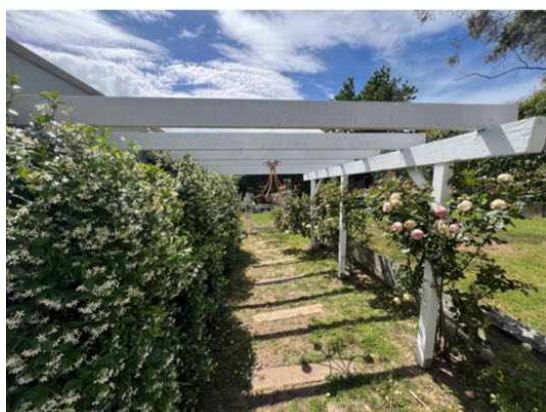
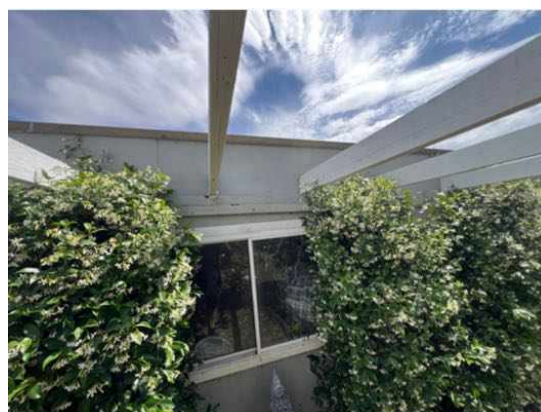
Finding 6.09

Building: Yard
 Location: The Site
 Finding: Garden Beds - Conditions Conducive to Termites
 Information: Garden beds were observed around the perimeter of the building, obstructing visual inspection of lower wall areas and providing potential concealed termite entry points.

Raised soil levels and retained moisture from watering can allow termites to access wall cavities or weep holes undetected, while timber edging materials may further encourage activity.

It is recommended that garden beds be reduced or cleared from the building

perimeter, or that regular timber pest inspections be carried out in accordance with AS 4349.3 or AS 3660.2 to monitor risk.

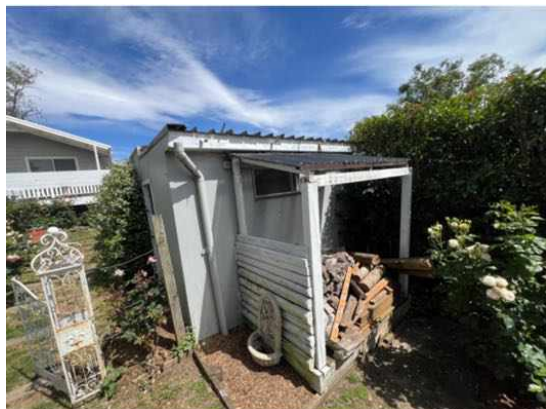
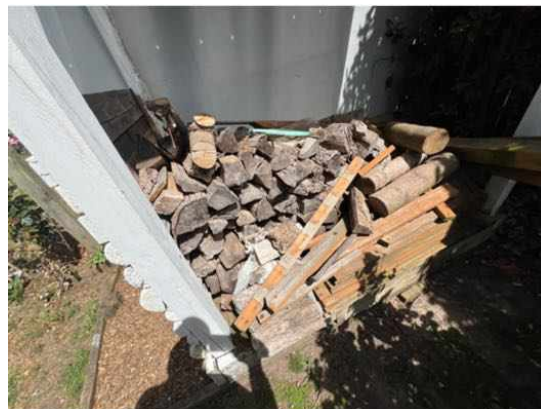
Finding 6.10

Building: Garage
 Location: Garage
 Finding: Firewood Stored Directly on Ground – Conducive to Timber Pest Activity
 Information: Firewood was observed to be stored directly on the ground within the property. Timber stored in direct contact with soil creates conditions highly conducive to termite activity and timber decay, as the ground retains moisture and provides shelter for timber pests.

It is recommended that firewood be stored off the ground on a raised platform or in a dedicated storage rack to minimise the risk of timber pest attack. Regular inspections of the stored timber and the surrounding ground area are also advised. The client should consult a licensed pest controller for further advice on timber pest management and preventative measures.

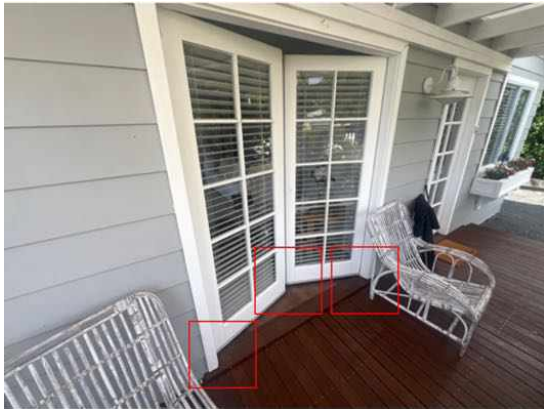
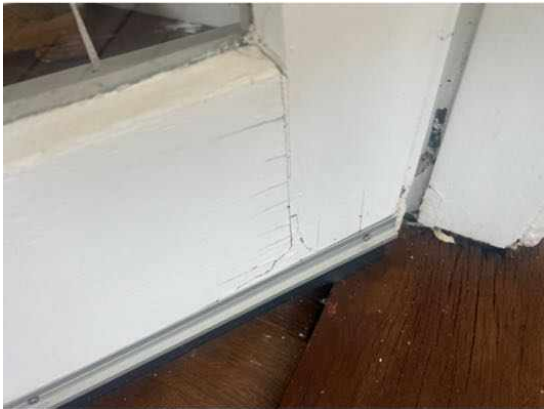
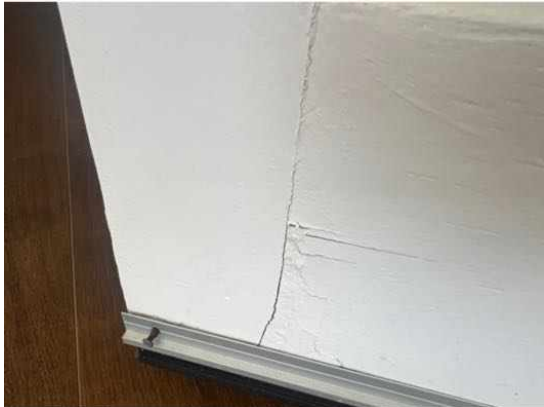
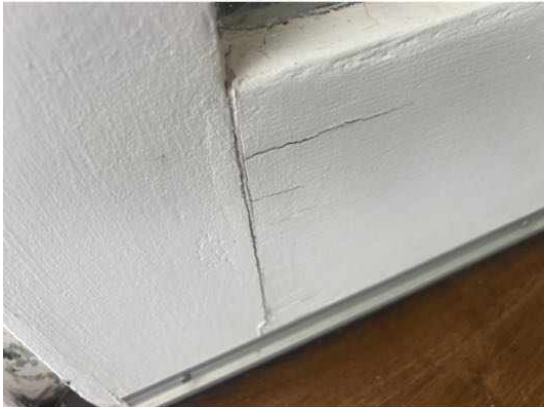
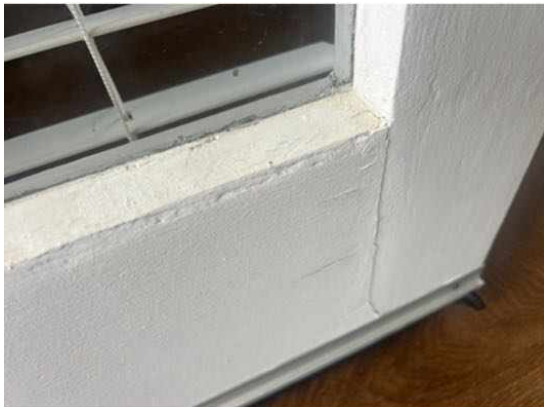
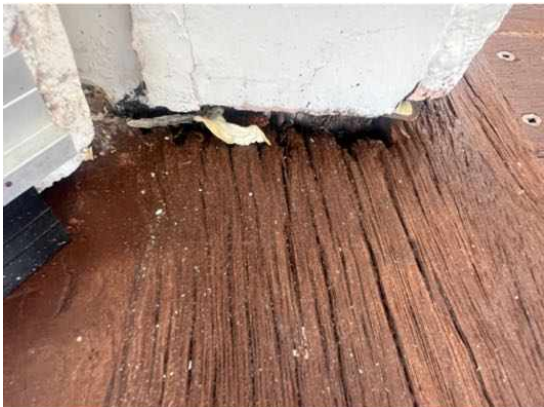
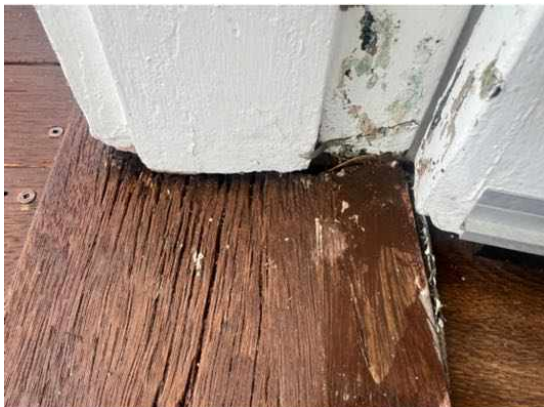
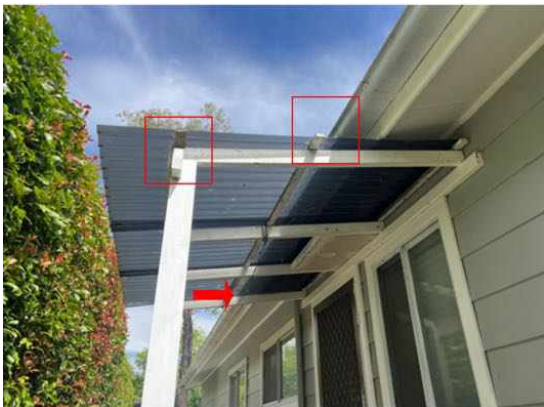
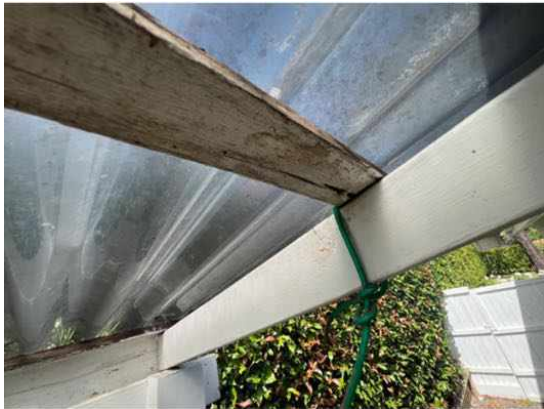
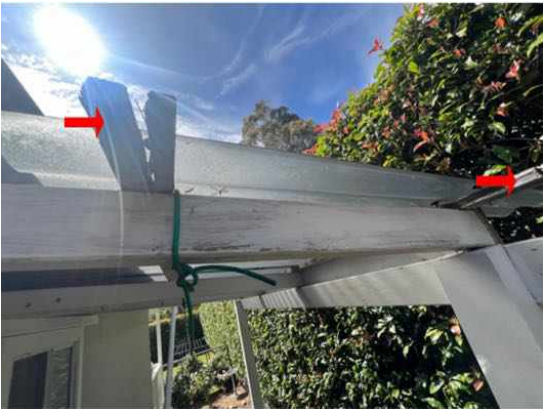
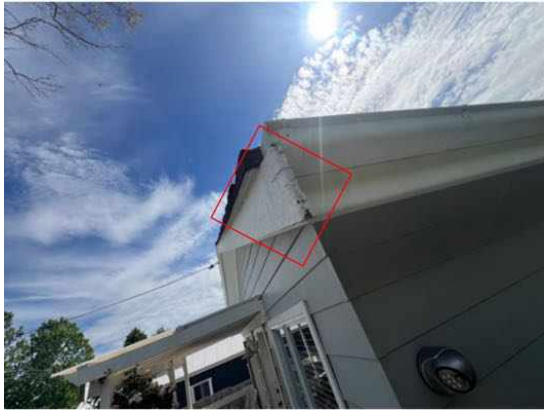
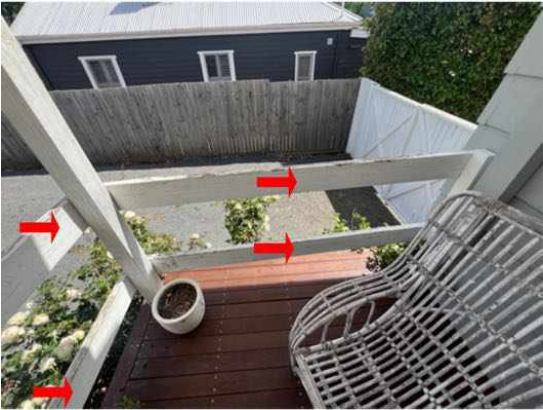
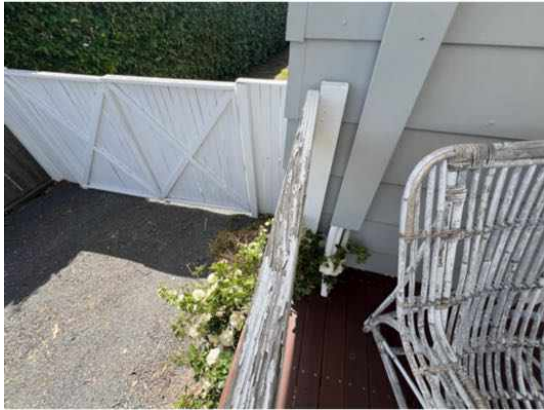
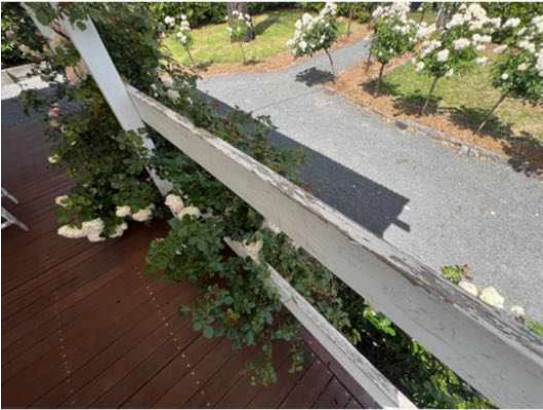
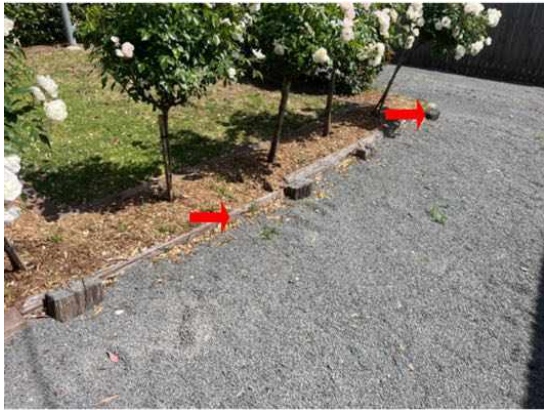
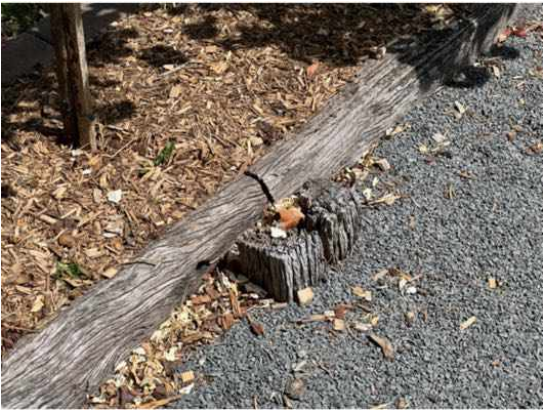
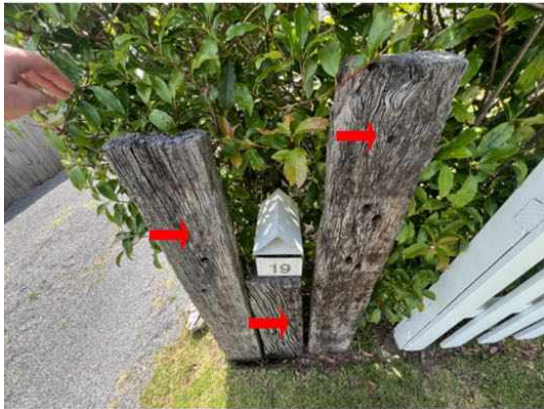
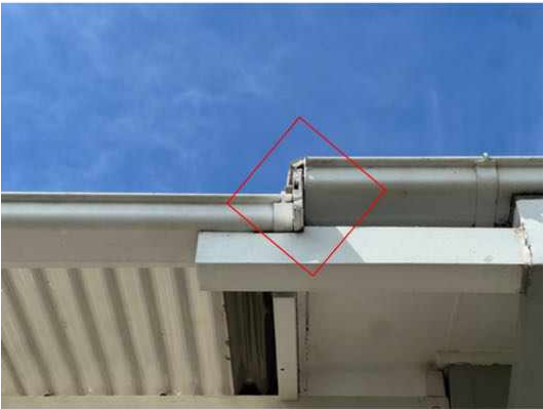
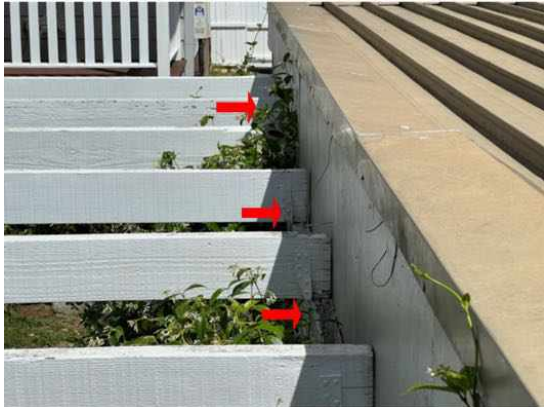
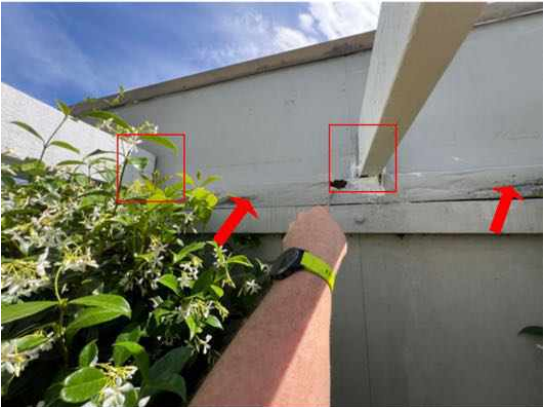
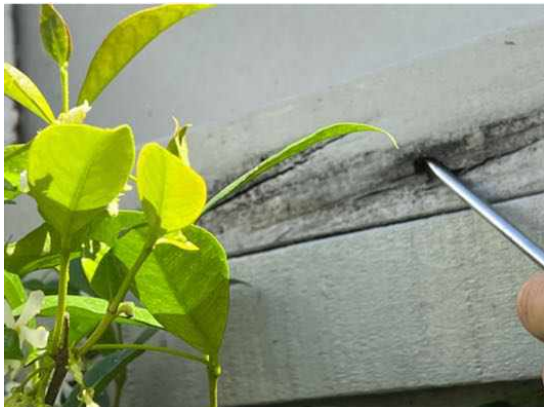
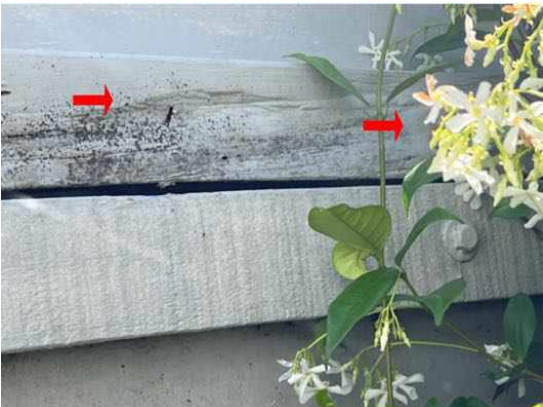
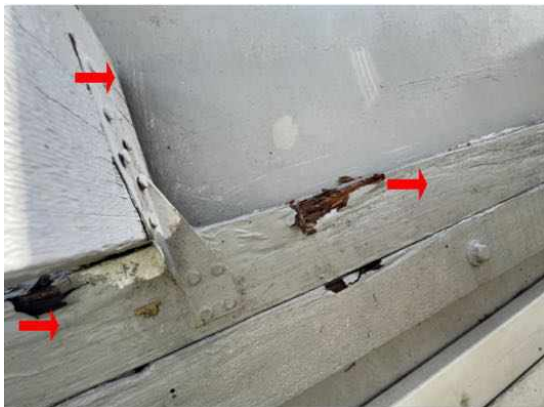
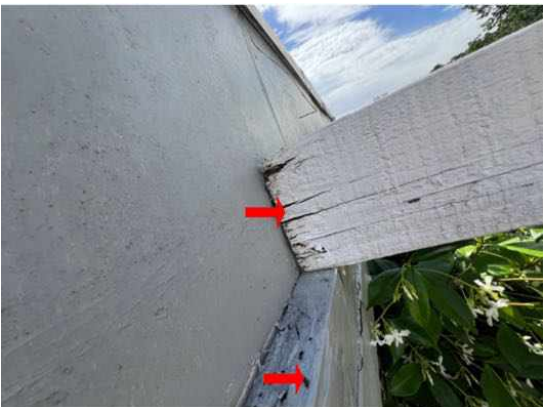
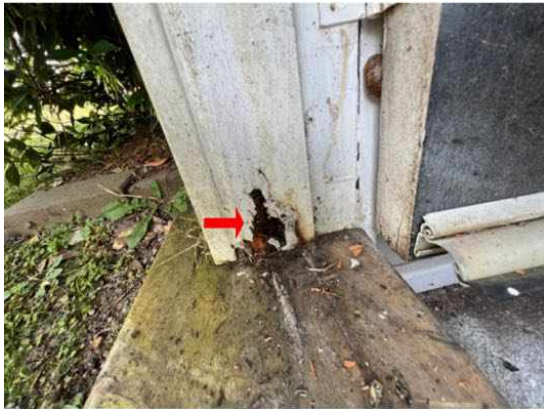
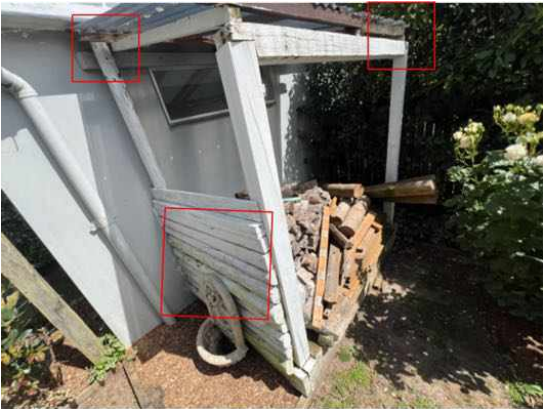
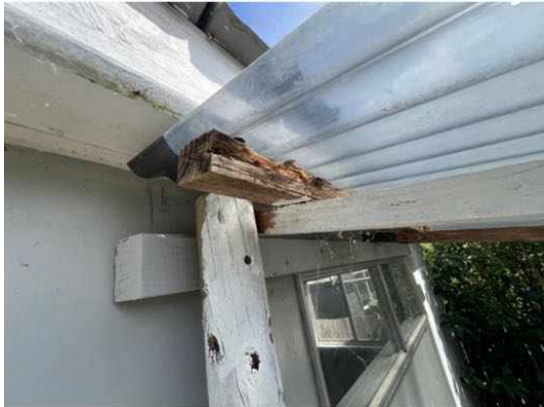
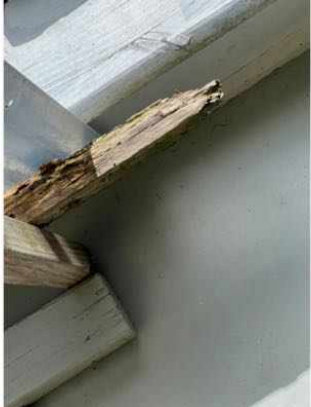
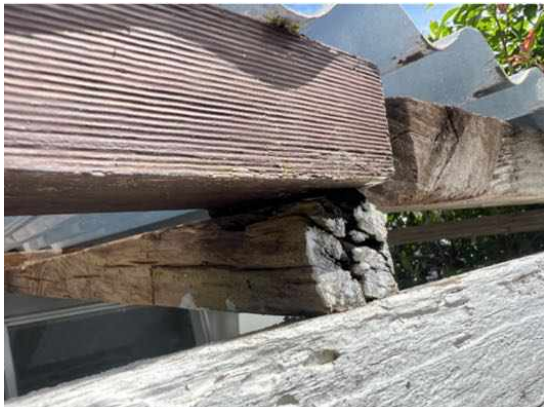
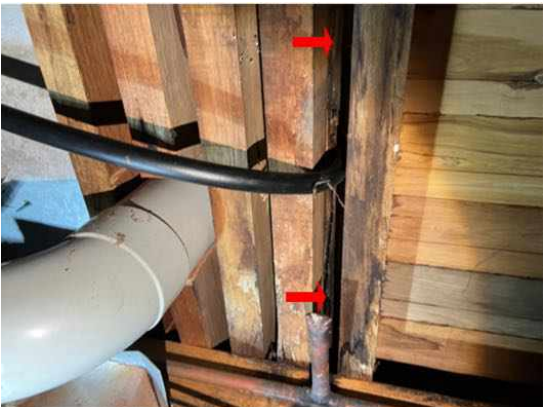
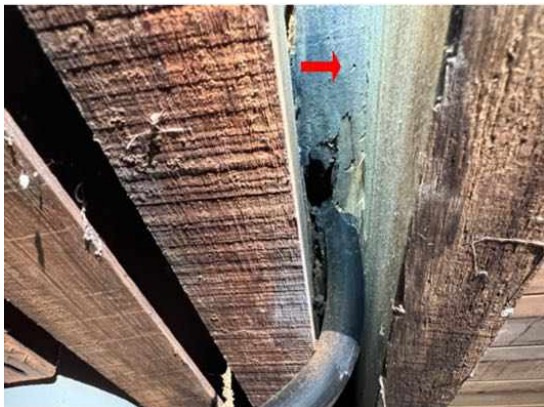
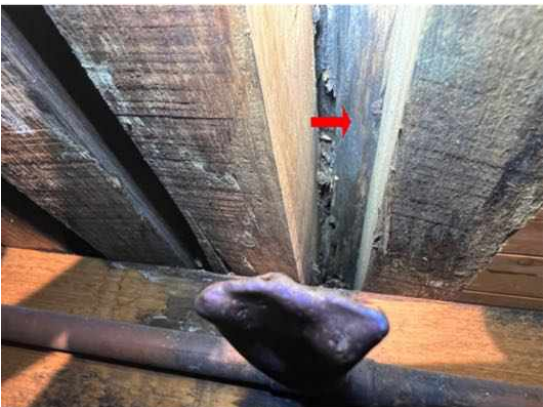
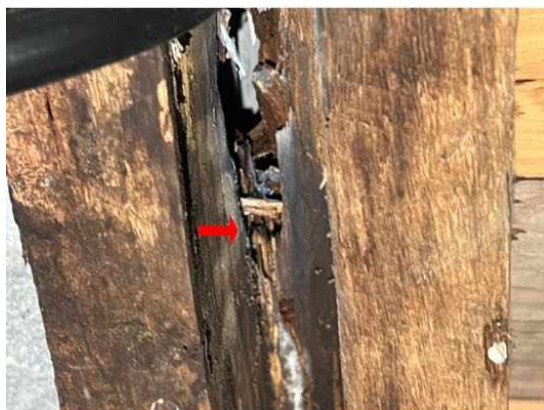
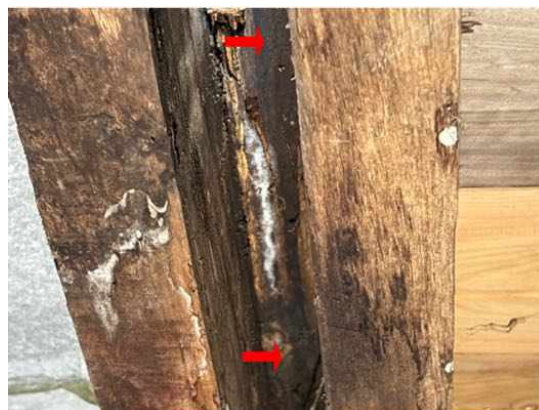
Building:	
Location:	All Areas
Finding:	Fungal decay - present (localised)
Information:	Fungal decay also known as wood decay or wood rot generally refers to the deterioration of timber elements when in contact with excessive levels of moisture for a prolonged period of time.

The development of fungal decay is accelerated by temperatures in the range of 5degreeC to 40degreeC as well as the presence of oxygen. Generally fungal decay develops on timber elements that are in use in an external environment which are exposed to rain penetration.

In this case although the affected timber element is in a decaying state the extent of any visible damage appears to be localised to a specific area and is yet to spread to other parts of the building element or affect adjoining structures. The fungal decay is therefore likely to be of a relatively superficial nature with minimal impact on the structural integrity or tensile strength of the timber element.

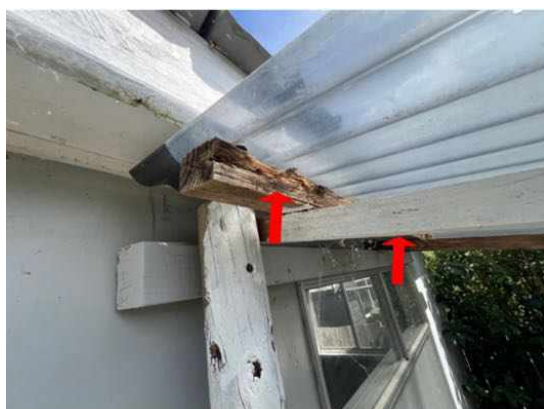
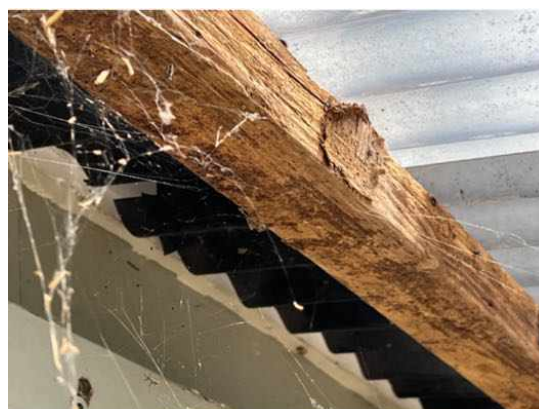
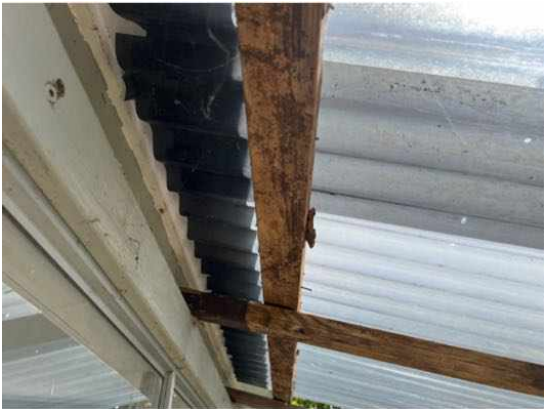
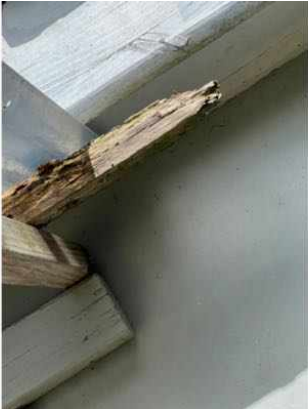
Finding 8.01

Information: Wood borers small beetles that colonise in exposed timber elements are a common timber pest that are regularly mistaken for termites. Although wood borer activity is generally not detrimental to the affected timber they may lead to serious damage and necessitate replacement of certain building elements if left unattended.

The other commonly known borer the Anobium borer is more likely to attack floorboards and may cause severe structural damage to flooring areas.

As no live wood borer activity was identified treatment is not required at this time. Replacement of affected timbers may be considered by the client for superficial reasons.
