Building and Timber Pest Inspection Report VR

Inspection Date: Thu, 20 Nov 2025

Property Address: 19 Hill St, Bundanoon NSW 2578,
Australia

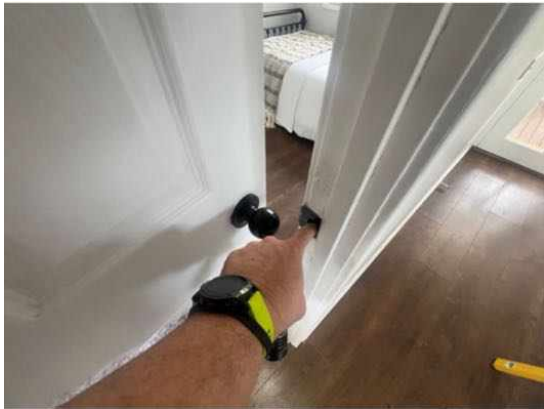
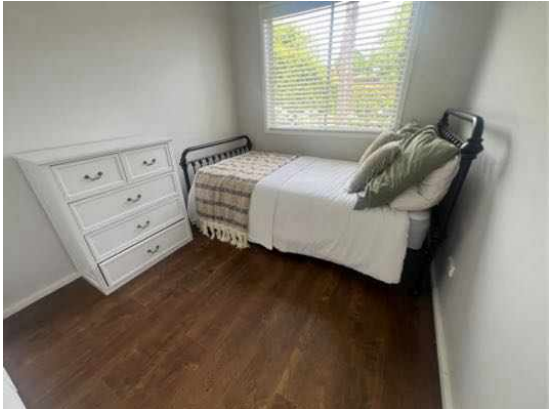
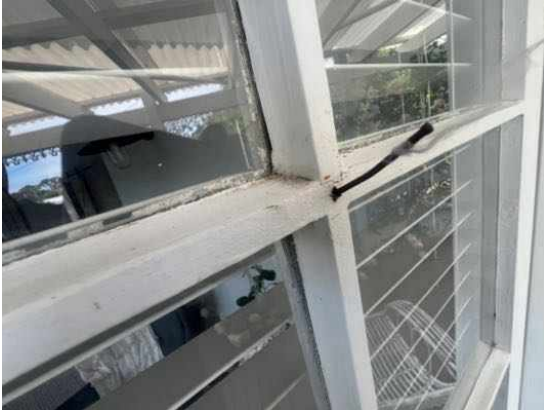
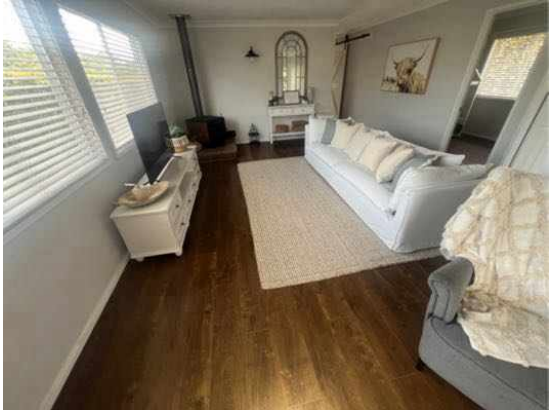
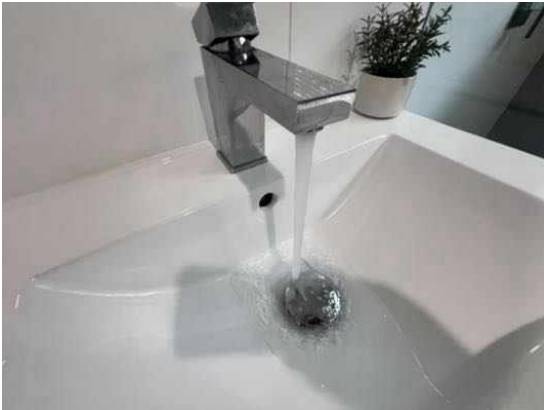
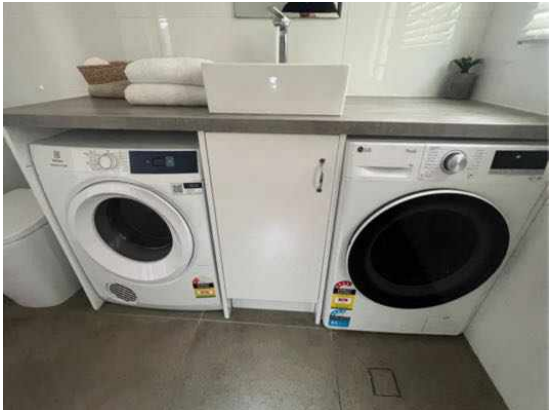
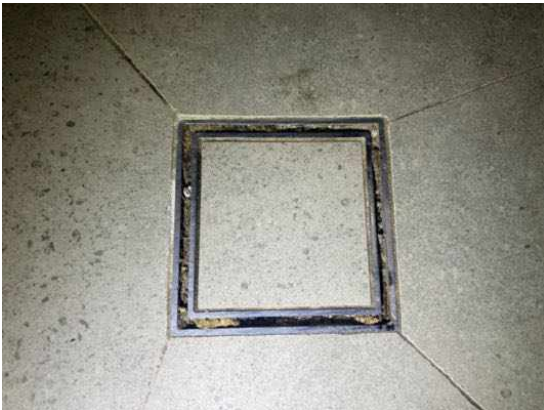
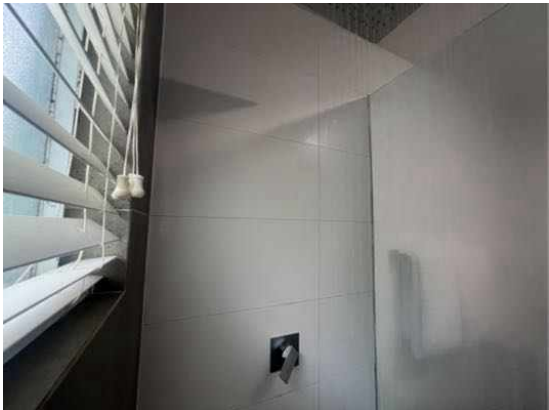
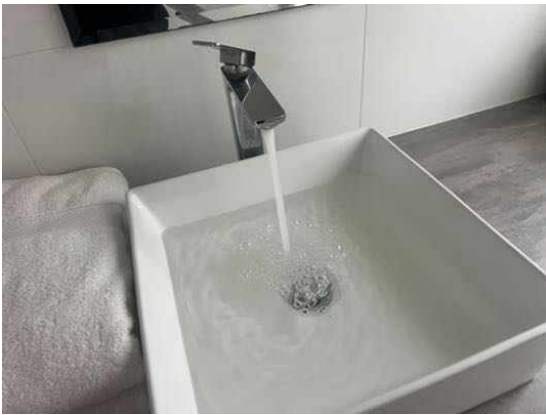
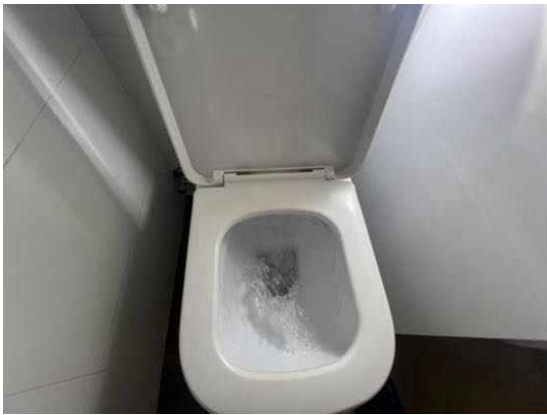
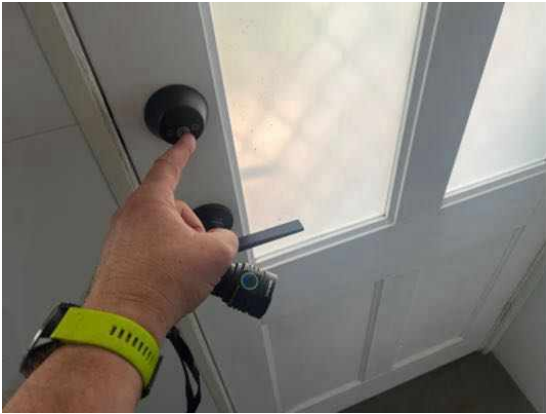
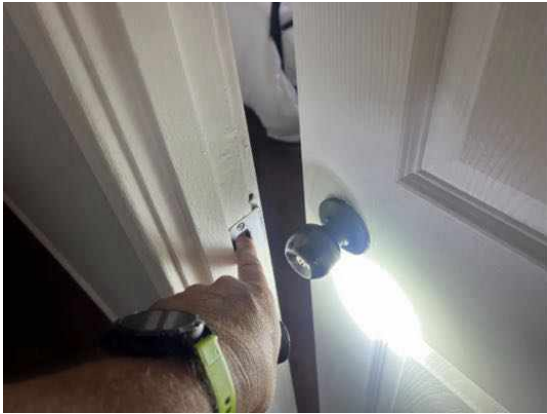
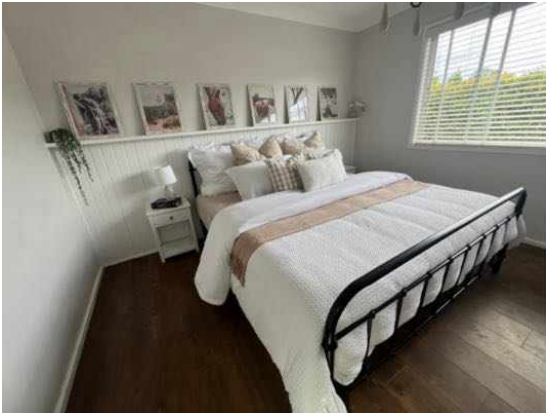
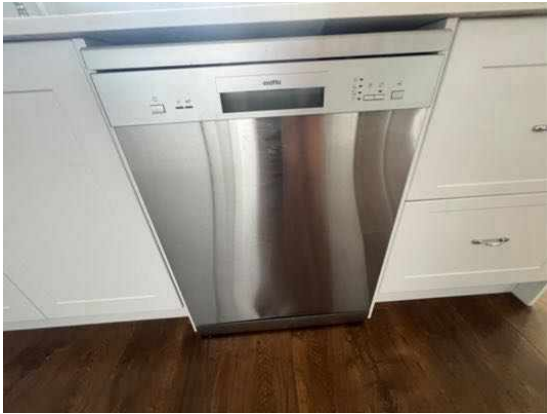
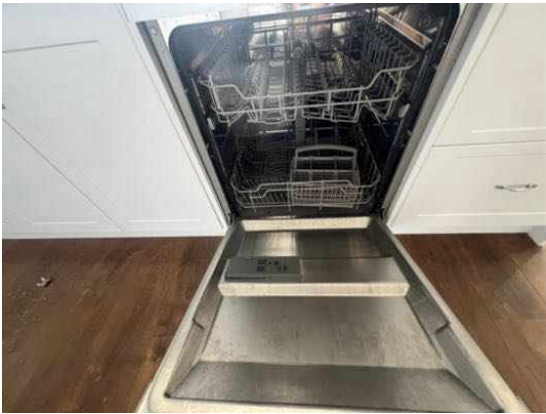
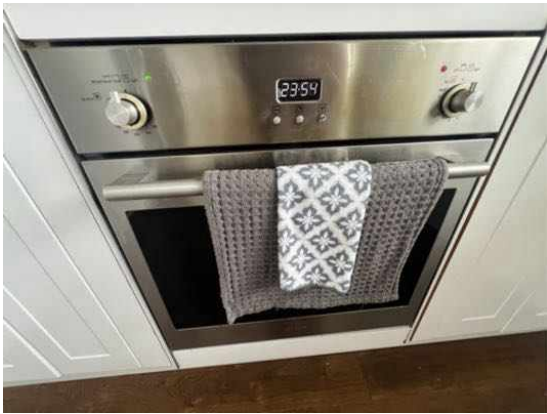
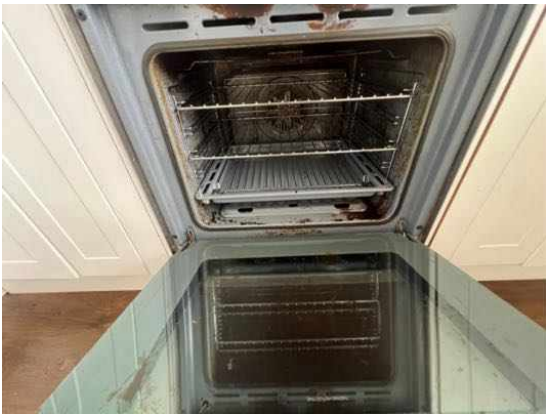
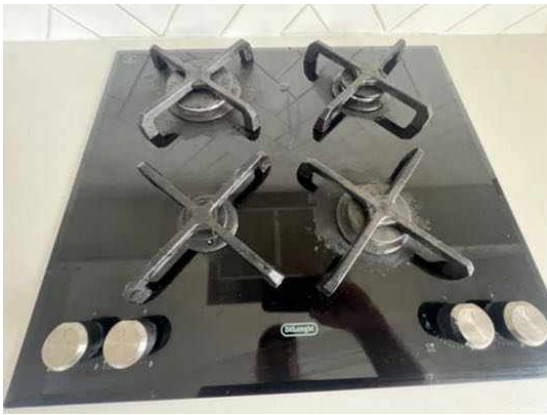
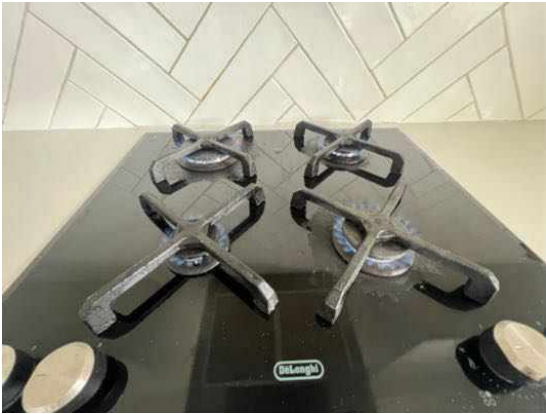
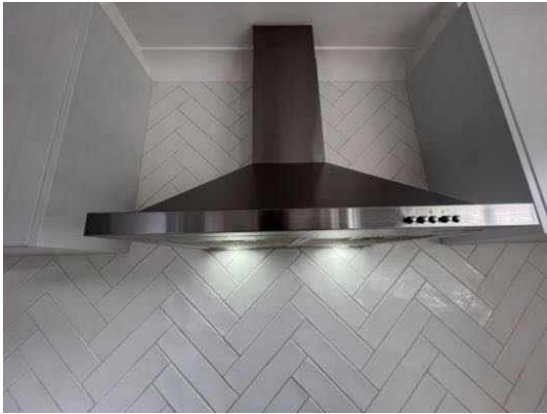
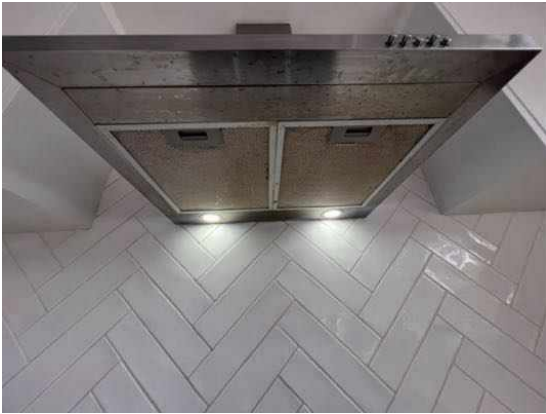
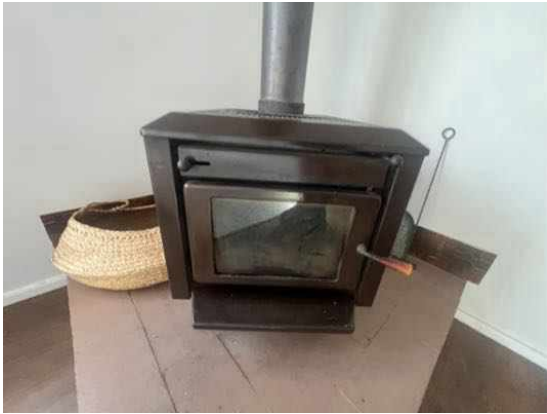
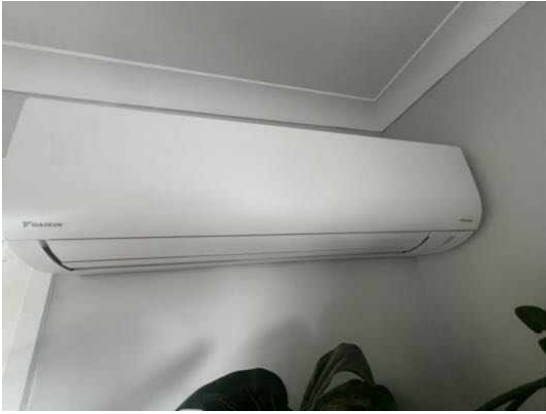
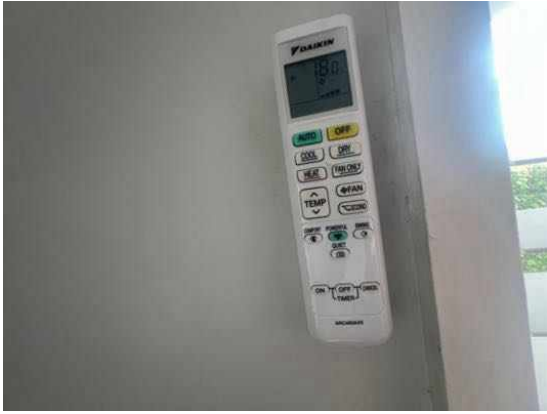
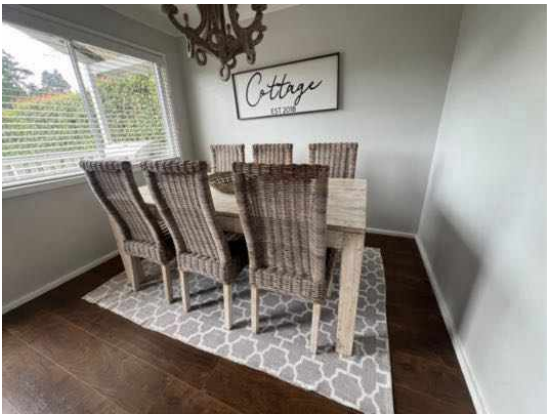
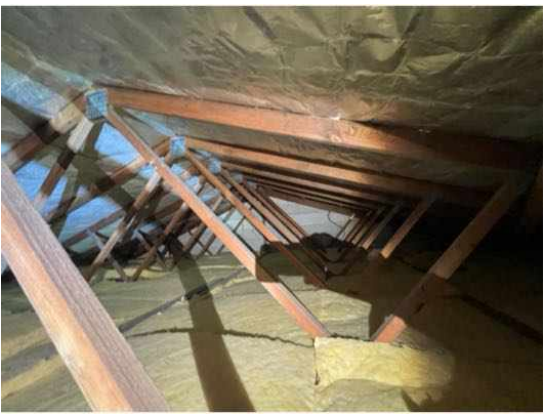
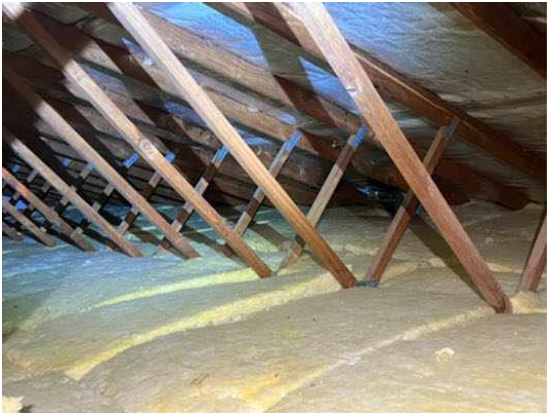
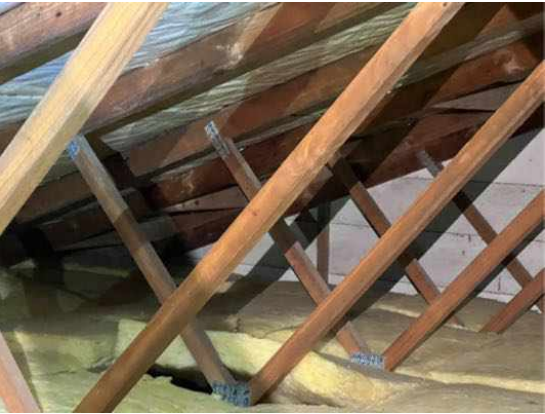
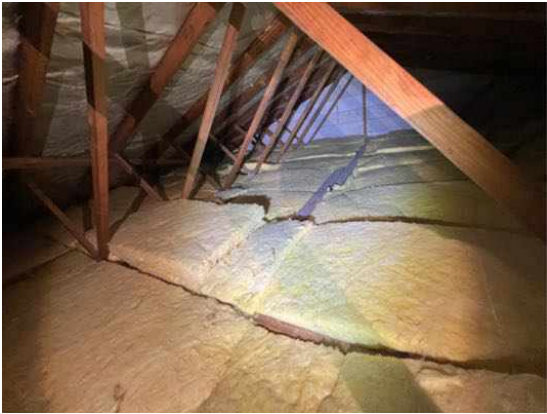
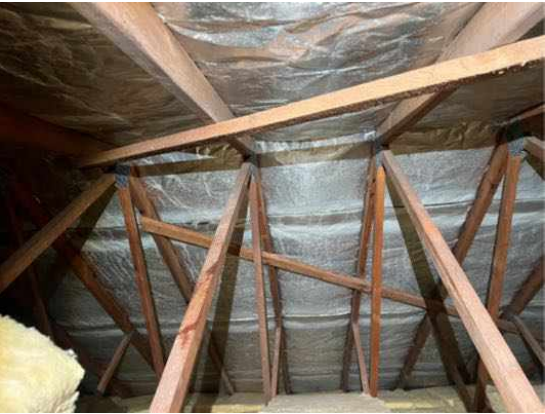
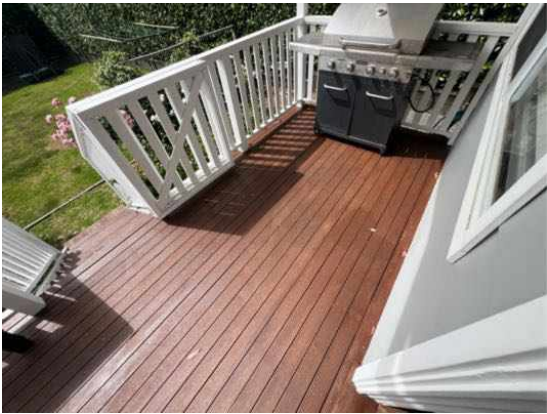
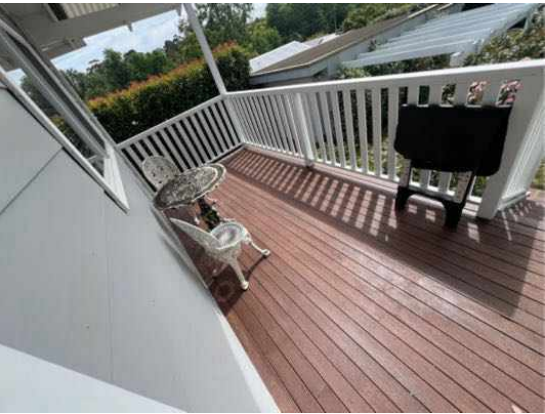
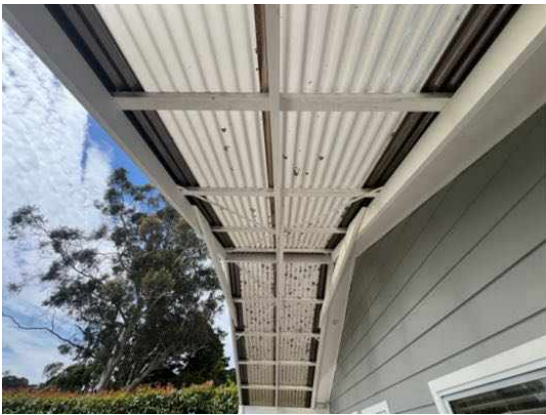
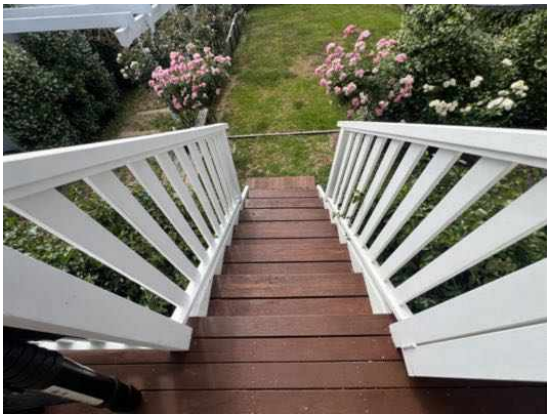
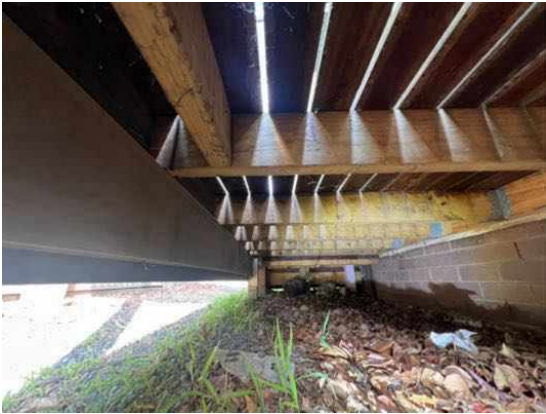
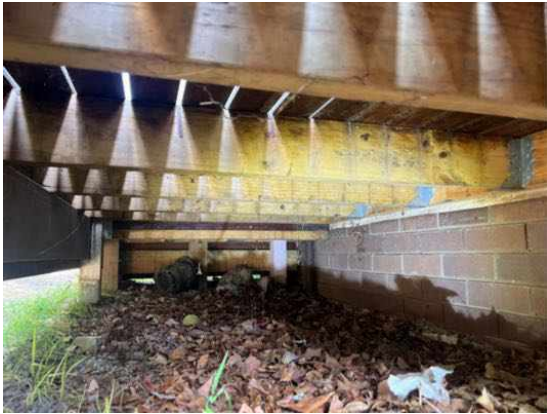
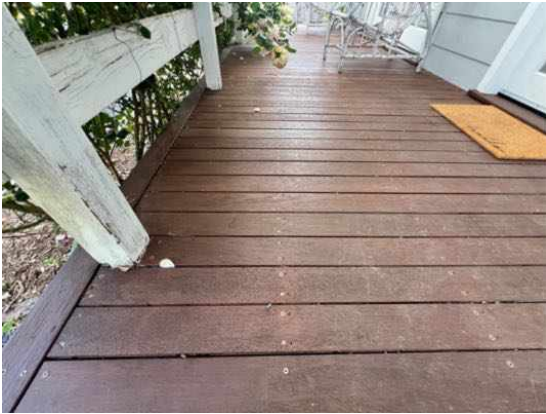
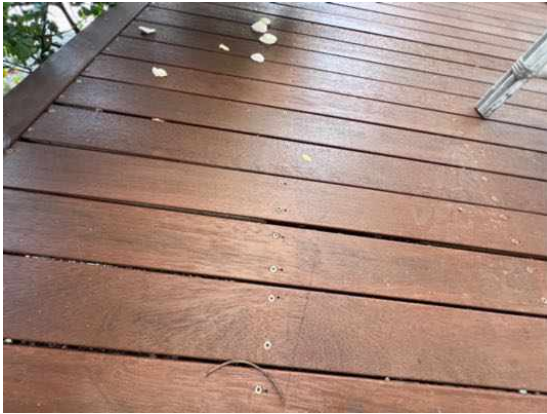
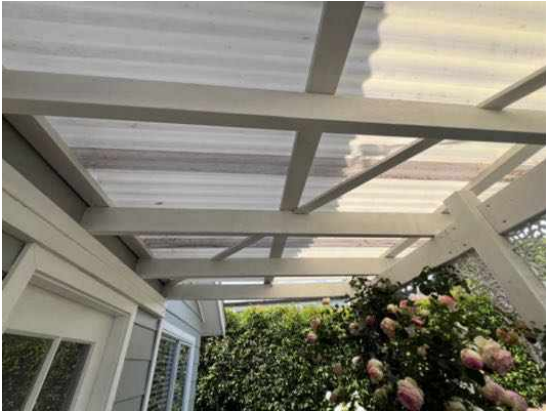
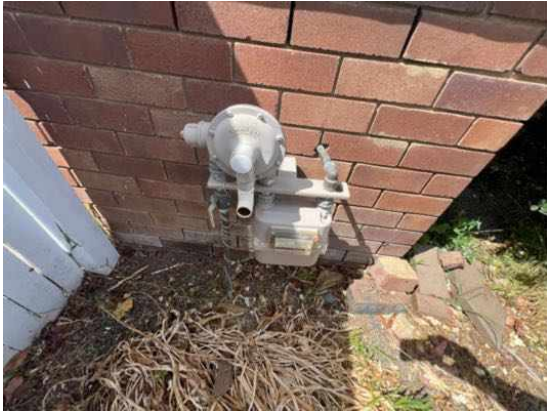
Finding: FYI - Additional Photos

Information: Additional photos are provided for your general reference and may include obstructions, testing of water & windows, moisture readings or minor maintenance items.
