Building and Timber Pest Inspection Report

Inspection Date: Tue, 10 Mar 2026

Property Address: 4 Stephen St, Urbenville NSW 2475,
Australia

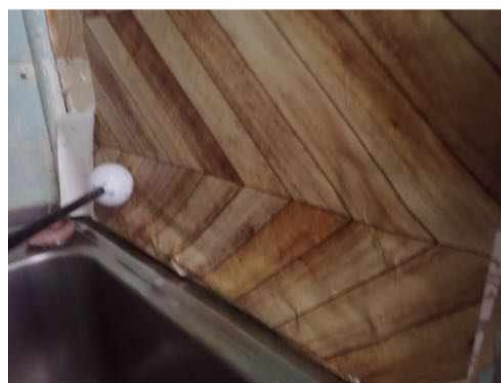
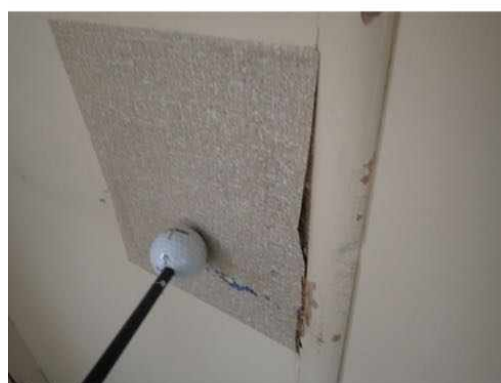
Finding 1.01

Building:	Main Building
Location:	Laundry and bedroom
Finding:	Contact Covering Suspected Holes in Internal Wall Cladding
Information:	Contact material was observed covering suspected holes in the internal wall cladding in the bedroom and laundry at the time of inspection. Covering damaged areas in this manner may conceal defects or damage to the wall lining and prevents a proper assessment of the underlying condition. It should be noted that the wall cladding may contain asbestos due to the age and type of materials used in buildings of this era. Disturbance of asbestos-containing materials can present health risks if fibres become airborne. Asbestos detection and identification is outside the scope of this inspection. It is recommended that the affected areas be further investigated and that any works involving the wall cladding be carried out by suitably qualified professionals. Repairs should be carried out as deemed necessary.

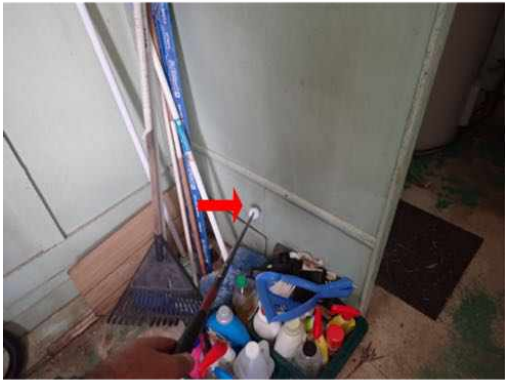
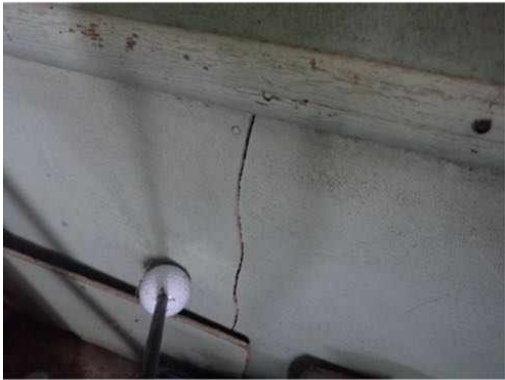
Finding 1.02

Finding: Cracks and Damage to Laundry Wall Cladding – Possible Asbestos Containing Material

Information: Cracks and damage were identified to the laundry wall cladding at the time of inspection. Deterioration of wall cladding may allow further damage if not addressed. The wall cladding may contain asbestos due to the age and type of materials commonly used in buildings of this era. Disturbance of asbestos-containing materials can present health risks if fibres become airborne. Asbestos detection and identification is outside the scope of this inspection. It is recommended that the affected cladding be treated with caution and that any repairs or alterations be carried out by suitably qualified professionals. Repairs should be carried out as soon as possible.

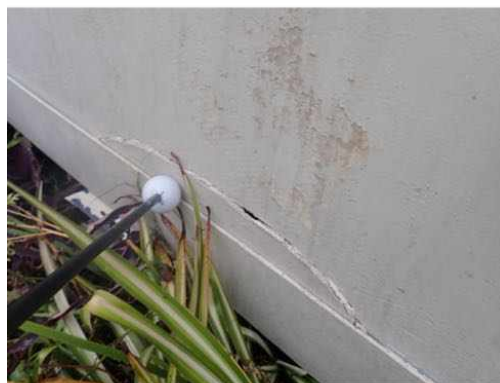
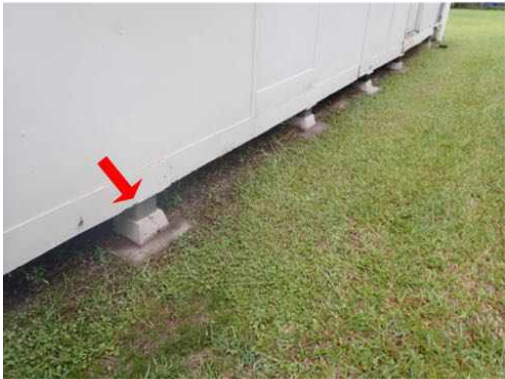
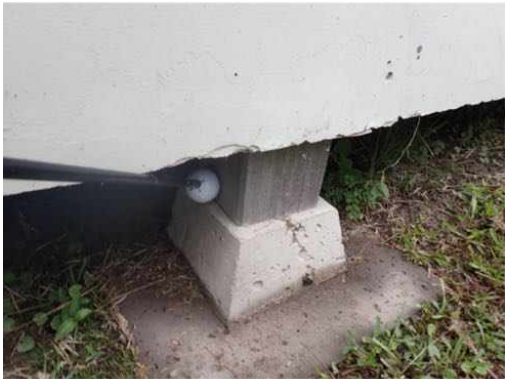
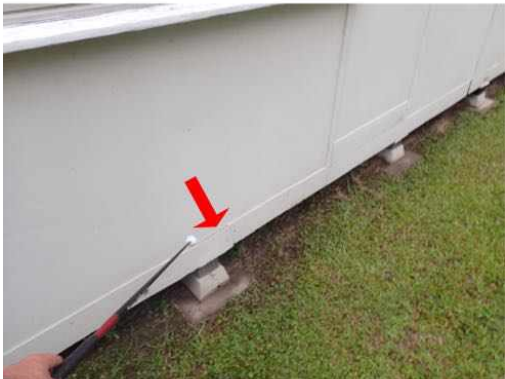
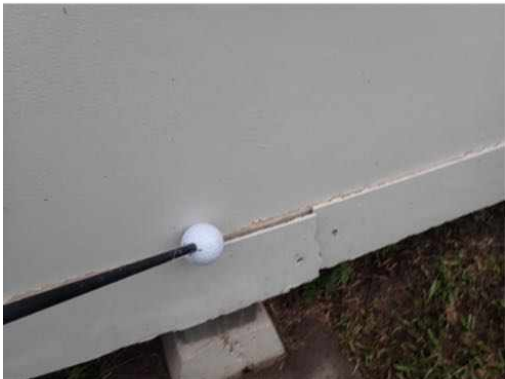
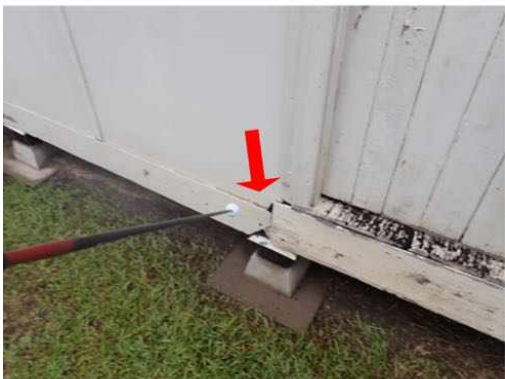
Finding 1.03

Building:	Main Building
Location:	External cladding
Finding:	Damaged External Wall Cladding – Possible Asbestos Containing Material
Information:	Multiple areas of damaged external wall cladding were identified at the time of inspection. Damage to wall cladding may allow moisture ingress and further deterioration of the building fabric if not addressed. Due to the age and type of materials commonly used in buildings of this era, the cladding may contain asbestos. Disturbance of asbestos-containing materials can present health risks if fibres become airborne. Asbestos detection and identification is outside the scope of this inspection. It is recommended that the affected cladding be treated with caution and that any repairs, removal, or alterations be carried out by suitably qualified professionals. Repairs should be carried out as deemed necessary.

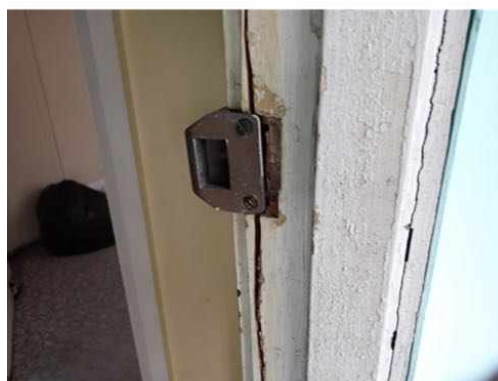
Finding 2.01

Building:	Main Building
Location:	Entry door
Finding:	Front Door Lock Not Secure – Split Door Jamb at Latch
Information:	The front door lock was observed to engage but was not very secure at the time of inspection. A split was identified in the door jamb at the lock latch location which may affect the ability of the door to latch securely. Damage to the door jamb in this area can reduce the effectiveness of the locking mechanism and may worsen over time if not repaired. It is recommended that a qualified carpenter or suitably experienced handyman repair or replace the damaged section of the door jamb and ensure the lock and strike plate are properly secured. Repairs should be carried out as deemed necessary.

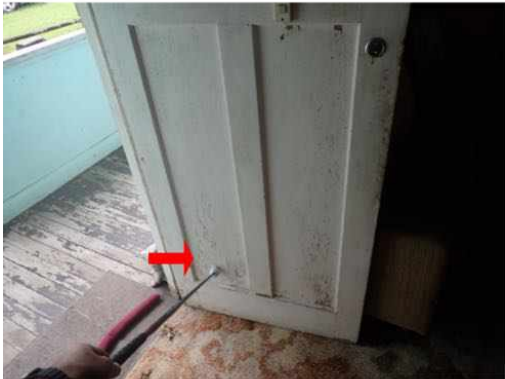
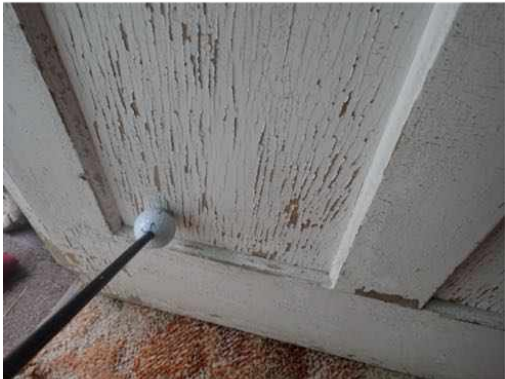
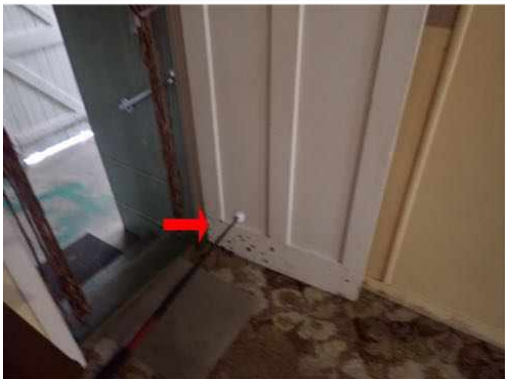
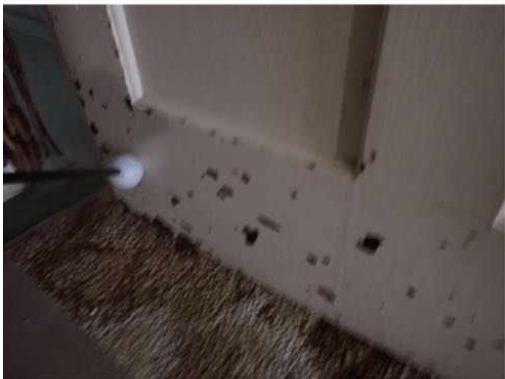
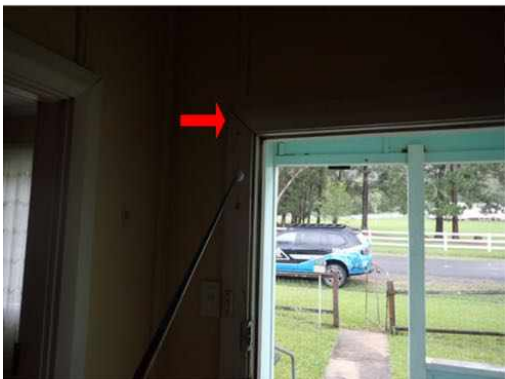
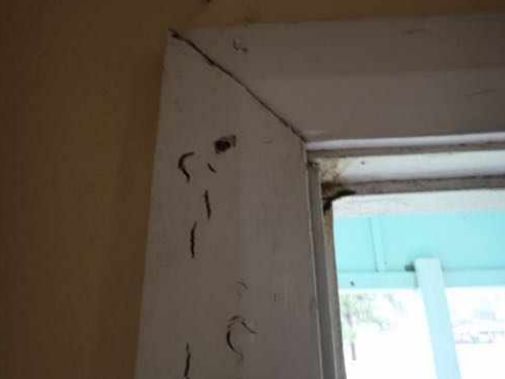
Finding 2.02

Finding: Internal Paintwork in Poor Condition

Information: The internal paintwork was found to be in poor condition at the time of inspection. Areas affected included walls, ceilings, doors, windows, and timber trims such as skirting boards, architraves, and cover strips. Deterioration of painted surfaces can occur over time due to general wear, ageing of coatings, and lack of maintenance. It is recommended that a qualified painter prepare the affected surfaces and carry out repainting as required to restore the protective and cosmetic finish. Repairs and maintenance should be carried out as deemed necessary.

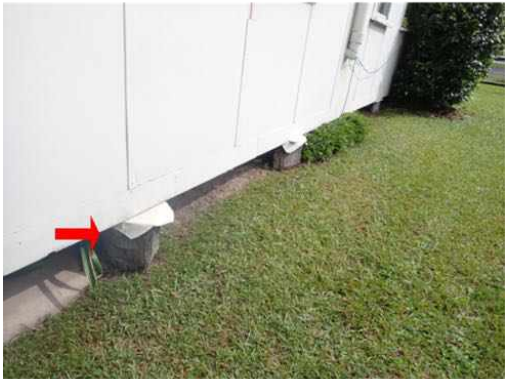
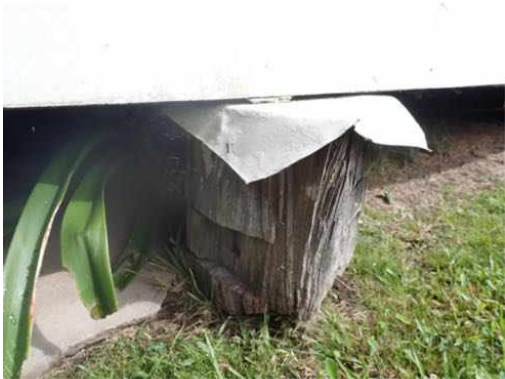
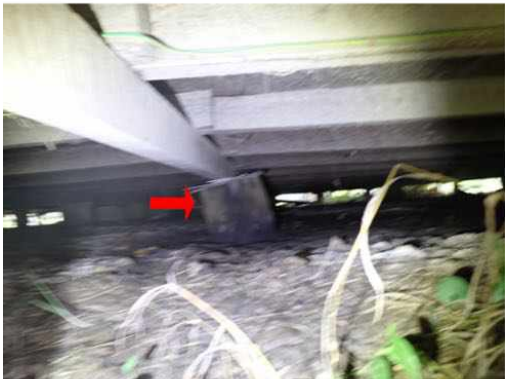
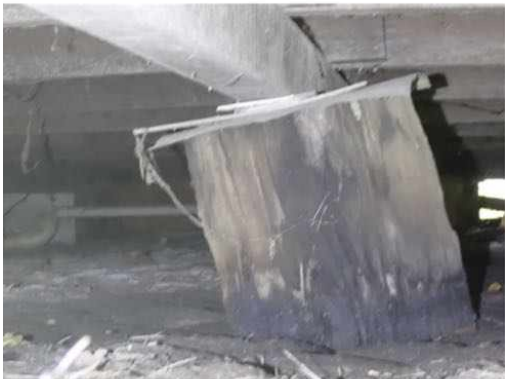
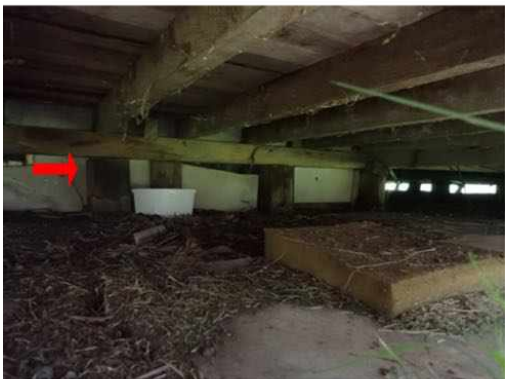
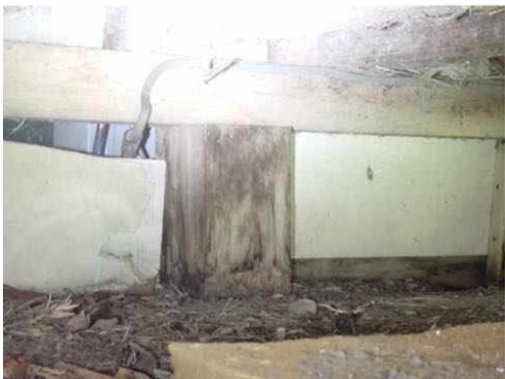
Finding: Uneven Timber Flooring and Deteriorated Timber Stumps

Information: The timber flooring throughout the building was observed to be wavy and out of level at the time of inspection. The timber stumps supporting the building were also found to be in poor condition, with defects including wood rot, movement, leaning out of plumb, and signs of sinking. It should be noted that the condition of the stumps below ground level could not be determined during the visual inspection. The external stumps on two sides of the building appeared to have been replaced at some stage. Deterioration of subfloor supports can lead to uneven floors and may indicate ongoing structural movement if not addressed. It is recommended that a qualified builder assess the condition of the timber stumps and subfloor supports and carry out repairs, replacement, or re-levelling of the building as required to prevent further deterioration. Further investigation and rectification works should be carried out as deemed necessary.

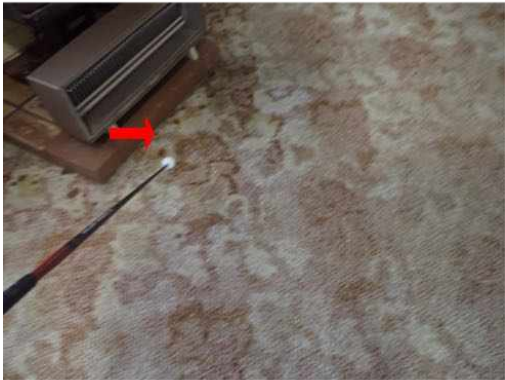
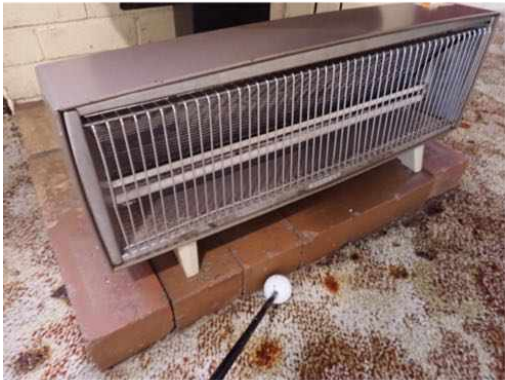
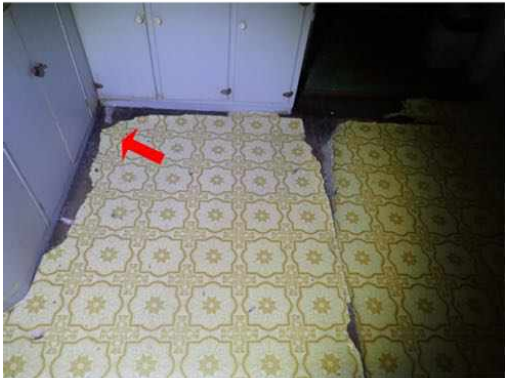
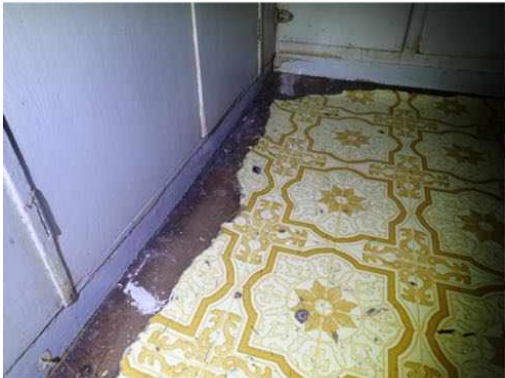
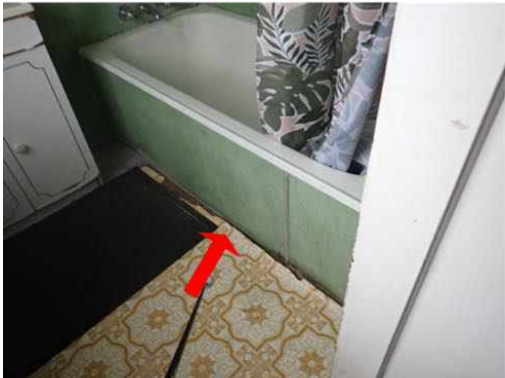
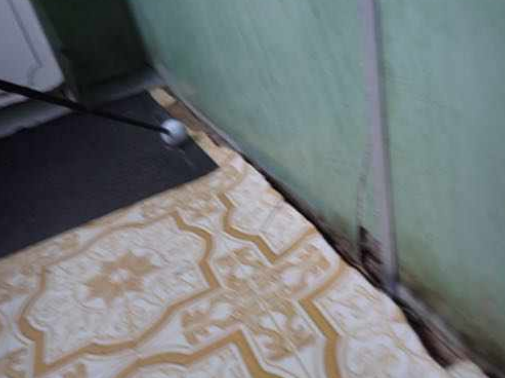
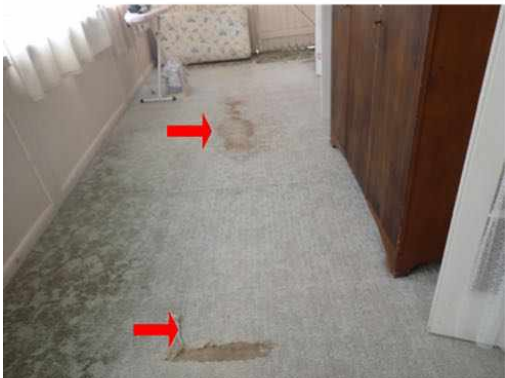
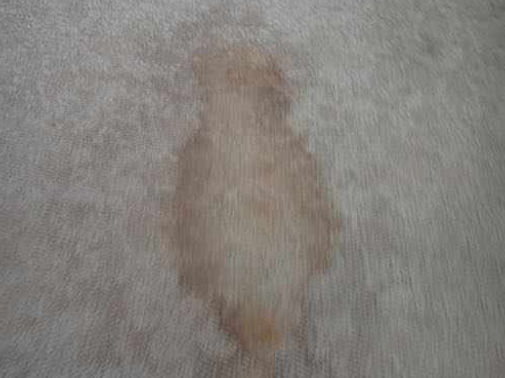
Finding 2.04

Building: Main Building
Location: Floor
Finding: Carpet and Vinyl Flooring in Poor Condition Throughout Building
Information: The carpet and vinyl flooring throughout the building were found to be in poor condition at the time of inspection. Visible wear, deterioration, and general ageing of the floor coverings were noted. Floor coverings of this nature can deteriorate over time due to normal use and ageing of the materials. It is recommended that the affected carpet and vinyl flooring be replaced as required to restore the condition and appearance of the floor surfaces. Replacement should be carried out as deemed necessary.

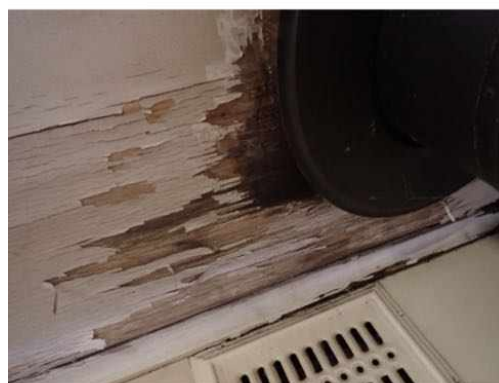
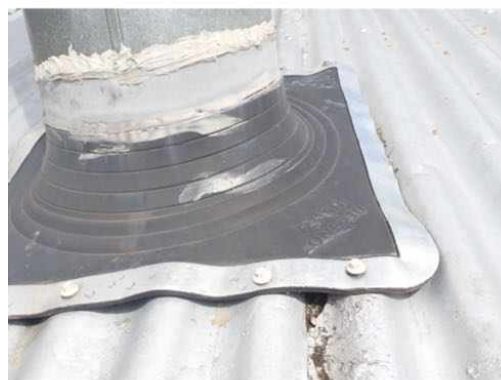
Finding 2.05

Building:	Main Building
Location:	Ceiling living room and roof exterior
Finding:	Active Leak to Fireplace Flue and Ceiling Damage
Information:	An active leak was identified at the fireplace flue, with damage noted to the ceiling around the flue penetration at the time of inspection. Water ingress in this area may lead to further deterioration of the ceiling materials and surrounding building elements if not addressed. This condition may be associated with defects in the roof flashing, sealing around the flue penetration, or deterioration of associated roof components. It is recommended that a qualified roofer or builder assess the flue penetration and carry out repairs as required to stop the leak and repair the damaged ceiling area. Repairs should be carried out as deemed necessary.

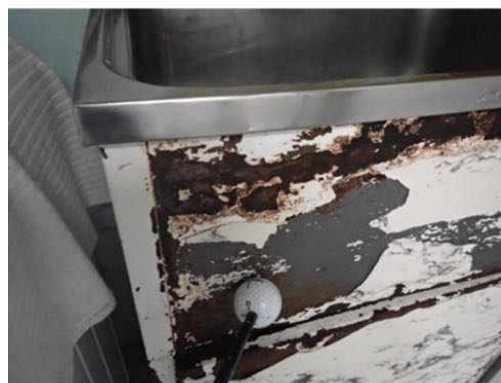
Finding 2.06

Finding: Laundry Tub Cabinet in Poor Condition

Information: The laundry tub cabinet was found to be in poor condition at the time of inspection. Deterioration of cabinets in laundry areas is commonly associated with ongoing moisture exposure, ageing of materials, and general wear over time. Continued deterioration may affect the durability and functionality of the cabinet if not addressed. It is recommended that a suitably experienced handyman repair or replace the cabinet as required to maintain the condition and usability of the laundry area. Repairs or replacement should be carried out as deemed necessary.

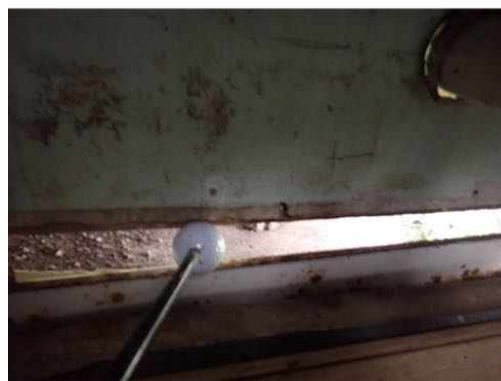
Finding 2.07

Information: A gap was identified in the wall cladding within the laundry tub cabinet at the time of inspection. Openings in wall linings may allow moisture, pests, or debris to enter the wall cavity and may lead to further deterioration of surrounding materials if not addressed. It is recommended that a suitably experienced handyman or qualified tradesperson assess the affected area and carry out appropriate repairs as required.

Repairs should be carried out as deemed necessary.

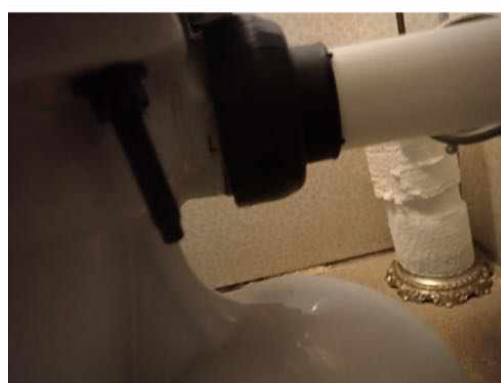
Finding 2.10

Building:	Main Building
Location:	Toilet (WC)
Finding:	Toilet Leaking When Flushed
Information:	The toilet was observed to leak when flushed at the time of inspection. Plumbing leaks can lead to water wastage and moisture-related damage to surrounding building materials if not addressed. The leak may be due to worn seals, faulty fittings, or deterioration of internal cistern or plumbing components. It is recommended that a qualified plumber inspect the toilet and carry out repairs or replacement of defective components as required to ensure the fixture is functioning correctly and to prevent further damage. Repairs should be carried out as deemed necessary.

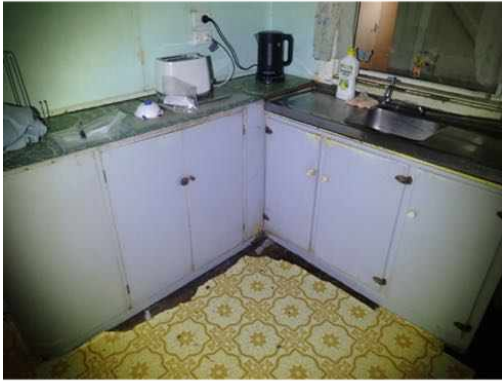
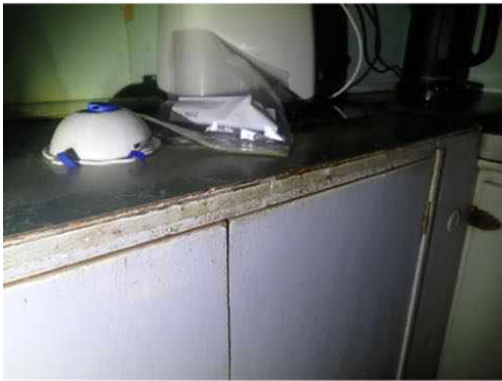
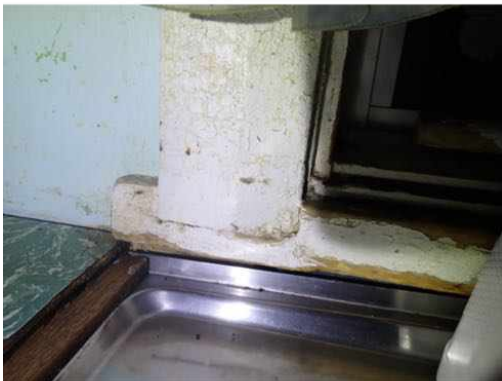
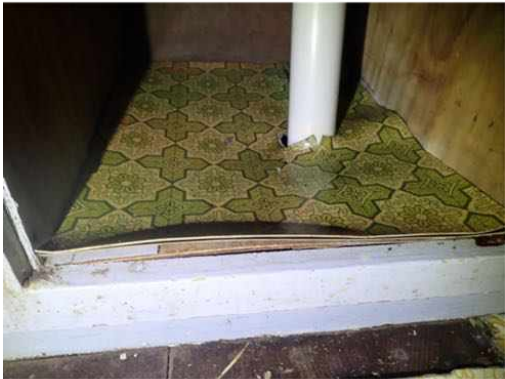
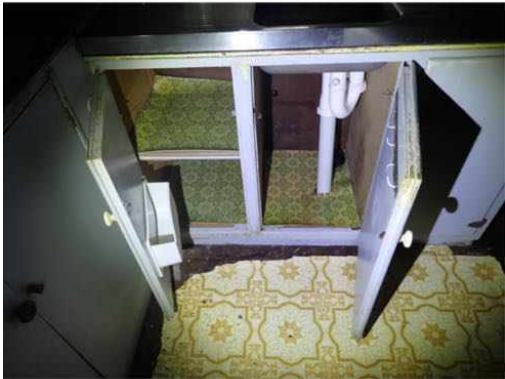
Finding 2.11

Building:	Main Building
Location:	Kitchen
Finding:	Kitchen in Poor Condition

Information: The kitchen was found to be in poor condition at the time of inspection. Deterioration of kitchen components can occur over time due to general wear, ageing of materials, and ongoing use. Continued deterioration may affect the functionality and durability of the kitchen if not addressed. It is recommended that a qualified carpenter, kitchen installer, or suitably experienced handyman assess the kitchen and carry out repairs, maintenance, or replacement of deteriorated components as required. Repairs or replacement should be carried out as deemed necessary.

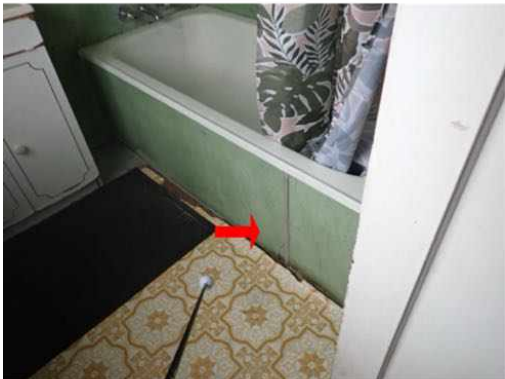
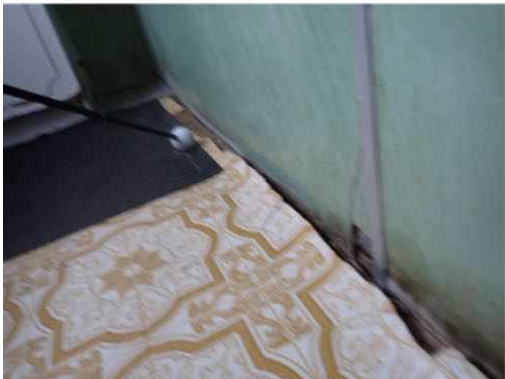
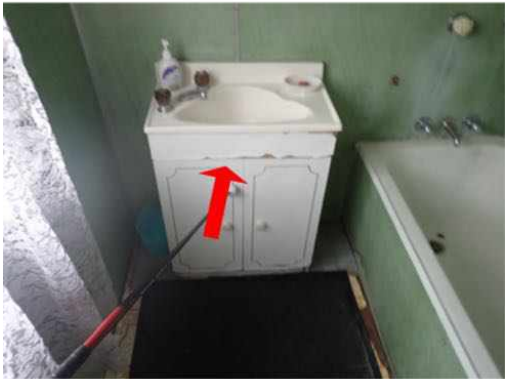
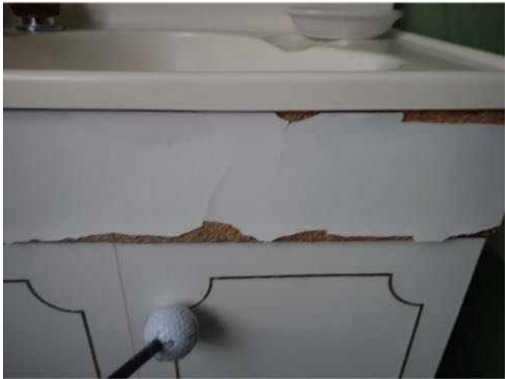
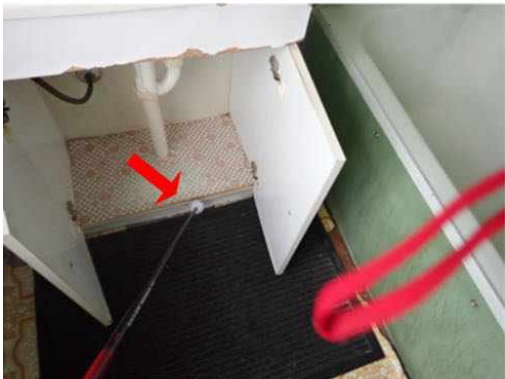
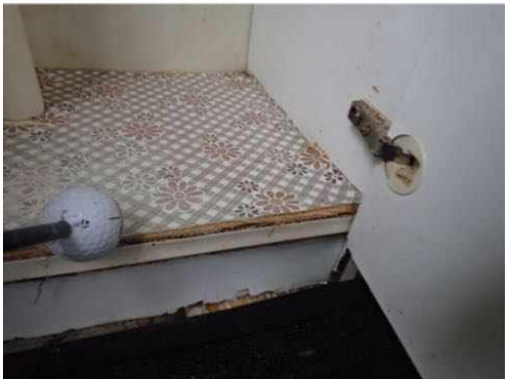
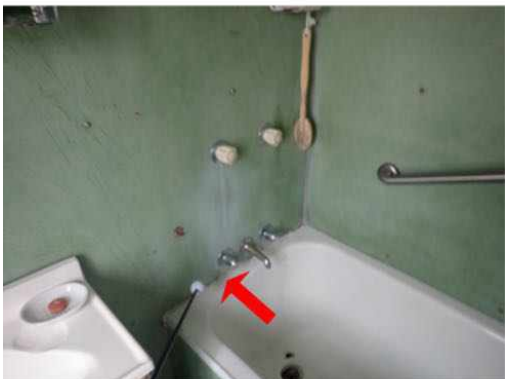
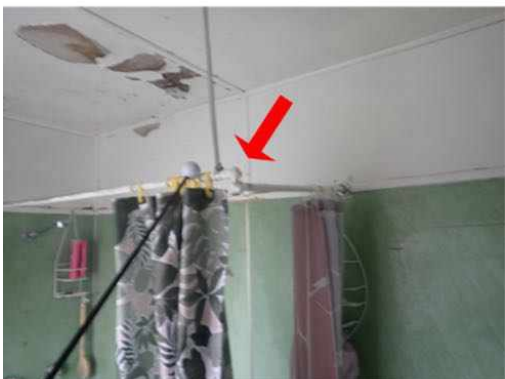
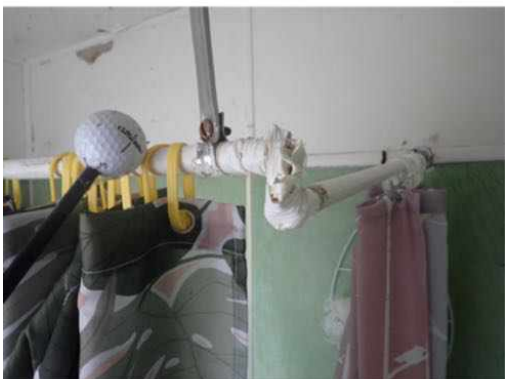
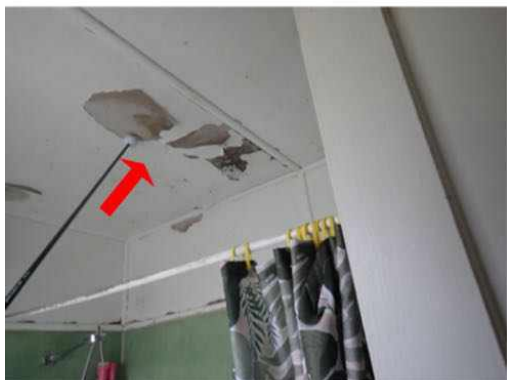
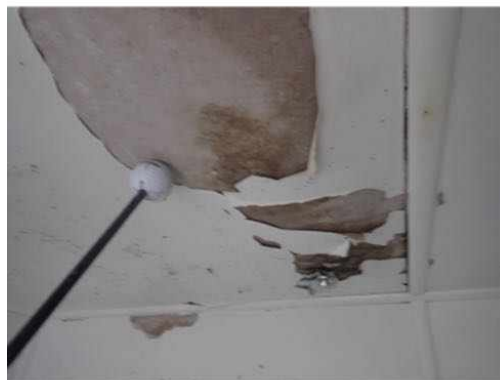
Finding 2.12

Building: Main Building
Location: Bathroom
Finding: Bathroom in Poor Condition

Information: The bathroom was found to be in poor condition at the time of inspection. Defects observed included deteriorated or missing silicone to junctions, the shower rail corner being held together with duct tape, swelling to the vanity cupboard, water damage to the ceiling, and general deterioration of bathroom components. Deterioration of this nature is commonly associated with prolonged moisture exposure and ageing of materials in wet areas. It is recommended that a qualified plumber and suitably experienced tradesperson assess the bathroom and carry out repairs or replacement of the affected components as required to prevent further deterioration. Repairs should be carried out as deemed necessary.

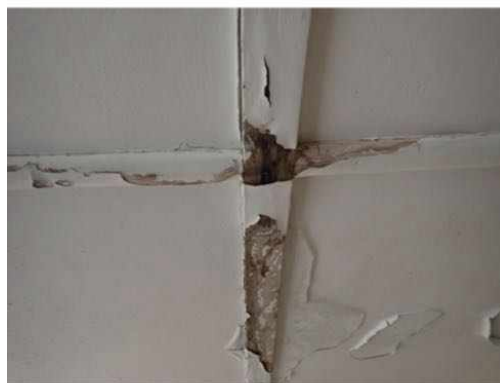
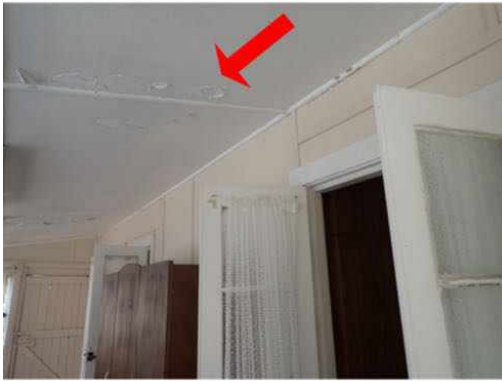
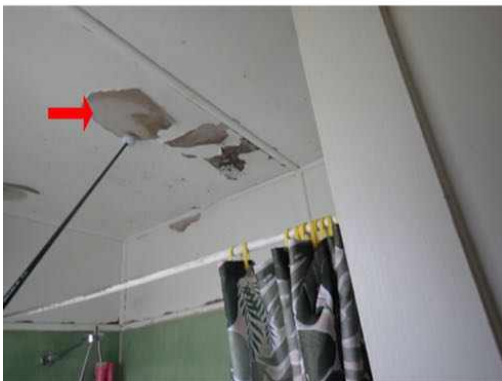
Finding 2.13

Finding: Water Damage to Ceilings in Bathroom and Bedroom

Information: Water damage was identified to the ceilings in the bathroom and bedroom at the time of inspection. Moisture staining and deterioration of ceiling linings can occur due to roof leaks, plumbing leaks, or condensation issues. Continued moisture exposure may lead to further deterioration of the ceiling materials if not addressed. The source of the moisture could not be confirmed during the visual inspection. It is recommended that a qualified builder, roofer or plumber investigate the cause of the moisture and carry out repairs as required, and that the damaged ceiling areas be repaired once the source of the moisture has been rectified. Repairs should be carried out as deemed necessary.

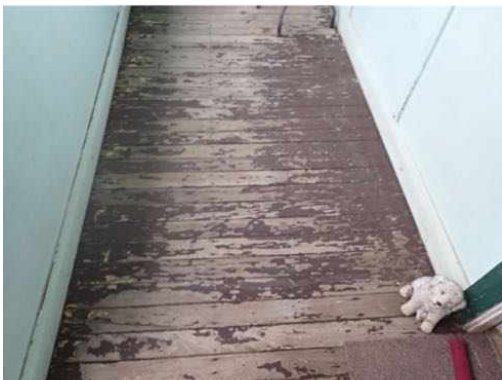
Finding 2.14

Building:	Main Building
Location:	Front porch
Finding:	Front Porch Timber Decking in Poor Condition
Information:	The timber decking to the front porch was found to be in poor condition at the time of inspection. Deterioration of external timber decking can occur due to prolonged exposure to weather, moisture, and general ageing of the timber. Continued deterioration may affect the durability and safety of the decking if not addressed. It is recommended that a qualified carpenter assess the decking and carry out repairs or replacement of deteriorated timber components as required. Repairs or replacement should be carried out as deemed necessary.

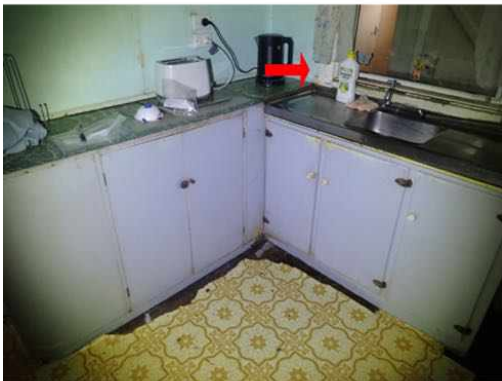
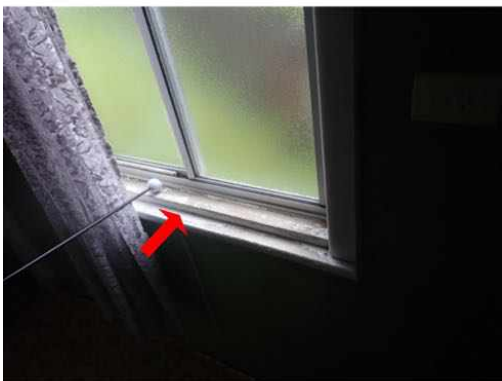
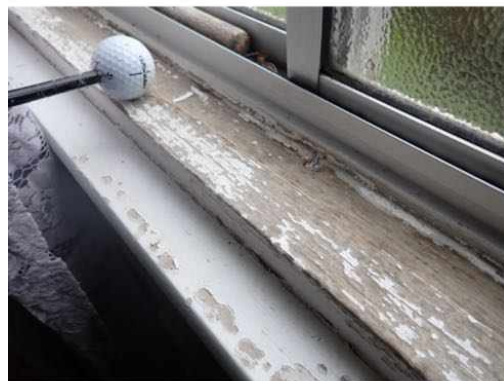
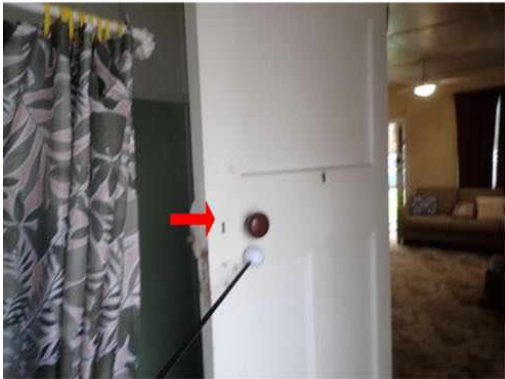
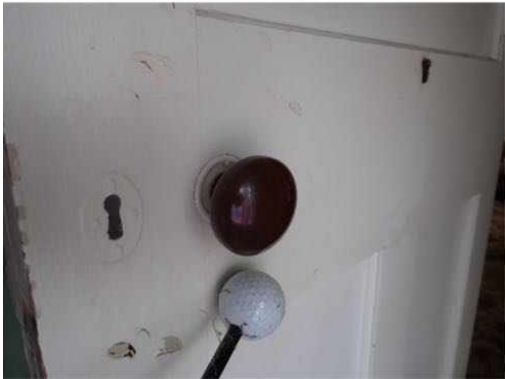
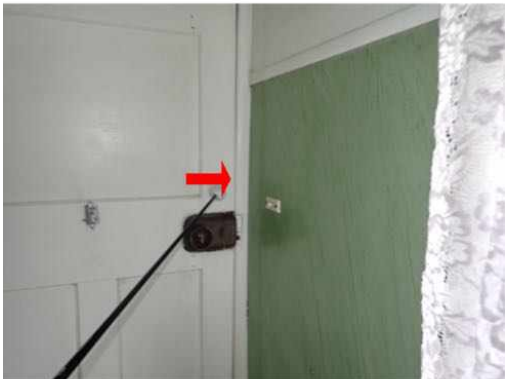
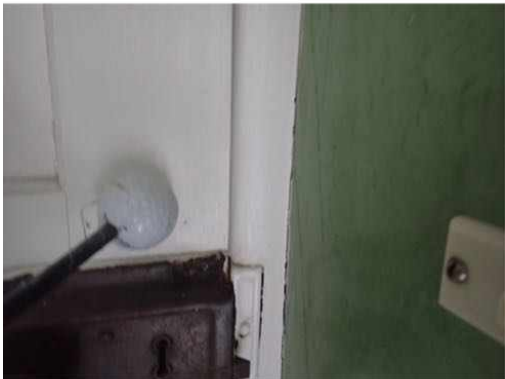
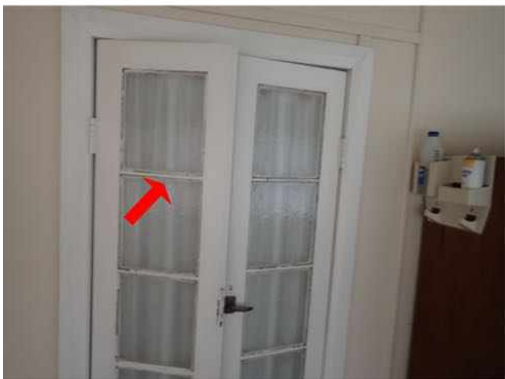
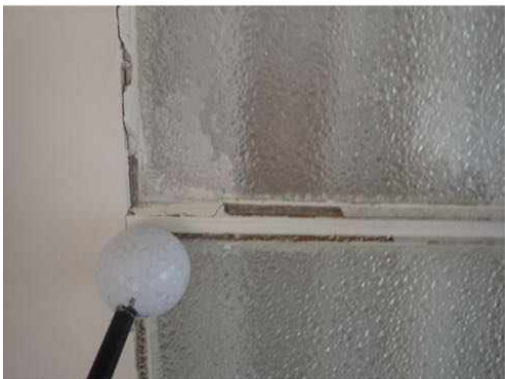
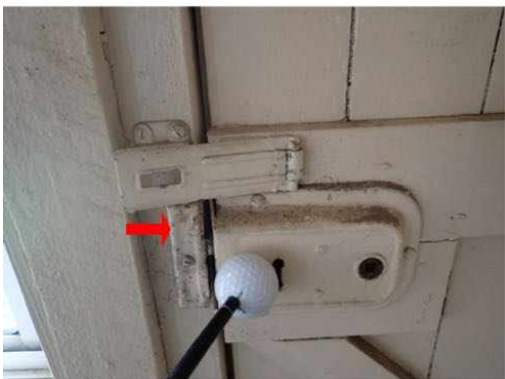
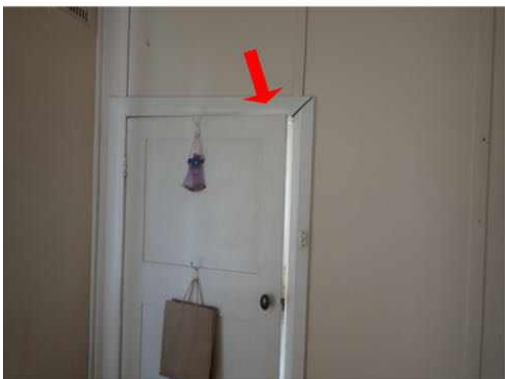
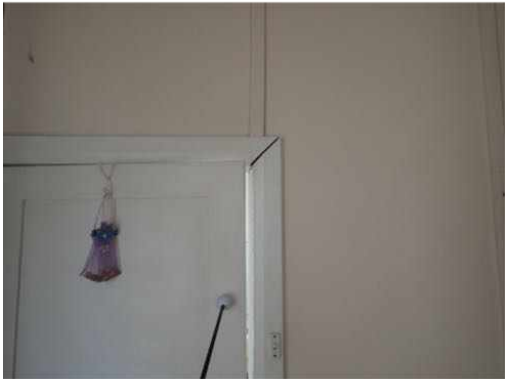
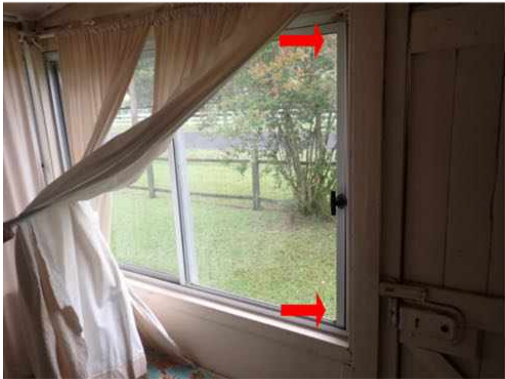
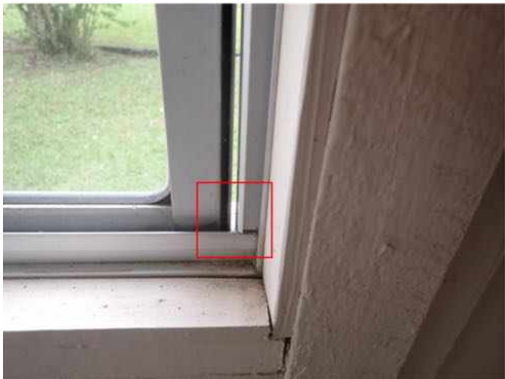
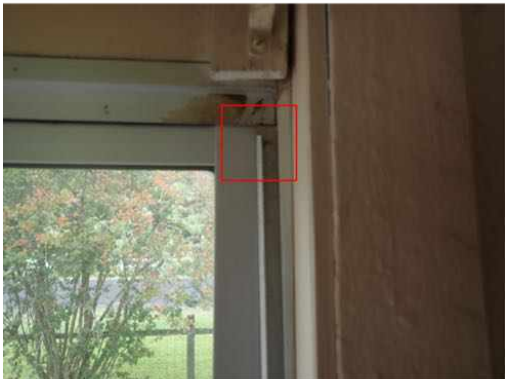
Finding: Doors and Windows in Poor Condition

Information: The majority of the doors and windows throughout the building were found to be in poor condition at the time of inspection. Defects observed included doors catching on door jambs, deteriorated paintwork, damaged doors, worn hardware, and general deterioration of components. Deterioration of doors and windows can occur over time due to ageing of materials, general wear, and lack of maintenance. It is recommended that a qualified carpenter or suitably experienced handyman assess the affected doors and windows and carry out repairs, maintenance, or replacement of deteriorated components as required. Repairs should be carried out as deemed necessary.

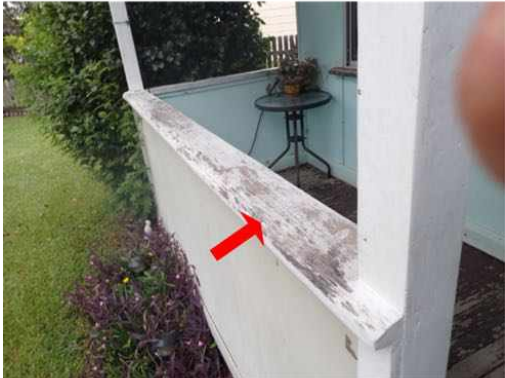
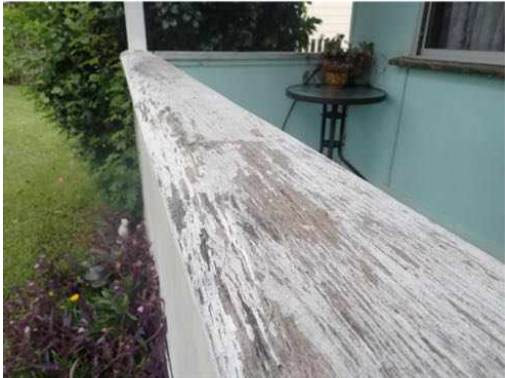
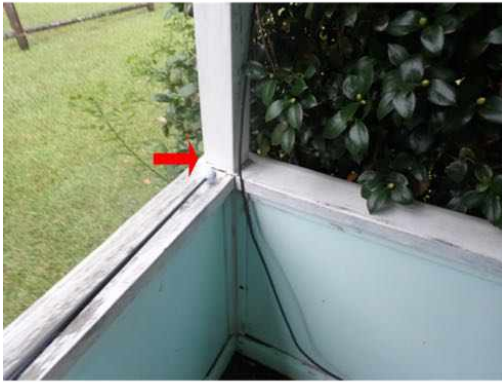
Finding 2.16

Building: Main Building
Location: Front porch
Finding: Deteriorated Timber Front Porch Handrail
Information: The timber handrail to the front porch was found to be deteriorated at the time of inspection. Deterioration of external timber elements commonly occurs due to prolonged exposure to weather, moisture, and general ageing of the timber. Continued deterioration may affect the durability and safety of the handrail if not addressed. It is recommended that a qualified carpenter assess the handrail and carry out repairs or replacement of the deteriorated timber components as required. Repairs or replacement should be carried out as deemed necessary.

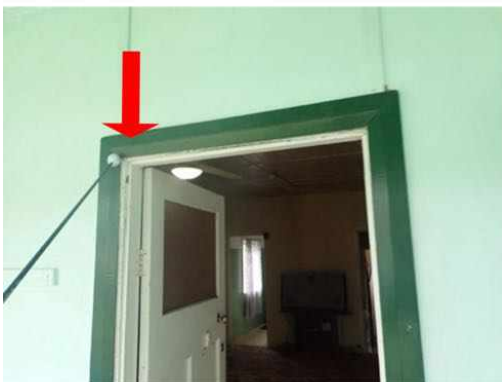
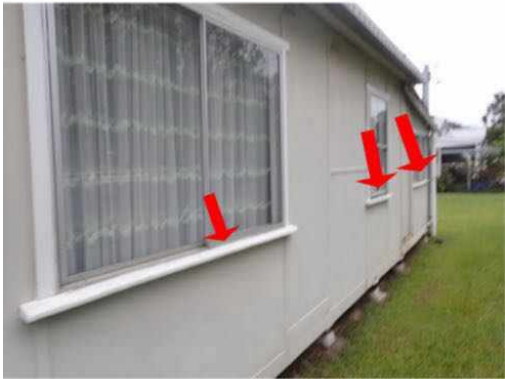
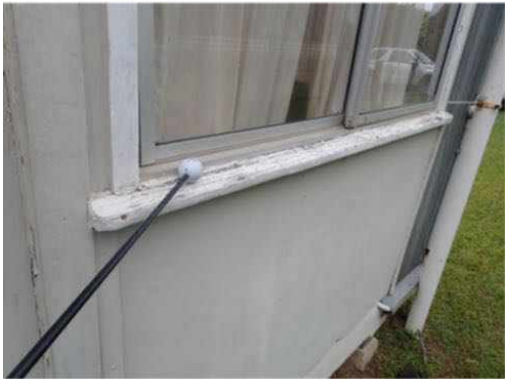
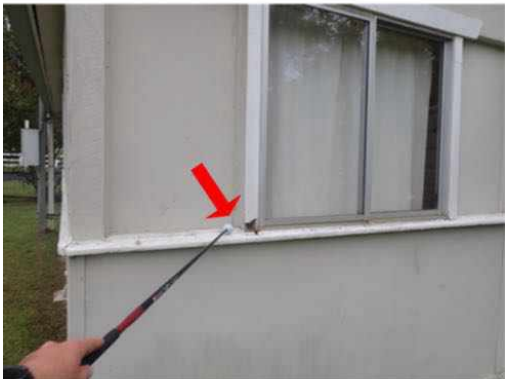
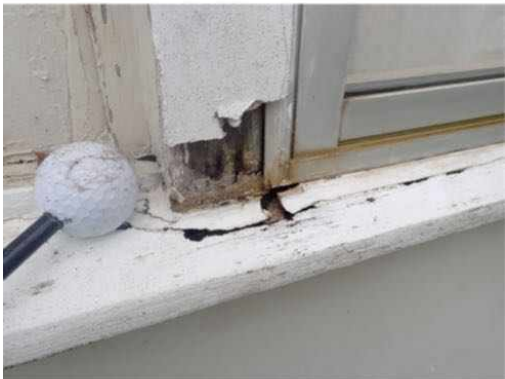
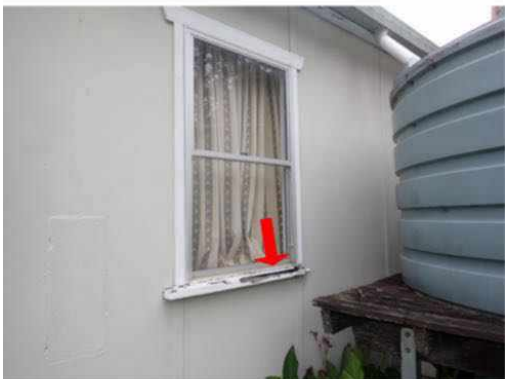
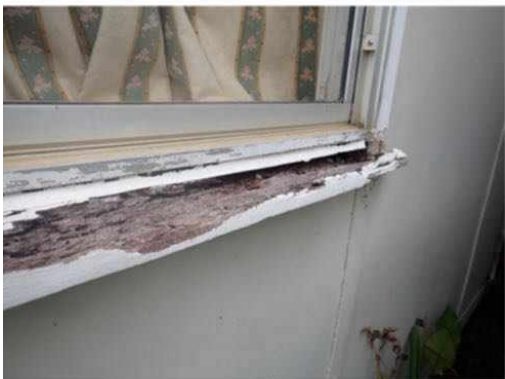
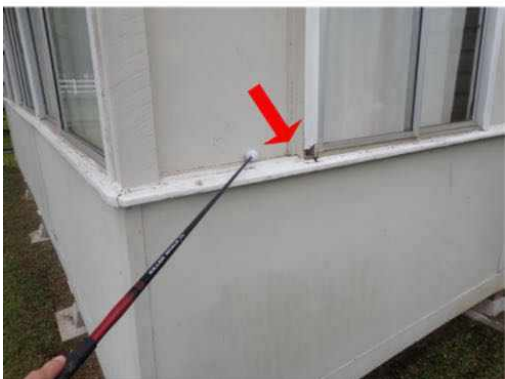
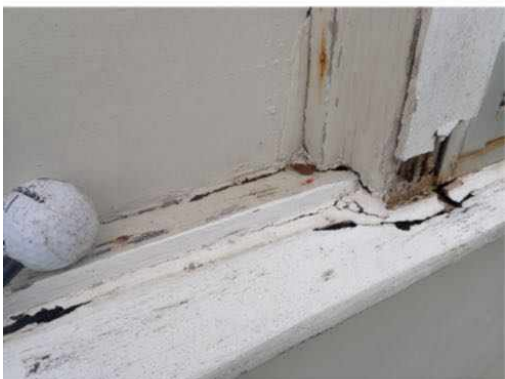
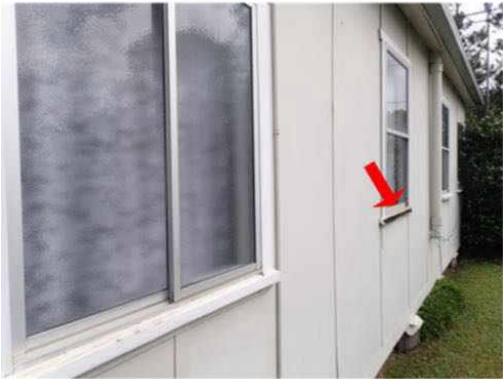
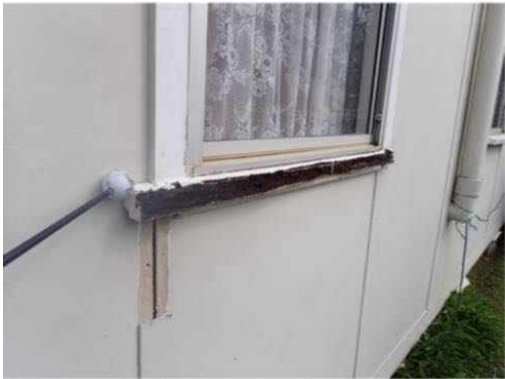
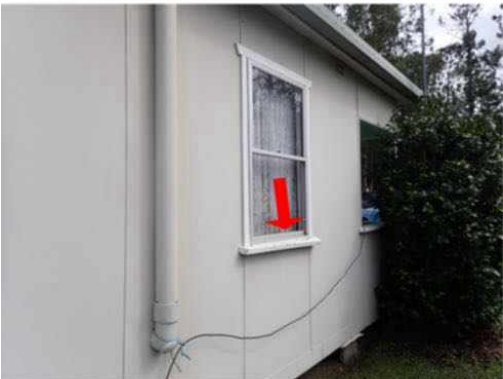
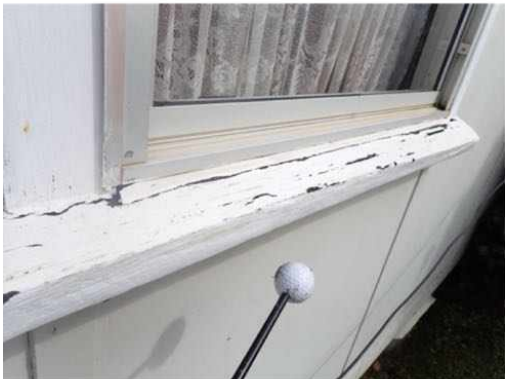
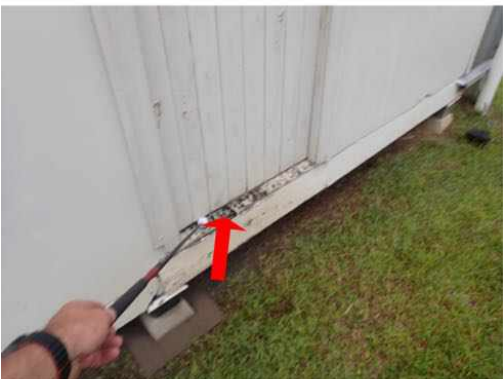
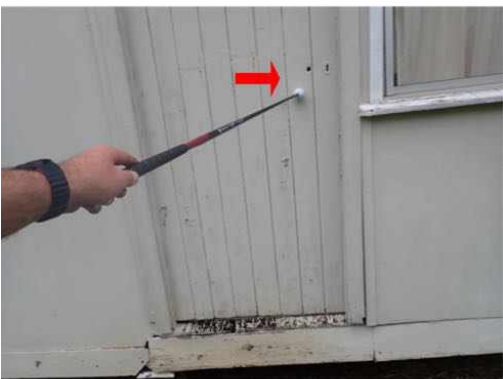
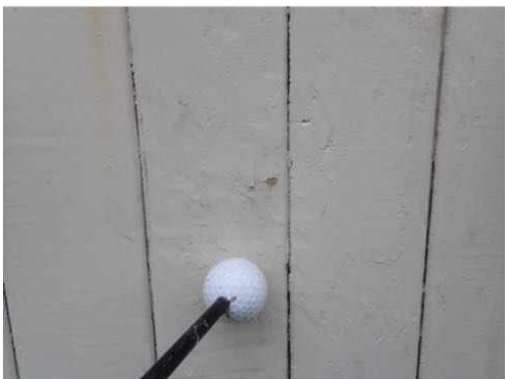
Finding 2.17

Finding: External Doors and Windows in Poor Condition

Information: The majority of the external doors and windows were found to be in poor condition at the time of inspection. Defects observed included wood rot and deteriorated paintwork to several components. Deterioration of external timber doors and windows commonly occurs due to prolonged exposure to weather, moisture, and general ageing of the materials. Continued deterioration may affect the durability and functionality of these elements if not addressed. It is recommended that a qualified carpenter assess the affected doors and windows and carry out repairs or replacement of deteriorated components as required. Repairs should be carried out as soon as possible.

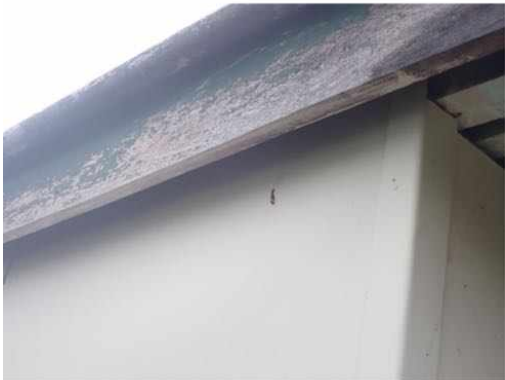
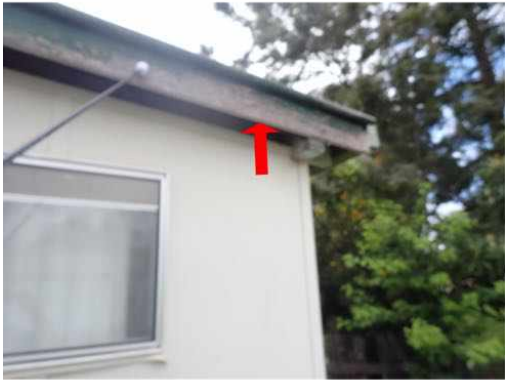
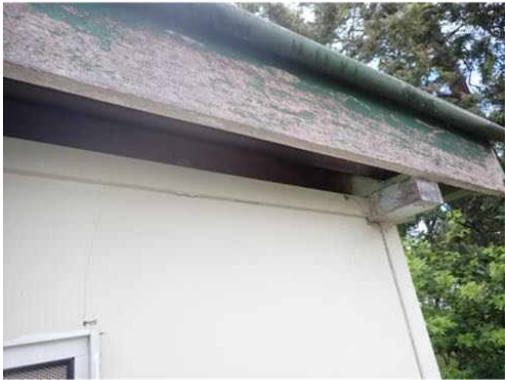
Finding 2.18

Building: Main Building
Location: Eaves and fascia boards
Finding: Eaves and Fascia Boards in Poor Condition
Information: The eaves and fascia boards were found to be in poor condition at the time of inspection. Defects observed included missing sections, deteriorated paintwork, gaps, wood rot, and general wear to several areas. Deterioration of external timber elements commonly occurs due to prolonged exposure to weather, moisture, and ageing of the materials. Continued deterioration may allow moisture or pests to enter roof spaces and may lead to further damage if not addressed. It is recommended that a qualified carpenter assess the affected areas and carry out repairs or replacement of deteriorated components as required. Repairs should be carried out as deemed necessary.
