Building and Timber Pest Inspection Report

Inspection Date: Tue, 10 Mar 2026

Property Address: 4 Stephen St, Urbenville NSW 2475,
Australia

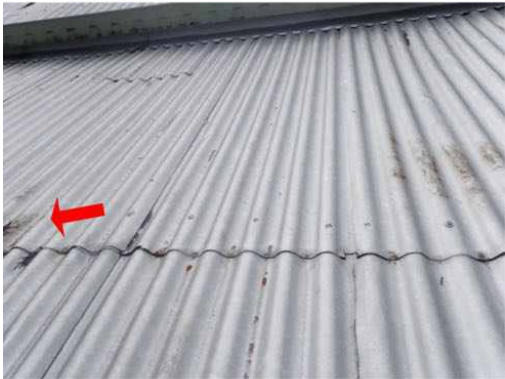
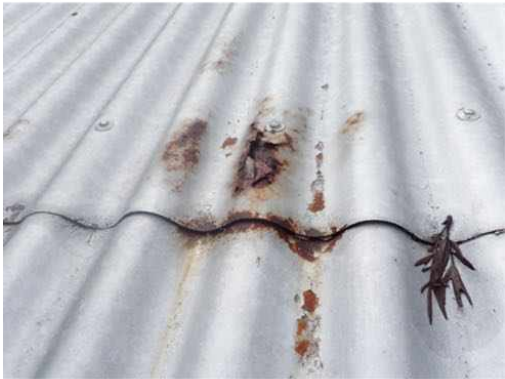
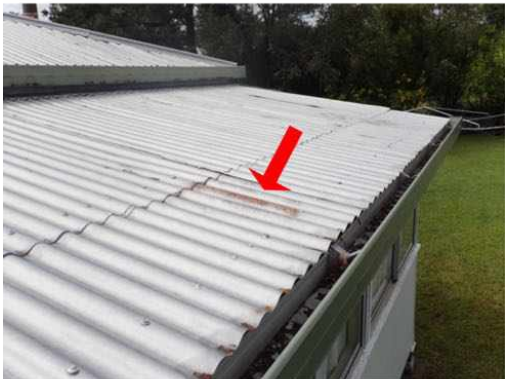
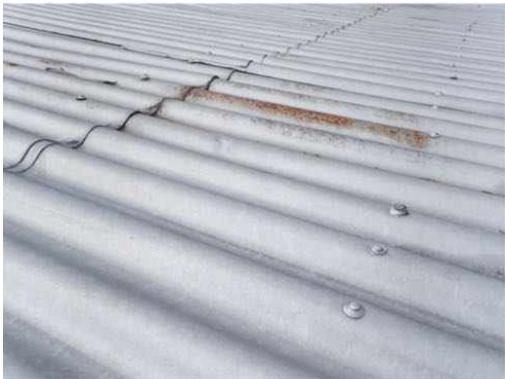
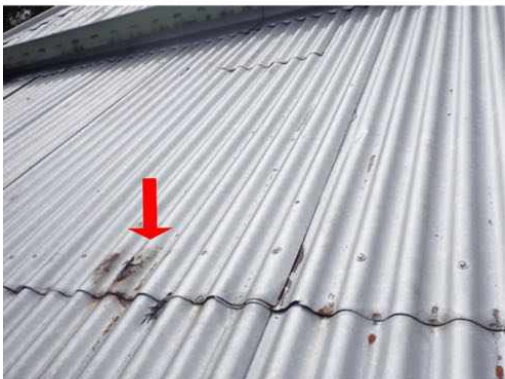
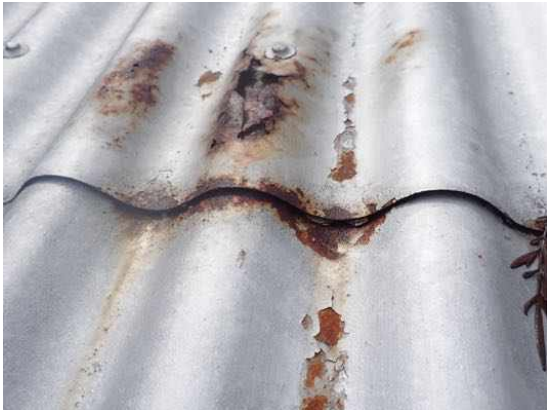
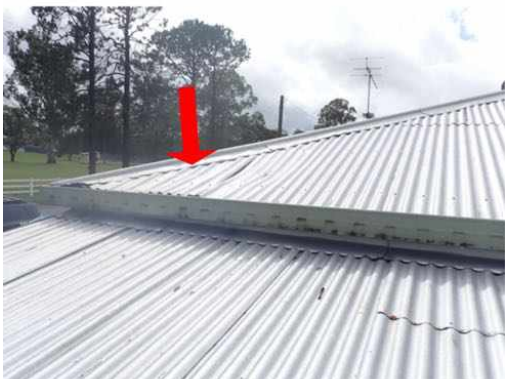
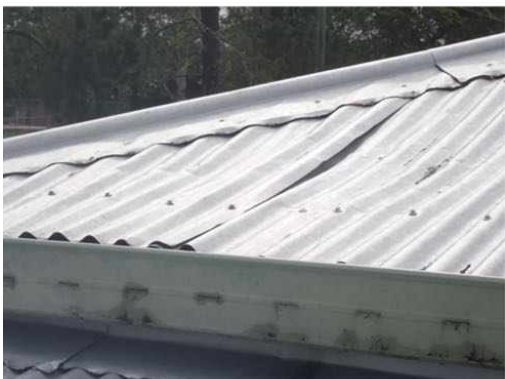
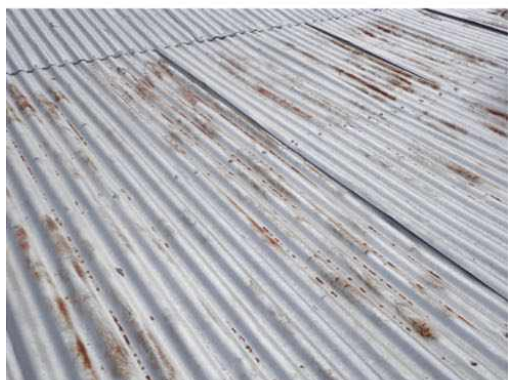
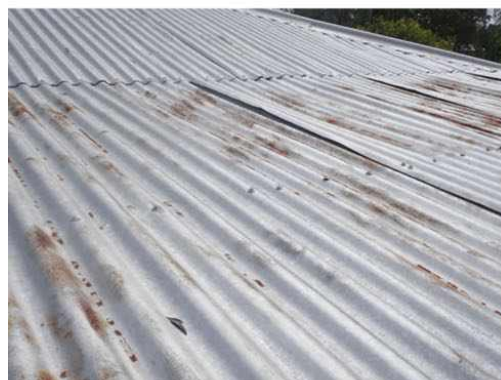
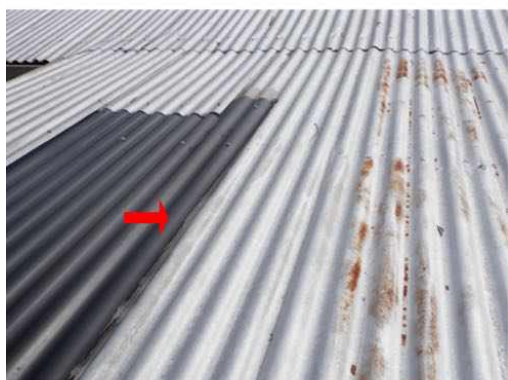
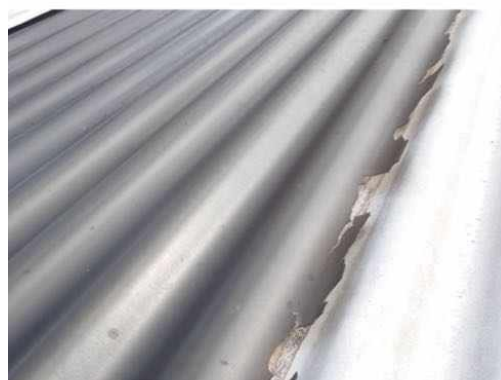
Finding 2.19

Finding: Iron Roof Cladding in Poor Condition

Information: The iron roof cladding was found to be in poor condition, with visible deterioration, corrosion, and general wear consistent with age and prolonged exposure to the elements. In plain terms, the metal roof sheets are worn and rusting in areas and may not provide reliable long-term weather protection. Possible causes include ageing of the material, weather exposure, inadequate maintenance, and deterioration of protective coatings. If not addressed, this condition may allow water ingress and further deterioration of surrounding building components. Preventative measures

include routine roof inspections and maintenance. Repairs or replacement of the affected roof cladding should be carried out by a licensed roofing contractor as soon as possible to prevent further damage to associated building materials.

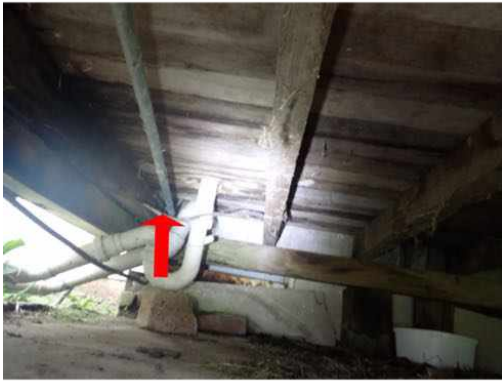
Finding 2.20

Building:	Main Building
Location:	Subfloor
Finding:	Wood Rot Identified to Subfloor Timbers Around Bathroom Area
Information:	Wood rot was identified to subfloor timbers in the area around the bathroom, indicating deterioration of the timber likely associated with prolonged moisture exposure. Possible causes include past or ongoing plumbing leaks, poor ventilation to the subfloor, or moisture penetration from the bathroom area above. Deteriorated and moisture affected timbers are also considered conducive to termite attack. If left unaddressed, the damage may worsen and affect the structural performance of the affected timbers. Preventative measures include ensuring plumbing is watertight, improving subfloor ventilation, and maintaining adequate moisture control. Further assessment and repairs should be carried out by a licensed builder or appropriately qualified contractor as soon as possible to prevent further deterioration of the affected structural timbers.

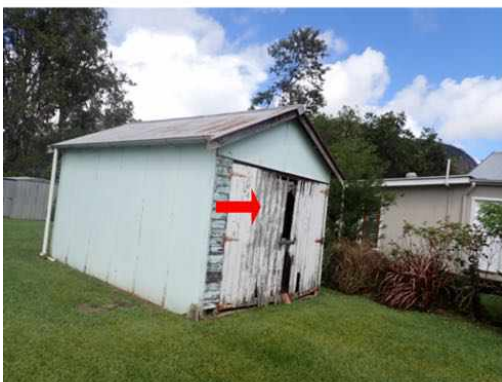
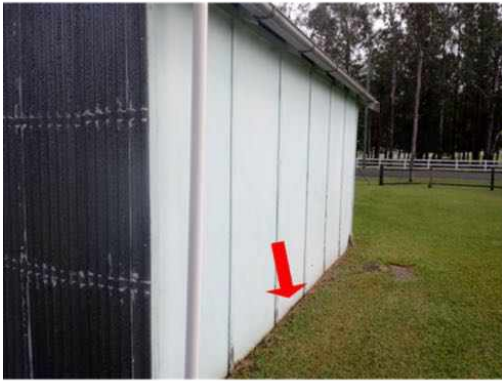
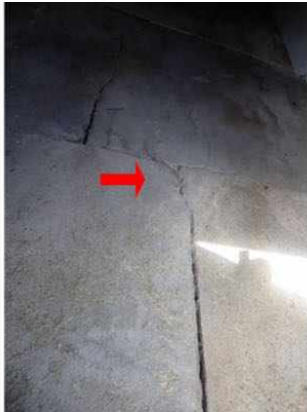
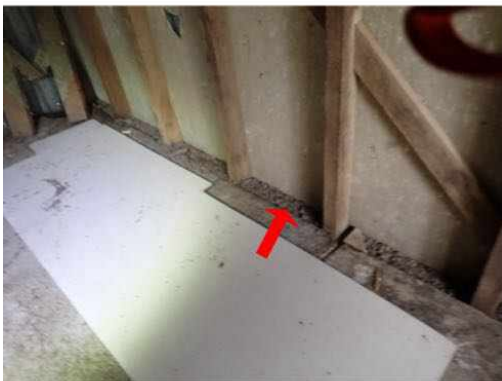
Finding 2.21

Finding: Old Garage in Poor Condition

Information: The old garage was found to be in poor condition overall. Defects identified include deteriorated doors requiring replacement, large structural cracks in the concrete floor, deteriorated external cladding, rust to the roof cladding, and timber framing in direct contact with the ground. Possible causes include age, weather exposure, lack of maintenance, and ground movement contributing to cracking of the concrete slab. Timber elements in contact with the ground are considered conditions conducive to termite attack and timber decay. If left unaddressed, the condition of the structure may continue to deteriorate and could lead to further structural instability and damage to associated building materials. Preventative measures include maintaining adequate ground clearances to timber elements and carrying out routine maintenance to protect exposed materials. Further assessment and rectification works should be carried out by a licensed builder as soon as possible to prevent further deterioration of the structure.

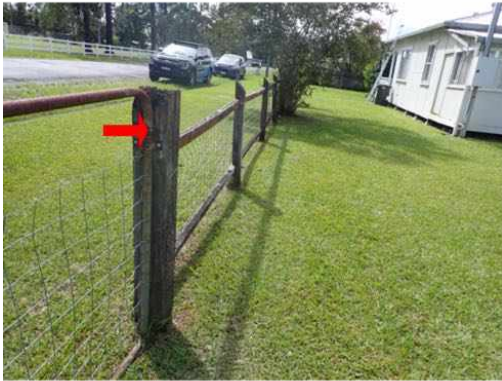
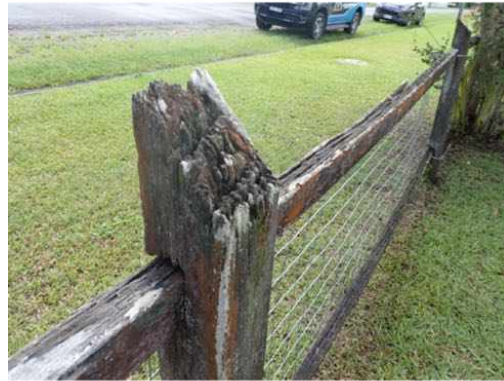
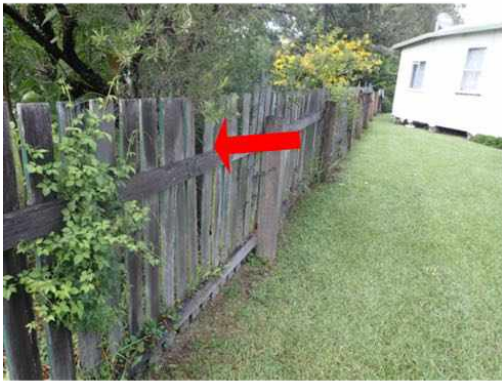
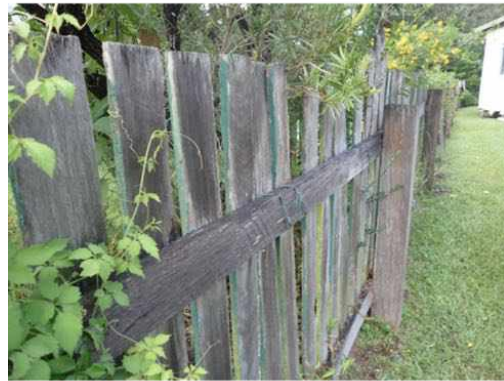
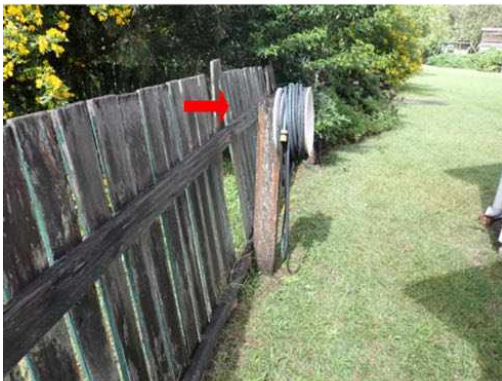
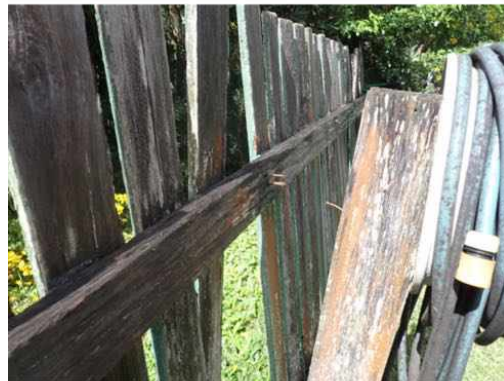
Finding 2.22

Building:	Yard
Location:	Fences
Finding:	Timber Fences in Poor Condition
Information:	The timber fences around the property were found to be in poor condition, with visible deterioration consistent with age, weather exposure, and general wear. Possible causes include prolonged exposure to the elements, lack of maintenance, timber decay, and possible timber pest activity. If left unaddressed, the condition of the fencing may continue to deteriorate and sections may become unstable or fail. Preventative measures include routine maintenance, sealing or treating exposed timber, and ensuring adequate ground clearance to reduce moisture exposure.

Repairs or replacement of the affected fencing should be carried out by a fencing contractor or licensed builder at the as required prevent further deterioration.

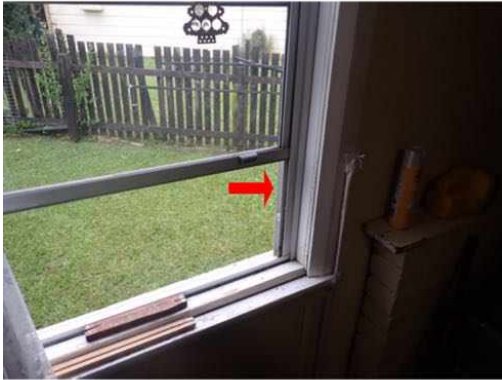
Finding 3.01

Building:	Main Building
Location:	Windows
Finding:	Aluminium Windows Will Not Stay Open
Information:	The aluminium windows throughout the building were found to be in fair condition at

the time of inspection; however, they would not remain open without being propped. This condition is commonly associated with worn or faulty window winders, hinges, or support mechanisms and is typical with windows of this age and type. It is recommended that a suitably experienced handyman or window specialist inspect the windows and carry out repairs or replacement of worn components as required to restore normal operation. Repairs should be carried out as deemed necessary.

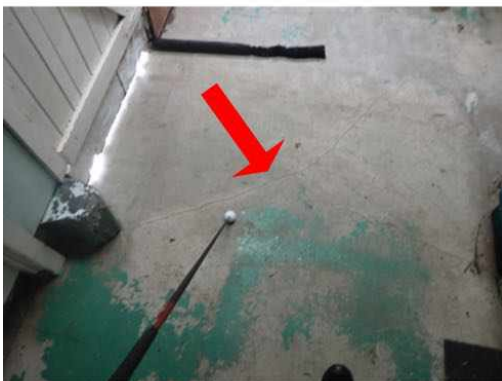
Finding 3.02

Finding: Minor Cracks in Laundry Concrete Floor

Information: Minor cracks were identified in the laundry concrete floor at the time of inspection. Cracking of this nature can occur due to normal shrinkage of the concrete, minor ground movement, or ageing of the slab and is a common defect with concrete of this age. It is recommended that the affected area continue to be monitored and that a suitably experienced tradesperson carry out repairs if the cracking worsens. Repairs should be carried out as deemed necessary.

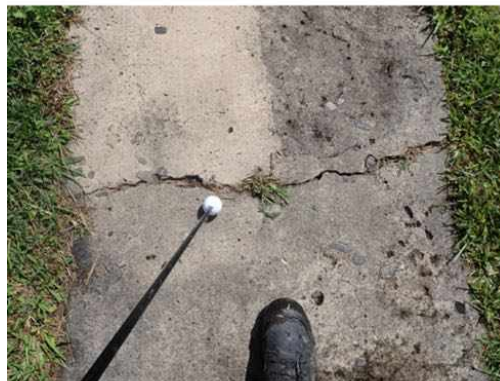
Finding 3.03

Finding: Large Cracks in Front Concrete Path

Information: Large cracks were identified in the front concrete path. Possible causes include ground movement, shrinkage of the concrete over time, tree root movement, or inadequate original construction. Cracking of this nature is a common defect with concrete paths of this age. If left unaddressed, the cracking may worsen and could create a potential trip hazard and allow further deterioration of the concrete. Preventative measures include maintaining stable ground conditions and monitoring surrounding vegetation that may influence ground movement. Assessment and rectification works should be carried out by a licensed concreter or builder as required.

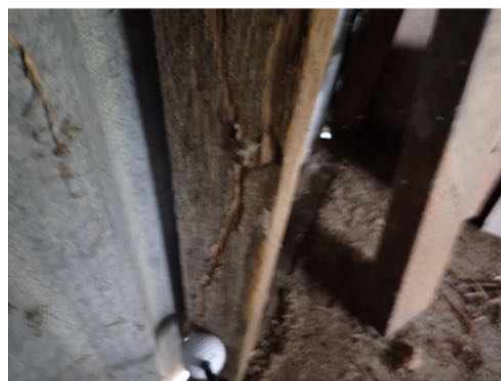
Finding: Minor Termite Damage to Timber Framing Within Old Garage

Information: Minor termite damage was identified to sections of the timber framing within the old

garage. Possible causes include past termite activity and the presence of conditions conducive to termite attack such as timber elements in contact with the ground and general deterioration of building materials. Although the damage appears minor at the time of inspection, concealed areas may contain additional damage that was not visible during the visual inspection. Preventative measures include removing conditions conducive to termite activity and implementing an appropriate termite management system. Further assessment and repairs should be carried out by a licensed builder and a qualified pest management professional as soon as possible to prevent further damage to associated building materials.

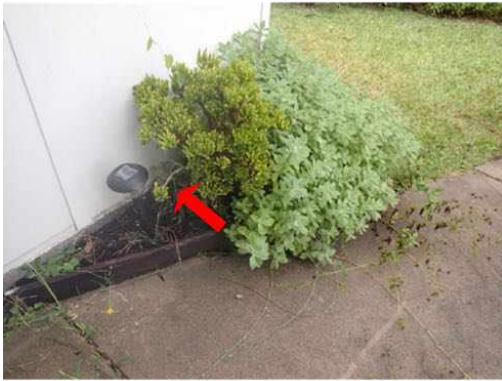
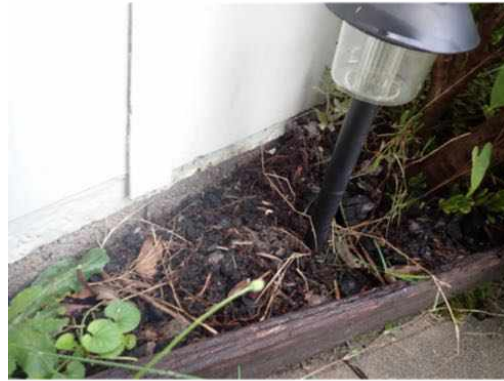
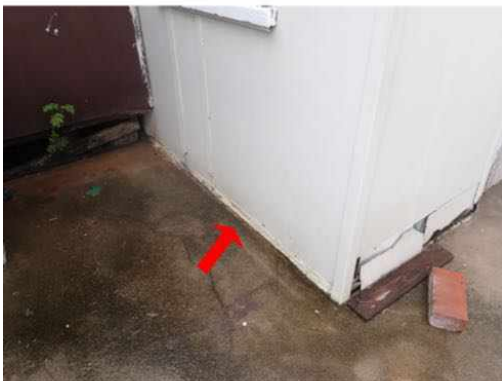
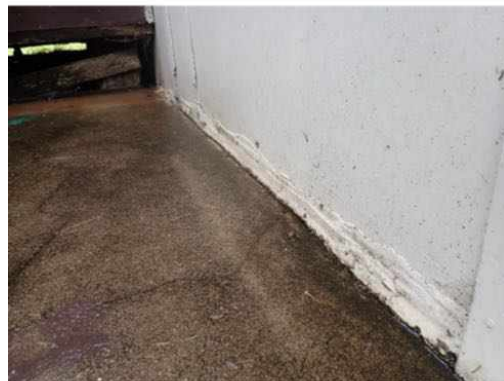
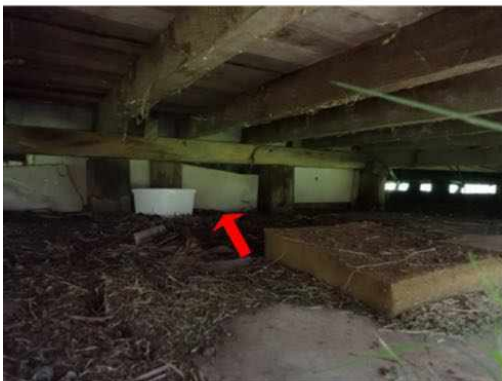
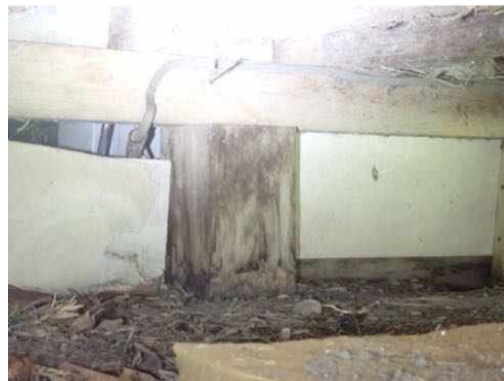
Finding 6.01

Building:	Main Building
Location:	Subfloor and perimeter of building
Finding:	Conditions Conducive to Termite Attack Around Building and Subfloor Area
Information:	Multiple conditions conducive to termite attack were identified around the perimeter of the building and within the subfloor area and structure at the time of inspection. These conditions included timber in contact with the ground and low clearance and obstructions restricting inspection to the majority of the subfloor area. Such conditions may increase the risk of termite activity and can limit the ability to adequately inspect and monitor the subfloor structure. It is recommended that a licensed pest control specialist assess the building, address conducive conditions where possible, and implement an appropriate termite management and protection plan. This may include removing timber from ground contact and improving access and clearance within the subfloor area. Rectification and further assessment should be carried out as soon as possible.

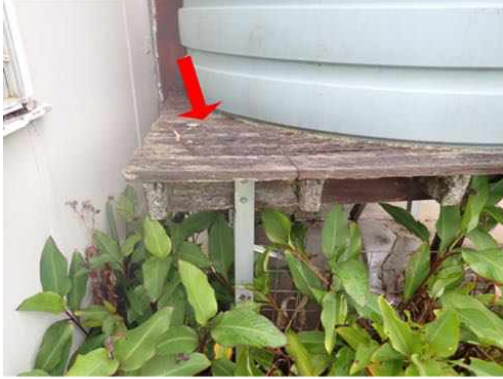
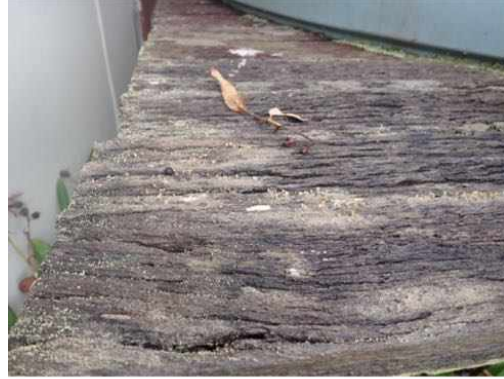
Finding 7.01

Finding: Wood Rot to Timber Framing Supporting Water Tank

Information: Wood rot was identified to the timber framing supporting the water tank at the time of inspection. Deterioration of timber elements in this location is commonly associated with prolonged moisture exposure and may worsen if not addressed. Continued decay may reduce the strength and durability of the supporting structure. It is recommended

that a qualified carpenter or suitably experienced handyman assess the timber framing and carry out repairs or replacement of the deteriorated timber as required to maintain adequate support for the water tank. Repairs should be carried out as deemed necessary.

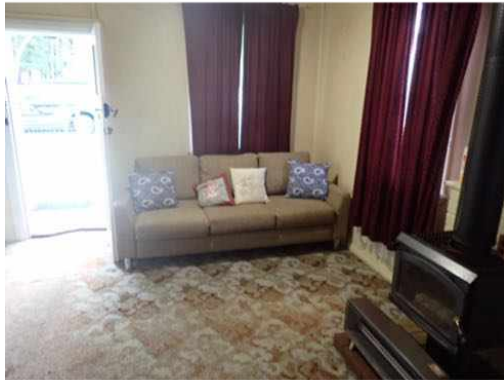
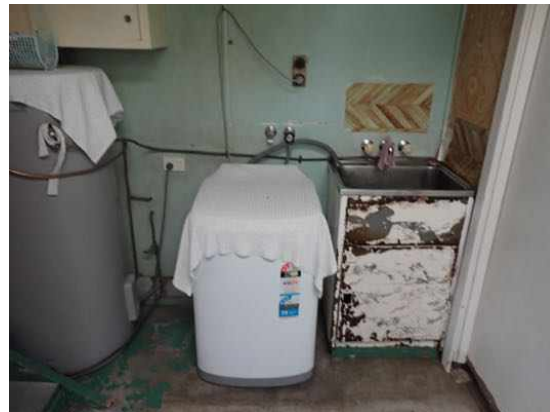
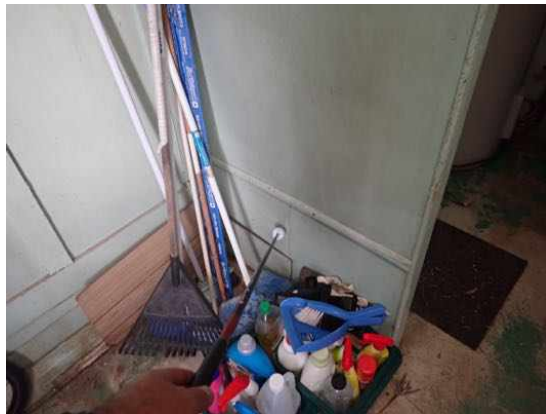
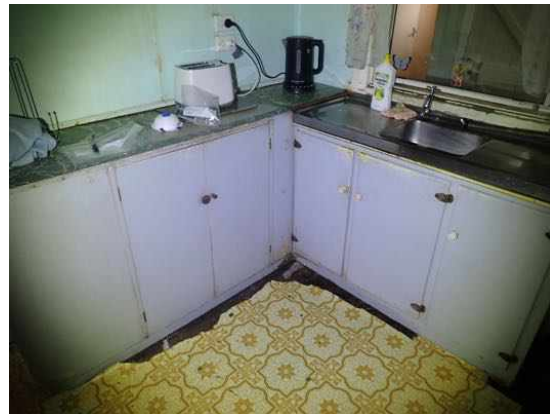
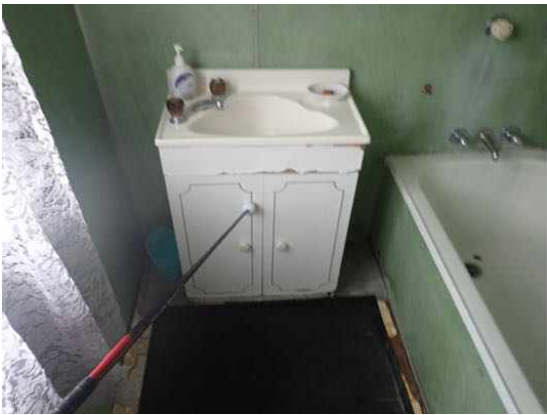
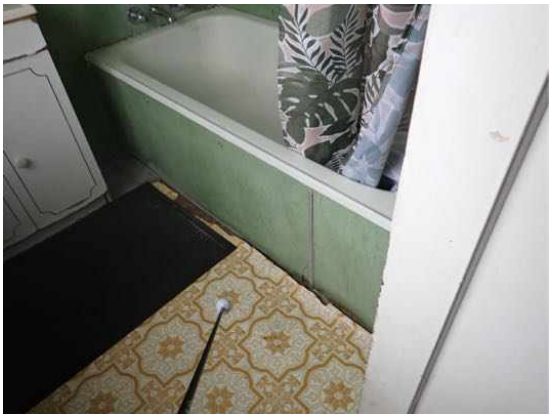
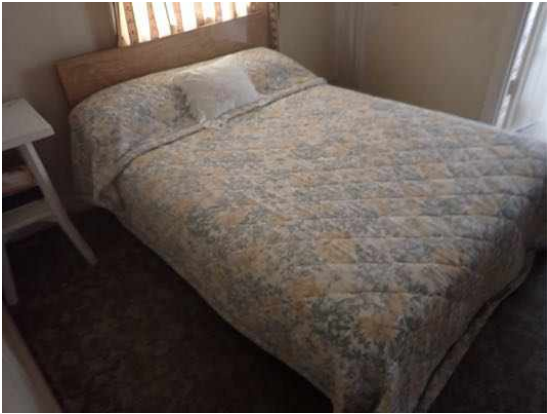
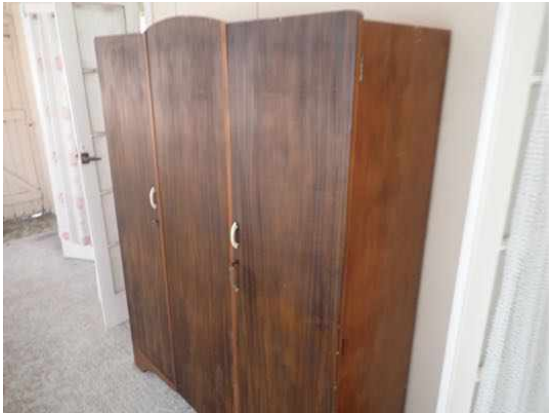
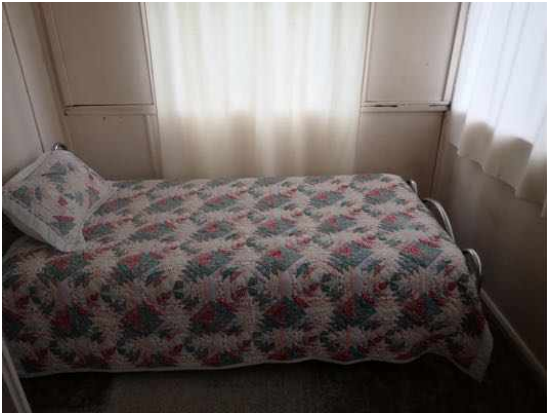
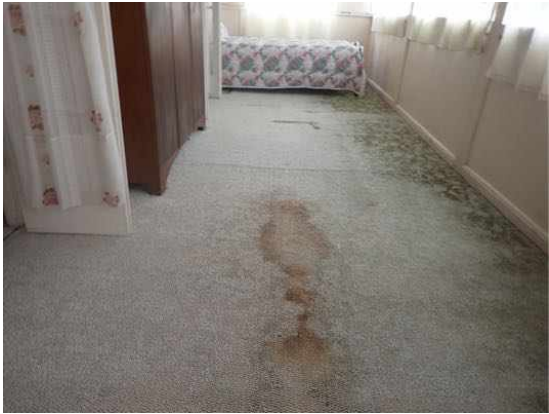
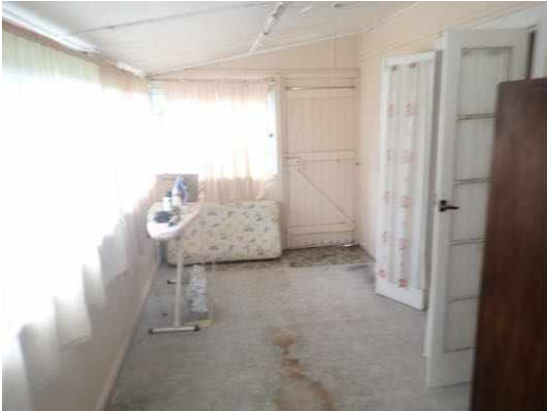
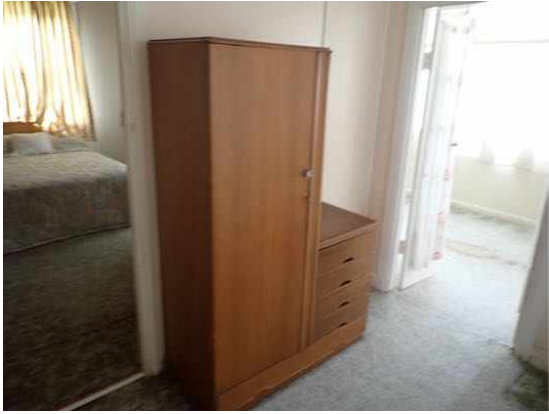
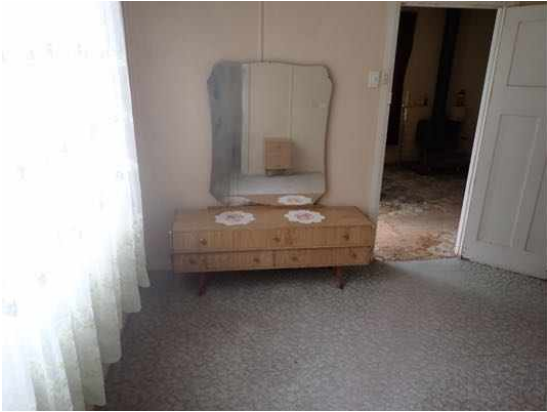
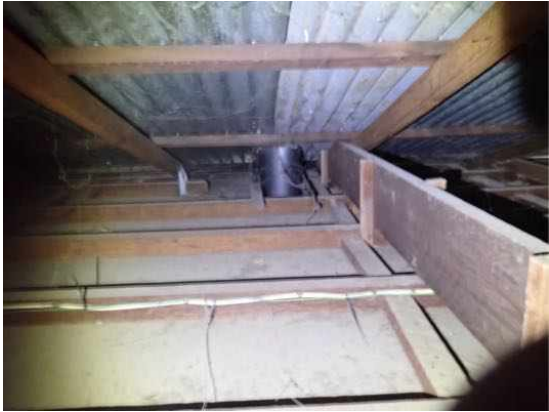
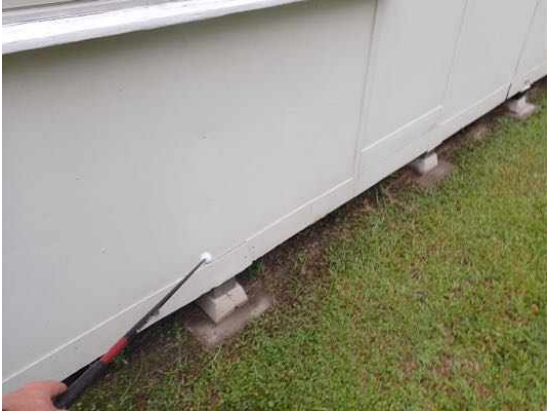
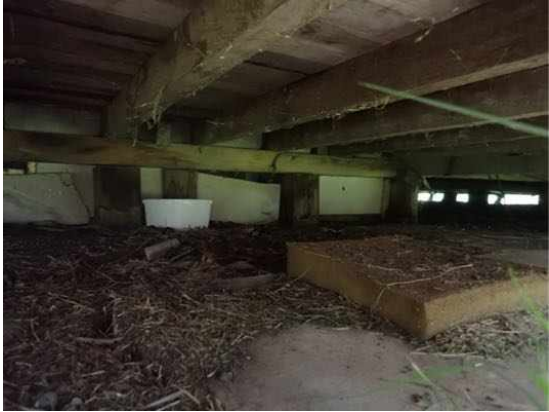
Building: Main Building
Location: All Areas
Finding: Additional Photos - Obstructions and Limitations
Information: These photographs are an indication of the obstructions and limitations which impeded full inspection of the area at the time of inspection. These obstructions can hide an array of defects and should be removed to allow full inspection to be carried out. A re-inspection is recommended once the areas are made accessible.
