Building and Timber Pest Inspection Report

Inspection Date: Thu, 26 Feb 2026

Property Address: 8A Universal Ave, Dunmore NSW 2529,
Australia

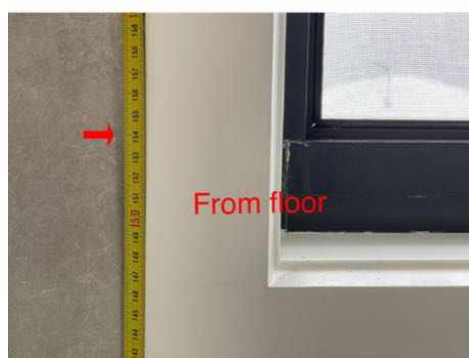
Building:	Building 1
Location:	Upstairs bathroom window
Finding:	Window opening restrictors missing.
Information:	The Building Code of Australia rules require all openable windows (where the internal floor is more than 2m above the ground outside) in residential rooms to be fitted with a suitable screen or restrictor. Windows located 1.7m above the floor level do not require protection.

Window restrictors are required where people who are vulnerable to the risk of falling have access to windows. This means all windows above ground level which do not have another fall prevention safety measure in place, such as a balcony or balustrade should have a restrictor. This bathroom allows children to climb on the bath increasing the risk in this area.

These need to be added urgently for the safety of all persons.

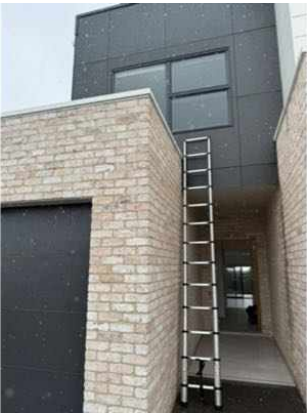
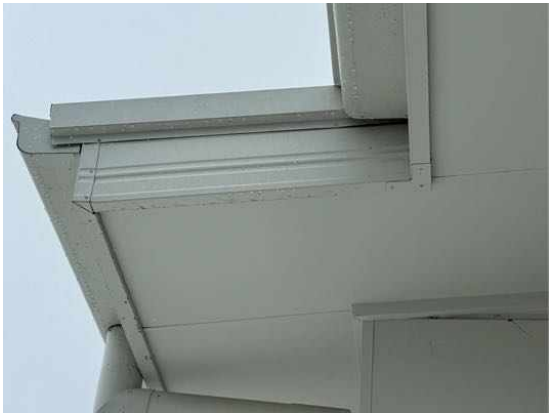
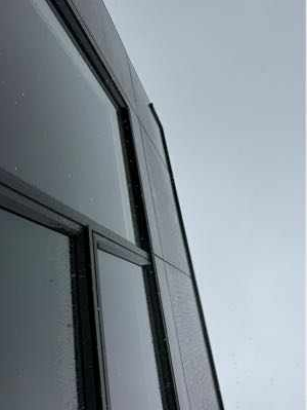
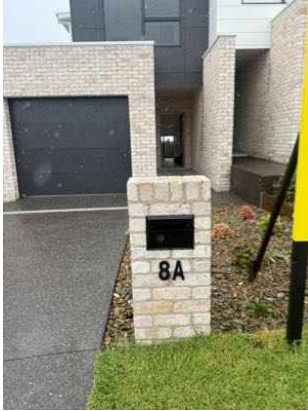
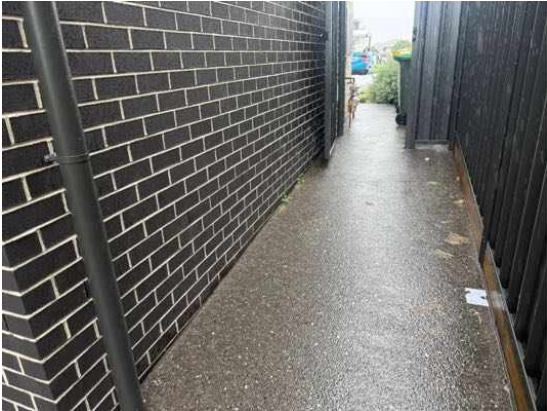
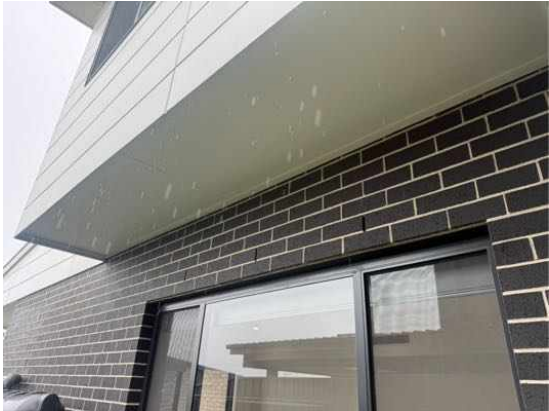
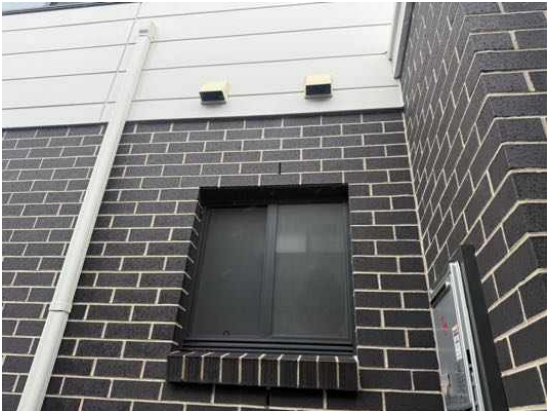
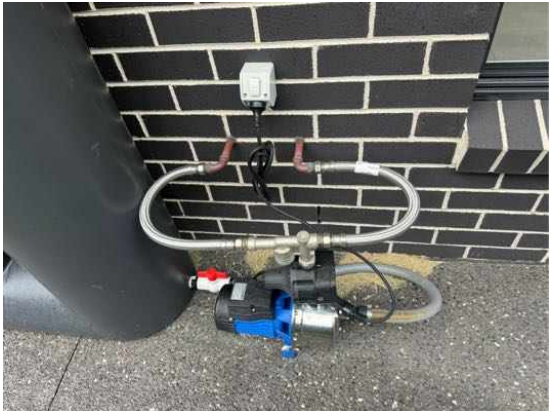
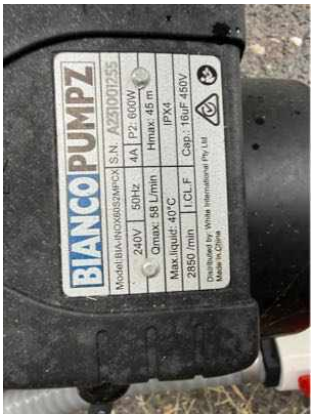
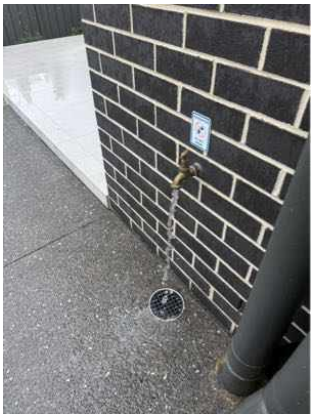
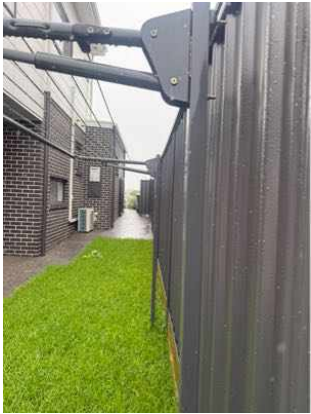
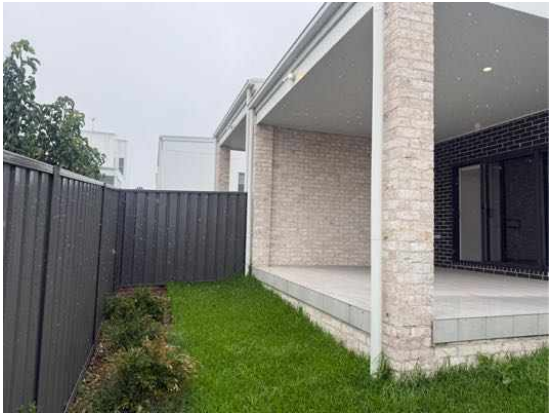
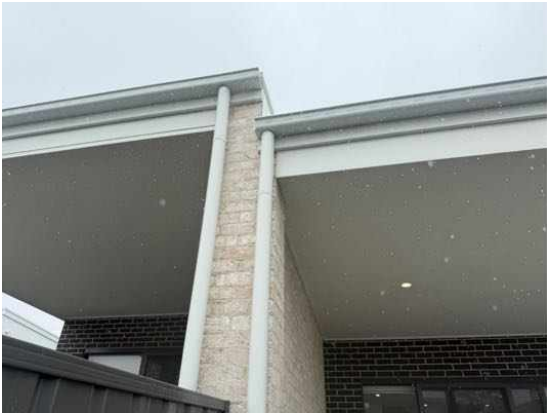
Building: Building 1
 Location: All External Areas
 Finding: Additional Photos - Obstructions and Limitations of EXTERNAL AREAS
 Information: These photographs are an indication of the obstructions and limitations which impeded full inspection of external areas at the time of inspection. These obstructions can hide an array of defects and should be removed to allow full inspection to be carried out. A re-inspection is recommended once the areas are made accessible.

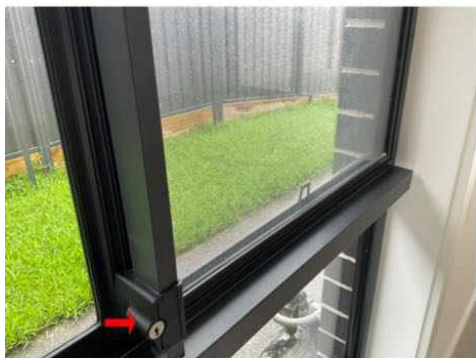
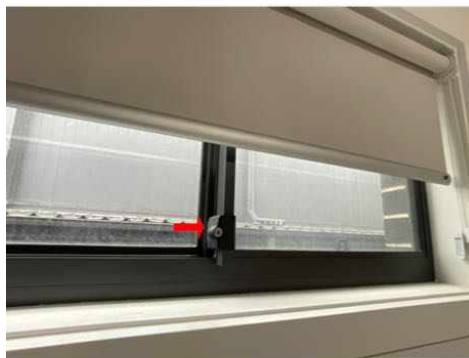
Building: Building 1
 Location: All Internal Areas
 Finding: Additional Photos - Obstructions and Limitations of INTERNAL AREAS
 Information: These photographs are an indication of the obstructions and limitations which impeded full inspection of Internal areas at the time of inspection. These obstructions can hide an array of defects and should be removed to allow full inspection to be carried out. A re-inspection is recommended once the areas are made accessible.

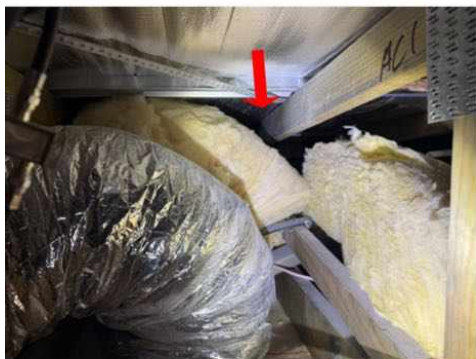
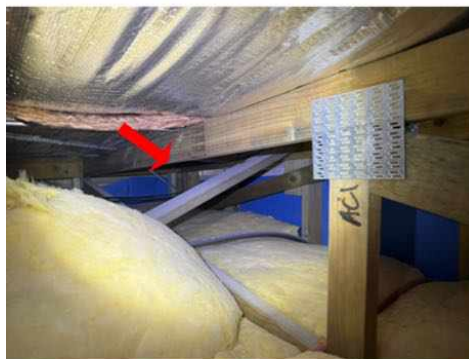
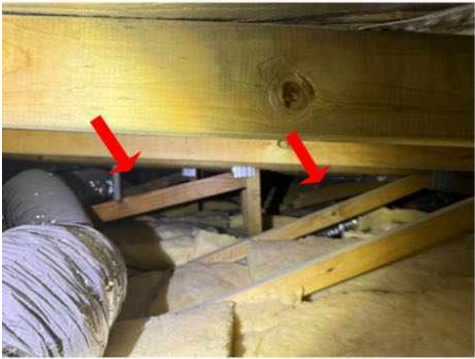
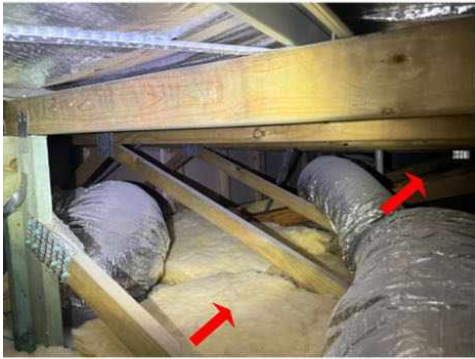
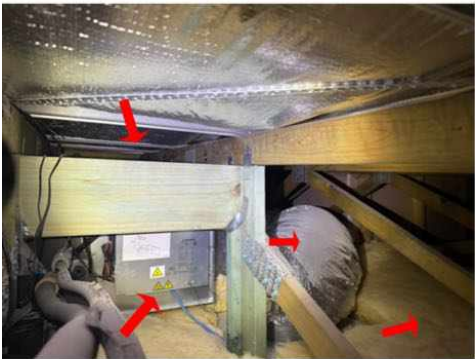
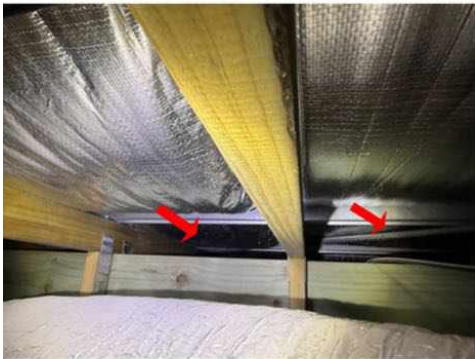
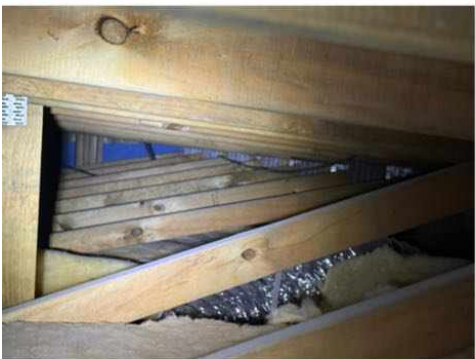
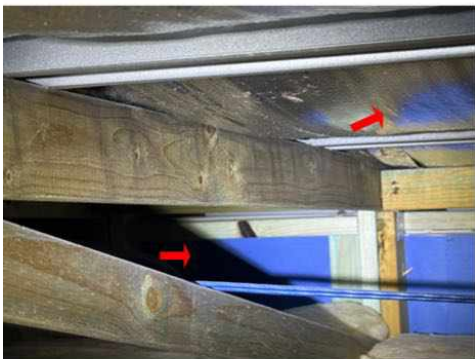
Building: Building 1
 Location: All Roof cavity areas
 Finding: Additional Photos - Obstructions and Limitations of the ROOF CAVITY
 Information: These photographs are an indication of the obstructions and limitations which impeded full inspection of roof cavity areas at the time of inspection. These obstructions can hide an array of defects and should be removed to allow full inspection to be carried out if applicable. A re-inspection is recommended once the areas are made accessible.

The inspection was also limited to areas with an allowable crawl space of 600mm x 600mm, in particular towards the external walls where the roof line diminishes, these areas were not accessible.
