Building and Timber Pest Inspection Report

Inspection Date: Tue, 7 Apr 2026

Property Address: 45 Charming Street, Hampton East, VIC
3188

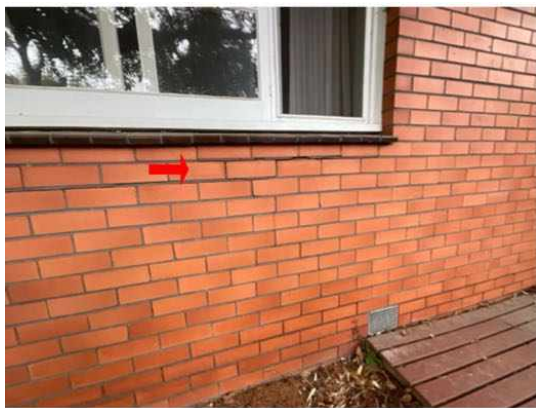
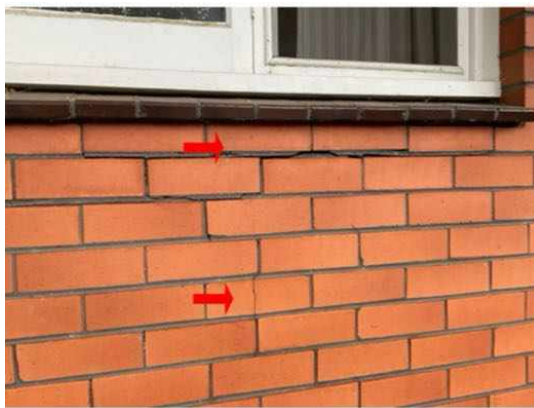
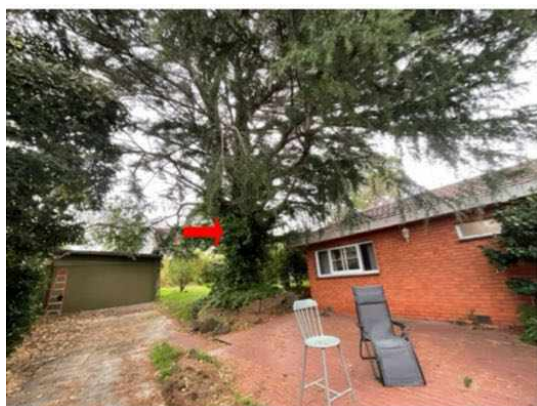
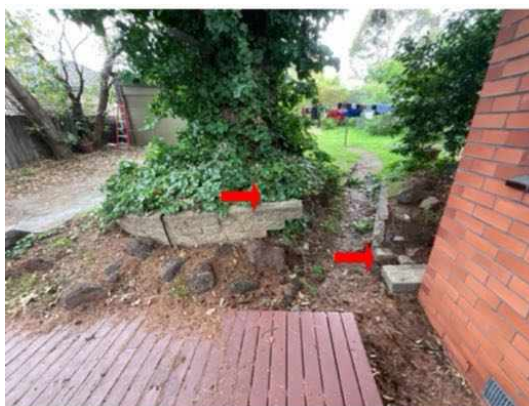
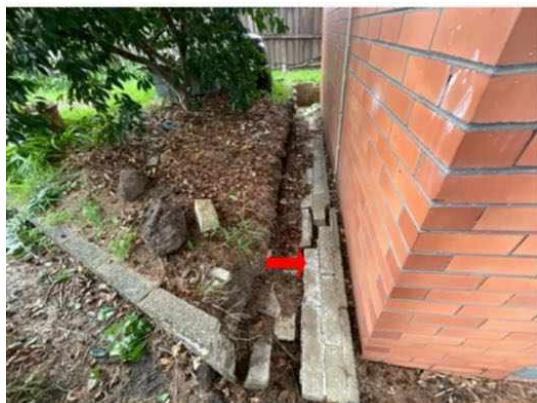
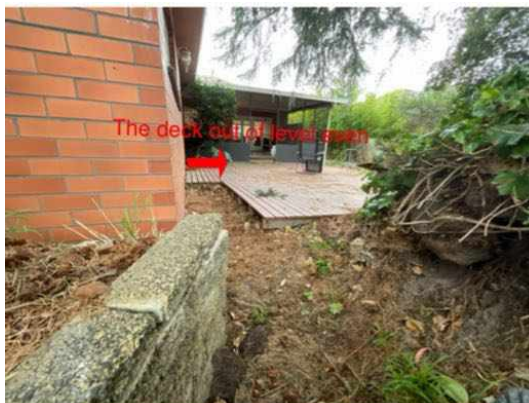
Building:	Main Building
Location:	All External Areas
Finding:	External Brickwork & Retaining Wall – Step Cracking and Movement (Potential Major Issue – Must Address ASAP)
Information:	Step cracking was observed within sections of the brickwork, and movement and deterioration were noted to a section of the retaining wall. These conditions are indicative of possible structural or ground movement.

The presence of a large tree in proximity to the structure may be influencing soil conditions through root activity and moisture variation, which may contribute to movement affecting masonry and retaining elements.

An arborist may need to assess the tree and its root system, and a structural engineer may need to assess the extent of movement and structural impact as soon as possible. Early intervention is important, as ongoing movement may lead to more significant damage and increased rectification costs.

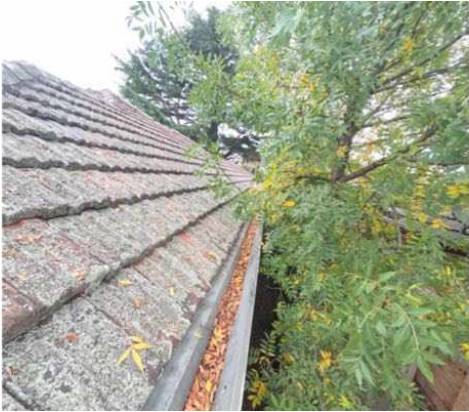
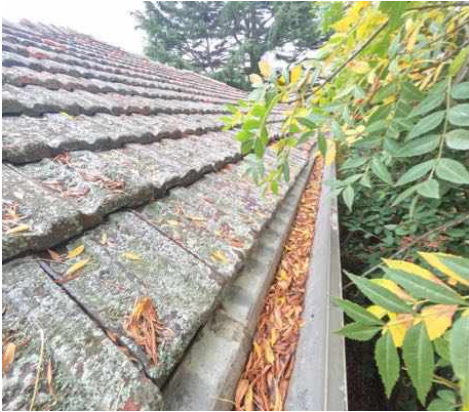
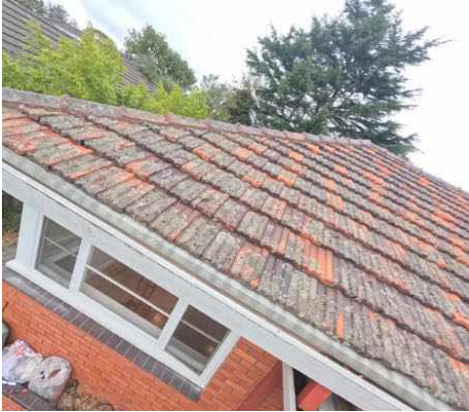
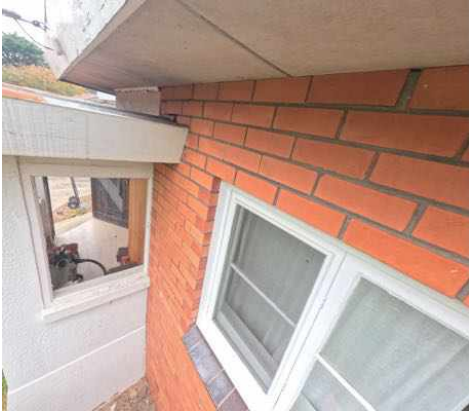
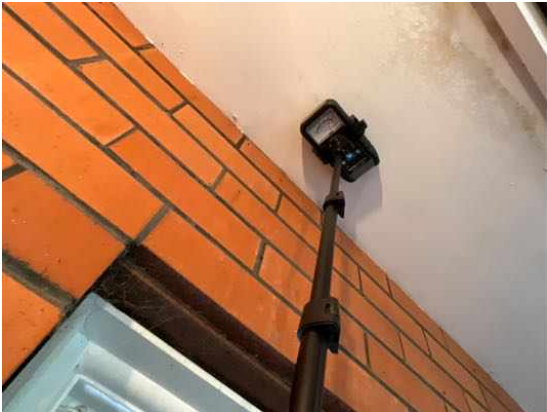
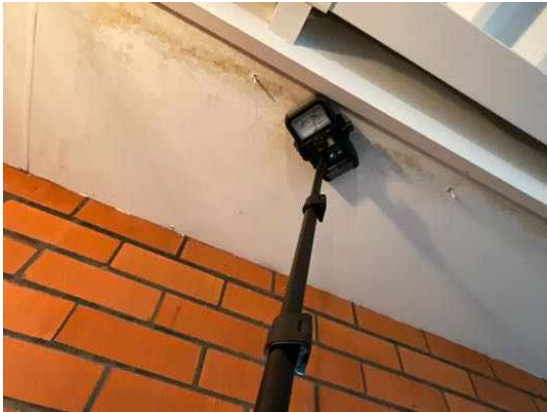
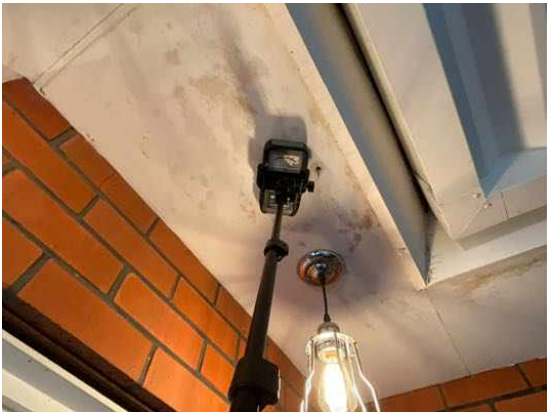
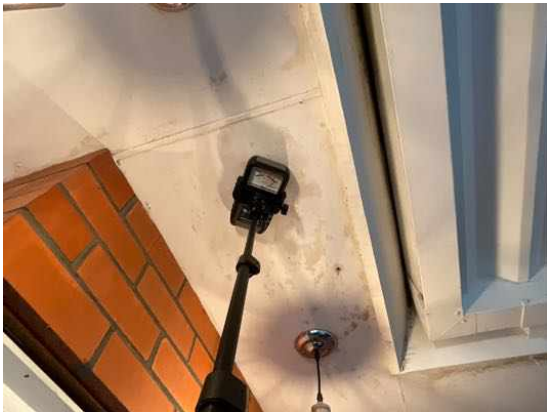
Finding 2.02

Building:	Main Building
Location:	All External Areas
Finding:	Roof gutter Drainage – Moisture / Moss Growth with Suspected Mould (Potential Major Issue – Must Address ASAP)
Information:	Elevated moisture readings were detected in sections of the roof area using a moisture meter. Moss growth and vegetation overhang were also observed adjacent to the roof and within the gutter system. Suspected mould-like staining was noted to sections of the eaves.

These conditions indicate inadequate drainage performance, including insufficient fall and/or limited downpipe capacity, resulting in water retention and prolonged moisture exposure. Such conditions are conducive to moss growth, mould development, and deterioration of roofing and adjacent building elements over time.

A licensed roof plumber and suitable contractor may need to assess the drainage system and surrounding vegetation as soon as possible. Rectification may include clearing vegetation and debris, improving drainage performance, and addressing moisture-affected areas to prevent further deterioration.

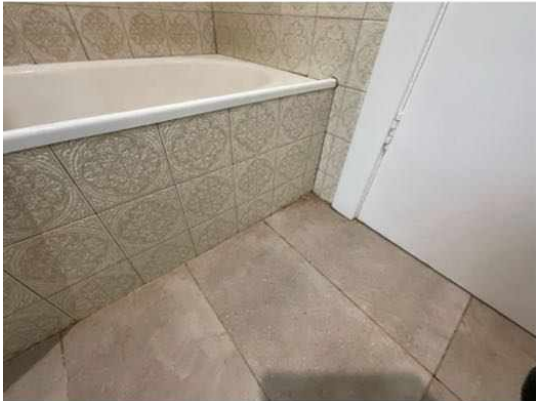
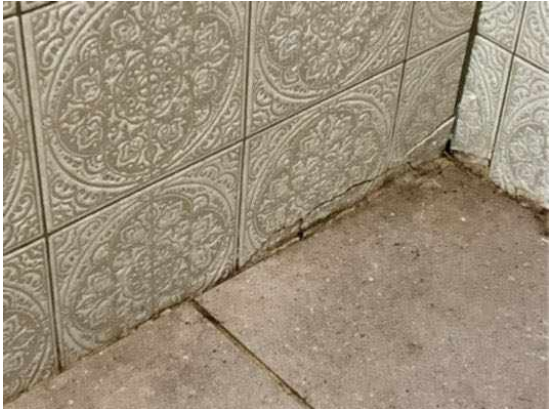
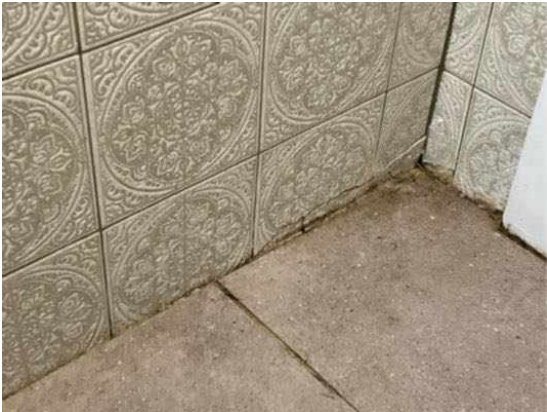
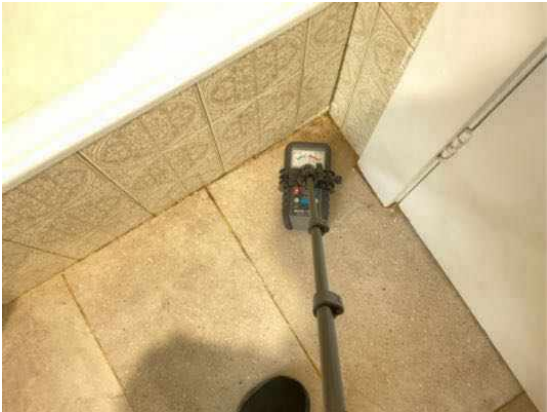
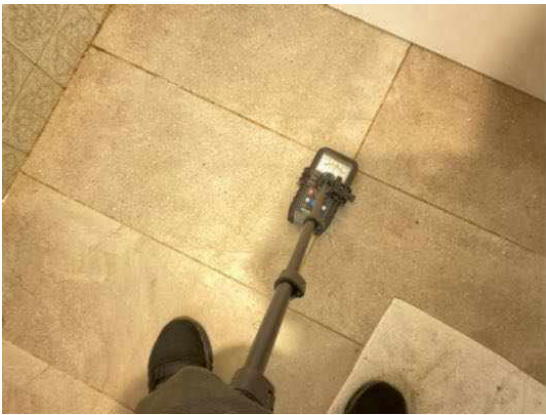
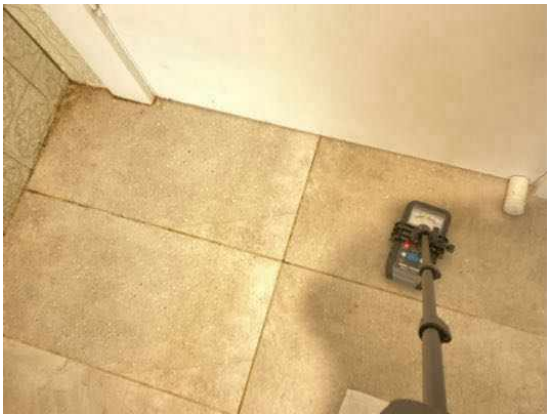
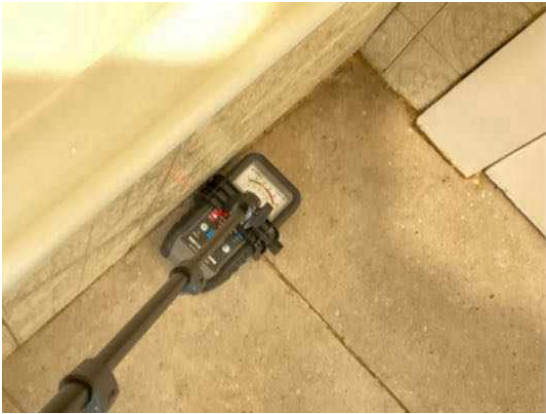
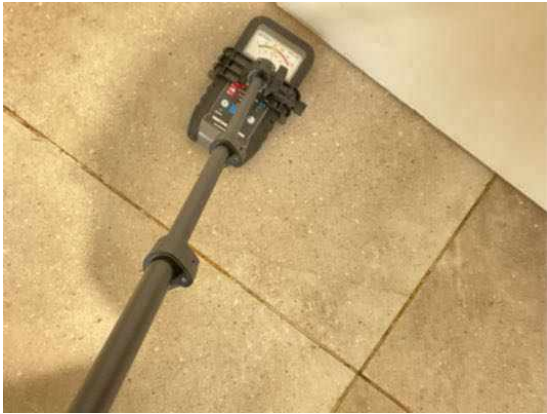
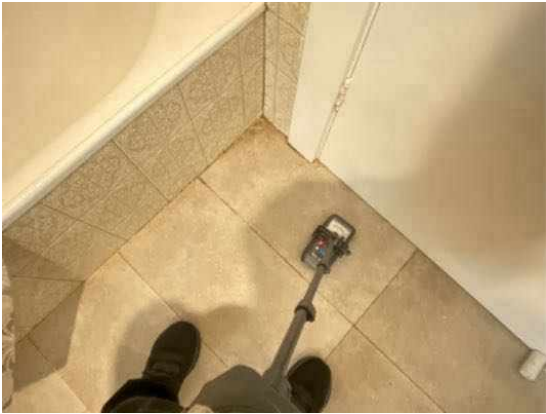
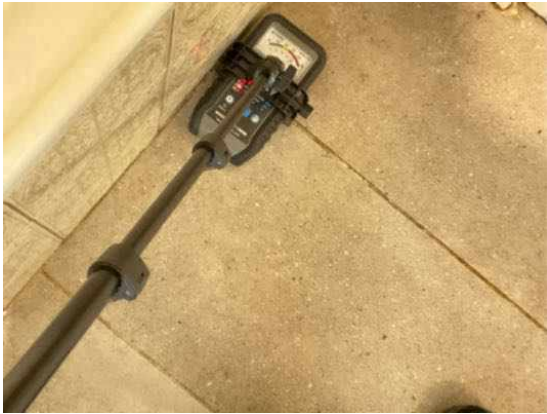
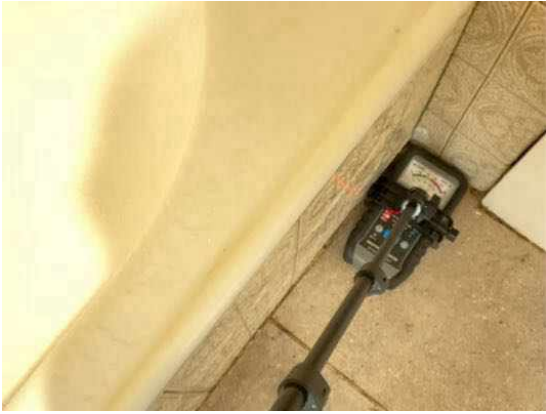
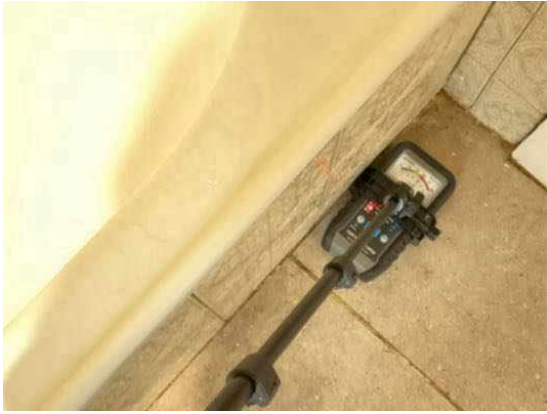
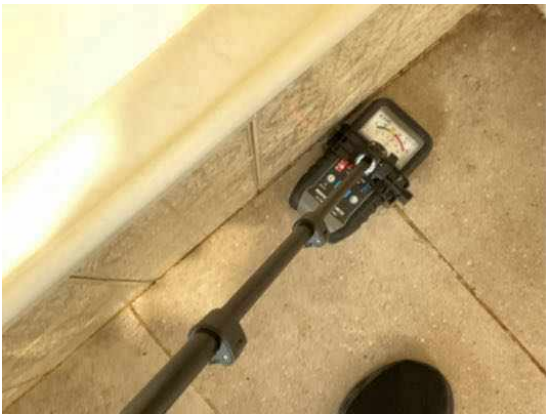
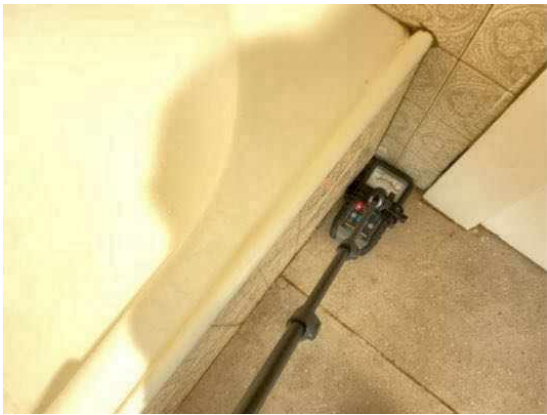
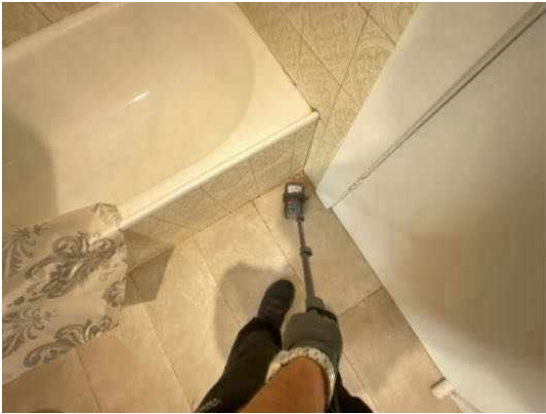
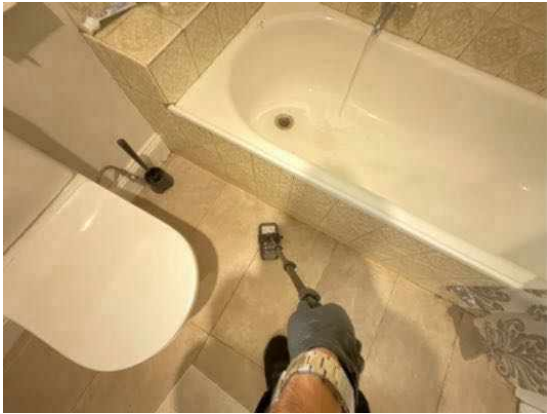
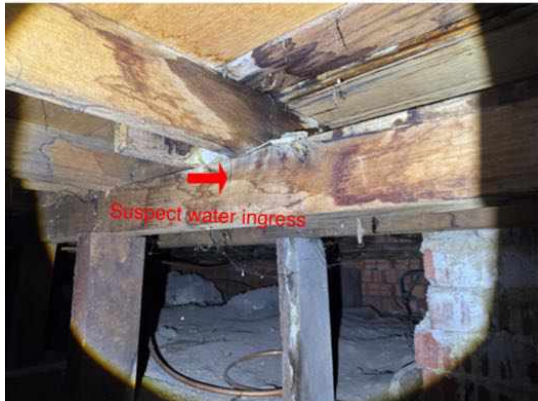
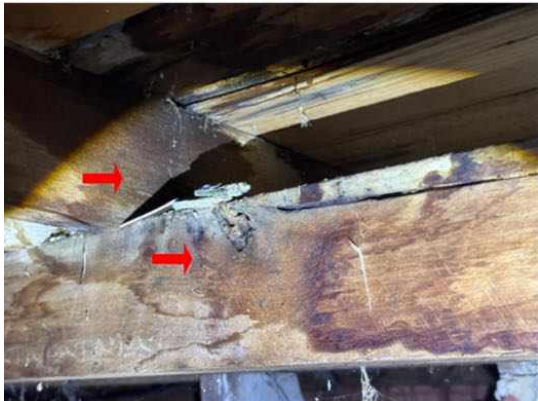
Finding 2.03

Building: Main Building
 Location: All Areas
 Finding: Bathroom – Cracked Tiles with Moisture Detection (Potential Major Issue – Must Address ASAP)

Information: Cracked tiles were observed in a section of the bathroom, and elevated moisture readings were detected using a moisture meter in the surrounding area.

Cracked tiles may allow water to penetrate behind the surface, and the presence of moisture indicates possible leakage or failure of the waterproofing system. Prolonged exposure to moisture may lead to deterioration of underlying materials and concealed

damage.

A licensed plumber and suitable contractor may need to assess the area as soon as possible to identify the source of moisture and carry out necessary repairs, which may include rectification of waterproofing and replacement of affected materials.

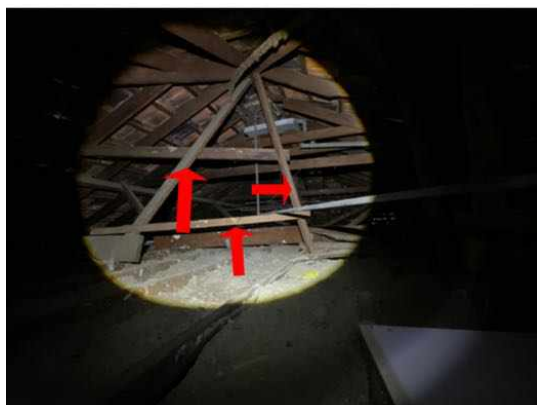
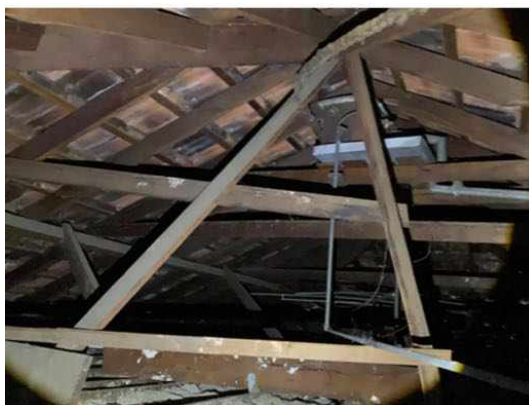
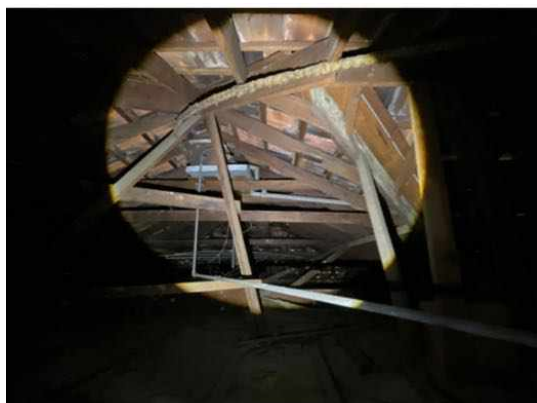
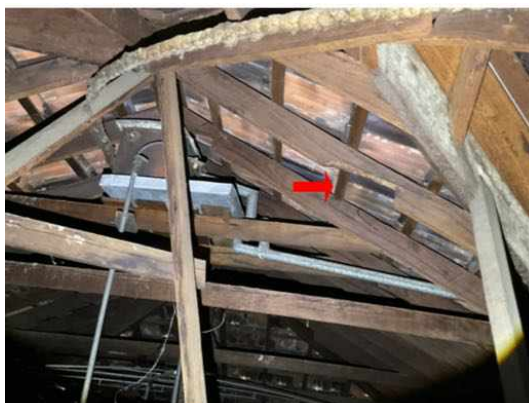
Finding 2.04

Building: Main Building
Location: Roof Void
Finding: Roof Structure – Temporary Support and Damaged Rafter (Potential Major Issue – Must Address ASAP)

Information: A section of the roof structure appears to be temporarily supported with improvised bracing. In addition, a rafter shows significant damage and partial section loss.

Due to limited access within the roof void, the full extent of the damage could not be determined at the time of inspection.

A structural engineer may need to assess the roof structure as soon as possible, and a suitable contractor may need to carry out proper structural rectification works to ensure the integrity and safety of the roof system.

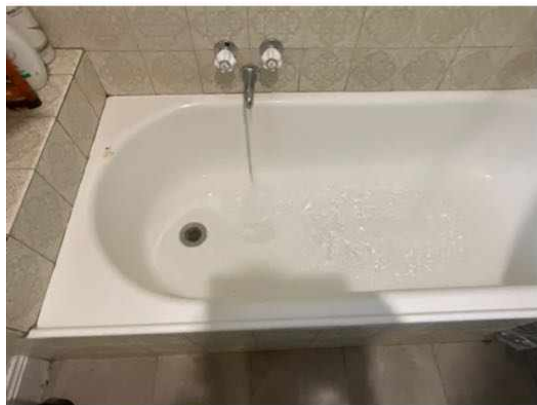
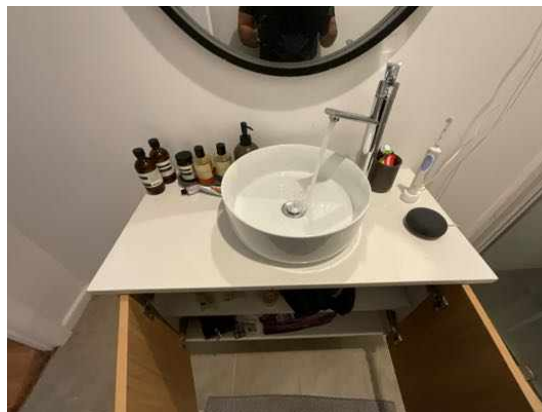
Finding 3.01

If not rectified, the slow drainage may contribute to minor moisture buildup around the basin area and general functional inconvenience for the occupants.

Rectification should be carried out as soon as practicable by a licensed plumber to clear the waste line and restore proper drainage.

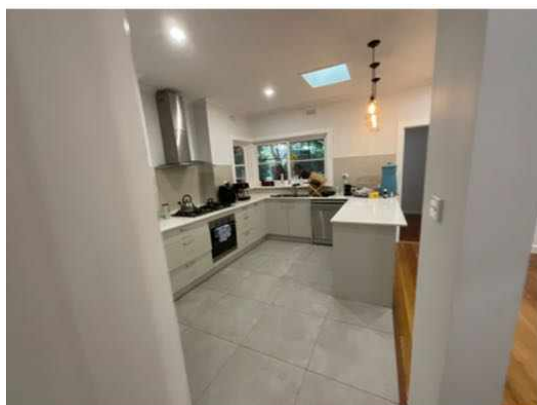
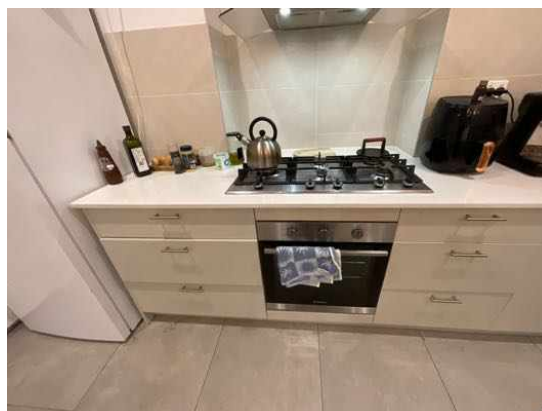
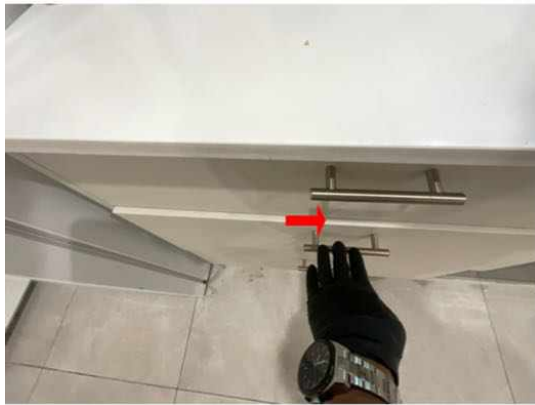
Information: Sections of the cabinetry were noted to be out of alignment, with doors or panels not sitting evenly or closing correctly. This condition may be due to hinge movement, installation tolerances, or normal building movement over time.

If left unrectified, the continued misalignment may lead to wear on hinges, rubbing on adjacent panels, or reduced functionality of the cabinetry.

Rectification should be carried out as soon as practicable by a qualified cabinetmaker or carpenter to adjust the fittings and restore proper alignment.

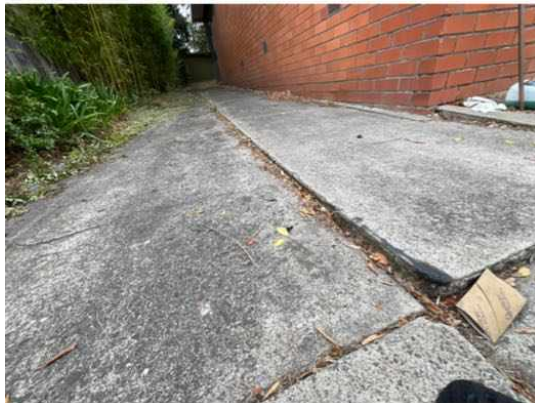
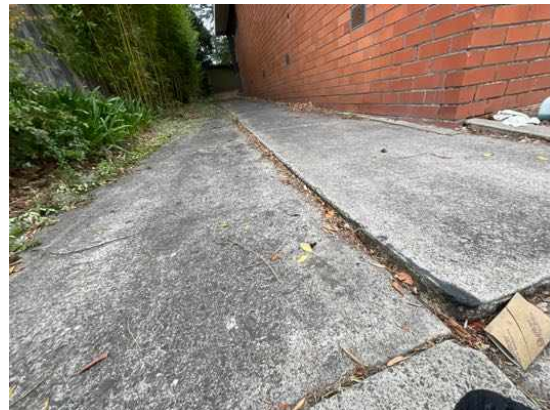
Finding 3.03

Building: Main Building
 Location: All External Areas
 Finding: External Concrete – Cracking Observed (General Movement)
 Information:

Cracking was observed to sections of the external concrete surfaces. The cracks appear consistent with general movement, ageing, or shrinkage of the material.

Concrete cracking of this nature is commonly observed in external areas and may occur due to natural ground movement, environmental conditions, or long-term wear and tear.

A suitable contractor may wish to assess and repair the affected areas as required to maintain surface condition and prevent further deterioration.

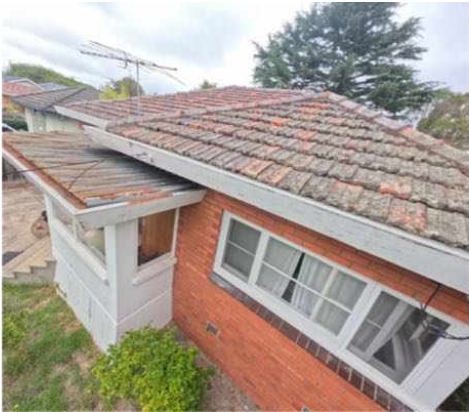
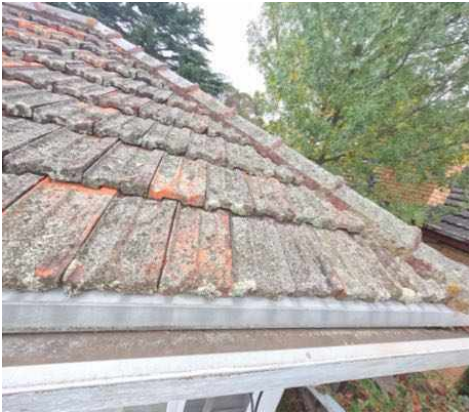
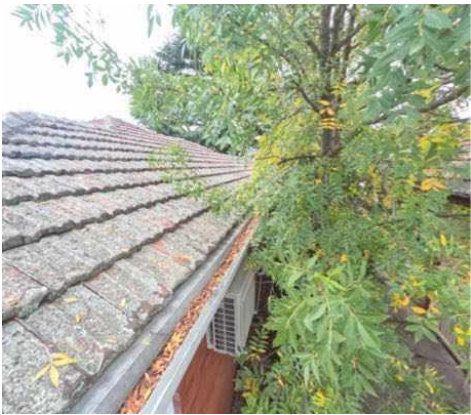
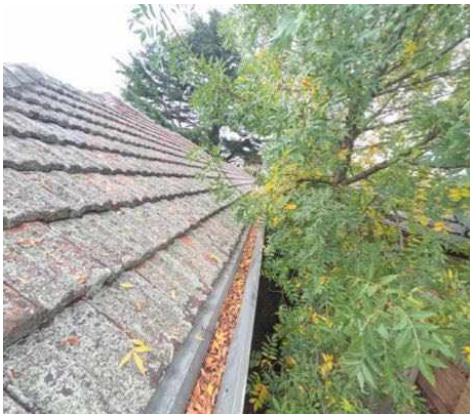
Finding 3.04

Building: Main Building
Location: Roof Exterior
Finding: Roof – Moss Growth and General Deterioration (Maintenance Required)
Information:

Moss and organic growth were observed on sections of the roof surface. General ageing and wear to the roof covering were also noted.

Moss accumulation may retain moisture against the roof surface, which can contribute to deterioration of roofing materials over time and may impact drainage if left unaddressed.

A roof contractor may wish to carry out cleaning, treatment, and general maintenance as soon as practicable to prolong the lifespan of the roof covering and maintain effective performance.

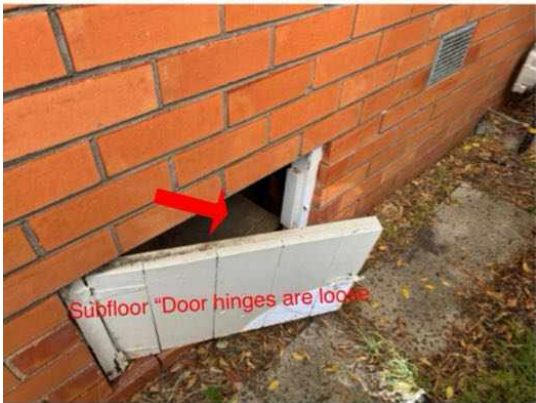
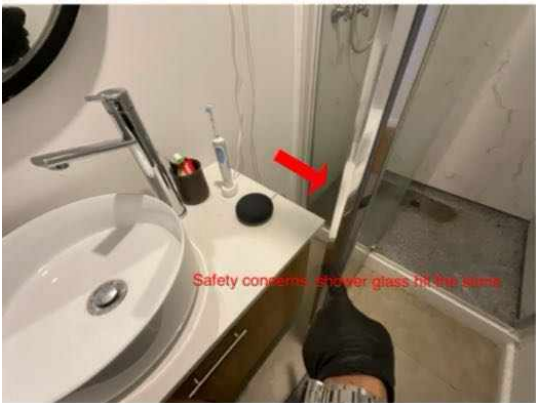
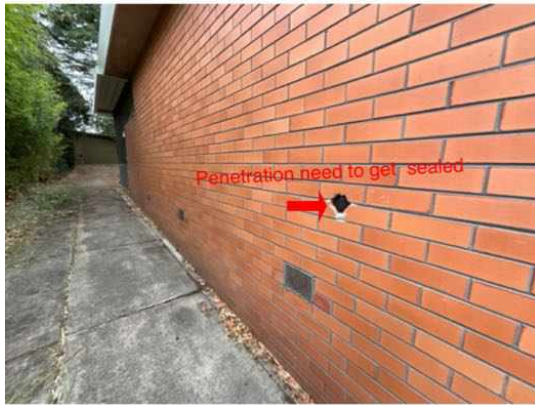
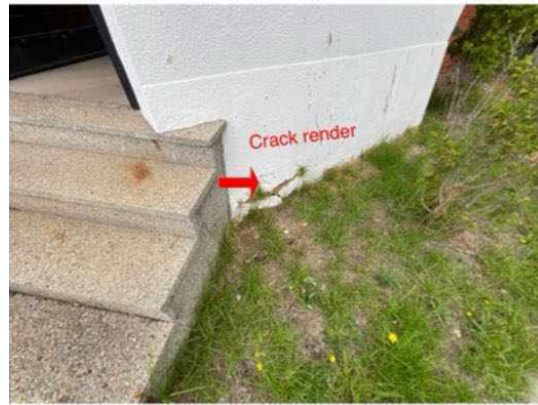
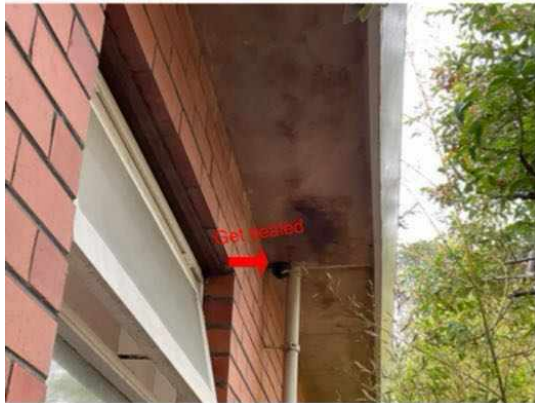
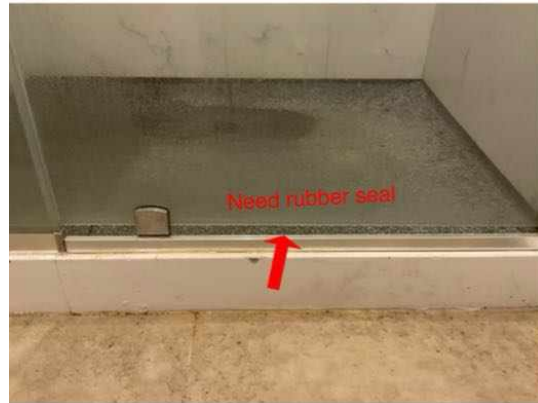
Finding 3.05

Building: Main Building
Location: All Areas
Finding: Maintenance – General Wear and Tear
Information: A number of areas throughout the property show signs of general wear and tear consistent with normal use over time. These conditions may include minor scuffs, surface marks, paint imperfections, and ageing of internal finishes.

These observations are not considered structural defects, but they indicate that routine maintenance may be beneficial to preserve the appearance and functionality of the affected areas. Addressing general upkeep helps prevent minor deterioration from progressing.

Maintenance and touch-ups should be carried out as soon as practicable by a suitably qualified tradesperson, depending on the specific item requiring attention.

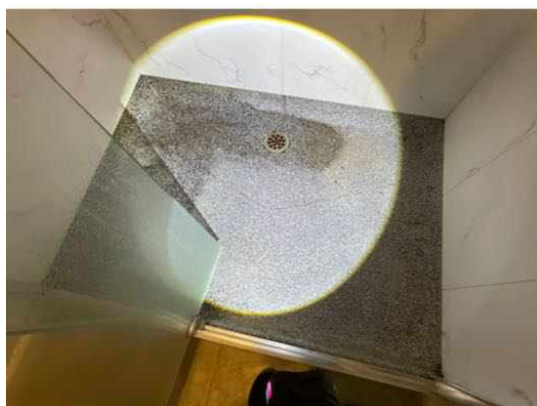
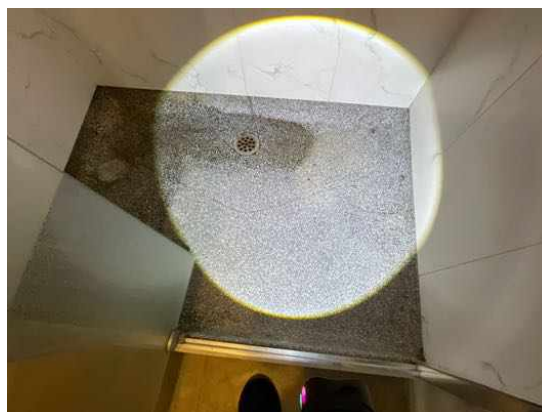
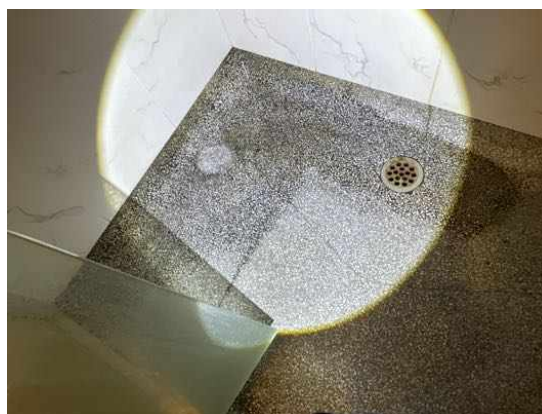
Finding 3.06

Building: Main Building
 Location: Bathroom
 Finding: Shower Base – Hairline Cracking Observed (General Wear and Tear)
 Information:

Hairline cracking was observed to the shower base surface. The cracks appear minor and limited to the surface finish.

Such cracking may occur due to normal wear, ageing, or minor movement of the substrate. At the time of inspection, no significant failure was evident; however, cracks in wet areas may allow moisture penetration over time if they worsen.

A suitable contractor may wish to monitor and maintain the area, and carry out repairs if deterioration progresses to prevent potential moisture ingress.

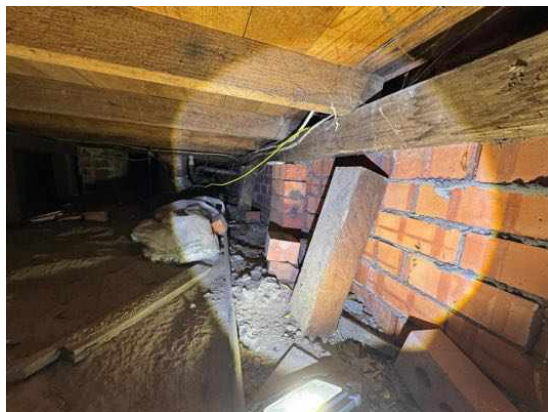
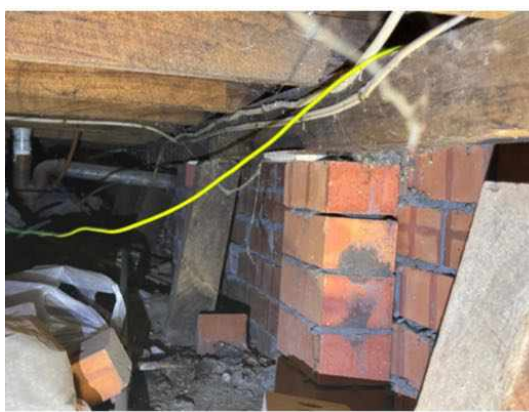
Finding 3.07

Building: Main Building
 Location: Subfloor
 Finding: Subfloor – Loose / Displaced Stump (Potential Major Issue – Must Address ASAP)
 Information:

A section of subfloor support stump appears loose and/or displaced. The support does not appear to be adequately bearing or aligned, which may affect the stability of the supported structure.

Inadequate or compromised support may lead to uneven load distribution, movement of the structure, and potential damage to flooring and superstructure elements over time.

A structural engineer may need to assess the condition as soon as possible, and a suitable contractor may need to carry out rectification works to ensure adequate structural support is provided.

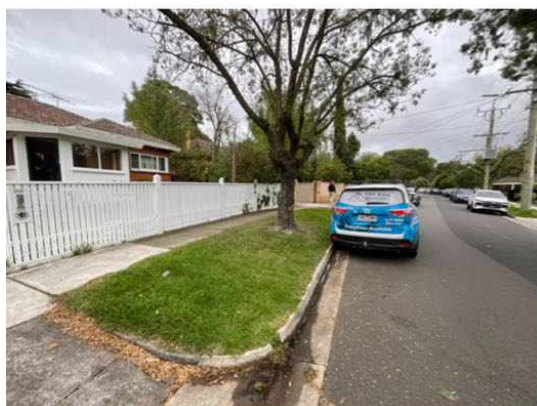
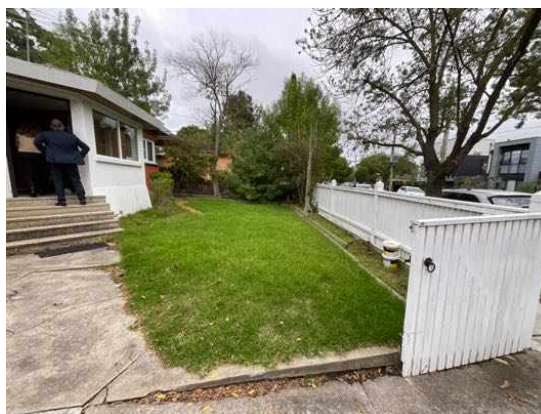
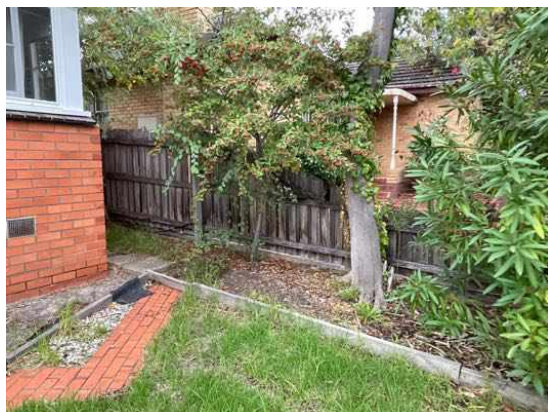
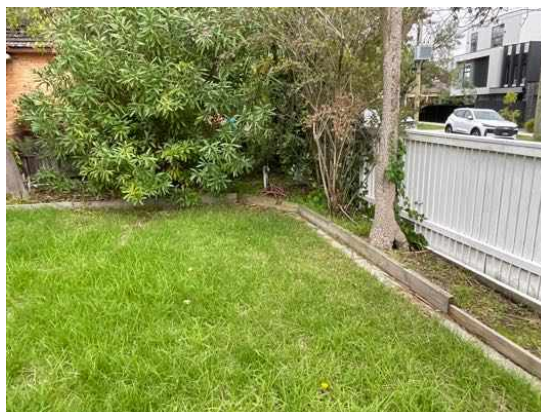
Building:	Main Building
Location:	All External Areas
Finding:	Trees Around Property – Conducive Conditions
Information:	Vegetation and trees positioned close to the property were observed around sections of the external areas. The proximity of foliage, roots, and organic debris creates conditions that are conducive to timber decay and termite activity. Moisture retention around walls and footings is also increased in these areas.

These conditions may lead to deterioration of external elements, encourage fungal growth, and provide concealed pathways for termites. Any moisture in contact with timber is considered highly conducive, and if not addressed, this issue may escalate into a more significant concern.

Rectification should be carried out as soon as practicable by a qualified gardener or arborist to trim vegetation away from the structure and improve airflow. A pest technician may also be needed to reassess conducive conditions once vegetation is cleared.

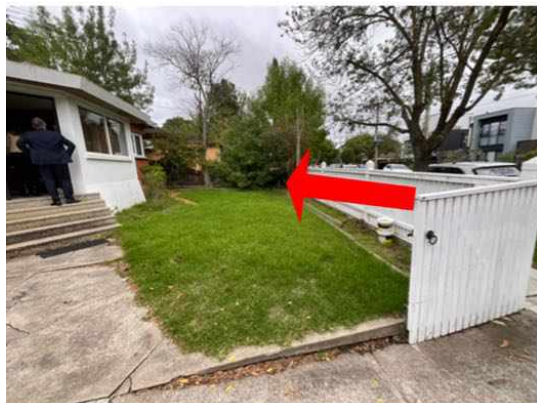
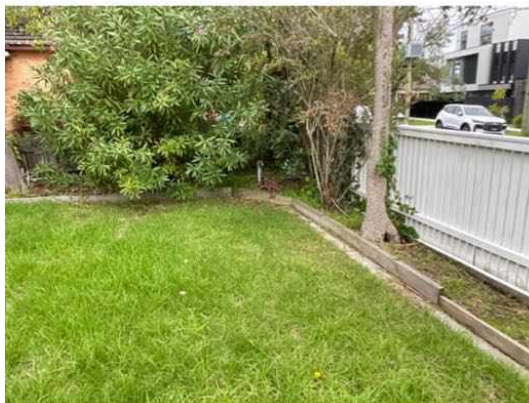
Finding 6.02

Building:	Main Building
Location:	All External Areas
Finding:	Tap No Drainage
Information:	A tap in the external area shows inadequate drainage, with water pooling around the base instead of dispersing effectively. Standing water in this area creates conditions that are conducive to timber decay, fungal growth, and termite activity if nearby building elements are exposed to moisture.

Poor drainage can also lead to deterioration of surrounding materials and may increase moisture levels around footings or adjacent structural components. Any moisture in contact with timber is highly conducive and may escalate into a more significant issue if not addressed.

Rectification should be carried out as soon as practicable by a licensed plumber to improve drainage and ensure water is directed away from the property. A pest technician may also be required to reassess after drainage improvements are completed.

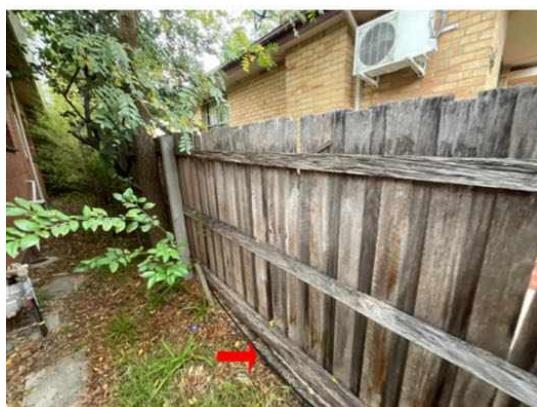
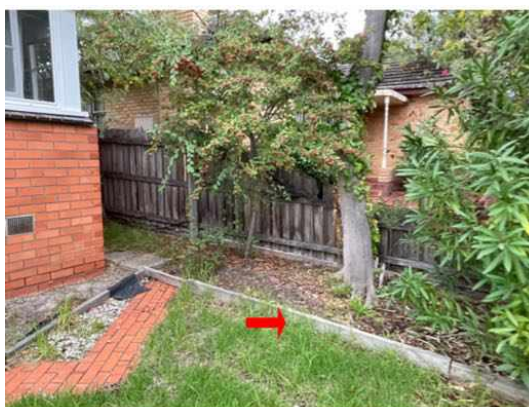
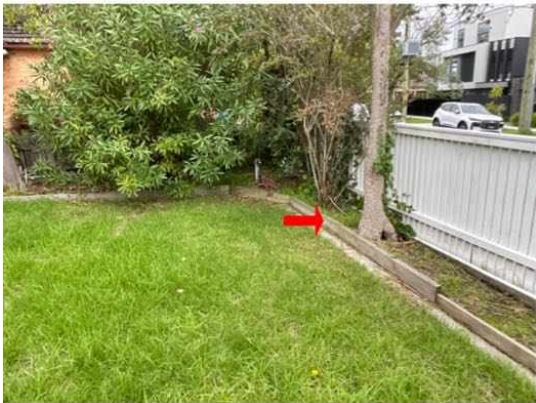
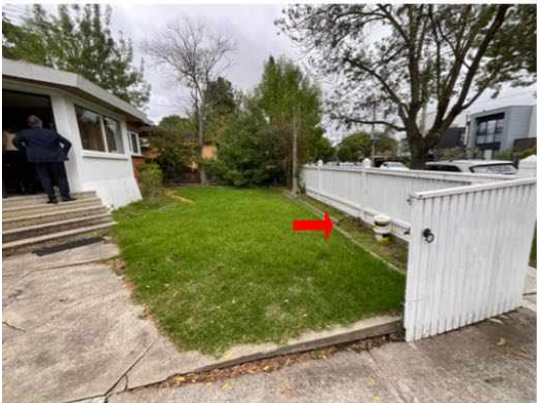
Finding 6.03

Building:	Main Building
Location:	All External Areas
Finding:	Timber in Contact With Soil – Conductive Conditions
Information:	Timber elements were observed in direct contact with soil around the property. This condition is conducive to termite activity and moisture absorption, as soil contact keeps the timber damp and provides concealed access points for termites.

If left unrectified, the timber may deteriorate, absorb moisture, and increase the risk of concealed pest entry or deterioration of connected components. This area should also be kept under observation, particularly after rain or changes in ground moisture levels.

Rectification should be carried out as soon as practicable by a qualified carpenter or builder to separate the timber from soil and install an appropriate barrier.

A licensed termite management technician is also recommended to inspect the area and advise on suitable termite management system options once conducive conditions are reduced.

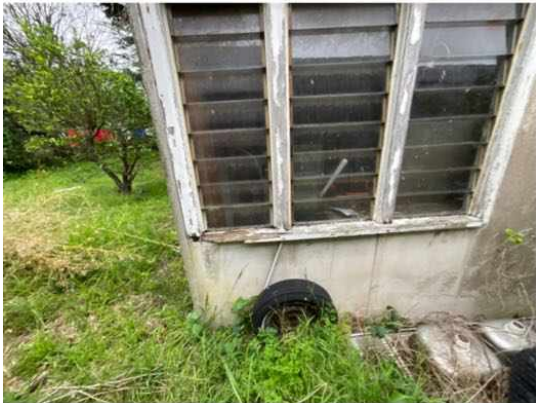
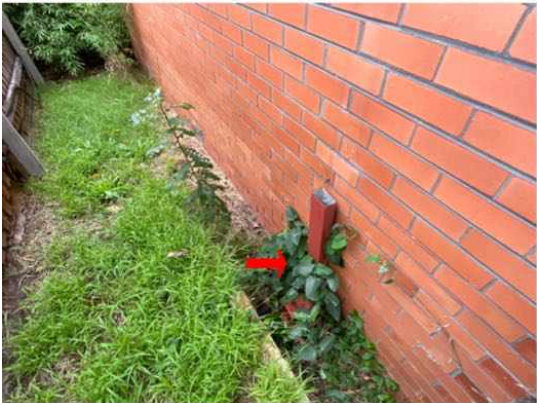
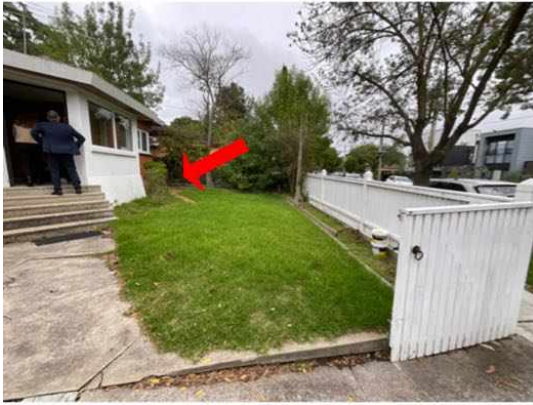
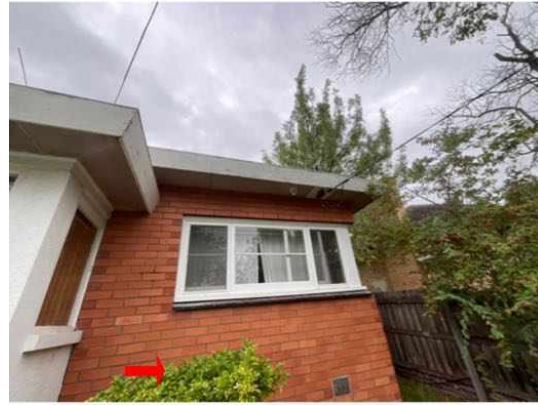
Finding 6.04

Building: Main Building
Location: All External Areas
Finding: Vegetation, Soil and Mulch Against Property – Conducive Conditions
Information:

Trees, vegetation, mulch, and soil were noted in direct contact with sections of the external walls. This condition retains moisture against the structure, can conceal deterioration, and reduces visibility for timber pest inspection. A clear physical separation or barrier is required to protect the building.

Moisture retained against external walls is conducive to termite activity, and this should be addressed as soon as practicable to prevent potential deterioration of nearby building materials.

Rectification should include lowering soil or mulch levels, trimming vegetation away from walls, and creating an adequate barrier or clearance line around the perimeter. A licensed gardener, landscaper, or pest technician can assist depending on the required works.

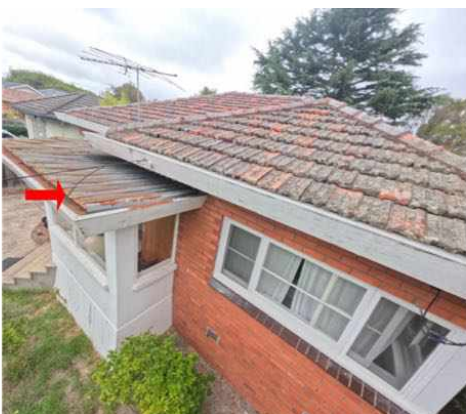
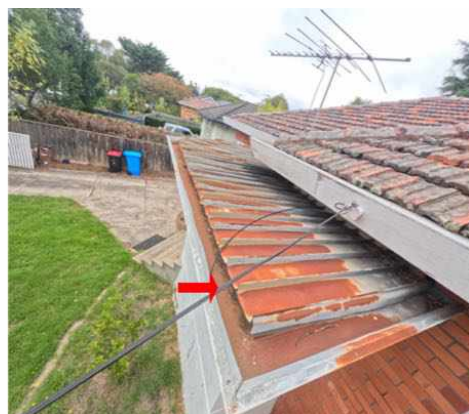
Finding 6.05

Building: Main Building
 Location: All External Areas
 Finding: Roof Rust – Corrosion / Rust Deterioration (Potential Major Issue – Must Address ASAP)

Information: Corrosion and rusting were observed to sections of the roof covering. The affected areas show signs of material deterioration, which may impact the integrity of the roofing system.

Advanced rusting may lead to thinning of the metal surface, potential perforation, and an increased risk of water ingress over time. The extent of deterioration may vary across the roof and could worsen if not addressed.

A licensed roof contractor may need to assess the condition of the roof covering as soon as possible to determine whether repair, treatment, or full replacement is required to maintain weatherproof performance.

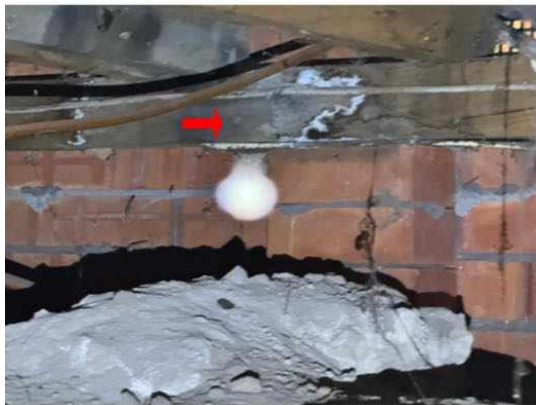
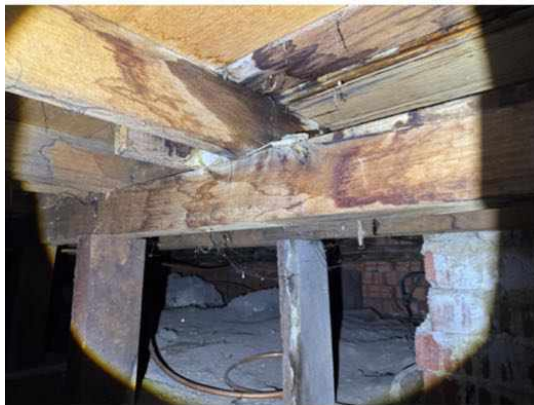
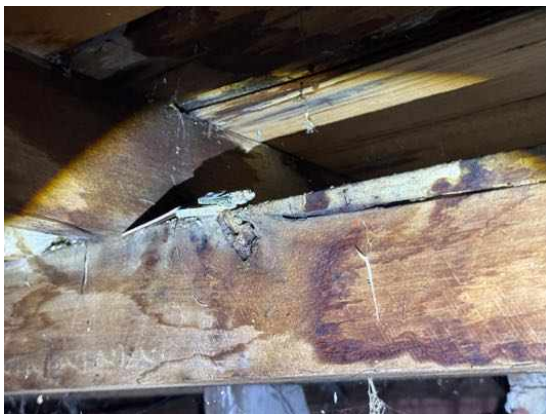
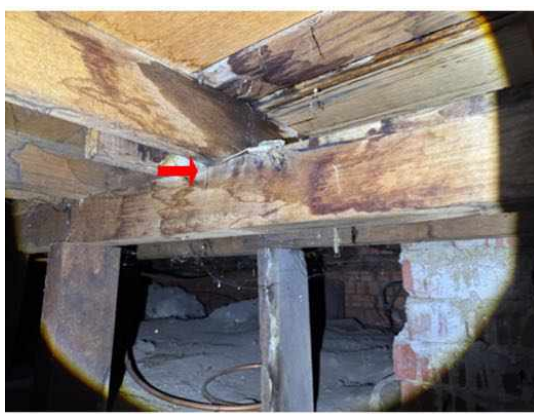
Finding 6.06

Building: Main Building
 Location: Subfloor
 Finding: Subfloor – Moisture / Water Ingress and Structural Integrity Concern (Conductive

Condition – Must Address as Soon as Practicable)

Signs of moisture and possible water ingress were observed within the subfloor area. Sections of flooring appear softened, which may indicate prolonged exposure to moisture.

Moisture within subfloor areas may lead to deterioration of structural timber elements and may affect the elevation and overall structural integrity of the flooring system. These conditions are conducive to termite activity and may result in further structural issues if not addressed.

A licensed plumber may need to identify and rectify the source of moisture, and a structural engineer may need to assess the elevation and structural integrity as soon as practicable to prevent further deterioration.

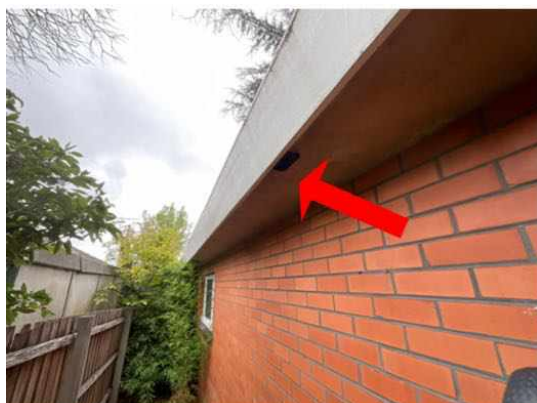
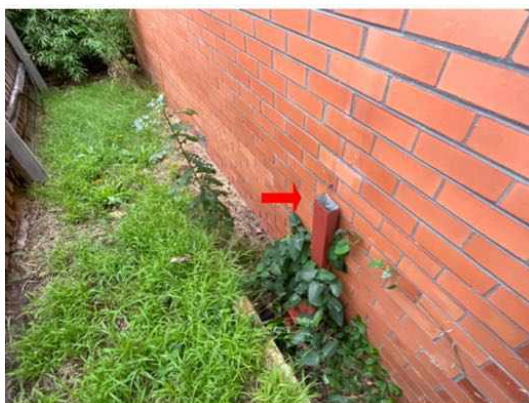
Finding 6.07

Building: Main Building
 Location: All External Areas
 Finding: Missing Down pipe, Roof Drainage
 Information:

A downpipe was observed to be missing from a section of the roof drainage system. As a result, rainwater is discharging directly onto the ground below.

This condition may lead to continuous moisture accumulation at the base of the structure, creating damp or saturated conditions. Such conditions are conducive to deterioration of building elements and may affect surrounding areas over time.

A licensed roof plumber may need to install an appropriate downpipe and ensure proper discharge away from the structure as soon as practicable.

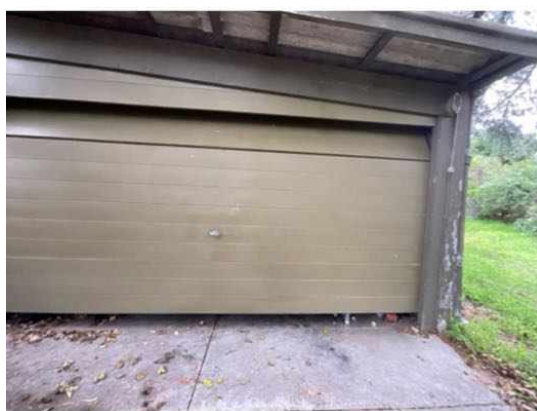
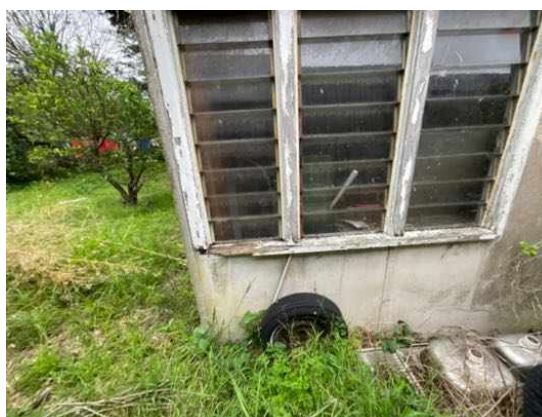
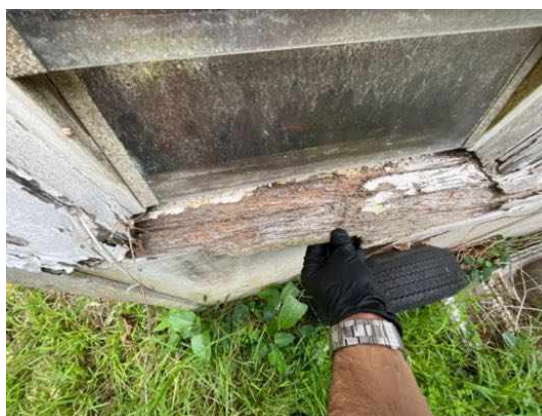
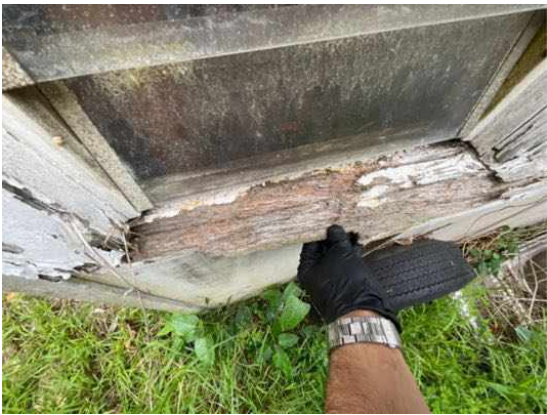
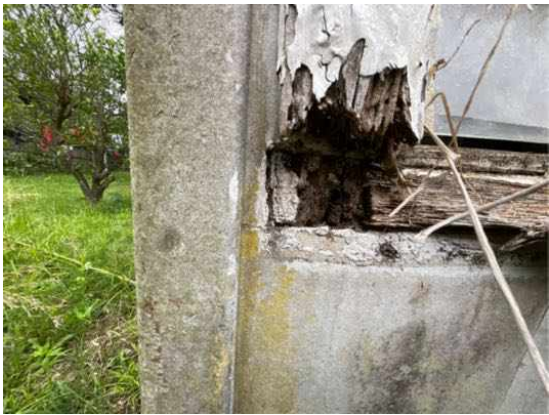
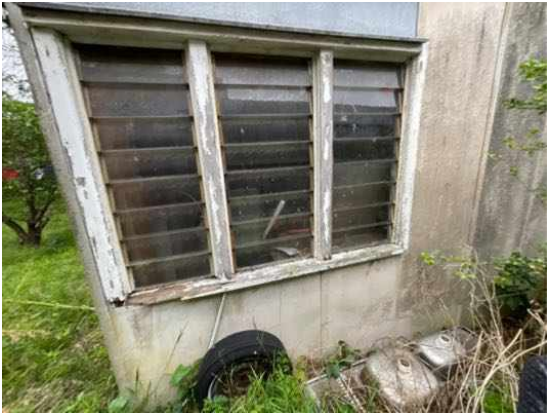
Finding 7.01

Evidence of fungal decay activity and/or damage

Building: Main Building
 Location: All Areas
 Finding: Fence and Timbers Elements – Suspected Decay and Deterioration

Information: A section of the external timber elements shows signs of possible decay and deterioration. This condition may be related to weathering, inadequate sealing, or moisture exposure affecting the integrity of the timber surfaces.

If not attended to, deterioration may progress and affect the performance of the surrounding building materials. Any moisture in contact with timber is conducive to termite activity, so this matter should be addressed as soon as practicable to avoid further damage.

Rectification should be carried out by a licensed carpenter or builder, who can repair or replace affected sections and ensure all exposed timber is properly sealed and protected. A licensed structural engineer may be required if any structural impact is suspected.
