Building and Timber Pest Inspection Report

Inspection Date: Tue, 7 Apr 2026

Property Address: 45 Charming Street, Hampton East, VIC
3188

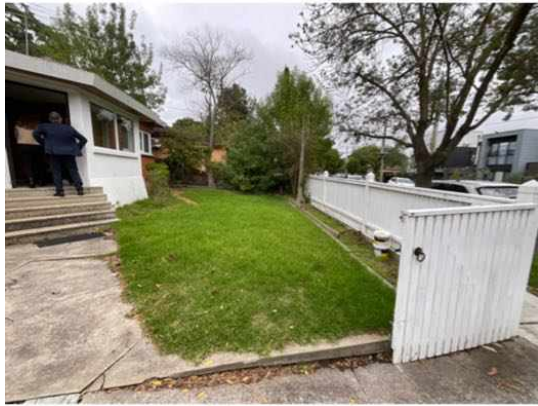
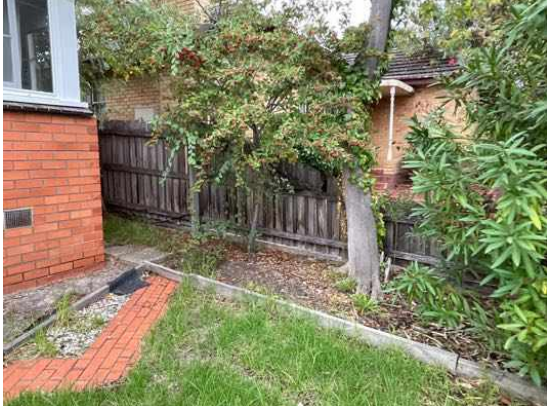
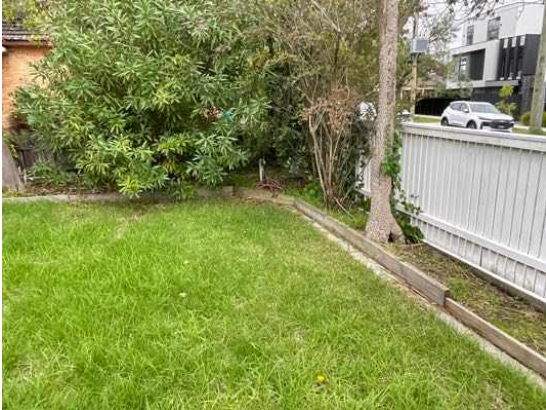
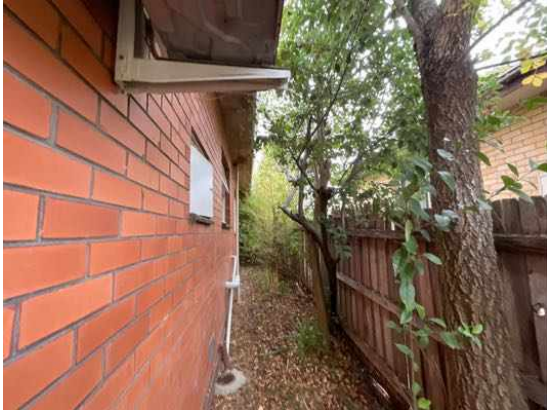
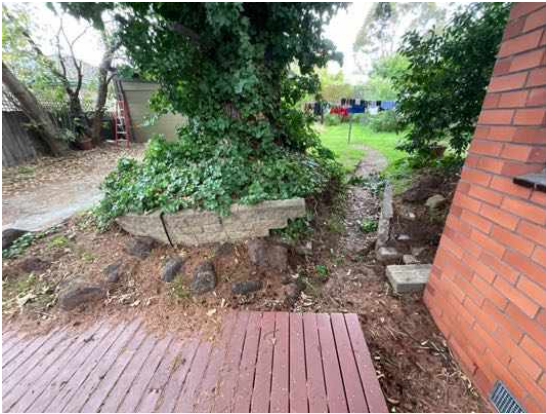
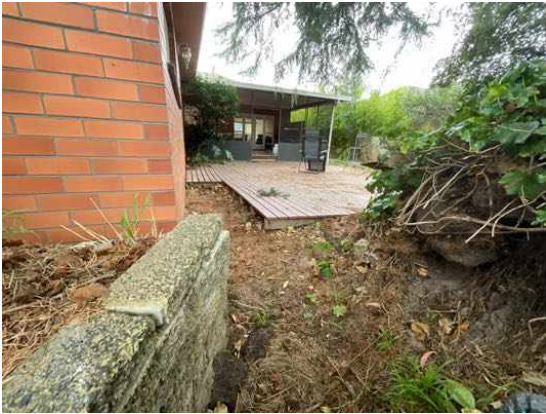
Building: Main Building
Location: All Areas
Finding: Additional Photos - Obstructions and Limitations
Information: These photographs are an indication of the obstructions and limitations which impeded full inspection of the property at the time of inspection. These obstructions can hide an array of defects and should be removed to allow full inspection to be carried out. A re-inspection is recommended once the areas are made accessible.

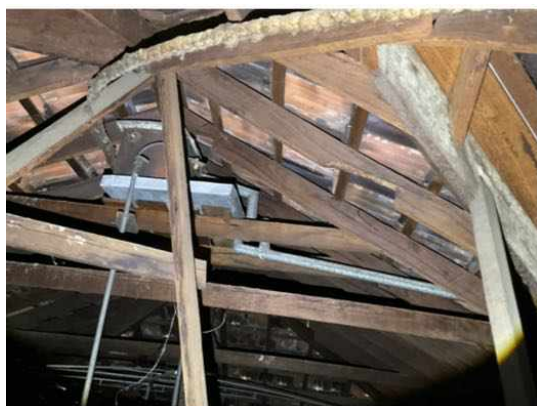
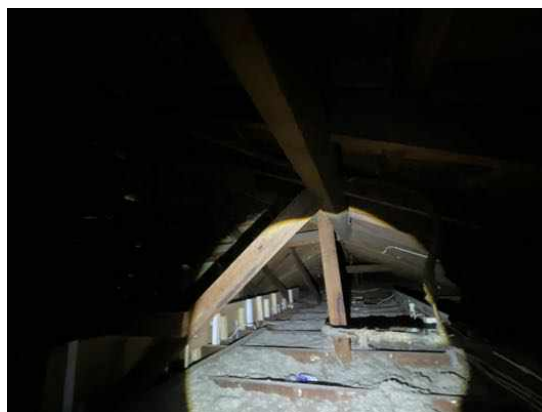
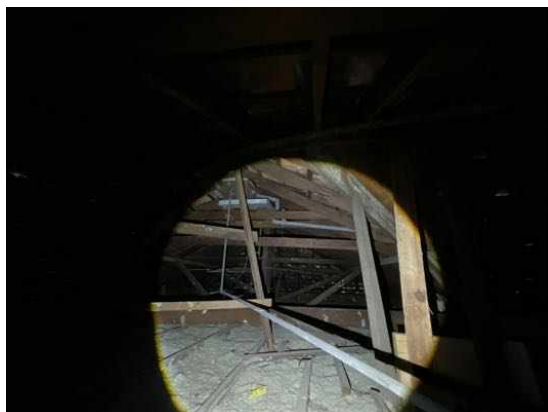
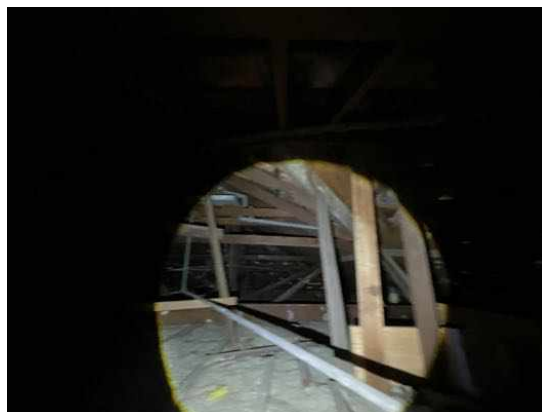
Building: Main Building
Location: Roof Void
Finding: Roof void access limitations
Information: Limited access to the roof void was present due to facts including but not limited to access hatch size or placement, for this reason access to the roof void was minimal.

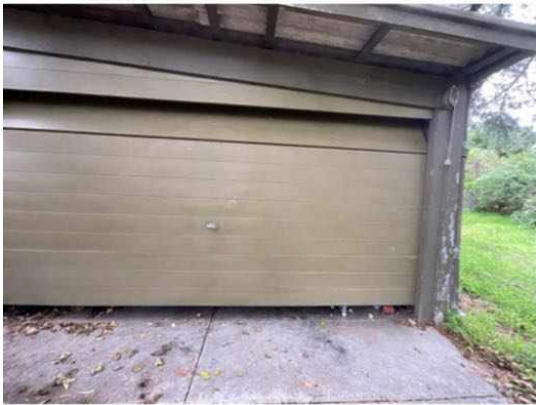
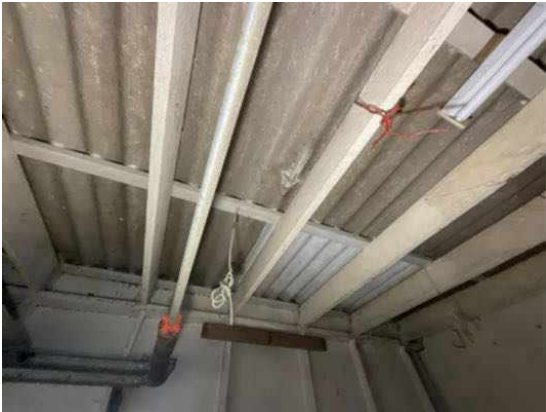
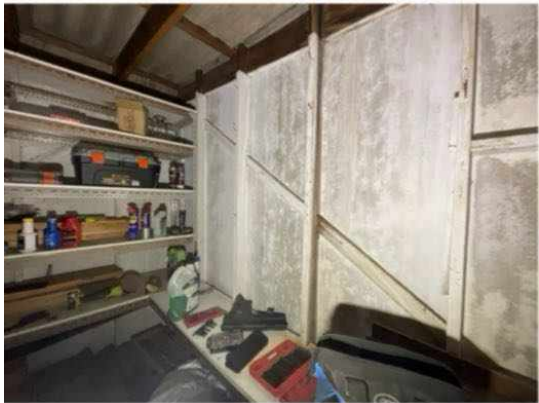
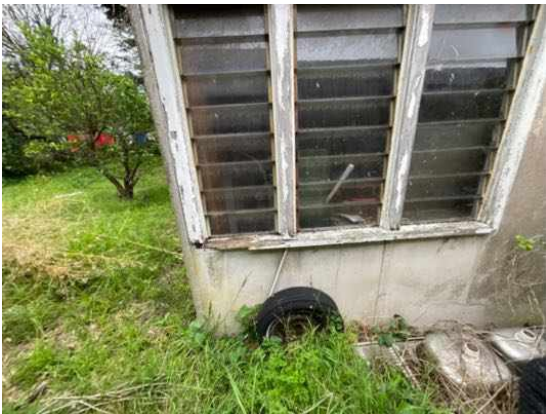
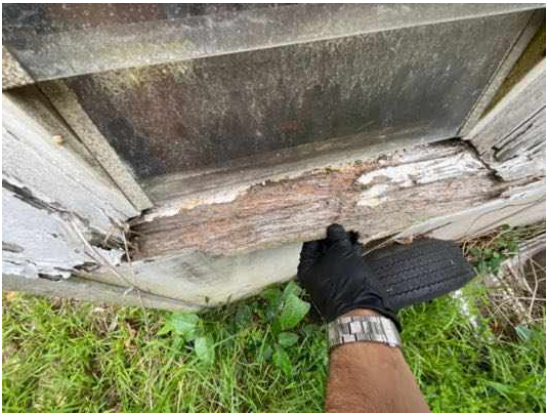
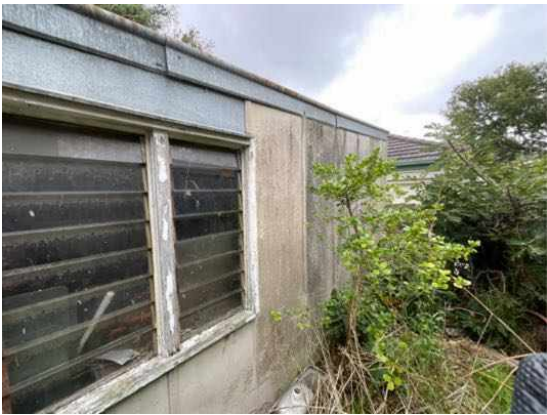
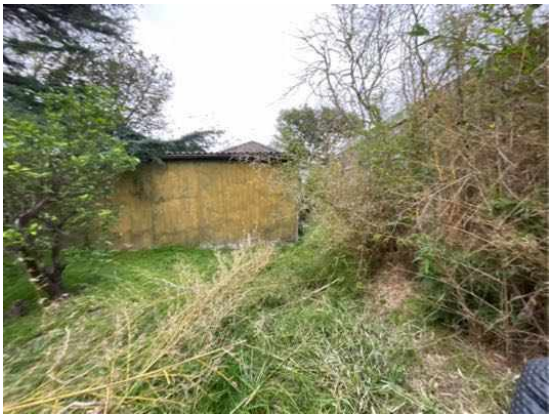
Building:	Main Building
Location:	All External Areas
Finding:	Garage / Outbuilding – Suspected Asbestos Material and Structural Deterioration (Safety Hazard – Must Address ASAP)
Information:	Cement-based sheet materials were observed within the garage / outbuilding. Based on the apparent age of the structure, these materials may contain asbestos; however, this could not be confirmed at the time of inspection as no sampling was undertaken.

General ageing and deterioration were also observed to the structure, which may affect its overall integrity and pose a safety concern.

An asbestos specialist may need to carry out further investigation, including sampling and laboratory testing, to confirm the presence of asbestos. A suitable contractor may need to assess the structural condition as soon as possible and carry out necessary rectification works to ensure safety.
