Building and Timber Pest Inspection Report

Inspection Date: Tue, 27 Jan 2026

Property Address: 51 Flaxton Dr, Mapleton QLD 4560,
Australia

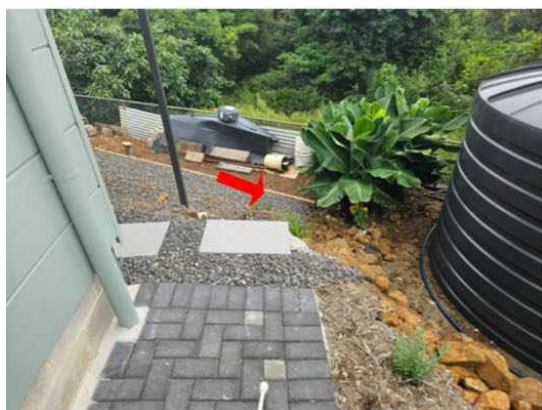
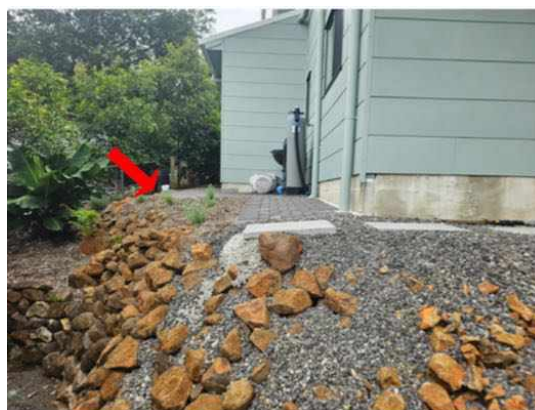
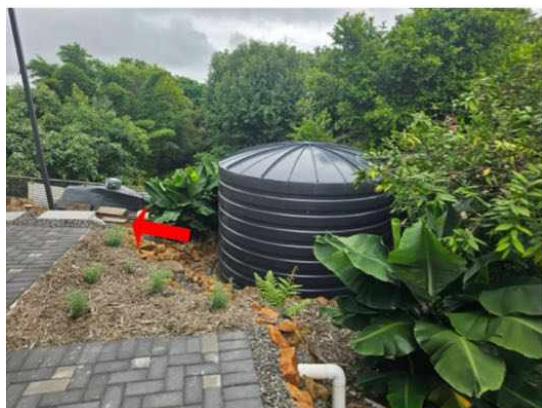
Building:	Main Building
Location:	As shown
Finding:	Fall risk - retaining wall / bank
Information:	It was noted on the day of inspection that the rear retaining wall / bank adjacent to the rain water tank has an unrestricted fall risk. The wall is in excess of 1.0m high without a handrail or restrictive barrier.

Where it is possible to fall 1m or more measured from the level of the trafficable surface to the surface beneath (shown in figure 11.3.3a of the code).

- a. A retaining wall unless the retaining wall forms part of, or is directly associated with, a delineated path of access to a building from the road, or a delineated path of access between buildings (shown in figure 11.3.3b of the code).

It would be advisable to consider the installation of a fall restriction device or handrail for any portion over 1m in height.

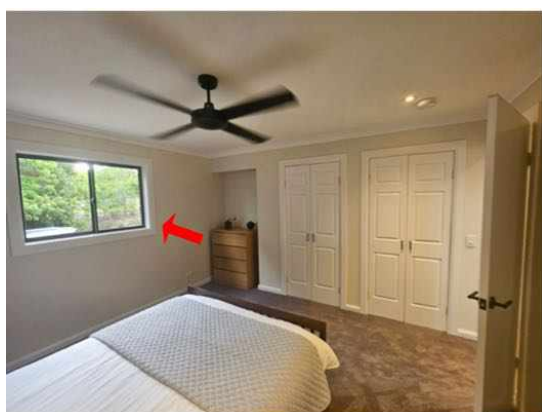
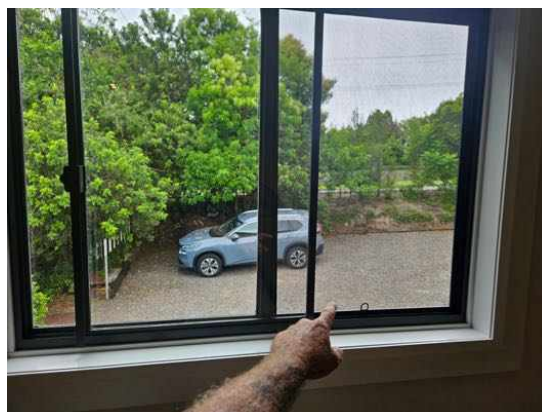
Finding 1.02

Building:	Main Building
Location:	Bedroom 3
Finding:	Window barriers - for information only
Information:	It appears that the windows shown in the bedrooms are suspected of not complying with current provisions of the Building Code of Australia (BCA), the National Construction Code (NCC), Part 3.9,2; Barriers and Handrails or the Australian Standards.

Windows to be protected Windows are defective if they do not comply with provision 3.9.2.6 of Volume 2 of the BCA that requires that a window opening must have protection if the floor below the window in a bedroom is 2m or more above the ground surface beneath.

Type of protection Windows requiring protection are defective if they are not fitted with a device to restrict the window opening or a screen, with secure fittings. The device or screen, where required, is defective if it permits a 125mm sphere to pass through the window or screen or is unable to resist an outward horizontal action of 250 N.

In cases where the screen or device can be removed, unlocked or over ridden, the installations are defective if they are not fitted with a child resistant release mechanism. Barrier In addition to window protection, windows are defective if a barrier is also not installed below the window whenever a child resistant release mechanism is required to be installed in a bedroom; or for all openable windows, in any room, that has a floor level located 4m or more above the ground surface beneath, if the window is not protected. The barrier is defective if it permits a 125mm sphere to pass through it or if it has any horizontal or near horizontal elements between 150mm and 760mm above the floor that can facilitate climbing.

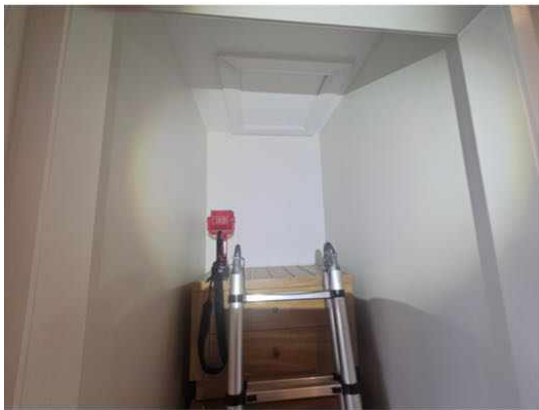
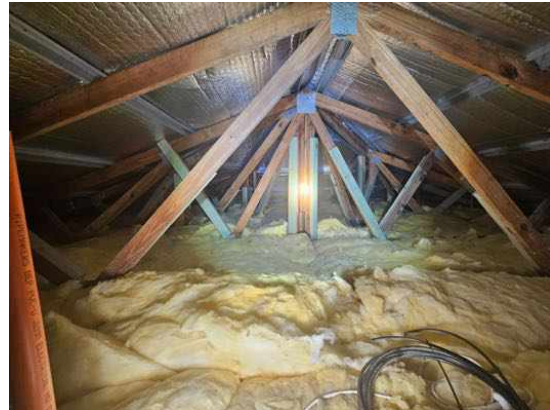
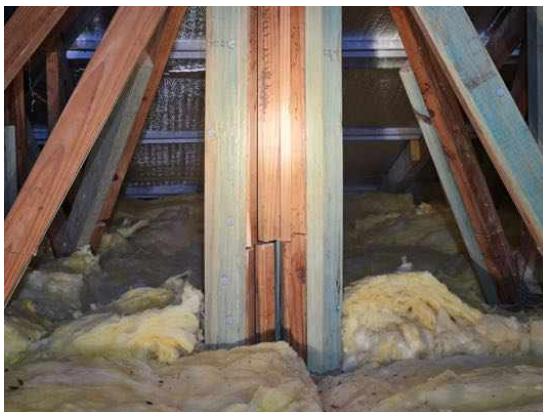
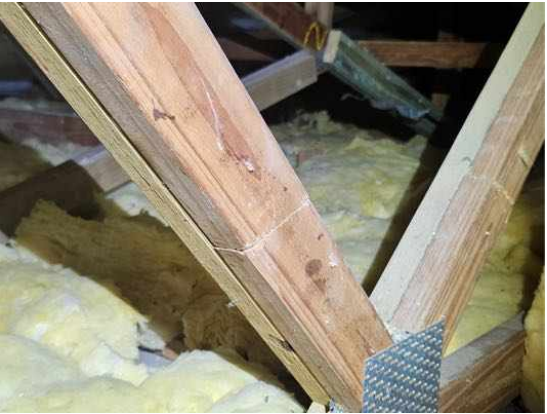
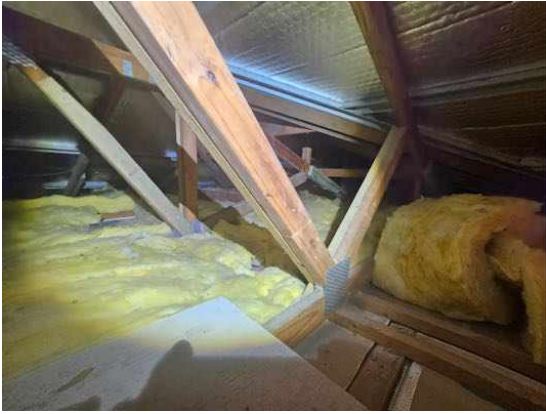
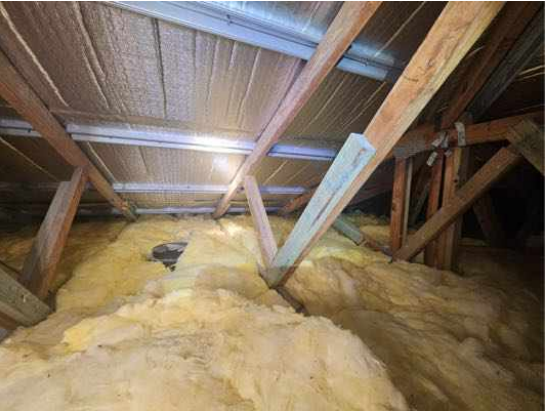
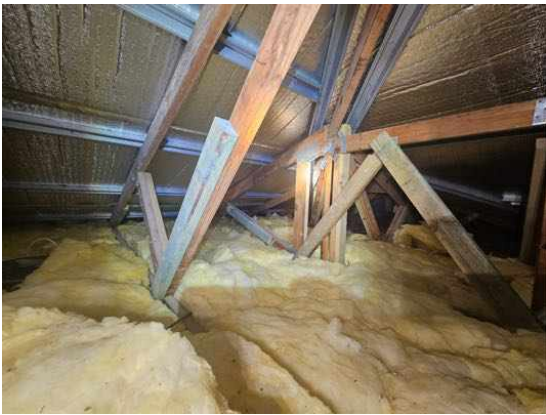
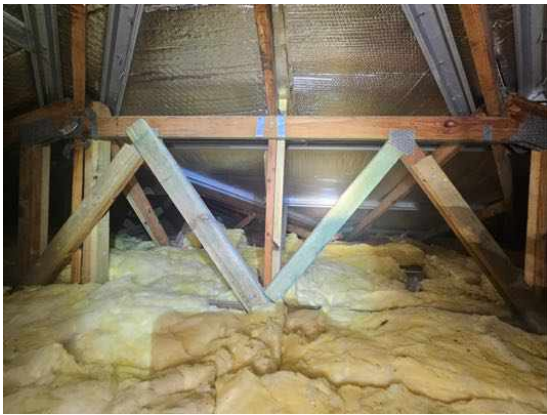
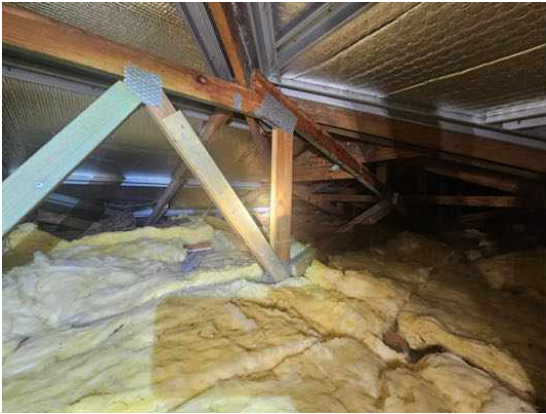
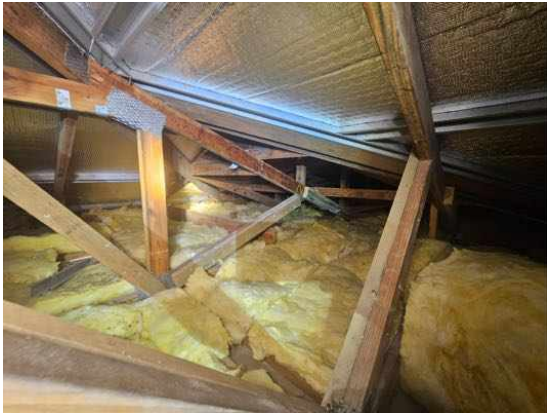
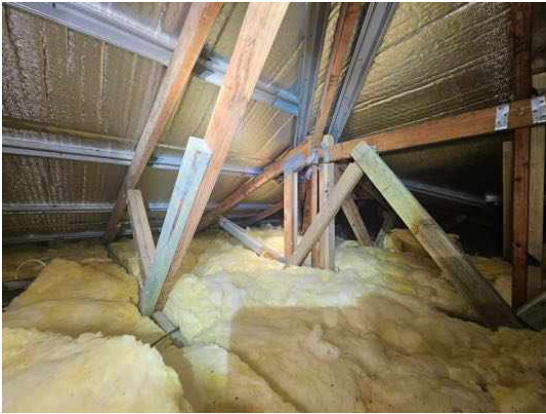
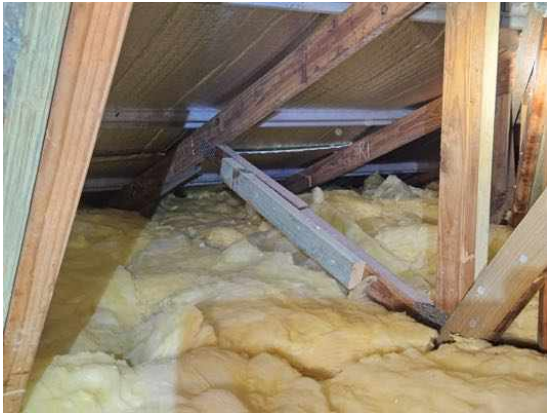
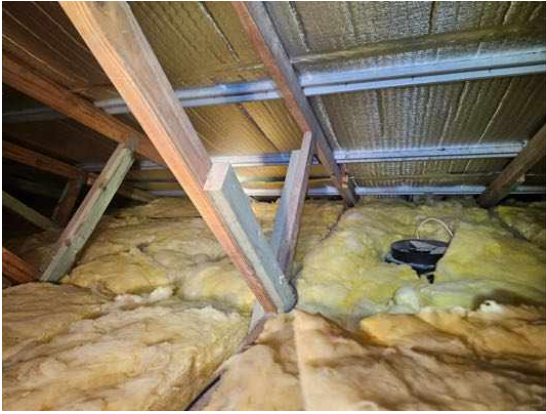
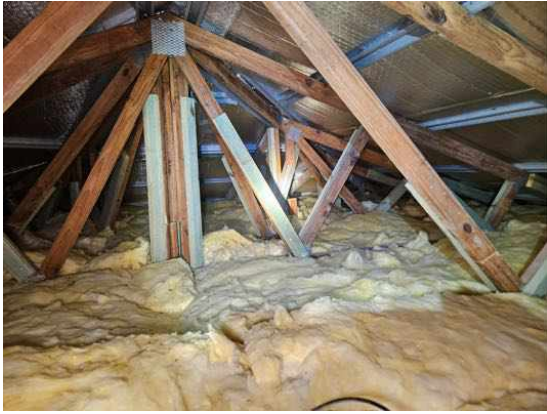
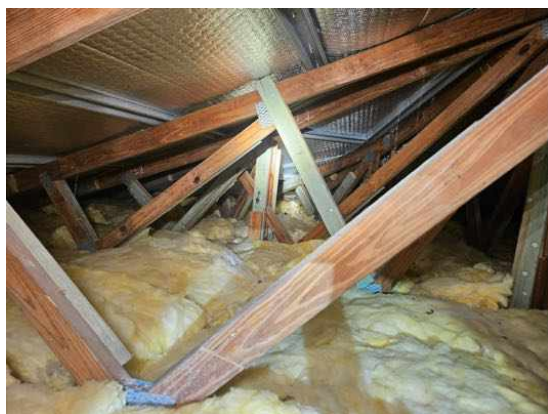
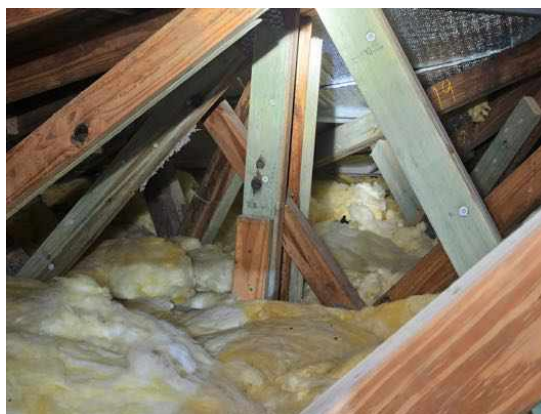
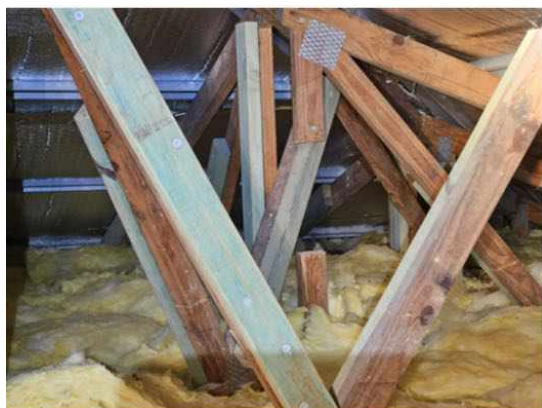
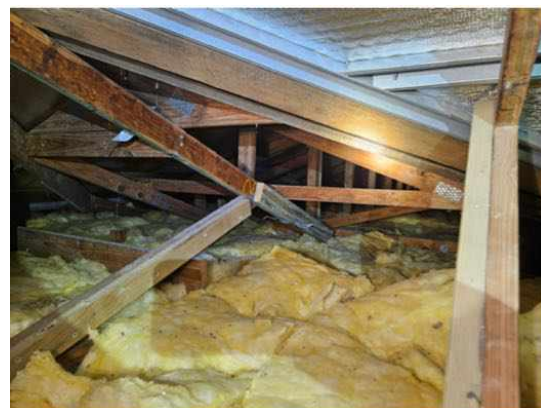
Finding 2.01

Building:	Main Building
Location:	All areas viewed
Finding:	Roof truss repairs
Information:	On the day of inspection it was noted that repair works had been carried out on the roof trusses above the upper floor rooms above the garage. The majority of trusses in this section of the structure appear to have been cut in various positions. The reason

for this is not determined. Repairs have been carried out.

The remaining section of roof could not be inspected on the day due to the restrictive nature of the framing.

Certification for this work was not available. It is recommended that the client obtain an engineers or the manufacturers certification the repairs. Given the volume of damaged trusses, if the repairs are not in accordance the correct standards, there is a risk of failure is undue stress is placed on the roof structure. The certifiers certificates were made available for reading; however, there is no mention of this damage, the repairs or certification for the repairs. The original engineering frame design certification is dated 17/11/21, and the frame inspection was carried out on 30/9/22. It is assumed that the damage occurred after these dates.

The client is encouraged to seek a copy of the certification for this repair. This will be required to comply with manufacturers warranty conditions.

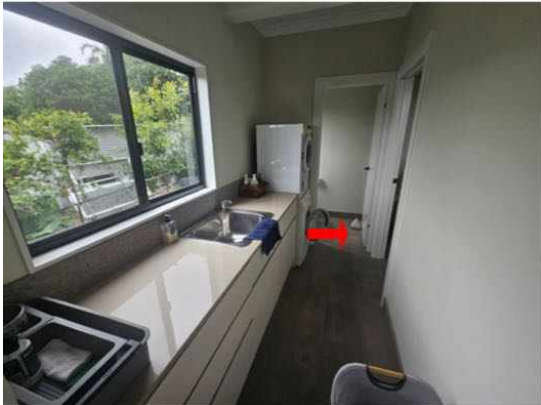
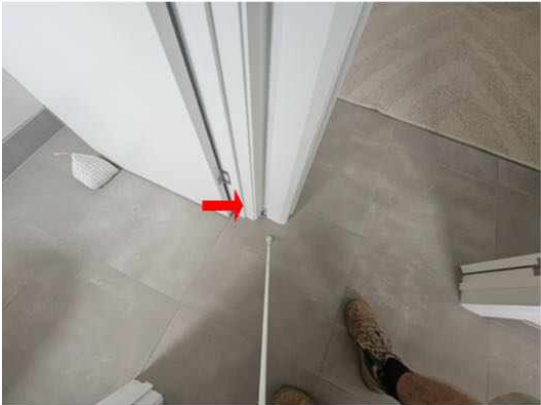
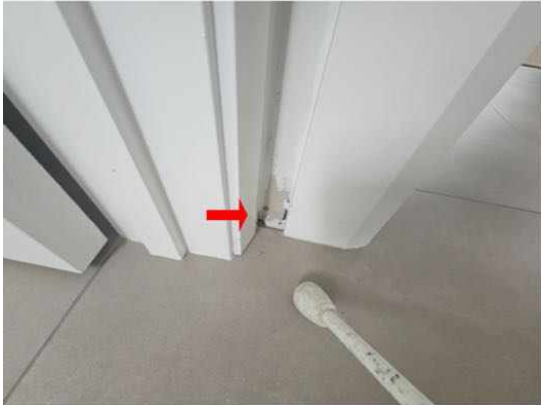
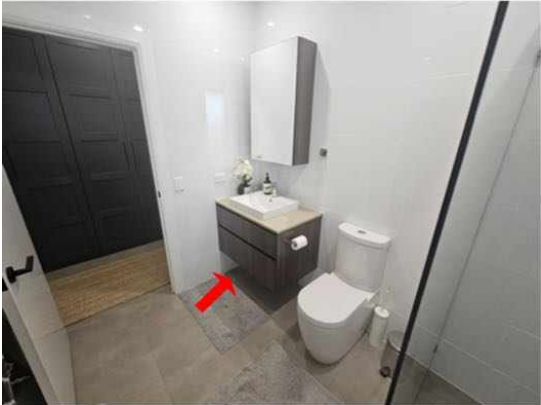
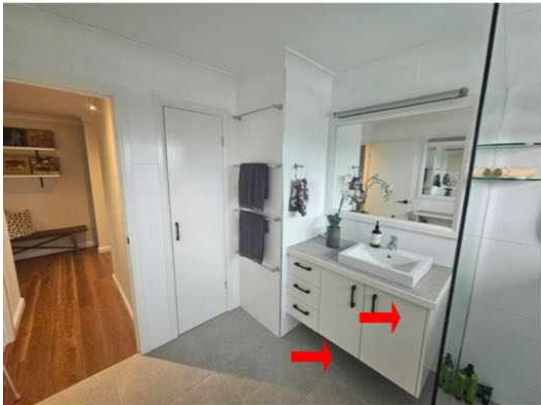
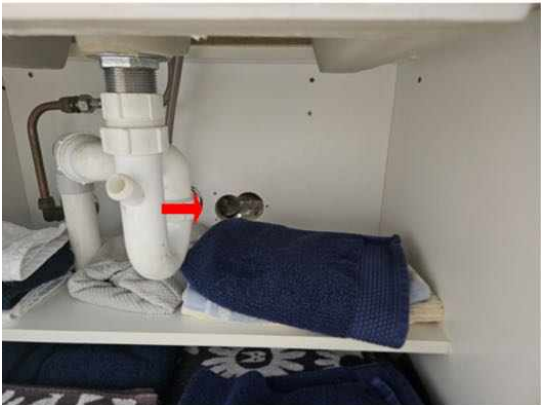
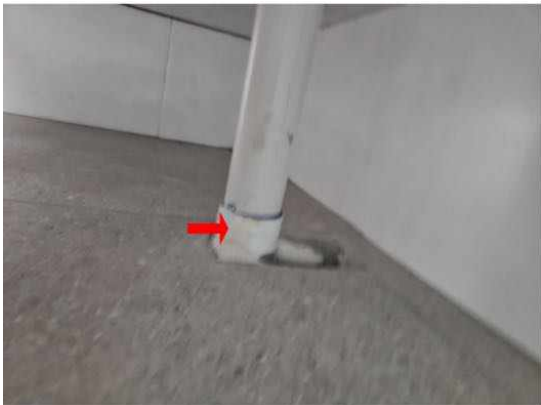
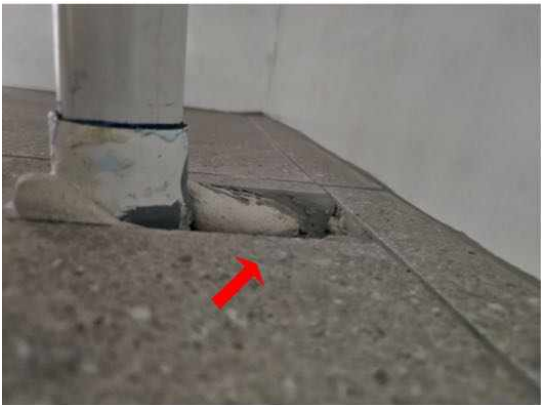
Finding 3.01

1. Skirting tile to laundry door edge missing.
2. Ground floor bathroom, skirting tile under vanity is not sealed.
3. Upper floor bathroom, unsealed holes in the back of vanity cupboard, waste pipe under vanity not sealed to tiles.

These minor defects should be attended to in the short term to prevent further deterioration.

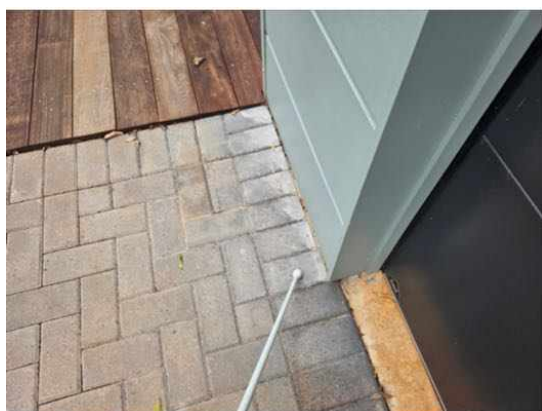
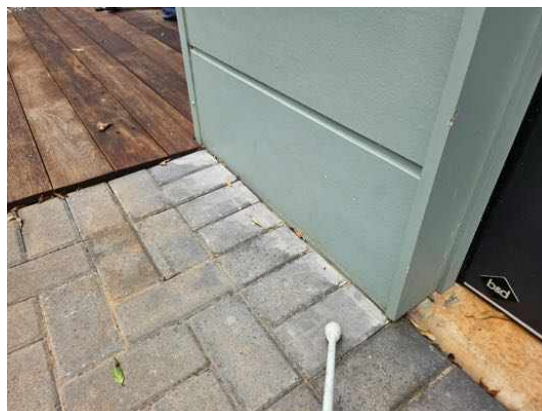
Where bridging has occurred full inspection is prevented and termites may enter a property in a concealed or undetectable manner.

It is recommend that the client consult with a licensed timber pest controller to ascertain the ideal rectification to satisfy the barriers requirements.

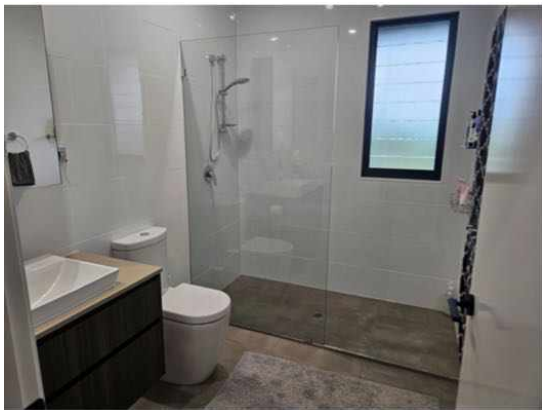
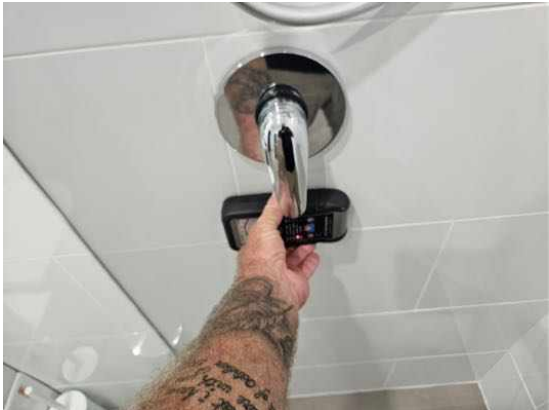
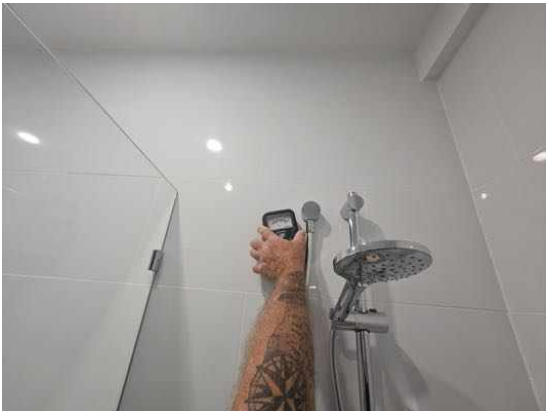
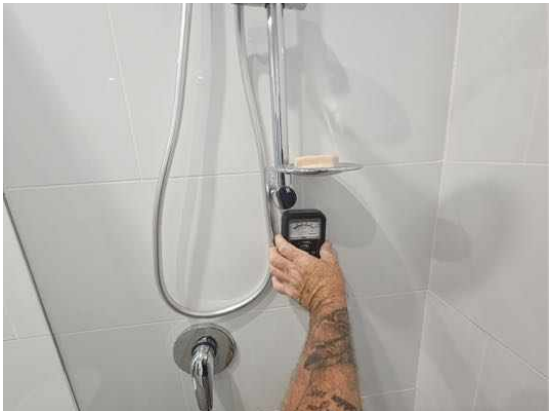
Building: Main Building
Location: Bathrooms
Finding: No moisture detected in bathrooms
Information: On the day of inspection the showers in the bathroom/s are measure for moisture using a "Tramex" moisture meter. During this inspection no moisture was detected in these areas and the tiled / sheeted surfaces appear to be in good order.

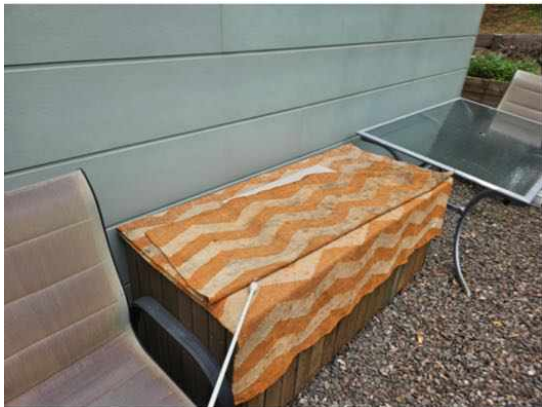
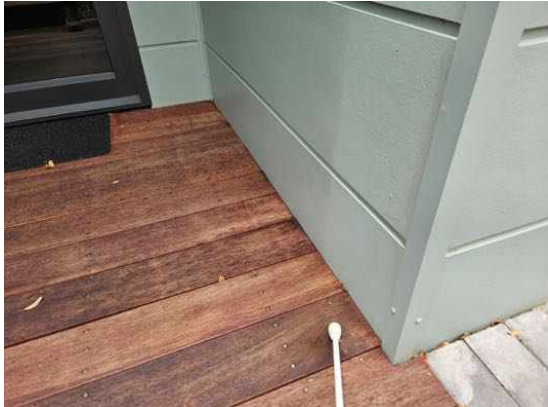
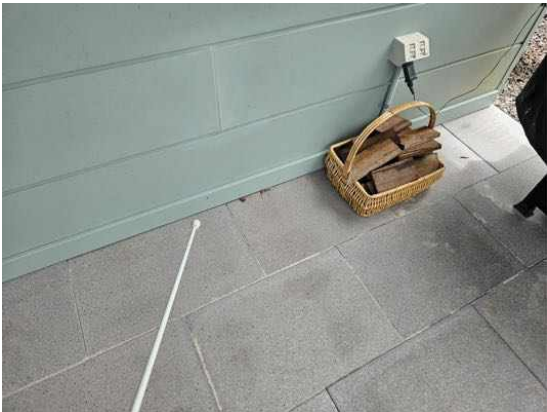
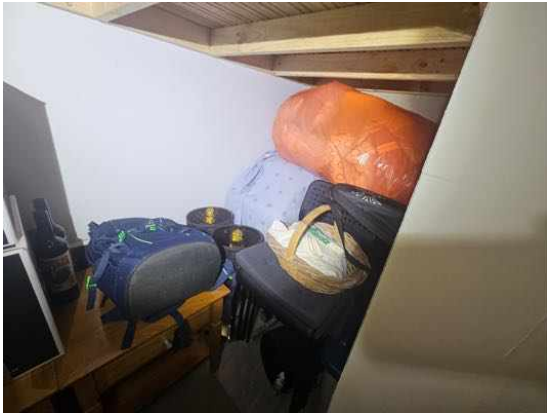
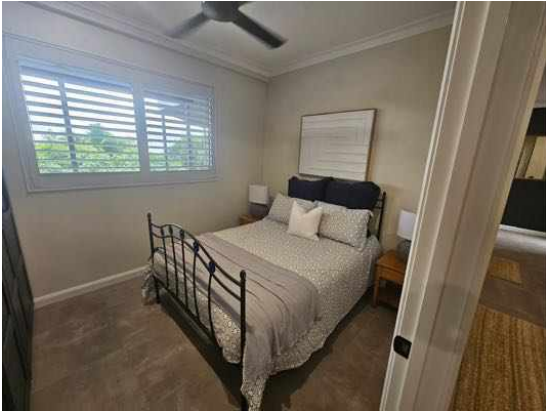
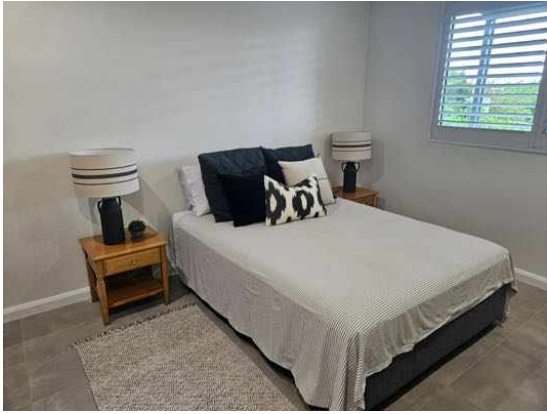
Building: Main Building
Location: All Areas
Finding: Additional Photos - Obstructions and Limitations
Information: These photographs are an indication of the obstructions and limitations which impeded full inspection of the property at the time of inspection. These obstructions can prevent full inspections of the areas shown.

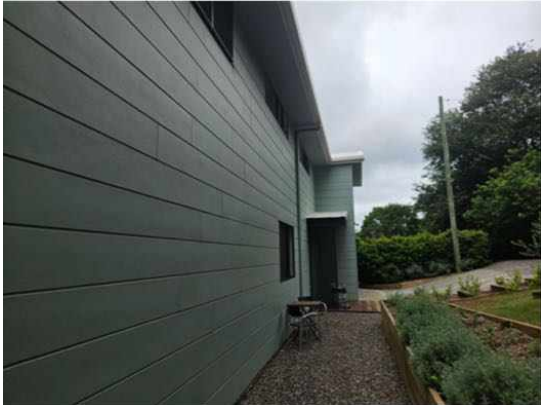
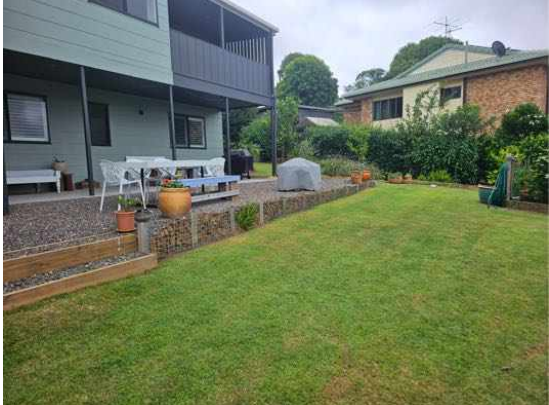
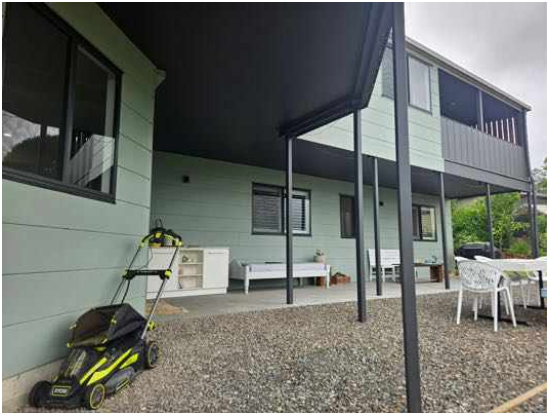
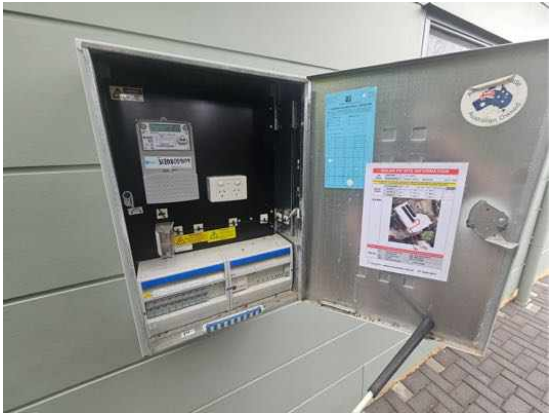
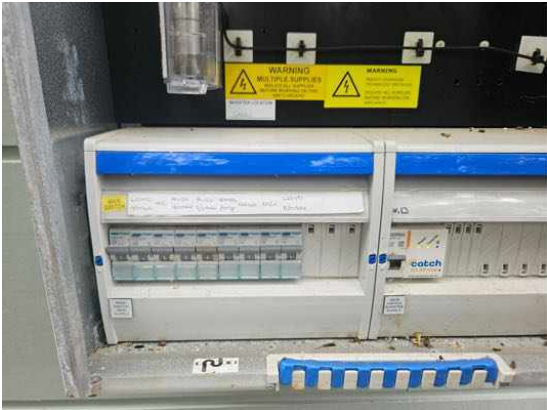
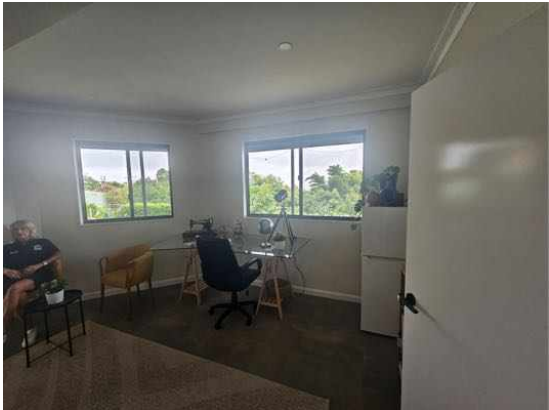
Building: Main Building
Location: All Areas
Finding: Additional Photos for client reference
Information: Additional photos are provided for your general reference.

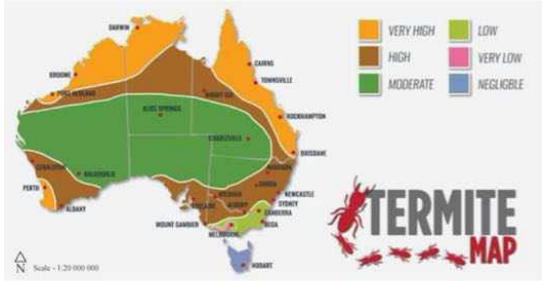
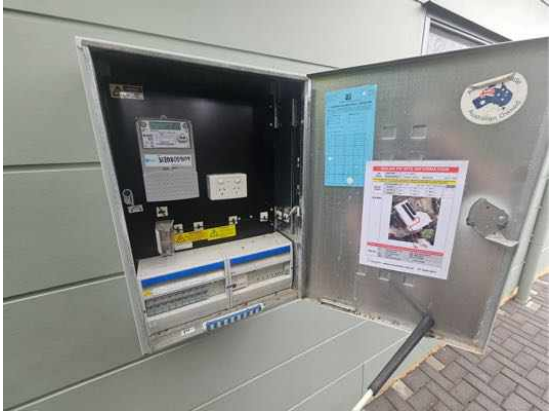
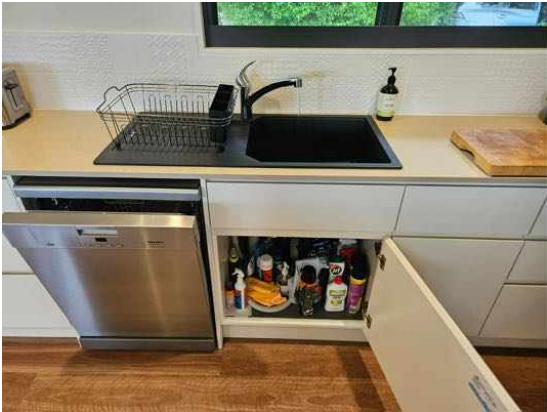
Building: Main Building
 Location: Meter box, kitchen cupboard
 Finding: Durable pest inspection notice - not assessable
 Information: On the day of inspection it was noted that the durable timber pest inspection / treatment notice was missing, not visible or out of date. These notices / stickers are to verify the timber pest inspection dates, the inspector, the currency and type of timber pest system / barrier in place or being used in and around the property.

Annual, or more regular, inspections are crucial in maintaining and managing the properties timber pest risk profile. By not having regular inspections of the property raises the properties risk of undetected defects and damage. Without regular inspection at intervals of not greater than annually the buildings risk profile will categorised as high. Properties with trees within 50m and with gardens close to the building are at greater risk and will have a high risk profile.

It is recommend that a licensed timber pest controller be contacted to assess the properties needs and provide costings for an annual inspection programme.
