Building and Timber Pest Inspection Report

Inspection Date: Thu, 5 Feb 2026

Property Address: 24 Travers St, Moorebank NSW 2170,
Australia

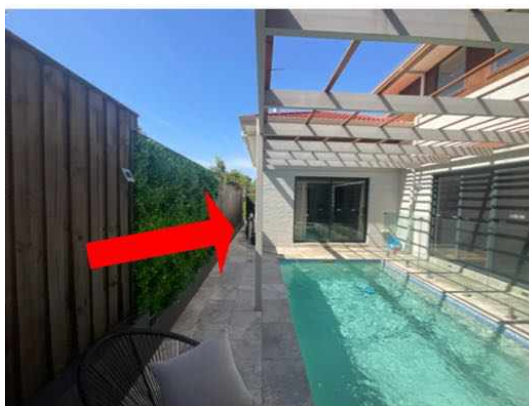
Building:	Main Building
Location:	Pool Area
Finding:	Pool Safety Fence / Gate (Non-Compliant) - Missing
Information:	Location: Side access adjacent to swimming pool

A required pool safety fence and/or self-closing, self-latching gate is missing to the side access path adjacent to the swimming pool. The pool area is therefore not effectively enclosed, allowing direct and uncontrolled access to the pool.

- Absence of a compliant pool safety fence and gate to fully isolate the swimming pool.
- Failure to provide a continuous, child-resistant barrier with controlled access only through a compliant gate.
- Pool access not restricted in accordance with AS 1926.1 Clause 2.1 & 2.2.

This condition presents a serious safety hazard, particularly to young children, due to unrestricted access to the swimming pool.

Install a compliant pool safety fence and self-closing, self-latching gate in accordance with NCC 2022 and AS 1926.1–2012. All works should be carried out by a suitably licensed contractor, and certification by an accredited pool safety inspector is strongly recommended upon completion.

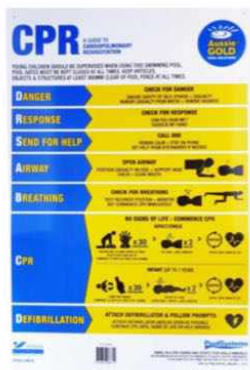
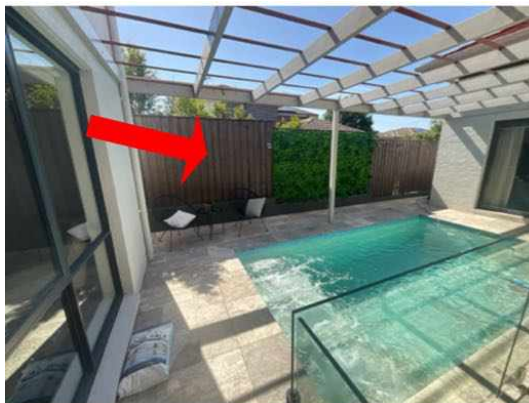
Finding 1.02

Building:	Main Building
Location:	Pool Area
Finding:	Pool Resuscitation sign - missing
Information:	The pool was not provided with a resuscitation sign. Swimming pools are required to be provided with a compliant resuscitation sign.

The resuscitation sign must be located in a position visible from within the pool enclosure and the sign must be in good condition and legible from a distance of three (3) metres.

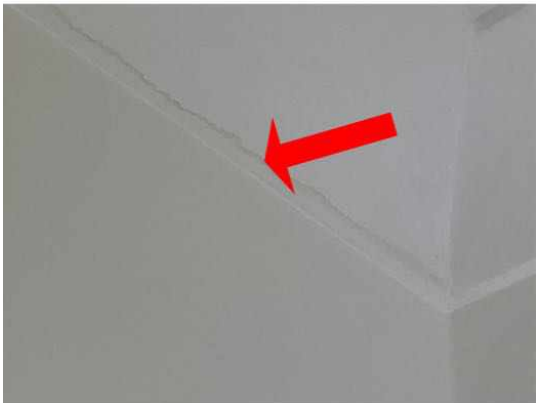
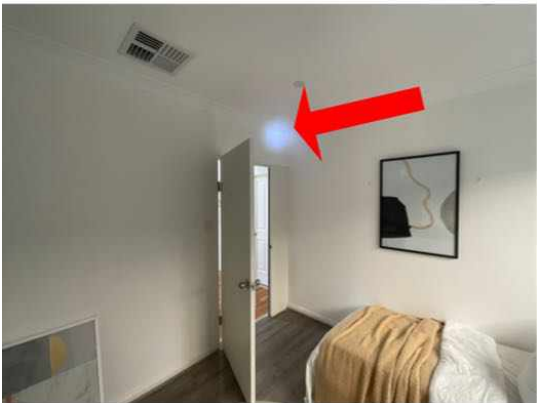
Finding 2.01

Building:	Main Building
Location:	Bedroom > Ground Level
Finding:	Water Staining to Ceiling – Downstairs Bedroom
Information:	Water staining and discolouration were observed to the ceiling lining of the downstairs bedroom. This condition is indicative of moisture penetration and suggests a current or previous water leak above the affected area.

Based on the location, the source of moisture is suspected to be associated with the bathroom or wet area located above, which may include plumbing leaks, failed waterproofing, or deteriorated seals. The extent of damage behind the ceiling lining could not be determined at the time of inspection.

If not addressed, ongoing moisture ingress may result in deterioration of ceiling linings, mould growth, potential timber damage, and further internal damage.

The client is advised to confirm with the Vendor whether the source of the leak has been properly identified and rectified. A licensed plumber and/or waterproofer should be engaged to investigate, identify the source of moisture, and carry out necessary rectification works. Damaged materials should be repaired or replaced after the leak is resolved.

Invasive inspection is highly recommended to confirm the cause, extent of damage, and adequacy of any prior repairs.

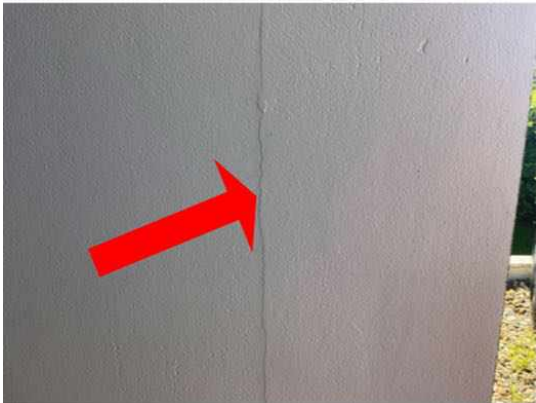
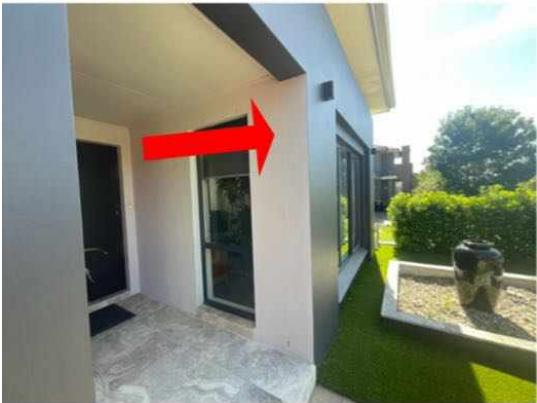
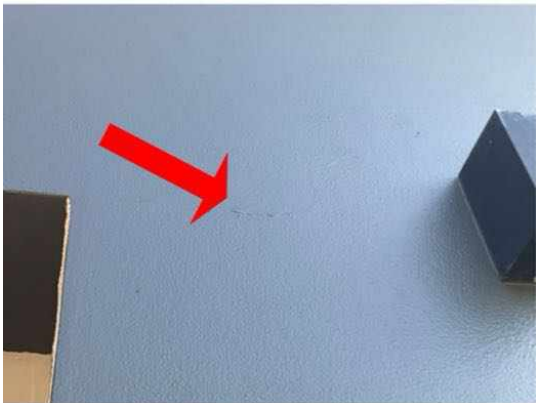
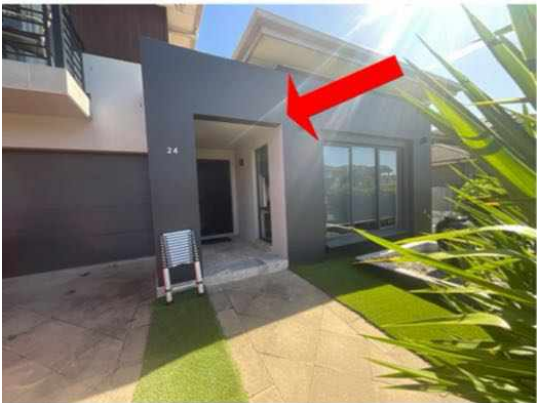
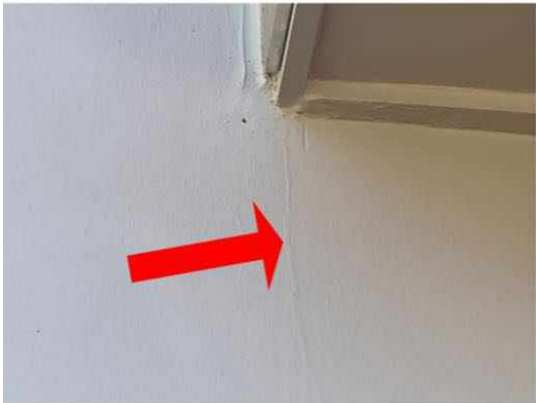
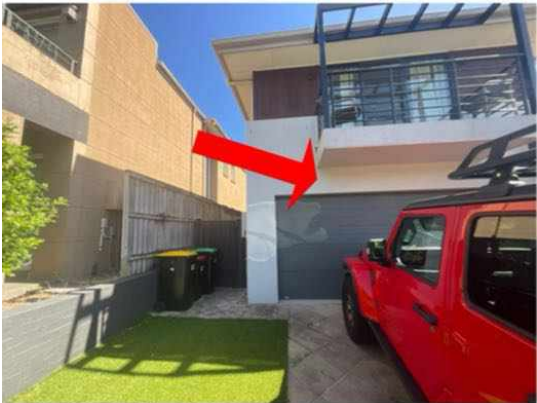
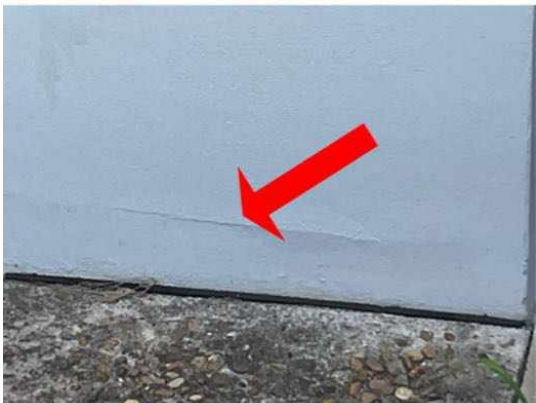
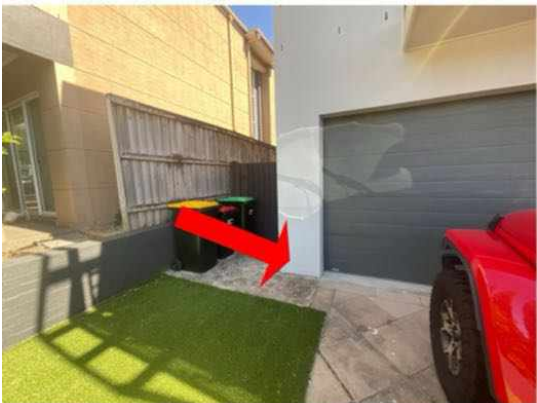
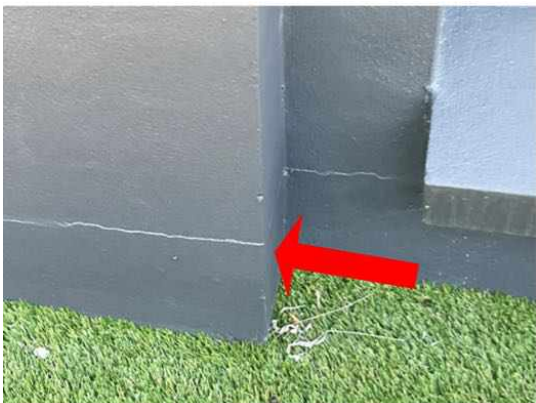
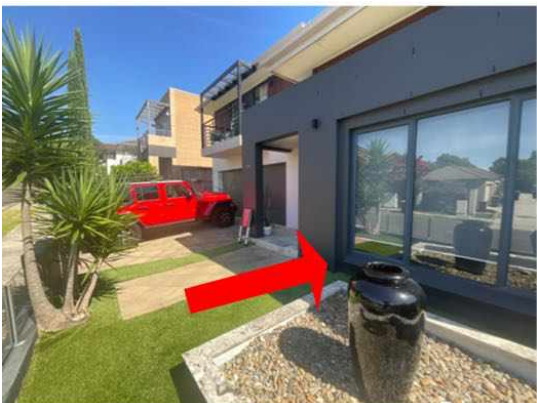
Finding 3.01

Building: Main Building
Location: Exterior walls
Finding: Cracks to external render - Category 1
Information: It has been observed that cracking to internal rendered surfaces has occurred. The degree of damage falls within Category 1, described as fine cracks that do not need repair and which are less than 1.0mm in width limit.

Damage of this category is not considered a defect for rectification. Always contact your building inspector should cracks widen, lengthen, or become more numerous.

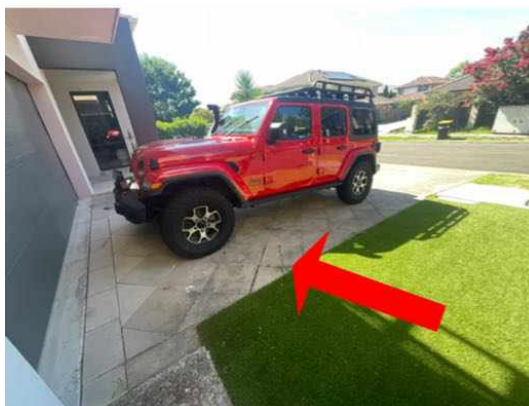
Finding 3.02

Building:	Main Building
Location:	All External Areas
Finding:	Damaged paving
Information:	At the time of inspection, damaged or broken paving were identified. Where this is due to the contractor workmanship or damage occurring during construction it is considered a defect. While being an appearance defect, such damage is expected during construction of a property. A relevant tradesperson should be appointed to perform these rectification works at discretion of the client.

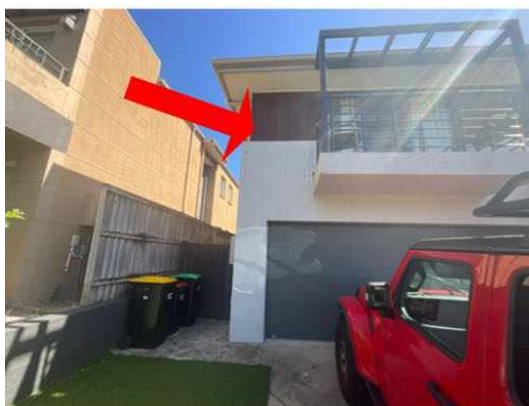
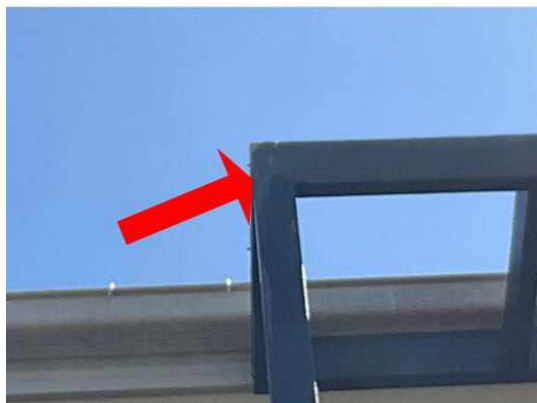
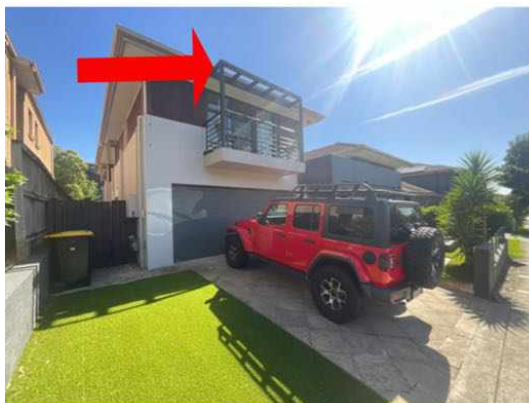
Finding 3.03

Building:	Main Building
Location:	All External Areas
Finding:	External painting deteriorated.
Information:	Much of the external paintwork including but not limited to windows, fascias, guttering, veranda and other external fitments have been neglected and require attention to prepare and re-paint.

Whilst incomplete or missing paint finish is generally an appearance defect, it can also lead to the development of secondary building defects over time. Incomplete areas of paint finish expose the area to moisture, potentially accelerating the deterioration of underlying building materials.

Degraded paint finishes should be sanded back, filled, leveled and painted, as applicable. Where inadequate or missing paint protection has led to the deterioration of the associated building element, repair and/or replacement of this building element may be required.

A painting contractor should be appointed as soon as possible to perform necessary works to aid the appearance of the affected area and to ensure the area is protected against further deterioration. Alternatively, the homeowner following manufacturer instructions may perform these works.

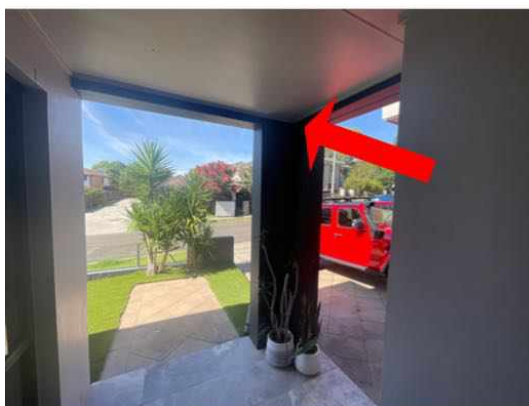
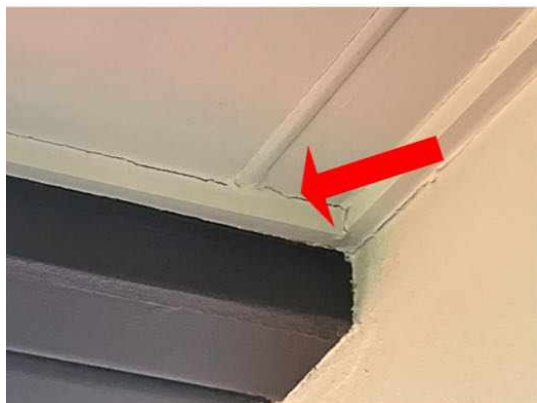
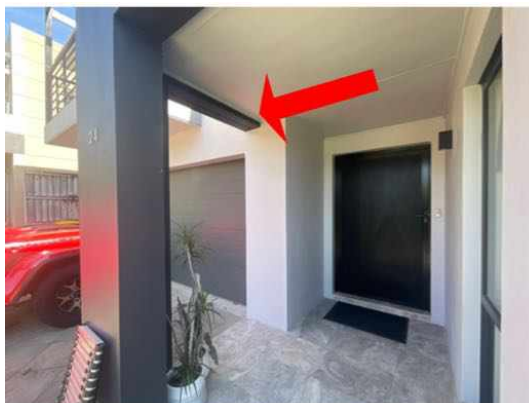
Finding 3.04

Building:	Main Building
Location:	All External Areas
Finding:	Beads - damage
Information:	Where beading (also known as 'quad') are damaged from the eaves It was noted at the time of inspection that beading in this area has deteriorated. Beading is important in weatherproofing the surrounding building elements and preventing termite or pest ingress. Furthermore, beading works to protect the joints of building materials, which are more susceptible to deterioration and decay. Repair or replacement of the beading is advised to ensure the protection and longevity of any associated building elements. Such works may be performed by a general handyperson or qualified carpenter.

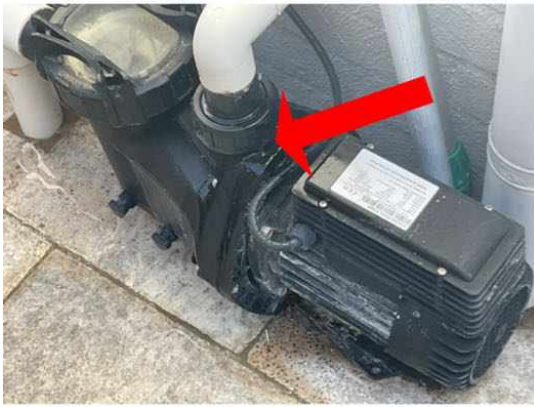
Finding 3.05

Building:	Main Building
Location:	Pool Area
Finding:	Swimming pool circulation pump - leaking
Information:	Water leakage was observed at the swimming pool circulation pump, including around the pump housing and pipe connections.

Ongoing leakage may lead to pump failure, electrical hazards, water loss, and deterioration of surrounding surfaces.

A licensed pool technician or plumber should inspect, repair or replace the leaking pump and associated fittings as required. Any electrical components affected by moisture should also be checked by a licensed electrician.

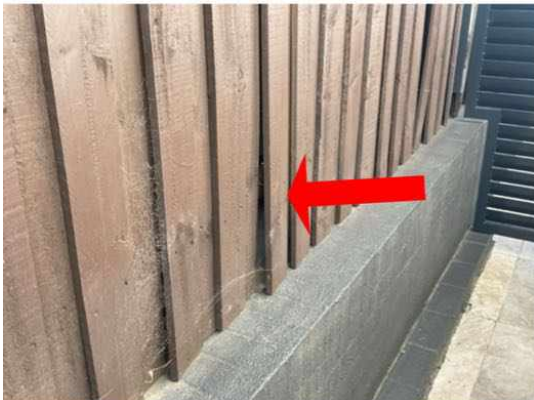
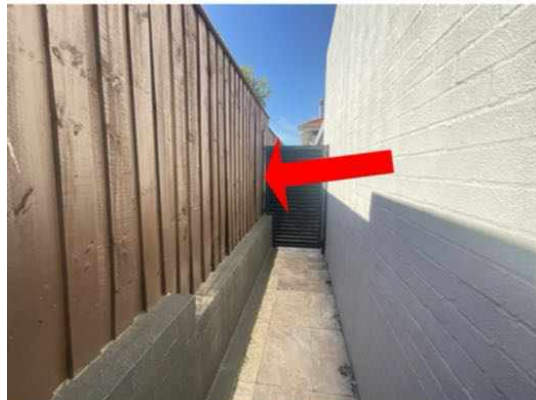
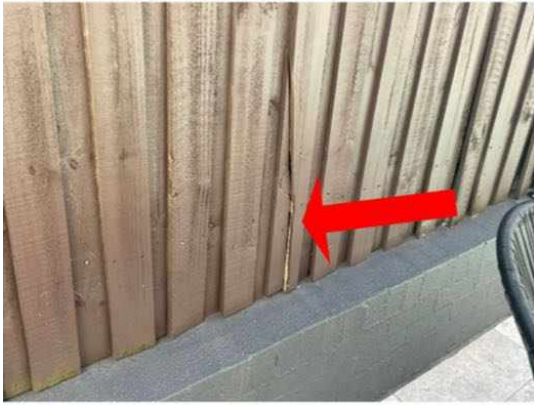
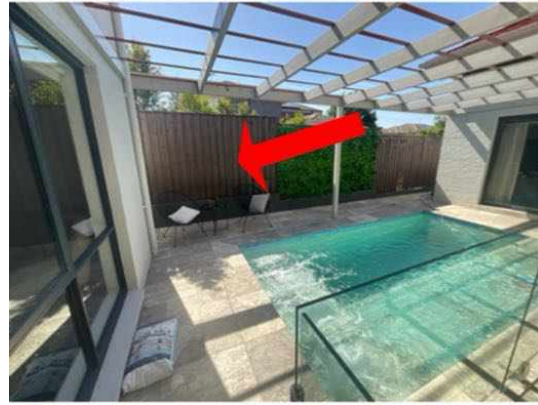
Finding 3.06

Finding: Fencing - Deteriorated

Information: It was noted at the time of inspection that sections of the fencing throughout the property have deteriorated. Typically fencing deteriorates due to age and or wear and or rust which is generally expected for a structure of this age, due to prolonged exposure to weather conditions. Sometimes inadequate installation or maintenance can be to blame.

If left unattended, it is likely that further damage will occur. It is suspected that repair of several elements of the fencing may be required however replacement may be a consideration of the client also.

A licensed fencing contractor should be appointed to provide further advice and perform rectification works as necessary.

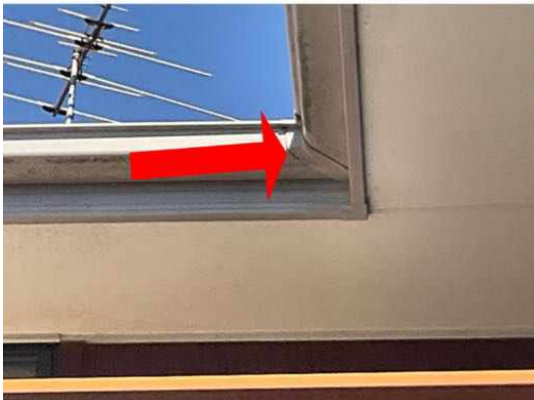
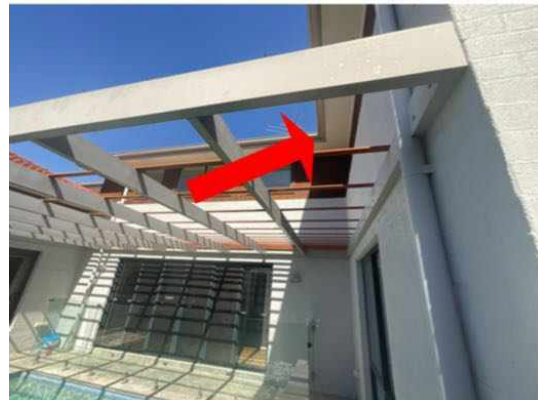
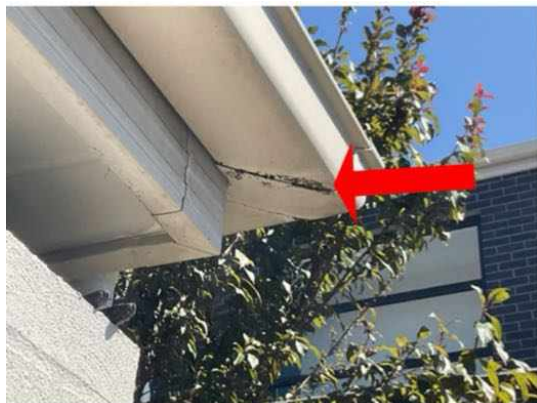
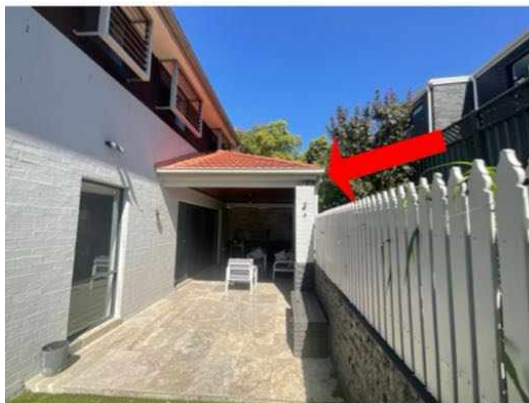
Finding 3.07

Finding: Water Leak - Gutters

Information: Water leaks were found to be present to exterior plumbing work. Leaks are generally caused by deterioration of the plumbing elements over time, due to exposure to weather conditions, but may have also been caused by minor impact damage.

Such leaking creates damp conditions in the affected area, causing potential for water pooling and subsequent water damage if left unattended. These conditions may also attract termite attack, particularly if the area is subject to minimal levels of sun throughout daylight hours.

It is highly advised that a licensed plumber be appointed to rectify any water leaks that may be present. Areas of repair and replacement of plumbing fittings and fixtures may be required and, as such, a quotation should be sought.

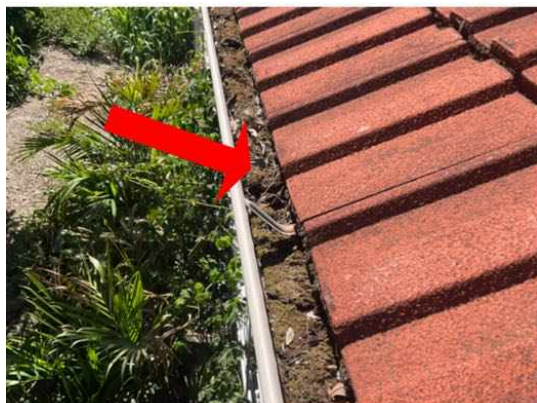
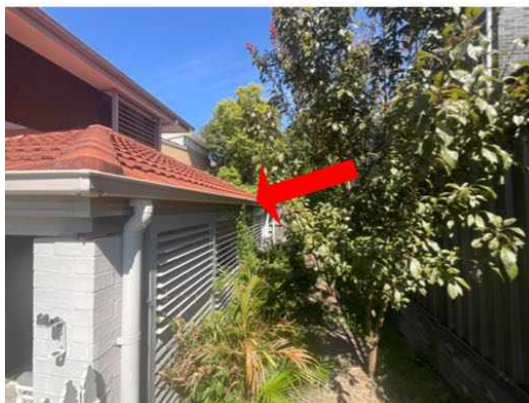
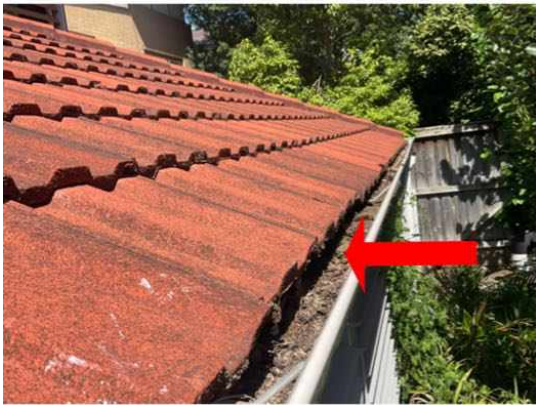
Finding 3.08

Blocked gutters are likely to lead to high levels of moisture in the affected areas. Such moisture will not only cause rust and decay of the associated building materials, but can also provide conditions that are conducive to termite and timber pest activity. Blockages in gutters should therefore be removed immediately to ensure dry conditions are maintained.

Consult a Licensed Plumber for further specific advice on remedial works that may be required. In the interim, it is highly advised that blocked gutters be removed by the homeowner or a general handyperson as a matter of urgency.

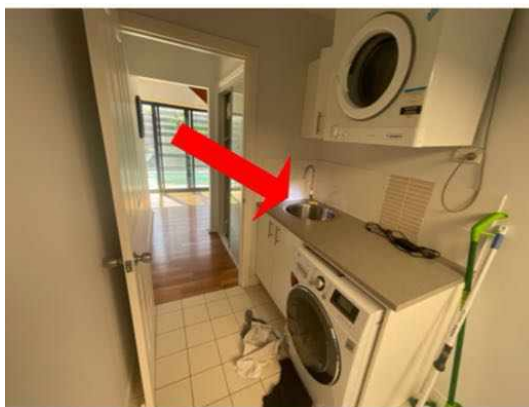
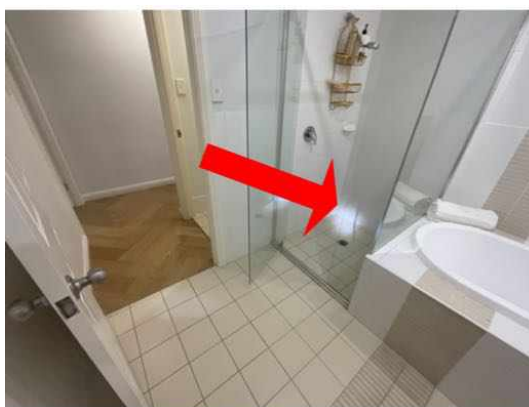
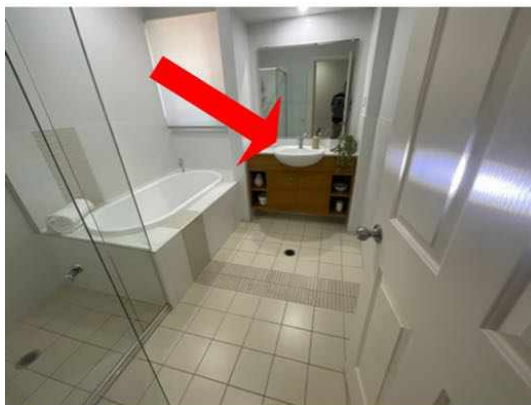
Building:	Main Building
Location:	Bathrooms
Finding:	Sealant and grouting - Missing or damaged
Information:	It was noted on inspection that sealant or grout is degraded to the tiled shower alcove and or other areas of the bathroom.

Different materials and floor areas move at different rates, generally causing cracking to grout or sealant at this point. A flexible sealant is required to allow for expected expansion and contraction, while keeping the joint water tight and protective of all associated building materials.

There appears to be excessive mould to the sealant and grout which will likely require scraping out and replacement.

Flexible and mould resistant materials should be applied to affected areas to prevent any subsequent water damage that is likely to occur. Regular maintenance and replacement of damage or missing or damaged sealant and grout is highly recommended to the wet areas, as this is a regular wear and tear defect. Sealant and grouting in areas that come into regular contact with water should be maintained for the long term care of your property.

A sealant specialist or tiling contractor should be appointed to complete these works as soon as possible

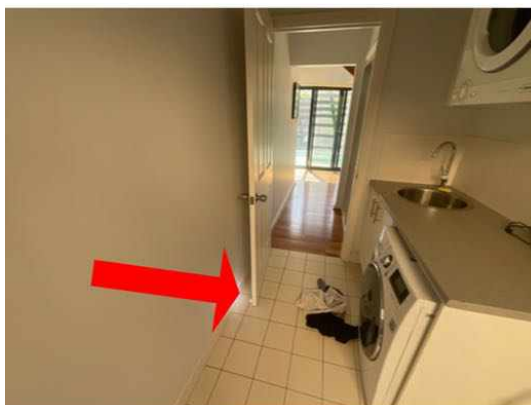
Finding 3.11

Building:	Main Building
Location:	All Internal Areas
Finding:	Door stop - Missing
Information:	The door stop is missing or is inadequate to stop the door handle from damaging the wall. Although some building elements may seem irrelevant or unnecessary, all building elements play a key role in the operation and function of the overall structure and its performance.

Re-installation or replacement of the door stop is advised as soon as possible to prevent any subsequent damage to the door or associated structures. A general handyman may be appointed to perform these works at client discretion.

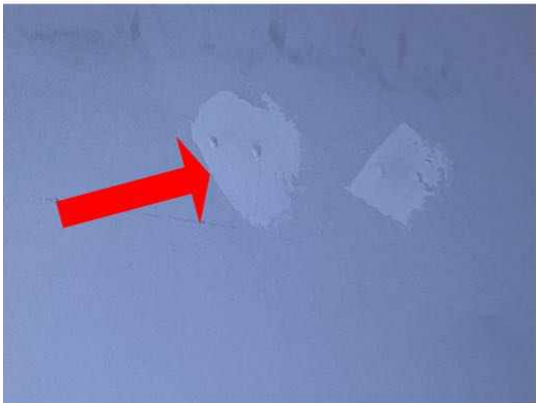
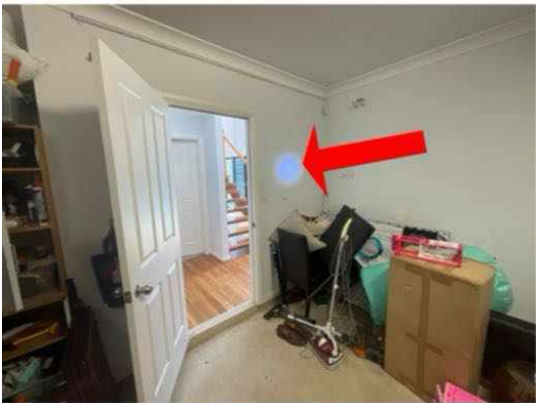
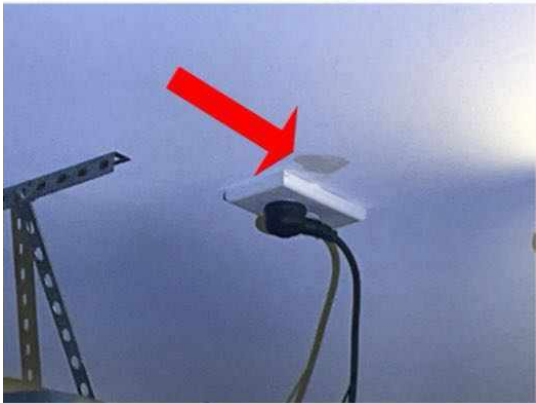
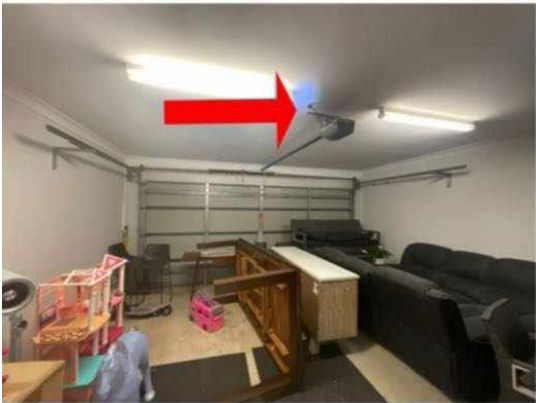
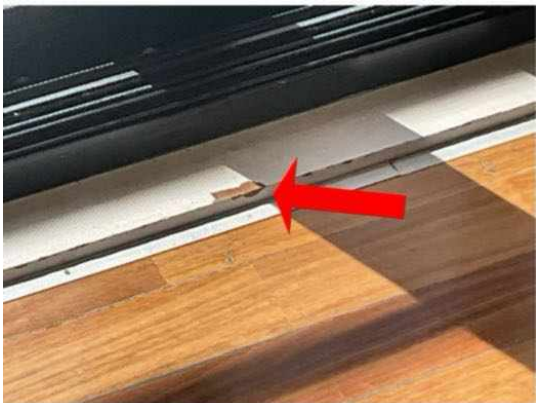
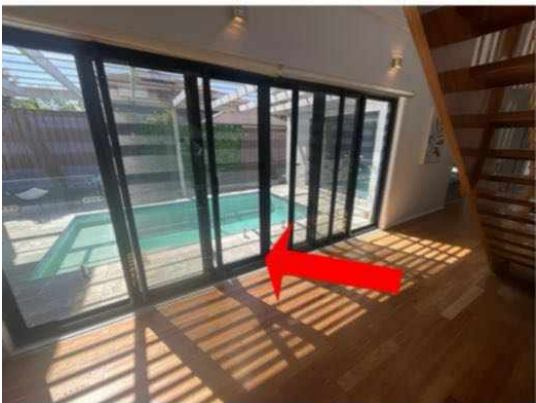
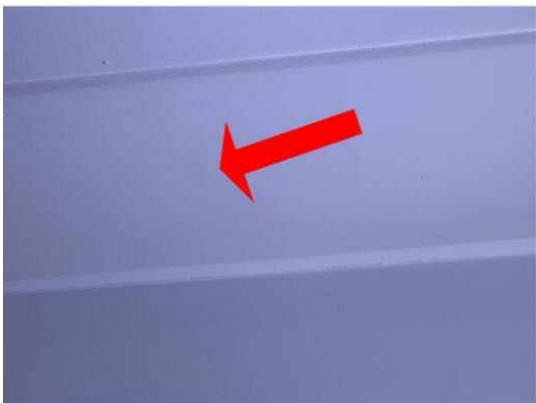
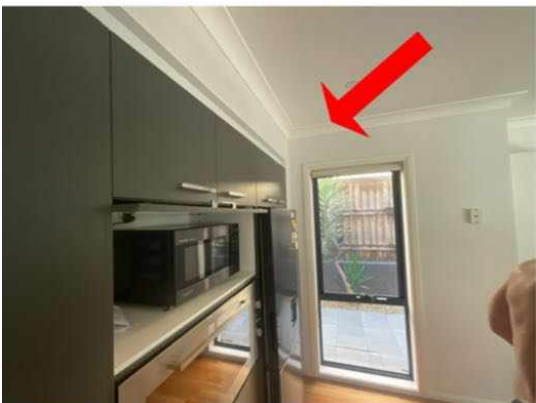
Finding 3.12

Building:	Main Building
Location:	All Internal Areas
Finding:	Paint finish - Substandard, Wear and Tear
Information:	The paint finish in this area was found to have been completed to a substandard level or wear and tear as the normal deterioration of a property from ordinary, everyday use. Exposure to the elements, time, as well as day to day living can cause fair wear and tear.

If this applies, further areas of poor and incomplete finishes could develop over time. Furthermore, substandard, wear and tear paint finishes in areas exposed to moisture, e.g. external areas or wet areas, could lead to deterioration of underlying building materials.

Substandard, wear and tear paint finishes should be sanded back, filled, leveled and repainted, as applicable. Where inadequate paint protection has led to the deterioration of the associated building element, repair and/or replacement of this building element may be required.

A painting contractor should be appointed as soon as possible to perform necessary works to aid the appearance of the affected area and to ensure that the area is protected against further deterioration. Alternatively, the homeowner following manufacturer instructions may be able to provide this service.

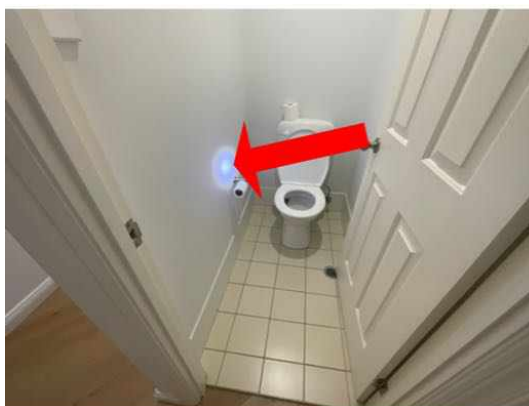
Finding 3.13

Building:	Main Building
Location:	All Internal Areas
Finding:	Cracking - Damage Category 1 - Fine (up to 1mm)
Information:	Although fine cracks are quite noticeable, they are often only considered to be an appearance defect, and usually do not indicate any structural damage. Generally, the cause of a fine crack is indicative of a separation between building materials and finishes (e.g. paint, plaster, etc.) along joins.

Cracking of this nature can generally be repaired with minor sanding, filling and/or repainting. Such works should be performed by a qualified painter or a general handyman.

Monitoring of all cracking should be conducted frequently. Always contact a building inspector should cracks widen, lengthen, or become more numerous.

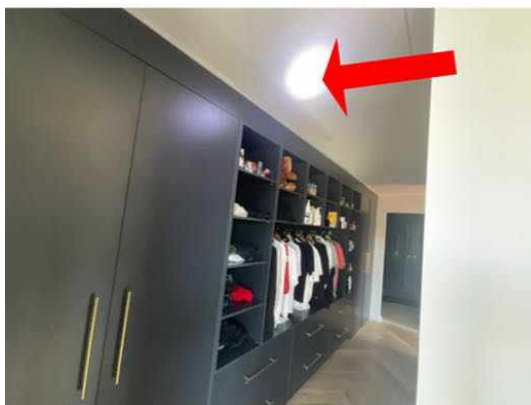
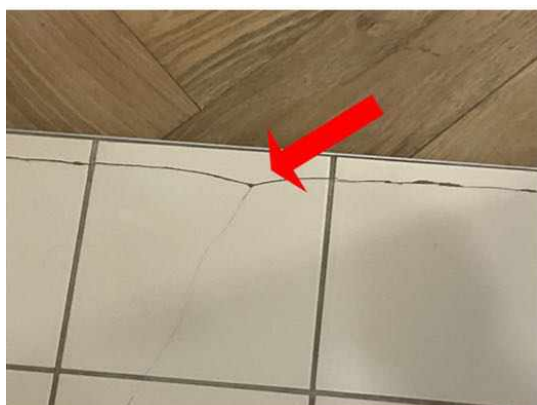
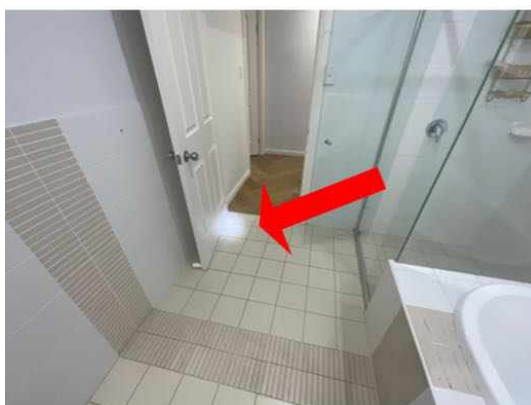
Finding 3.16

Building: Main Building
 Location: Bathroom > Upstairs
 Finding: Tiles - Cracked or damaged
 Information: Cracking was evident to the tiling in this area at the time of inspection. While the cracking appears to be minor, this area is frequently exposed to water, allowing potential for water penetration into adjoining sections of walls or flooring.

If left unmanaged, water penetration to these areas may lead to subsequent water damage, which is likely necessitate repair work to affected building elements.

A tiling contractor should be appointed to ensure that no further water damage occurs. The re-application of silicone and grouting throughout remaining tile work is also advised, to further protect the area against water penetration.

Where water penetration has led to water damage, appointment of a relevant tradesperson may be required to repair damaged building elements.

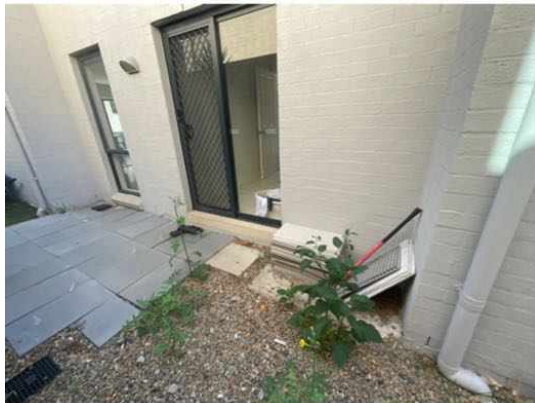
Finding 6.01

Building: Main Building
Location: All Areas
Finding: Garden Beds - Conditions Conducive to Termites
Information: Garden beds were found to be evident in the garden area. These garden beds can include untreated timber, and with a combination of moisture from watering hosing can make conditions conducive to termite activity and termite ingress.

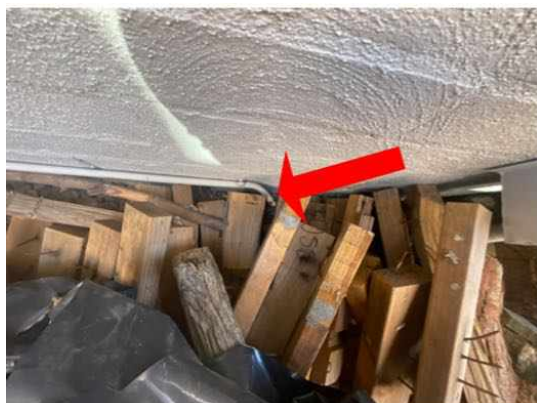
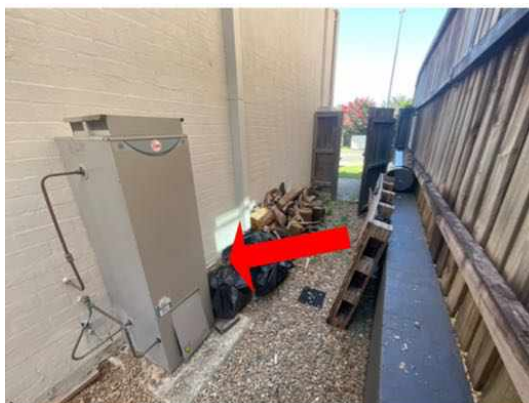
Finding 6.02

Building: Main Building
Location: All Areas

Finding: HWS Overflow - Not Connected
 Information: The Hot Water System (HWS) overflow was found to be disconnected from storm water drainage and is creating excessive moisture in the surrounding area.

These damp conditions can lead to secondary defects such as rot, rust or corrosion of associated building elements, the formation of fungal decay, or even the creation of potential slip hazards. When coupled with poor site drainage, pooling of water may also attract termite activity to this area.

It is highly recommended that a licensed plumber be appointed to connect the HWS overflow in order to prevent such an environment from being created. These minor works should be carried out as soon as possible.

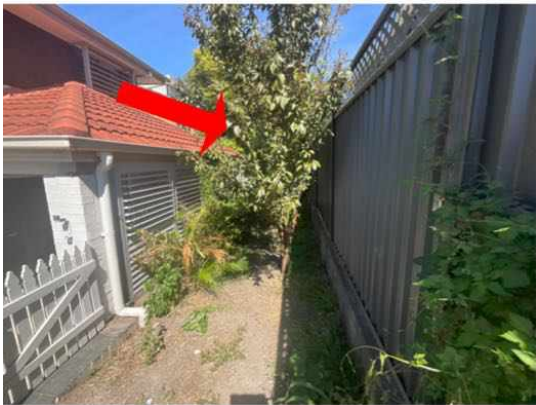
Finding 6.03

Building: Main Building
 Location: All Areas
 Finding: Trees - Overhanging and filling gutters
 Information: Overhanging trees often result in excessive amounts of leaf debris accumulating in gutters.

Gutters are a critical part of the building's management of storm water and rain. It is therefore important that they be kept clear to prevent secondary damage to associated building elements, including exterior and interior walls, ceiling linings and any adjoining building elements. Where gutters are blocked, pooling of rainwater is likely to occur, fast-tracking rust and corrosion of the roof plumbing elements.

It is highly advised that all overhanging tree branches be removed as soon as possible to prevent any further damage. Repair and/or replacement of sections of damaged guttering may also be required where the extent of the damage necessitates.

Such works should be performed by the homeowner; however, appointment of a landscape contractor or an arborist may be required. Consultation with a licensed roof plumber is required where guttering has been damaged.

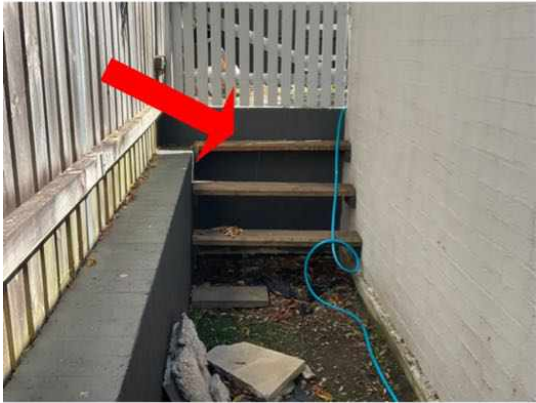
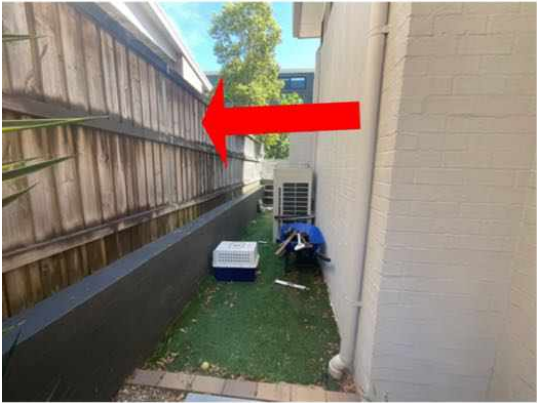
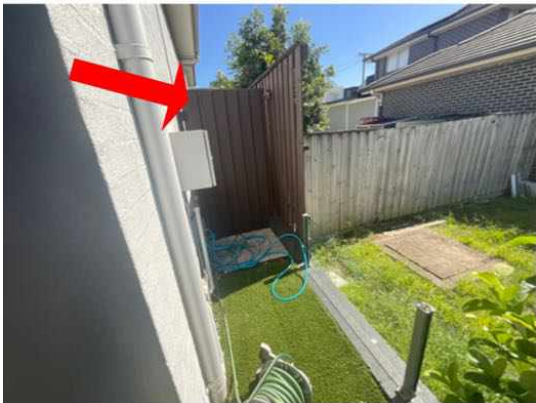
Finding 6.04

Building: Main Building
Location: All Areas
Finding: Timber - exposed to weather
Information: External timbers that are frequently exposed to harsh weather conditions require adequate protection in order to maintain their condition. Where timbers have not been painted or treated adequately, general deterioration is likely to occur at an accelerated rate.

If left unattended, replacement of these timbers is likely to be necessary in the short-term future. Adequate treatment of these timbers is required as soon as possible by a painting contractor or general handyman.

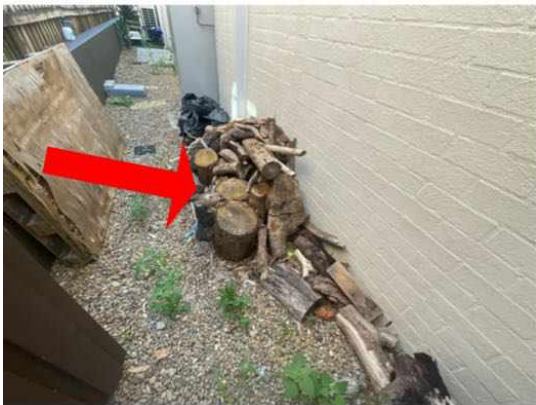
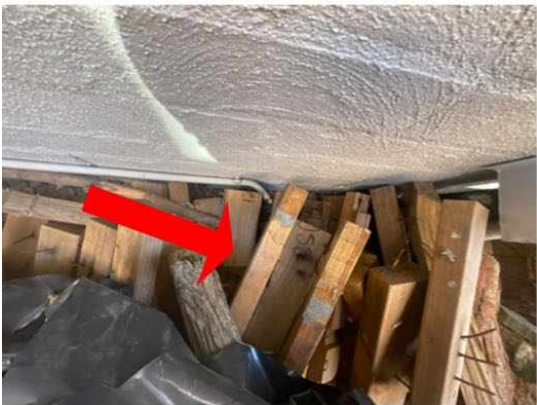
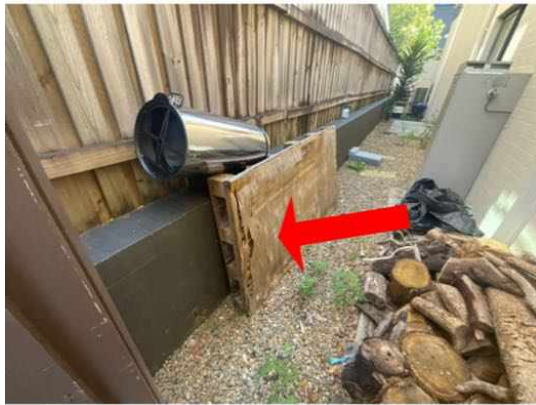
Finding 6.05

Building: Main Building
Location: All Areas
Finding: In ground contact
Information: Any timbers in direct ground contact provide opportunity for concealed termite entry and are likely to be subject to premature rot and decay as the soil retains moisture or damp conditions against the timbers.

Remove untreated timber that is in direct contact with external grounds. Consider replacement with more durable materials i.e. treated timber or non timber elements. Frequent pest inspections are advised to readily identify any termite activity in these areas.

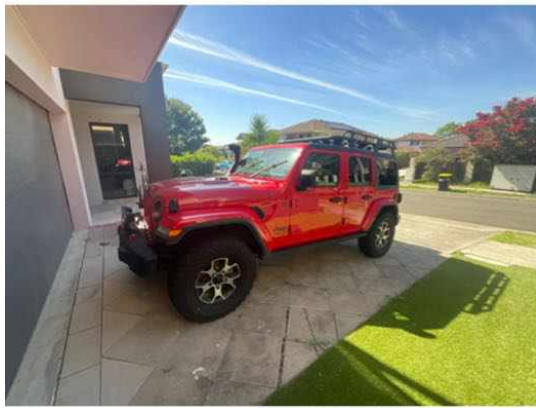
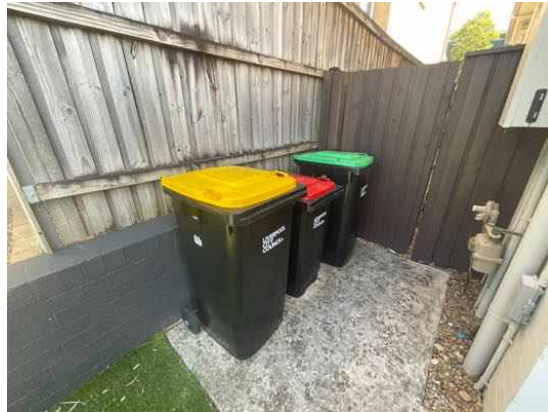
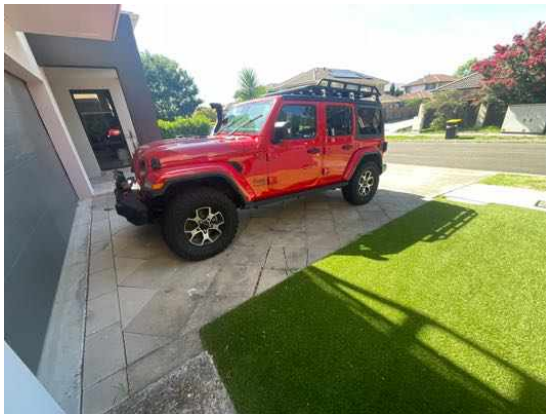
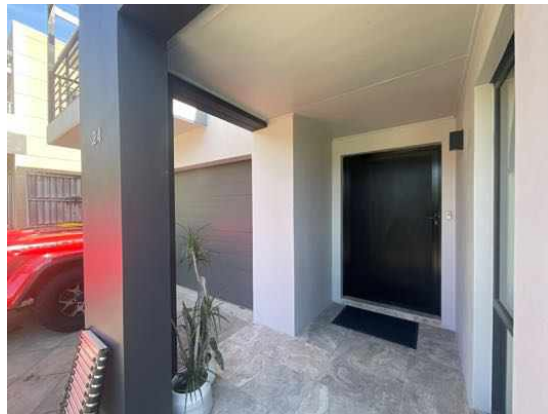
Noted Item

Building: Main Building
Location: All Areas
Finding: Additional Photos - Obstructions and Limitations
Information: These photographs are an indication of the obstructions and limitations which impeded full inspection of the property at the time of inspection. These obstructions can hide an array of defects and should be removed to allow full inspection to be carried out. A re-inspection is recommended once the areas are made accessible.
