Building and Timber Pest Inspection Report

Inspection Date: Thu, 5 Feb 2026

Property Address: 24 Travers St, Moorebank NSW 2170,
Australia

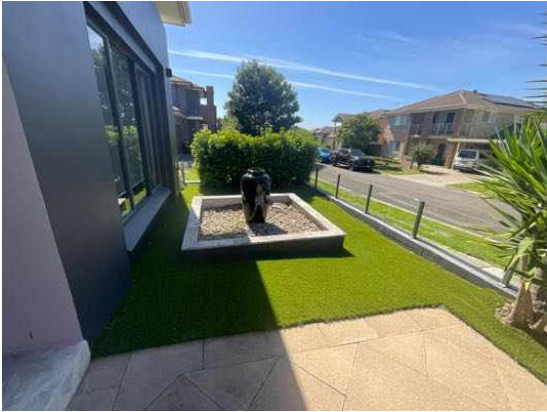
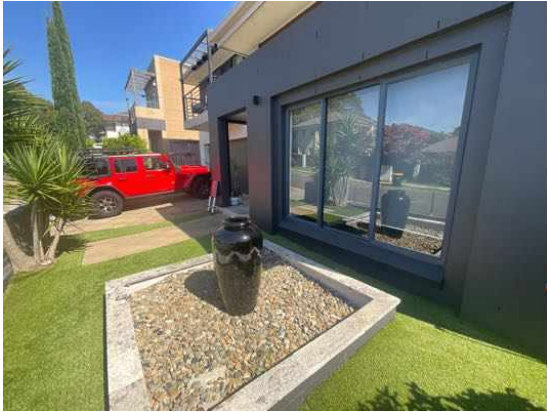
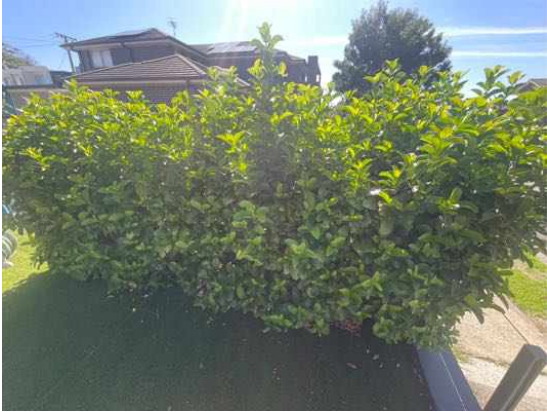
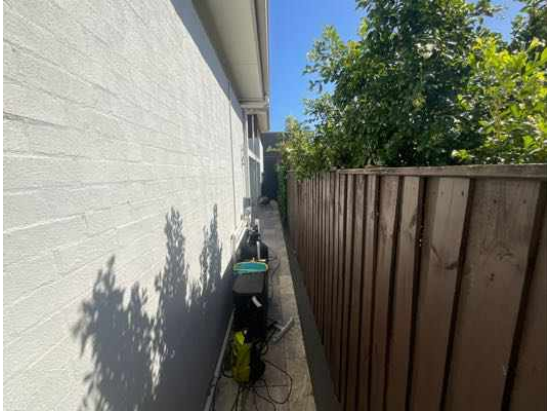
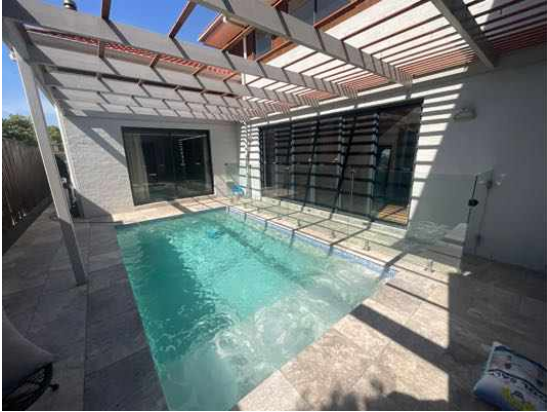
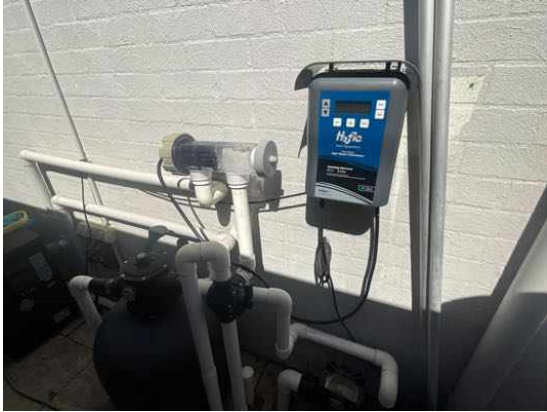
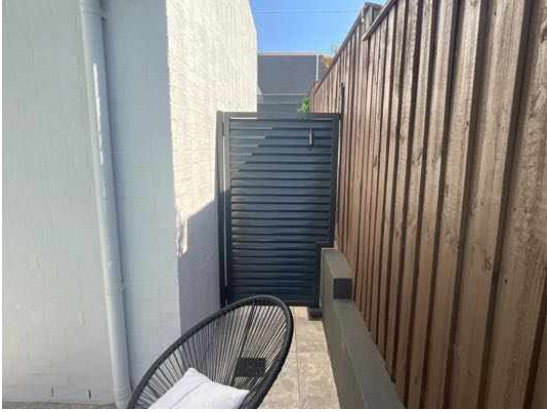
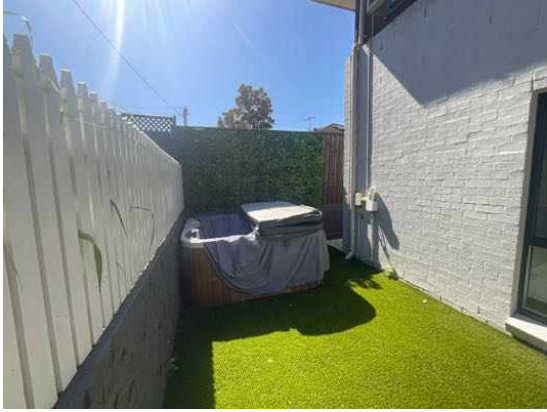
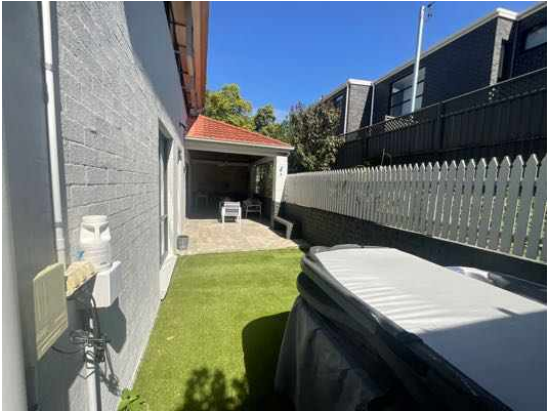
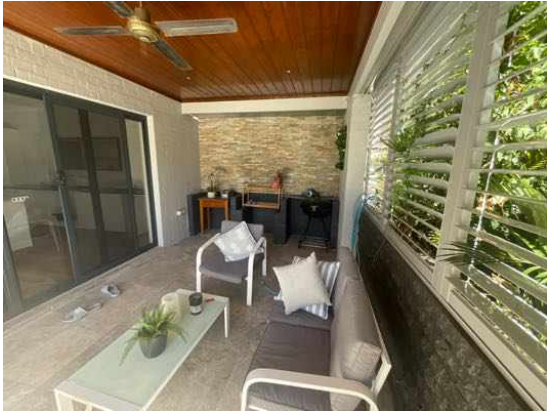
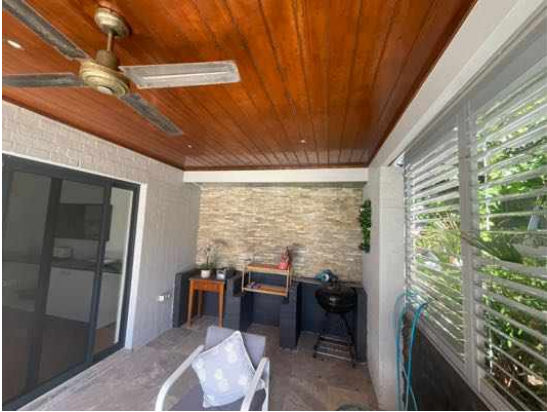
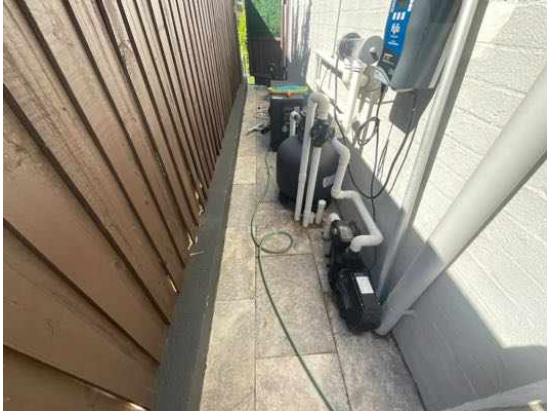
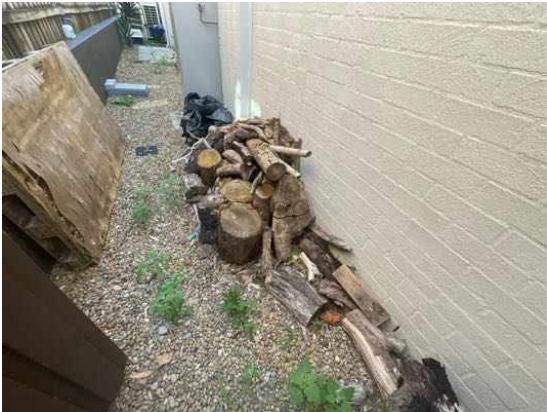
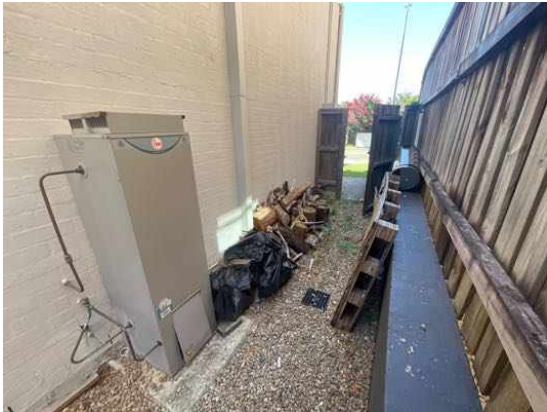
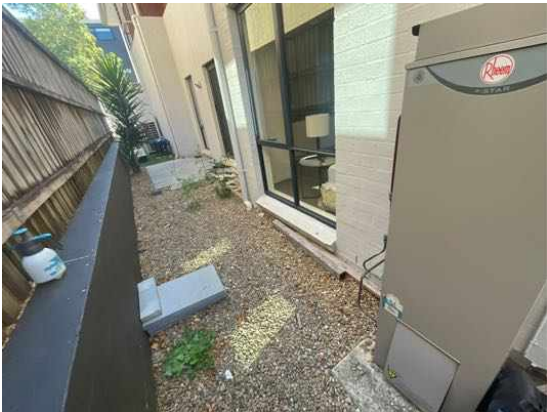
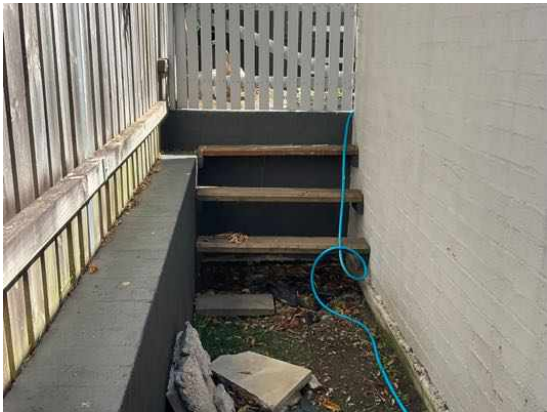
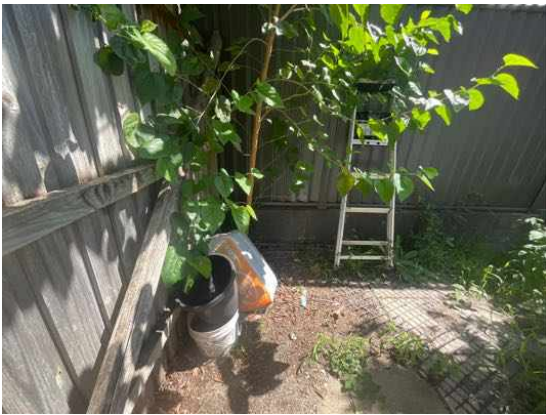
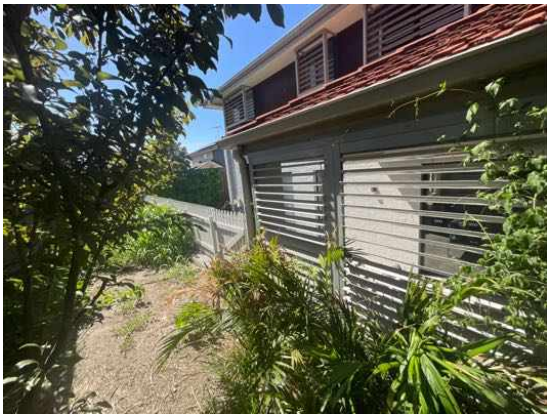
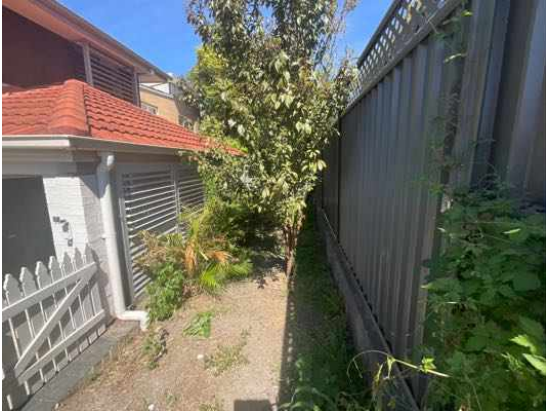
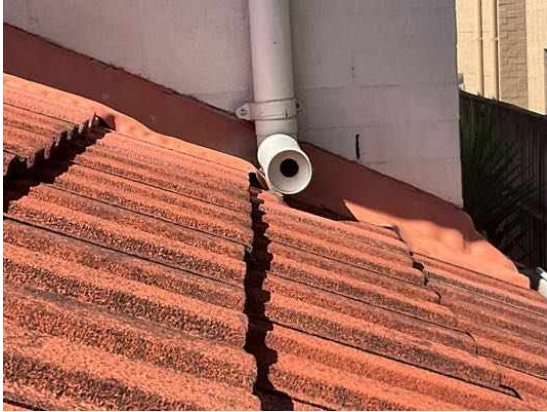
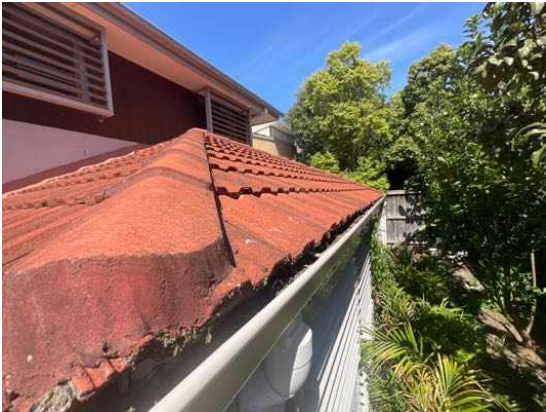
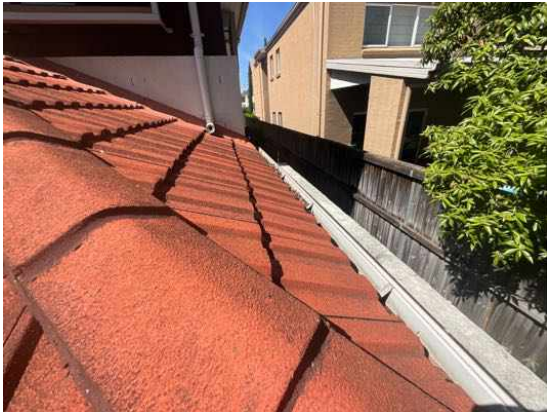
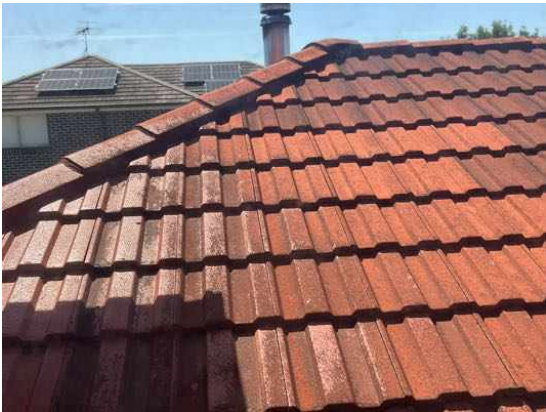
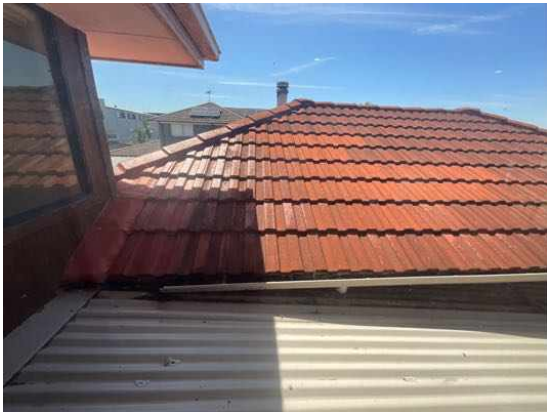
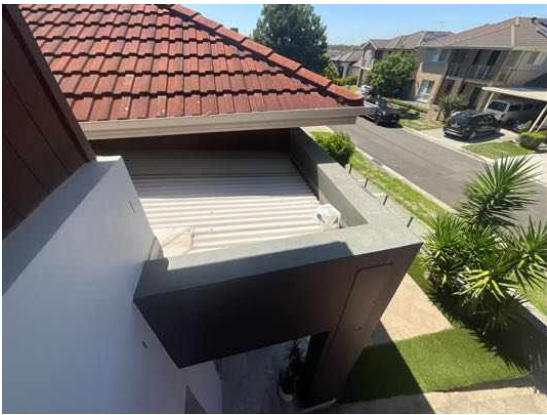
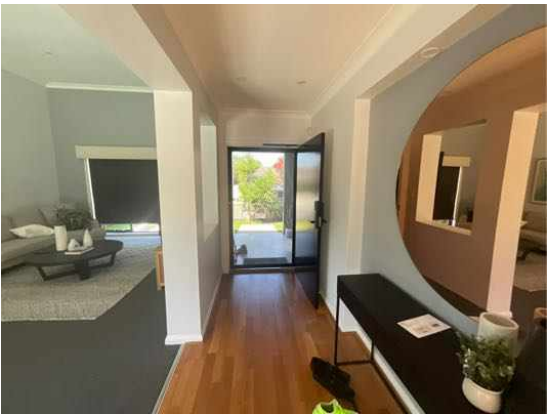
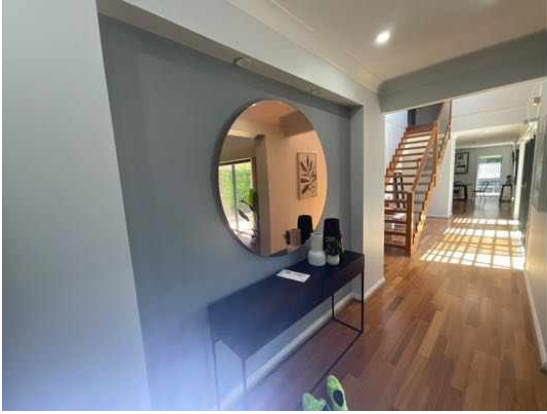
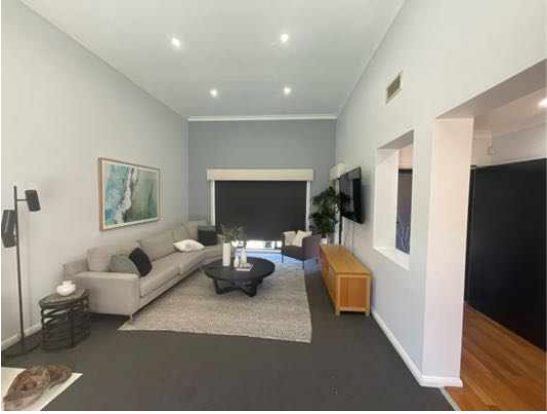
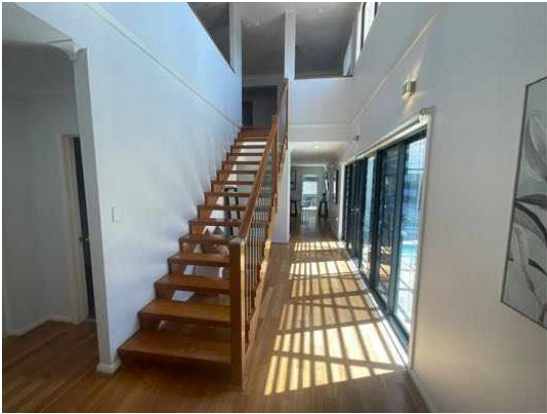
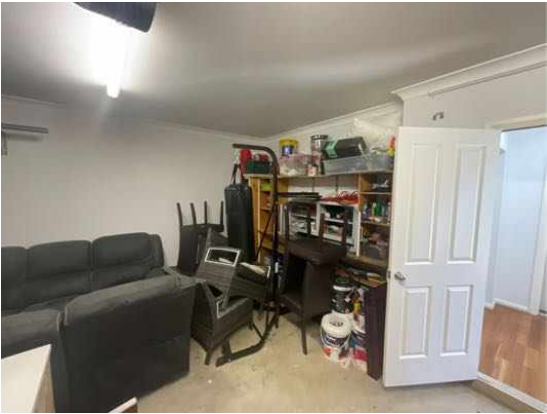
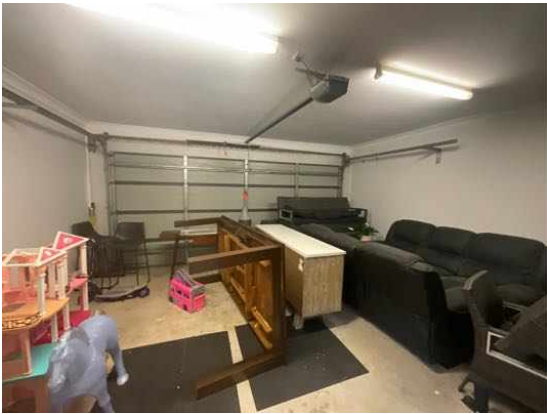
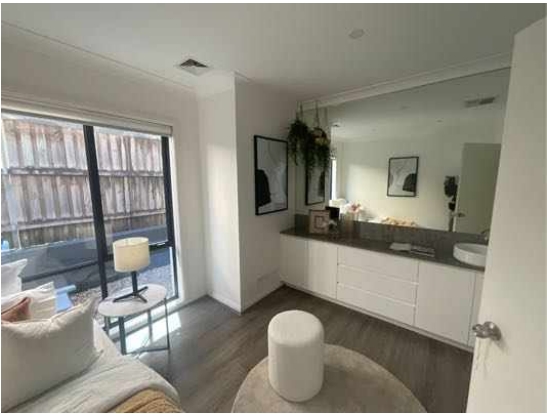
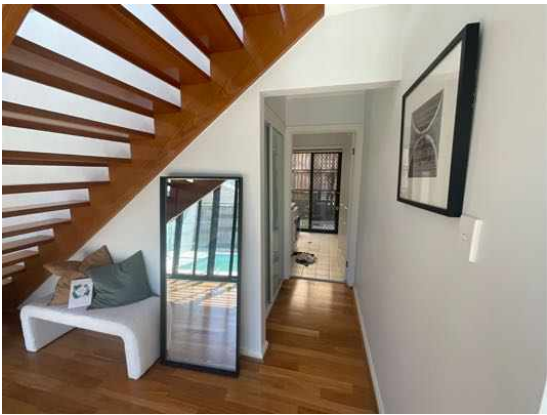
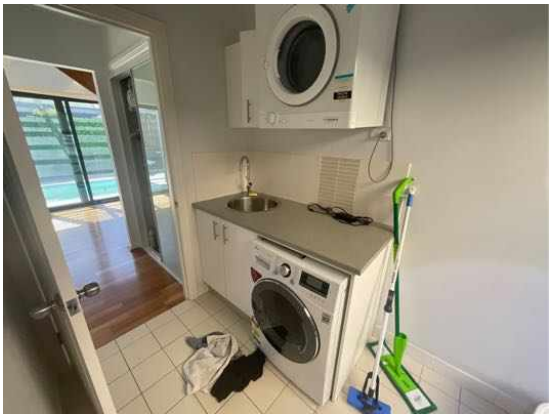
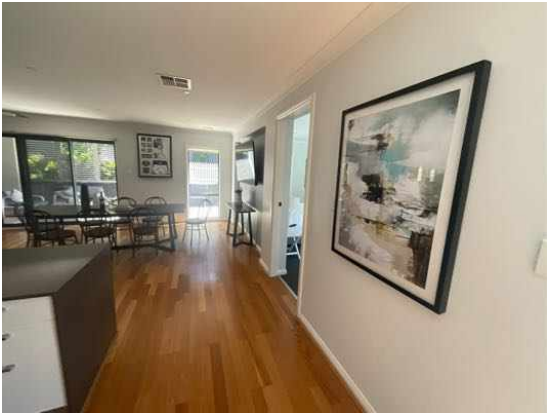
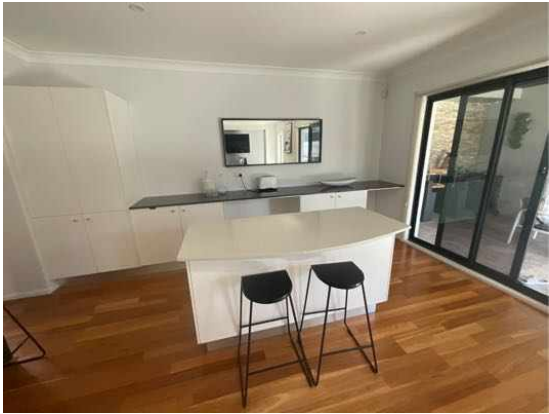
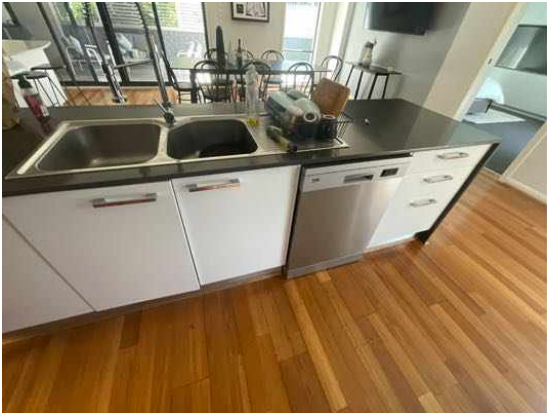
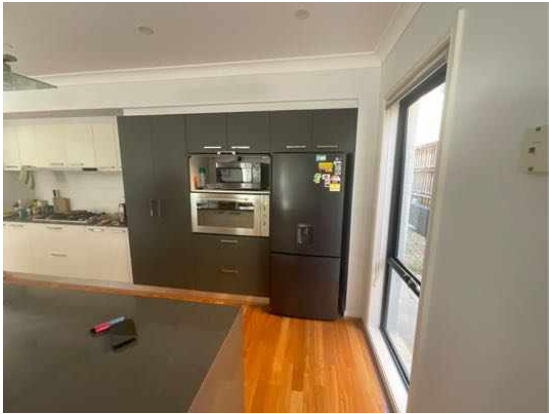
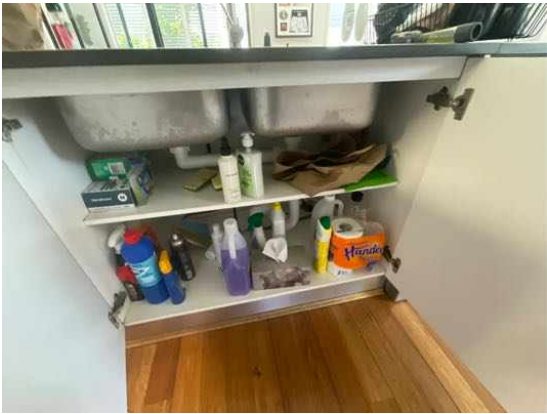
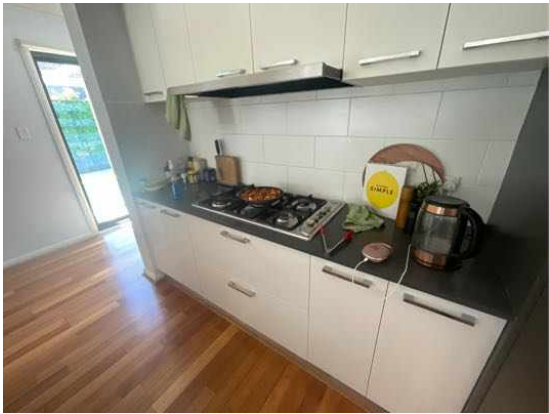
Building: Main Building
Location: All Areas
Finding: Additional Photos - Obstructions and Limitations
Information: These photographs are an indication of the obstructions and limitations which impeded full inspection of the property at the time of inspection. These obstructions can hide an array of defects and should be removed to allow full inspection to be carried out. A re-inspection is recommended once the areas are made accessible.

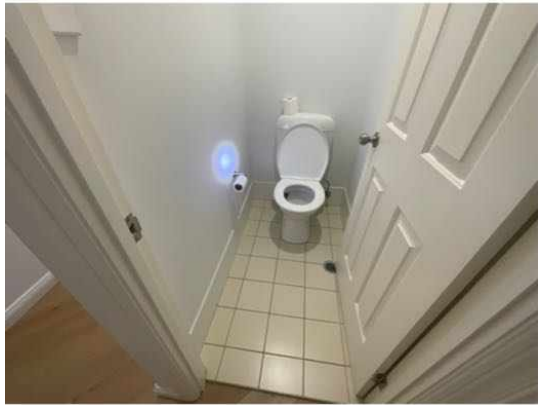
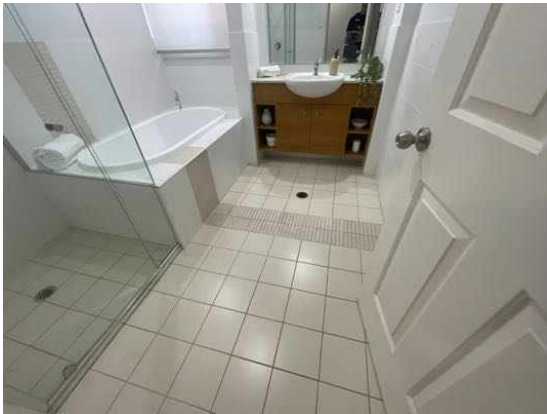
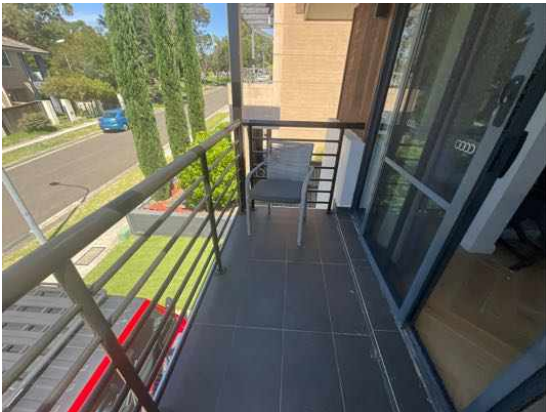
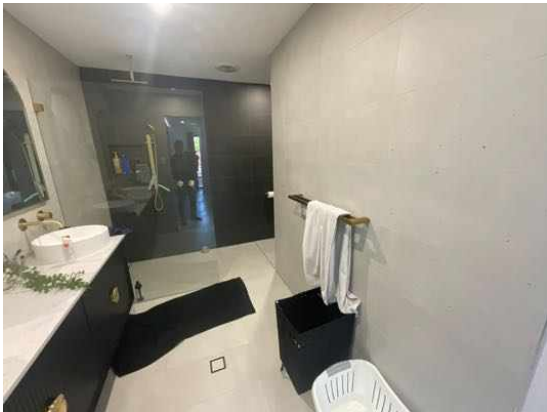
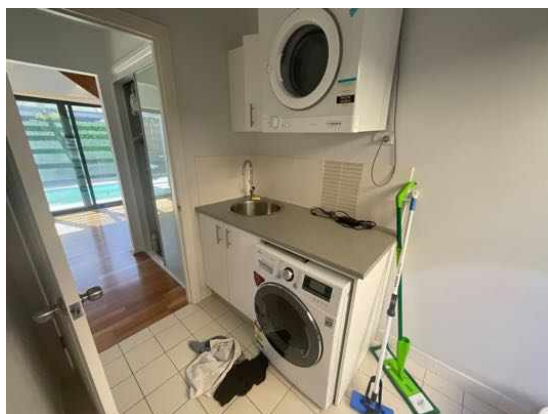
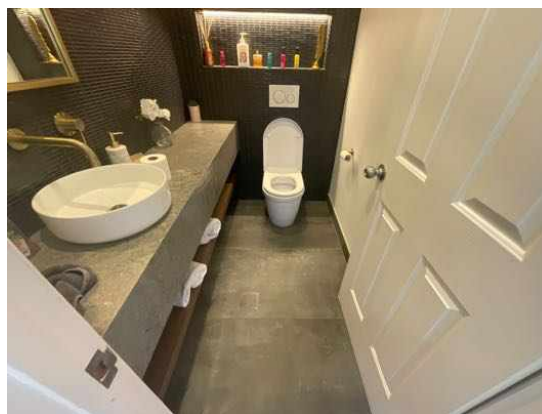
Building: Main Building
Location: All Areas
Finding: Water Proofing Membranes - Information Only
Information: Internal Water Proofing Membranes, are crucial in preventing water ingress into the property is important to know that the Membrane System used is to Australian Standards and has been installed correctly. Please refer to the original Building Documents or Maintenance Schedule for the relevant information including; - Membrane used and Manufacturers Specifications. - The Installer and Installation Certification. Especially with older property's where this information is unavailable, all wet areas should be monitored. Generally new waterproofing with a certificate may only have a guarantee of 8yrs. If any leaks, water staining, peeling or bubbling of the paint become evident to any adjacent walls or ceilings below a licensed builder or waterproofing specialist is recommended to investigate further.

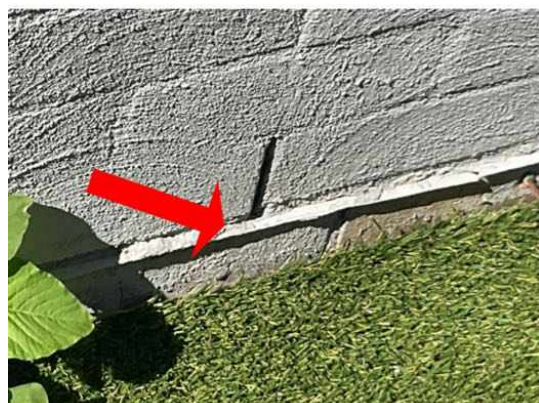
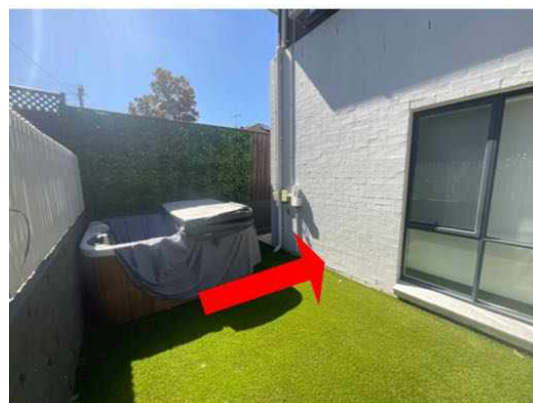
Building: Main Building
 Location: All Areas
 Finding: Evidence of a previous termite management system was identified
 Information: There are a number of factors which indicate the presence of a previously installed or applied termite barrier. The most common are a durable notice (to the inside of your meter box) observable physical barriers installed to building perimeter and in ground reticulation systems.

Where a Termite Management System has been identified you should refer to the type of barrier date of installation warranty conditions and any documentation provided by a builder or past owner. Consult the company who installed the barrier to confirm whether the system is still under warranty.

Most chemical termite management systems expire and require replenishment and all physical systems are primarily designed to prevent concealed entry.

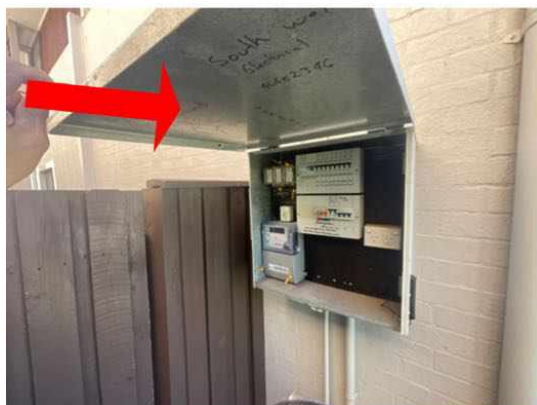
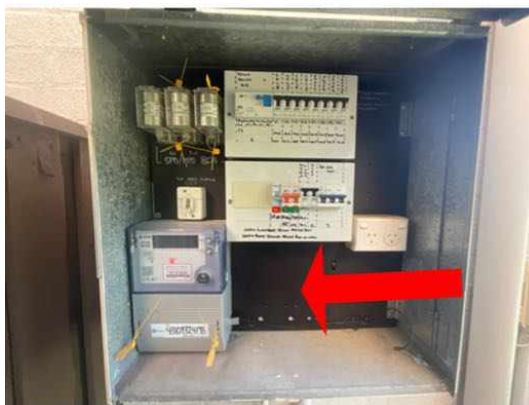
Building: Main Building
 Location: All Areas
 Finding: Durable Notice - missing

Information: The house should have a Durable Notice, which is usually a sticker inside your electrical meter box. Durable notice was not found during the inspection.

- the product or system used to protect the house,
 - the life expectancy of that product or system as per the manufactures register label
 - the company's name and date of Installation.
- If there is no durable notice or certificate, the best thing would be to get a reputable Pest Management contractor to install system that is protecting your property.

Make sure they explain the system that is protecting your home, and what you need to do to maintain it.
