# Building and Timber Pest Inspection Report

Inspection Date: Sat, 7 Feb 2026

Property Address: 13 Morton St, Parramatta NSW 2150,  
Australia

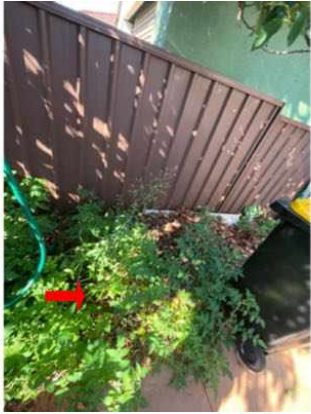
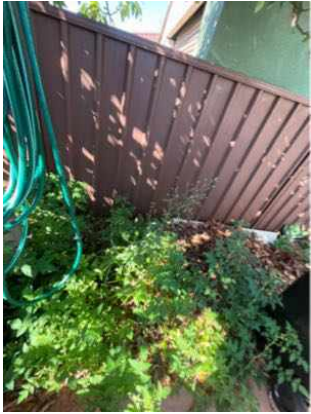
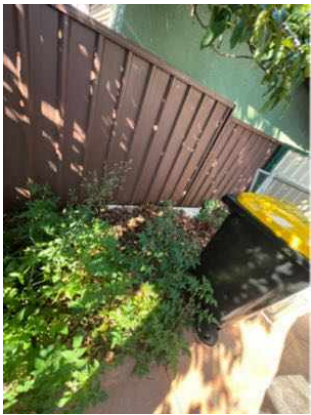
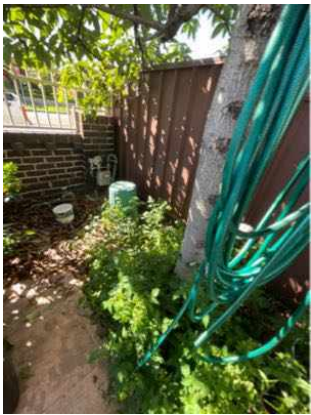
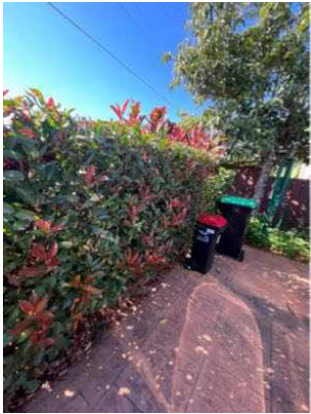
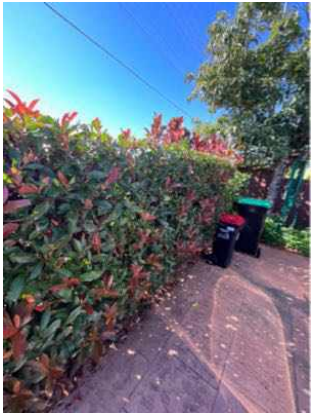
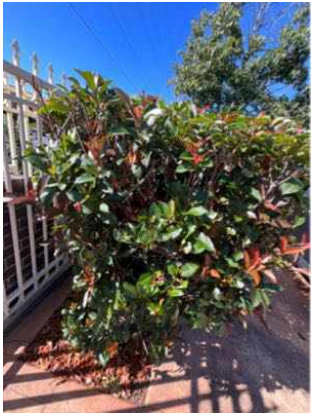
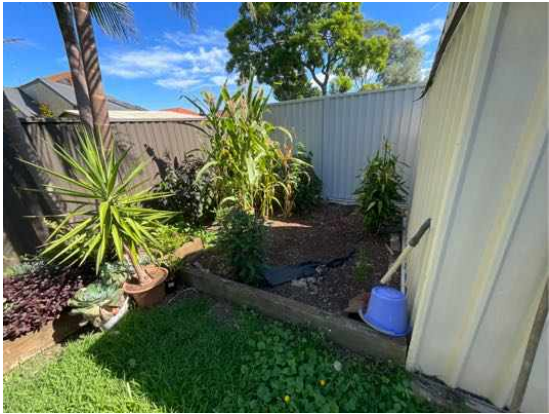
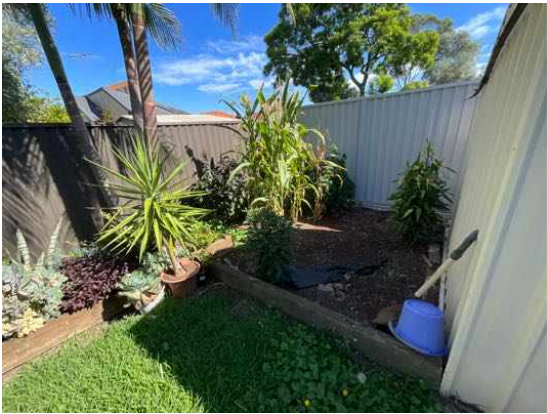
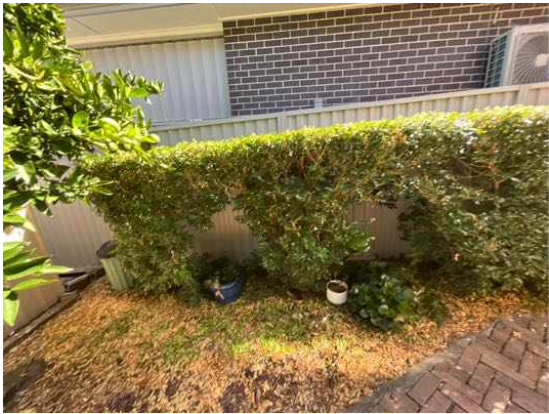
**Finding 6.02**

Building: Main Building  
Location: All Areas  
Finding: vegetation around a property can increase the risk of termite infestation  
Information: The presence of vegetation around a property can increase the risk of termite infestation, as it provides a conducive environment for them. To address this, consider maintaining a clear space between the vegetation and your home. If you suspect a termite issue, it's advisable to consult with a licensed pest control professional for inspection and treatment.

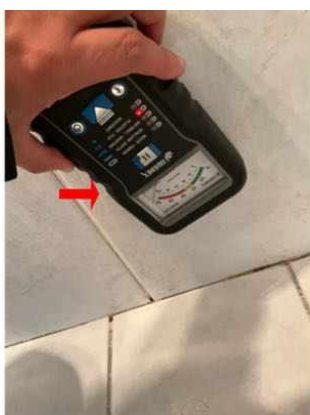
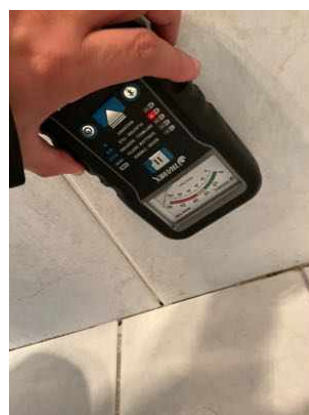
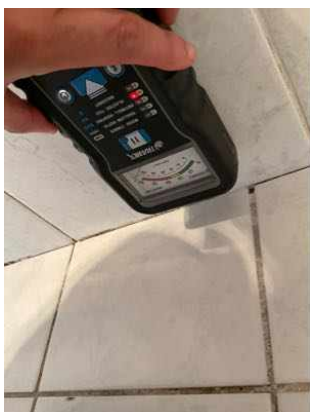
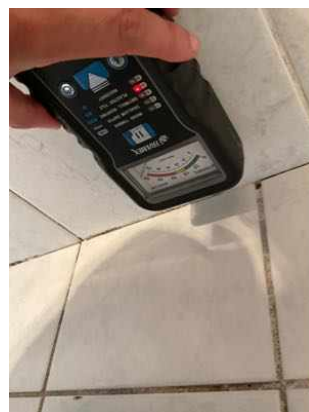
### Finding 6.04

Building:	Main Building
Location:	Ensuite
Finding:	Excessive moisture - Conducive to Timber pest
Information:	Excessive moisture can attract termites and produce conditions that promote fungal growth and wood decay.

If mould growth has been found there may be environmental biological or health issues involved. In these cases an appropriately qualified inspector should also be contacted.

Prior to any remedial works being performed a qualified plumber should be appointed to further inspect the property and to identify the cause of the excessive moisture. Works to remove affected building elements may then be necessary and should be performed by an appropriate tradesperson.

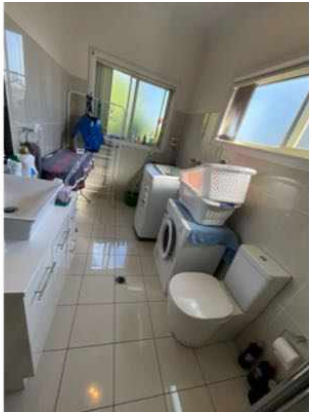
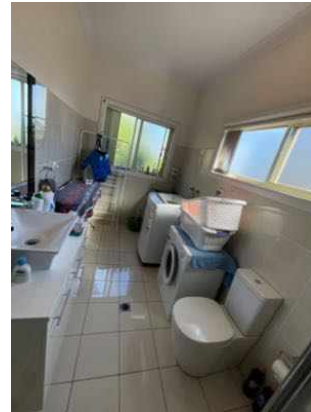
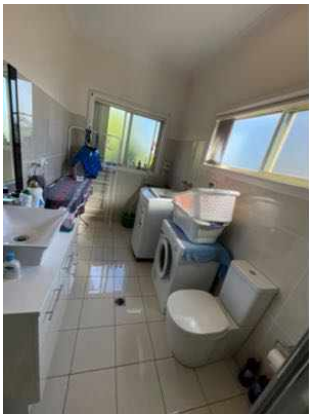
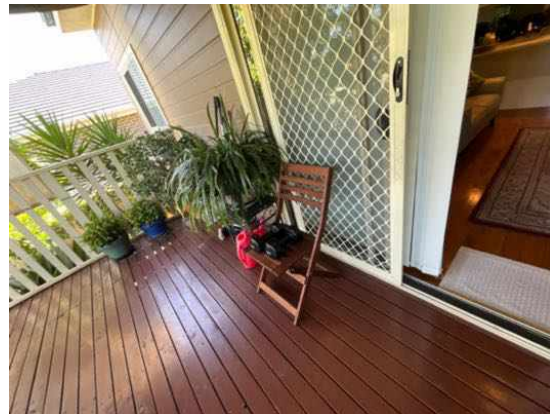
Finding: Additional Photos - Obstructions and Limitations

Information: These photographs are an indication of the obstructions and limitations which impeded full inspection of the property at the time of inspection. These obstructions can hide an array of defects and should be removed to allow full inspection to be carried out. A re-inspection is recommended once the areas are made accessible.

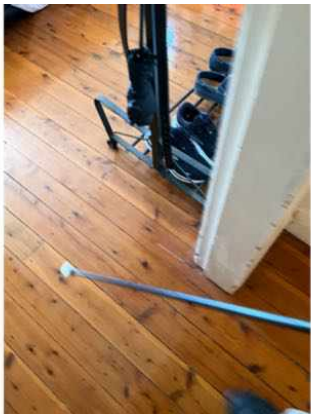
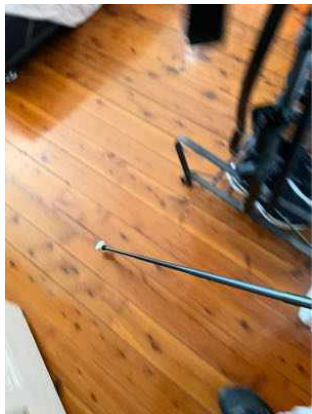
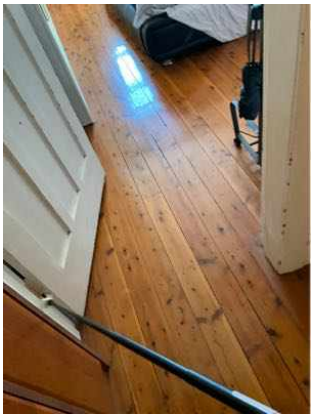
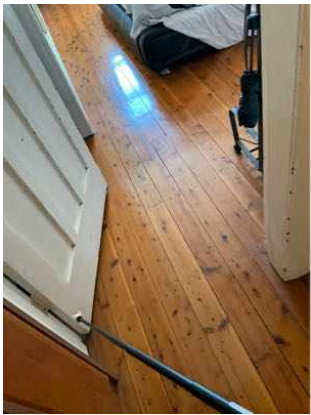
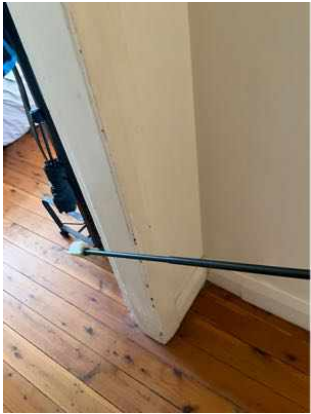
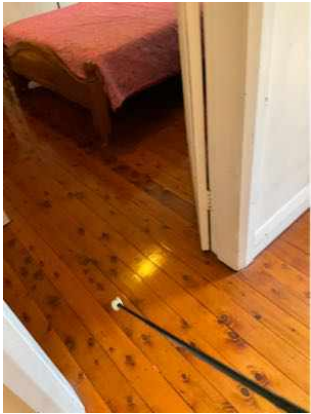
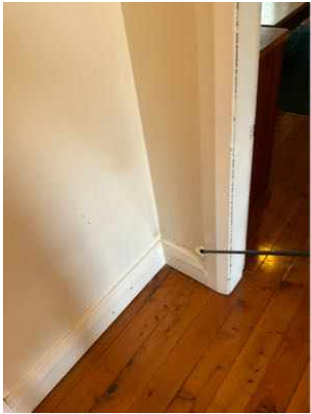
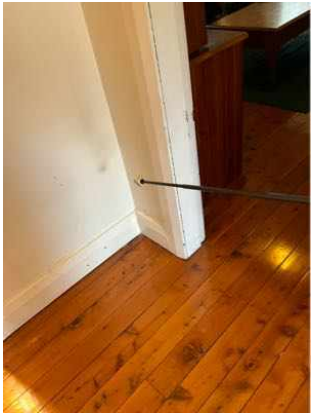
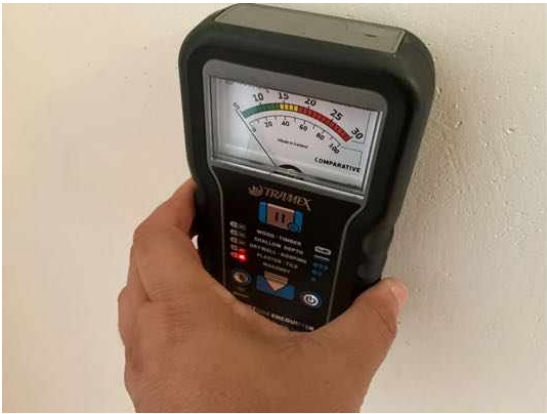
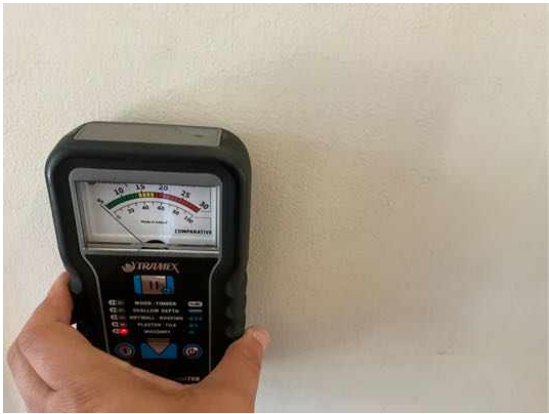
**Noted Item**

Building: Main Building  
Location: All Areas  
Finding: Additional Photos  
Information: Additional photos are provided for your general reference
