Building and Timber Pest Inspection Report

Inspection Date: Wed, 18 Feb 2026

Property Address: 13 Wickham Rd, Hampton East VIC 3188,
Australia

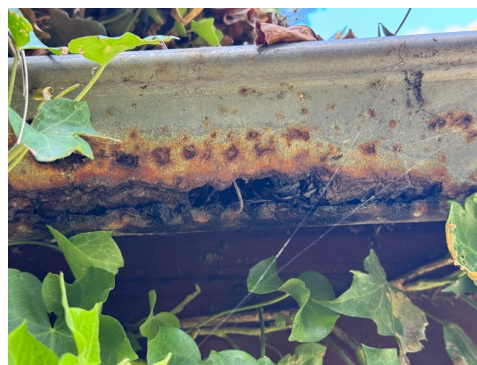
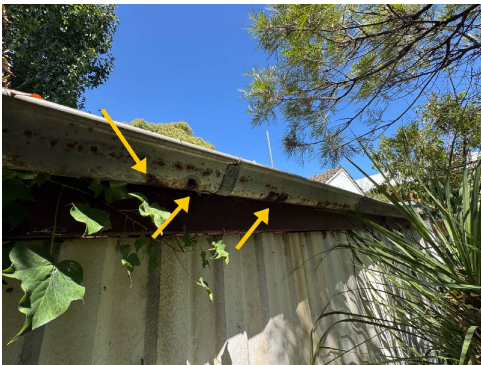
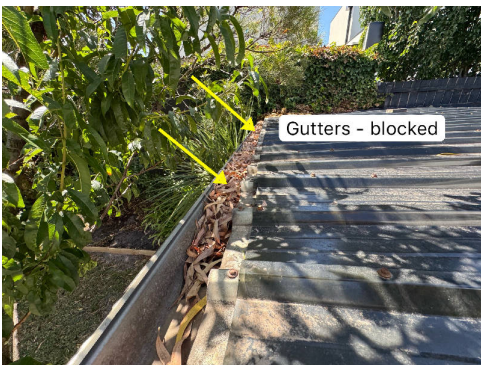
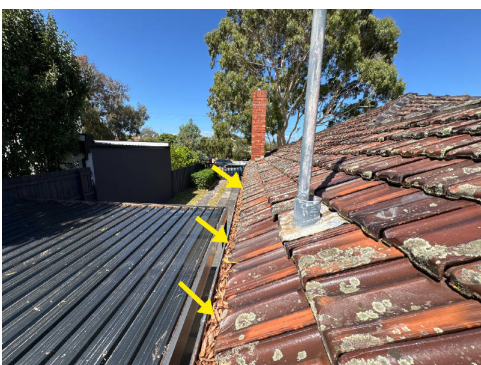
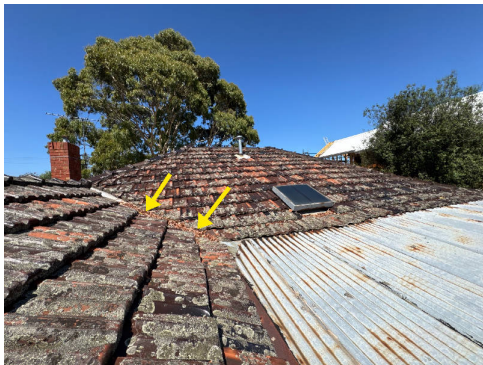
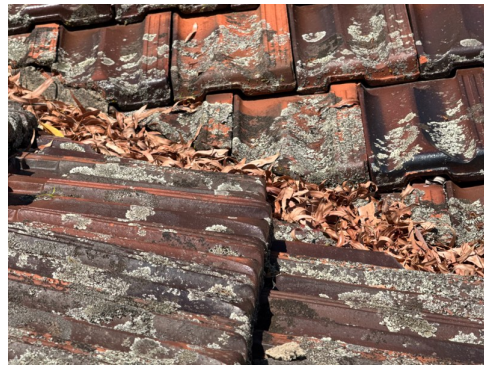
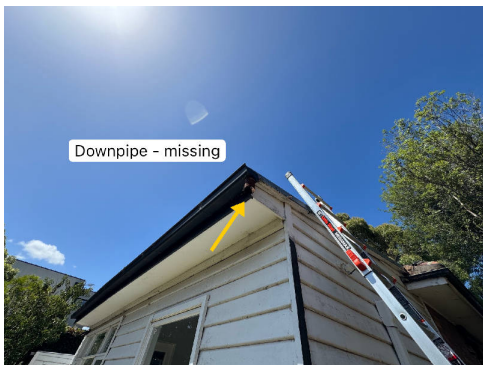
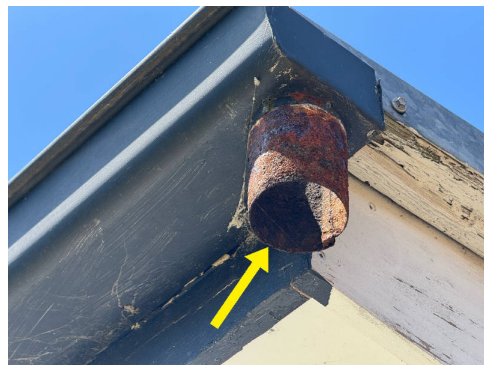
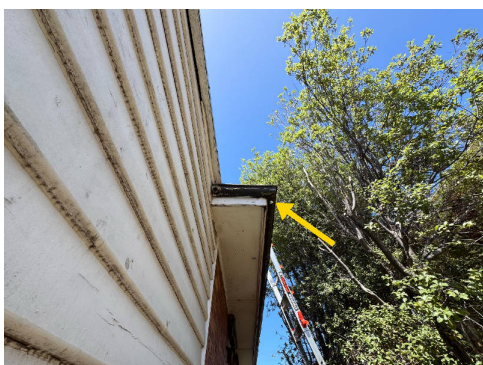
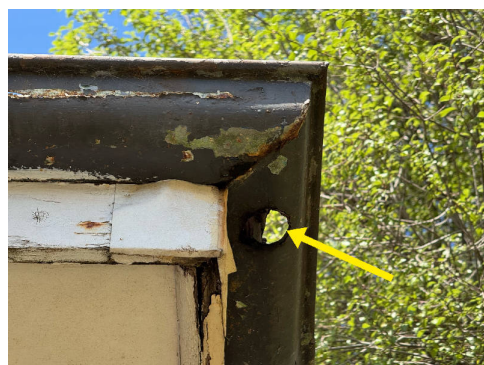
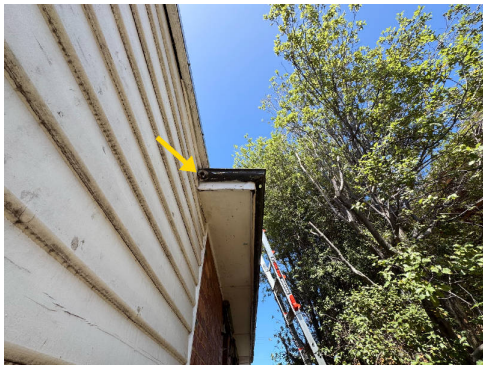
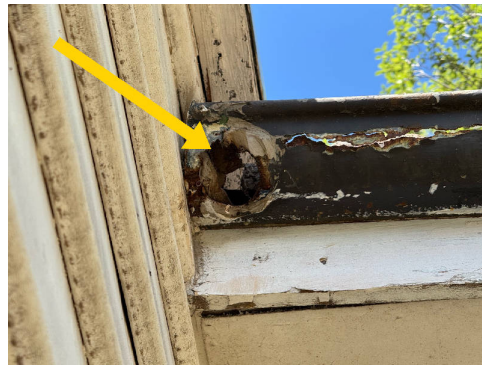
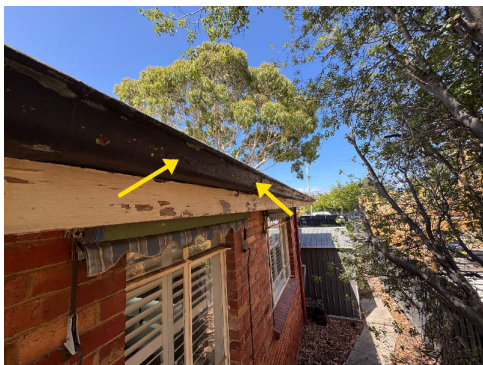
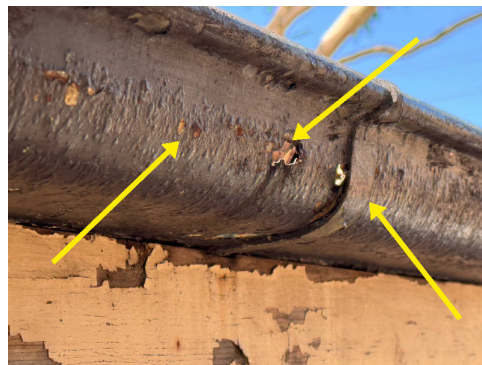
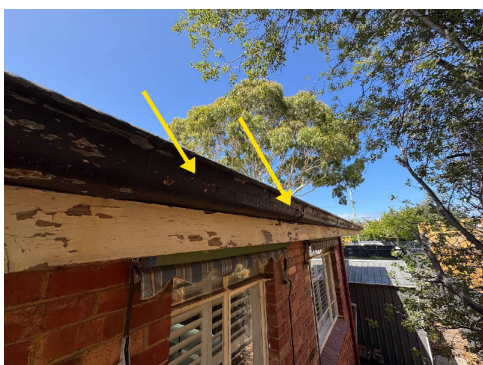
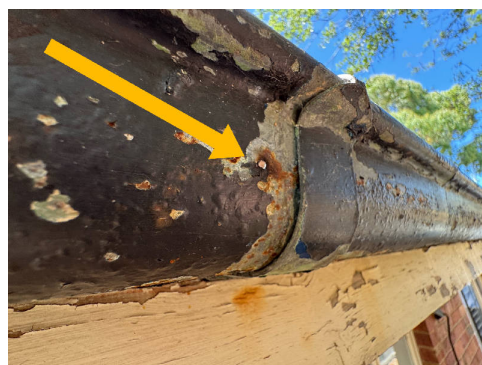
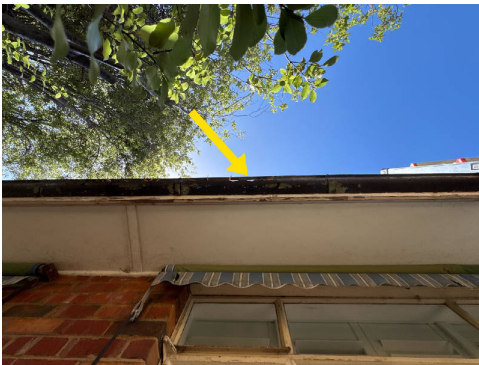
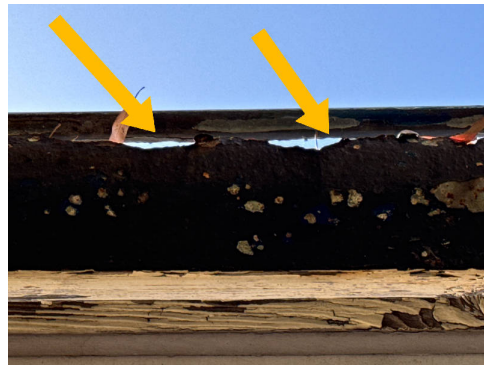
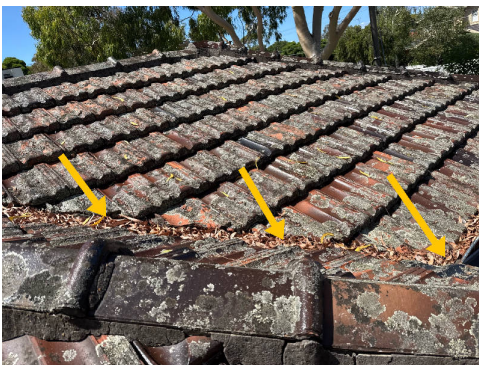
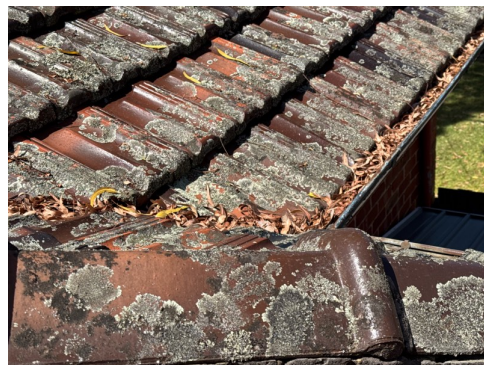
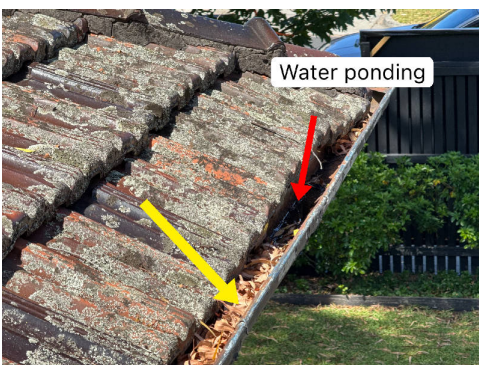
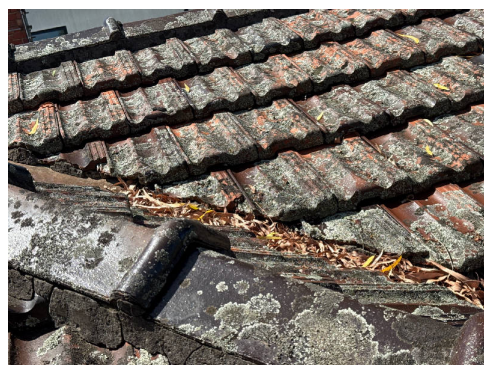
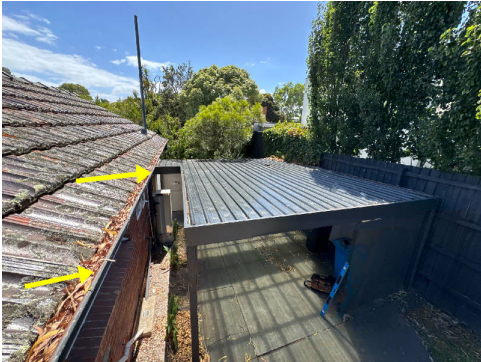
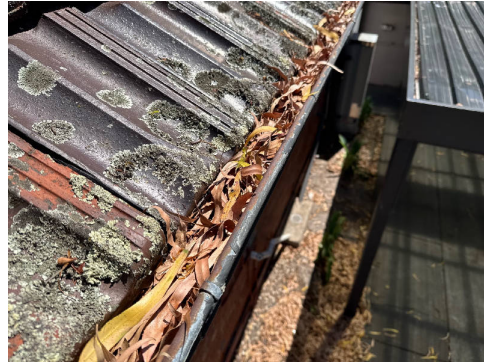
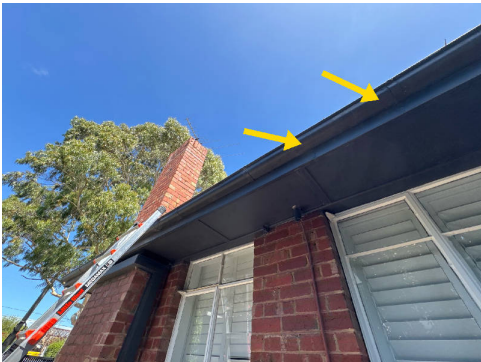
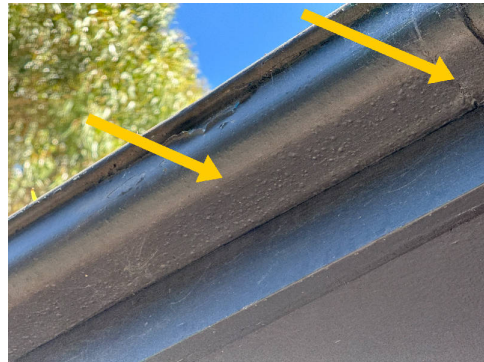
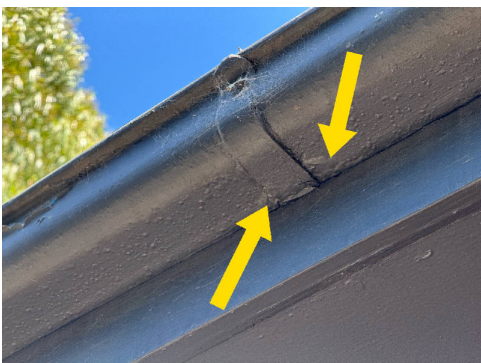
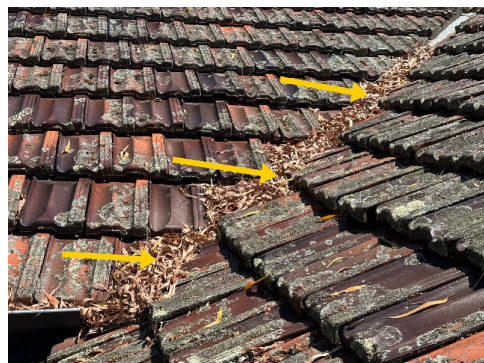
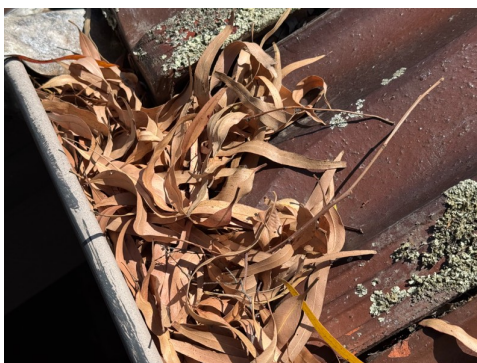
Finding 3.01

Finding: Roof drainage system-poor condition

Information: At the time of inspection, the roof drainage system was found to be in poor condition, particularly to the western elevation of the building. Sections of the gutters are heavily corroded, with perforations and areas of complete material loss, significantly compromising the ability of the guttering to effectively collect and discharge rainwater. In addition, all gutters and roof valleys were blocked with accumulated leaf debris, further restricting stormwater flow and increasing the likelihood of overflow during rainfall events.

Some downpipes were also missing, resulting in uncontrolled discharge of stormwater adjacent to the external walls. This condition is likely to contribute to ongoing moisture exposure to fascia boards, eaves linings, and wall elements, increasing the risk of timber decay, paint failure, and potential foundation movement over time. Blocked gutters and valleys may also accelerate corrosion due to prolonged water retention and organic build-up.

Given the extent of corrosion, blockage, and deterioration observed, localised patch repairs would not be adequate. It is recommended that the affected guttering and associated components be fully replaced by a licensed roofing plumber. The entire roof drainage system should be cleared of debris and assessed for correct falls, secure fixing, and compliant stormwater discharge away from the building.

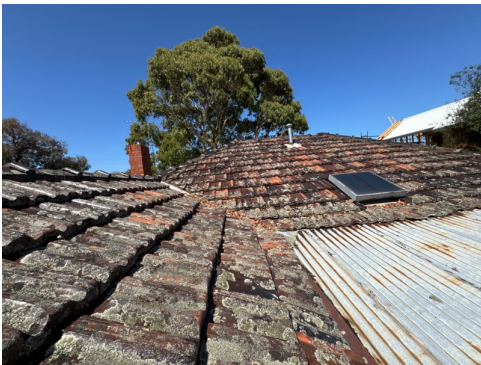
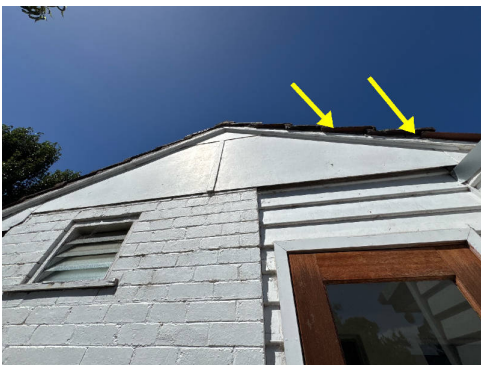
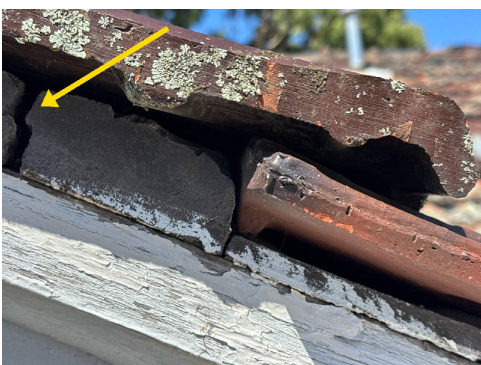
Finding: Roof tiles – fair condition (fretting tiles) and localised mortar bedding deterioration

Information: At the time of inspection, the tiled roof covering was found to be in serviceable condition; however, short-term maintenance works are required. Lichen growth was present across multiple roof tile surfaces, and cleaning is recommended as part of routine roof maintenance. Accumulated organic growth can retain moisture and contribute to accelerated surface deterioration of the tiles over time.

Inspection within the roof void identified several tiles, in accessible areas, affected by fretting. Fretting is characterised by surface erosion and granular breakdown of the tile material, which may reduce long-term durability. Ongoing lichen growth may further accelerate this deterioration process if not addressed.

In addition, localised cracking and deterioration of bedding mortar were identified, particularly to ridge tiles. While the current condition does not require immediate urgent action, comprehensive maintenance is recommended. All cleaning, tile replacement, and renewal of defective bedding mortar should be carried out by a registered roof contractor to ensure compliant and durable rectification works.

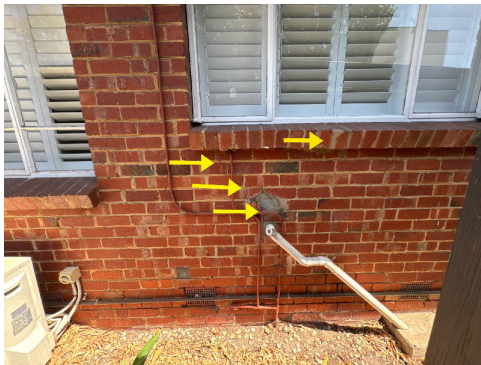
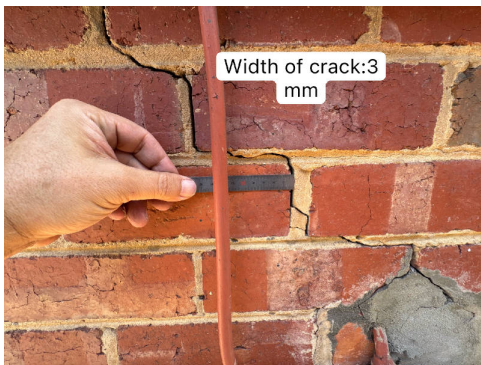
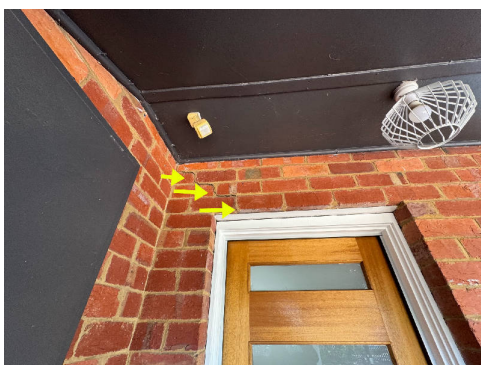
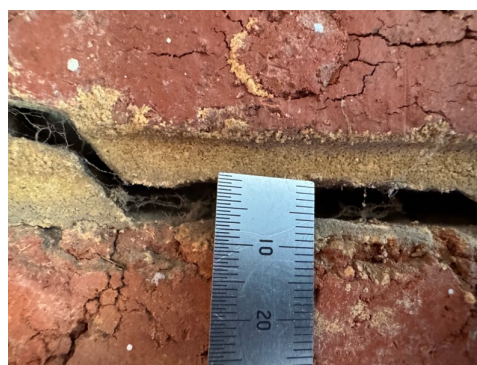
Finding 3.07

Finding: Brickwork - Step cracking(category 3 - noticeable cracking <5 mm)

Information: Step cracking was identified in the exterior walls at the time of inspection. This type of cracking, like other forms, can have various causes, with the most common being the subsidence of adjacent footings. Step cracking is relatively common, particularly near windows, doors, and other openings. The failure of mortar between affected bricks highlights the stresses and tensions impacting the wall. If the step cracking is extensive or severe, it is recommended that a structural engineer be consulted. Minor step cracking, however, can serve as an early warning to address underlying issues such as nearby trees, water leaks, soil erosion, or reactive soils, which may be contributing to the stress on the wall.

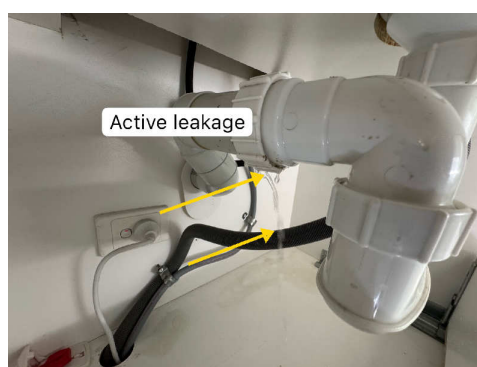
Finding 3.08

Finding: Active leakage beneath kitchen sink

Information: At the time of inspection, active water leakage was identified beneath the kitchen sink from waste connection, with moisture evident to the base of the cabinet.

The leakage is likely associated with the plumbing connections and may lead to deterioration of the vanity unit and surrounding materials if not rectified. Rectification by a licensed plumber is recommended.

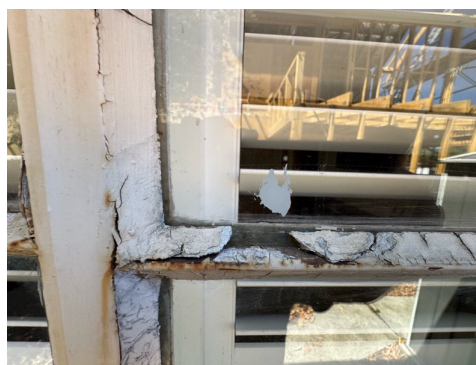
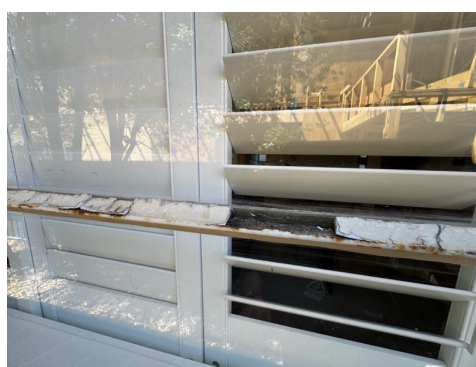
Finding 3.09

Finding: Window seals - deteriorated

Information: The window seals have deteriorated and are in a generally poor condition. Due to frequent exposure to weather conditions and subsequent moisture, deterioration of window seals is expected in a property of this condition and age.

Where window seals have deteriorated, the window is no longer weather-tight; rain penetration and subsequent water damage is therefore likely to ensue. Insulation of the area against external weather conditions will also be compromised.

It is recommended that all deteriorated window seals be replaced by a general handyman or sealant expert to prevent any further damage and to restore the window to a fully functional level.

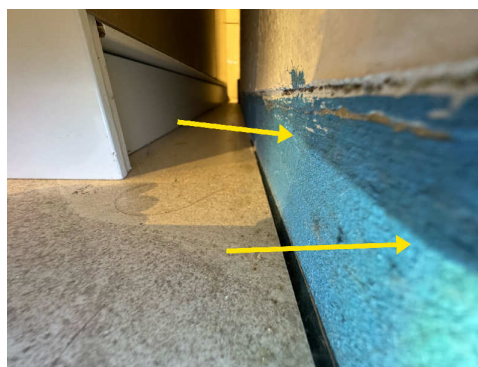
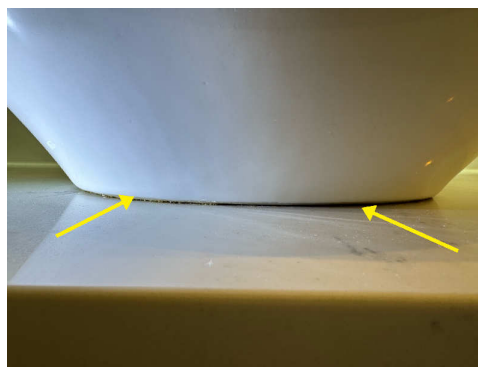
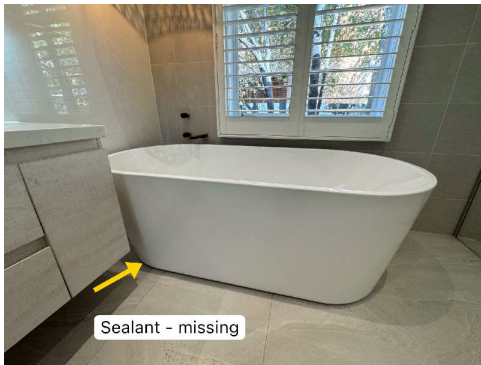
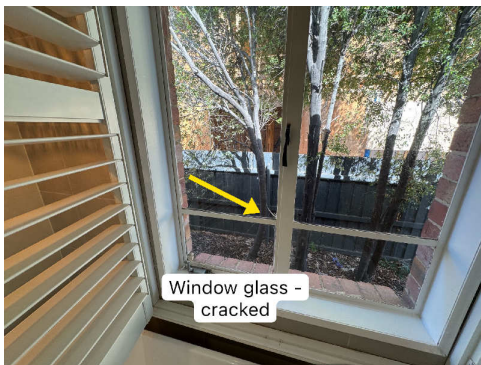
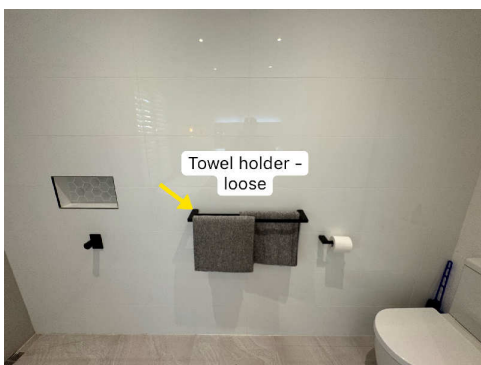
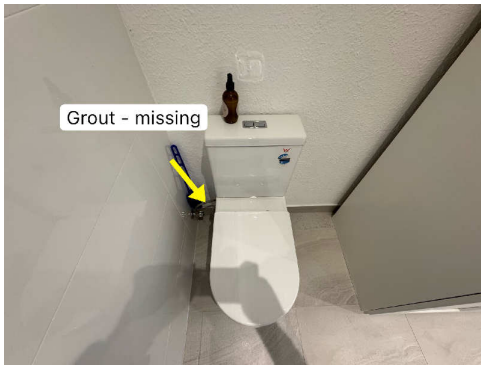
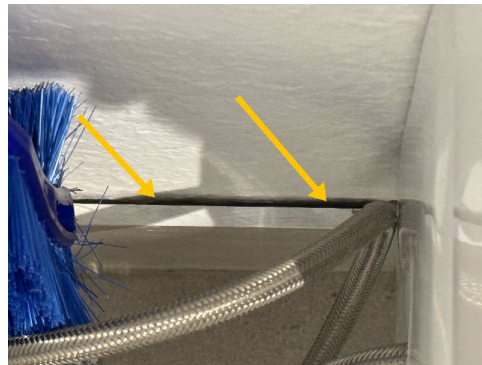
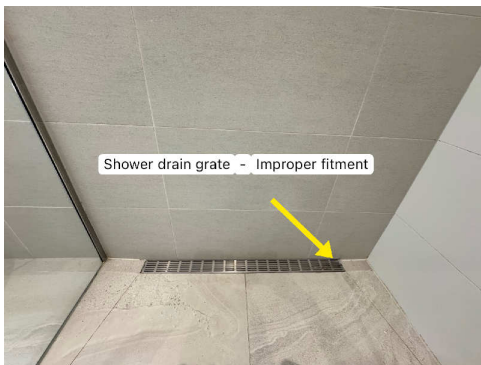
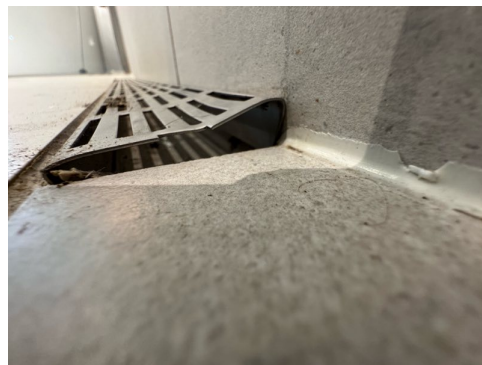
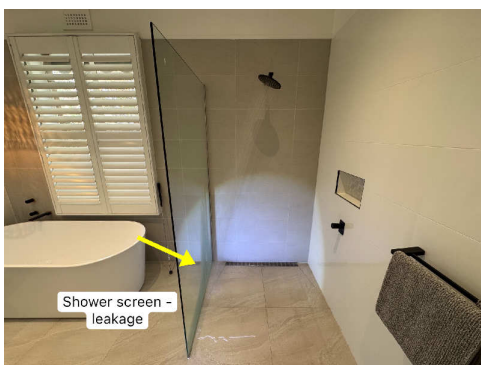
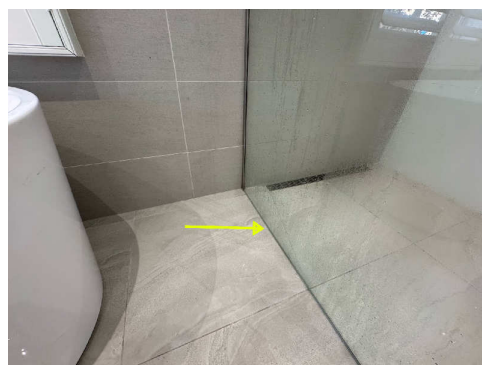
Finding 3.10

Finding: Common Maintenance Defects (Wear and Tear)

Information: In every home, regardless of age, there are maintenance defects or normal wear and tear that occur over time. These issues are completely normal and can be grouped under a broad category of expected wear, which can either be overlooked as part of the home's character or addressed through repairs. Examples of these defects might include hairline cracks in concrete or walls, loose door or window handles, patched sections on walls, and dents or deformities in fences or other building elements. These are all typical issues that arise from the natural aging of a house.

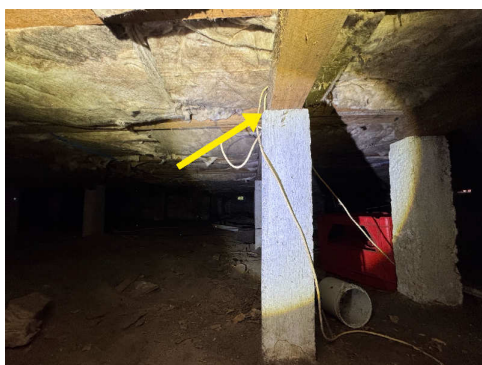
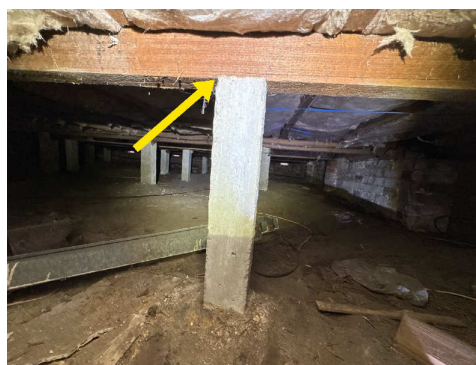
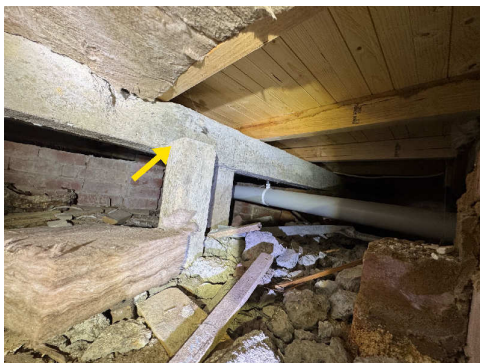
Finding: Ant caps- Not installed

Information: Ant caps have not been installed to the subfloor structure at the time of inspection. Generally, ant caps are installed to the intersection between the top of the stumps (or piers) and the subfloor structures. Installed during the construction process, ant caps are designed to easily identify termite or pest ingress from stumps to the adjoining bearers. Where ant caps have not been installed, frequent monitoring of these areas should be carried out in order to identify any signs of termite or timber pest workings.

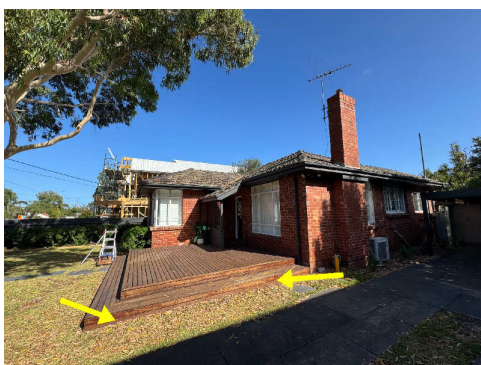
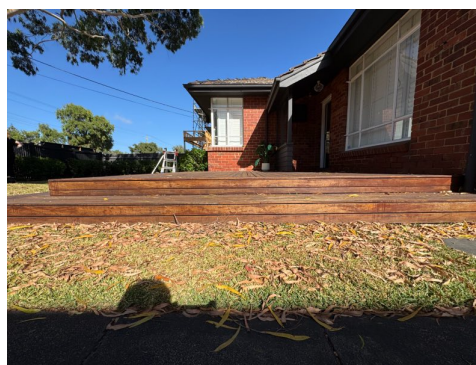
Finding 6.02

Finding: Ground level deck - conducive to moisture and timber decay

Information: The ground level deck can be conducive to timber pest infestations due to its close proximity to the soil. Without proper precautions, the moisture in the soil can create an ideal environment for timber decay and other termites to thrive. Regular inspection and treatments can help prevent infestations and protect the decks structural integrity. An invasive inspection of the area is recommended to determine further actions .

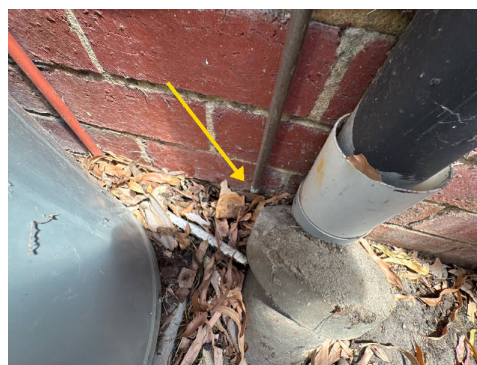
Finding 6.03

Finding: HWS - Drip tray missing

Information: The drip tray for the Hot Water System unit is missing, allowing leaks from the unit to affect the surrounding building elements. Generally, a drip tray will be installed to catch expected leaks from the unit, and allow them to evaporate without creating excessive moisture in the area.

Without a drip tray, the leaks from the HWS unit are creating conditions in the area that is likely to develop in the rust, corrosion, or wood rot of associated building elements. Additionally, excessive moisture creates an environment that is conducive to termite and timber pest activity, creating potential for further secondary damage.

It is highly advised that a licensed plumber be appointed to install the necessary drip tray in order to prevent any secondary damage.

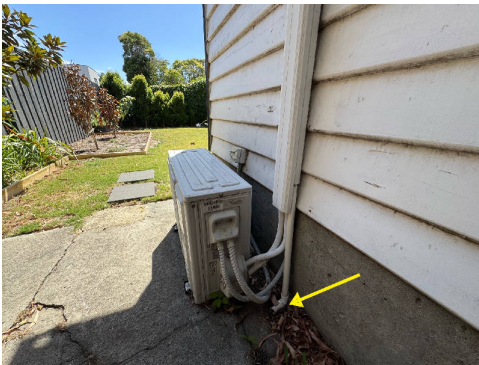
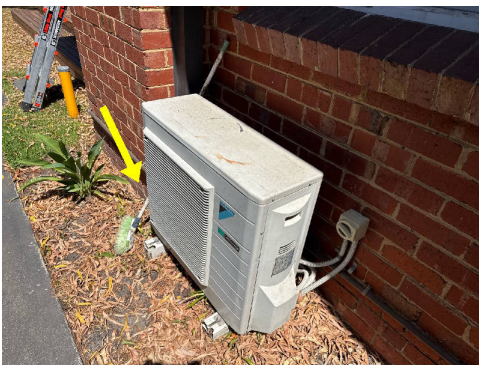
Finding 6.04

Finding: Air conditioner discharge - Not plumbed or drainage

Information: The Air conditioner discharge is not plumbed or connected to suitable drainage, which has resulted in the surrounding area becoming excessively damp. These damp conditions can lead to secondary defects such as rot, rust or corrosion of associated building elements, the formation of fungal decay, or even the creation of potential slip hazards. When coupled with poor site drainage, pooling of water may also attract termite activity to this area. It is highly recommended that a qualified plumber be appointed to install adequate drainage to the overflow. These works will ensure that the area remains dry and free of any secondary defects.

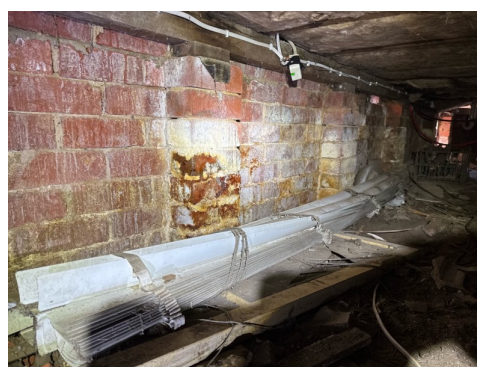
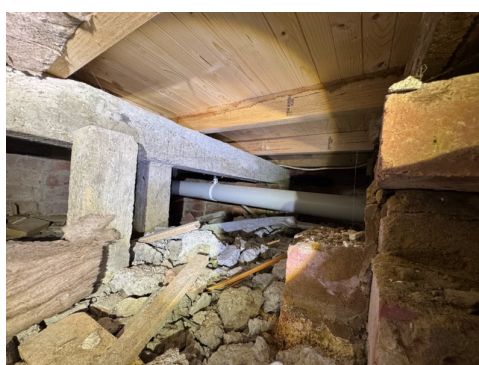
Finding 6.05

An array of debris was found in the subfloor area at the time of inspection. Debris in this area restricts subfloor ventilation and creates potential for concealed pest entry. Stored timbers and other materials may also make the area susceptible to termite activity and wood rot.

A clear and empty subfloor will be better ventilated and easier to maintain in a dry condition. The removal of any timber debris is vital in minimising the risk of termite or wood borer activity.

Debris in the subfloor should be removed as soon as possible. Depending on the location and amount of debris and stored items, the homeowner may elect to undertake this task. Alternatively there are a large number of rubbish removal subcontractors that could undertake these works.

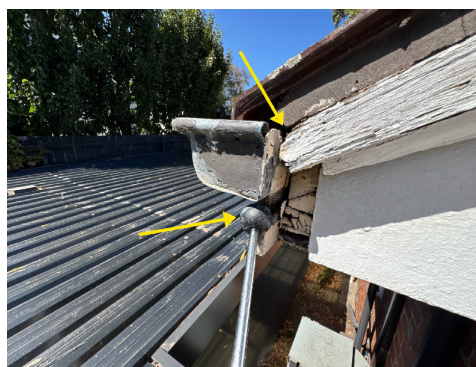
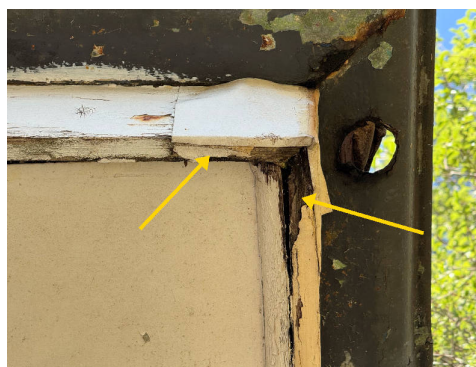
Finding 7.01

Finding: Fascias - Wood rot

Information: Wood rot was found to be affecting fascias in these areas. Wood rot, also known as Fungal Decay, occurs when timbers and other cellulose building materials are exposed to damp conditions on an ongoing basis.

It is likely that this wood rot has developed as a result of faults in the roof plumbing, creating excessive moisture in this areas. Frequent exposure to rain and other weather conditions also make fascias and barges susceptible to accelerated deterioration.

It is advised that a roof plumber be appointed to inspect all roof plumbing and subsequently identify the cause of the wood rot. Replacement of affected fascias and barges may then be a necessary step in protecting surrounding building elements from such deterioration.

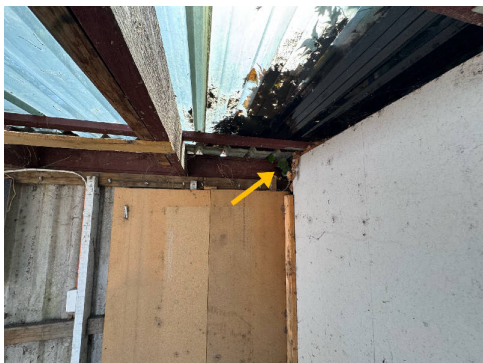
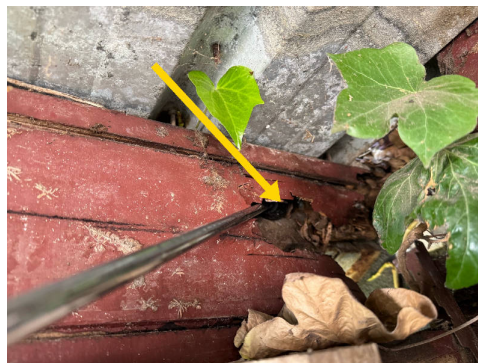
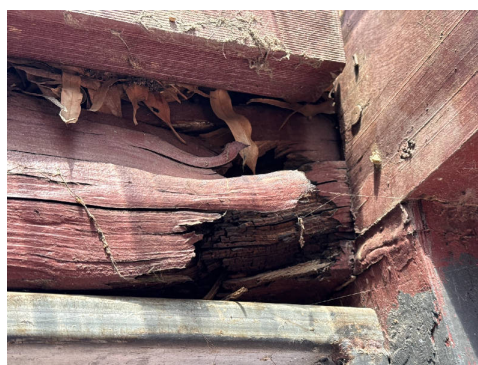
Finding 7.02

Finding: Wood rot

Information: This building element shows evidence of wood rot, also known as fungal decay, which occurs when timbers and other cellulose building materials are exposed to damp conditions on an ongoing basis. This could result from prolonged weather exposure or excessive moisture from adjacent building materials. It's important to note that untreated wood rot can potentially lead to termite infestation or attack, as both termites and fungi in moist environments and compromised wood structures. To mitigate these risks, it is recommended to promptly address the underlying moisture issue causing the wood rot. Solutions may include improving drainage around the affected area, repairing leaks, ensuring proper ventilation to reduce humidity levels, and treating the affected wood with appropriate fungicides or preservatives. Regular inspections and maintenance are also crucial to identify and address wood rot early, preventing further damage and potential pest issues

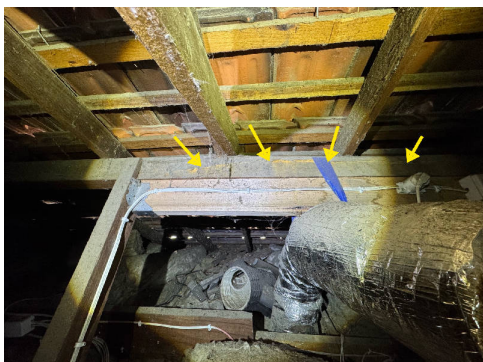
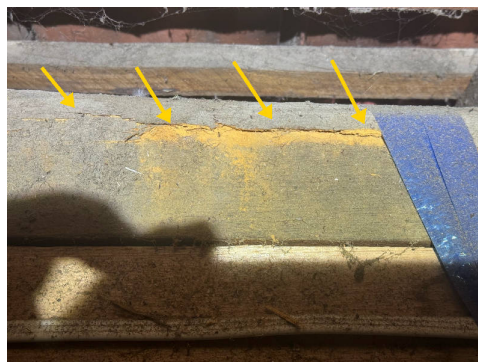
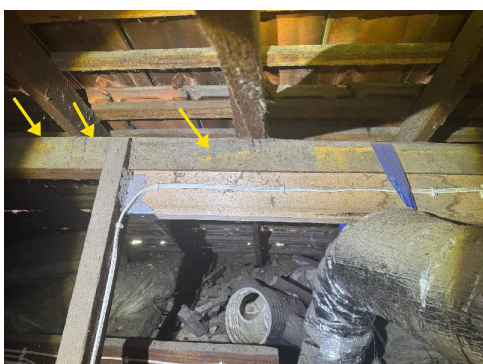
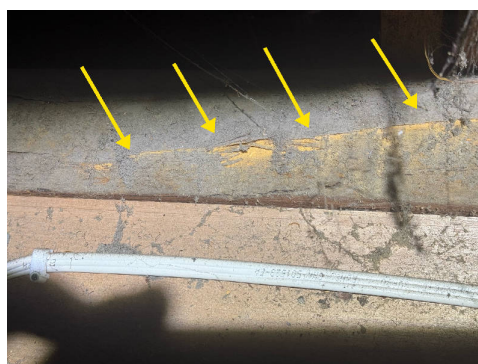
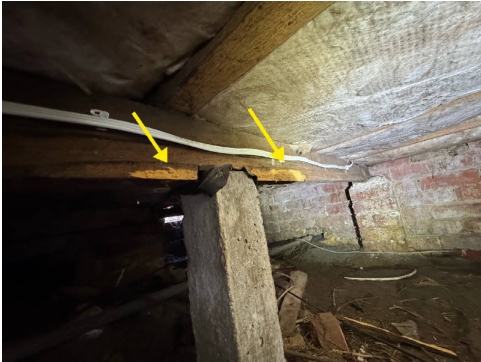
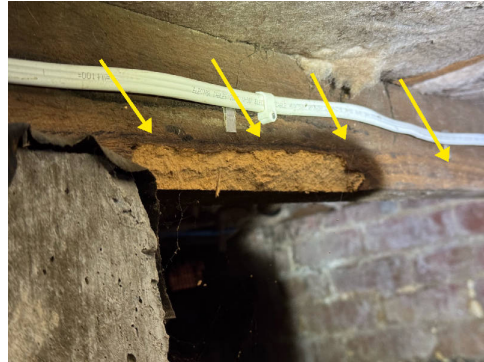
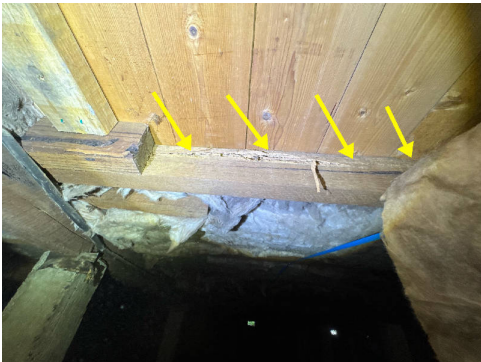
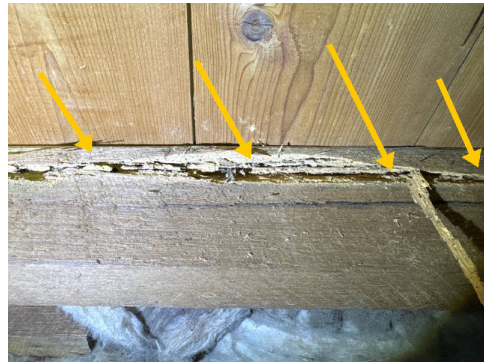
Finding 8.01

Wood borers are small beetles that colonise exposed timber elements and are a common timber pest frequently mistaken for termites. Although wood borer activity is often not immediately detrimental to the affected timber, prolonged or untreated infestation may result in significant structural damage and necessitate replacement of affected building components.

The Lyctid borer, which typically attacks seasoned hardwoods such as subfloor and roof framing timbers, is generally identified by the presence of fine, powdery frass (dust) surrounding the affected timber. The Anobium borer, another commonly encountered species, is more likely to infest softwoods such as floorboards and may cause severe structural damage to flooring elements over time.

It is recommended that a licensed timber pest management professional be engaged to further investigate the extent of damage, determine whether the borer activity is current and live, and carry out appropriate treatment if required.

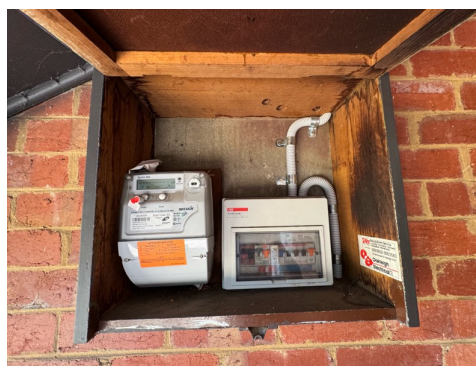
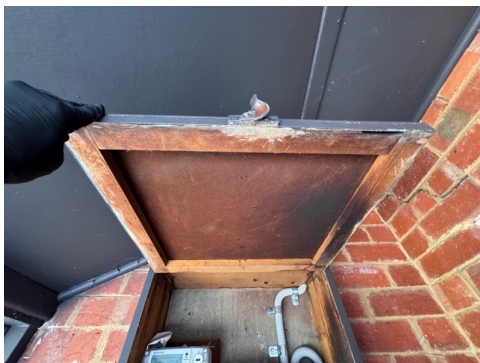
Information: The application of a post-construction chemical termite barrier is highly recommended for all properties, particularly if live termite activity has been found on the site previously. Such barriers are highly effective in preventing termite attack on any timber building elements throughout the property.

A durable notice should be placed in the switchboard unit to indicate current termite barriers. At the time of inspection, it appeared as though no termite management system has been installed, with no evidence to suggest preventative works taking place.

The client may consider gaining further advice from a pest controller as to the costs and procedures involved with this application. It is recommended that obtaining such advice be a short-term priority.

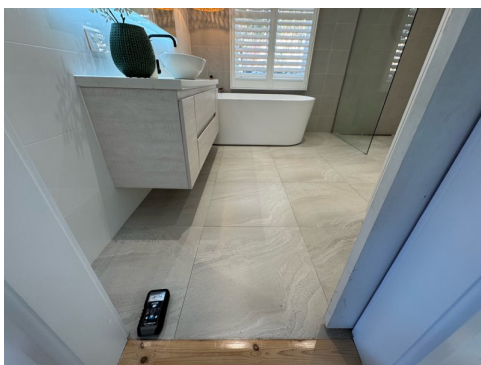
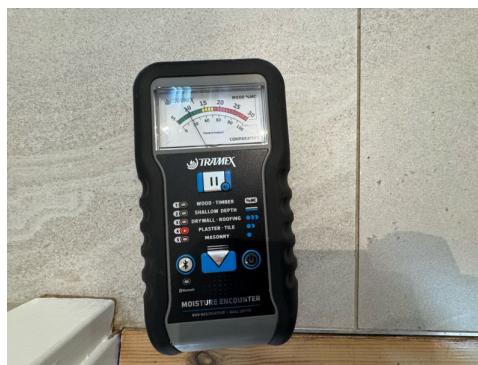
Finding: No moisture was present at the time of inspection - Good condition

Information: During the inspection, a moisture meter and thermal camera were used to check for the possible existence of excessive moisture, particularly in wet areas, walls adjacent to wet areas, and around all openings. As can be seen in the attached pictures, no high moisture readings were present at the time of inspection except area indicated in the report

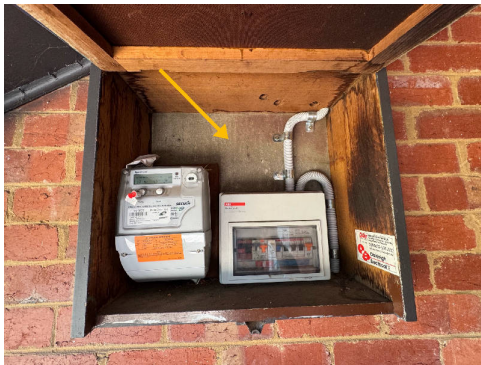
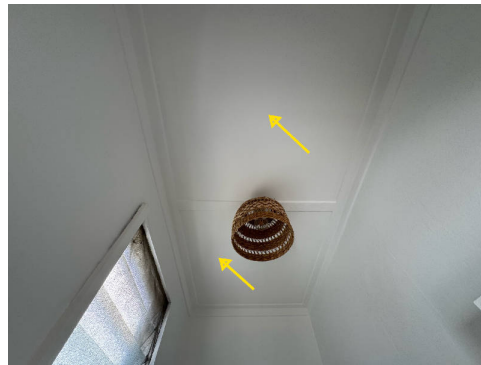
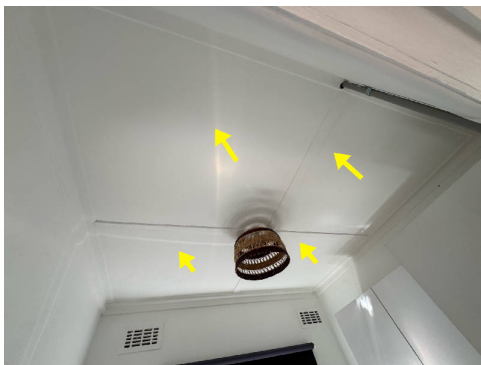
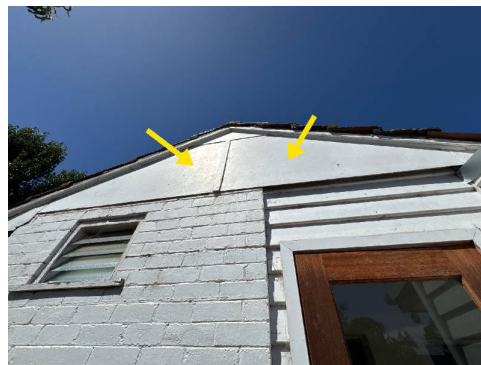
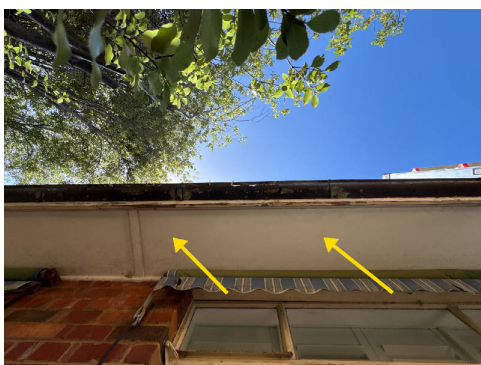
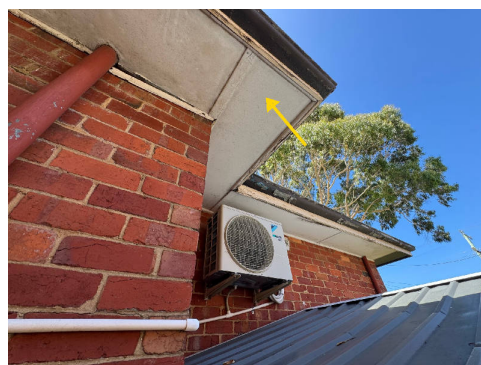
Finding: Asbestos - Suspected ACM Identified on Site

Information: Reporting on Asbestos is outside the Scope of this Report. This suspected defect is highlighted as a caution only. We suspect, based on our experience in the building industry, that there is a higher risk of the identified building element containing asbestos. As Asbestos Reporting is outside the scope of this report, we advise that you consider a separate Asbestos Inspection and Condition Audit, which can include the taking of samples for definitive confirmation of the presence of Asbestos. In the interim, the client is advised to act with caution, especially when considering any damage to building materials general wear and tear renovations extensions demolition and general maintenance activities due to the suspected presence of Asbestos.

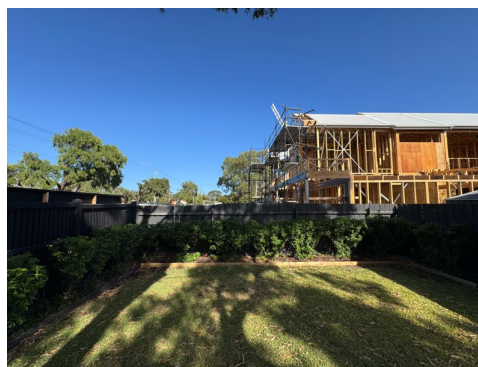
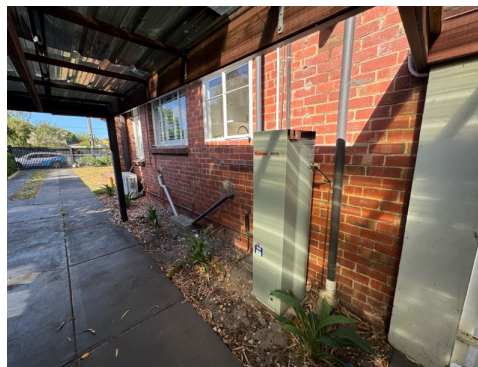
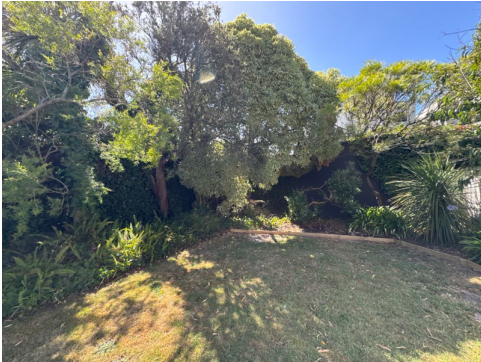
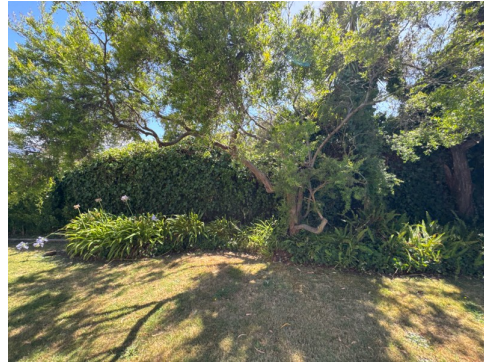
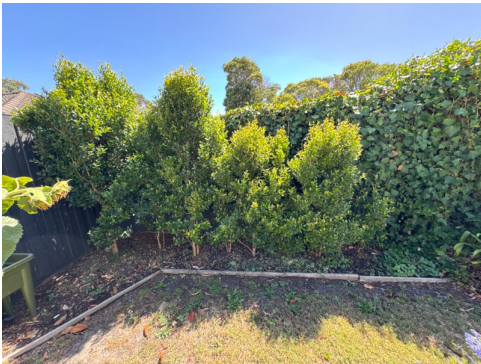
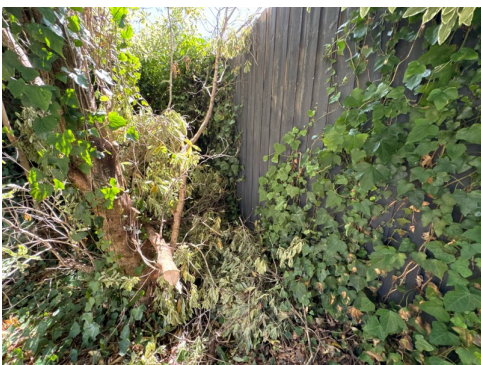
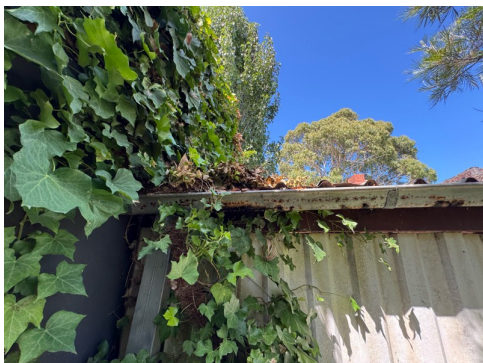
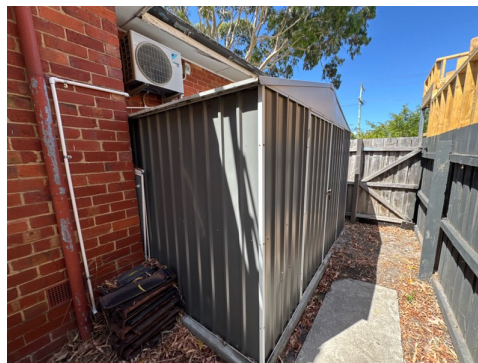
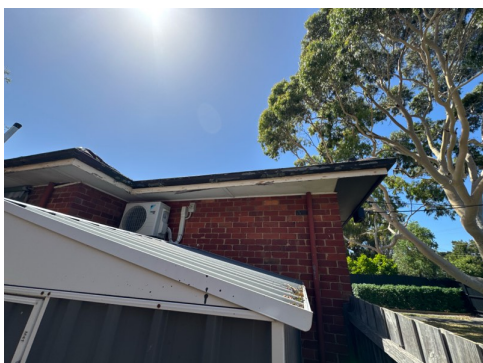
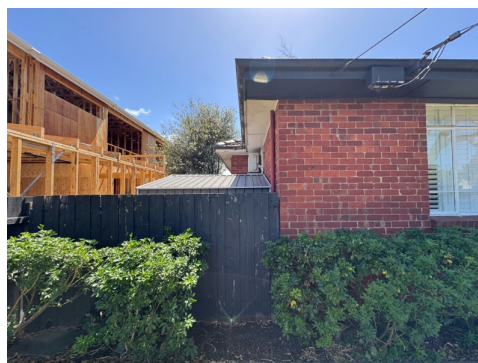
Finding: Obstructions and Limitations - External Areas

Information: These photographs are an indication of the obstructions and limitations which impeded full inspection of the external areas at the time of inspection. These obstructions can hide an array of defects and should be removed to allow full inspection to be carried out. A re-inspection is recommended once the areas are made accessible.

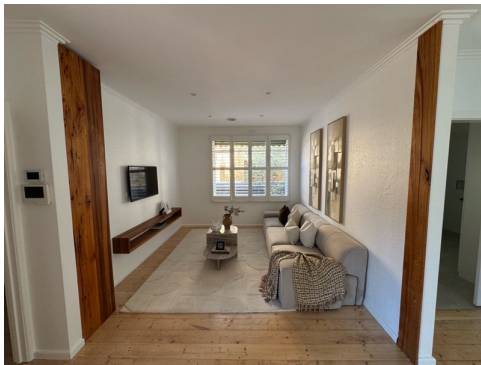
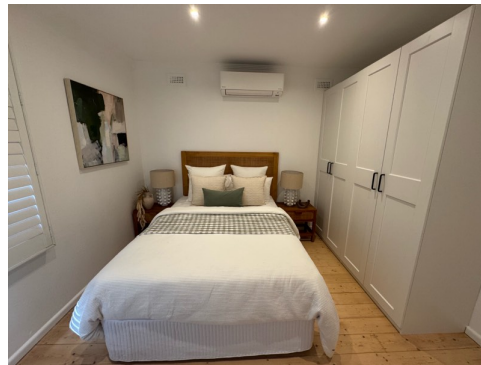
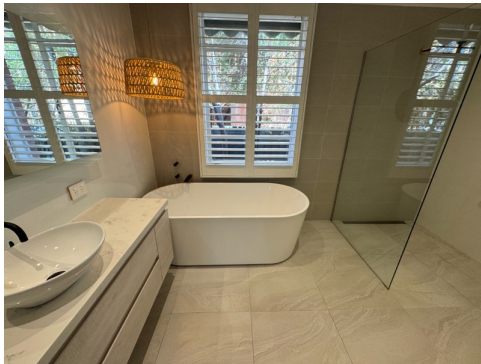
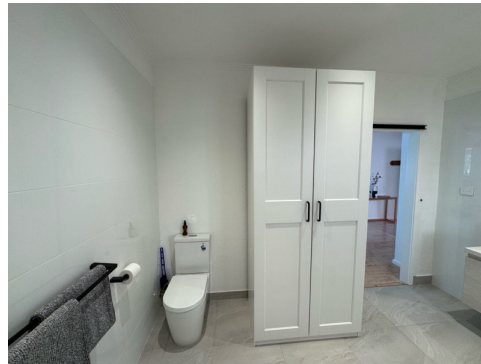
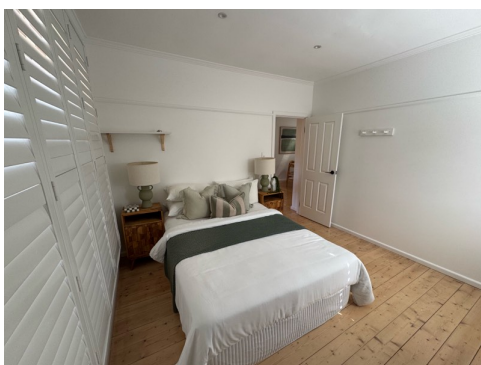
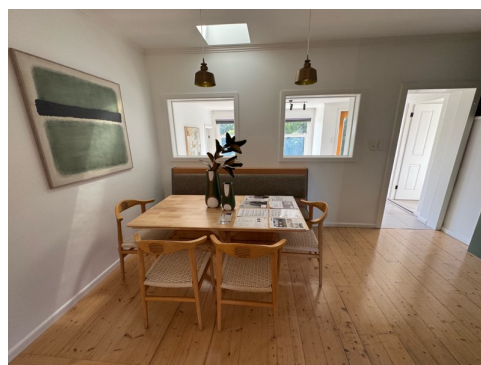
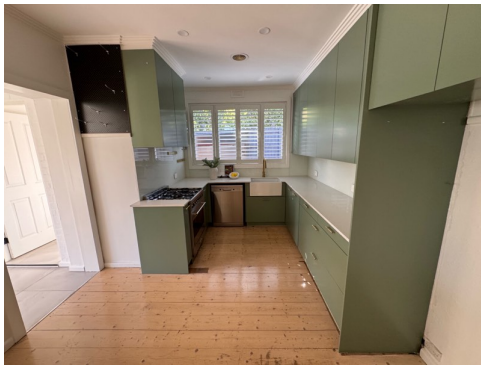
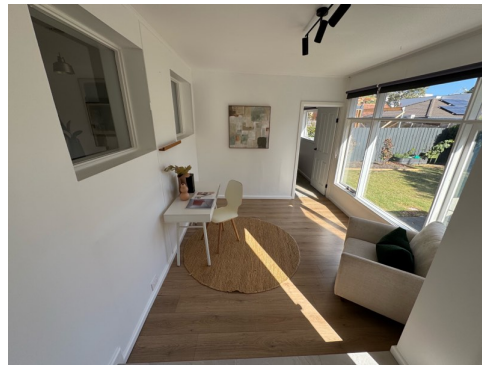
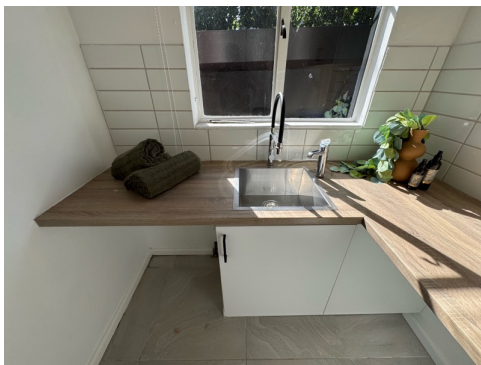
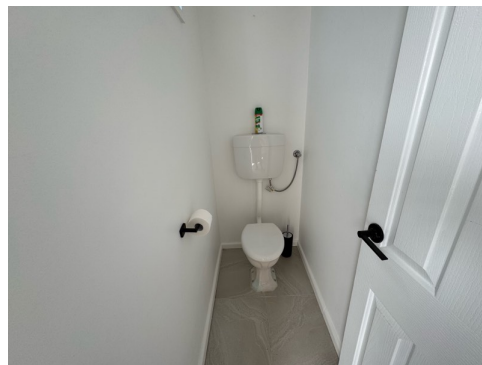
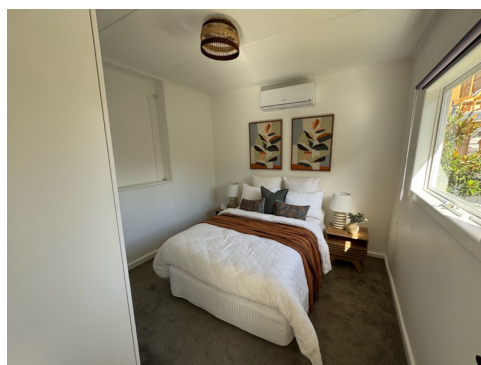
Finding: Obstructions and Limitations - Internal Areas

Information: These photographs are an indication of the obstructions and limitations which impeded full inspection of the internal areas at the time of inspection. These obstructions can hide an array of defects and should be removed to allow full inspection to be carried out. A re-inspection is recommended once the areas are made accessible.
