Building and Timber Pest Inspection Report

Inspection Date: Wed, 18 Feb 2026

Property Address: 13 Wickham Rd, Hampton East VIC 3188,
Australia

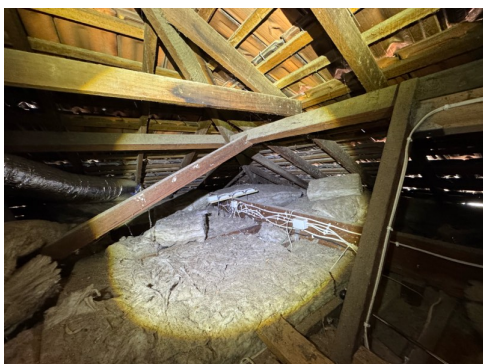
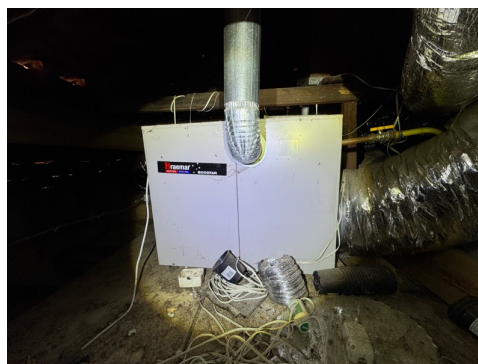
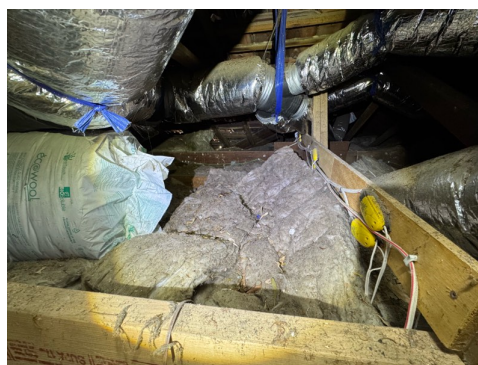
Finding: Obstructions and Limitations - Roof Cavity

Information: These photographs are an indication of the obstructions and limitations that impeded the full inspection of the roof cavity at the time of inspection. Note that the insulation covered nearly all the ceiling joists, which are a major structural element of the ceiling structure; the inspection was also limited to areas with an allowable crawl space of 600mm x 600mm, in particular towards the external walls where the roof line diminishes, it was not accessible. These obstructions and limitations can hide an array of defects and should be removed to allow full inspection to be carried out. A re-inspection is recommended once the areas are made accessible.

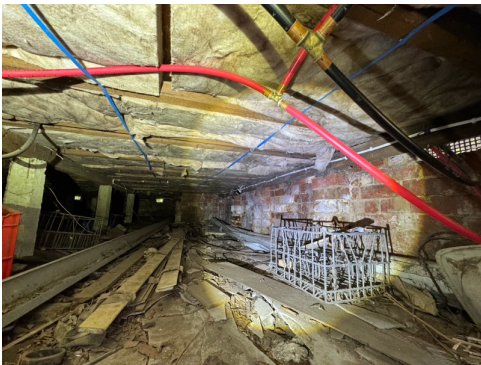
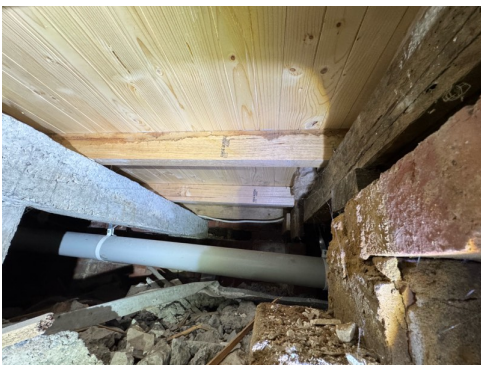
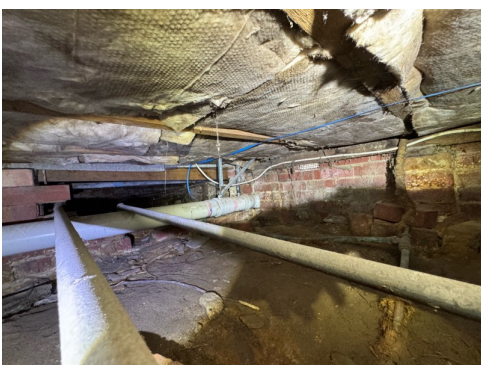
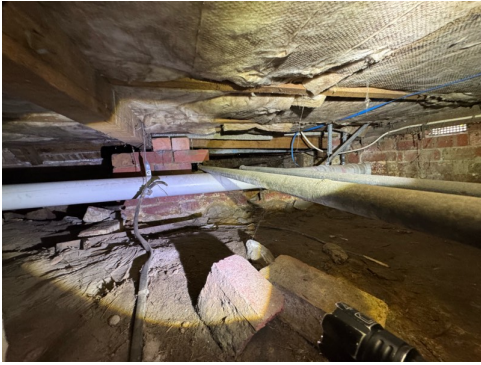
Finding: Obstructions and Limitations – Subfloor

Information: These photographs are an indication of the obstructions and limitations which impeded the full inspection of the subfloor area, including major structural flooring elements, at the time of inspection. These obstructions can hide an array of defects and should be removed to allow full inspection to be carried out. A re-inspection is recommended once the areas are made accessible.
